## SURFACE MINING INSPECTION REPORT

## **SITE CONDITIONS**

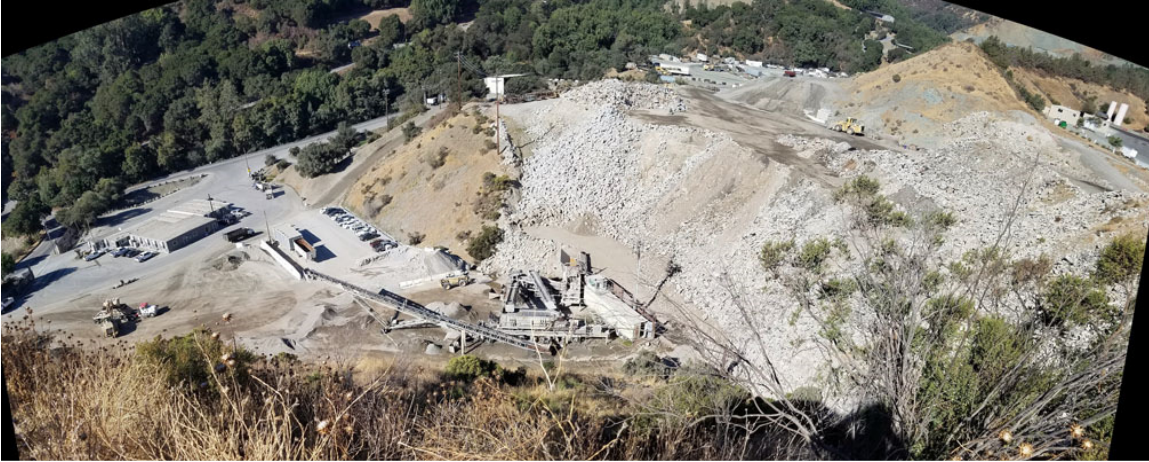
*Photo 1 (taken 9-15-2016): Recycling operation on Parcel A.*

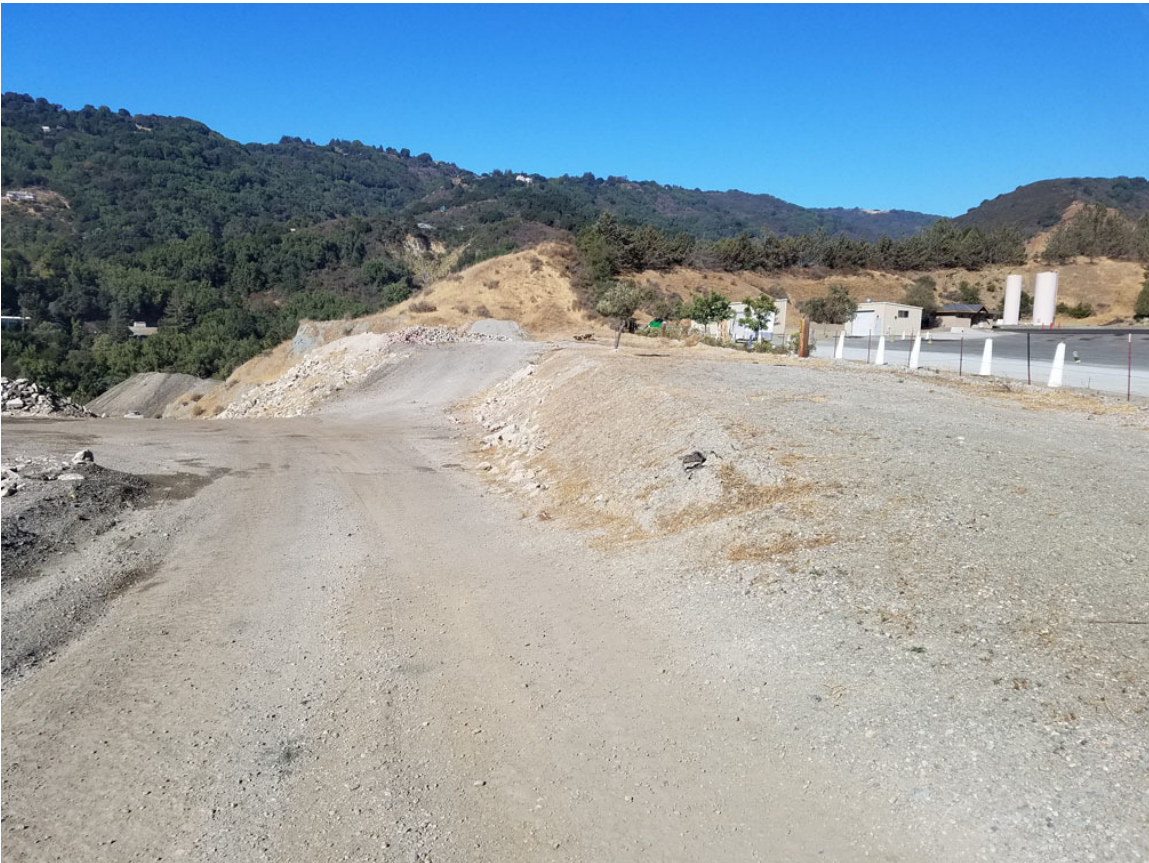
*Slump Repair:* An area located east of the recycling operation on Parcel A had a slump repair (2012) that is now buried and appears stable. (See Photo 2.)

*Photo 2 (taken 9-15-2016): Repaired slope between Parcel A and gun club.*

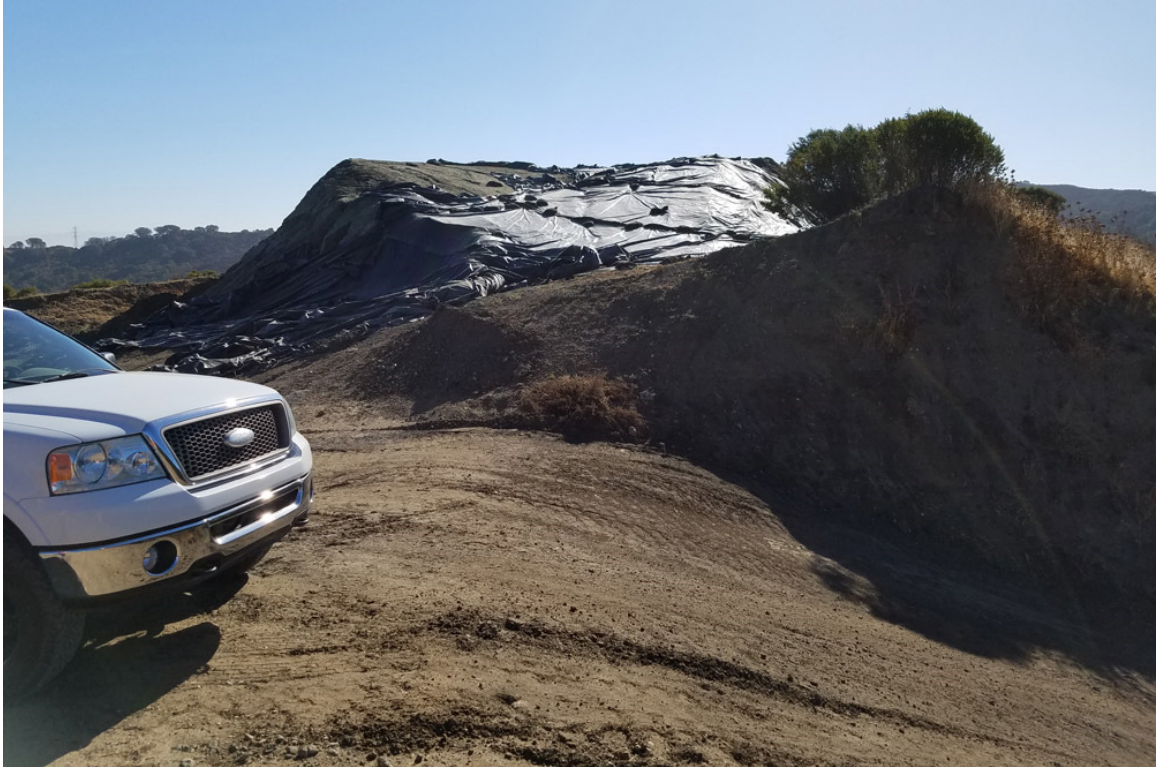
*Stockpile Parcel A:* Inspectors observed large stockpile on Parcel A. (See Photo 3.) Based upon visual inspection, it is unclear if the volume of stockpiled materials observed on-site is sufficient to bring the final slopes of the current mine pit on Parcel B up to the approved Reclamation Plan standards. Operator states there is sufficient fill and has calculations to confirm (verbal communications with R. Voss). Operator submitted calculations with the revised FACE.

Photo 3 (taken 9-15-2016): Stockpiled soil on Parcel A.

6. *Stockpile Cover Material:* County inspectors observed material stockpile on Parcel A consistent with the Reclamation Plan maps. Mine operator pointed out some additional stockpile material on Parcel B. Rough volume calculations conducted by a third-party engineer hired by the County, indicated the on-site volume of cover material may be insufficient to meet reclamation requirements for the current quarry pit. In the post inspection meeting, the Operator stated the calculations generated from a highly accurate cut/fill terrain model of the site indicate there is sufficient fill. The operator agreed to share the methodology and output of the terrain model with the County and the third-party engineer to rectify the discrepancy.

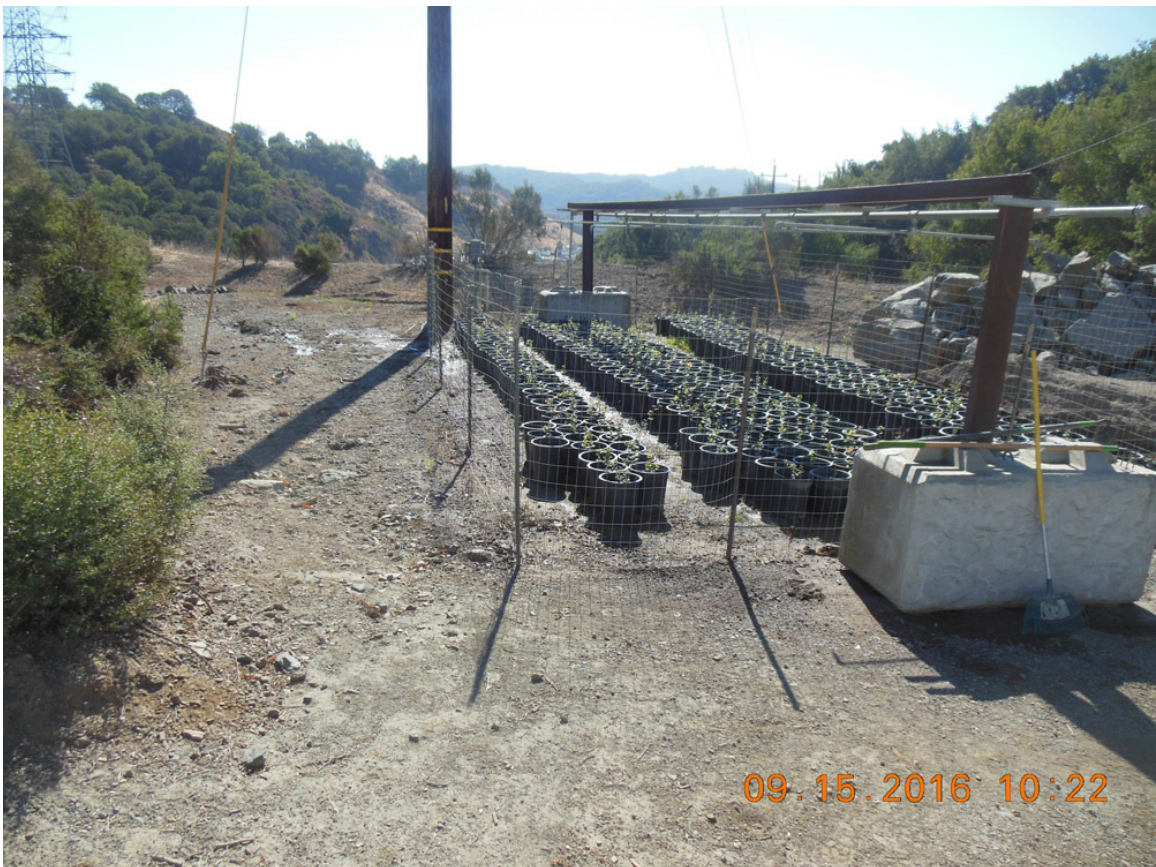
Photo 4 (taken 9-15-2016): Nursery for germinating native oak trees.

1. *Revegetation:* Operator has installed a nursery with an automatic watering system to germinate and raise native oak trees. (See Photo 9.) County recommends the Mine Operator establish vegetation test plots on quarried conditions similar to those that will exist for reclamation to prove the viability of proposed reclamation plantings. County recommends Mine Operator retain a botanist or qualified biologist for the installation and reporting to achieve results for revegetation in accordance with the standards of the Reclamation Plan.

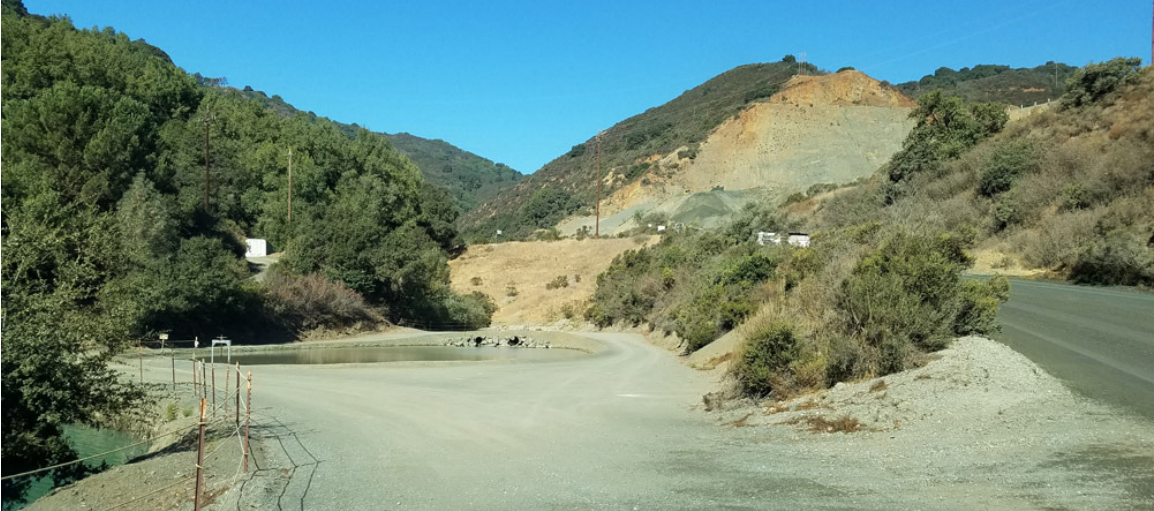
*Photo 5 (taken 9-15-2016): Face of dam between upper and middle settling basins.*

4. *Ponds, stream, earthen dam wall:* County inspectors observed several [in-creek] ponds, identified in the Reclamation Plan as Upper, Middle and Lower Settling Basins, and an earthen dam, approximately 47 feet tall. Upon County recommendation, Operator agreed to research and consult with State Department of Water Resources, and other applicable agencies, to determine jurisdictional status of the dam and report status to County.

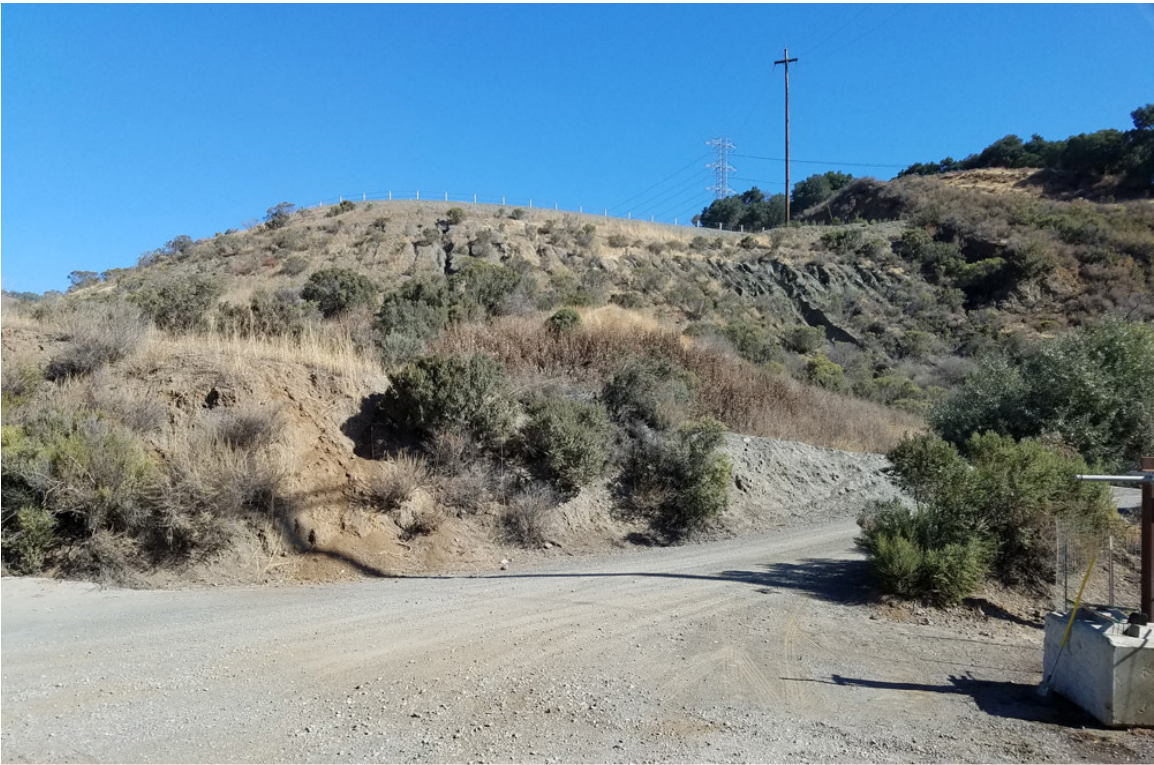
*Stormwater BMPs:* County observed ongoing erosion gullies located on fill slopes (Parcel B) above haul road. (See Photo 6.) County requires operator to implement soil stabilization measures and install adequate BMPs no later than November 1, 2015. Erosion control and BMP measures, including hydroseeding for winter, should be implemented at all locations where active grading or

*Photo 6 (taken 9-15-2016): Erosion rills on fill slope above main haul road.*

3. *Stormwater BMPs:* County inspectors observed fill slopes with no erosion control measures, primarily in area of new crusher and adjacent to haul road. County requires operator to implement soil stabilization measures and install adequate BMPs, including

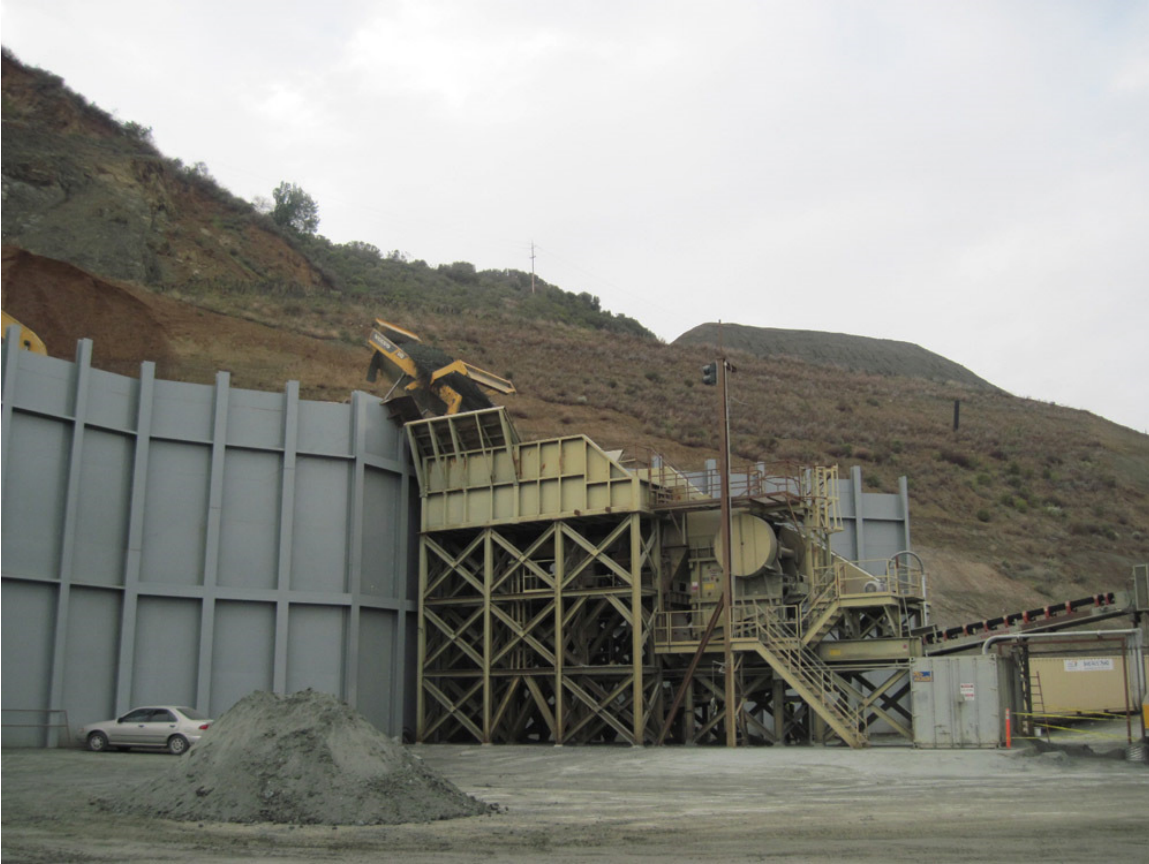
*Crusher and Retaining Wall:* Mining is conducted in Parcel B in a north-northwest trending quarry where Franciscan greenstone bedrock is extracted. Equipment for crushing and sorting rock materials is located on Parcel B. Inspectors observed crusher equipment was relocated to the southeast portion of Parcel B. (See Photo 7.) Building permits were required for the foundation and the retaining wall.

Photo 7 (taken 1-28-2016 by Regional Water Quality Control Board): Relocated rock crusher.

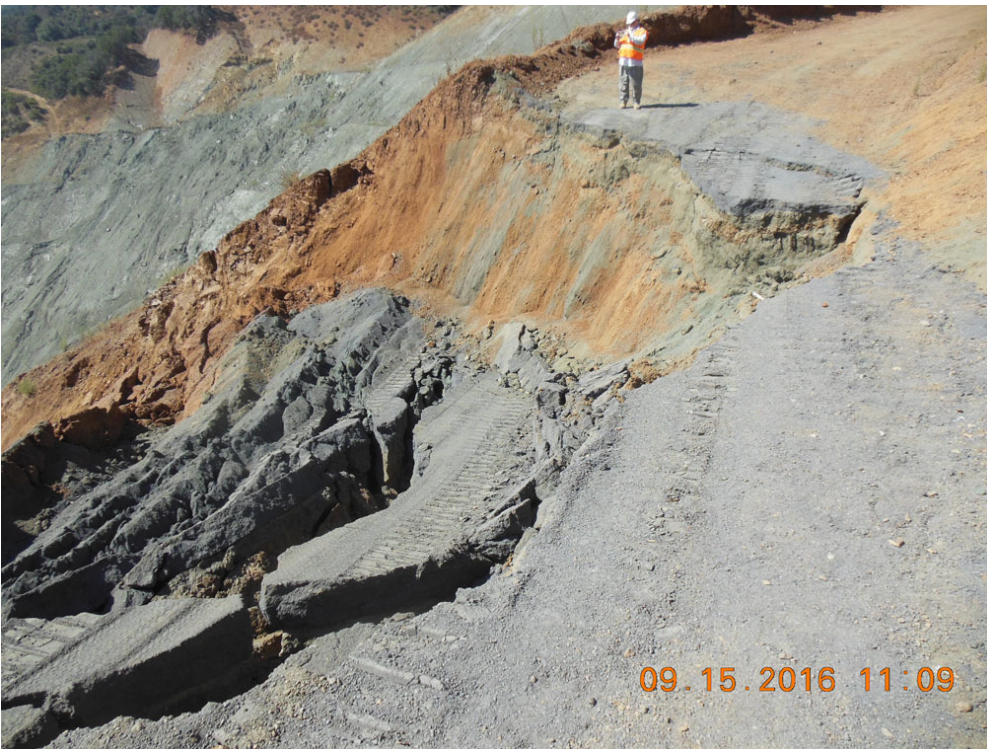
County inspectors observed a portion of the perimeter access road (located within a few feet of the northern property line and Reclamation Plan boundary) was disrupted by the headscarp of a large landslide. (See Photo 8.) County required the quarry operator to have the property line surveyed to determine whether or not ground cracks were outside of the mine property. During subsequent inspections, County inspectors observed the progress of retaining wall construction and buttress fill placement. (See Photos 9, 10, 11, 12, and 13.) Consulting Geologist Derraga conducted an evaluation of the slope stability. The report containing those findings was submitted to the County on 2-1-2017. The report recommends that an additional width (200 feet) of buttress be added to the toe of the slope in order to achieve an acceptable factor of safety. The County is reviewing the report.

Photo 8 (taken 9-15-2016): Headscarp of failure on north high wall and perimeter road.

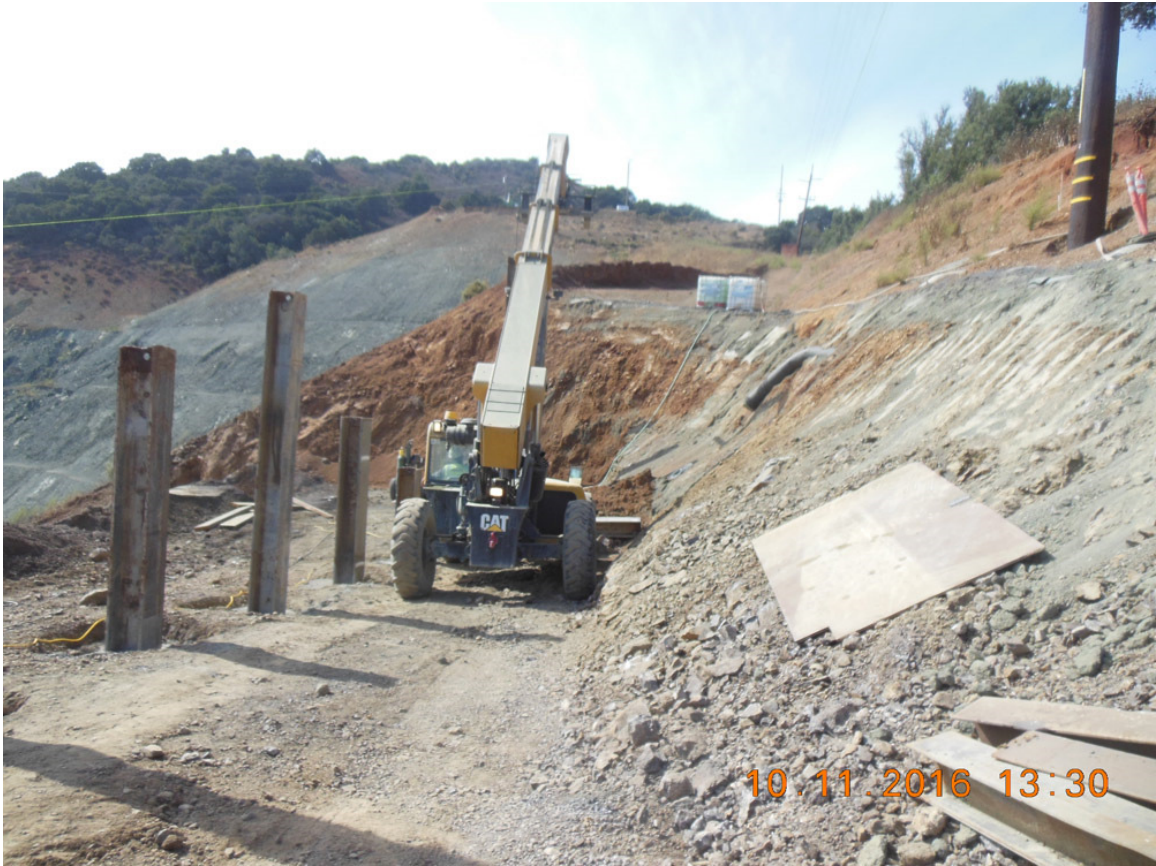
*Photo 9 (taken 10-11-2016): Construction of retaining wall on north high wall.*

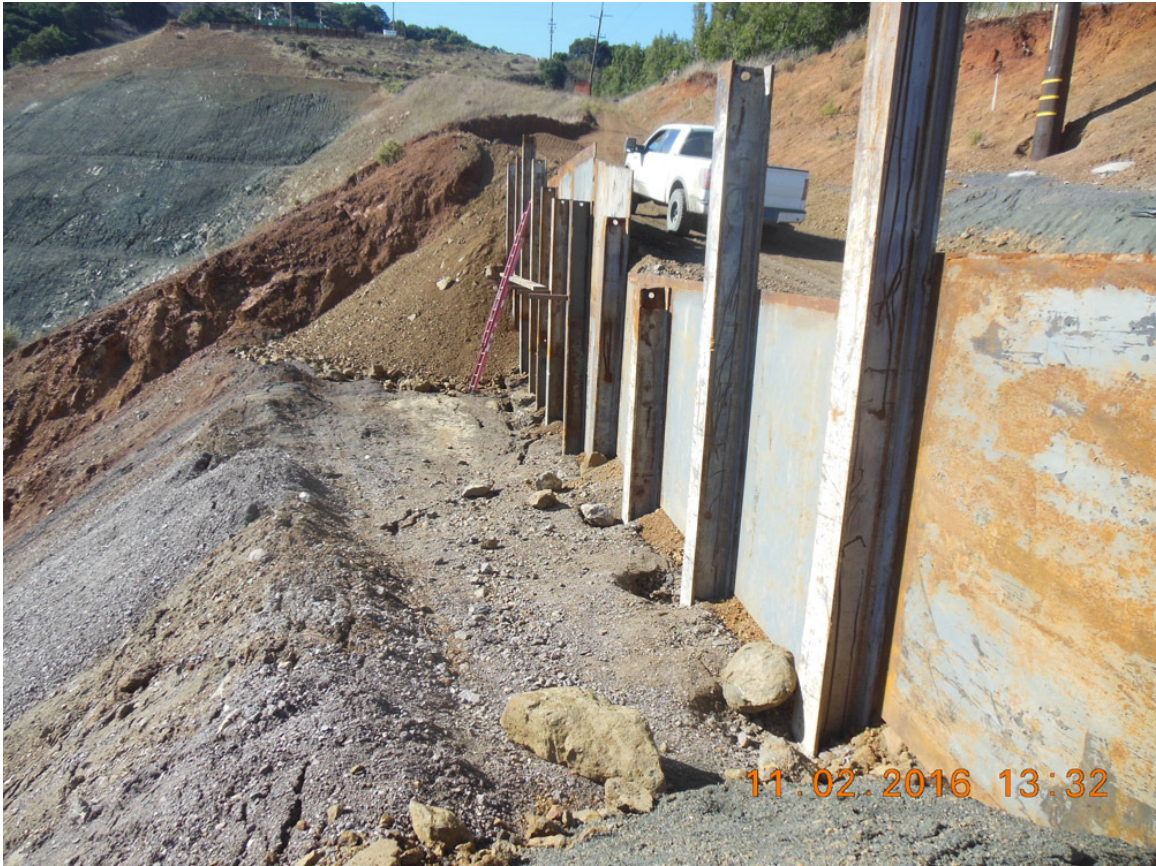
*Photo 10 (taken 11-2-2016): Retaining wall on north high wall.*

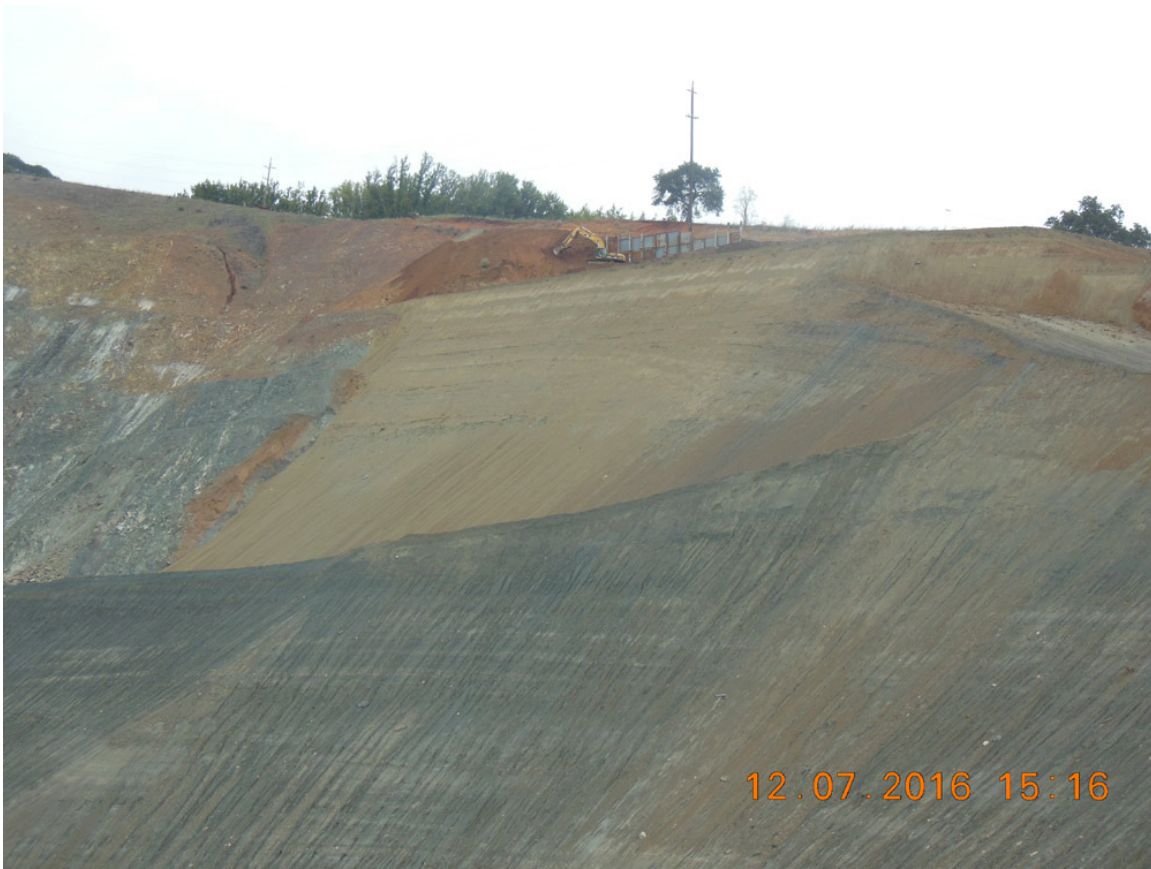
*Photo 11 (taken 12-07-2016): Buttress fill below retaining wall on north high wall.*

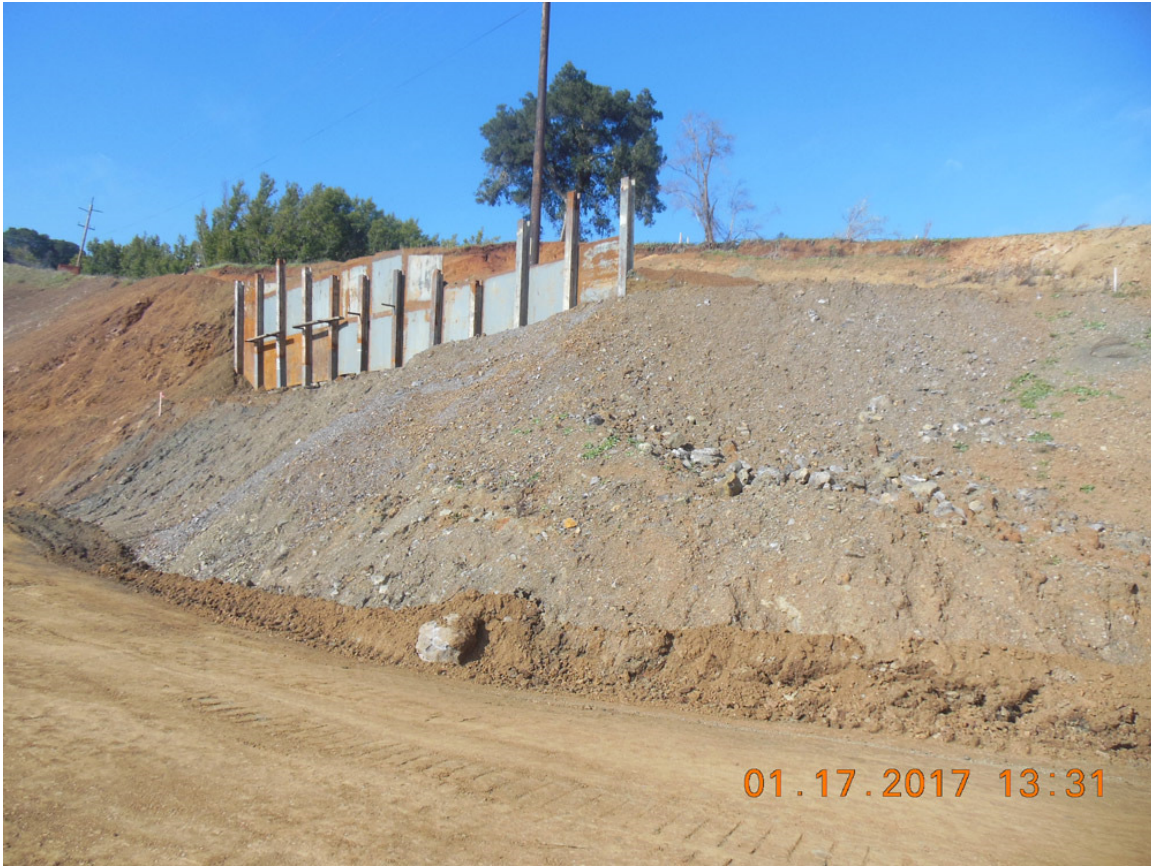
*Photo 12 (taken 1-17-2017): Retaining wall on north high wall.*

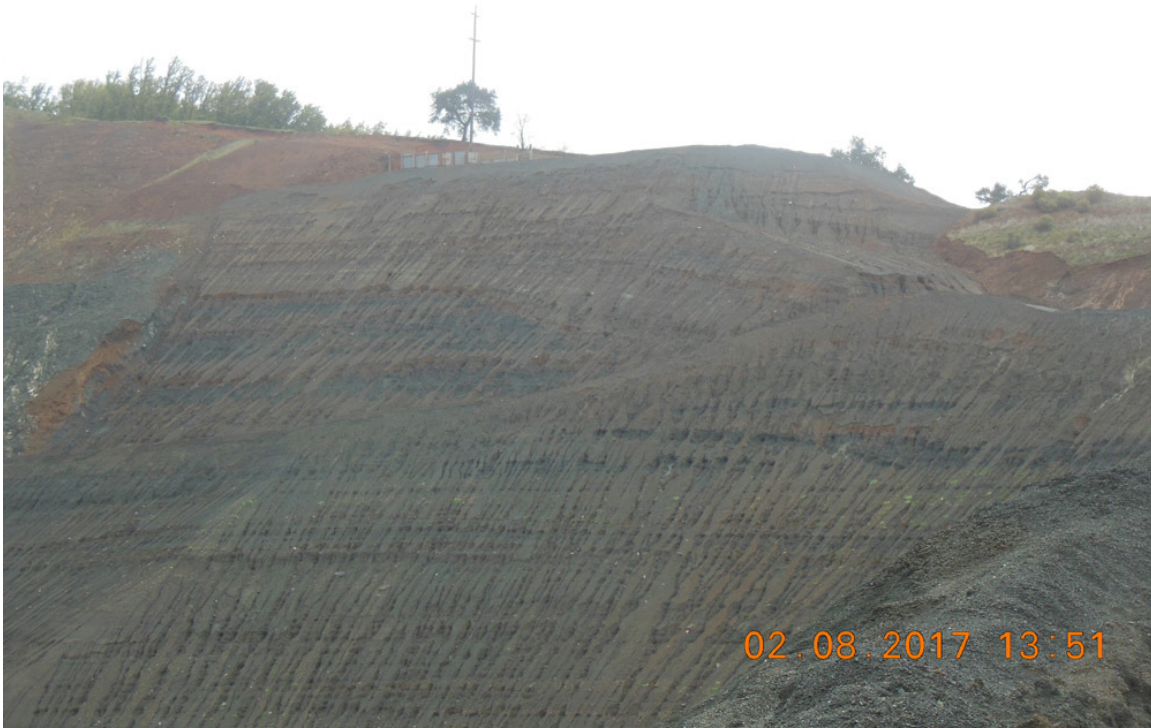
*Photo 13 (taken 2-8-2017): Buttress fill below retaining wall on north high wall.*

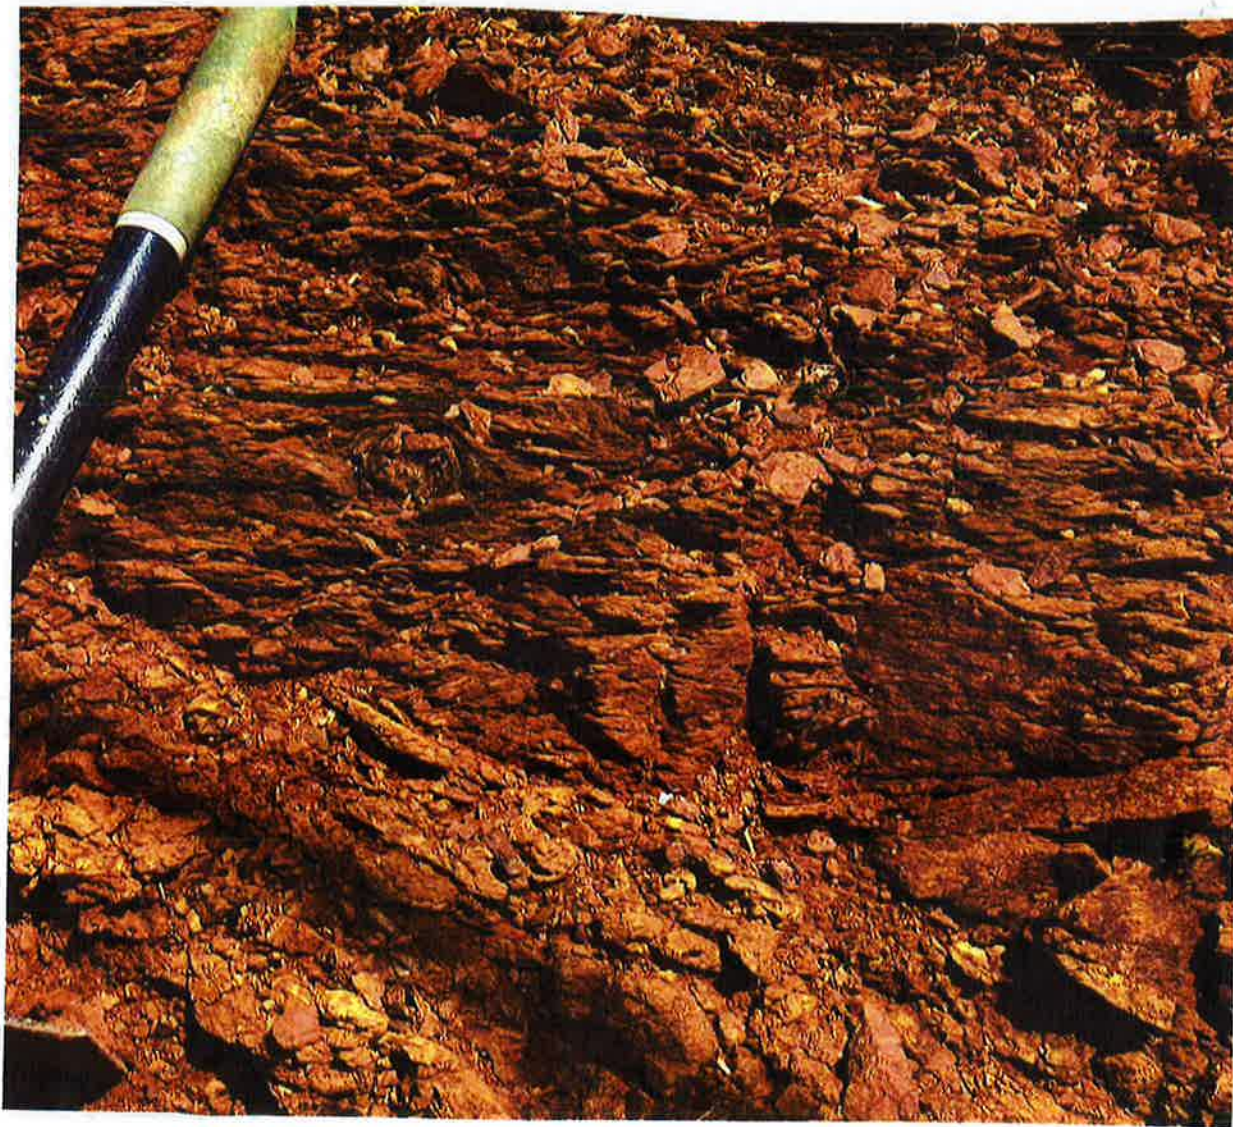
STEVENS CREEK QUARRY	Project Number:	SCP-1	FOLIATED GREENSTONE BEDROCK CUPERTINO, CALIFORNIA	Plate  2
	Date:	MAY '16		
	Entry By:	SD		
	Checked By:			
	Date:

FOLIATED & OXIDIZED GREENSTONE (IN-PLACE).  
NOTE TIGHT FOLIATIONS.

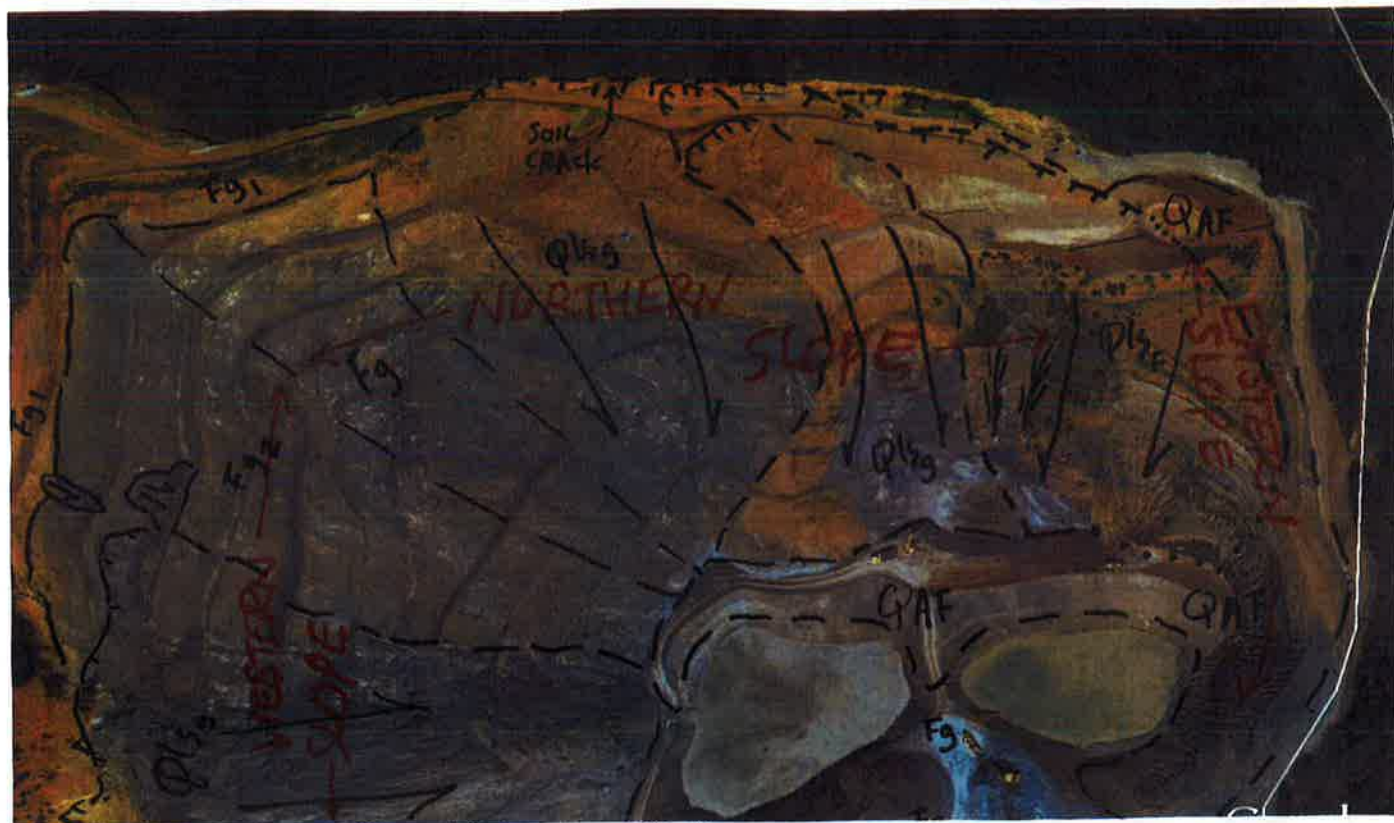
GEOLOGY OF THE  
 NORTHERN SLOPE  
 CUPERTINO,  
 CALIFORNIA

The eastern portion of the Northern Slope is comprised of fill soil that has been placed there and mechanically compacted after the Eastern Slope was mined previously. The central section of the Northern Slope has experienced significant landslide downslope movement nearly along its entire slope height. The greenstone bedrock involved in slope movement appeared sheared, closely and highly fractured, dilated, polished, shiny, and weak. ✓

The uppermost part of the landslide's headscarp is marked by an arcuate shape, open soil crack that is situated near the top of the slope along the north side of the perimeter access dirt roadway. The soil crack is located near the top of the slope and the slope switches dip to the north just beyond the soil crack and the head of the landslide.

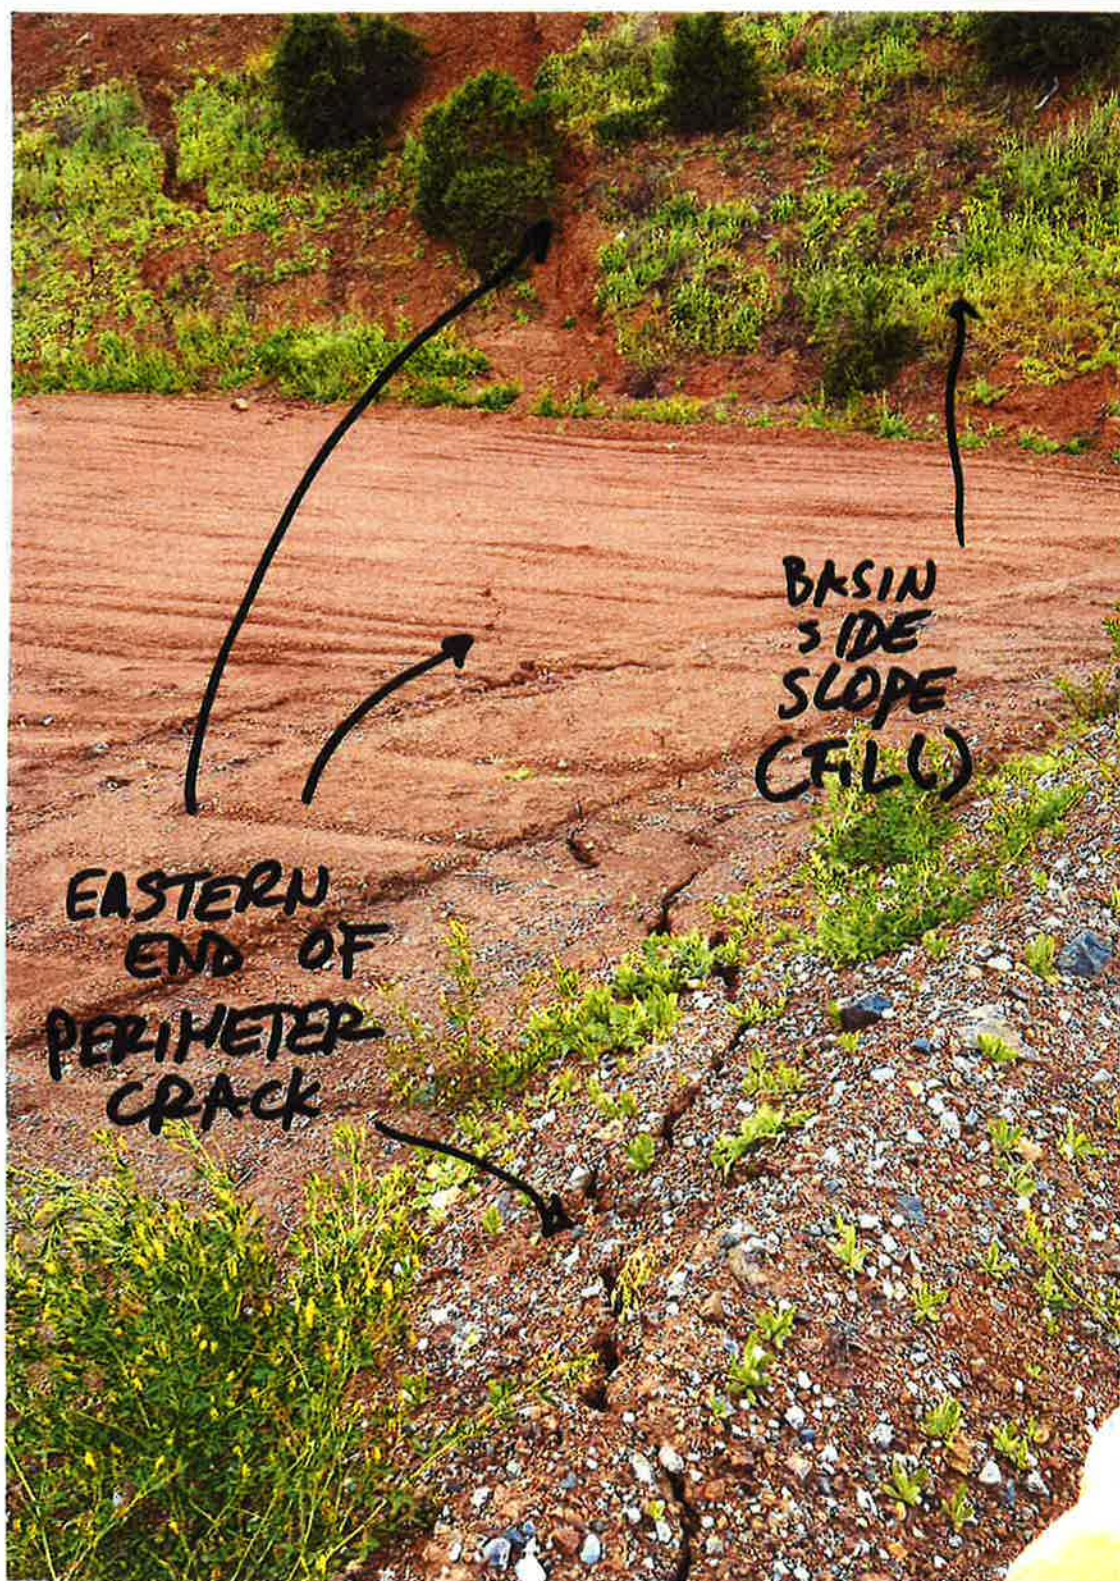
Project Number:	SCQ-1	EASTERN END OF OPEN SOIL CRACK CUPERTINO, CALIFORNIA
Date:	MAY '16	
Entry By:	SD	
Checked By:		
Date:

The uppermost open soil crack marking the headscarp generally extended in an east/west trend along the north side of the dirt perimeter roadway and then crosses the dirt access road twice as it turns and trends toward the southeast along its eastern end and southwest along its western margin. The western margin of the open soil crack turns abruptly southward where shown on Plate 4 (Geology of the Northern Slope) to mark the western limit of the area that has experienced downslope movement. The eastern end of the open soil crack extends in a southeastern direction through the detention pond located along the !

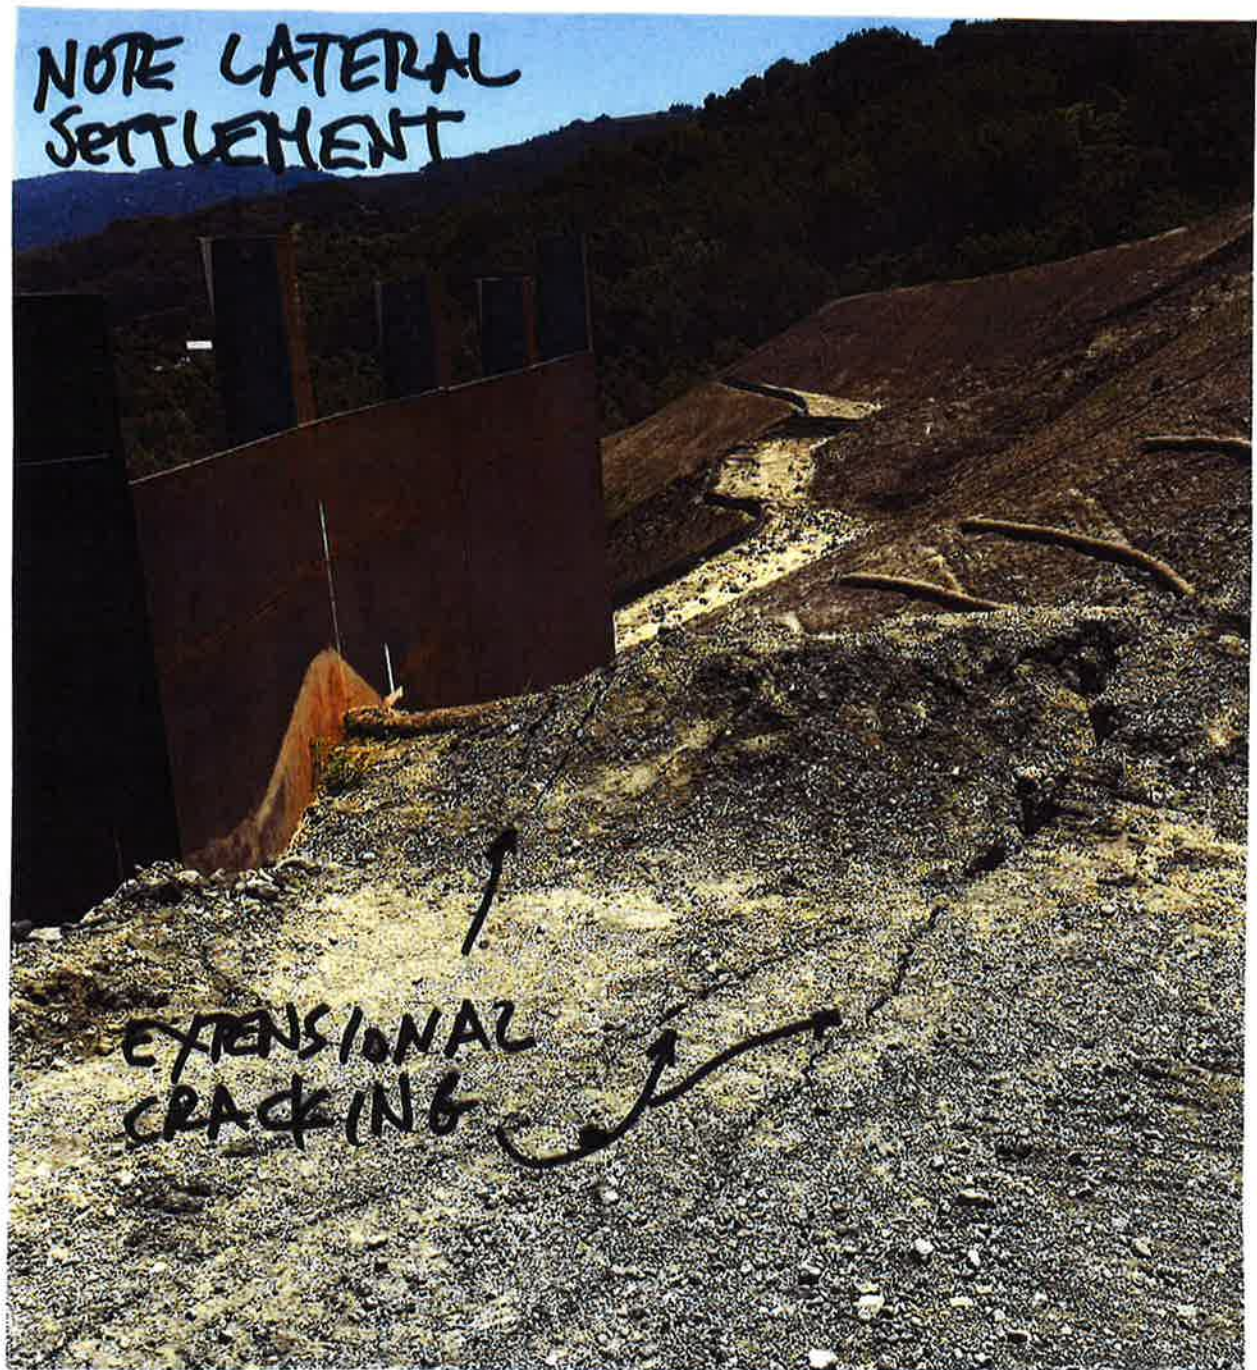
STEVENS CREEK QUARRY	Project Number:	SCQ-1	EXTENSIONAL PAD CRACKING	Plate
	Date:	MM/DD/YY		
	Entry By:	SD		
	Checked By:			
	Date:		CUPEERTINO, CALIFORNIA	13

SOUTHWARD VIEW FROM THE JAW CRUSHER  
PAD AREA.

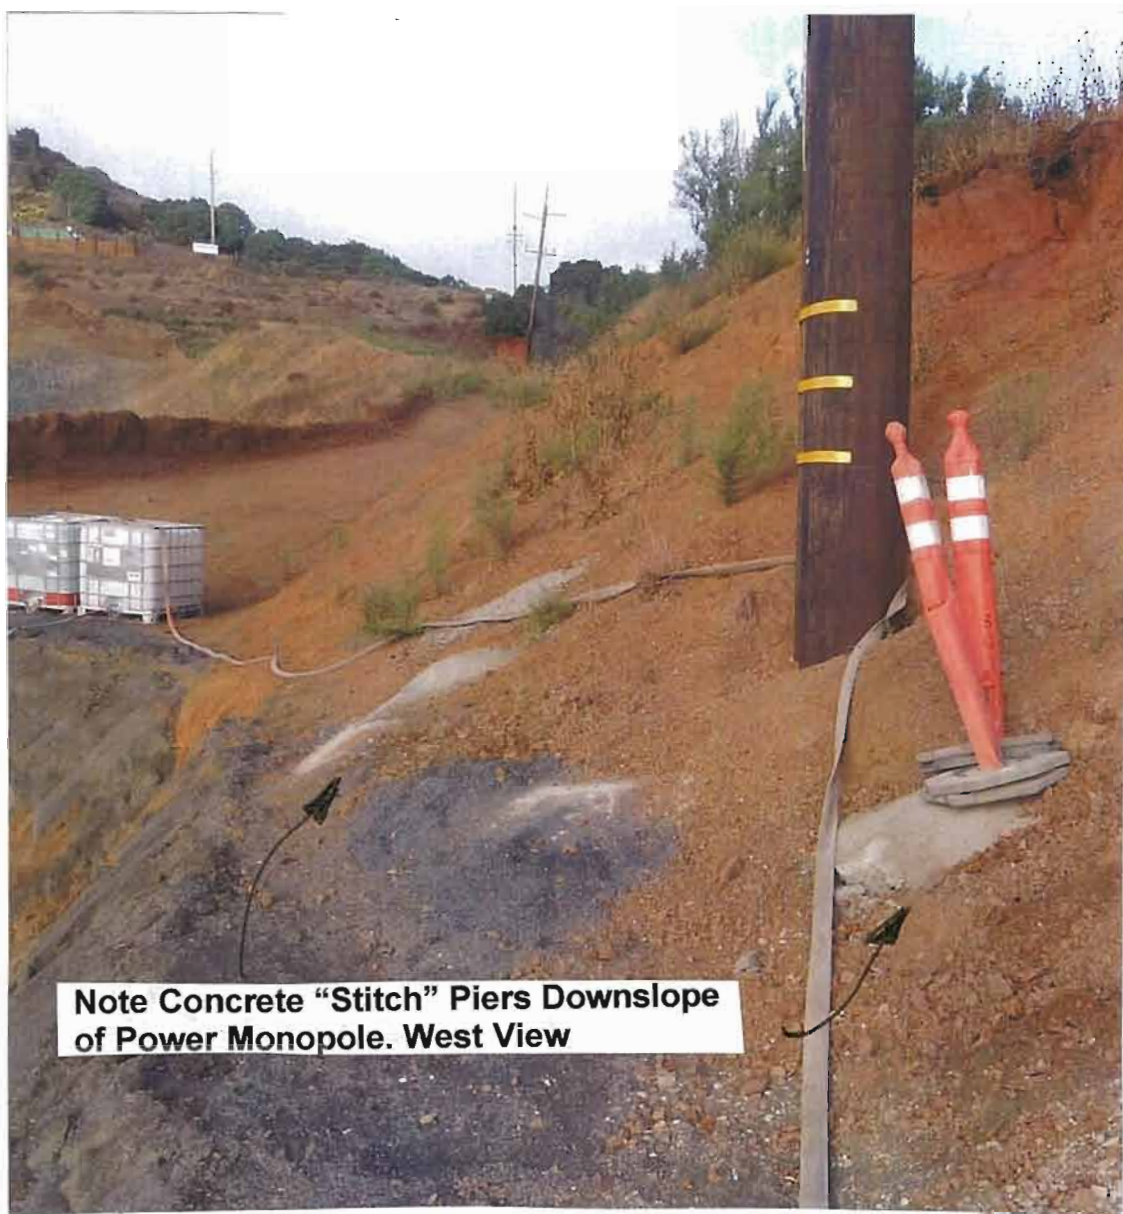
No Annular Void around Power Pole  
And No significant Tilt
