County of Santa Clara

**Subject: MRRC-1 Winter Inspection Report for the Stevens Creek Quarry
County Planning Office File 1253-15PAM
State Mine ID #91-43-0007
Violation**

SURFACE MINING INSPECTION REPORT

I. Mine Name (As Shown on Approved Reclamation Plan) Stevens Creek Quarry	Inspection Date: 12-22-15 and 01-28-16	CA MINE ID# 91- 43-0007
---	--	-----------------------------------

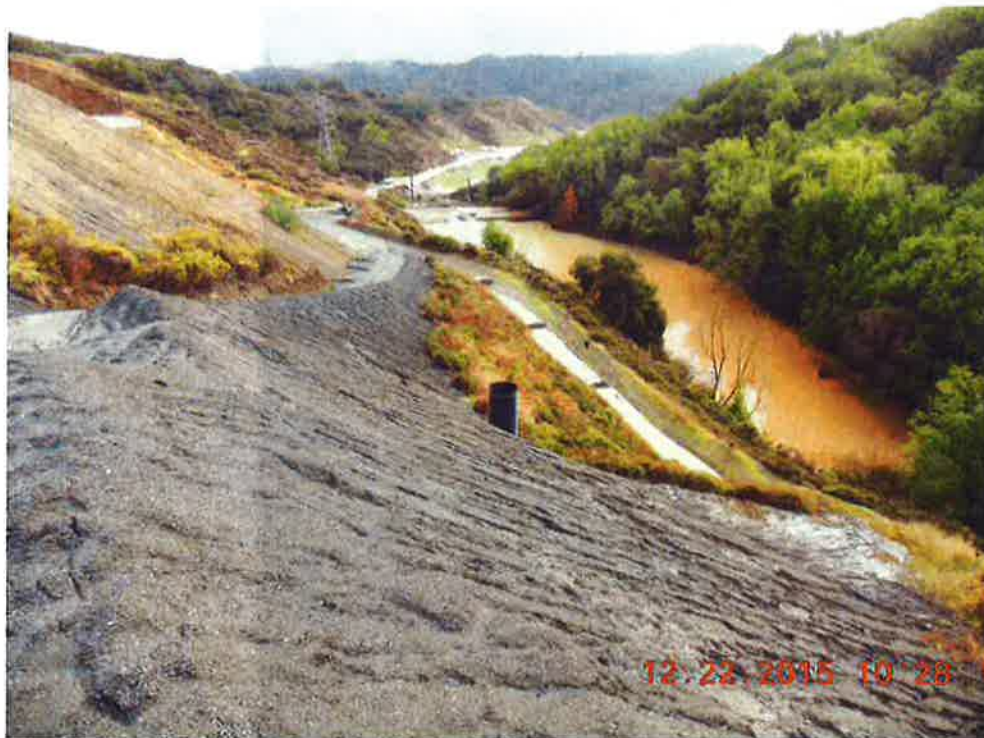
(Pic 1)

1. **Boundary Demarcation** was recommended within the last Summerization Inspection report, still uncompleted within the "upper access road to the northerly property line." It was again recommended that T-stakes painted with bright paint be installed to demarcate boundaries. This item was noted as number 2 in the Summerization Corrections to be completed by 12/1/2015.
2. **Stormwater BMP's:**
 - a) **Southern fill slope(s) above creek in Parcel B** had minimal BMP's (Pics 1,2) to protect

the newly constructed fill slope(s) to prevent slope erosion and erosion gullies from entering storm inlets. Fill material and sediment was observed over land onto the lower existing vegetative hillslopes, that eventually had sediment turbid water entering the creek. **(Pic 3)** The minimal fill slope BMP's that were installed post the 10/29/15 inspection helped; however, were overwhelmed with recent storm activity due to the lack of fill slope BMP's. **(Pic 4)** It was recommended to address all fill slopes with BMP's, maintain existing failed BMP's, and install more BMP's to the area to prevent erosion and sediment from reaching the lower creek / reservoir. **(Pic 5)**

The above noted site conditions and compliance issues should be addressed immediately. Hand work with BMP maintenance / installation should immediately start with the fill slope area (Item A) and lower creek area. Slope stabilization on all newly graded slopes, previously noted eroded fill slopes, and along with the Quarries overall BMP maintenance / installation; should be addressed by their Engineer of Record.

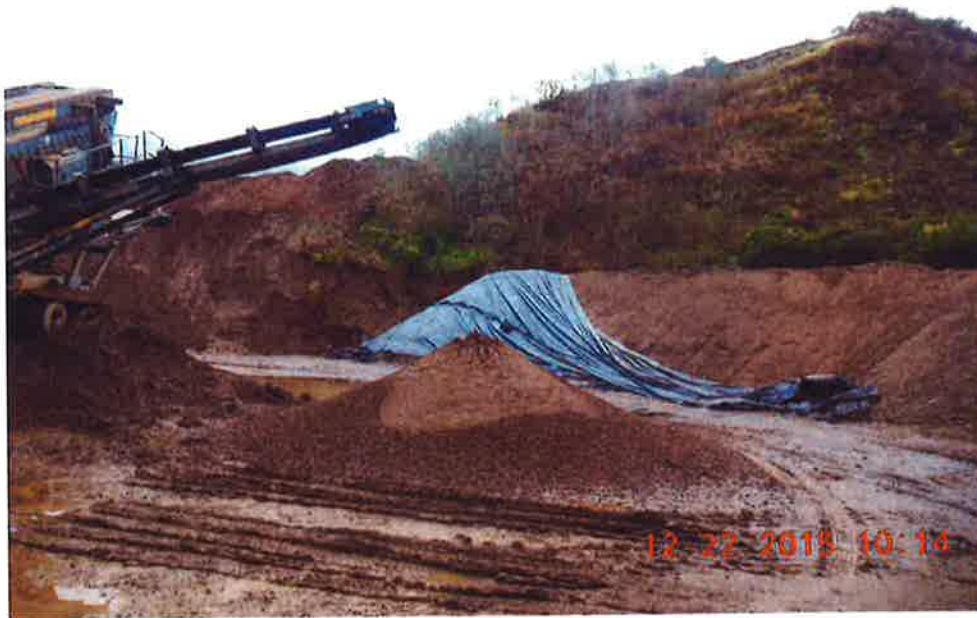
(Pic 9)

- e) **Soil Stock Piles in Parcel A and the upper soil stock pile** in need of housekeeping and winterization pre and post rain events. Multiple stock piles were uncovered due to the weather conditions with one stock pile needing to be covered completely. **(Pic 9)**

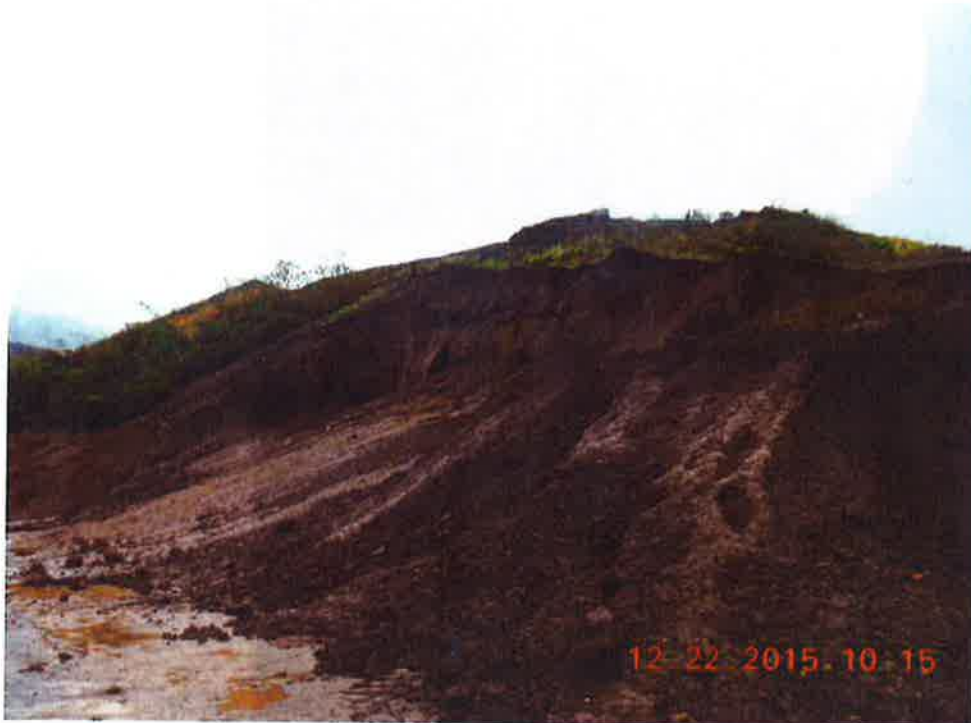
(Pic 10)

- h) **Large Stock Pile on Parcel A** lack BMP's. This large stockpile onsite will be used as fill material to reclaim the current pit to the approved Reclamation Plan. The disturbed locations and disturbed soil appear to be offhauled from the quarry within the clean soil operation. The two disturbed areas were noted in need of BMP's, the larger being on top and the minor area to the stock pile corner near the lower recycling area. **(Pic 10)**

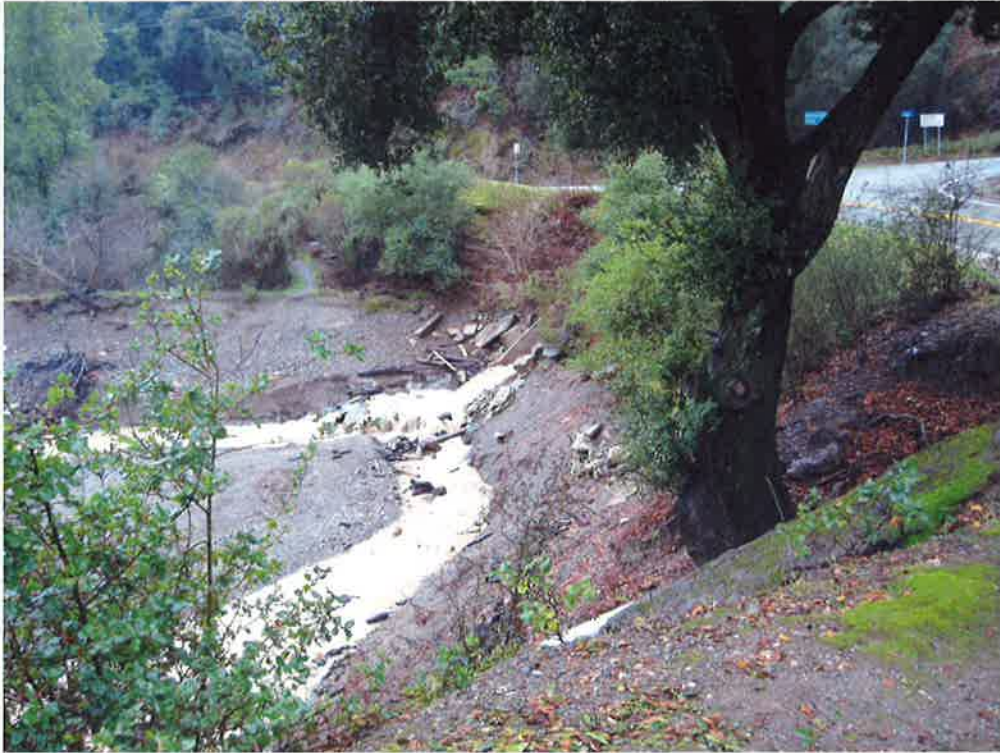
PHOTO # 11, Swiss Creek discharge to Stevens Creek Reservoir (photo MRush, Dec 2015)

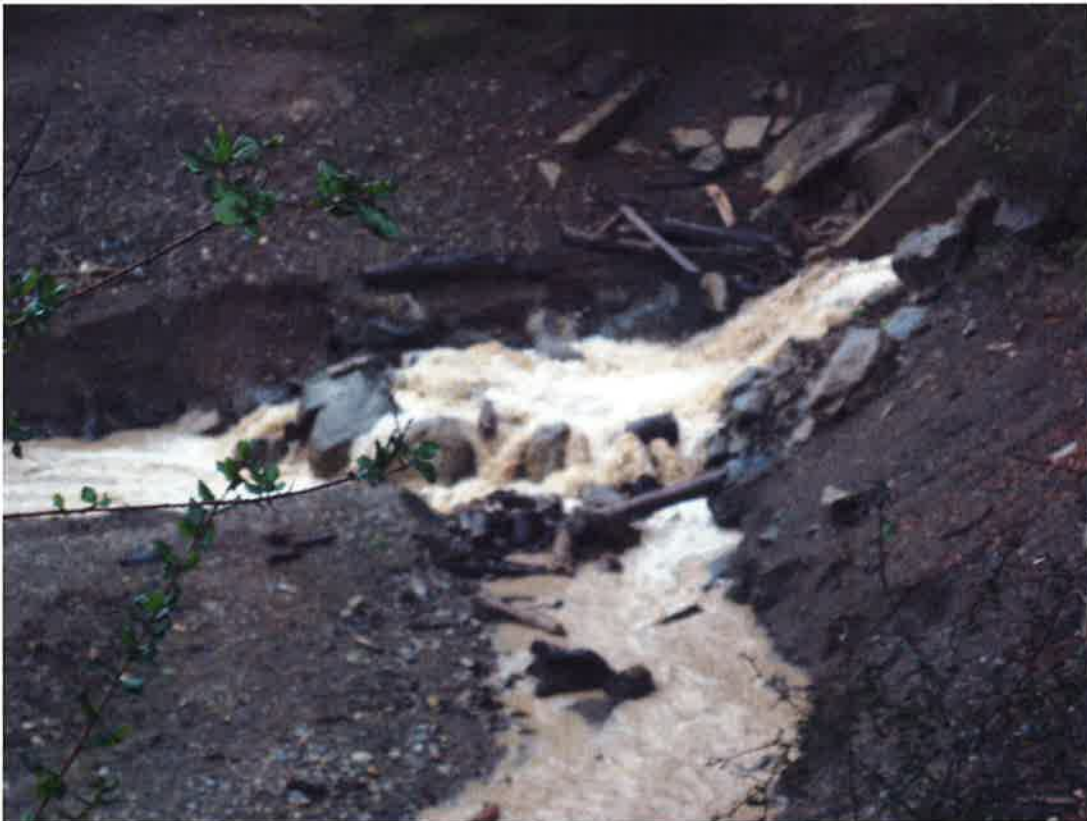
Photo #12, Swiss Creek discharge to Stevens Creek Reservoir (photo MRush, Dec 2015)

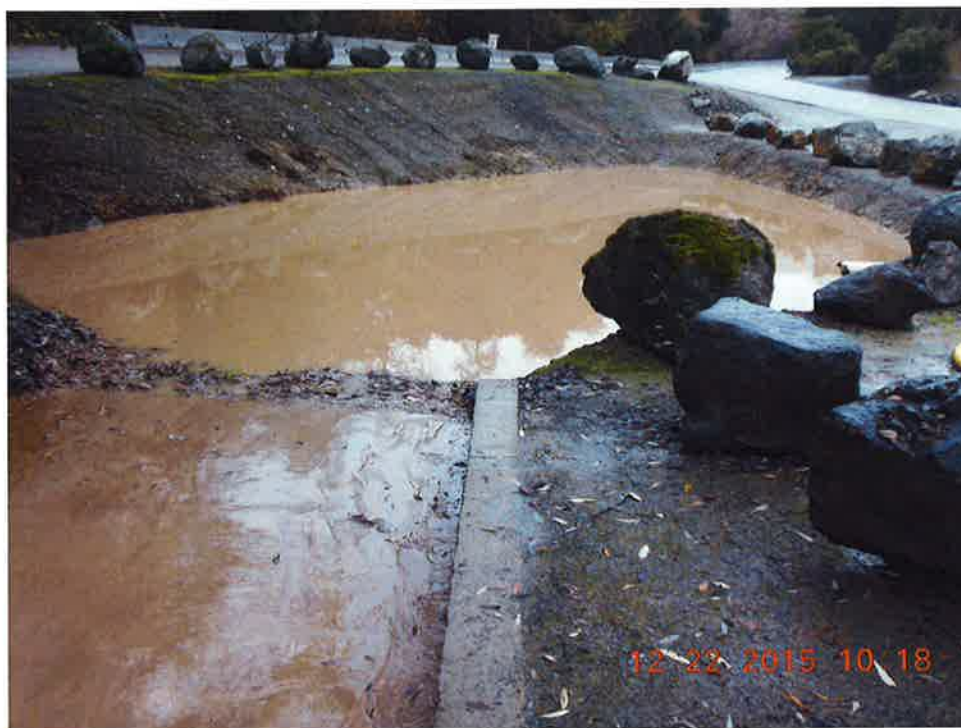
Detention pond, Parcel A. (Photo by S. Beams)

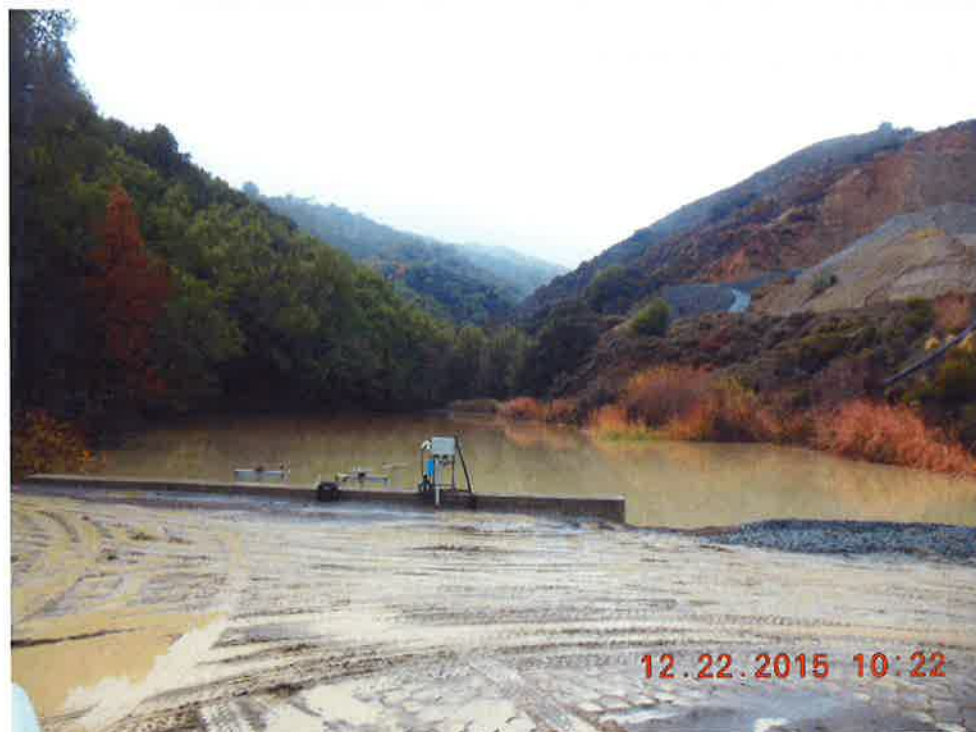
Upper Settling Basin, fill slope in distance. (Photo by S. Beams)

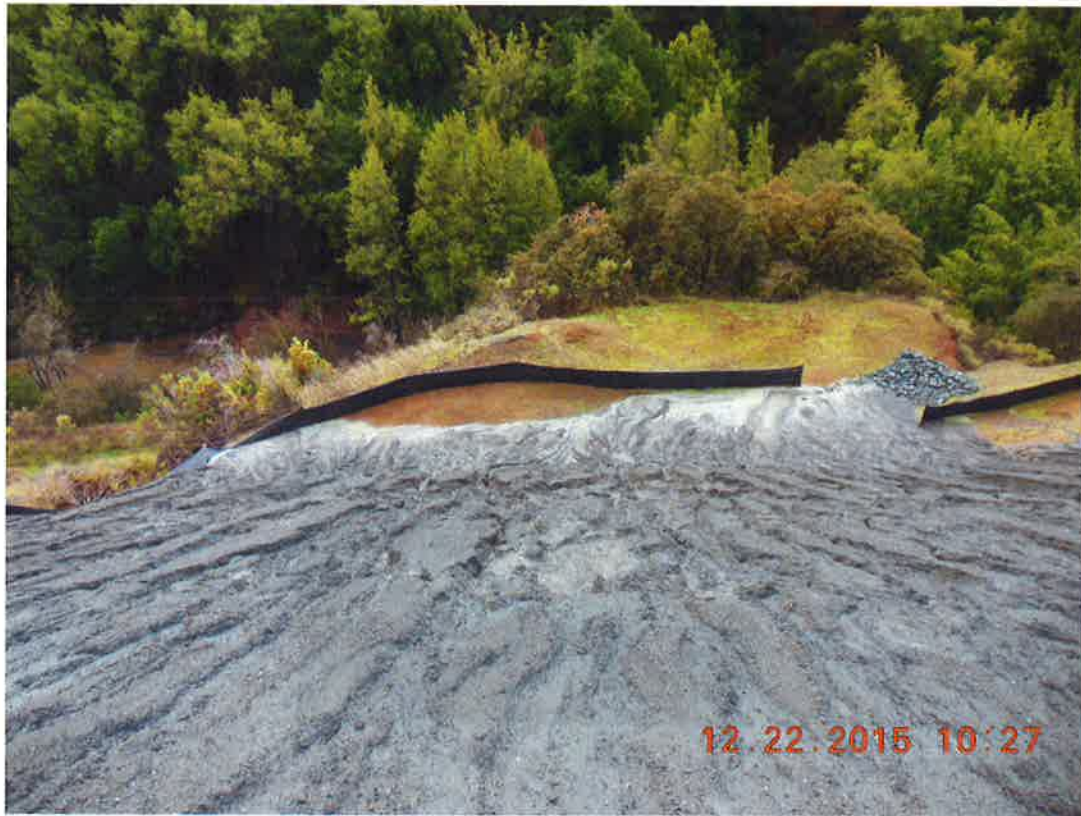
Erosion, runoff to Montebello Creek (Photo by S. Beams)

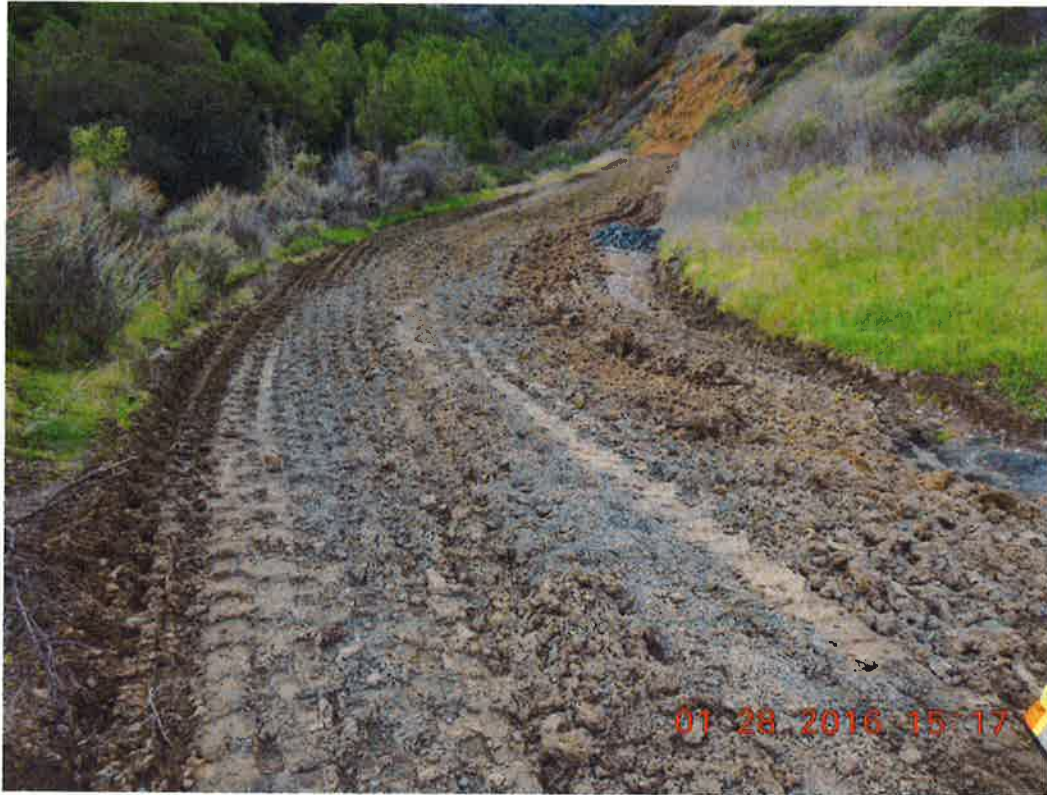
(Pic 1)

- a) **Southern fill slope(s) above creek in Parcel B** had minimal BMP's to protect the newly constructed fill slope(s) to prevent slope erosion and erosion gullies from entering storm inlets. Fill material and sediment was observed over land onto the lower existing vegetative hillslopes, that eventually had sediment turbid water entering the creek. The minimal fill slope BMP's that were installed post the 10/29/15 inspection helped; however, were overwhelmed with recent storm activity due to the lack of fill slope BMP's. It was recommended to address all fill slopes with BMP's, maintain existing failed BMP's, and install more BMP's to the area to prevent erosion and sediment from reaching the lower creek / reservoir.

No Change in Condition(s), Conditions worsened. Additional disturbed closer activity to the creek / access road, with equipment activity disturbing additional soil material (Pic 1, 2, 3). The minimum amount of fill slope BMP's that were installed post the 10/29/15 Inspection failed due to the straw wattle incorrectly installed. Furthermore, allowing sediment to erode under and around the incorrectly placed wattles, (maintenance / housekeeping needed (Pic 4, 5). An additional upper inboard access road bench with fillslope was recently graded and no BMPS's were place, observed, nor installed, etc, (Pic 6, 7). Note: After a lengthy field discussion, SCQ then agreed to have their stormwater consultant address the BMP's. A post inspection 1/29/16 email was sent by Jason Voss with minor BMP installation to the lower access road and recently graded upper access road.

The above noted site conditions and compliance issues should be addressed immediately. Slope stabilization on all newly graded slopes, previously noted eroded fill slopes, and along with the Quarries overall BMP maintenance / installation; should be addressed by their Engineer of Record and or Stormwater Consultant, QSD, etc.

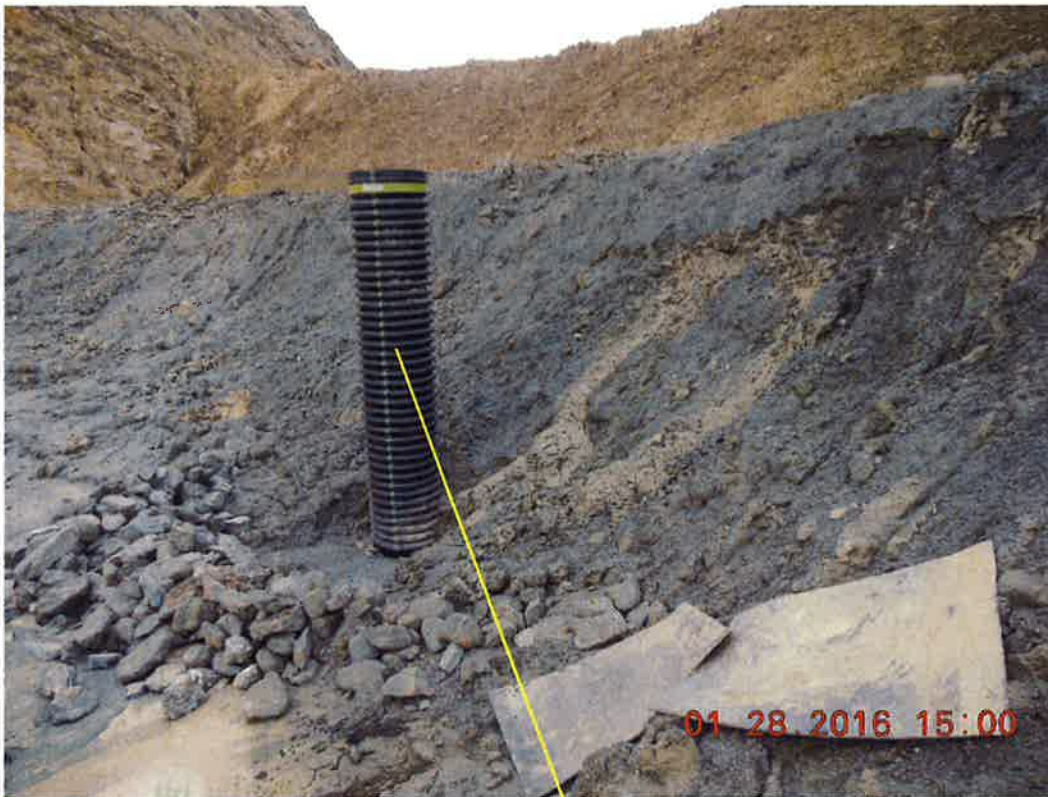
(Pic 8)

No Change in Condition(s). One small rock inlet dissapator was observed. Fillslopes lack BMP's and area platform was compacted creating more stormwater sheetflow to one inlet. (Pic 8, 9) Note: After a lengthy field discussion, SCQ then agreed to have their stormwater consultant address the BMP's. A post inspection 1/29/16 email was sent by Jason Voss with minor additional BMP installation to the area field inlet. Rear fillslopes still lack BMP's.

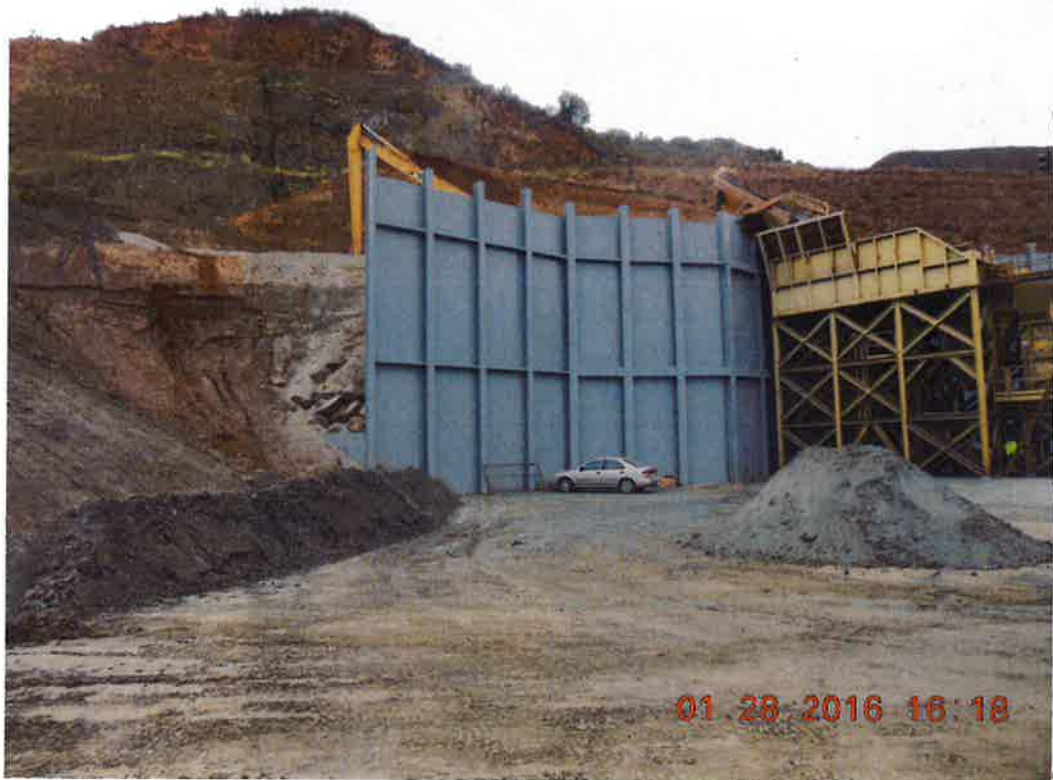
(Pic 10)

No Change in Condition(s). Further erosion was observed to the rear high retaining wall and upper slope failure above crusher intake platform. (Pic 10). After a lengthy field discussion with site conditions, nothing was achieved with future anticipated BMP installation. With the absence of the SCQ stormwater consultant, (due to having to leave the inspection), it was again recommended to Jason Voss that their stormwater consultant view the area to assist with BMP implementation. Also, any engineering with future potential storm improvements to the area.

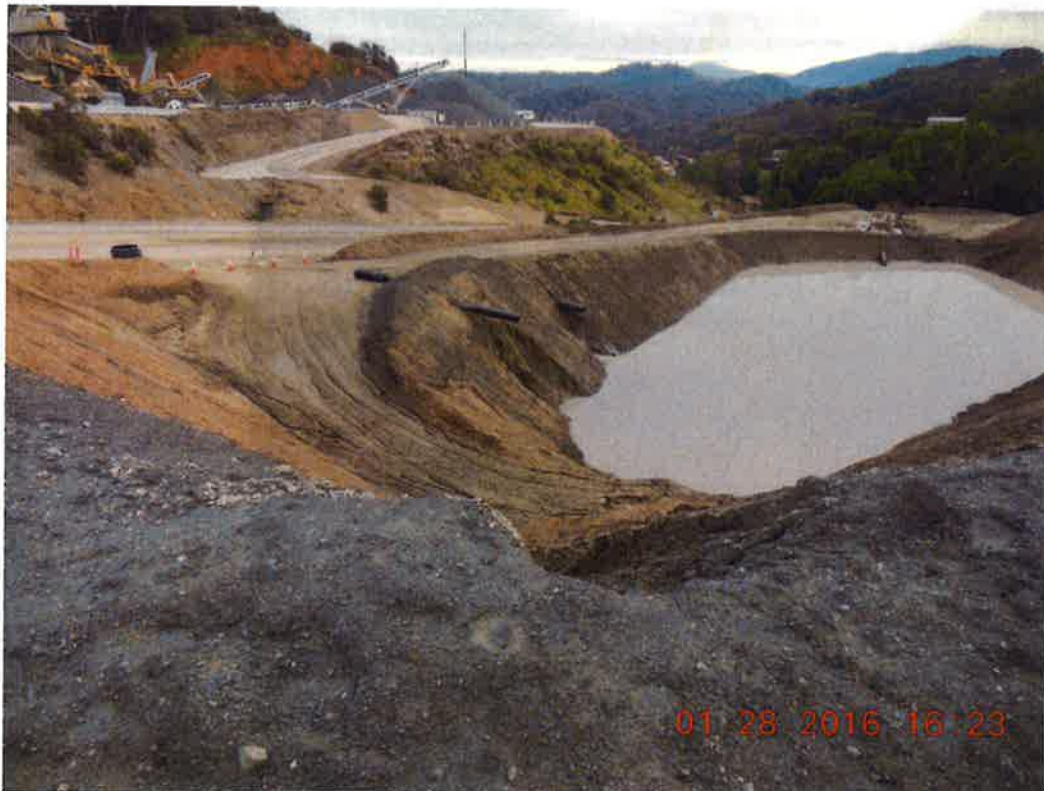
(Pic 11)

No Change in Condition(s). Continued sediment buildup observed on fill bench above basin. No change in conditions with lack of fill slope BMP's. Further erosion observed to basin inlets with basin at capacity (Pic 11). It was noted that since a "polymer" was added to the basin to assist with stormwater de-sedimentation, extra basin maintenance will be required with activity. Both fill slopes above basin now have erosion rills and new slope slumping combined with sediment onto fill bench (Pic 12). No BMP's onsite or placed since last inspection 12/22/15.

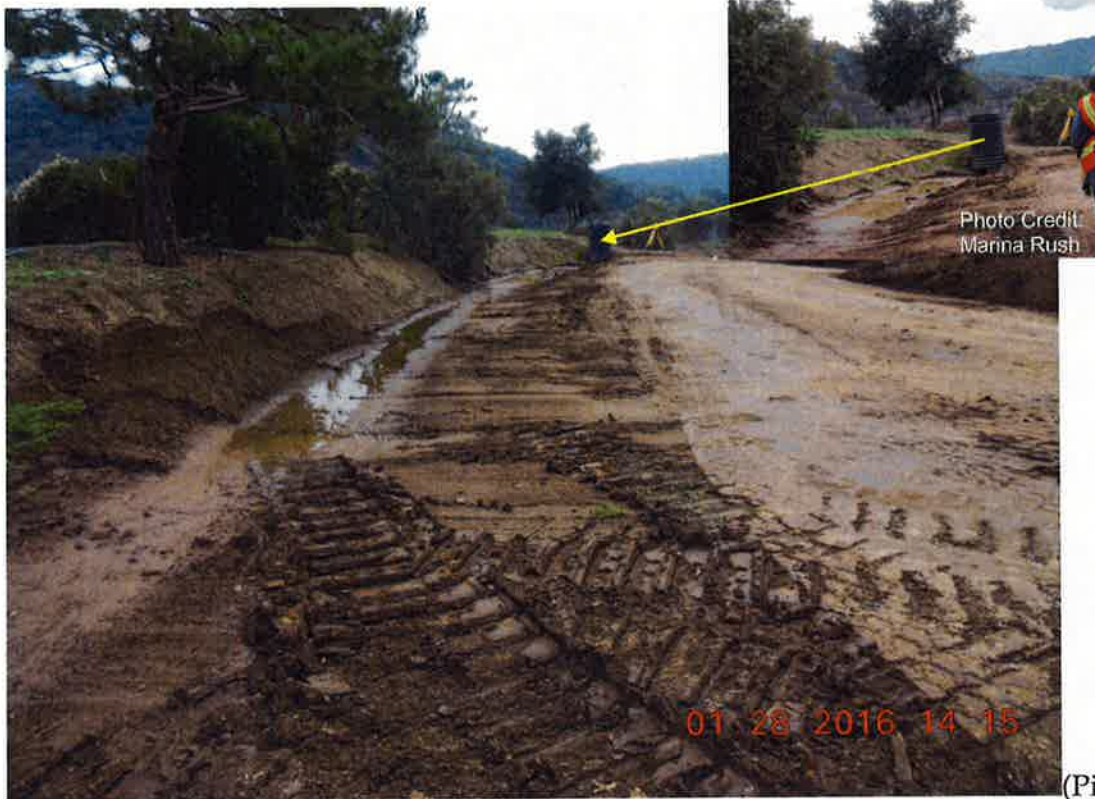
(Pic 16)

- l) **Parcel A Clean Soil Operation** lacks inlet protection with all inlets, lack of BMP's to drainage swales / v ditches before stormwater / sediment reaches inlets (Pic 16). It was noted that compacting flat disturbed soil with compaction equipment is not a BMP, thus only creating more stormwater runoff / sediment for area with unprotected storm inlets.

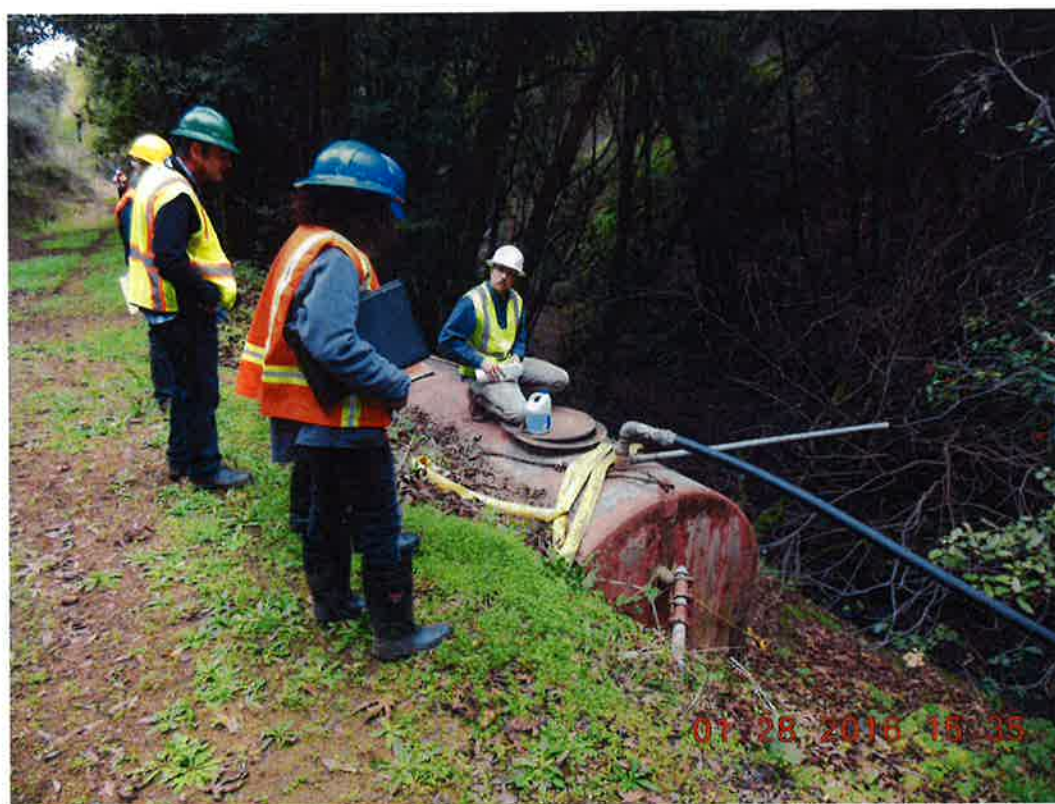
(Pic 17)

- m) **Upper Rattlesnake Creek Pump Equipment** was observed to be operational with an electric sump pump placed into the lower creek. An existing metal tank used for a nonoperational spring 10-12 years ago, (stated by Jason Voss), was now used with the placed equipment into the creek for related pumping activity (Pic 17). A follow up

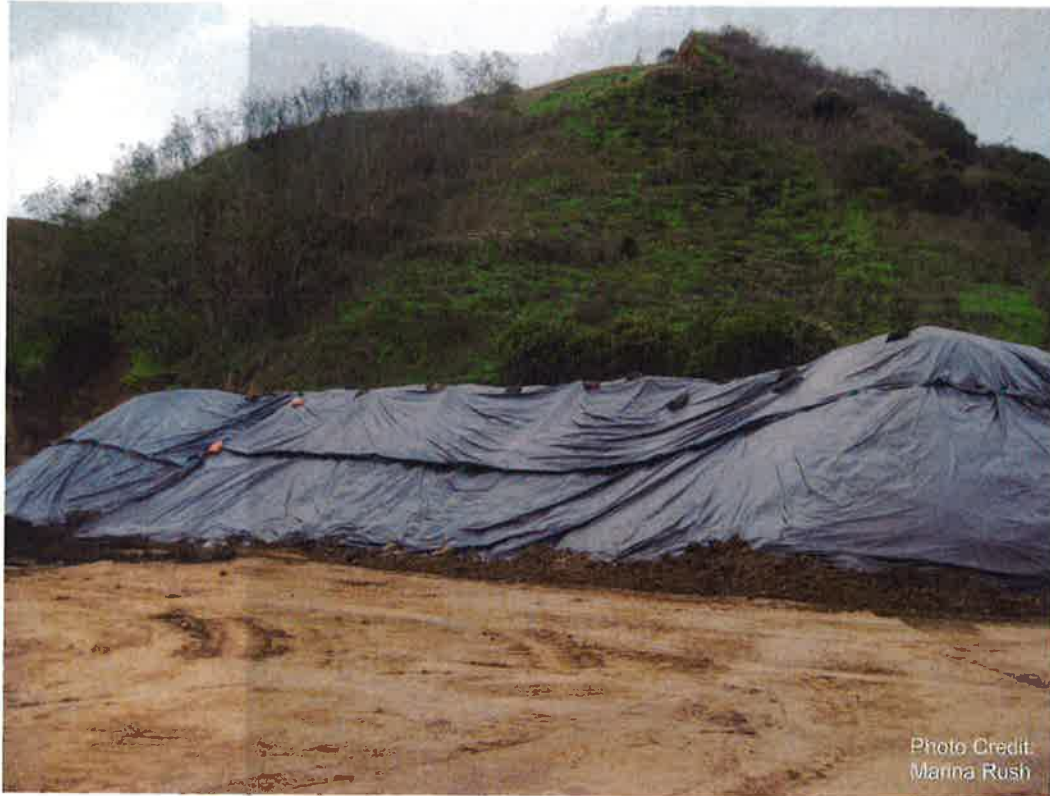
Completed and observed within Inspection. Note: Email sent late 1/28/16 by Jason Voss showing active piles covered at the end of the day. (Pic 22)

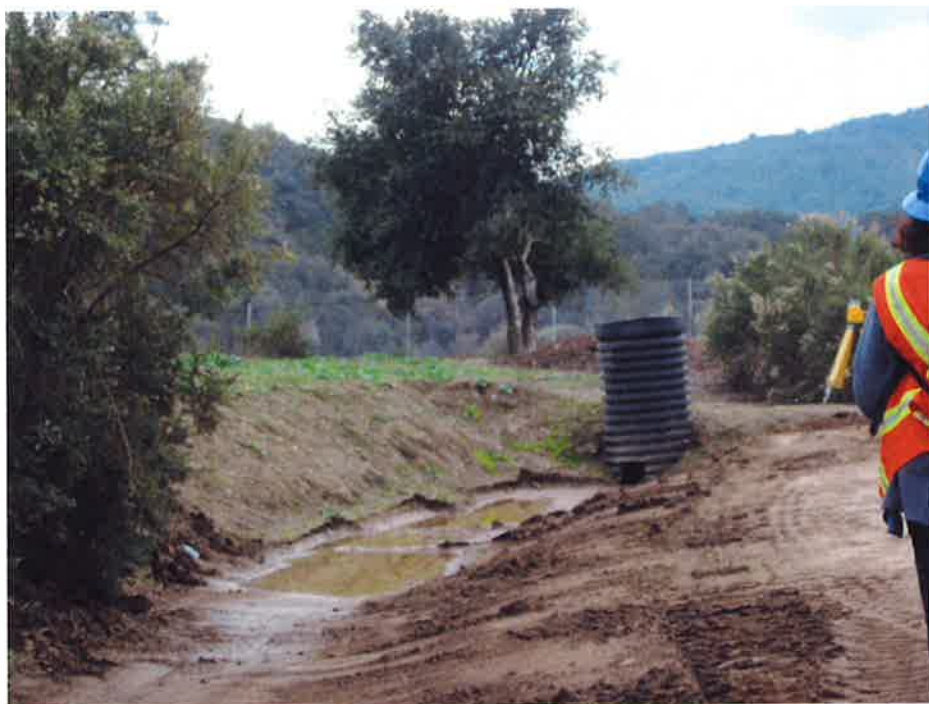
Photo 24 (Recycling Area/Parcel A, pipe discharges to creek per J. Voss, Photo by MRush, January 2016)
