County of Santa Clara

Department of Planning and Development
Planning Office

SUBJECT: NOTICE OF VIOLATION – STEVENS CREEK QUARRY

Stevens Creek Quarry
Map of Violations
September 5, 2017

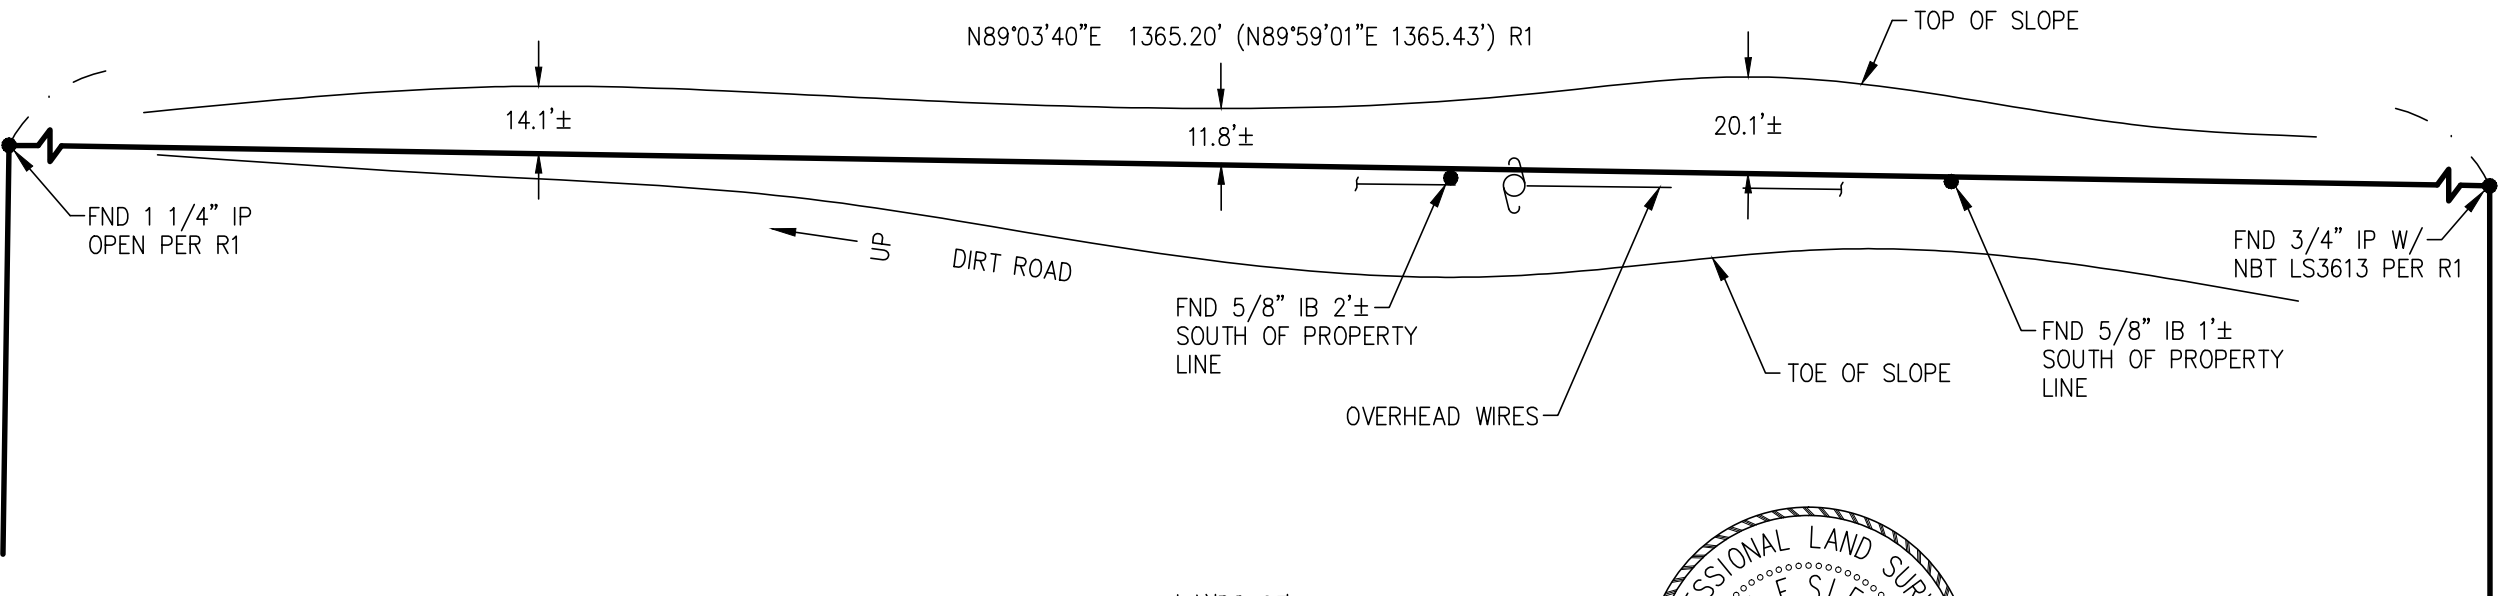
The County observed surface mining-related ground disturbances beyond the northern property line, as documented in the September 15, 2016 inspection (Attachment I and J). Enclosed as Attachment D is a survey by the County Surveyor (dated January 2017) which shows mining related ground disturbances located north of the northern property line and outside the Reclamation Plan area. The survey shows that the ground

disturbances—labeled “Top of Slope”—extend north of the northern property line. Consequently, these ground disturbances are in violation of County Ordinance Code §4.10.370, Part II(A)(6) and Public Resources Code §2773(a), because the ground disturbance shown in Attachment D is located outside of the approved Reclamation Plan area.

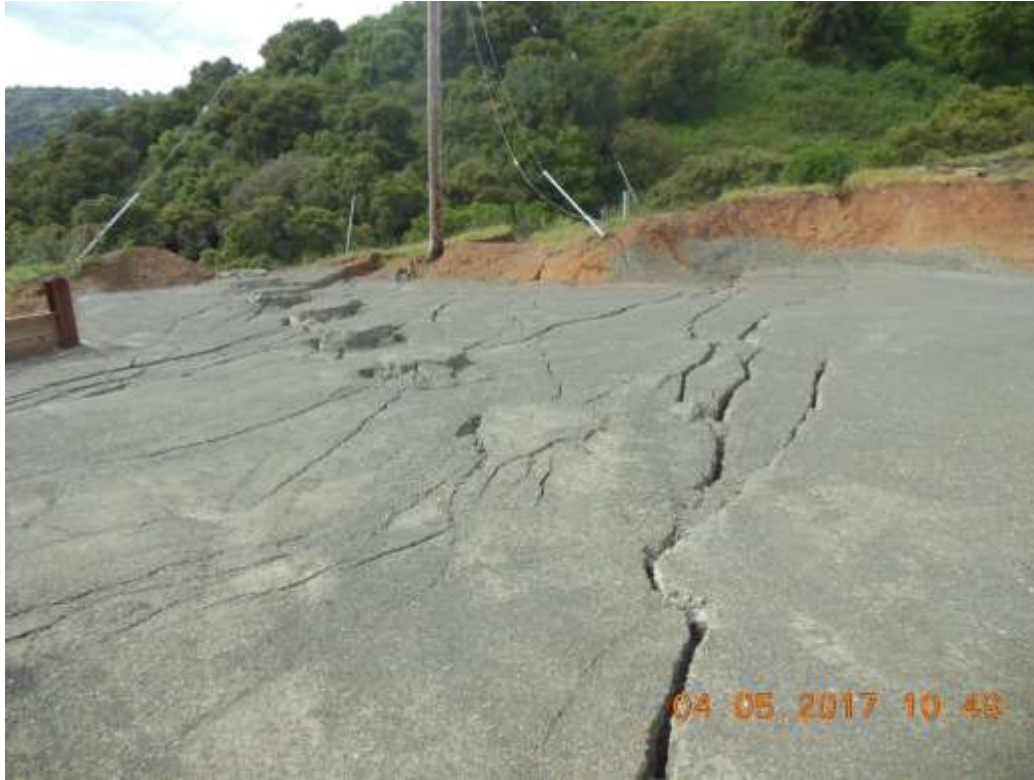
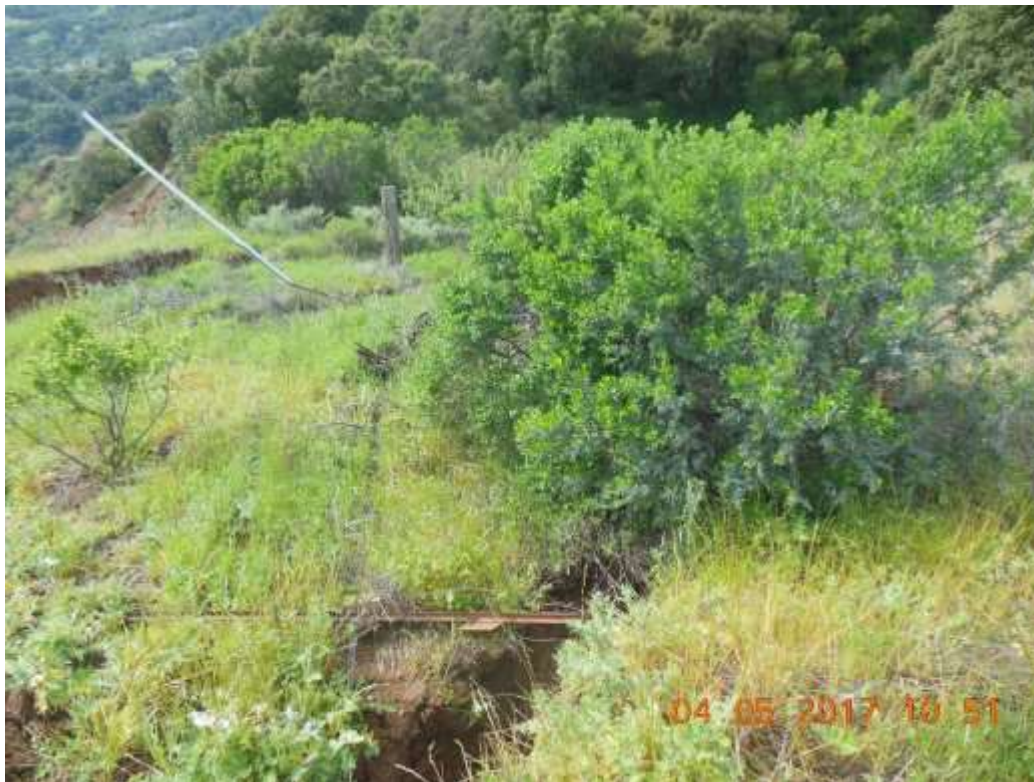
During a recent site visit, County staff observed and photographed indications that failure of the mine's cut slope may have caused ground deformation to occur outside of the mining boundary. (See attached photo of the area along the western property line south of the radio containers.) This may precipitate the need to amend the Reclamation Plan.

Please have your Engineering Geologist evaluate the area to determine if any mitigation measures are needed to prevent further disturbances outside of the mine boundary. In addition, have him examine and evaluate the adequacy of the slope repairs that you have apparently completed on the northern property line where ground movement occurred (where you constructed a retaining wall and buttress fill). Submit a written report that describes his findings and conclusions within 45 days (by June 15th).

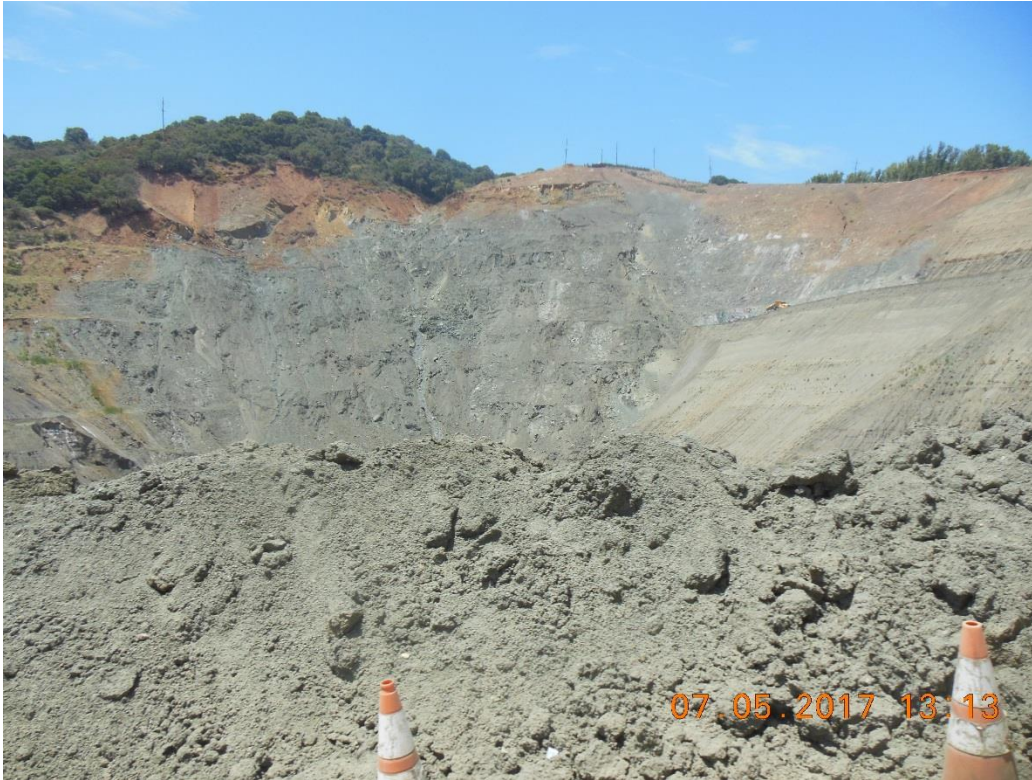
The County inspectors observed areas on the western finished cut slopes that show signs of progressive ground movement between the inspections on July 5, 2017 and September 14, 2017 (see photos in Attachment G). According to the approved Reclamation Plan, these particular slopes were intended to be finished cut slopes. These slope failures have made the finished slopes unstable and, therefore, are inconsistent with the approved Reclamation Plan and constitute a violation of California Code of Regulations 14 § 3704(f).

Photo 1 - Northwest Slope Failure (taken July 5, 2017)

4. Apply for a Reclamation Plan Amendment that includes drawings and supporting documentation showing revised final slopes to correct the violation by restoring slope stability.

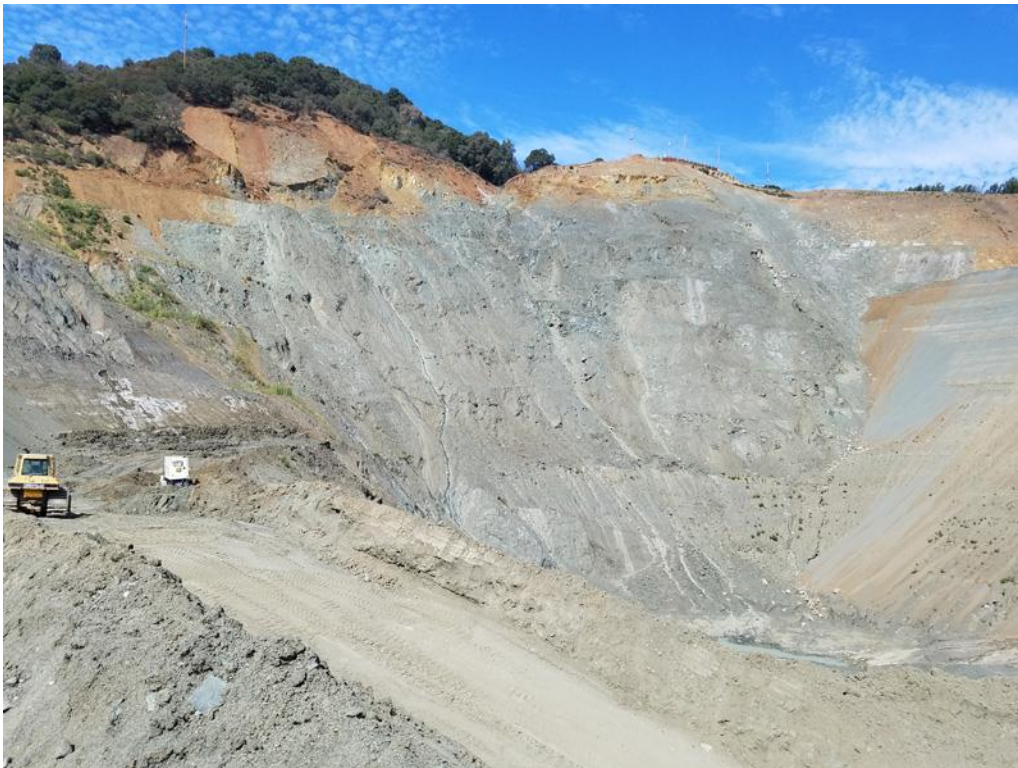
Photo 2 - Northwest Slope Failure (taken September 14, 2017)

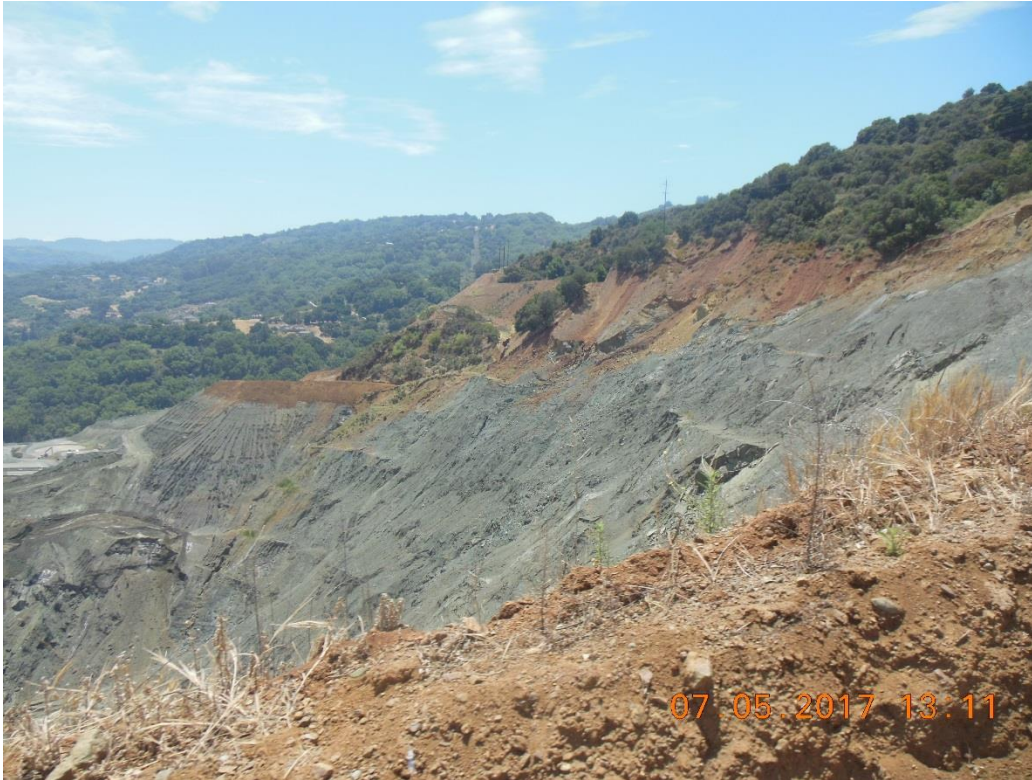
Photo 3 - Side view of Northwest Slope Failure (taken July 5, 2017)

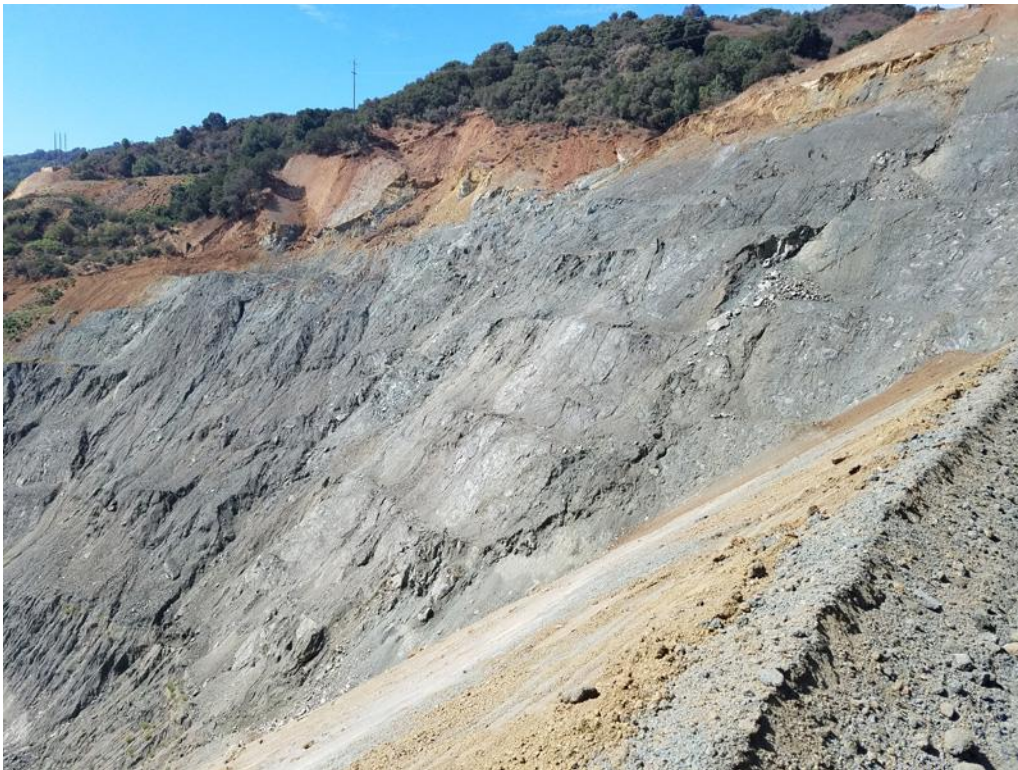
Photo 4 - Side view of Northwest Slope Failure (taken September 14, 2017)

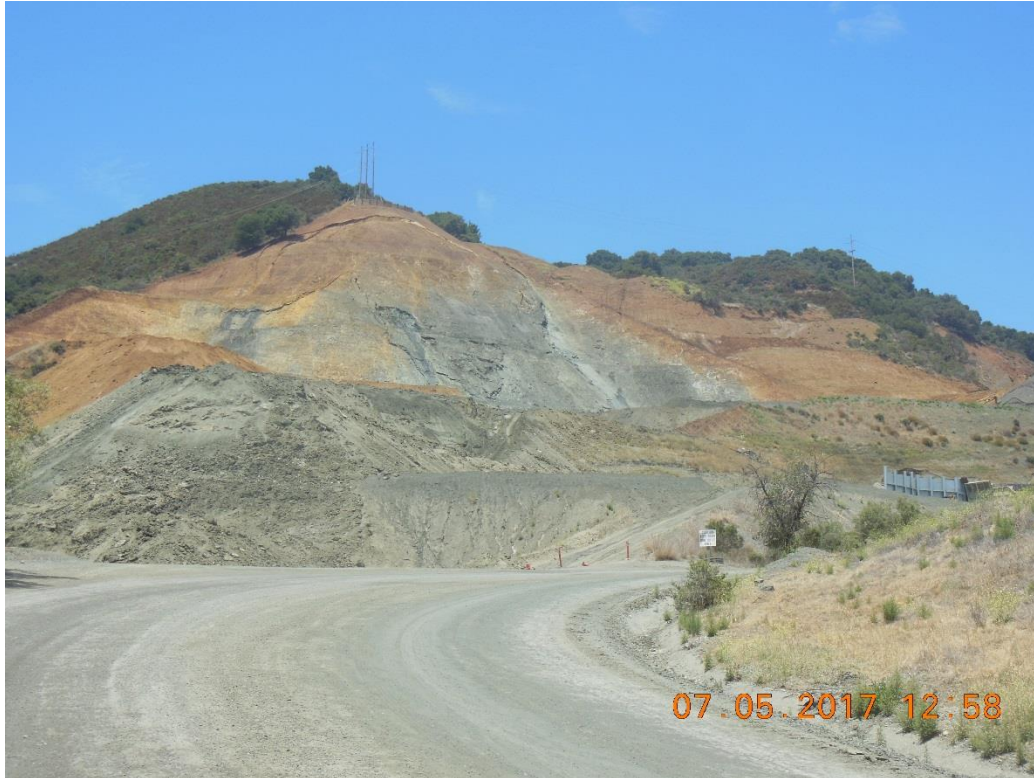
Photo 5 - Southwest Slope Failure (taken July 5, 2017)

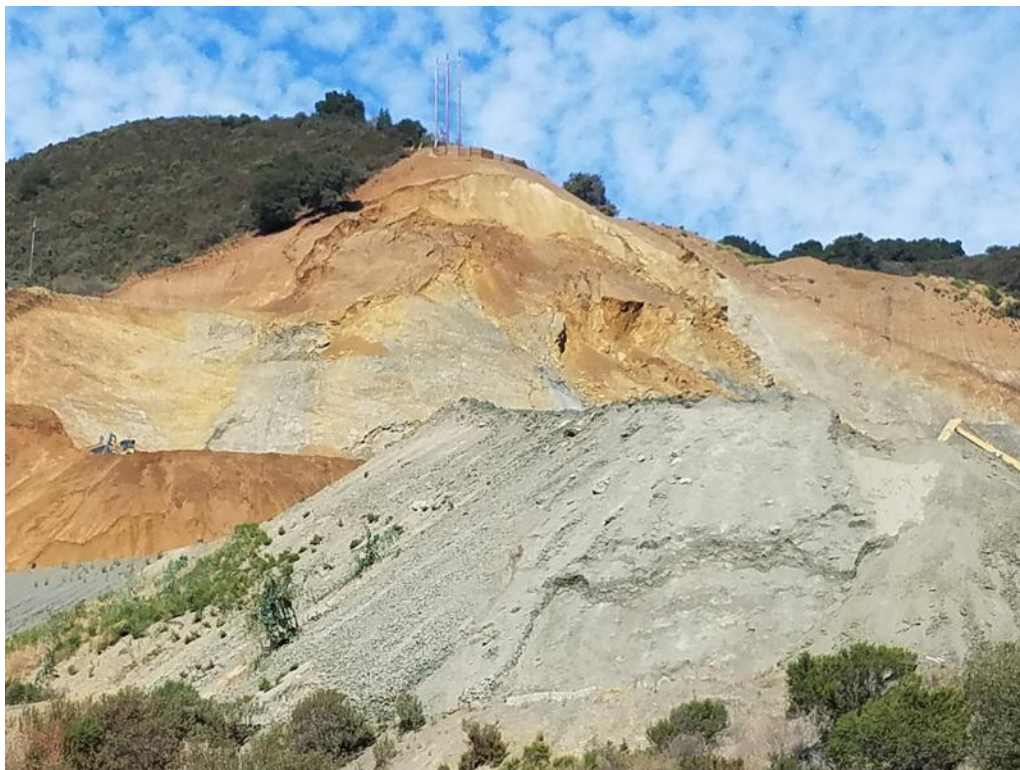
Photo 6 - Southwest Slope Failure (taken September 14, 2017)

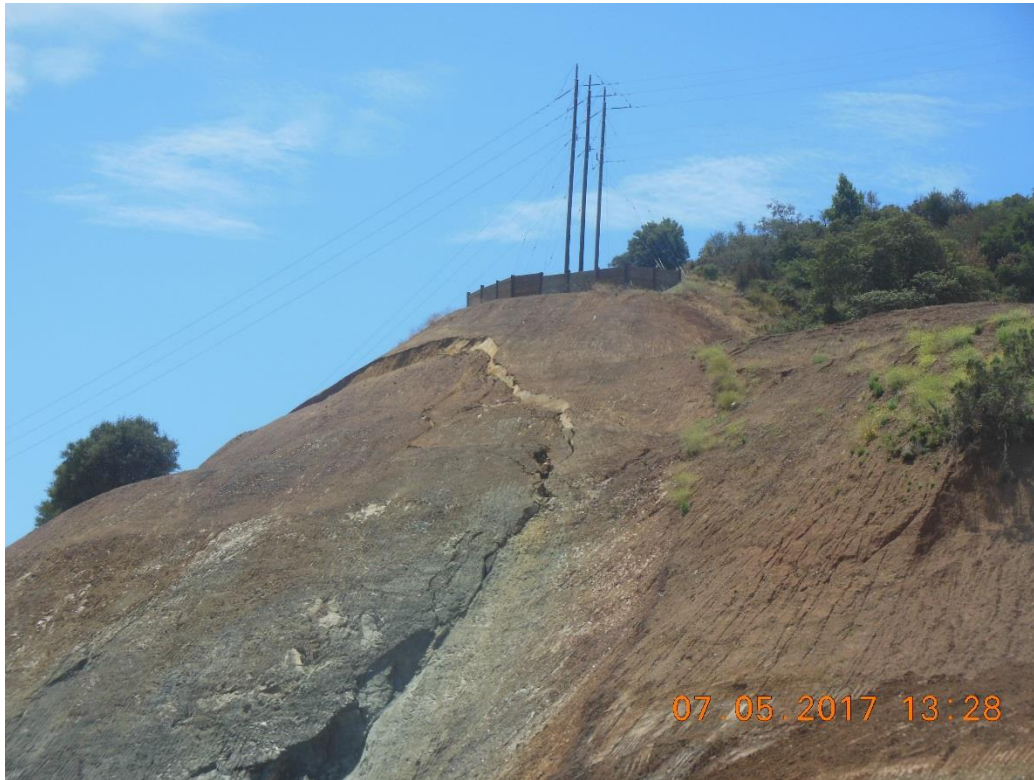
Photo 7 - Side view of Southwest Slope Failure (taken July 5, 2017)

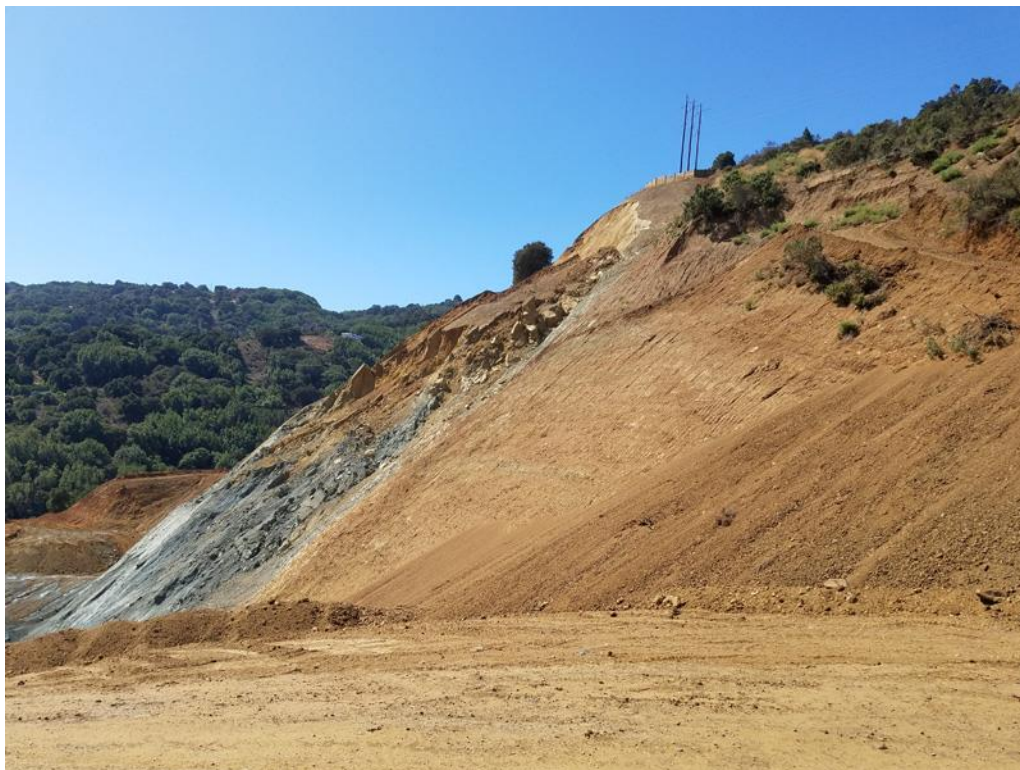
Photo 8 - Side view of Southwest Slope Failure (taken September 14, 2017)

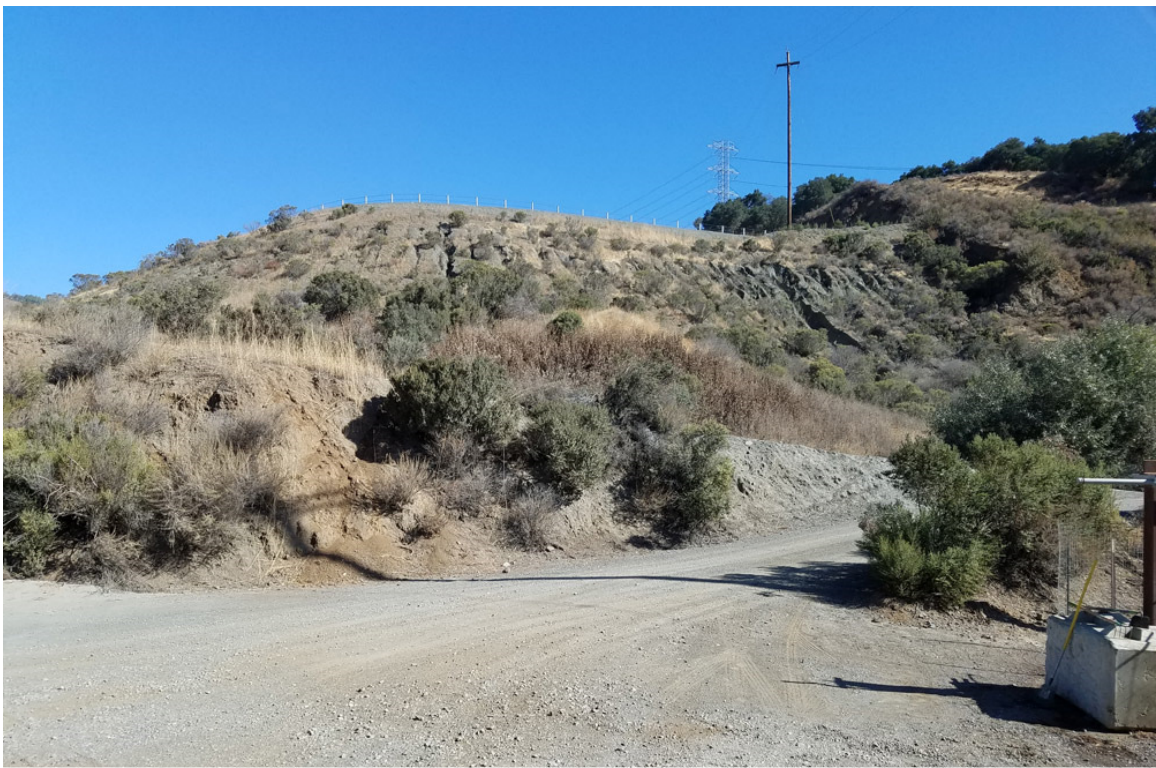
Photo 6 (taken 9-15-2016): Erosion rills on fill slope above main haul road.

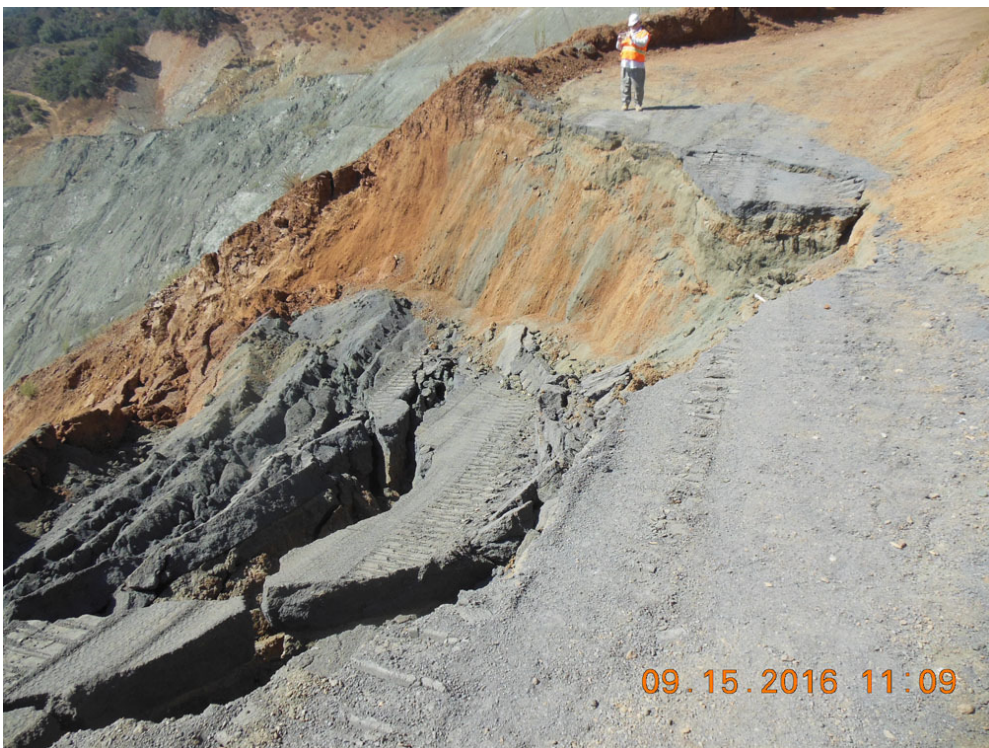
Photo 8 (taken 9-15-2016): Headscarp of failure on north high wall and perimeter road.

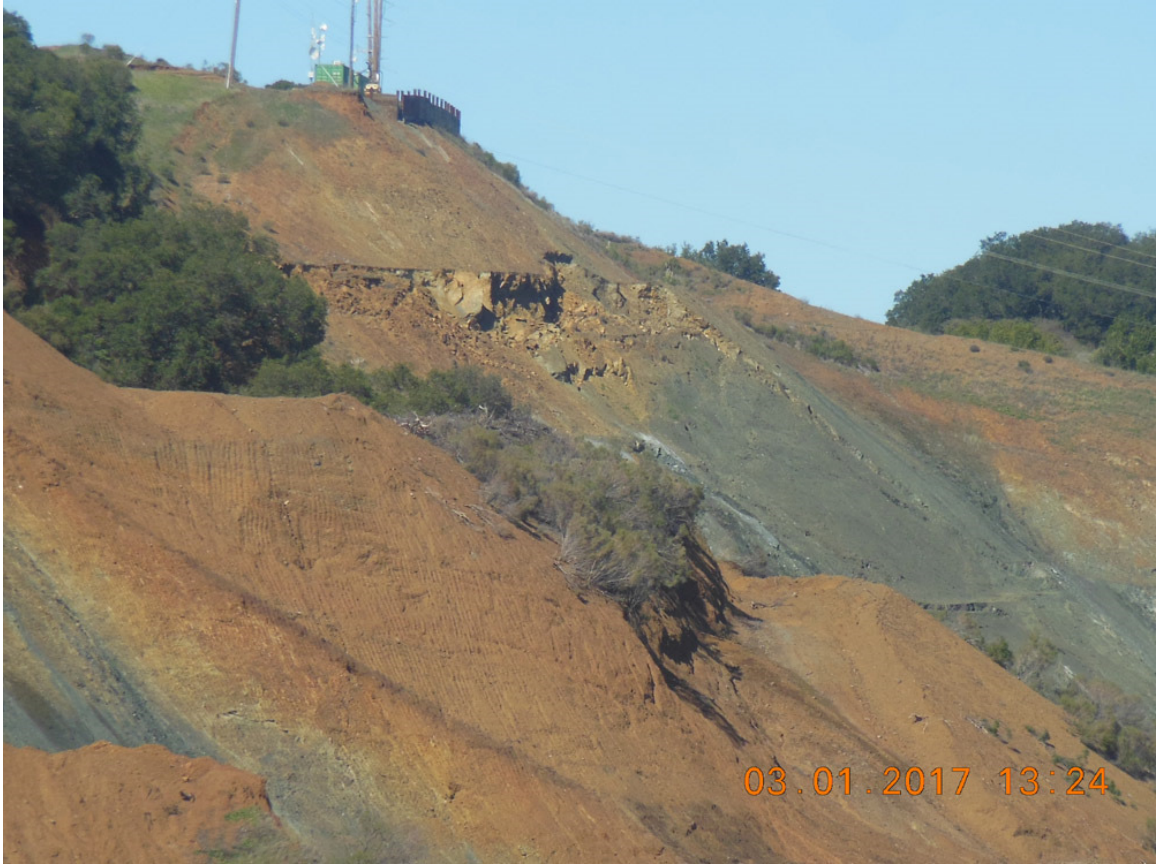
Photo 14 (taken 3-1-2017): Slope failure on western high cut wall.

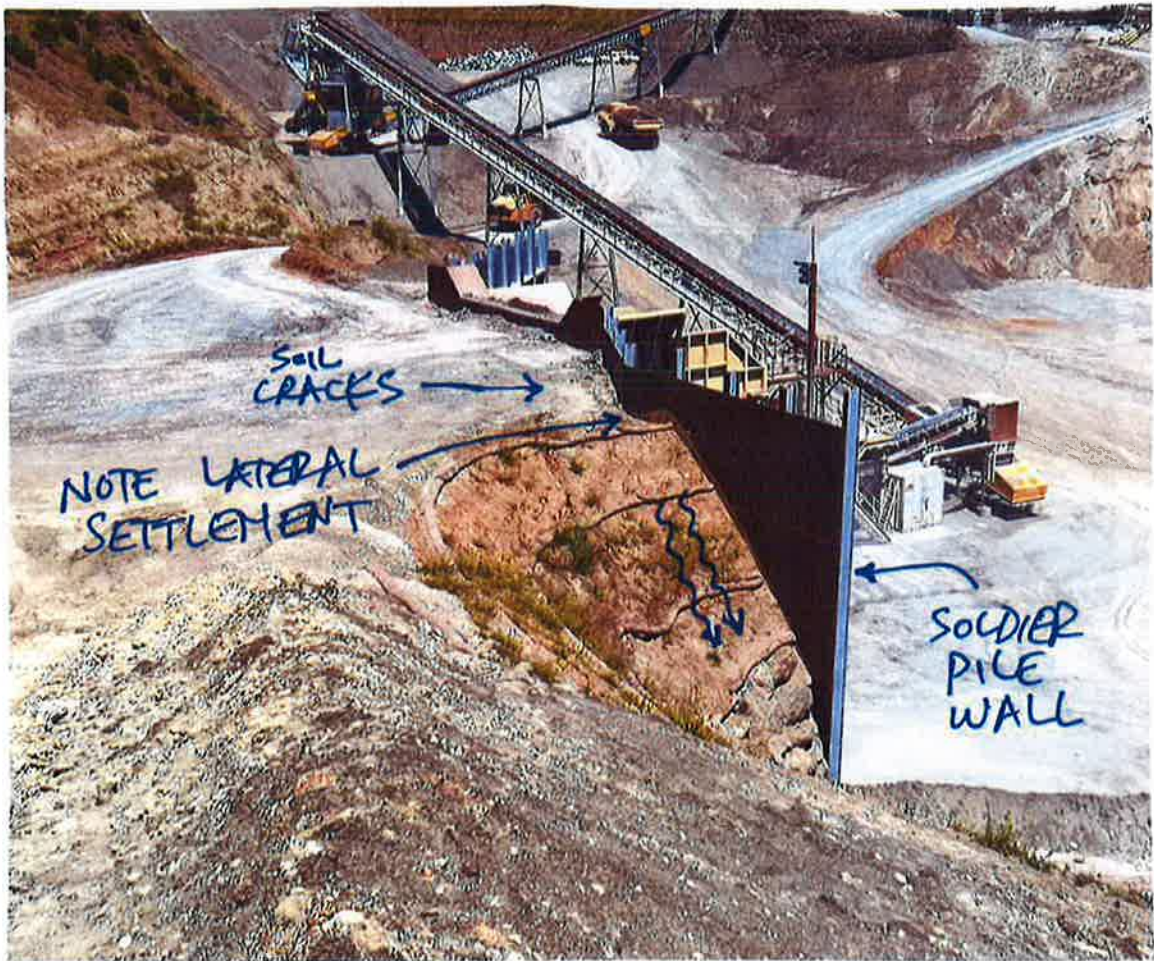
Project Number:	SCQ-1	JAW CRUSHER PAD	Plate
Date:	MAY '16		
Entry By:	SB	CUPERTINO,	12
Checked By:		CALIFORNIA	
Date:

MINOR CREEP & SETTLEMENT

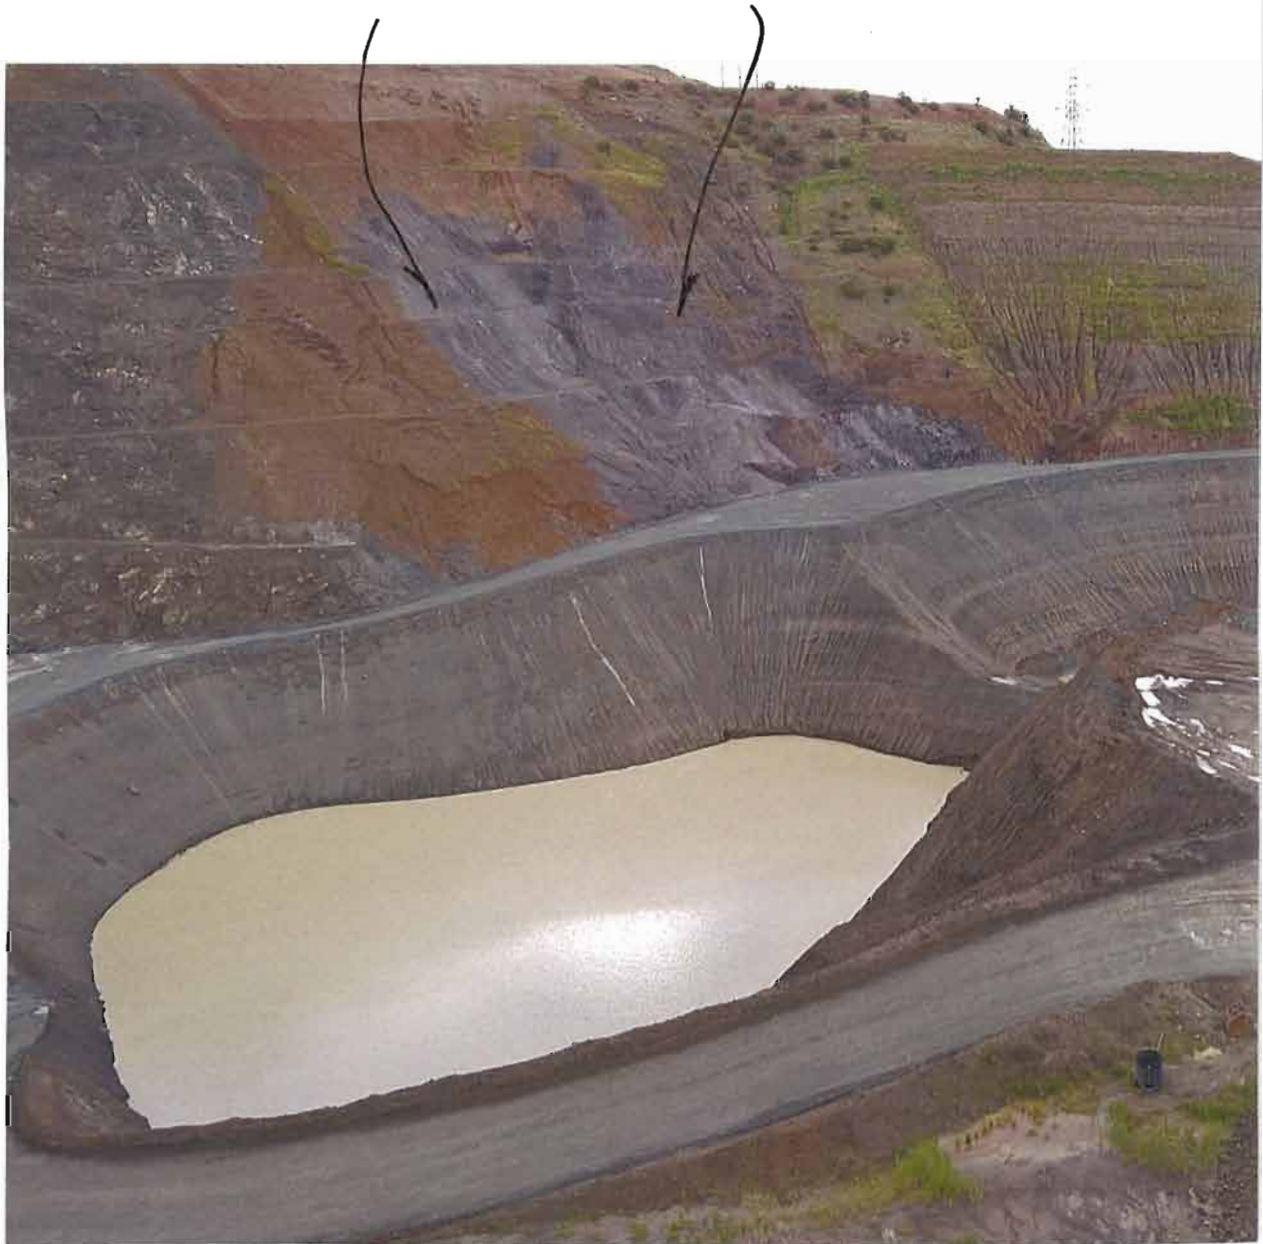
Plate 2

Note
Landslide Activity Upslope of Buttress

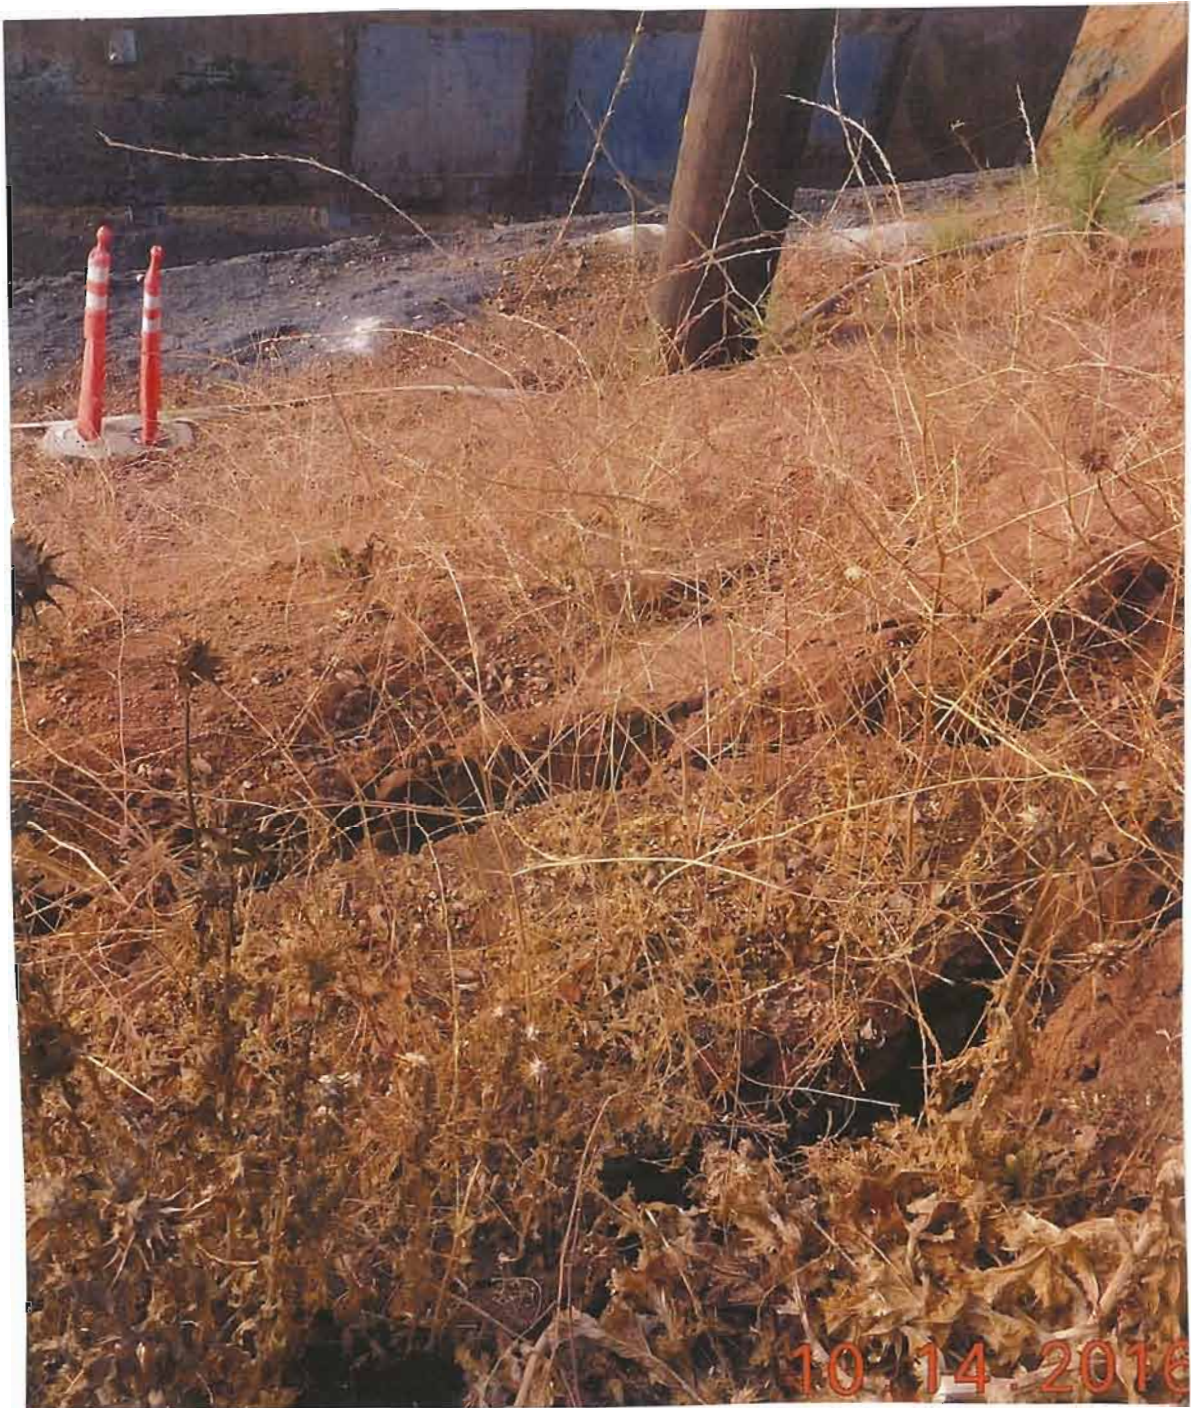
Plate 7

Open Soil Crack Marking Landslide Headscarp
