**SURFACE MINING INSPECTION REPORT**

I. Mine Name (As Shown on Approved Reclamation Plan) <b>Stevens Creek Quarry</b>	Inspection Date: <b>9-14-2018</b>	CA MINE ID# <b>91- 43-0007</b>
---	--------------------------------------	-----------------------------------

### **2018 Annual SMARA Inspection of**

### **Stevens Creek Quarry**

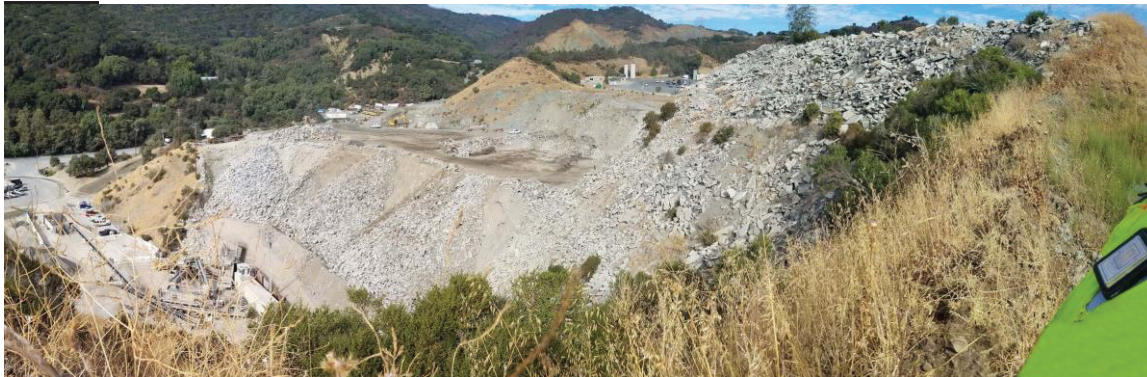
Recycling Operations: The northeastern portion of Parcel A was previously mined and is currently used for (1) storage of overburden materials to eventually be used to backfill the lower portion of the cut slopes of the Quarry pit on Parcel B, and (2) recycling of concrete, asphalt and topsoil that are brought to the site from nearby construction projects. Large stockpiles of these imported materials are placed along the northern portion of the Parcel A boundary and partially bury the previously mined slope. The recycling equipment is located north of the Quarry offices on Parcel A.

*Photo 1: Recycling operation on Parcel A.*

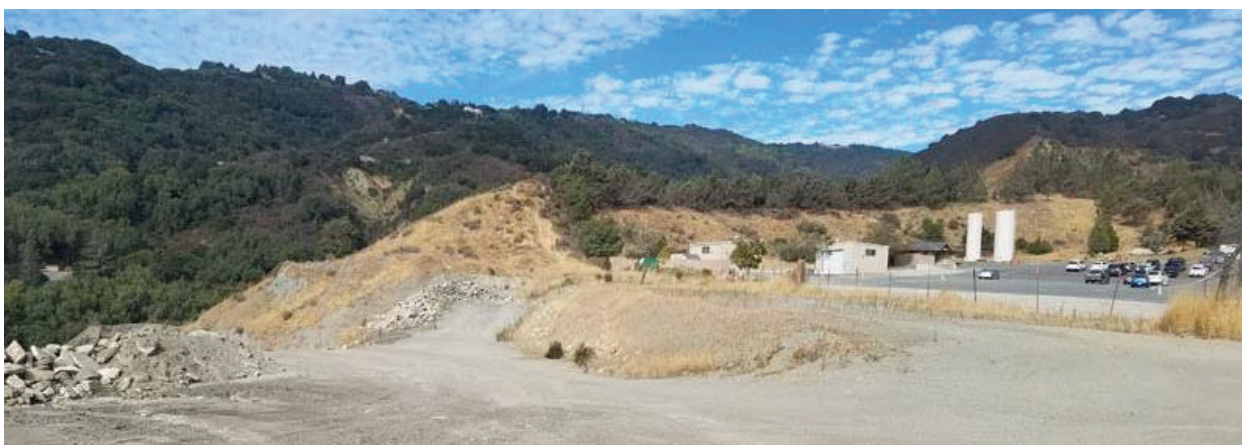
Slump Repair: An area located east of the recycling operation on Parcel A had a slump repair (2012) that is now buried and appears stable.

*Photo 2: Repaired slope between Parcel A and gun club.*

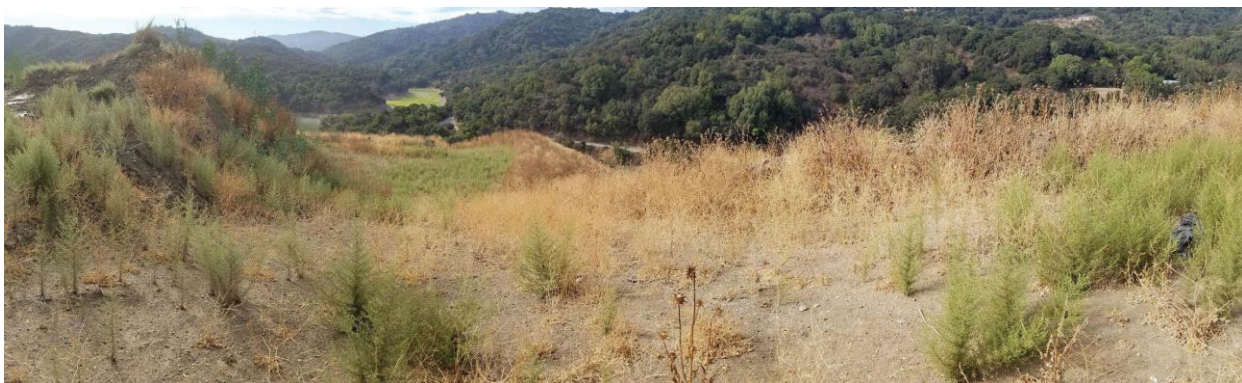
Stockpile Parcel A: Inspectors observed a large stockpile of topsoil on Parcel A.

*Photo 3: Stockpiled soil on Parcel A.*

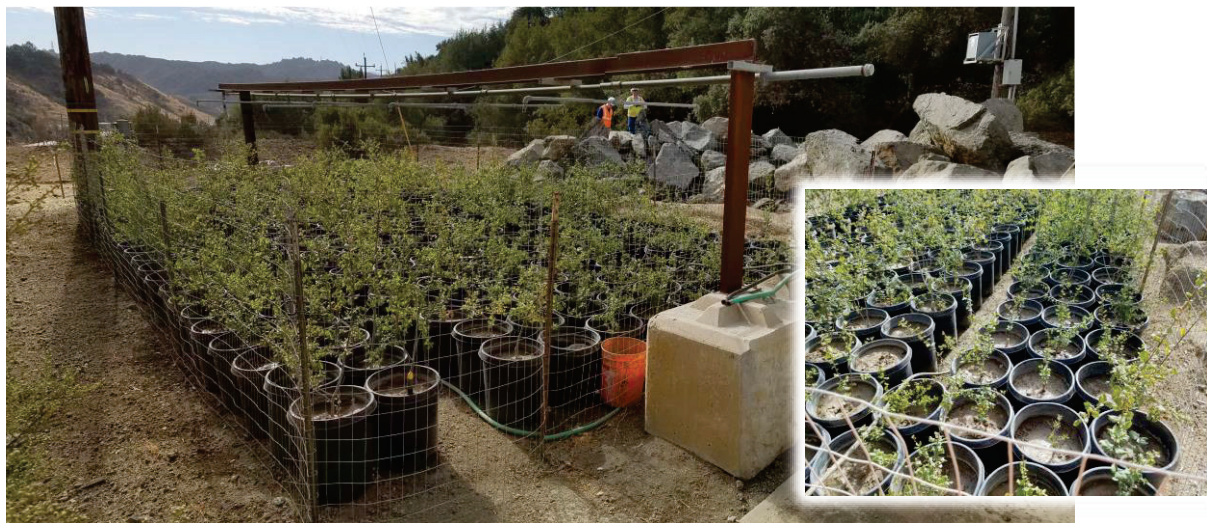
Photo 4: Nursery for germinating native oak trees with close-up inset.

1. *Revegetation:* Operator has installed a nursery with an automatic watering system to germinate and raise native oak trees. County recommends the Mine Operator establish vegetation test plots on quarried conditions similar to those that will exist for reclamation to prove the viability of proposed reclamation plantings. County recommends Mine Operator retain a botanist or

qualified biologist for the installation and reporting to achieve results for revegetation in accordance with the standards of the Reclamation Plan.

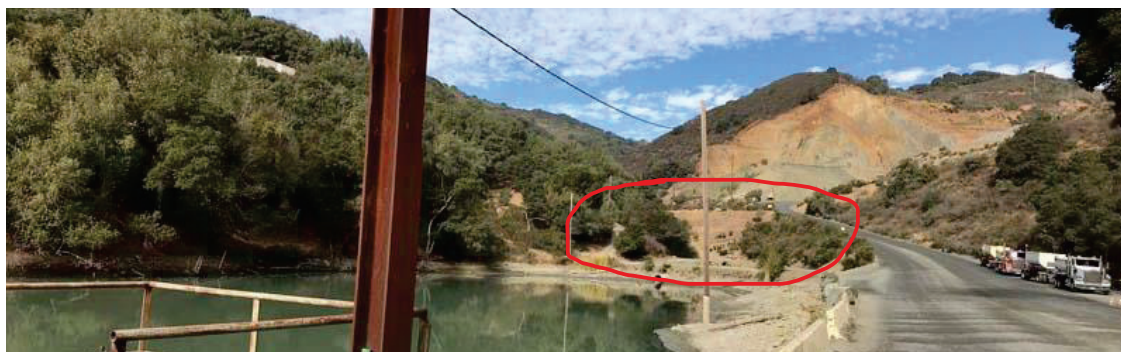
Photo 5: Face of dam between upper and middle settling basins.

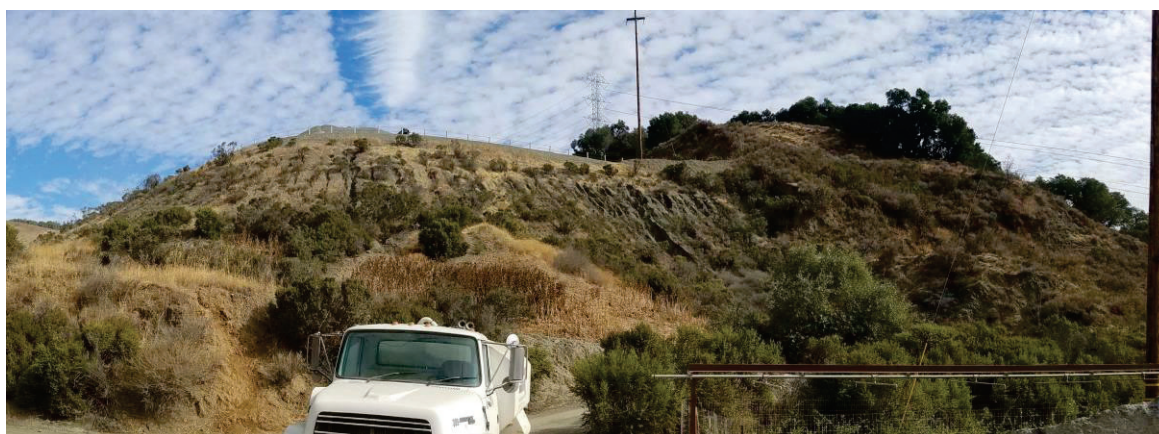
Stormwater Best Management Practices (BMPs): County observed ongoing erosion gullies located on fill slopes (Parcel B) above haul road. Erosion control and BMP measures, including hydroseeding for winter, should be implemented at all locations where active grading or disturbed soil exists (new crusher, fill slope near creek, etc.). The County intends to conduct a final inspection of the completed work.

Photo 6: Erosion rills on fill slope above main haul road.

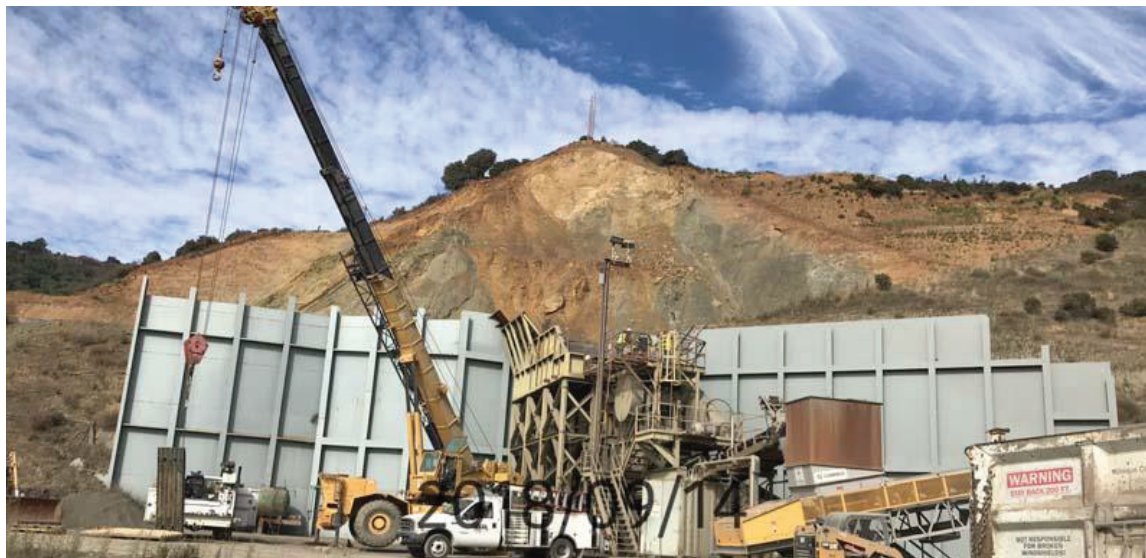
Crusher and Retaining Wall: Mining is conducted in Parcel B in a north-northwest trending quarry where Franciscan greenstone bedrock is extracted. Equipment for crushing and sorting rock materials is located on Parcel B. Inspectors observed crusher equipment was relocated to the southeast portion of Parcel B. The Quarry excavated the soil from behind the north wall, replaced the wall panels, and recompacted the slope behind the wall.

*Photo 7: Relocated rock crusher.*

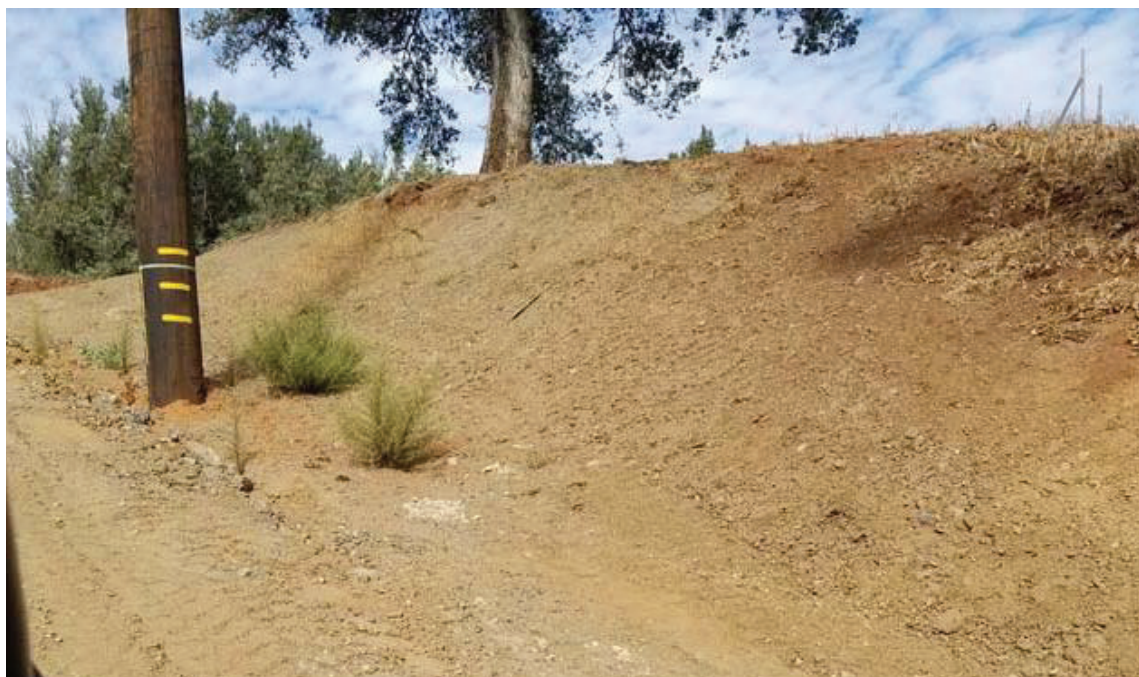
County inspectors observed the repair of the perimeter access road which was previously disrupted by the headscarp of a large landslide.

*Photo 8: North perimeter road cut slope. Grading has obliterated the ground movement cracks observed in 2017.*

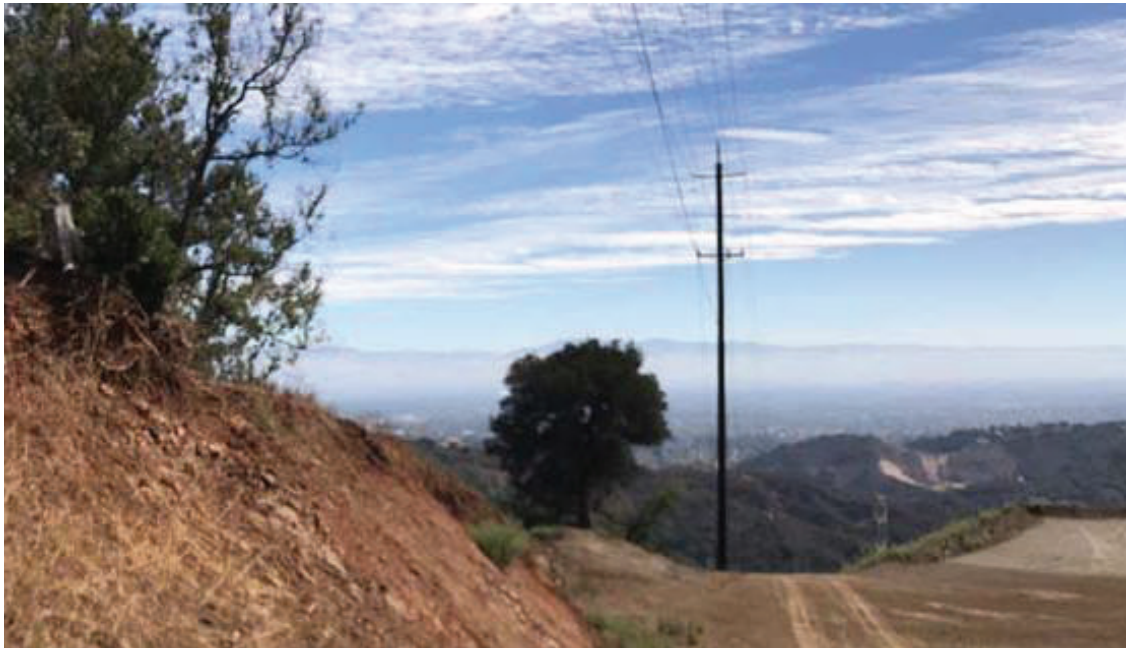
*Photo 9: Area of former retaining wall above north high wall.*

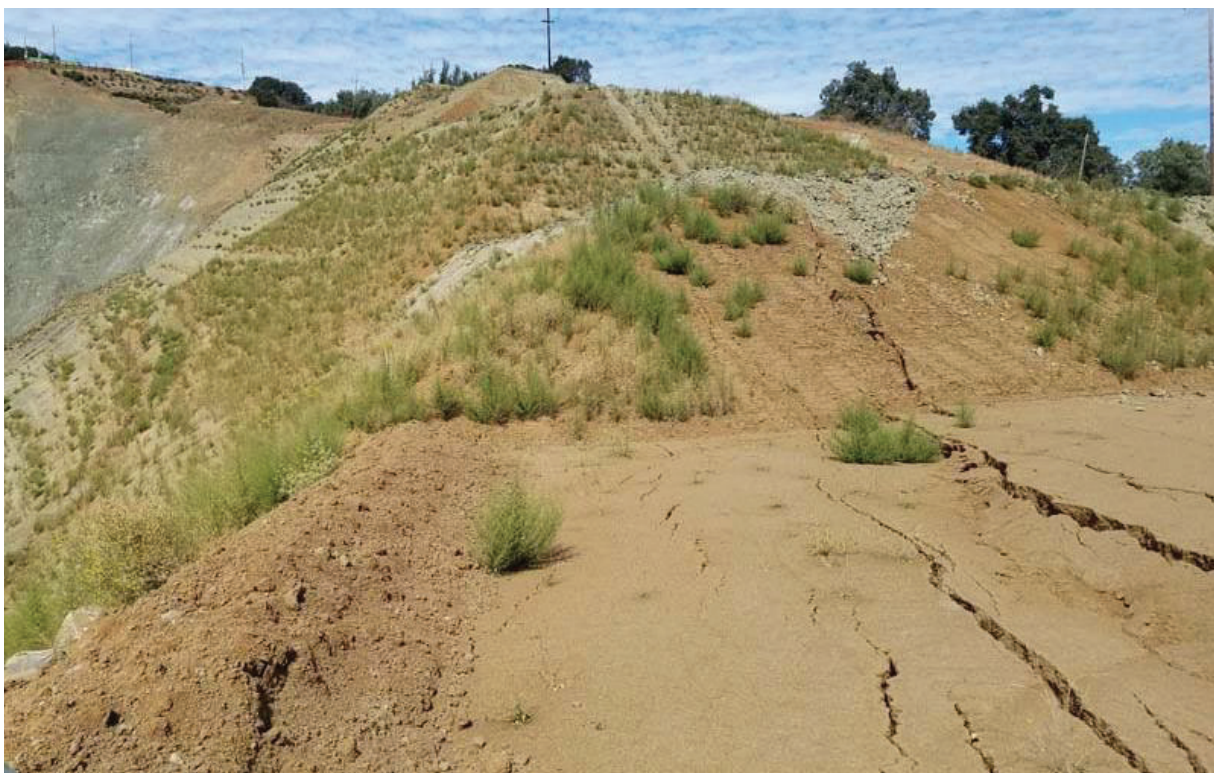
*Photo 10: Ground crack on top of buttress fill of north high wall.*

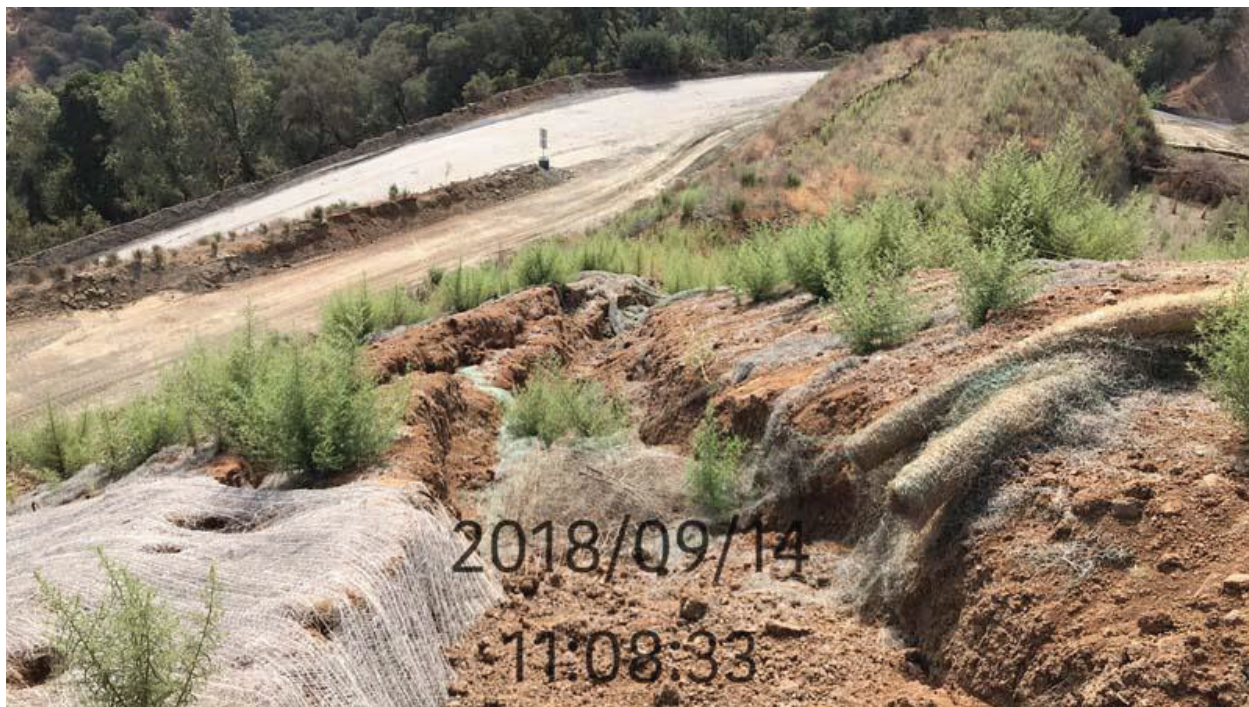
*Photo 11: Ground crack on east-facing fill slope near northeastern corner of property. Haul road to Lehigh visible.*

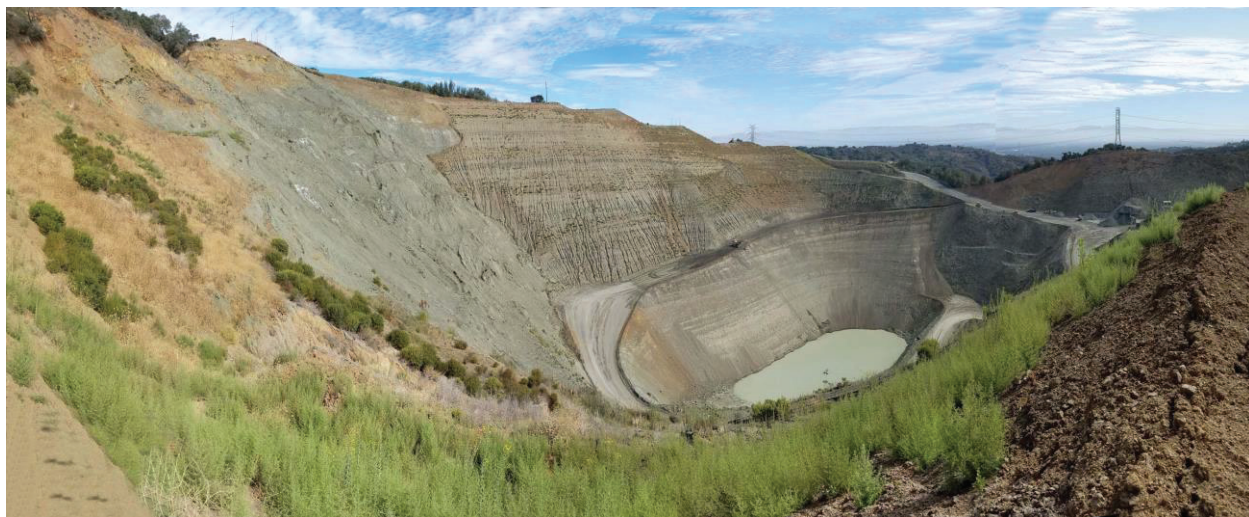
Operator submitted a geologic report dated 1-29-2017 that recommended an additional width (200 feet) of buttress be added to the toe of the slope in order to achieve an acceptable factor of safety. As of the date of the inspection, a large buttress fill was being placed against the lower and middle portions of the slope below the north slope.

*Photo 12: Buttress fill on north high wall. West side of pit visible on the left.*

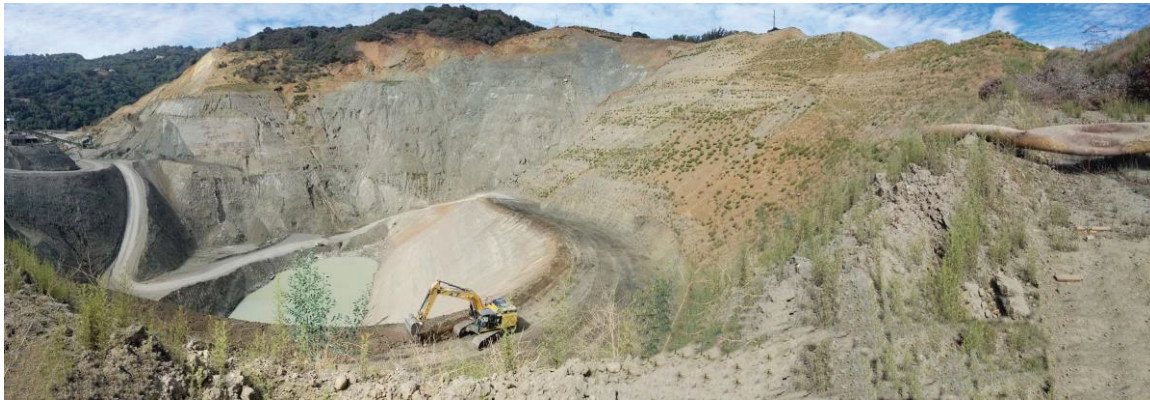
*Photo 13: Buttress fill on north high wall. West side of pit visible on the left.*

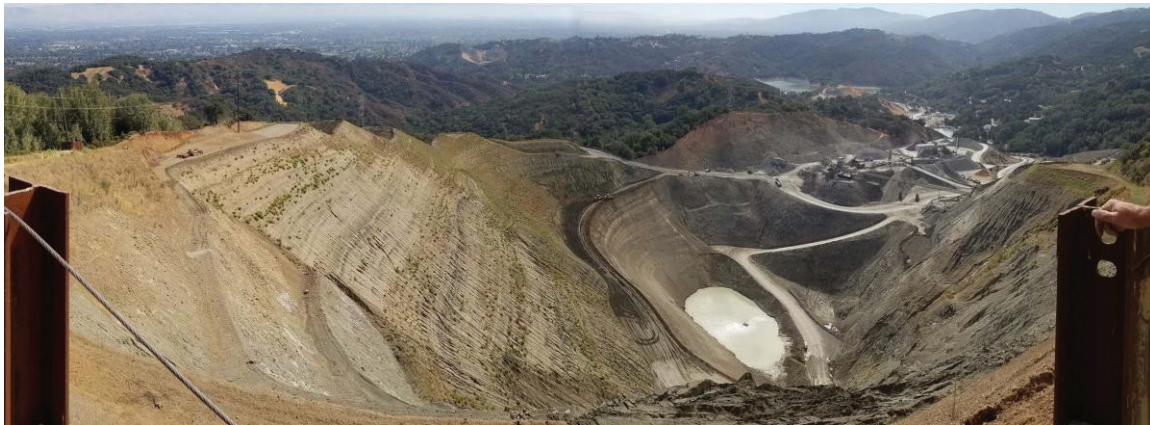
*Photo 14: Panorama of buttress fill below retaining wall on northwest high wall.*

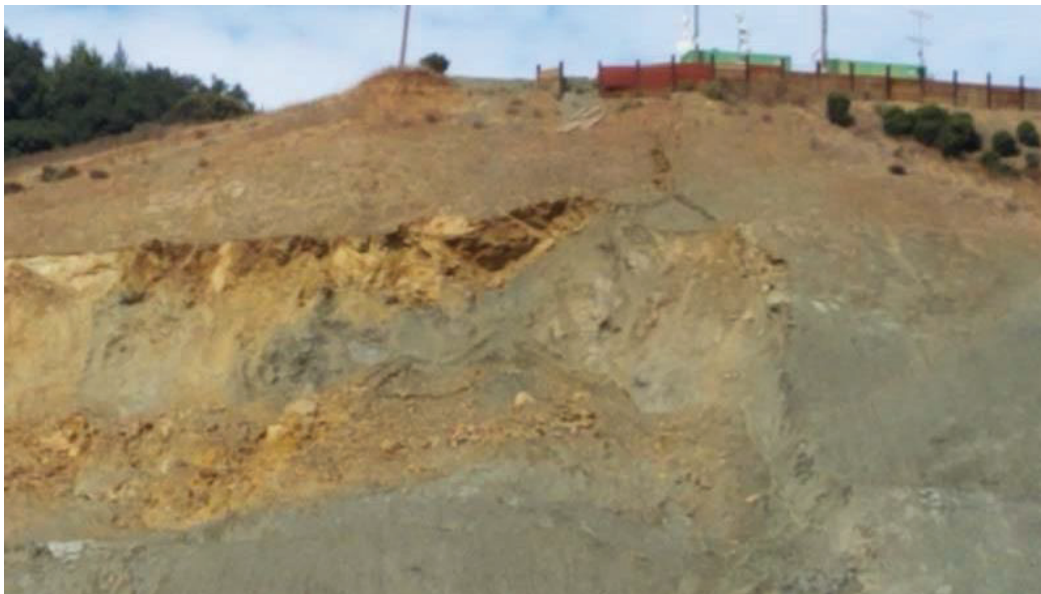
Another slope failure has disrupted the cut slope on the northwest side of the quarry pit. The headscarp of that failure has affected the southern end of the retaining wall built to protect the radio shack at the top of the slope.

*Photo 15: Slope failure on western high cut wall.*

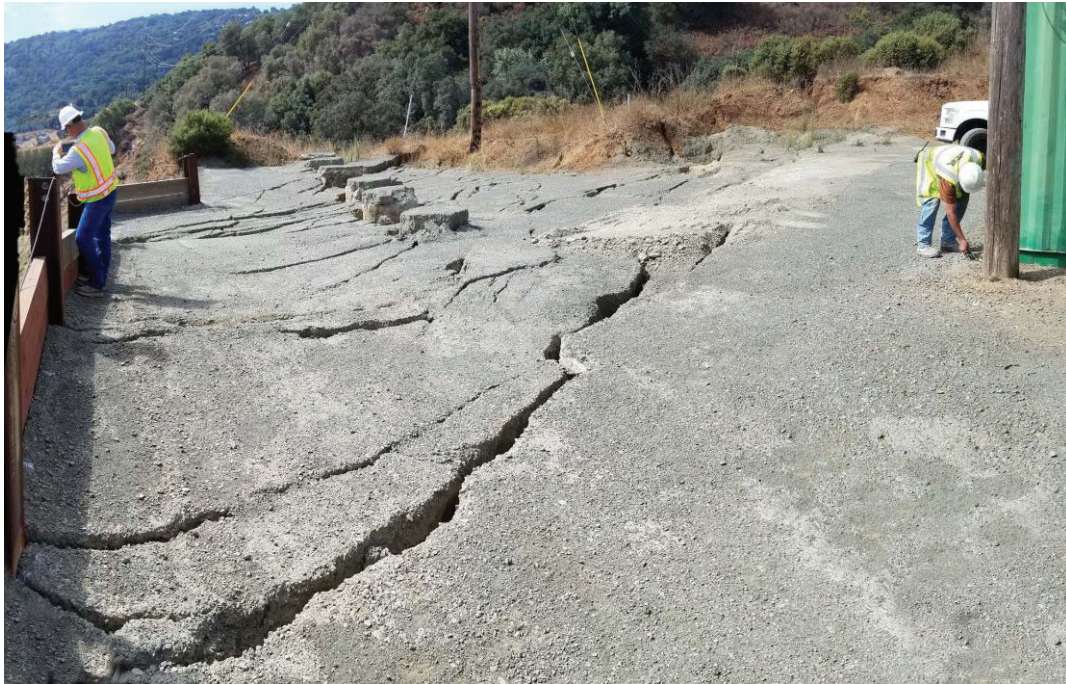
The ground surface adjacent to the radio shack has dropped, causing the protrusion of concrete piers. Associated ground cracks were observed at the top of the slope failure, west of the western property boundary.

*Photo 16: Ground cracks and subsidence at northwest property line.*

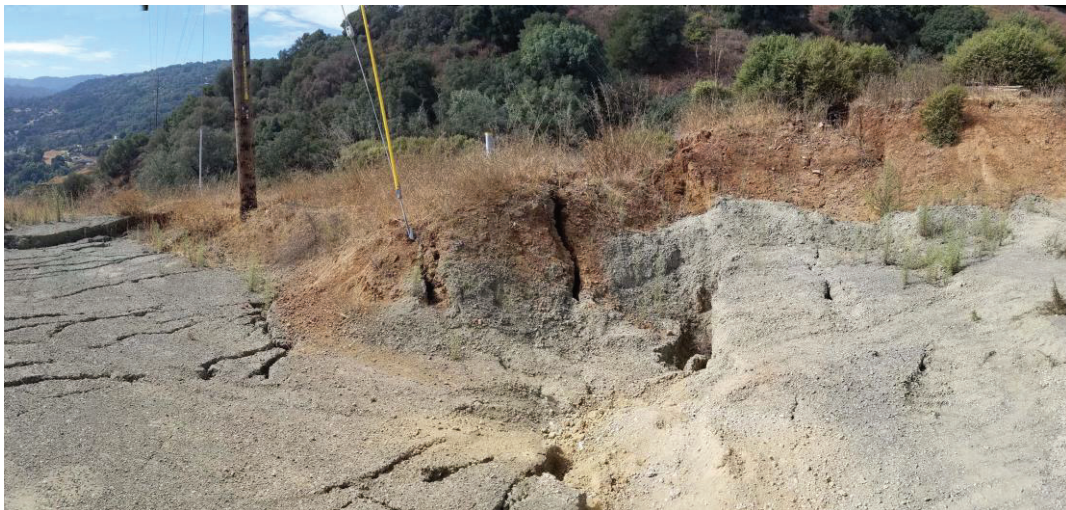
*Photo 17: Ground cracks and headscarp beyond northwest property line.*

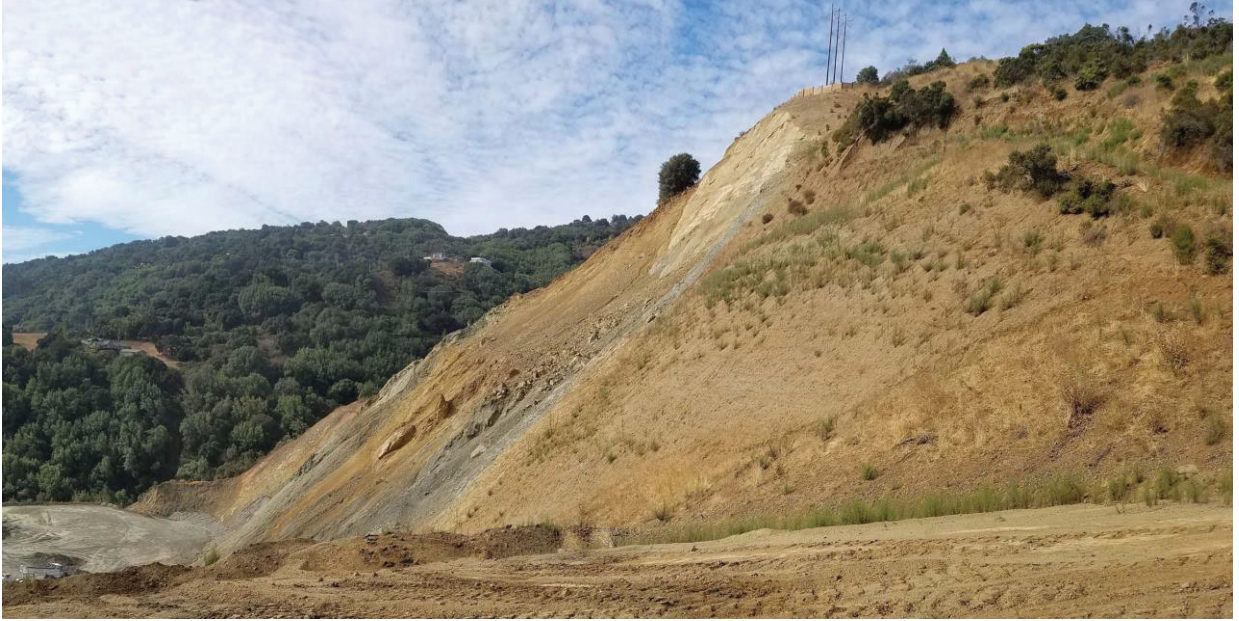
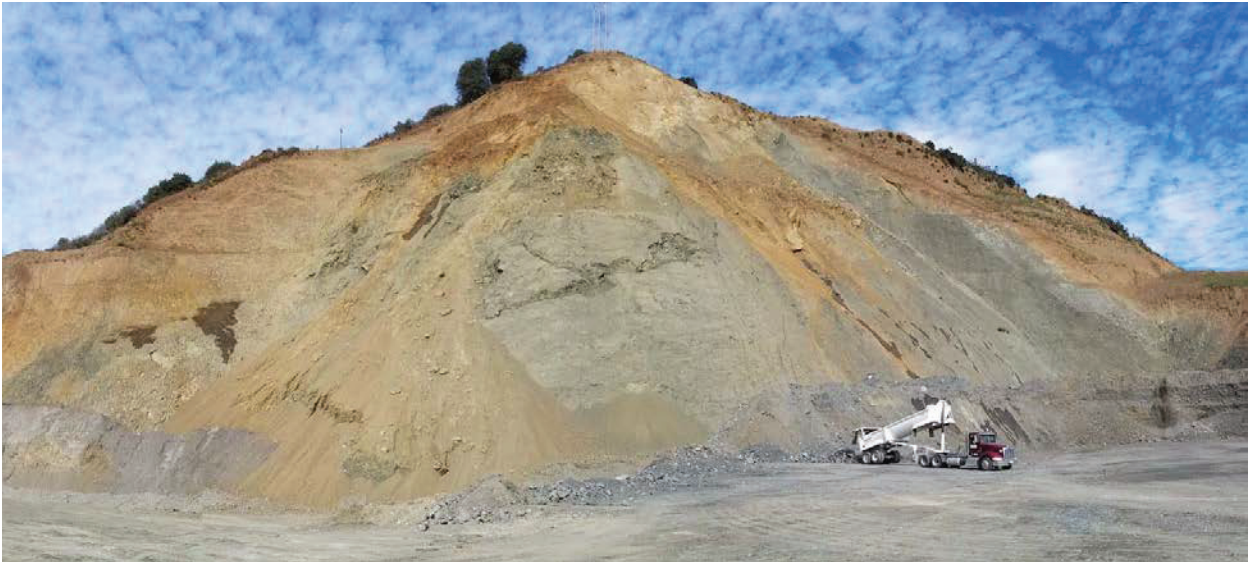
Another slope failure has disrupted the cut slope on the southwest side of the quarry on Parcel B. Inspectors observed the headscarp of the failure approaching the retaining wall built to protect three PG&E power poles. Landslide debris was observed to have accumulated at the toe of the slope.

*Photo 18: Slope failure on southwestern high cut wall, looking south. (Profile view)*

*Photo 19: Slope failure on southwestern high cut wall, looking west. (Head-on view)*

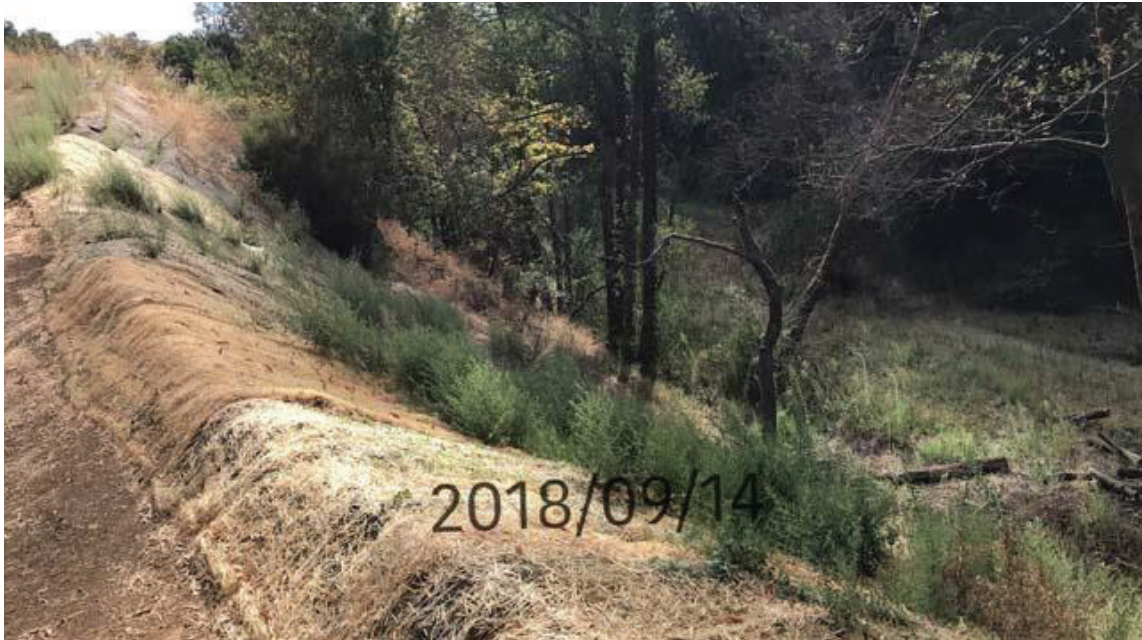
In 2017, County observed a slope failure above Rattlesnake Creek along a road towards the west end of Parcel B. The Quarry built a fill slope to repair the road and installed jute netting on said slope.

*Photo 20: Regraded slope along the north side of Rattlesnake Creek.*

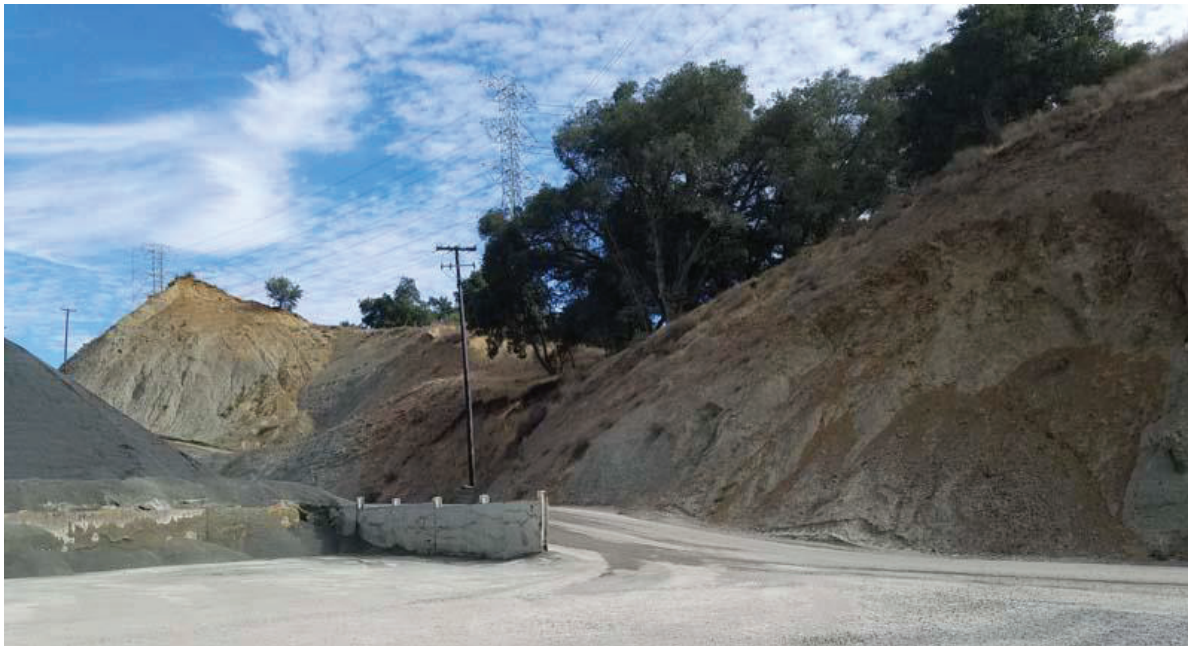
A slope adjacent to the operating equipping toward the southeastern corner of Parcel B has had a shallow failure. Although the ground has moved, the County expects this area to be corrected during final reclamation.

*Photo 21: Shallow failures of cut slope along east side of Parcel B.*

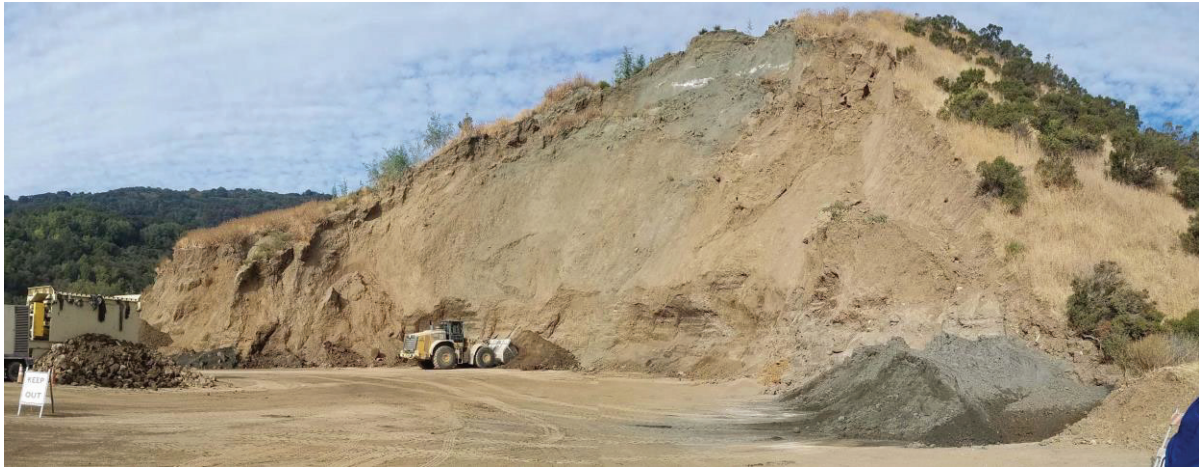
*Photo 22: Dirt stockpile at eastern portion of Parcel A.*

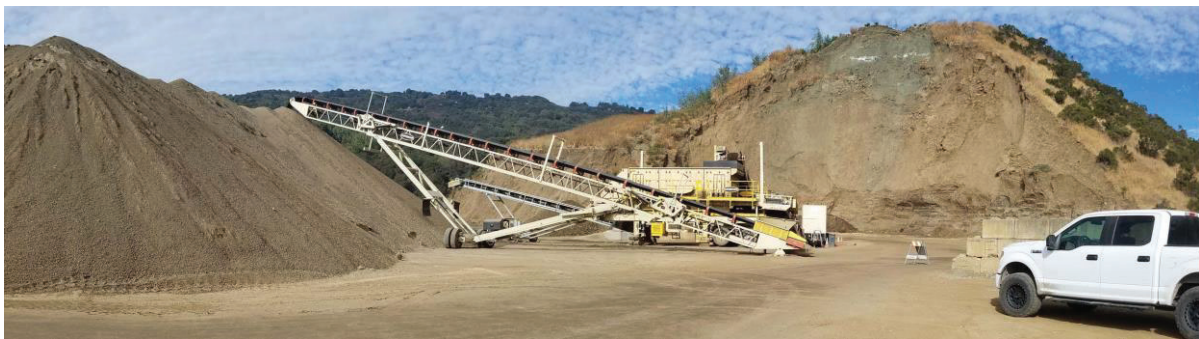
*Photo 23: Dirt stockpile processing at eastern portion of Parcel A.*

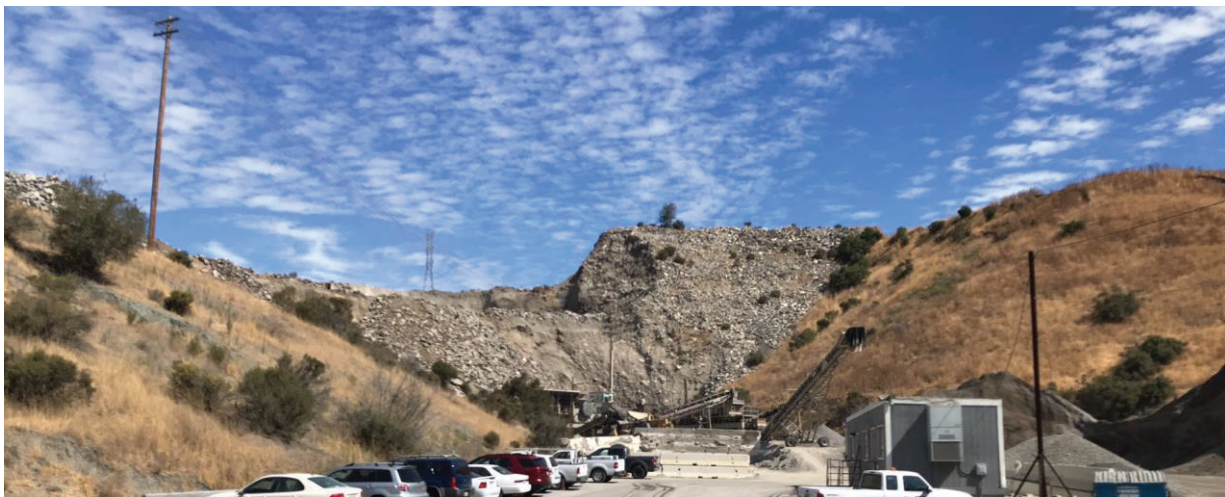
*Photo 24: Recycle stockpile has been reduced in size.*

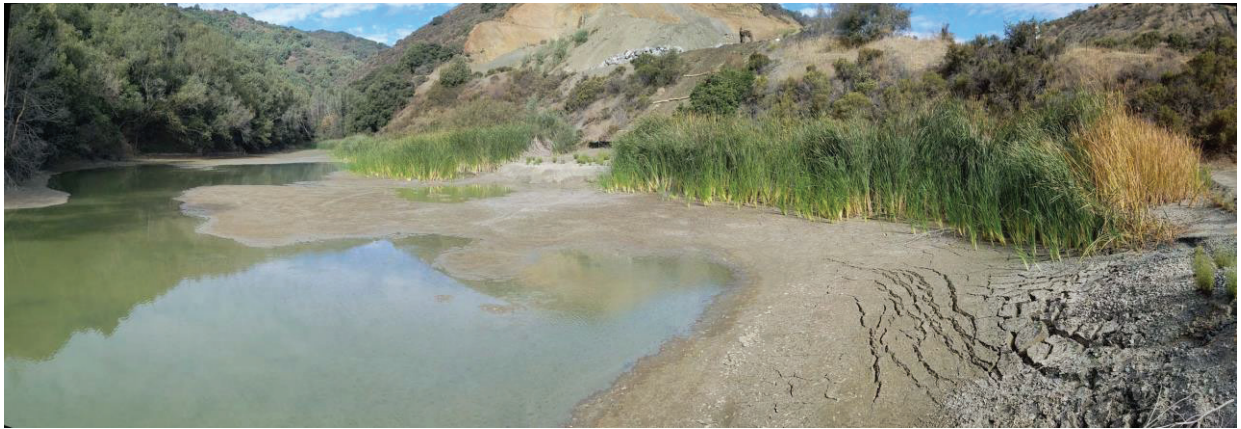
*Photo 25: Upper Settling Basin showing area where discharge pipe was removed and straw wattles placed.*

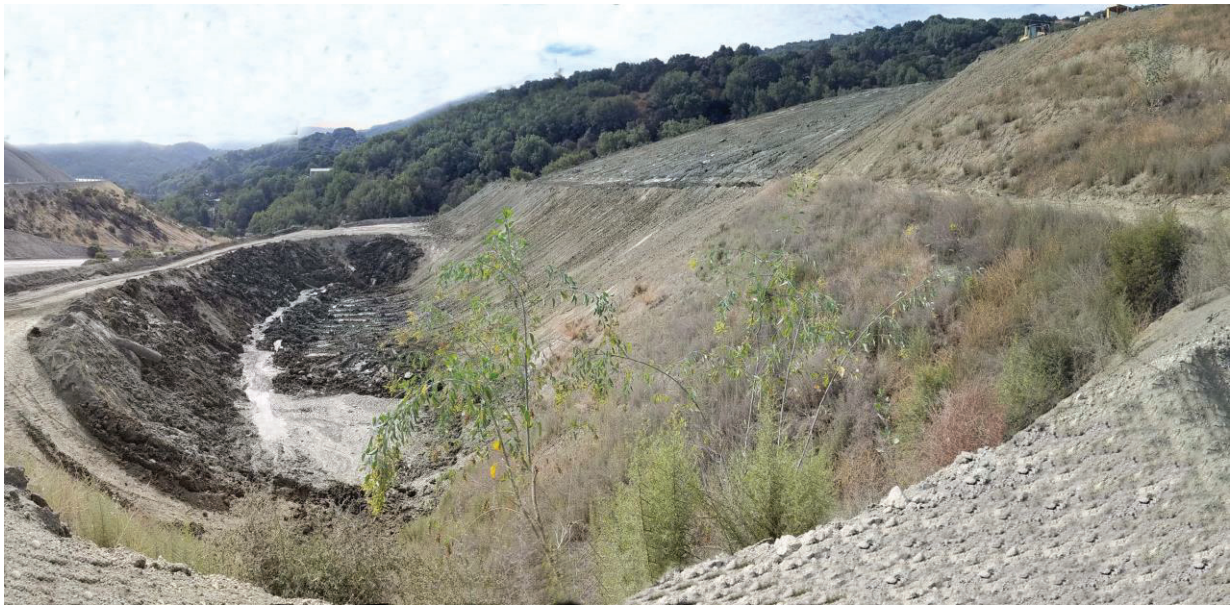
*Photo 26: Pond 5.*

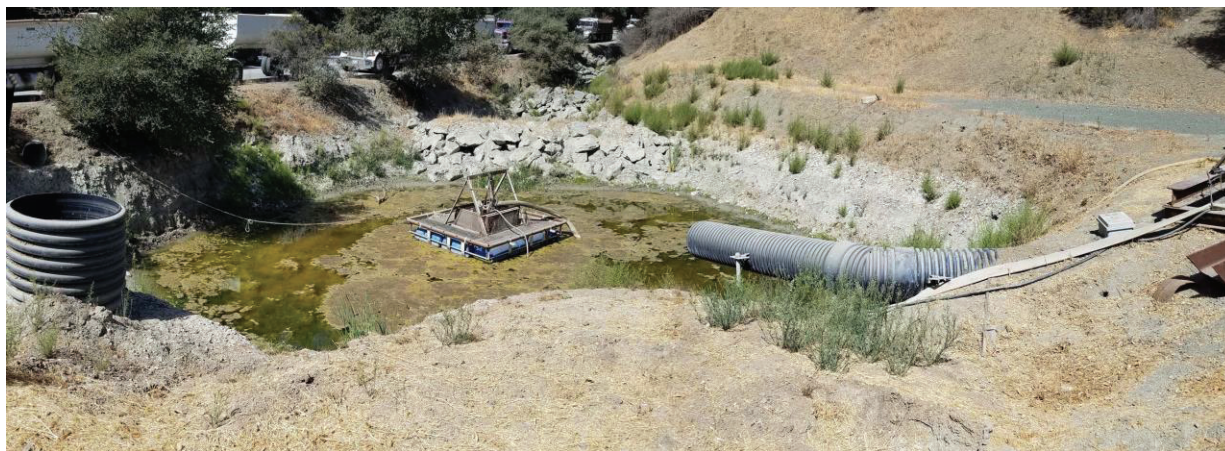
*Photo 27: Pond west of office.*

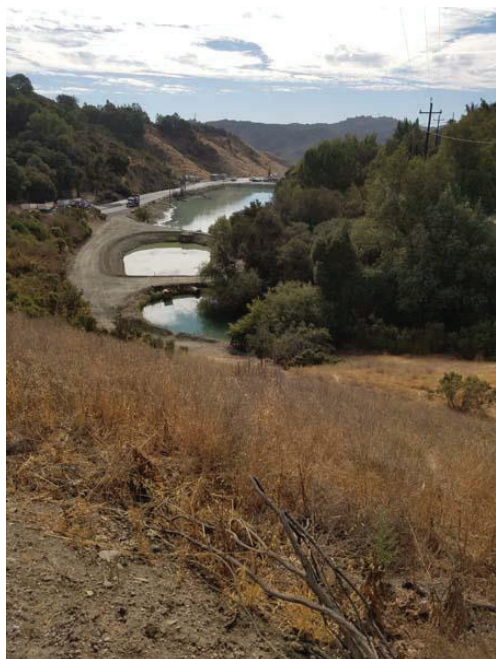
Settling Basins: Stormwater from the Quarry is stored in a series of settling basins (Upper Settling Basin, Middle Settling Basin, Lower Settling Basin) located in the southern portion of the site. Two of these basins (Middle and Lower) are in Parcel A, the Lower basin being the largest. The settling basins eventually discharge off-site via a southeastern stormwater detention basin adjacent to the mine entrance. Discharge water enters a tributary feeding Stevens Creek Reservoir. An earthen dam (approximately 55 feet high) is located between Upper Settling Basin and Middle Settling Basin. The southern portions of the dam and Upper Settling Basin were previously located beyond the property line. A lot line adjustment was recorded on July 19, 2017 to expand the property boundary to include these features. A Reclamation Plan Amendment (RPA) is needed to modify the boundary of the Reclamation Plan area to include the entirety of the Upper Settling Basin and dam. The County identified this violation and sent the Quarry a Notice of Violation in September 2017. The Quarry subsequently entered into a Stipulated Order to Comply and Compliance Agreement with the County on May 16, 2018. The Quarry is currently performing an in-depth geologic evaluation that will inform the Reclamation Plan Amendment process in the near future.

*Photo 28: Middle and Lower Settling Basins.*

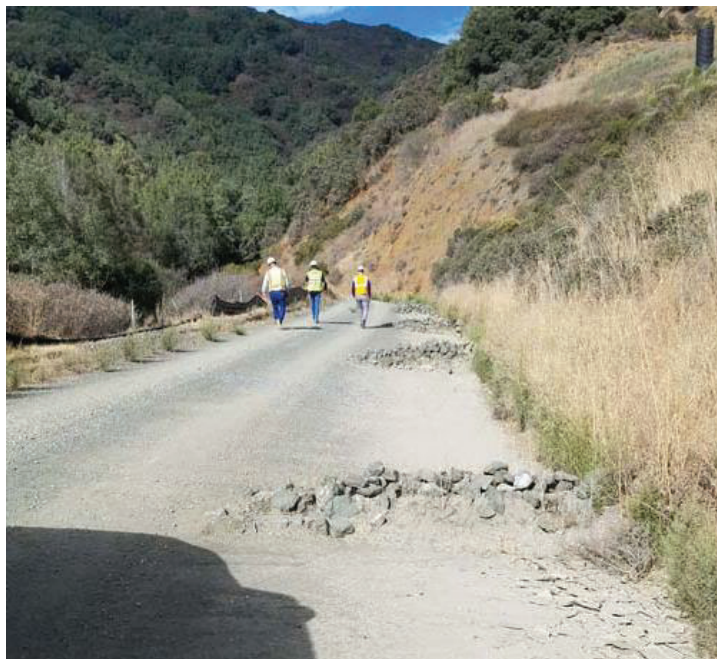
*Photo 29: Check dams along road by northside of Rattlesnake Creek.*
