## SURFACE MINING INSPECTION REPORT

### **2019 Stevens Creek Quarry Annual SMARA Inspection**

**County File 1253-19PAM  
State Mine ID #91-43-0007**

**Inspection Date: September 12, 2019**

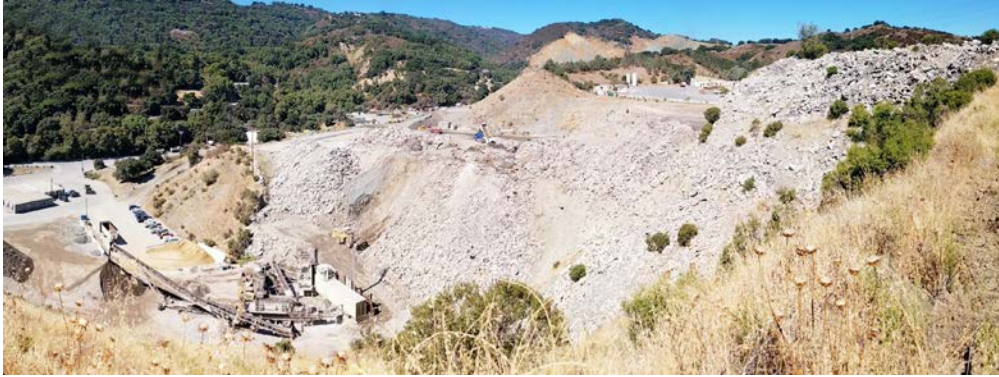
*Photo 1: Recycling operation on Parcel A.*

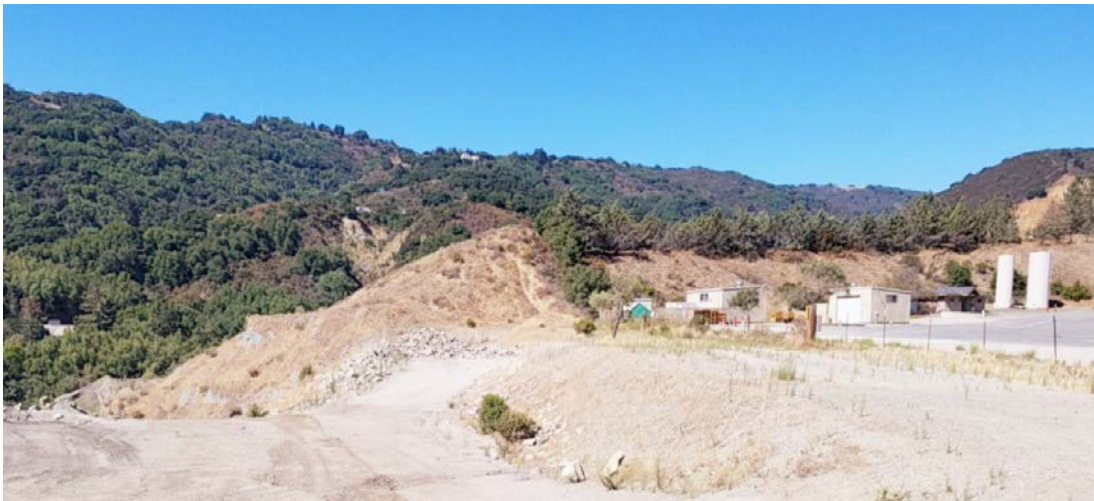
*Slump Repair:* An area located east of the recycling operation on Parcel A had a slump repair (2012) that is now buried and appears stable. [See **Photo 2** below.]

*Photo 2: Repaired slope between Parcel A and gun club.*

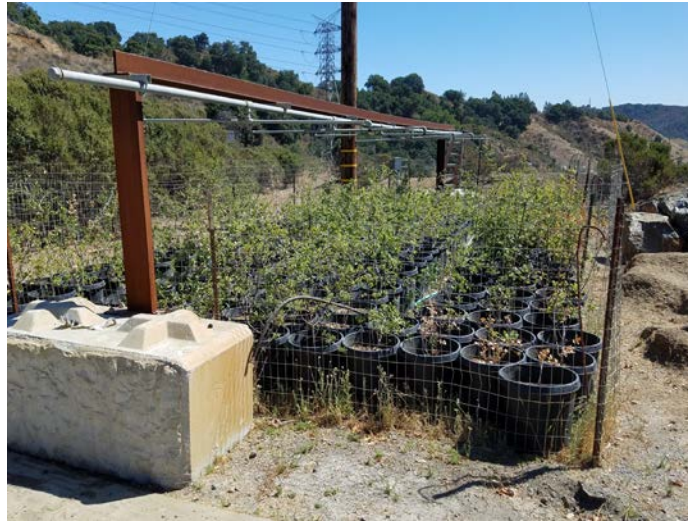
Photo 4: Nursery for germinating native oak trees with close-up inset.

1. *Revegetation:* Operator has installed a nursery with an automatic watering system to germinate and raise native oak trees. [See **Photo 4** below.] County suggested that the Mine Operator establish vegetation test plots on quarried conditions similar to those that will exist for reclamation to prove the viability of proposed reclamation plantings, and retain a botanist or

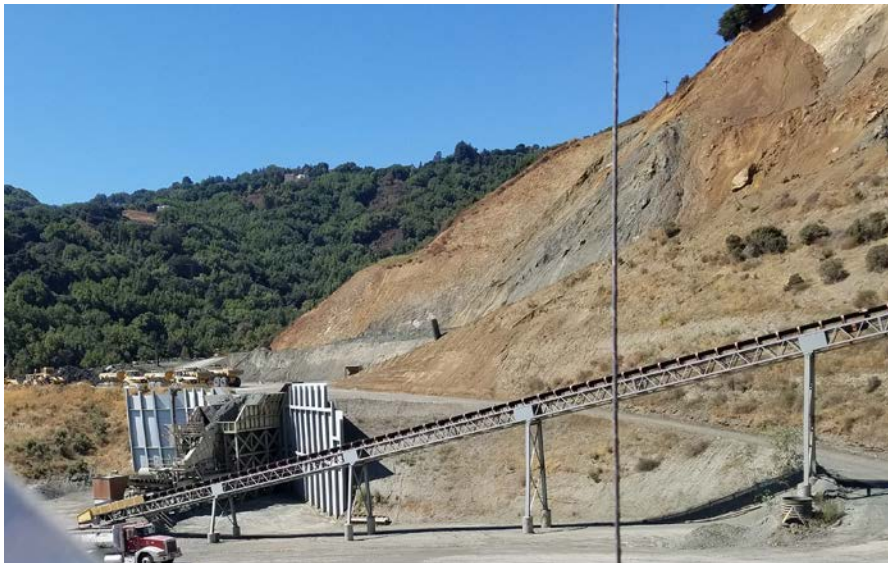
*Crusher and Retaining Wall:* Mining is conducted in Parcel B in a north-northwest trending quarry where Franciscan greenstone bedrock is extracted. Equipment for crushing and sorting rock materials is located on Parcel B. Inspectors observed crusher equipment was relocated to , the southeast portion of Parcel B. [See **Photo 7** below.] Last year the operator excavated soil from behind the north wall, replaced the wall panels, and recompact the slope behind the wall.

Photo 7: Relocated rock crusher.

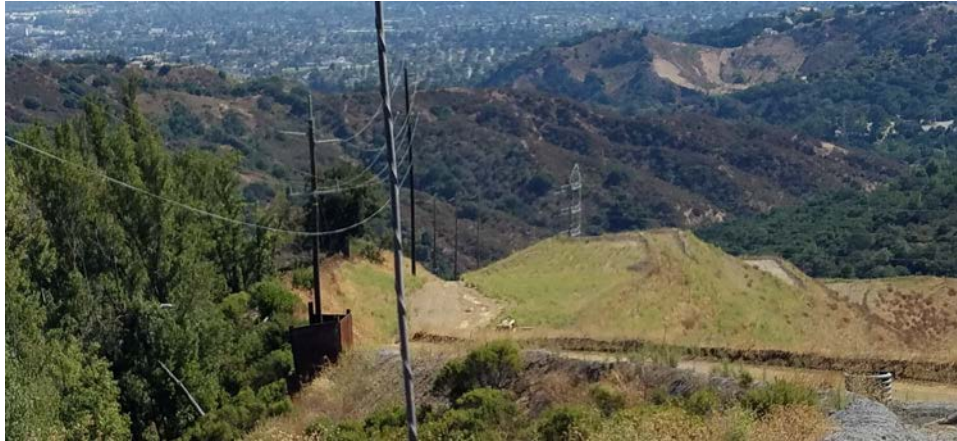
County inspectors observed the repair of the perimeter access road which was previously disrupted by the headscarp of a large landslide. [See **Photo 9** below.]

*Photo 9: Area of former retaining wall above north high wall.*

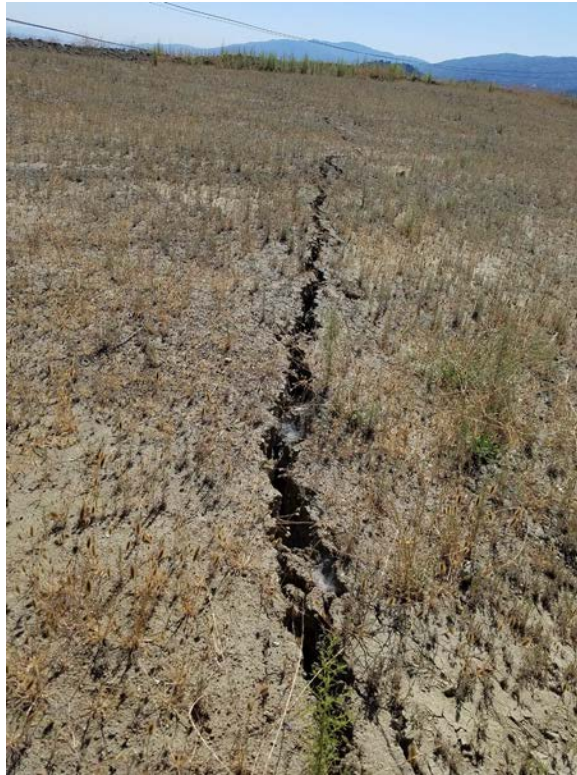
safety. Last year a large buttress fill was being placed against the lower and middle portions of the slope below the north slope. This year County inspectors observed that additional buttress fill had been placed. [See **Photo 14** below.] However, County inspectors observed new ground cracks in the buttress fill material. [See **Photo 10** below.]

*Photo 10: Ground crack on top of buttress fill of north high wall.*

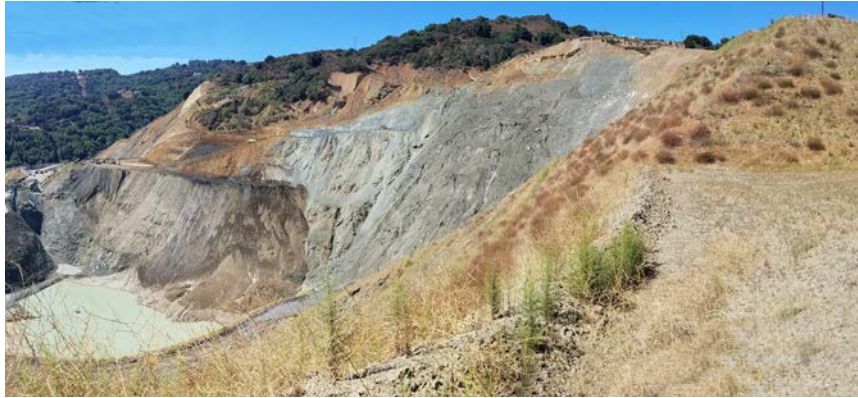
Another slope failure has disrupted the cut slope on the northwest side of the quarry pit. The headscarp of that failure has affected the southern end of the retaining wall built to protect the radio shack at the top of the slope. [See **Photos 13 and 15** below.]

*Photo 13: Buttress fill on north high wall. West side of pit visible on the left.*

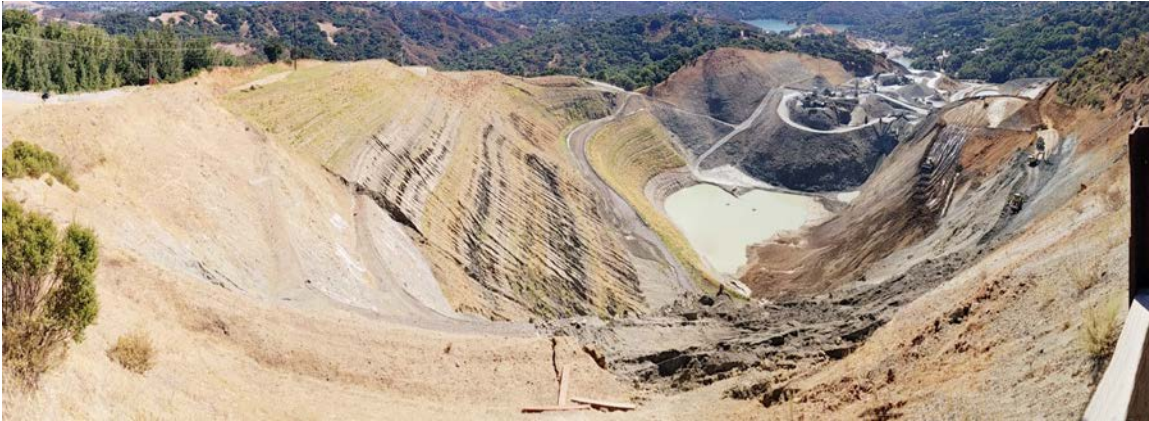
*Photo 14: Panorama of buttress fill below retaining wall on northwest high wall.*

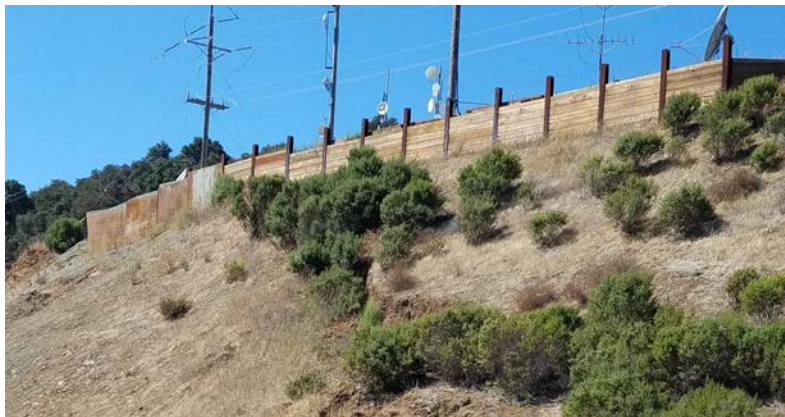
*Photo 15: Slope failure on western high cut wall.*

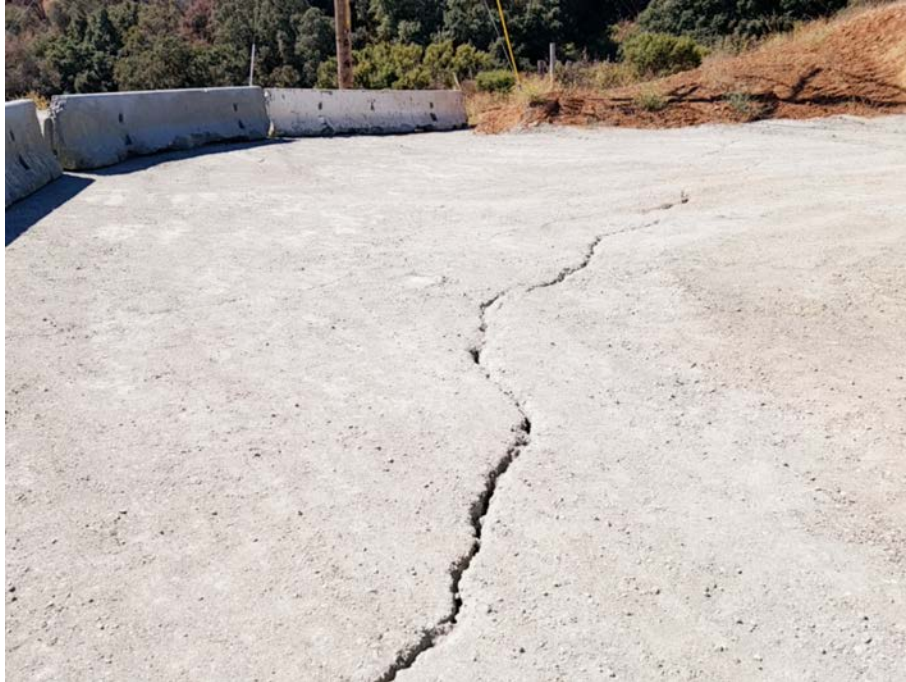
Last year, County inspectors observed that the ground surface adjacent to the radio shack had dropped, causing protrusion of concrete piers. Since then, the operator placed gravel, burying the piers. [See **Photo 16** below.] However, associated ground cracks were observed at the top of the slope failure, west of the western property boundary. [See **Photo 17** below.] The County has requested additional geotechnical analysis of these slopes as part of the forthcoming RPA needed to fully abate existing SMARA violations.

*Photo 16: Ground cracks near northwest property line.*

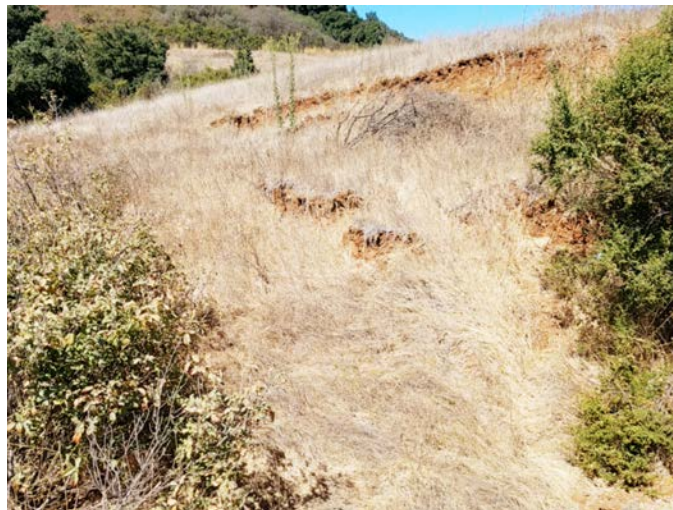
*Photo 17: Ground cracks and headscarp beyond northwest property line.*

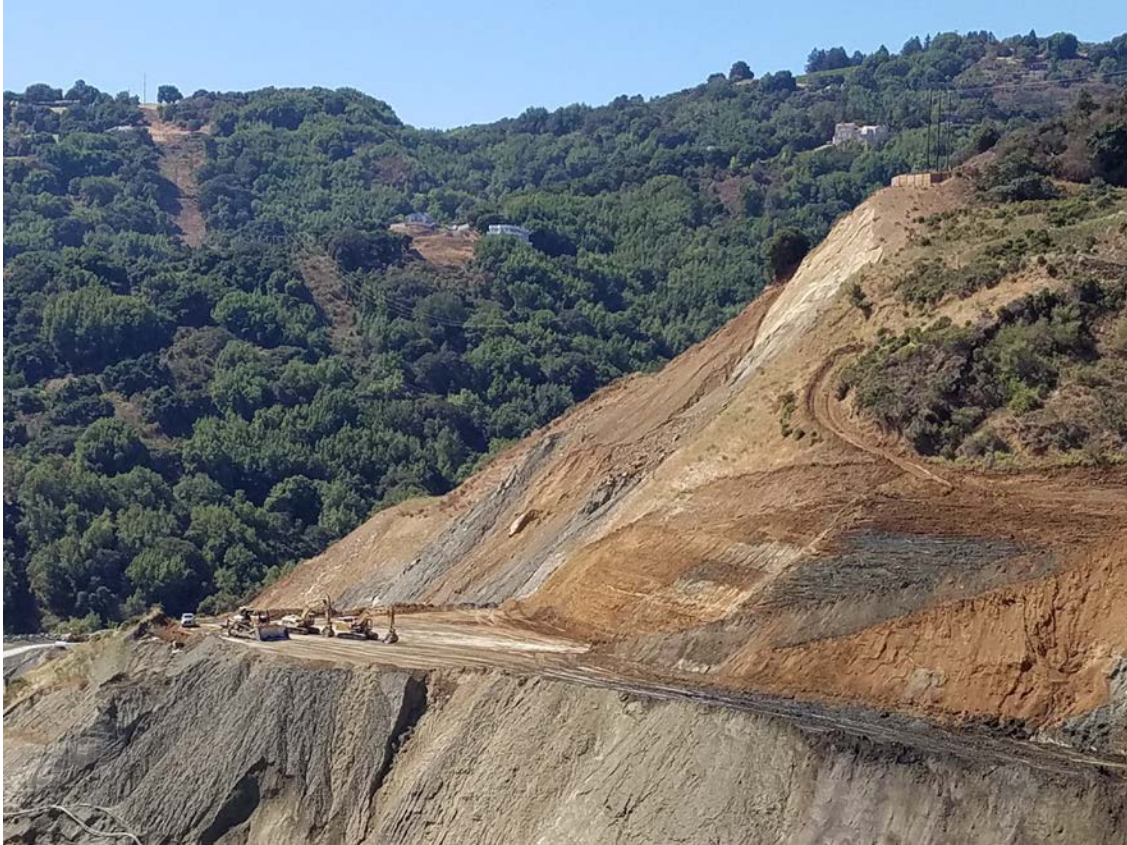
Another slope failure has disrupted the cut slope on the southwest side of the quarry on Parcel B. Inspectors observed that the headscarp of the failure had approached the retaining wall built to protect three PG&E power poles. [See **Photo 18** below.] Last year, County inspectors observed landslide debris accumulation at the toe of the slope. During the current inspection, the operator was in the process of removing this material. [See **Photo 19** below.]

*Photo 18: Slope failure on southwestern high cut wall, looking south. (Profile view)*

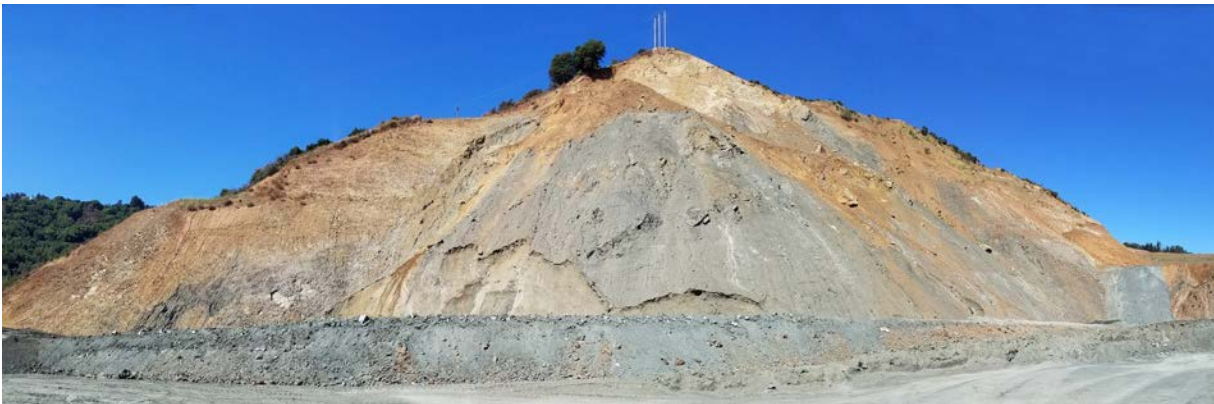
*Photo 19: Slope failure on southwestern high cut wall, looking west. (Head-on view)*

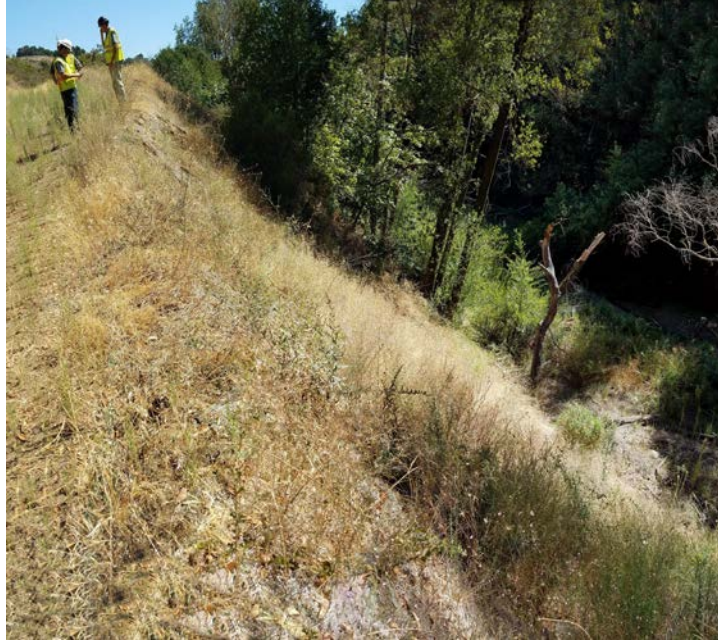
In 2017, County observed a slope failure above Rattlesnake Creek along a road towards the west end of Parcel B. The Quarry built a fill slope to repair the road and installed jute netting on said slope. [See **Photo 20** below.]

*Photo 20: Regraded slope along the north side of Rattlesnake Creek.*

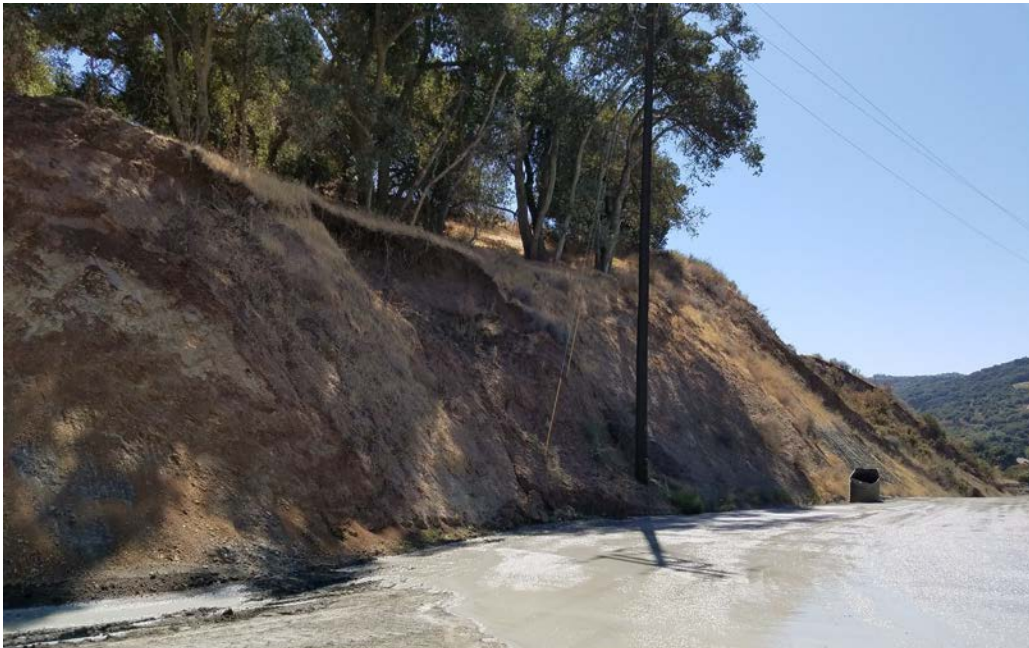
A slope adjacent to the operating equipping toward the southeastern corner of Parcel B has had a shallow failure. [See **Photo 21** below.] Although the ground has moved, the County expects this area to be corrected during final reclamation.

*Photo 21: Shallow failures of cut slope along east side of Parcel B.*

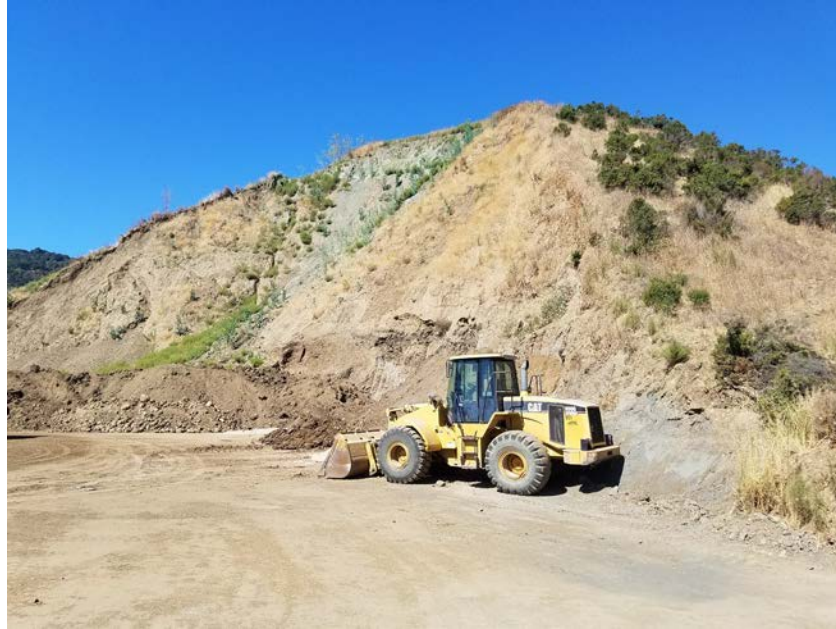
*Photo 22: Dirt stockpile at eastern portion of Parcel A.*

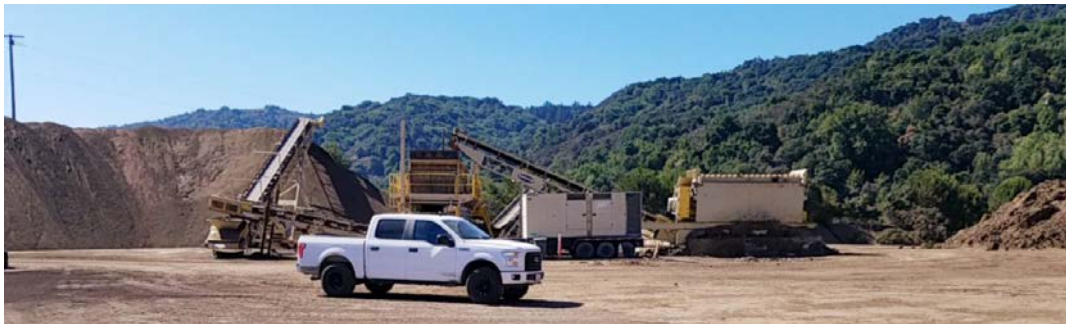
soil that are brought to the site from nearby construction projects. Large stockpiles of these imported materials are placed along the northern portion of the Parcel A boundary and partially bury the previously mined slope. [See **Photo 1** below.] The recycling equipment is located north of the Quarry offices on Parcel A. [See **Photos 23 and 24** below.]

*Photo 23: Dirt stockpile and processing equipment at eastern portion of Parcel A.*

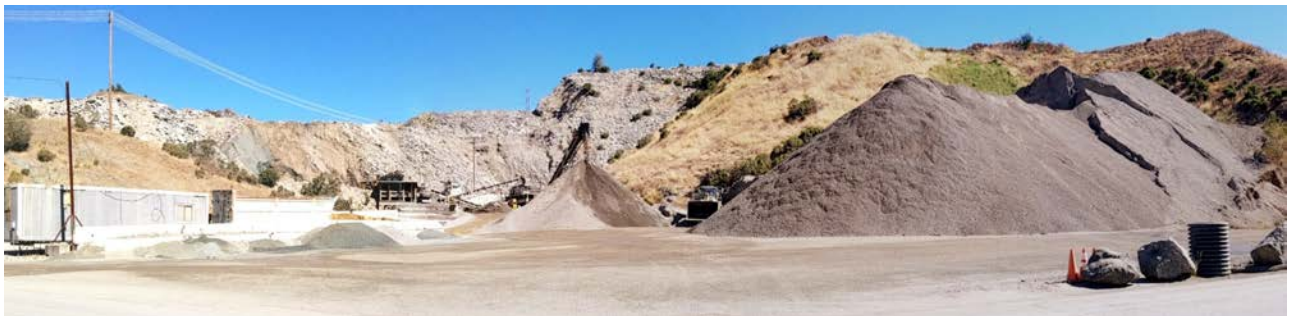
*Photo 24: Recycle stockpile has been reduced in size since last year.*

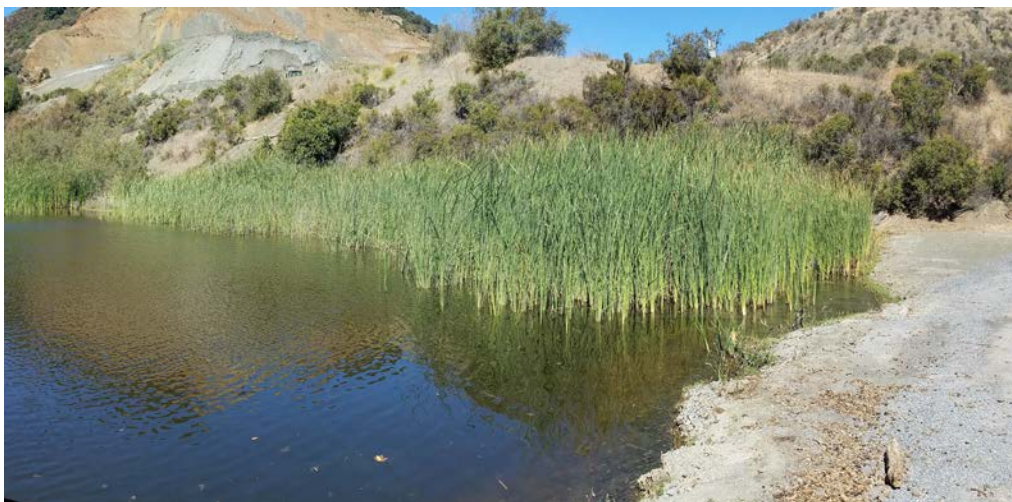
*Photo 25: Upper Settling Basin.*

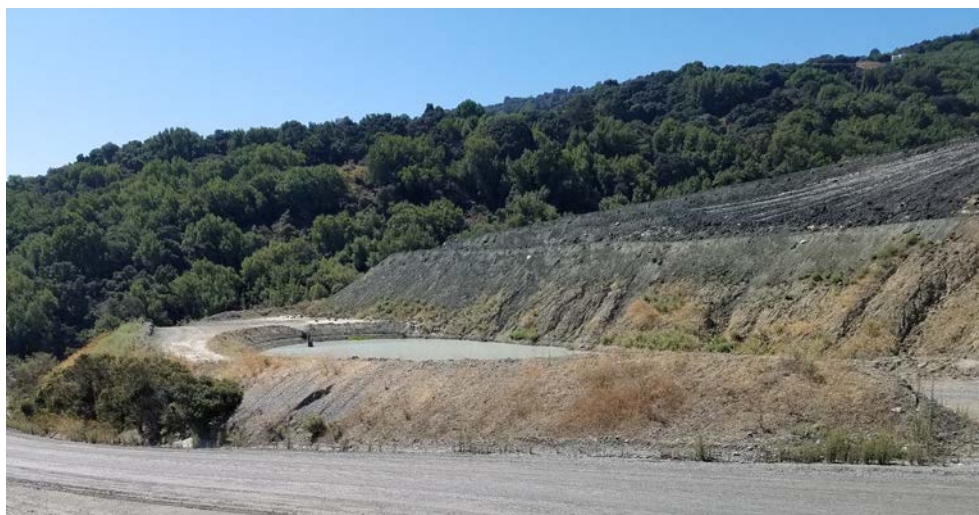
*Photo 26: Pond 5.*

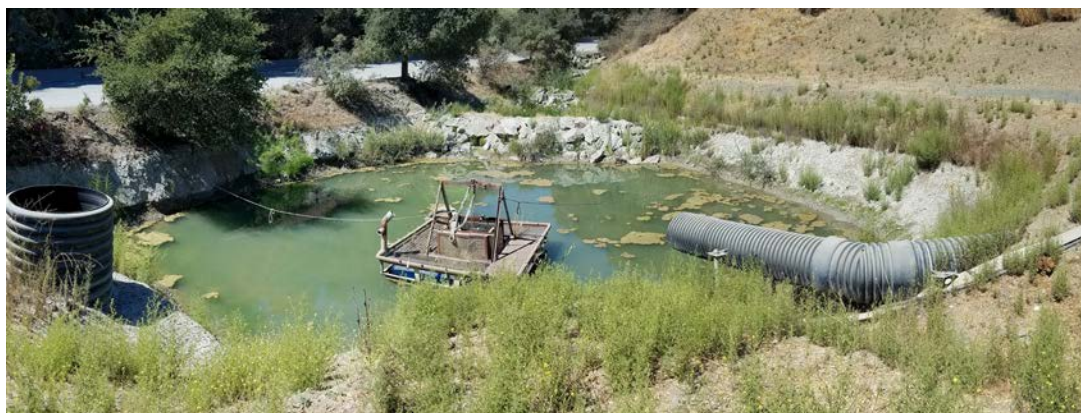
*Photo 27: Pond west of office.*

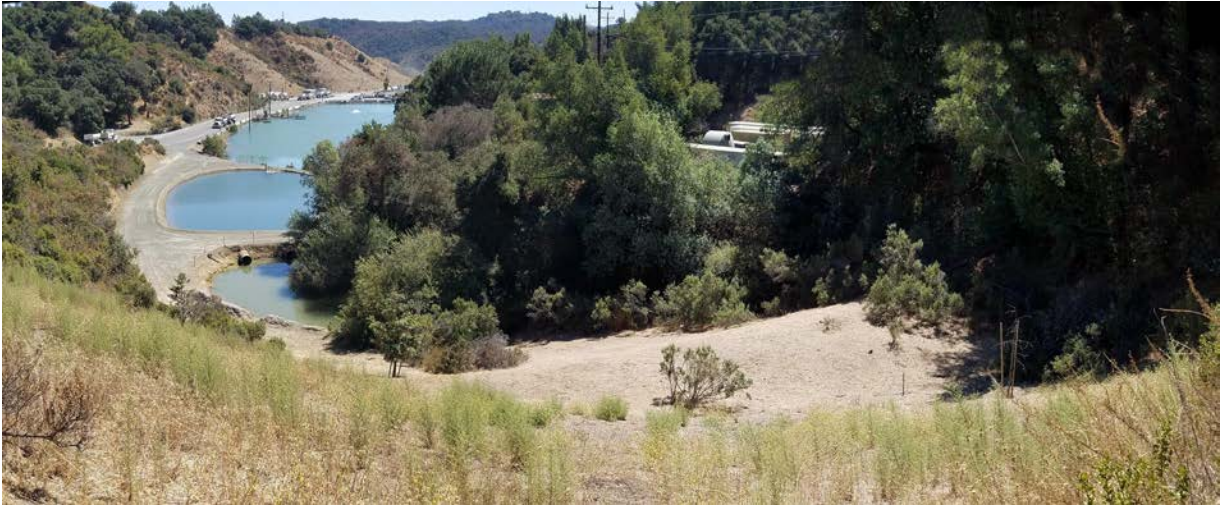
*Photo 28: Middle and Lower Settling Basins.*

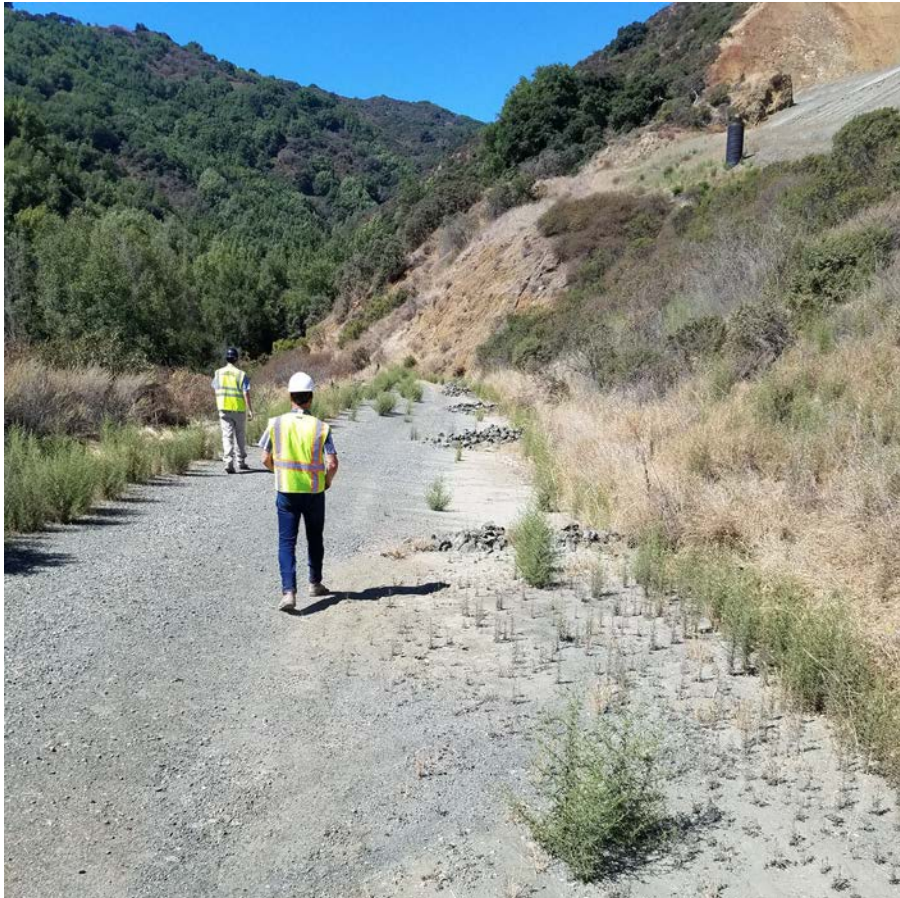
*Photo 29: Check dams along road by northside of Rattlesnake Creek.*

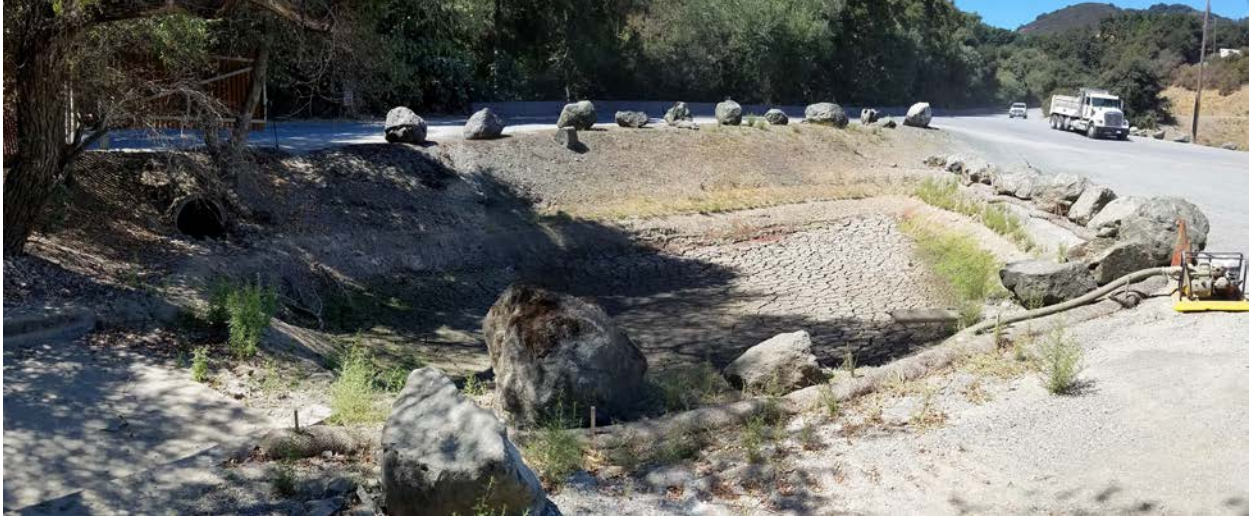
*Photo 30: Settling basin near main entrance.*
