Attachment A

2020 Stevens Creek Quarry Annual SMARA Inspection

County File PLN07-1253-2020-Annual Report State Mine ID #91-43-0007

Inspection Date: September 14, 2020

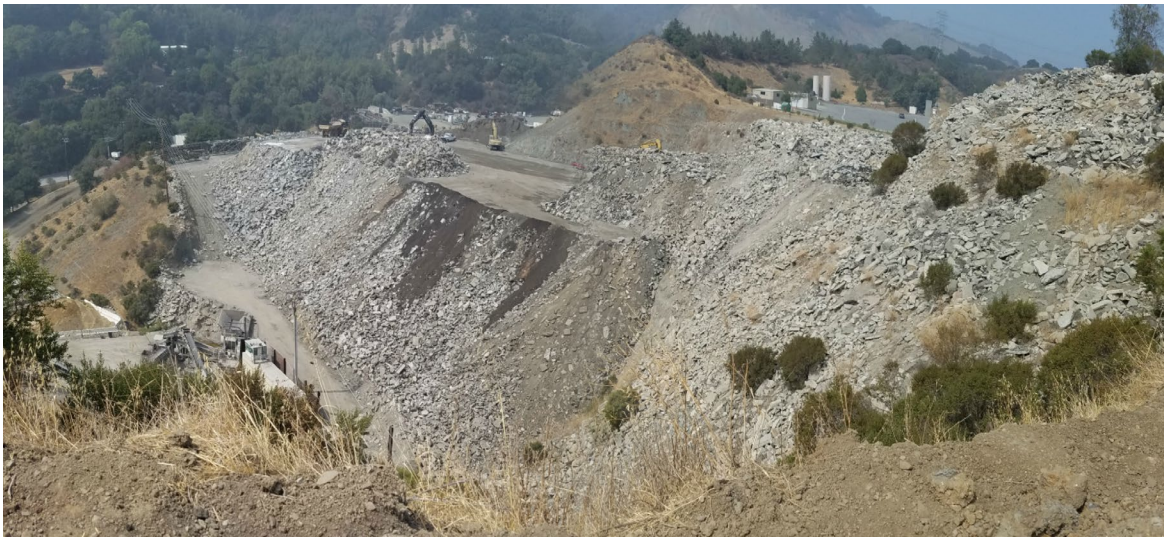
Photo 1: Recycling operation on Parcel A.

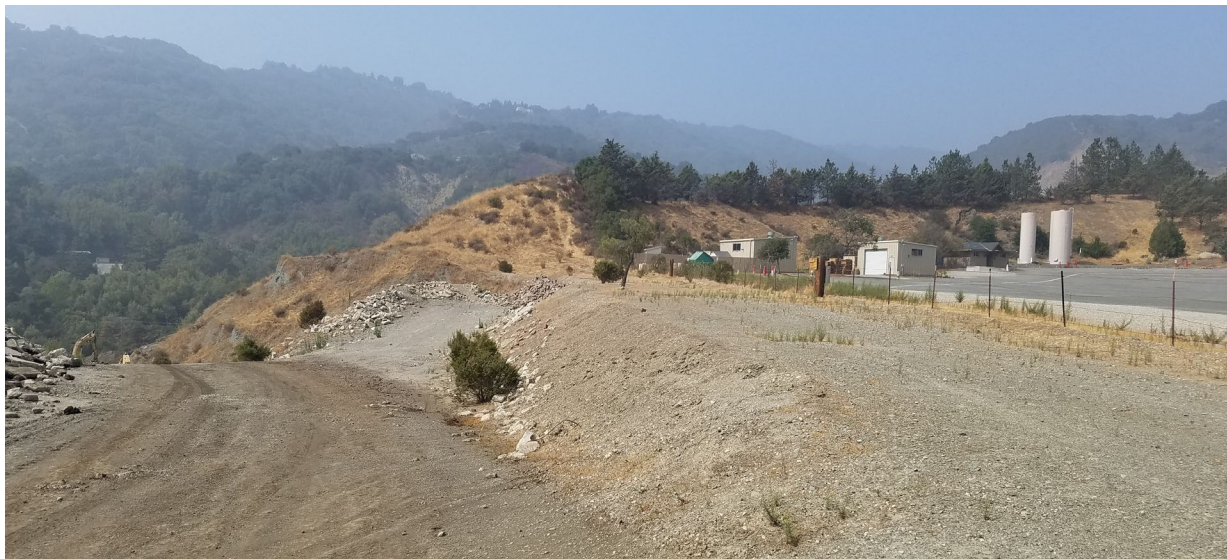
Slump Repair: An area located east of the recycling operation on Parcel A had a slump repair (2012) that is now buried and appears stable. [See **Photo 2** below.]

Photo 2: Repaired slope between Parcel A and gun club.

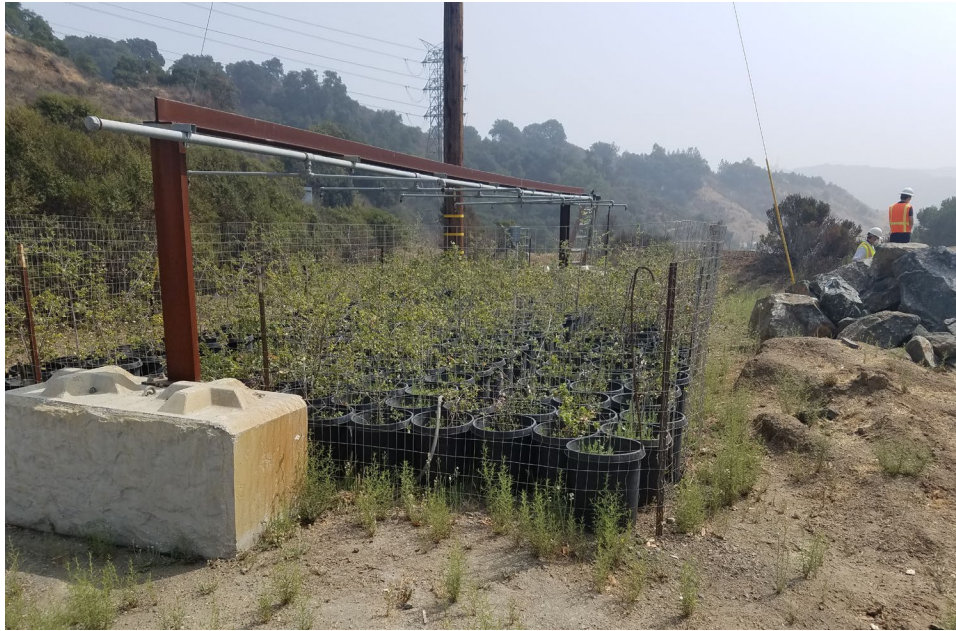
Photo 4a: Nursery for germinating native oak trees

1. *Revegetation:* Operator has installed a nursery with an automatic watering system to germinate and raise native oak trees. [See **Photos 4a nad 4b** below.] County suggested that the Mine Operator establish vegetation test plots on quarried conditions similar to those that will exist for reclamation to prove the viability of proposed reclamation plantings, and retain a botanist or

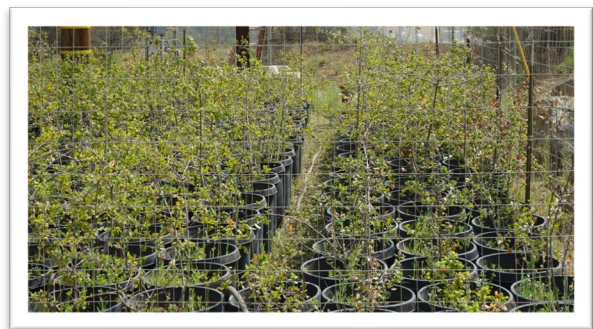
Photo 5b: Close-up of germinating native oak trees in Nursery

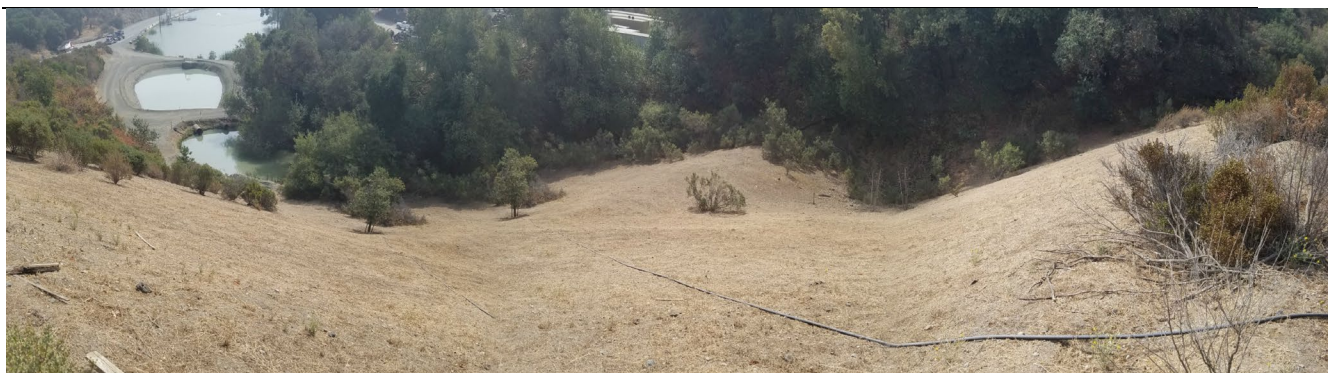
Photo 6: Face of dam between upper and middle settling basins.

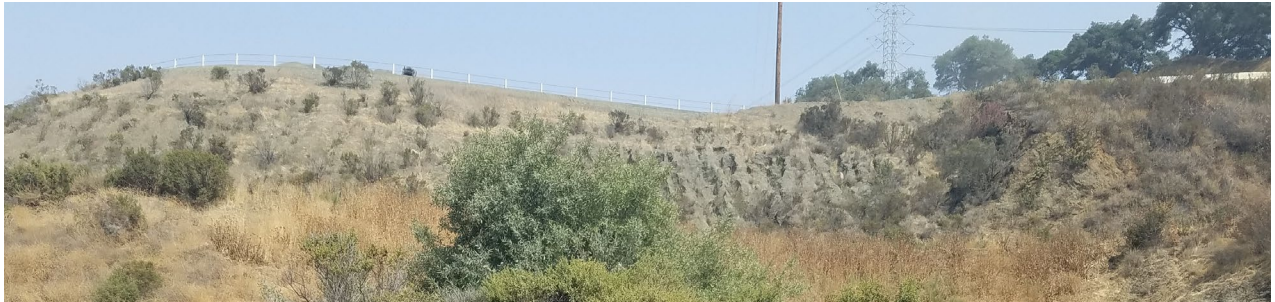
Stormwater Best Management Practices (BMPs): County previously observed ongoing erosion gullies located on fill slopes (Parcel B) above haul road. The operator implemented erosion control and BMP measures at the suggestion of the County including hydroseeding. These measures appear to be functioning adequately. [See **Photo 29** below.] The County will continue to inspect this area to ensure these necessary BMPs are maintained.

Photo 7: Erosion rills on fill slope above main haul road.

3. *Stormwater BMPs:* Last year, County inspectors observed fill slopes with no erosion control measures, primarily in the area of the new crusher and adjacent to the haul road. County required the operator to implement soil stabilization measures and install adequate BMPs, including hydroseeding, at all locations where active grading or disturbed soil have occurred. Subsequently, these measures were implemented and appeared to be functioning adequately. The County will perform follow-up inspections to verify that BMPs are maintained.

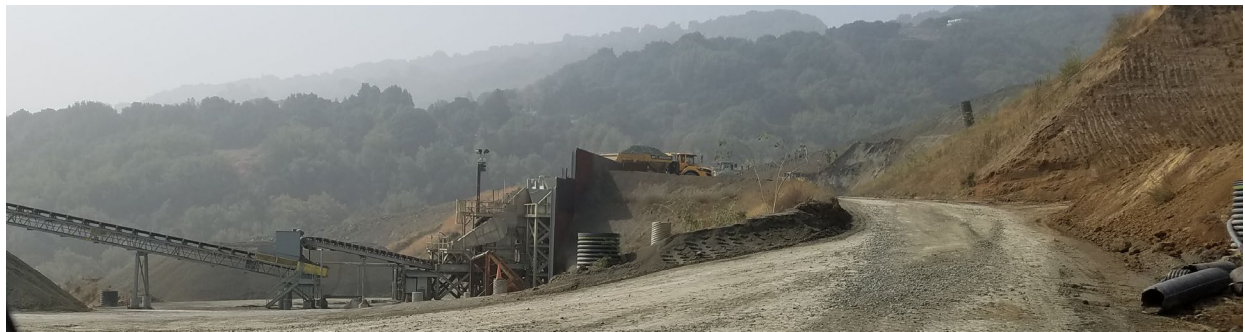
Crusher and Retaining Wall: Mining is conducted in Parcel B in a north-northwest trending quarry where Franciscan greenstone bedrock is extracted. Equipment for crushing and sorting rock materials is located on Parcel B. Inspectors observed crusher equipment was relocated to , the southeast portion of Parcel B. [See **Photo 7** below.] Last year the operator excavated soil from behind the north wall, replaced the wall panels, and recompact the slope behind the wall.

Photo 8: Relocated rock crusher.

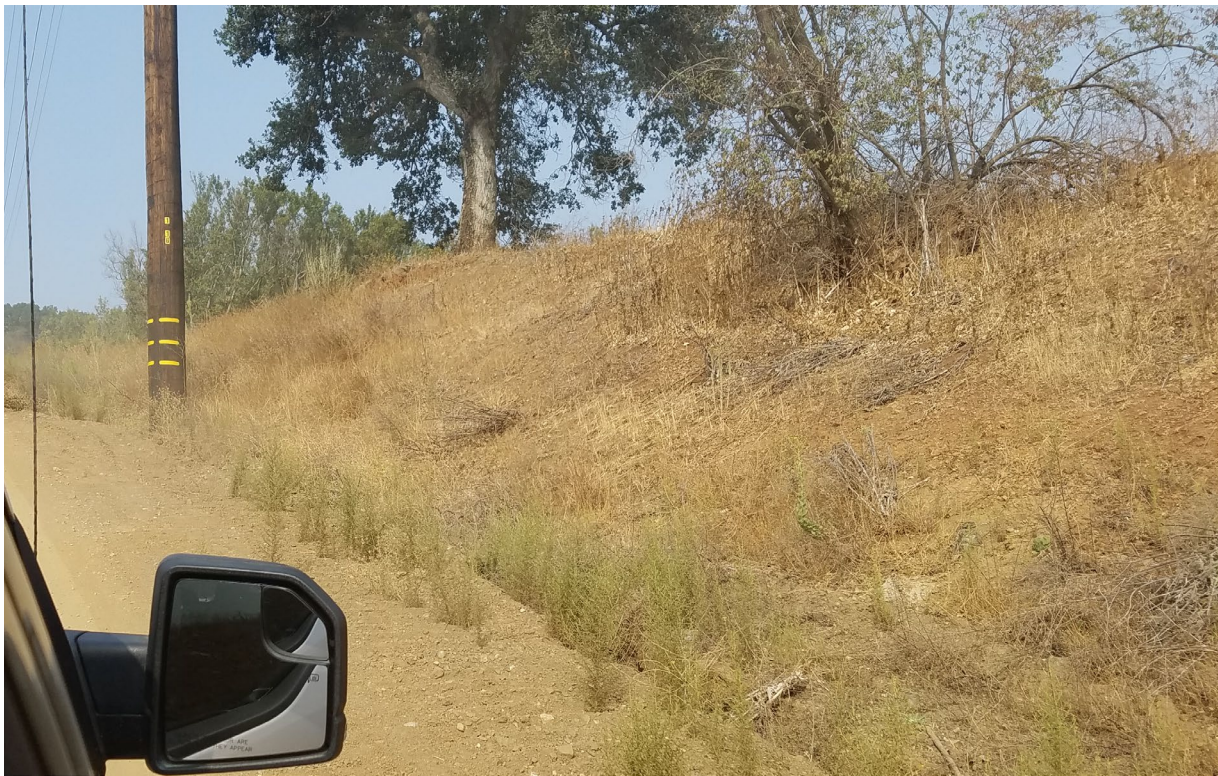
County inspectors observed the repair of the perimeter access road which was previously disrupted by the headscarp of a large landslide. [See **Photo 9** below.]

Photo 9: North perimeter road cut slope. No change in condition –

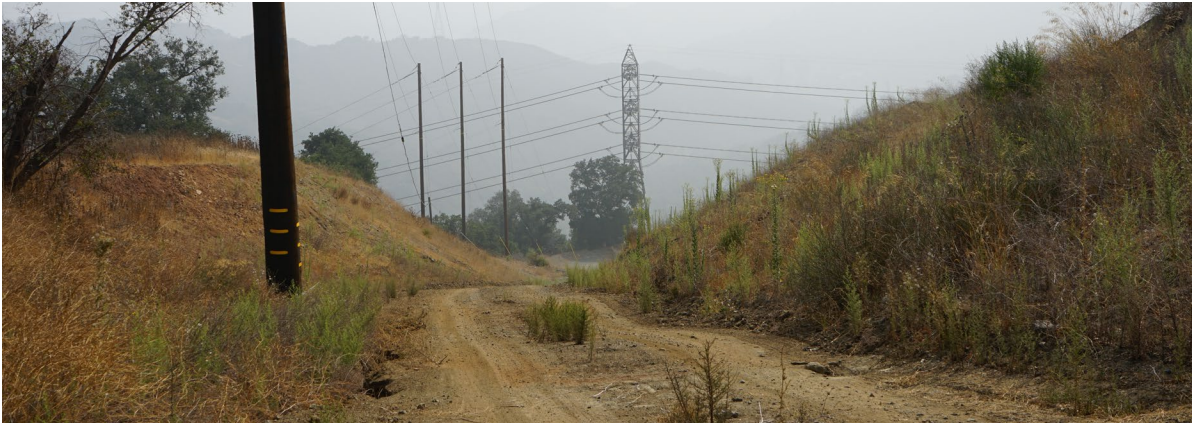
Photo 10: Area of former retaining wall above north high wall.

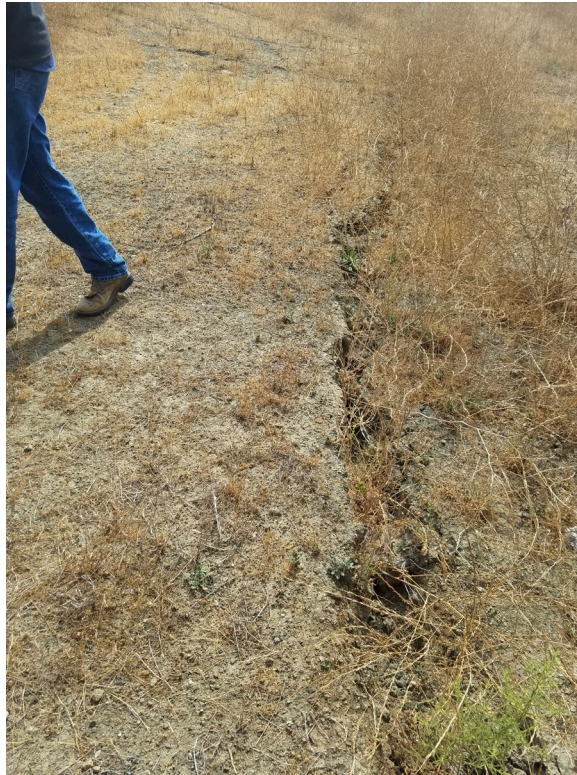
had been placed. [See **Photo 14** below.] However, County inspectors observed new ground cracks in the buttress fill material. [See **Photo 10** below.]

Photo 11: Ground crack on top of buttress fill of north high wall.

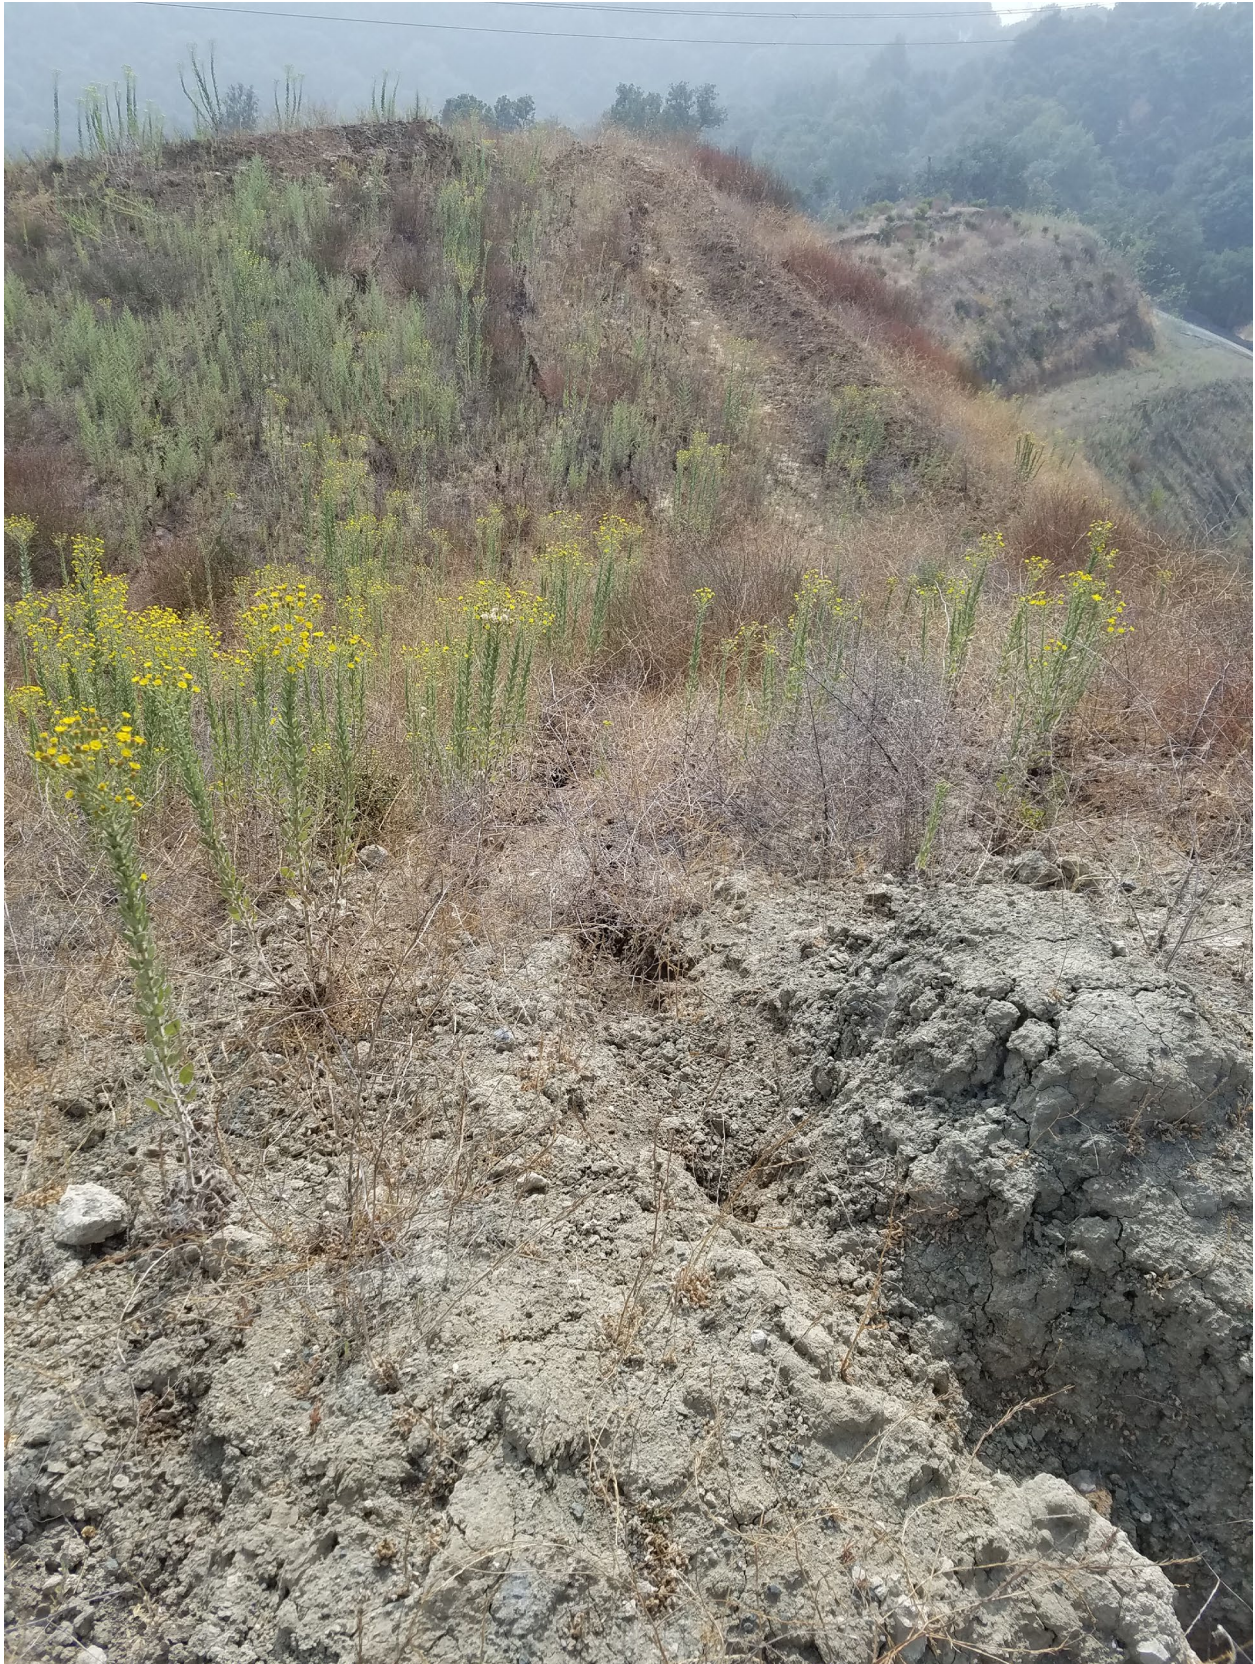
Photo 12: Ground crack on east-facing fill slope near northeastern corner of property.

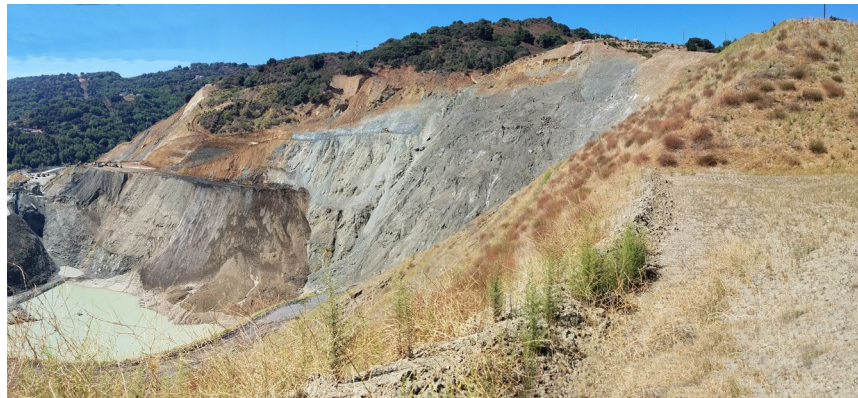
Operator submitted a geologic report dated 1-29-2017 that recommended an additional width (200 feet) of buttress be added to the toe of the slope in order to achieve an acceptable factor of safety. Last year a large buttress fill was being placed against the lower and middle portions of the slope below the north slope. This year County inspectors observed that additional buttress fill

Photo 14: Buttress fill on north high wall. West side of pit visible on the left.

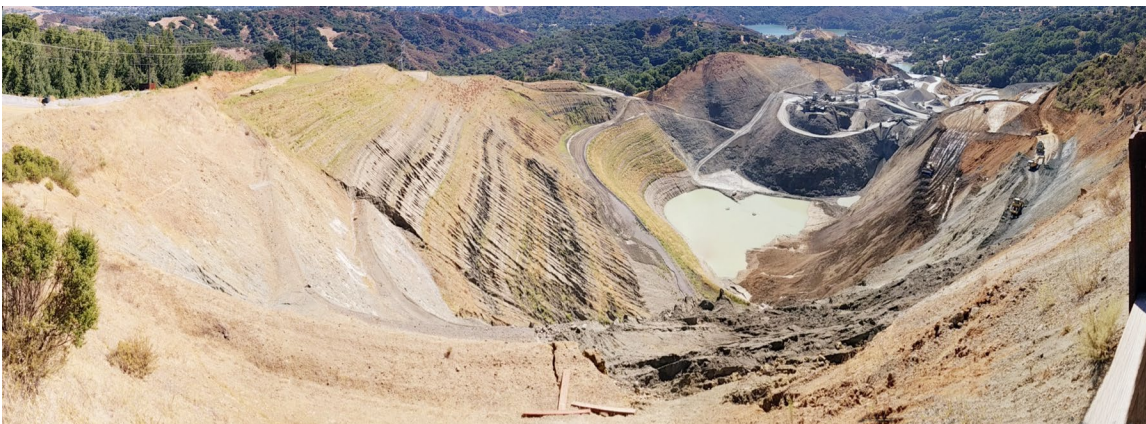
Another slope failure has disrupted the cut slope on the northwest side of the quarry pit. The headscarp of that failure has affected the southern end of the retaining wall built to protect the radio shack at the top of the slope. [See **Photos 13 and 15** below.]

Photo 15: Panorama of buttress fill below retaining wall on northwest high wall.

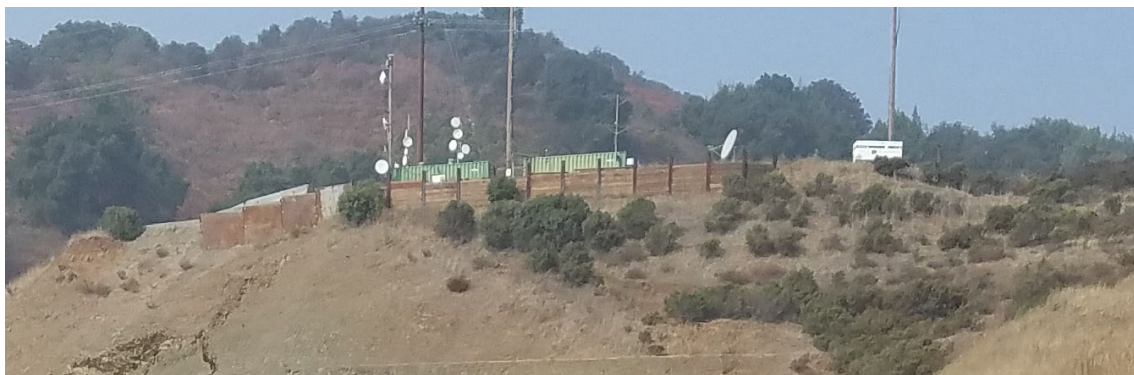
Last year, County inspectors observed that the ground surface adjacent to the radio shack had dropped, causing protrusion of concrete piers. Since then, the operator placed gravel, burying the piers. [See **Photo 16** below.] However, associated ground cracks were observed at the top of the slope failure, west of the western property boundary. [See **Photo 17** below.] The County has requested additional geotechnical analysis of these slopes as part of the forthcoming RPA needed to fully abate existing SMARA violations.

Photo 1516: Slope failure on western high cut wall.

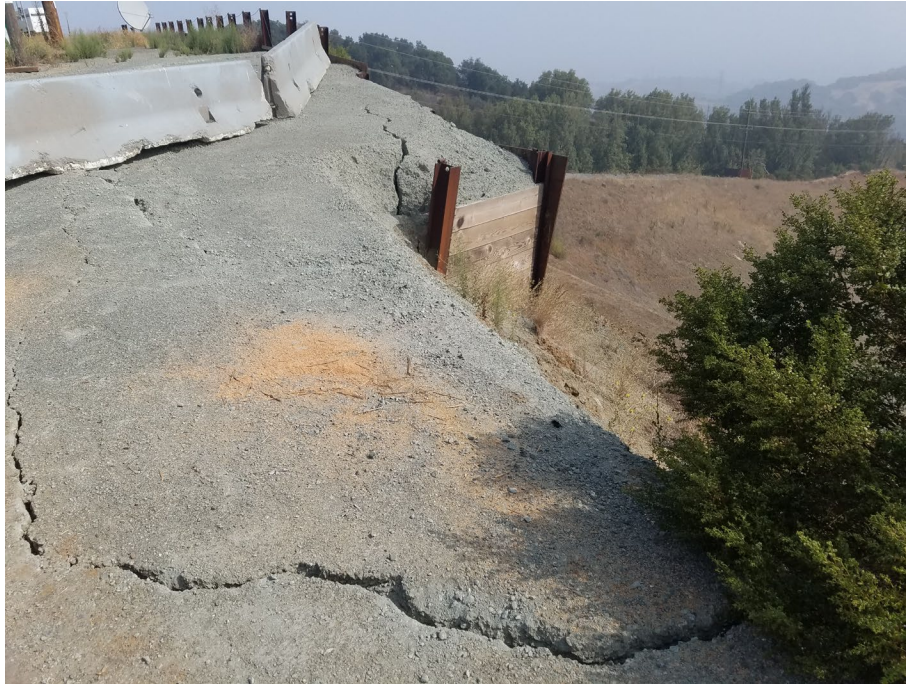
Photo 17: Ground cracks near northwest property line.

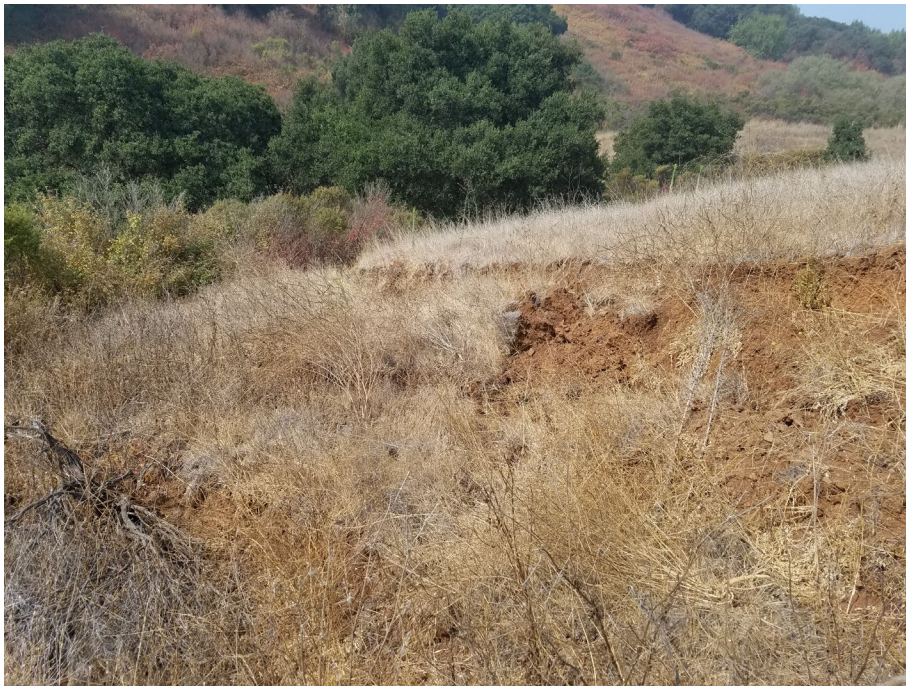
Photo 18: Ground cracks and headscarp beyond northwest property line.

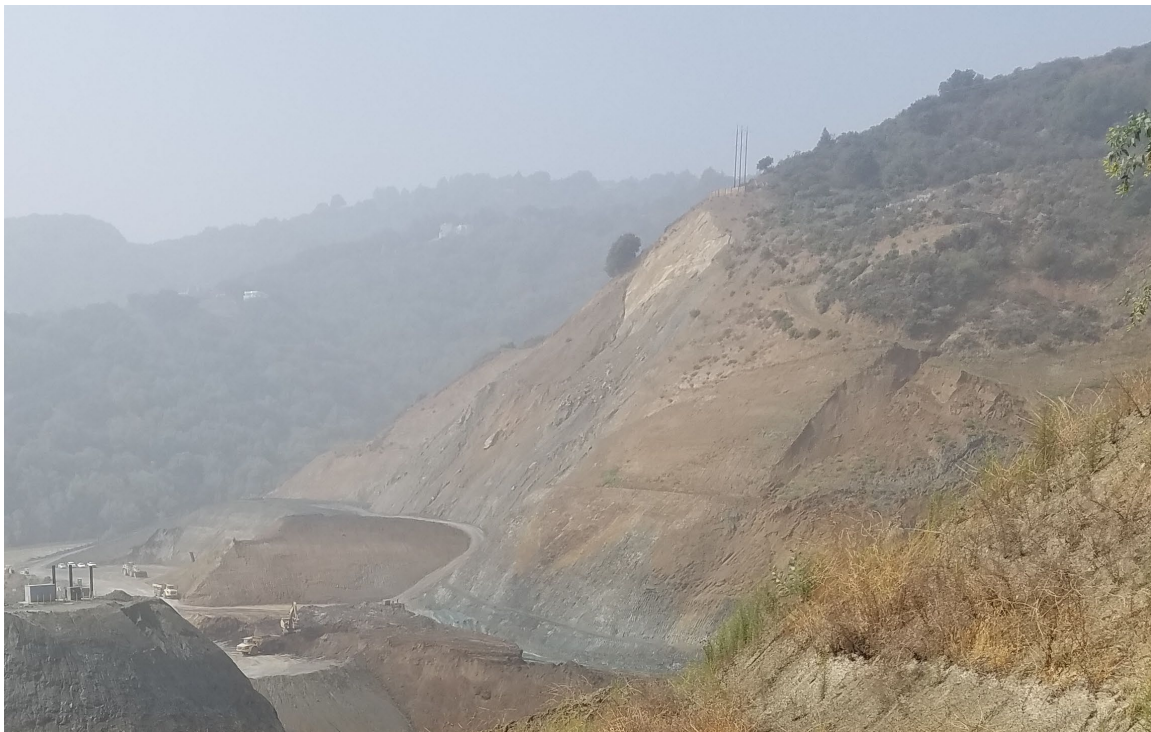
Another slope failure has disrupted the cut slope on the southwest side of the quarry on Parcel B. Inspectors observed that the headscarp of the failure had approached the retaining wall built to protect three PG&E power poles. [See **Photo 18** below.] Last year, County inspectors observed landslide debris accumulation at the toe of the slope. During the current inspection, the operator was in the process of removing this material. [See **Photo 19** below.]

Photo 19: Slope failure on southwestern high cut wall, looking south. (Profile view)

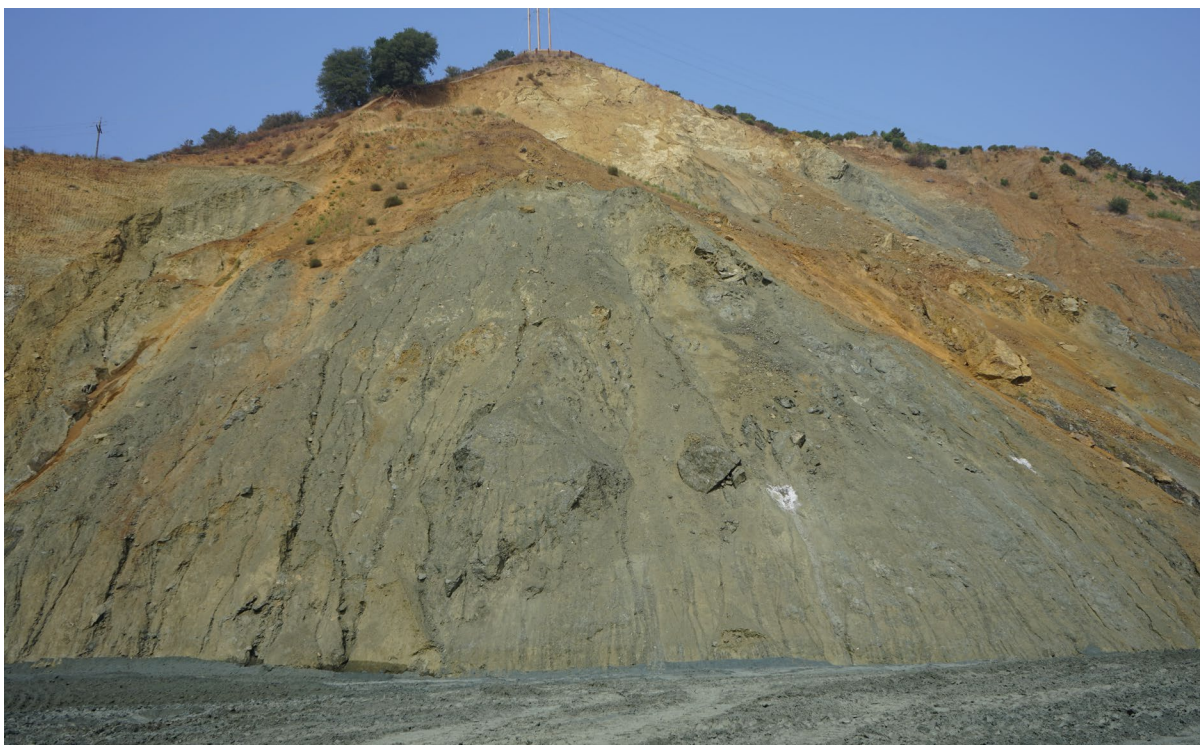
Photo 20: Slope failure on southwestern high cut wall, looking west. (Head-on view)

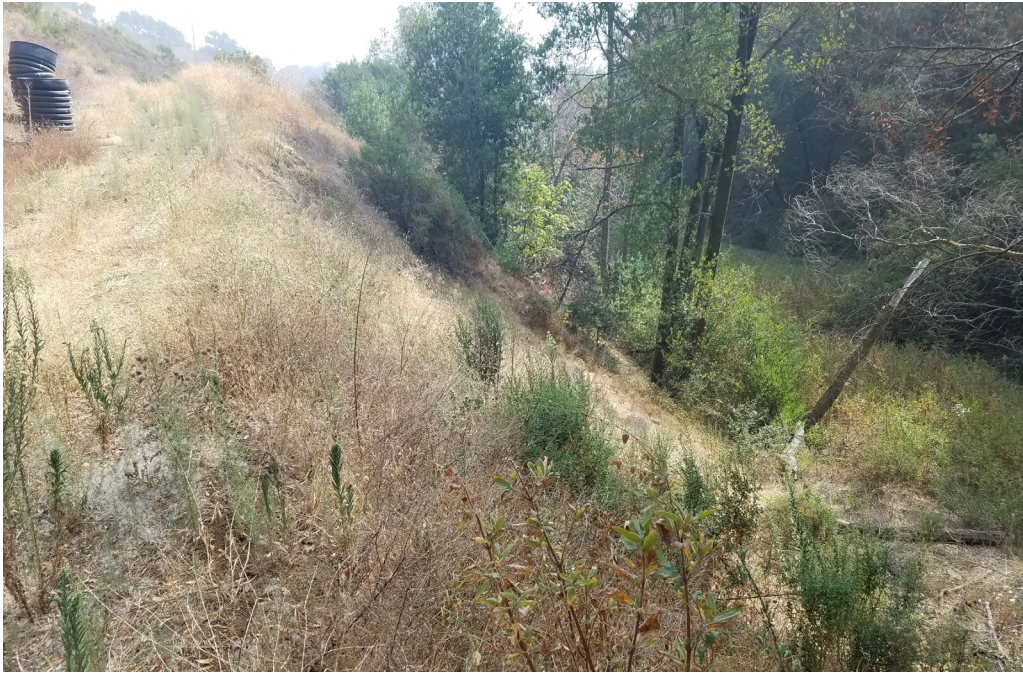
In 2017, County observed a slope failure above Rattlesnake Creek along a road towards the west end of Parcel B. The Quarry built a fill slope to repair the road and installed jute netting on said slope. [See **Photo 20** below.]

Photo 21: Regraded slope along the north side of Rattlesnake Creek.

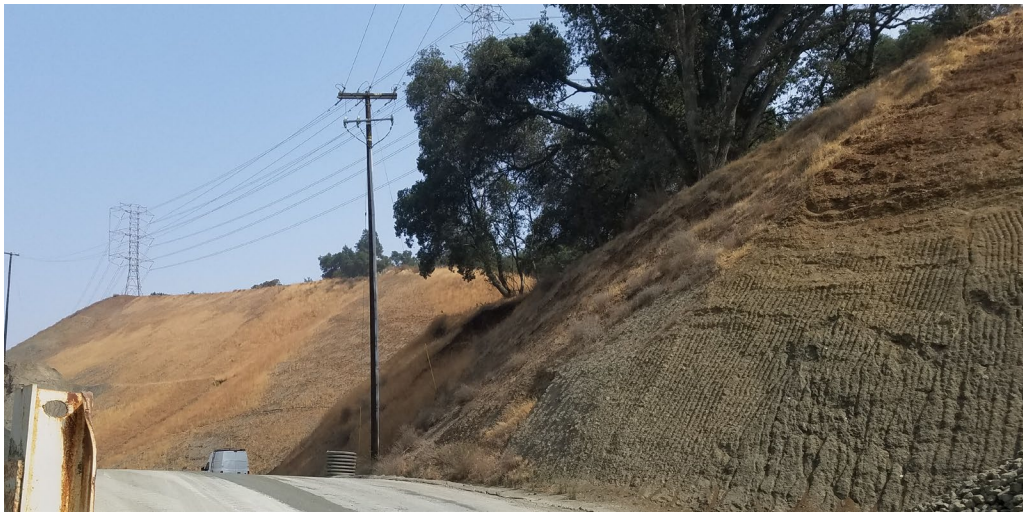
A slope adjacent to the operating equipping toward the southeastern corner of Parcel B has had a shallow failure. [See **Photo 21** below.] Although the ground has moved, the County expects this area to be corrected during final reclamation.

Photo 22: Shallow failures of cut slope along east side of Parcel B.

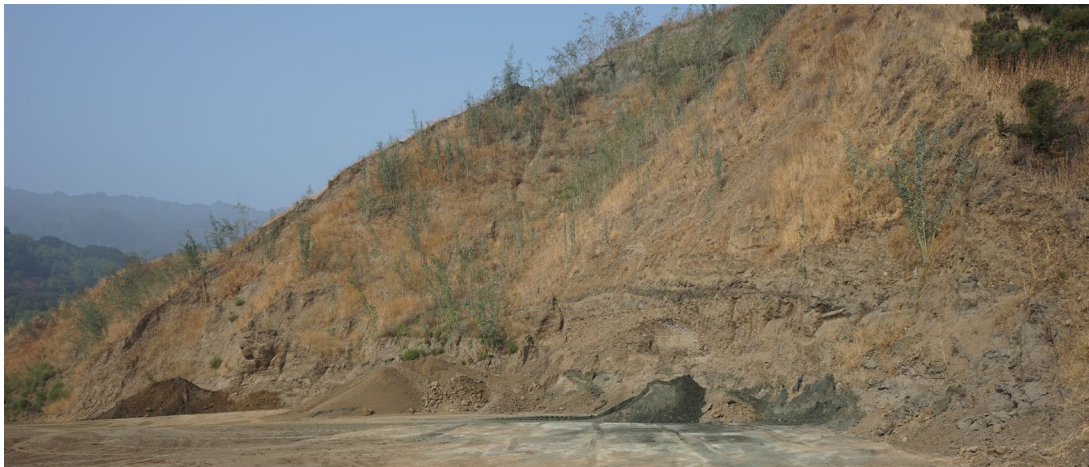
Photo 23: Dirt stockpile at eastern portion of Parcel A.

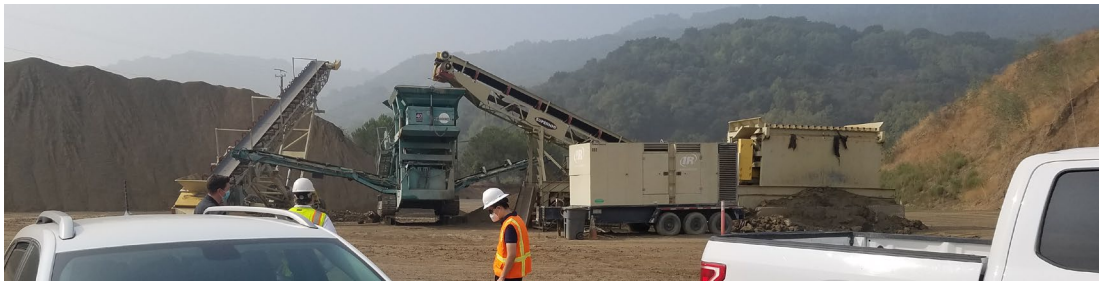
Photo 24: Dirt stockpile and processing equipment at eastern portion of Parcel A.

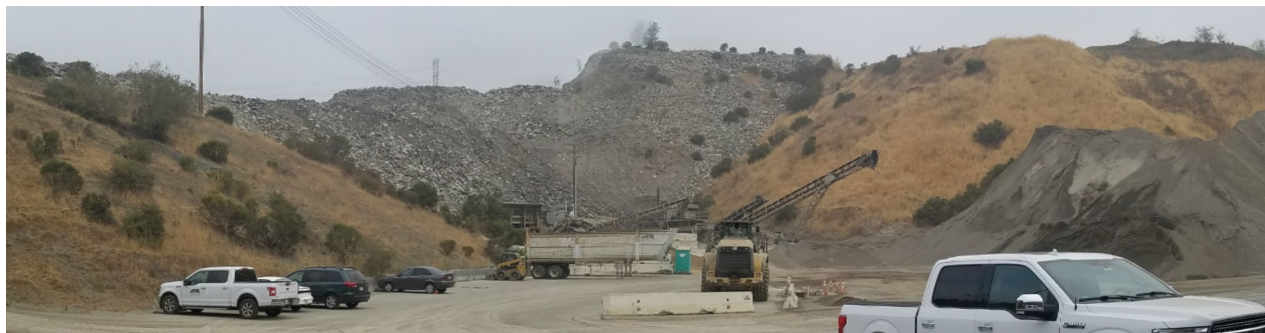
Photo 25: Recycle stockpile has been reduced in size since last year.

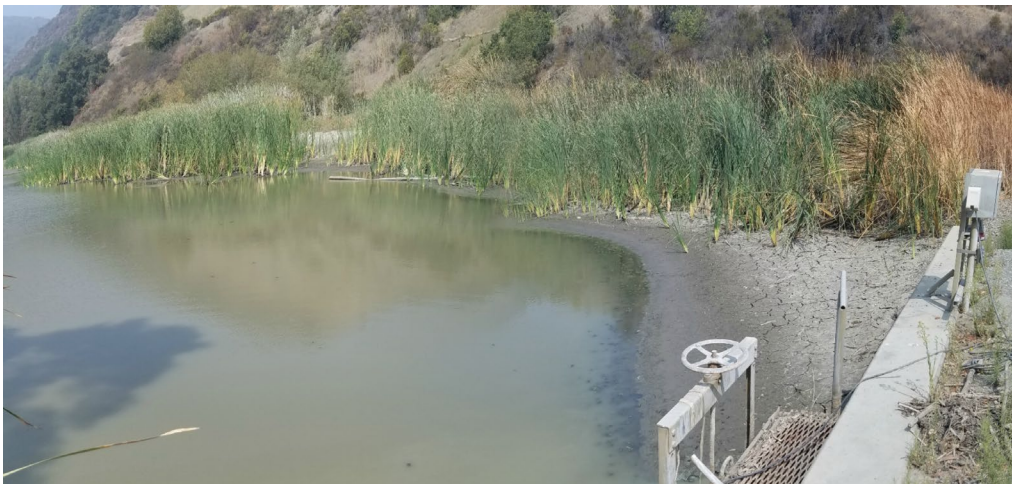
Photo 26: Upper Settling Basin.

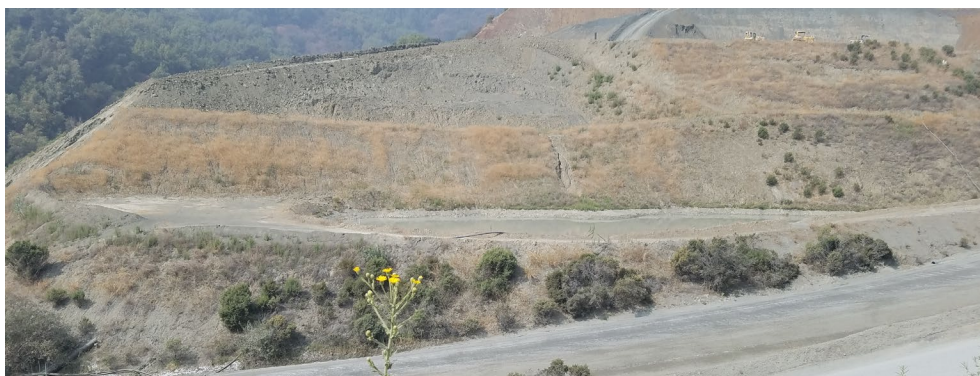
Photo 27: Pond 5.

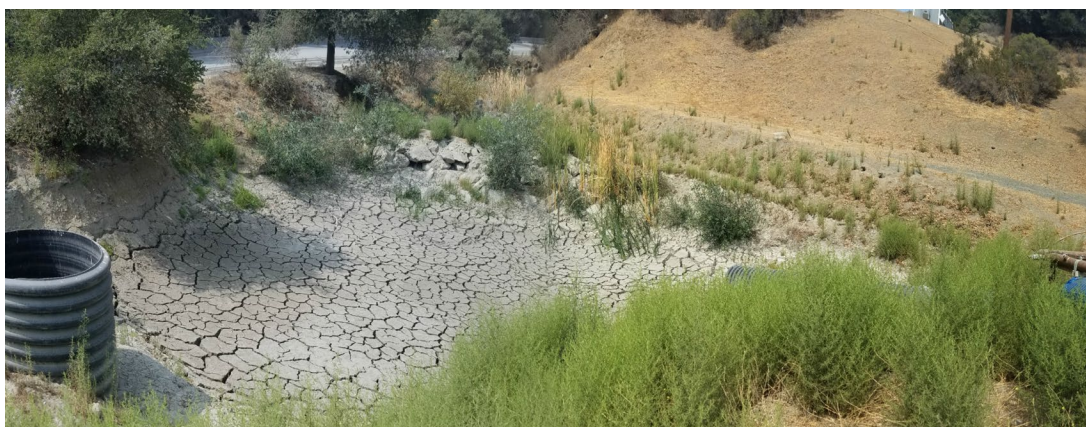
Photo 28: Pond west of office.

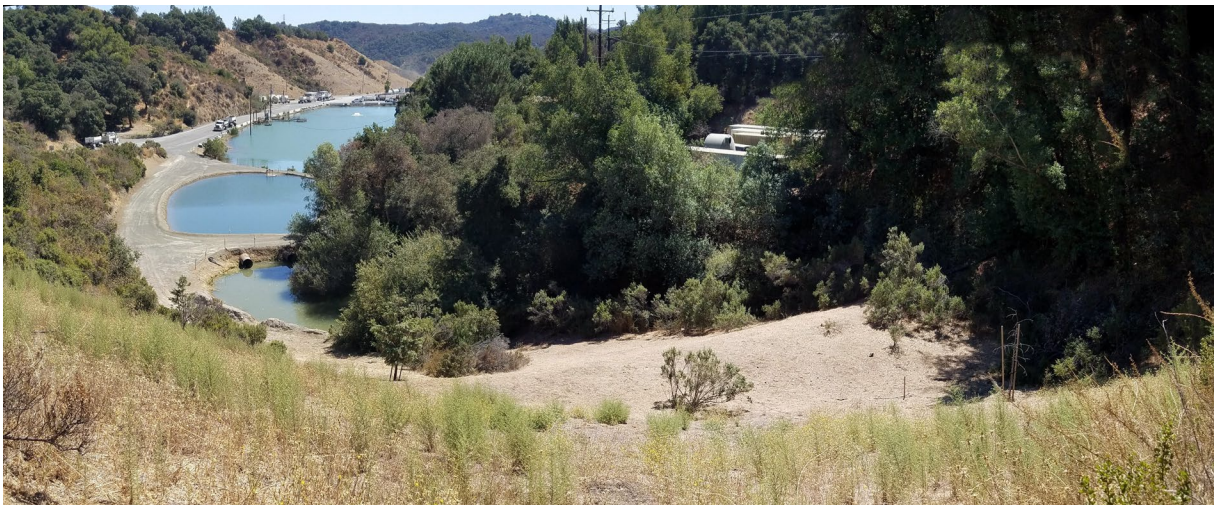
Photo 29: Middle and Lower Settling Basins.

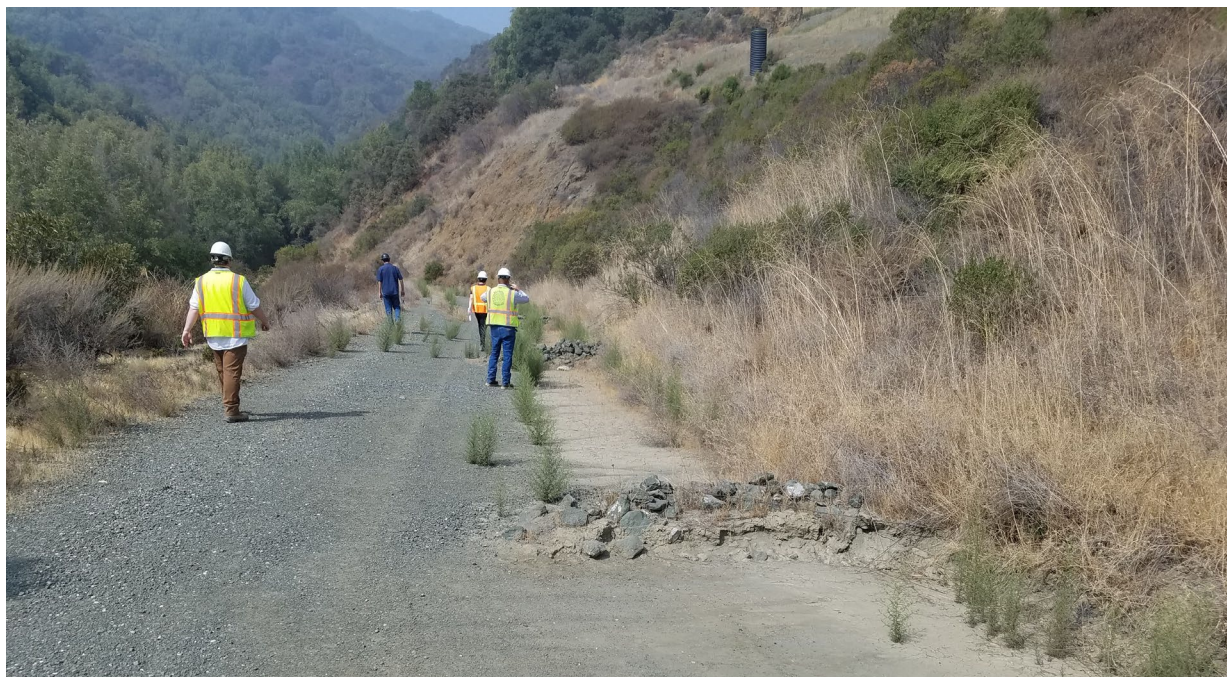
Photo 30: Check dams along road by northside of Rattlesnake Creek.

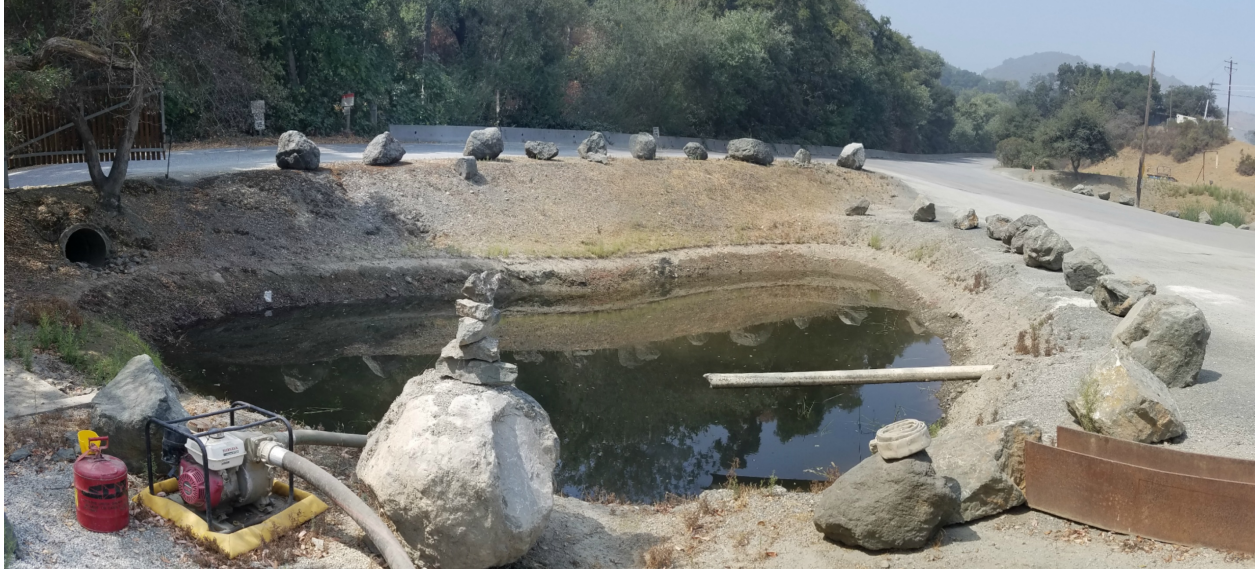
Photo 30: Settling basin near main entrance.
