2021 Stevens Creek Quarry Annual SMARA Inspection

County File PLN07-1253-2021-Annual Report State Mine ID #91-43-0007

Inspection Date: September 15, 2021

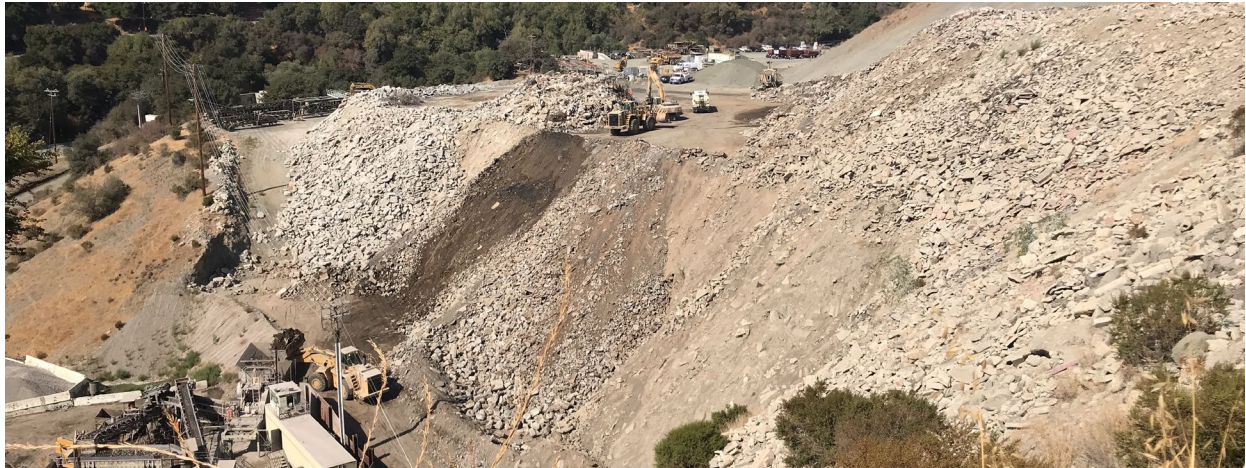
Photo 1: Recycling operation on Parcel A.

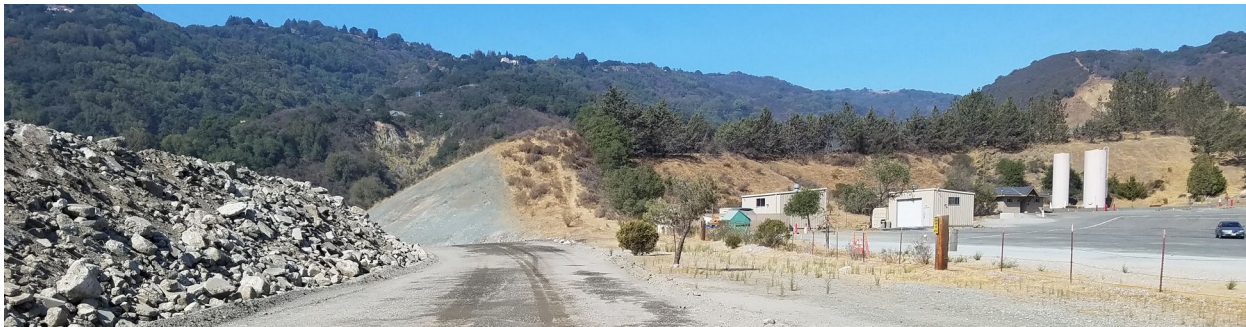
Slump Repair: An area located east of the recycling operation on Parcel A had a slump repair (2012) that is now buried and appears stable. [See **Photo 2** below.]

Photo 2: Repaired slope between Parcel A and gun club.

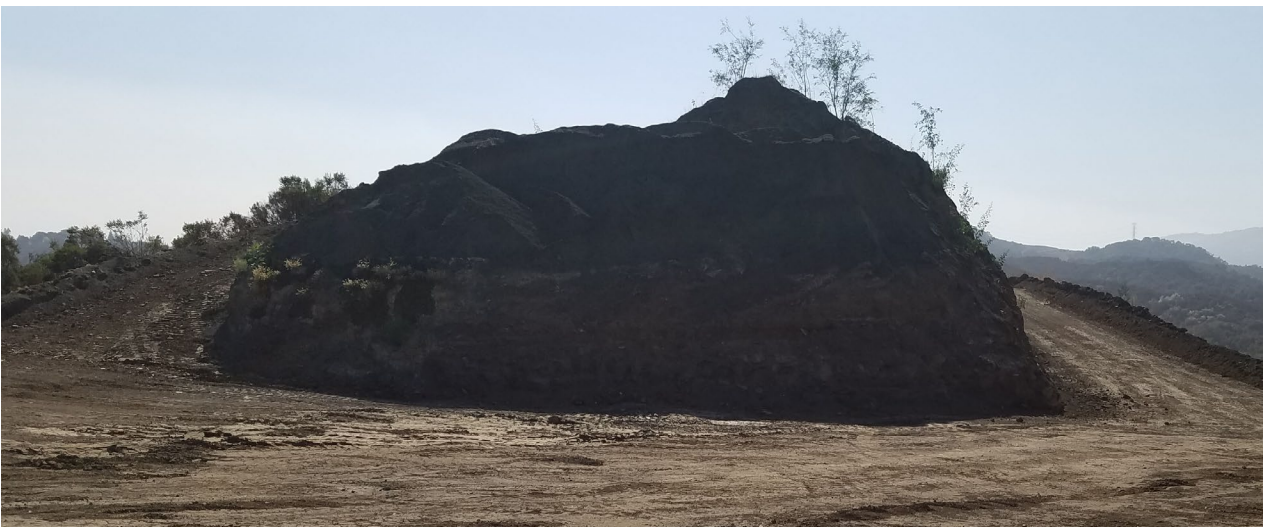
Stockpile Parcel A: Inspectors observed a large stockpile of topsoil on Parcel A. [See **Photo 3** below.]

Photo 3: Stockpiled soil on Parcel A.

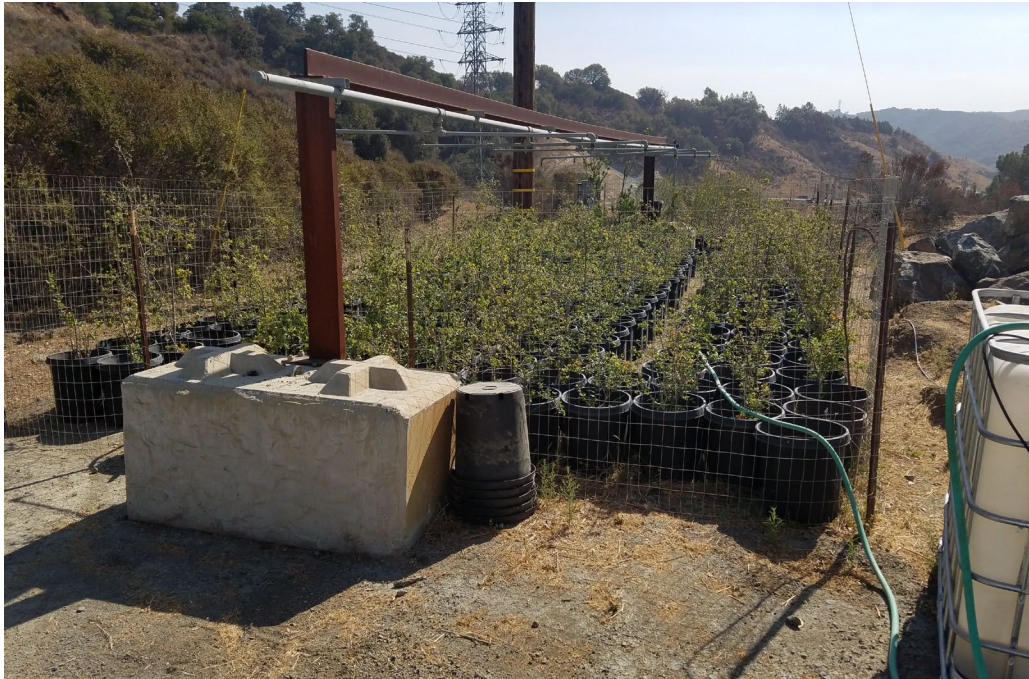
1. *Revegetation:* Operator has installed a nursery with an automatic watering system to germinate and raise native oak trees. [See **Photos 4a and 4b** below.] County suggested last year that the Mine Operator establish vegetation test plots on quarried conditions similar to those that will exist for reclamation to prove the viability of proposed reclamation plantings, and retain a botanist or qualified biologist for the installation and reporting to achieve results for revegetation in accordance with the standards of the Reclamation Plan. As of this inspection, test plots have not been established by the operator.

Photo 4a: Nursery for germinating native oak trees

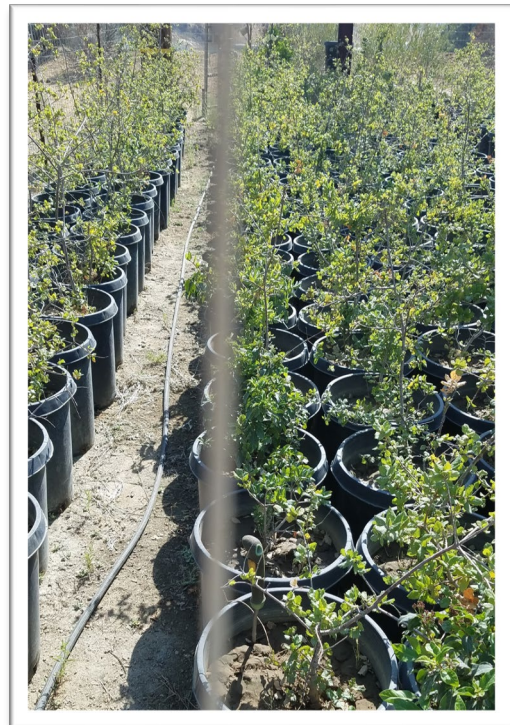
Photo 5b: Close-up of germinating native oak trees in Nursery

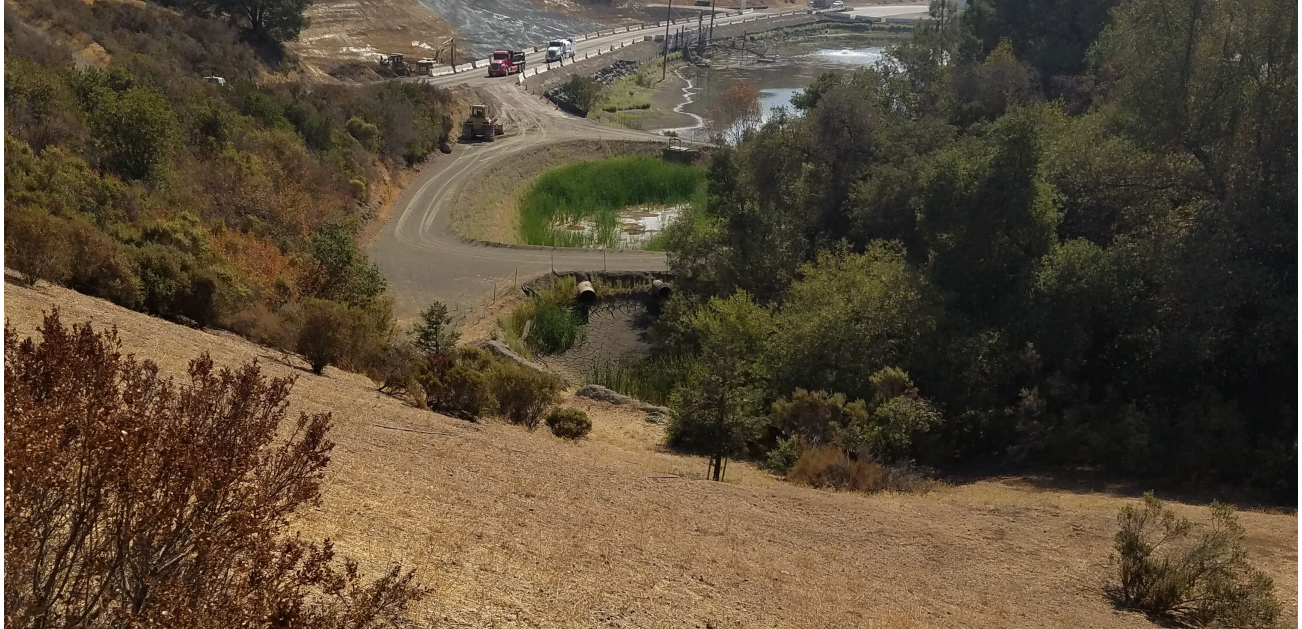
Photo 6: Face of dam between upper and middle settling basins.

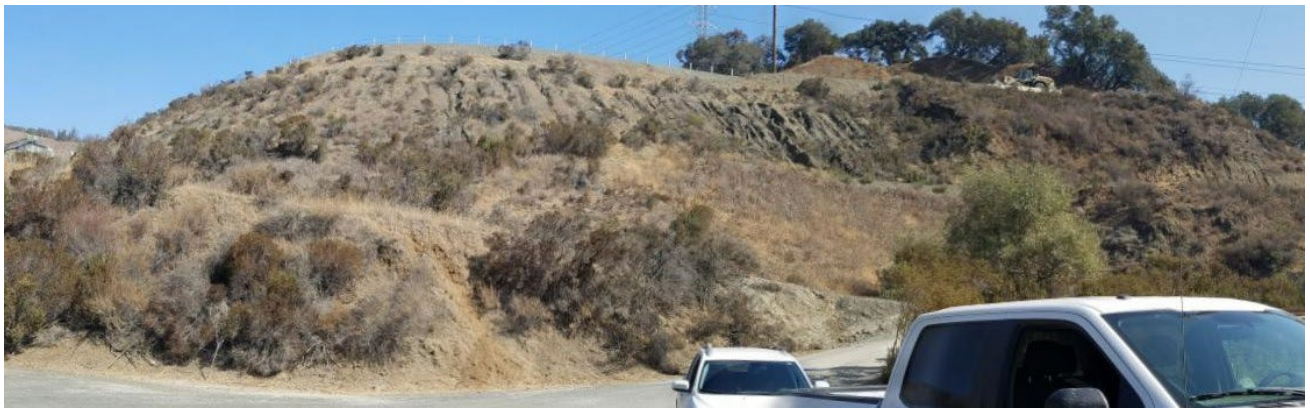
Stormwater Best Management Practices (BMPs): County previously observed ongoing erosion gullies located on fill slopes (Parcel B) above haul road. The operator implemented erosion control and BMP measures at the suggestion of the County including hydroseeding and installation of check dams. These measures appear to be functioning adequately. [See **Photo 29** below.] Recently, the operator has been making improvements to the Parcel A stormwater system at the direction of the RWQCB. These include regrading internal access roads, and re-routing drainage channel to reduce sediment transport. These improvements were done to reduce the level of sediment in discharge water. The County will continue to inspect this area to ensure these necessary BMPs are maintained.

Photo 7: Erosion rills on fill slope above main haul road.

2. *Stormwater BMPs:* During past inspections, County inspectors observed fill slopes with no erosion control measures, primarily in the area of the new crusher and adjacent to the haul road. The County previously required the operator to implement soil stabilization measures and install adequate BMPs, including hydroseeding, at all locations where active grading or disturbed soil have occurred. Subsequently, these measures were implemented and appeared to be functioning adequately during last year's inspections. The County will continue to inspect these areas to verify that BMPs are maintained.

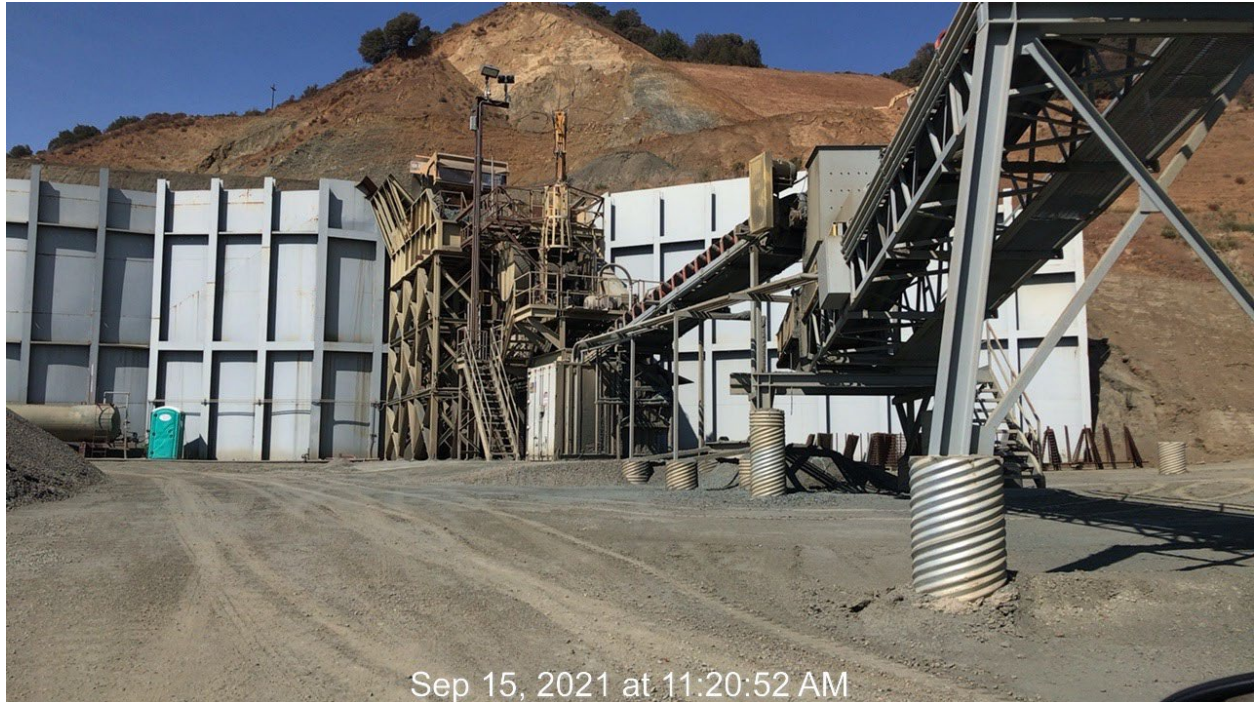
Crusher and Retaining Wall: Mining is conducted in Parcel B in a north-northwest trending quarry where Franciscan greenstone bedrock is extracted. Equipment for crushing and sorting rock materials is located on Parcel B. Inspectors observed crusher equipment was relocated to the southeast portion of Parcel B. [See **Photo 7** below.]

Photo 8: Relocated rock crusher.

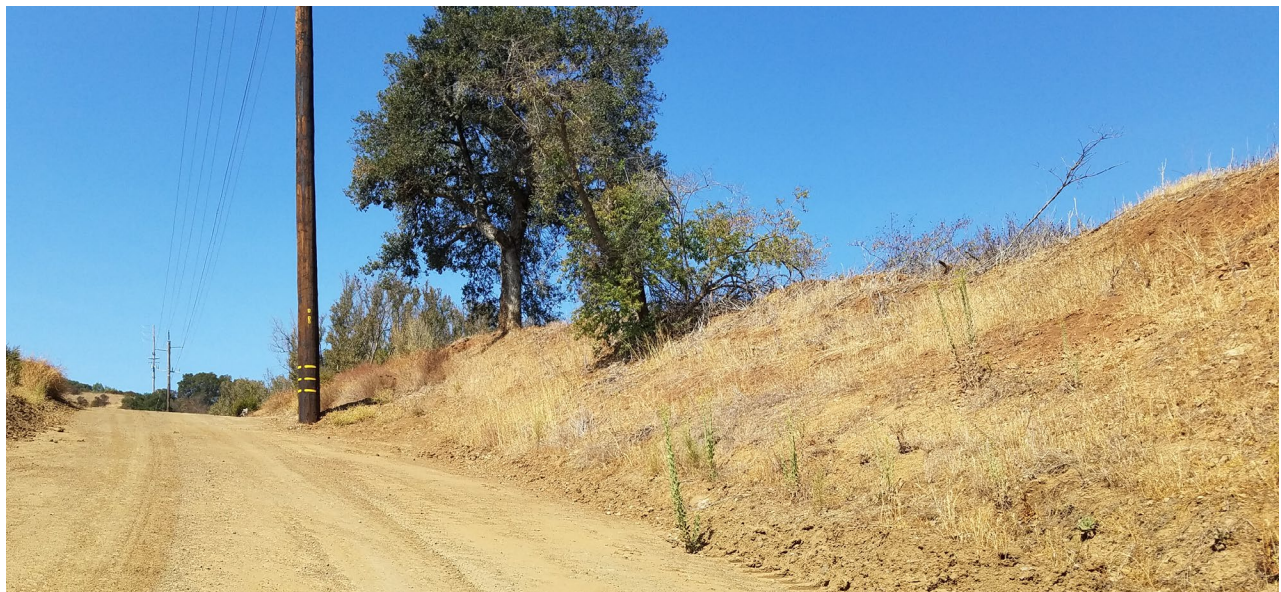
Photo 9: North perimeter road cut slope. No change in condition.

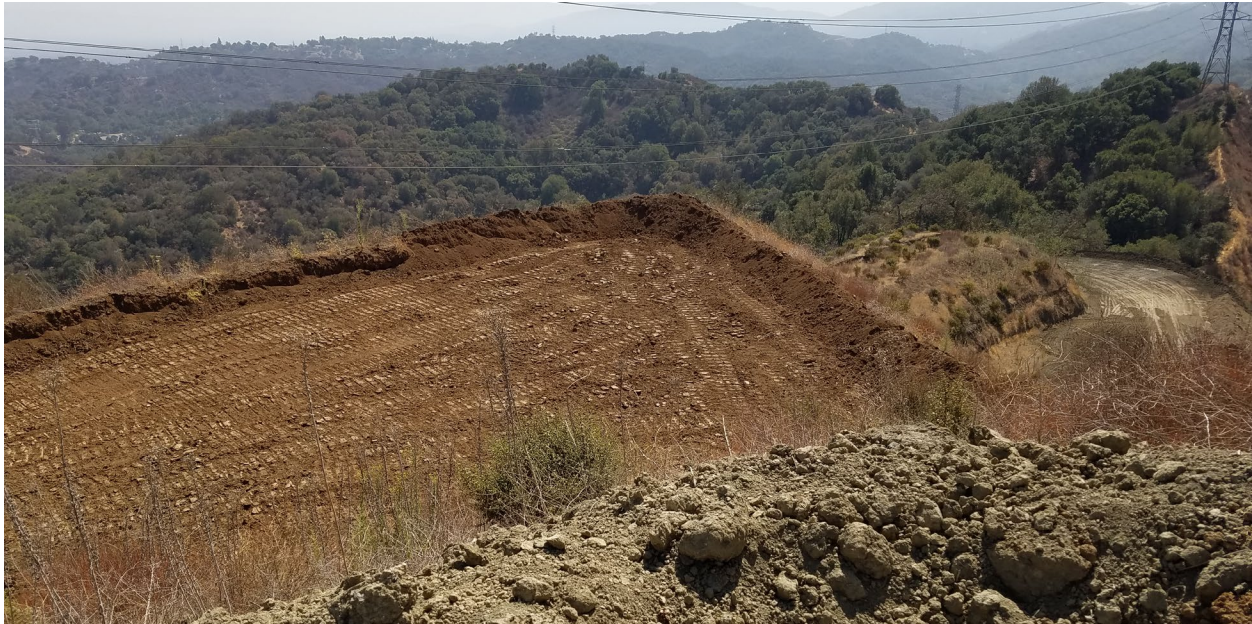
Failure of North “Finished” Cut Slope: County inspectors observed the repair of the perimeter access road which was previously disrupted by the headscarp of a large landslide. [See **Photo 8** below.] The operator submitted a geologic report dated 1-29-2017 that recommended an additional width (200 feet) of buttress be added to the toe of the slope in order to achieve an acceptable factor of safety. Last year a large buttress fill was being placed against the lower and middle portions of the slope below the north slope. This year County inspectors observed that additional buttress fill had been placed. [See **Photos 12 and 14** below.] Previously observed ground cracks in the buttress fill material have been filled in by the operator. [See **Photos 10 and 11** below.]

Photo 11: Regraded area where ground cracks on top of buttress fill of north high wall were observed during 2020 inspection.

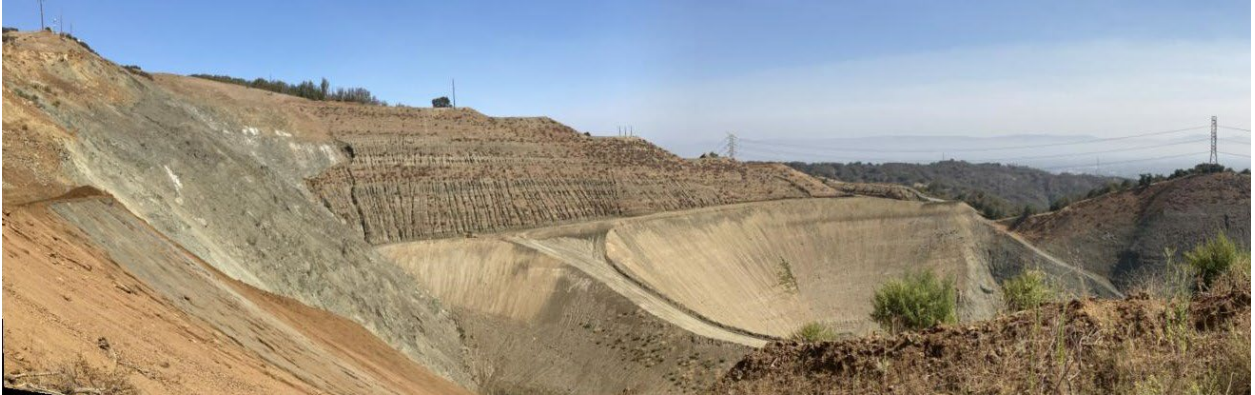
Failure of Northwest “Finished” Cut Slope: Another slope failure has disrupted the cut slope on the northwest side of the quarry pit. The headscarp of that failure has affected the southern end of the retaining wall built to protect the radio shack at the top of the slope. [See **Photos 13 and 15** below.]

Photo 13: Buttress fill on north high wall.

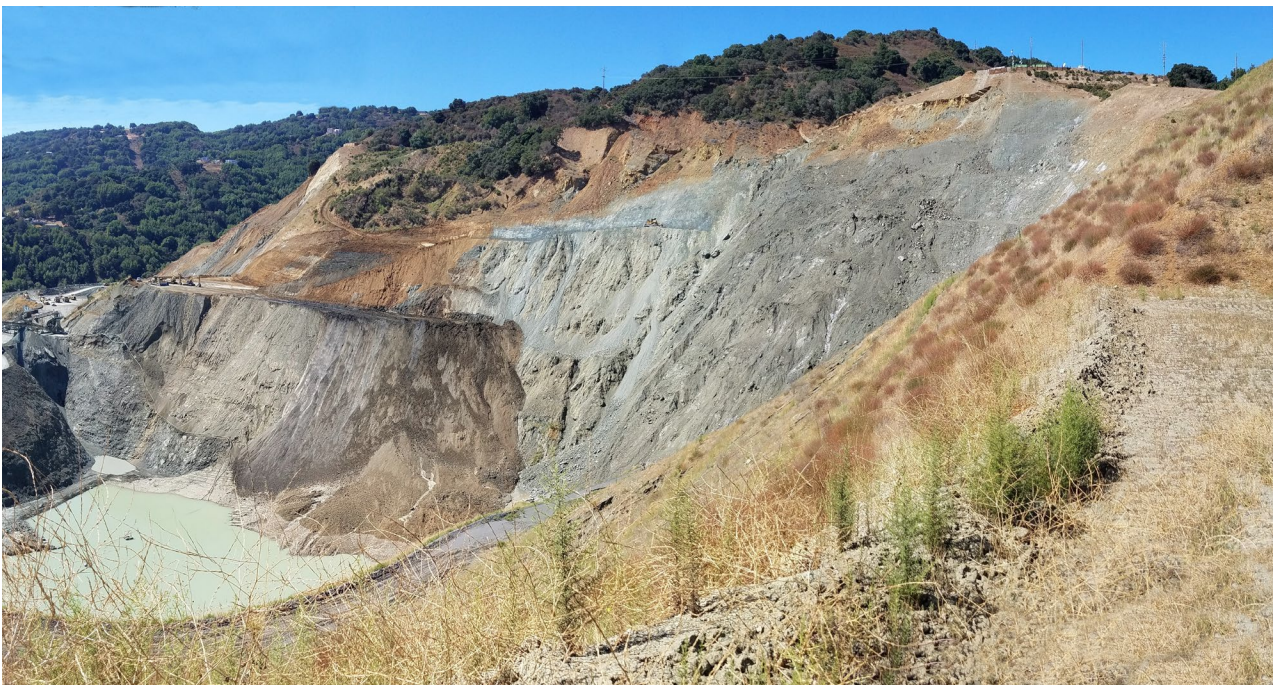
Photo 14: Buttress fill on north high wall. West side of pit visible on the left.

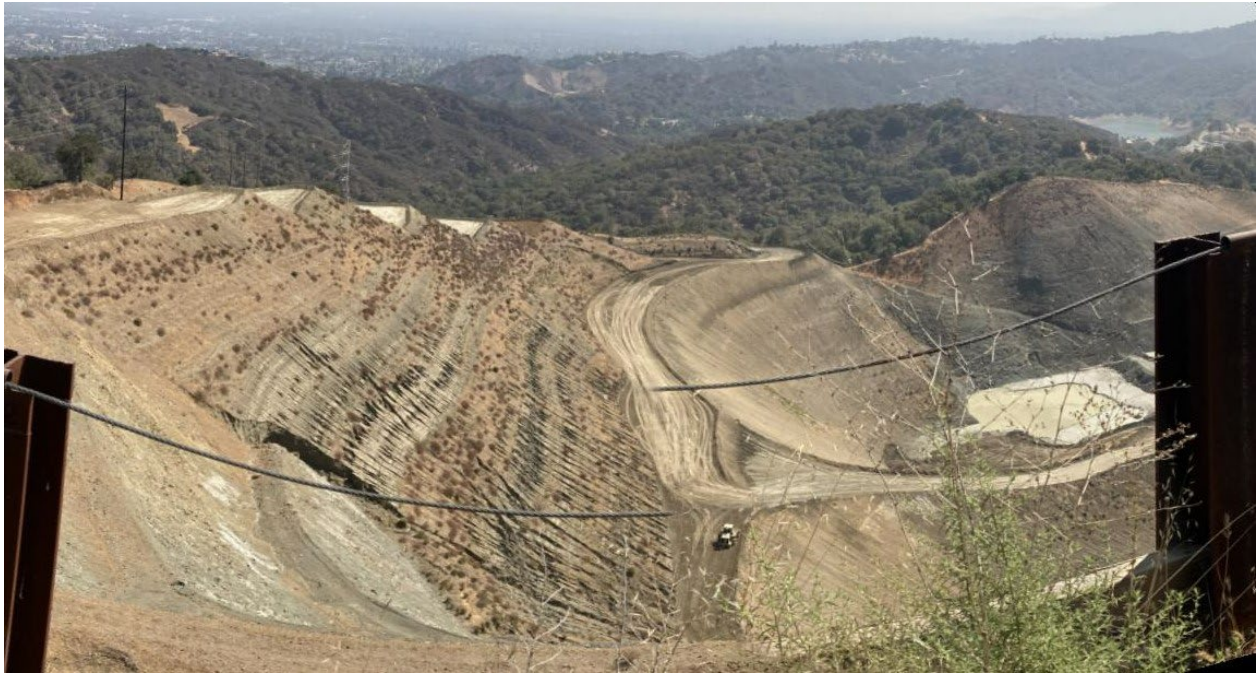
Photo 15: Panorama of buttress fill below retaining wall on northwest high wall.

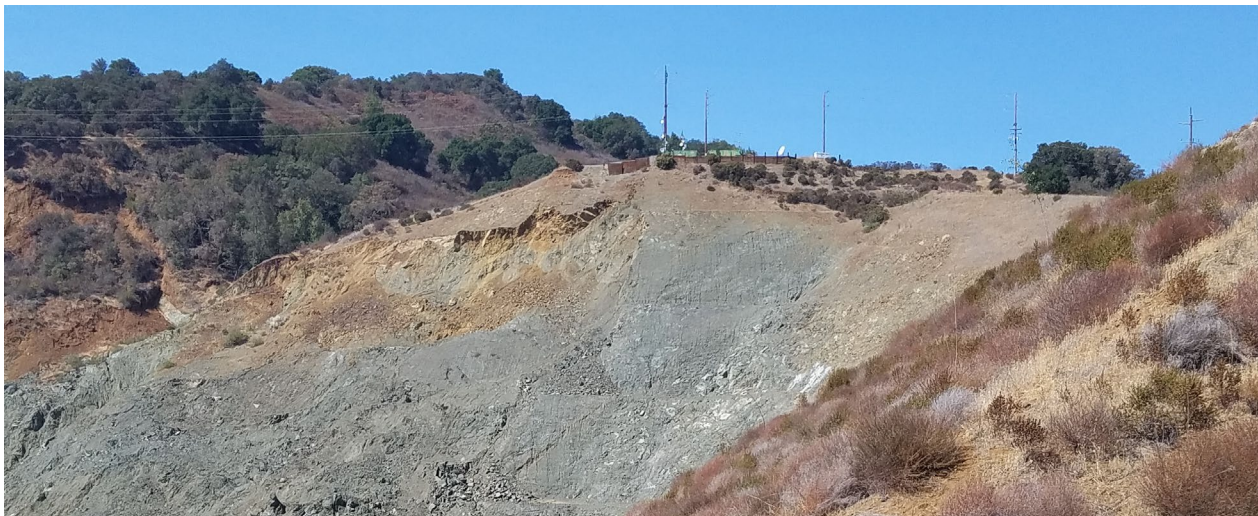
Photo 1516: Slope failure on western high cut wall.

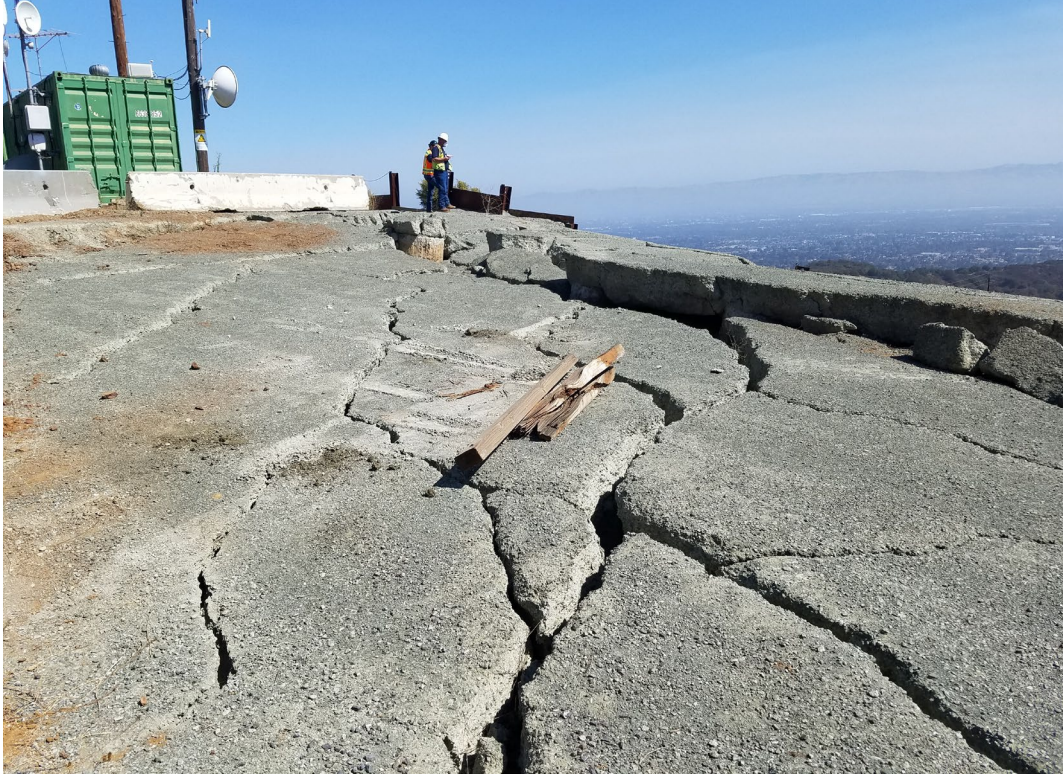
ensure that they do not impermissibly mine within buffer areas or cross the RPA boundary. County inspectors did not observe evidence of any mining activities outside of RPA boundary. As shown in **Photo 17** and discussed above, previously observed ground cracks that cross the northwest property line have grown since the prior inspection, and will need to be corrected by the operator.

Photo 17: Ground cracks near northwest property line.

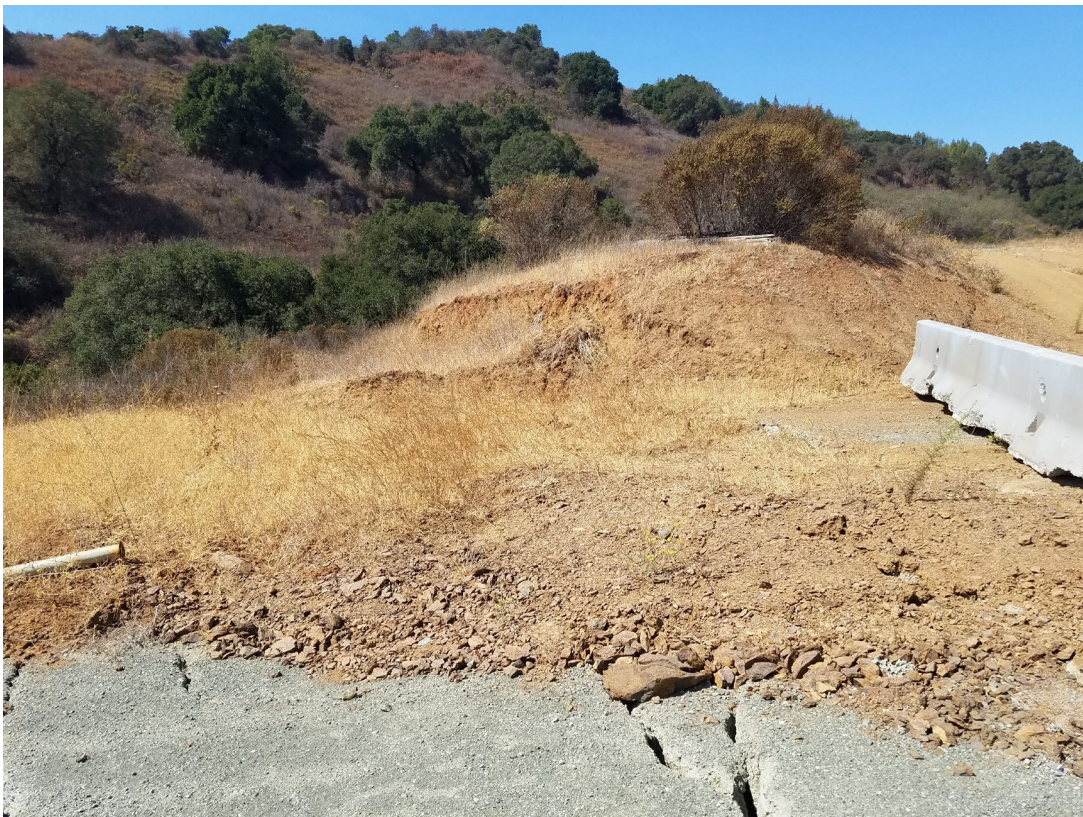
Photo 18: Ground cracks and headscarp beyond northwest property line.

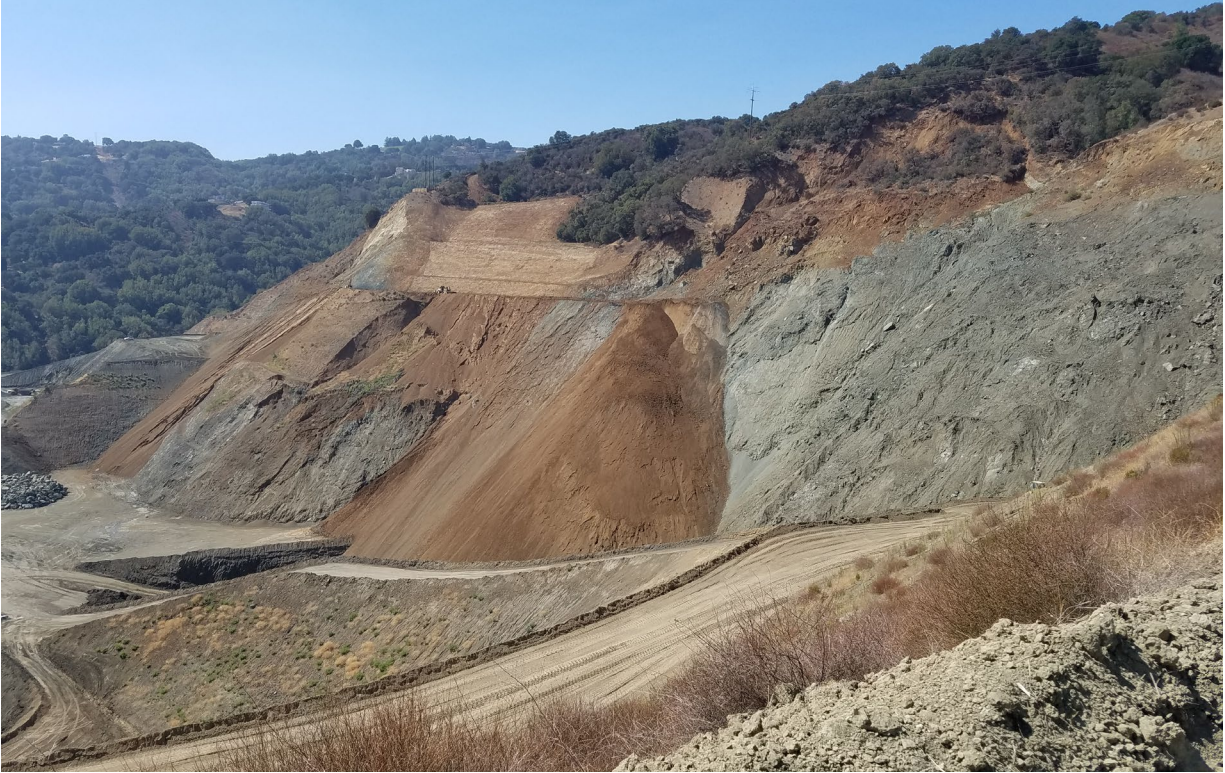
Failure of Southwest “Finished” Cut Slope: Another slope failure has disrupted the cut slope on the southwest side of the quarry on Parcel B. Inspectors observed that the headscarp of the failure had approached the retaining wall built to protect three PG&E power poles. [See **Photo 18** below.] County inspectors observed landslide debris accumulation at the toe of the slope, and observed the operator removing this material during last year’s inspection. During the past year, the operator graded in a new cut slope in the upper portion and desposited uncompacted spoils below the new cut. [See **Photo 19** below.]

Photo 19: Slope failure on southwestern high cut wall, looking south. (Profile view)

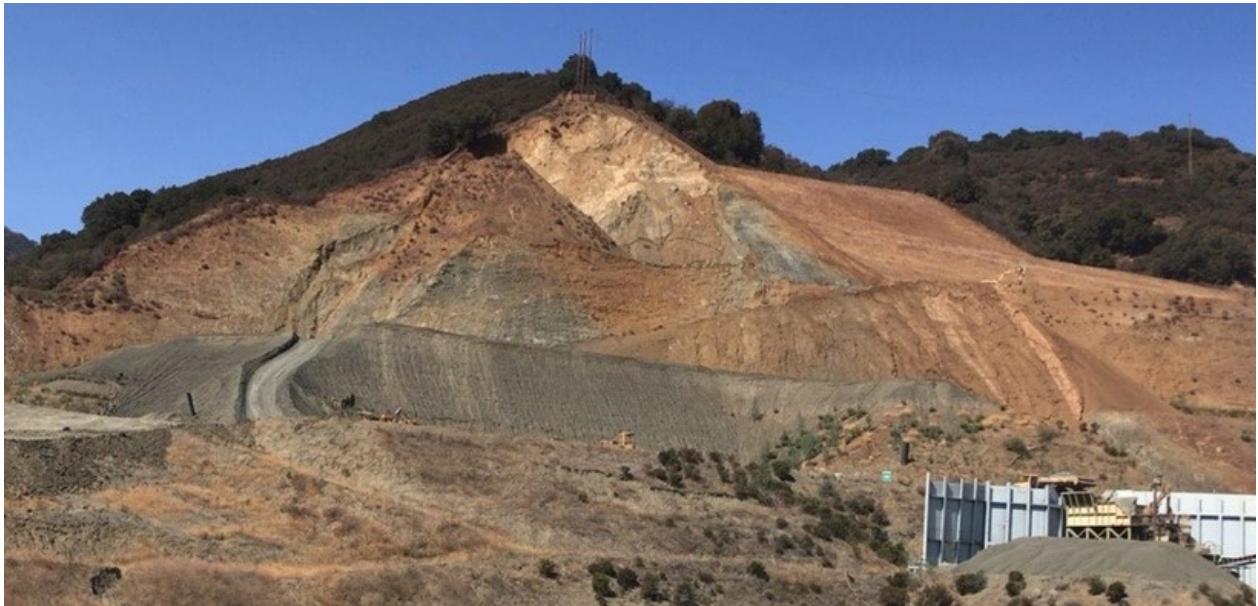
Photo 20: Slope failure on southwestern high cut wall, looking west.

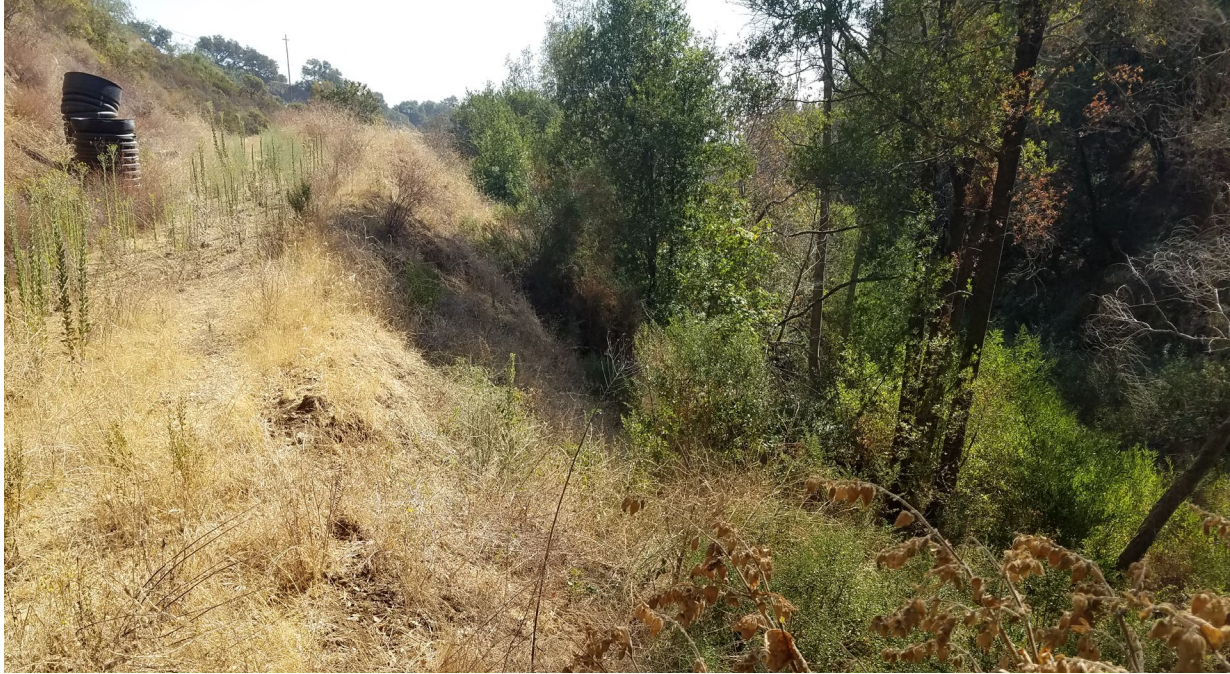
Rattlesnake Creek: In 2017, County observed a slope failure above Rattlesnake Creek along a road towards the west end of Parcel B. The Quarry built a fill slope to repair the road and installed jute netting to minimize erosion. The slope appears to be stable, and vegetation has been reestablished in this area. [See **Photo 20** below.]

Photo 21: Reggraded slope along the north side of Rattlesnake Creek.

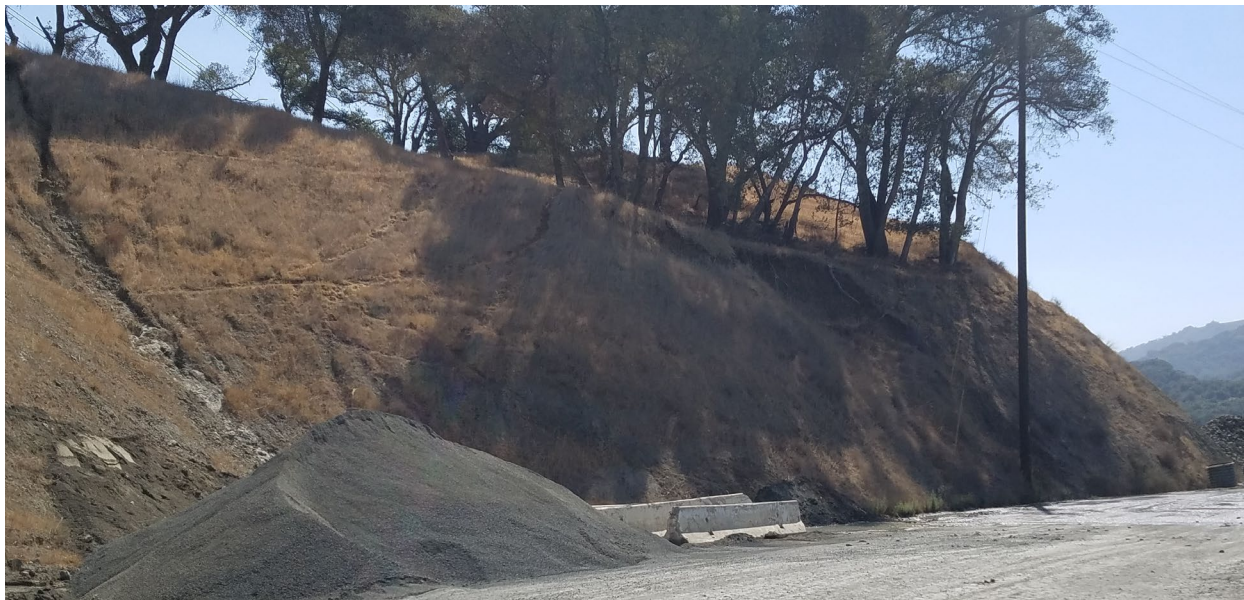
Cut Slope Along Southeastern Side of Parcel B: A shallow failure in the cut slope adjacent to the operating equipment located in the southeastern corner of Parcel B, first observed during previous inspections, does not appear to have progressed. [See **Photo 21** below.] Although the ground has moved, the County expects this area to be corrected during final reclamation. The County will continue to monitor this shallow failure during monthly inspections of the quarry.

Photo 22: Shallow failures of cut slope along east side of Parcel B.

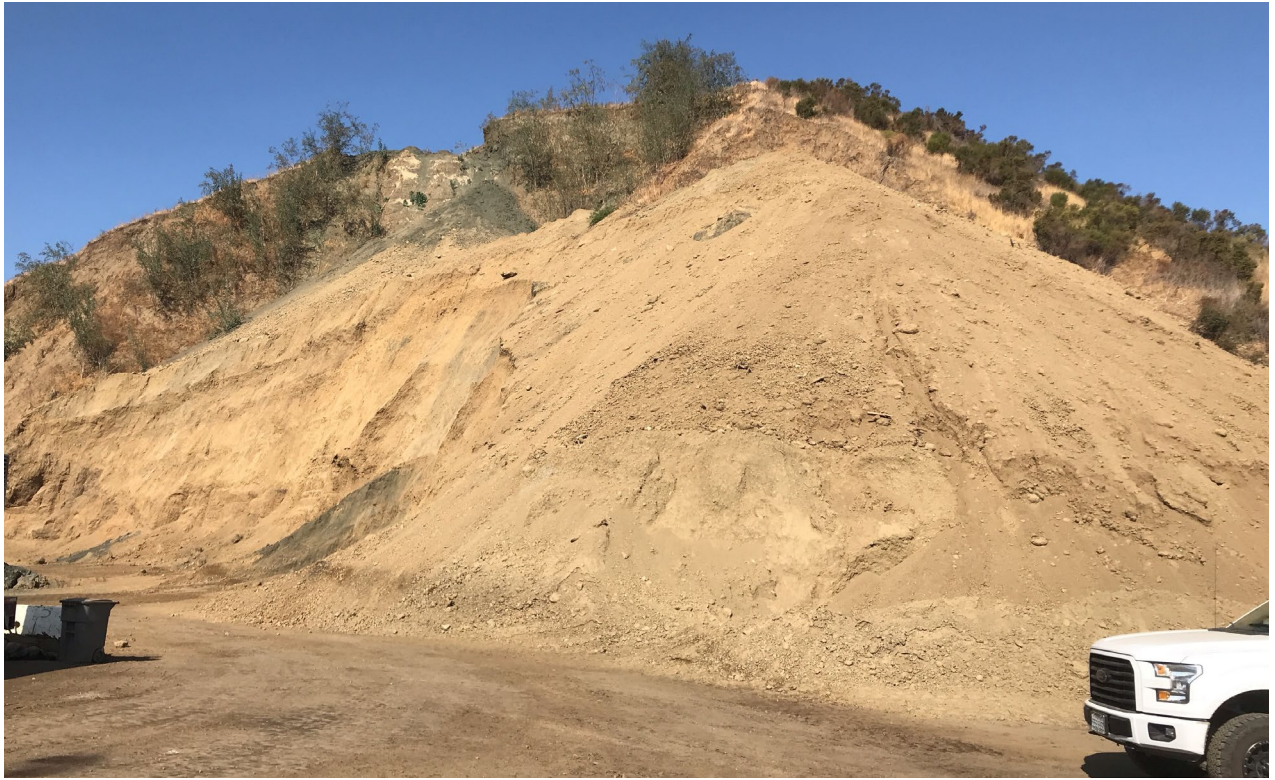
Photo 23: Dirt stockpile at eastern portion of Parcel A.

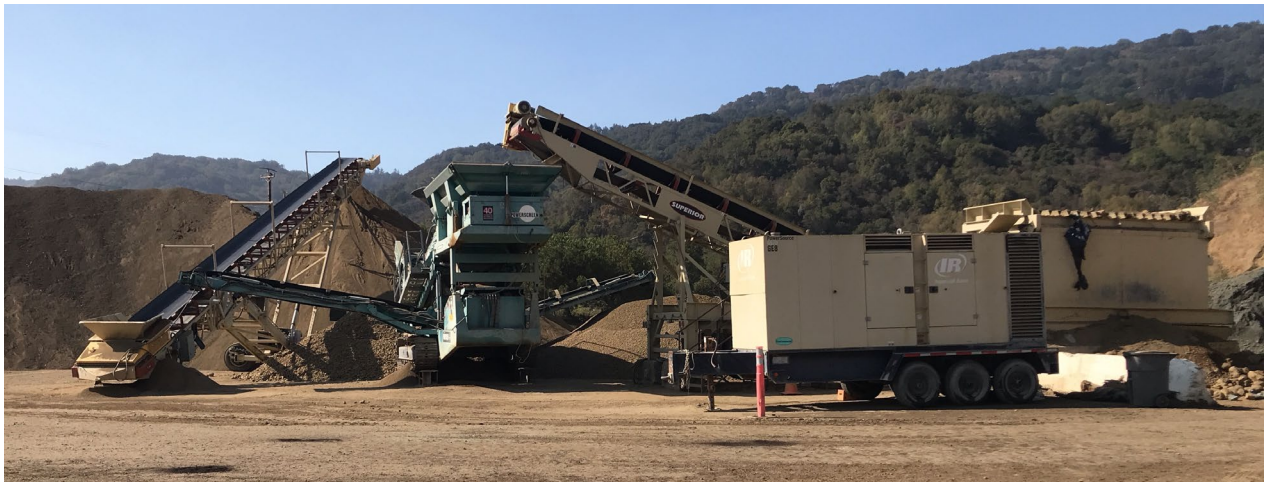
Photo 24: Dirt stockpile and processing equipment at eastern portion of Parcel A.

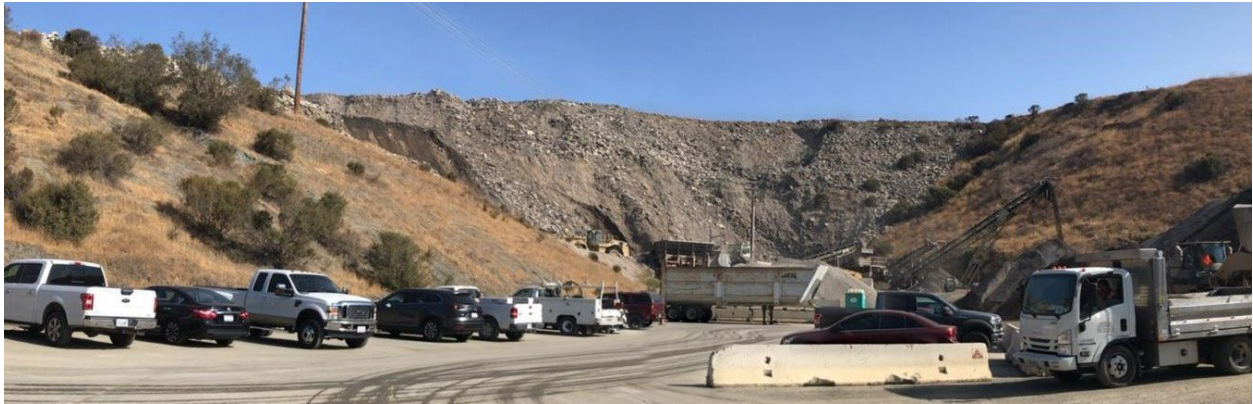
Photo 25: Recycle stockpile has been reduced in size since last year.

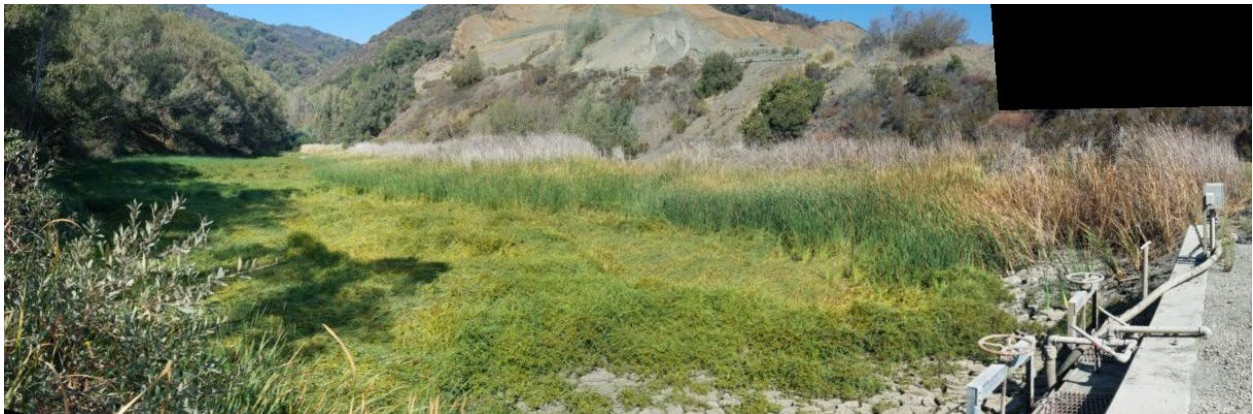
Photo 26: Upper Settling Basin.

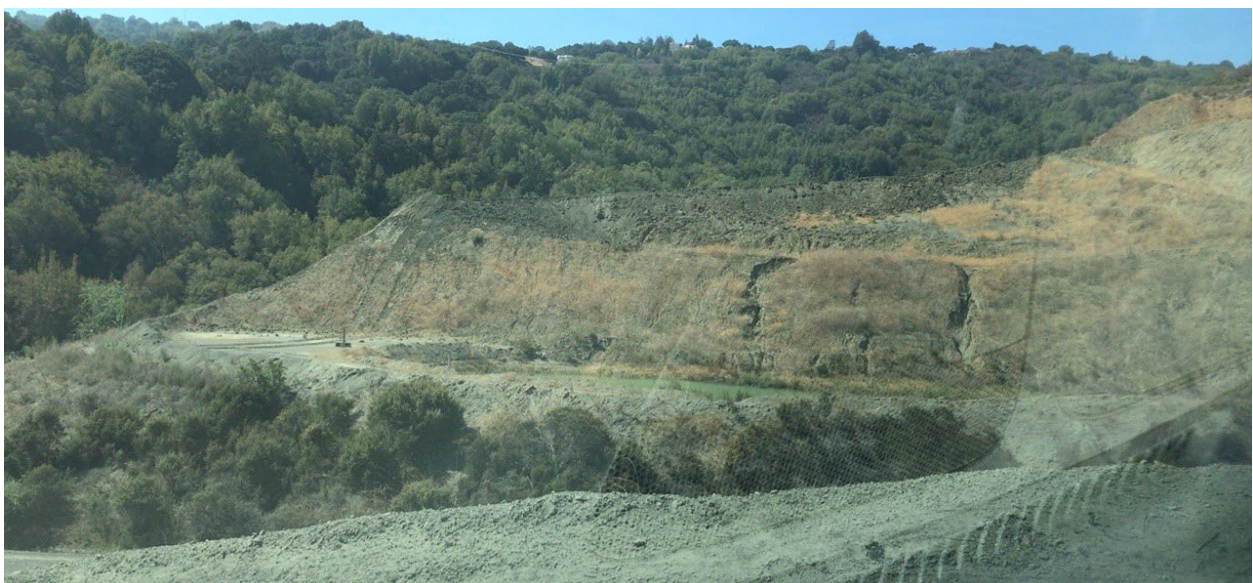
Photo 27: Pond 5.

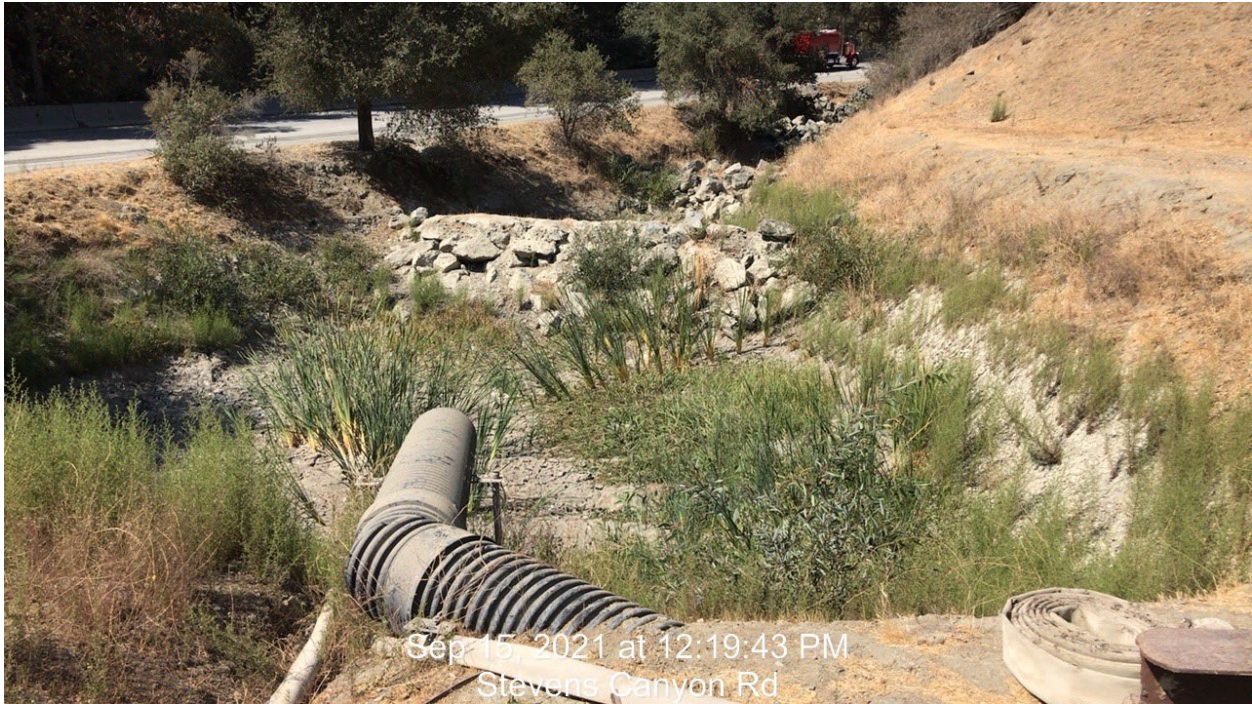
Photo 28: Pond west of office.

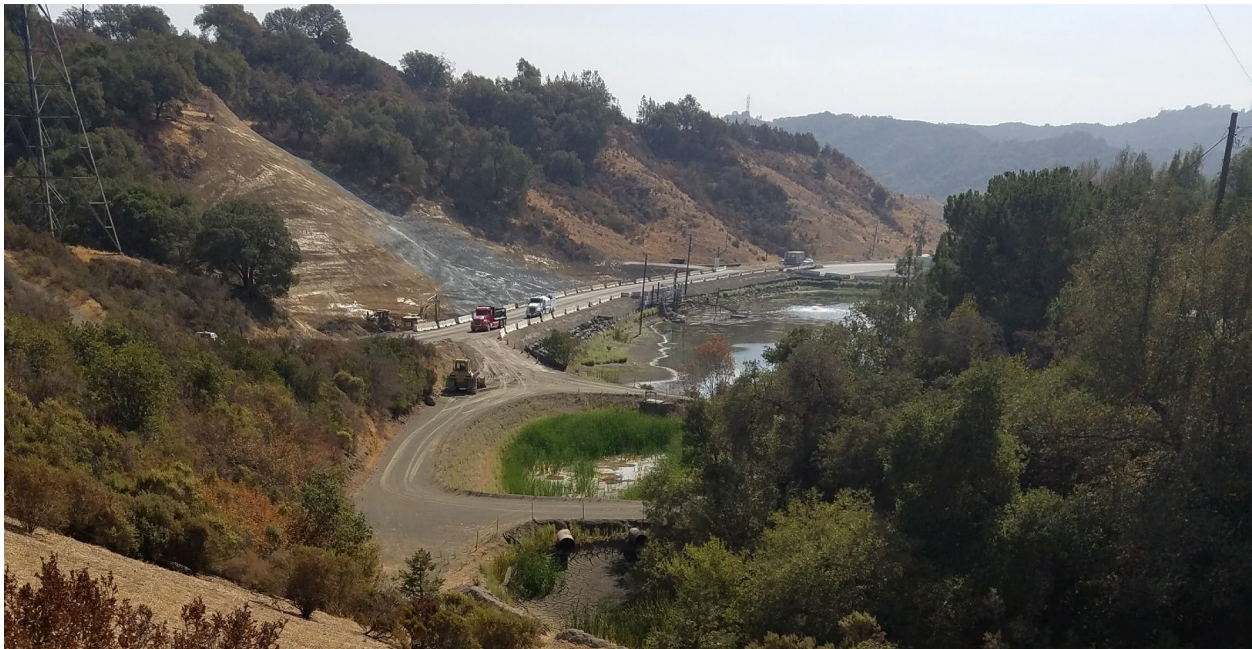
Settling Basins: Stormwater from the Quarry is stored in a series of settling basins (Upper Settling Basin, Middle Settling Basin, Lower Settling Basin) located in the southern portion of the site. Two of these basins (Middle and Lower) are in Parcel A, the Lower basin being the largest. [See **Photo 28** below.] Per direction from the RWQCB and the County, the operator is installing a new settling basin [See **Photos 31a-c**] adjacent to the main access road, that will once completed, replace the function of the in-stream settling basins. The settling basins eventually discharge off-site via a southeastern stormwater detention basin adjacent to the mine entrance. Discharge water enters a tributary feeding Stevens Creek Reservoir. An earthen dam (approximately 55 feet high) is located between Upper Settling Basin and Middle Settling Basin. [See **Photo 25** below, taken from top of dam looking upstream at inactive upper settling basin.] The southern portions of the dam and Upper Settling Basin were previously located beyond the property line. A lot line adjustment was recorded on July 19, 2017 to expand the property boundary to include these features. A Reclamation Plan Amendment (RPA) is needed to modify the boundary of the Reclamation Plan area to include the entirety of the Upper Settling Basin and dam. The County identified this violation and sent the Quarry a Notice of Violation in September 2017 and subsequently entered into a Stipulated Order to Comply and Compliance Agreement with the operator on May 16, 2018. The Compliance Agreement was subsequently modified to include the date for RPA application submittal and processing milestones. On September 21, 2020 the operator submitted an RPA and Use Permit application to correct the violations. On December 8, 2021 the County deemed the application complete and EIR preparation is anticipated to begin once an updated scope and bid have been prepared.

Photo 29: Middle and Lower Settling Basins.

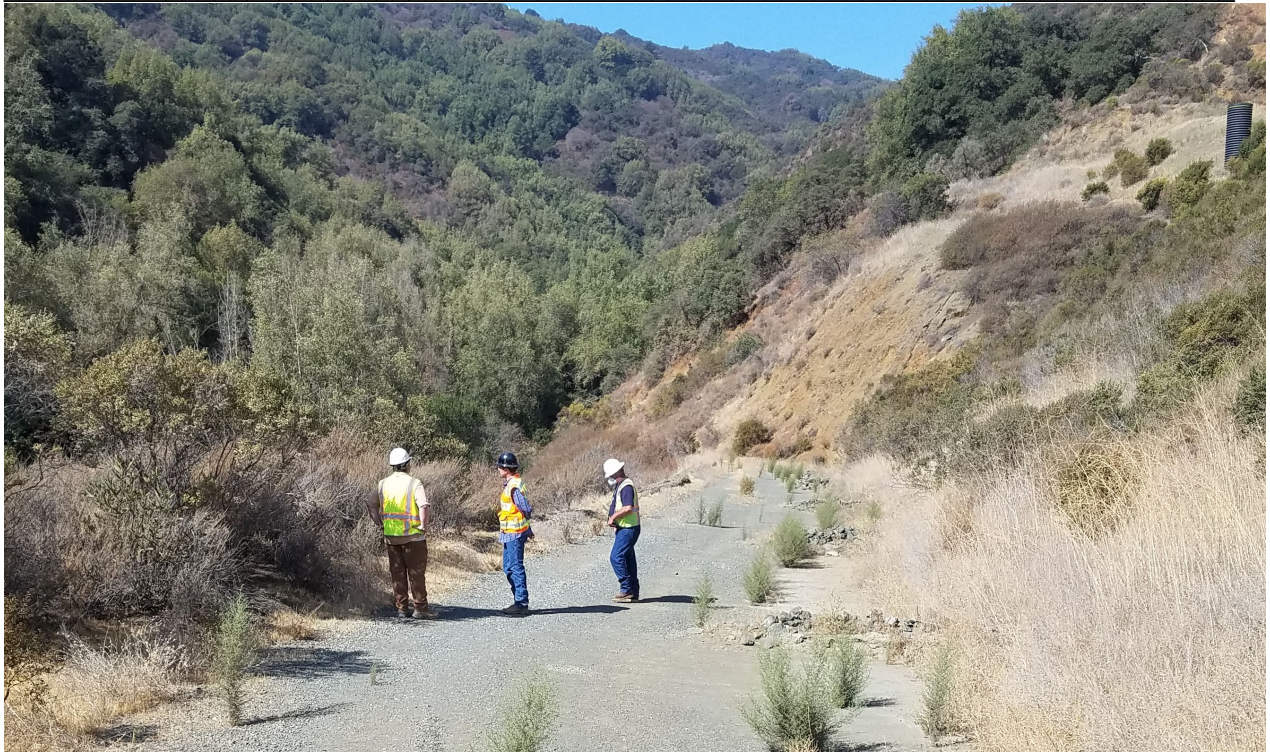
Photo 30: Check dams along road by northside of Rattlesnake Creek.
