2021 Stevens Creek Quarry Annual SMARA Inspection

County File PLN07-1253-2021-Annual Report State Mine ID #91-43-0007

Inspection Date: September 15, 2021

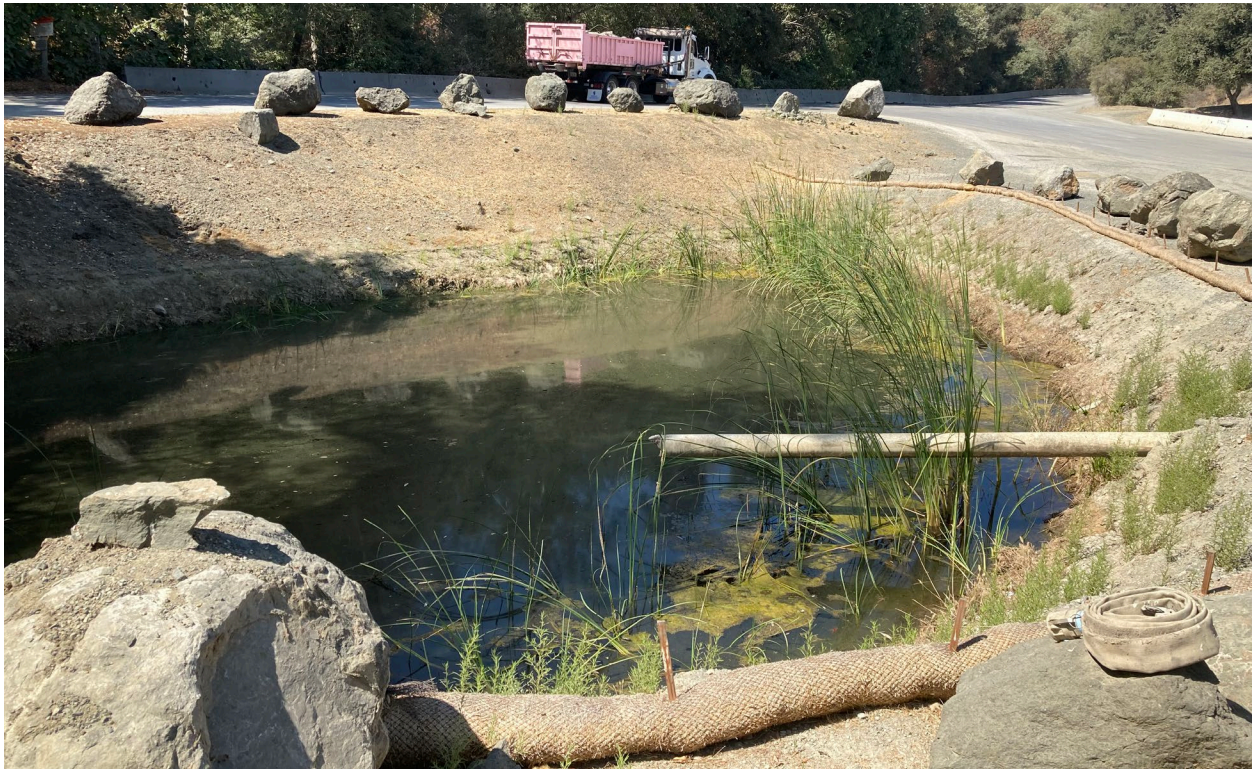
Photo 30: Settling basin near main entrance.

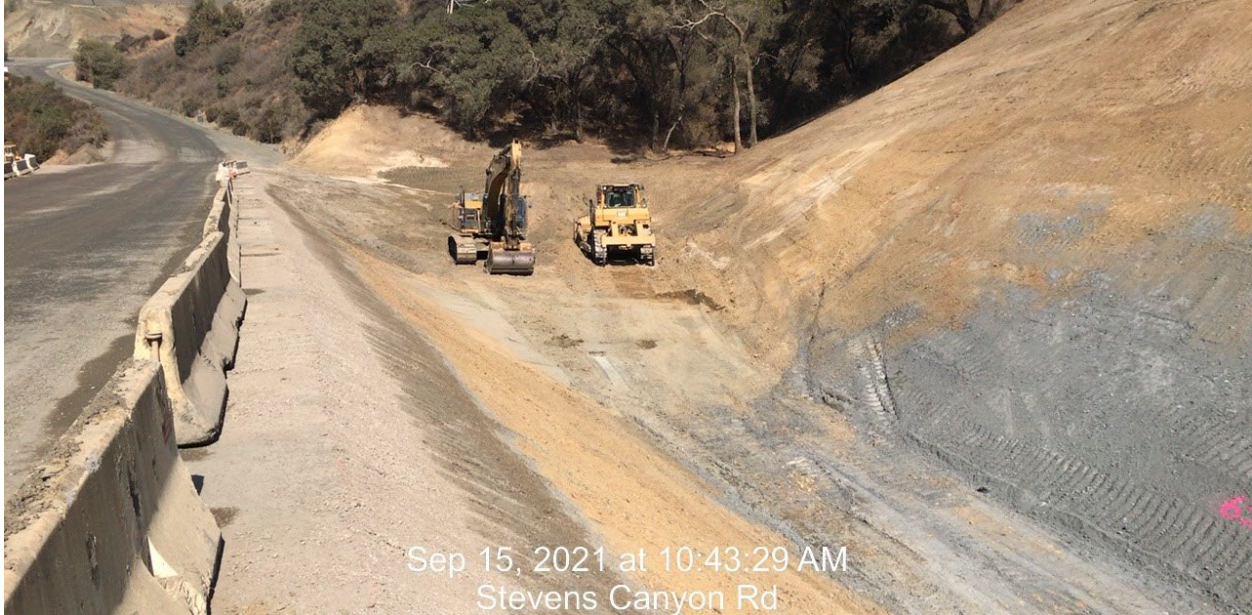
Photo 3 I a: West end of recently graded settling basin (known as BAGG basin) installed to comply with RWQCB requirements.

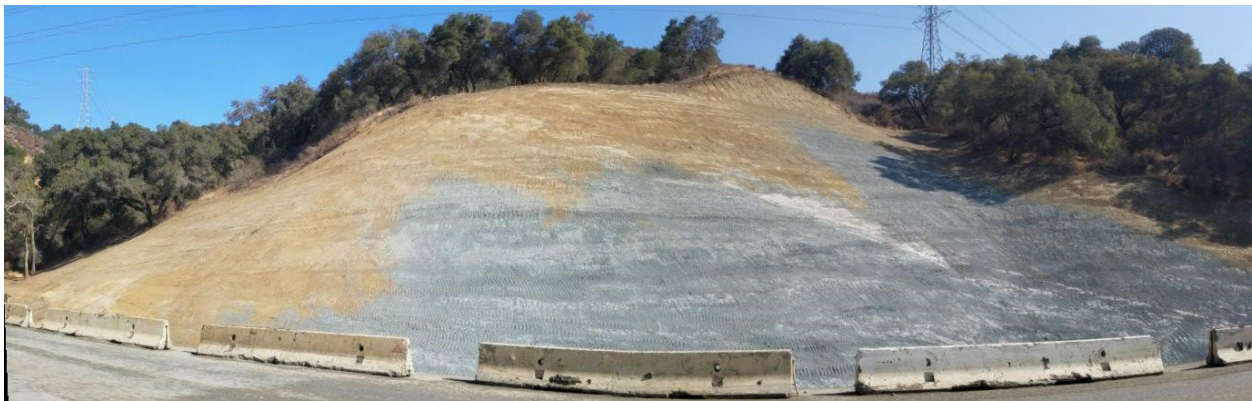
Photo 3 I b: Cut slope above recently graded BAGG basin (looking North).

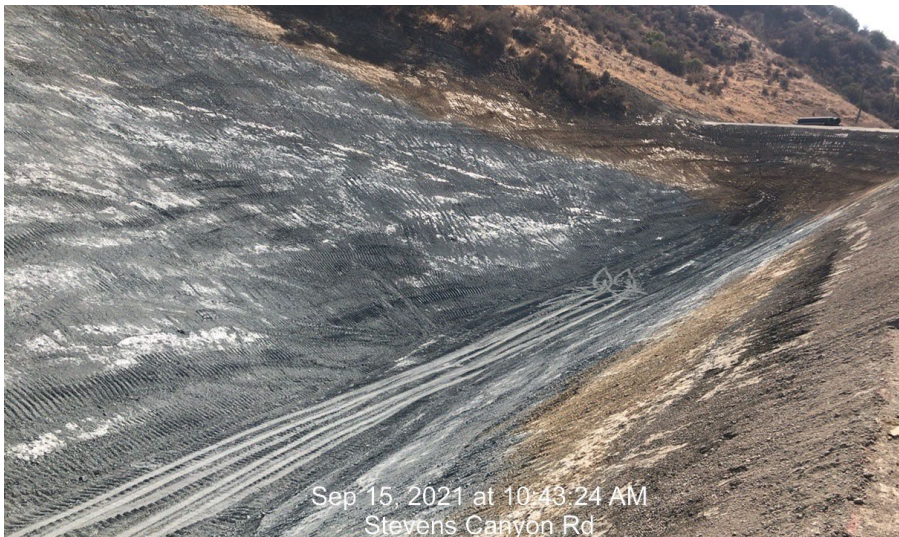
Photo 3 I c: BAGG pond (looking East).

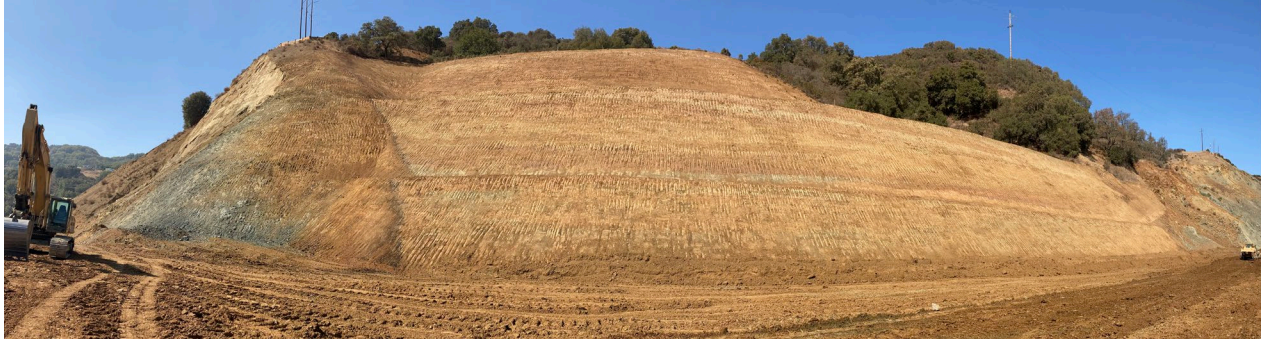
Photo 32: New cut slope along western part of property.
