SURFACE MINING INSPECTION REPORT

In addition to the annual SMARA inspections, County staff inspects Stevens Creek Quarry (Quarry) on a monthly basis to monitor stormwater controls and compliance with conditions of approval.

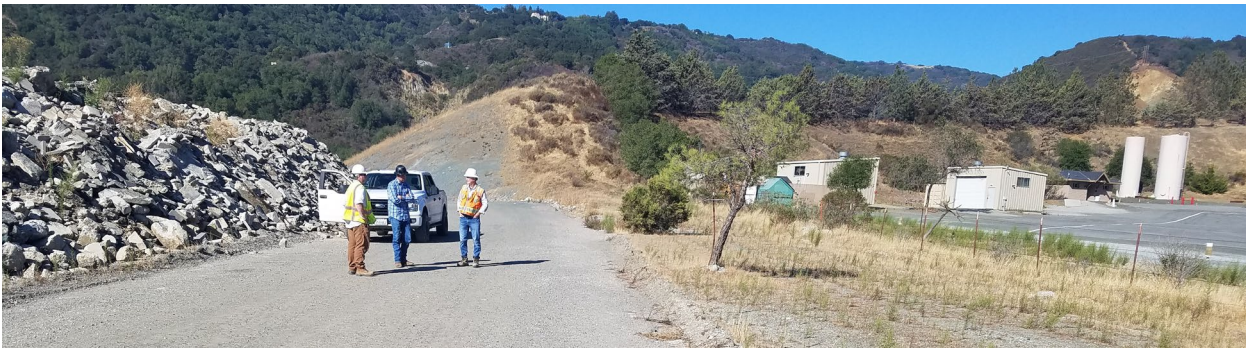
Slump Repair: An area located east of the recycling operation on Parcel A had a slump repair (2012) that is now buried and appears stable. [See **Photo 2** below.]

Photo 2: Repaired slope between Parcel A and gun club.

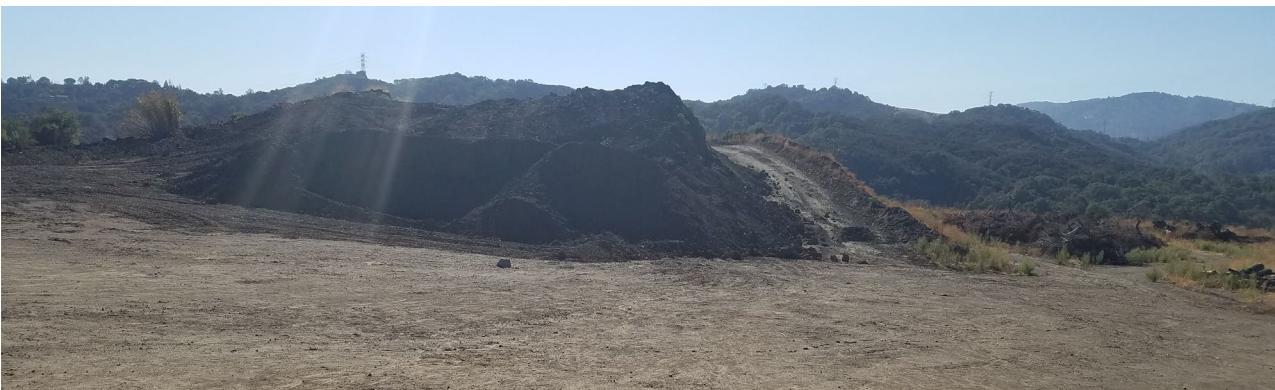
Stockpile Parcel A: Inspectors observed a large stockpile of topsoil on Parcel A. [See **Photos 3 and 22** below.]

Photo 3: Stockpiled soil on Parcel A.

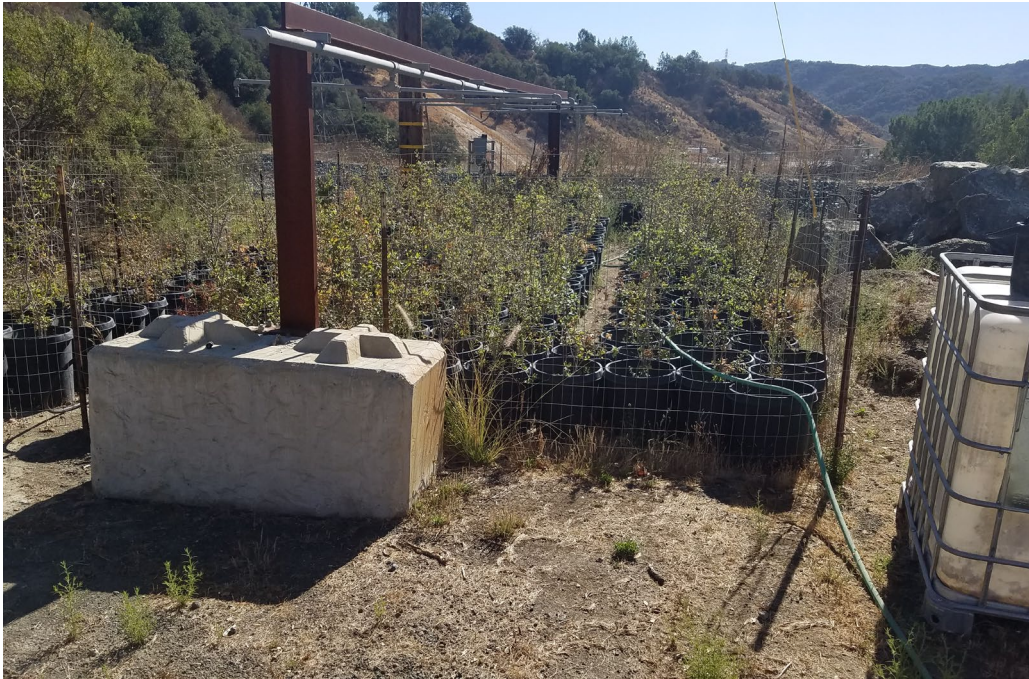
1. *Revegetation:* Operator has installed a nursery with an automatic watering system to germinate and raise native oak trees. [See **Photos 4a and 4b** below.] County suggested last year that the Mine Operator establish vegetation test plots on quarried conditions similar to those that will exist for reclamation to prove the viability of proposed reclamation plantings and retain a botanist or qualified biologist for the installation and reporting to achieve results for revegetation in accordance with the standards of the Reclamation Plan.

Photo 4a: Nursery for germinating native oak trees

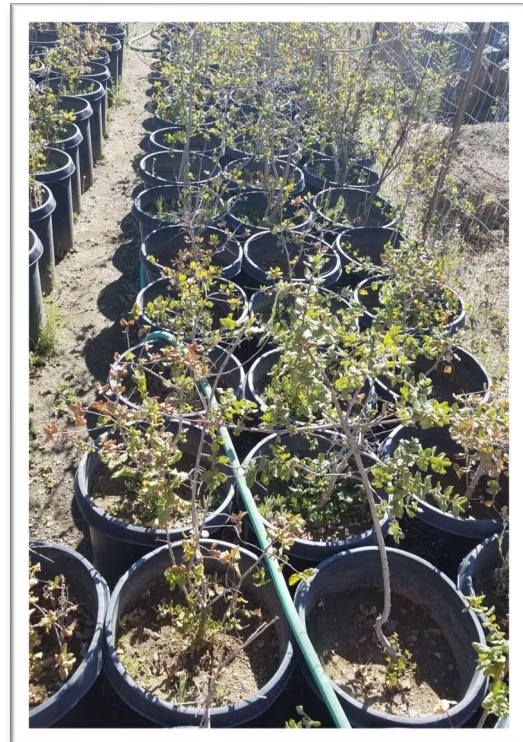
Photo 5b: Close-up of germinating native oak trees in Nursery

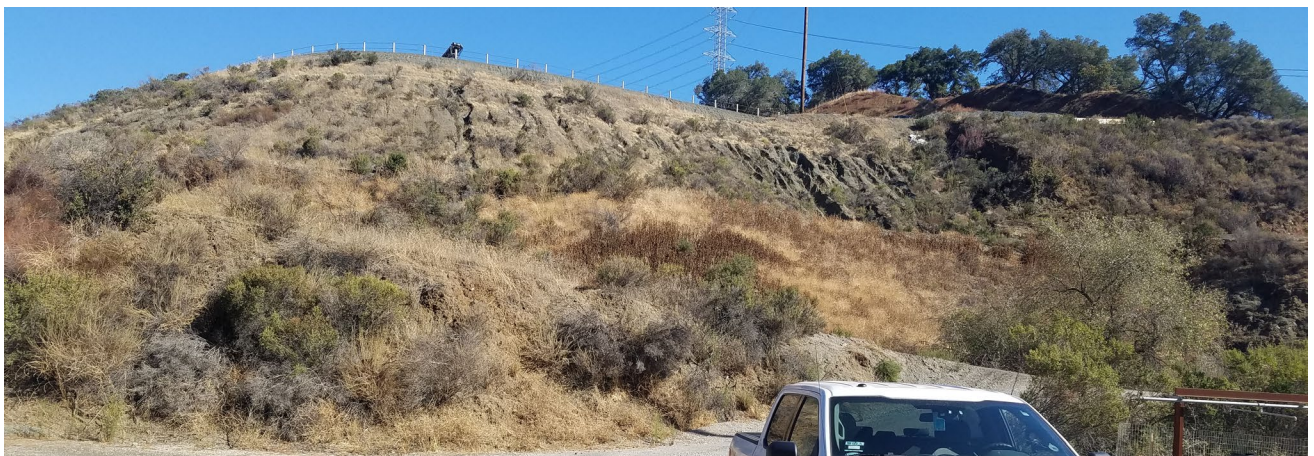
Stormwater Best Management Practices (BMPs): County previously observed ongoing erosion gullies located on fill slopes (Parcel B) above haul road [see **Photo 6**]. The operator implemented erosion control and BMP measures at the suggestion of the County including hydroseeding and installation of check dams. These measures appear to be functioning adequately [see **Photo 29** below]. Recently, the operator has been making improvements to the Parcel A stormwater system at the direction of the RWQCB. These include regrading internal access roads, re-routing drainage channels to reduce sediment transport, and a new sediment removal system, currently being tested by the operator prior to permanent installation [see **Photos 27, 30, and 36**]. These improvements were done to reduce the level of sediment in discharge water. The County will continue to inspect this area to ensure these necessary BMPs are maintained.

Photo 7: Erosion rills on fill slope above main haul road.

2. *Stormwater BMPs:* During past inspections, County inspectors observed fill slopes with no erosion control measures, primarily in the area of the new crusher and adjacent to the haul road. The County previously required the operator to implement soil stabilization measures and install adequate BMPs, including hydroseeding, at all locations where active grading or disturbed soil have occurred. Subsequently, these measures were implemented and appeared to be functioning adequately during last year's inspections. The County will continue to inspect these areas to verify that BMPs are maintained.

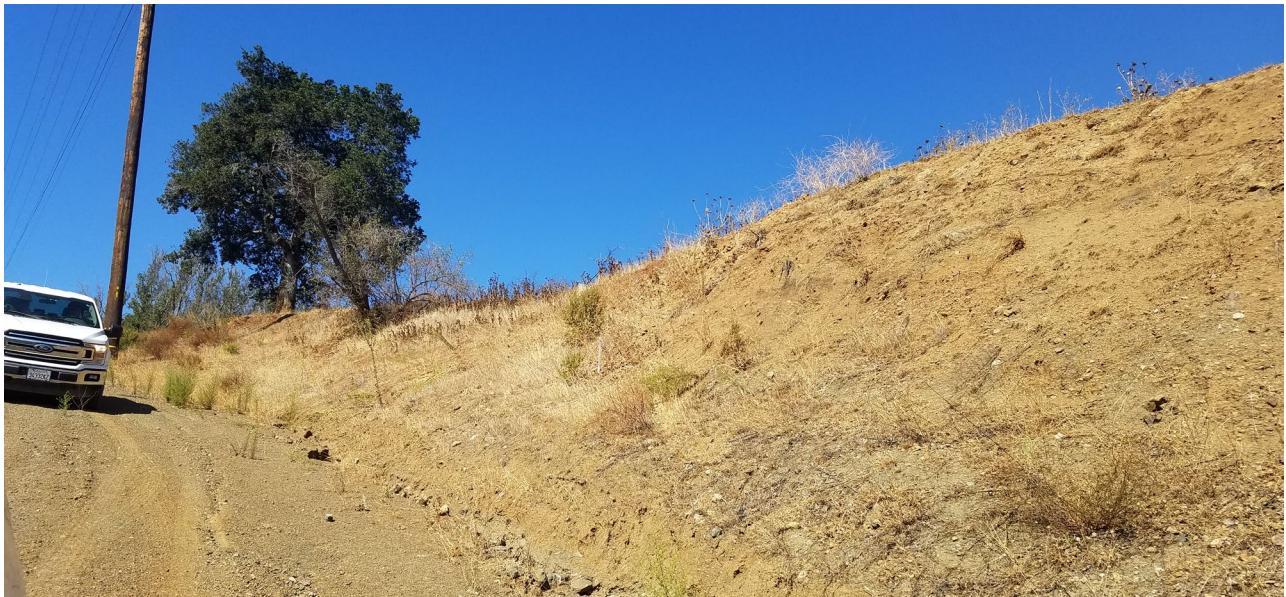
Photo 9: North perimeter road cut slope. No change in condition.

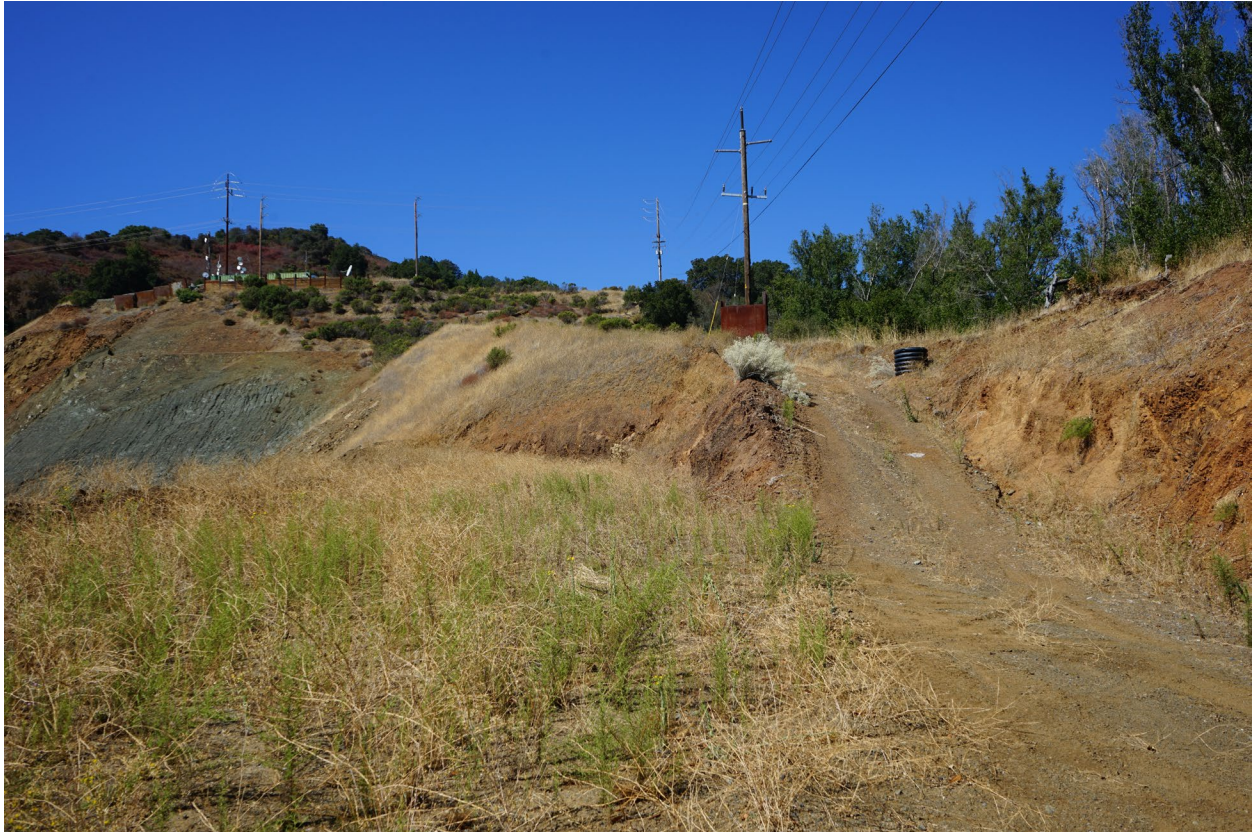
Failure of North “Finished” Cut Slope: Previously observed ground cracks that were repaired by the operator have not reappeared [see **Photo 8** below]. County inspectors observed the repair of the perimeter access road which was previously disrupted by the headscarp of a large landslide [see **Photo 9** below]. The operator submitted a geologic report dated January 29, 2017 that recommended an additional width (200 feet) of buttress be added to the toe of the slope in order to achieve an acceptable factor of safety. Last year, a large buttress fill was being placed against the lower and middle portions of the slope below the north slope. This year County inspectors observed that additional buttress fill had been placed. [See **Photos 12 and 14** below.] Previously observed ground cracks in the buttress fill material was filled in by the operator; ground cracks have not reappeared in this [See **Photos 10 and 11** below].

Photo 10: Area of former retaining wall above north high wall (buried)

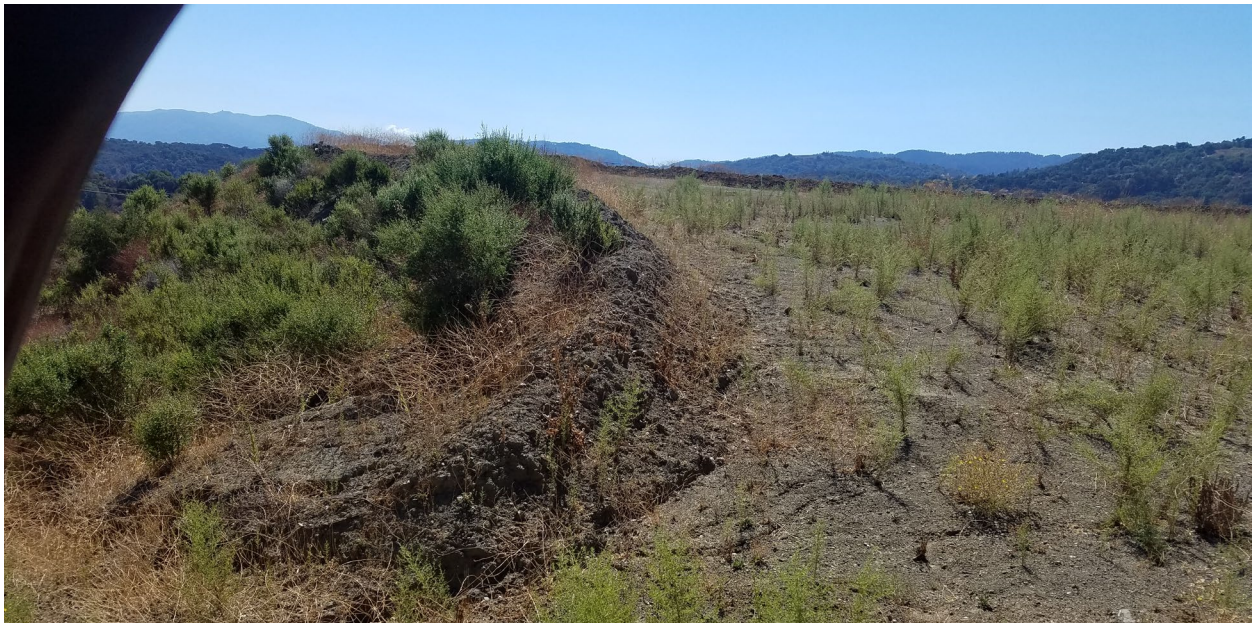
Photo 11: Regraded area where ground cracks on top of buttress fill of north high wall were observed during 2020 inspection.

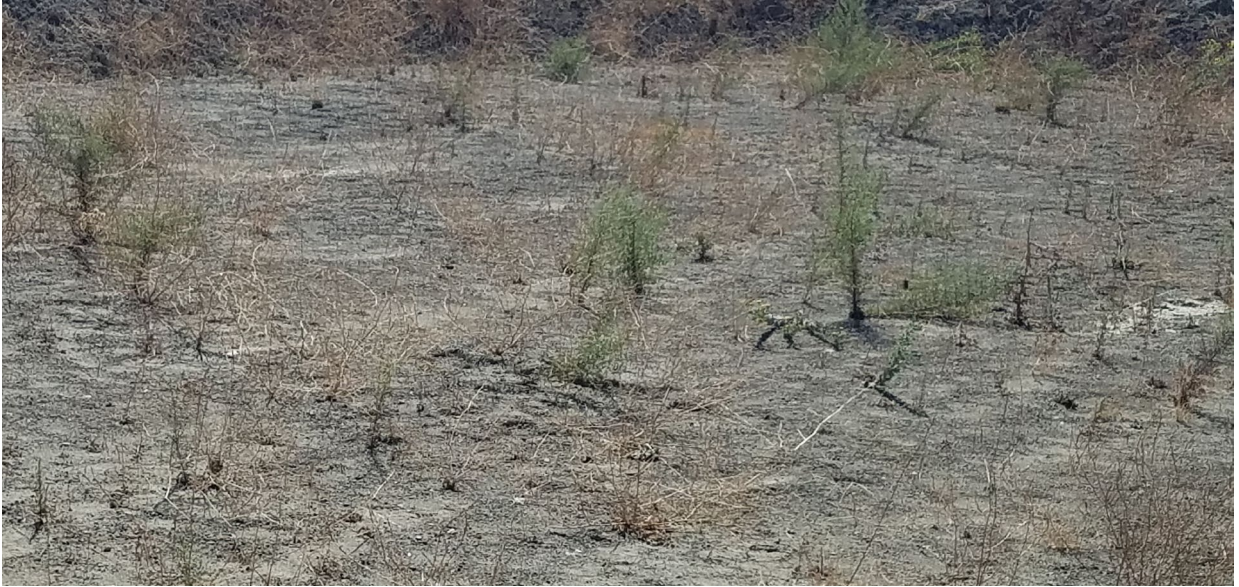
Photo 12: Location of former ground crack on east-facing fill slope near northeastern corner of property.

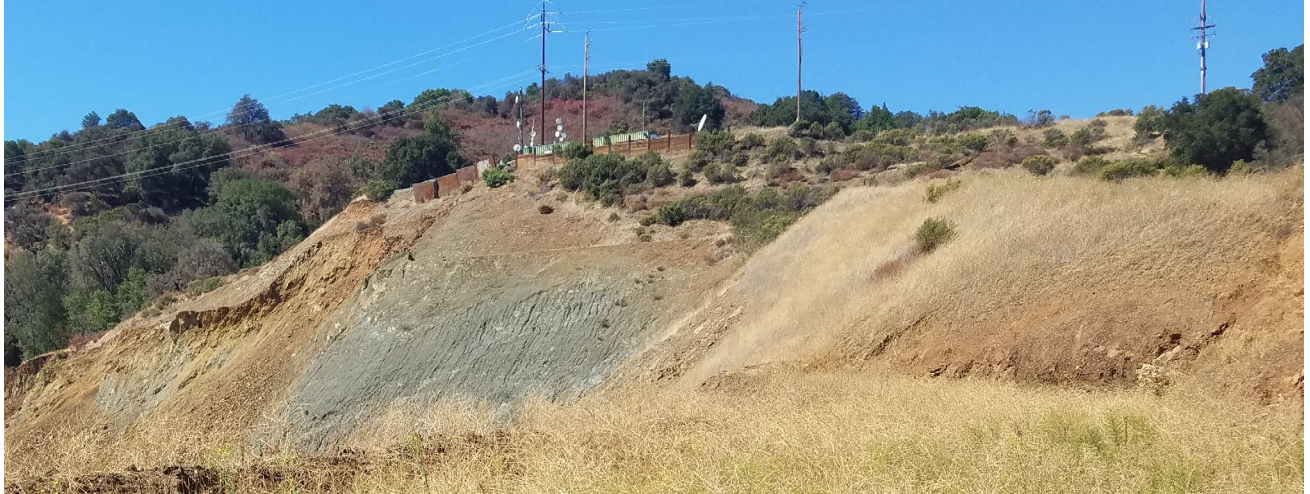
Failure of Northwest “Finished” Cut Slope: Another slope failure has disrupted the cut slope on the northwest side of the quarry pit. The headscarp of that failure has affected the southern end of the retaining wall built to protect the radio shack at the top of the slope. [See **Photos 13 and 15** below.]

During previous annual inspections, County inspectors observed that the ground surface adjacent to the radio shack had dropped, causing protrusion of concrete piers. The operator placed gravel, to bury the piers but they have since reappeared due to additional slope movement [see **Photo 16** below]. However, associated ground cracks were observed at the top of the slope failure, west of the western property boundary. [See **Photo 17** below.] The County requested additional geotechnical analysis of these slopes as part of the Reclamation Plan Amendment currently under review by the County. Since the last annual SMARA inspection ground cracks have grown larger, and the retaining wall constructed by the operator has been damaged due to ground movement, indicating continuing instability in these slopes.

Photo 1516: Slope failure below radio containers on western high cut wall.

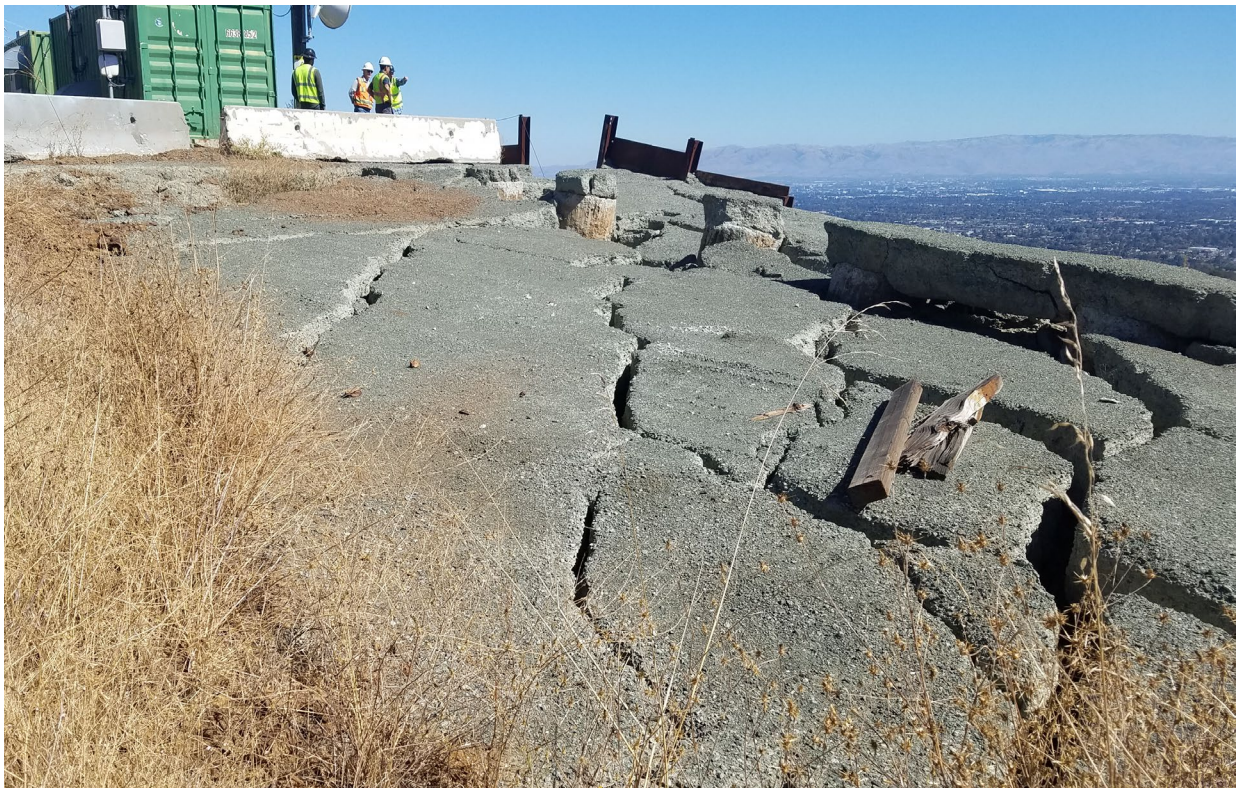
Photo 17: Ground cracks near radio containers at northwest property line.

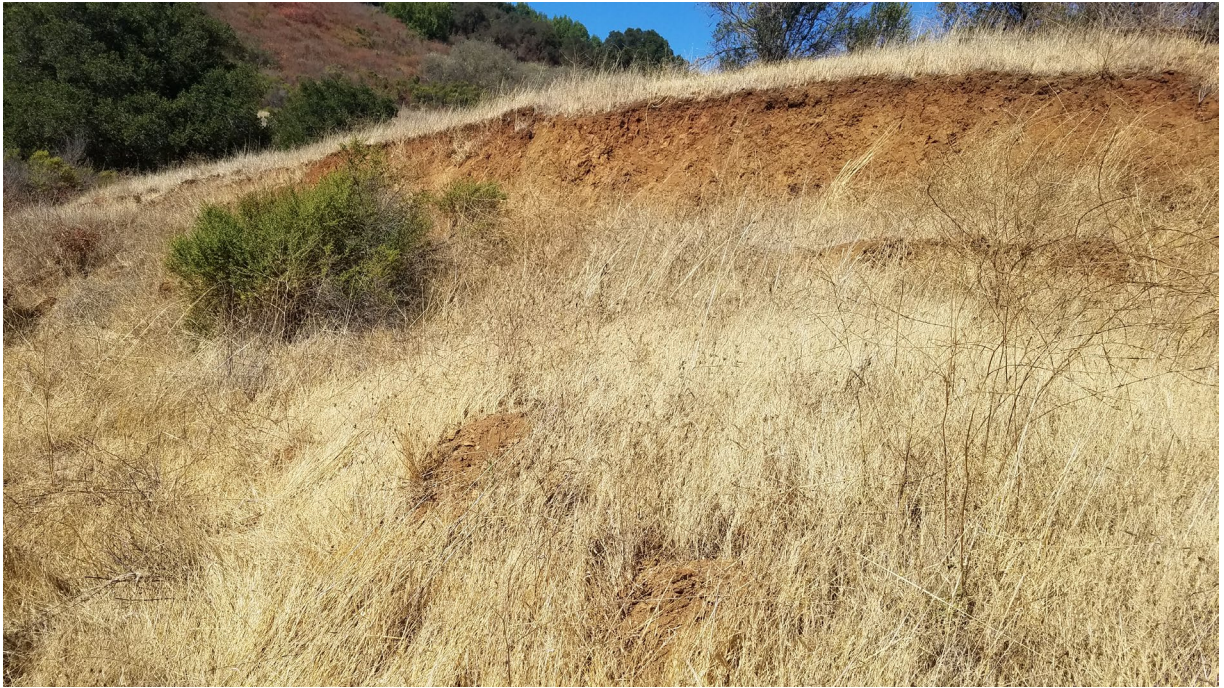
Photo 18: Ground cracks and headscarp beyond northwest property line.

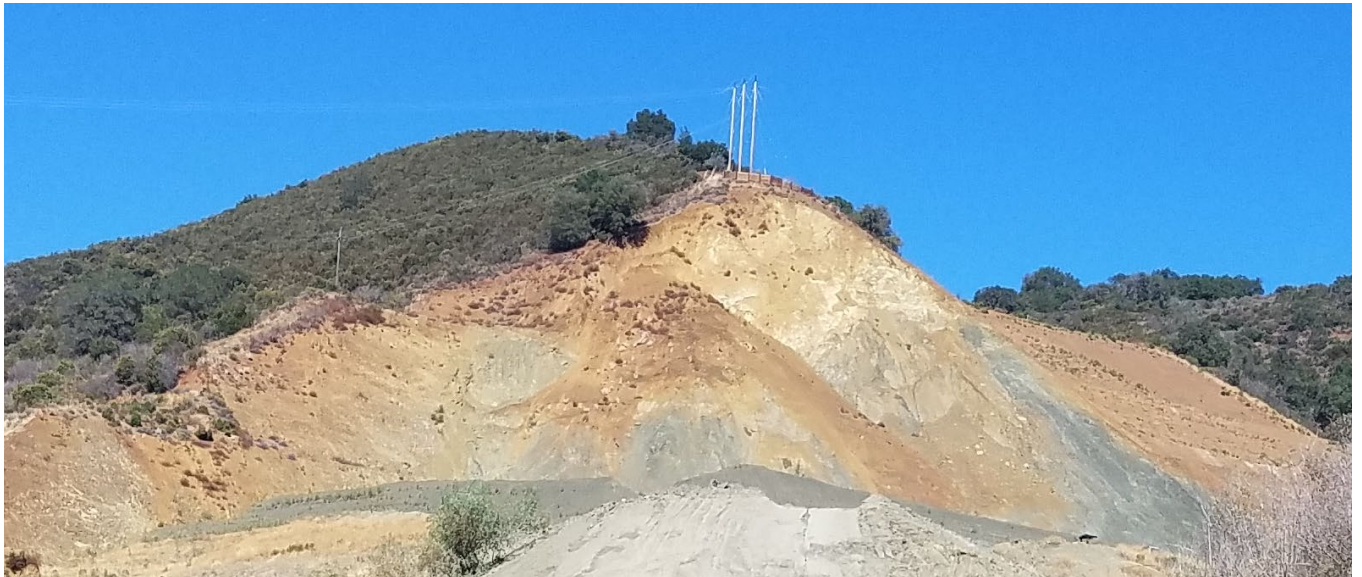
Failure of Southwest “Finished” Cut Slope: Another slope failure has disrupted the cut slope on the southwest side of the quarry on Parcel B. Inspectors observed that the headscarp of the failure had approached the retaining wall built to protect three PG&E power poles. [See **Photo 18** below.] County inspectors observed landslide debris accumulation at the toe of the slope, and observed the operator removing this material during last year’s inspection. During the past year, the operator graded in a new cut slope in the upper portion and deposited uncompacted spoils below the new cut. [See **Photo 19** below.]

Photo 19: Slope failure on southwestern high cut wall, looking south. (Profile view)

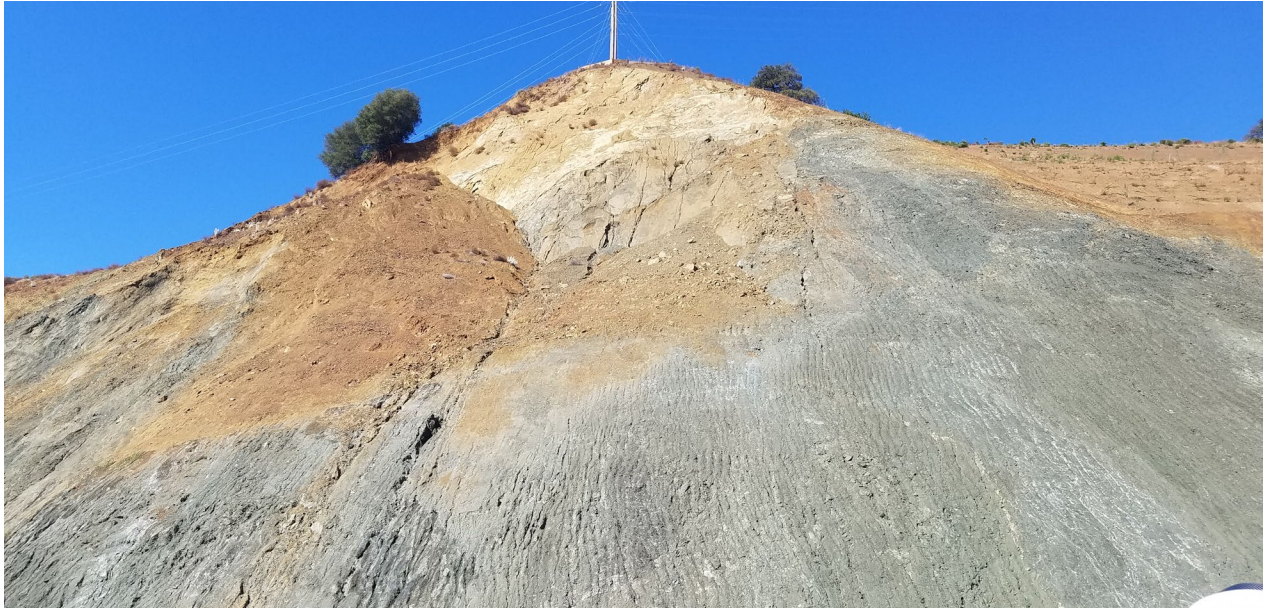
Photo 20: Slope failure on southwestern high cut wall below three PG&E poles, looking west.

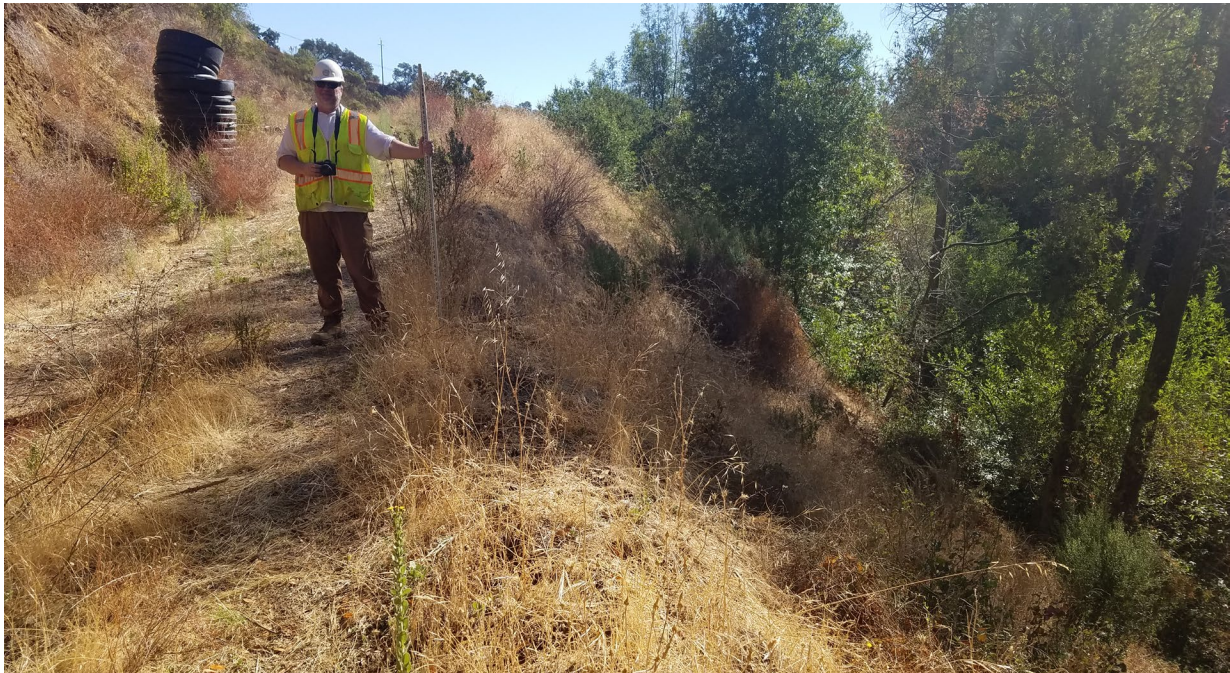
Rattlesnake Creek: In 2017, County observed a slope failure above Rattlesnake Creek along a road towards the west end of Parcel B. The Quarry built a fill slope to repair the road and installed jute netting to minimize erosion. The slope appears to be stable, and vegetation has been reestablished in this area. [See **Photo 20** below.]

Photo 21: Regraded south-facing slope along the north side of Rattlesnake Creek.

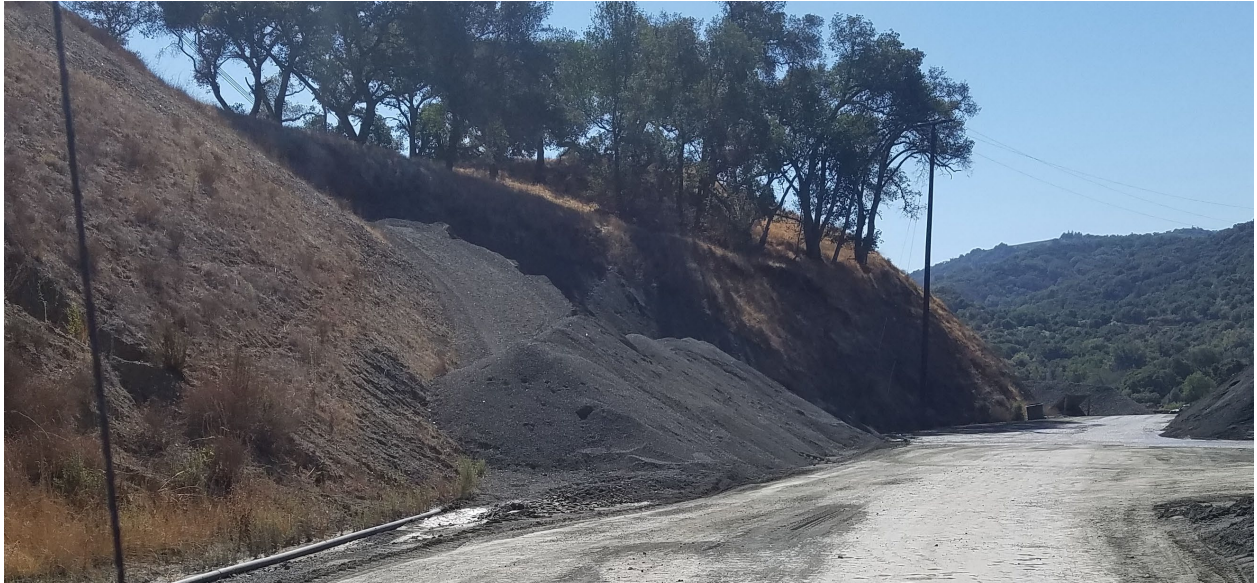
Cut Slope Along Southeastern Side of Parcel B: A shallow failure in the cut slope adjacent to the operating equipment located in the southeastern corner of Parcel B, first observed during previous inspections, does not appear to have progressed. [See **Photo 21** below.] Although the

Photo 22: Shallow failures of cut slope along east side of Parcel B (in tree shadows).

ground has moved, the County expects this area to be corrected during final reclamation. The County will continue to monitor this shallow failure during monthly inspections of the quarry.

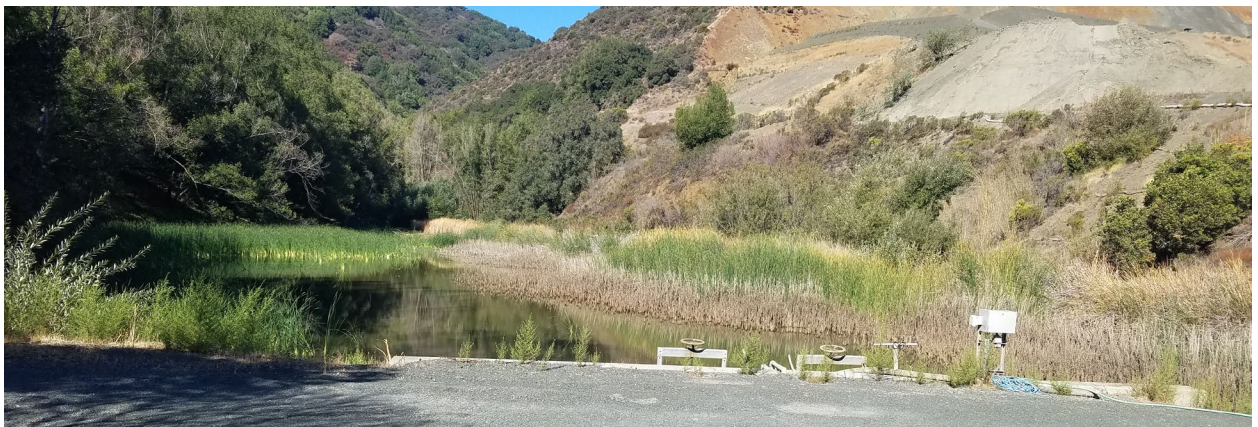
Photo 26: Former Upper Settling Basin; no longer receiving sediment from quarry operations.

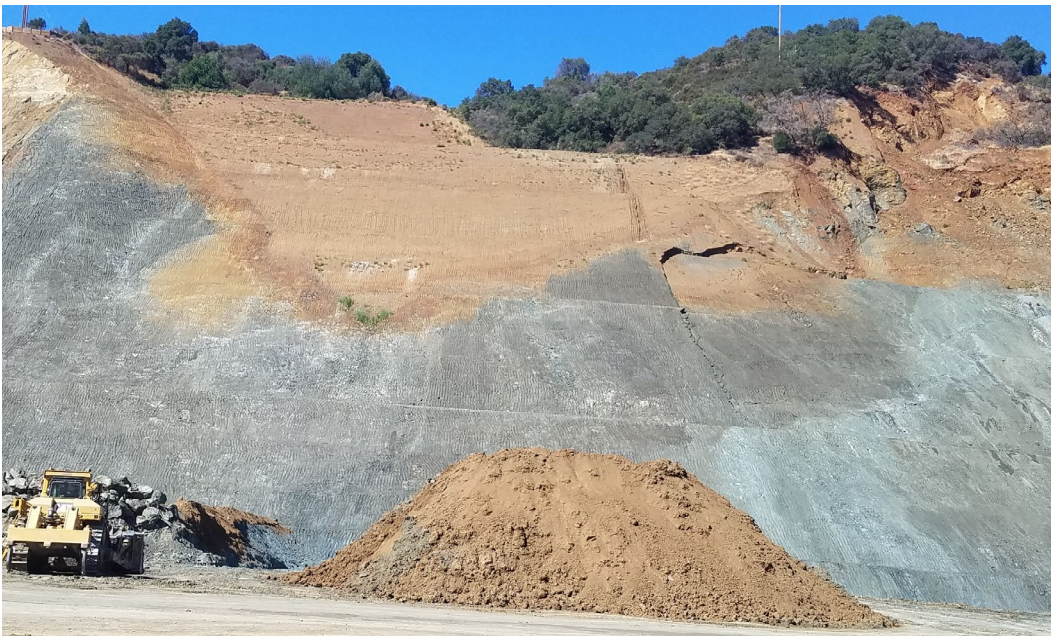
"Finished" slope along western property line: Finished cut slope along Western property line showing ground cracks indicating ground movement. County has directed the operator to monitor this area, and County inspectors will continue to monitor this area during monthly inspections [see **Photo 32**].

Photo 32: Final cut slope along western side of pit (center portion).

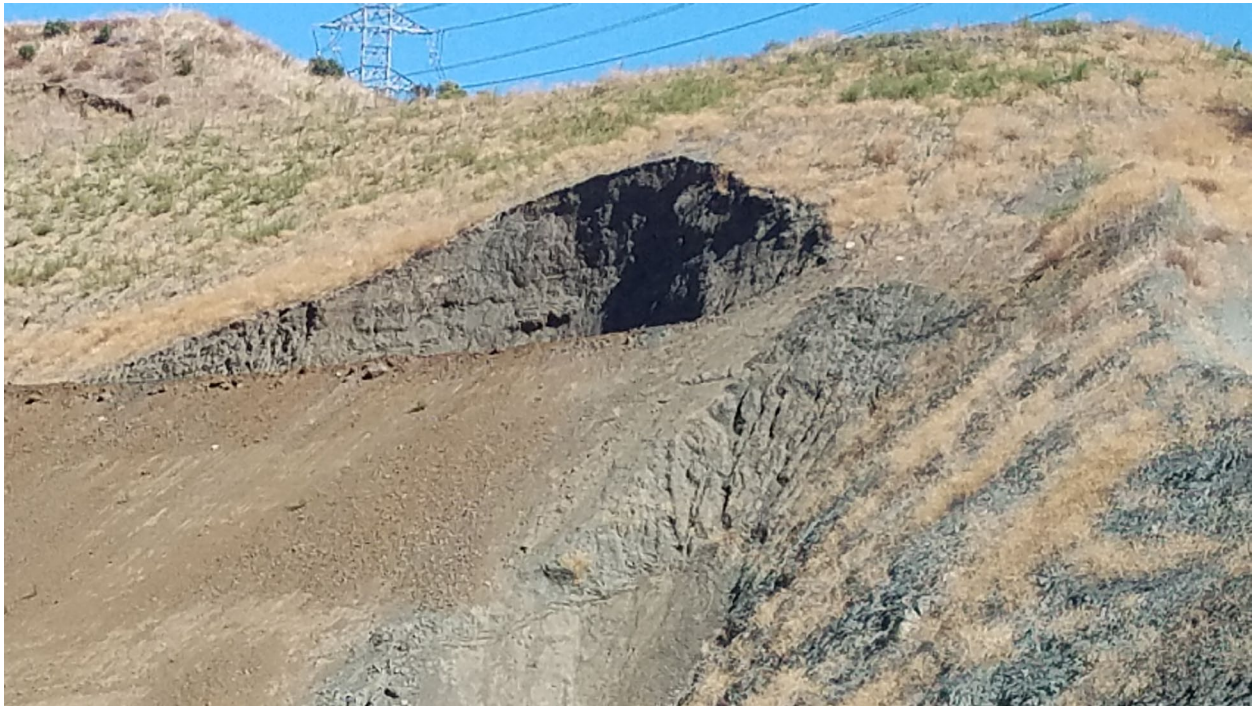
"Finished" slope along eastern property line: A separate localized failure was excavated by the operator and will need to be removed or repaired [see **Photo 33**]. The operator has excavated the final cut slope along the eastern property line [see **Photo 34**].

Photo 33: Slope failure scar (debris removed) located near the northeastern corner of Parcel B.

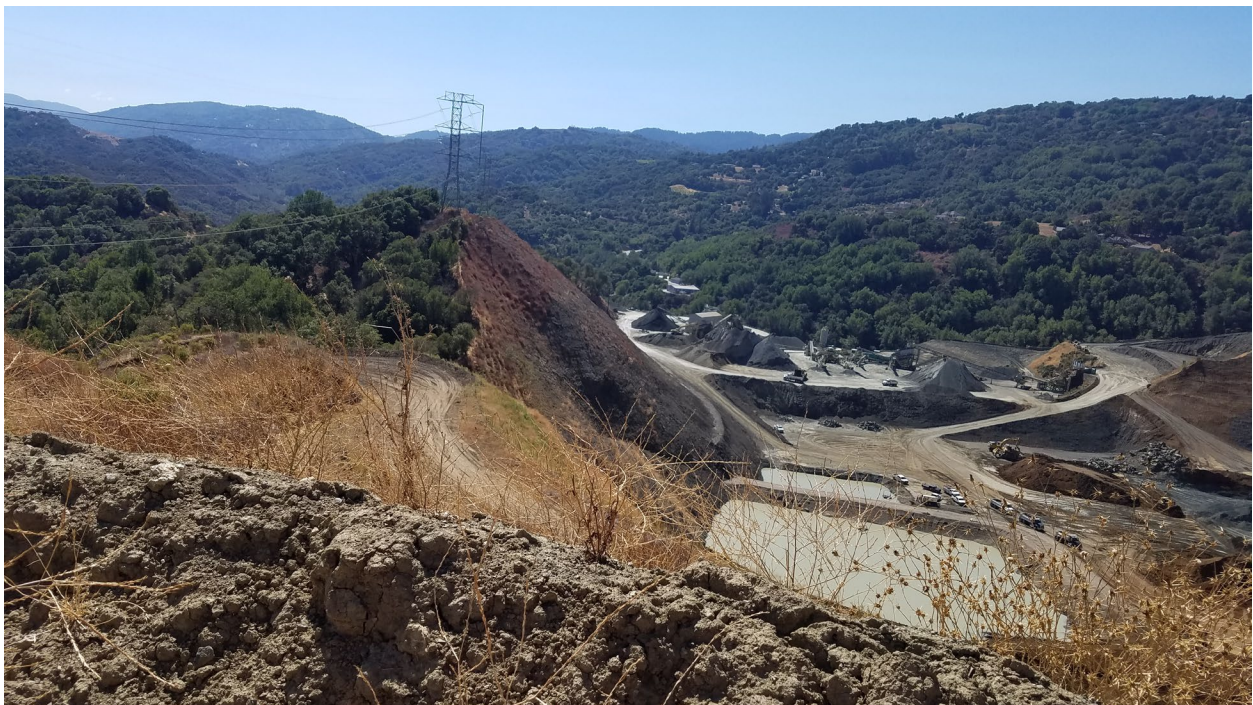
Photo 34: Looking south along cut slope on east side of pit.

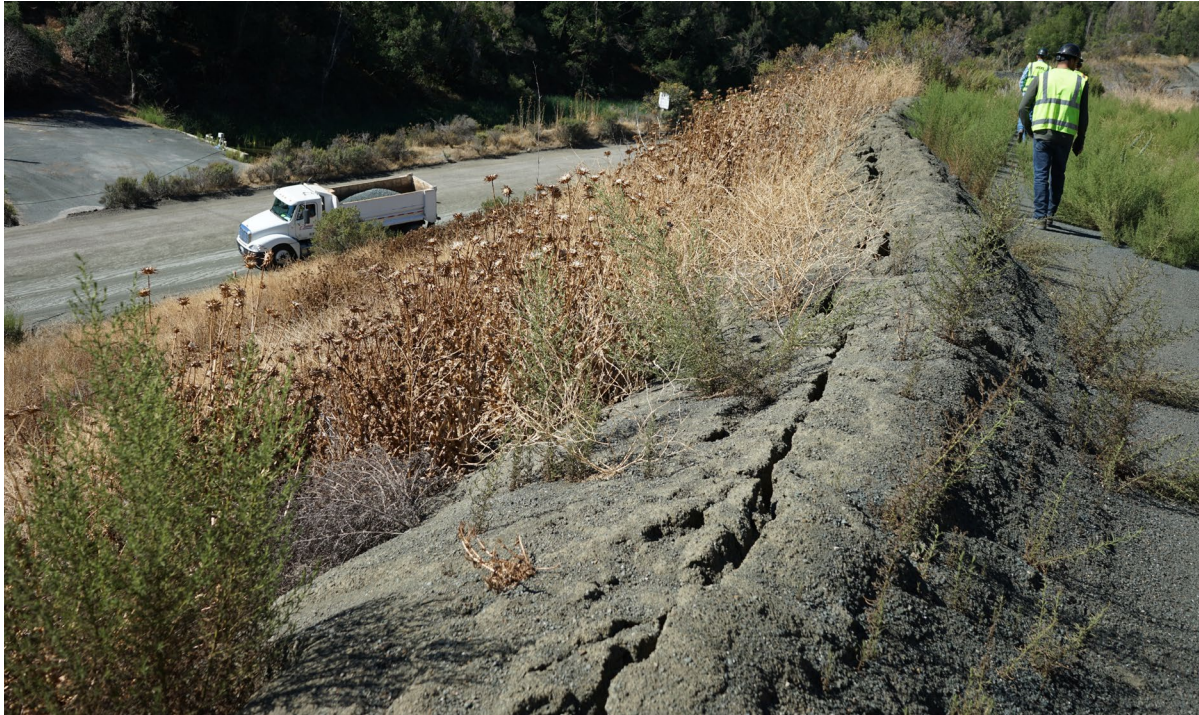
Photo 35: Open crack in fill berm and non-native weeds located along south side of graded road above main haul road.
