PERMANENTE CREEK LONG-TERM RESTORATION PLAN

Prepared for
Lehigh Southwest Cement Company
24001 Stevens Creek Boulevard
Cupertino, CA 95014

March 11, 2011

URS Corporation
1333 Broadway, Suite 800
Oakland, CA 94612
510-893-3600
26817215.20000

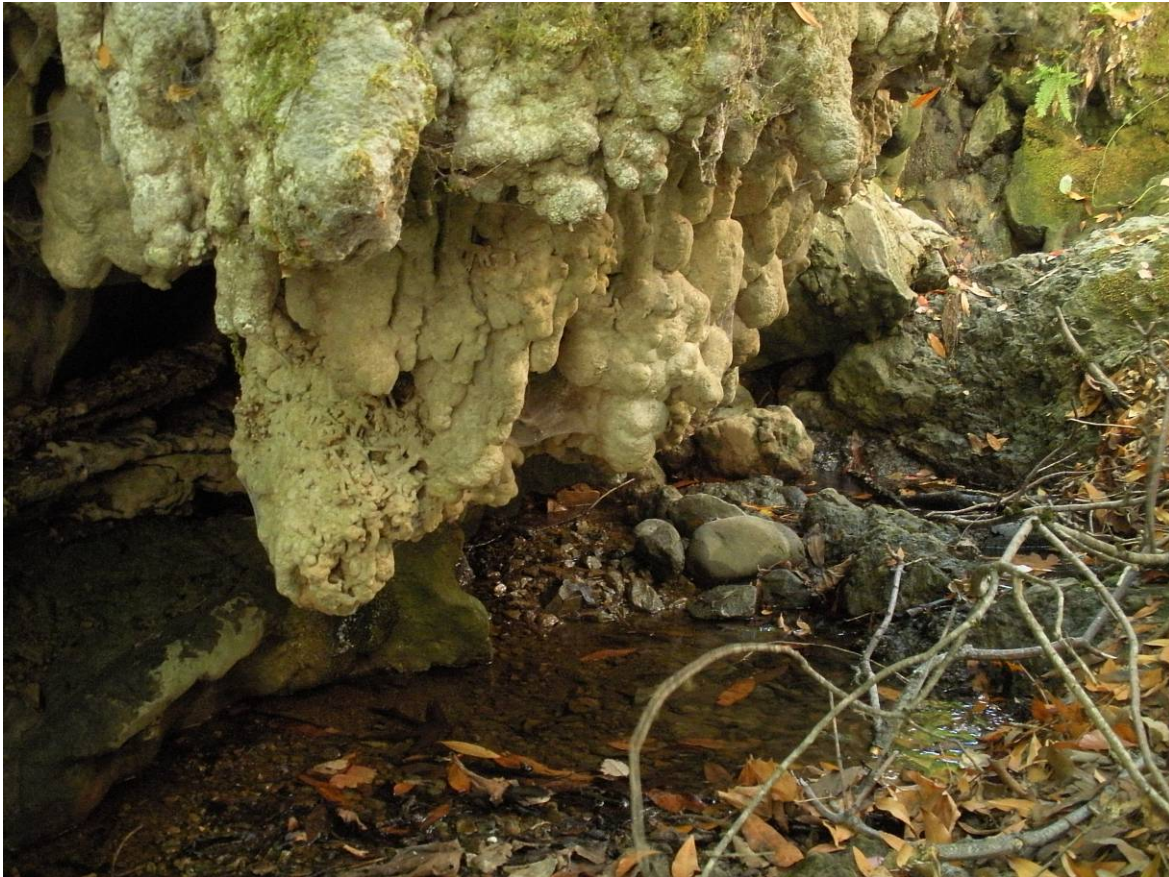
A natural feature of Permanente Creek is the abundance of a conglomerate formation in the channel. Conglomerate generally consists of sand, gravel, silica, and a binding material such as calcium carbonate. Calcium carbonate, dissolved in the water, precipitates in many portions of the Creek where it encrusts stream gravel, leaves, branches, or other material in the water (Figure 2-1). Leaf and twig debris collects around boulders and other constrictions and become encrusted in calcium carbonate forming small, circular step-pools (Figure 2-2). In areas where the precipitate is concentrated, streambed gravels regularly inundated by water bind together, forming a conglomerate. This property armors the bed, limits transport of bed material, and reduces the quality of spawning gravels. Stream banks are similarly bound together by calcium carbonate precipitated by subsurface flow seeping from adjacent slopes. Portions of the stream channel have become incised where the precipitate has made banks resistant to erosion. Since much of the precipitate occurs on the southern banks and flows from seeps and tributaries on the southern side where there have not been mining or other industrial operations, the high calcium carbonate concentrations in the Creek are not a result of Facility operations.

Figure 2-1 Calcium carbonate-encrusted roots and rock steps (right) within the ordinary high water elevation of the Creek

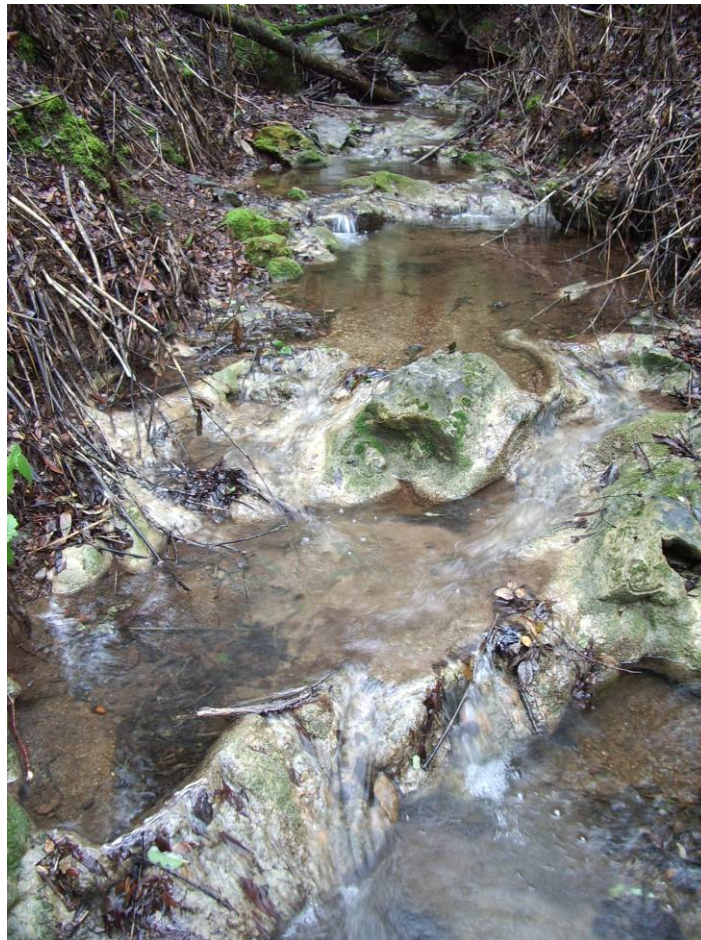
Figure 2-2 Precipitate rock forming step pools

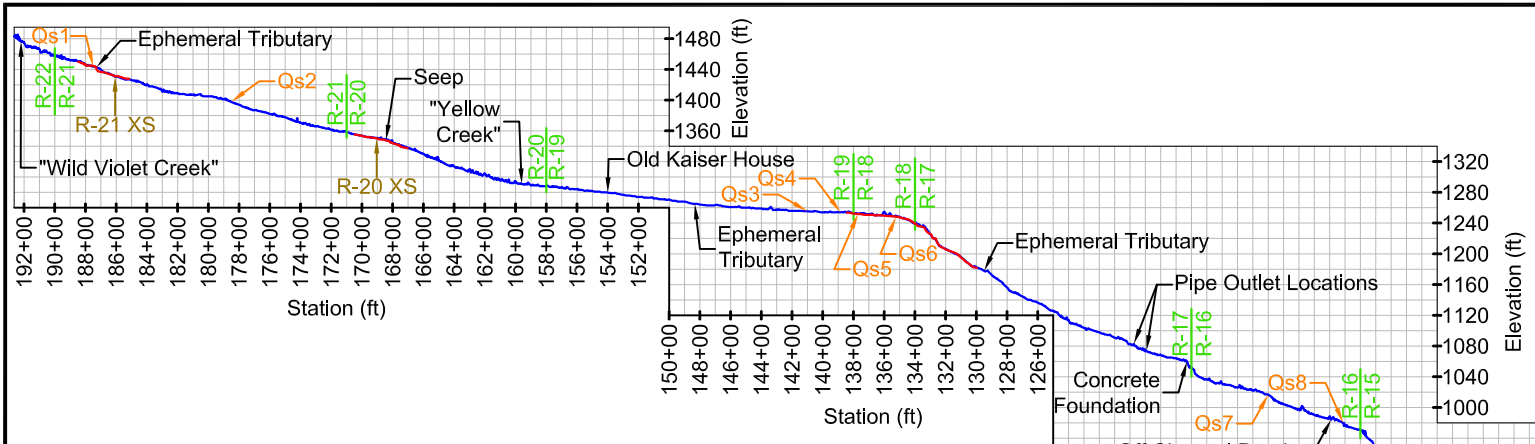
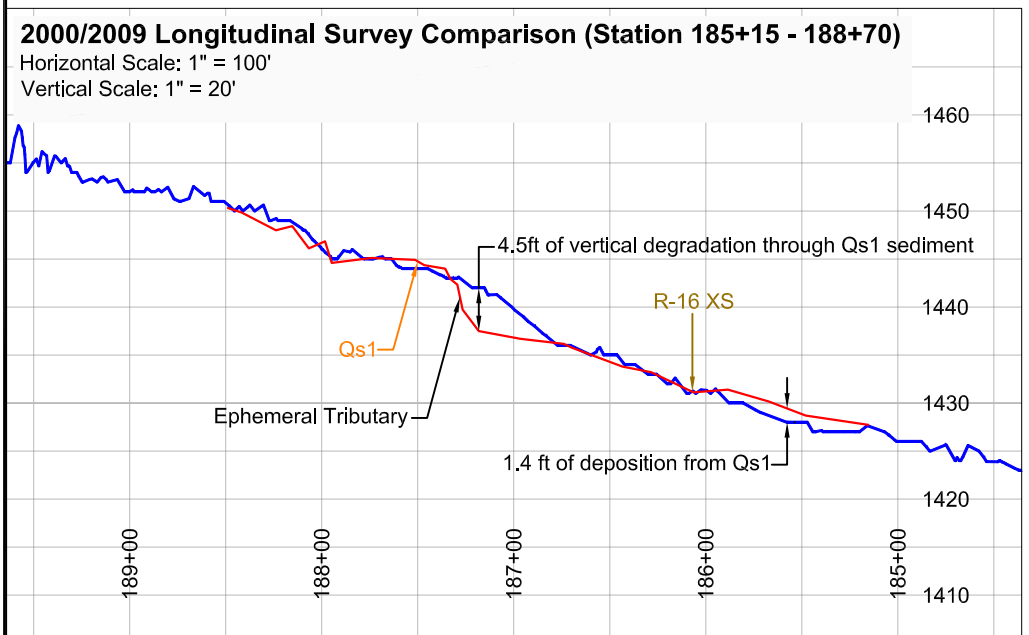
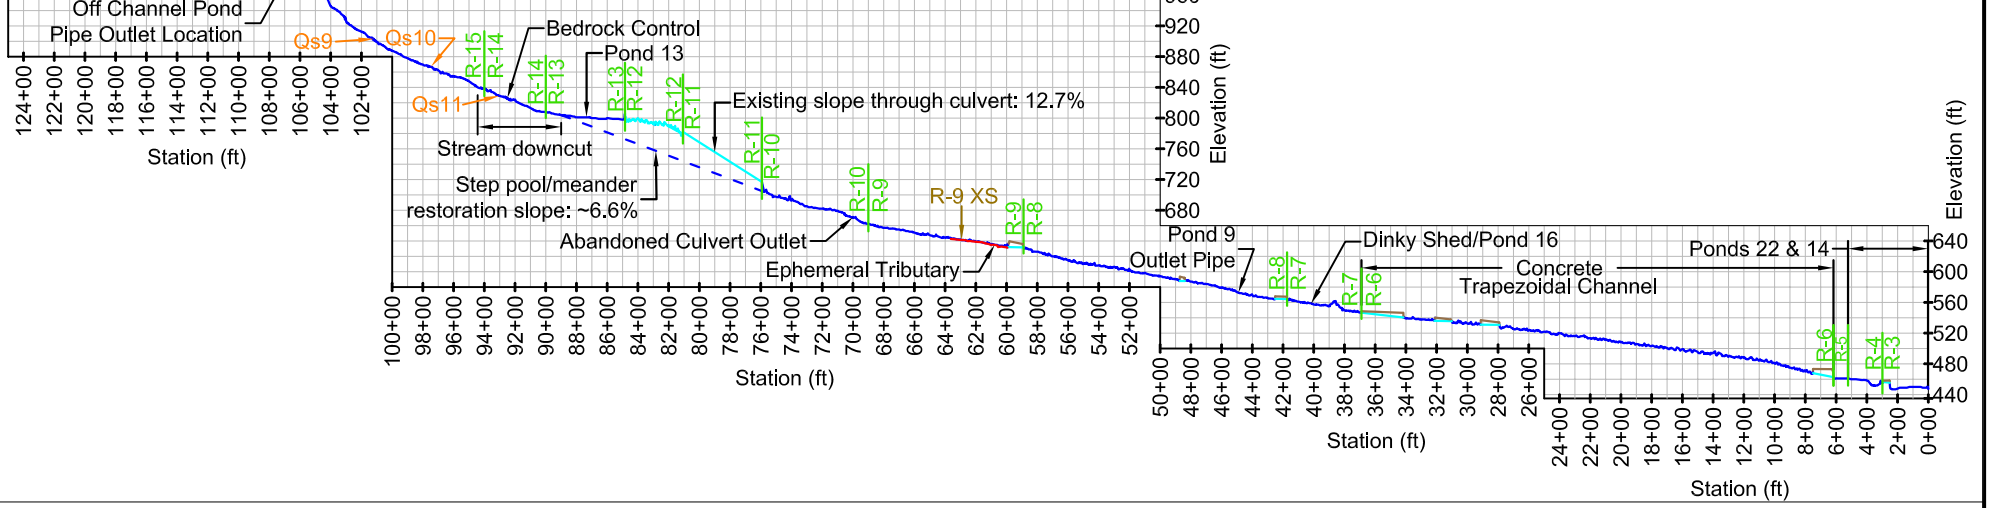
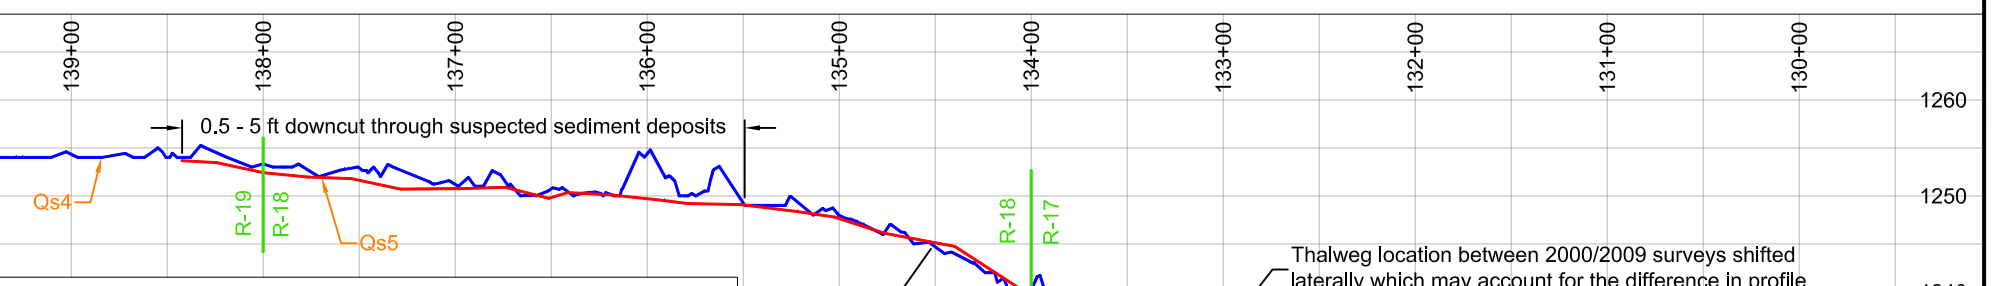
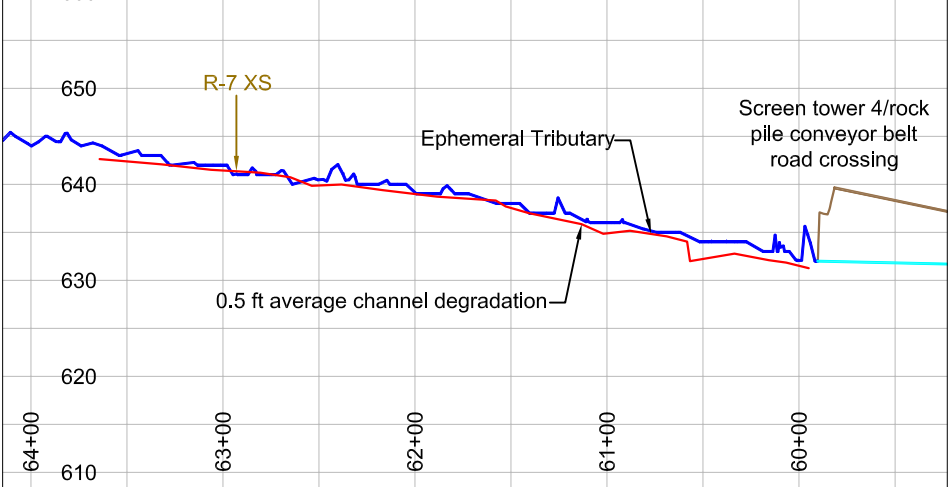
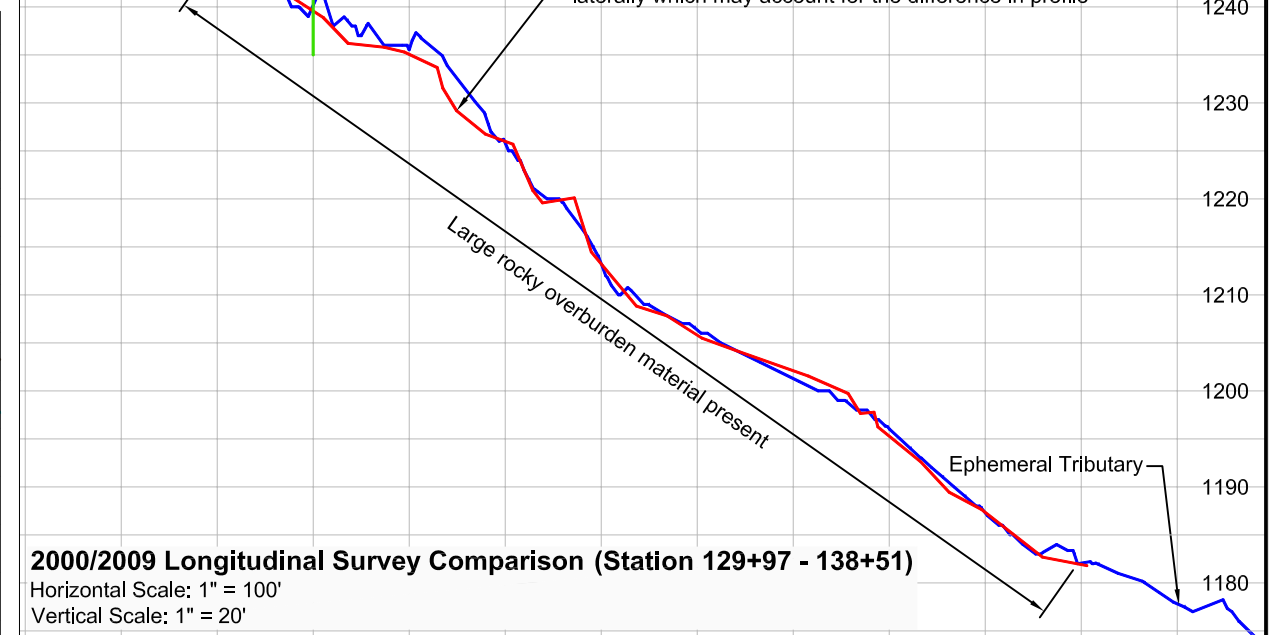
Project No. 26817215	Permanente Creek Long-term Restoration Plan Permanente Creek Longitudinal Profile	FIGURE 2-5
	LEHIGH SOUTHWEST CEMENT COMPANY

2009 Resurveyed Reach		Change Between 2000 and 2009
Stations	Length (LF)	
59+95 to 63+69	374	Entire reach: average 0.5 foot of degradation
129+97 to 138+51	854	135+50 to 138+40: 0.5 to 5 feet of degradation through fine sediment deposits
167+12 to 170+52	340	167+12 to 169+28: 0.5 to 1.2 feet of degradation
185+15 to 188+70	355	185+15 to 185+92: 1.4 feet of deposition from upstream Q_s 1 material 186+79 to 187+31: 4.5 feet of degradation through Q_s 1 material

Figure 2-5 presents a comparative longitudinal profile of the stream thalweg showing 2000 and 2009 surveys. Predominantly, the resurveyed reaches experienced thalweg degradation of approximately 0.5 foot. In the reach from Stations 135+50 to 138+40, the 5 feet of degradation cited in the table occurs in two localized areas near Stations 135+63 and 136+00; the degradation does not occur over a long distance. The 4.5 feet (Stations 186+79 to 187+31) of degradation through Q_s 1 deposits can be seen in Figure 2-6. Based on the profile and field observations, it appears that the material eroded from this area has deposited in the reach from Station 185+15 to 185+92.

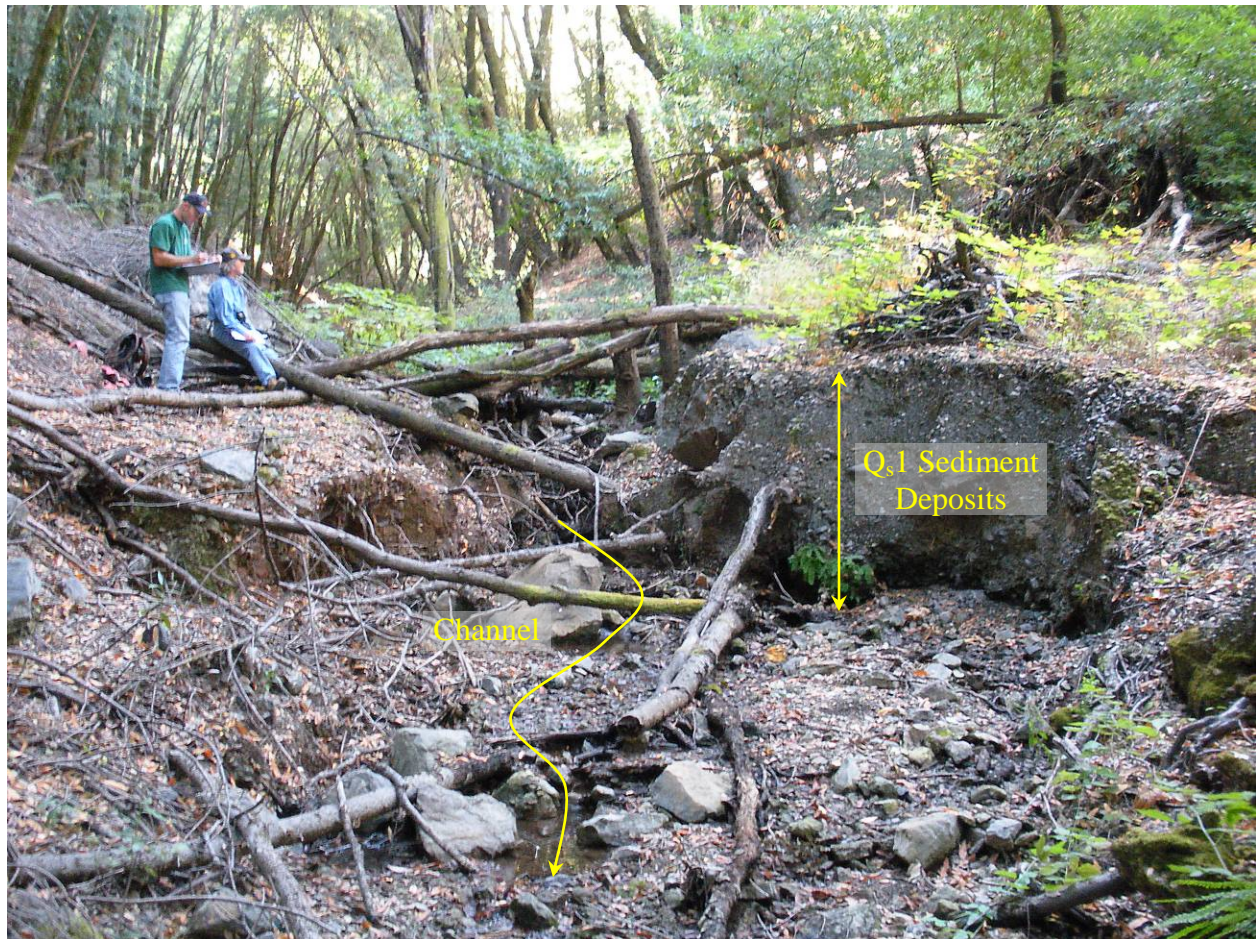
Figure 2-6 Channel cut through Q_s1 material

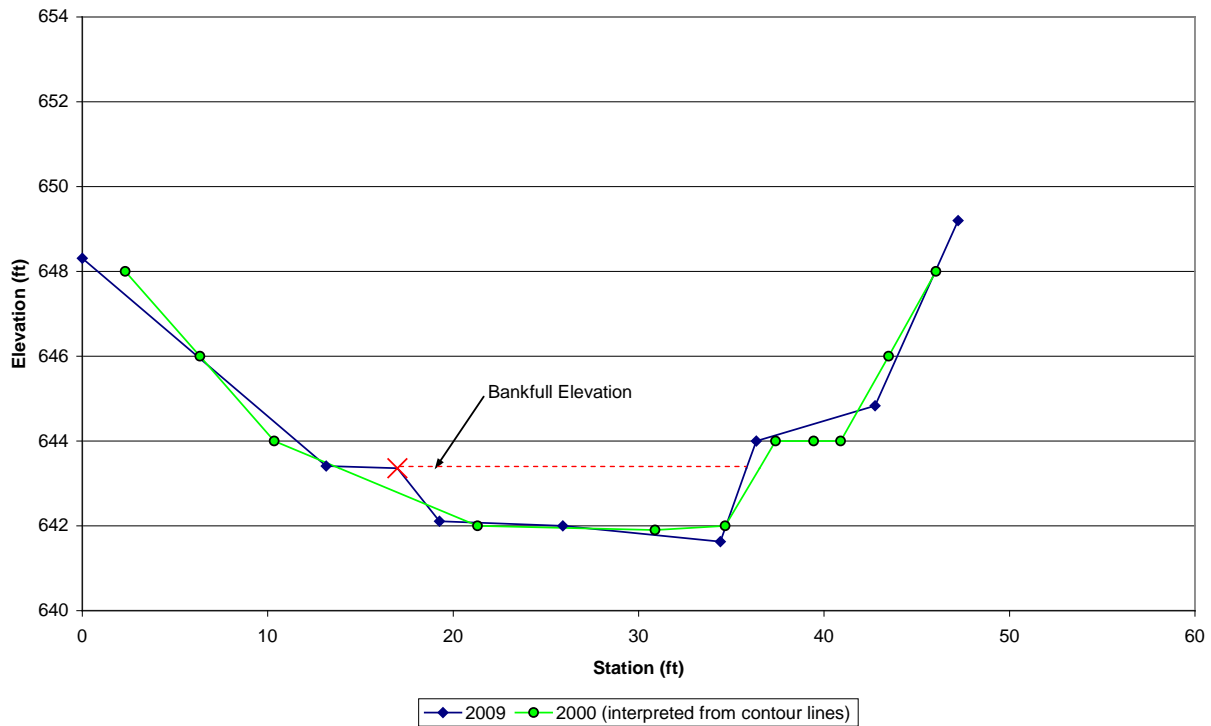
Three cross-sections were surveyed during 2009 at Stations: 62+92, 169+03, and 185+95 (locations shown in Figures 2-5 and 3-1. The 2009 cross-sections were compared to cross-sections derived from the contours of the 2000 topographic survey (see Figure 2-8, Figure 2-9, and Figure 2-10. Bankfull data, such as area, width, and depth, were calculated for both the 2009 and the derived 2000 cross-sections using the 2009 bankfull elevations. Table 2-2 summarizes the comparison data.

Figure 2-8 Station 62+92 (Reach 9) cross-section comparison

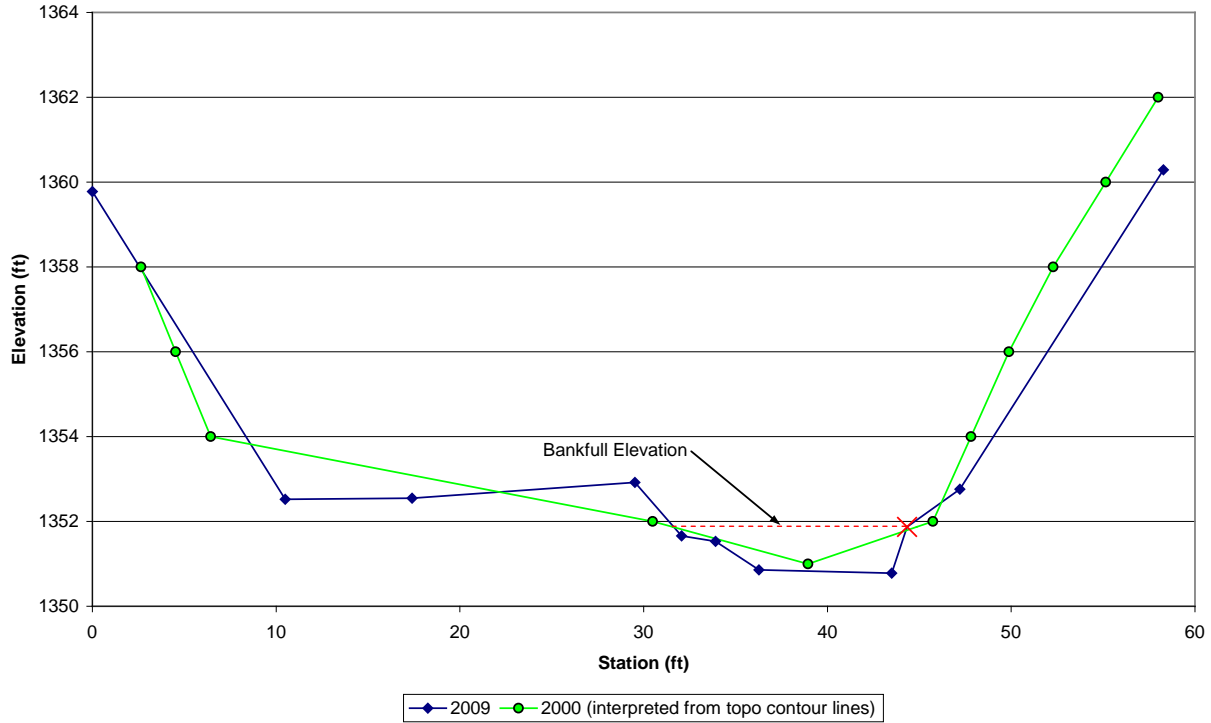
Figure 2-9 Station 169+03 (Reach 20) cross-section comparison

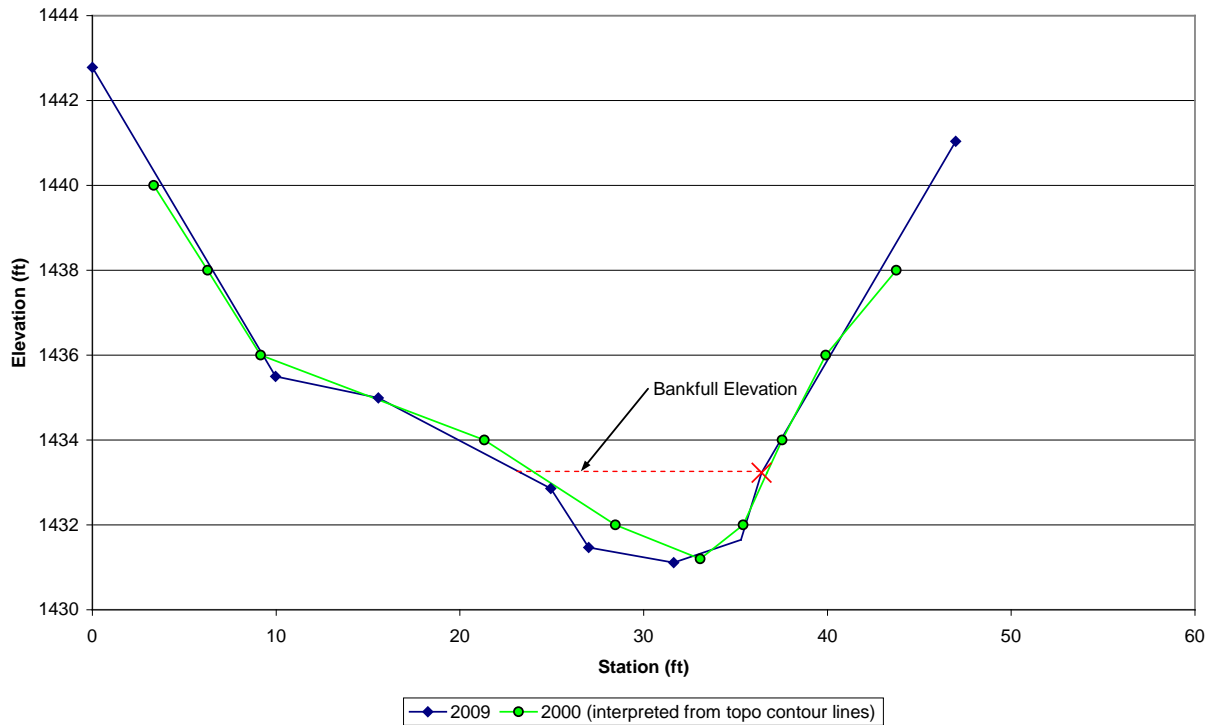
Figure 2-10 Station 185+95 (Reach 21) cross-section comparison

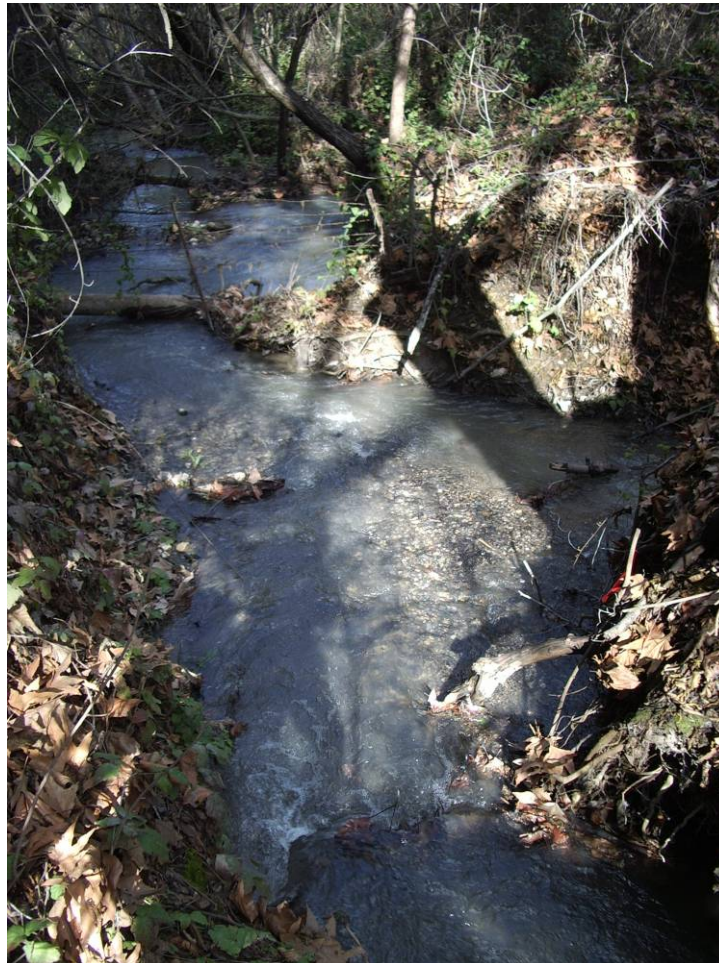
This reach is offsite and was assessed to understand downstream conditions and their effect on restoration activities (see Figure 2-11). The channel appears to have downcut and become disconnected from its former floodplain. However, it has widened sufficiently to build benches within the channel, and it is moderately stable at its current elevation.

Figure 2-11 Looking downstream on Reach [1]

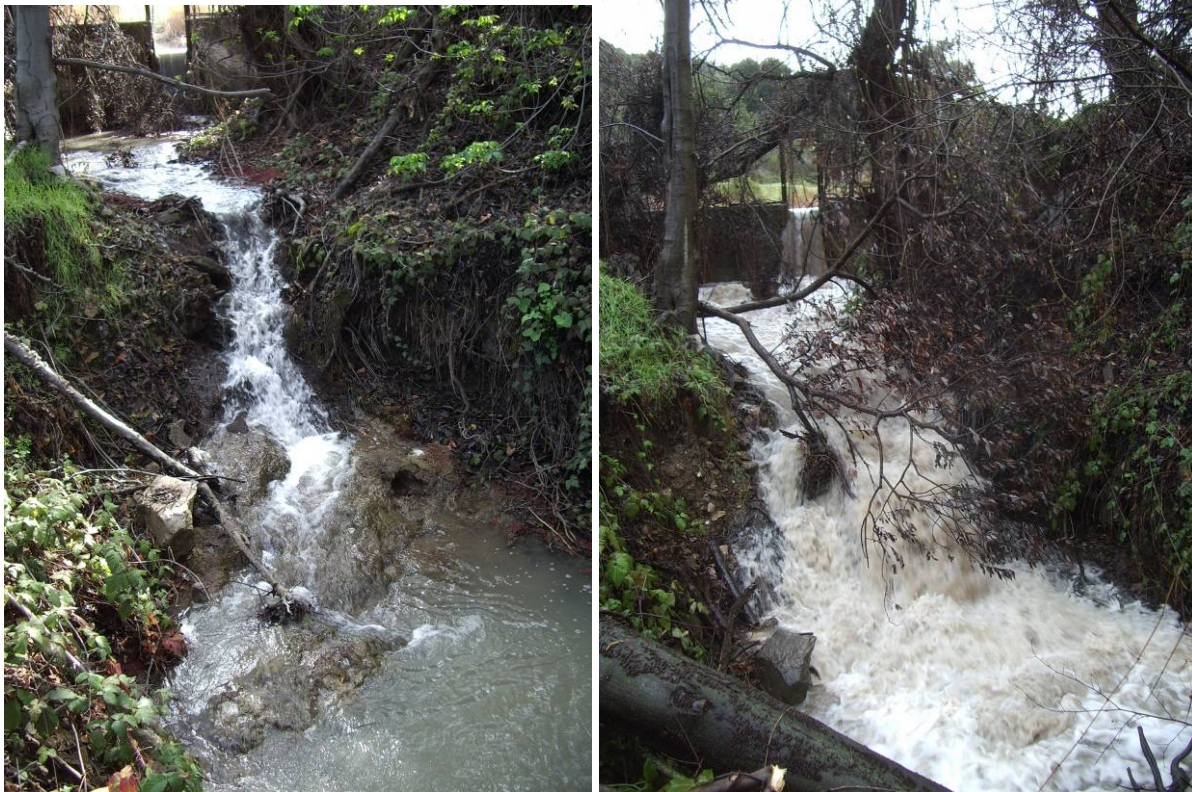
former stream channel (thus lacked any sediment/gravel sorting or channel armoring). Combined with a nickpoint or break in slope between the pond outlet and the confluence with the main channel this flow could easily cause a headcut and channel degradation. Clear water discharge (lacking sediment and bedload) from the pond has a higher capacity to erode and carry away sediment than water transporting and replacing the full gradation of streambed particles that maintain the channel roughness and integrity. The headcut has potential to erode the Pond 14 weir if the four trees between the headcut and the weir are compromised by scour erosion or windfall.

Figure 2-12 Headcut downstream of the Pond 14 weir

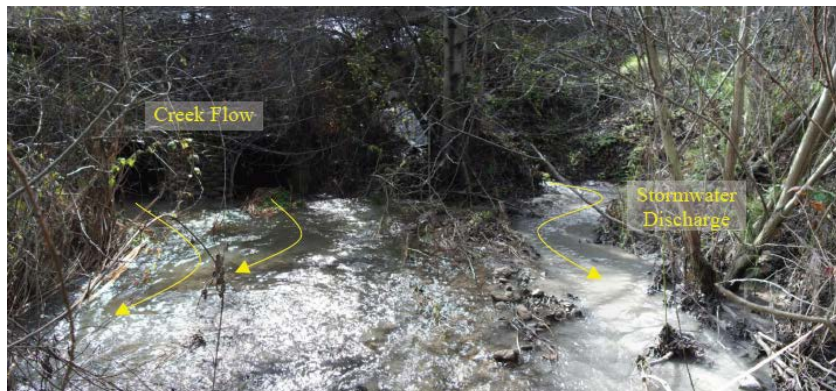
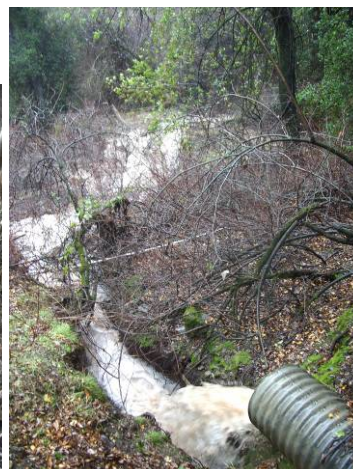
This short reach connects the culverts under the railroad tracks to the upper end of Pond 22. The channel is entrenched due to the access road and railroad tracks and in a state of fluctuation due to what appears to be frequent events of sediment inundation in the active channel causing channel widening and braiding within the entrenched flood-prone area. Channel instability is caused by numerous factors: a sediment wedge that extends upstream from Pond 22, an inability of vegetation to become established along the active channel banks. The major sediment sources are likely from nearby upland areas and sediment ponds (e.g., the railroad tracks, Ponds 19, 20, and 21, upland drainage from the northwestern portion of the Facility, Pond 30, and deep hillslope rill erosion at the culvert outlet of Pond 30). Turbid stormwater runoff discharge to the Creek near Station 6+00 (Q_s 14) was observed during moderate rainfall events in 2009 and 2010 (Figure 2-15). The level of sediment contribution from this source and other sources will be addressed in detail in the proposed sediment source study. Corrective actions to prevent or reduce the sediment contribution to the creek will be administered pursuant to the SWPPP.

Figure 2-15 Reach [4] near Station 6+20

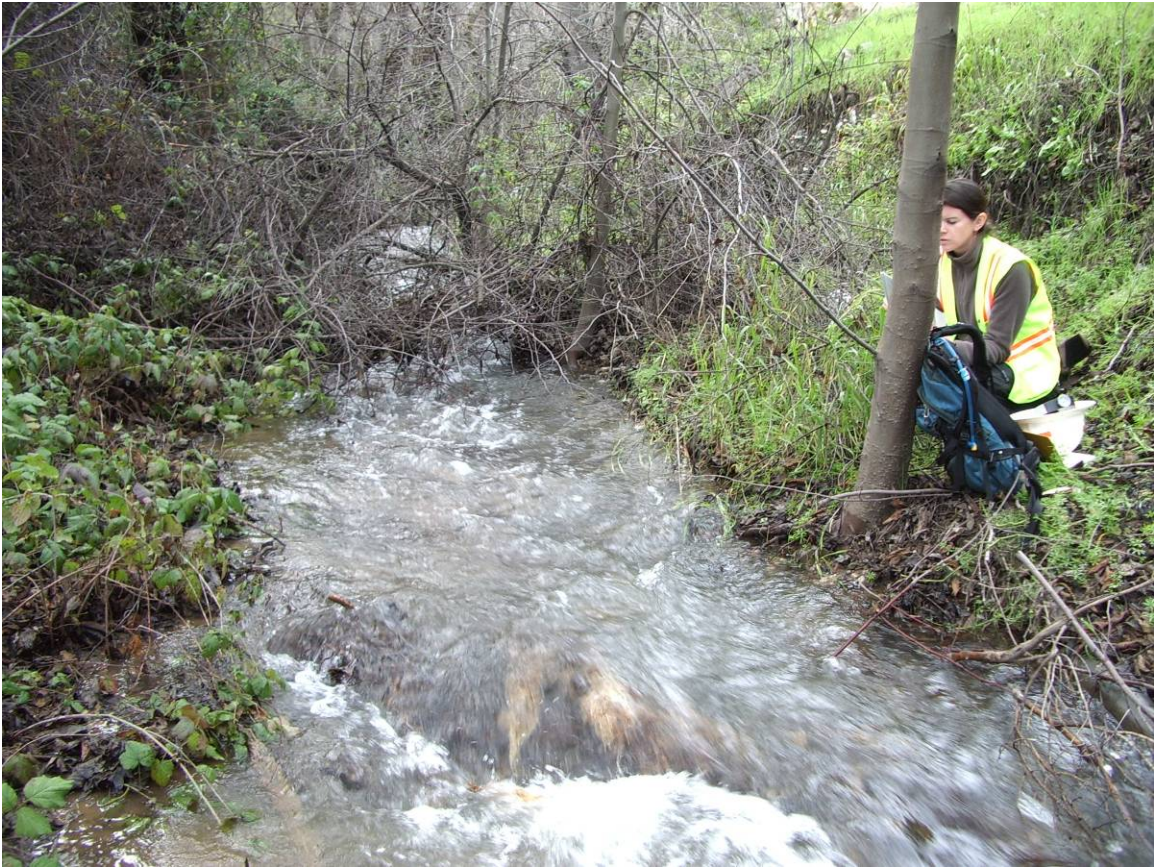
This reach begins with the two culverts under the conveyor crossing. Bank erosion has been observed on the upstream side, and the banks are hardened by tractor-tire retaining walls. The right culvert is partially blocked at the upstream end, and fully blocked at the downstream end. The banks immediately downstream of the culverts are also vertical.

Figure 2-17 Looking upstream near Station 63+00

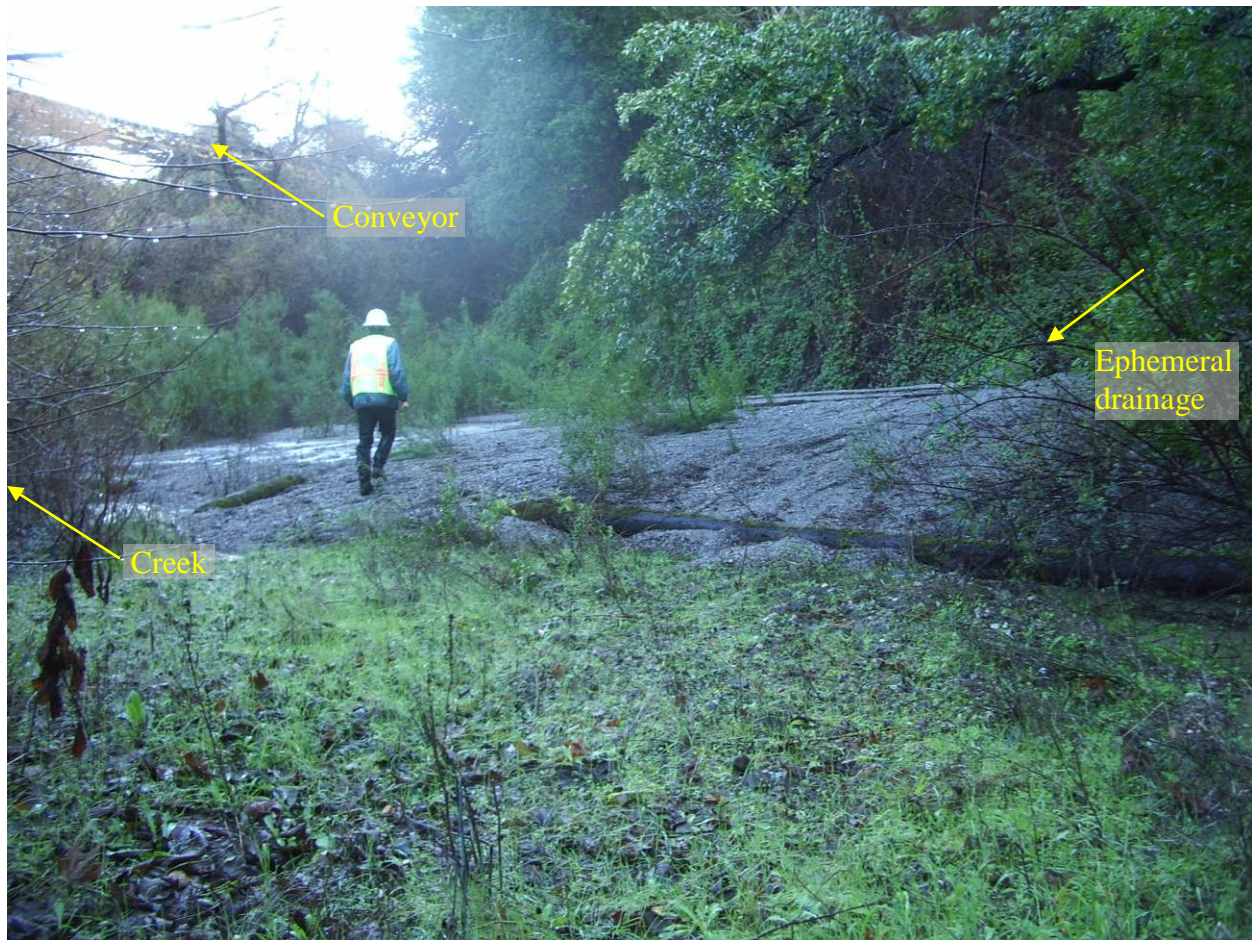
The reach upstream of the culverts has been confined to the southern side of the valley by roadway fill; however, the bed and banks are stabilizing in their new location and the channel has built bankfull benches at most locations (see Figure 2-17). The lower portion of this reach is influenced by a sediment fan (Q_s12) on the southern side of the channel. The geotechnical exploration roads in the upper watershed appeared to be the source of the sediment in 2009; however, a new larger fan of fine gravel was identified in 2010, extending from a storage area upstream along the tributary (Figure 2-18). The alluvial fan has expanded over the floodplain to begin delivering sediment and gravel to Permanente Creek during runoff events. The level of sediment contribution from this source and other sources will be addressed in detail under the proposed sediment source study. Corrective actions to prevent or reduce the sediment contribution to the creek will be administered pursuant to the SWPPP.

Figure 2-18 Looking downstream at an alluvial fan from an ephemeral drainage near Station 62+00

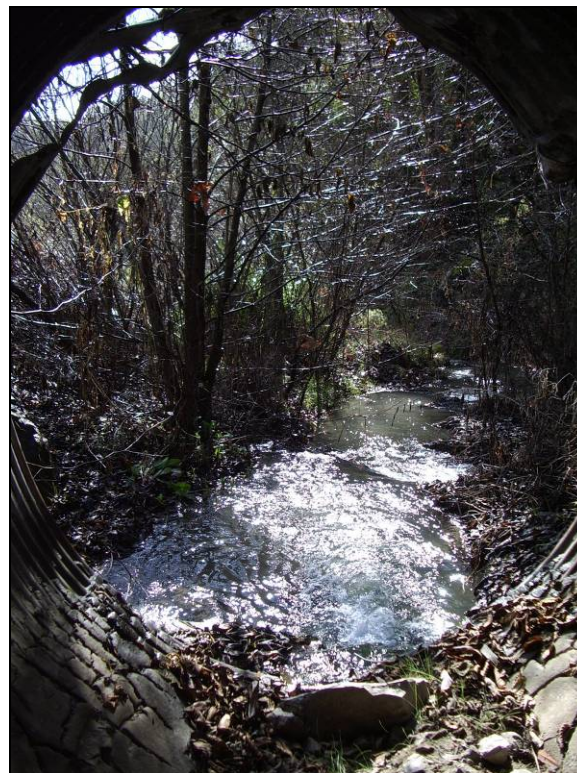
In the 2000 assessment, an eroded bank on the southern side of the Creek near Station 75+00 was identified. However, during the 2009 assessment, this bank was stable and vegetated. During a subsequent follow-up visit in January 2010, six small slumps (each less than 0.5 cubic yard) were observed on the steep bank on the southern side of the creek. Four of the slumps deposited directly into Permanente Creek, the other two slumped onto a bench above the channel. All of these slumps were natural in origin, not the result of the Facility operations (which occur on the northern side of the creek).

Figure 2-19 Looking downstream at Reach [9] from within the dry parallel culvert near Station 74+00

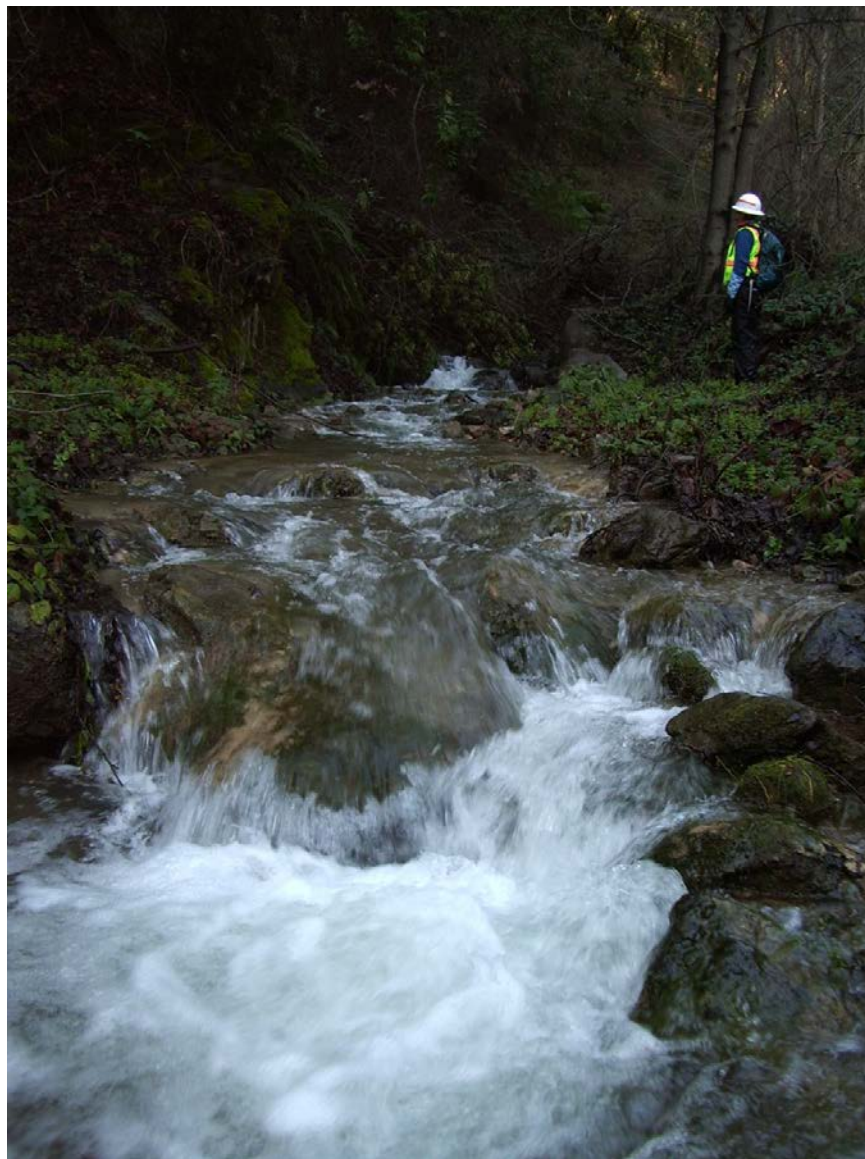
This reach is affected by the outfall from an off-line sedimentation pond. This reach is relatively stable (see Figure 2-21) and the old overburden slopes are stabilizing as most of the fine sediment has washed away in years past and some vegetation has become established on the slope. The old debris slides at Stations 106+00 (Q_s8) and 111+00 (Q_s7) are no longer significant sources since the gullies have eroded to bedrock in most locations and some vegetation has become established in the bed and on the banks, stabilizing portions of the gully. In 2009, new debris slides were observed near station 106+00. This debris slide formed after sheet piles at the top of the slope failed, releasing unconsolidated soil and rock down slope.

Figure 2-21 Stabilizing channel over old debris flow near Station 106+00

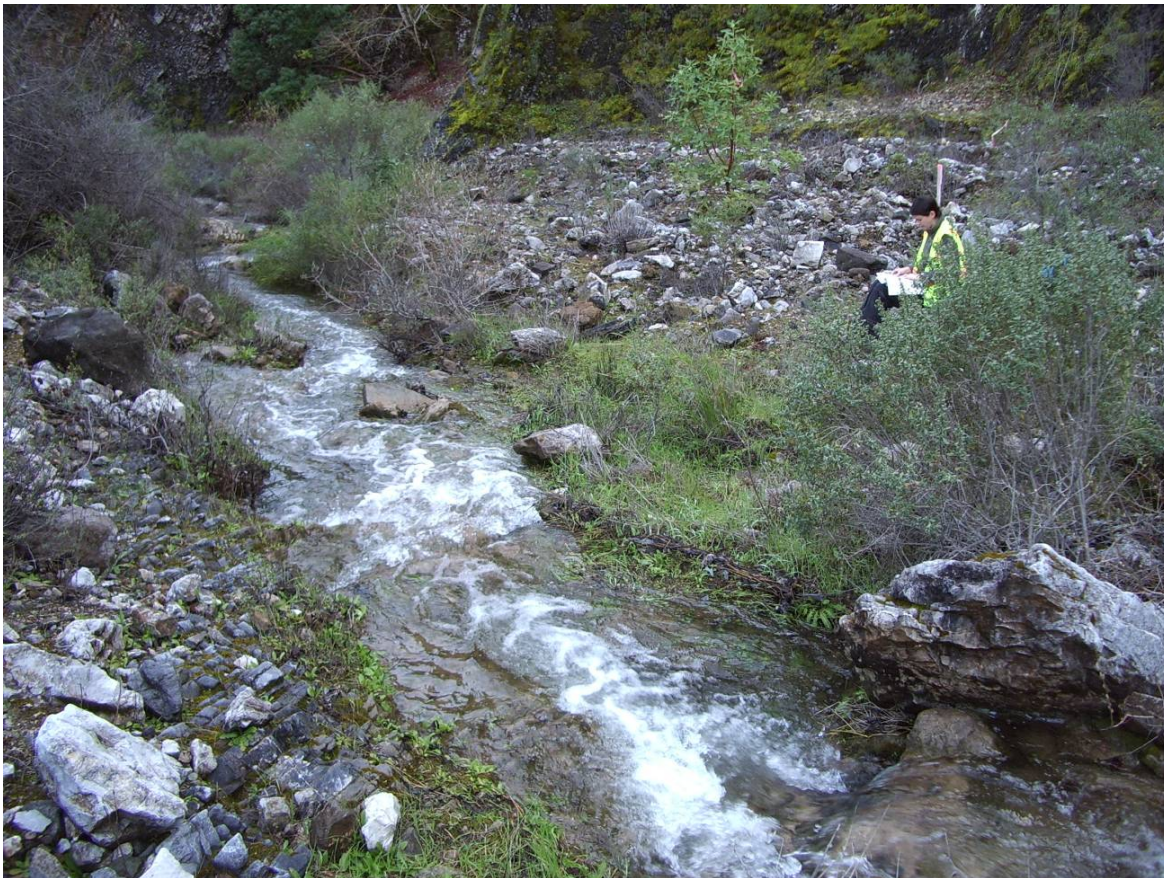
This area is characterized by historic overburden material, large rock piles, and steep, partially unvegetated slopes along the northern side. The ground cover conditions have limited vegetation to sparse populations of drought-resistant plant species. Despite the lack of vegetation and significant fill in the valley, the Creek appears to have predominantly stabilized with alternating sections of steeper and shallower gradients. A 150-foot portion of this reach (Station: 131+44 to 132+94) is experiencing some upstream migration. As discussed above, this slope has migrated approximately 4 feet upstream since the 2000 assessment. Despite the large amounts of overburden in the creek bottom, much of the fine sediment has washed downstream, leaving a surface protected from further erosion by the larger remaining rock (Figure 2-22).

Creek flow is mainly subsurface through this reach. During the lower flows (approximately 10 percent of bankfull) observed in October 2008, the Creek had flow in the channel above and below this reach, but this reach was dry. However, after a 4-inch rain event on February 16, 2009, and with flows at approximately 50 percent of bankfull, this reach was flowing with approximately the same flow as the upper and lower reaches (see Figure 2-22).

Figure 2-22 Looking downstream along Reach [17] near Station 122+50

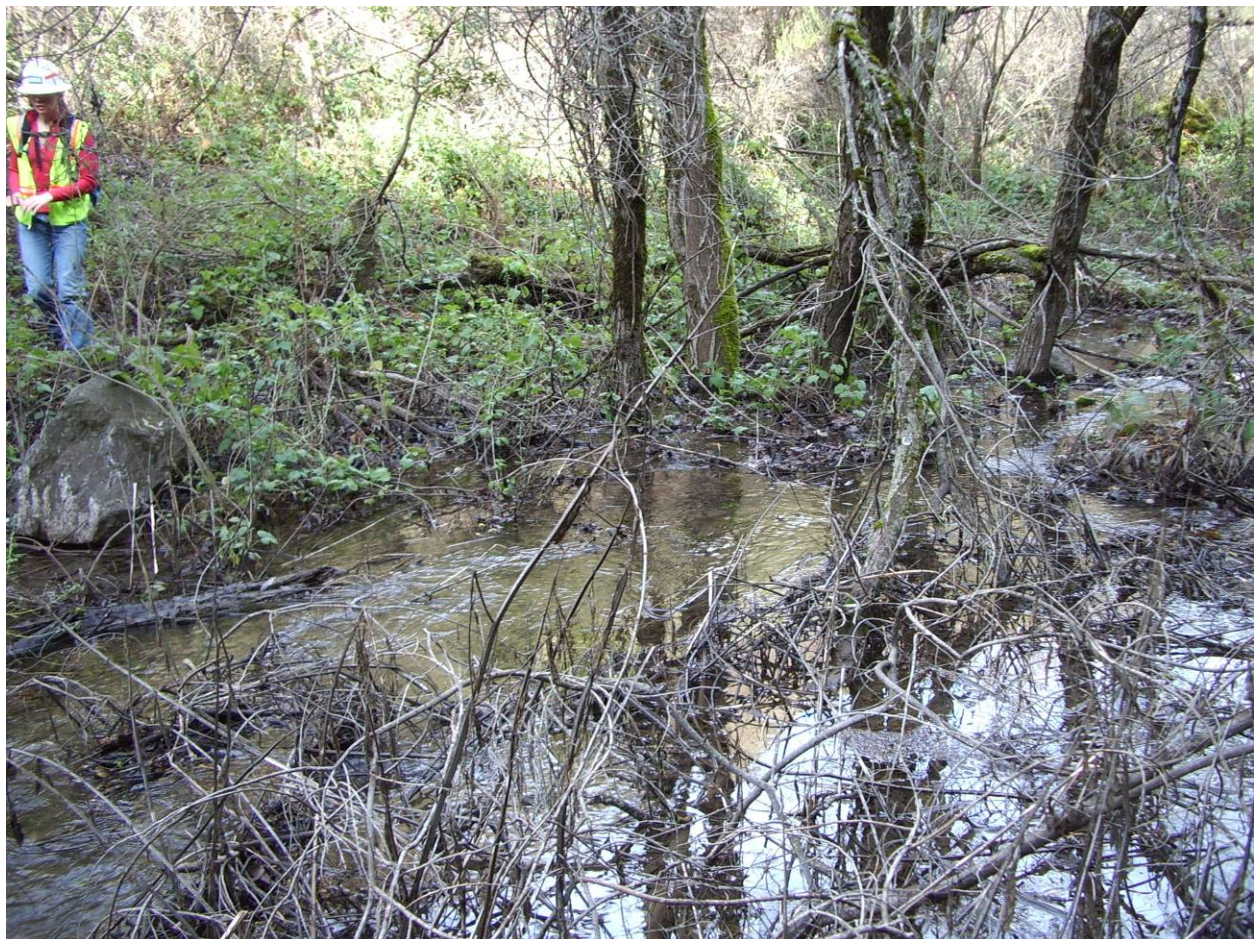
revegetated with willows, blackberries, nettles, and other vegetation. The stream is a low gradient, shallow, wetland-type drainage (see Figure 2-24), but it is developing a gravel substrate in some areas and these areas may become riffles. The reach rates as ‘poor’ due to its braided nature. The stability of the channel will likely improve in time as large flows scour sediments and form a single bankfull channel. The old debris slide at Station 139+00 (Q_s4) noted in the Phase 1 Report is stabilizing and is no longer a significant sediment source. The old debris slide at Station 141+20 (Q_s3) still appears to be a source of sediment to the Creek. The sediment is the result of a slump of loose material that had been pushed over the hillside. Surface flow is causing additional rills carrying sediment to the floodplain (Figure 2-25). The level of sediment contribution from this source and other sources will be addressed in detail under the proposed sediment source study. Corrective actions to prevent or reduce the sediment contribution to the creek will be administered pursuant to the SWPPP.

Figure 2-24 Reach [19] near Station 140+00

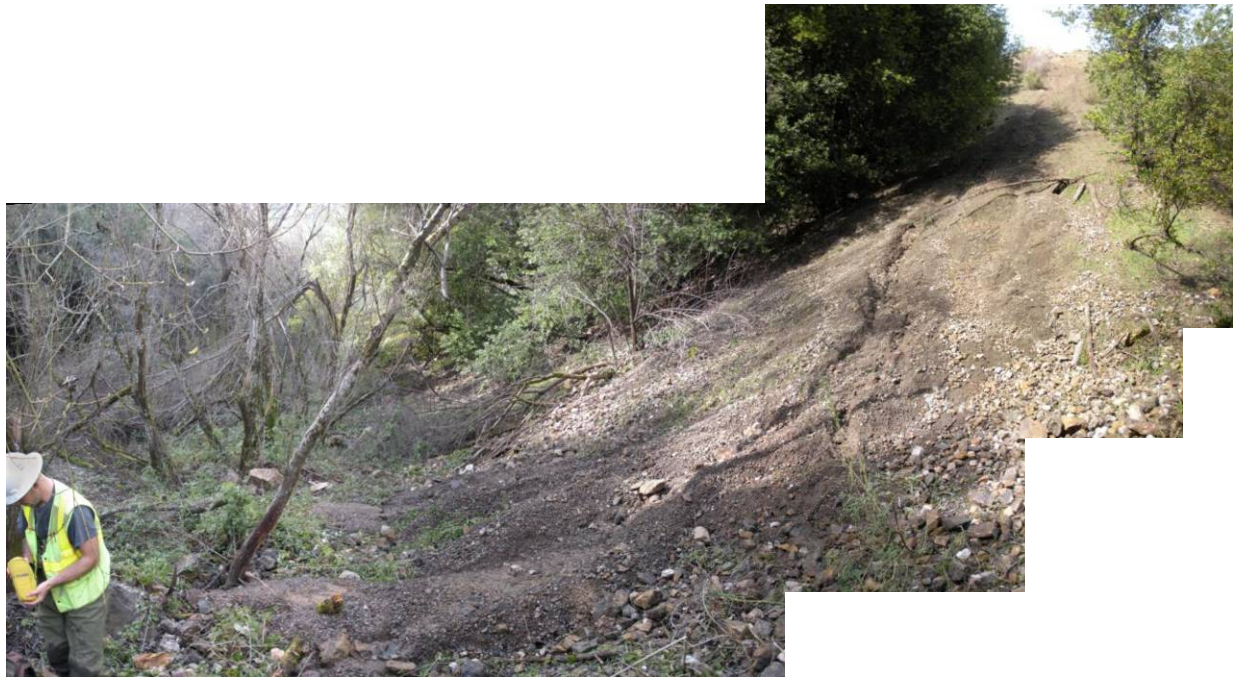
Figure 2-25 Sediment source near Station 141+20 (Q_s3)
