PERMANENTE CREEK LONG-TERM RESTORATION PLAN

Prepared for
Lehigh Southwest Cement Company
24001 Stevens Creek Boulevard
Cupertino, CA 95014

March 11, 2011

URS Corporation
1333 Broadway, Suite 800
Oakland, CA 94612
510-893-3600
26817215.20000

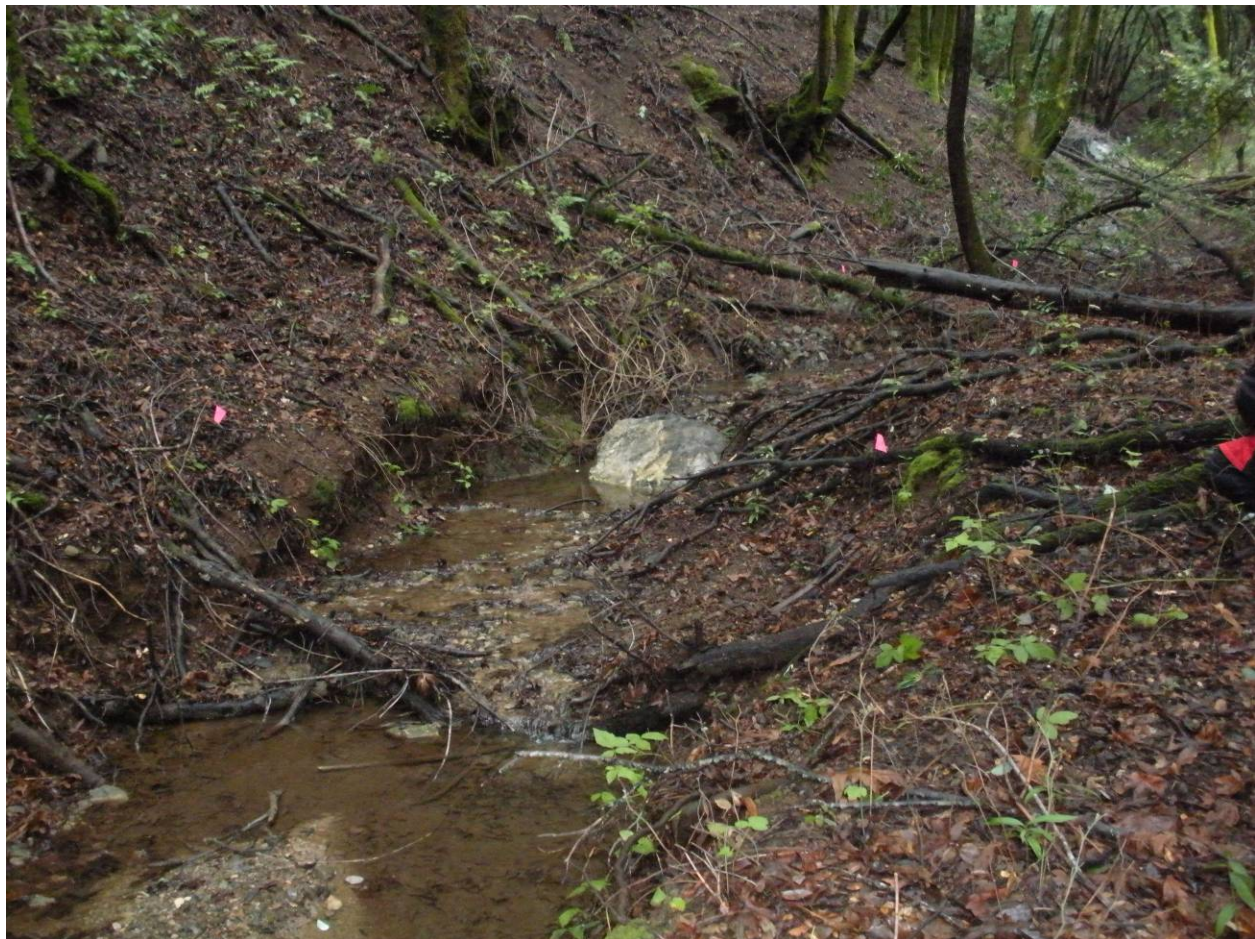
The exception is the area starting near the base of the debris slide at Station 187+50 (Q_s1) and continuing for approximately 355 feet downstream (Station: 185+15 to 188+70). As discussed in Section 2.3.2, the profile has downcut from 0.1 to 1.1 feet over the length of this reach, and the slope of the steepest portion at the base of Q_s1 has migrated approximately 12 feet upstream. The old debris slide at Station 178+50 (Q_s2) is still active along the upper slope, but it is no longer a significant source of sediment to the Creek, as most of the fines have already washed away and portions of the slope have begun to revegetate. The old debris slide at Station 187+50 (Q_s1) is no longer a significant source of sediment, as most of the fine-grained material has eroded away and vegetation has become established, stabilizing the slide. Small amounts of sediment may be dislodged as the stream continues to adjust its profile through the debris slide material in the streambed. Most of the down cutting has already occurred; however, the vertical banks will eventually erode to a more stable angle of repose.

Figure 2-27 View near Station 186+00 on Reach [21]

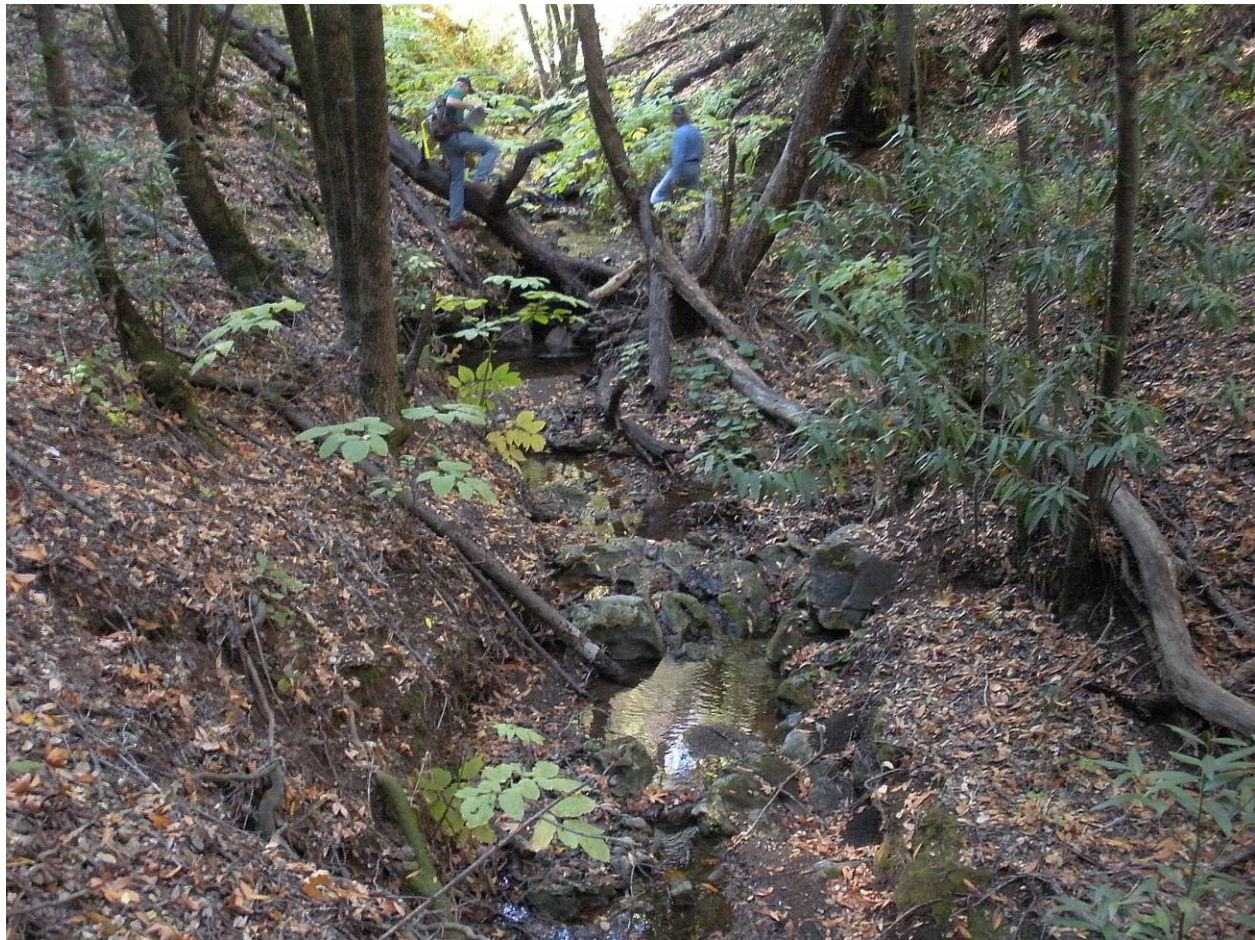
This reach is predominantly stable, with some inputs of very large boulders that likely have rolled down from the Upper Quarry Road. Unlike the lower reaches, this reach does not receive sediment from debris slides from the overburden areas, and it is considered to essentially be in reference condition considering the geology of the region (see Figure 2-28). Evidence of natural landslides and treefall appears along both sides of the Creek. These processes are typical hillslope processes in the Santa Cruz Mountains, but they cause this otherwise reference condition system to receive a Pfankuch rating of “fair.”

Figure 2-28 View on Reach [22] near Station 195+00
