# County of Santa Clara

**Subject: 2015 SMARA Inspection Report for the Permanente Quarry  
County Planning Office File 2250-15PAM  
State Mine ID #91-43-0004**

This letter report summarizes the findings of Michael Baker International's (Michael Baker) annual Surface Mining and Reclamation Act (SMARA) site inspection of the Permanente Quarry in Cupertino, CA (Mine ID #91-43-0004) conducted on September 3, 2015. Michael Baker was retained by Santa Clara County to assist County staff with the annual SMARA mine inspection and to provide written documentation of our observations, issues of concern and recommendations.

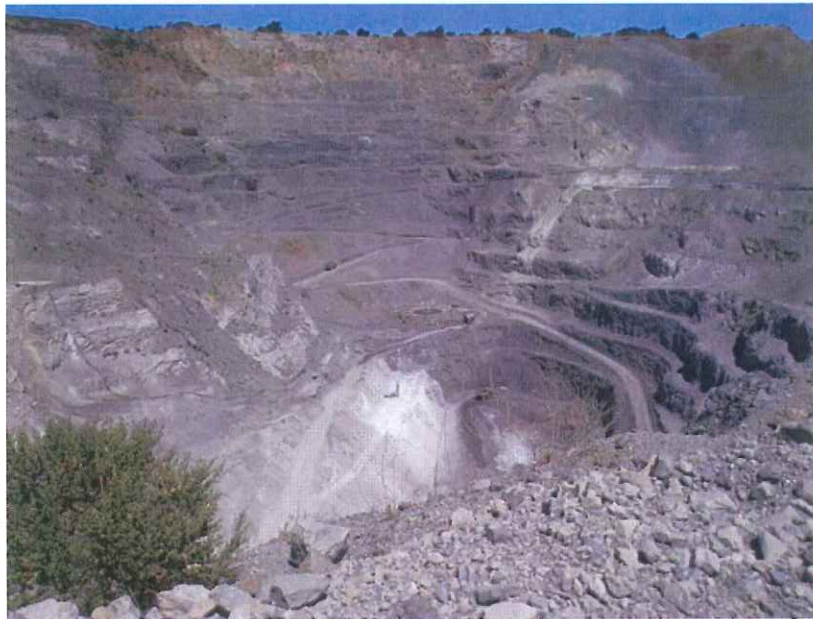
Photo 1: North Quarry, looking north. Waste rock material being placed at toe of western slope. Floor elevation of quarry at approximately 625 feet msl. Dated September 3, 2015.

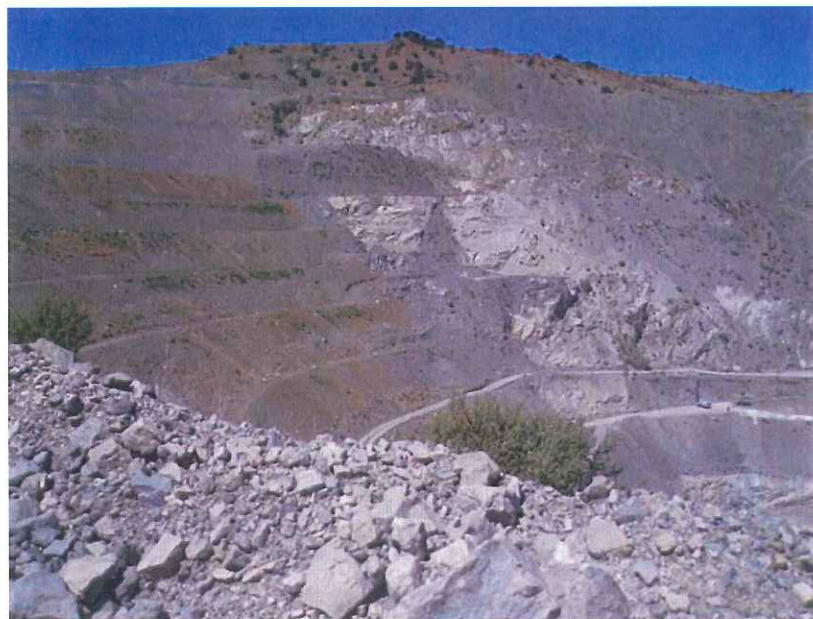
A fourth apparent landslide occurs on the western side of the pit. This area of movement was noted by Golder and Associates in their November 2007 Slope Stability Evaluation report and may extend westward below the toe of the eastern slope of the WMSA overburden stockpile. The County's Geologist, Mr. James Baker, referred to this western landslide as the "Haul Road Slide." The placement of overburden backfill against the western toe of the North Quarry is intended to stabilize this slide.

Photo 2: North Quarry western highwall with backfill. Dated September 3, 2015.

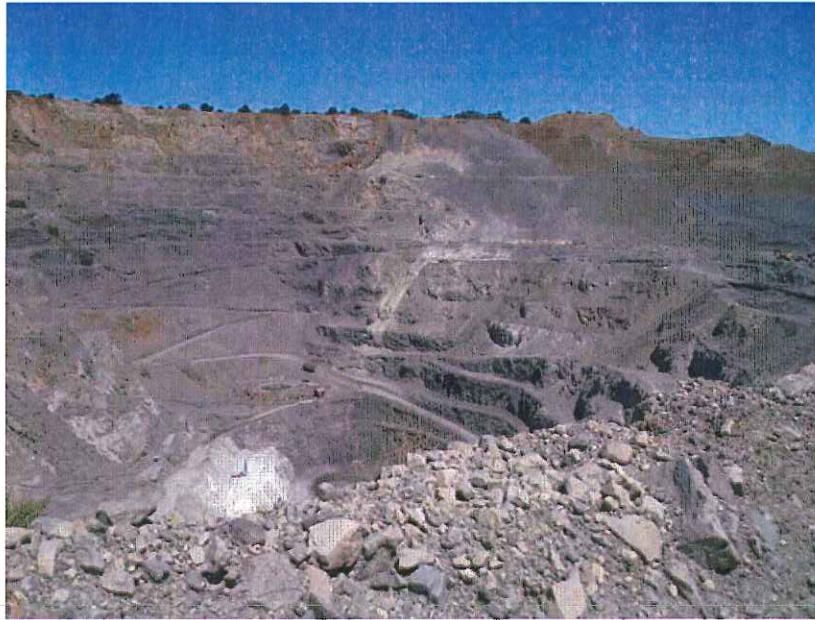
Photo 3: North Quarry eastern highwall at left side of photo. Upper portion near final reclamation grade. Mid-Pen Rockslide in right center of photo. Dated September 3, 2015.

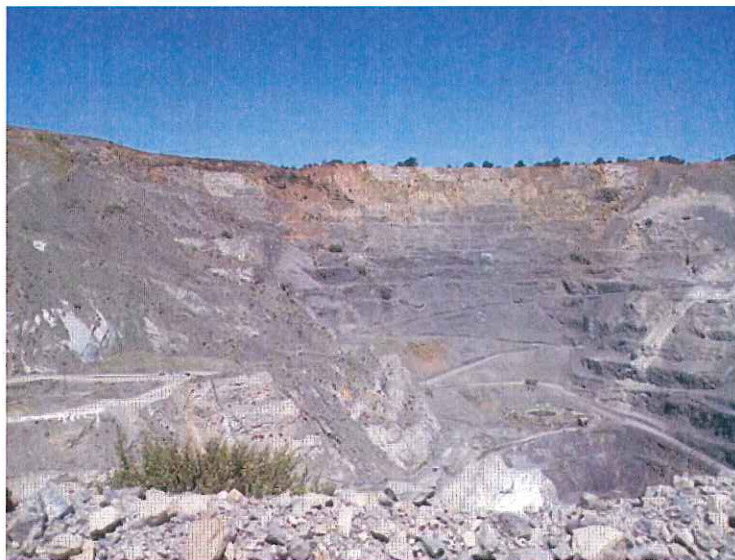
The northern highwall of the North Quarry has had three large rockslides, which are described in the RPA. No major new movement on these rockslides was observed during the 2015 inspection. The upper portions of the Mid-Pen Rockslide that extends approximately halfway down the eastern highwall was graded out recently during mining (**Photo 3**). The Scenic Easement Rockslide has a slope failure that extends down slope approximately as far as the Mid-Pen Rockslide (**Photo 4**). This rockslide lowered the ridgeline contrary to the 1972 Ridgeline Protection Easement requirement. The largest slide, the Main Rockslide, appears to extend across most of the current height of the northwestern highwall (**Photo 4**).

Photo 4: Looking north at the North Quarry. Main Rockslide on left, Scenic Easement Rockslide in center and remnants of Mid-Pen Rockslide on right. Compare to Photos 4, 5 and 6 in 2014 inspection report. Dated September 3, 2015.

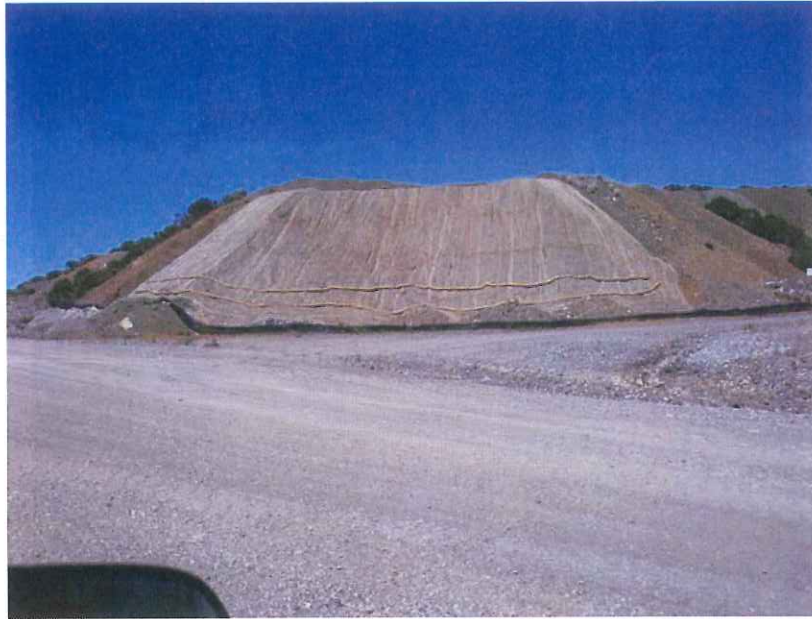
Photo 5: Looking northwest at older topsoil stockpile in WMSA. Dated September 3, 2015.

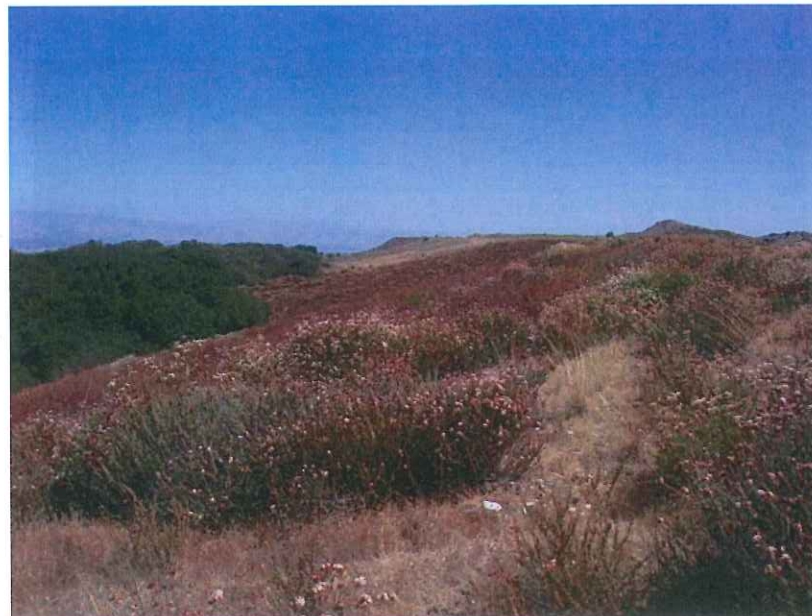
for later use in reclamation of Permanente Creek. Both of the WMSA topsoil stockpiles continue to be signed. Beginning around 2021 in Phase 2 of the RPA, approximately 48 million tons of overburden material from the WMSA including wash fines will be placed in the North Quarry to raise the final floor elevation to approximately 990 feet msl. Revegetation efforts along the northern WMSA were observed during the 2015 inspection (**Photo 6**).

Photo 6: Portion of re-vegetated north-facing slope of WMSA, looking east. A portion of this slope will be removed in Phase 2 to backfill of North Quarry. Dated September 3, 2015.

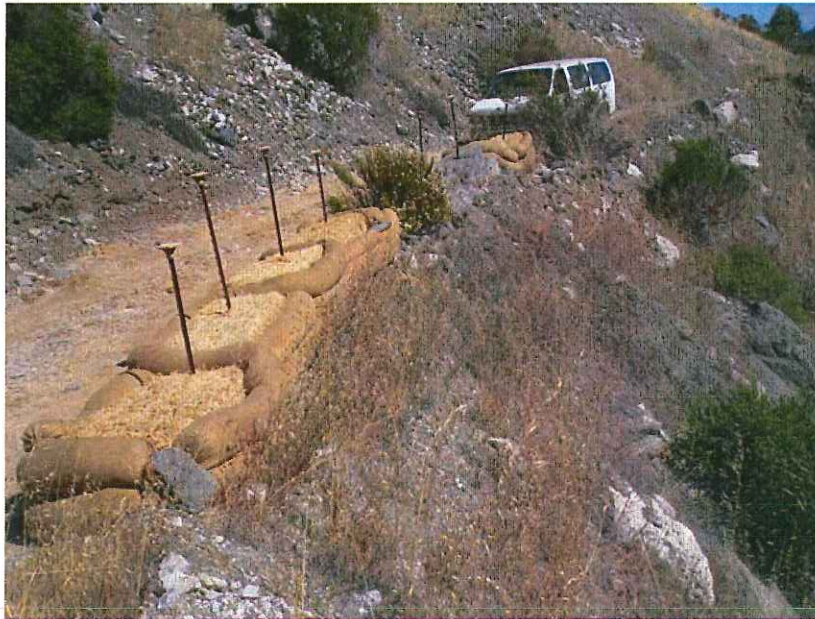
Photo 7: Straw waddle and haybale BMPs placed along mid-slope bench roadway in southern WMSA slope. Dated September 3, 2015.

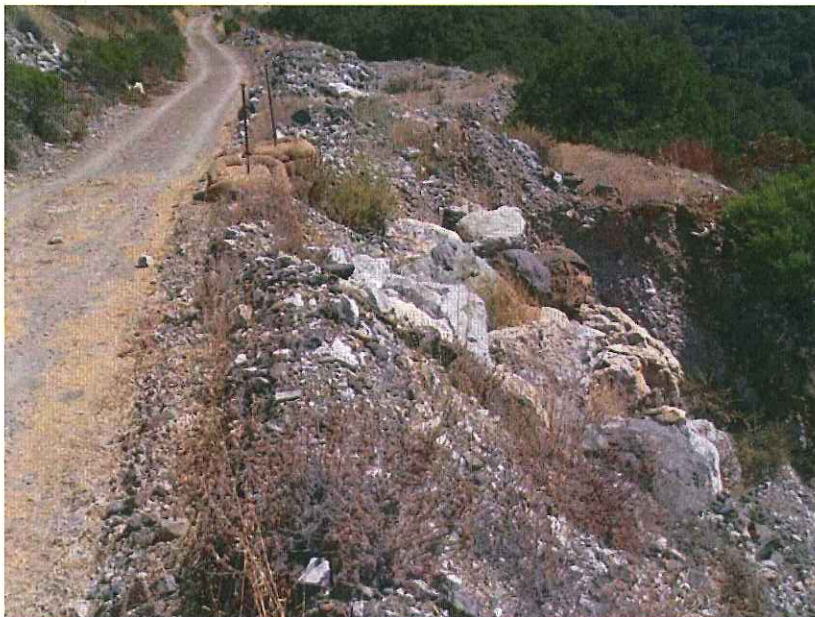
Photo 8: Rocked outfall in mid-slope bench on southern WMSA slope, looking southwest. Dated September 3, 2015.

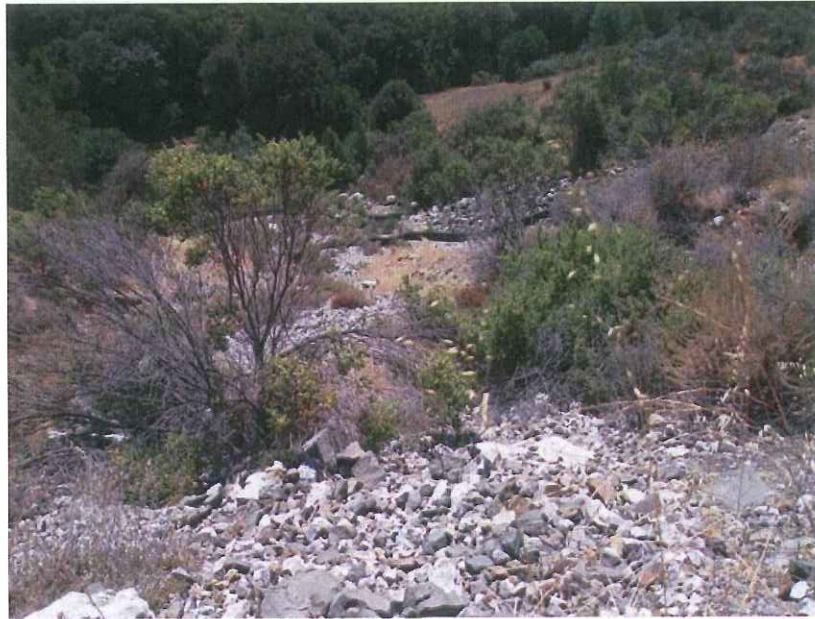
Photo 9: Looking downslope from rockied outfall shown in Photo 8 at silt fencing and area where soil mixed with talus was observed in 2012, 2013 and 2014 that may be the result of past slide; silt fence shows no visible significant displacement. Dated September 3, 2015.

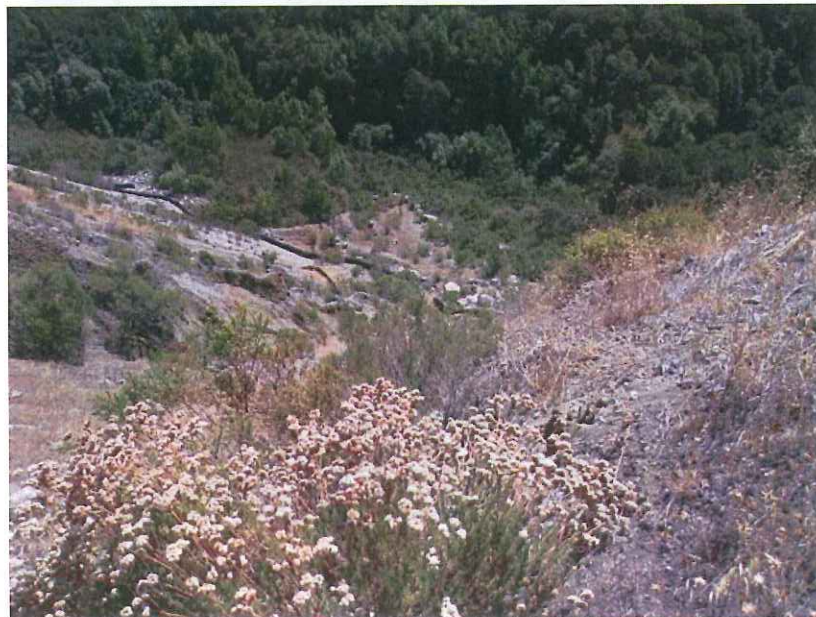
Photo 10: Silt fencing on southern slope of WMSA below mid-slope bench; silt fencing shows no visible significant displacement. Dated September 3, 2015.

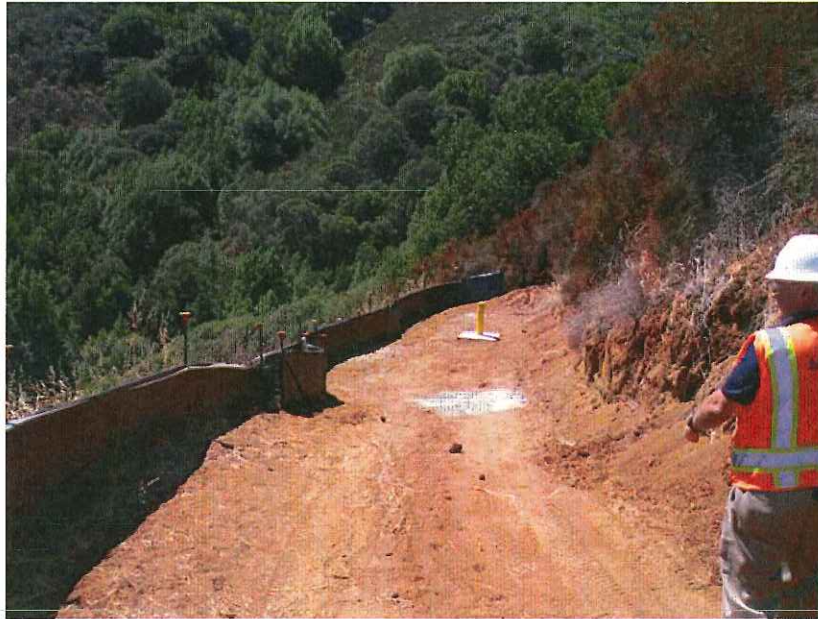
Lehigh at the request of the SFBRWQCB submitted on October 15, 2013 a workplan prepared by Golder Associates for investigation the EMSA and WMSA runoff and groundwater seepage. The SFBRWQCB issued a Conditional Concurrence letter for this workplan on November 5, 2013. On October 31, 2013, Lehigh submitted at the request of the SFBRWQCB a workplan prepared by Golder Associates to begin a groundwater characterization and detection-monitoring program for the WMSA and EMSA. A second revision of the groundwater workplan was prepared in November 2014. The SFBRWQCB issued a Conditional Concurrence letter for this revised groundwater workplan on January 14, 2015. Groundwater monitoring wells were installed across the mine site as part of the groundwater characterization effort (**Photo 11**).

Photo 11: Silt fencing on mid-slope bench roadway at western end showing protective riser for groundwater monitoring well. Dated September 3, 2015.

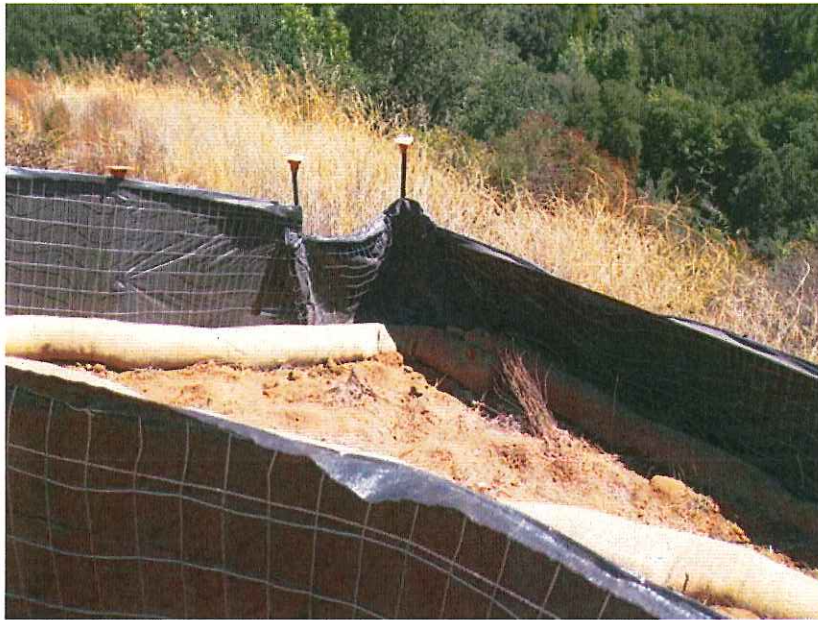
Photo 12: Silt fence and straw waddle BMPs along outer edge of mid-slope bench in southern slope of WMSA required by regrading the roadway for the installation of groundwater monitoring wells. Dated September 3, 2015.

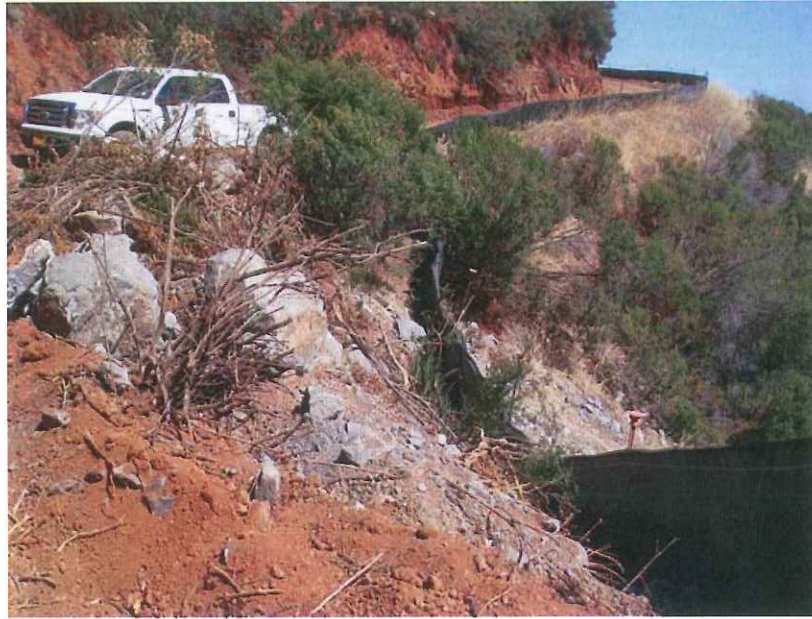
Photo 13: Silt fence BMP along outer edge of mid-slope bench in southern slope of WMSA required by regrading the roadway for the installation of groundwater monitoring wells. Dated September 3, 2015.

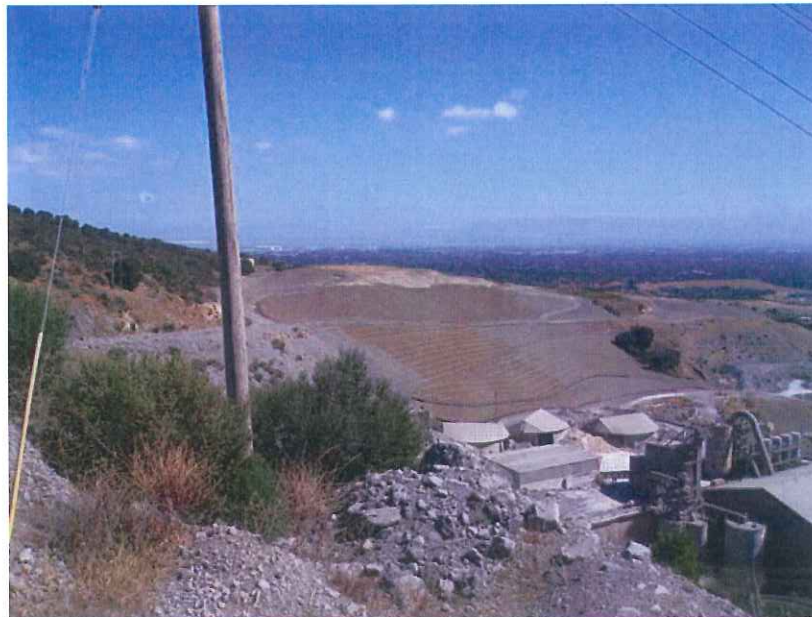
Photo 14: EMSA looking northwest at BMPs installed on finish grade slopes. Dated September 3, 2015

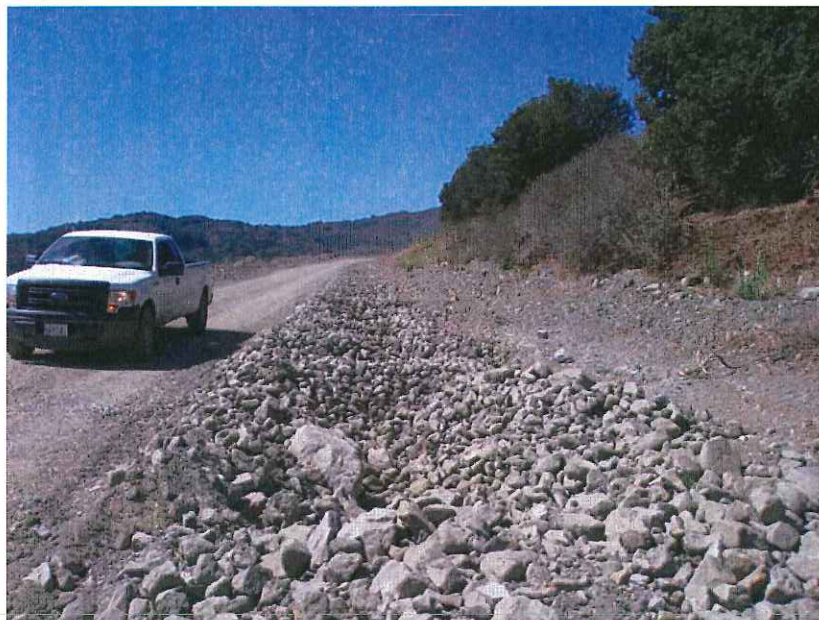
Photo 15: Non-limestone drainage channel/French drain on inside of main roadway in EMSA looking south. Drain discharges into channel shown in Photo 16. Dated September 3, 2015.

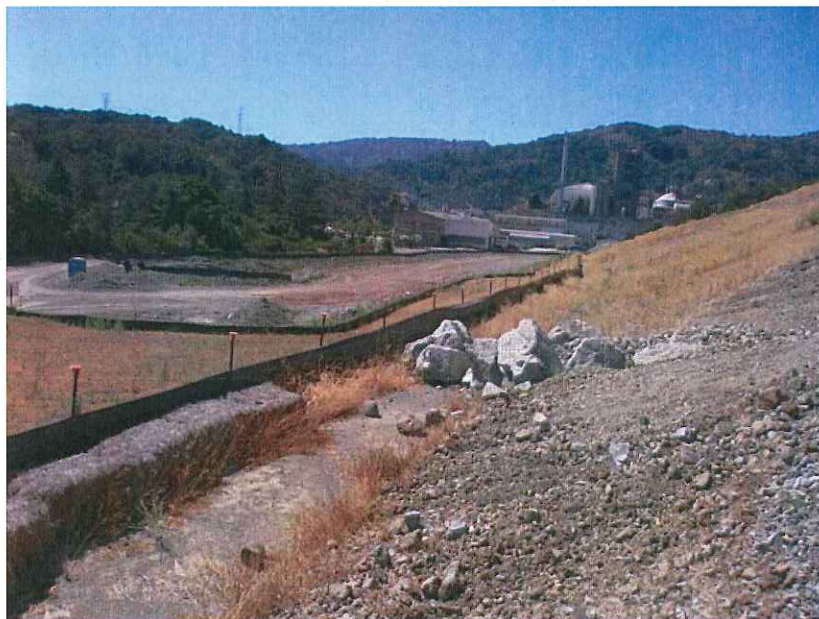
Photo 16: Looking south at a drainage channel running along the right side of the silt fence that takes EMSA runoff from a pipe discharging at the pile of rocks and then conveys it to the south into a sediment catch basins. Dated September 3, 2015.

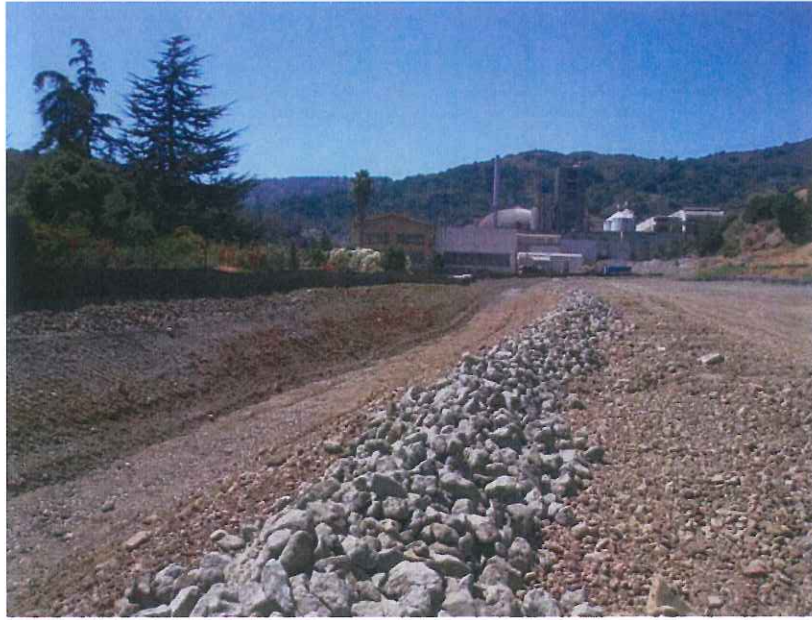
Photo 17: Looking south at drainage channel that flows northward to discharges EMSA stormwater into Pond 30. Dated September 3, 2015.

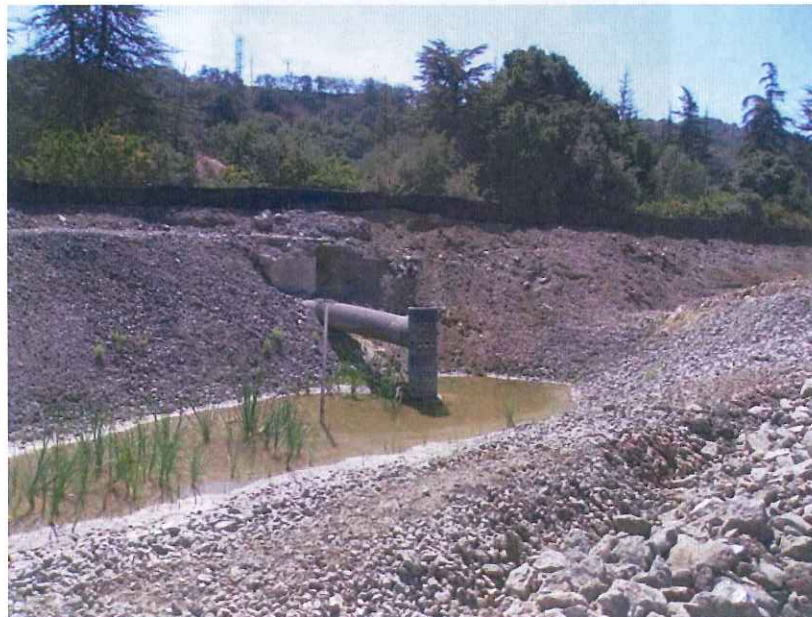
Photo 18: Pond 30 with outfall that discharges into Permanente Creek. Dated September 3, 2015.

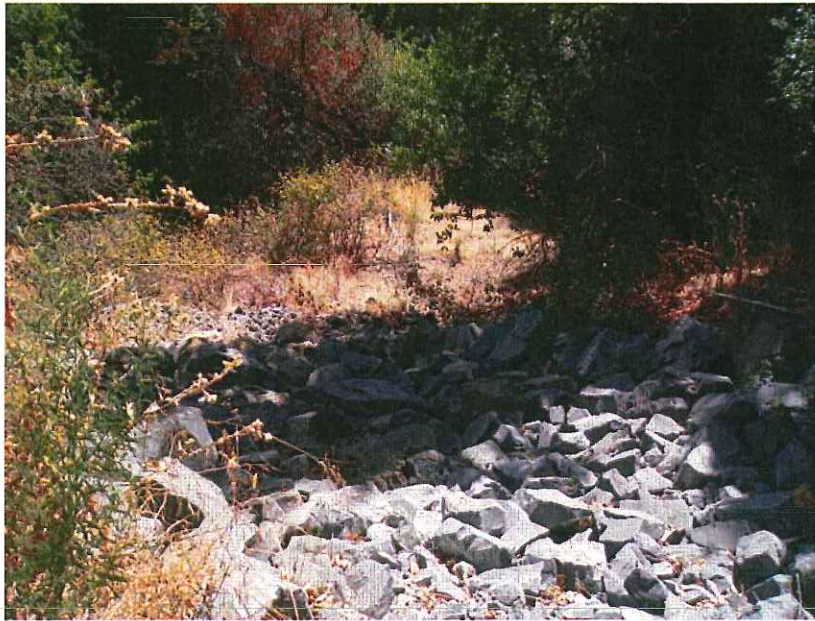
No overburden material or washout fines were being placed in the EMSA during the 2015 inspection. During 2015, the EMSA was graded to final grade and non-limestone rock material was placed as a cap. Lehigh has created a June 2015 contour map of the area, but at the time on the 2015 inspection the County surveyor hadn't completed their review to determine whether the final elevations comply with the 2012 Conditions of Approval (COAs) and RPA. The survey was scheduled for October 1, 2015. During the 2015 inspection, slope BMPs were observed (**Photo 14**) and a non-limestone drainage channel/french drain was constructed along the inside of the main road that runs northeast through the EMSA (**Photo 15**). Drainage from the main EMSA road discharges into a south draining silt fenced ditch that flows into a pond at the southeastern boundary of EMSA (**Photo 16**). This pond then discharges to a wide drainage ditch that flow northward to Pond 30 (**Photos 17 and 18**). Pond 30 lies in the northeastern portion of the EMSA and is a settling pond before EMSA stormwater discharges to Permanente Creek (**Photo 19**). The discharge from Pond 30 is metered (**Photo 20**).

Photo 19: Pond 30 rocked outfall to Permanente Creek. Dated September 3, 2015.

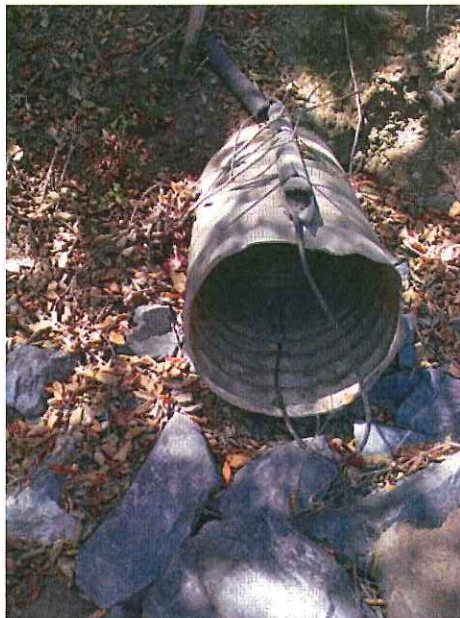
Photo 20: Pond 30 metered outfall to Permanente Creek. Dated September 3, 2015

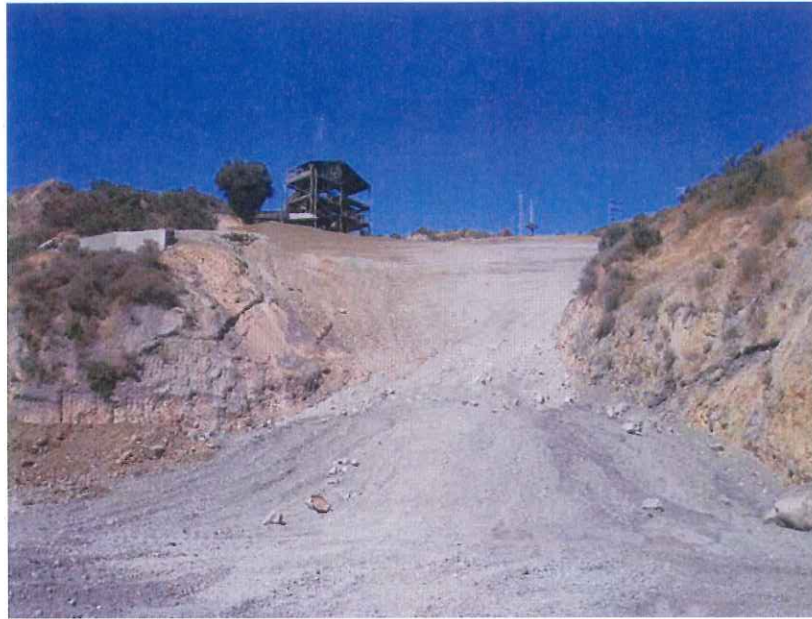
Photo 21: Looking west at fill placed in a drainage to mitigate past slope failures below conveyor that deposited limestone waste rock into EMSA drainage. Slopes will be hydroseeded before this winter. Compare with Photo 14 in 2013 Annual Inspection report. Dated September 3, 2015.

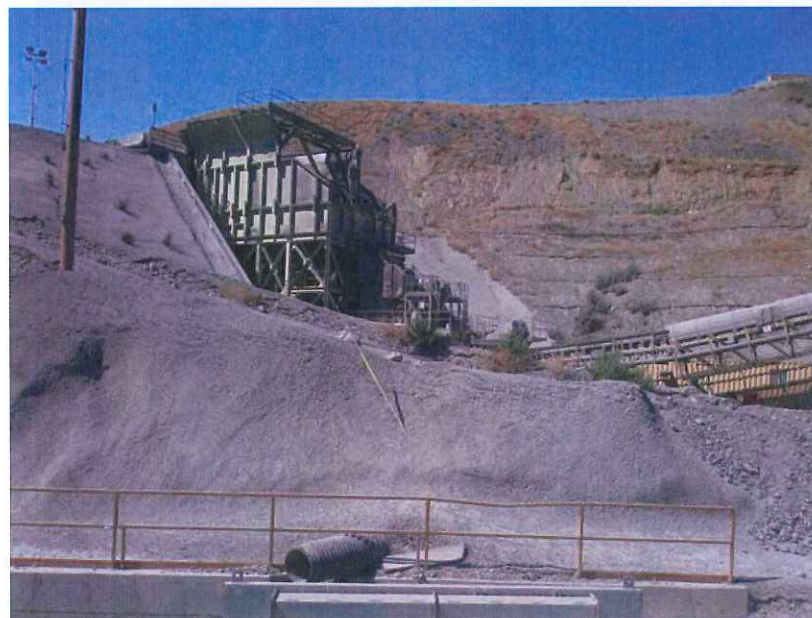
Photo 22: New primary crusher looking north. Drainage sump in foreground. Dated September 3, 2015.

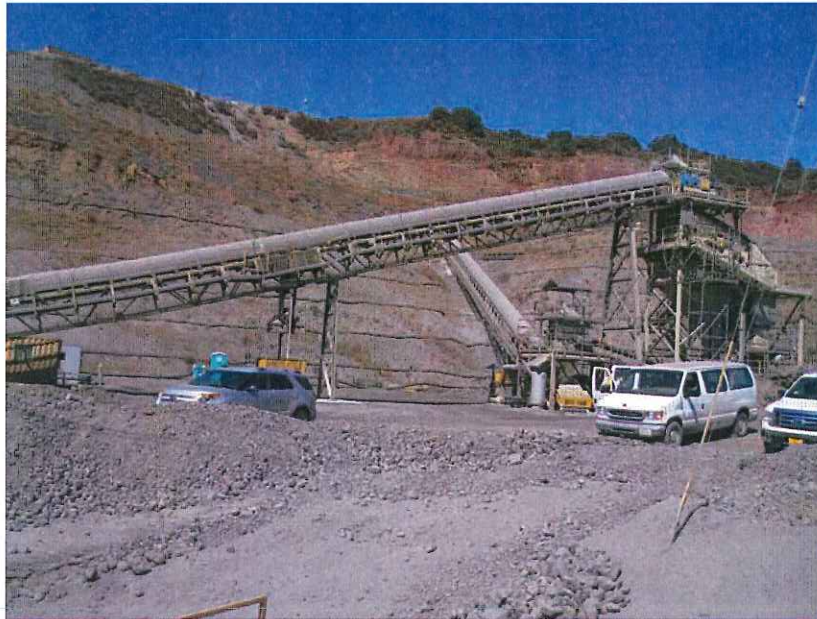
Photo 23: New crusher area conveyors looking northeast. Dated September 3, 2015.

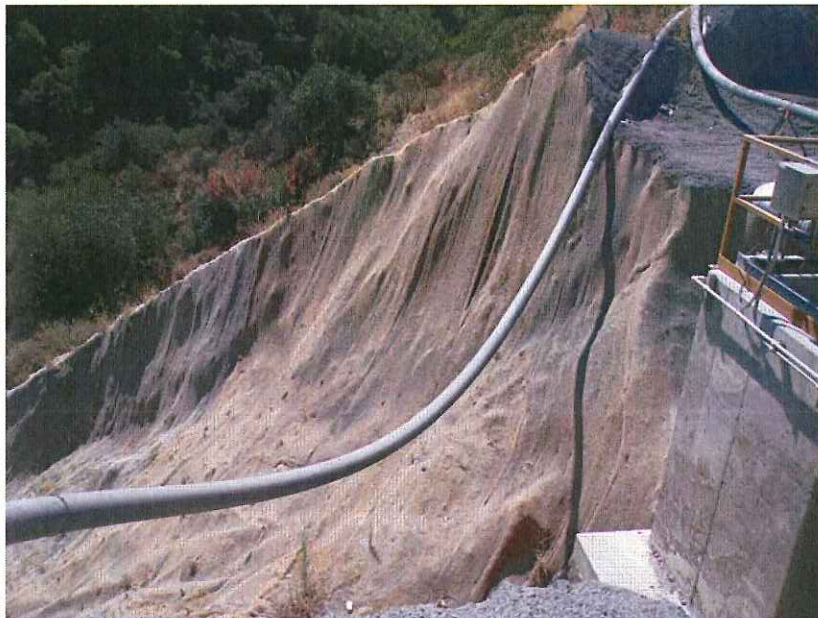
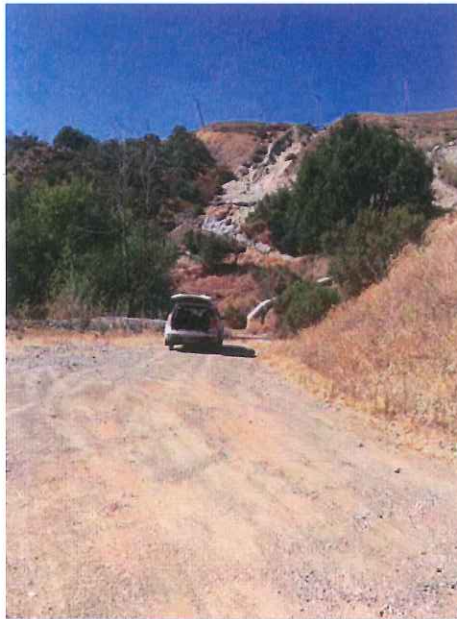
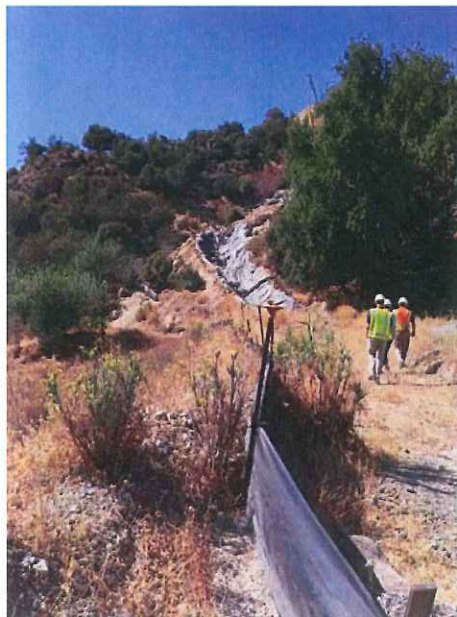
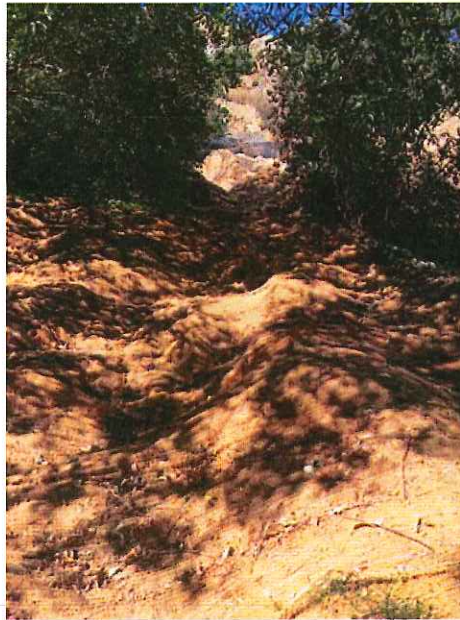
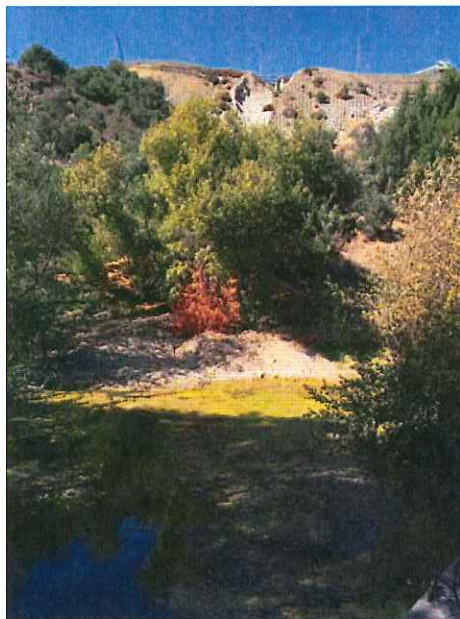
Photo 24: Upper portion of slope washed out by overflow of crusher sump. Sump wall exposed in lower right of image, looking west. Slope repair will need to underpin foundation of sump. Dated September 3, 2015.

Photo 25: Looking northwest from the area of Pond 13B at the washed out slope caused by overflow of the new crusher sump in December 2014. Dated September 3, 2015.

Photo 26: Looking northwest at the lower portion of washed out slope caused by overflow of the new crusher sump in December 2014. Dated September 3, 2015.

Photo 27: Lower portion of washed out slope caused by overflow of the new crusher sump in December 2014. Material discharged into Pond 13B. Dated September 3, 2015.

Photo 28: Looking north at Pond 13B with sediment fan created by washed out slope caused by overflow of the new crusher sump in December 2014. Dated September 3, 2015.

1. Implementation of the slope washout backfill and sump foundation stabilization work in the new crusher area should be started and completed before this winter. County staff should make periodic inspections of this work. Should this work not be fully completed before start of winter, the operator should install all BMPs and slope stabilization measure necessary to stabilize the area over the winter.

1. The washout area in the slope adjacent to the new crusher should be repaired and revegetated. County staff should continue to periodically inspect the performance of this repair and take corrective action as necessary.

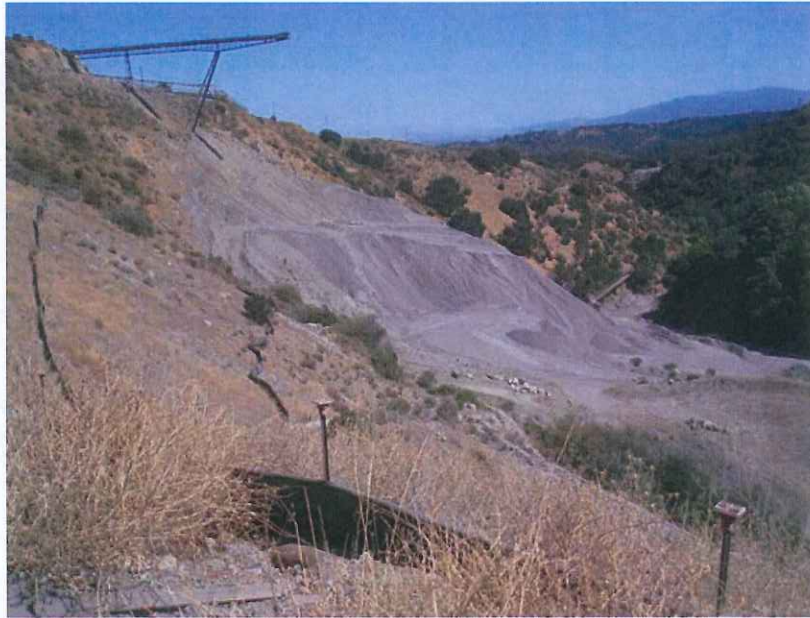
Photo 29: Looking southeast at Surge Pile along north side of Permanente Creek. Volume of material is less than in 2014. Compare with Photo 24 in 2014 Annual Report. Dated September 3, 2015.

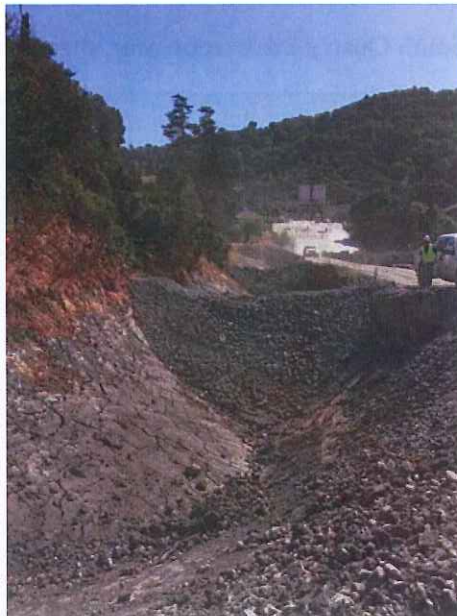
Photo 30: Pond 17 looking south at Rock Plant. Rock Plant was not in operation at the time of the 2015 inspection. Dated September 3, 2015.

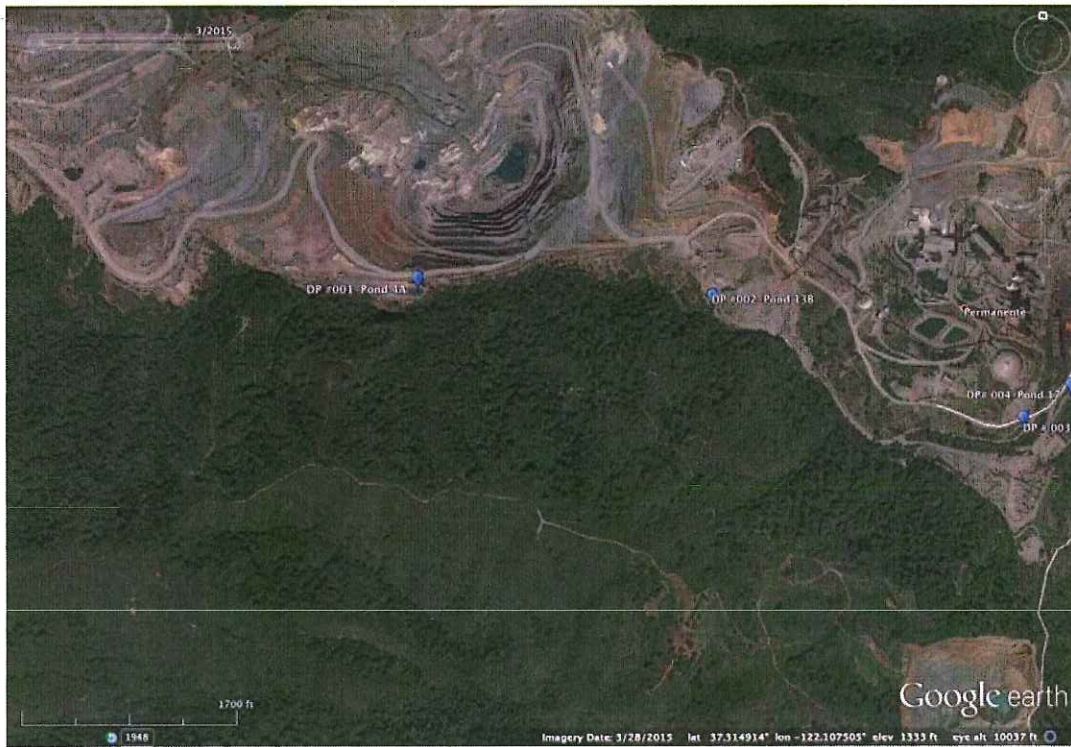
Photo 31: Google Earth Image of South Quarry Exploration area, dated March 2015.

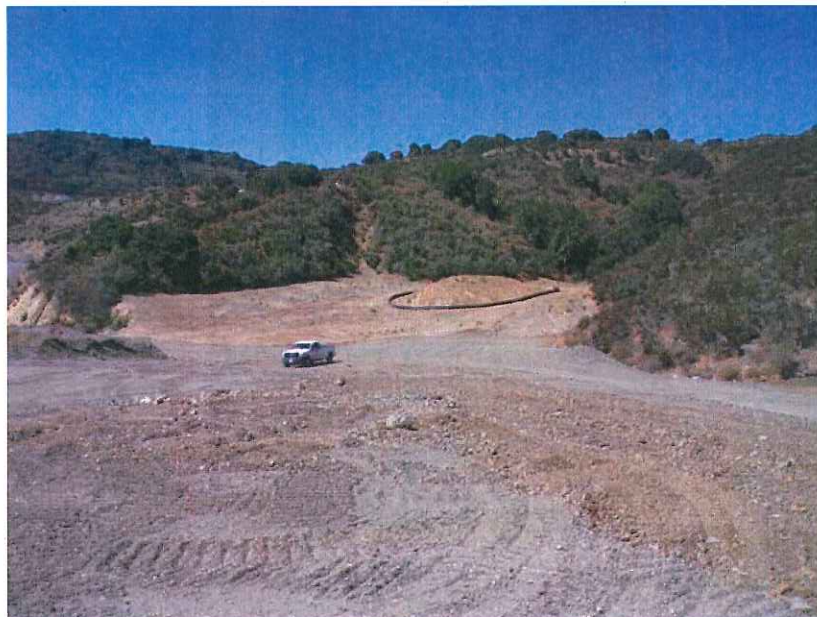
Photo 32: Topsoil stockpile in EMSA surrounded by silt fencing. Dated September 3, 2015.

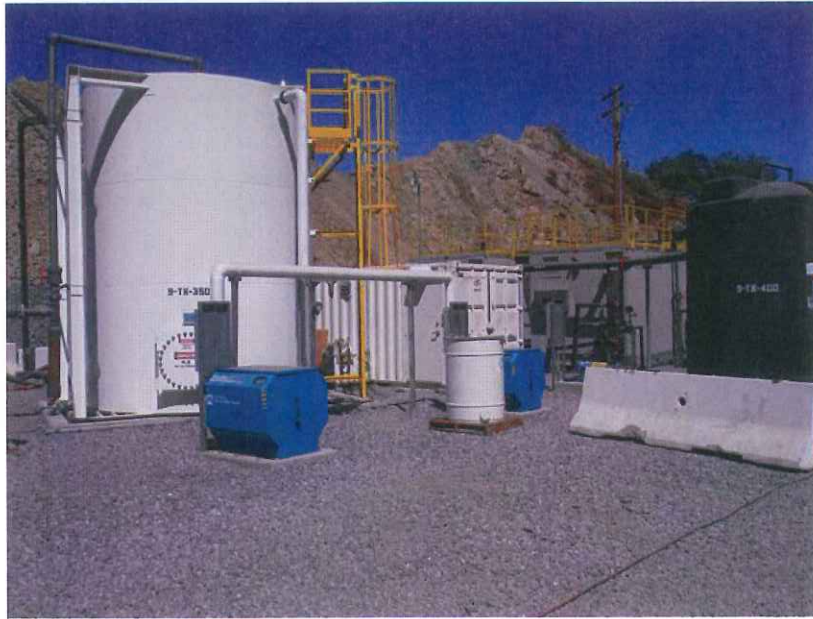
Photo 33: Interim treatment plant at south of North Quarry. Plant discharges to Pond 4A and then to Permanente Creek. Plant wasn't operating at time of 2015 inspection because all water was being used in mining operations. Dated September 3, 2015.

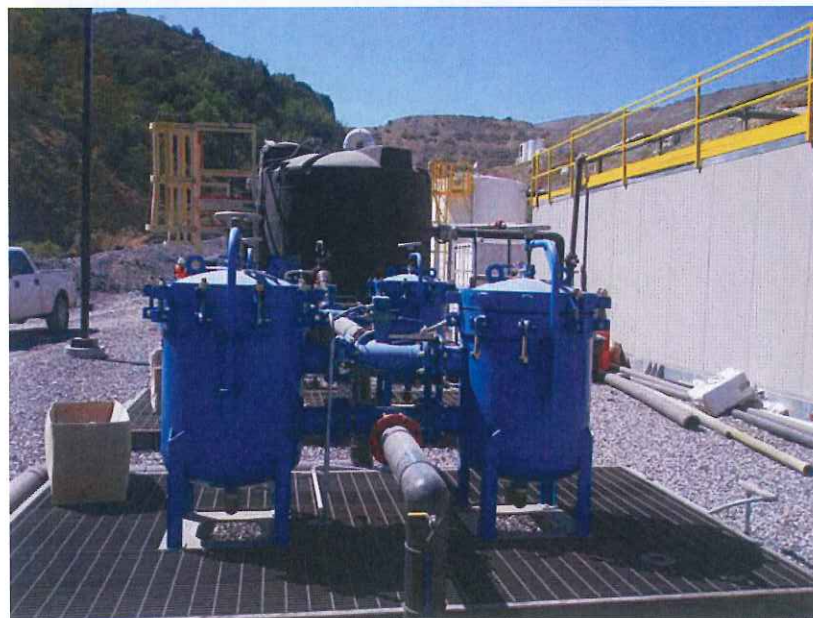
Photo 34: Interim treatment plant south of the North Quarry, looking west. Dated September 3, 2015.

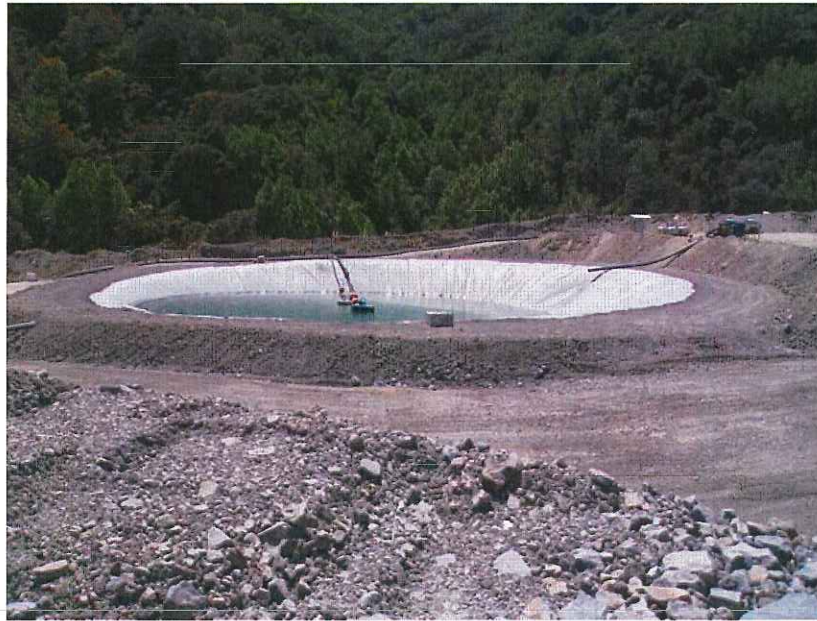
Photo 35: Looking south at the new lined pond south of the North Quarry that holds water for discharge to the interim treatment plant shown in Photos 33 and 34. Dated September 3, 2015.

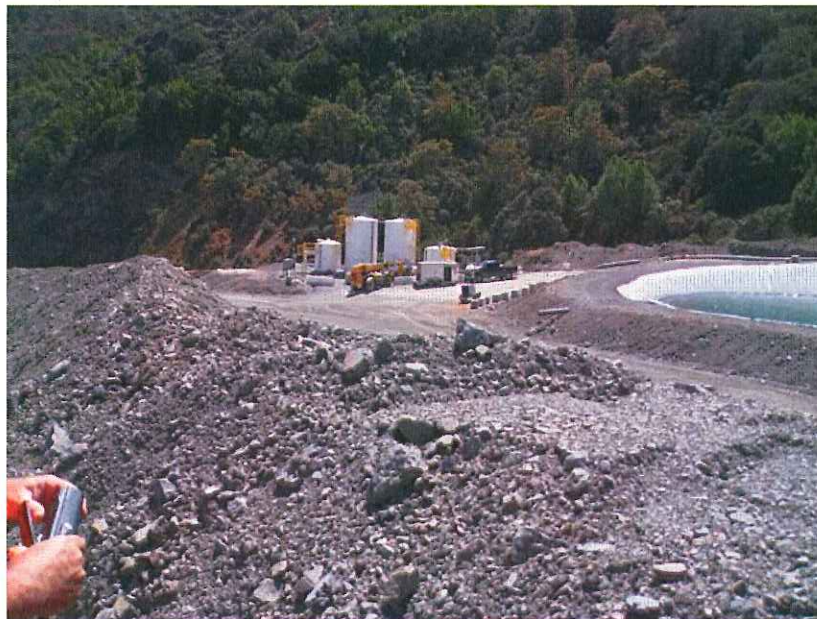
Photo 36: Holding tanks and new lined pond south of North Quarry that discharge to the interim treatment plant shown in Photos 33 and 34. Dated September 3, 2015.
