Subject: 2016 SMARA Annual Inspection Report (MRRC-1) for Lehigh Quarry
County Planning Office File 2250-16PAM
State Mine ID #91-43-0004

Enclosed for your records is a copy of our 2016 SMARA Inspection Report for the Lehigh (formerly Permanente) Quarry. Santa Clara County is the lead agency for administration of SMARA. The County Planning Office is responsible for conducting an annual SMARA inspection and preparing an annual report. The attached report includes the following documents:

The mine was active during the 2016 inspection. The following paragraphs describe our observations in each of the areas [with **PHOTOS** and captions that illustrate what we observed at or from the Map Locations indicated on the attached **AIR-PHOTO**].

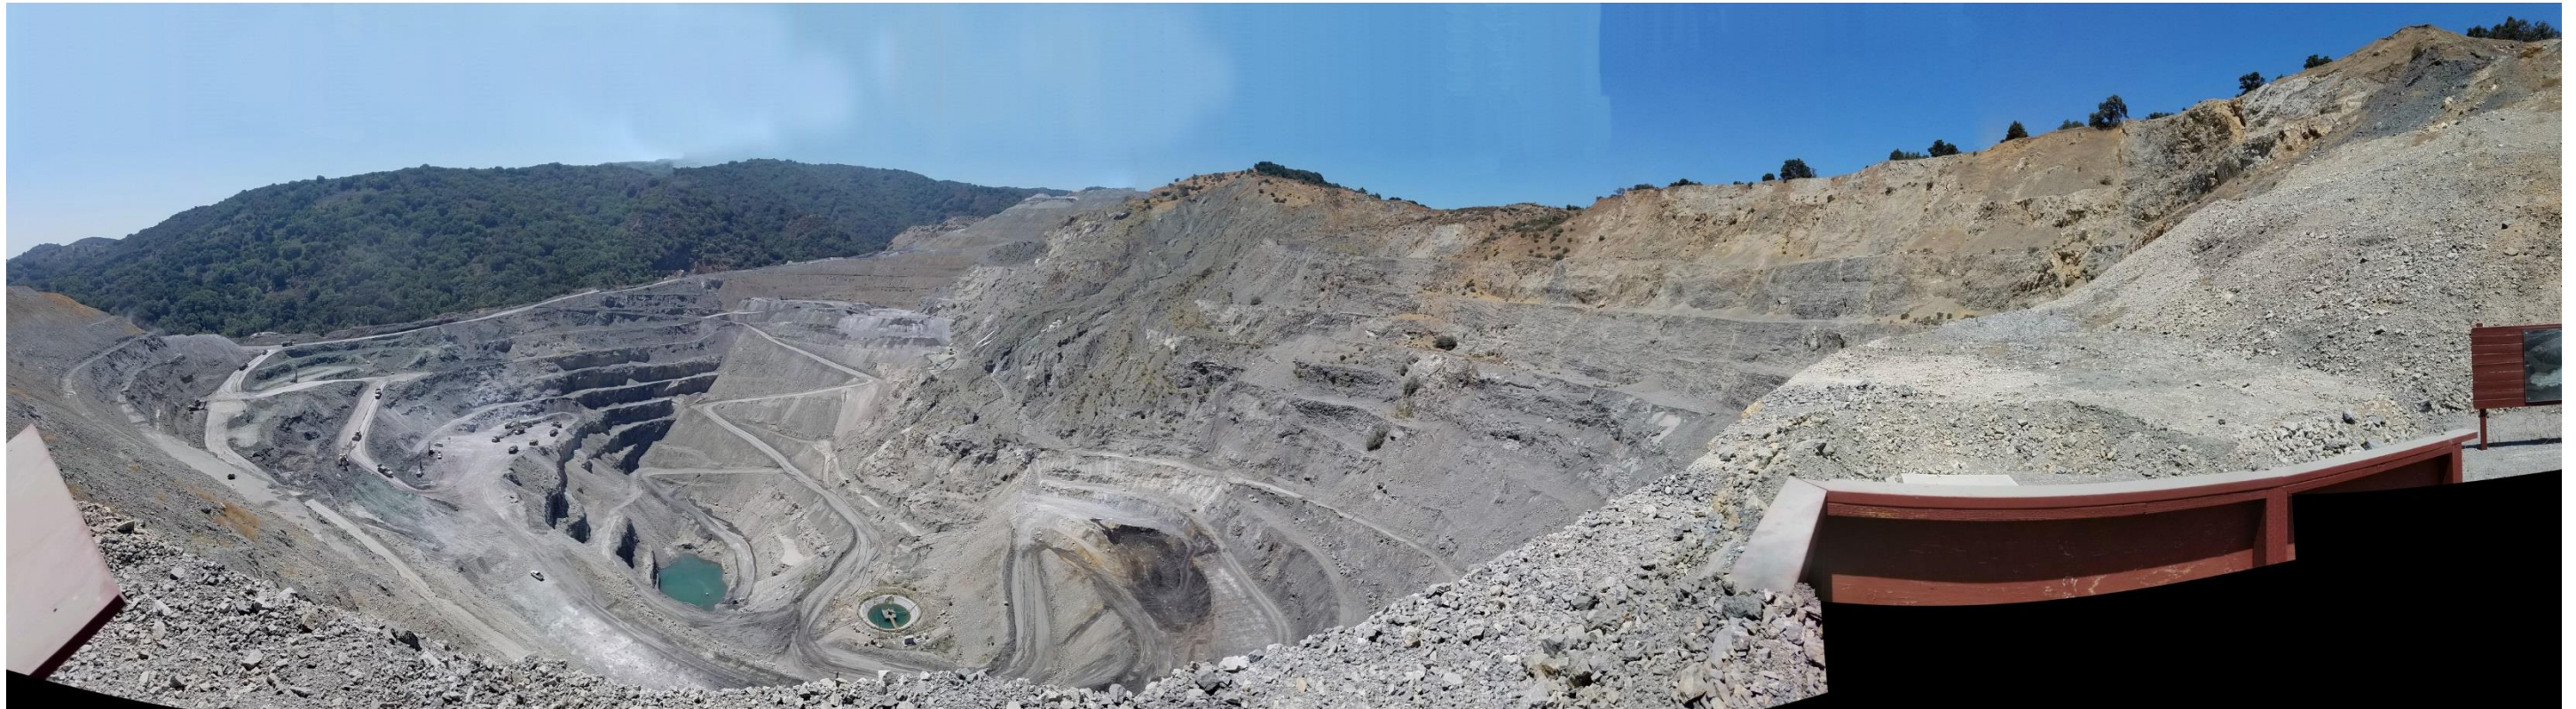
PHOTO #1 taken from Map Location 90 – North Quarry Main Pit (looking northwest)

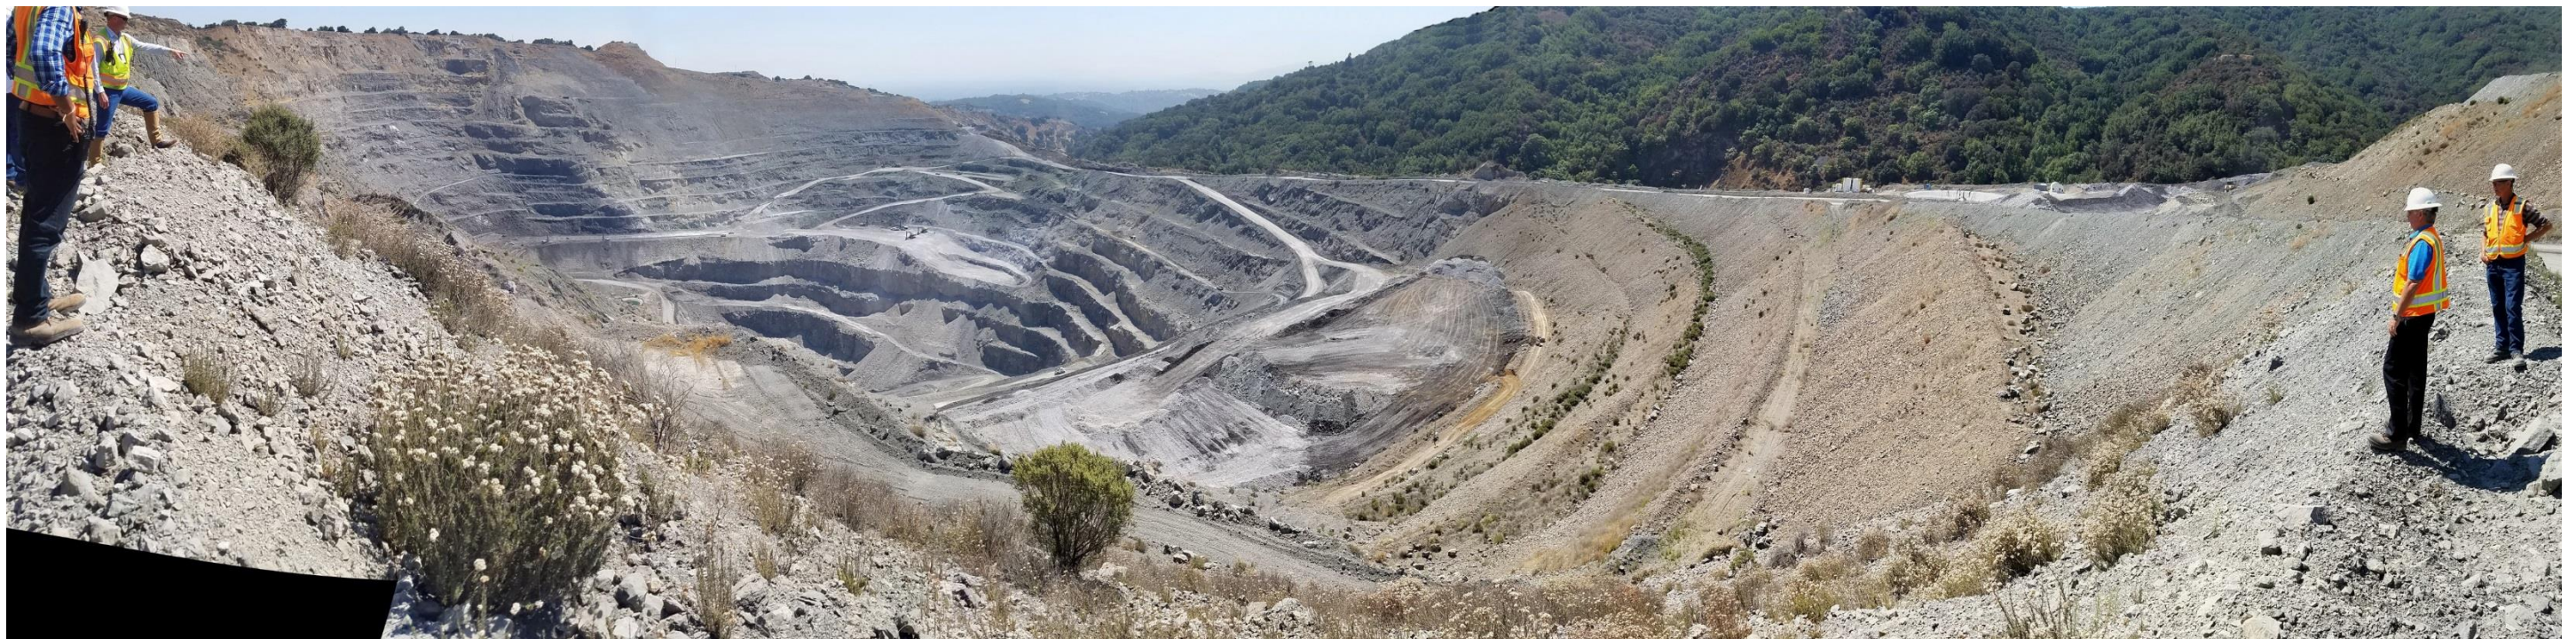
PHOTO #2 taken from Map Location 61 – North Quarry Main Pit (looking south)

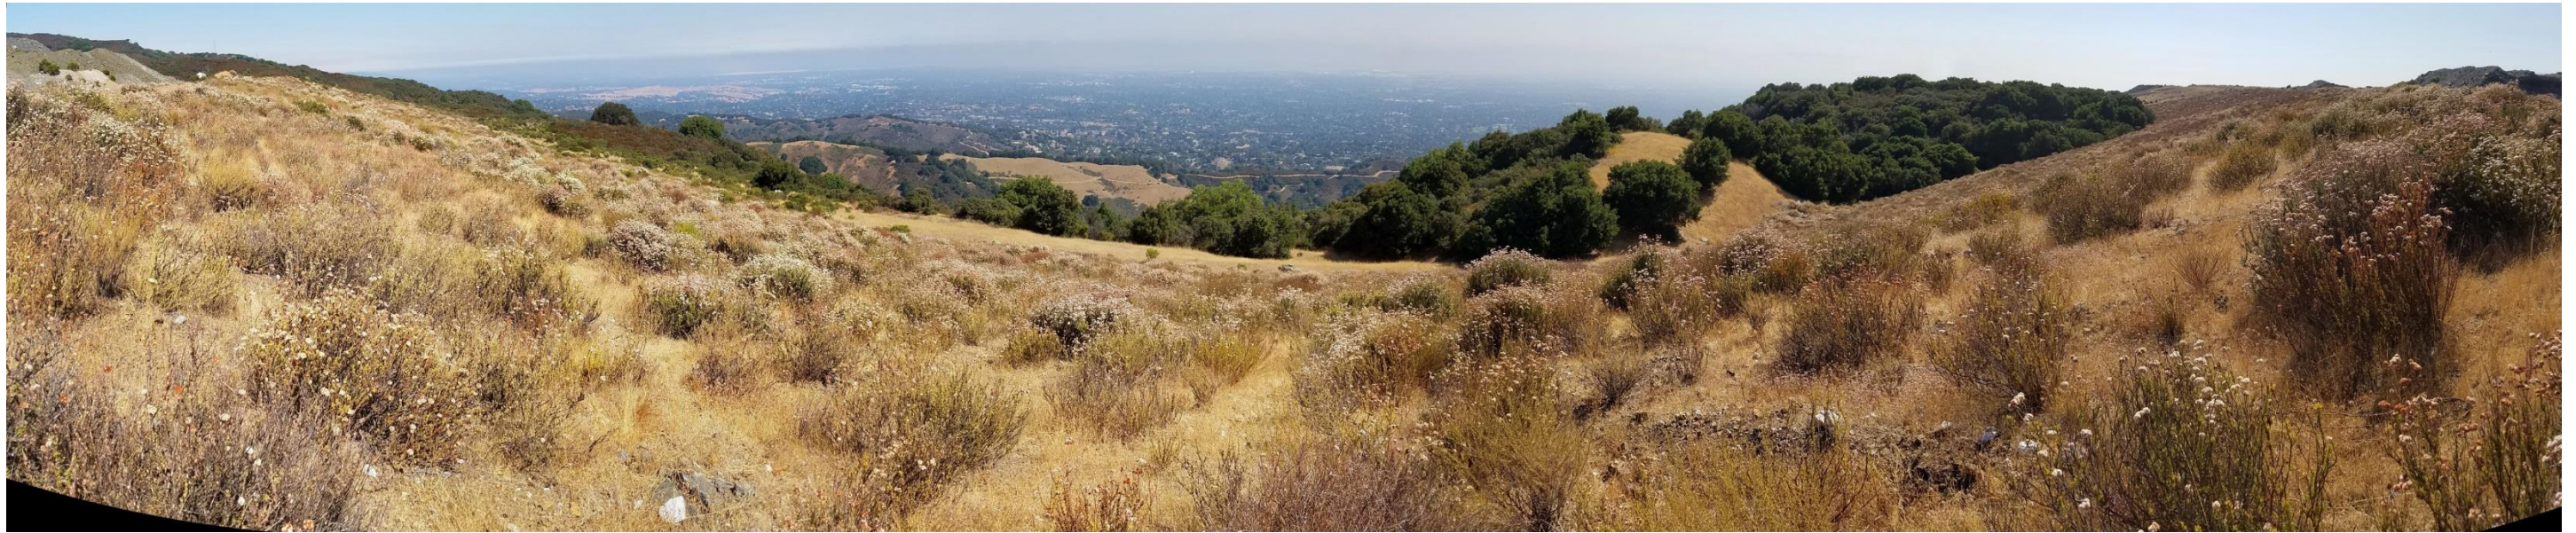
PHOTO #3 taken from Map Location 8 – WMSA (looking east)

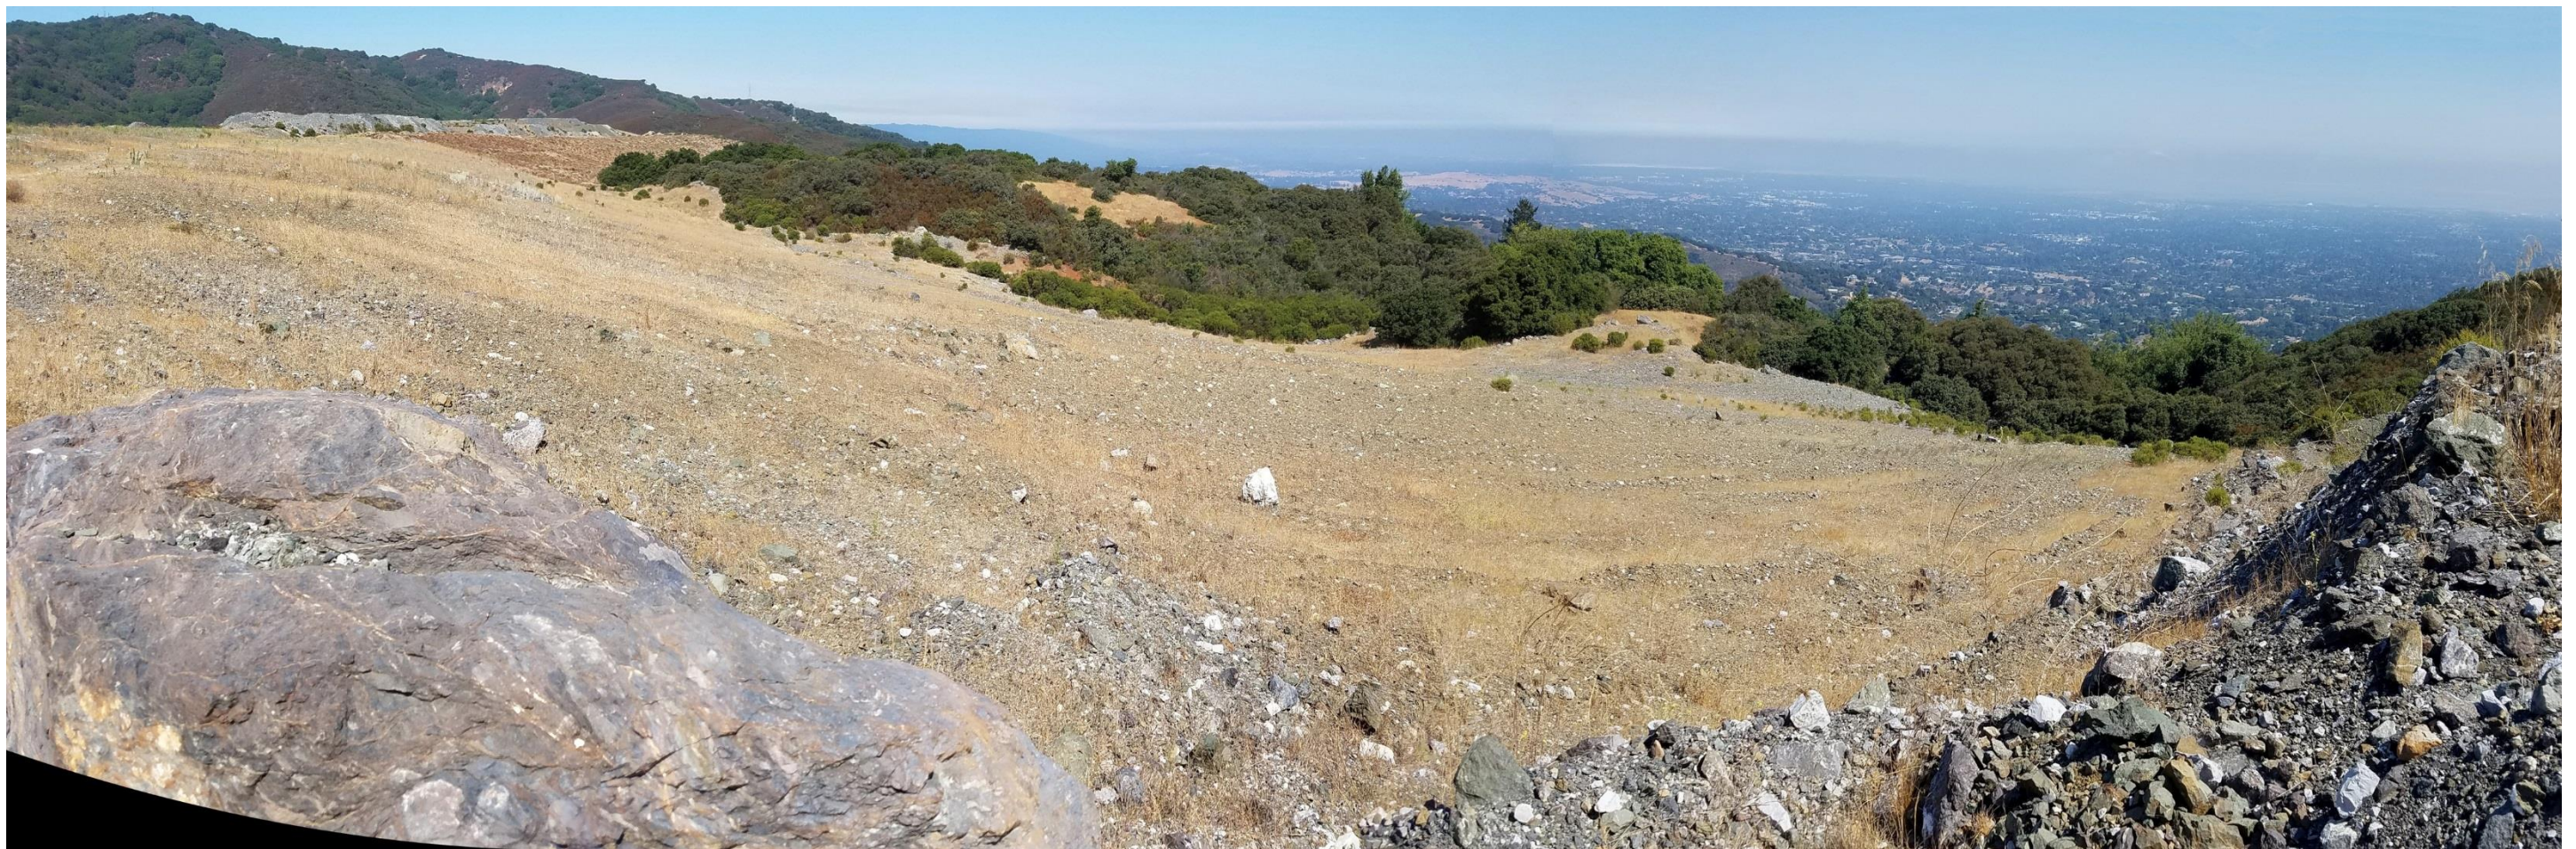
PHOTO #4 taken from Map Location 21 – WMSA (looking north)

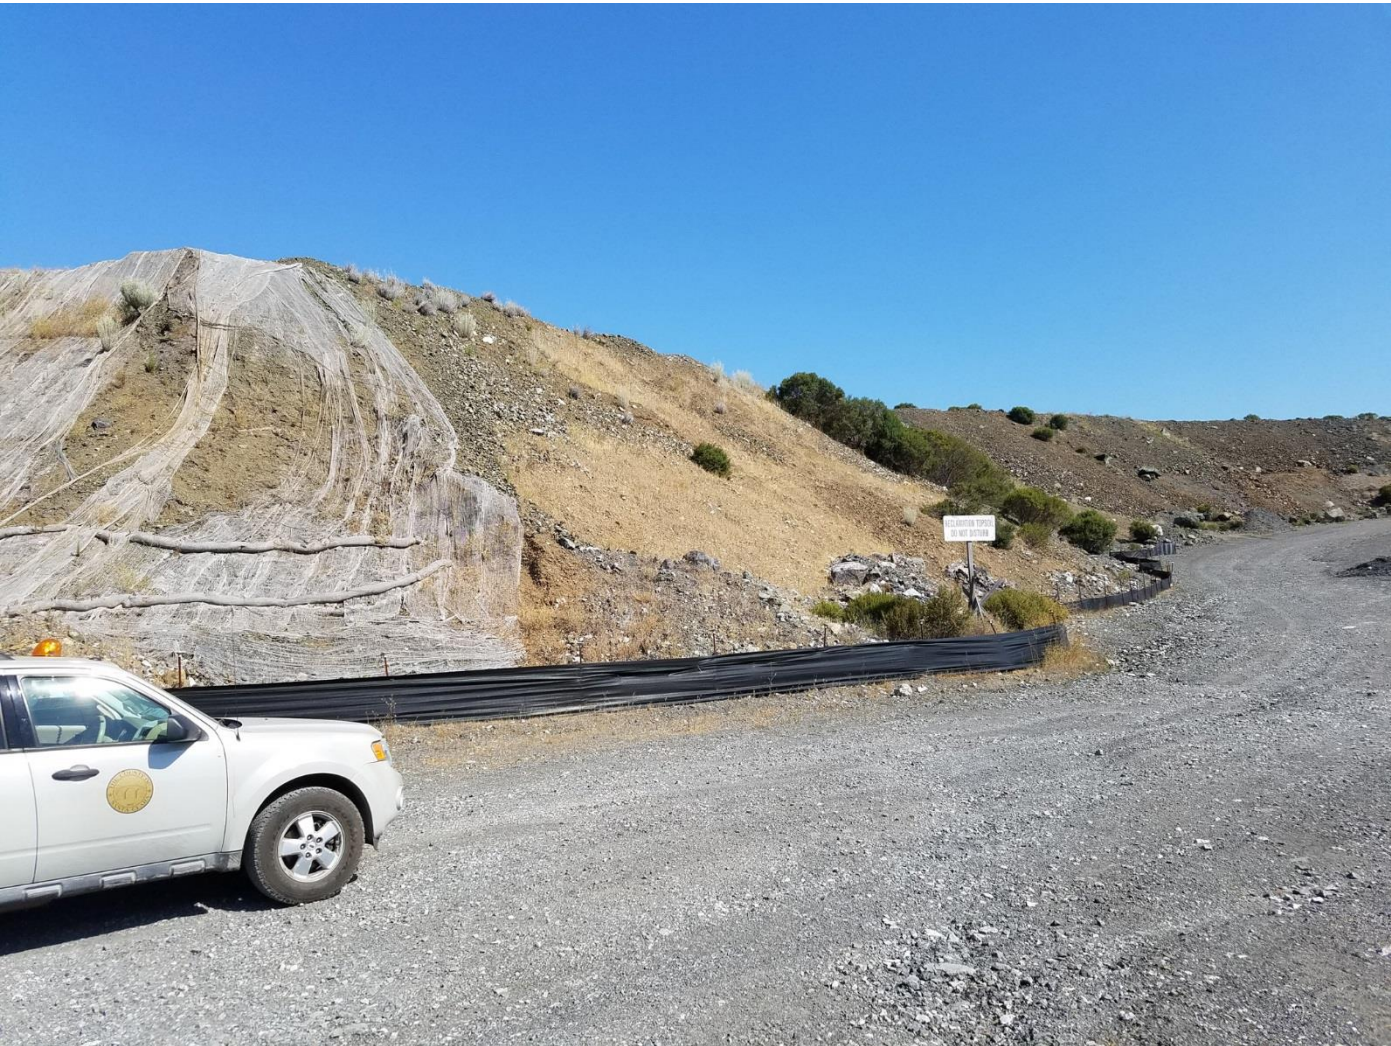
PHOTO #5 taken at Map Location 1 – Topsoil stockpile

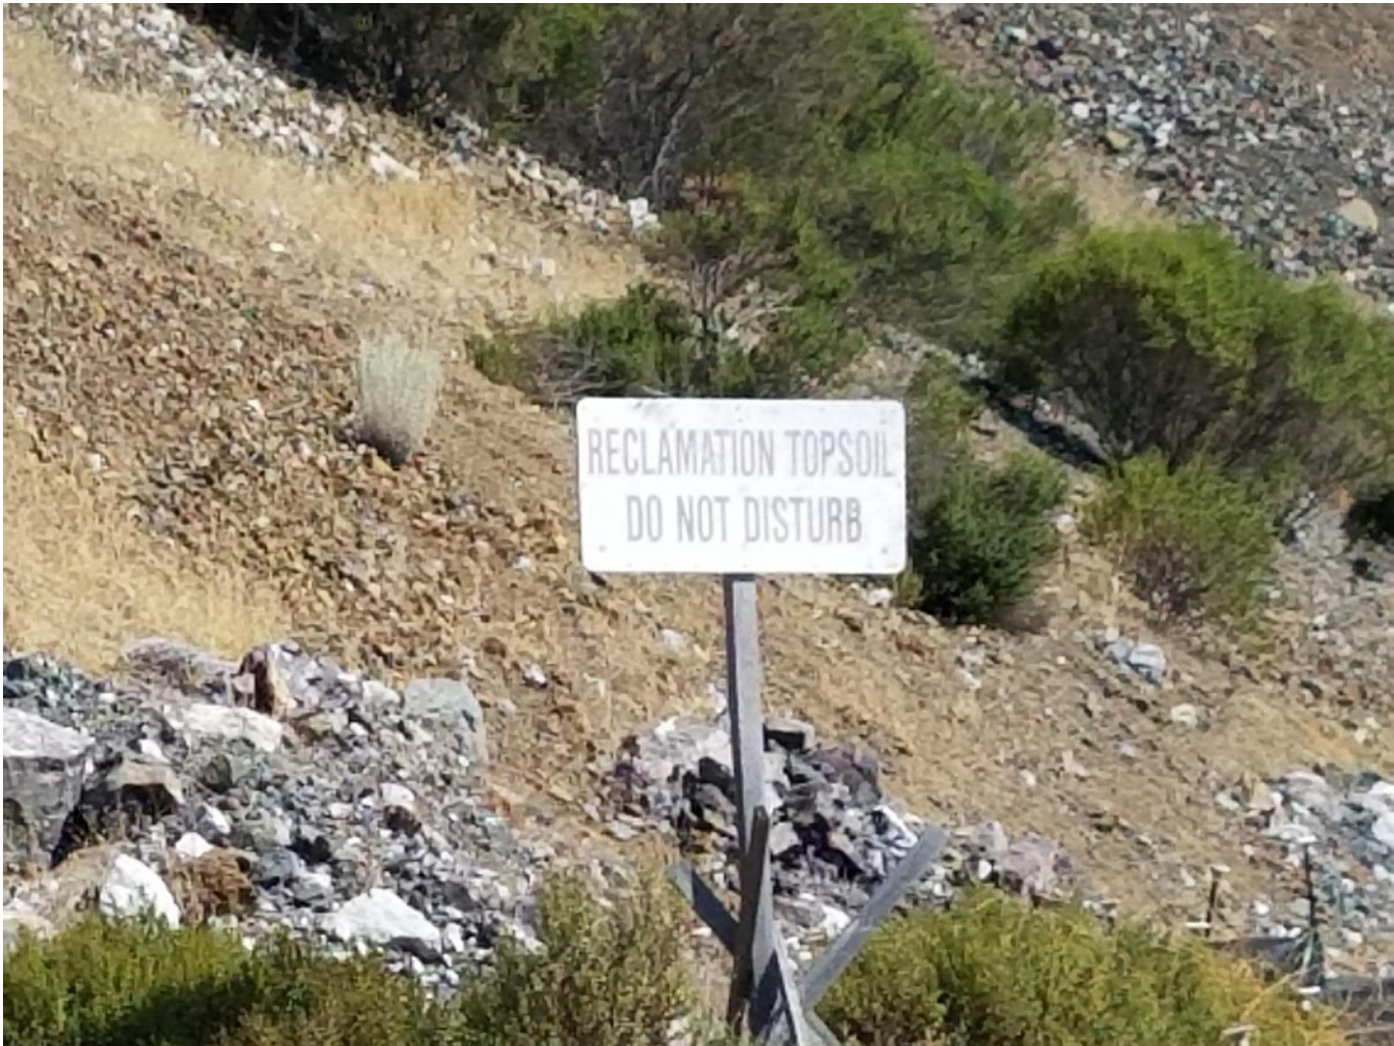
PHOTO #6 taken at Map Location 1 – Sign for topsoil stockpile

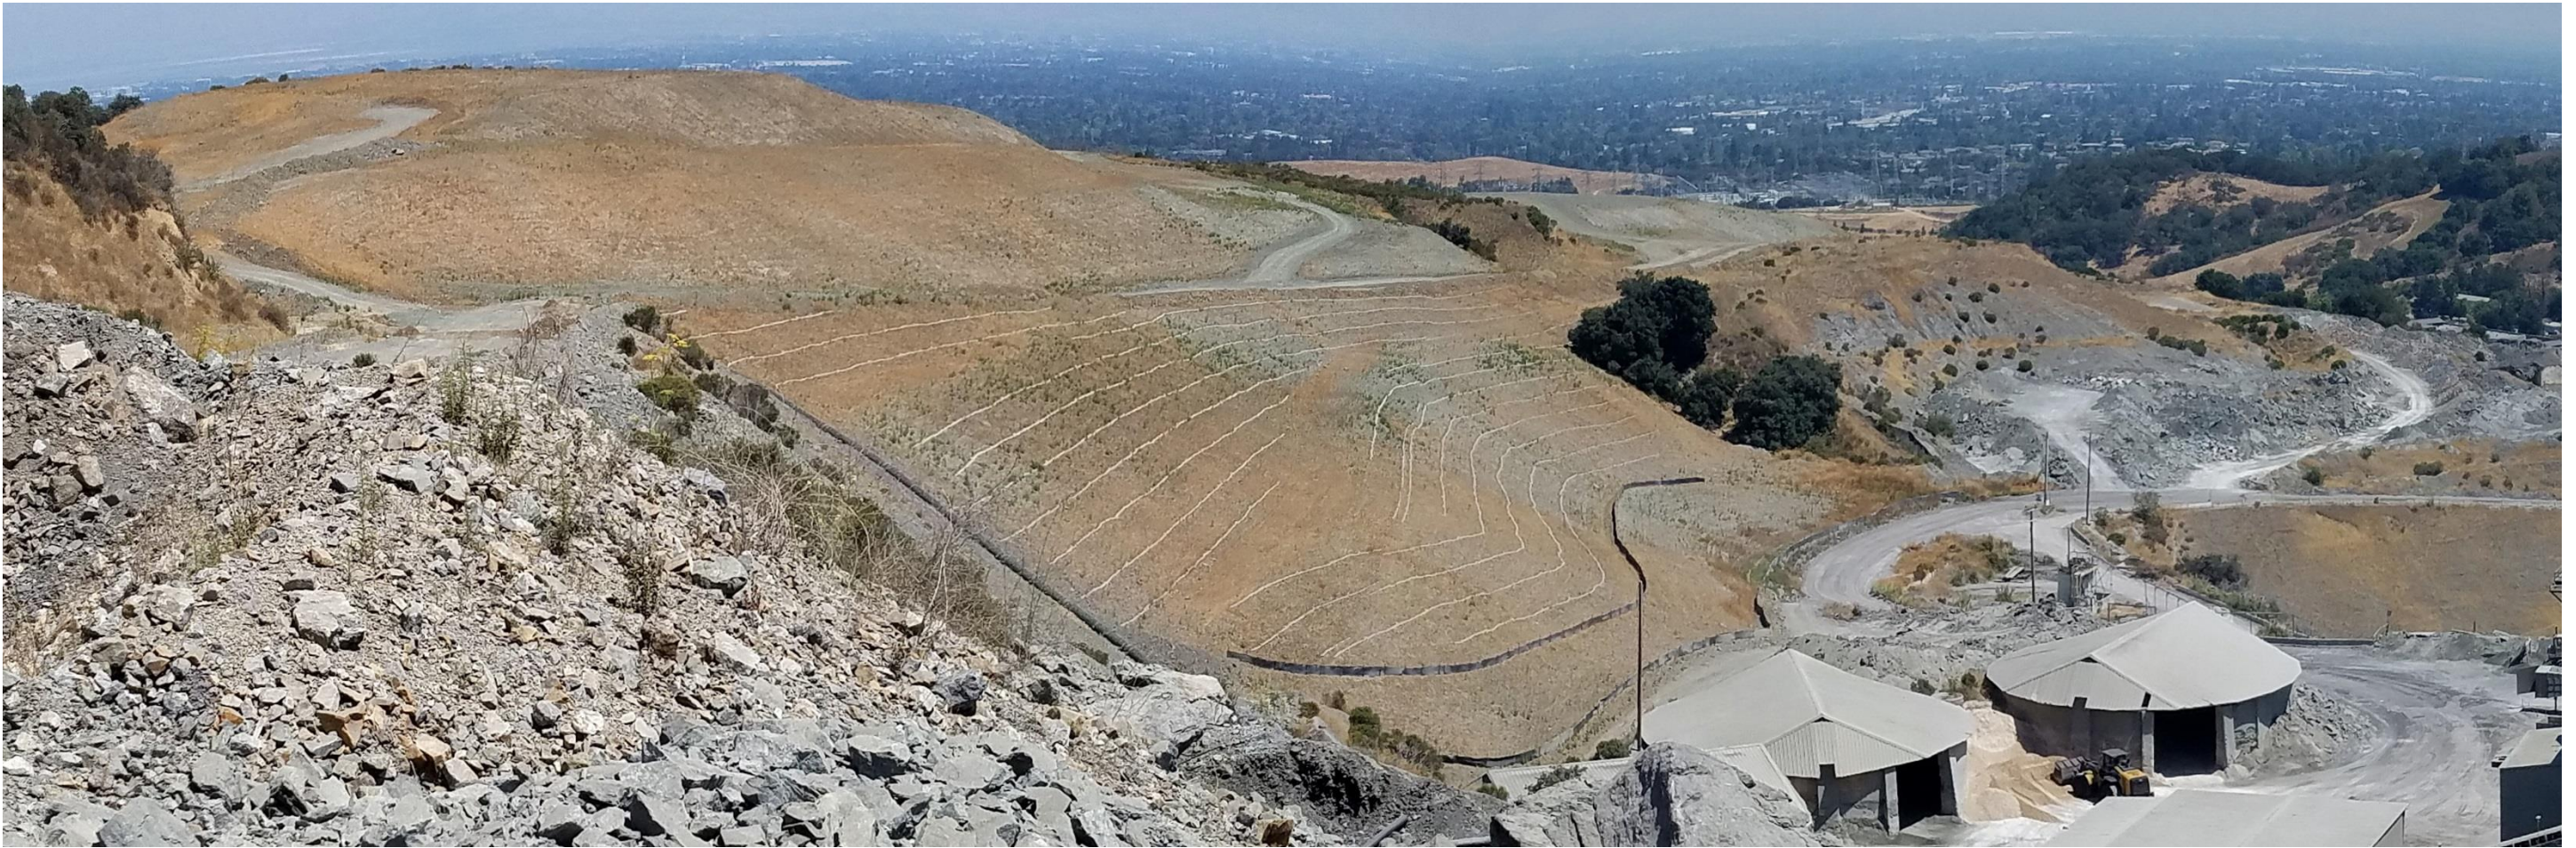
PHOTO #7 taken from Map Location 97 – Southern slopes of EMSA (looking east)

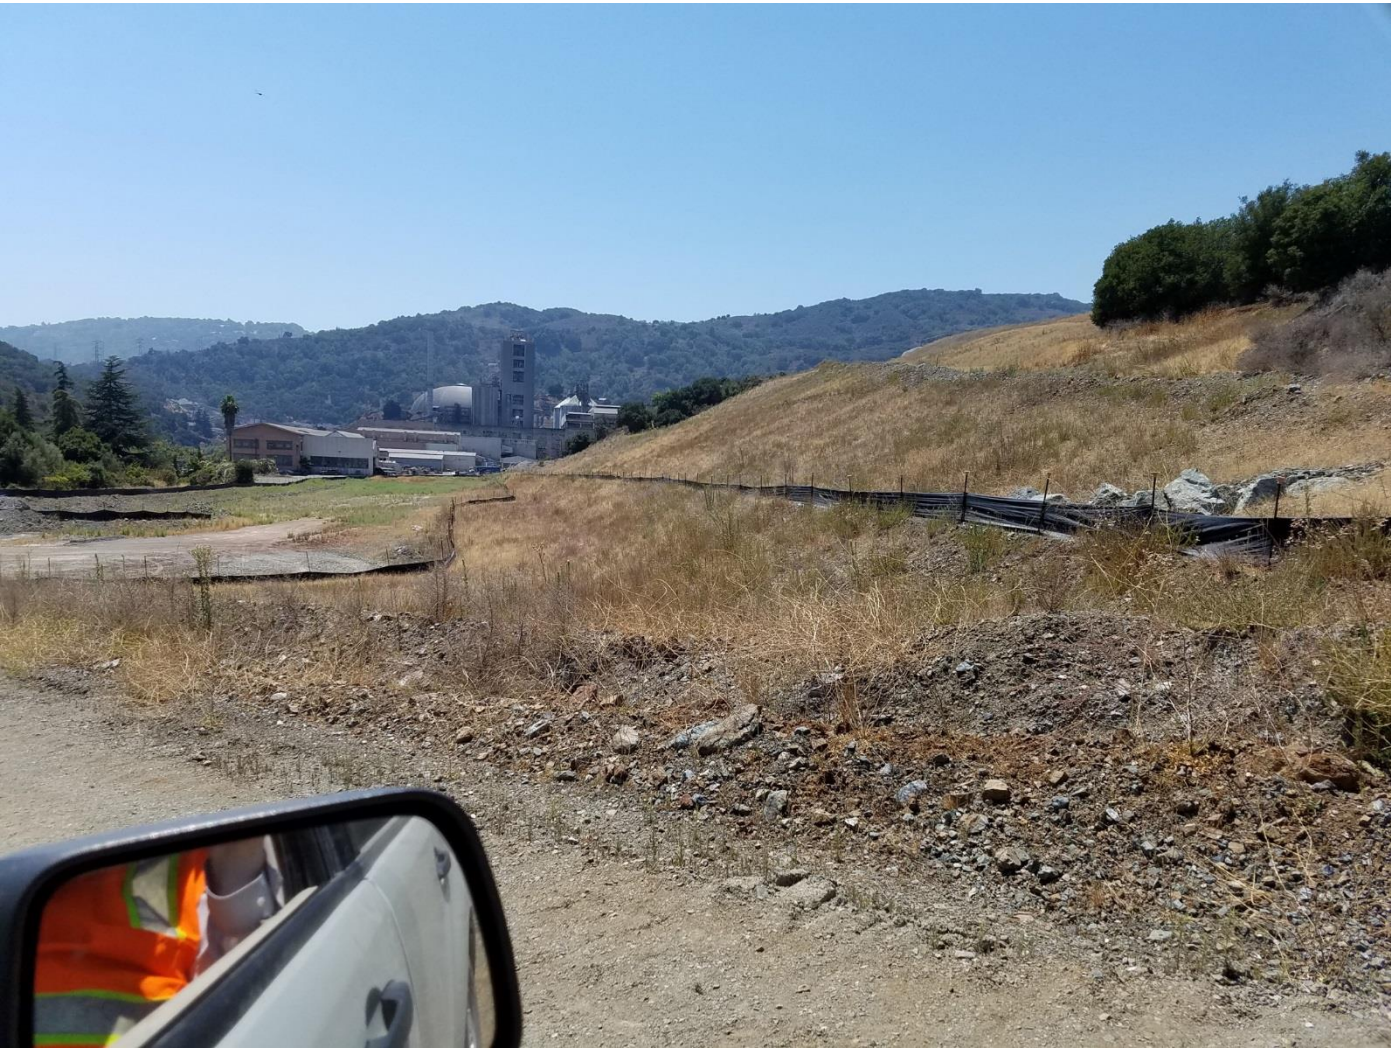
PHOTO #8 taken from Map Location 110 – EMSA bench with silt fence (looking west)

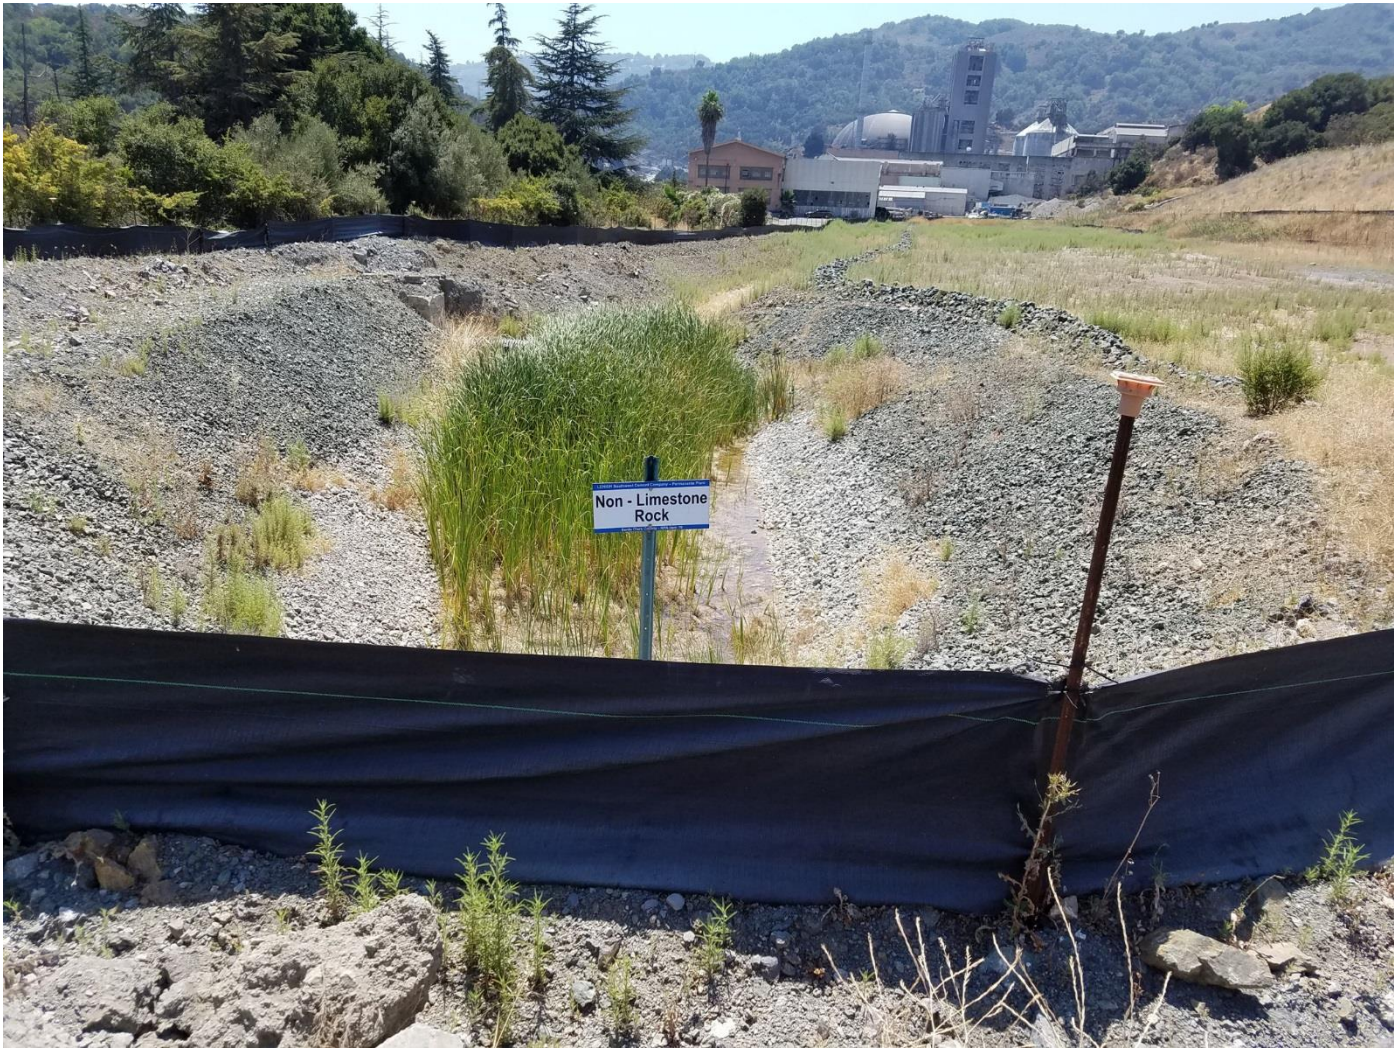
PHOTO #9 taken at Map Location 111 – Pond 30

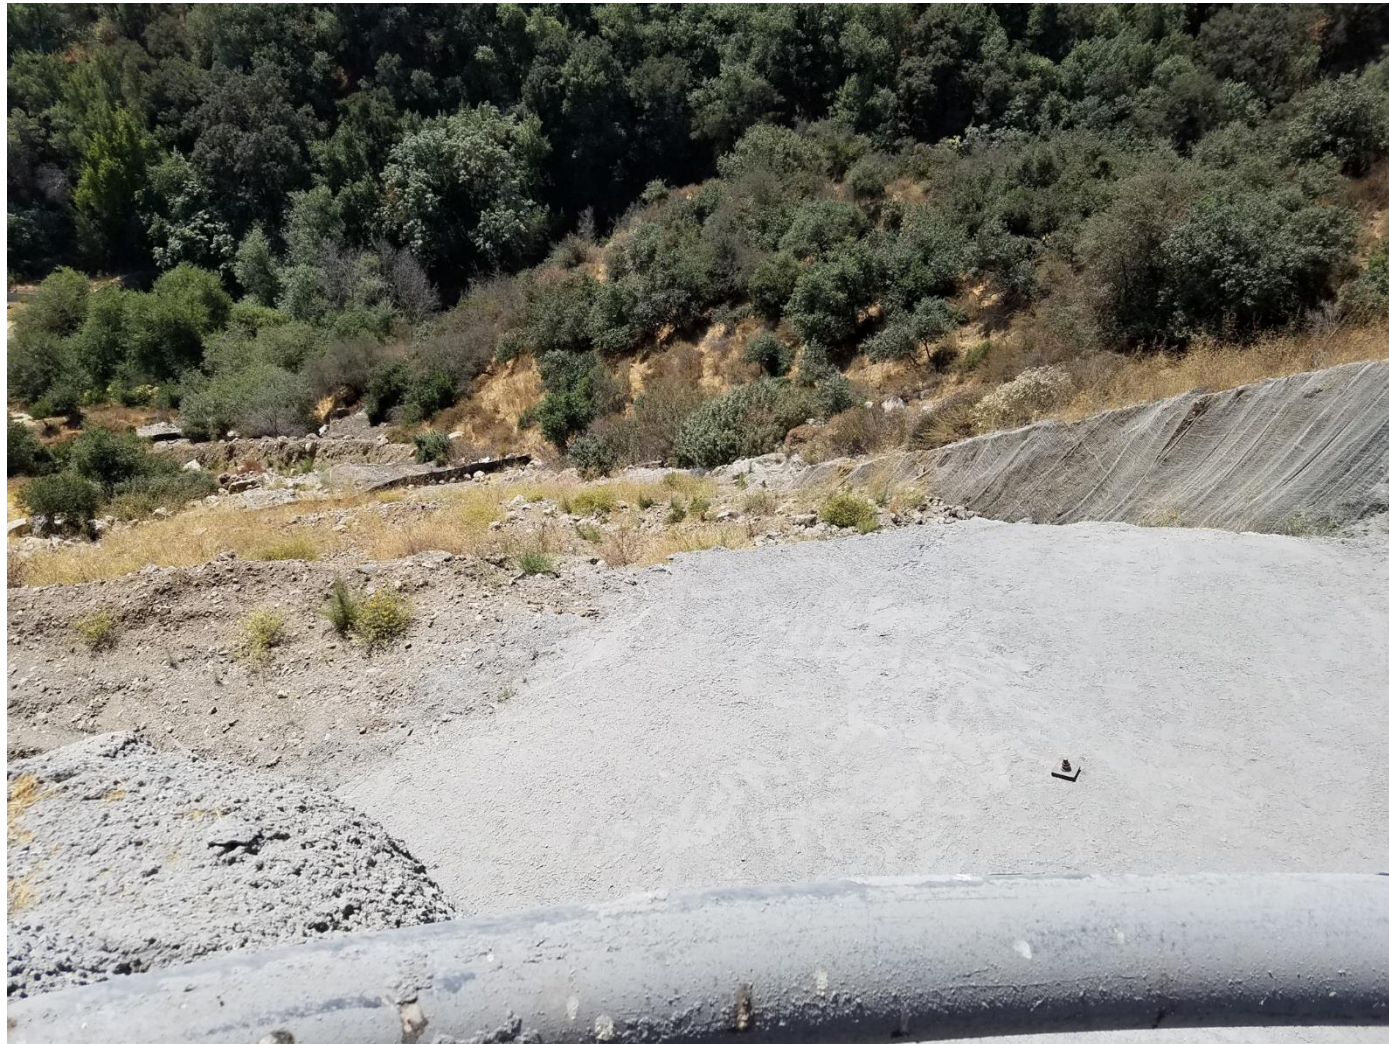
The crusher was constructed in 2013 against a 70-foot high retaining wall. Drainage from around the crusher is directed into a sump which overflowed due to a power failure in 2014. As a result, an erosion gully formed on the steep slope west of the crusher. The operator has had the gully lined with jute netting and several silt fences. [See **PHOTO #10** taken from Map Location 81.] Eroded material accumulated at the toe of the slope and extended into the eastern side of pond in PCRA. [See **PHOTO #11** taken at Map Location 118.] The operator had a soil-nail wall installed in the head of the erosion gully located downhill of the sump. [See **PHOTO #12** taken at Map Location 77.] The crusher and conveyor will be removed prior to final reclamation. The tunnel through which the conveyor travels will need to be filled and sealed. Wildlife protection procedures (outlined in the RPA and COAs) must be followed when the tunnel is backfilled.

PHOTO #10 taken from Map Location 81 – Jute netting lined erosion gully below crusher sump

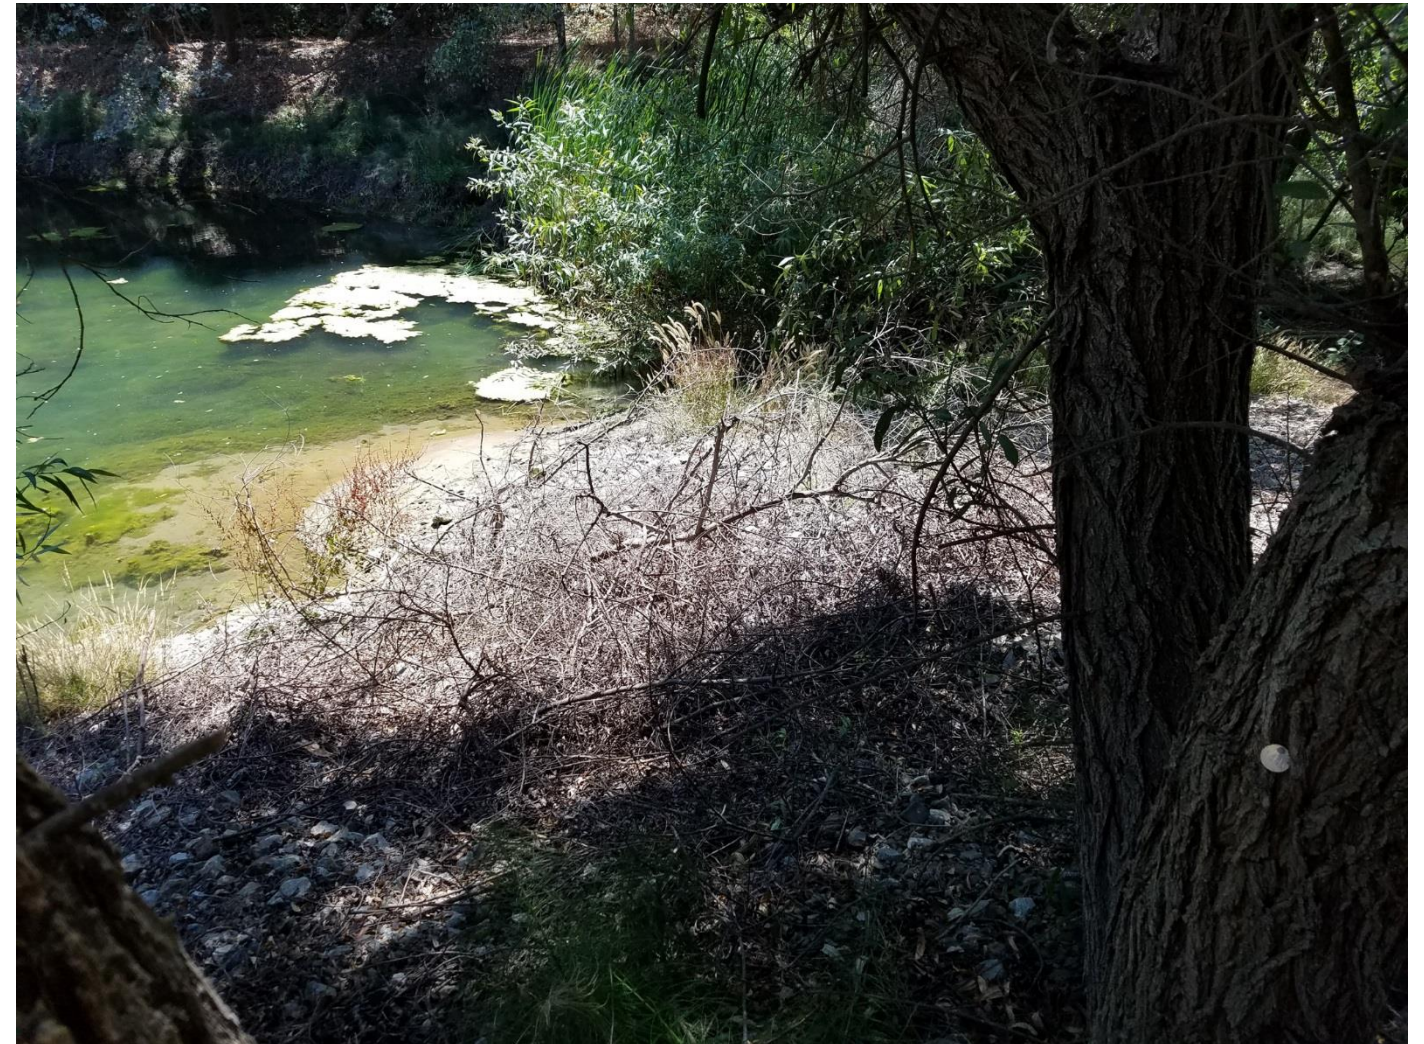
PHOTO #11 taken at Map Location 118 – Sediment in side of pond in PCRA

When the PCRA plan is approved by the SFBRWQCB and other permitting agencies, the plan must be incorporated into the RPA. Until then, the erosion control measures installed along Permanente Creek must be monitored and repaired as needed.

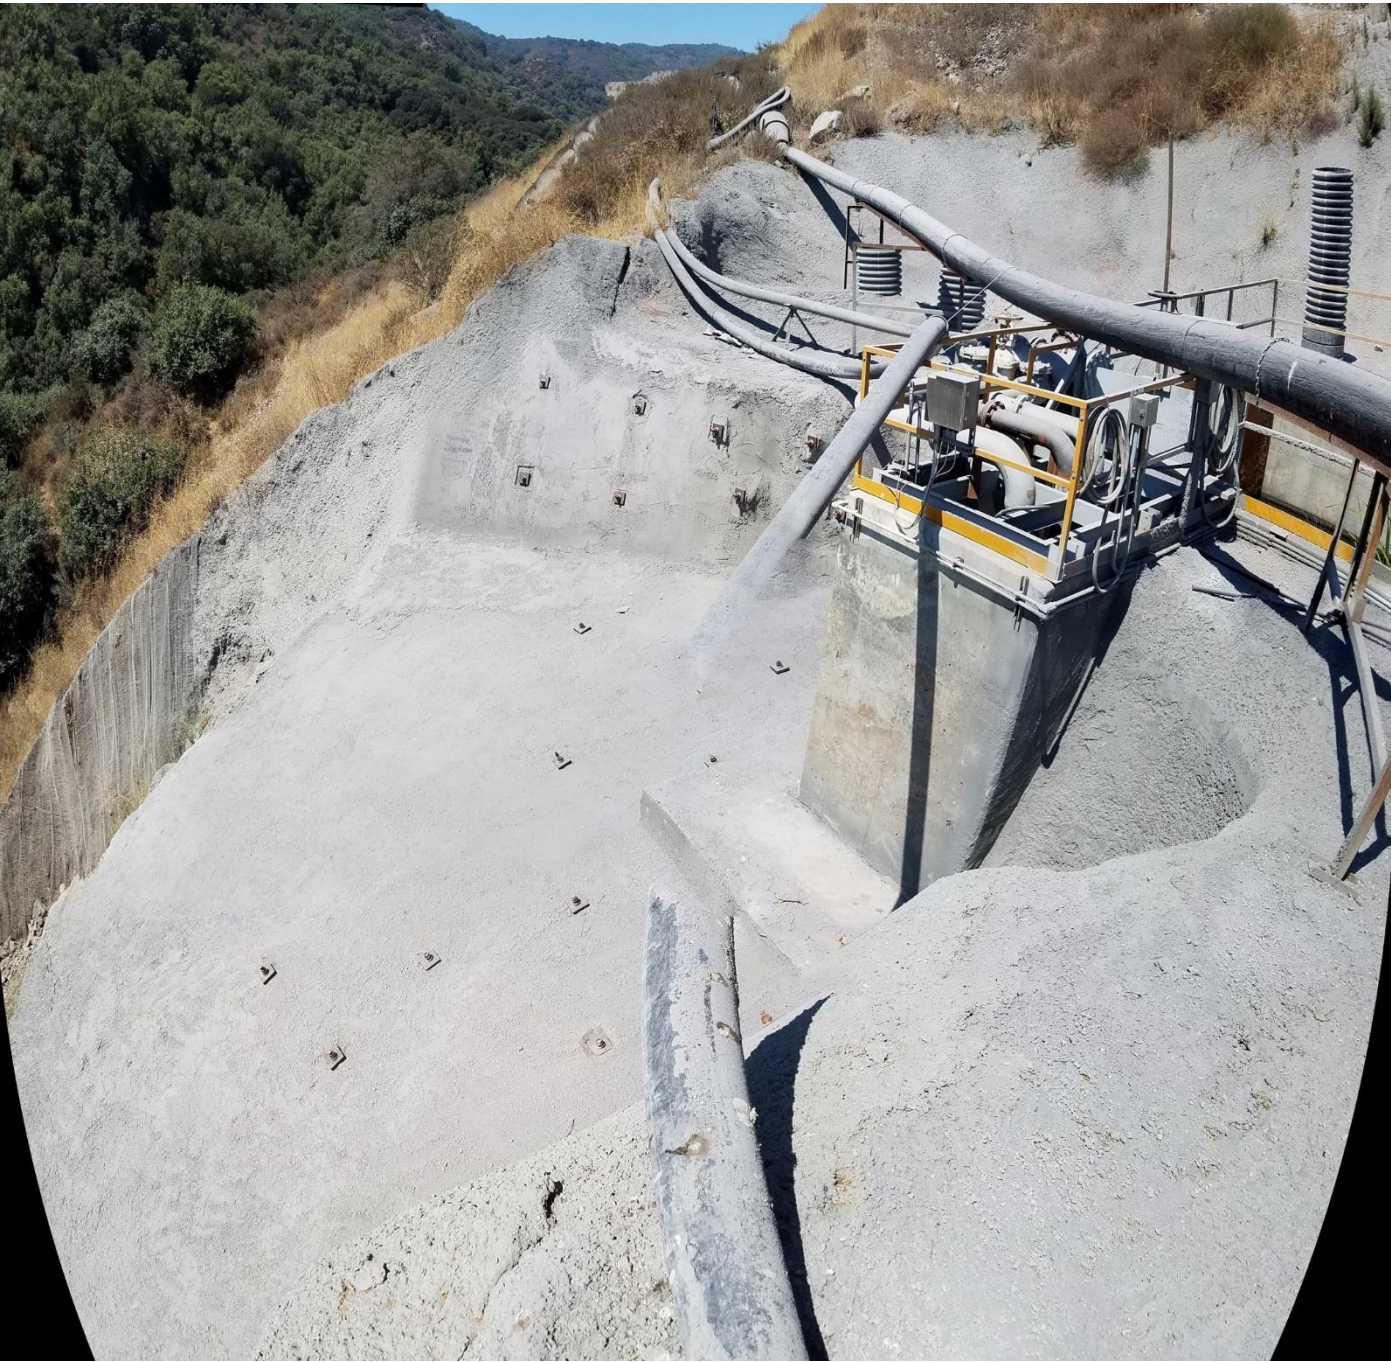
10) Structures	RPA 3.20; COA 31	New crusher is operational. Overflow erosion repaired with soil-nail wall. Old crusher removed. New mine office structure completed.

PHOTO #12 taken at Map Location 77 – Soil-nail wall in erosion scar below crusher sump

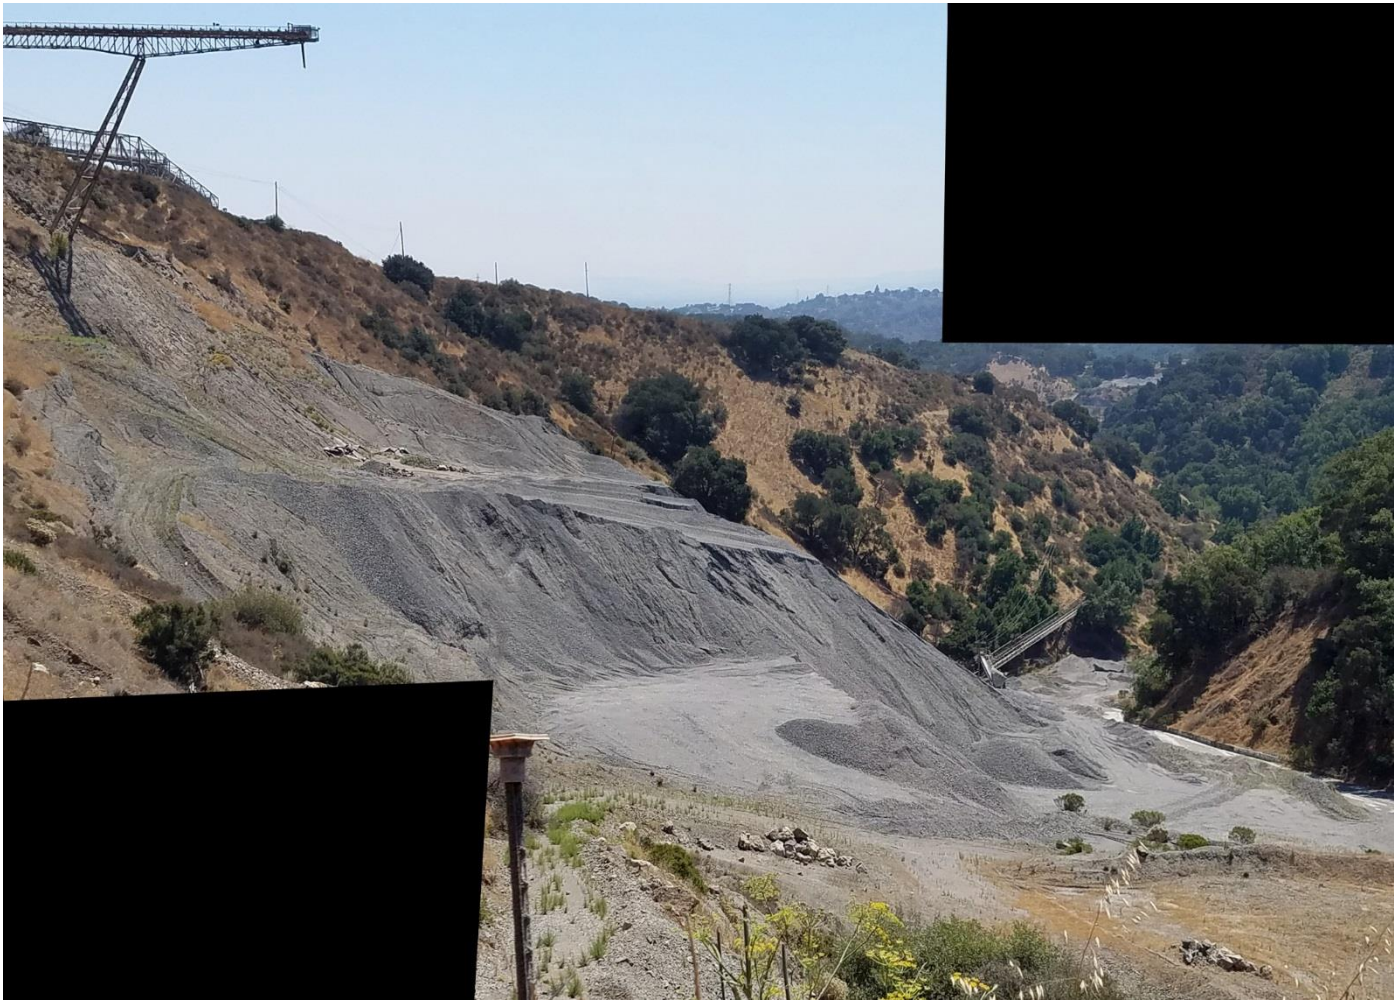
PHOTO #13 taken from Map Location 83 – Surge Pile
