Subject: 2016 SMARA Annual Inspection Report (MRRC-1) for Lehigh Quarry
County Planning Office File 2250-16PAM
State Mine ID #91-43-0004

Enclosed for your records is a copy of our 2016 SMARA Inspection Report for the Lehigh (formerly Permanente) Quarry. Santa Clara County is the lead agency for administration of SMARA. The County Planning Office is responsible for conducting an annual SMARA inspection and preparing an annual report. The attached report includes the following documents:

The mine was active during the 2016 inspection. The following paragraphs describe our observations in each of the areas [with **PHOTOS** and captions that illustrate what we observed at or from the Map Locations indicated on the attached **AIR-PHOTO**].

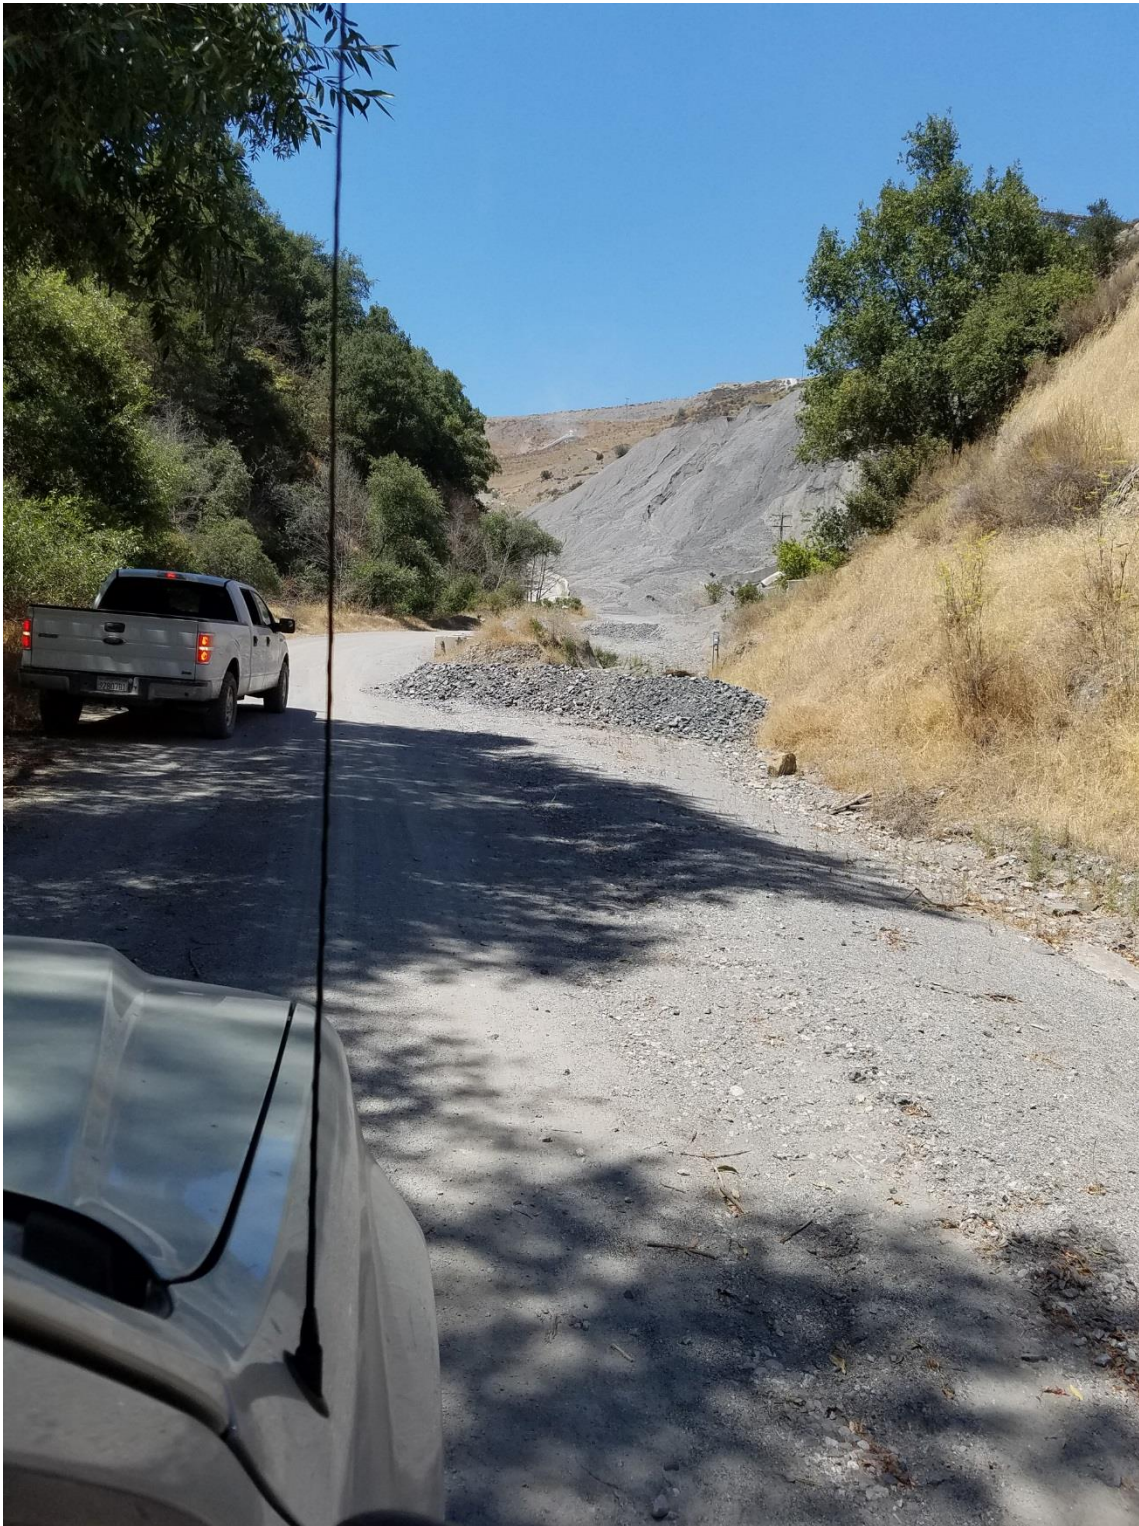
PHOTO #14 taken at Map Location 113 – Rock check dam on road below Surge Pile

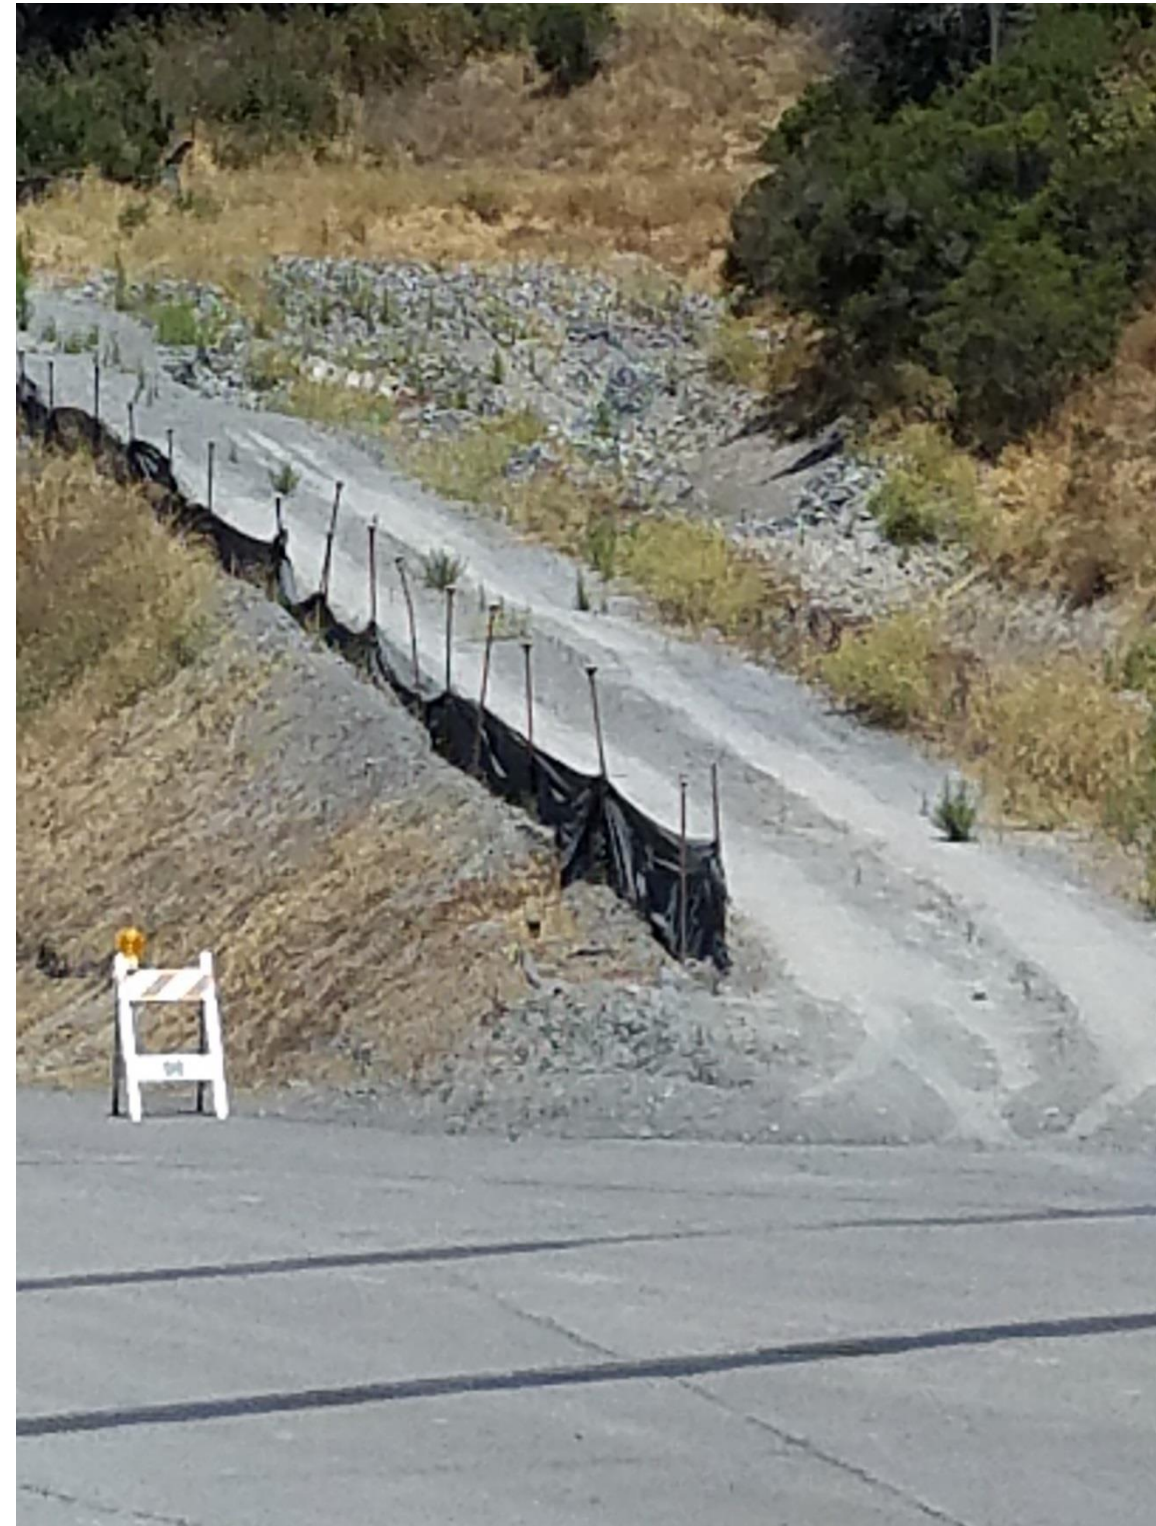
PHOTO #15 taken from Map Location 124 – Pond 17 for runoff from the Rock Plant
