SURFACE MINING INSPECTION REPORT

County File 2250-17PAM - Lehigh Quarry (formerly Permanente Quarry)

Notes and photographs from 2017 Annual SMARA mine inspection conducted on 8-10-2017 by James Baker, CEG#1021, County Geologist, and Steve Beams, Senior Construction Inspector.

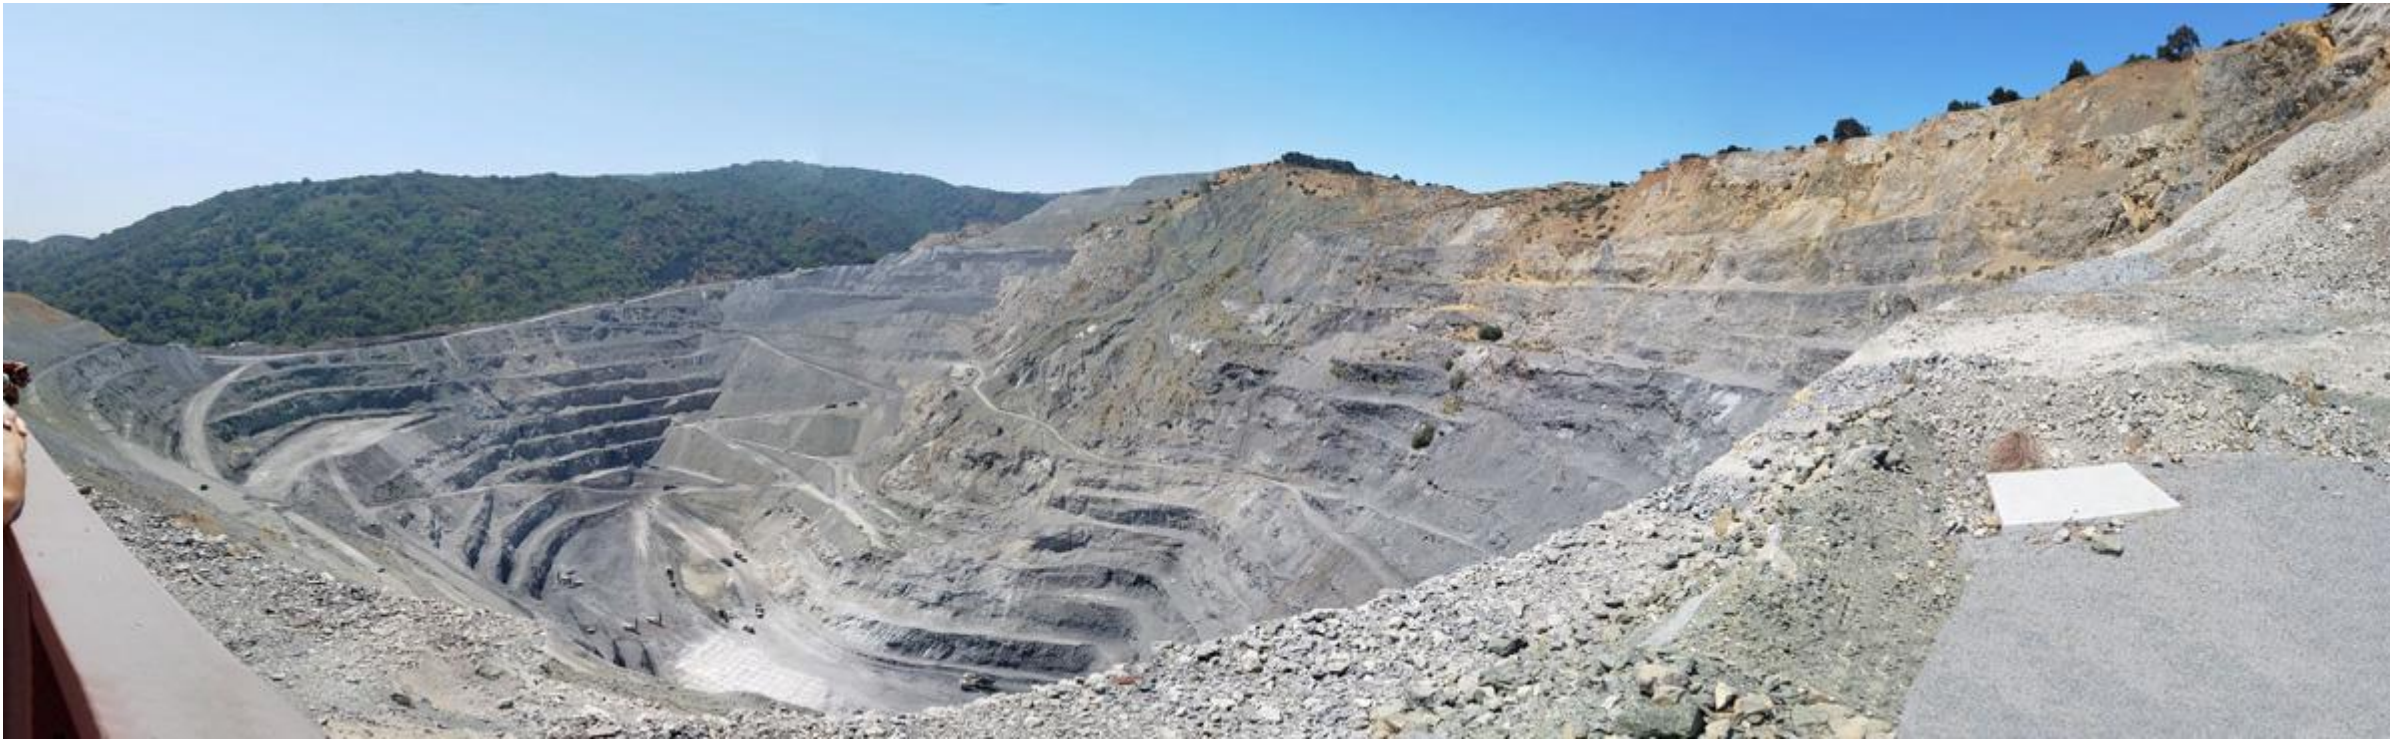
The highwalls on the north, east, and south are essentially complete (excavated benches); while the western side of the pit is still being actively mined (blasting and loading). Extraction of limestone was on-going in the main pit. Overburden materials were being placed and compacted against the northwestern highwall. [See **PHOTO #1** and **PHOTO #2**.]

PHOTO #1 – North Quarry Main Pit (looking southwest)

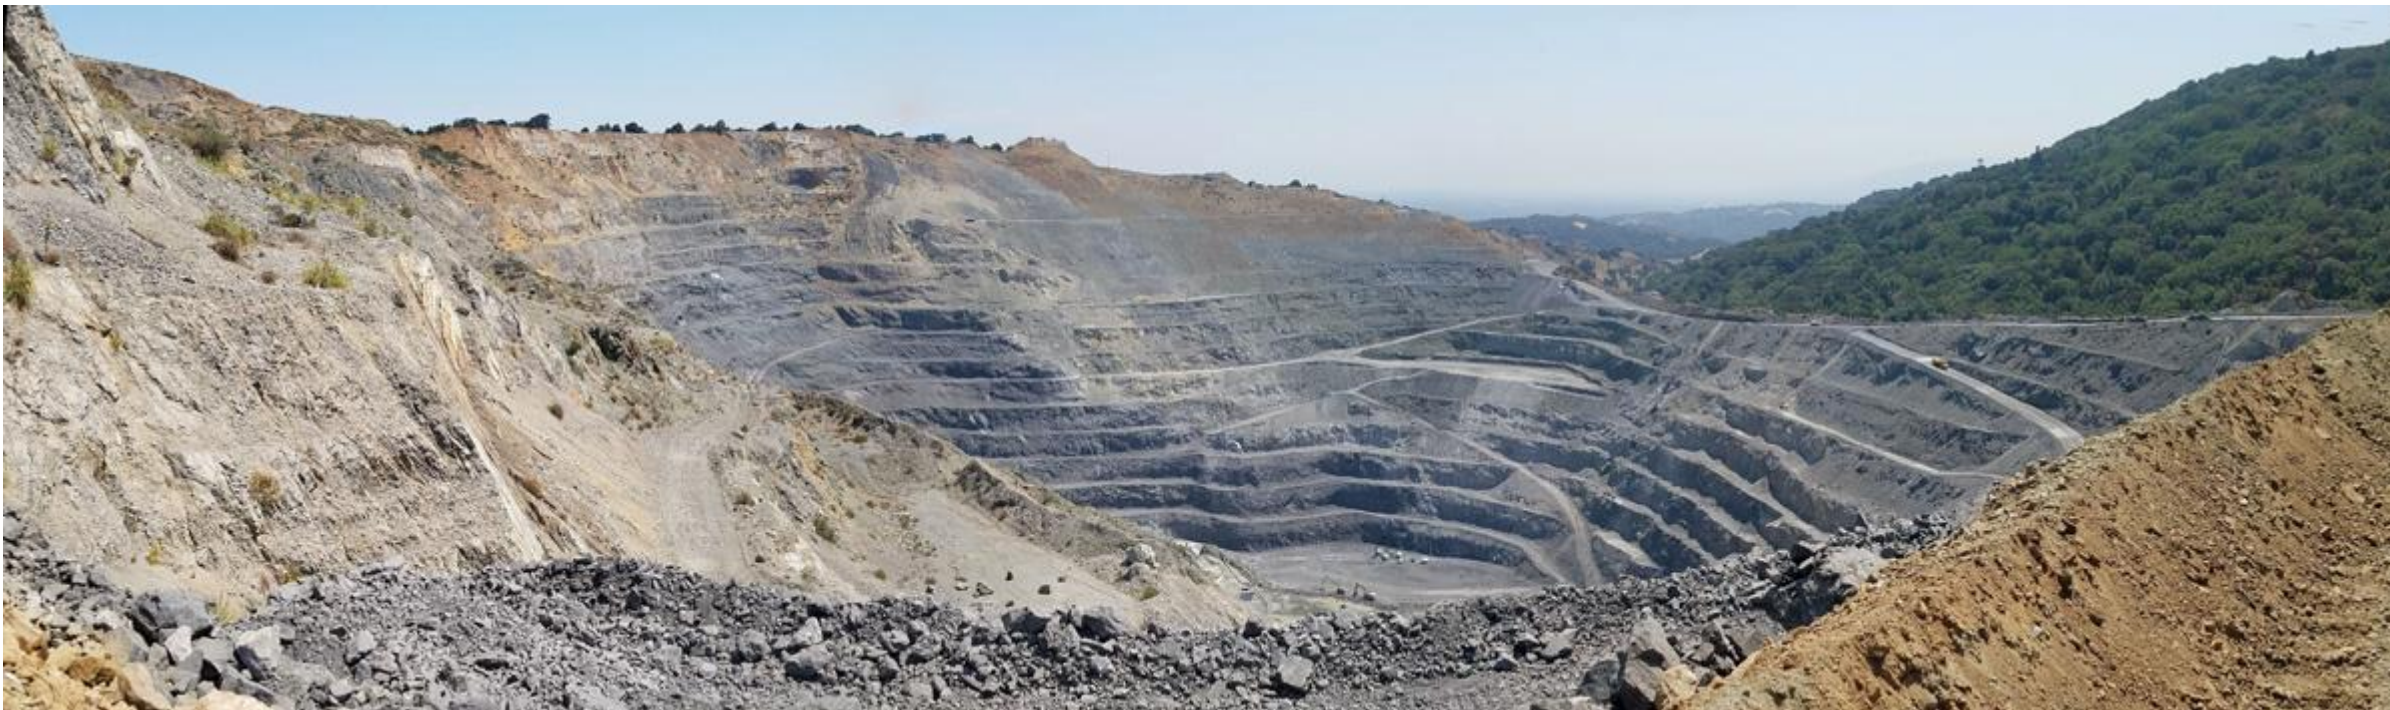
PHOTO #2 – North Quarry Main Pit (looking southeast)

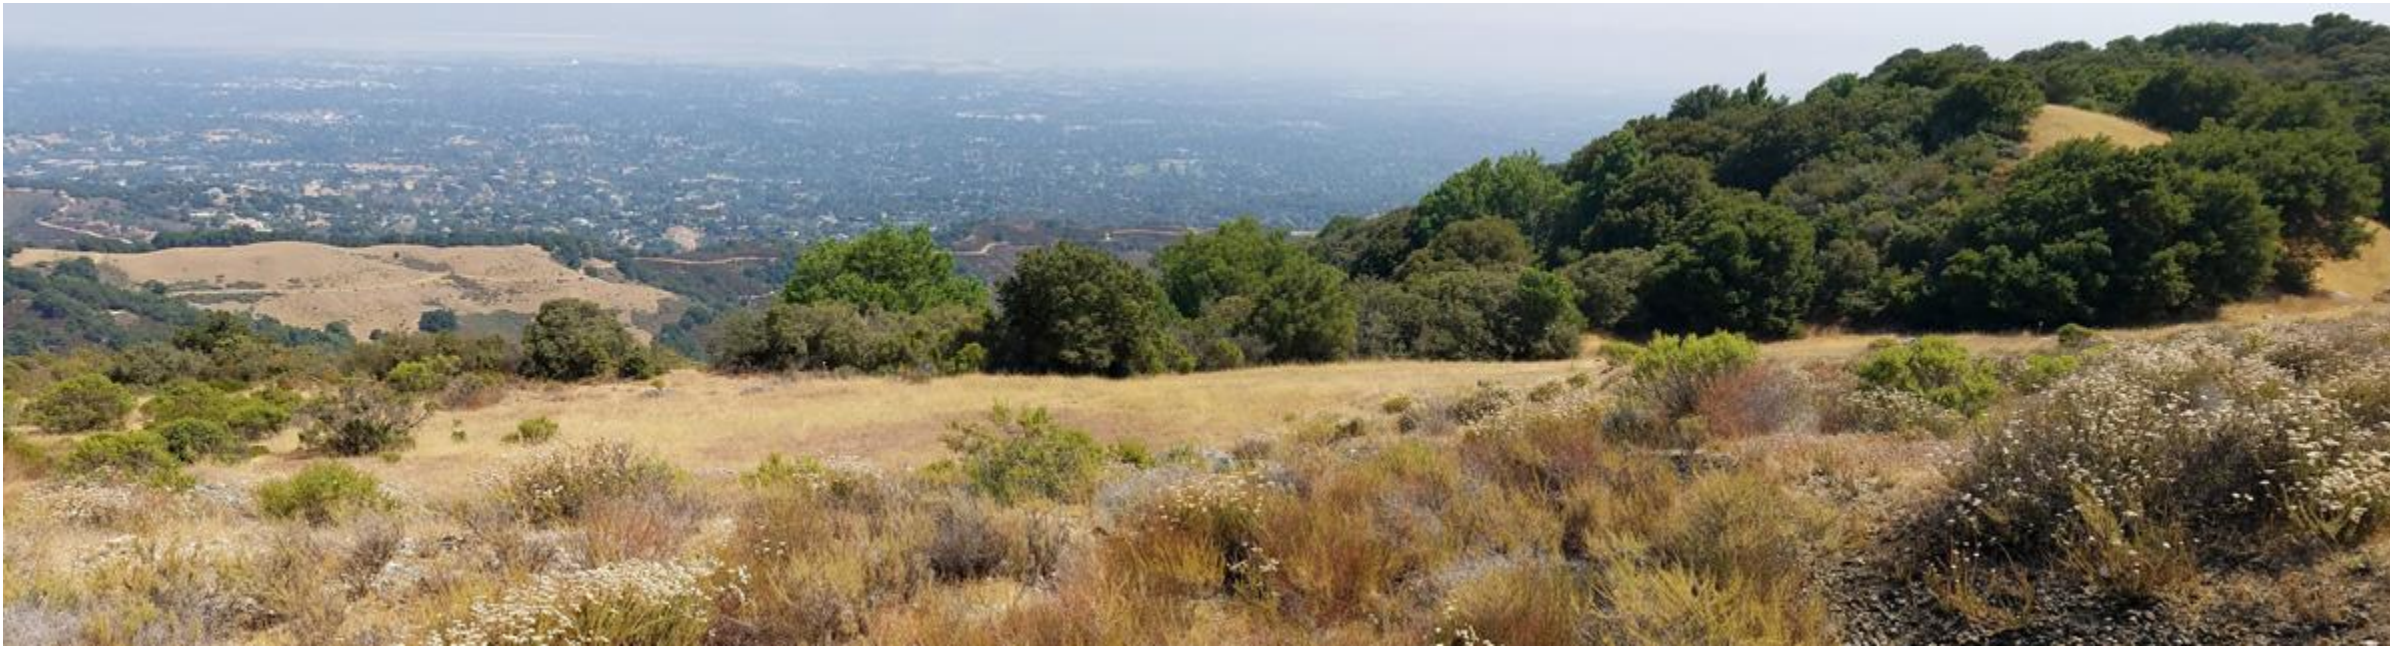
No new material was being placed in the West Materials Storage Area (WMSA). The northeast-facing slopes of the WMSA have well-established vegetation (grasses and some shrubs). [See **PHOTO #3** and **PHOTO #4**.] Topsoil and organics are stored and covered in the central portion of the WMSA. [See **PHOTO #5**.] There is a seep at the top of the haul road buttress. [See **PHOTO #6**.] (Most of the material stored in the WMSA will be moved and placed as backfill into the main quarry pit. Topsoil will be used to cover benches for plantings.)

PHOTO #3 – WMSA (looking northeast)

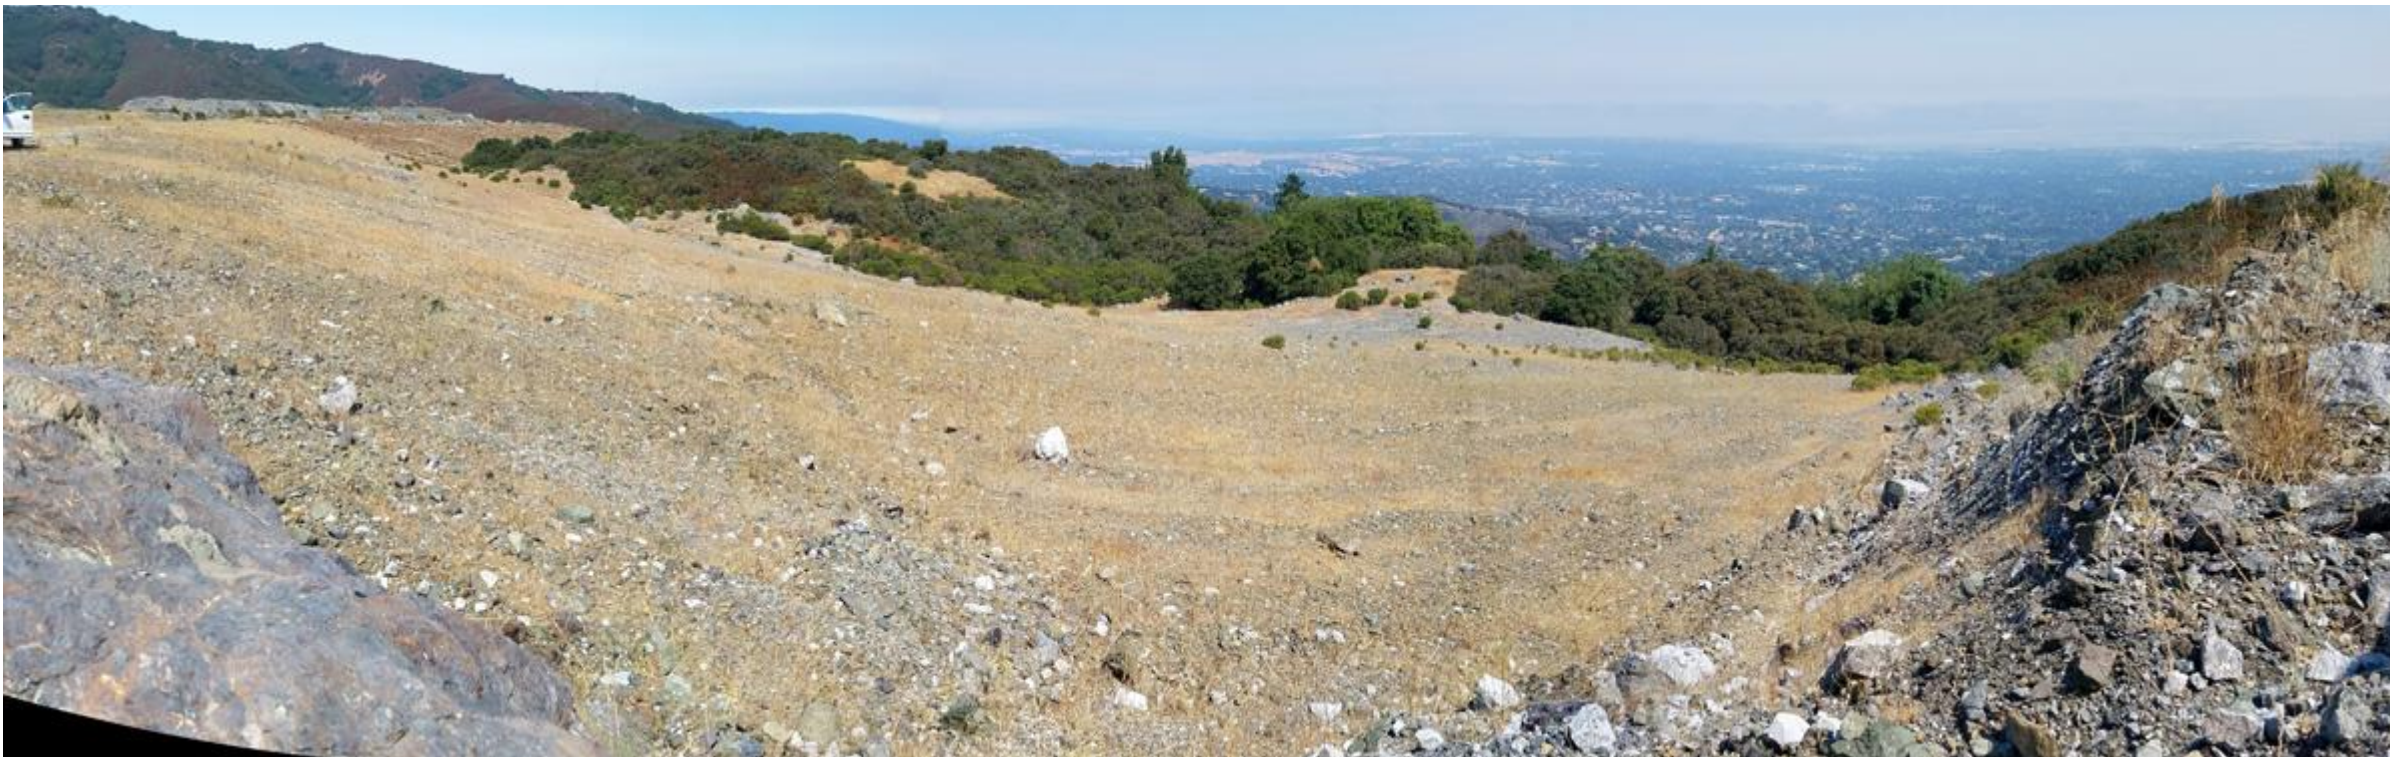
PHOTO #4 – WMSA (looking northwest)

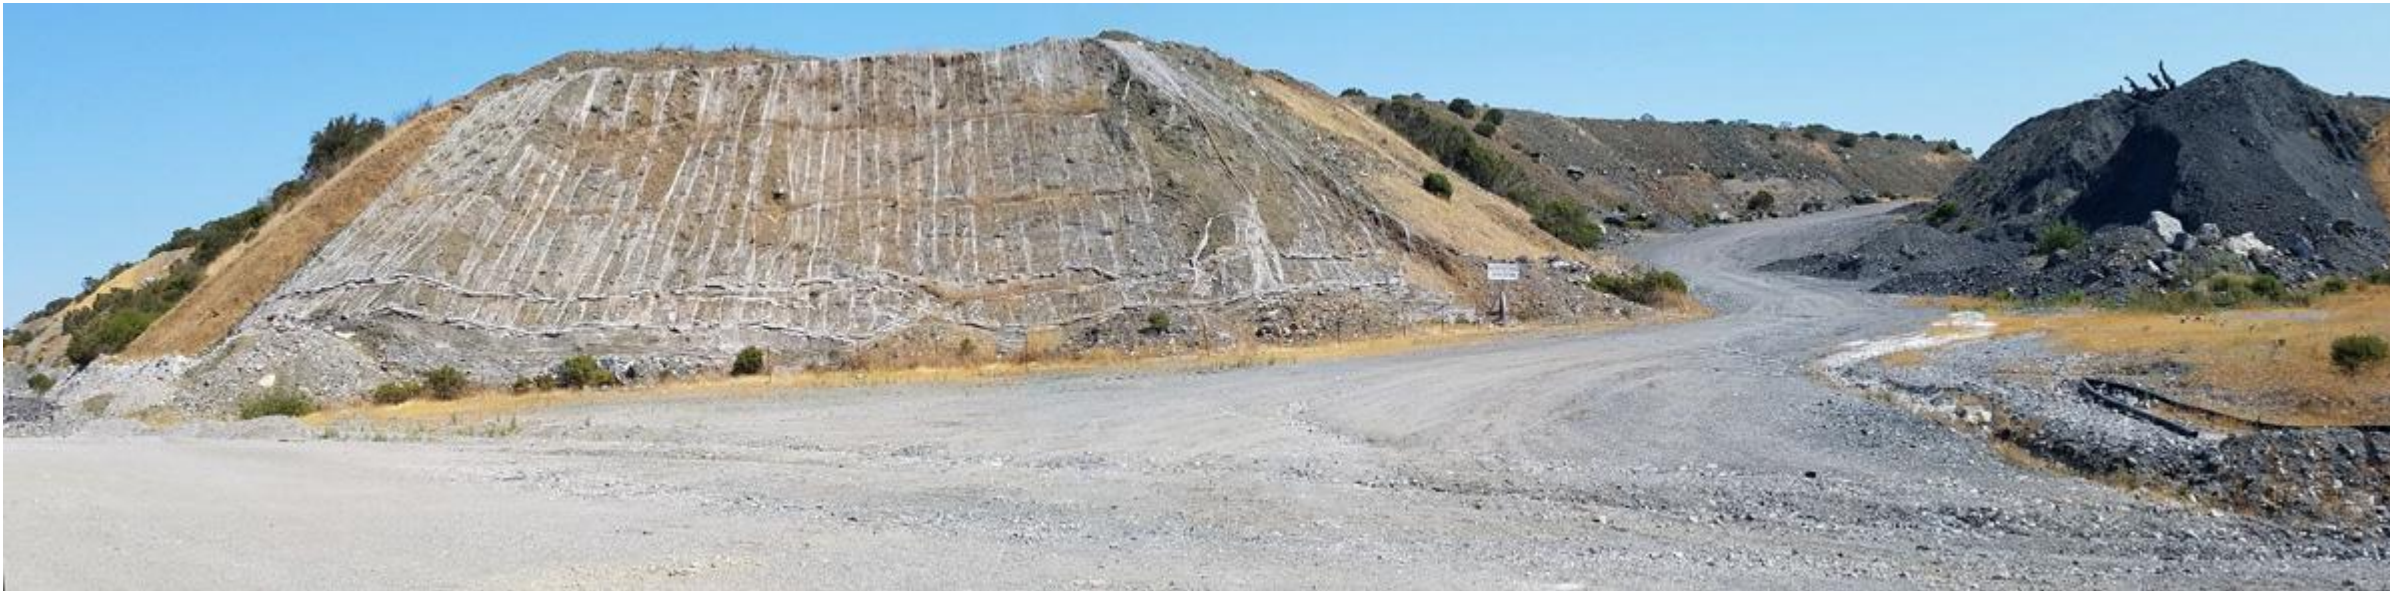
PHOTO #5 – Topsoil Stockpile

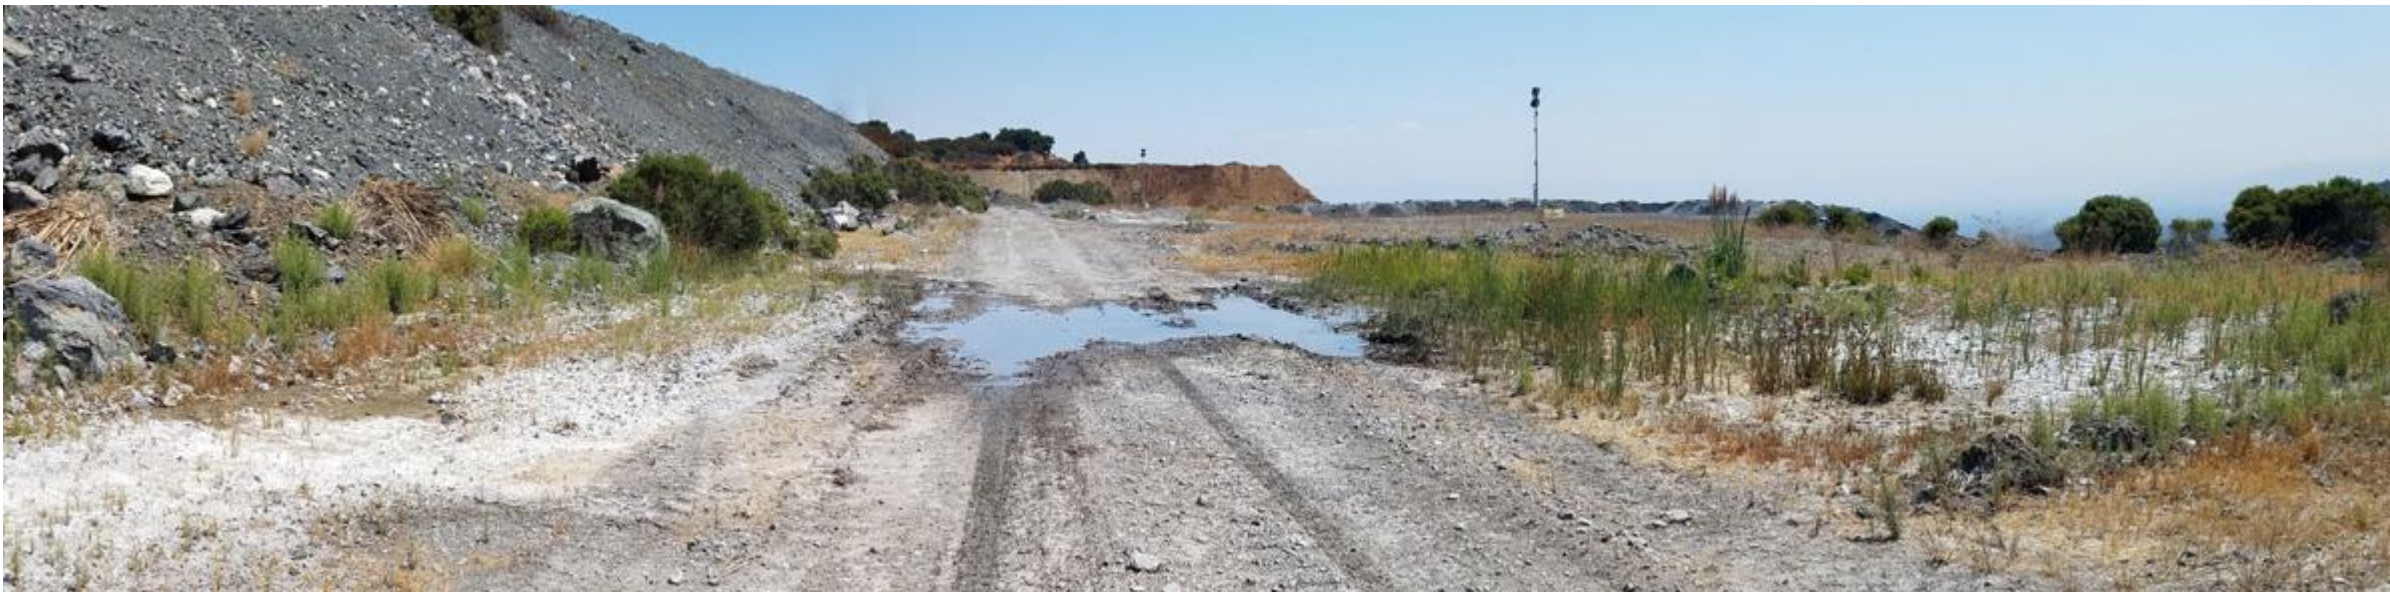
PHOTO #6 – Seep at top of haul road buttress

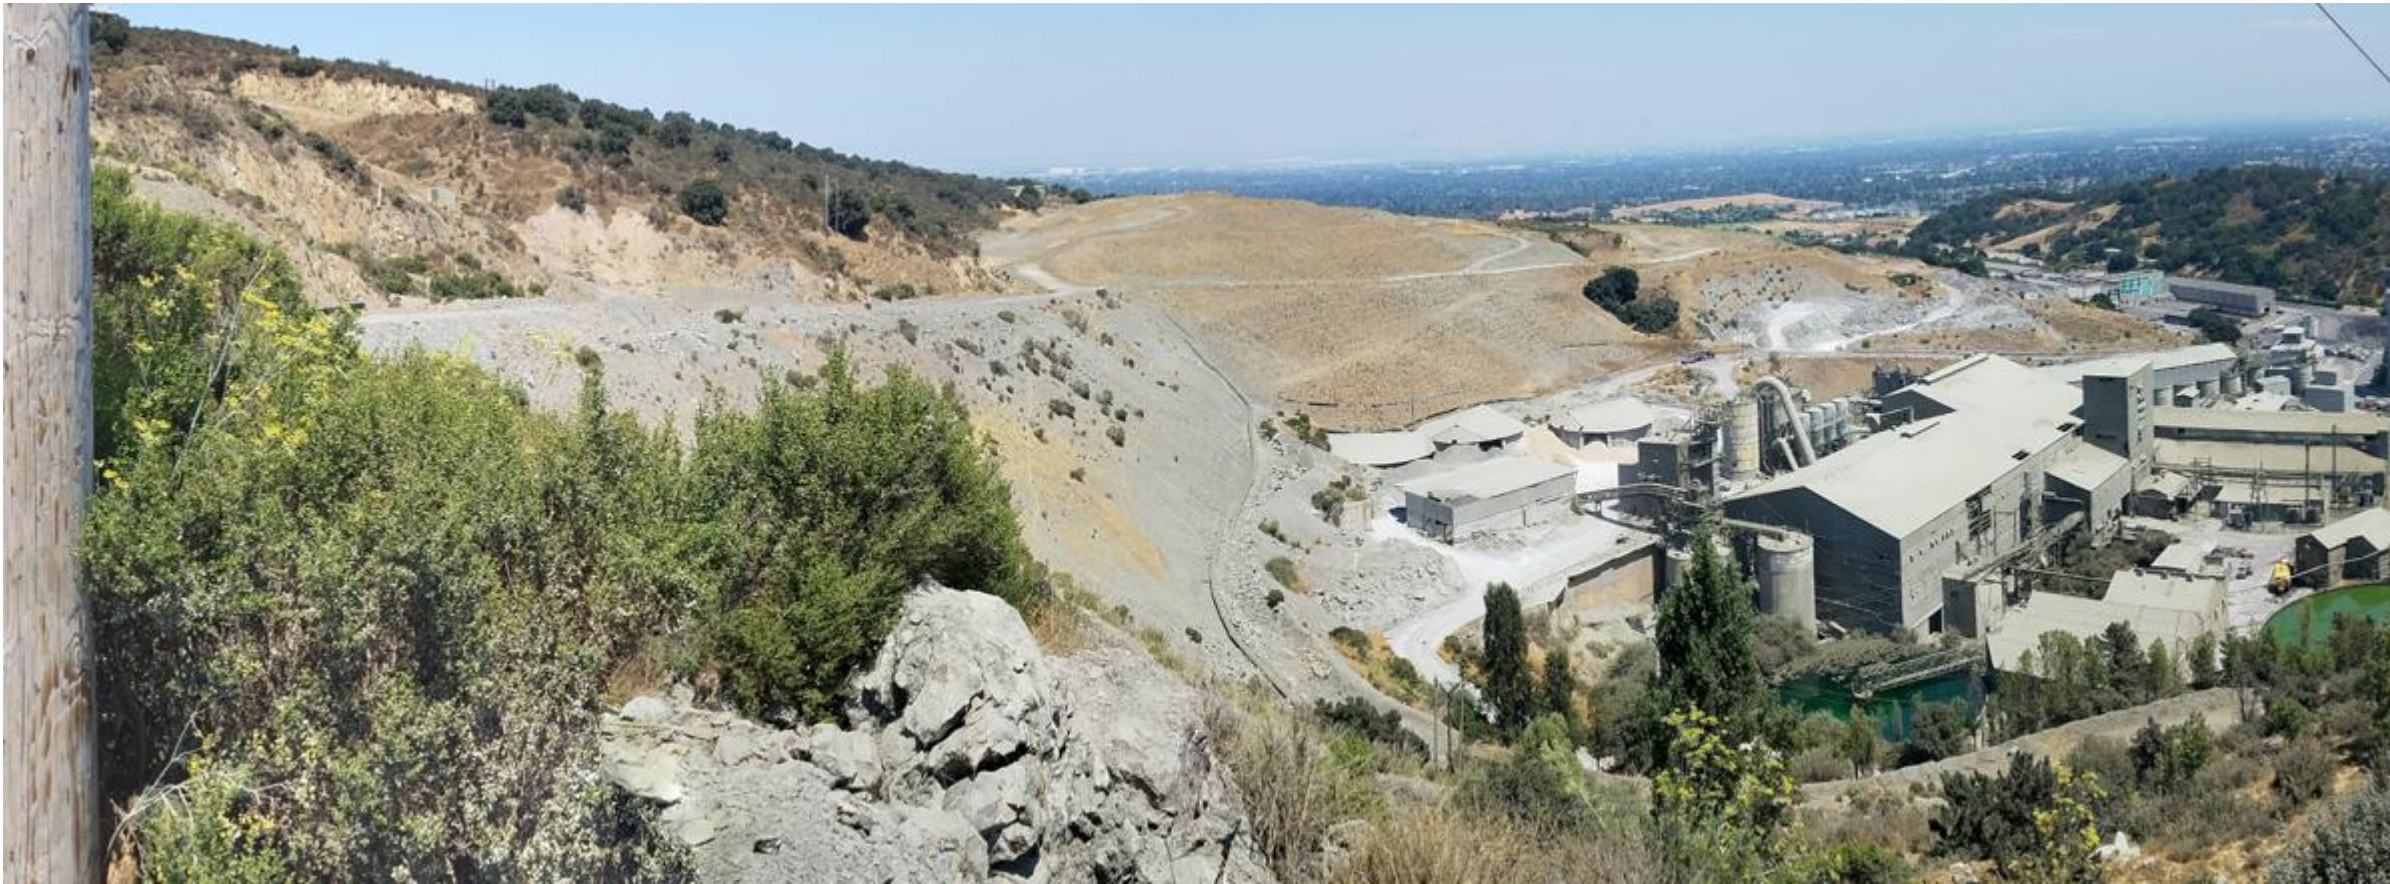
The EMSA slopes have been finish graded per the approved Reclamation Plan. The final elevations have been achieved with a non-limestone cover. BMPs have been placed on the slopes (wattles) and along the benches (rock check dams and silt fences). [See **PHOTO #7.**] Surface drainage is directed into Pond 30 which is rock-lined with non-limestone rock. [See **PHOTO #8** and **PHOTO #9.**] Water discharges through a pipe that outlets onto a rock apron adjacent to the creek.

PHOTO #7 – Southern slopes of EMSA (looking east)

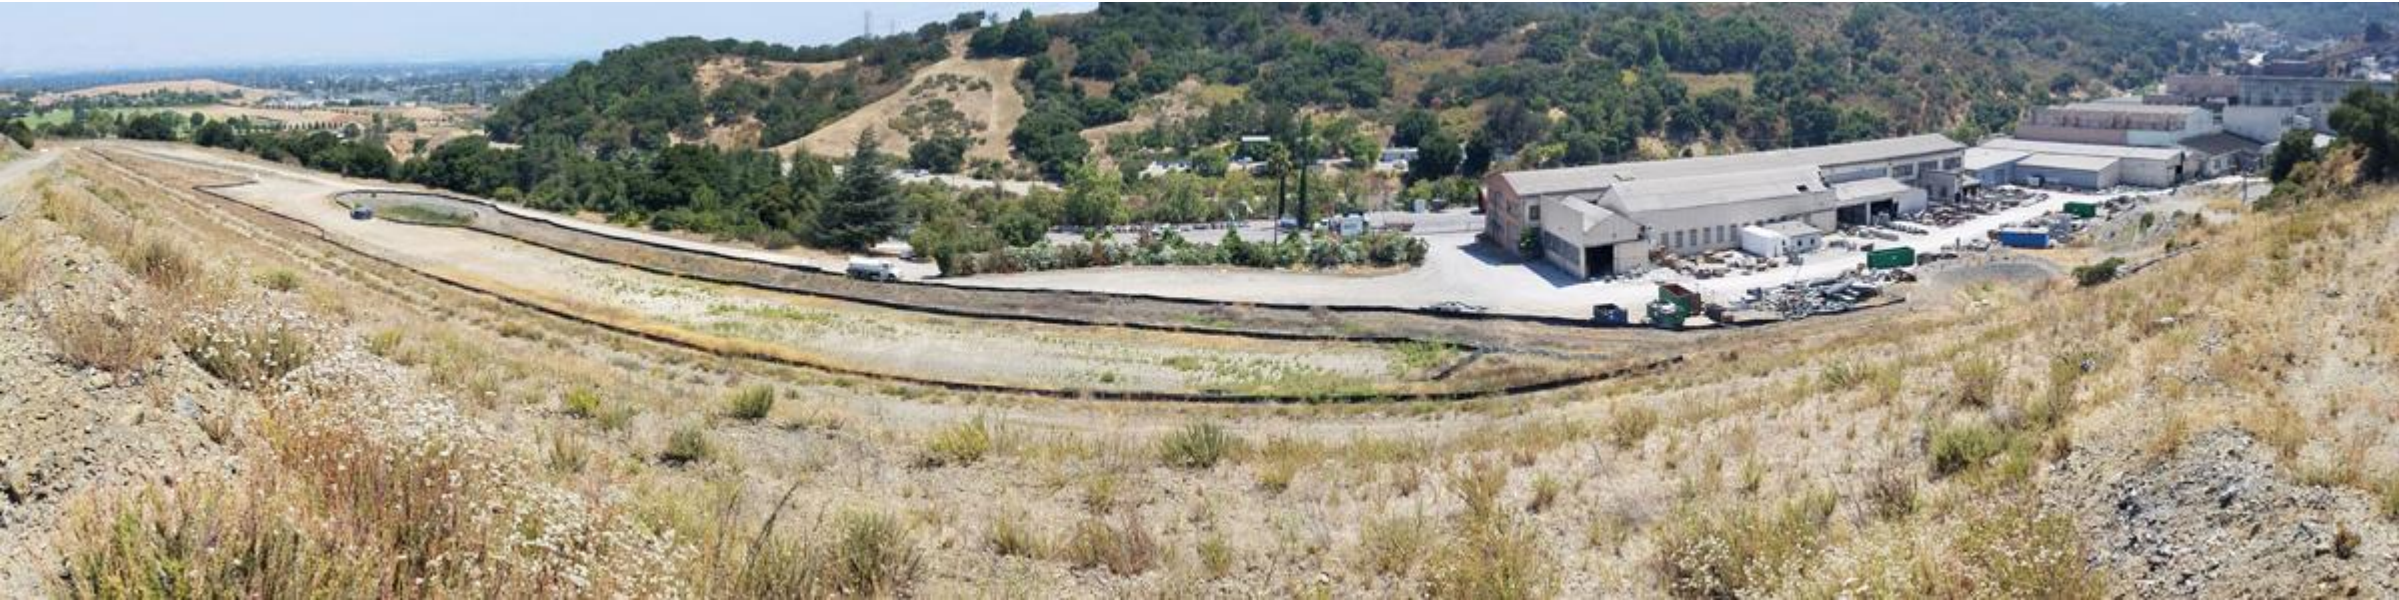
PHOTO #8 – Pond 30 and drainage swale leading to Pond 30 (looking south)

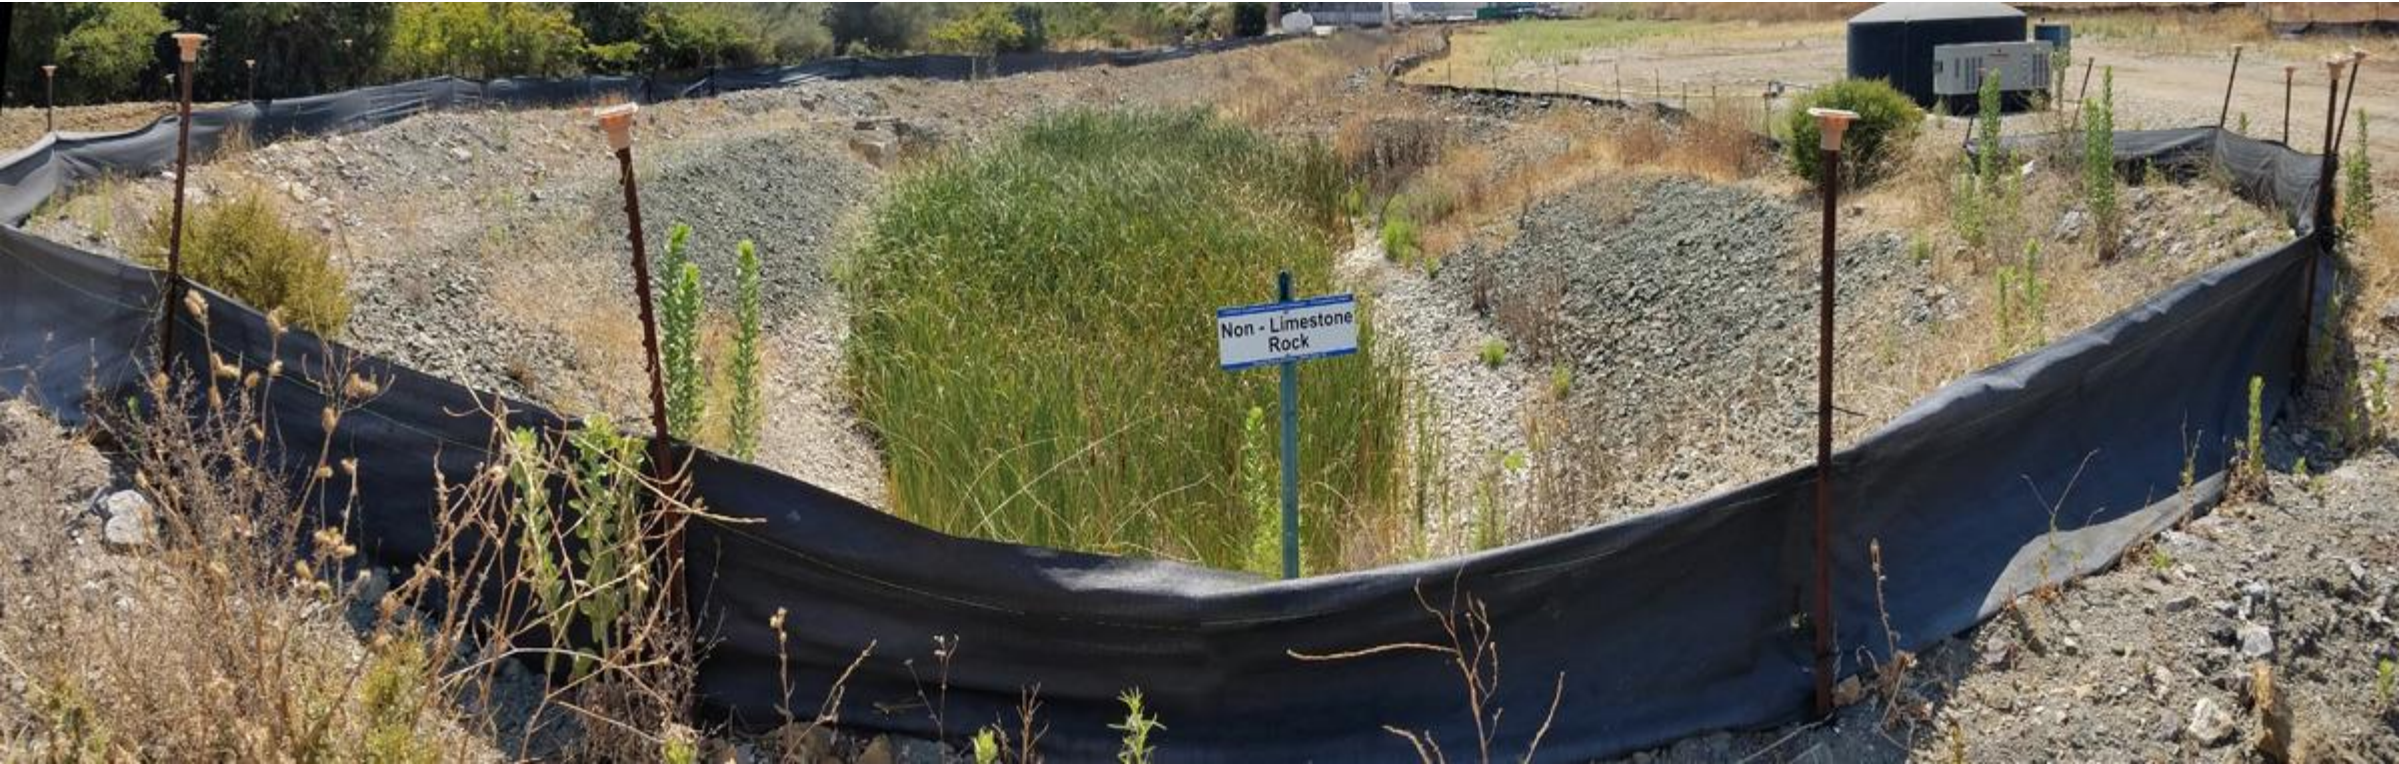
PHOTO #9 – Pond 30 (looking southwest)

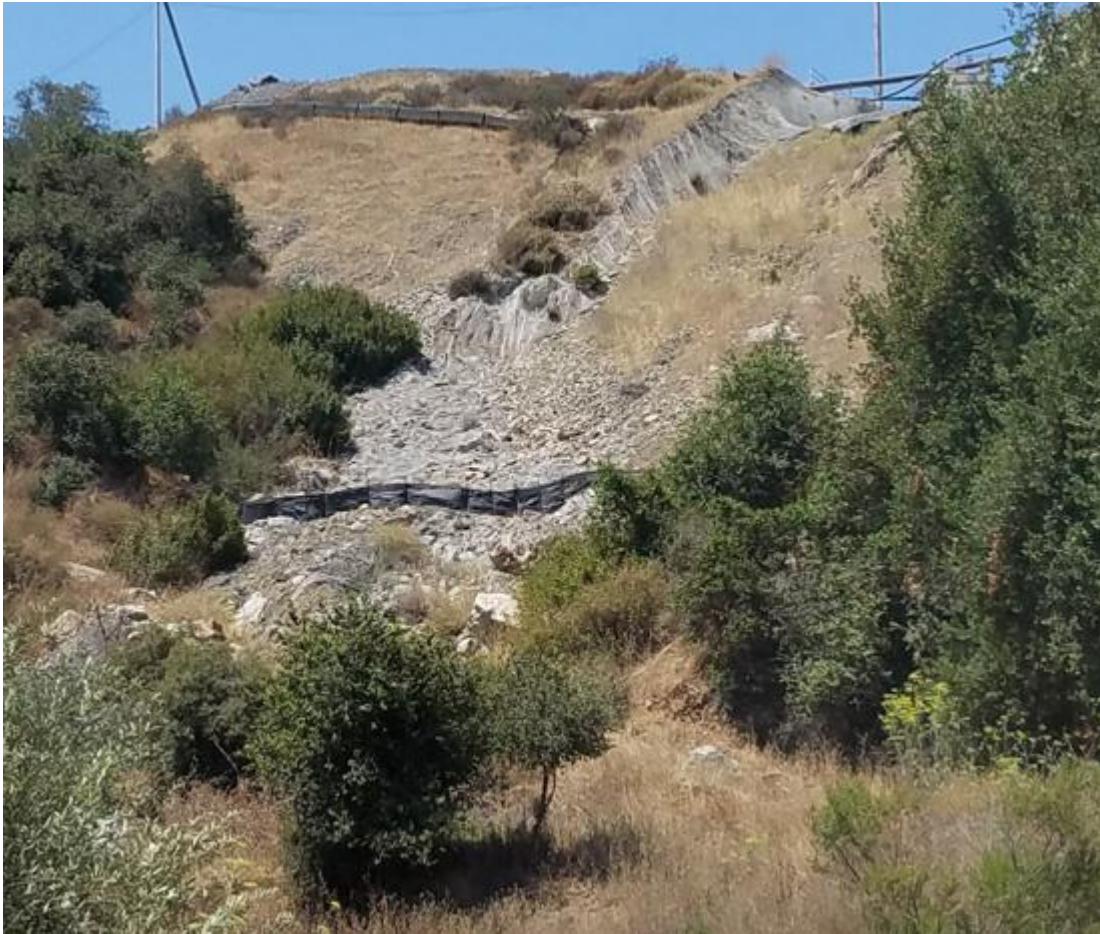
The crusher was constructed in 2013 against a 70-foot high retaining wall. Drainage from around the crusher is directed into a sump which overflowed due to a power failure in 2014. As a result, an erosion gully formed on the steep slope west of the crusher. The operator has had the gully lined with jute netting and several silt fences. [See **PHOTO #10.**] Eroded material accumulated at the toe of the slope and extended into the eastern side of Pond 13. [See **PHOTO #11.**] The operator had a soil-nail wall installed in the head of the erosion gully located downhill of the sump. [See **PHOTO #12.**] The crusher and conveyor will be removed prior to final reclamation. The tunnel through which the conveyor travels will be filled and sealed prior to closure. Wildlife protection procedures (outlined in the RPA and COAs) must be followed when the tunnel is backfilled.

PHOTO #10 –Debris track below crusher sump

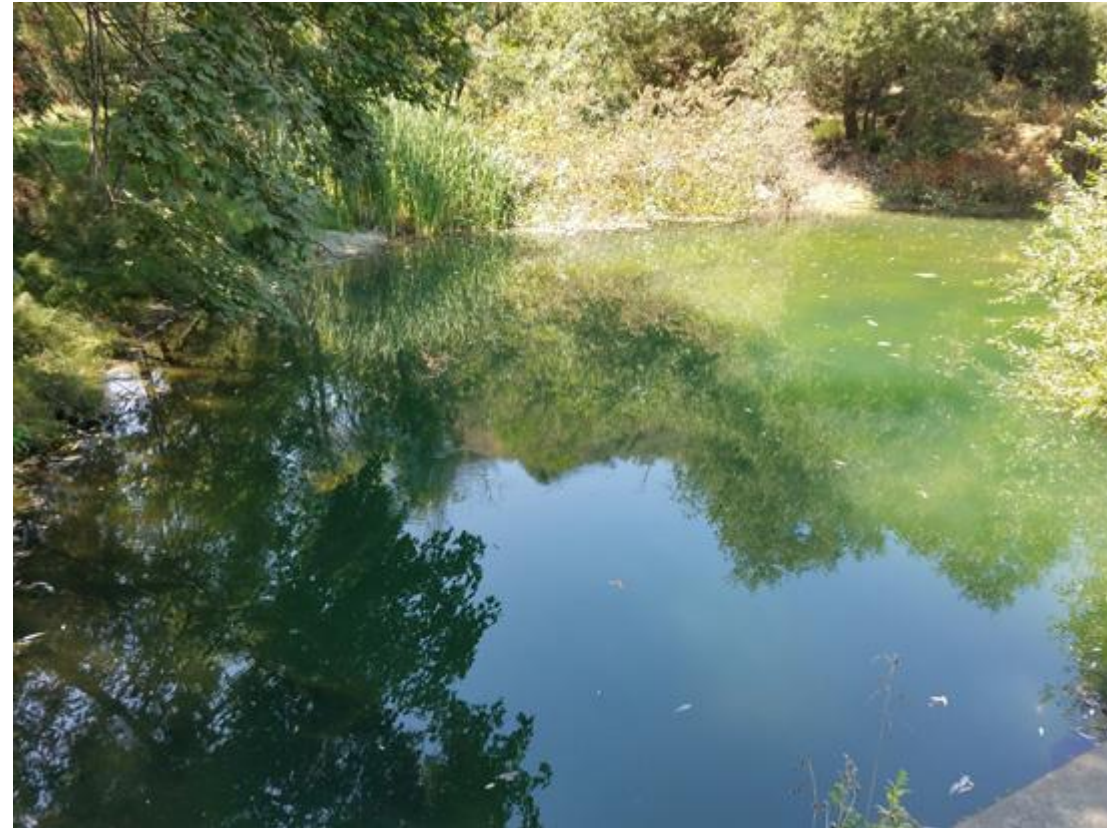
PHOTO #11 – Pond 13

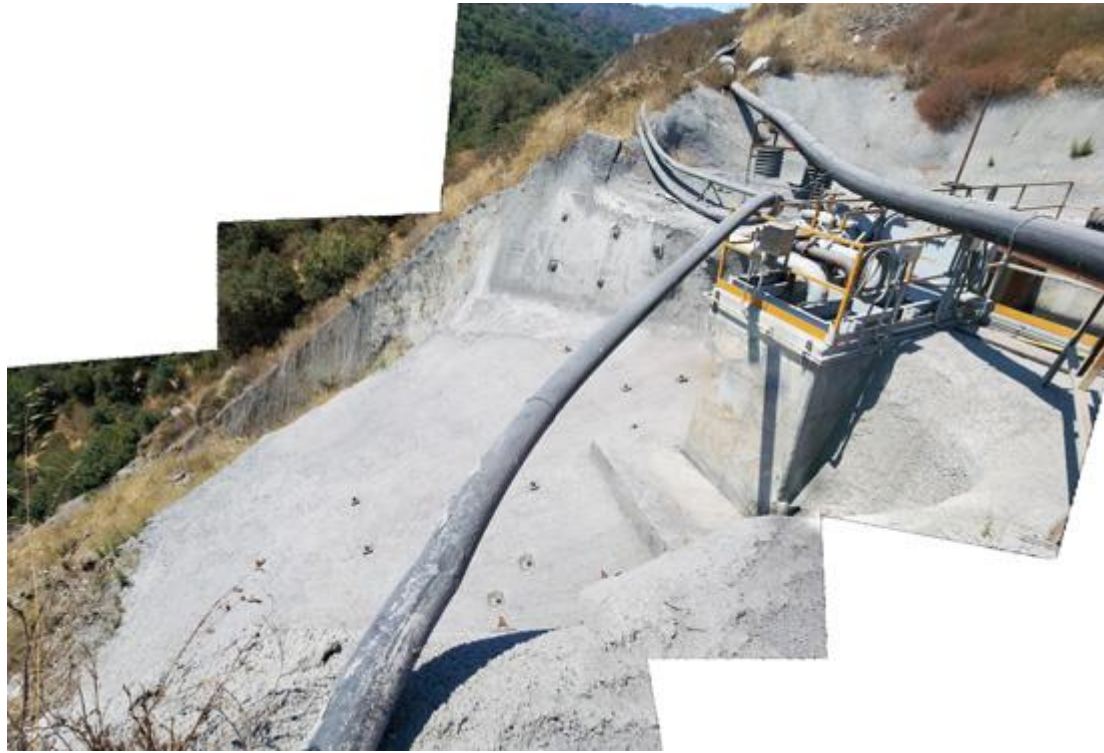
PHOTO #12 – Tie-back wall at crusher sump

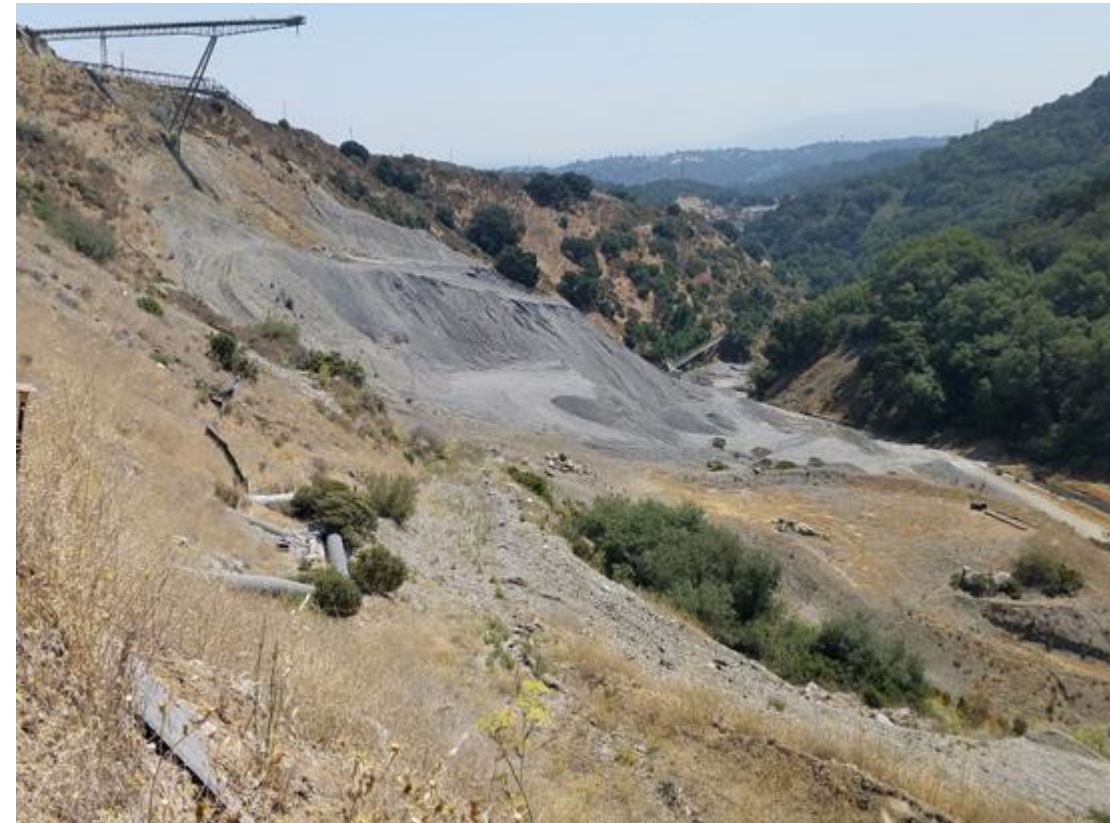
The surge pile has been reduced significantly since last year's inspection. [See **PHOTO #13.**] Sediment that erodes from the surge pile is detained in ponds. [See **PHOTO #14.**] During final reclamation, the surge pile will be removed and the underlying creek channel will be restored during the Creek Restoration work that has not yet been approved.

PHOTO #13 – Surge Pile looking southeast

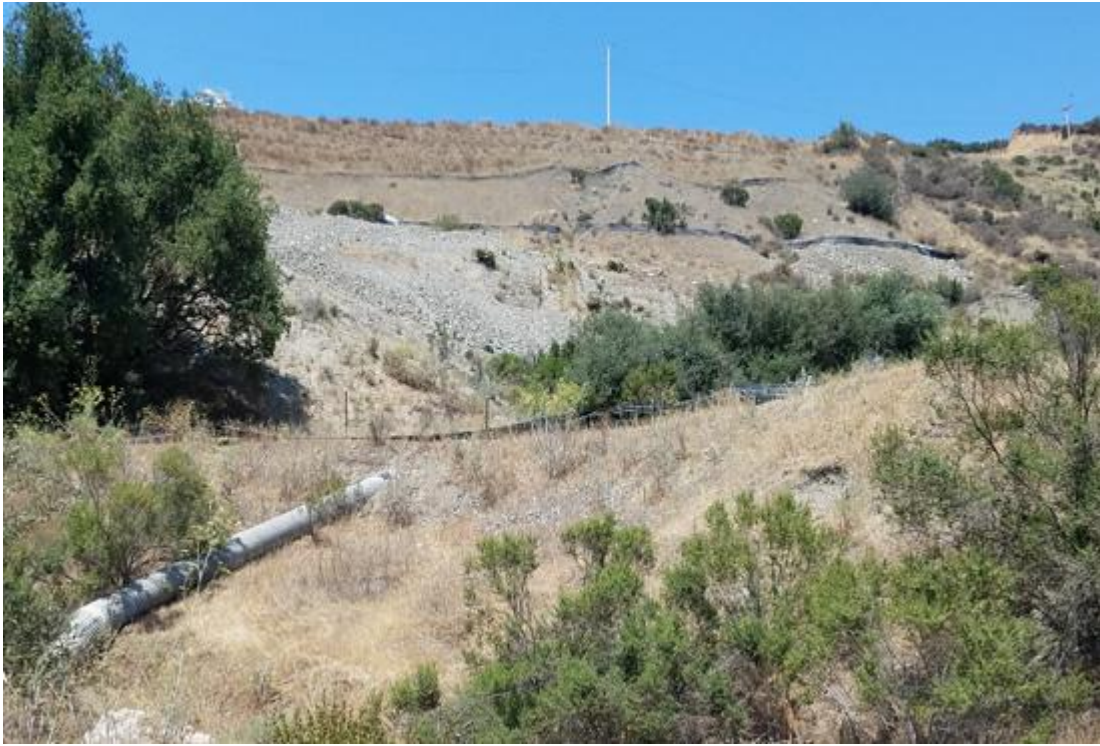
PHOTO #14 – Slopes above Pond 13
