SURFACE MINING INSPECTION REPORT

County File 2250-17PAM - Lehigh Quarry (formerly Permanente Quarry)

Notes and photographs from 2017 Annual SMARA mine inspection conducted on 8-10-2017 by James Baker, CEG#1021, County Geologist, and Steve Beams, Senior Construction Inspector.

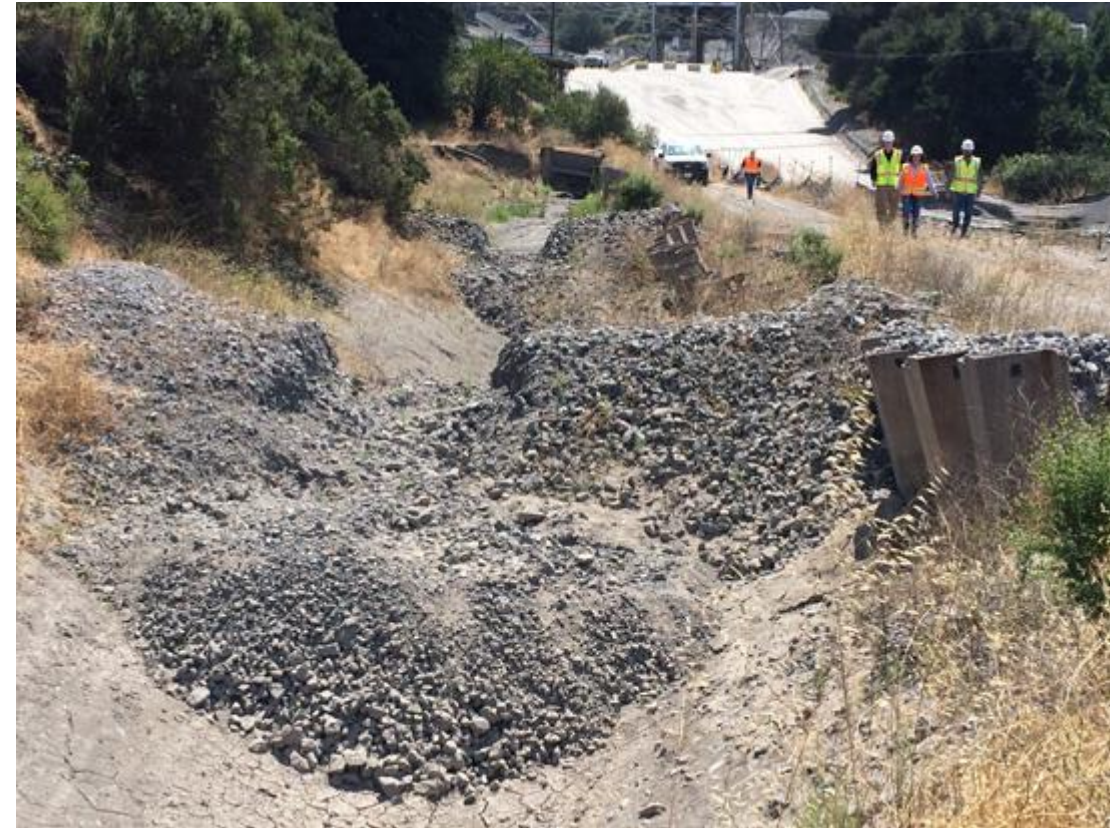
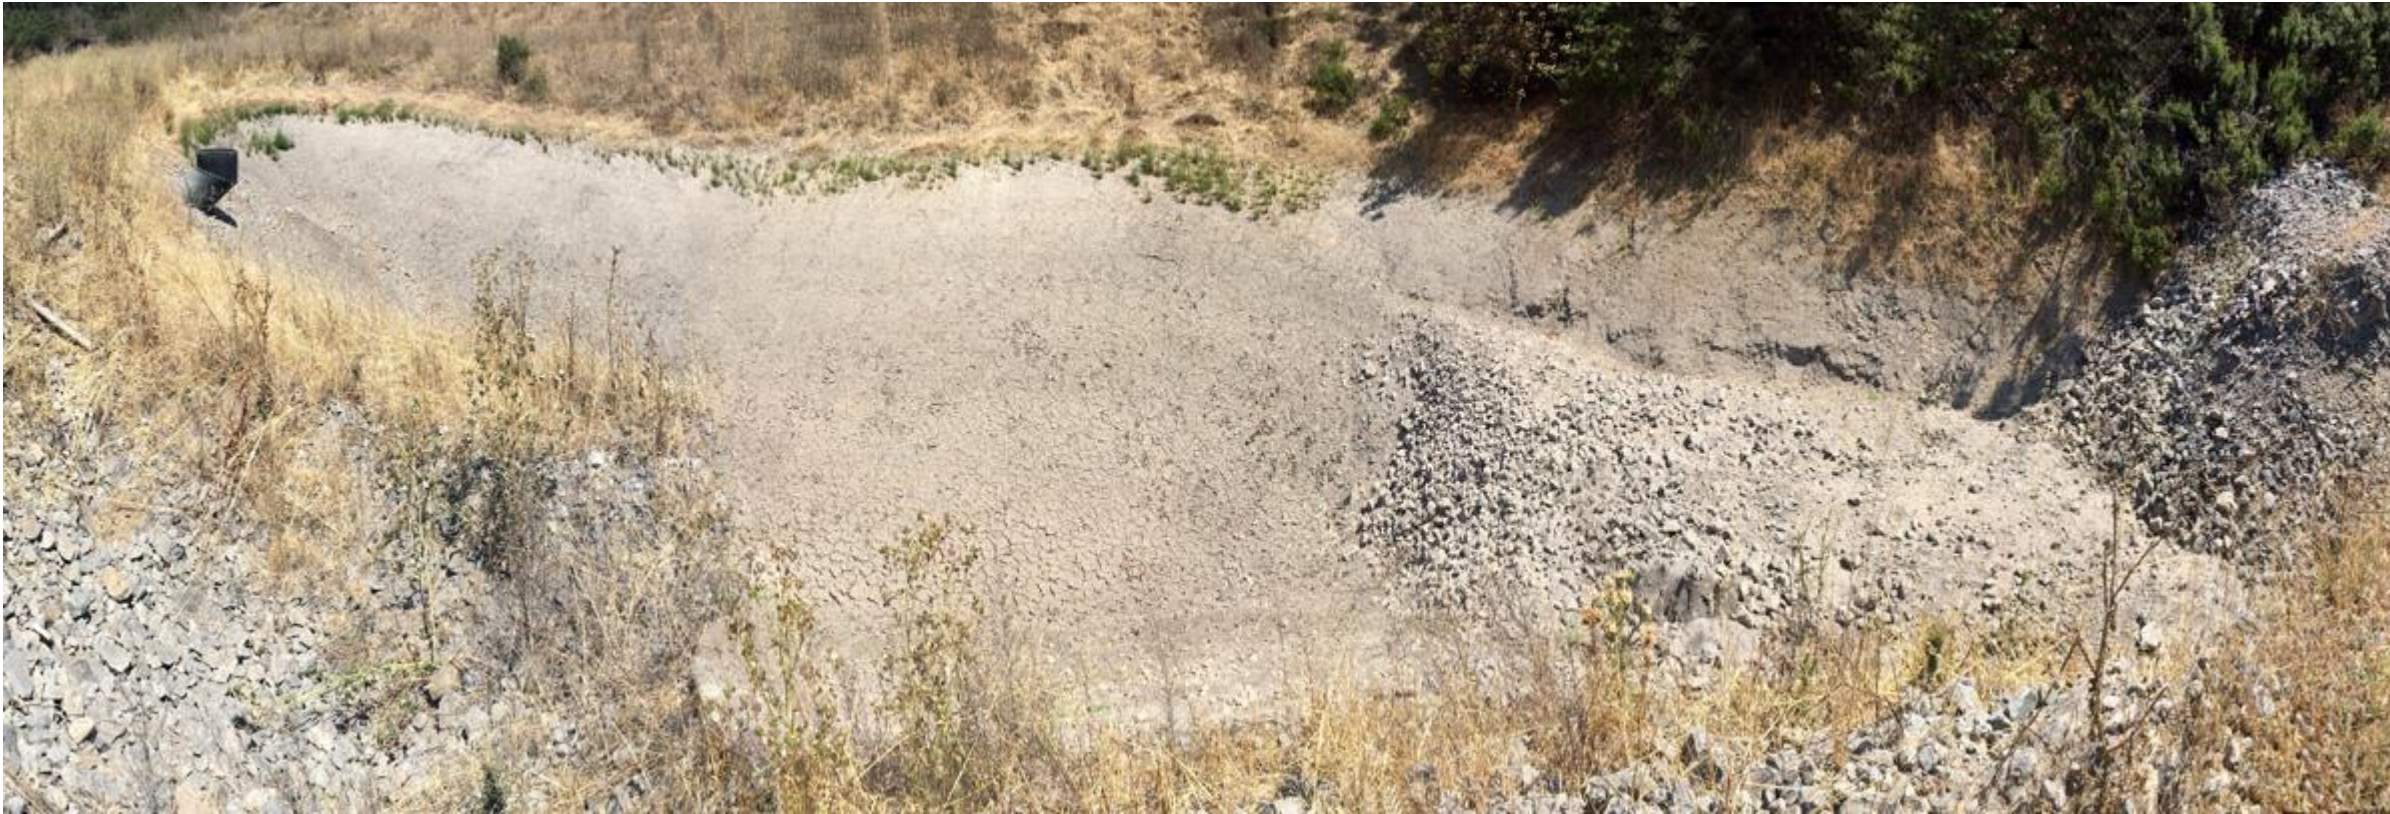
The rock plant was not in operation during the inspection. There are numerous stock piles and equipment in the rock plant area. Runoff from the rock plant is directed into Pond 17. The sheet pile wall along the north side of the channel leading to Pond 17 has failed inward. [See **PHOTO #15** and **PHOTO #16.**] The sheet pile wall needs to be repaired.

PHOTO #15 – Check dams and failing sheet pile wall leading to Pond 17

PHOTO #16 – Check dams and failing sheet pile wall leading to Pond 17

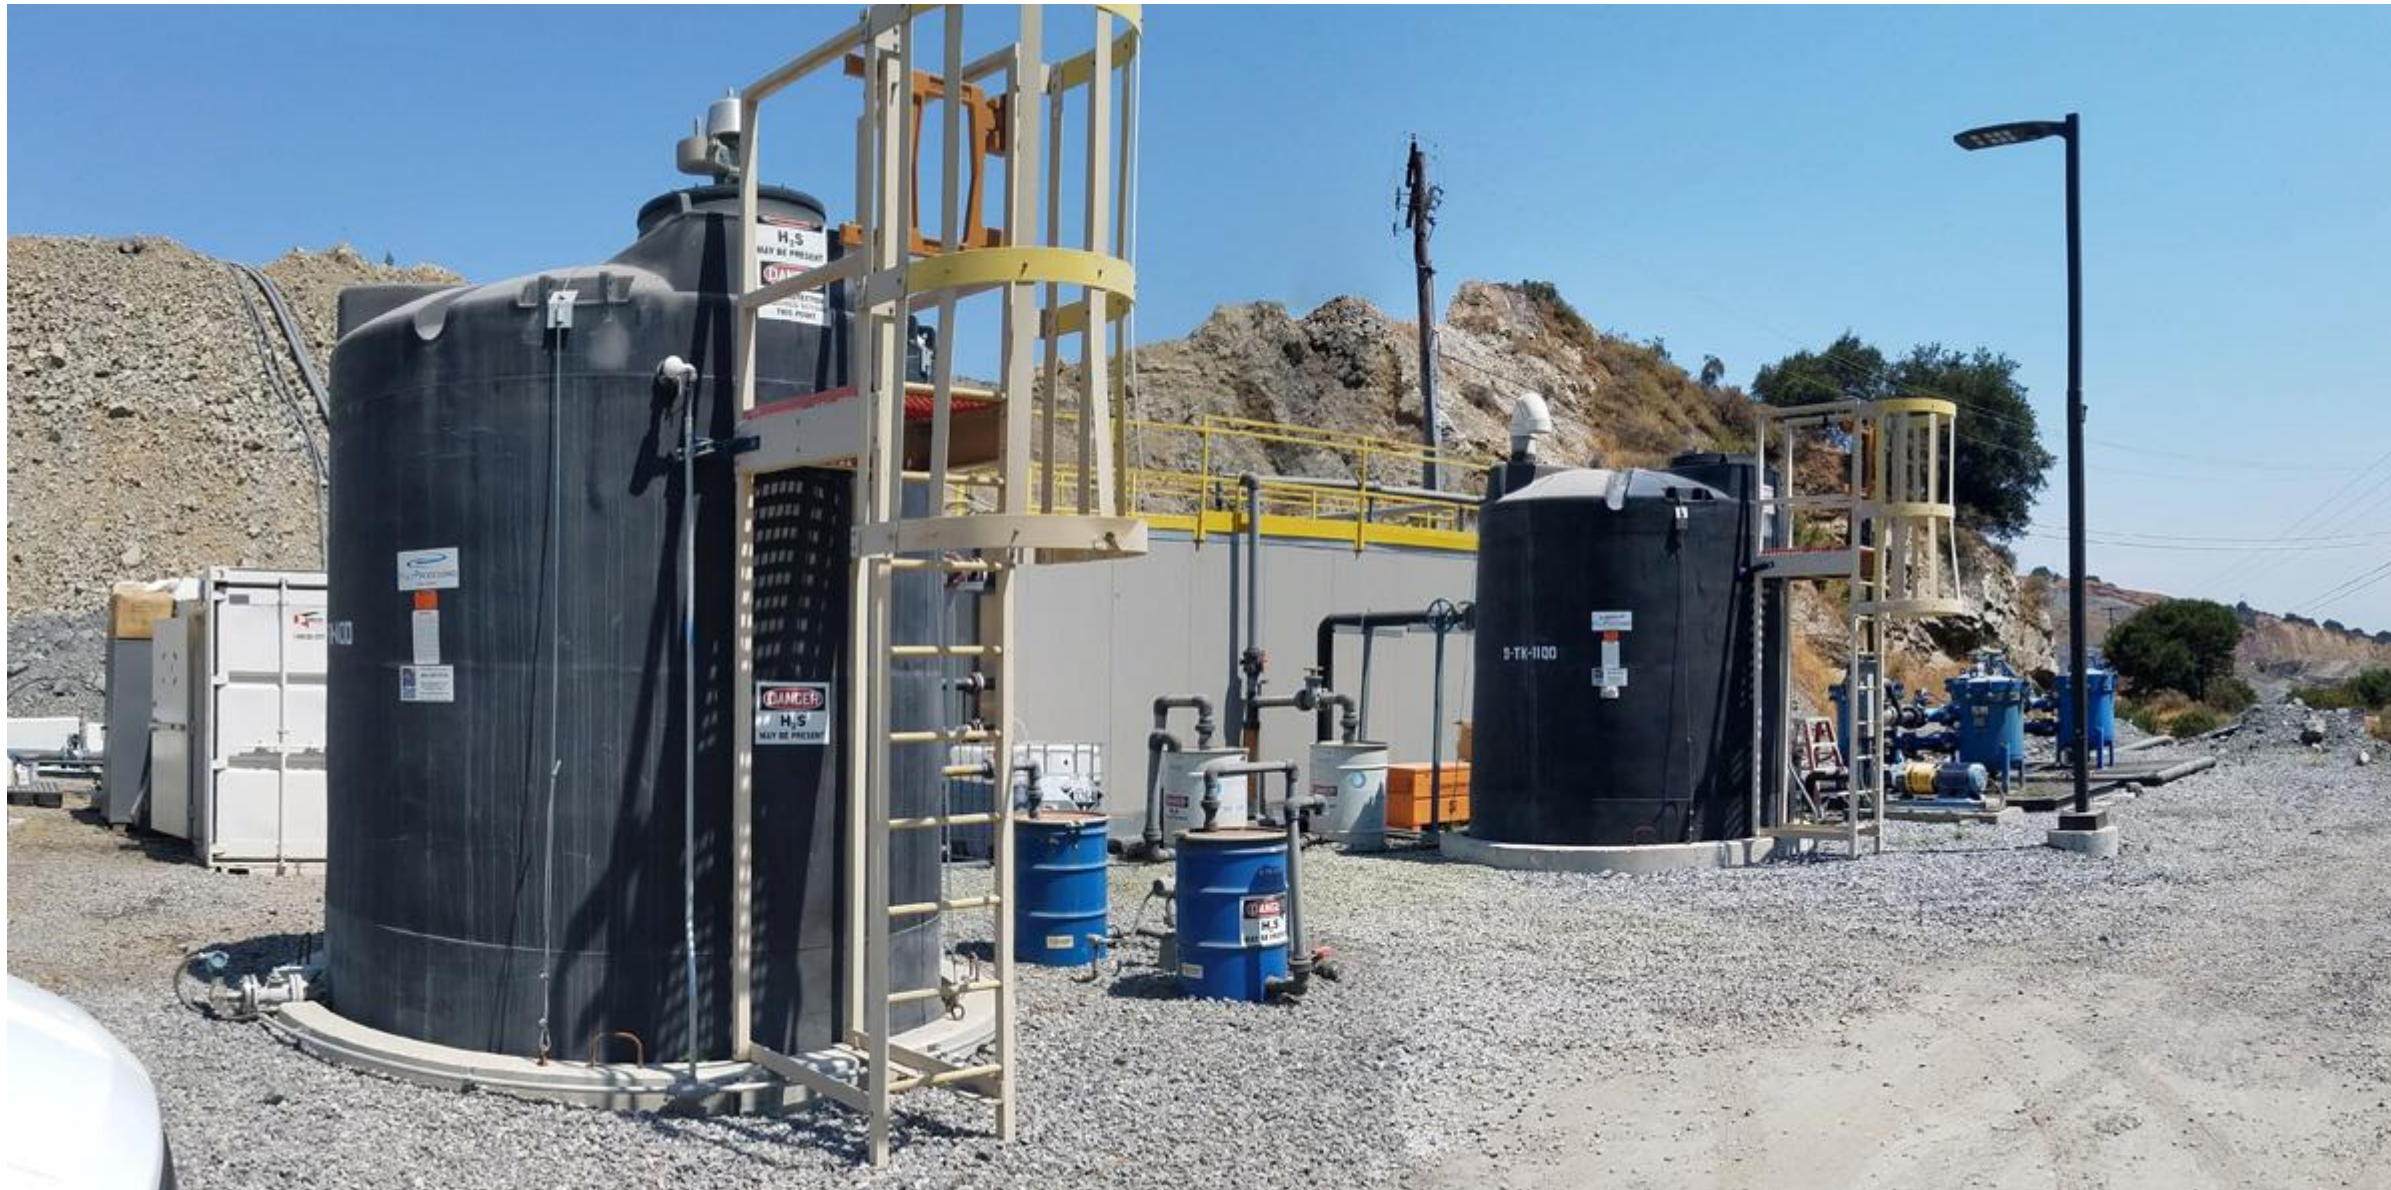
The Quarry is taking actions to comply with the requirements of the San Francisco Bay Regional Water Quality Control Board (SFBRWQCB) with regard to water quality and discharge permits. An Interim Treatment System is operational at Pond 4A. [See **PHOTO #17** and **PHOTO #18**.] This treatment system includes a biological reactor, augmented with a reverse osmosis system, to treat water before being discharged into Permanente Creek.

PHOTO #17 – Tanks at Interim Treatment System

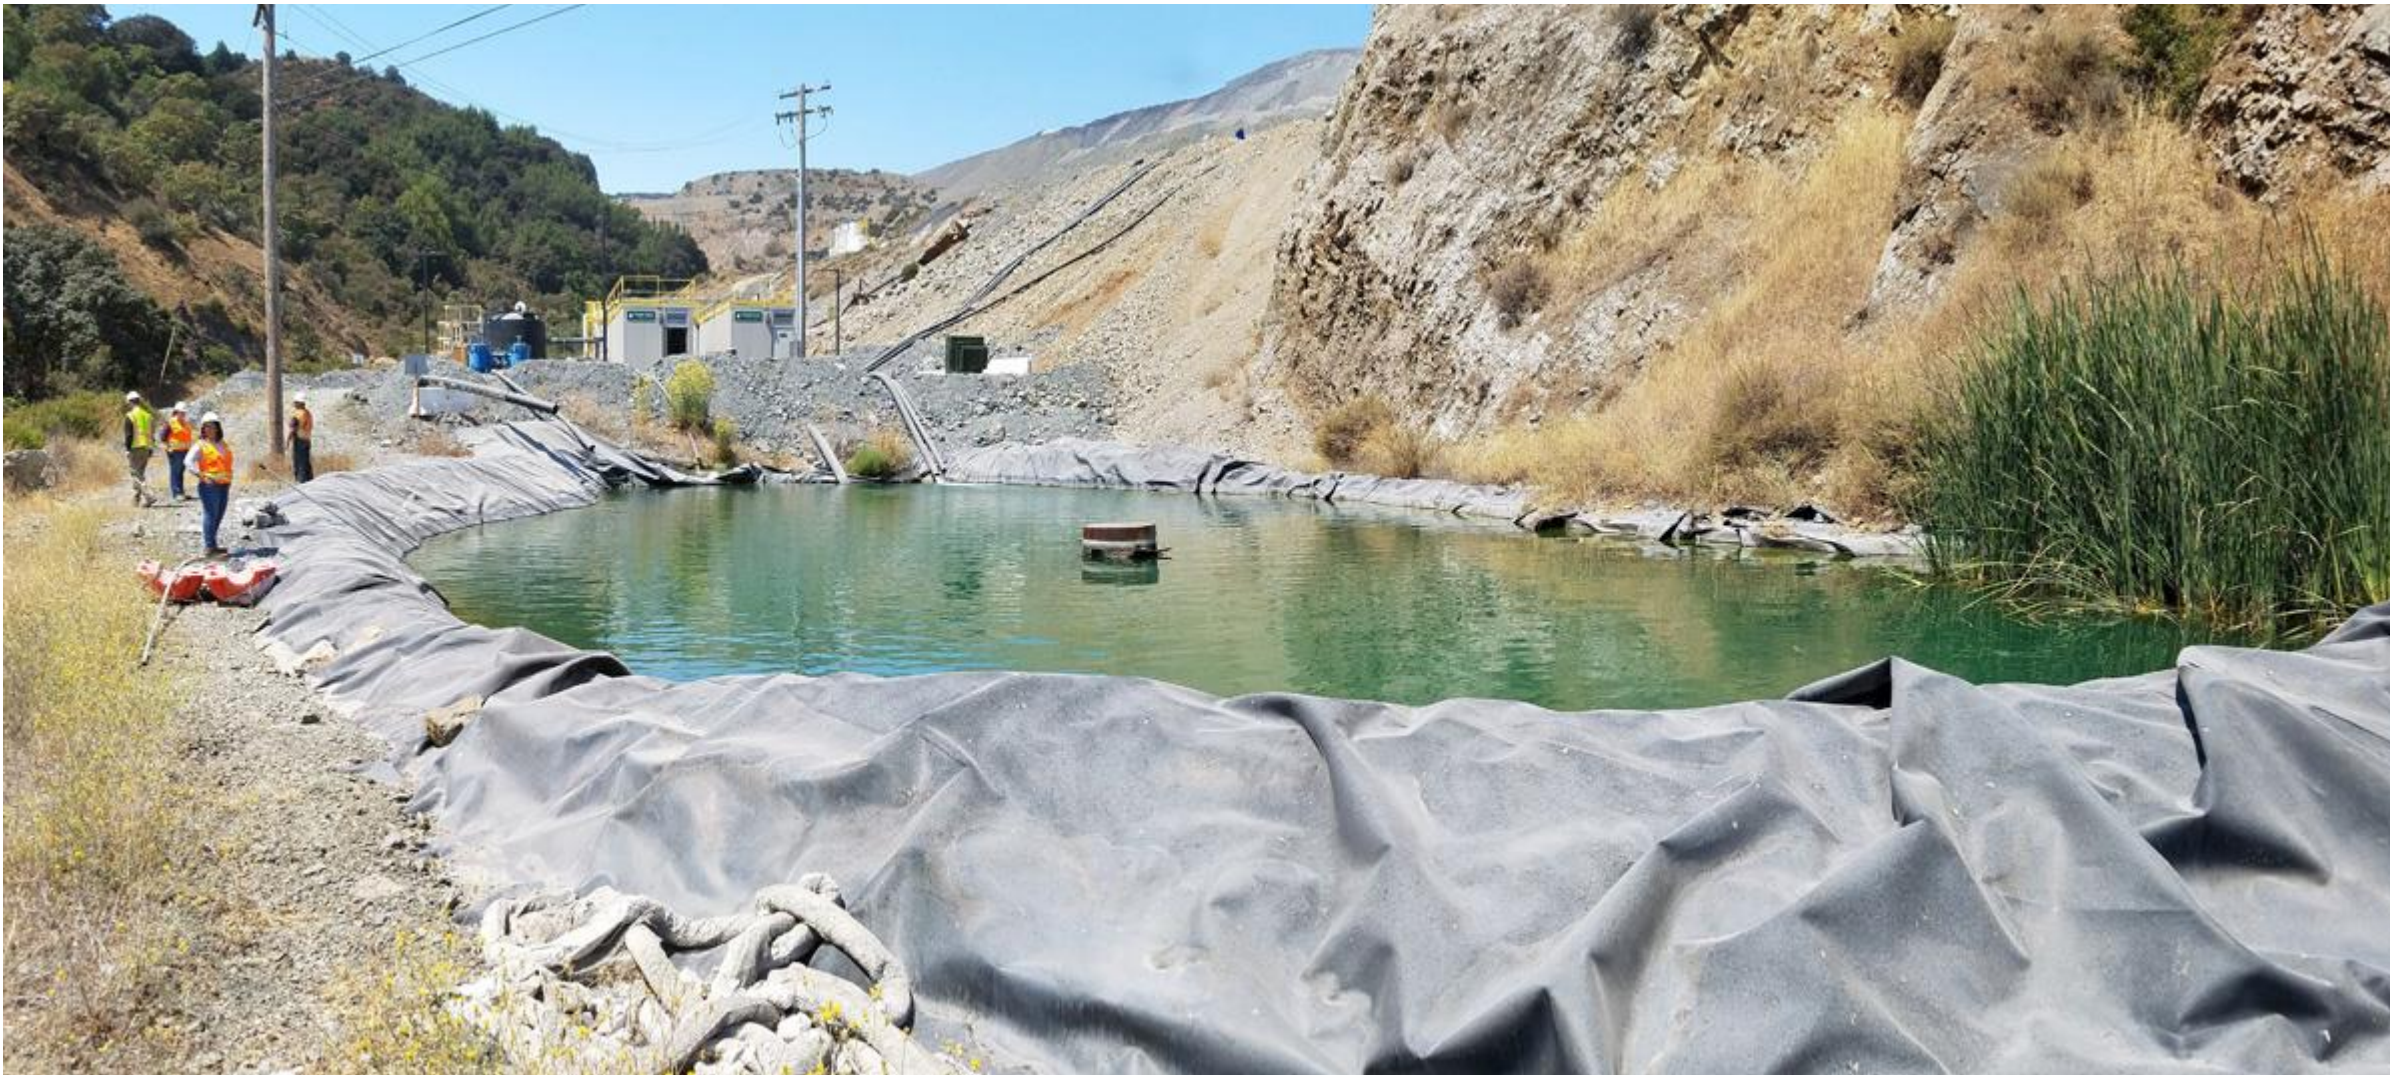
PHOTO #18 – Pond 4A looking northwest
