**APPENDIX G**  
**GEOTECHNICAL EVALUATIONS**

***APPENDIX G-1***  
***WMSA GEOTECHNICAL EVALUATION***

## West Materials Storage Area Geotechnical Evaluation

Permanente Quarry

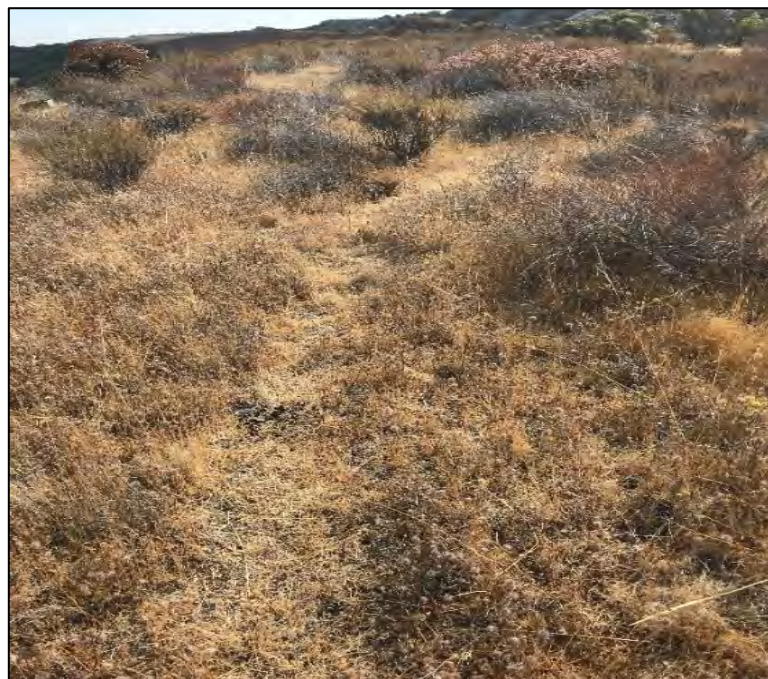
**Photo 2.1 Game Trail North of WMSA**

Stantec investigated the WMSA area during a site visit in October 2018. A primary goal of the site visit was to visually assess the pile conditions and look for signs of instability. Prior to the site visit, Stantec engineers reviewed aerial photographs, and several linear features were identified on the aerial photographs. In addition, Stantec engineers reviewed previous reports to identify features requiring on-site inspection, and two areas with potential cracks were identified in the review (Golder 2011). The on-site inspection consisted of traversing each bench on the WMSA, measuring slope angles, and looking for signs of instability including slumping, bulging, over steepened slopes, cracks, seeps, ponding, erosion, etc. Each area with linear features was investigated during the site visit, and these features were determined to be game trails, drainage control structures, or erosion control structures. The game trails occur on the grassed areas west and north of the pile. One of these game trails can be seen in Photo 2.1.

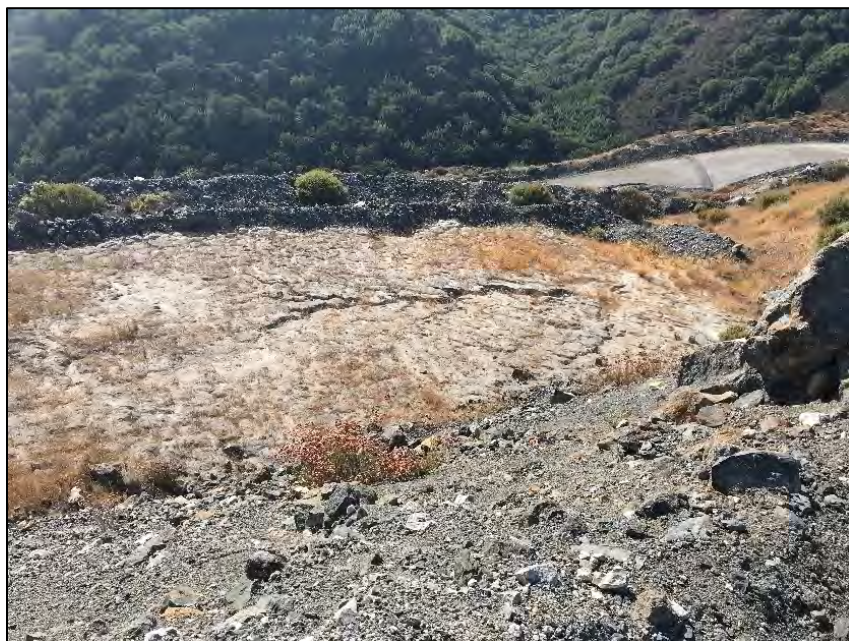
### Photo 2.3 Area Previously Identified with Cracks: Only Sediment and Erosion Identified

Two areas of potential cracking on the 1800 and 1900 benches of the WMSA were identified in the previous WMSA assessment performed by Golder (Golder 2011). Golder presented the crack locations on their maps, and the text states that “these cracks occurred along interim, angle-of-repose slopes for individual lifts” (Golder 2011). A Stantec engineer and engineering geologist visited each area of the potential cracking during the October inspection and found erosional features in the locations where cracks had been identified. No evidence of instability in these areas was observed. The erosional features observed are shown in Photo 2.3.

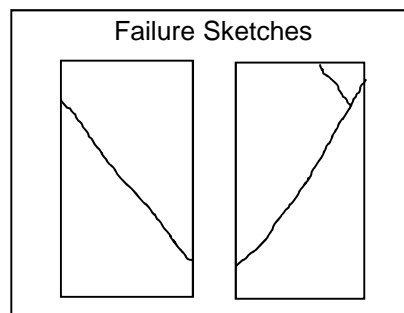
Comments Fragile nature of specimen inhibited preparation, required capping of ends with Hydro-Stone.  
Dimensional tolerances were not confirmed.  
Primary failure occurred along pre-existing healed fault.

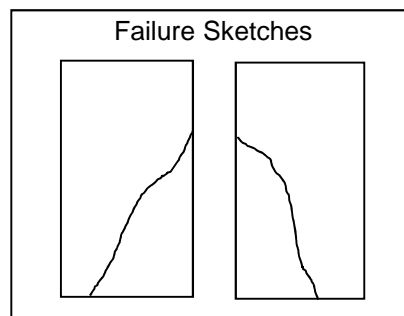
Comments Fragile nature of specimen inhibited preparation, required capping of ends with Hydro-Stone.  
Dimensional tolerances were not confirmed.  
Primary failure occurred along pre-existing healed fault.

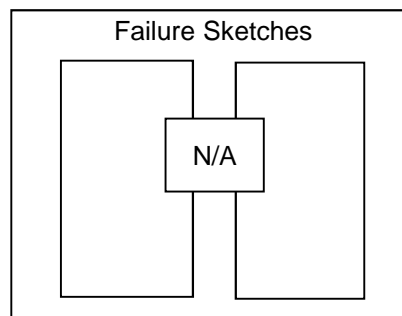
Comments Testing load indicated compressive failure of specimen, no external visual sign of failure was observed.
