SURFACE MINING INSPECTION REPORT

I. Mine Name (As Shown on Approved Reclamation Plan) Permanente Quarry (Lehigh Quarry)	Inspection Date: 08-06-2019	CA MINE ID# 91- 43-0004
--	---------------------------------------	-----------------------------------

Notes from 2019 Annual SMARA Inspection Conducted on 8-06-2019

Robert Salisbury, Senior Planner
James Baker, CEG#1021, County Geologist

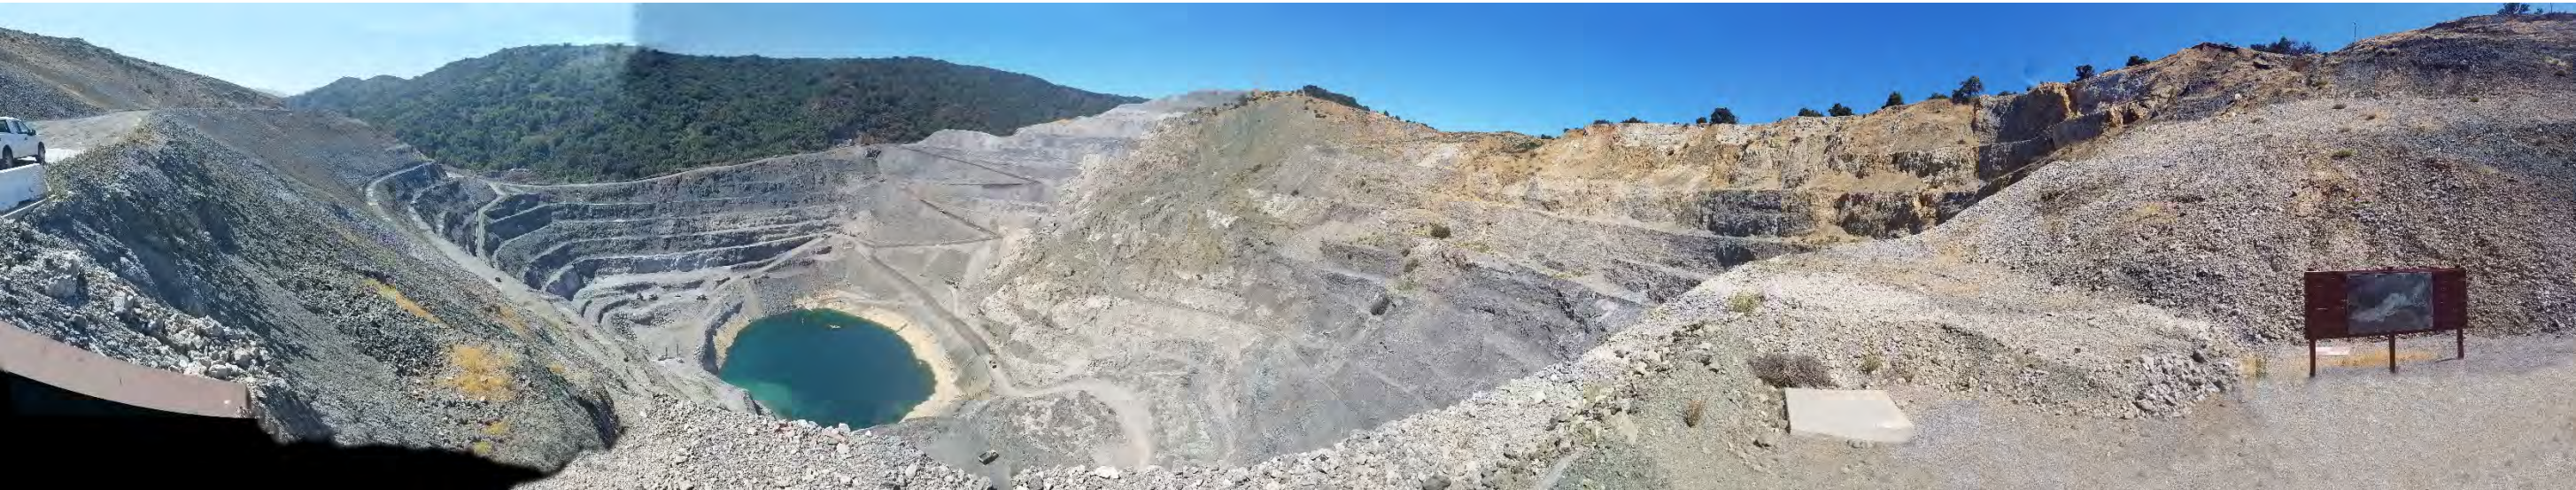
PHOTO #1 – North Quarry Main Pit (looking southwest)

The highwalls on the north, east, and south are essentially complete (excavated benches); while the southern side of the pit is still being actively mined (blasting and loading). Extraction of limestone was on-going in the main pit. [See **PHOTO #1** and **PHOTO #2**.] Material from Yeager Yard was being added to the WMSA. (Yeager Yard is located between WMSA and Permanente Creek.)

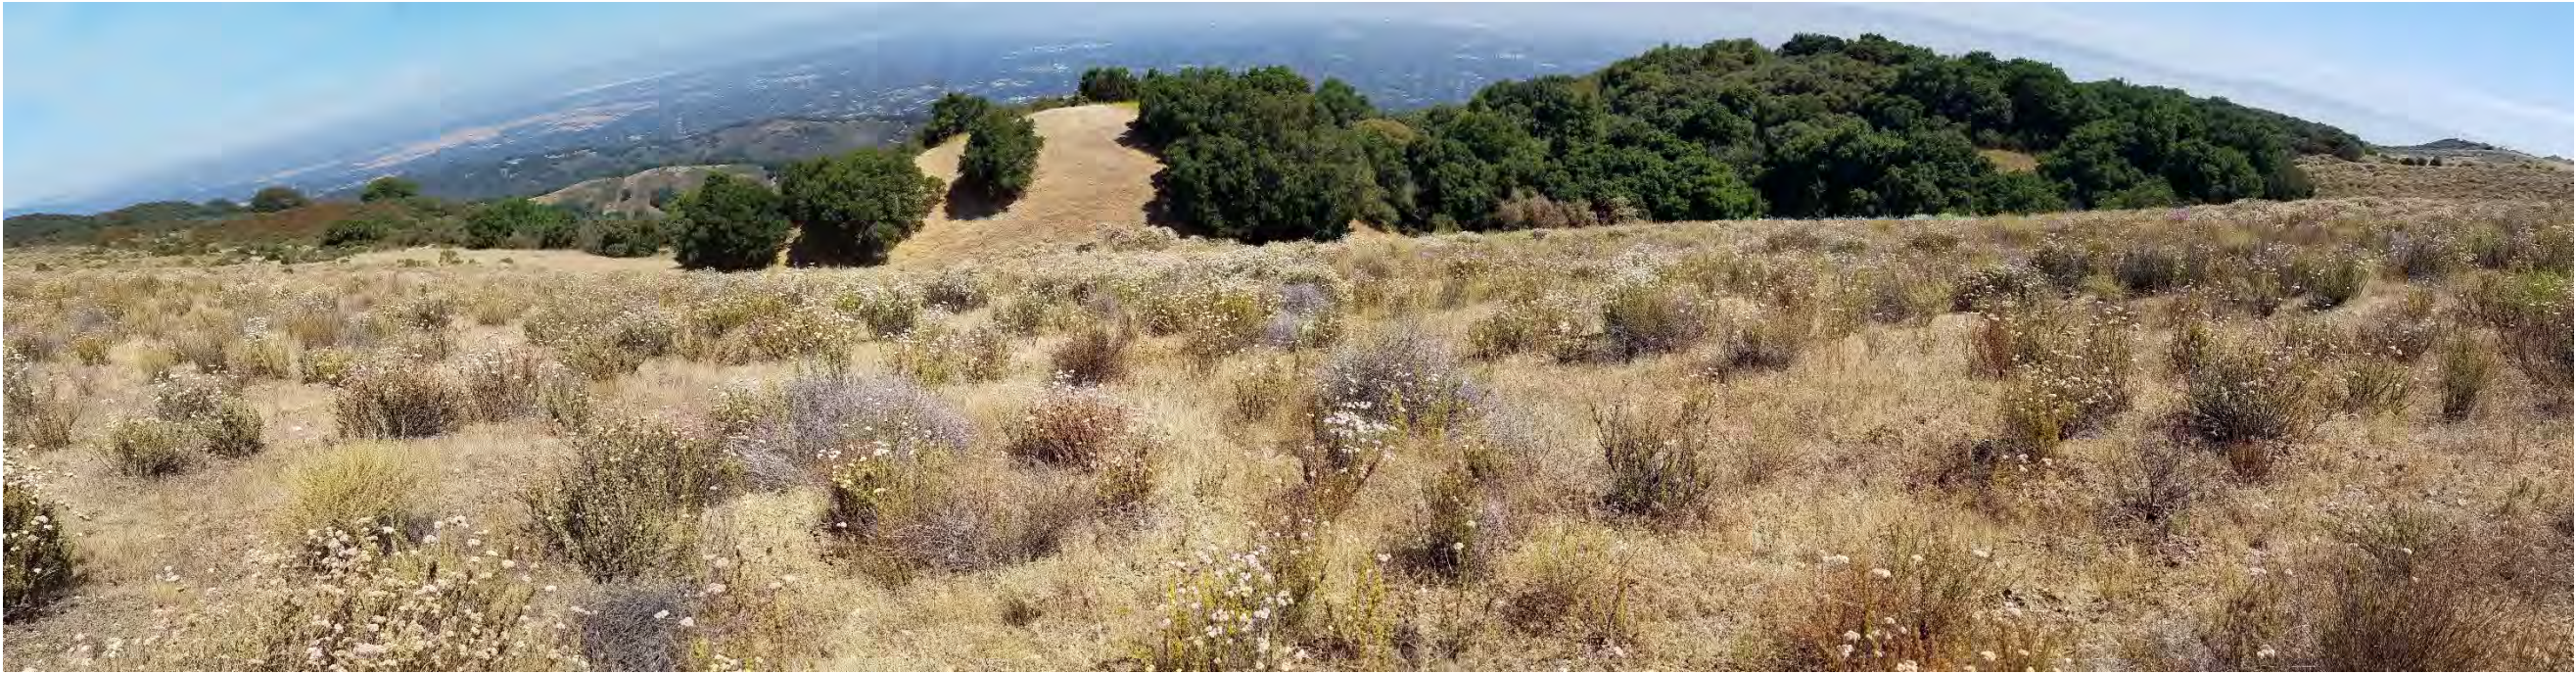
PHOTO #3 – WMSA (looking north)

New material was being placed in the WMSA. The northeast-facing slopes of the WMSA have well-established vegetation (grasses and some shrubs). [See **PHOTO #3** and **PHOTO #4**.] Topsoil and organics are stored and covered in the central portion of the WMSA. County staff observed deterioration of previously installed jute netting and minimal growth on the hydroseeded stockpile slopes. [See **PHOTOS #5A and #5B**.] Although no evidence of erosion was observed, County inspectors suggested that the operator monitor the stockpiles and replace erosion control measures as needed to prevent loss of stockpile material through erosion. The south slope of the WMSA was viewed by County inspectors, and although growth of hydroseeded grasses and shrubs on the south slope of WMSA was minimal, no evidence of erosion was observed. The operator should monitor this area and install erosion control BMPs as needed. [See **PHOTO #6**.] (The approved Reclamation Plan calls for much of the material stored in the WMSA to be moved and placed as backfill into the main quarry pit. Topsoil will be used for plantings.)

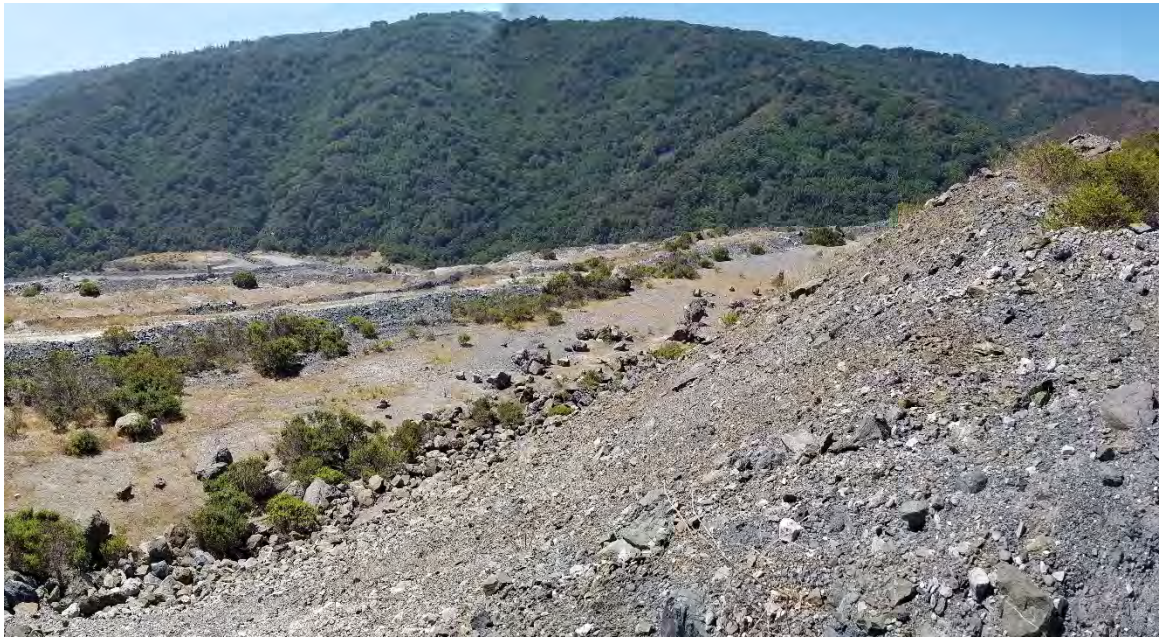
PHOTO #6 – WMSA South Slope (looking southeast)

- 1) (See map location 2) County inspectors suggested that the operator monitor the topsoil stockpiles WMSA south slope and replace erosion control measures as needed to prevent loss of material through erosion.
- 2) (See map location 12) Localized erosion on the haul road cut slopes needs to be managed by installation of erosion control BMPs. Operator has been directed to install these BMPs. Installation will be verified during forthcoming winterization inspection.

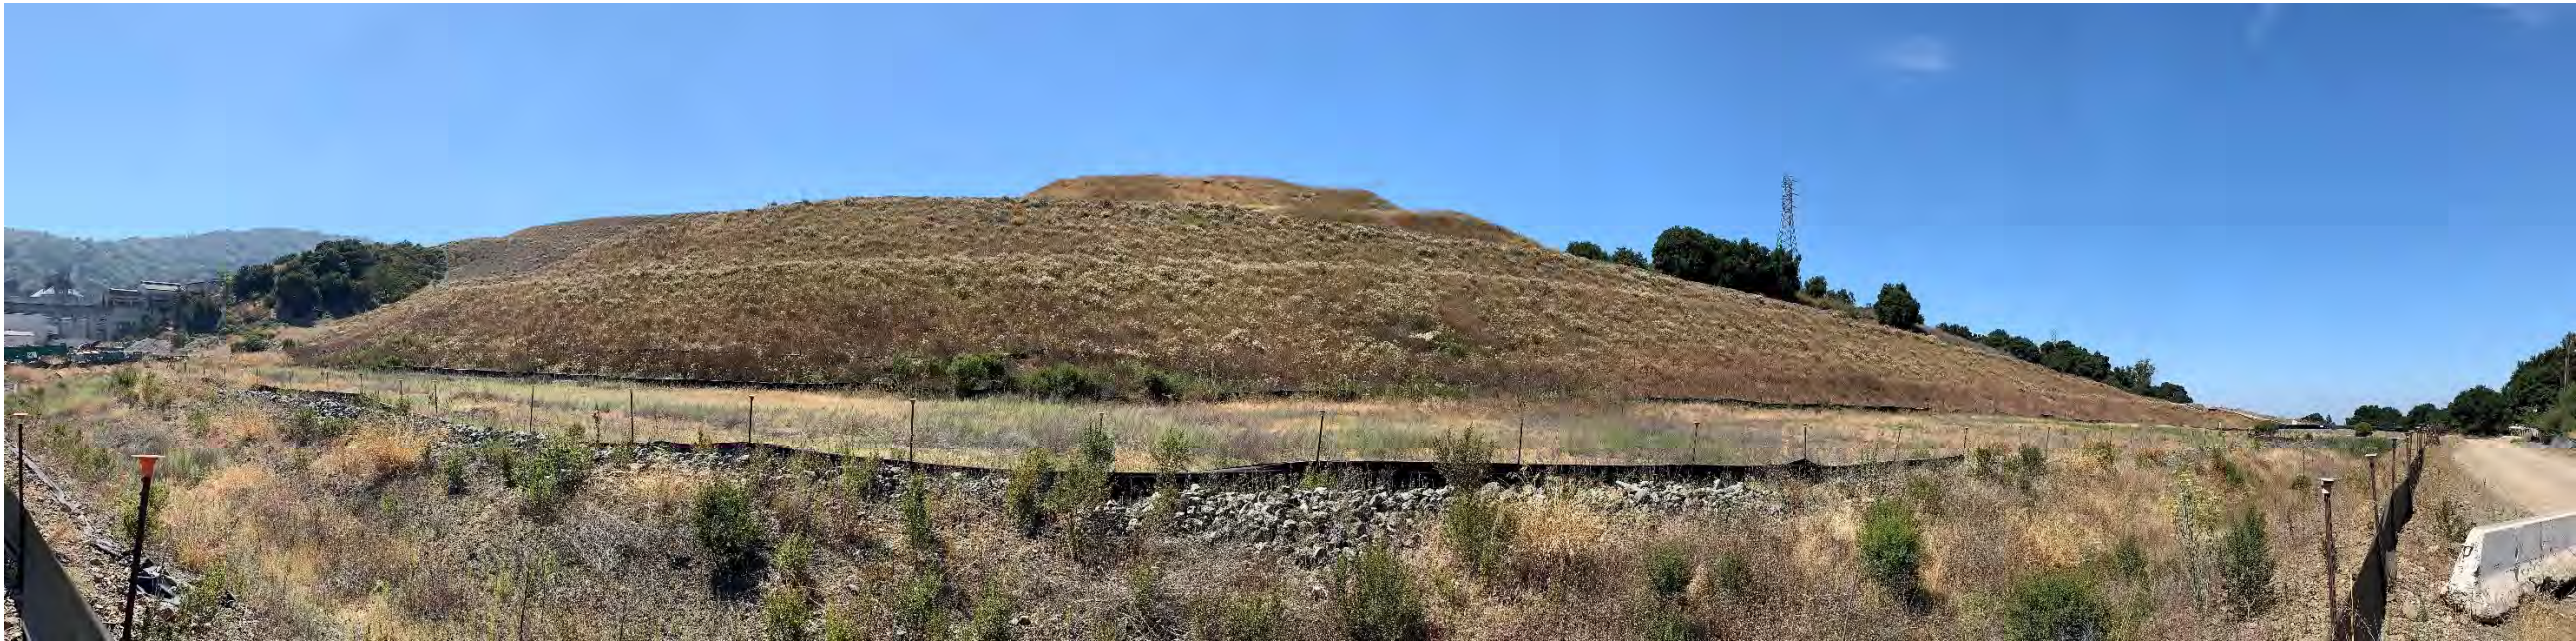
PHOTO #8 – Eastern slopes of EMSA, west of Pond 30 (looking west)

BMPs were previously placed on the slopes (wattles) and along the benches (rock check dams and silt fences). County inspectors observed substantial vegetation growth on the EMSA slopes [See **PHOTO #8.**] Surface drainage from EMSA is directed into Pond 30 which is rock-lined with non-limestone rock. [See **PHOTO #9B.**] Water from Pond 30 is then directed to a vault and pumped to the upper treatment system. [See **PHOTO #9A.**]

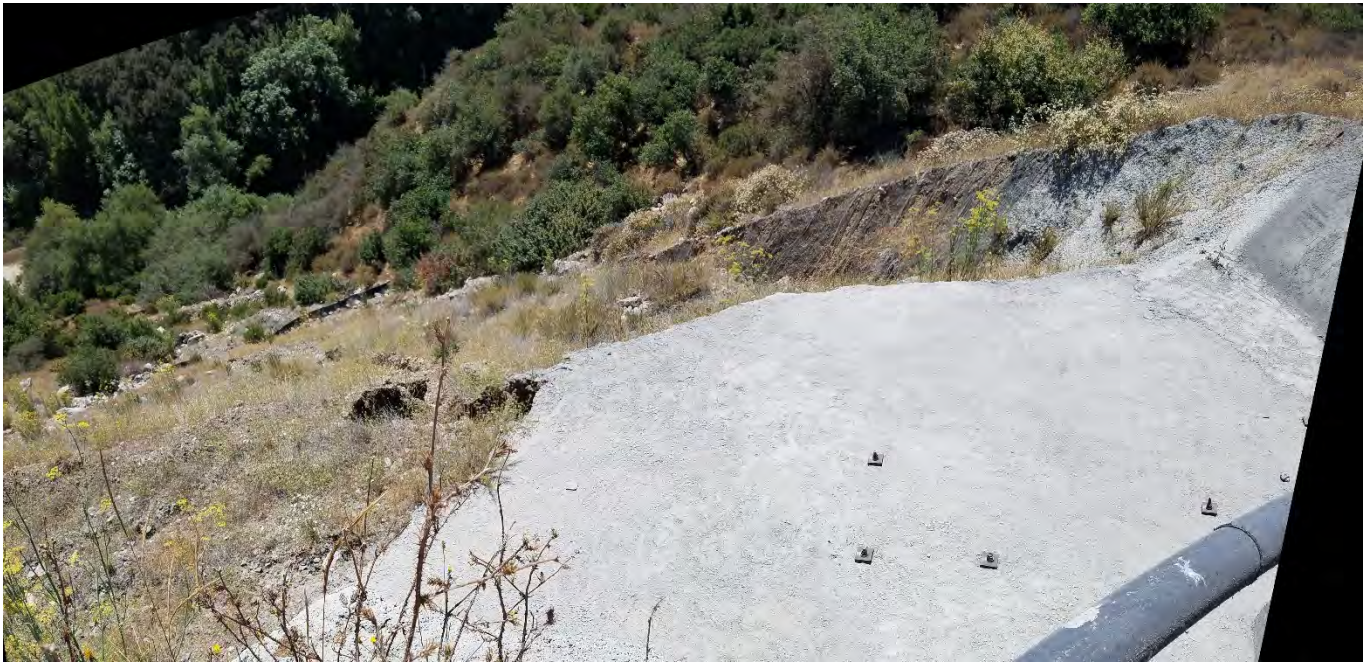
The crusher was constructed in 2013 against a 70-foot high retaining wall. Drainage from around the crusher is directed into a sump which overflowed due to a power failure in 2014. As a result, an erosion gully formed on the steep slope west of the crusher. The operator has had the gully lined with jute netting and several silt fences and installed a soil-nail wall in the head of the erosion gully located downhill of the sump. [See **PHOTOS #10A and #10B.**] Eroded material accumulated at the toe of the slope and extended into the eastern side of Pond 13. [See **PHOTO #11.**] A half-pipe exists downstream of Pond 13 for the continuance of Permanente Creek. [See **PHOTO #12.**] The Permanente Creek Restoration Project (County File No. 2250-17G), submitted by Lehigh and currently under review by the County, proposes removal of the half-pipe.

PHOTO #10A – Overflow scar near crusher sump

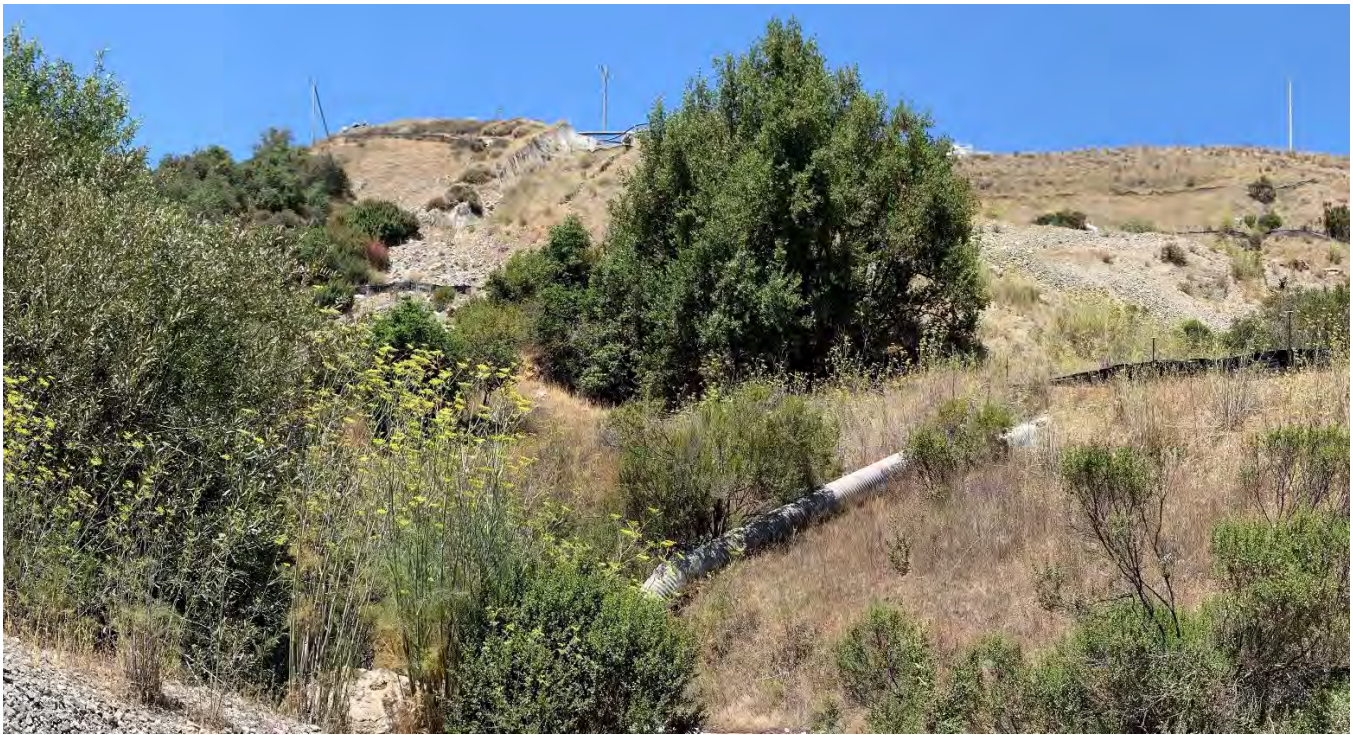
PHOTO #10B – Debris track below crusher sump

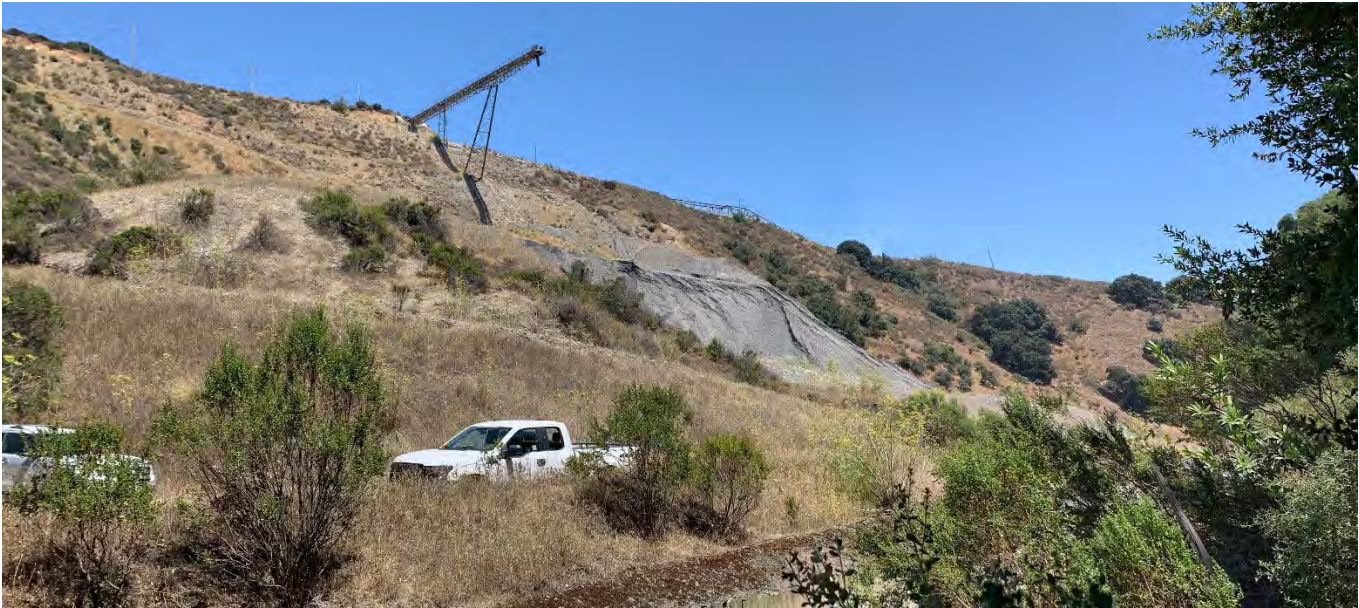
PHOTO #13 – Surge Pile looking east

The surge pile is significantly smaller than it was last year. [See **PHOTO #13.**] Sediment that erodes from the surge pile is detained in ponds. Next to the surge pile are slopes above Pond 13. [See **PHOTO #14.**] During the Permanente Creek Restoration Project referenced above, the surge pile will be removed, and the underlying creek channel will be restored once the project is approved.

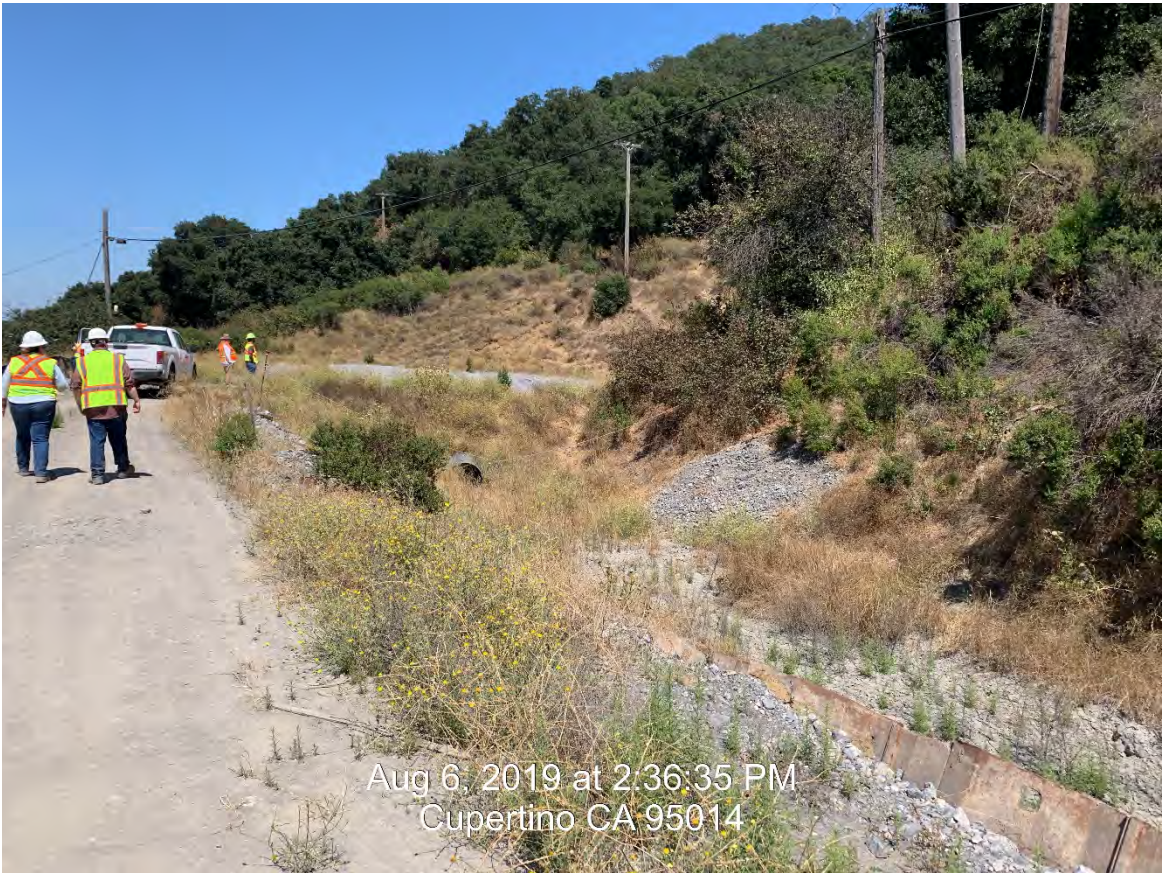
The rock plant did not appear to be operating during the inspection. There are numerous stockpiles and equipment in the rock plant area. [See **PHOTOS #15 and #16.**] Runoff from the rock plant was previously being directed into Pond 17. Since last year's inspection, Pond 17 has been decommissioned and the runoff which was previously routed to Pond 17 now flows into a new basin in Permanente Creek installed at the direction of the San Francisco Bay Regional Water Quality Control Board. (See Other Observations section below for more details and photo.)

PHOTO #15 – In-flow to Pond 17 and failing sheet pile wall

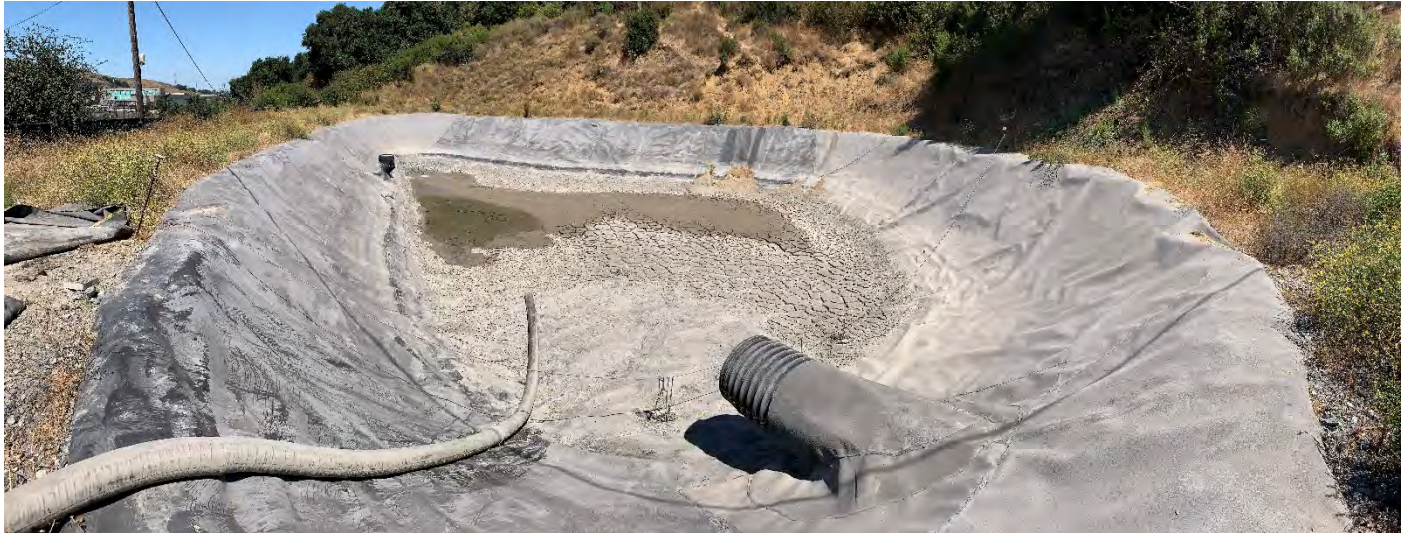
PHOTO #16 – Pond 17 with liner and sediment

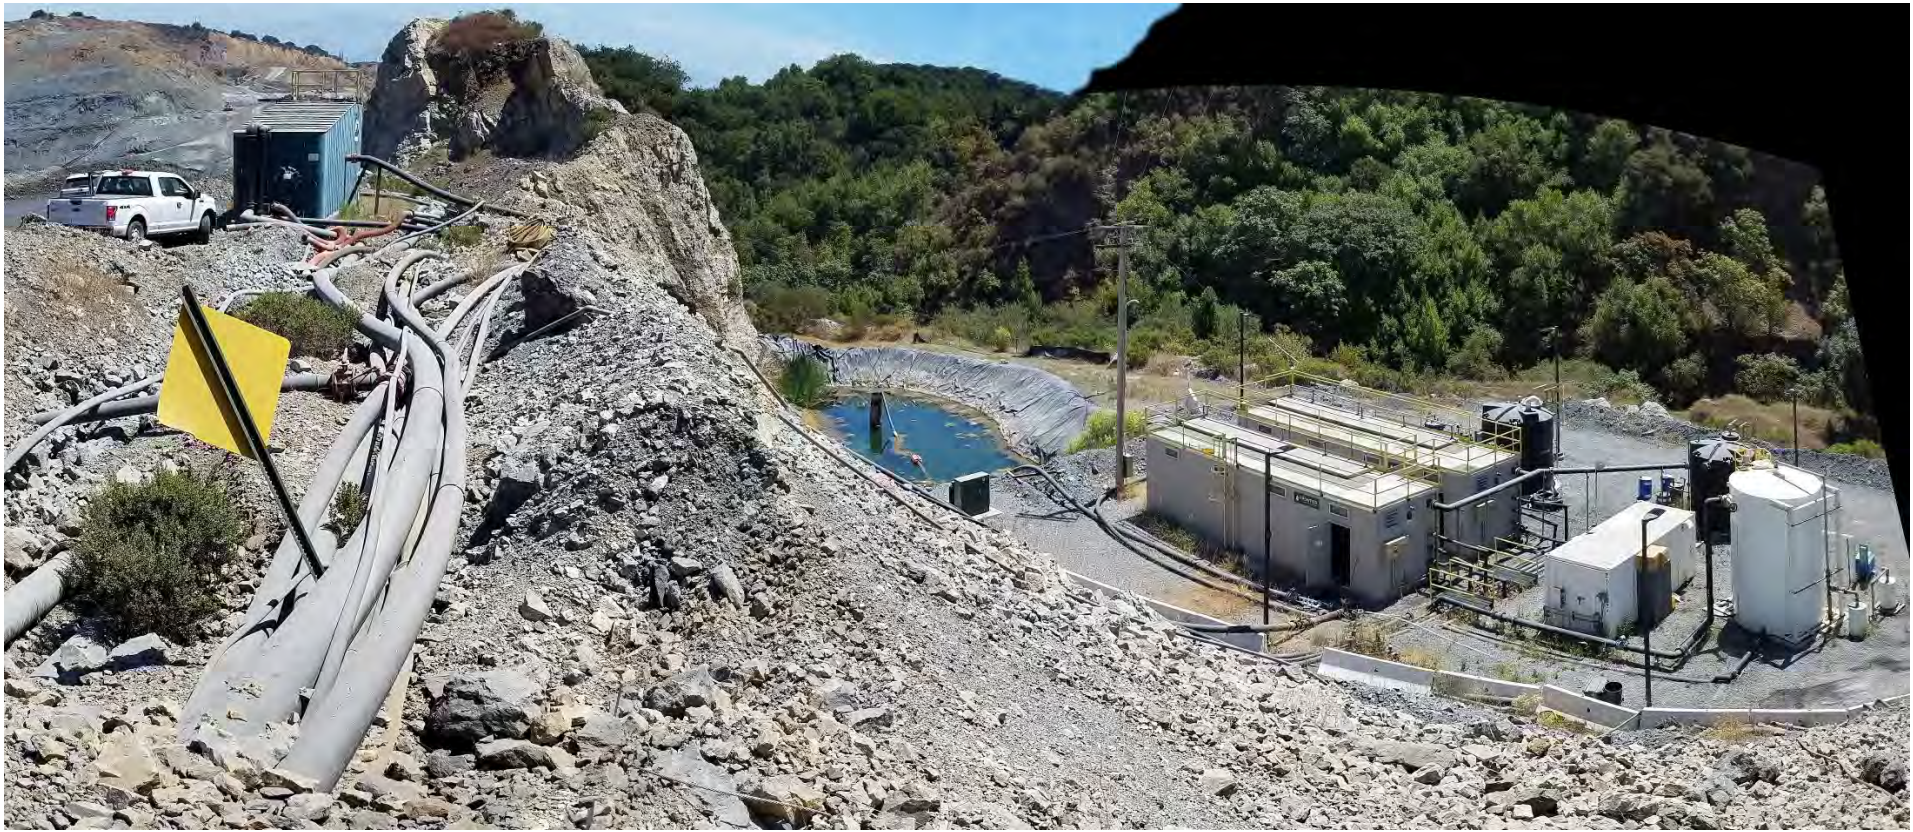
PHOTOS #17 and #18 – Pond 4A and Upper Treatment System with blending tank (at left)

Adjacent to Pond 4A are water treatment and filtration equipment used to remove selenium from quarry water prior to discharge into Permanente Creek. [See **PHOTOS #17 and #18.**] Associated tanks are located adjacent to Pond 1250. [See **PHOTO #19.**]

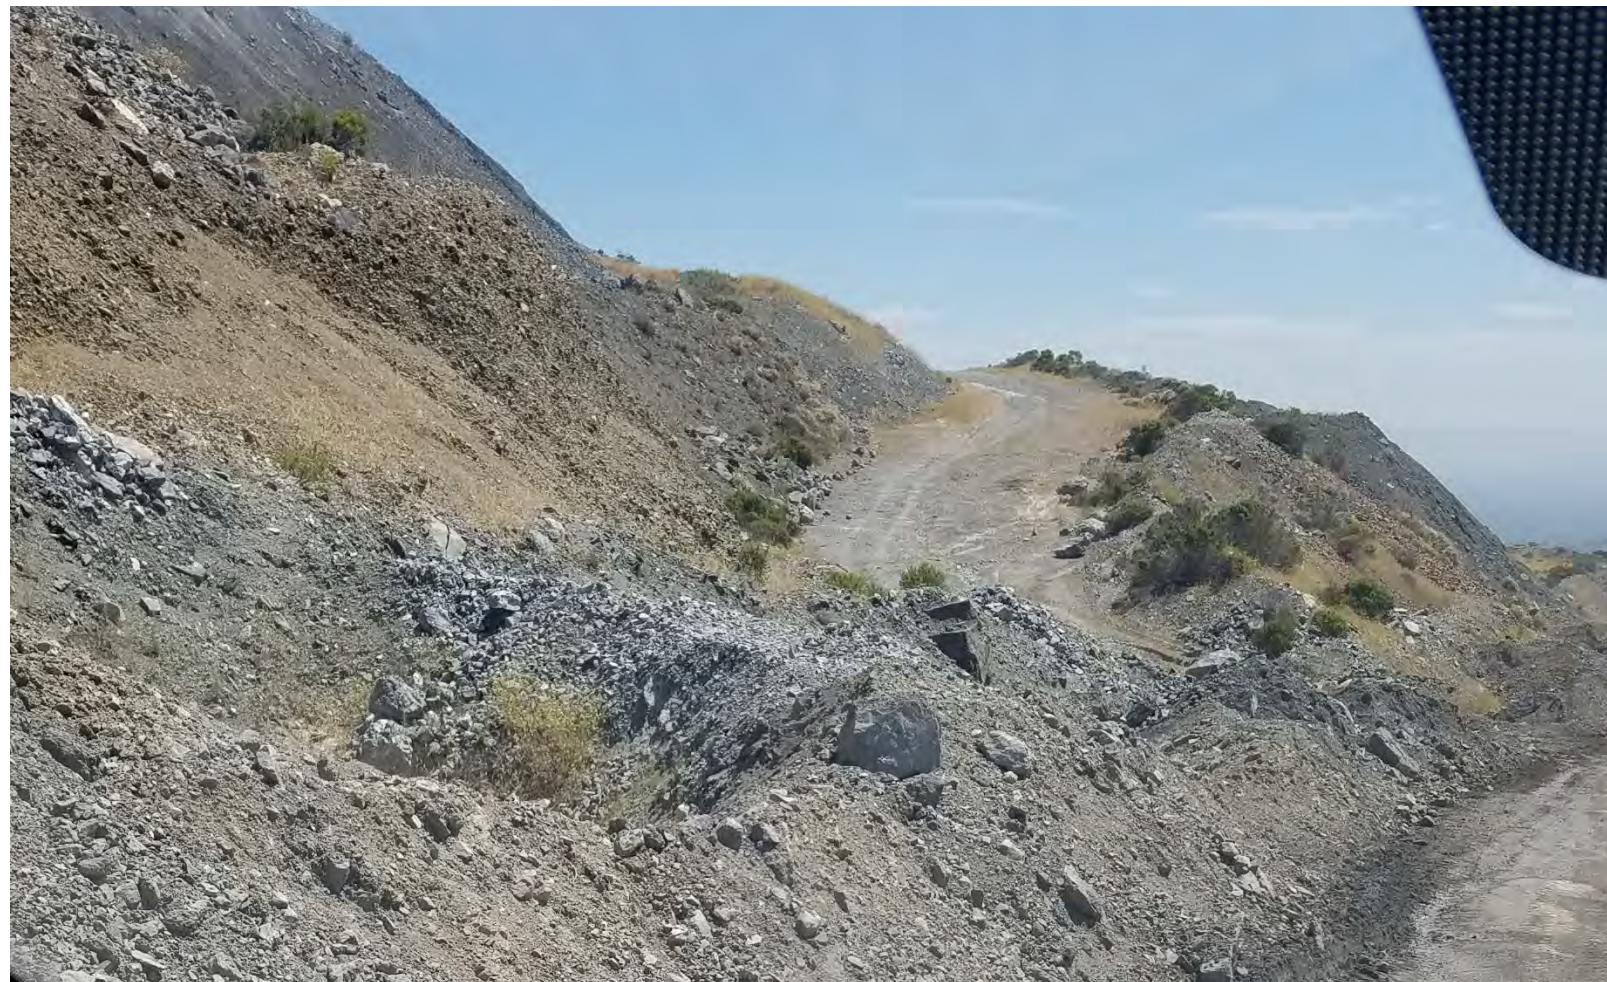
PHOTO #20 – Check dam on the WMSA road

Runoff and drainage are controlled on-site by various methods including check dams installed on internal access roads. [See **Photo #20** for example check dam.] Check dams are required to be made of non-limestone rock in order to prevent selenium contamination. Erosion control measures are typically installed before the rainy season and are inspected during winterization inspections. The County of Santa Clara issued a Notice of Violation related to inadequate erosion control measures which resulted in a discharge of sediment into Permanente Creek. See section below for more details on this violation.

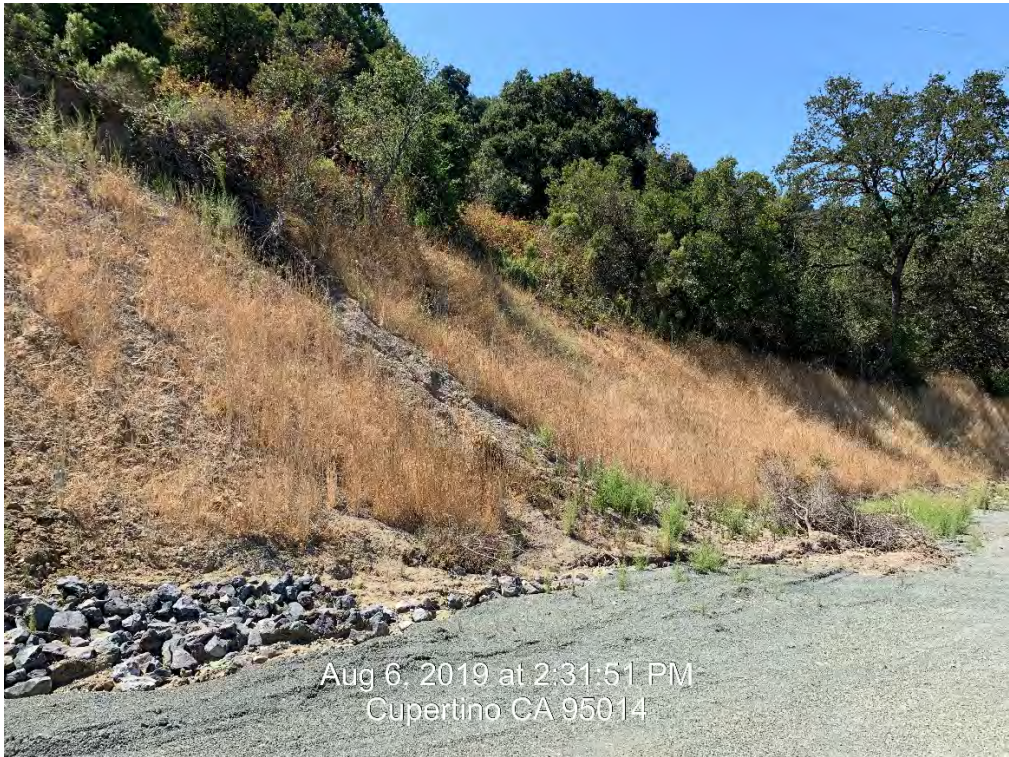
During the 2018 annual SMARA inspection inspectors observed that a new road linking Lehigh Quarry and Stevens Creek Quarry had been constructed without approval. The County issued a Notice of Violation on August 17, 2018 and noted the violation in the 2018 Lehigh Annual Inspection Report, dated August 8, 2018. Subsequently, Lehigh applied for a Reclamation Plan Amendment which, if approved, will expand the Reclamation Plan Boundary to include the haul road area. This reclamation plan amendment application is currently being processed. This haul road remains in place but is not being used. Inspectors noticed localized erosion which needs to be managed by installation of erosion control BMPs. [See **Photos #21A, 21B, and 21C.**] Installation of erosion control BMPs will be verified during winterization inspection.

Photo #21A – Cut slope on west side of illegally graded haul road

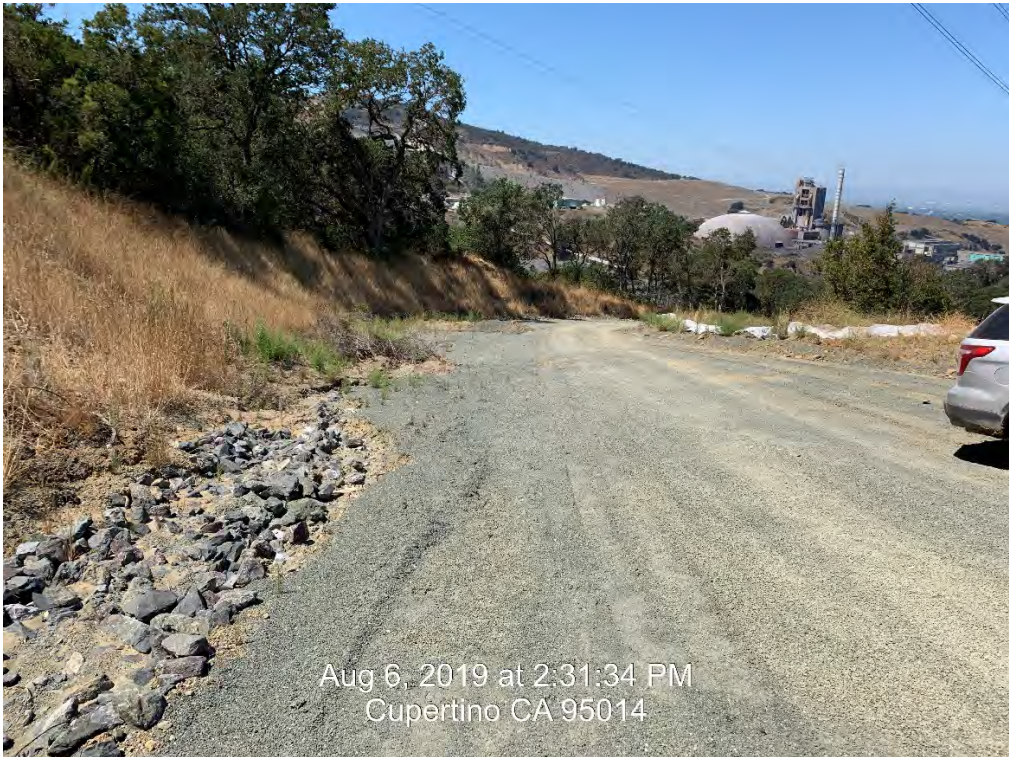
Photo #21B – Looking north along west side of illegally graded haul road

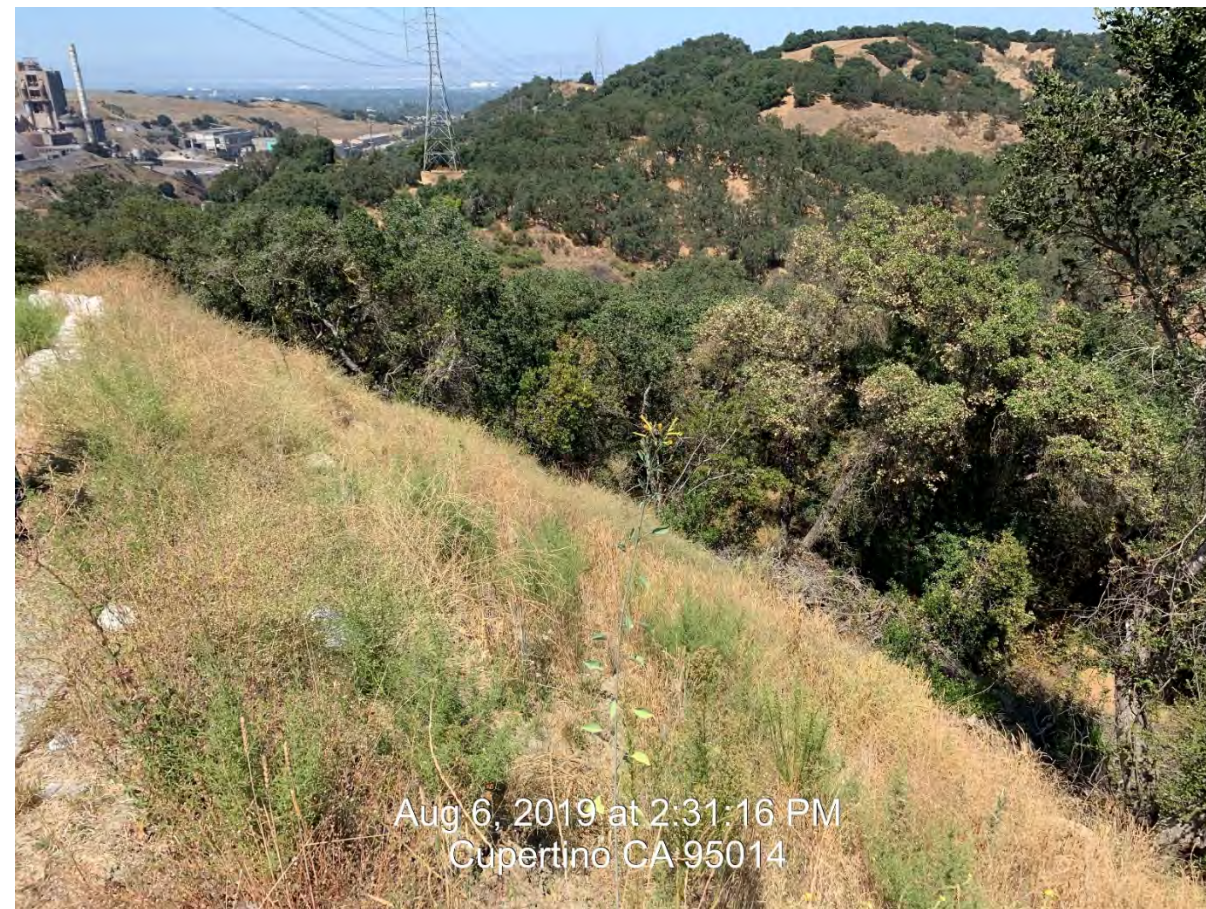
Photo #21C Fill slope below east side of illegally graded haul road

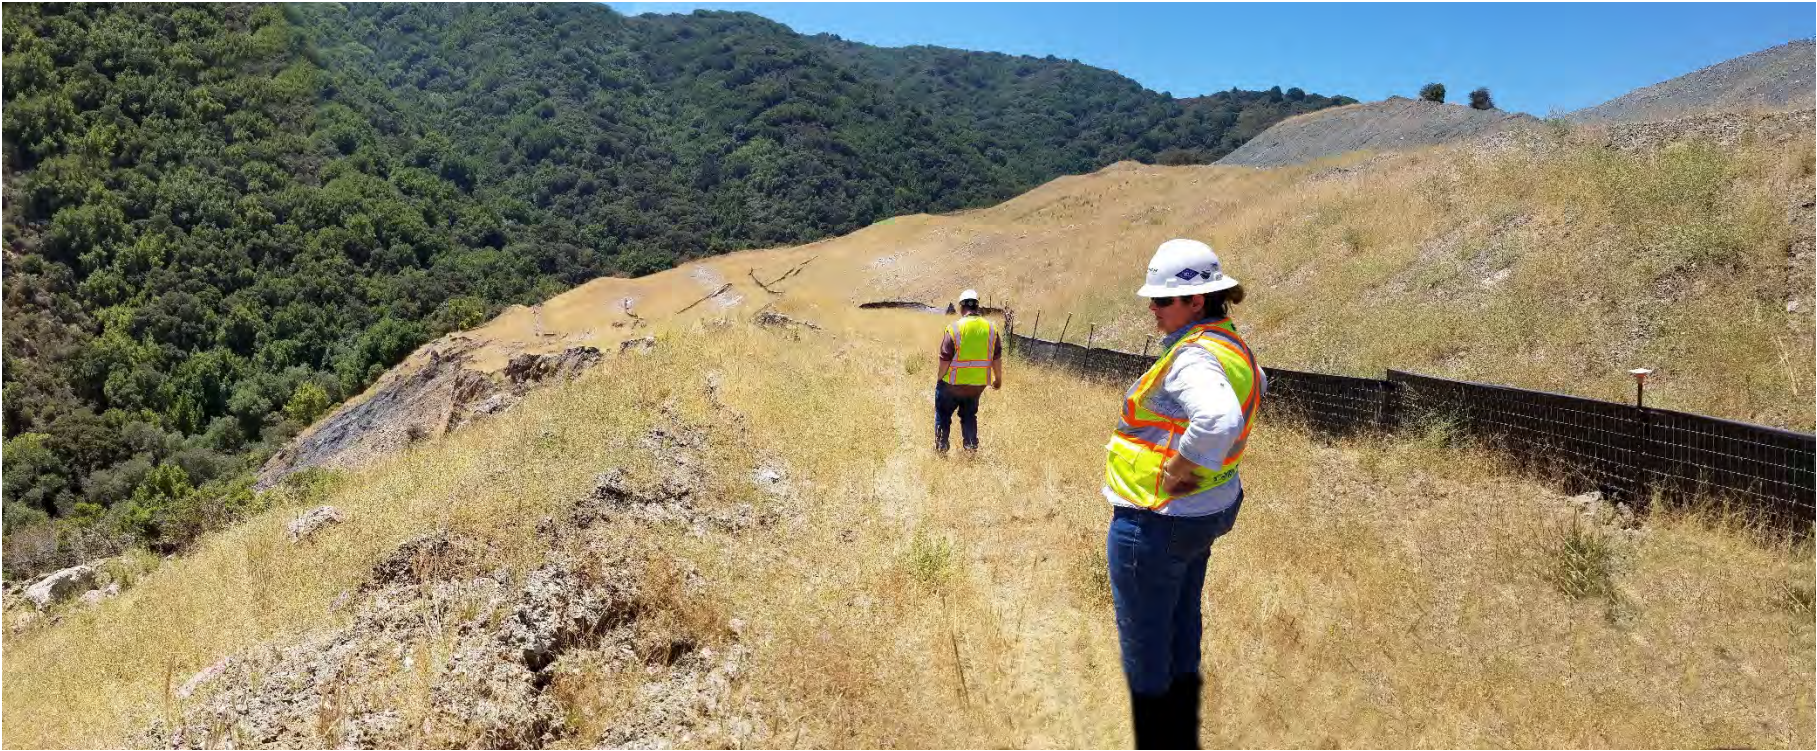
A new SMARA violation was noted during the monthly “boots on the ground” inspection conducted on April 30, 2019. During that inspection, County staff observed sediment eroded from a debris flow scar on the Yeager Yard slope entering Permanente Creek. It appears that this debris flow resulted from

slope instability below the Yeager Yard. [See **Photos #22, #23, and #24.**] The portion of Permanente Creek impacted by the debris flow was revisited on May 21, 2019 by County staff along with State Water Board staff. [See **Photos #25 and #26** taken during the joint inspection.] Refer to the attached Notice of Violation for further details. (See Attachment C.)

Photo #22 – Toe of Yeager Yard slide above Permanente Creek (out of view to the left)

1. **By June 28, 2019**, submit a plan for soil stabilization and stormwater control and erosion prevention in the violation area to prevent further discharge of sediment into Permanente Creek;

4. **By July 5, 2019**, implement the soil stabilization and stormwater control and erosion prevention plan noted under Item 1 above;
5. **By July 12, 2019**, submit slope stability calculations that analyze the stability of the south-facing slope of the West Materials Storage Area pursuant to California Code of Regulations, Title 14, § 3704(f), prepared by CEG. If unstable conditions are identified, you must also recommend remedial action; and

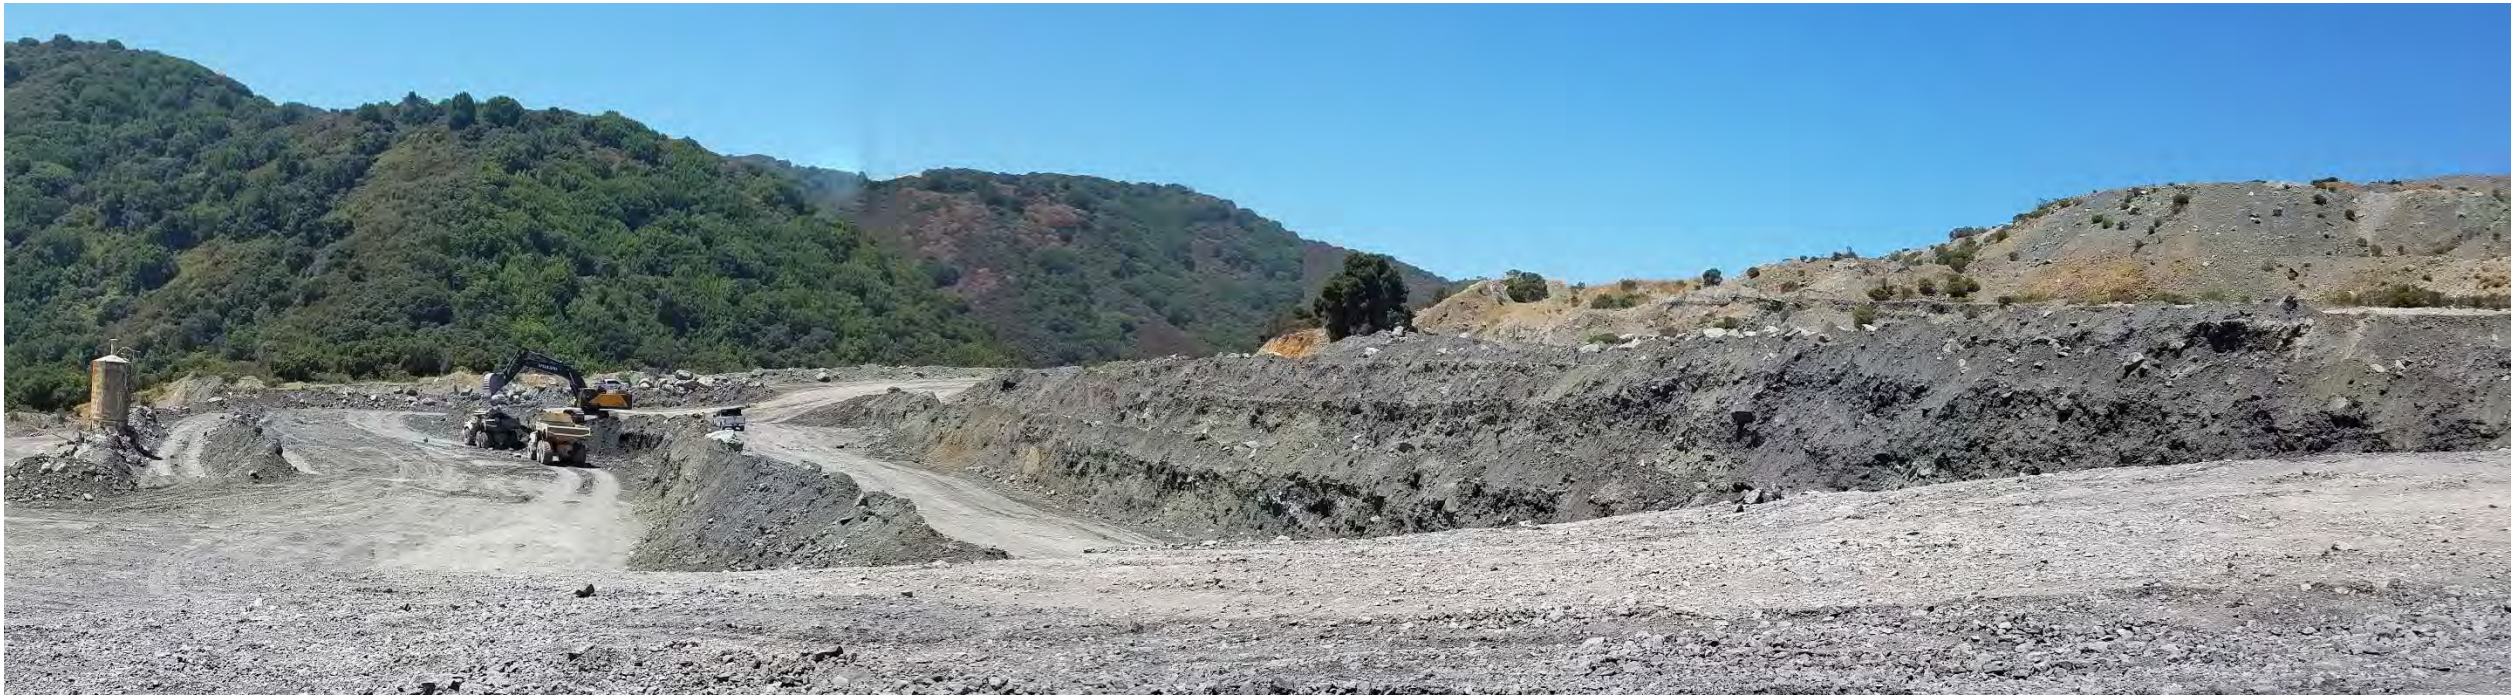
Photo #23 – Excavation above Yeager Yard
