SURFACE MINING INSPECTION REPORT

I. Mine Name (As Shown on Approved Reclamation Plan) Permanente Quarry (Lehigh Quarry)	Inspection Date: 08-06-2019	CA MINE ID# 91- 43-0004
--	---------------------------------------	-----------------------------------

Notes from 2019 Annual SMARA Inspection Conducted on 8-06-2019

Robert Salisbury, Senior Planner
James Baker, CEG#1021, County Geologist

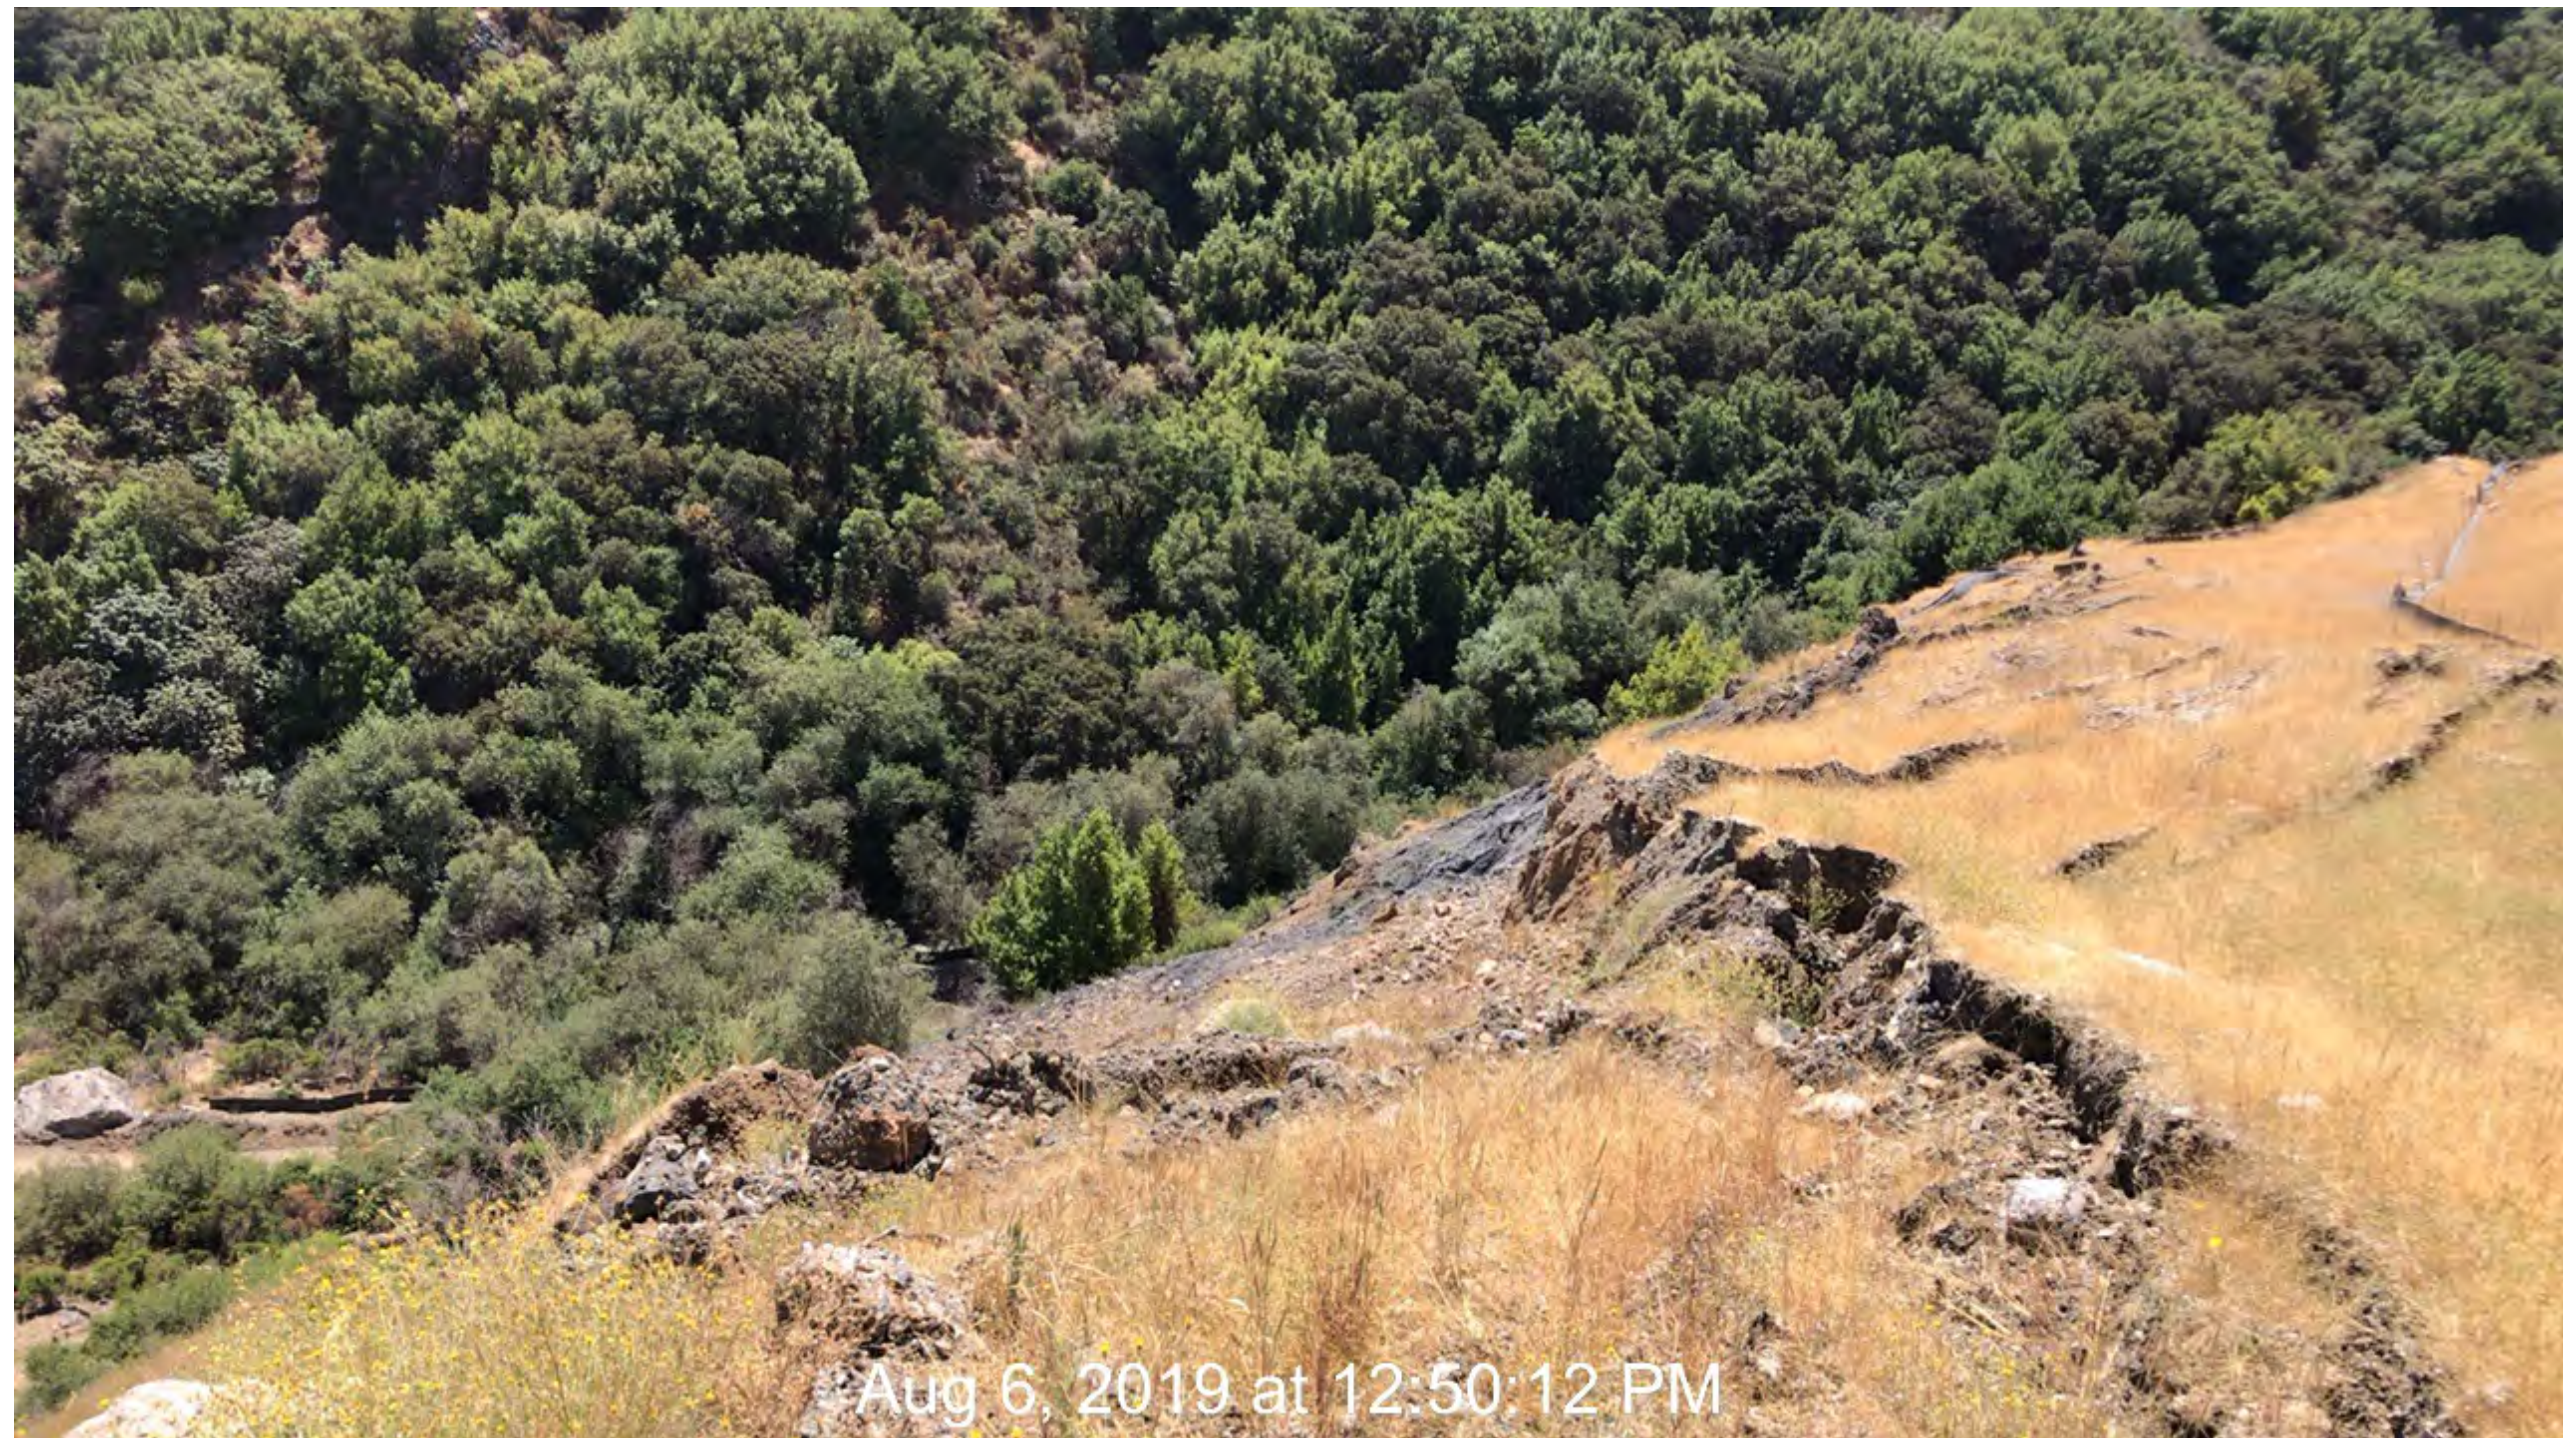
slope instability below the Yeager Yard. [See **Photos #22, #23, and #24.**] The portion of Permanente Creek impacted by the debris flow was revisited on May 21, 2019 by County staff along with State Water Board staff. [See **Photos #25 and #26** taken during the joint inspection.] Refer to the attached Notice of Violation for further details. (See Attachment C.)

Photo #24 – Toe of Yeager Yard land slide above Permanente Creek (lower left)

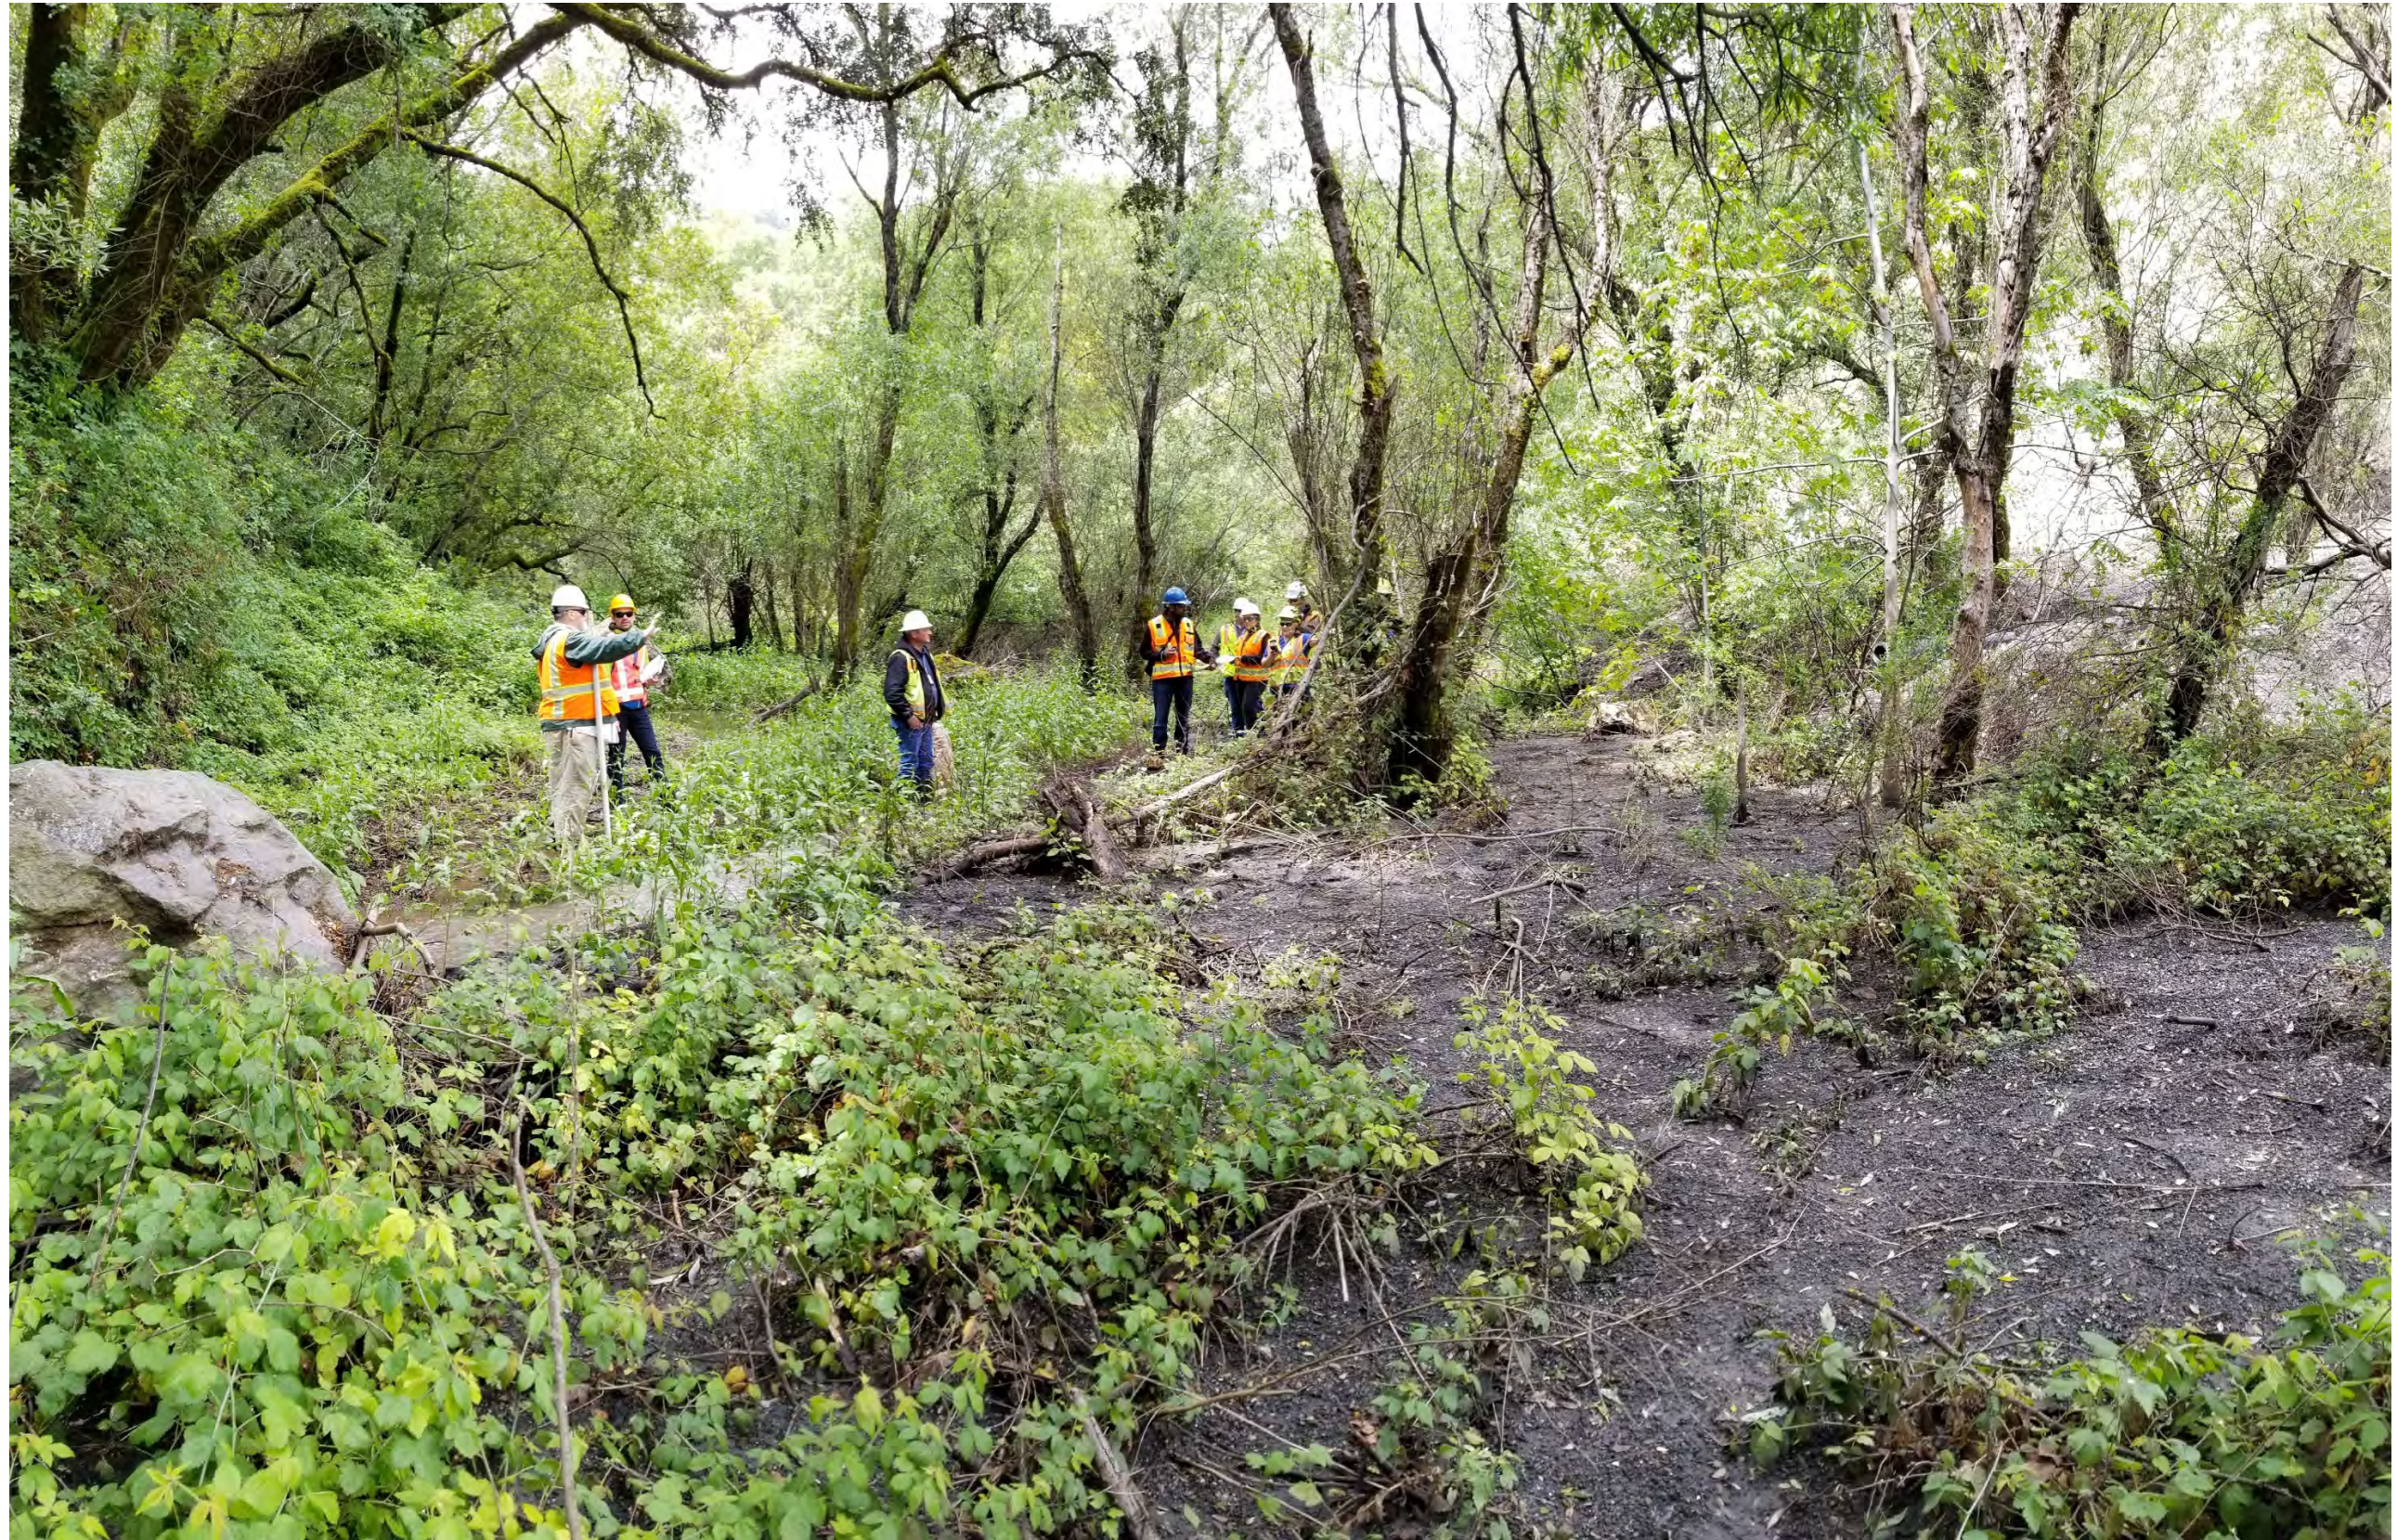
Photo #25 – Sediment deposited into Permanente Creek from Yeager Yard slope (off-camera to right) Photo taken on May 21, 2019

2. **By June 28, 2019**, test the sediment material discharged into Permanente Creek for contaminants, such as selenium and submit a report presenting the results of that testing to the County Department of Planning and Development Planning Division (Planning Division) and the California Regional Water Quality Control Board (Regional Board). Further action may be required based on the results of this testing;

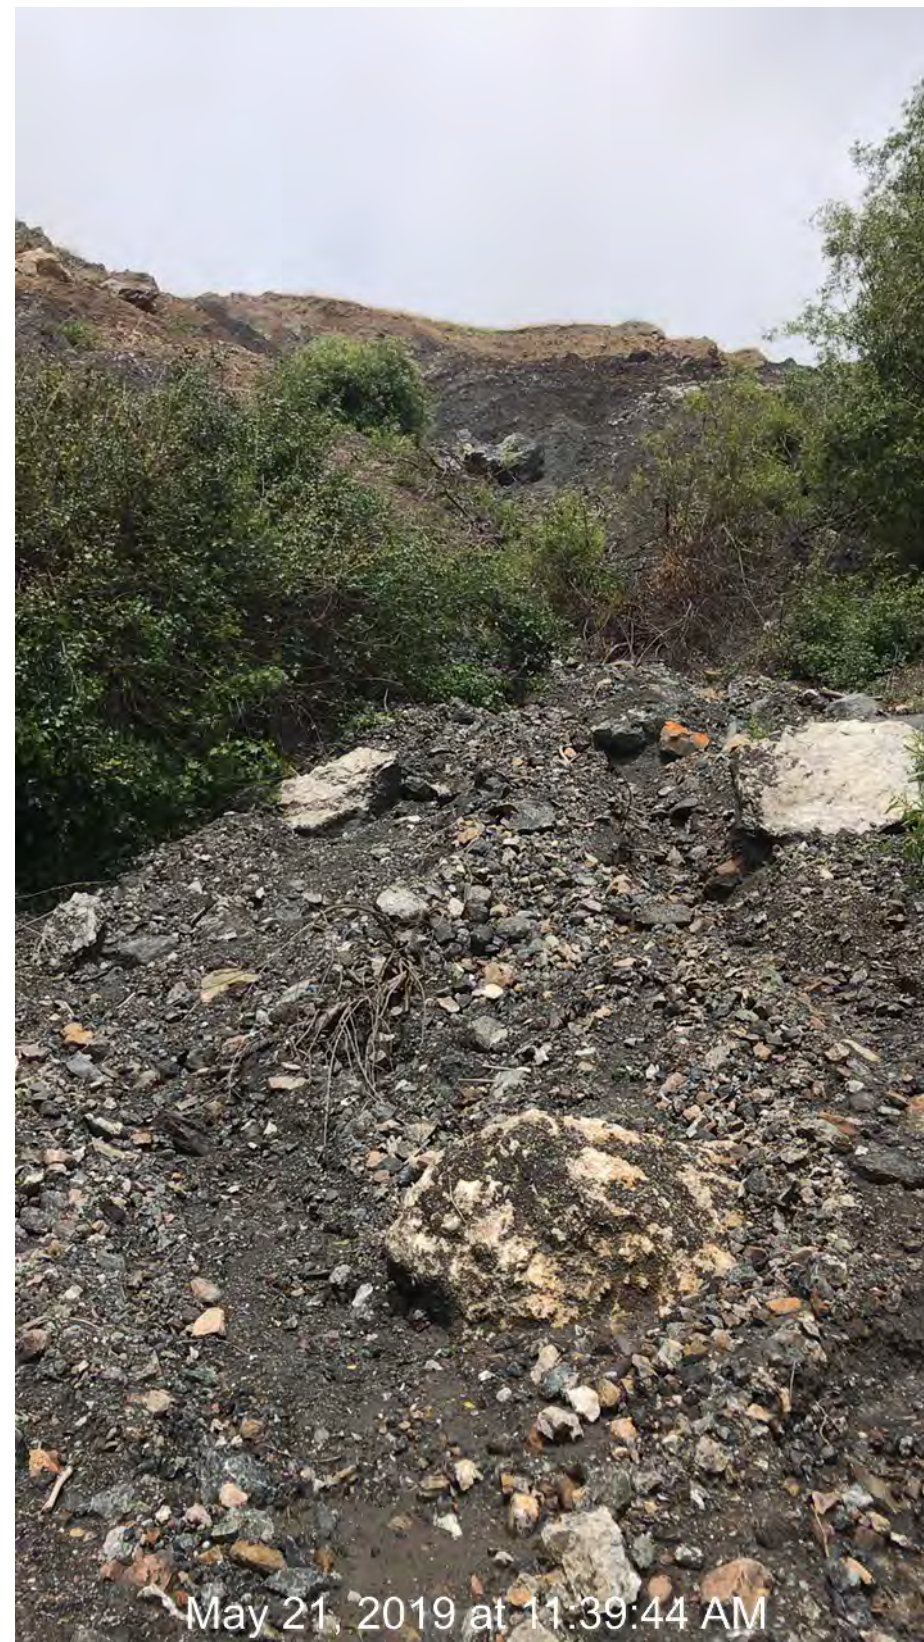
Photo #26 – Debris flow scar (source of sediment deposited in Permanente Creek) photo taken on May 21, 2019

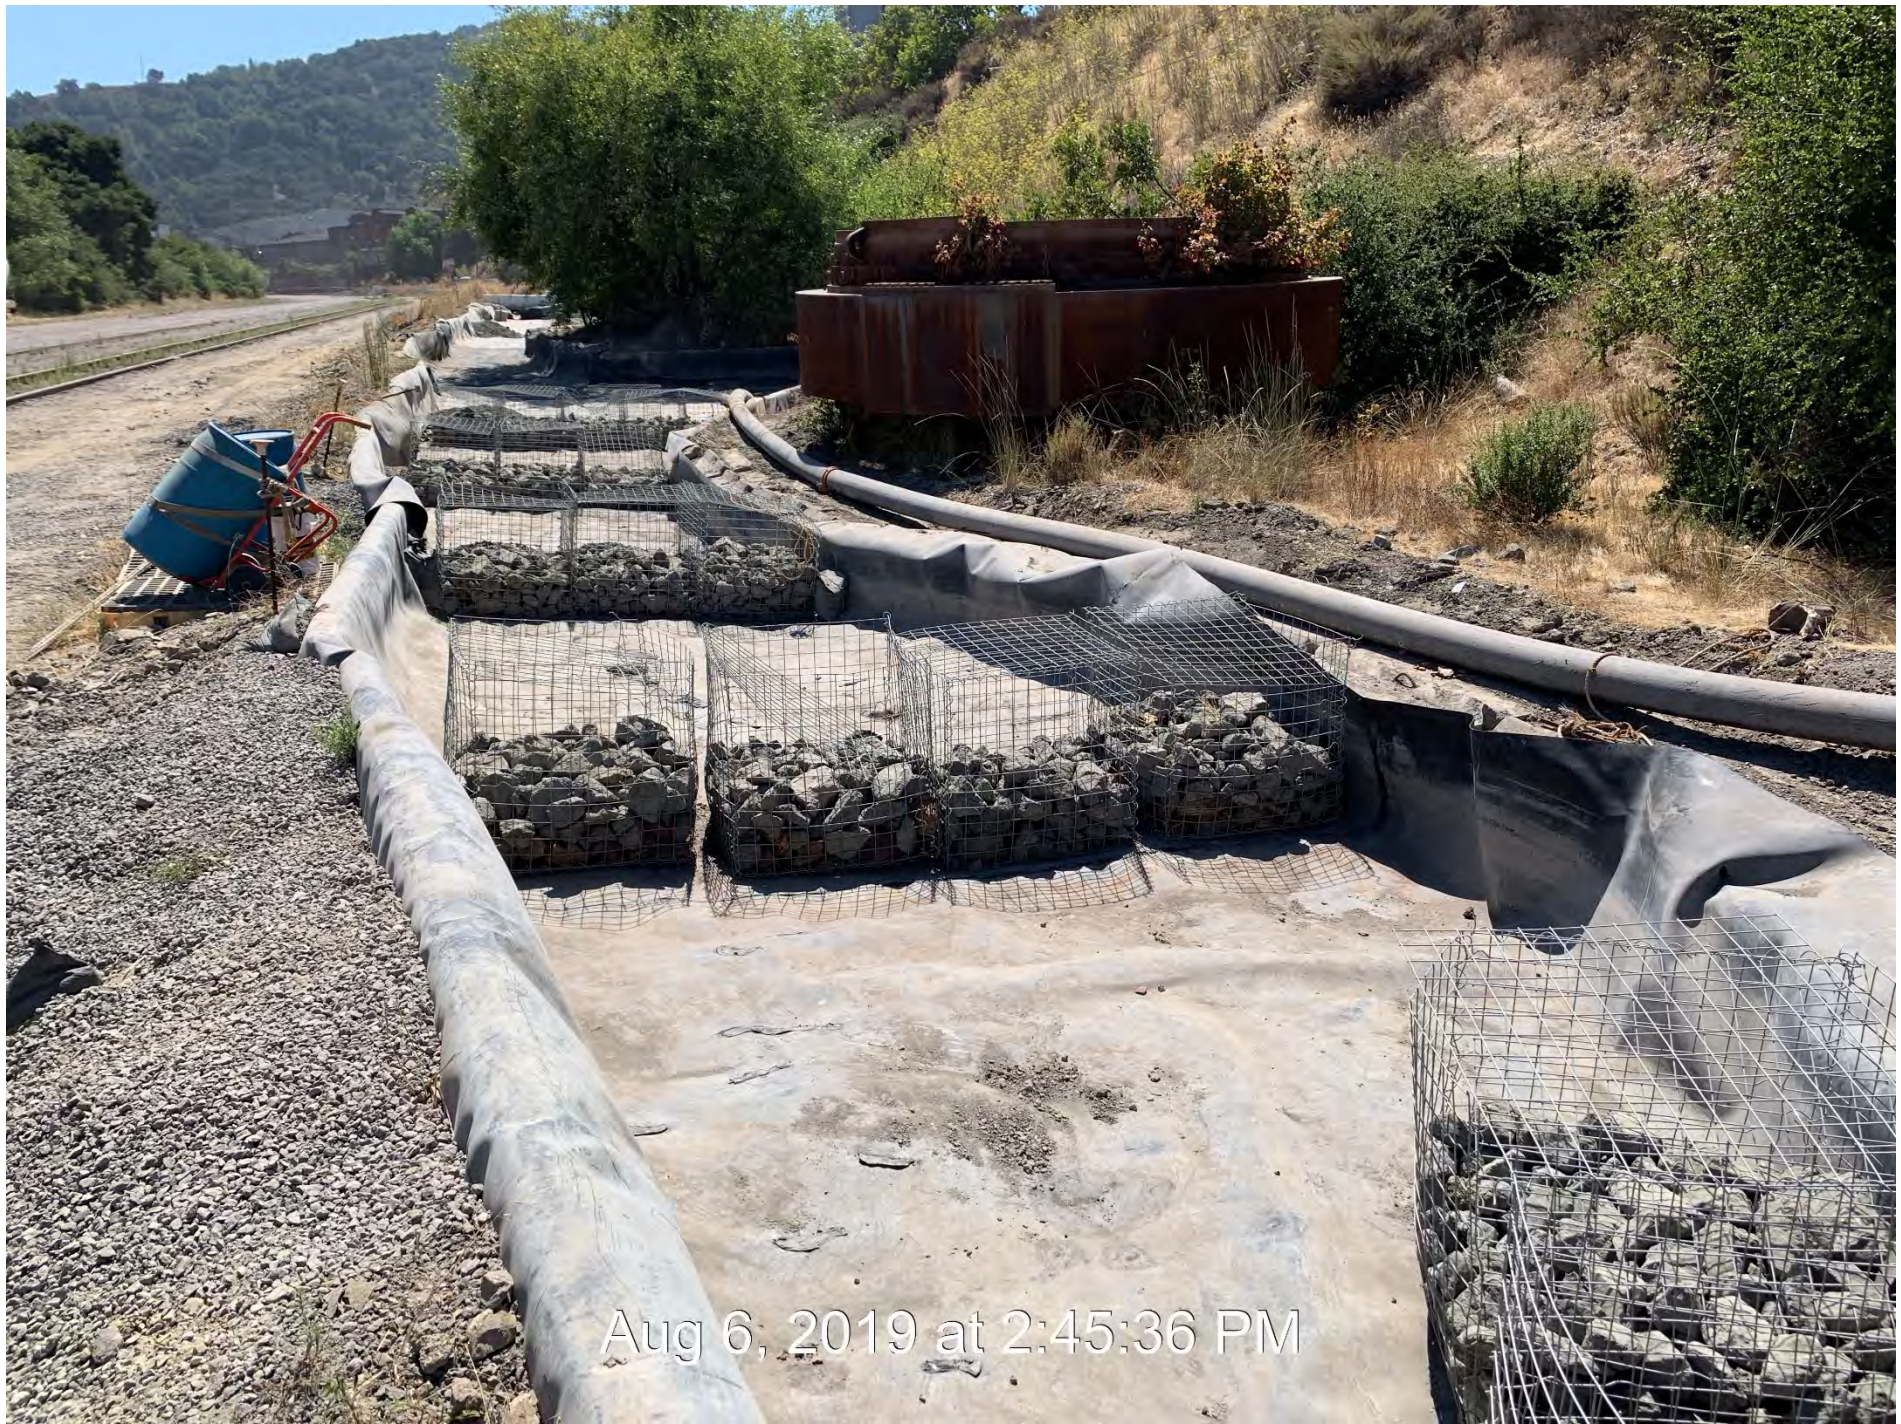
Photo #27 – Lining and gabions in new sediment catchment (alternative Pond 17)

During the annual inspection, the quarry operator informed County inspection staff that Lehigh discontinued use of Pond 17 during winter 2018/2019 and re-routed surface runoff to an instream sediment catchment consisting of a lined channel with rock-filled gabions and a release volume meter. [See **Photo #27.**] This in-stream catchment feature, located outside of the Reclamation Plan boundary, was installed September/October 2017 at the direction of the State Water Board.
