## SURFACE MINING INSPECTION REPORT

Photos from 2020 Annual SMARA Inspection Conducted on 8-06-2020

by  
Robert Salisbury, Senior Planner  
James Baker, CEG#1021, County Geologist  
Steve Beams, Senior Construction Inspector  
Glen Jia, Assistant Planner

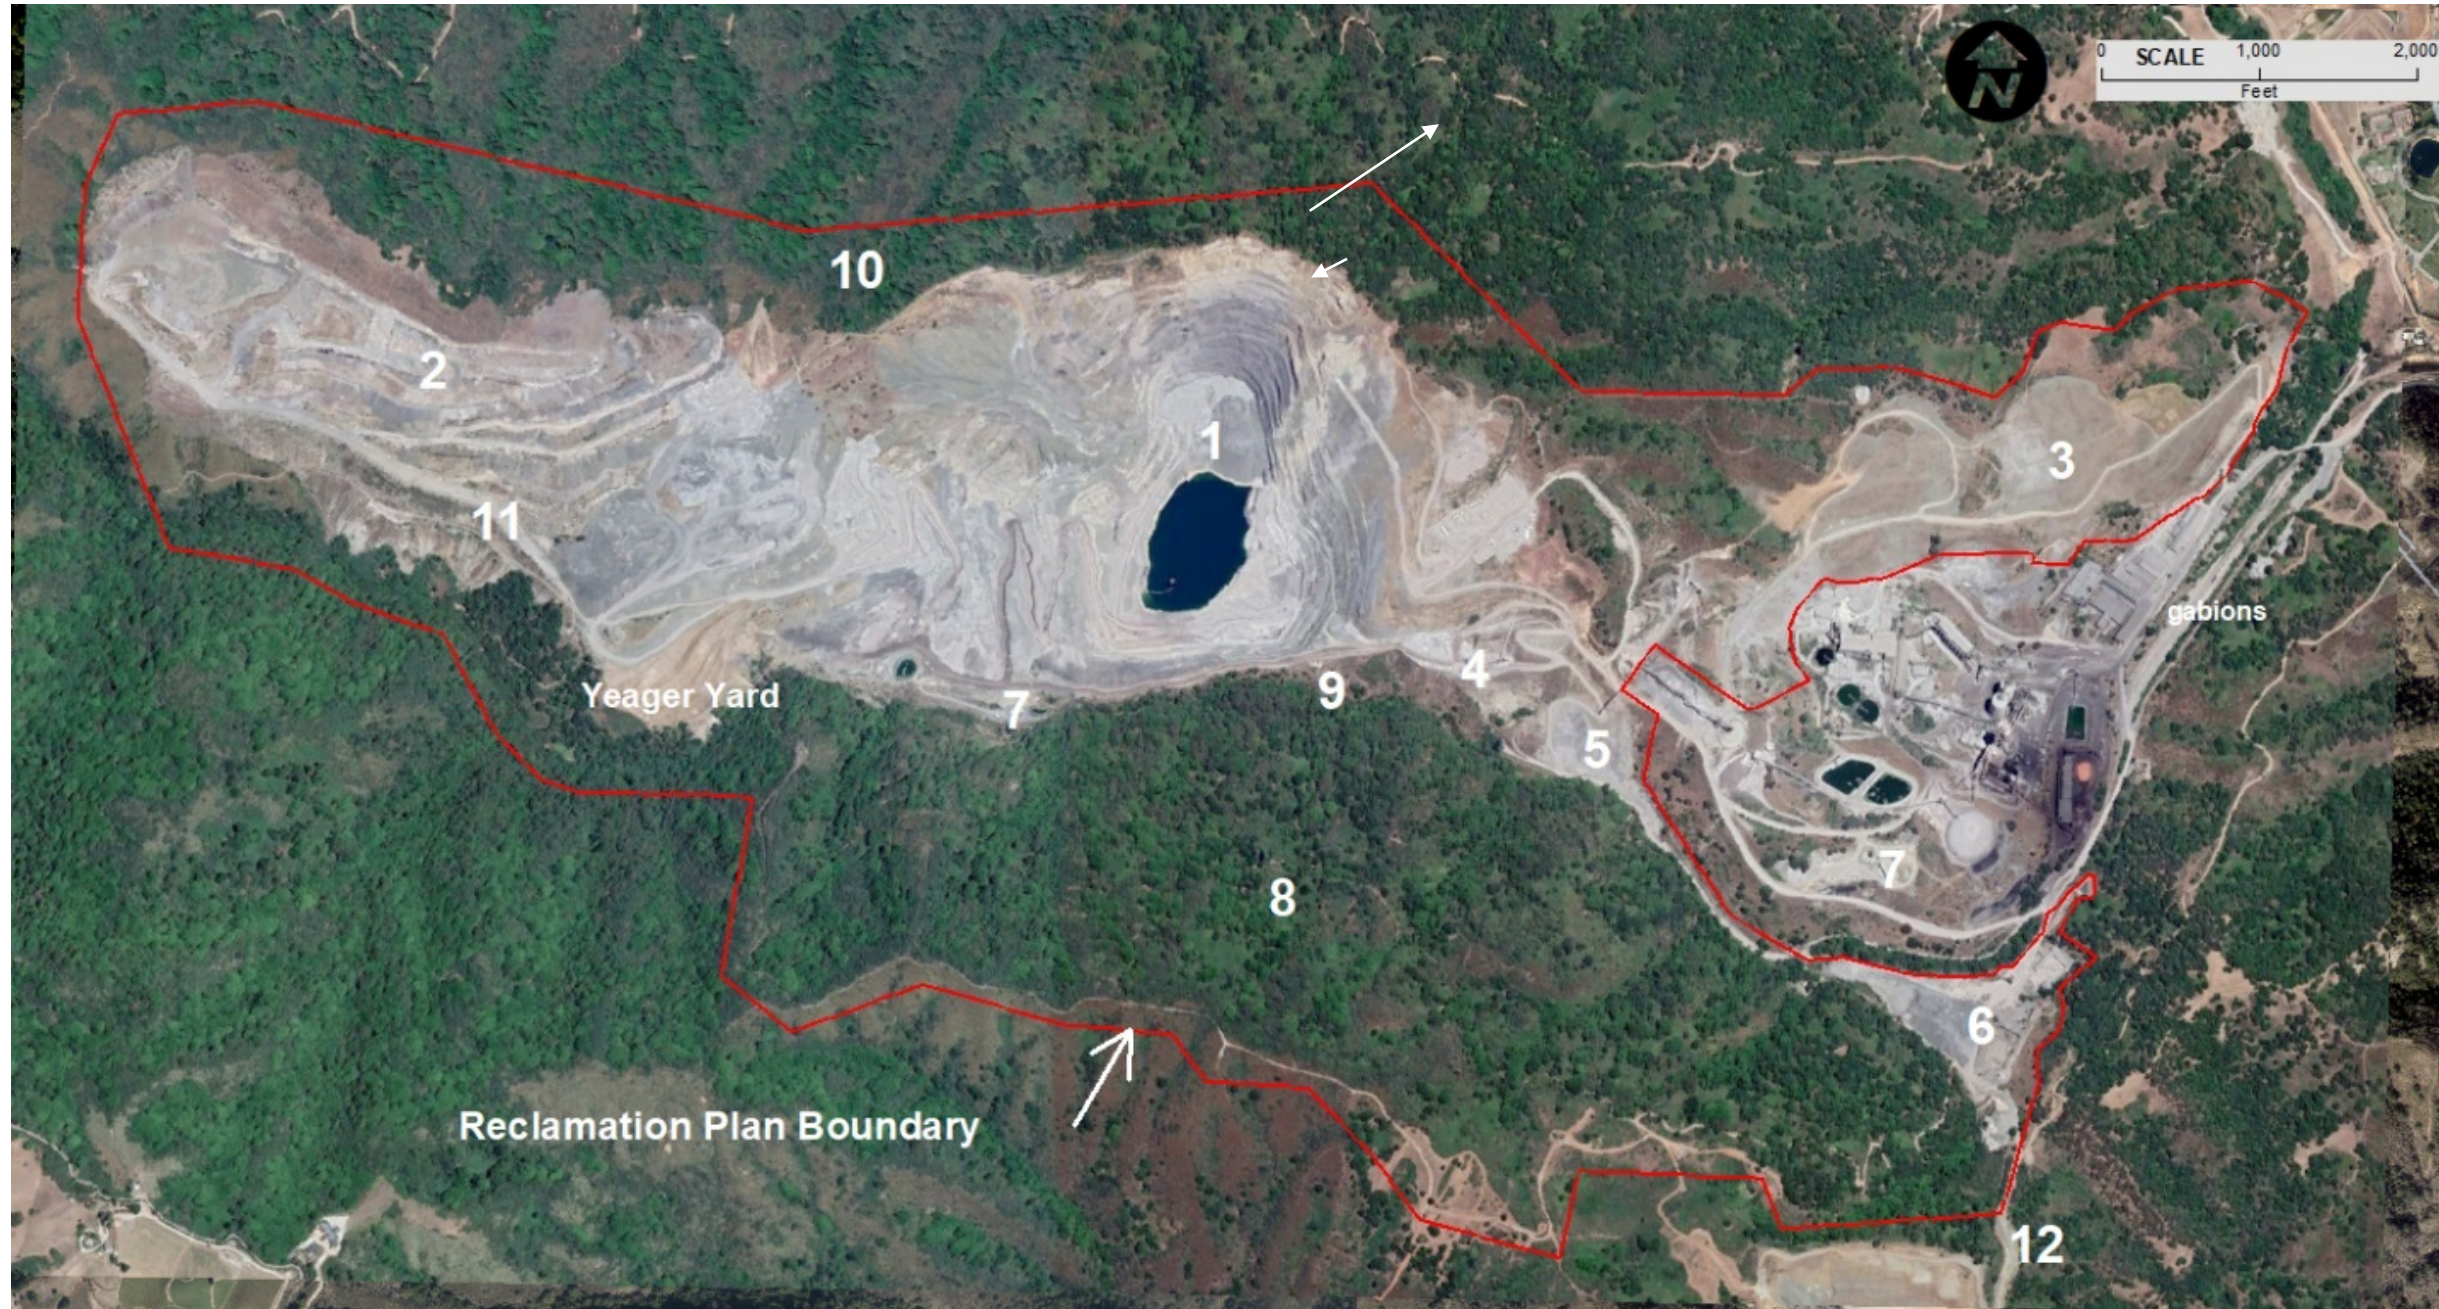
**PHOTO #1** – North Quarry Main Pit (looking southwest)

The highwalls on the north, east, and south are essentially complete (excavated benches); while the southern side of the pit is still being actively mined (blasting and loading). No extraction of limestone was occurring during the inspection. New material was being placed on the southern portion of the WMSA [See **PHOTO #1** and **PHOTO #2.**]

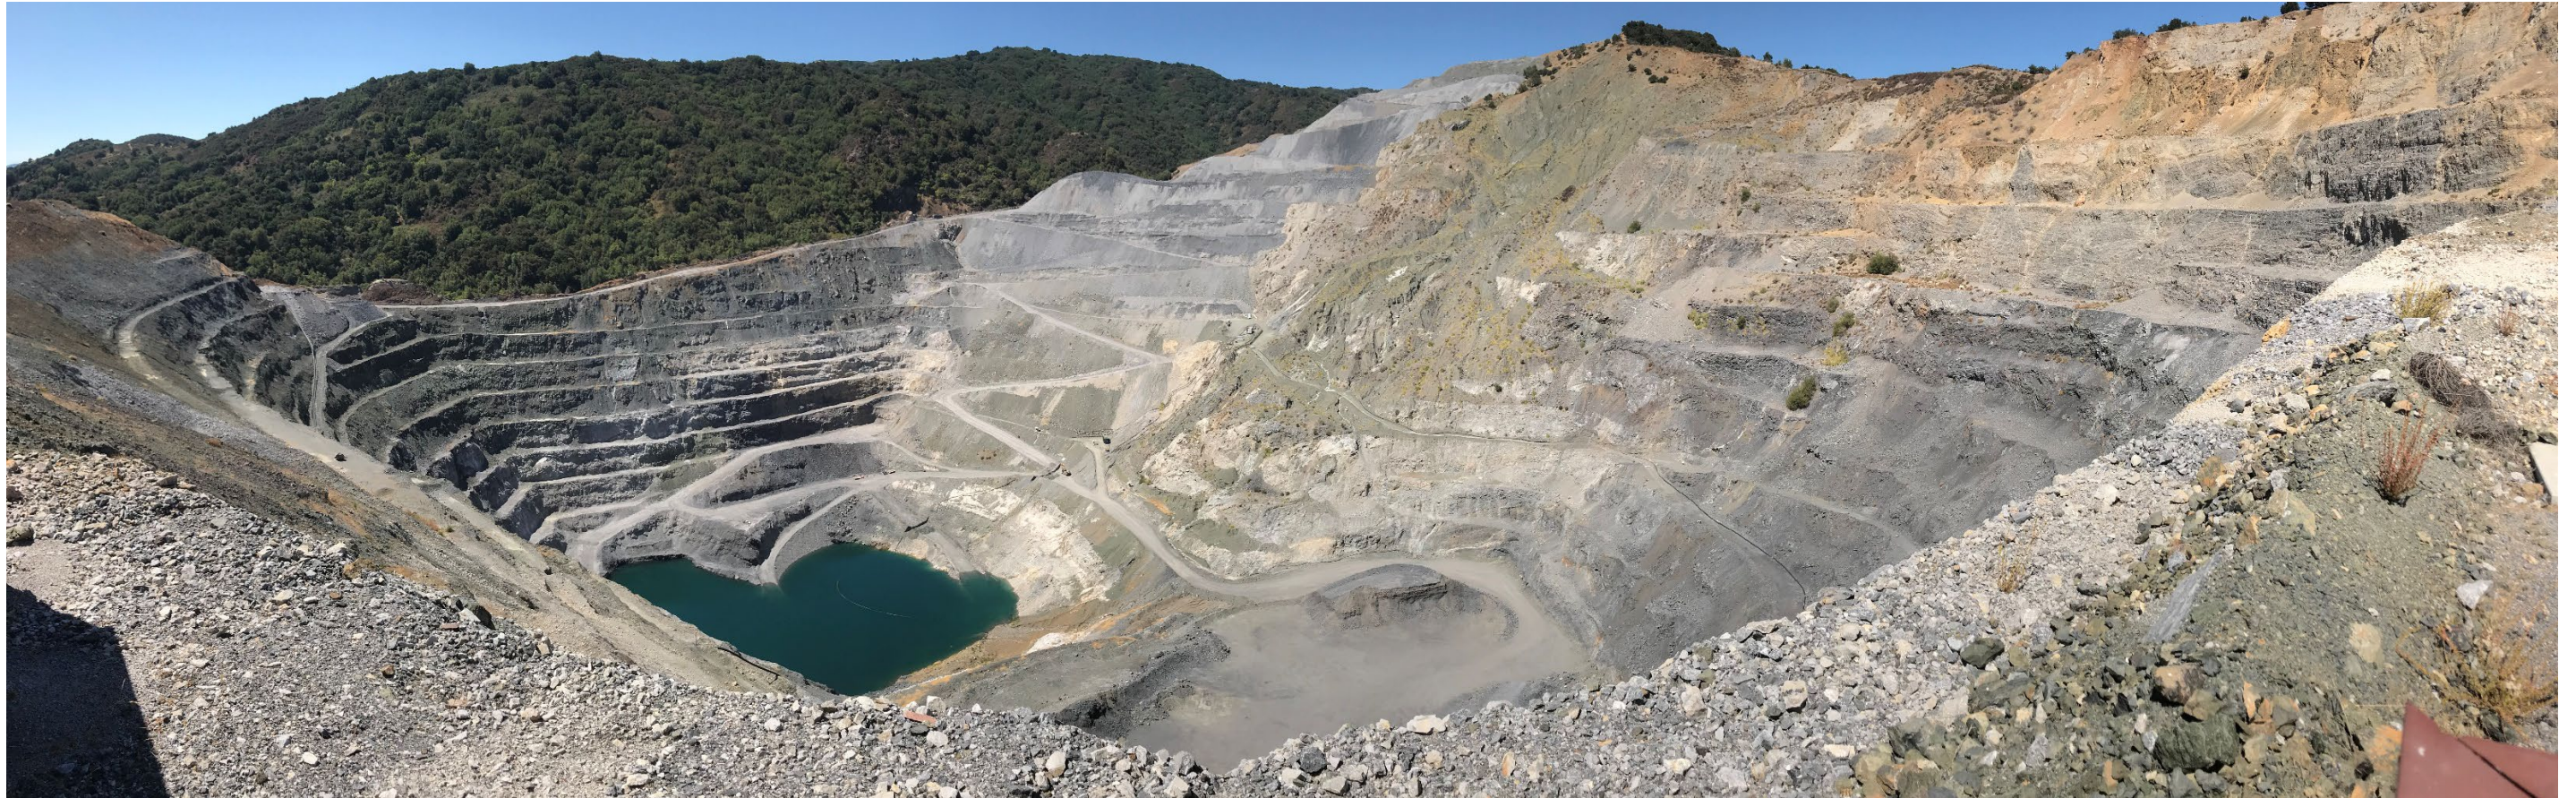
**PHOTO #2** – North Quarry Main Pit (looking northeast)

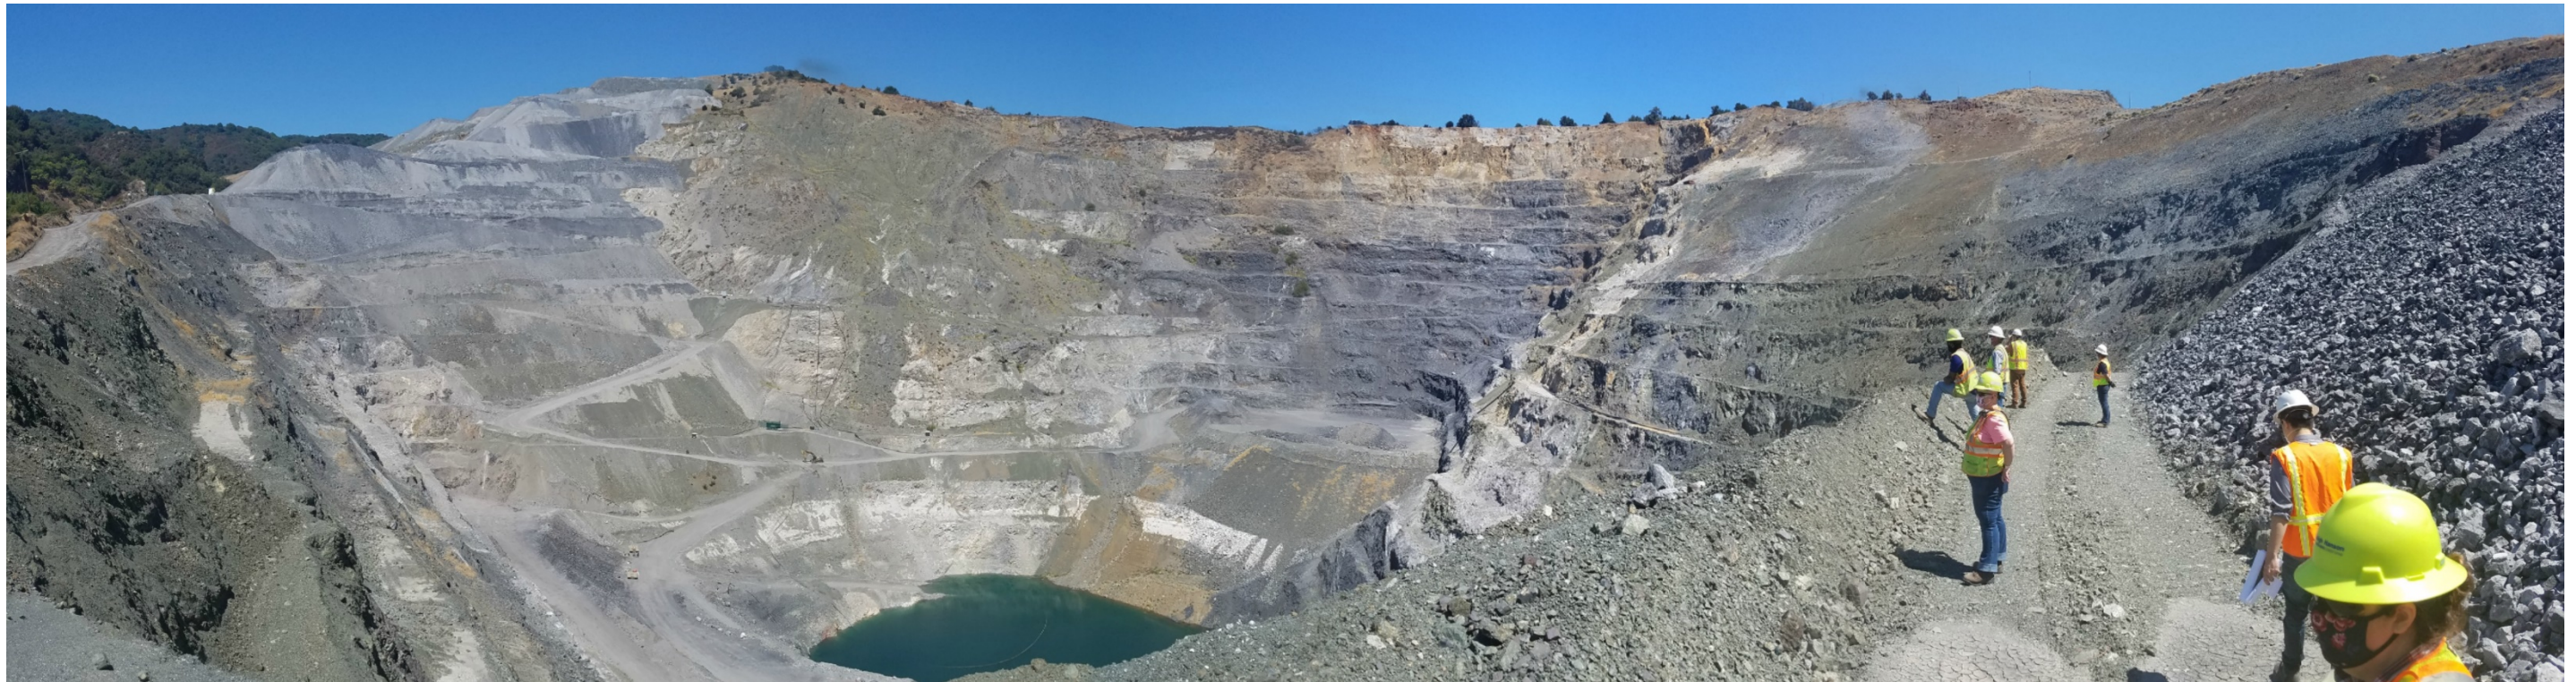
**PHOTO #3** – WMSA (looking northward)

The northeast-facing slopes of the WMSA have well-established vegetation (grasses and same shrubs). [See **PHOTO #3** and **PHOTO #4**.]

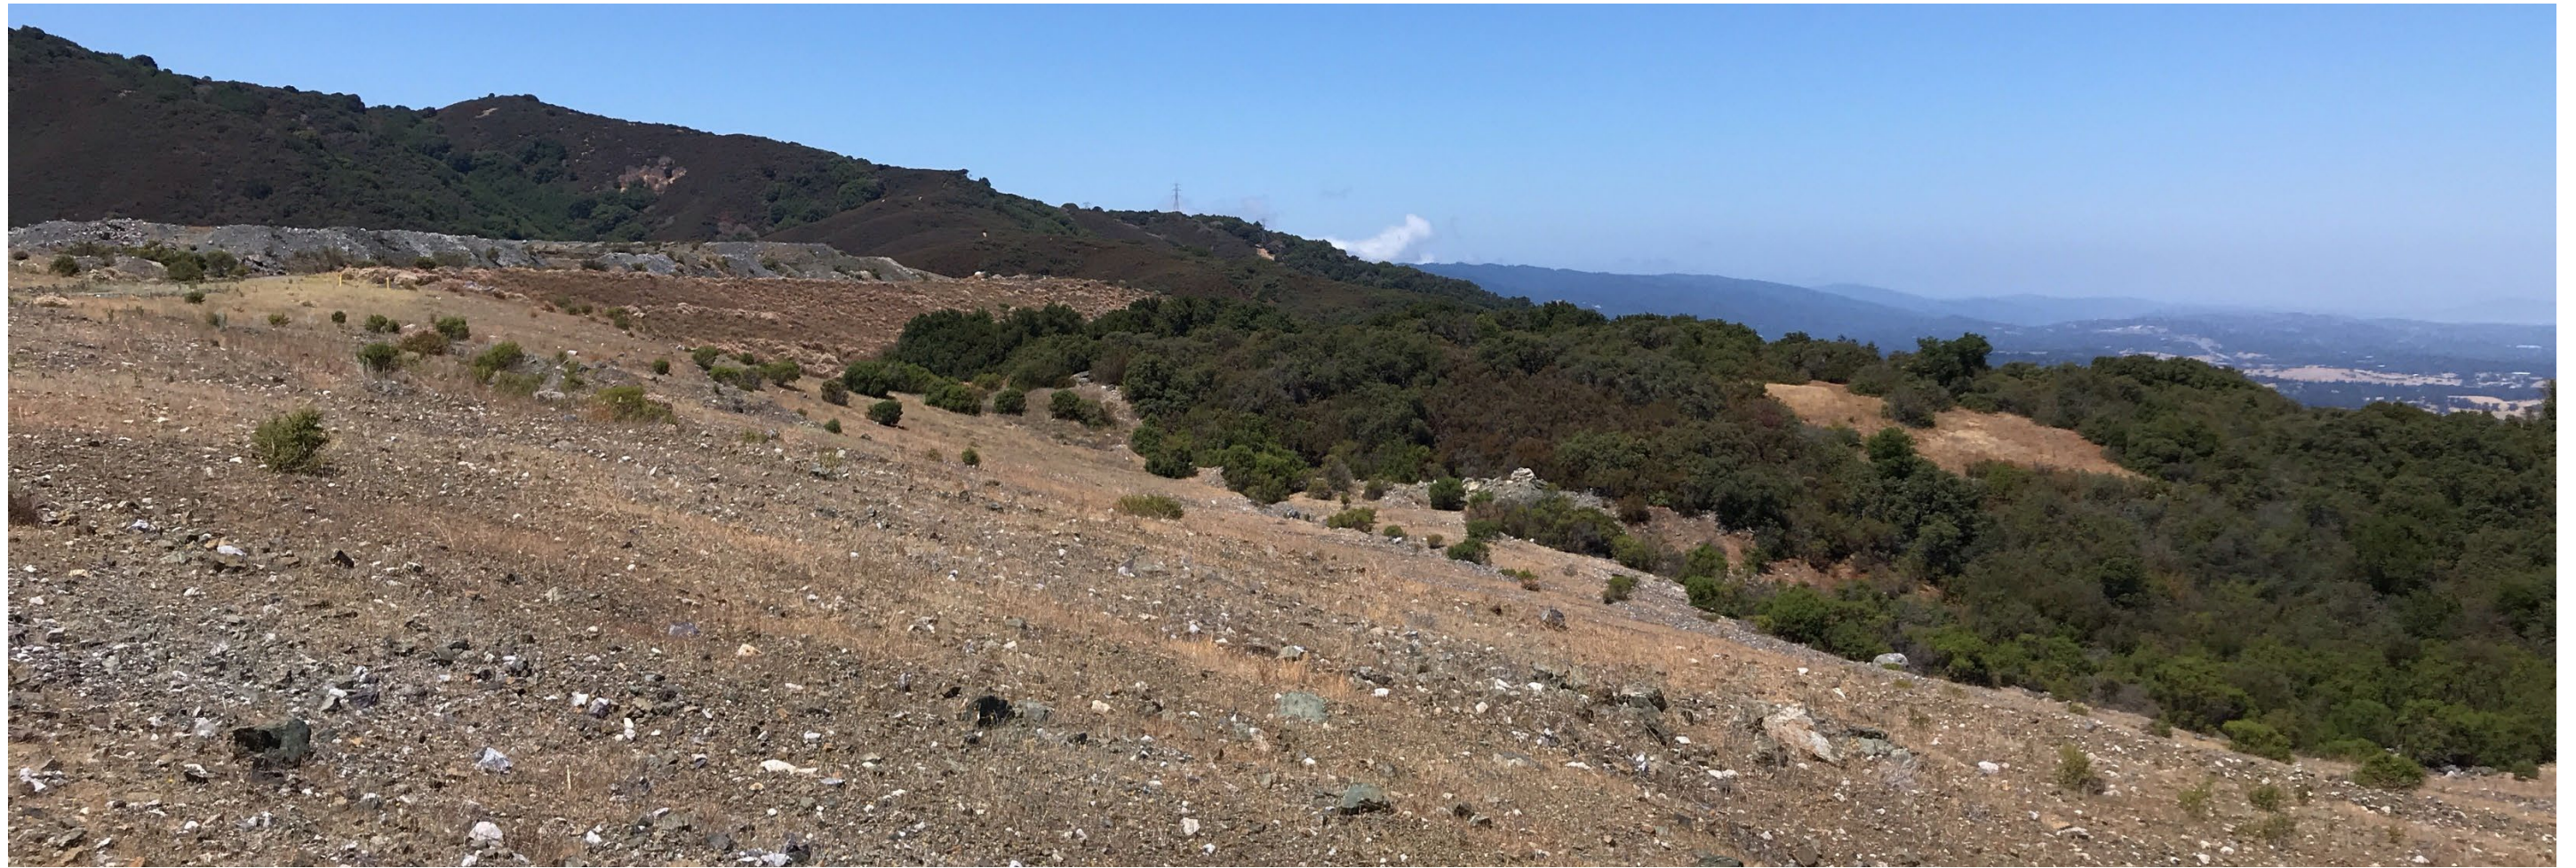
**PHOTO #4** – WMSA (looking northward)

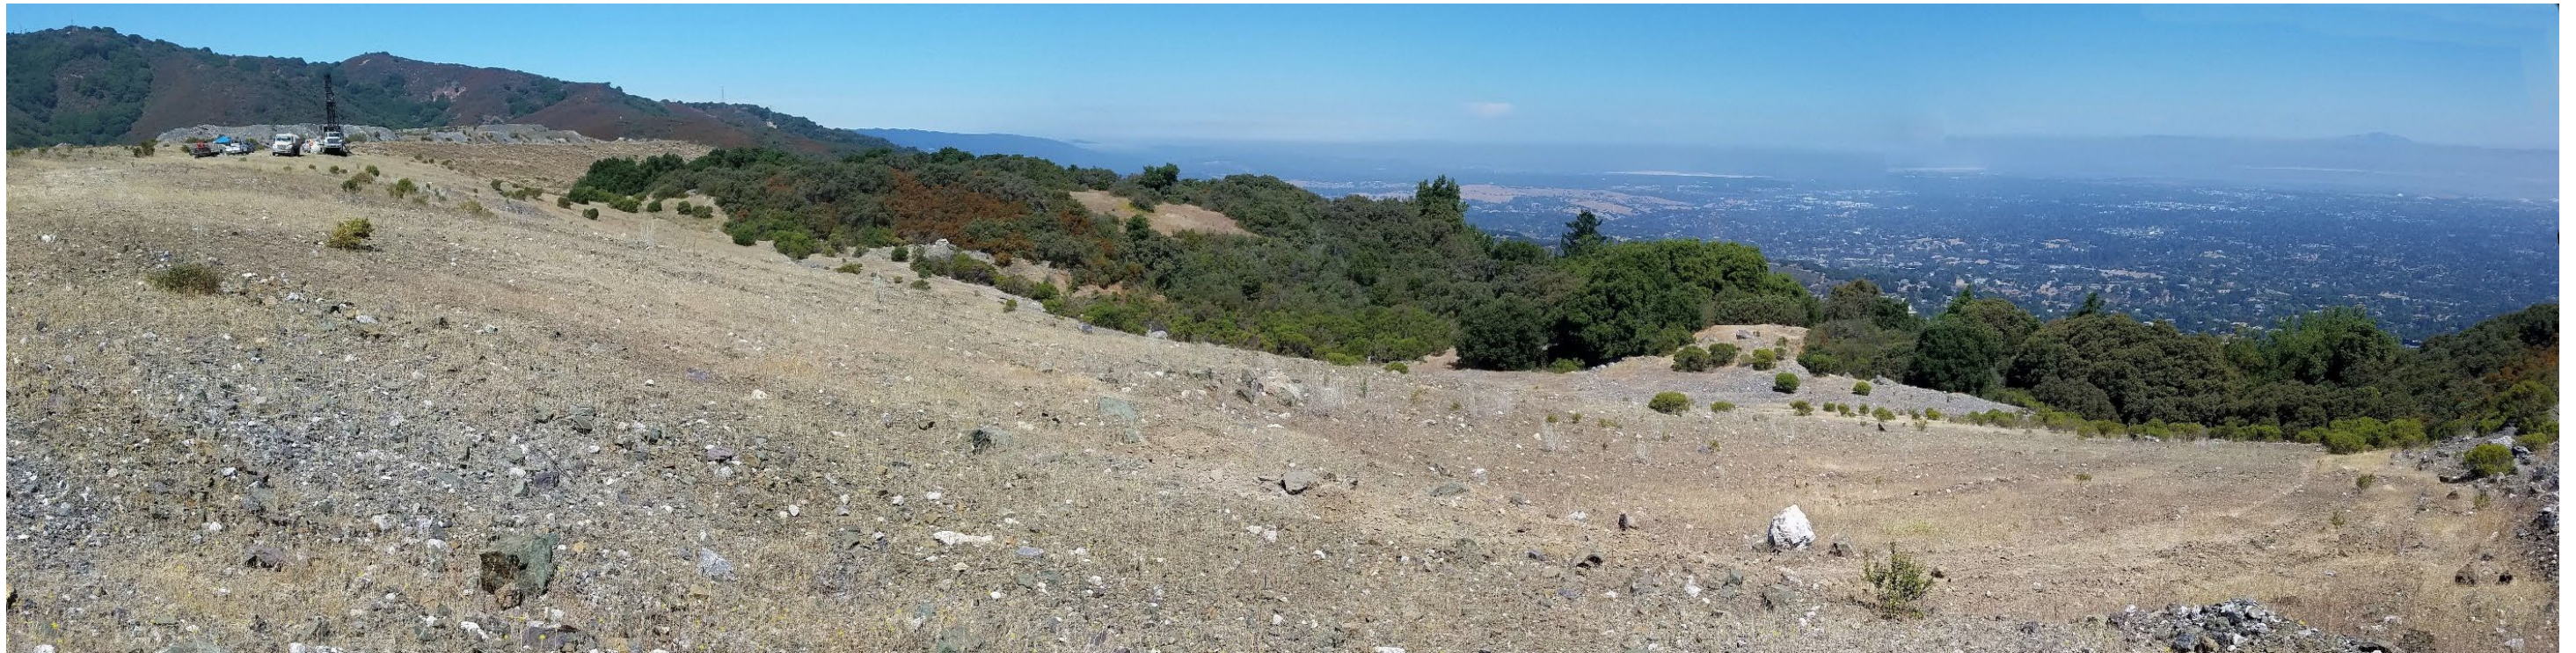
**PHOTO #5A – Topsoil Stockpiles**

Topsoil and organics are stored and covered in the central portion of the WMSA. County staff observed deterioration of previously installed jute netting and minimal growth on the hydroseeded stockpile slopes. [See **PHOTOS #5A and #5B.**] Although no evidence of erosion was observed, County inspectors suggested that the operator monitor the stockpiles and replace erosion control measures as needed to prevent loss of stockpile material through erosion.

- 1) (See map location 2.) County inspectors suggested that the operator monitor the topsoil stockpiles WMSA south slope and replace erosion control measures as needed to prevent loss of material through erosion.
- 2) (See map location 12.) Localized erosion on the haul road cut slopes needs to be managed by installation of erosion control BMPs. Operator has been directed to install these BMPs. Installation will be verified during forthcoming winterization inspection.
- 3) (See area between map locations 6 and 12.) Area of recent grading needs to be hydroseeded in order to minimize the potential for erosion during approaching rainy season.
- 4) (See map location 3.) Shallow slumps need to be regraded in order to minimized the potential for ongoing slope failure.

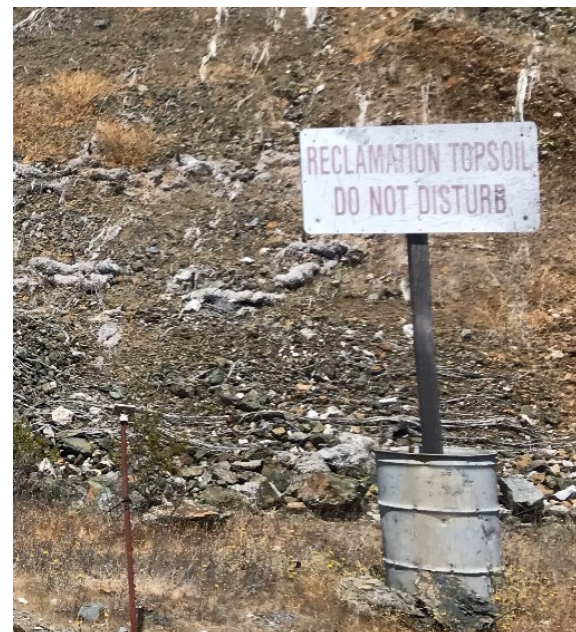
**PHOTO #6** – WMSA South Slope (looking southeast)

The south slope of the WMSA was viewed by County inspectors, and although growth of hydroseeded grasses and shrubs on the south slope of WMSA was minimal, no evidence of erosion was observed. The operator should monitor this area and install erosion control BMPs as needed. [See **PHOTO #6.**] (The approved Reclamation Plan calls for much of the material stored in the WMSA to be moved and placed as backfill into the main quarry pit. Topsoil will be used for plantings.)

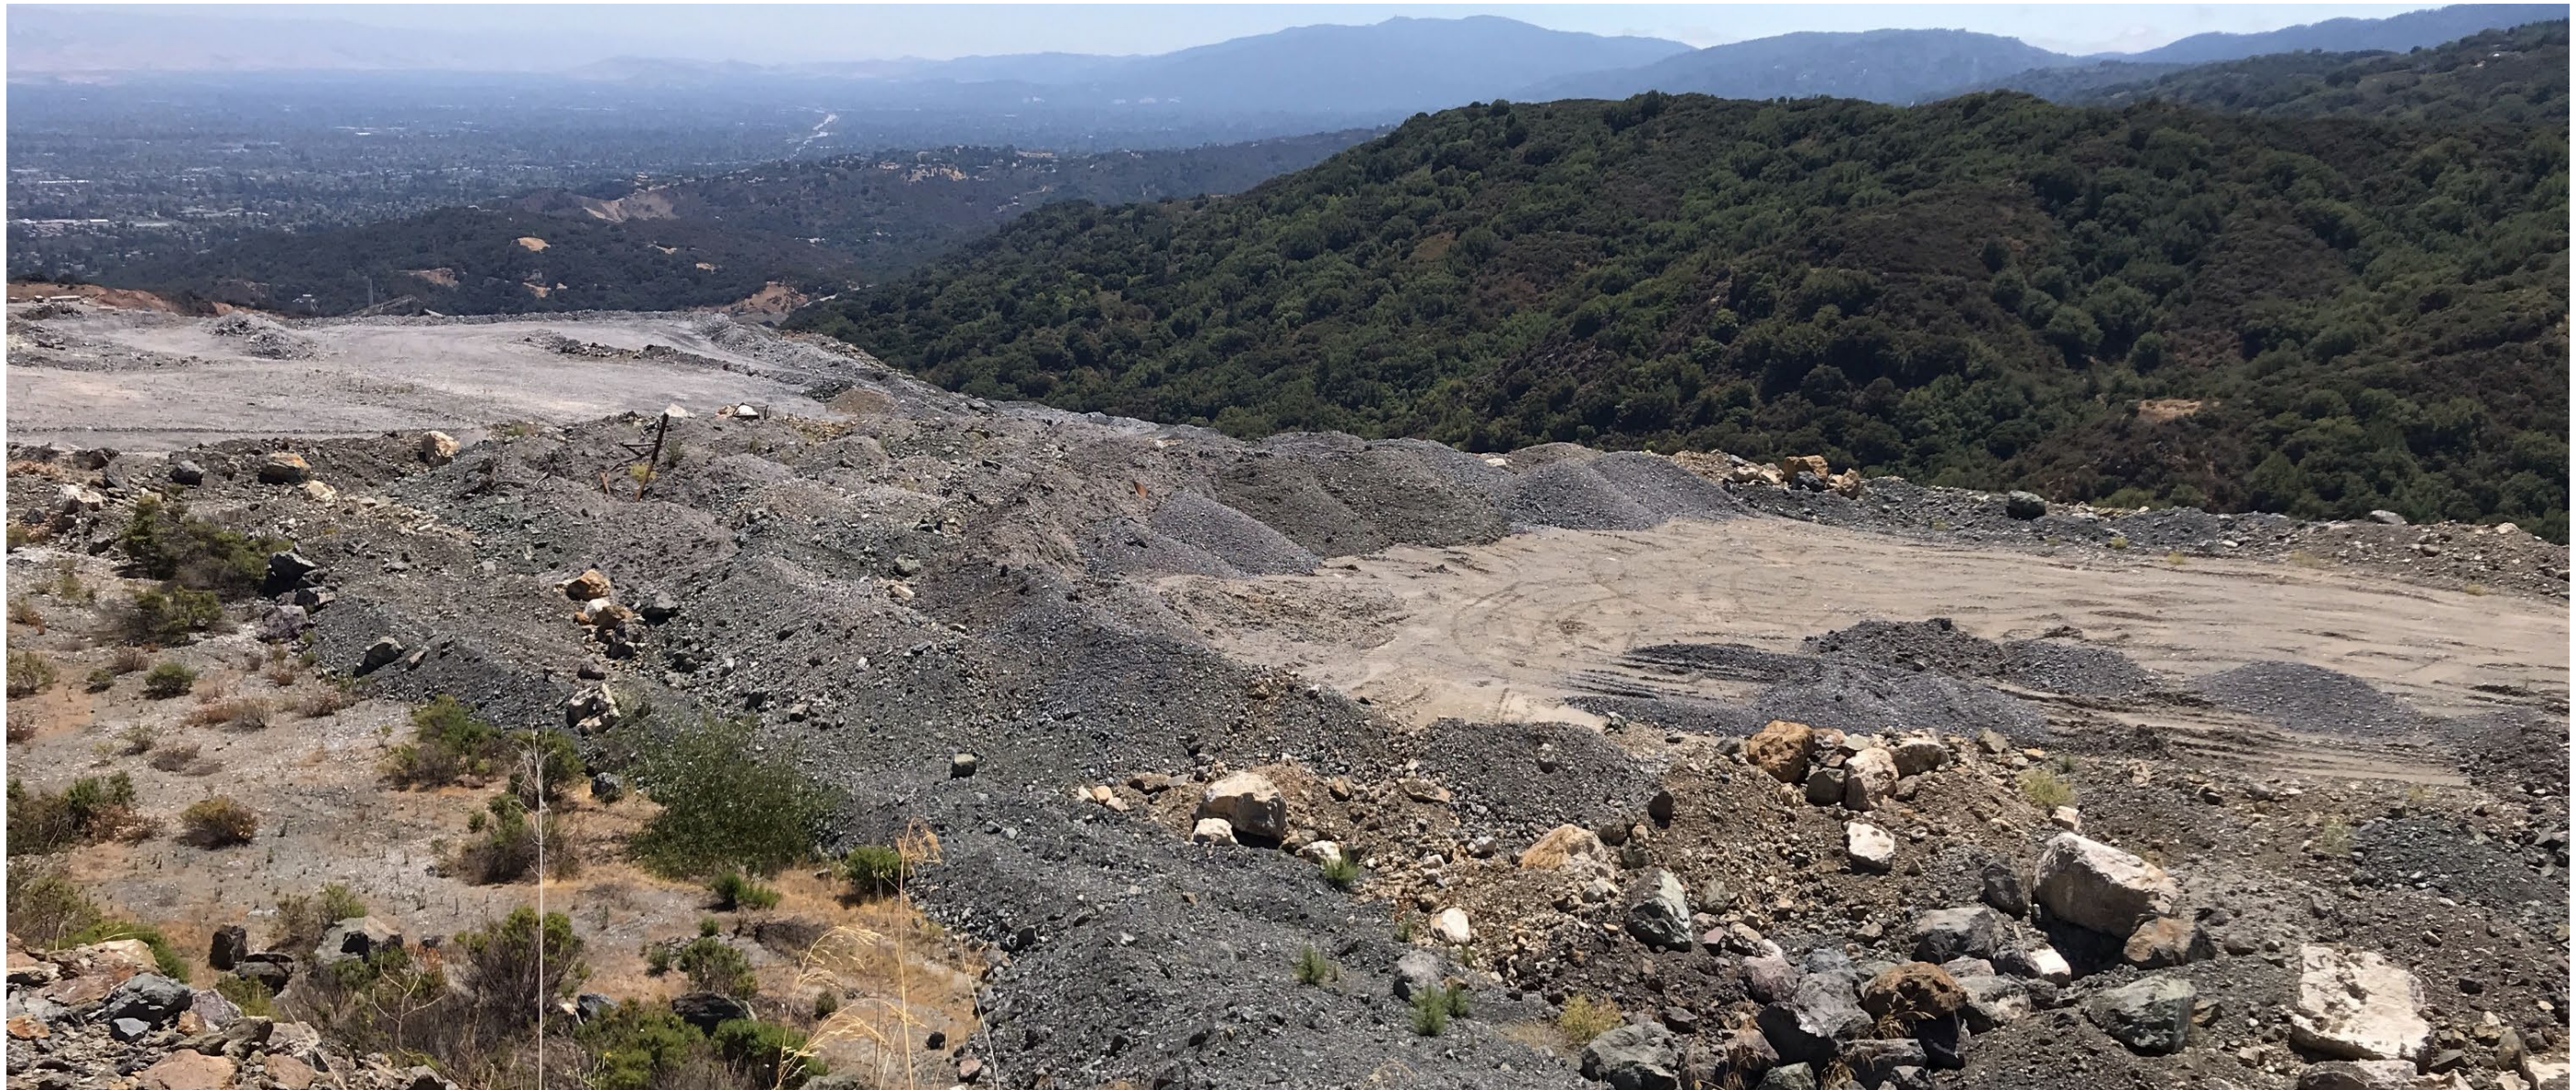
**PHOTO #7** – Southern slopes of EMSA (looking northeast)

BMPs were previously placed on the slopes (wattles) and along the benches (rock check dams and silt fences).

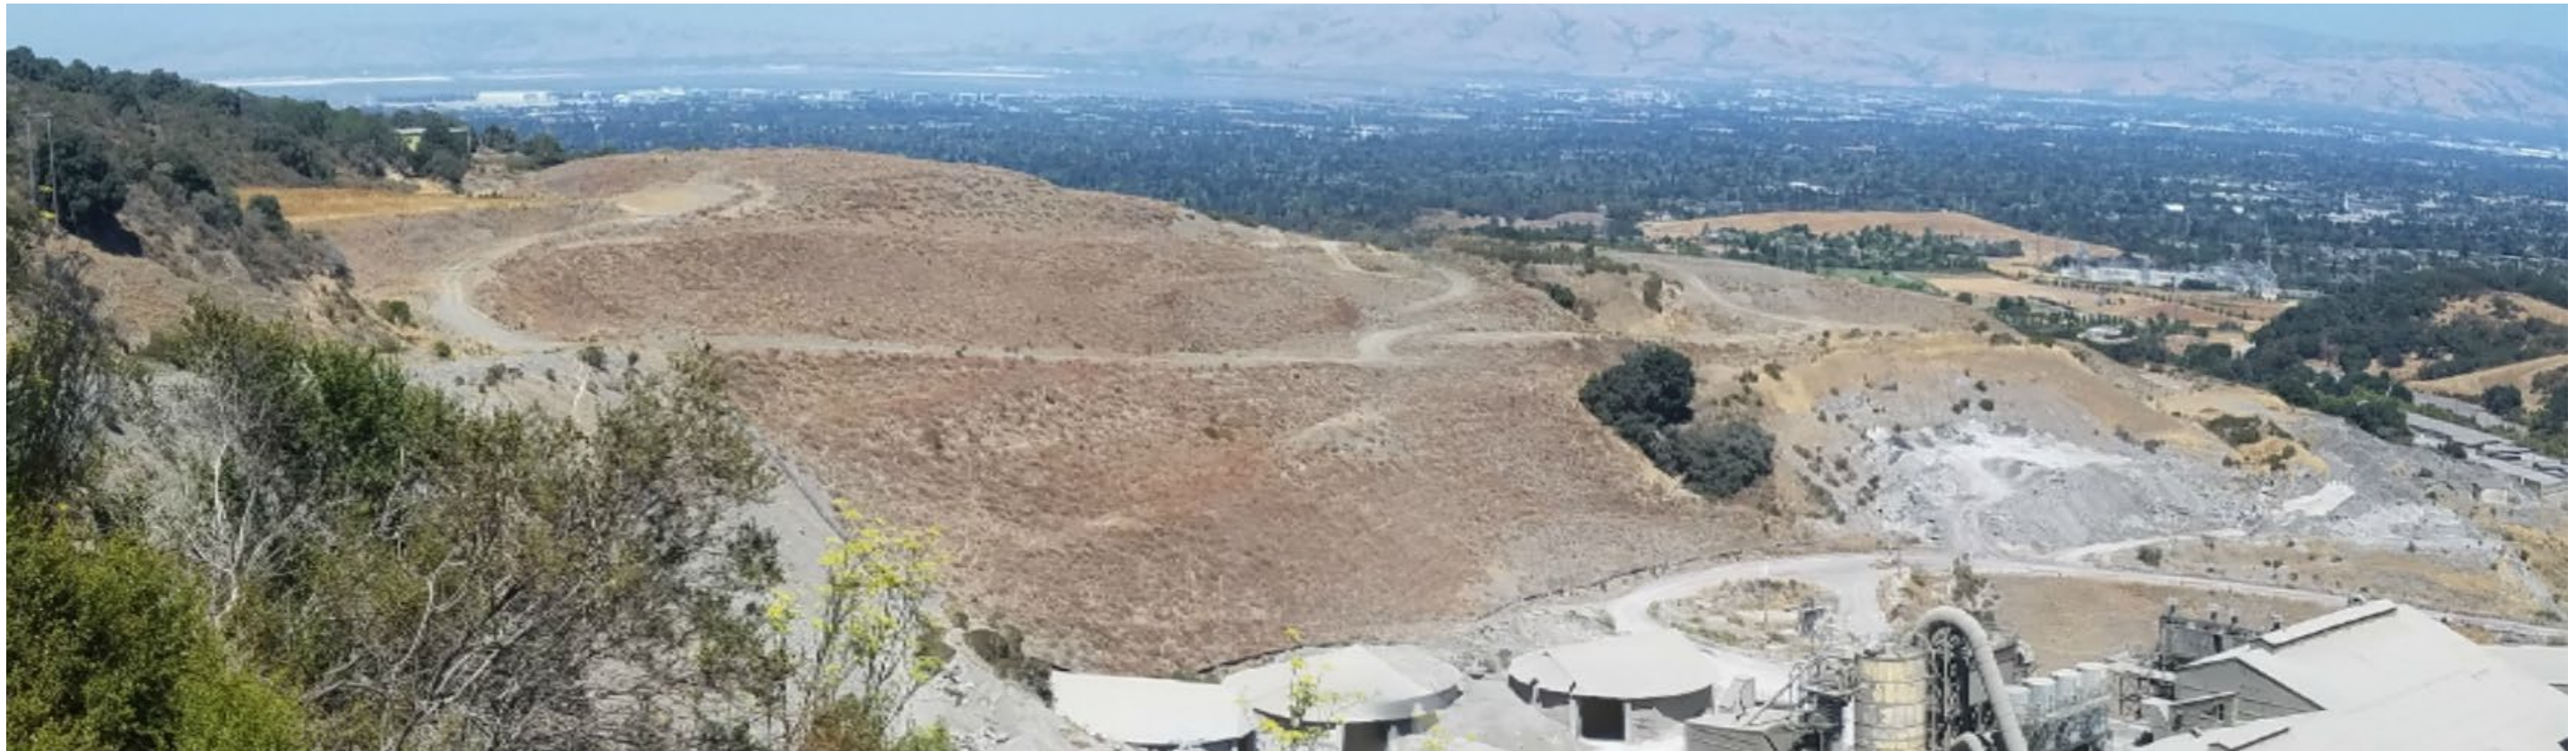
**PHOTO #8** – Eastern slopes of EMSA, north of Pond 30 (looking northwest)

County inspectors observed substantial vegetation growth on the EMSA slopes. [See **PHOTO #8**.]

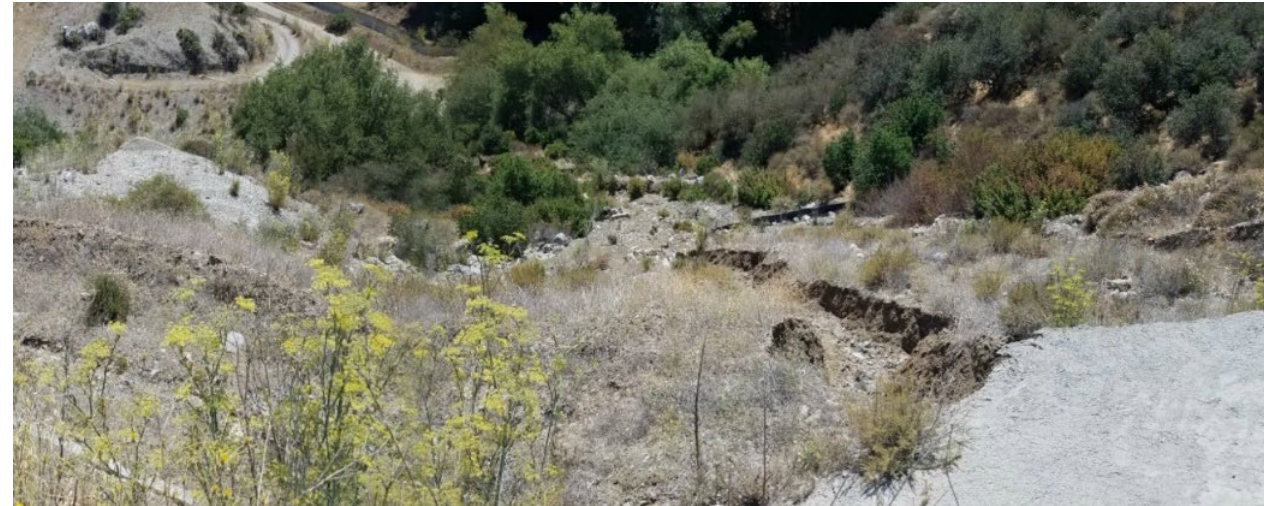
The crusher was constructed in 2013 against a 70-foot high retaining wall. Drainage from around the crusher is directed into a sump which overflowed due to a power failure in 2014. As a result, an erosion gully formed on the steep slope west of the crusher. The operator has had the gully lined with jute netting and several silt fences and installed a soil-nail wall in the head of the erosion gully located downhill of the sump. [See **PHOTOS #10A and #10B.**]

**PHOTO #10B** – Debris flow track below crusher

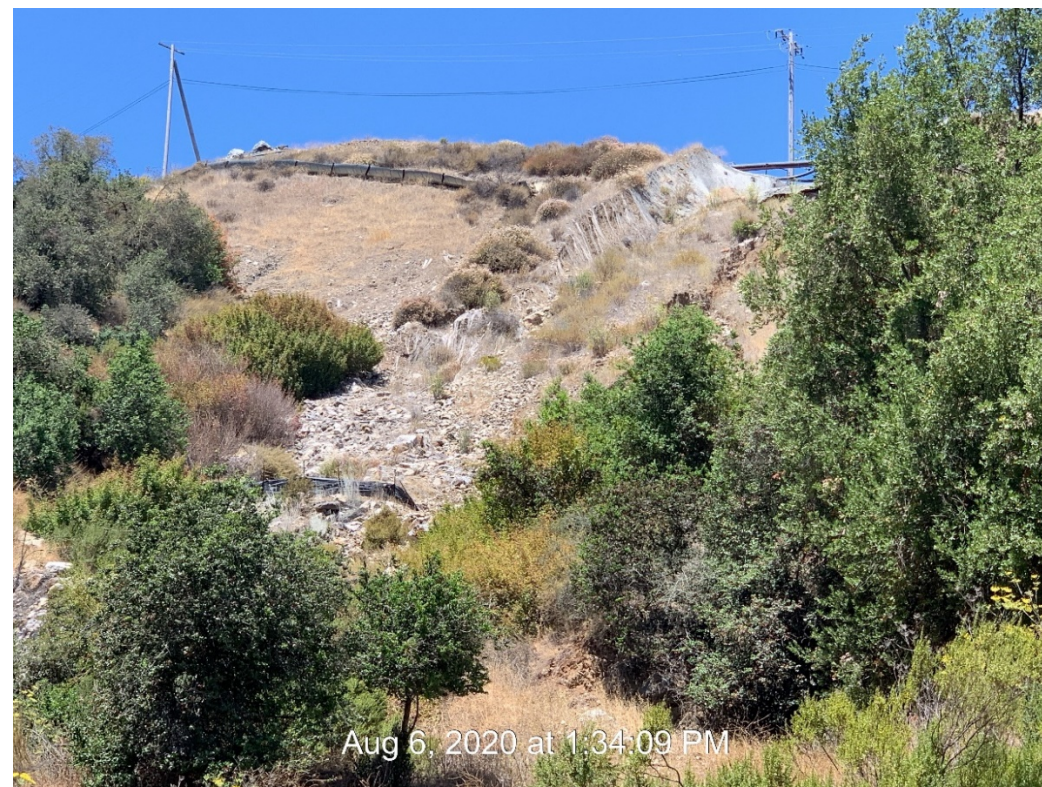
**PHOTO #11** – Pond 13 (dry)

Eroded material accumulated at the toe of the slope and extended into the eastern side of Pond 13. [See **PHOTO #11**]

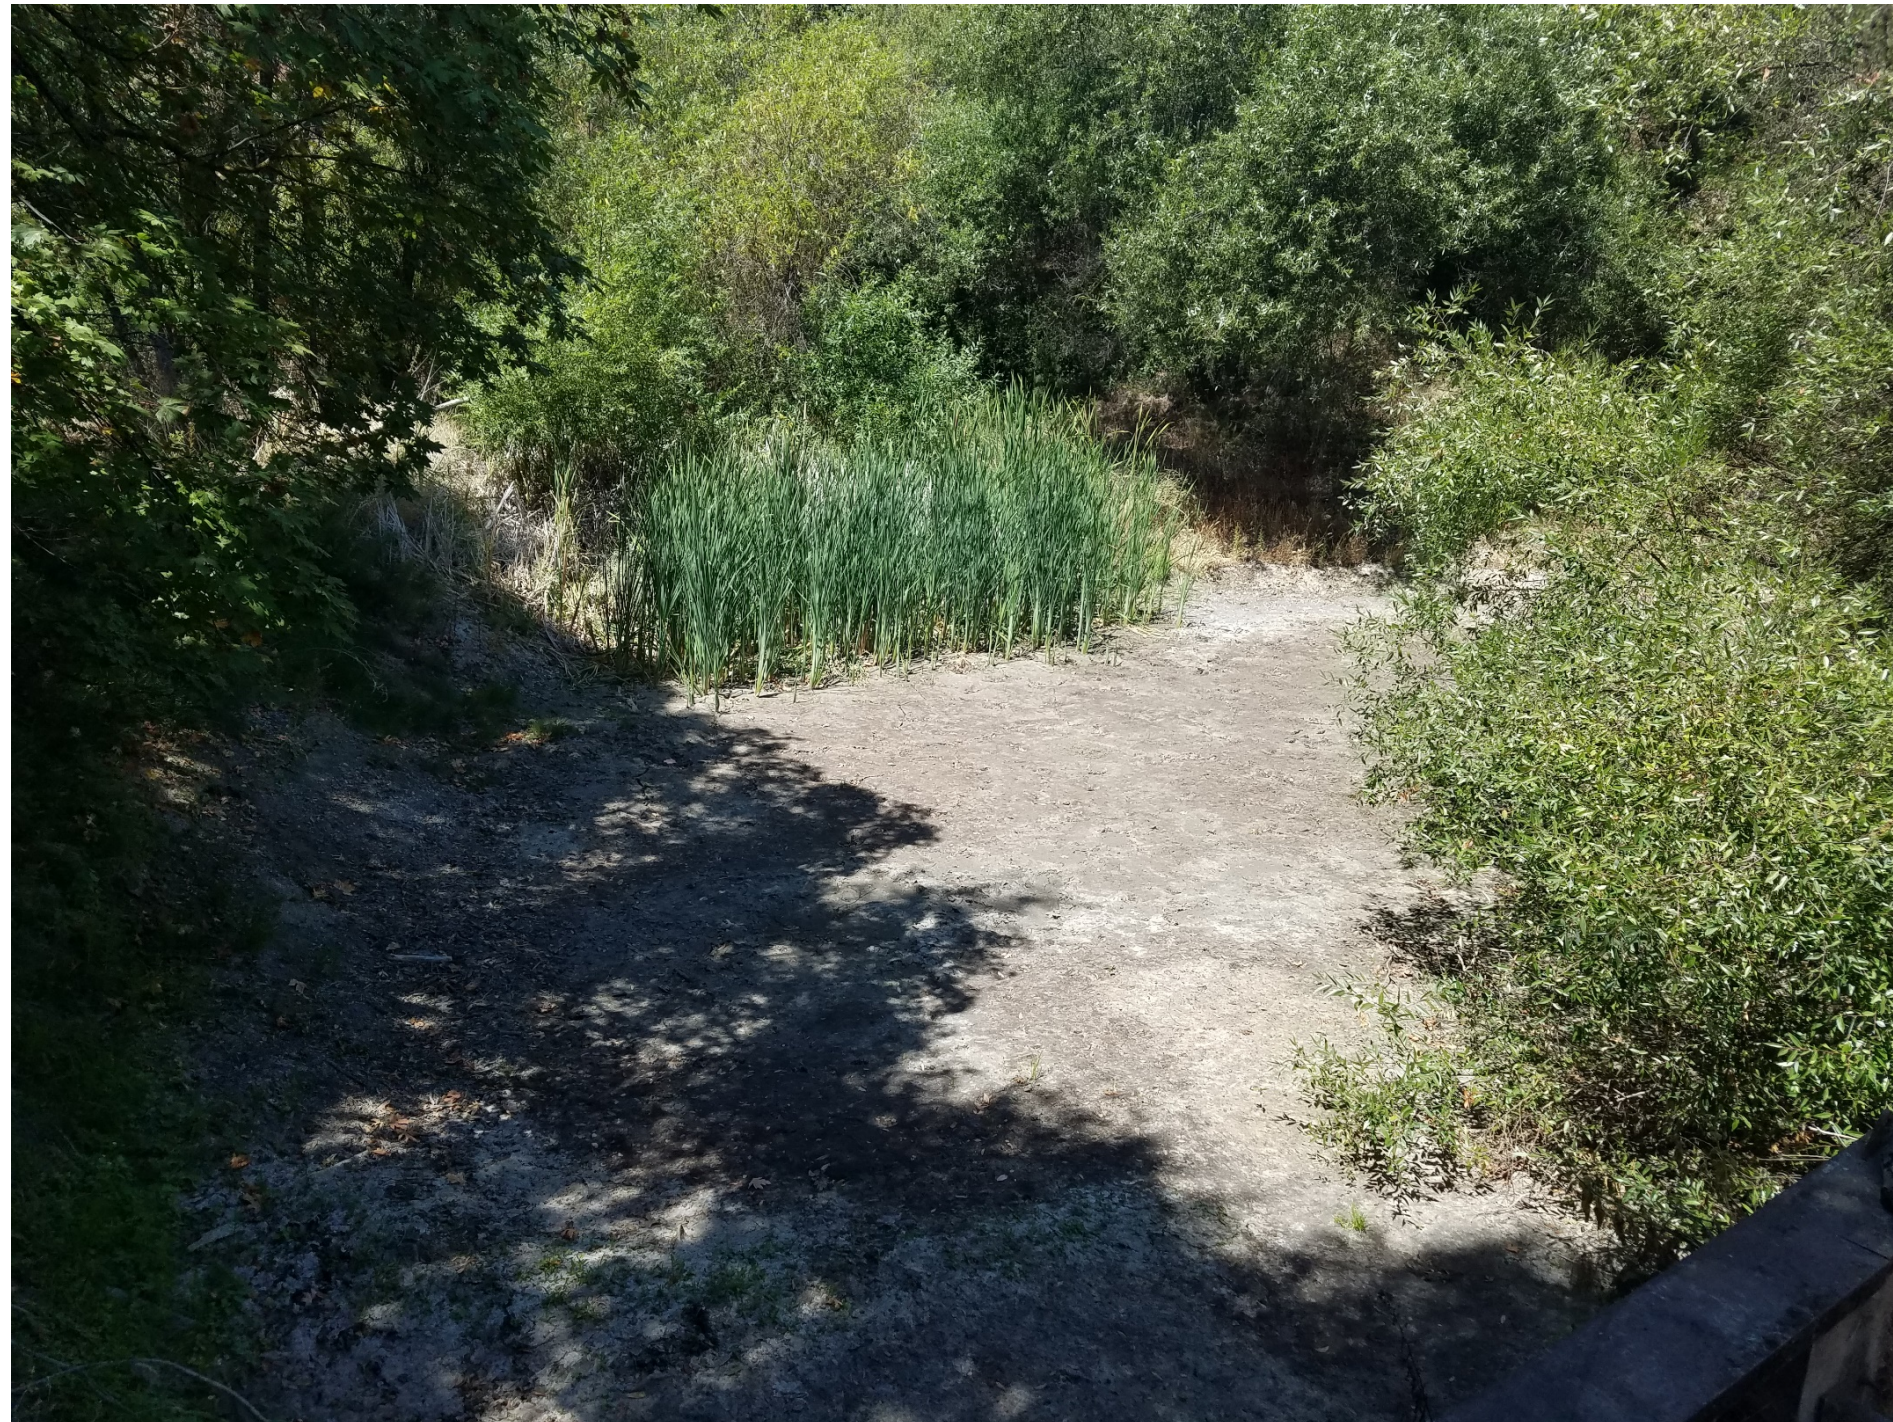
**PHOTO #12** – Half-pipe for outflow of Pond 13

A half-pipe exists downstream of Pond 13 for the continuance of Permanente Creek. [See **PHOTO #12.**]

The Permanente Creek Restoration Project (County File No. 2250-17G), submitted by Lehigh and currently under review by the County, proposes removal of the half-pipe.
