## SURFACE MINING INSPECTION REPORT

Photos from 2020 Annual SMARA Inspection Conducted on 8-06-2020

by  
Robert Salisbury, Senior Planner  
James Baker, CEG#1021, County Geologist  
Steve Beams, Senior Construction Inspector  
Glen Jia, Assistant Planner

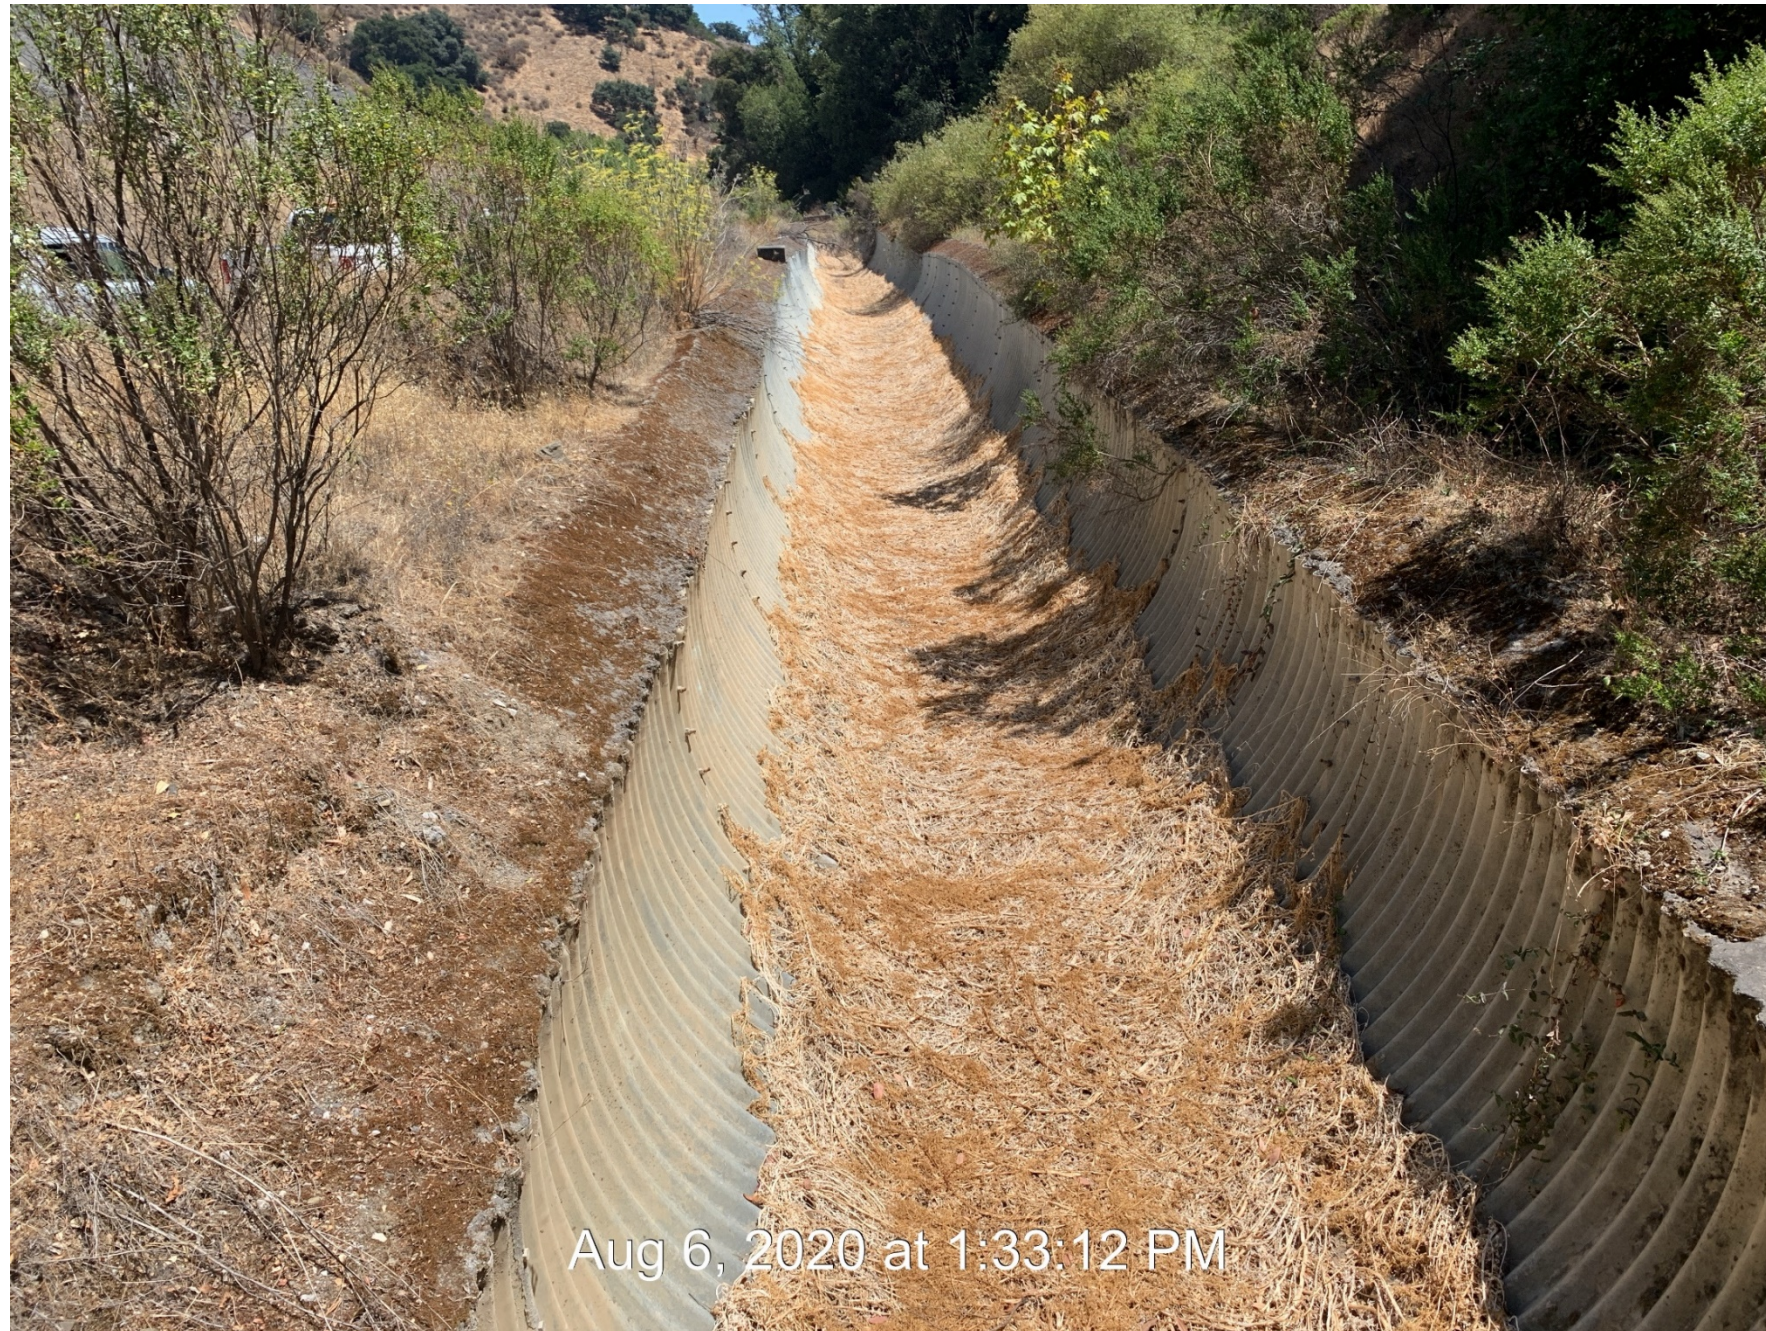
**PHOTO #13** – Surge Pile looking southeast

The surge pile is significantly smaller that it was last year. [See **PHOTO #13**.]

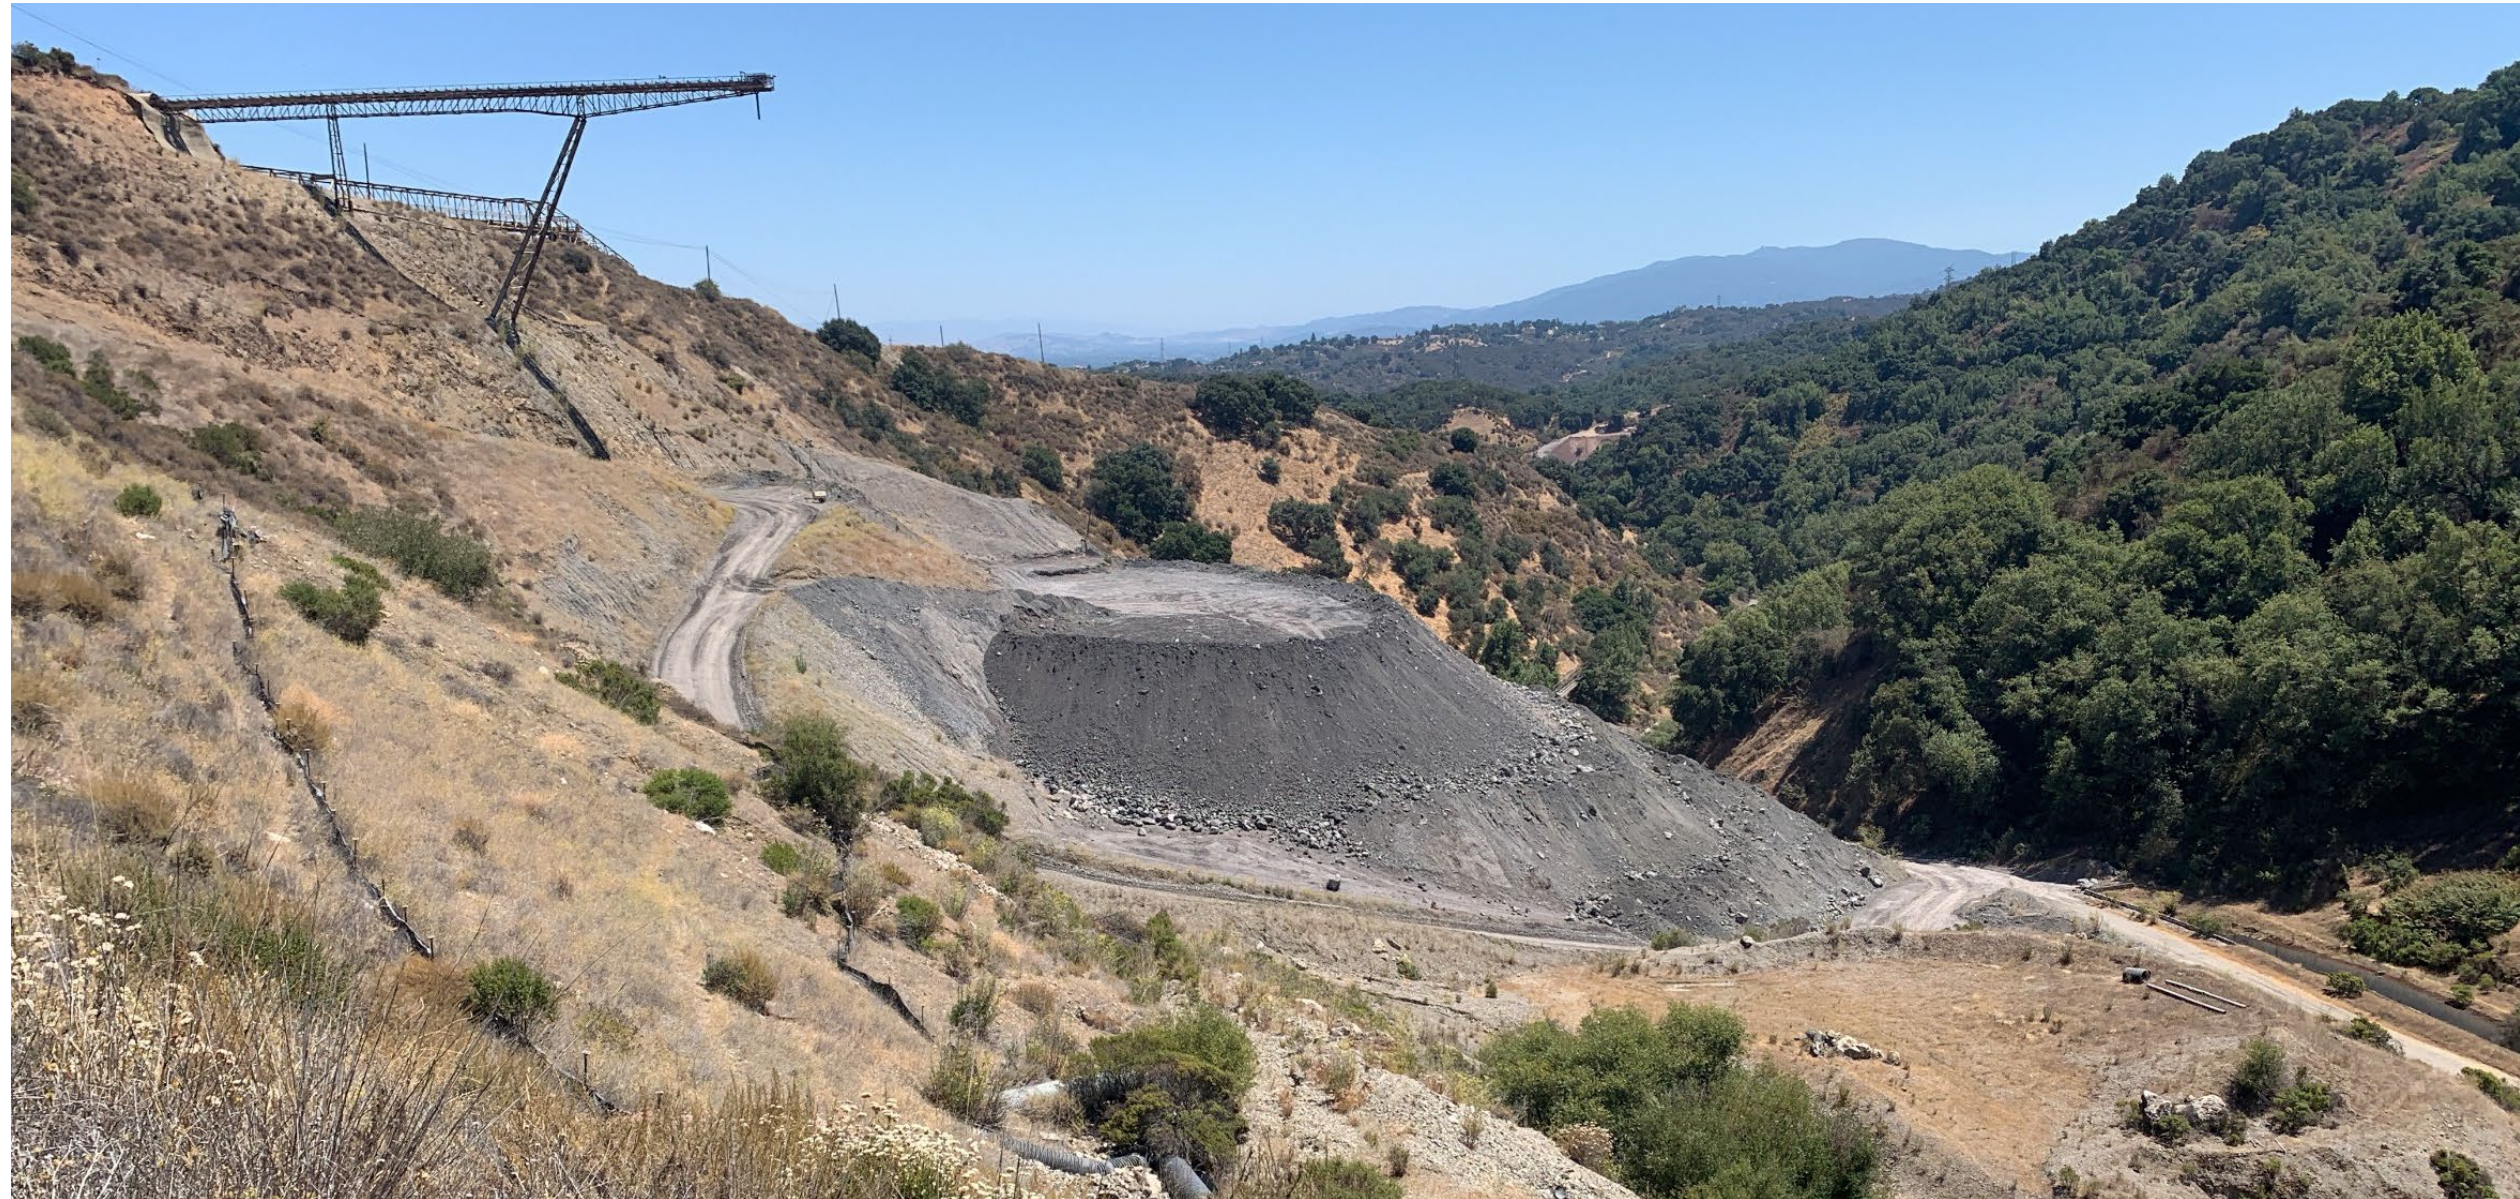
**PHOTO #14** – Slopes above Pond 13

Sediment that erodes from the surge pile is detained in ponds. Next to the surge pile are slopes above Pond 13. [See **PHOTO #14**.]

During the Permanente Creek Restoration Project referenced above, the surge pile will be removed, and the underlying creek channel will be restored once the project is approved.

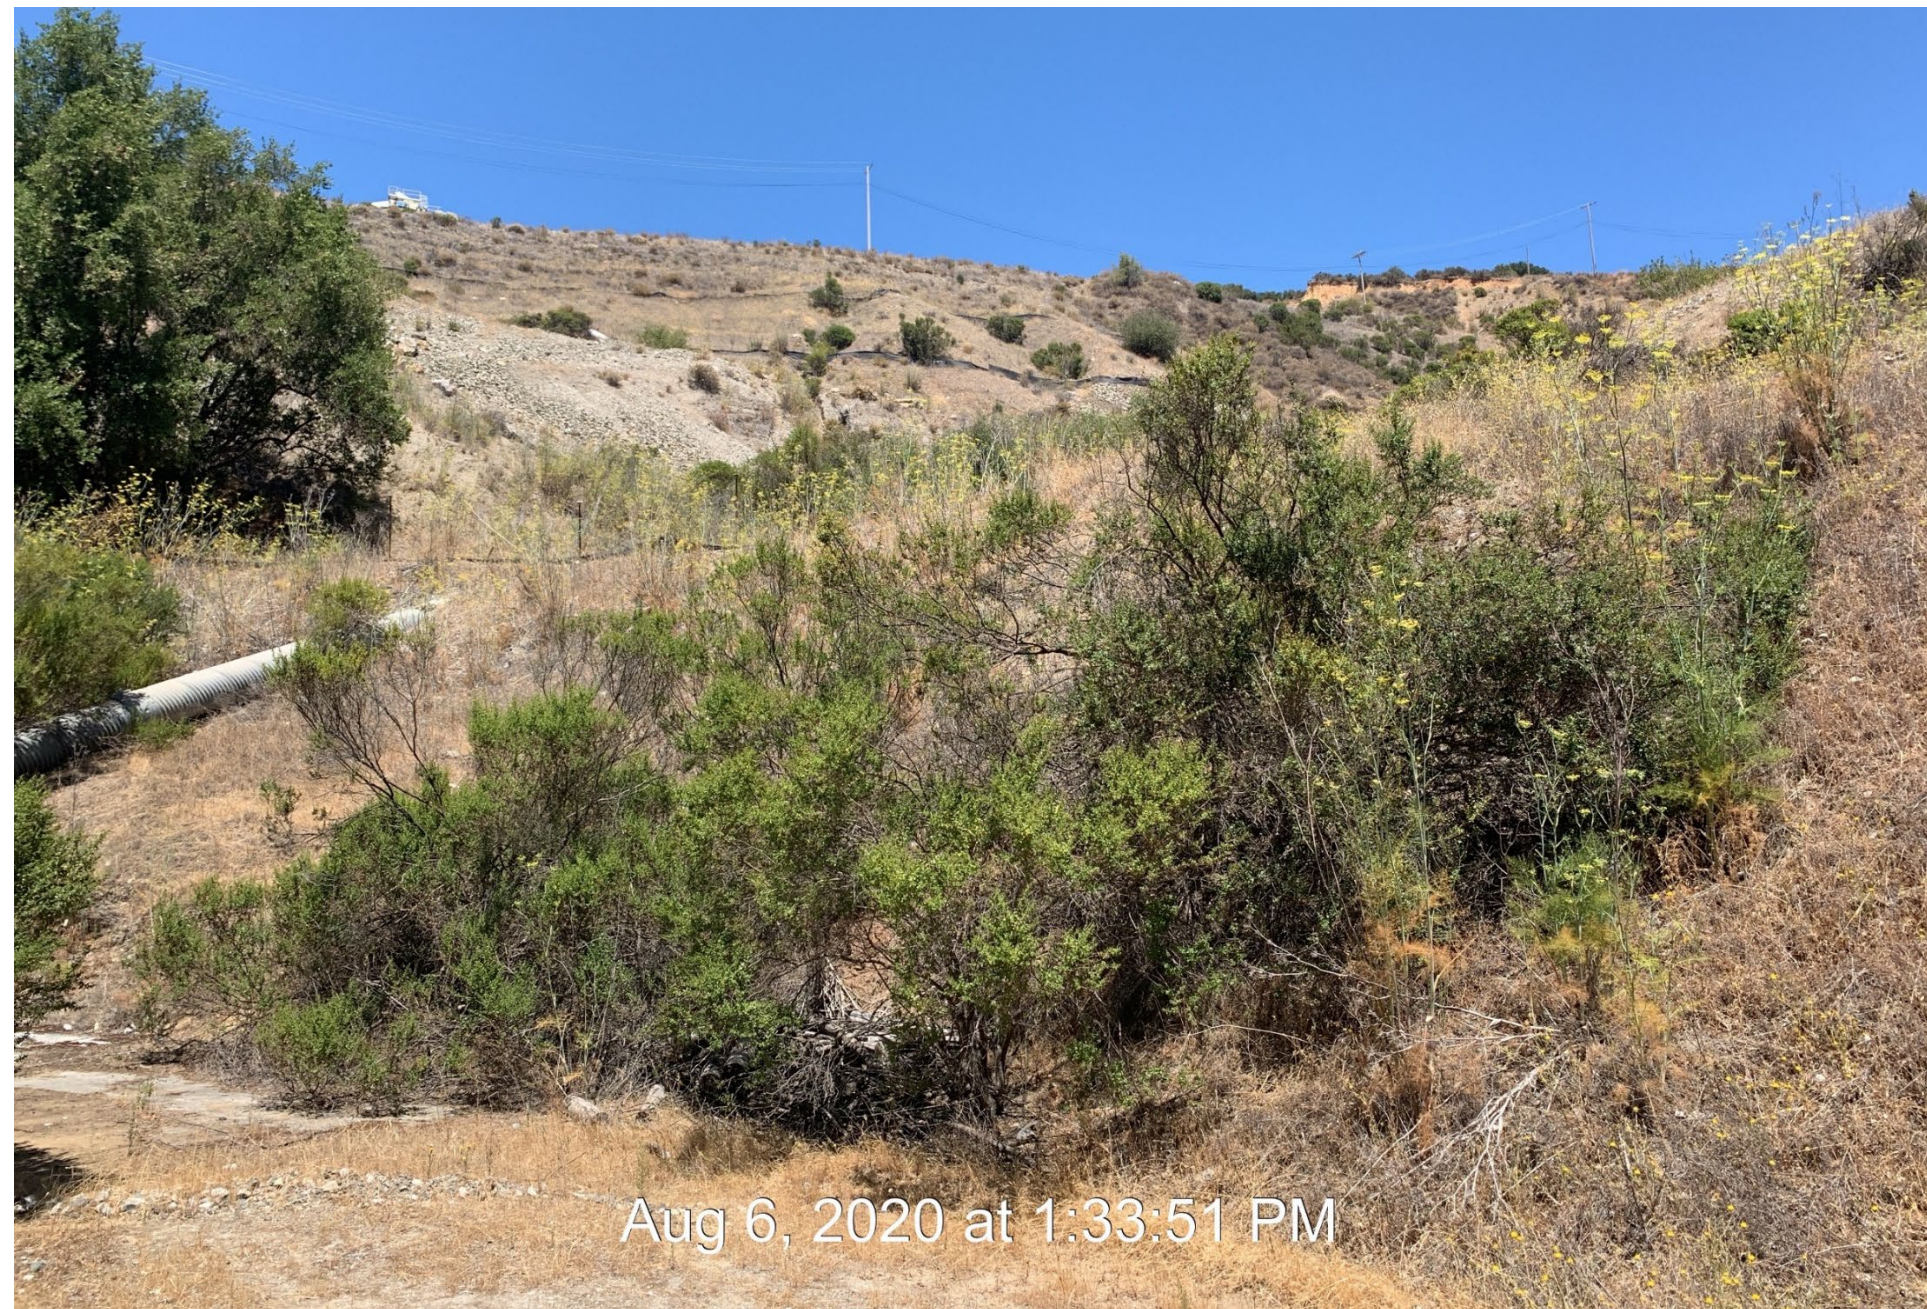
**PHOTO #15** – In-flow to Pond 17 and failing sheet pile wall

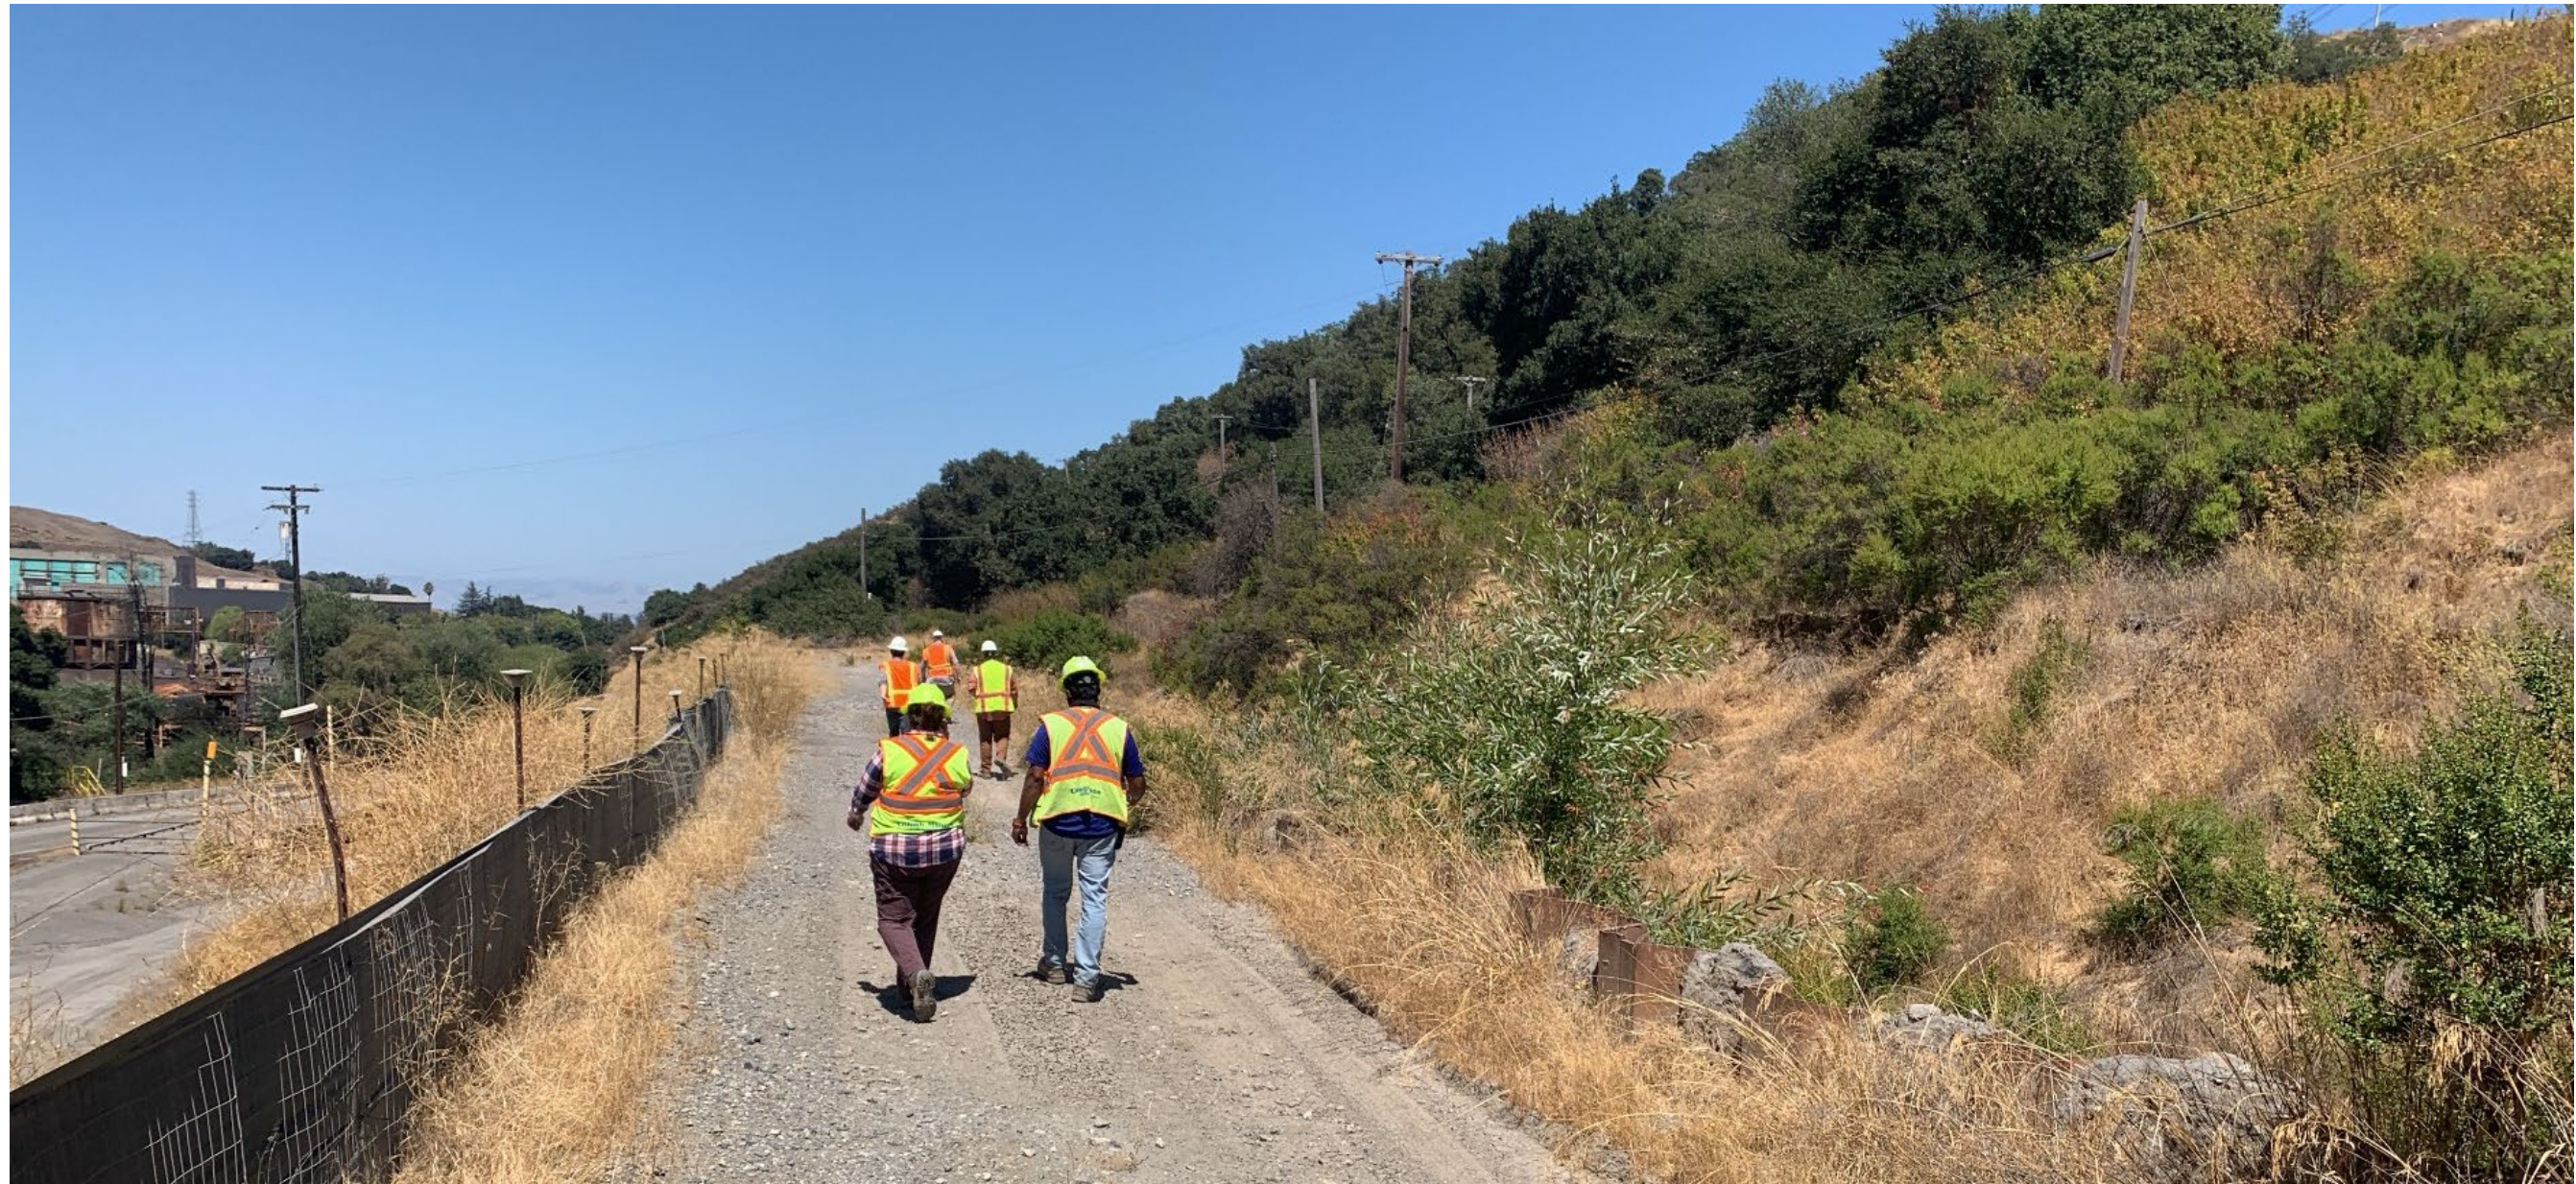
PHOTO #16 – Pond 17 with liner and sediment

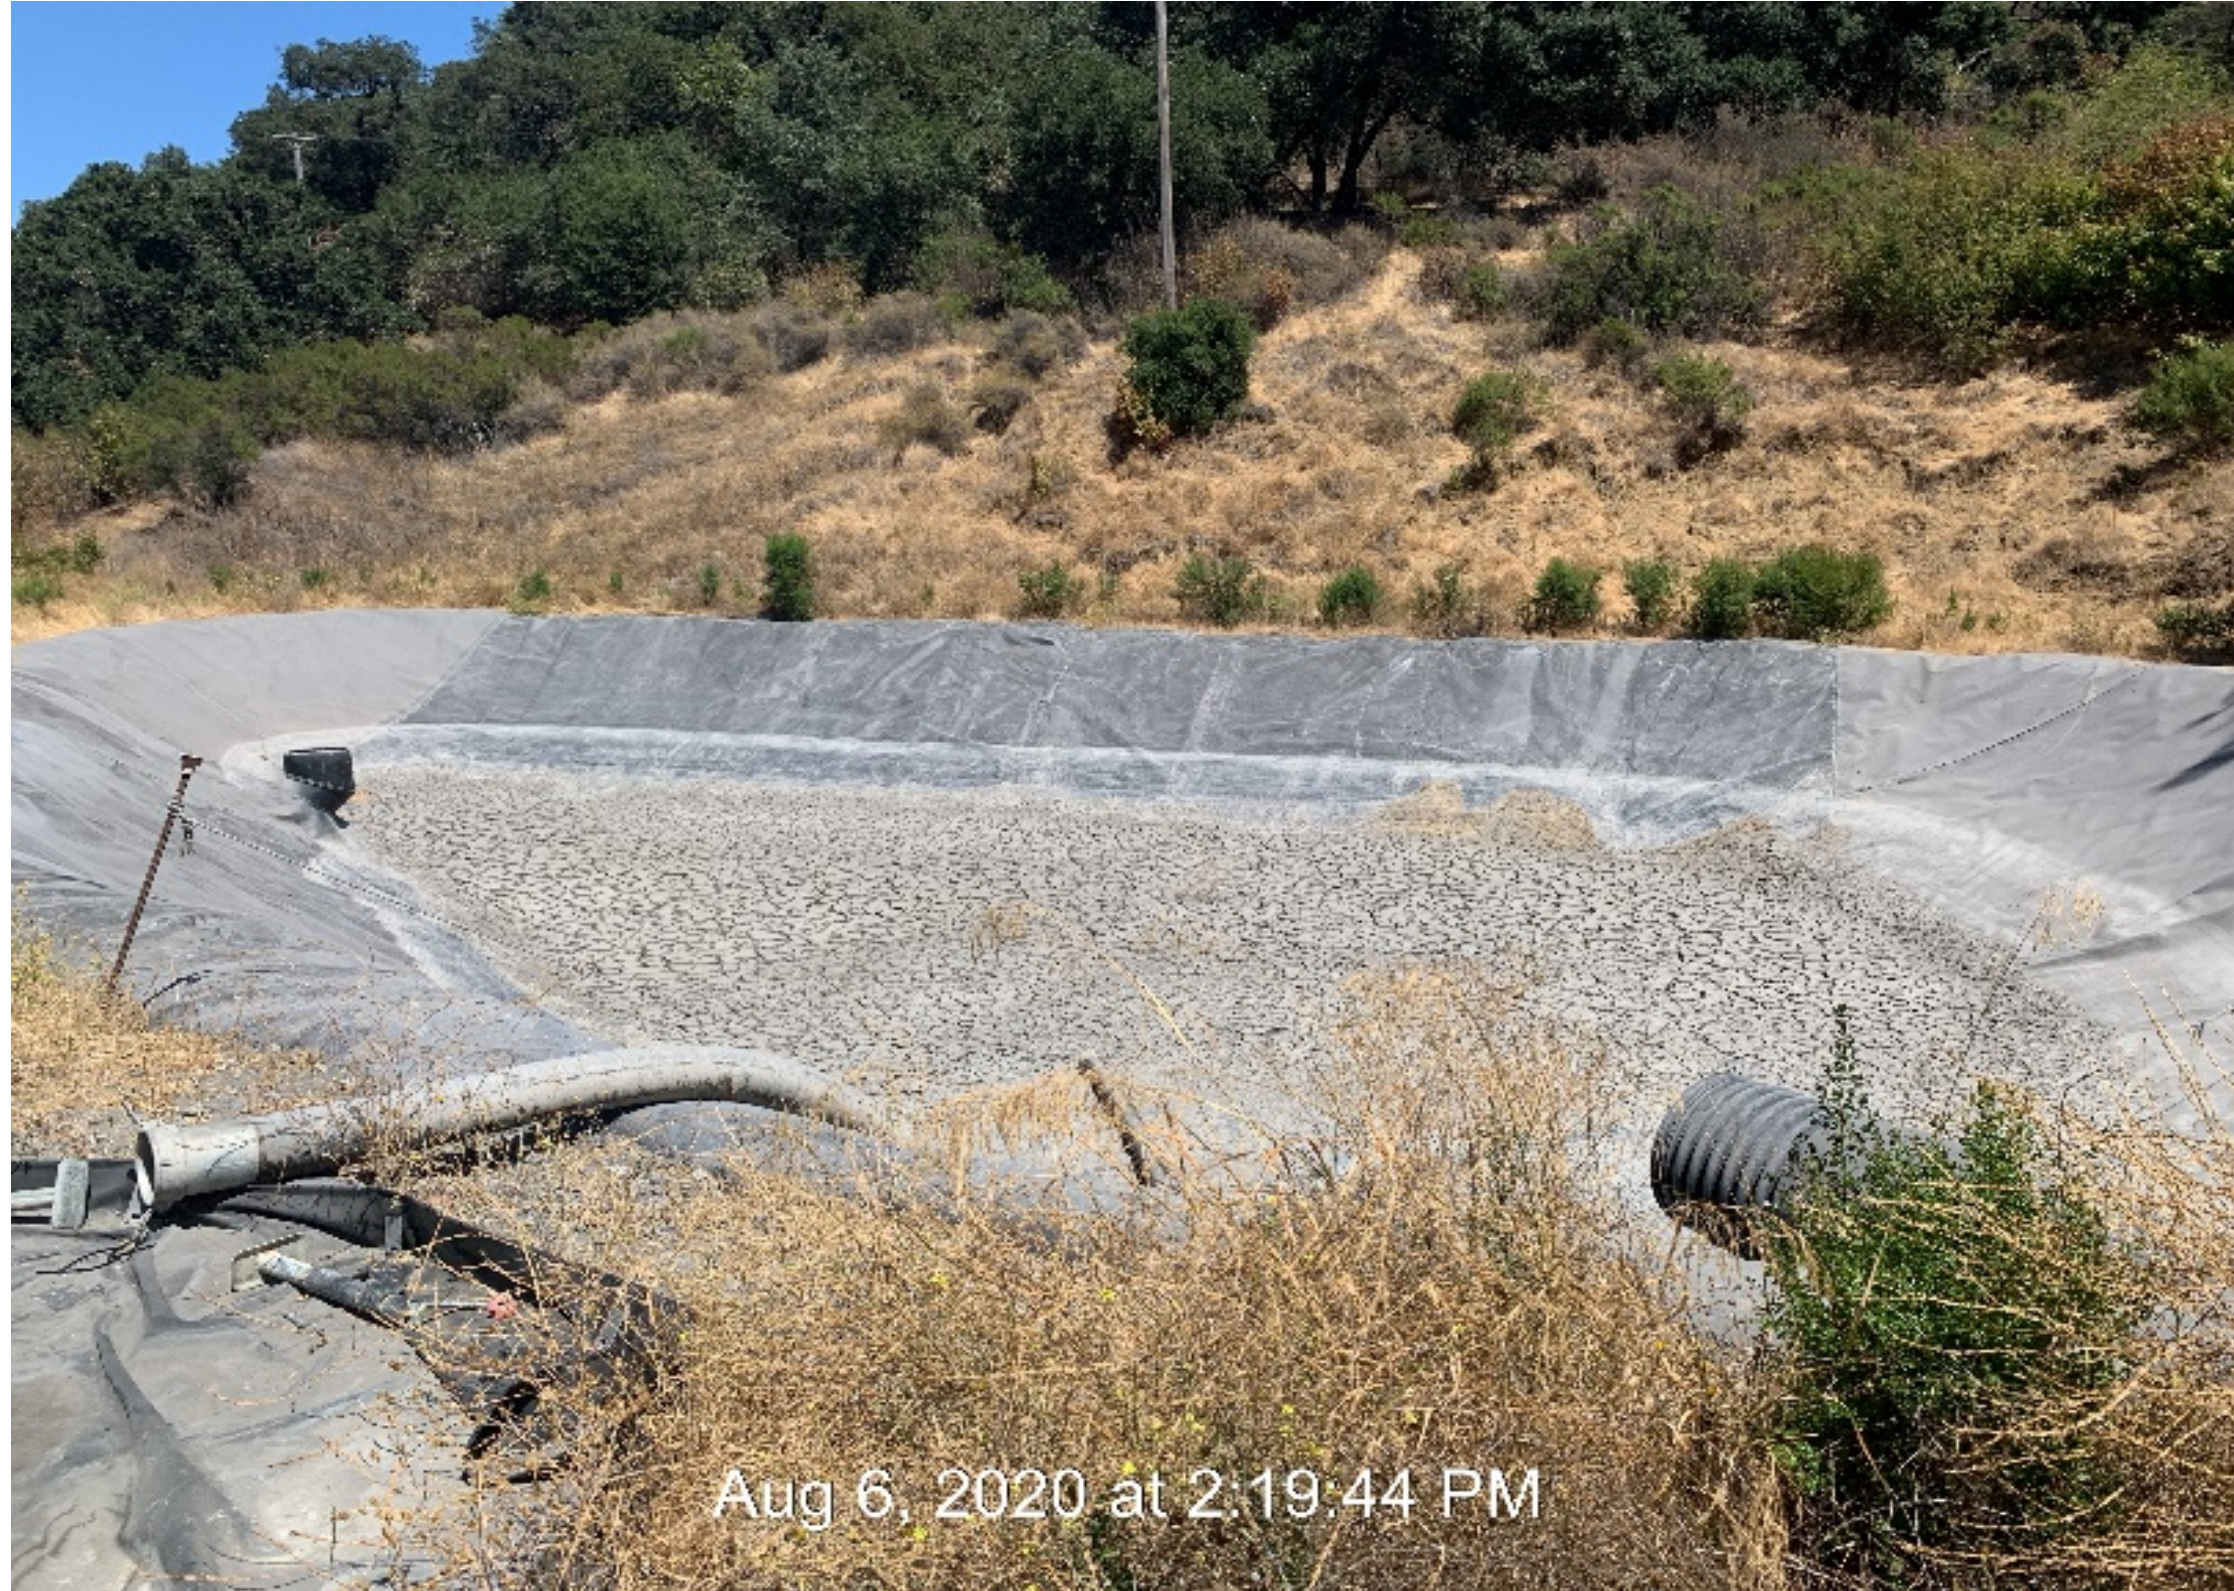
**PHOTO #17** Blending tank above Pond 4A

A portable blending tank is located on the bench above Poand 4A.

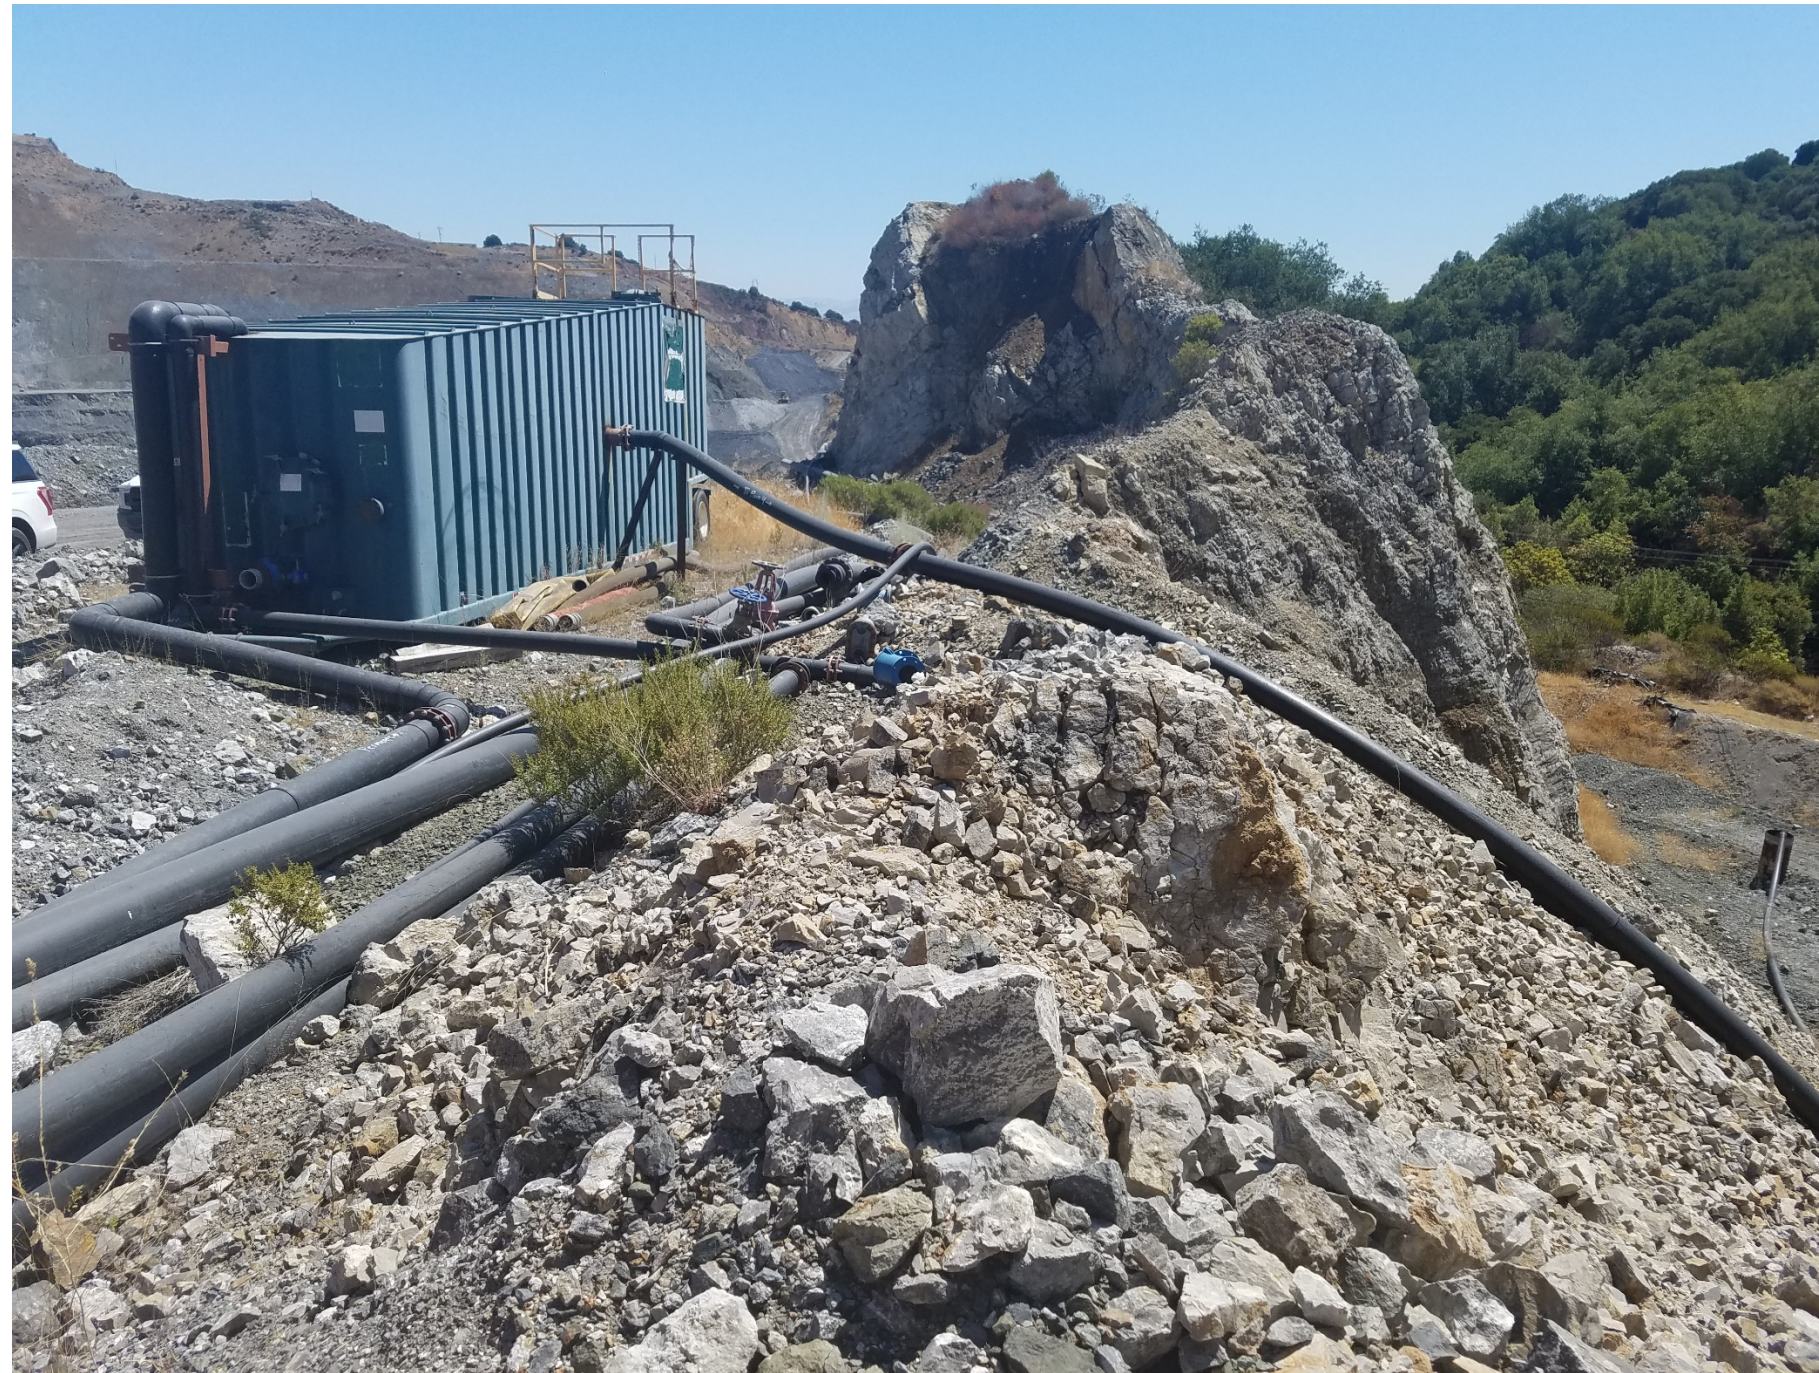
#18 – Pond 4A (filled in) and Treatment System

Adjacent to Pond 4A are water treatment and filtration equipment used to remove selenium from quarry water prior to discharge into Permanente Creek. [See PHOTO #18.]

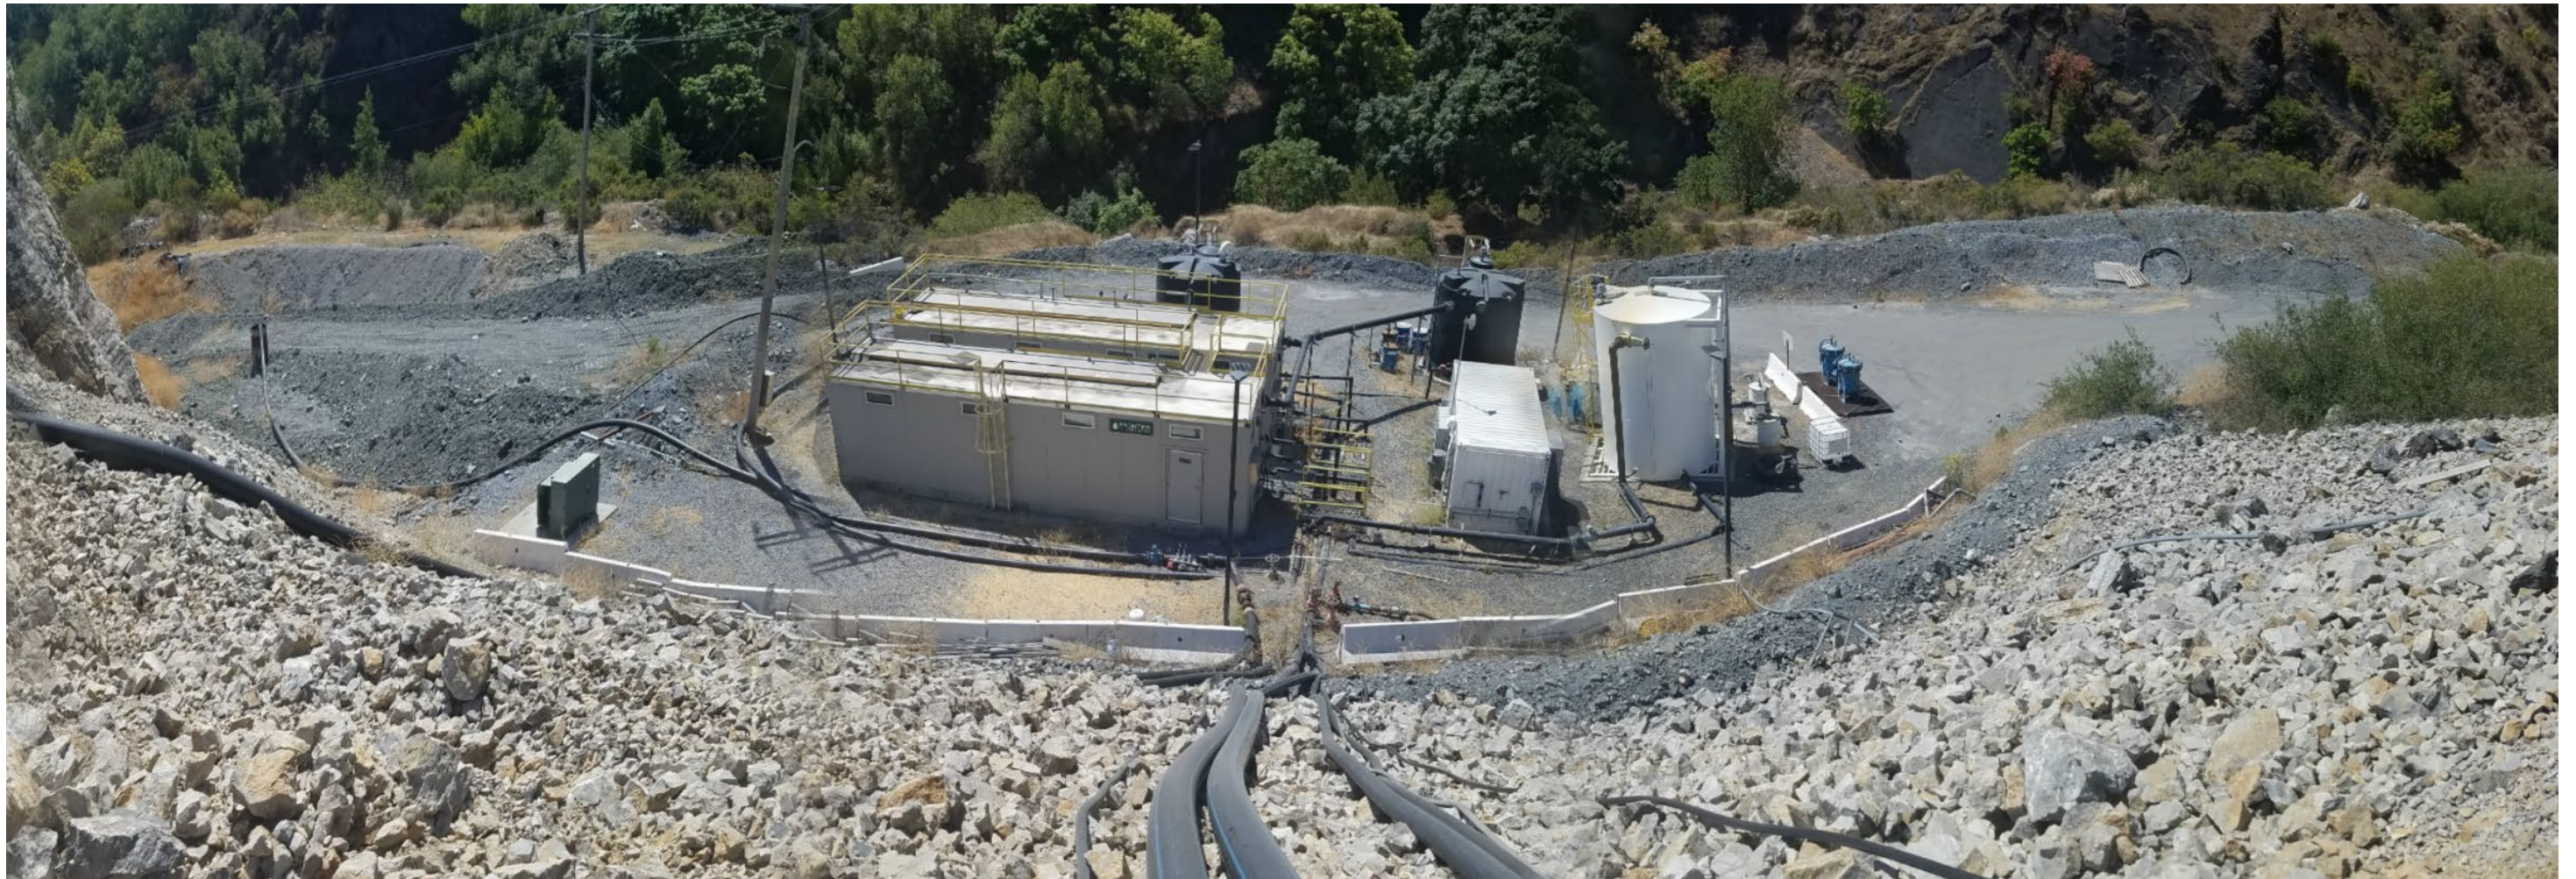
#19 – Treatment tanks near Pond 1250

.Associated tanks are located adjacent to Pond 1250. [See **PHOTO #19.**]

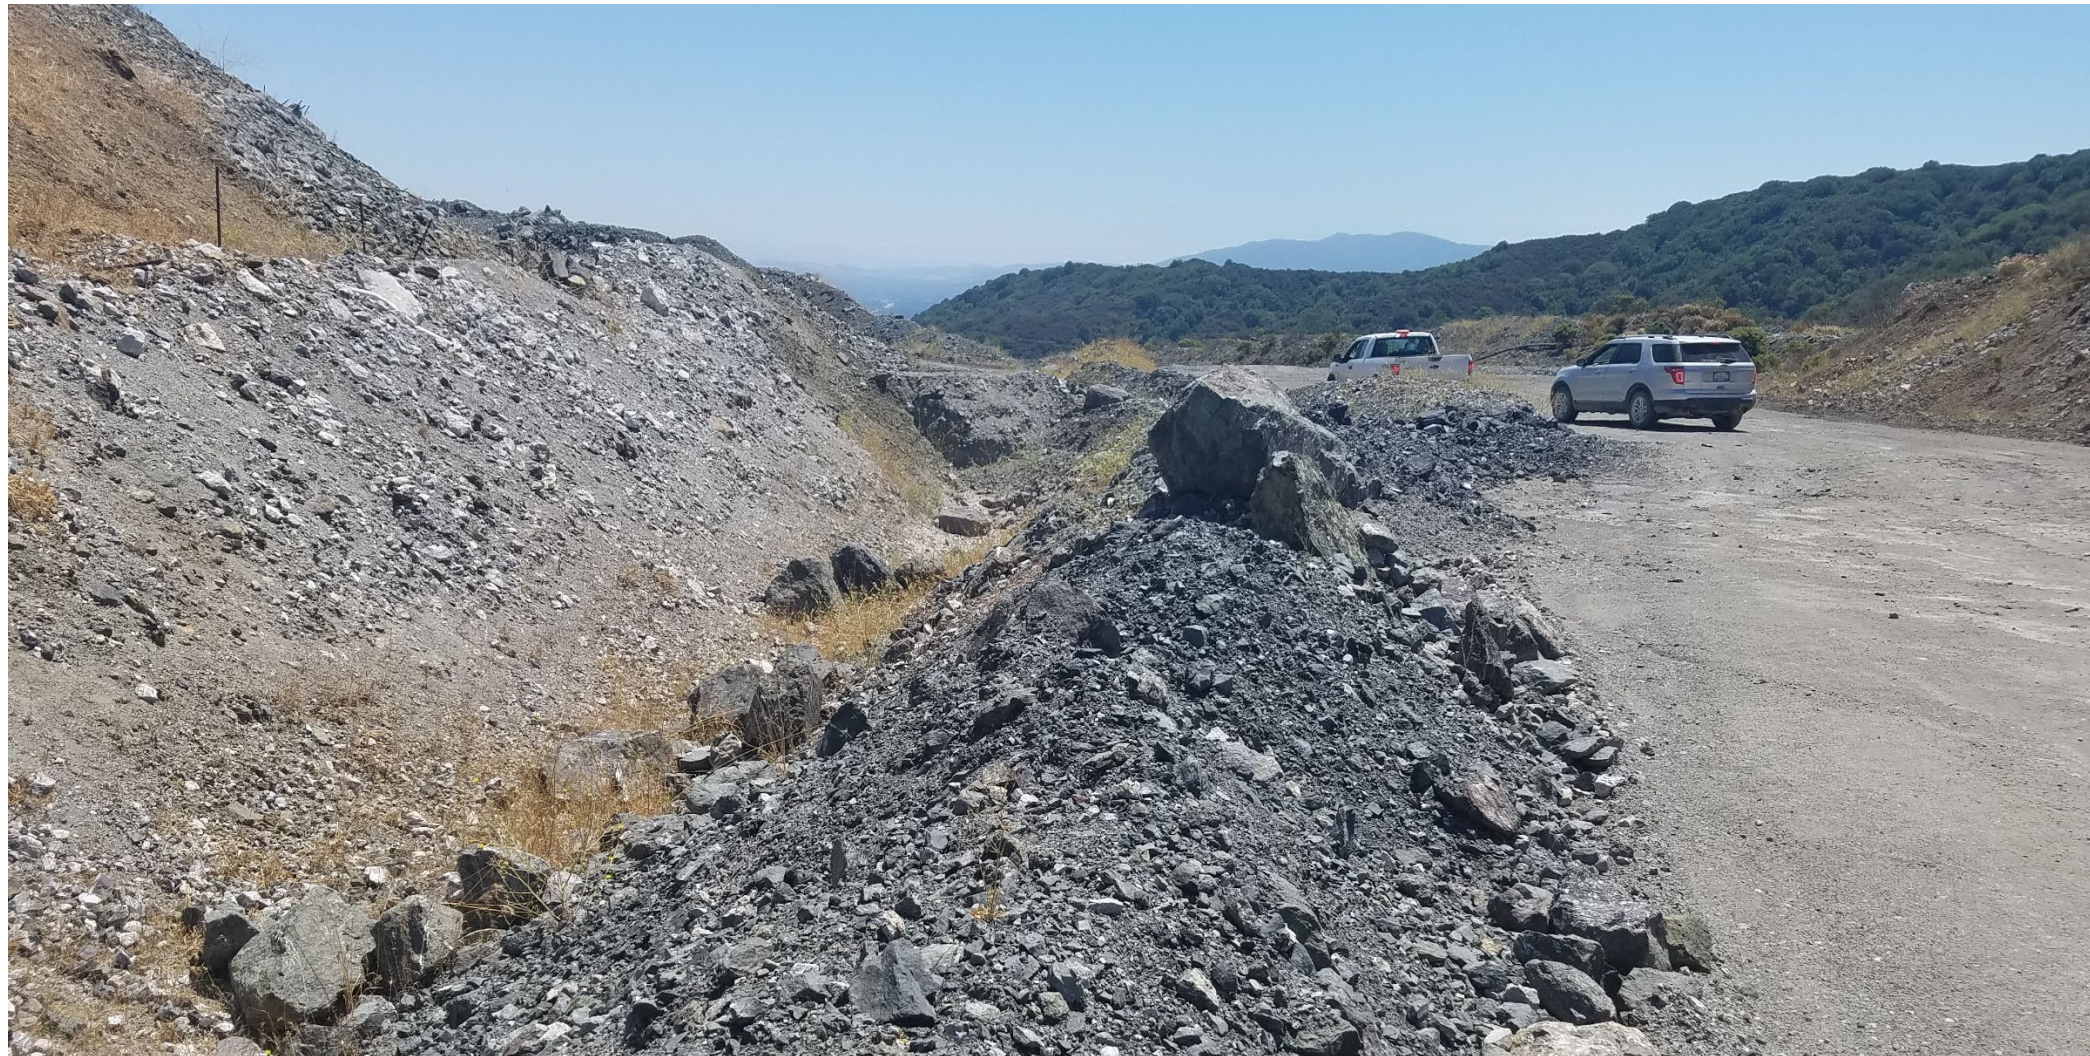
During the 2018 annual SMARA inspection inspectors observed that a new road linking Lehigh Quarry and Stevens Creek Quarry had been constructed without approval. The County issued a Notice of Violation on August 17, 2018 and noted the violation in the 2018 Lehigh Annual Inspection Report, dated August 8, 2018. Subsequently, Lehigh applied for a Reclamation Plan Amendment which, if approved, will expand the Reclamation Plan Boundary to include the haul road area. This reclamation plan amendment application is currently being processed. This haul road remains in place but is not

**Photo #21A** – Cut slope and drainage ditch on west side of illegally graded haul road
