## SURFACE MINING INSPECTION REPORT

Photos from 2020 Annual SMARA Inspection Conducted on 8-06-2020

by  
Robert Salisbury, Senior Planner  
James Baker, CEG#1021, County Geologist  
Steve Beams, Senior Construction Inspector  
Glen Jia, Assistant Planner

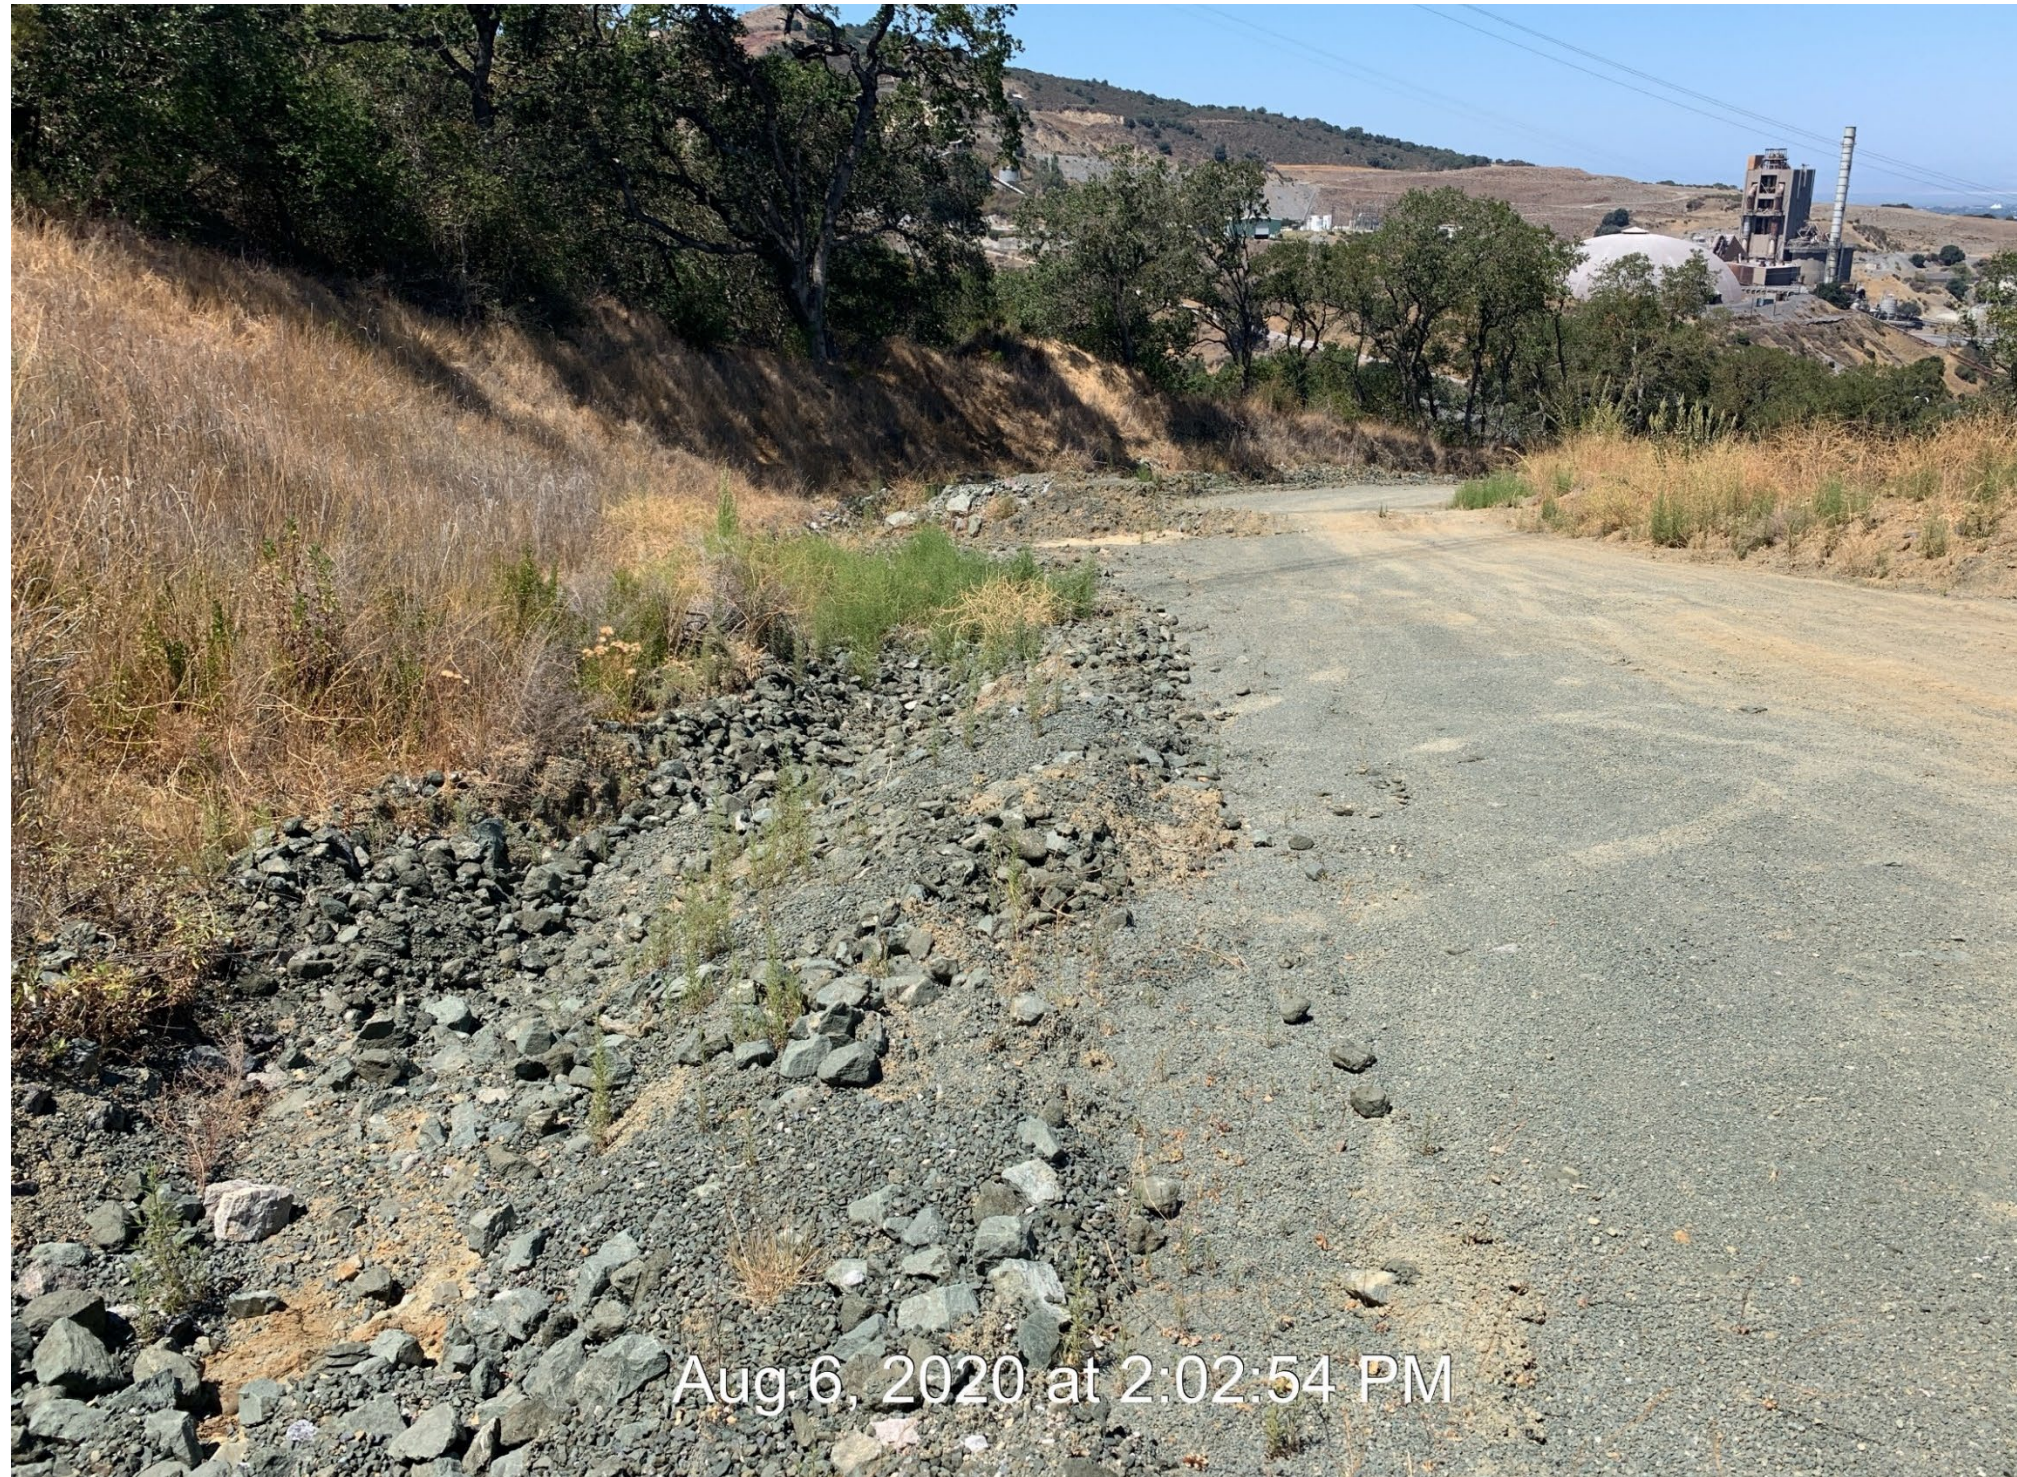
During the 2018 annual SMARA inspection inspectors observed that a new road linking Lehigh Quarry and Stevens Creek Quarry had been constructed without approval. The County issued a Notice of Violation on August 17, 2018 and noted the violation in the 2018 Lehigh Annual Inspection Report, dated August 8, 2018. Subsequently, Lehigh applied for a Reclamation Plan Amendment which, if approved, will expand the Reclamation Plan Boundary to include the haul road area. This reclamation plan amendment application is currently being processed. This haul road remains in place but is not

**Photo #21B** Fill slope below east side of illegally graded haul road

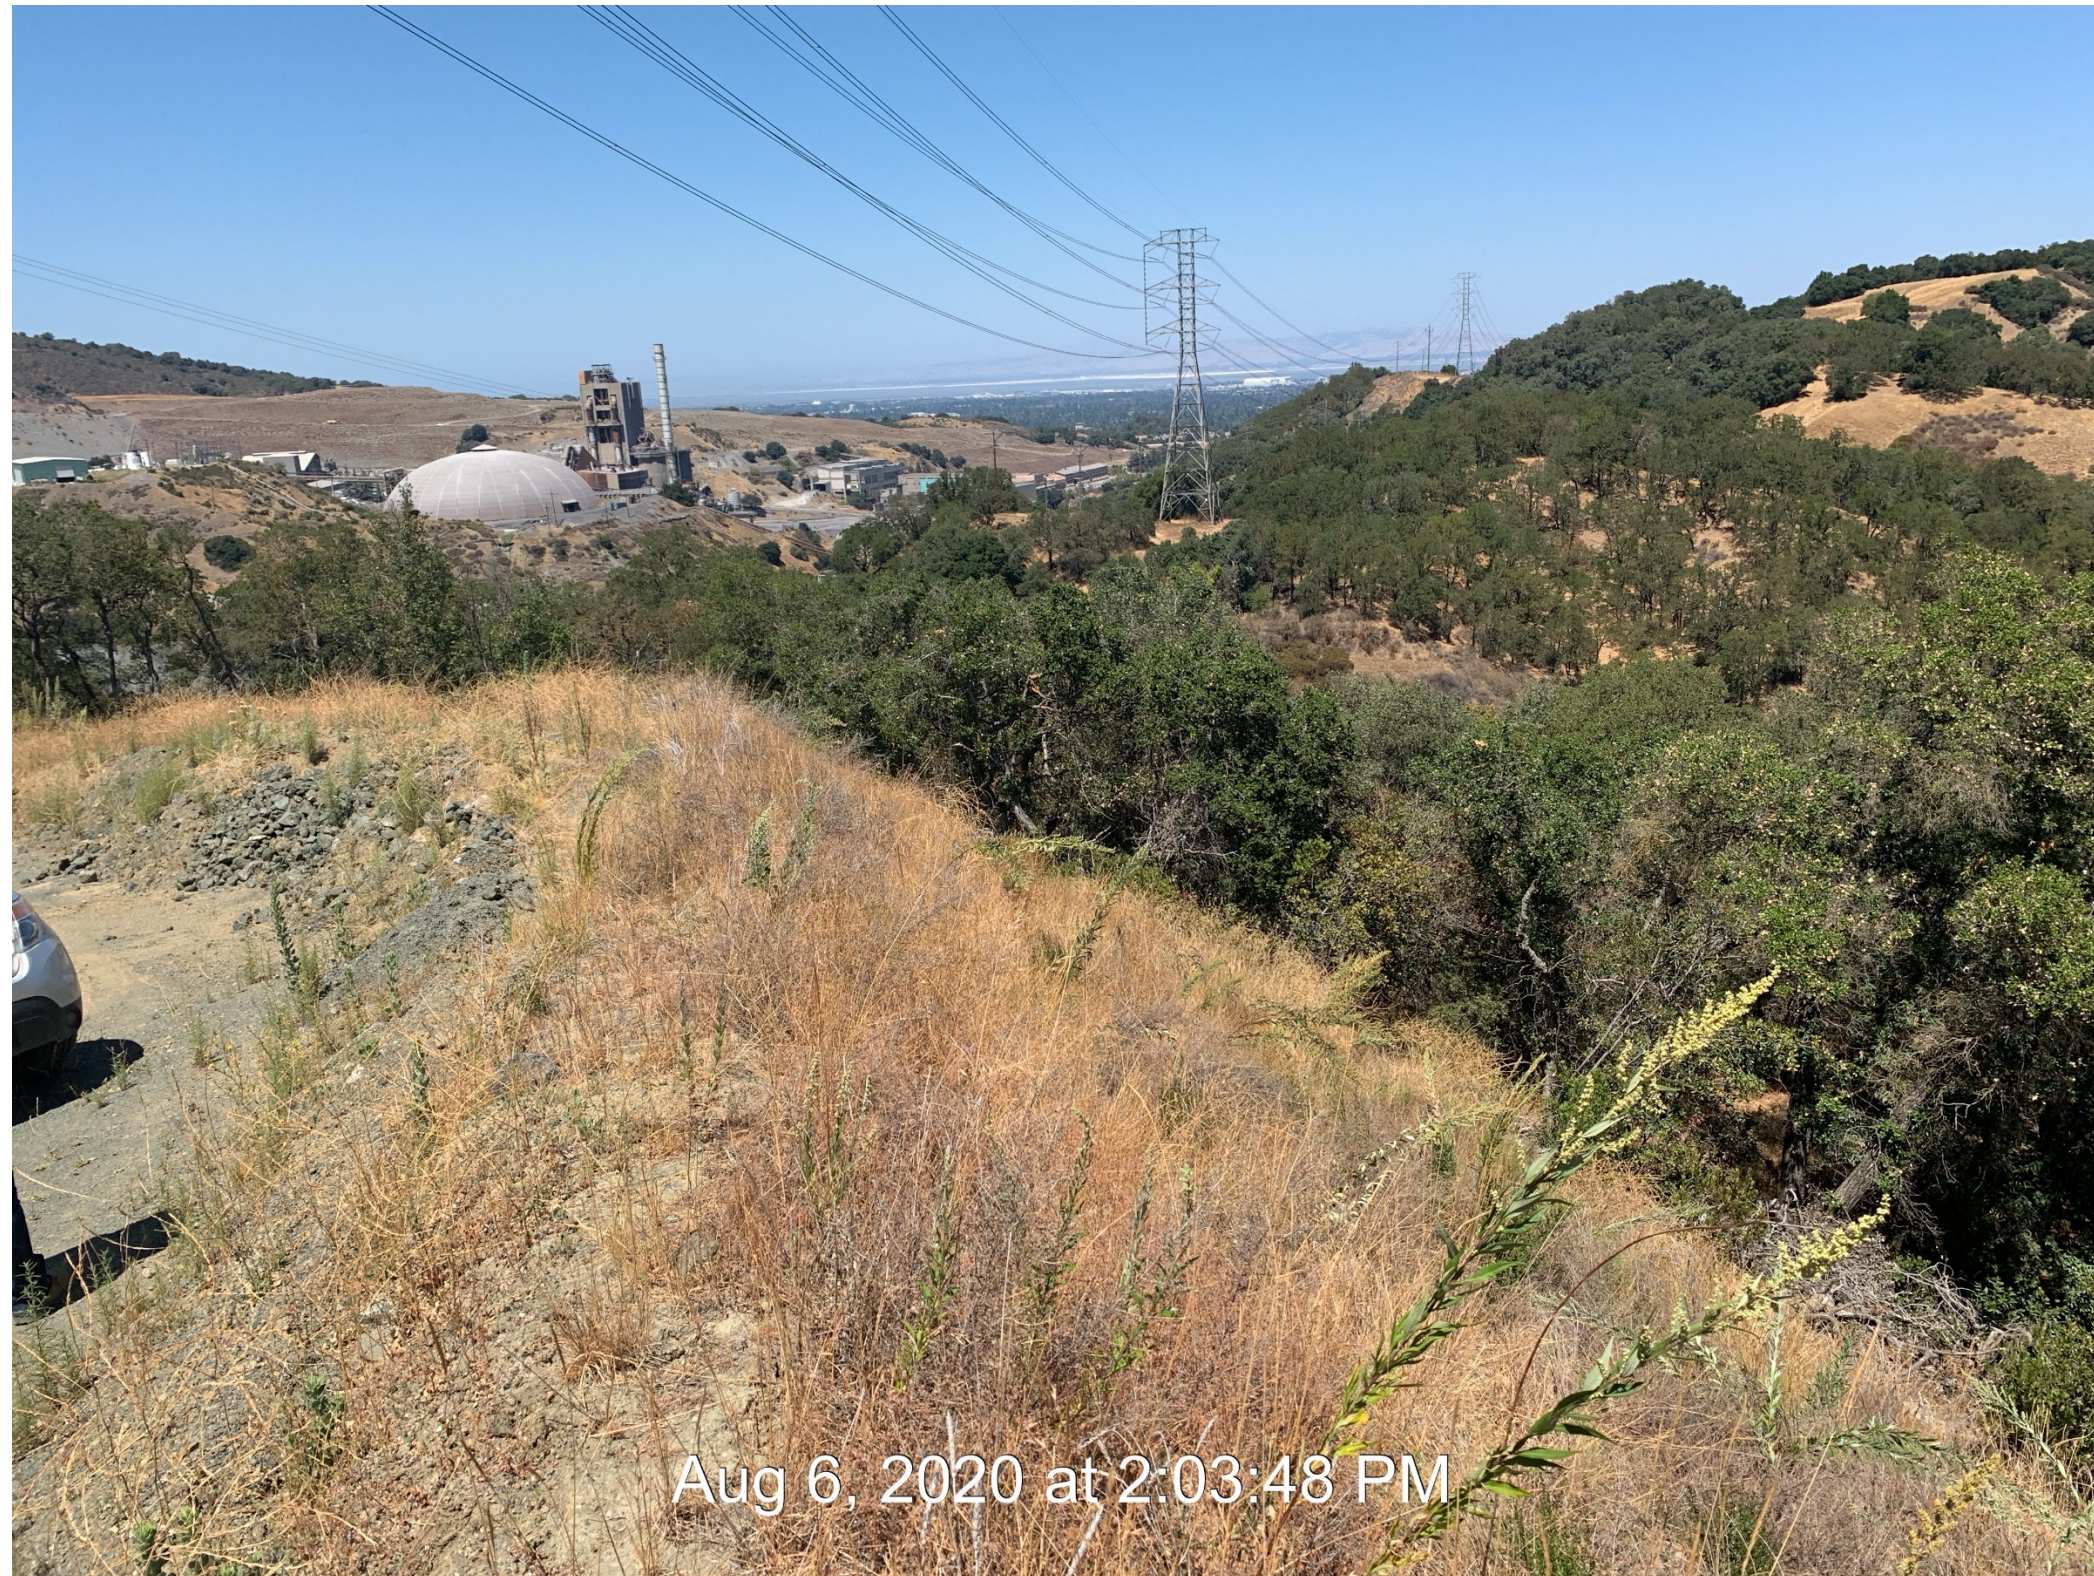
No new SMARA violations were noted during the annual inspection. As previously reported, on June 13, 2019 the County issued a Notice of Violation (Attachment C) for sediment discharge into Permanente Creek in the vicinity of the Yeager Yard [See **Photo 25**]. As required by this NOV, the operator created a lined sediment basin to prevent any more sediment or loose rock from entering the Permanente Creek channel [See **Photo 26**], replaced old silt fences upslope of the discharge area [See **Photo 22**], and placed straw bales above the lined sediment basin [See **Photo 27**]. On April 27, 2020, the County informed Lehigh that they had abated the violation.

Photo #22 – Toe of Yeager Yard slide above Permanente Creek (out of view to the left) taken on 6-19-2020

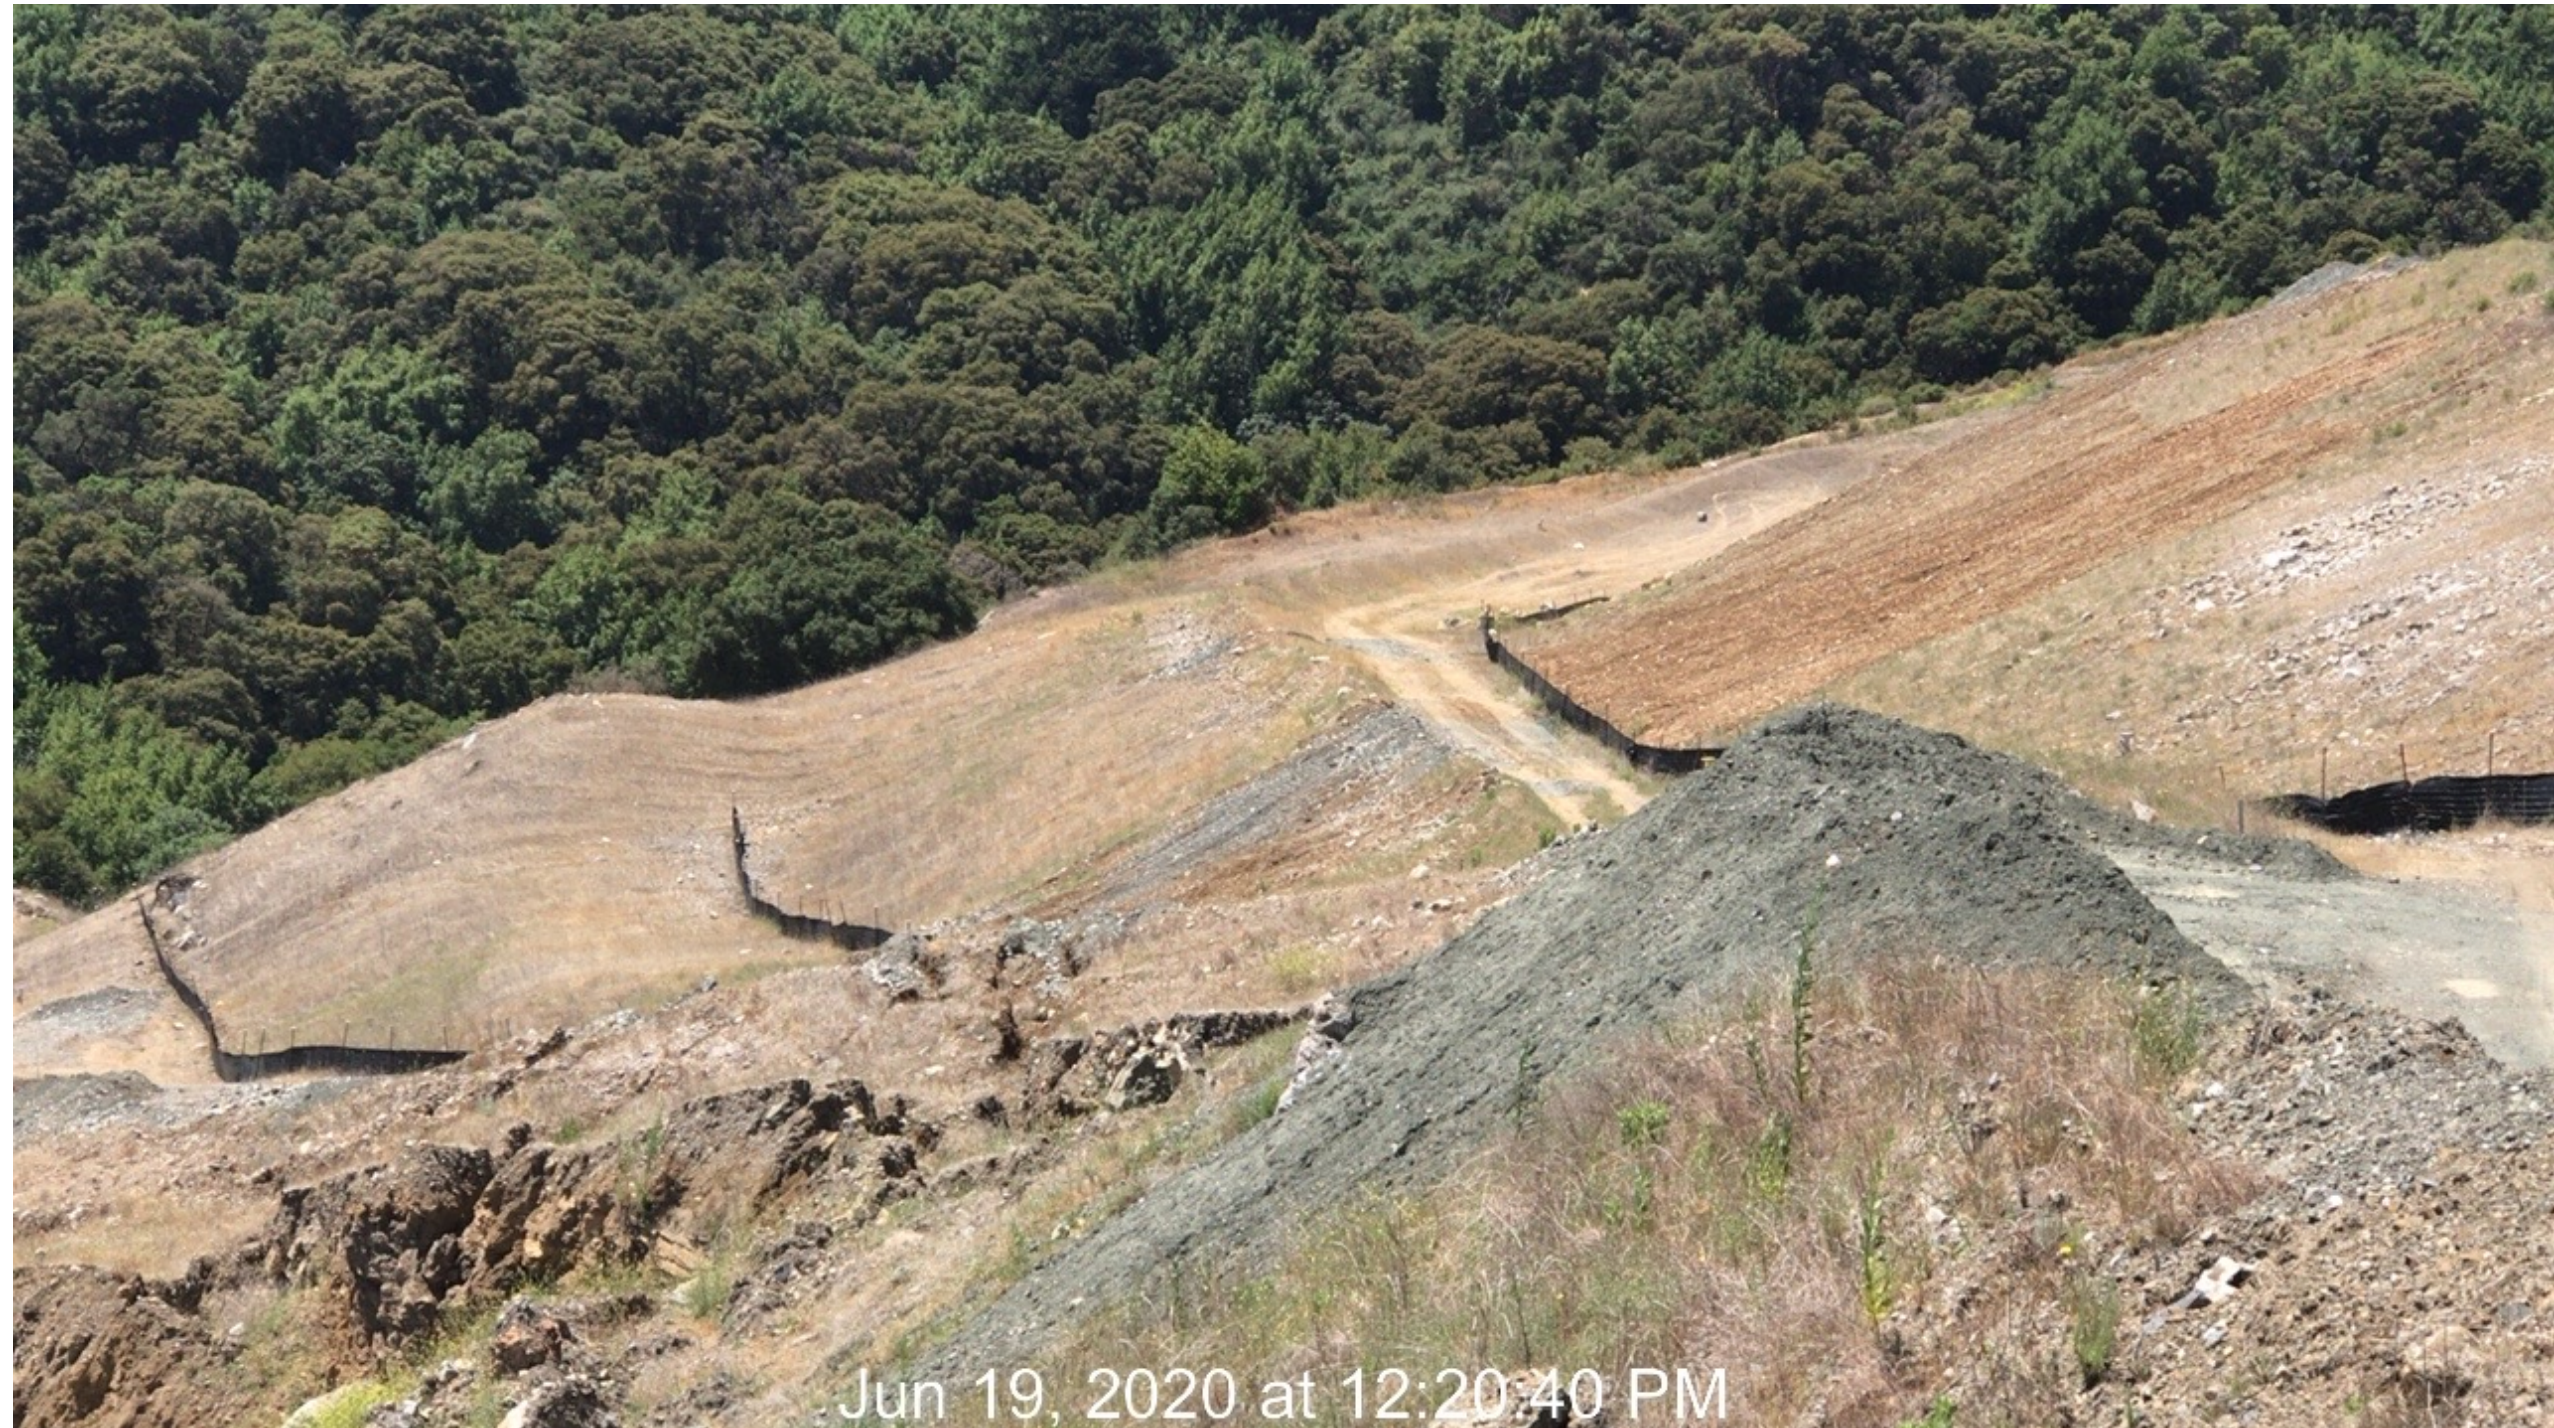
**Photo #23 – Excavation above Yeager Yard**

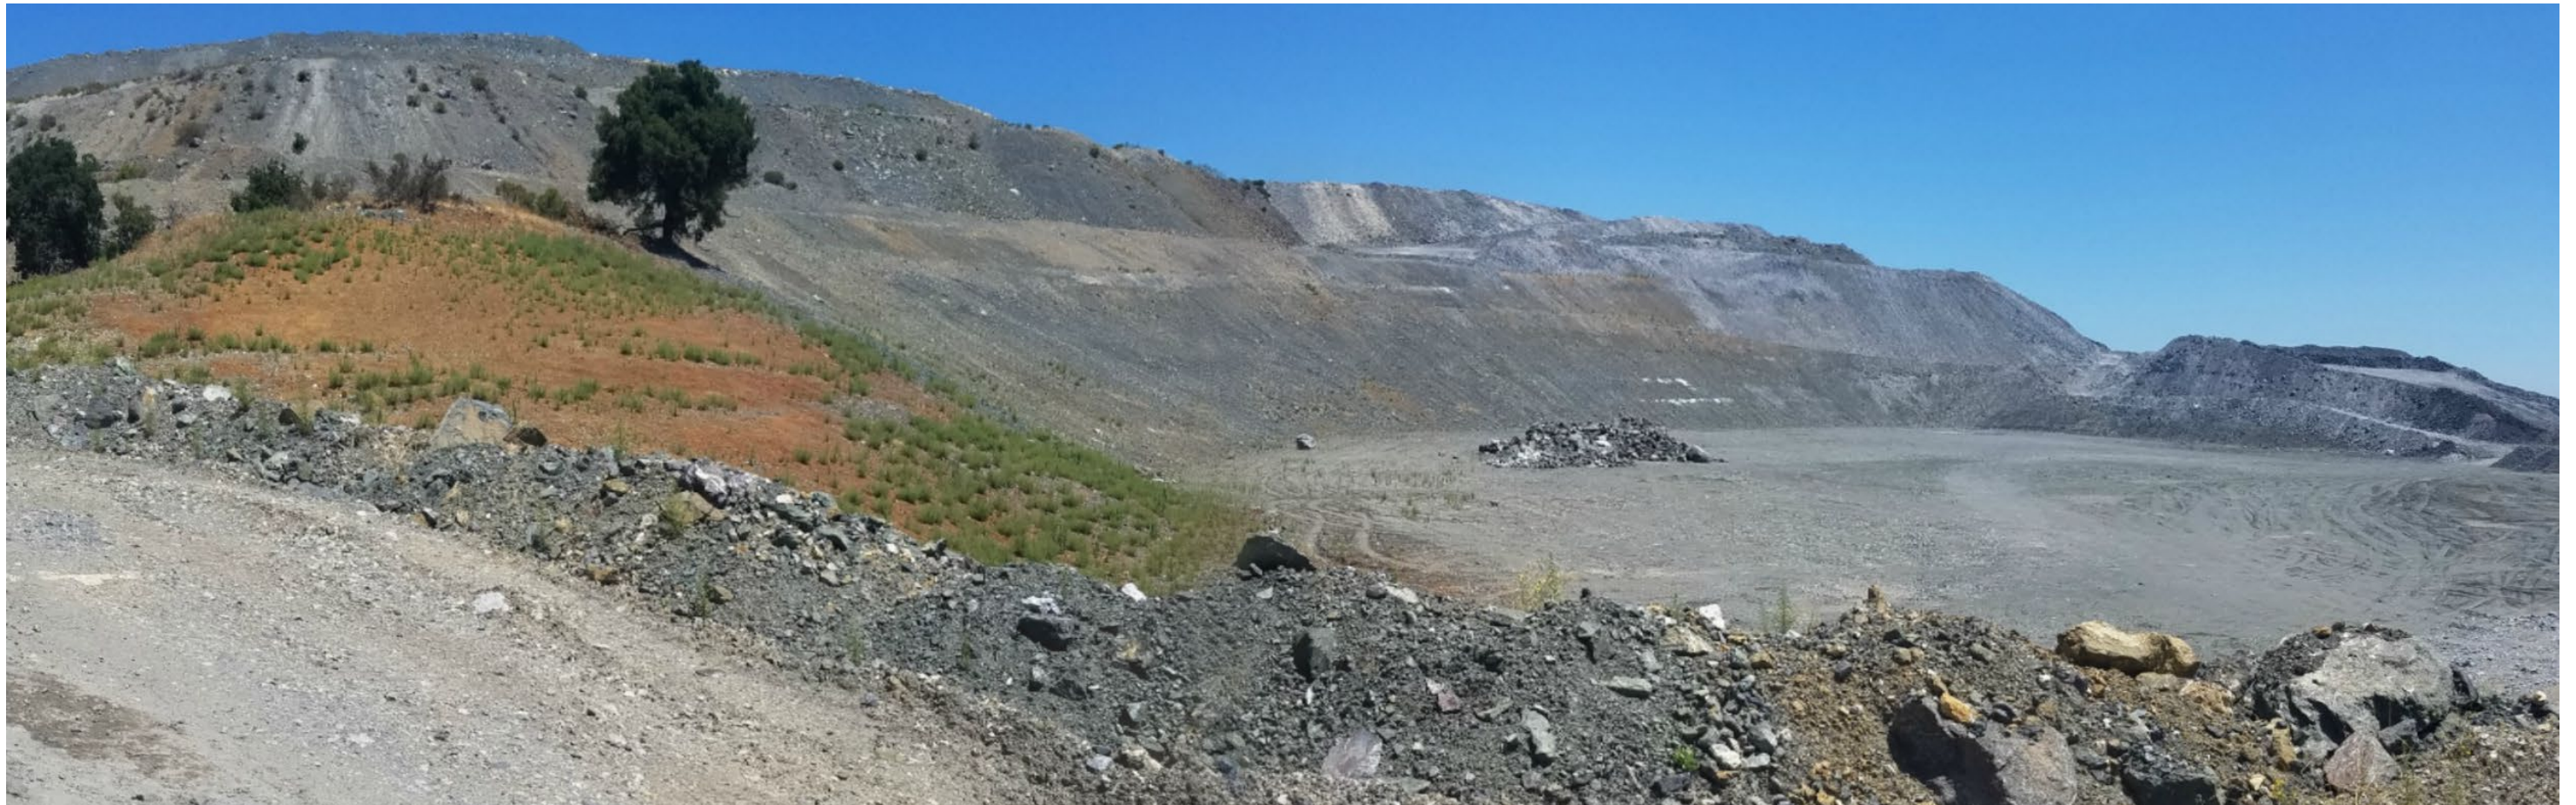
**Photo #24 – Toe of Yeager Yard land slide above Permanente Creek (lower left)**

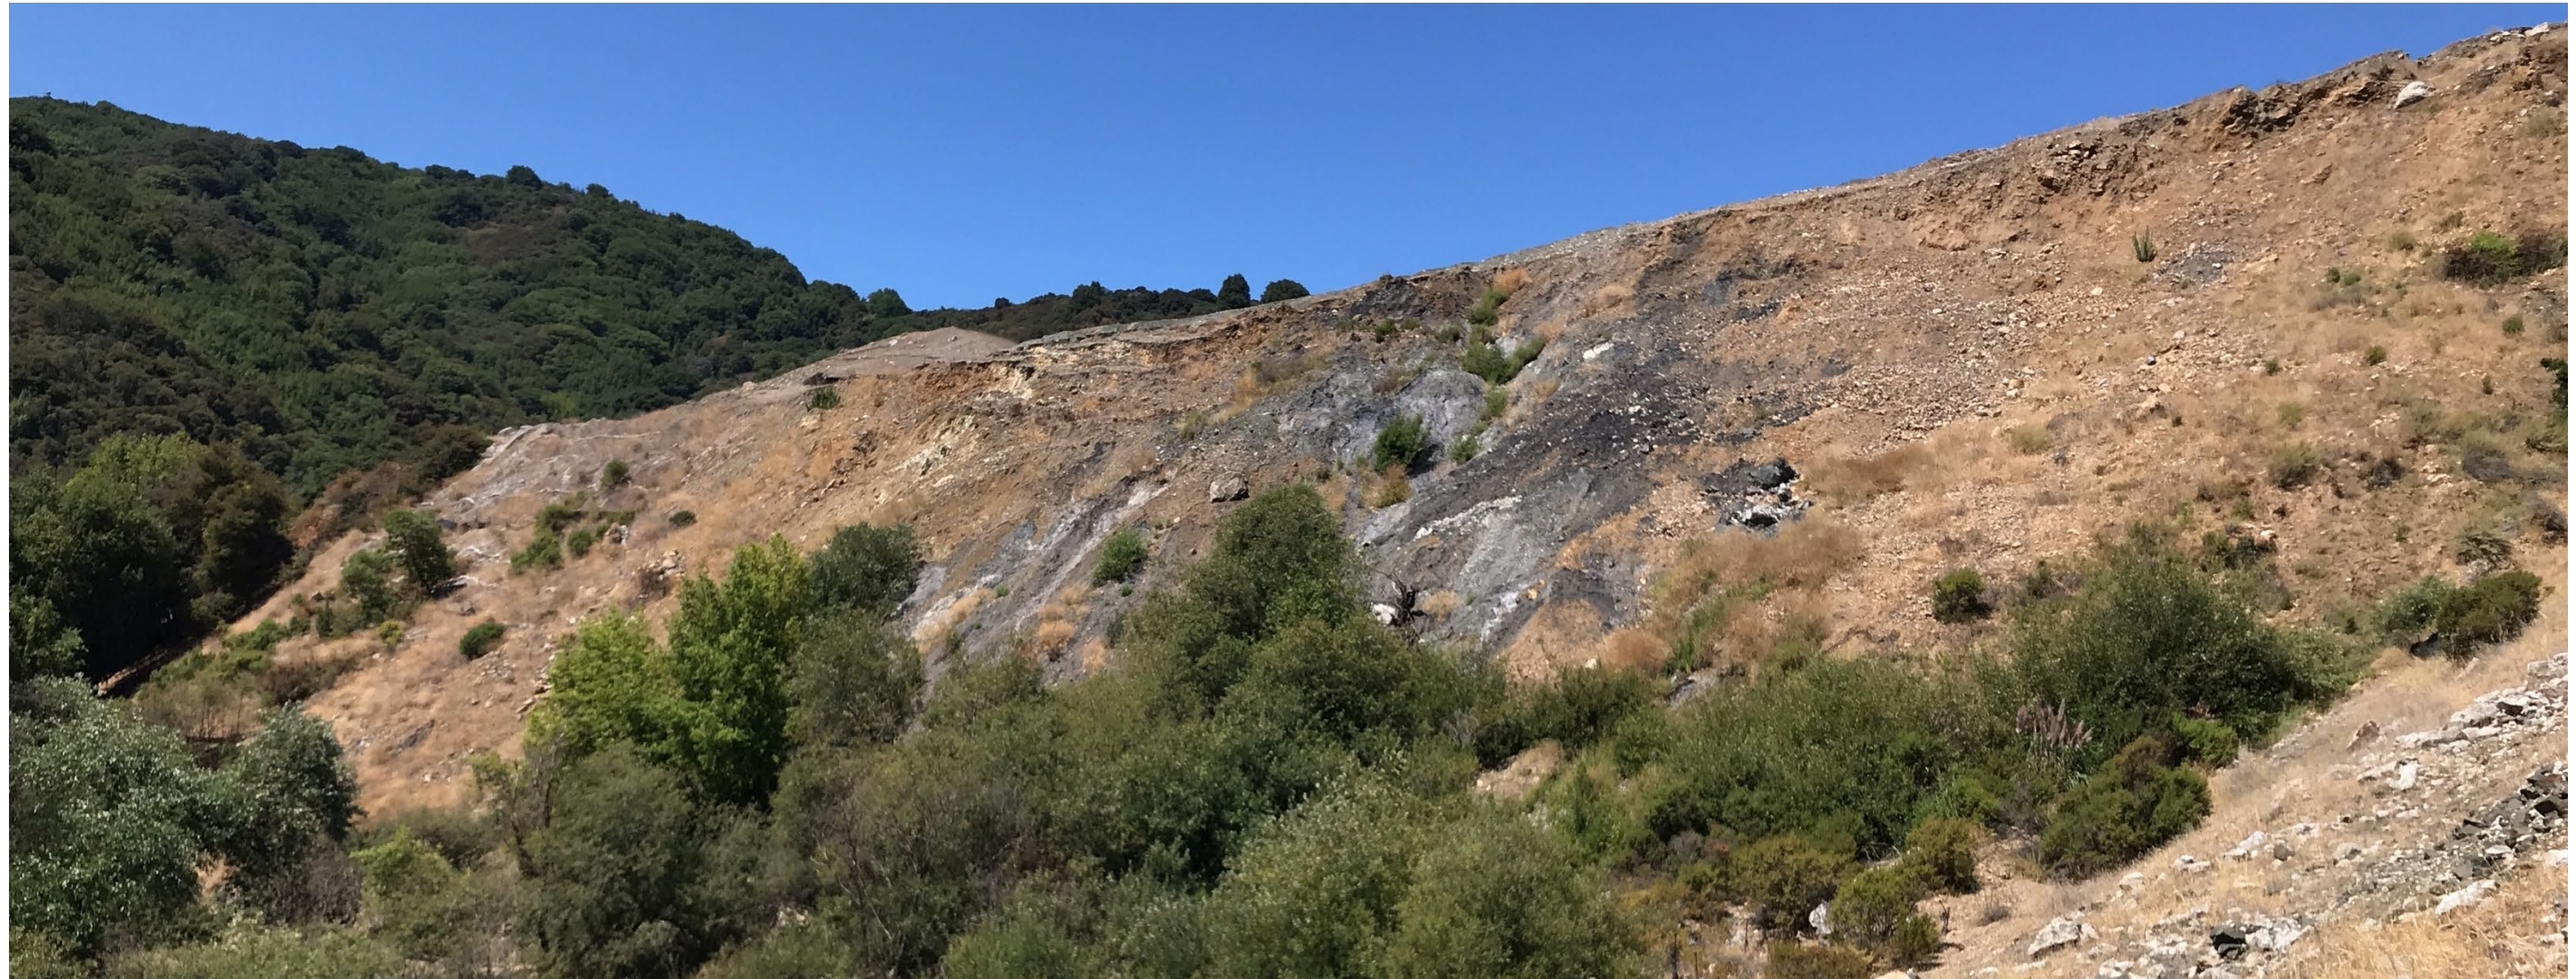
Photo #25 – Sediment deposited into Permanente Creek from Yeager Yard slope

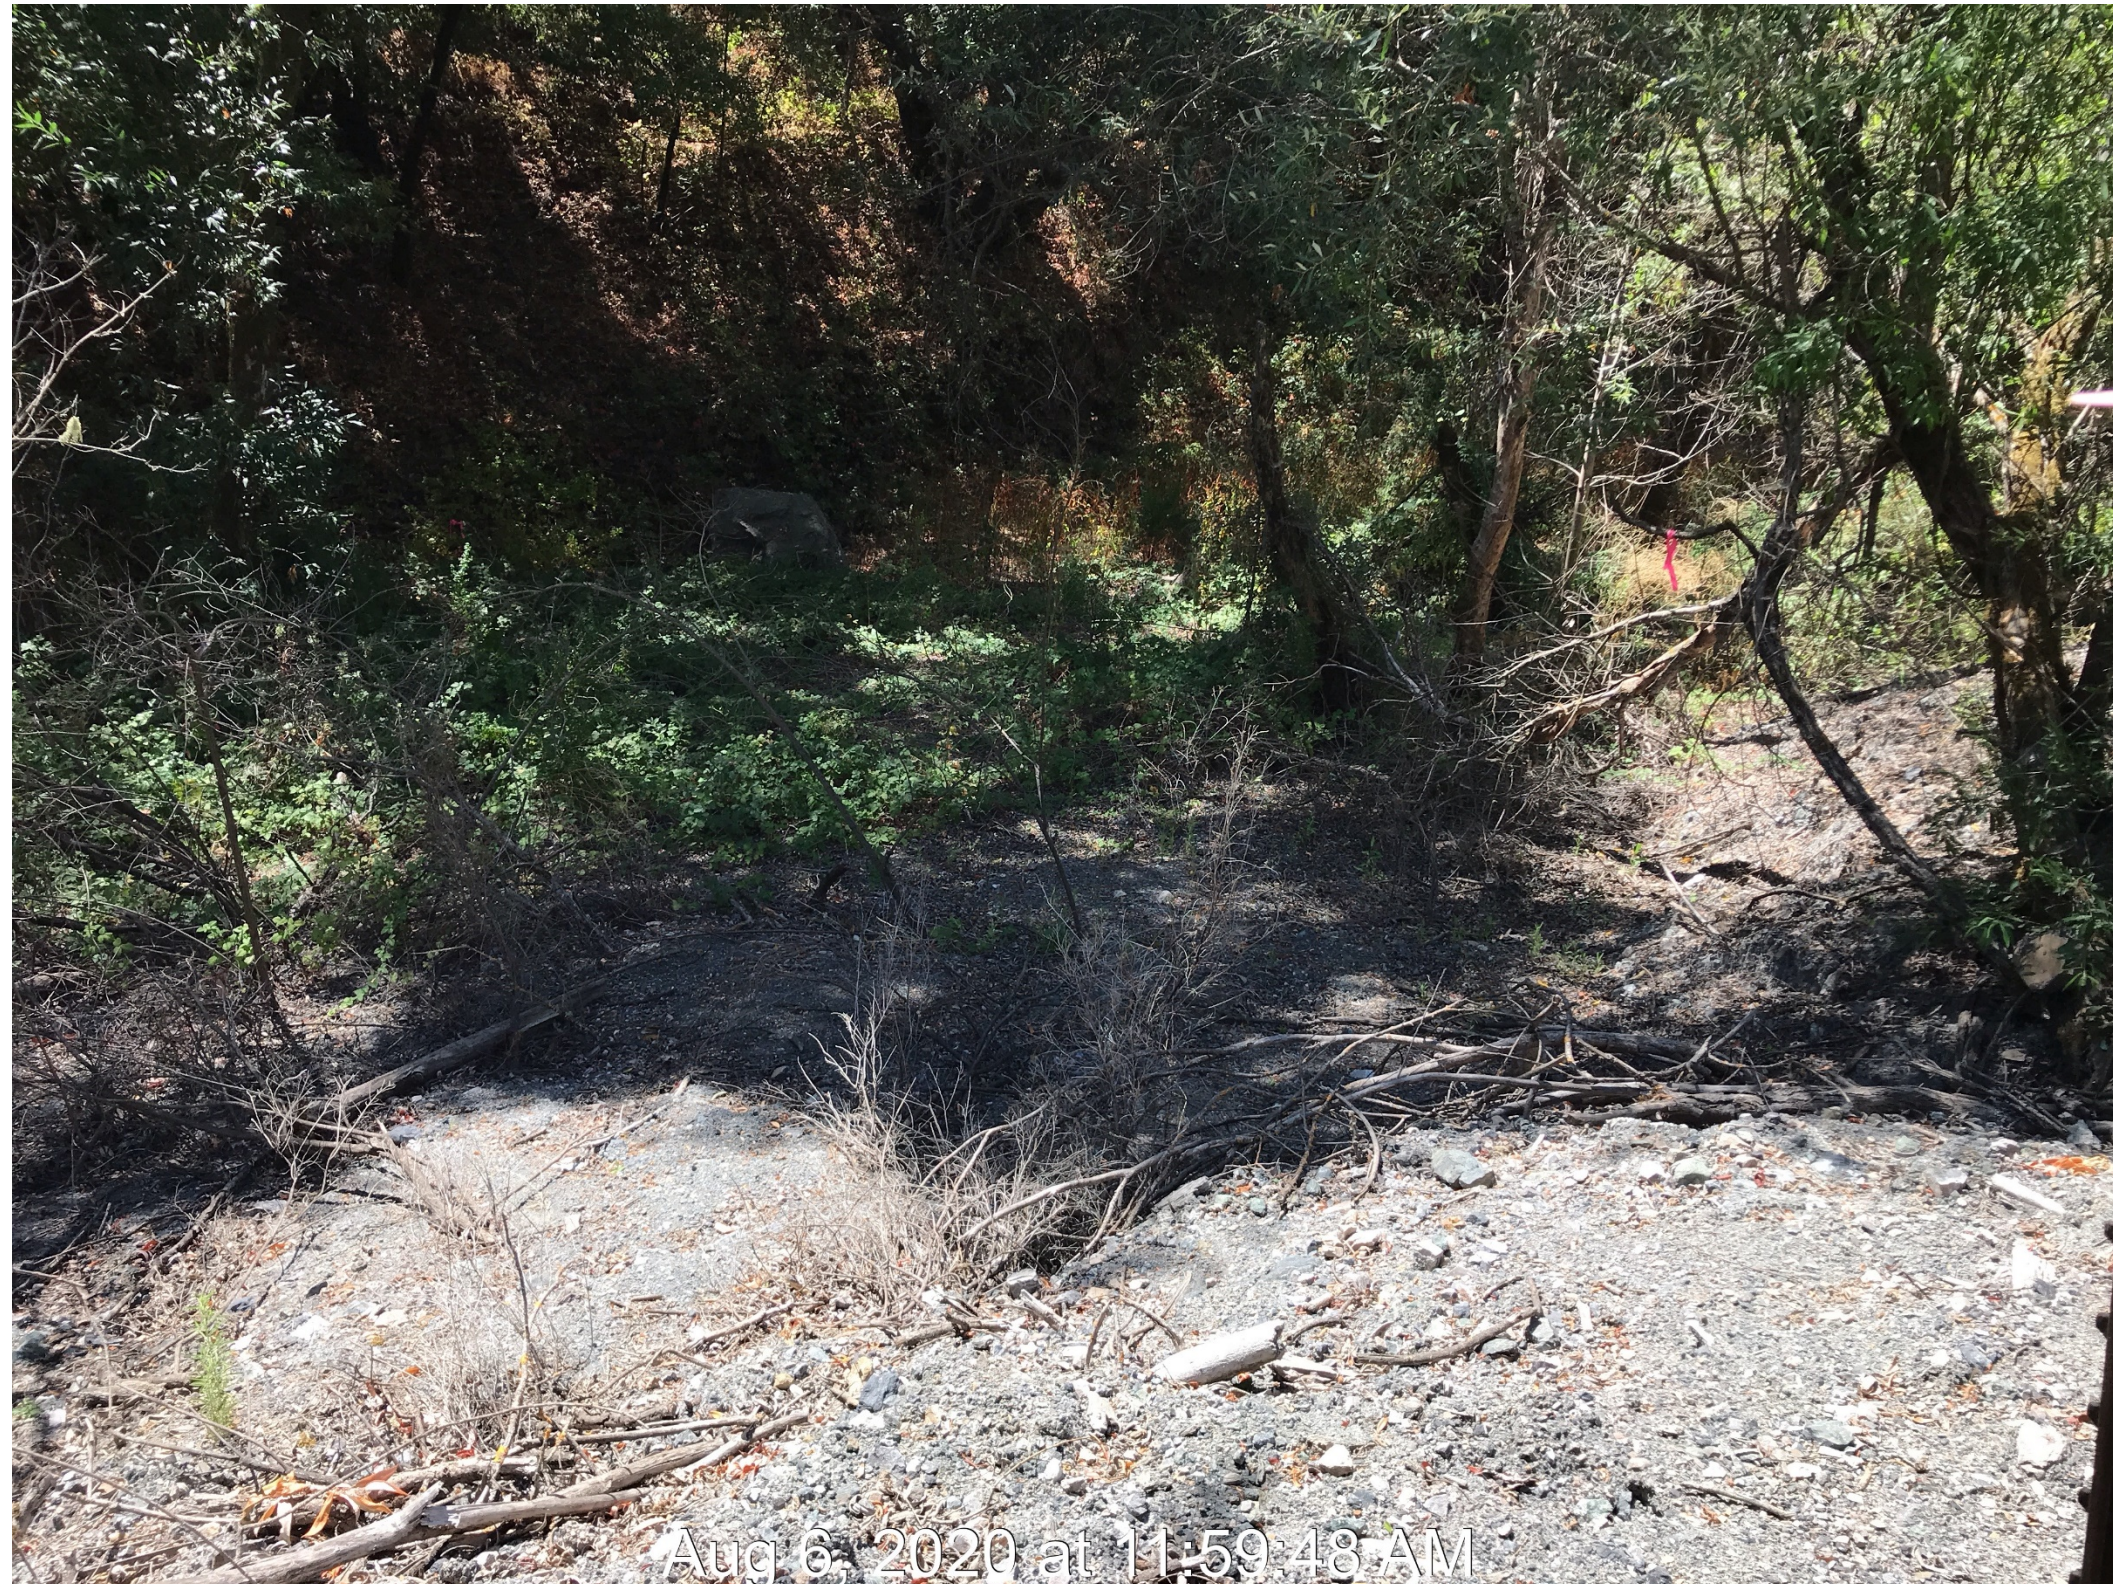
Photo #26 – Debris basin

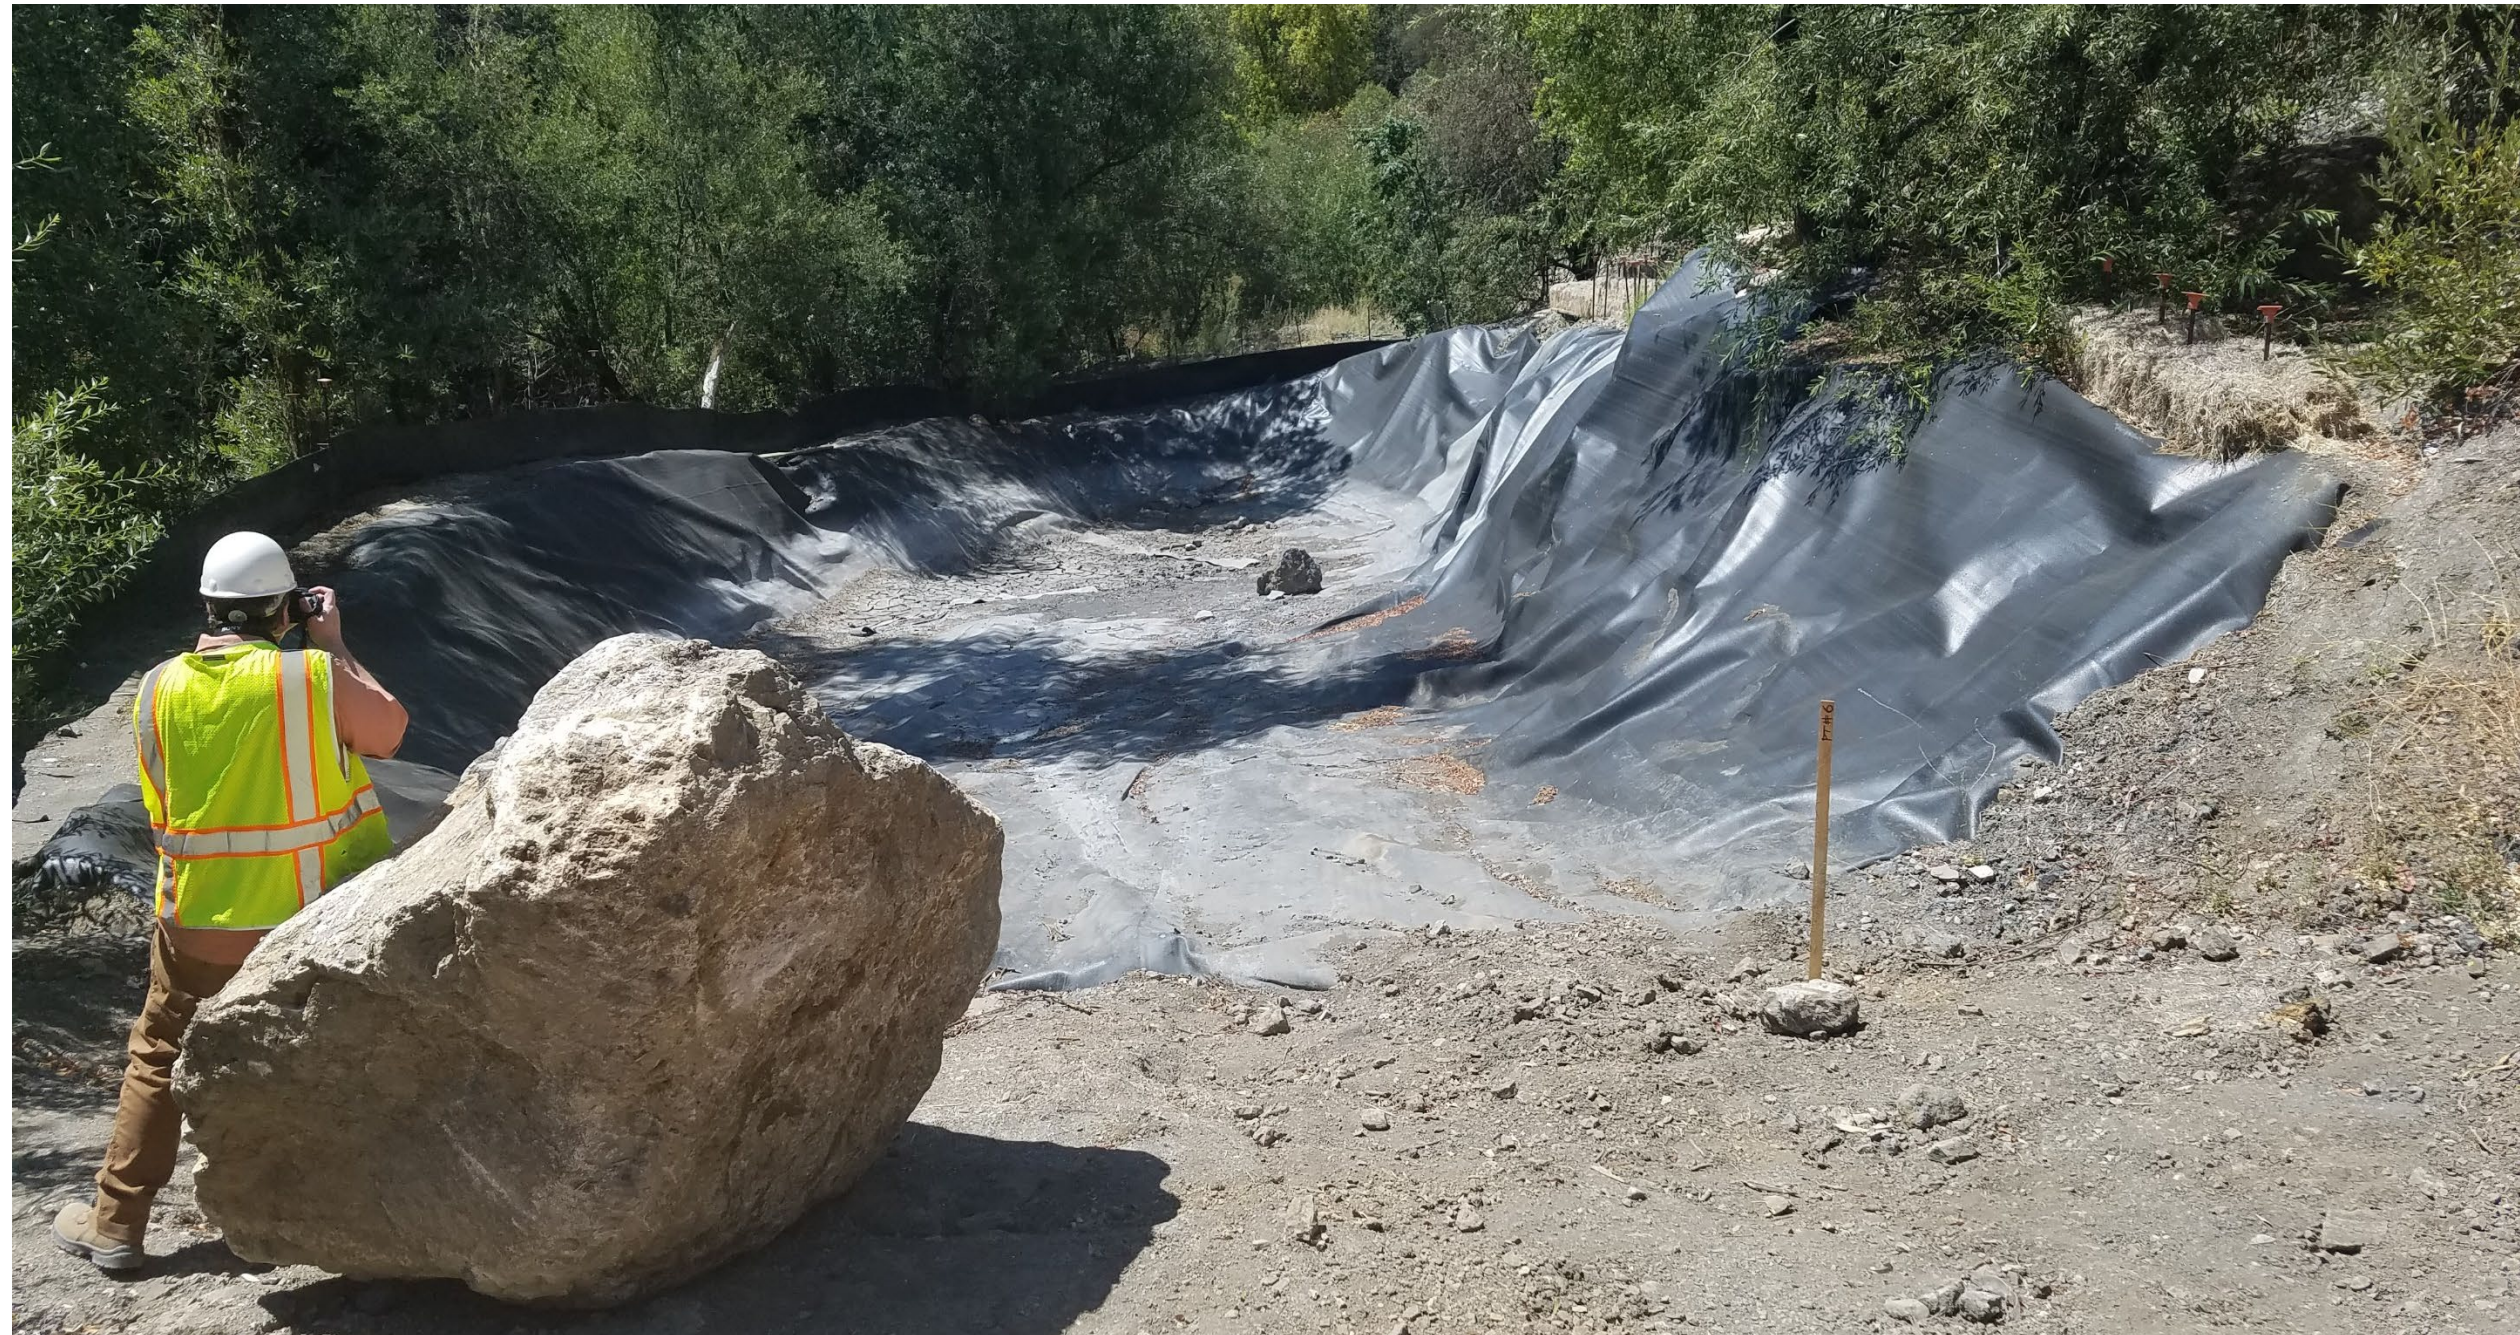
Photo #27 – Debris flow scar (source of sediment deposited in Permanente Creek)
