## SURFACE MINING INSPECTION REPORT

Photos from 2020 Annual SMARA Inspection Conducted on 8-06-2020

by  
Robert Salisbury, Senior Planner  
James Baker, CEG#1021, County Geologist  
Steve Beams, Senior Construction Inspector  
Glen Jia, Assistant Planner

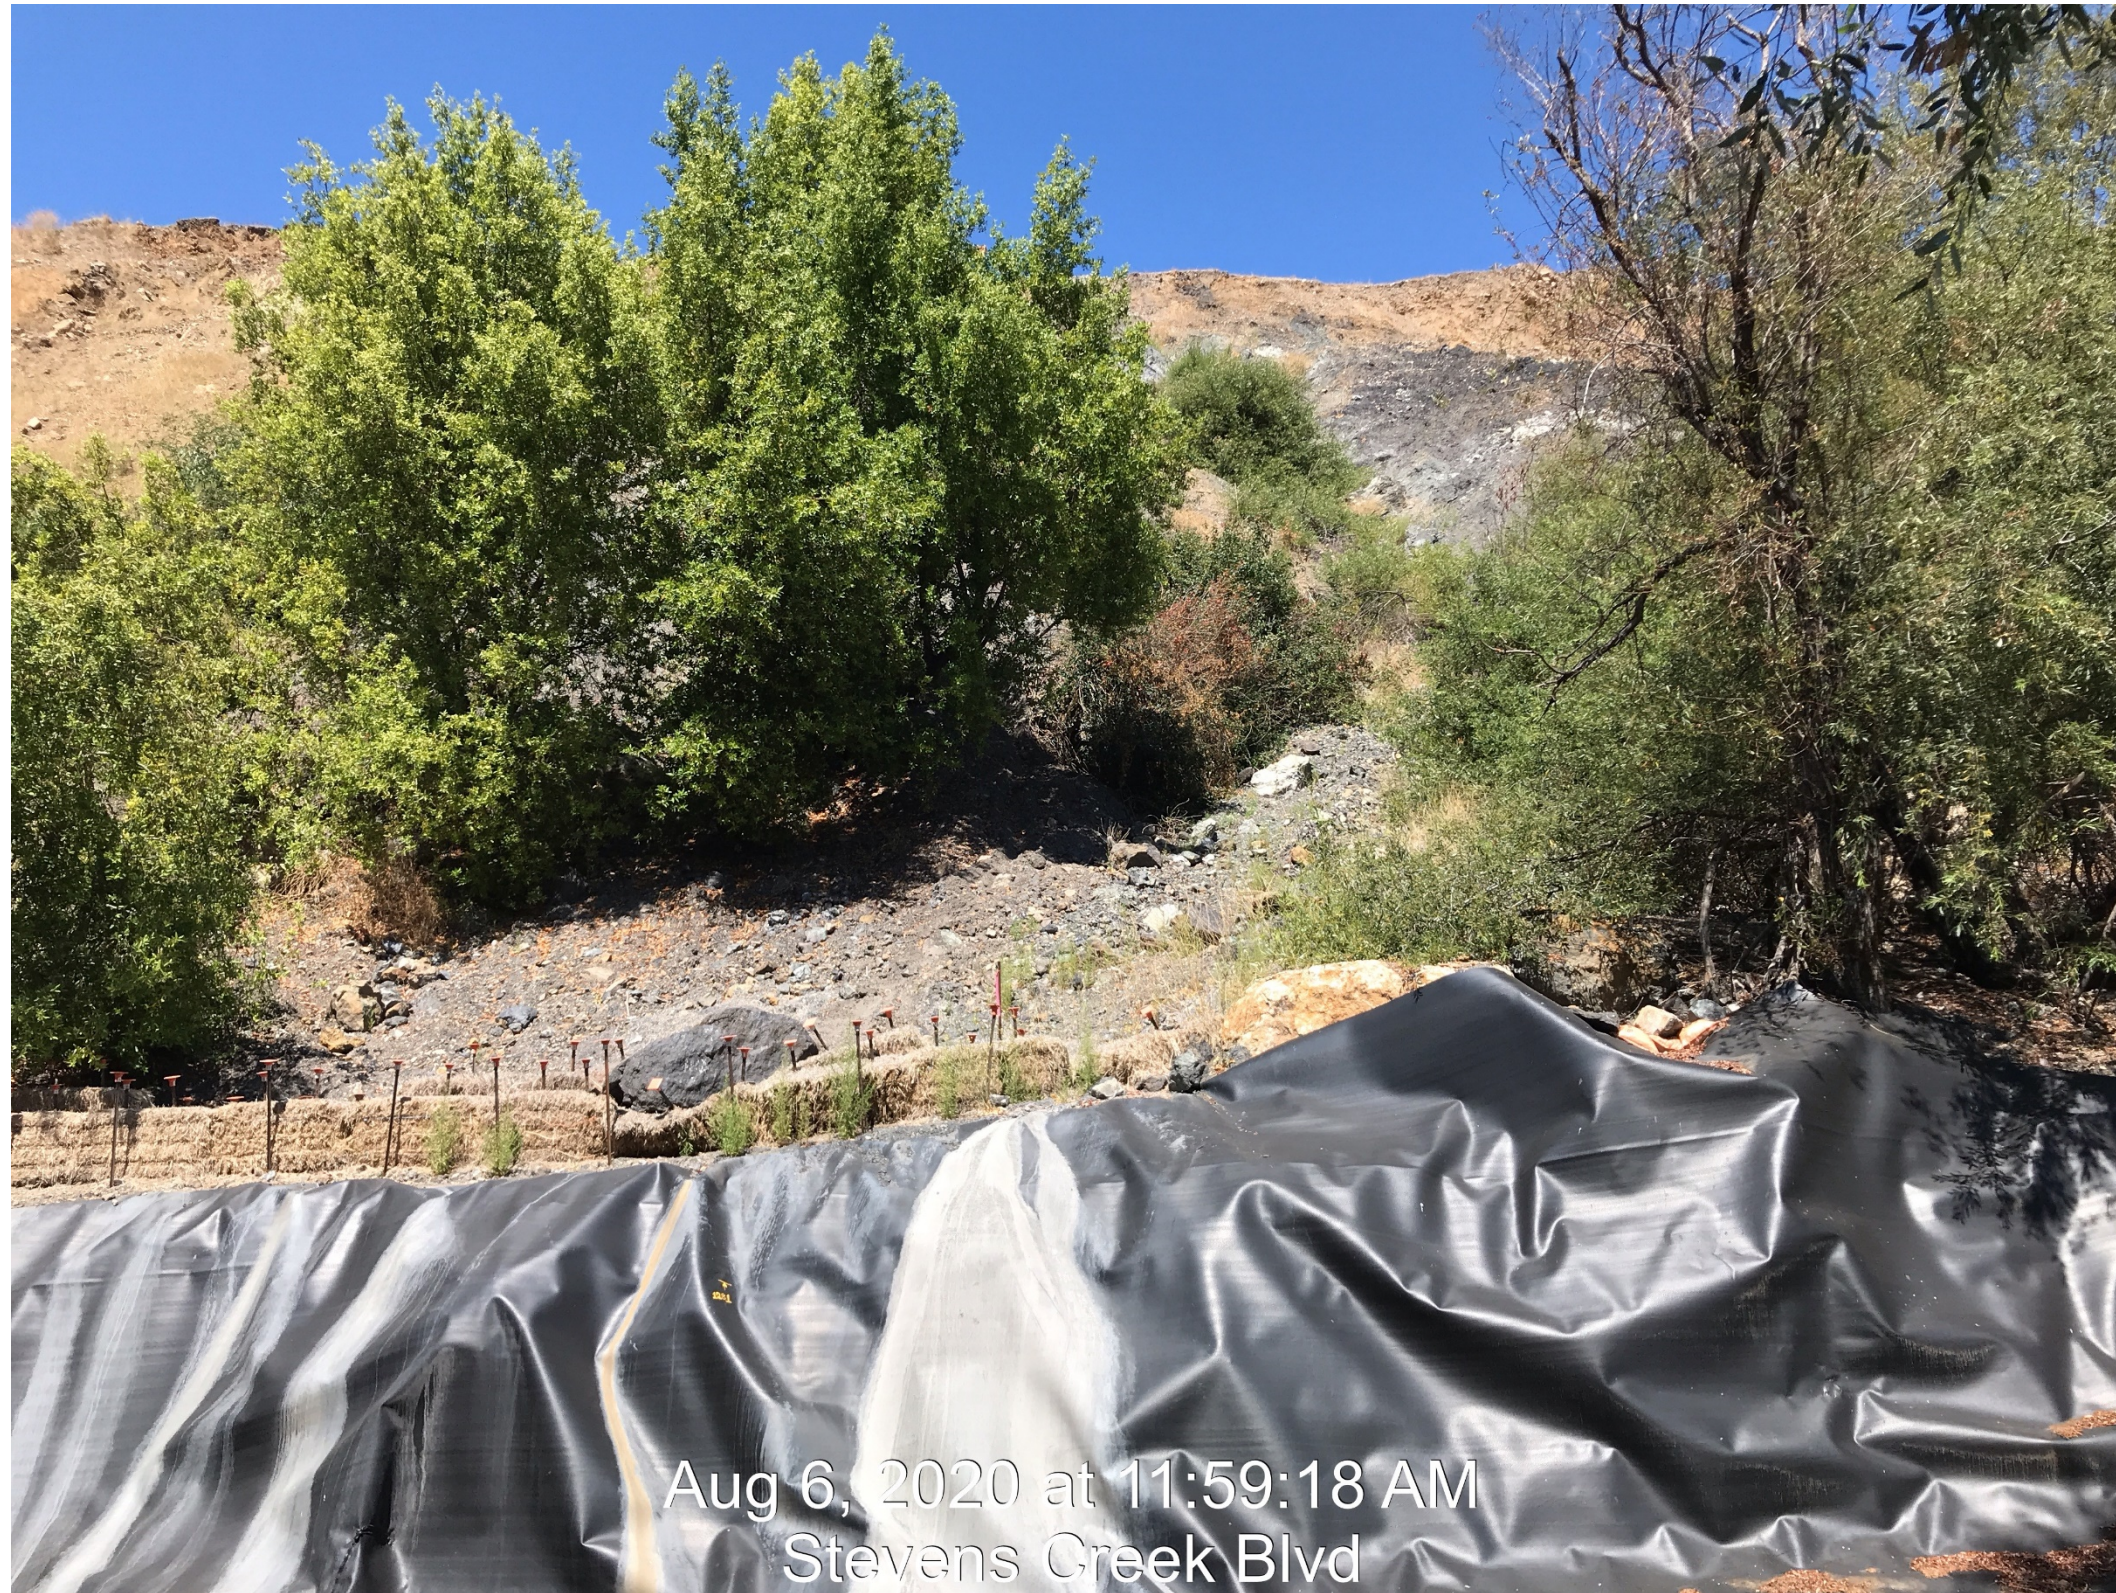
During the annual inspection, County inspectors observed an area in which recent grading had created a level pad adjacent to the modified utility road south of the Rock Plant. The fill slopes were covered with jute netting which had not yet been hydroseeded. [See **Photos 28a and 28b.**] In addition, County inspectors saw a localized area of shallow slumping of slopes on the northern side of fill placed in 2017 on top of the EMSA. [See **Photo 29.**]

Photo #28A - recent fill pad near Rock Plant

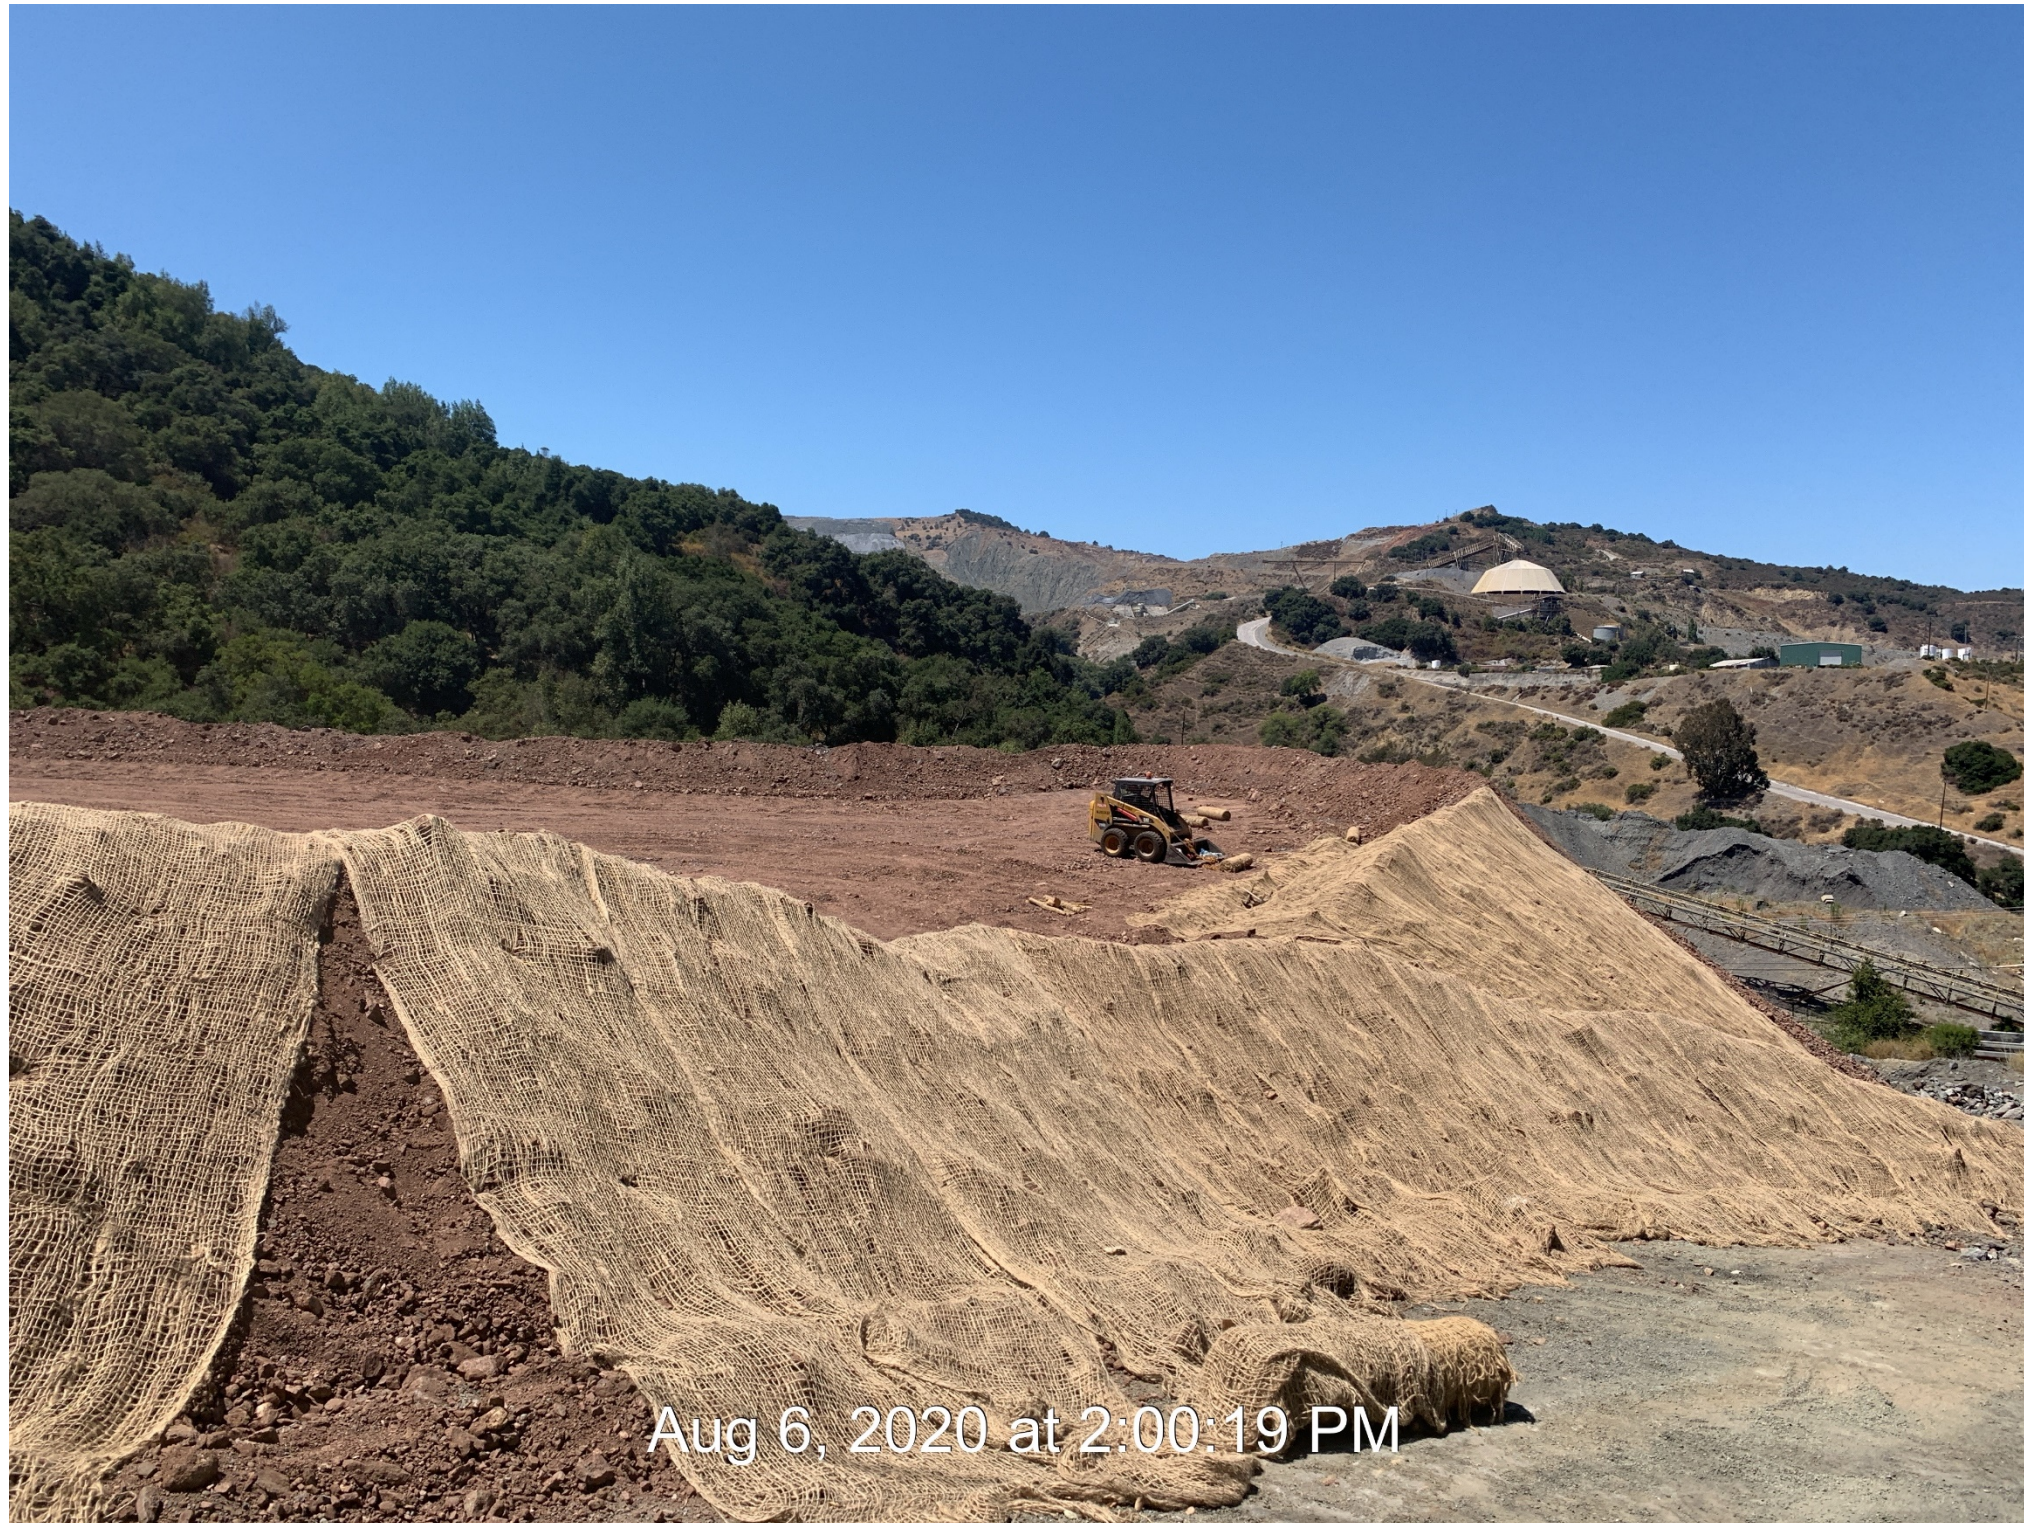
Photo #28B – recently cut pad near Rock Plant

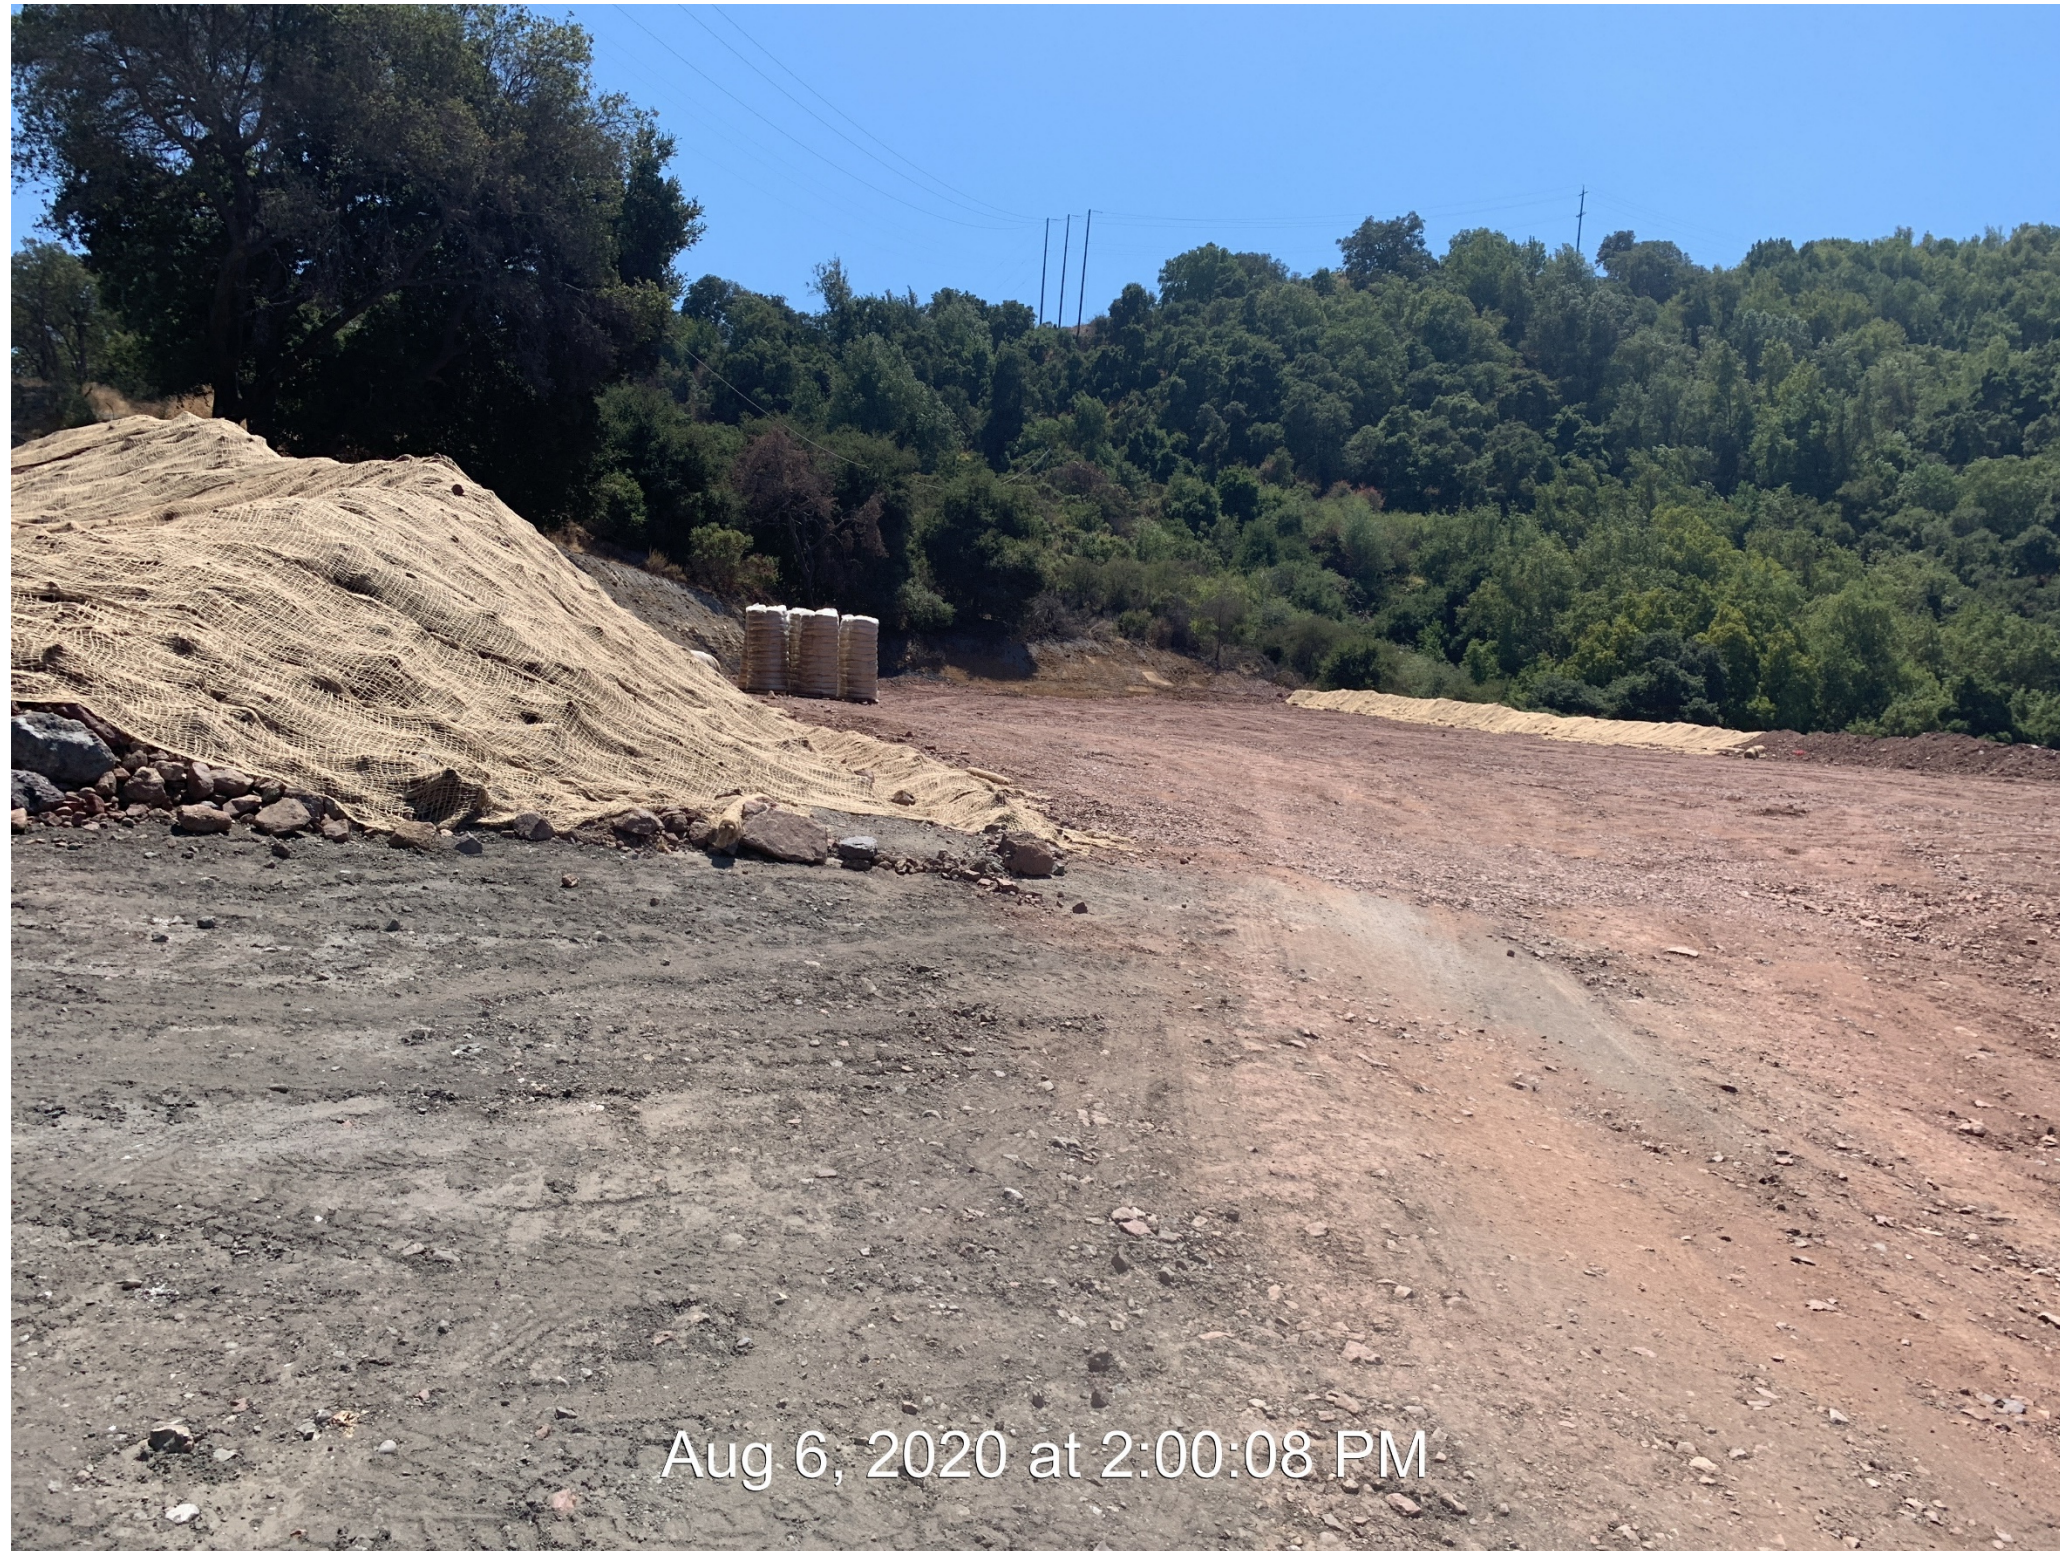
**Photo #29 – Shallow slumps in fill material added to EMSA beginning in September or October of 2017**
