## SURFACE MINING INSPECTION REPORT

Photos from 2021 Annual SMARA Inspection Conducted on 9-17-2021

by  
Robert Salisbury, Senior Planner  
James Baker, CEG#1021, County Geologist  
Steve Beams, Senior Construction Inspector

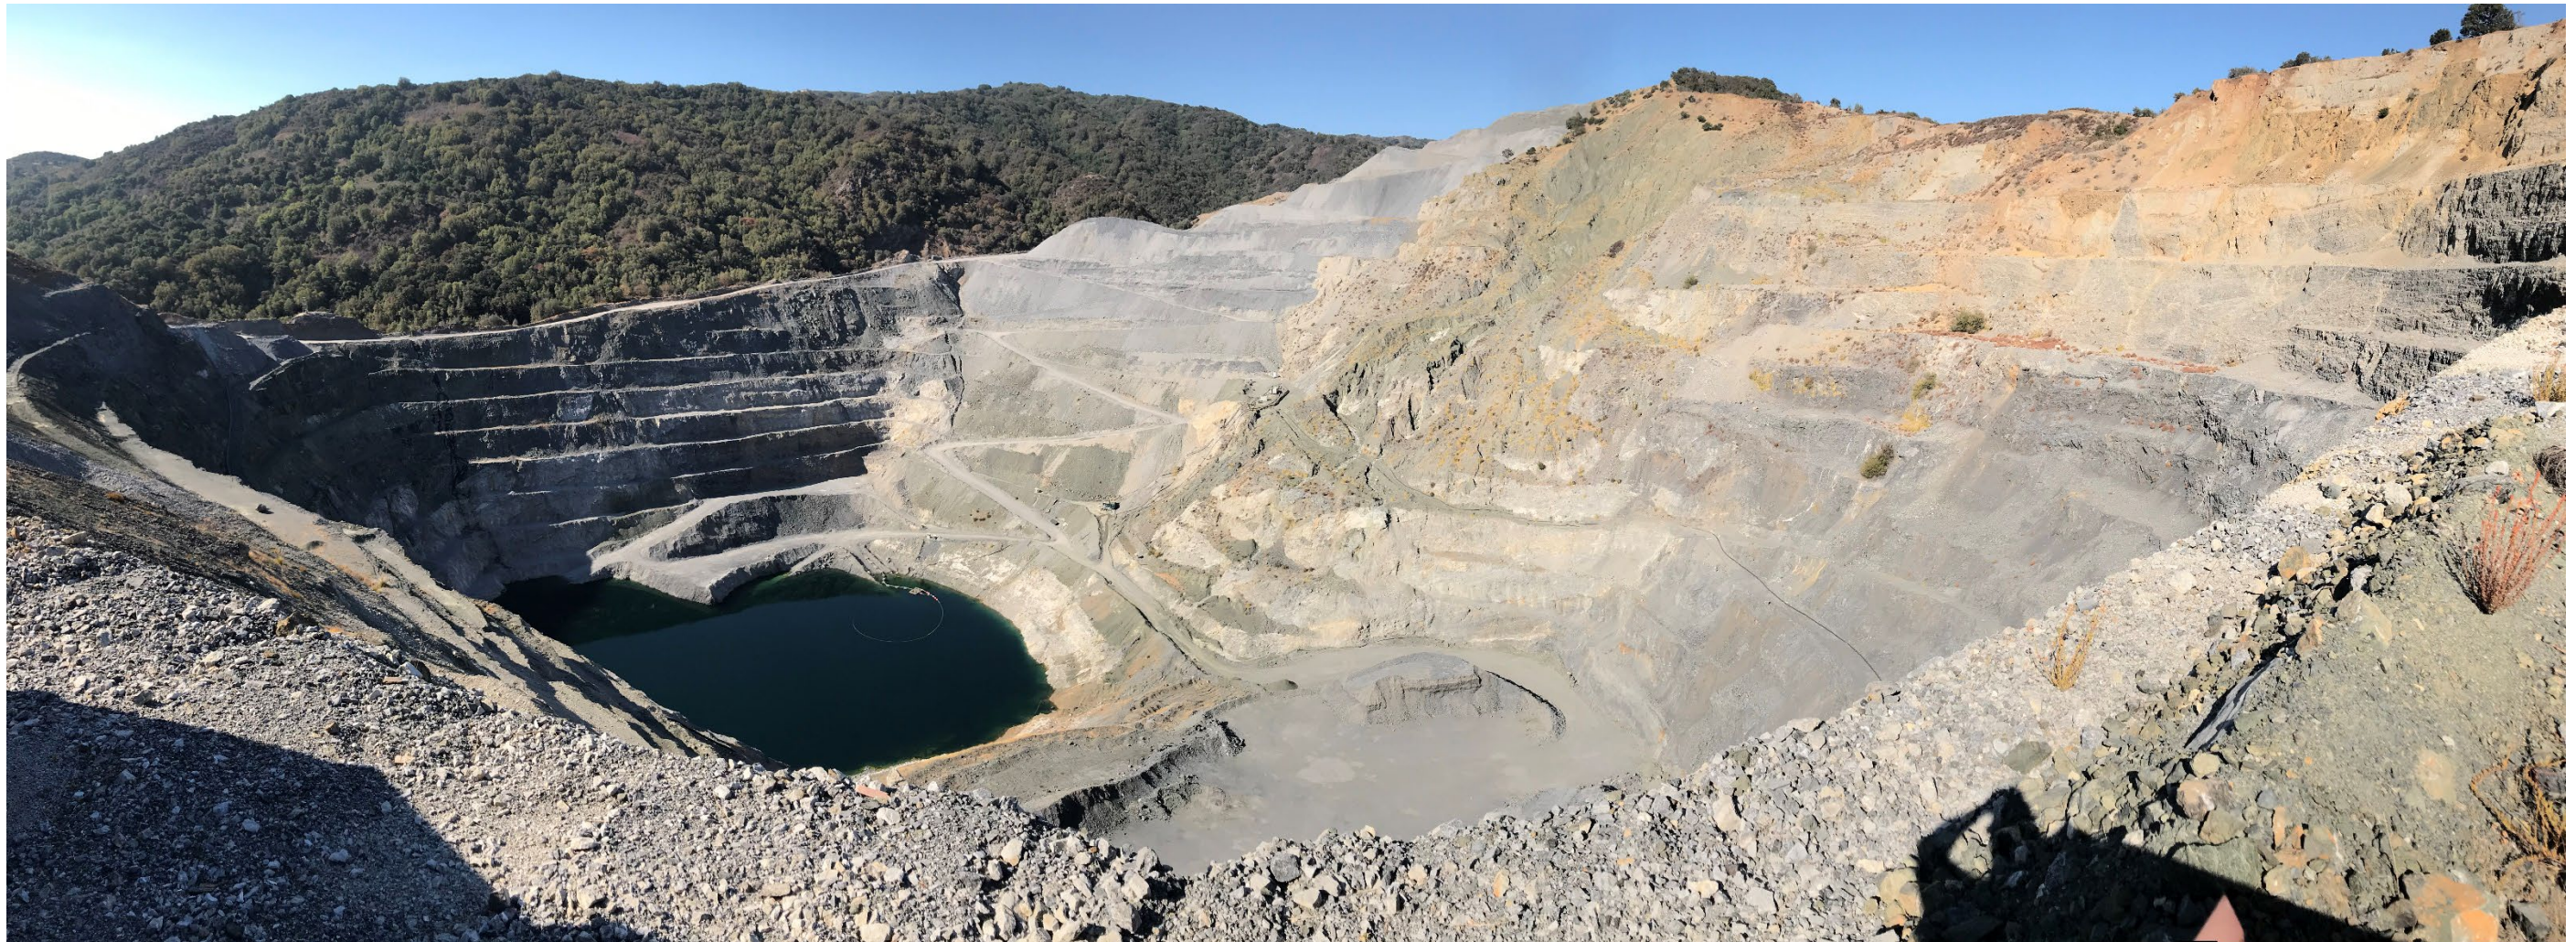
**PHOTO #1** – North Quarry Main Pit (looking southwest)

The highwalls on the north, east, and south were previously excavated and benched, however multiple slides occurred over the years leading to failure of parts of the benches. The proposed RPA currently under review by the County proposes changes in slope geometry intended to address the main pit slope failures. No extraction of limestone was occurring in this area during the annual inspection. [See **PHOTO #1** and **PHOTO #2**.]

The highwalls on the north, east, and south are essentially complete (excavated benches); while the southern side of the pit is still being actively mined (blasting and loading). No extraction of limestone was occurring during the inspection  
New material was being placed on the southern portion of the WMSA [See also **PHOTO #2.**]

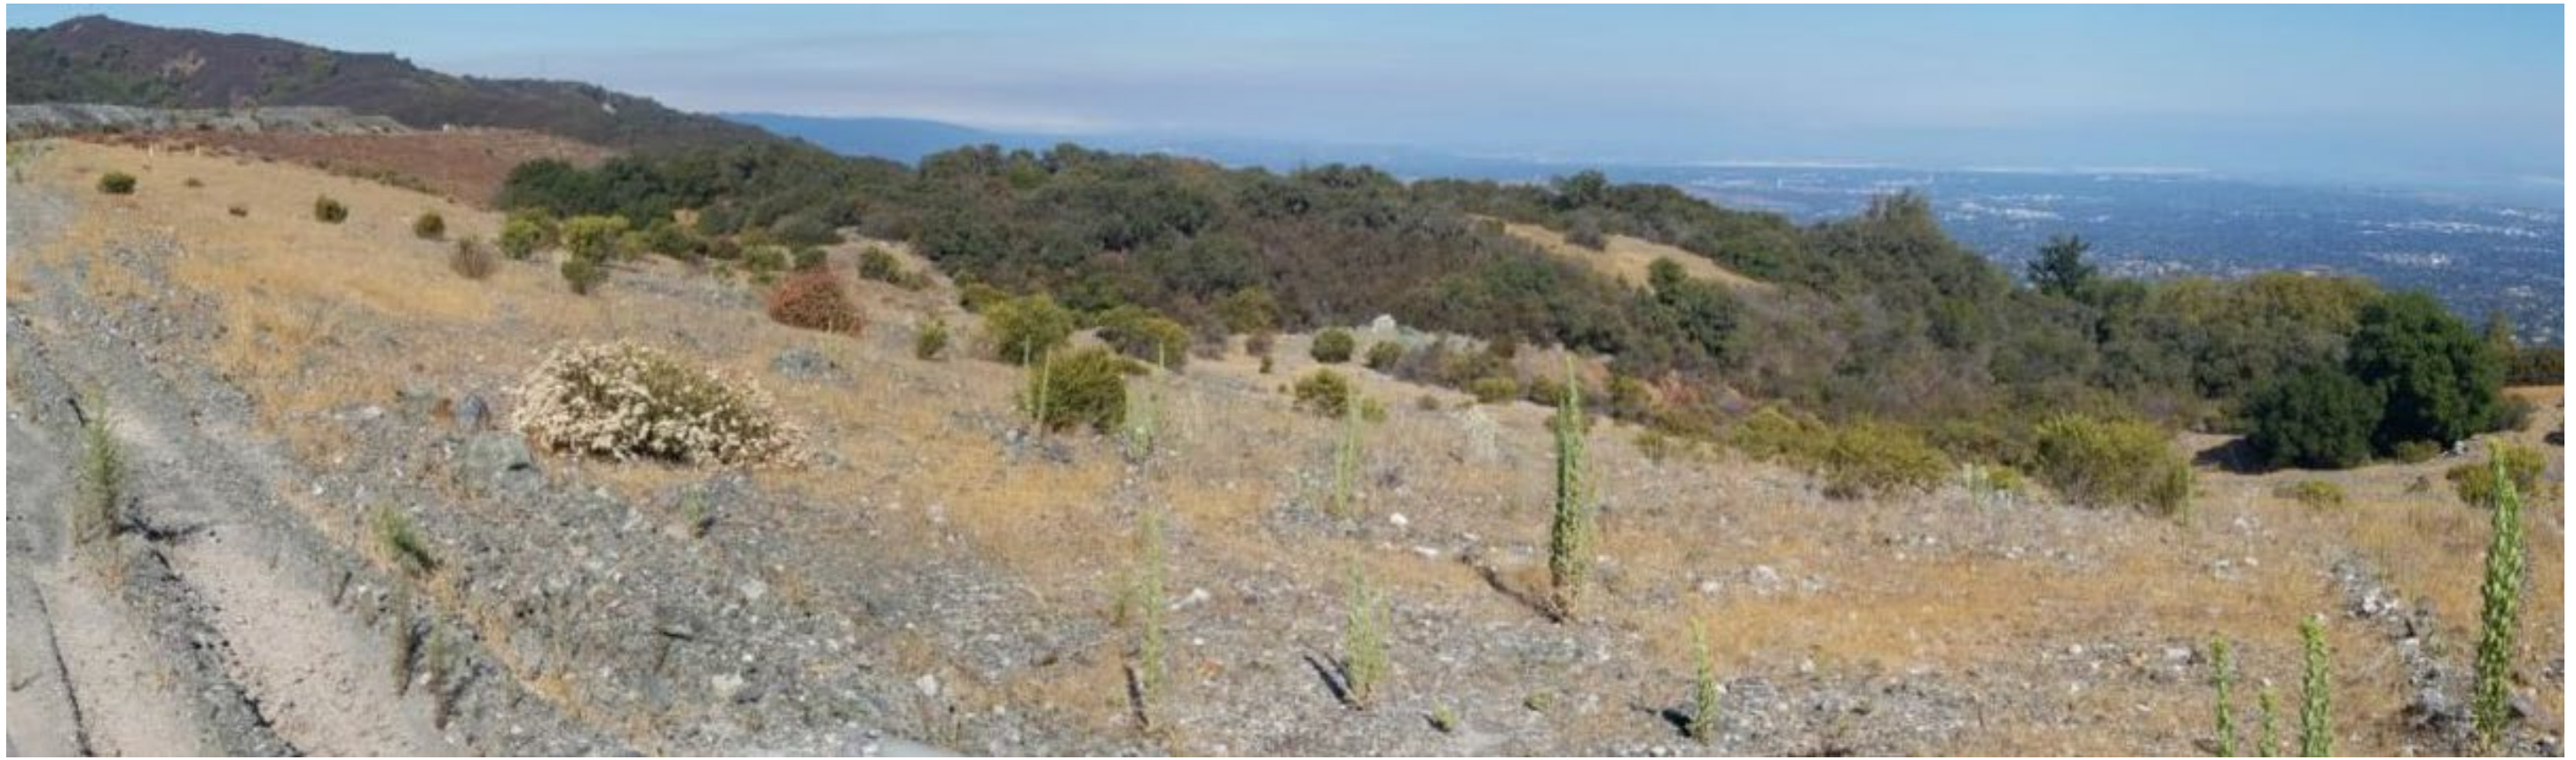
**PHOTO #3** – WMSA (looking northward)

The northeast-facing slopes of the WMSA have well-established vegetation (grasses and shrubs). [See **PHOTO #3** and **PHOTO #4**.]

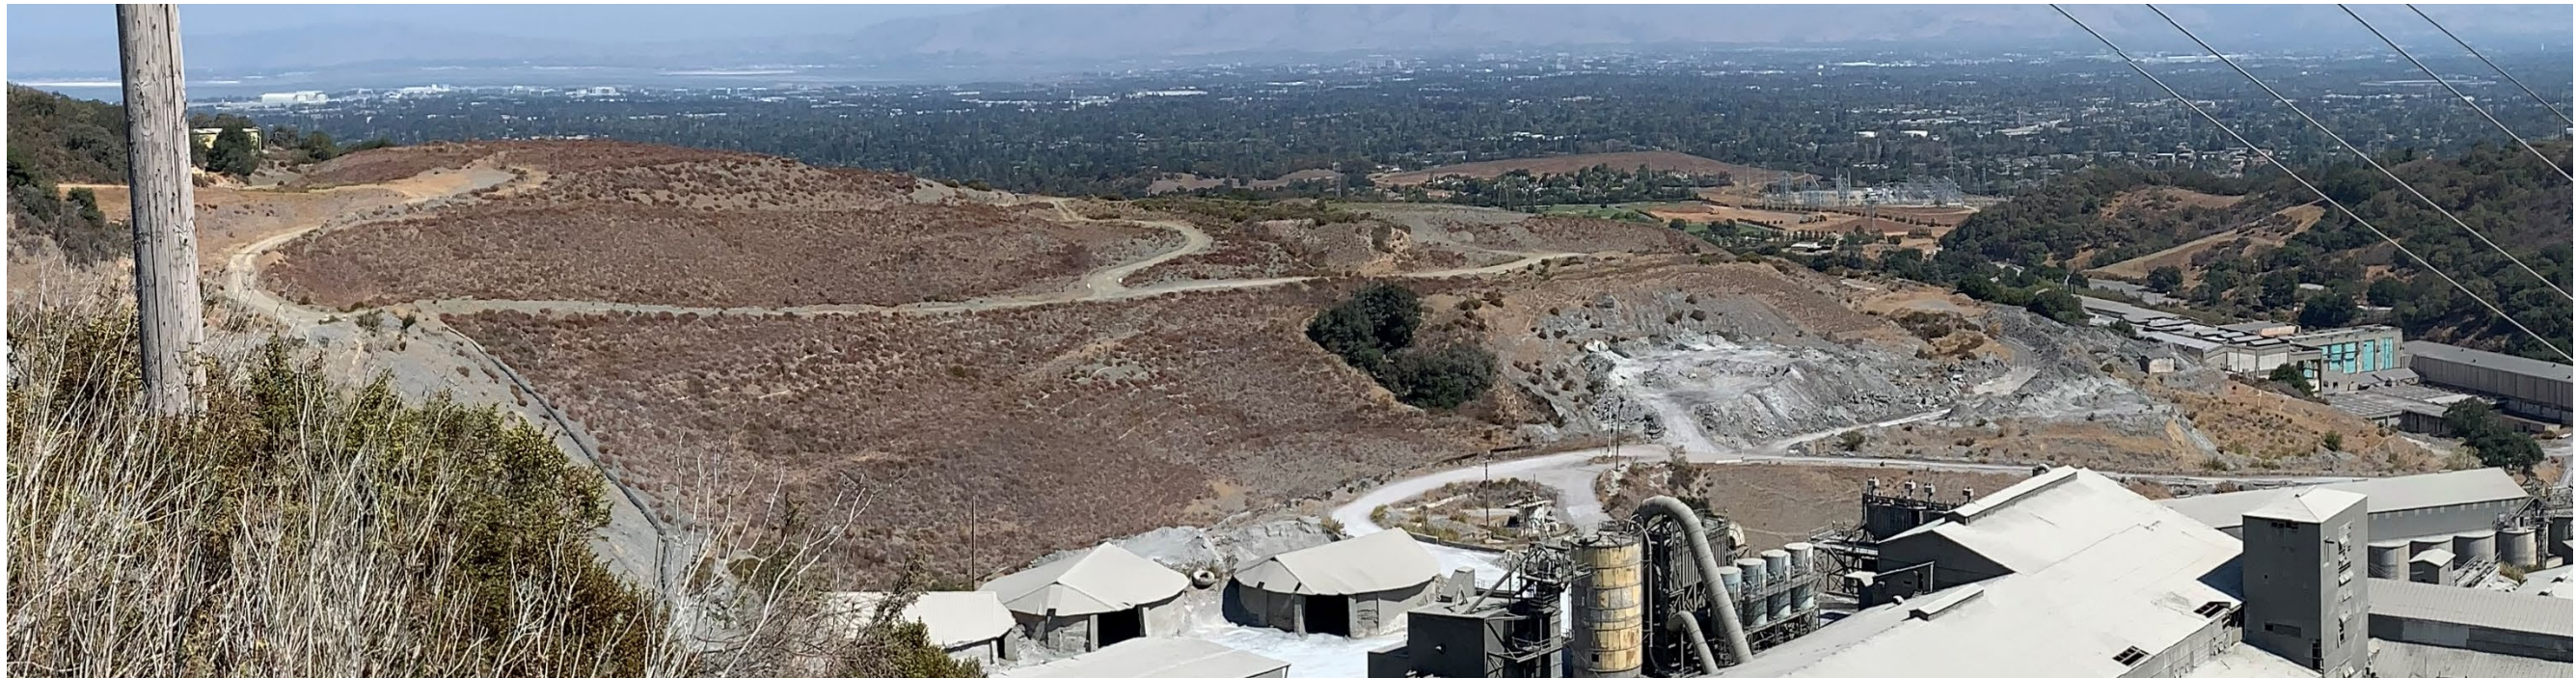
**PHOTO #7** – Southern slopes of EMSA (looking northeast)

BMPs were previously placed on the slopes (wattles) and along the benches (rock check dams and silt fences).

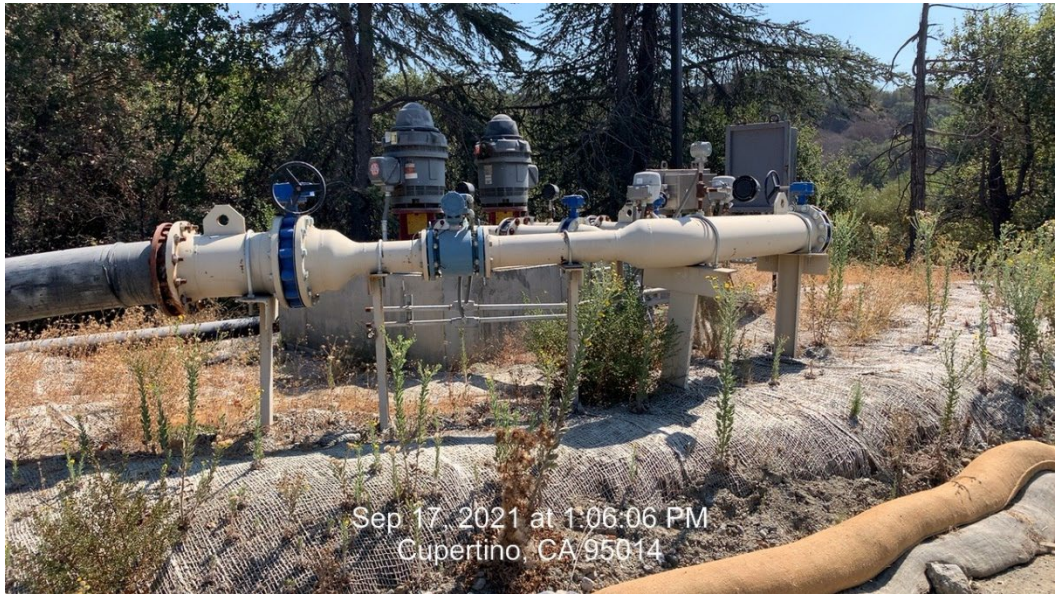
**PHOTO #9A**– Vault and pump at Pond 30

Surface drainage from EMSA is directed into Pond 30 which is rock-lined with non-limestone rock. [See **PHOTO #9B.**] Water from Pond 30 is then directed to a vault and pumped to the upper treatment system. [See **PHOTO #9A.**]

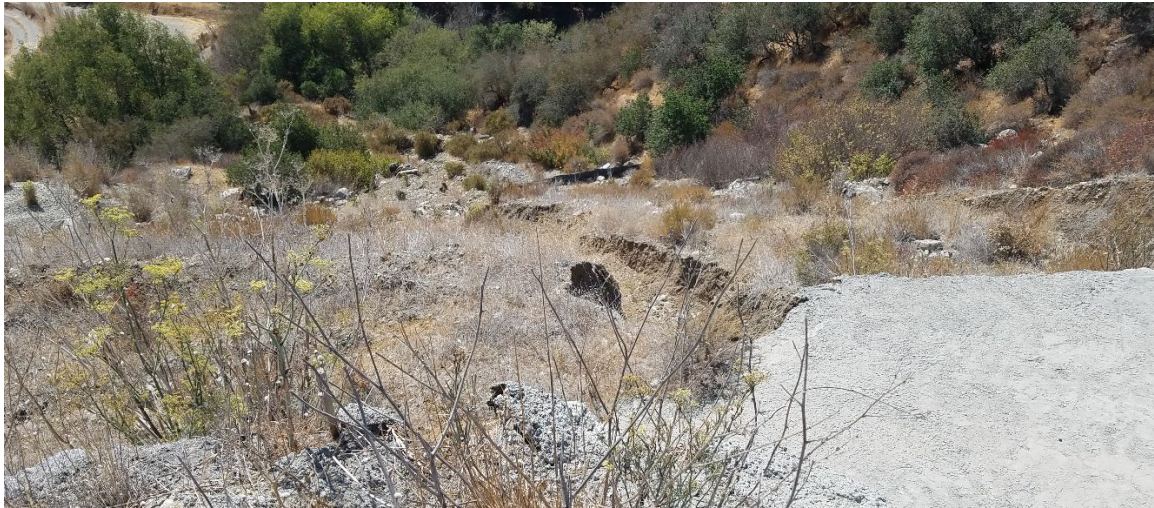
**PHOTO #10A** – Overflow scar below crusher sump

Drainage from around the crusher built in 2013 is directed into a sump that overflowed due to a power failure in 2014. As a result, an erosion gully formed on the steep slope west of the crusher. The operator has had the gully lined with jute netting and several silt fences and installed a soil-nail wall in the head of the erosion gully located downhill of the sump. [See **PHOTOS #10A and #10B.**] Eroded material accumulated at the toe of the slope and extended into the eastern side of Pond 13. Due to lack of rain, Pond 13 was completely dry during the 2021 inspection. [See **PHOTO #11.**] A half-pipe exists downstream of Pond 13 for the continuance of Permanente Creek. [See **PHOTO #12.**] The Permanente Creek Restoration Project (County File No. 2250-17G), submitted by Lehigh and currently under review by the County, proposes removal of the half-pipe.

The crusher was constructed in 2013 against a 70-foot high retaining wall. Drainage from around the crusher is directed into a sump which overflowed due to a power failure in 2014. As a result, an erosion gully formed on the steep slope west of the crusher. The operator has had the gully lined with jute netting and several silt fences and installed a soil-nail wall in the head of the erosion gully located downhill of the sump. [See **PHOTOS #10A and #10B.**]

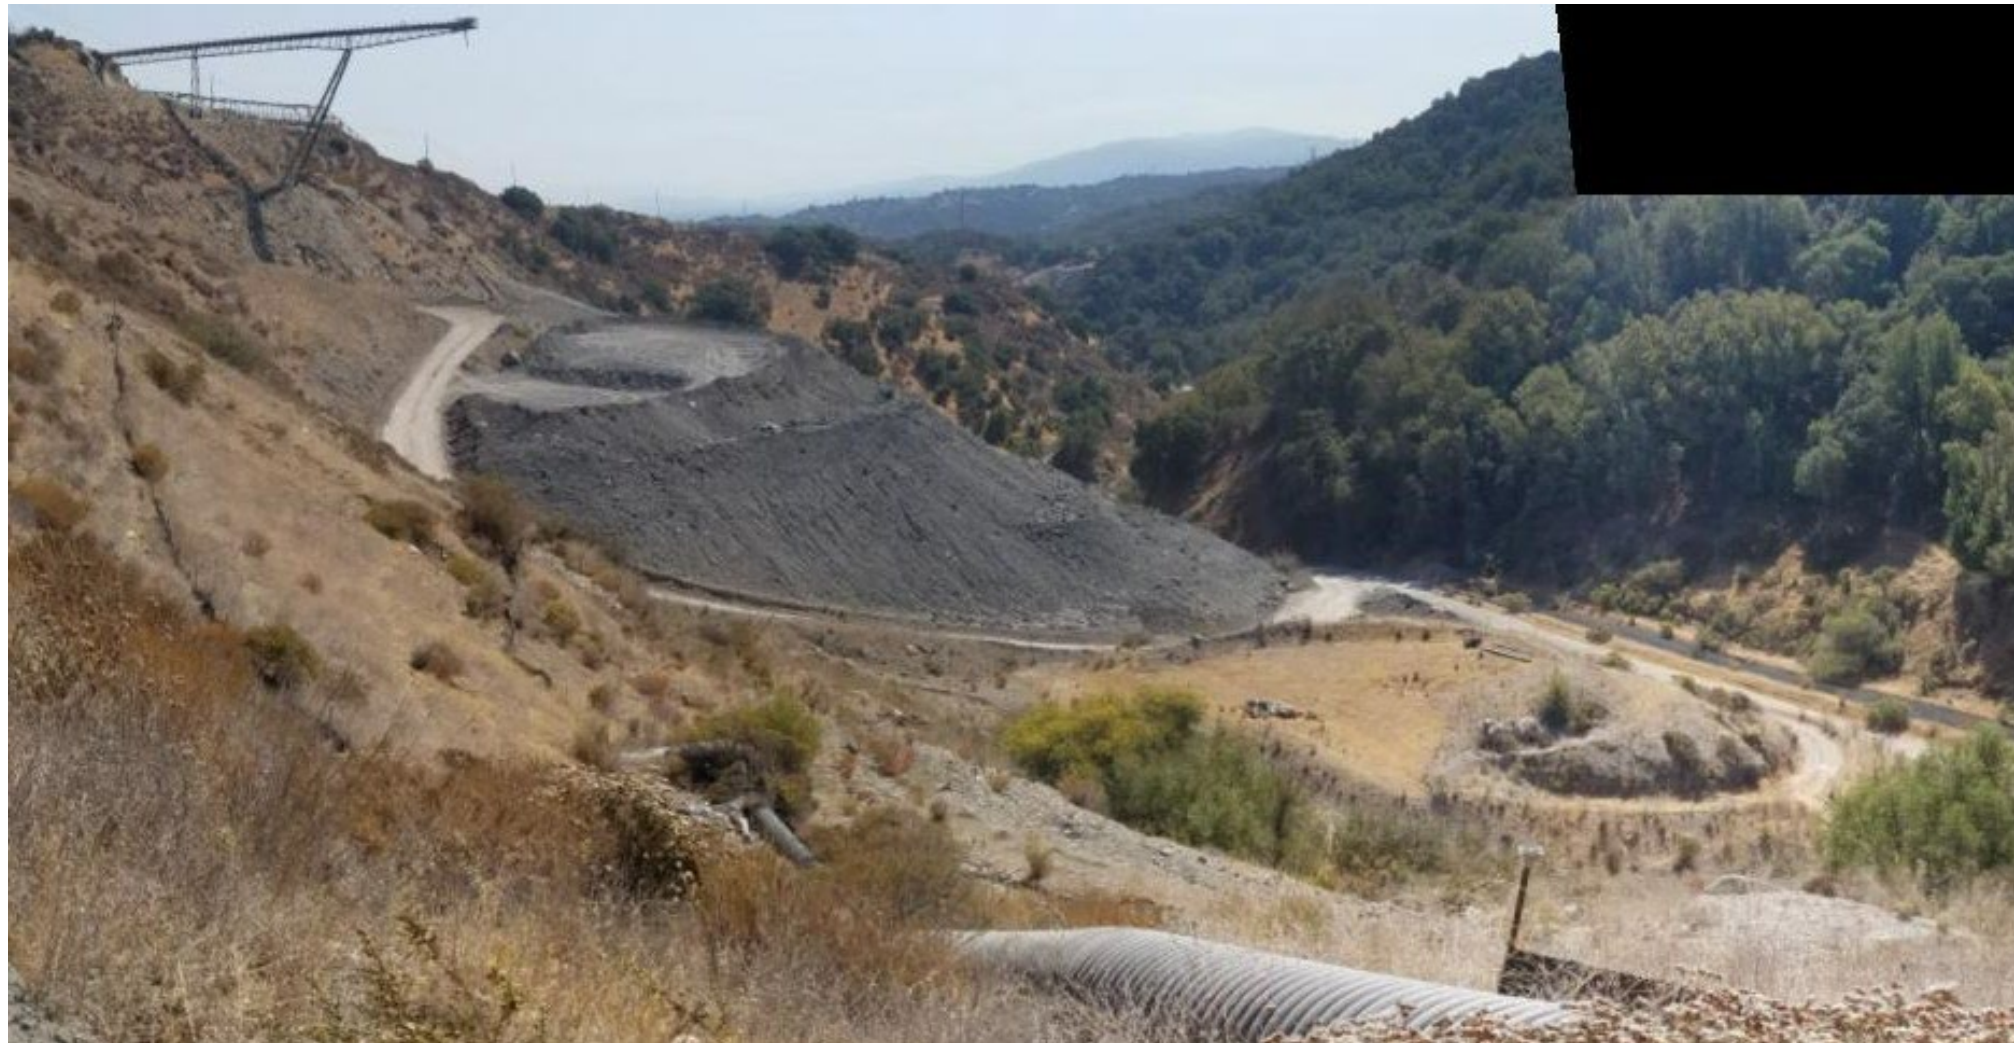
**PHOTO #13** – Surge Pile looking southeast

Additional material was added to the surge pile during the last year.

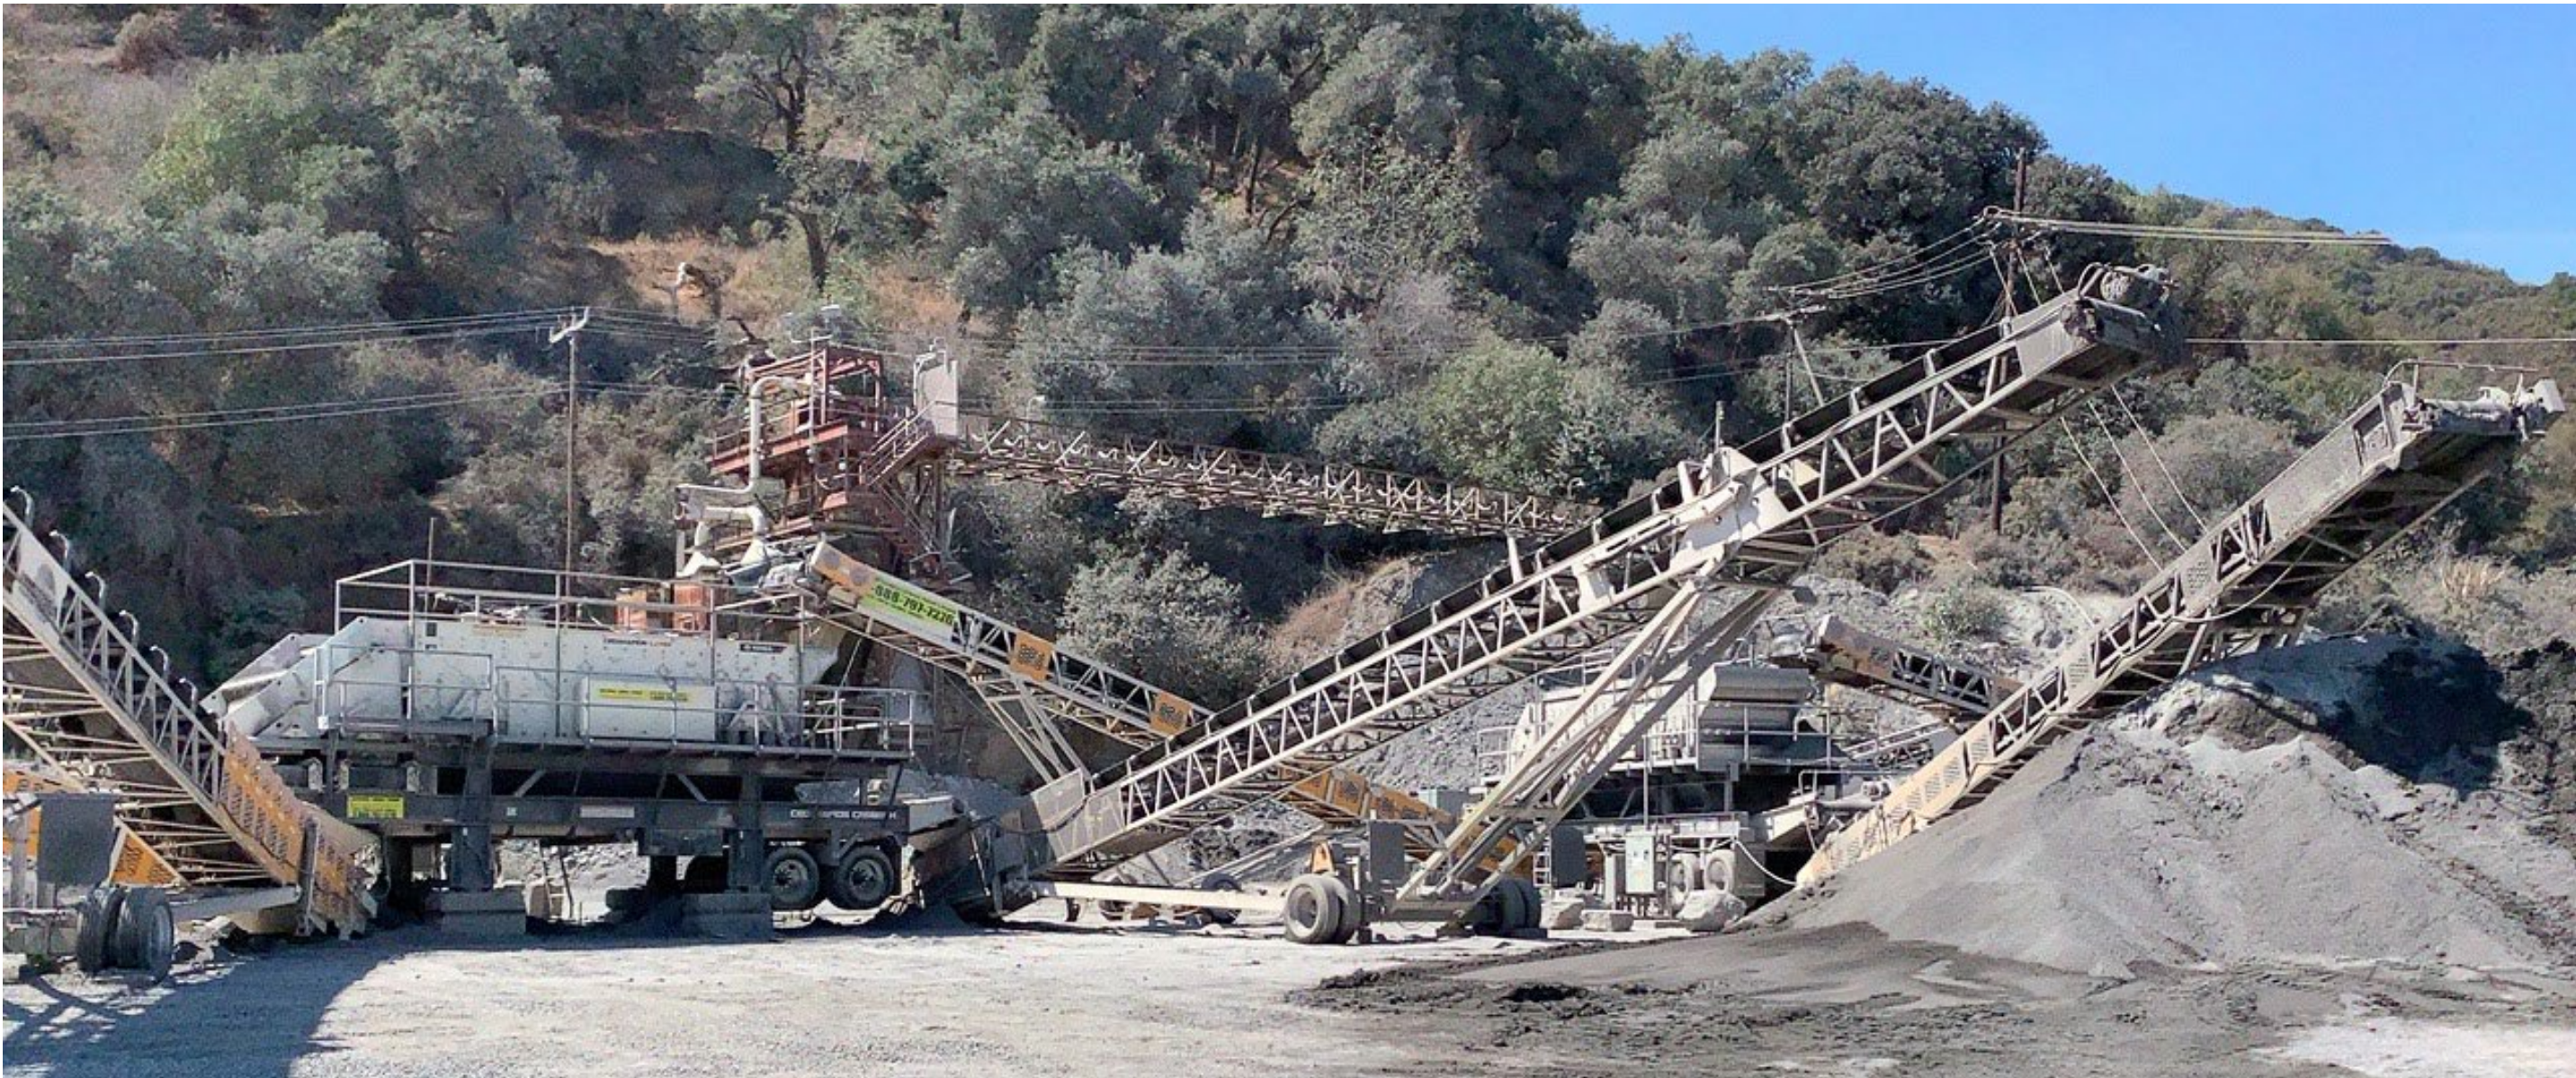
**PHOTO #15** – New aggregate processing equipment.

The rock plant did not appear to be operating during the inspection; however, it was active during portions of 2021. [See **PHOTO #15**.] Runoff from the rock plant was previously being directed into Pond 17 [See **PHOTO #16**]. Pond 17 has been decommissioned and the runoff which was previously routed to Pond 17 now flows into a new basin in Permanente Creek installed at the direction of the San Francisco Bay Regional Water Quality Control Board.

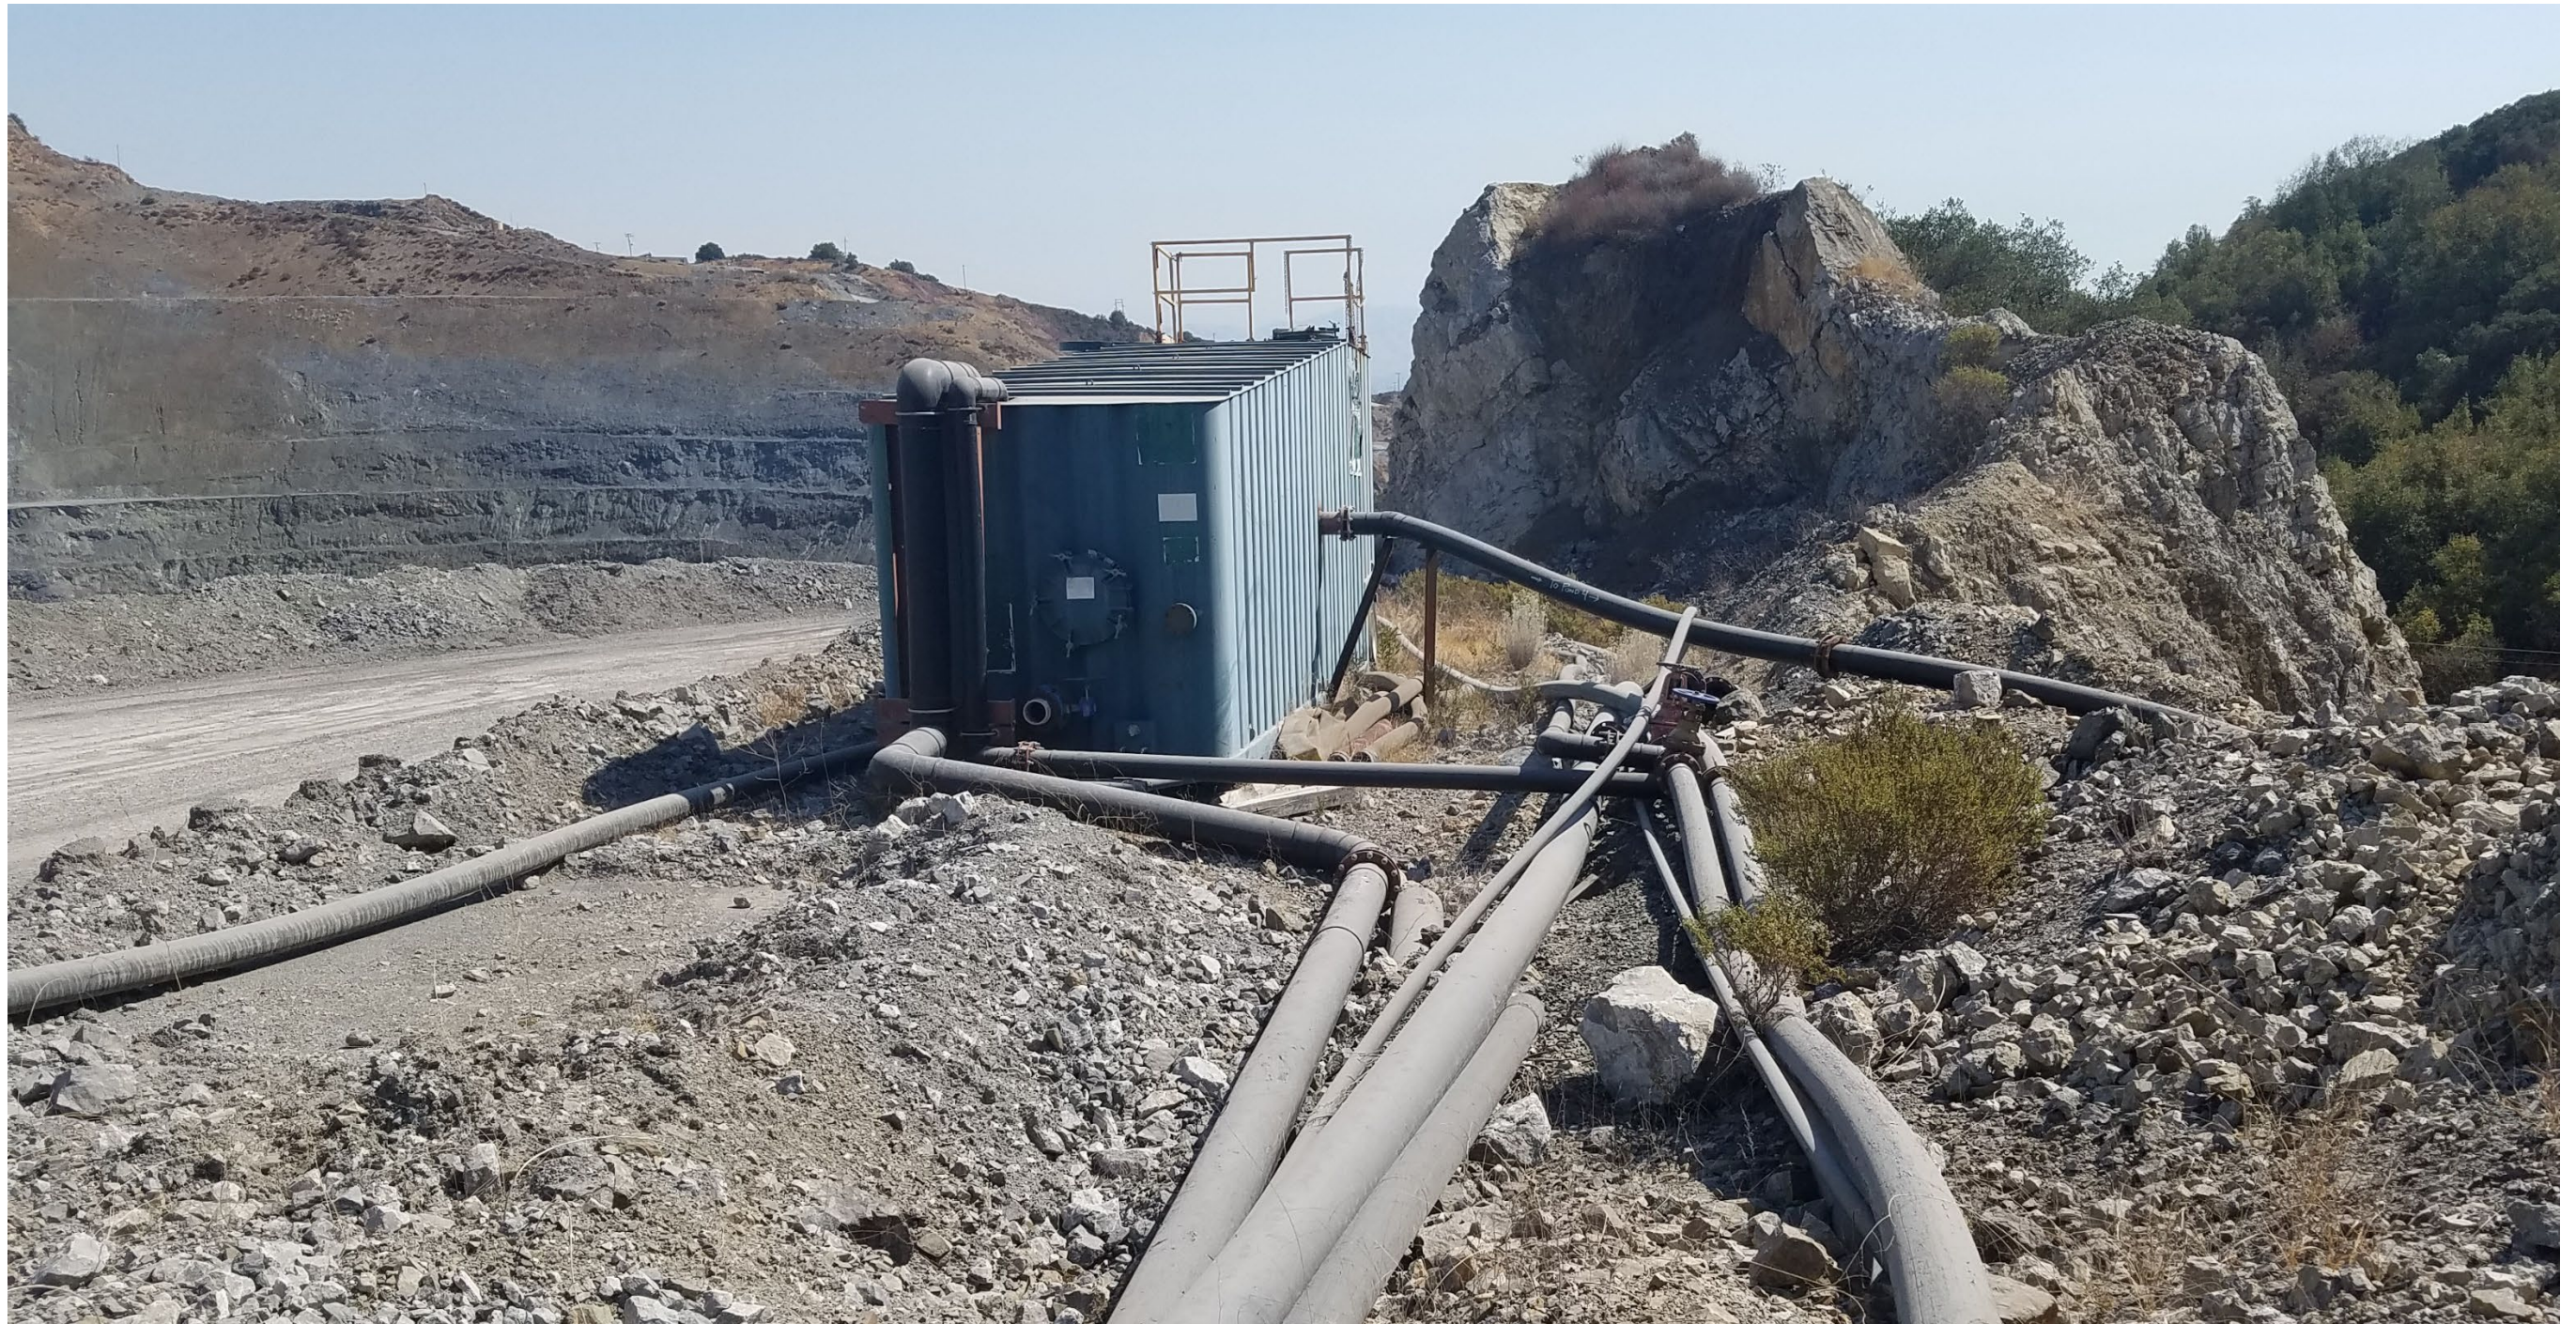
**PHOTO #17** Blending tank above former Pond 4A

A portable blending tank is located on the bench above former Pond 4A.

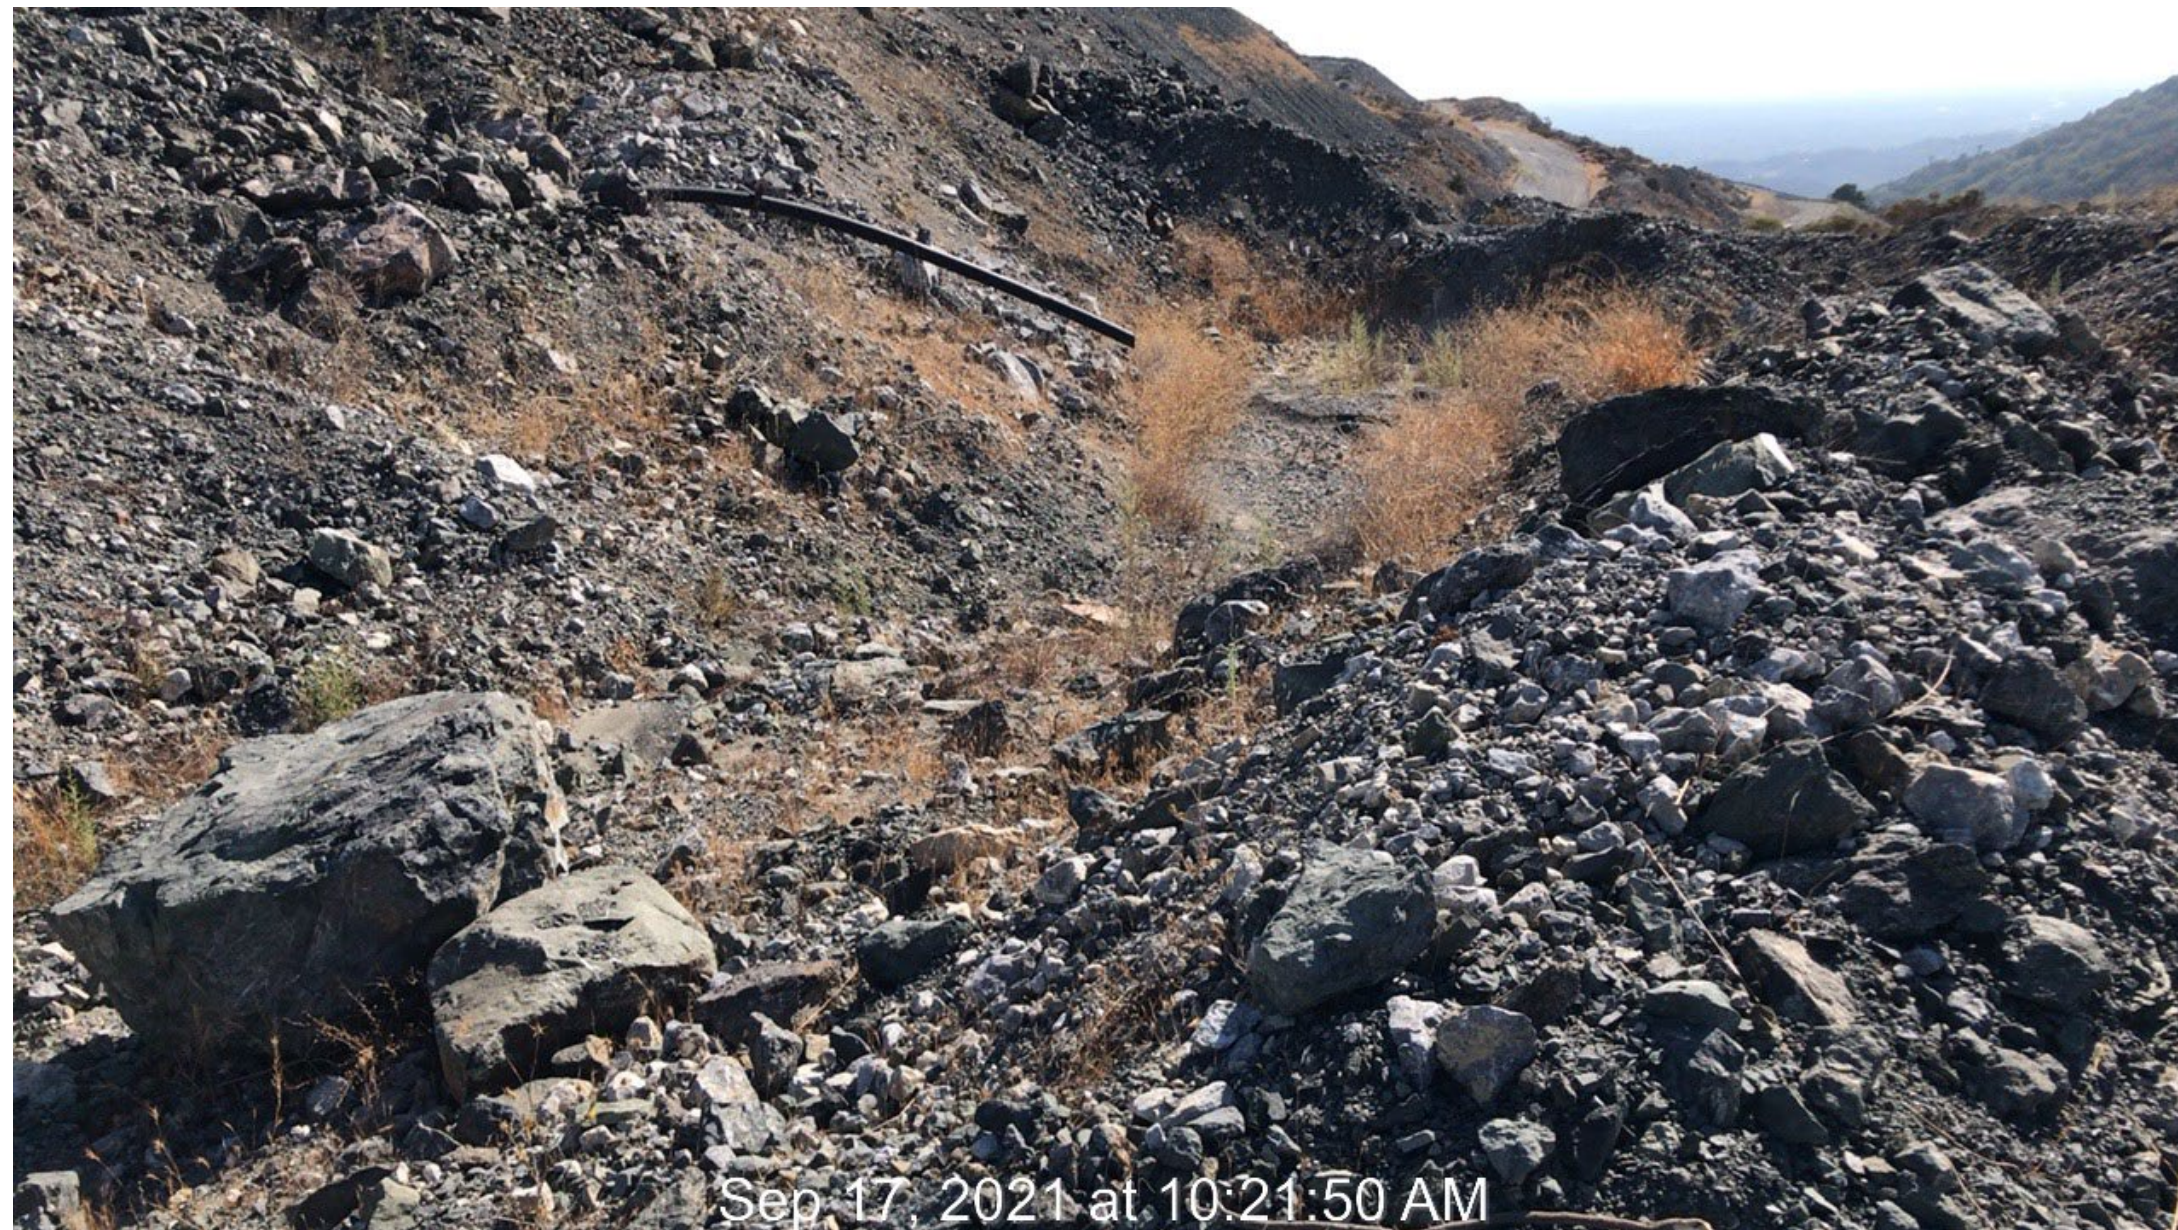
**PHOTO #20** – Check dam on the WMSA road

Runoff and drainage are controlled on-site by various methods including check dams installed on internal access roads. [See **Photo #20** for example check dam.] Check dams are required to be made of non-limestone rock in order to prevent selenium contamination. Erosion control measures are typically installed before the rainy season and are inspected during winterization inspections. As noted above, the County of Santa Clara issued a Notice of Violation related to inadequate erosion control measures which resulted in a discharge of sediment into Permanente Creek. Since then, the operator made numerous improvements to erosion control BMPs, and created a lined sediment basin to prevent any more sediment or loose rock from entering the Permanente Creek channel. See the Violations Section below for additional information.

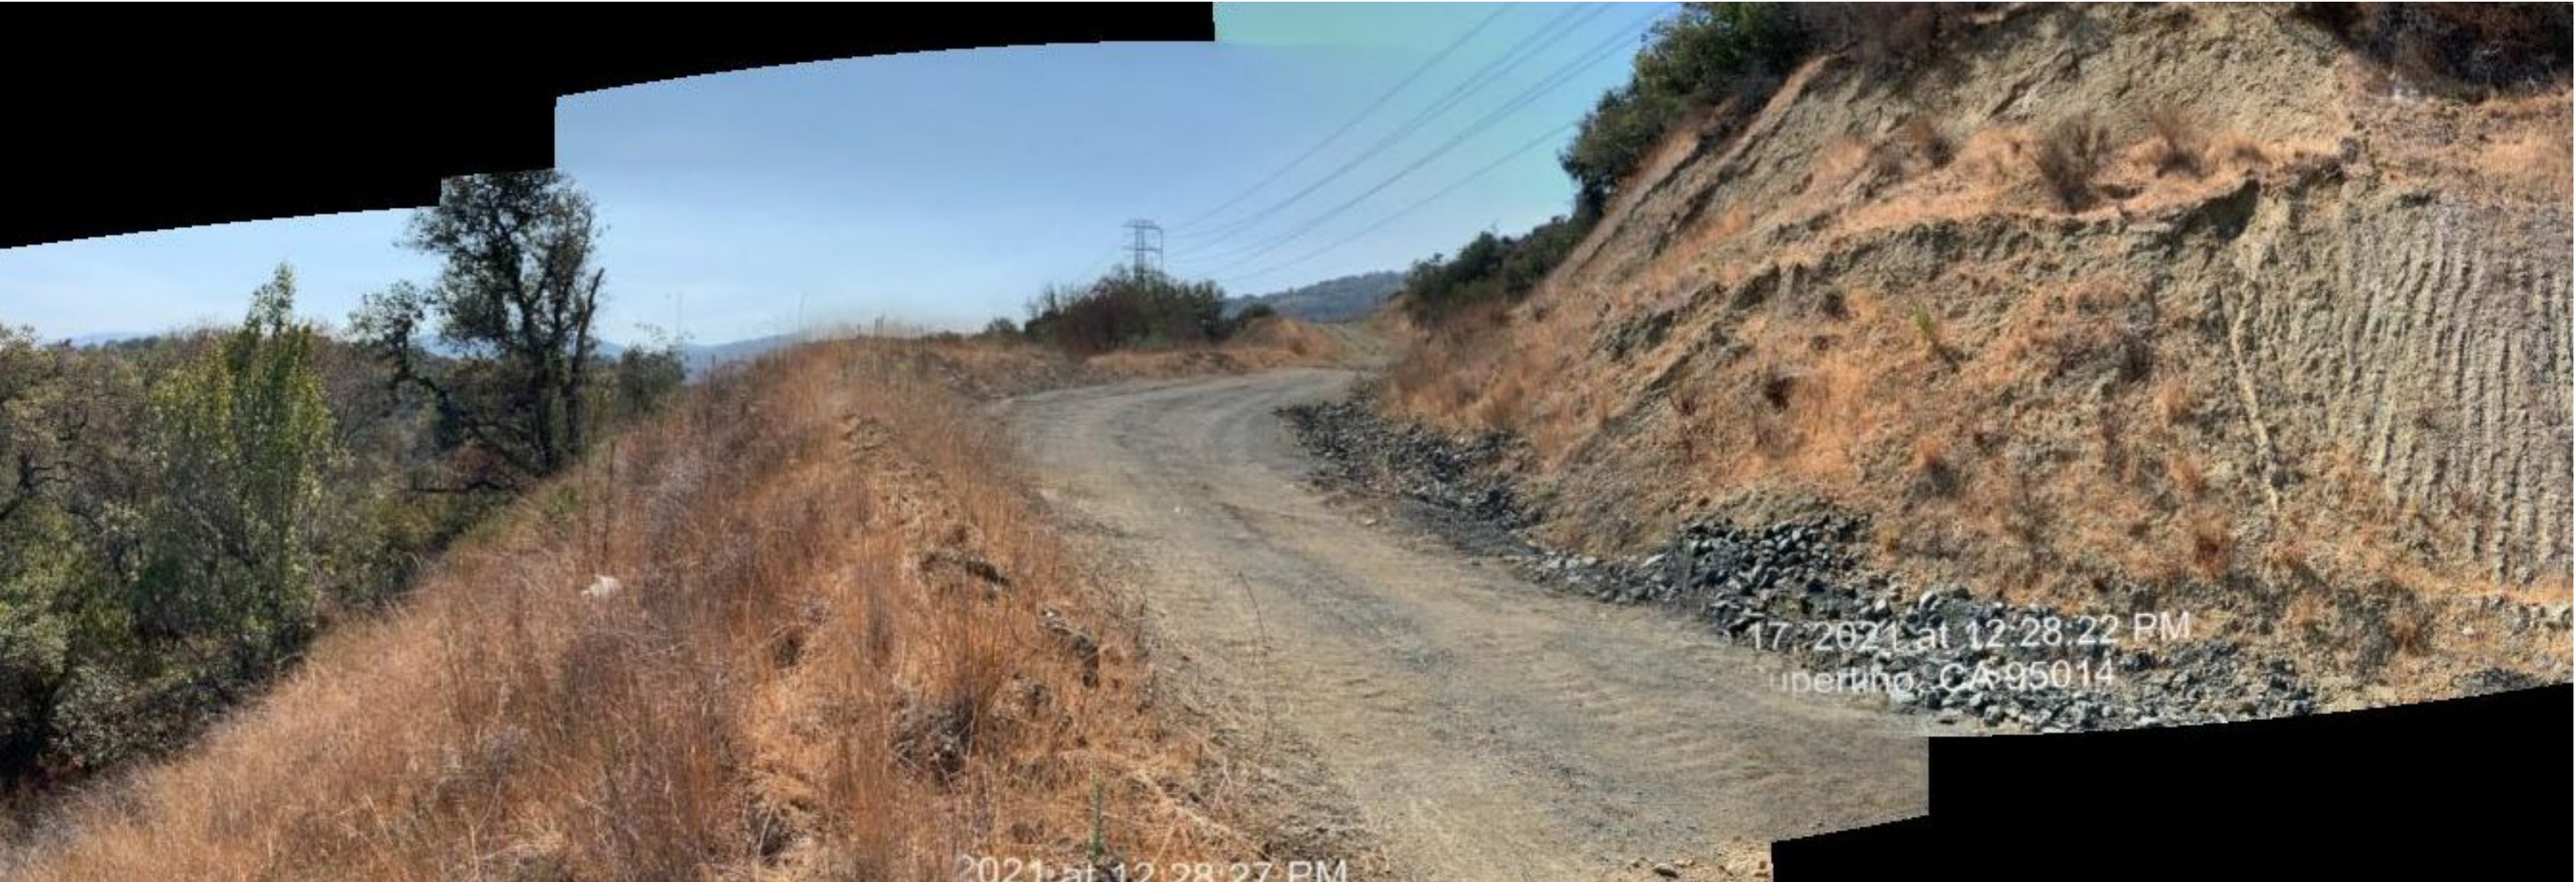
During the 2018 annual SMARA inspection inspectors observed that a new road linking Lehigh Quarry and Stevens Creek Quarry had been constructed without approval. The County issued a Notice of Violation on August 17, 2018 and noted the violation in the 2018 Lehigh Annual Inspection Report, dated August 8, 2018. Subsequently, Lehigh applied for a Reclamation Plan Amendment which, if approved, will expand the Reclamation Plan Boundary to include the haul road area. This reclamation plan amendment application is currently being processed. This haul road remains in place but is not being used. Inspectors noticed localized erosion which needs to be managed by installation of erosion control BMPs. [See **Photos #21A, and 21B.**] Installation and maintenance of erosion control BMPs will be verified during winterization inspection.

**Photo #21A** – Cut slope and drainage ditch on west side of unpermitted haul road
