## SURFACE MINING INSPECTION REPORT

Photos from 2021 Annual SMARA Inspection Conducted on 9-17-2021

by  
Robert Salisbury, Senior Planner  
James Baker, CEG#1021, County Geologist  
Steve Beams, Senior Construction Inspector

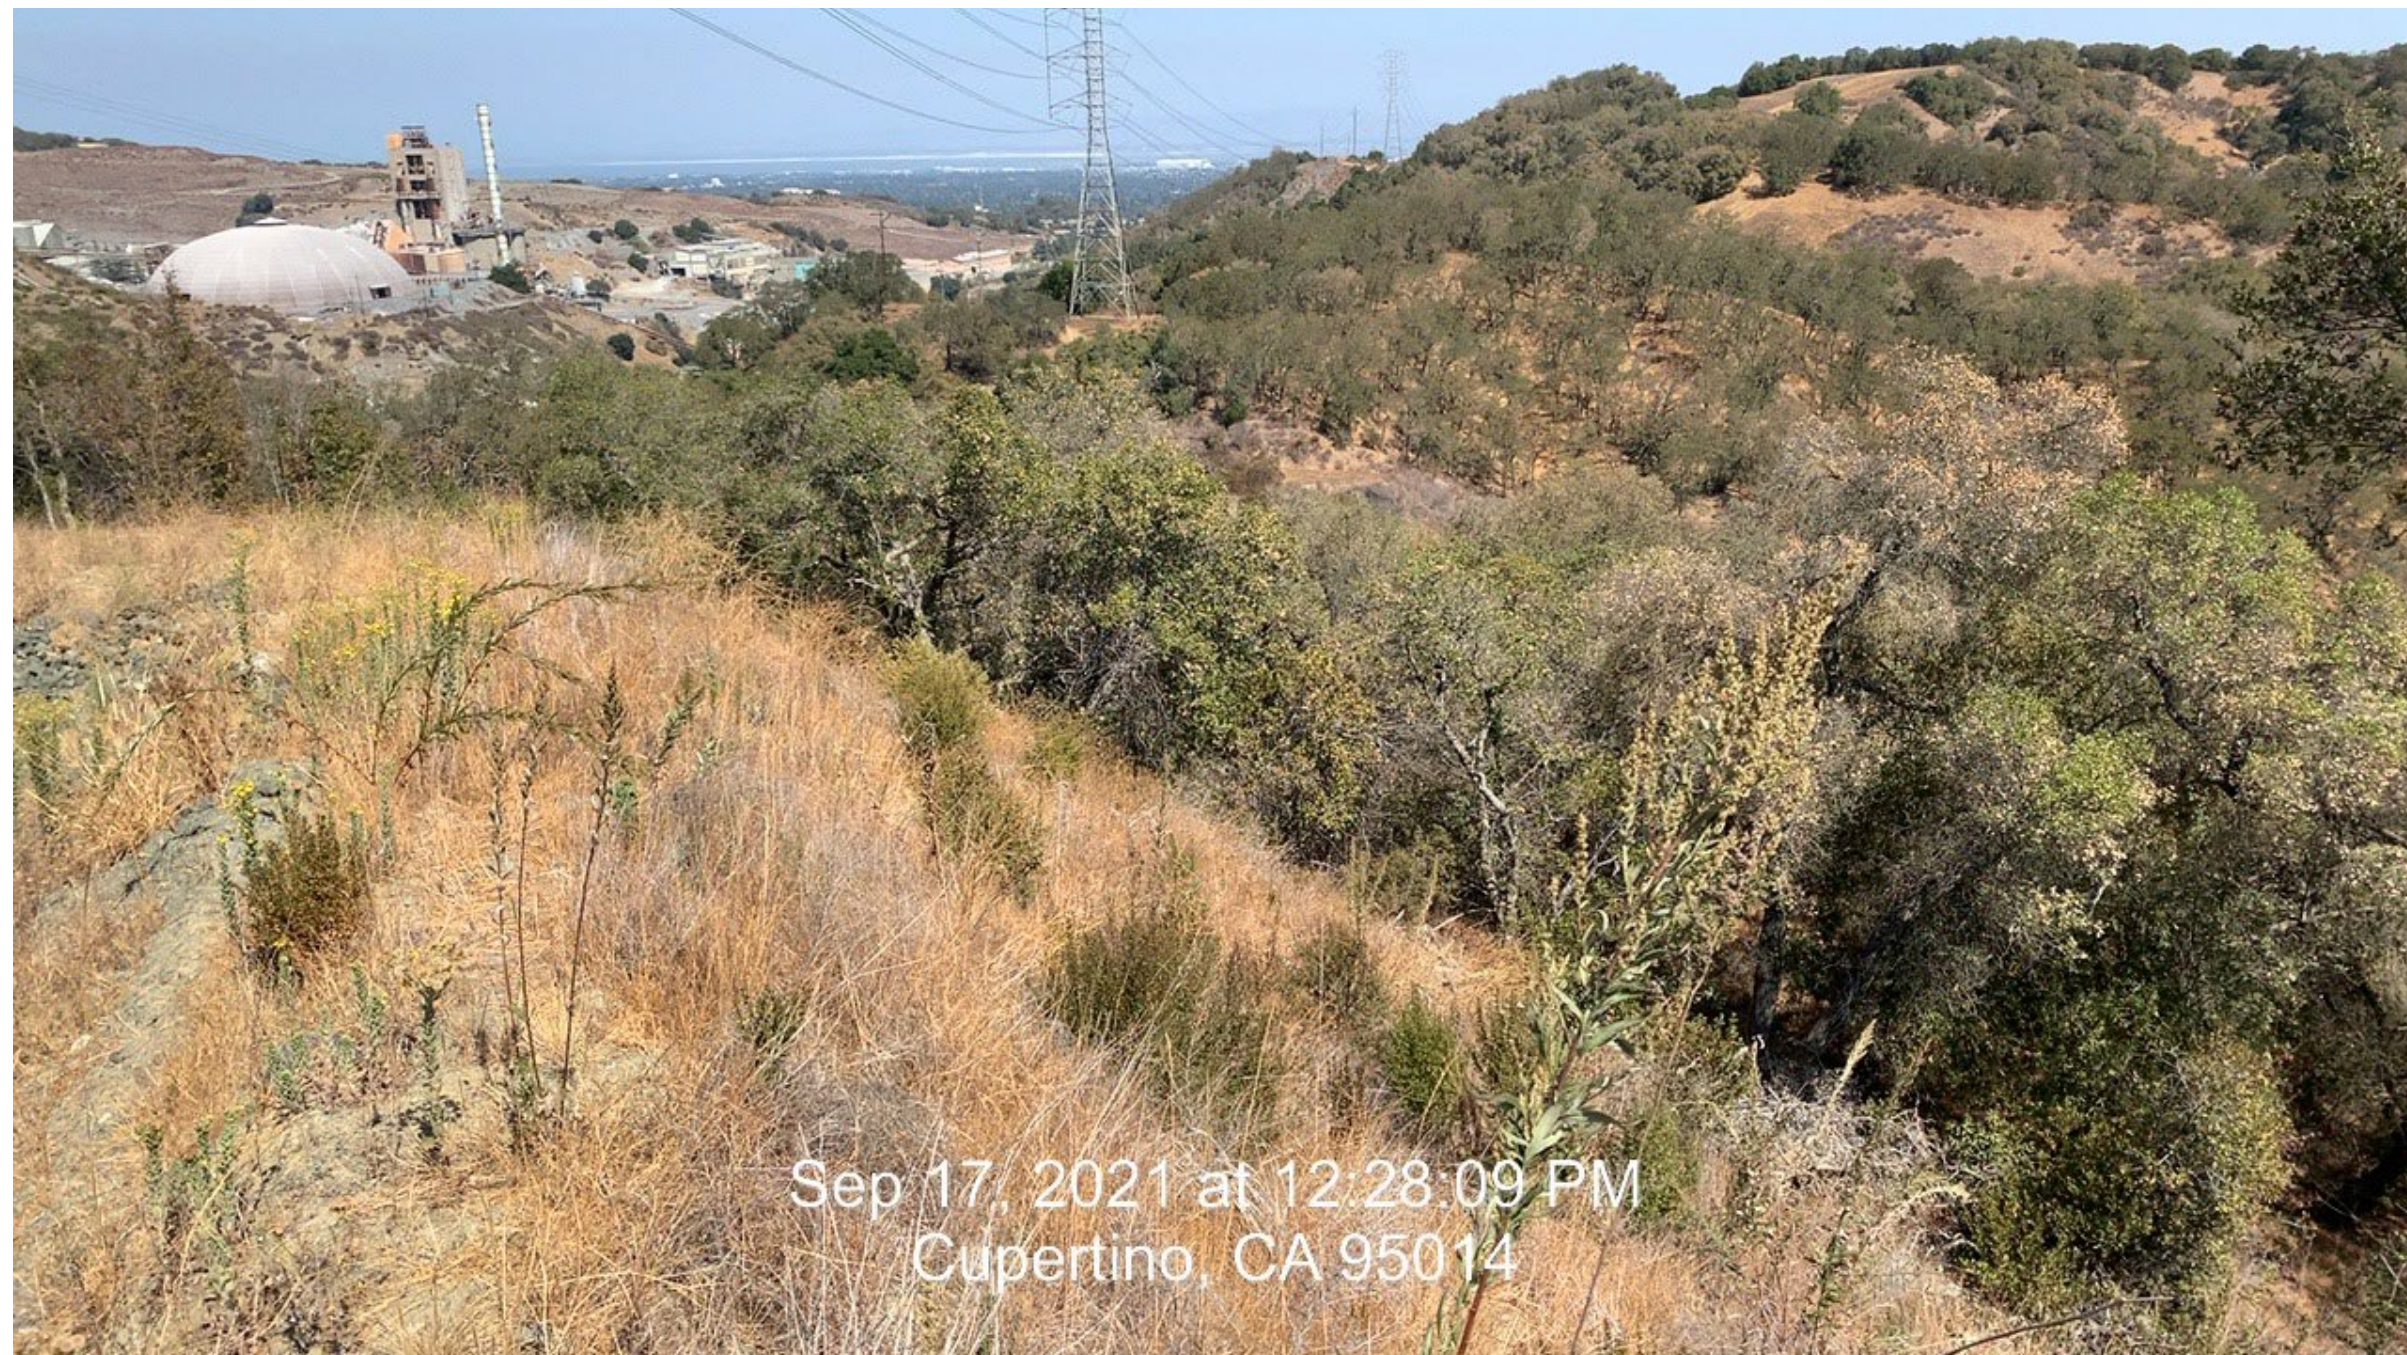
During the 2018 annual SMARA inspection inspectors observed that a new road linking Lehigh Quarry and Stevens Creek Quarry had been constructed without approval. The County issued a Notice of Violation on August 17, 2018 and noted the violation in the 2018 Lehigh Annual Inspection Report, dated August 8, 2018. Subsequently, Lehigh applied for a Reclamation Plan Amendment which, if approved, will expand the Reclamation Plan Boundary to include the haul road area. This reclamation plan amendment application is currently being processed. This haul road remains in place but is not being used. Inspectors noticed localized erosion which needs to be managed by installation of erosion control BMPs. [See **Photos #21A, and 21B.**] Installation and maintenance of erosion control BMPs will be verified during winterization inspection.

**Photo #21B** Fill slope below east side of illegally graded haul road

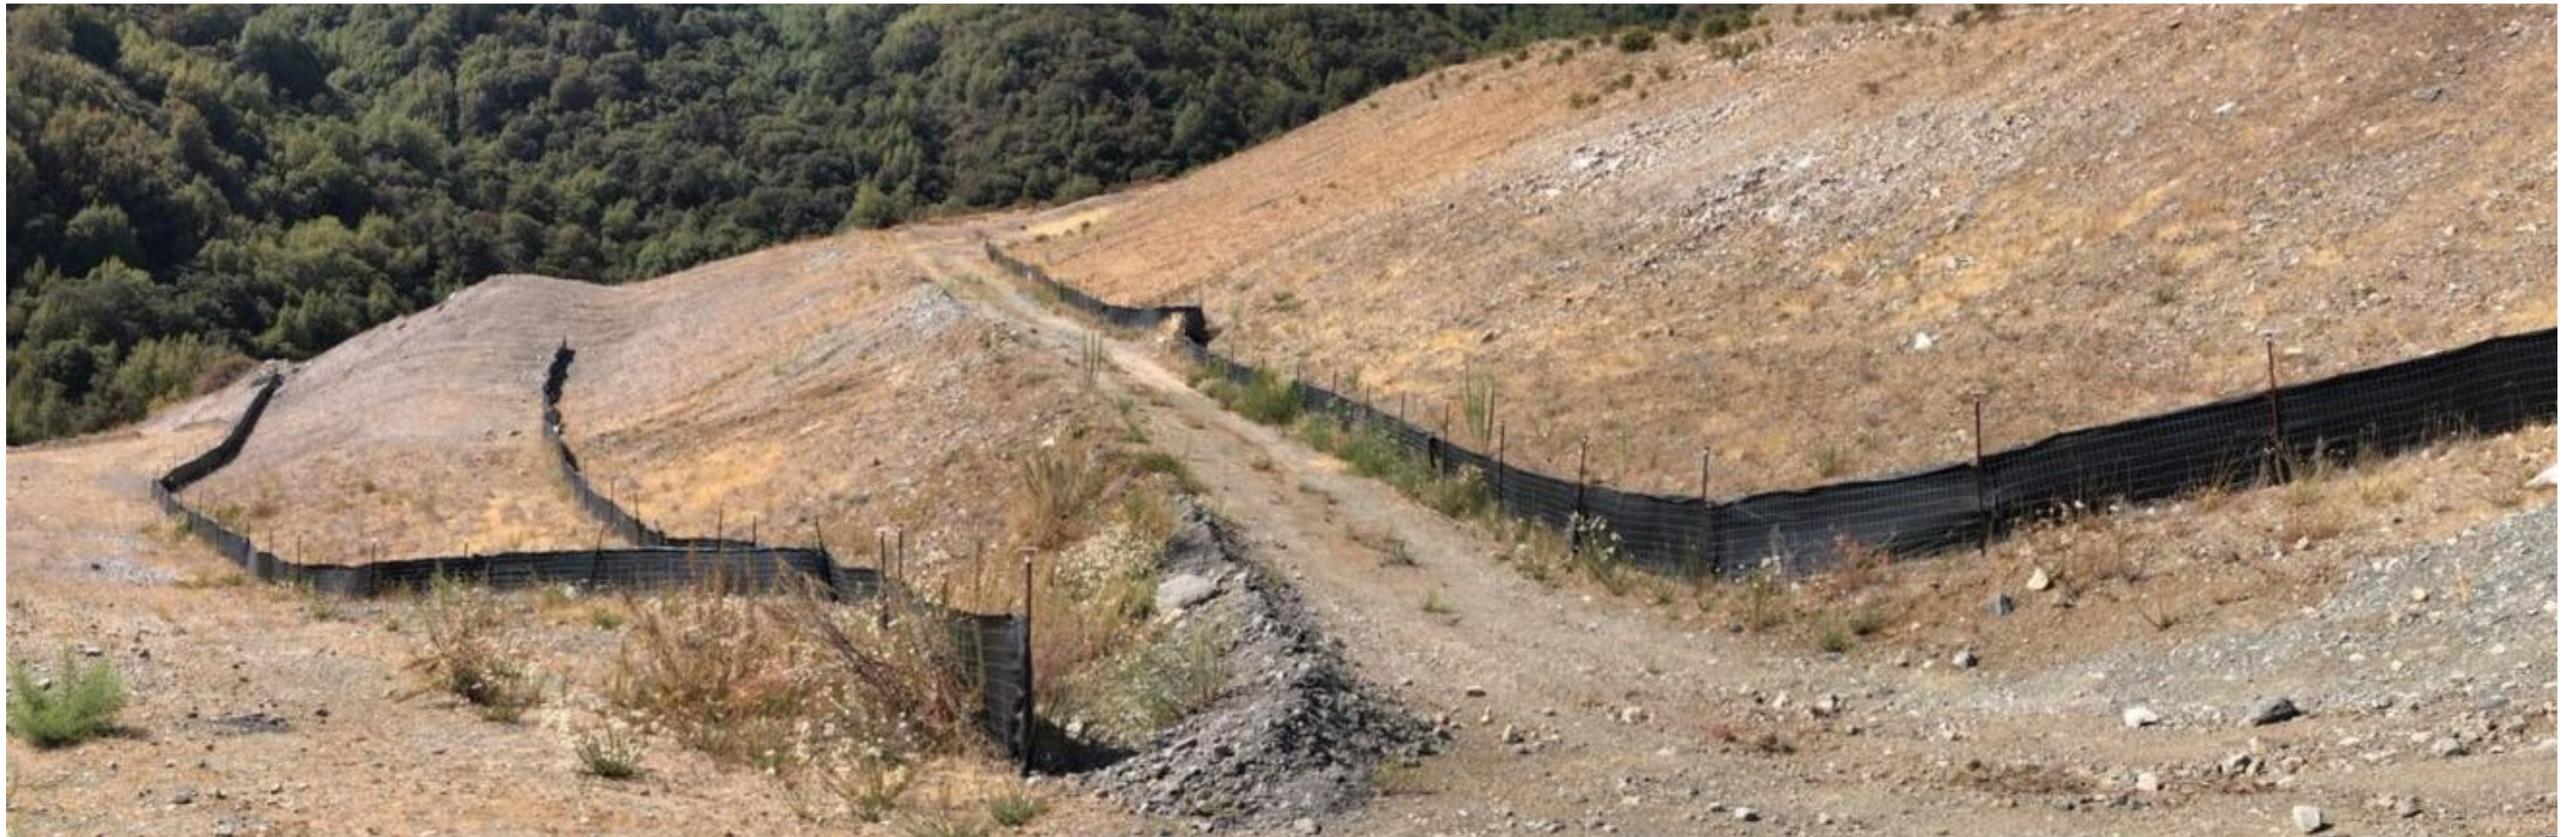
**Photo #22 – Toe of Yeager Yard slide above Permanente Creek (out of view to the left)**

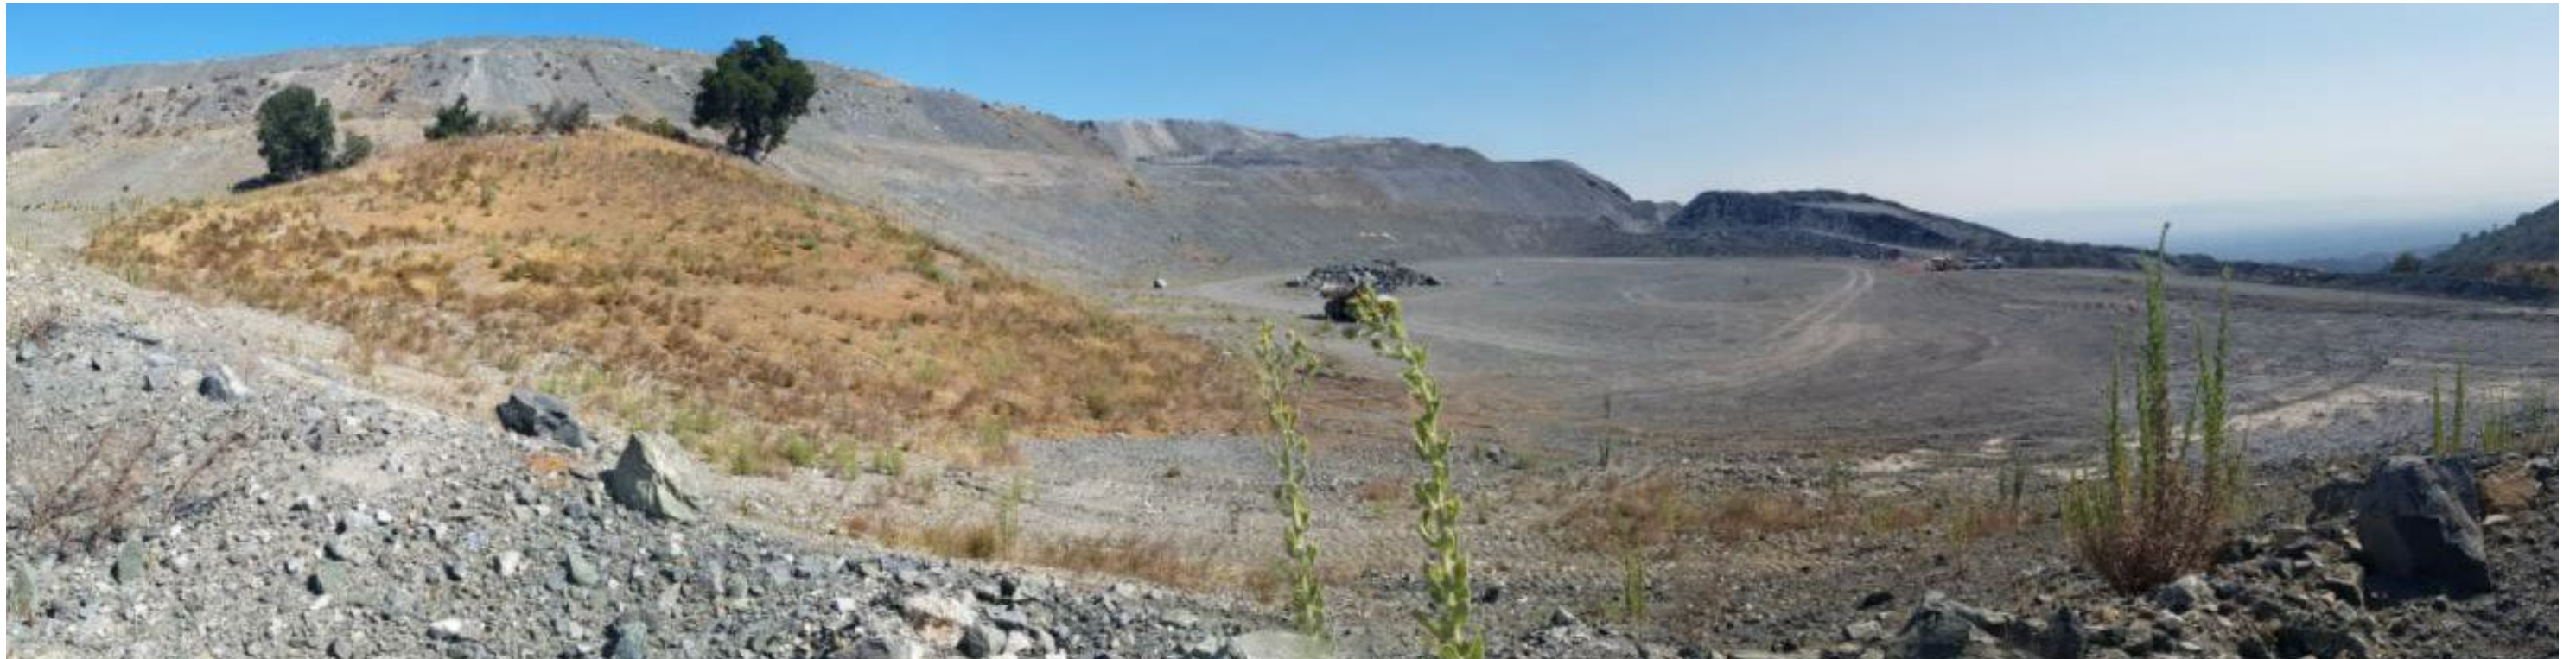
**Photo #23 – Excavation above Yeager Yard**

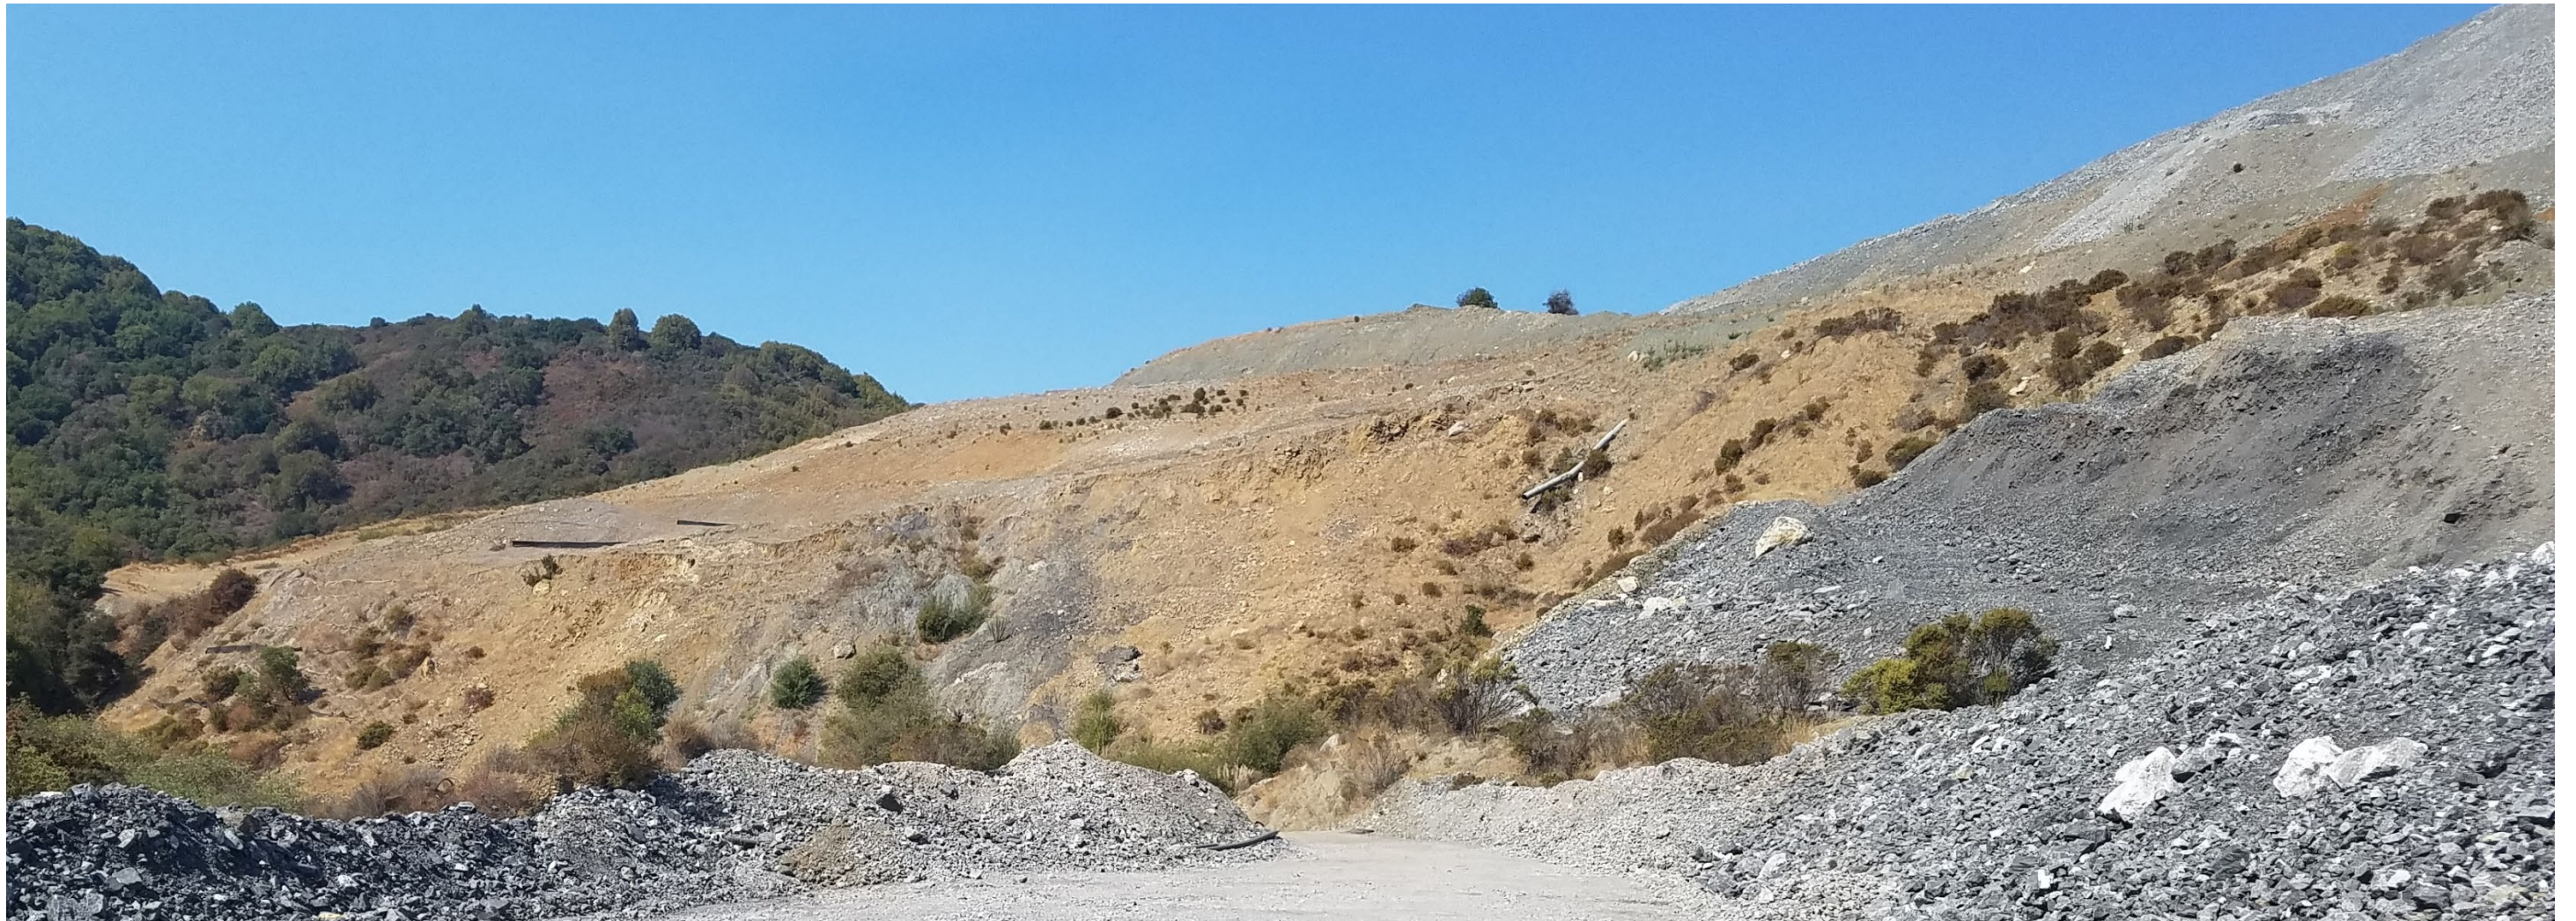
**Photo #24 – Toe of Yeager Yard land slide above Permanente Creek (lower left)**

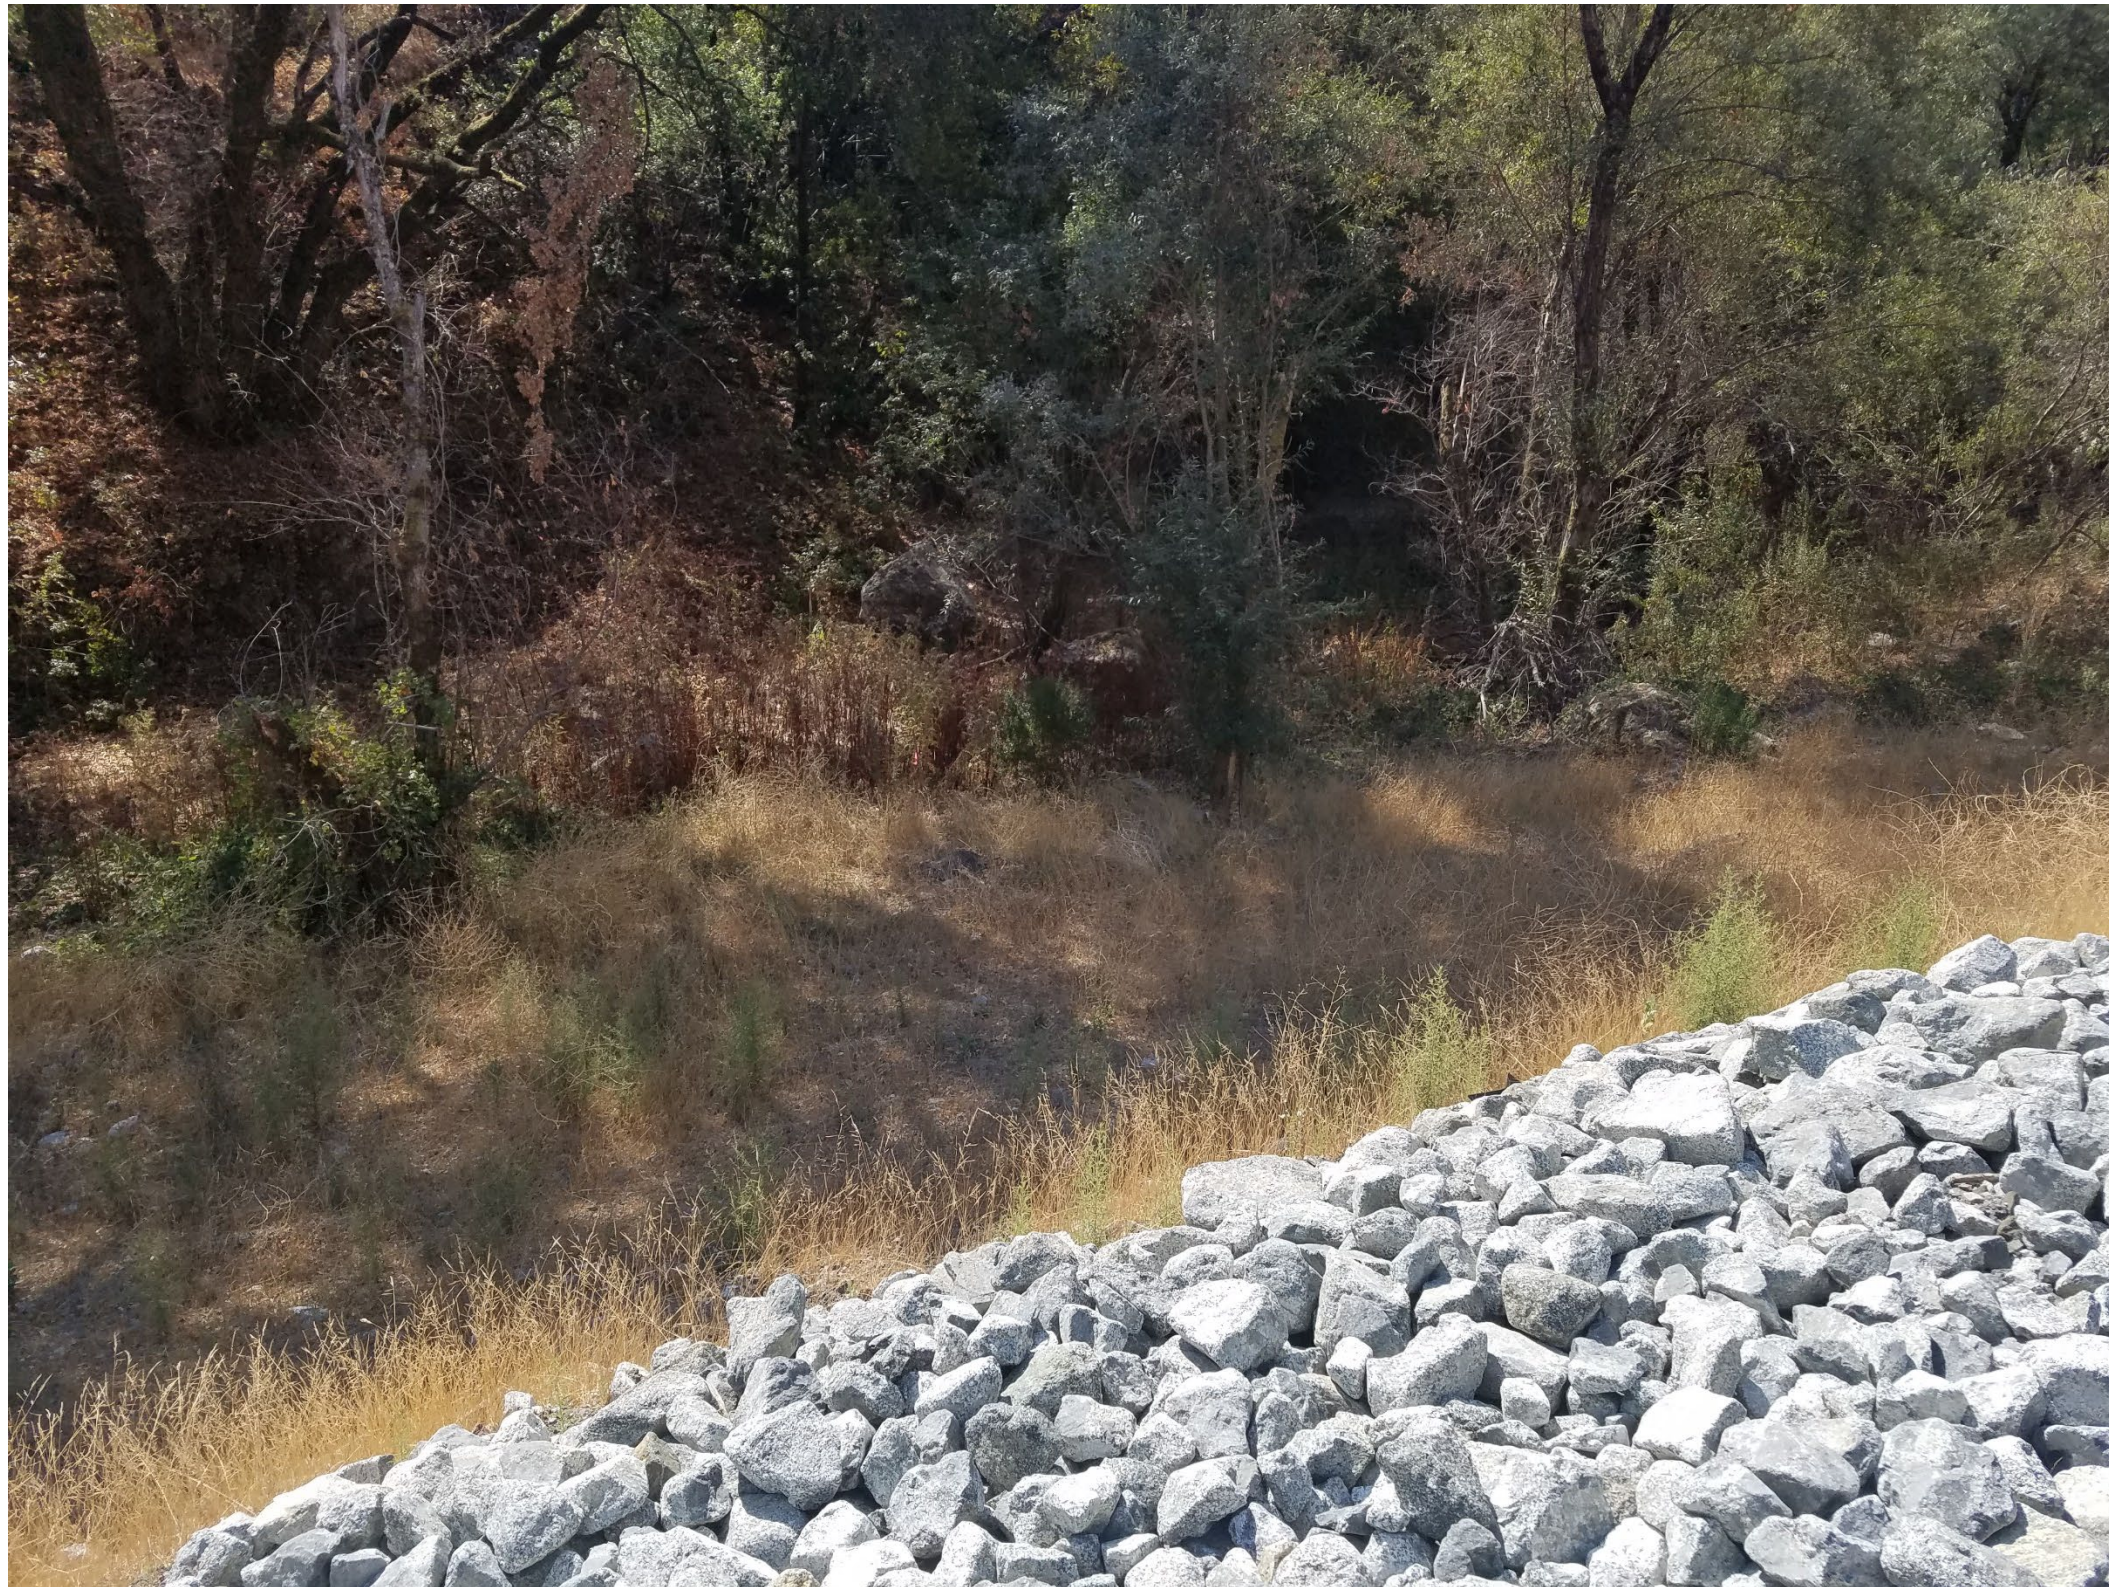
**Photo #25 – Rock armor added to area where sediment was deposited into Permanente Creek from Yeager Yard slope**

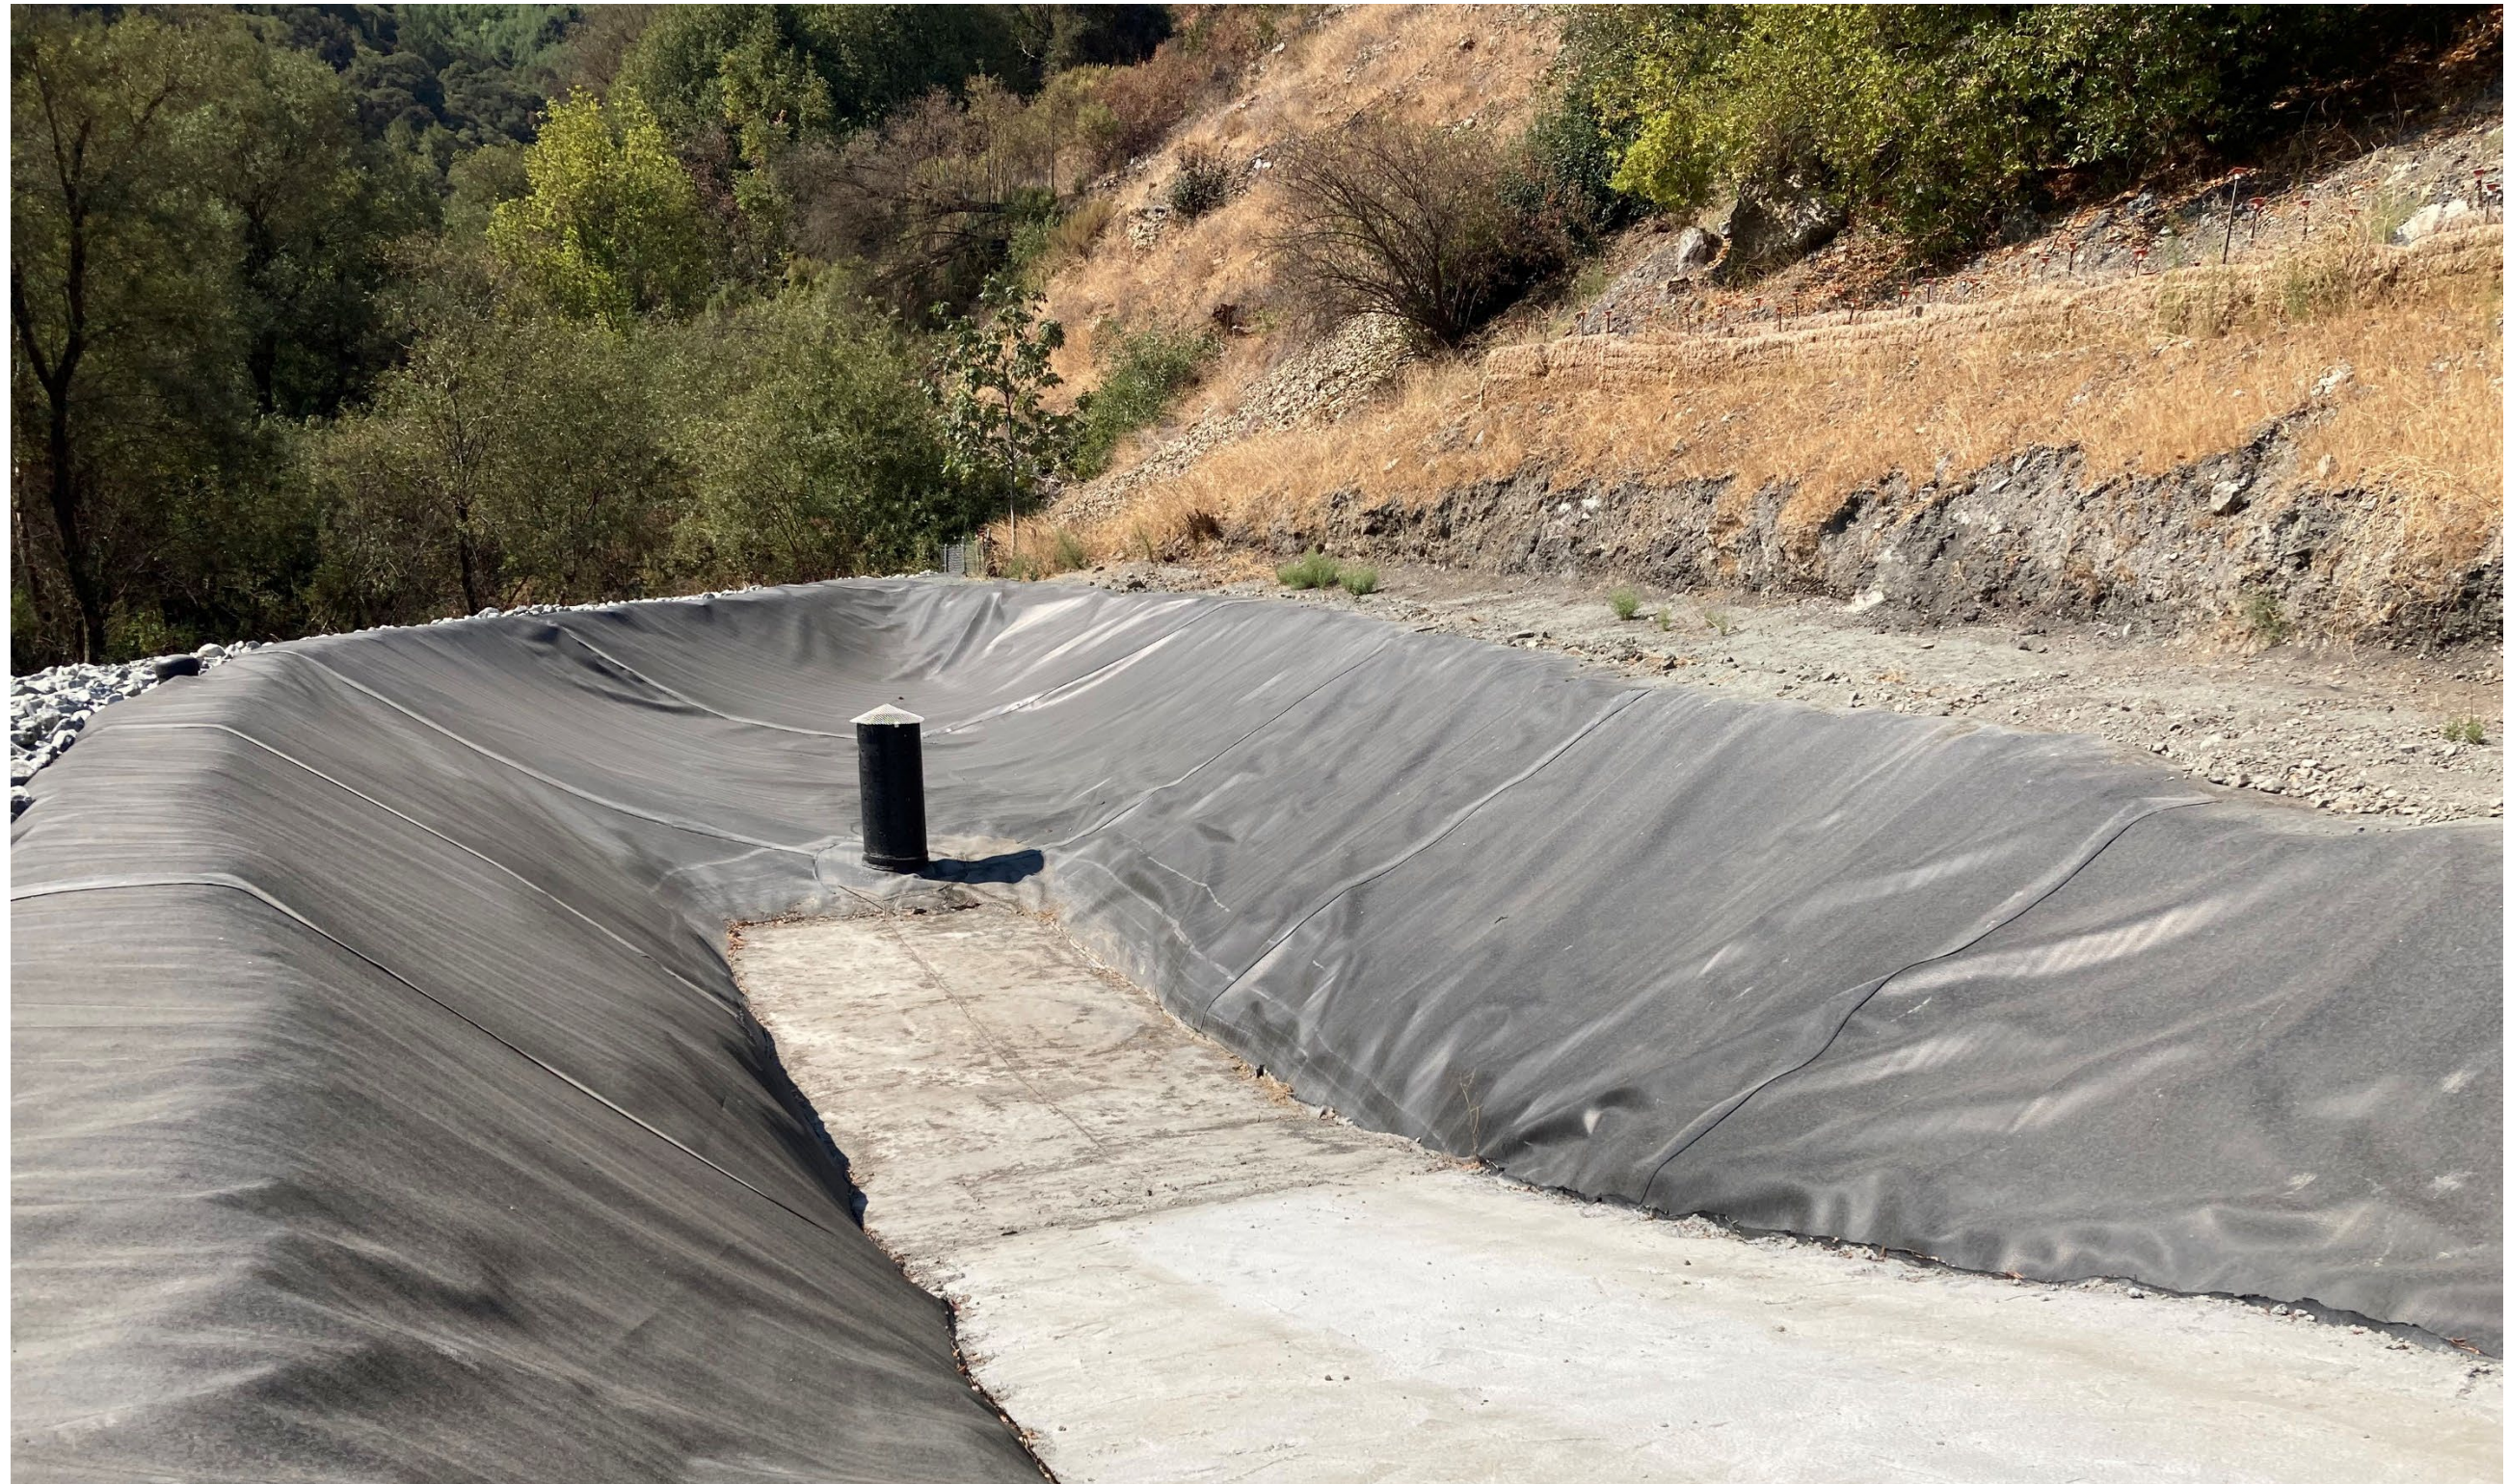
**Photo #26 – Debris basin**

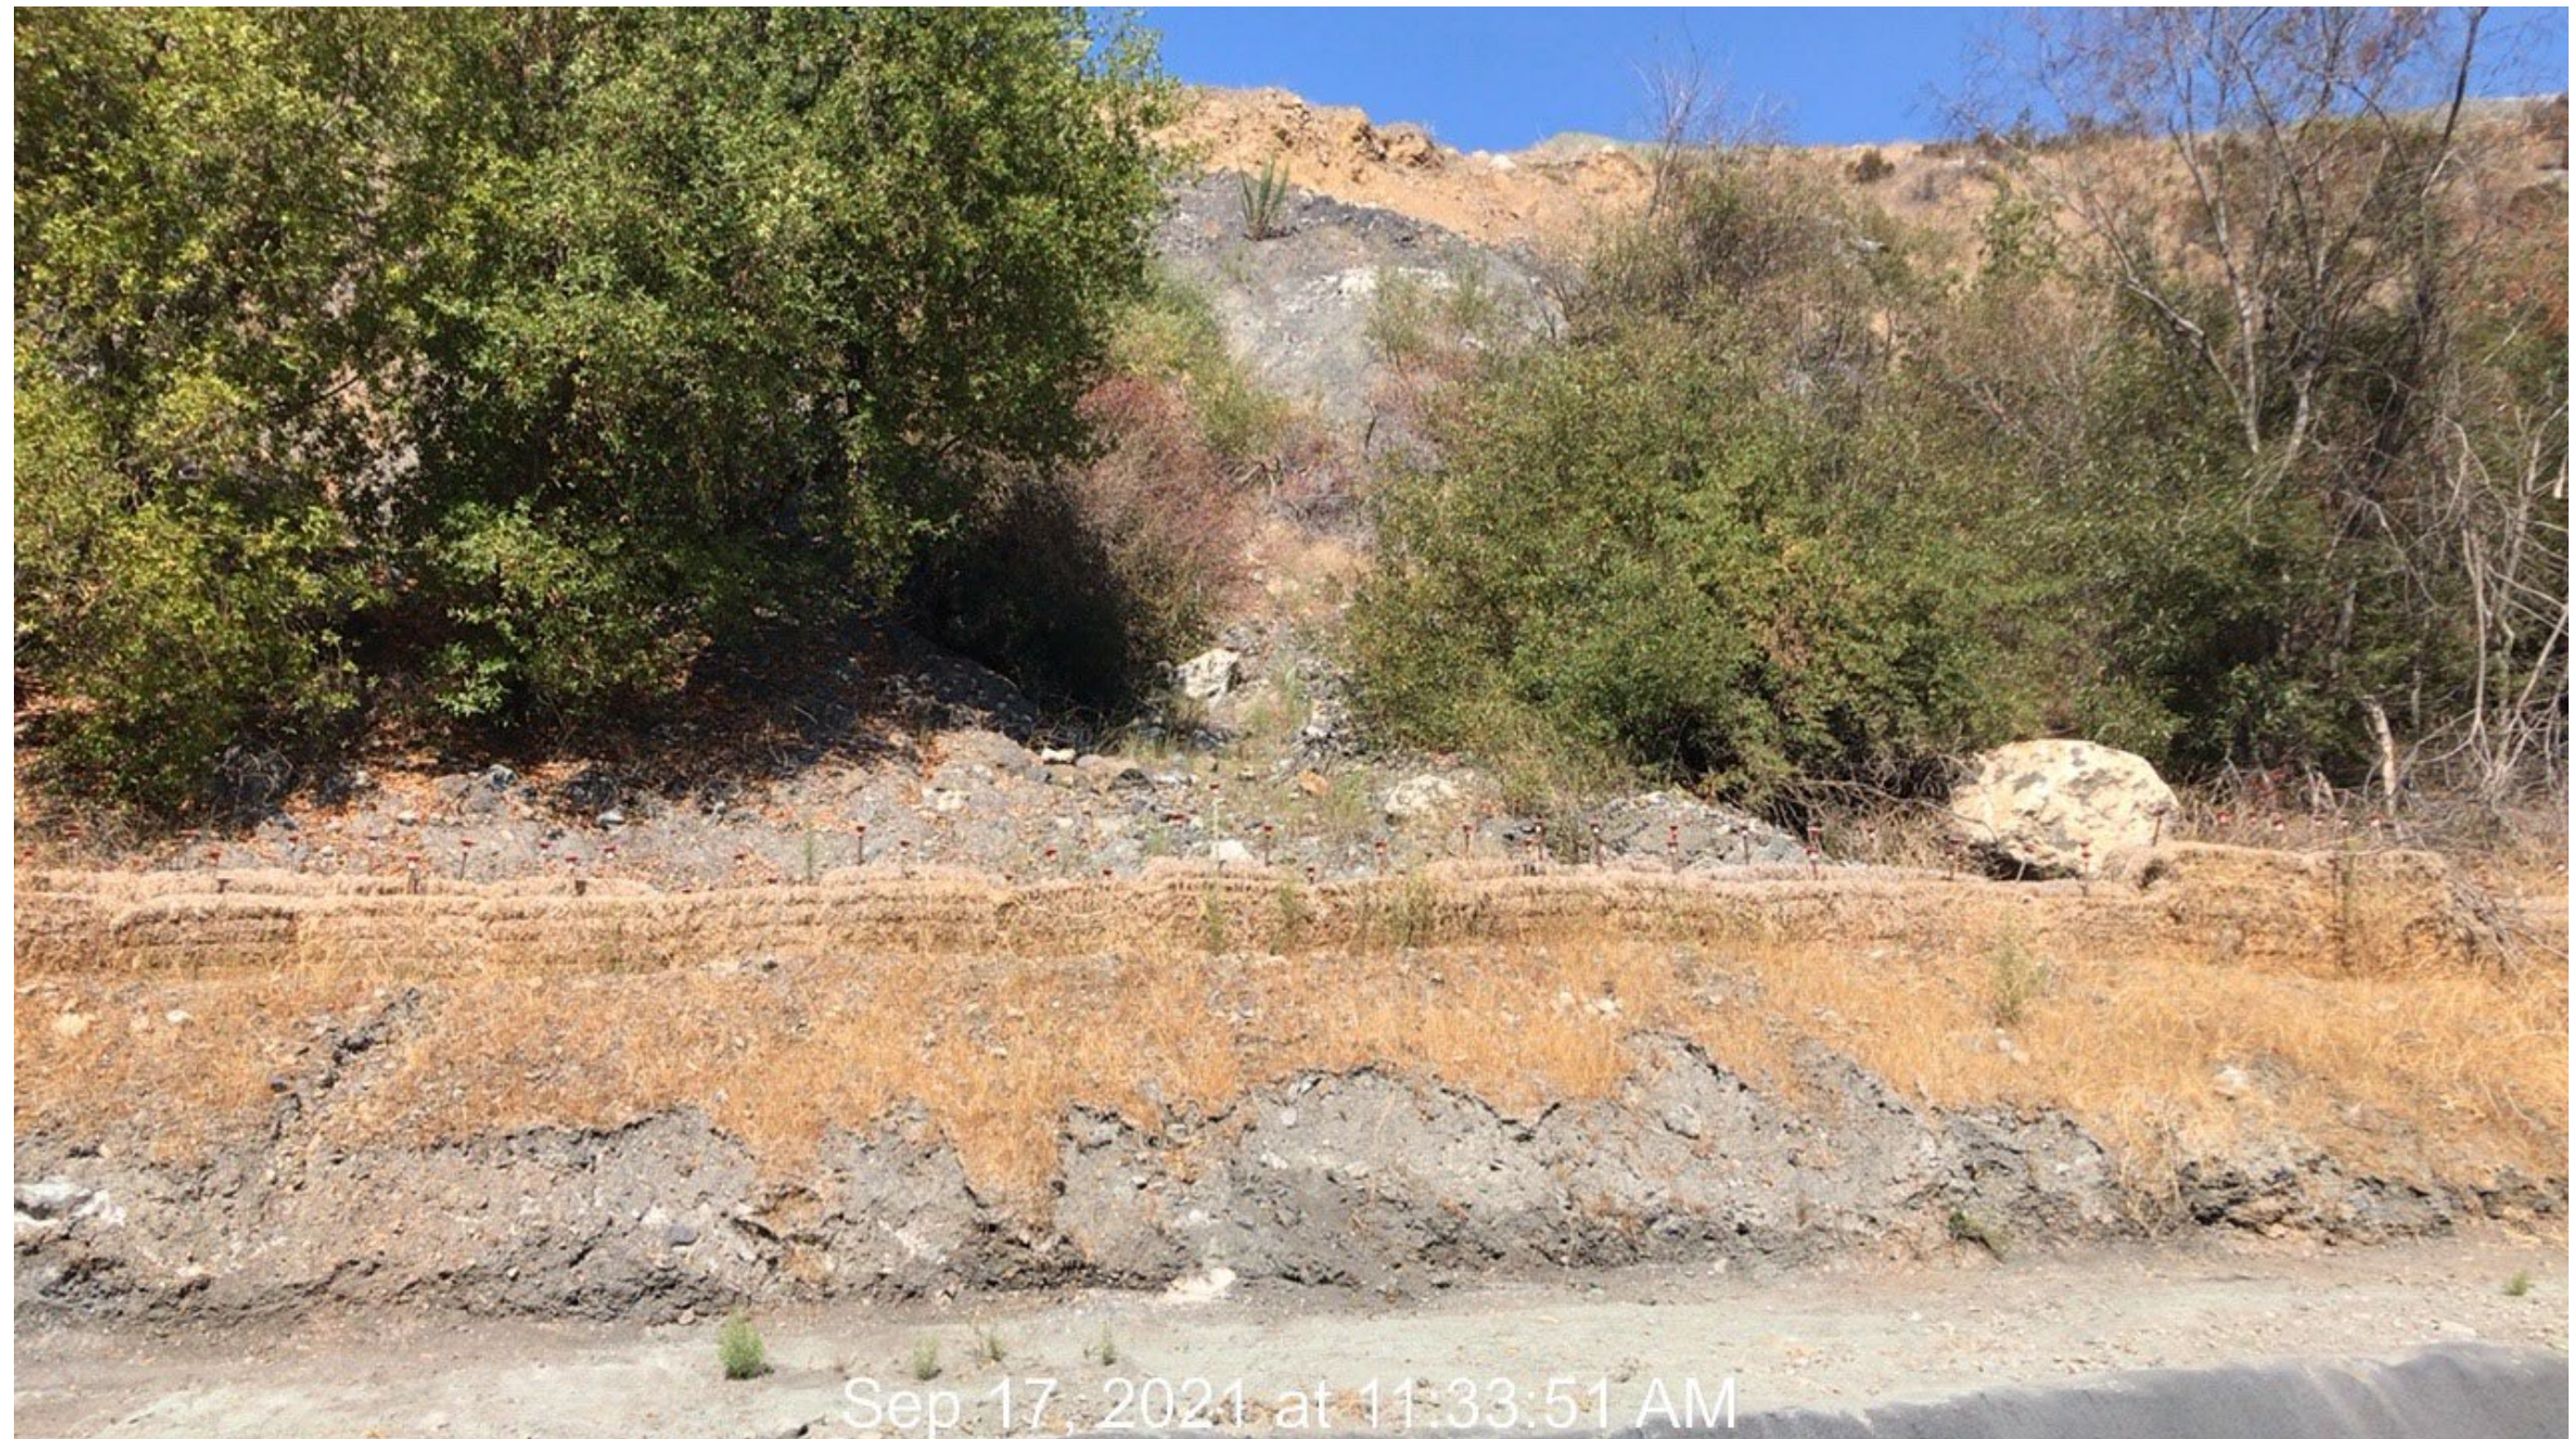
**Photo #27 – Debris flow scar (source of sediment deposited in Permanente Creek)**
