## SURFACE MINING INSPECTION REPORT

Photos from 2021 Annual SMARA Inspection Conducted on 9-17-2021

by  
Robert Salisbury, Senior Planner  
James Baker, CEG#1021, County Geologist  
Steve Beams, Senior Construction Inspector

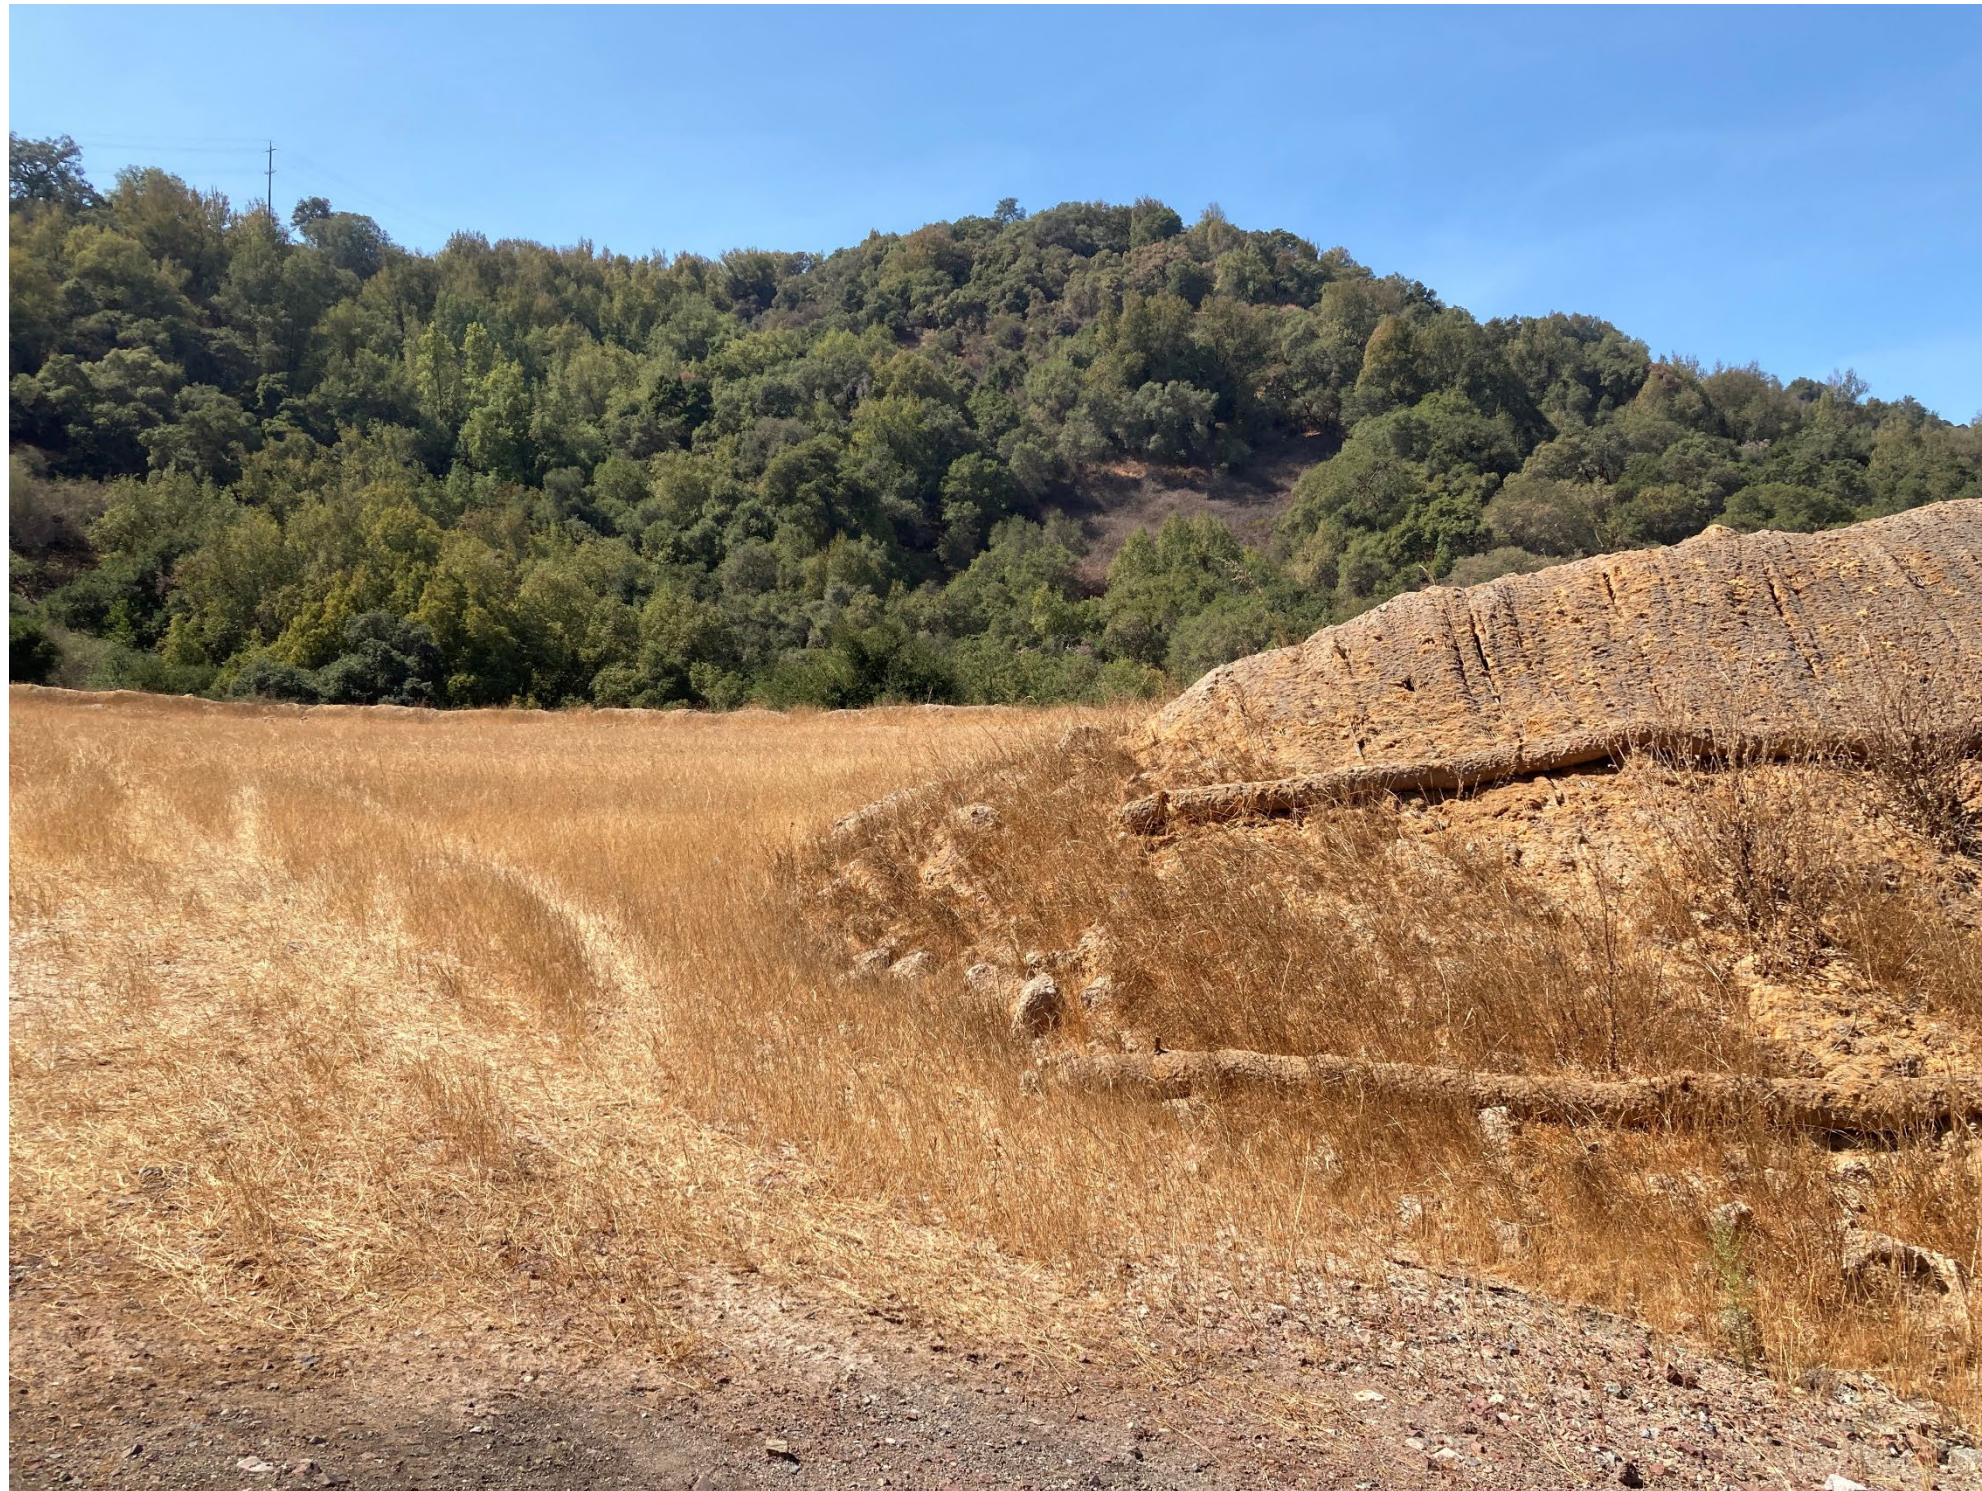
During the annual inspection, County inspectors observed an area in which recent grading had created a level pad adjacent to the modified utility road south of the Rock Plant. The fill slopes were covered with jute netting which had not yet been hydroseeded. [See **Photos 28A and 28B.**] In addition, County inspectors saw a localized area of shallow slumping of slopes on the northern side of fill placed in 2017 on top of the EMSA. [See **Photo 29.**]

**Photo #28A - recent fill pad near Rock Plant**

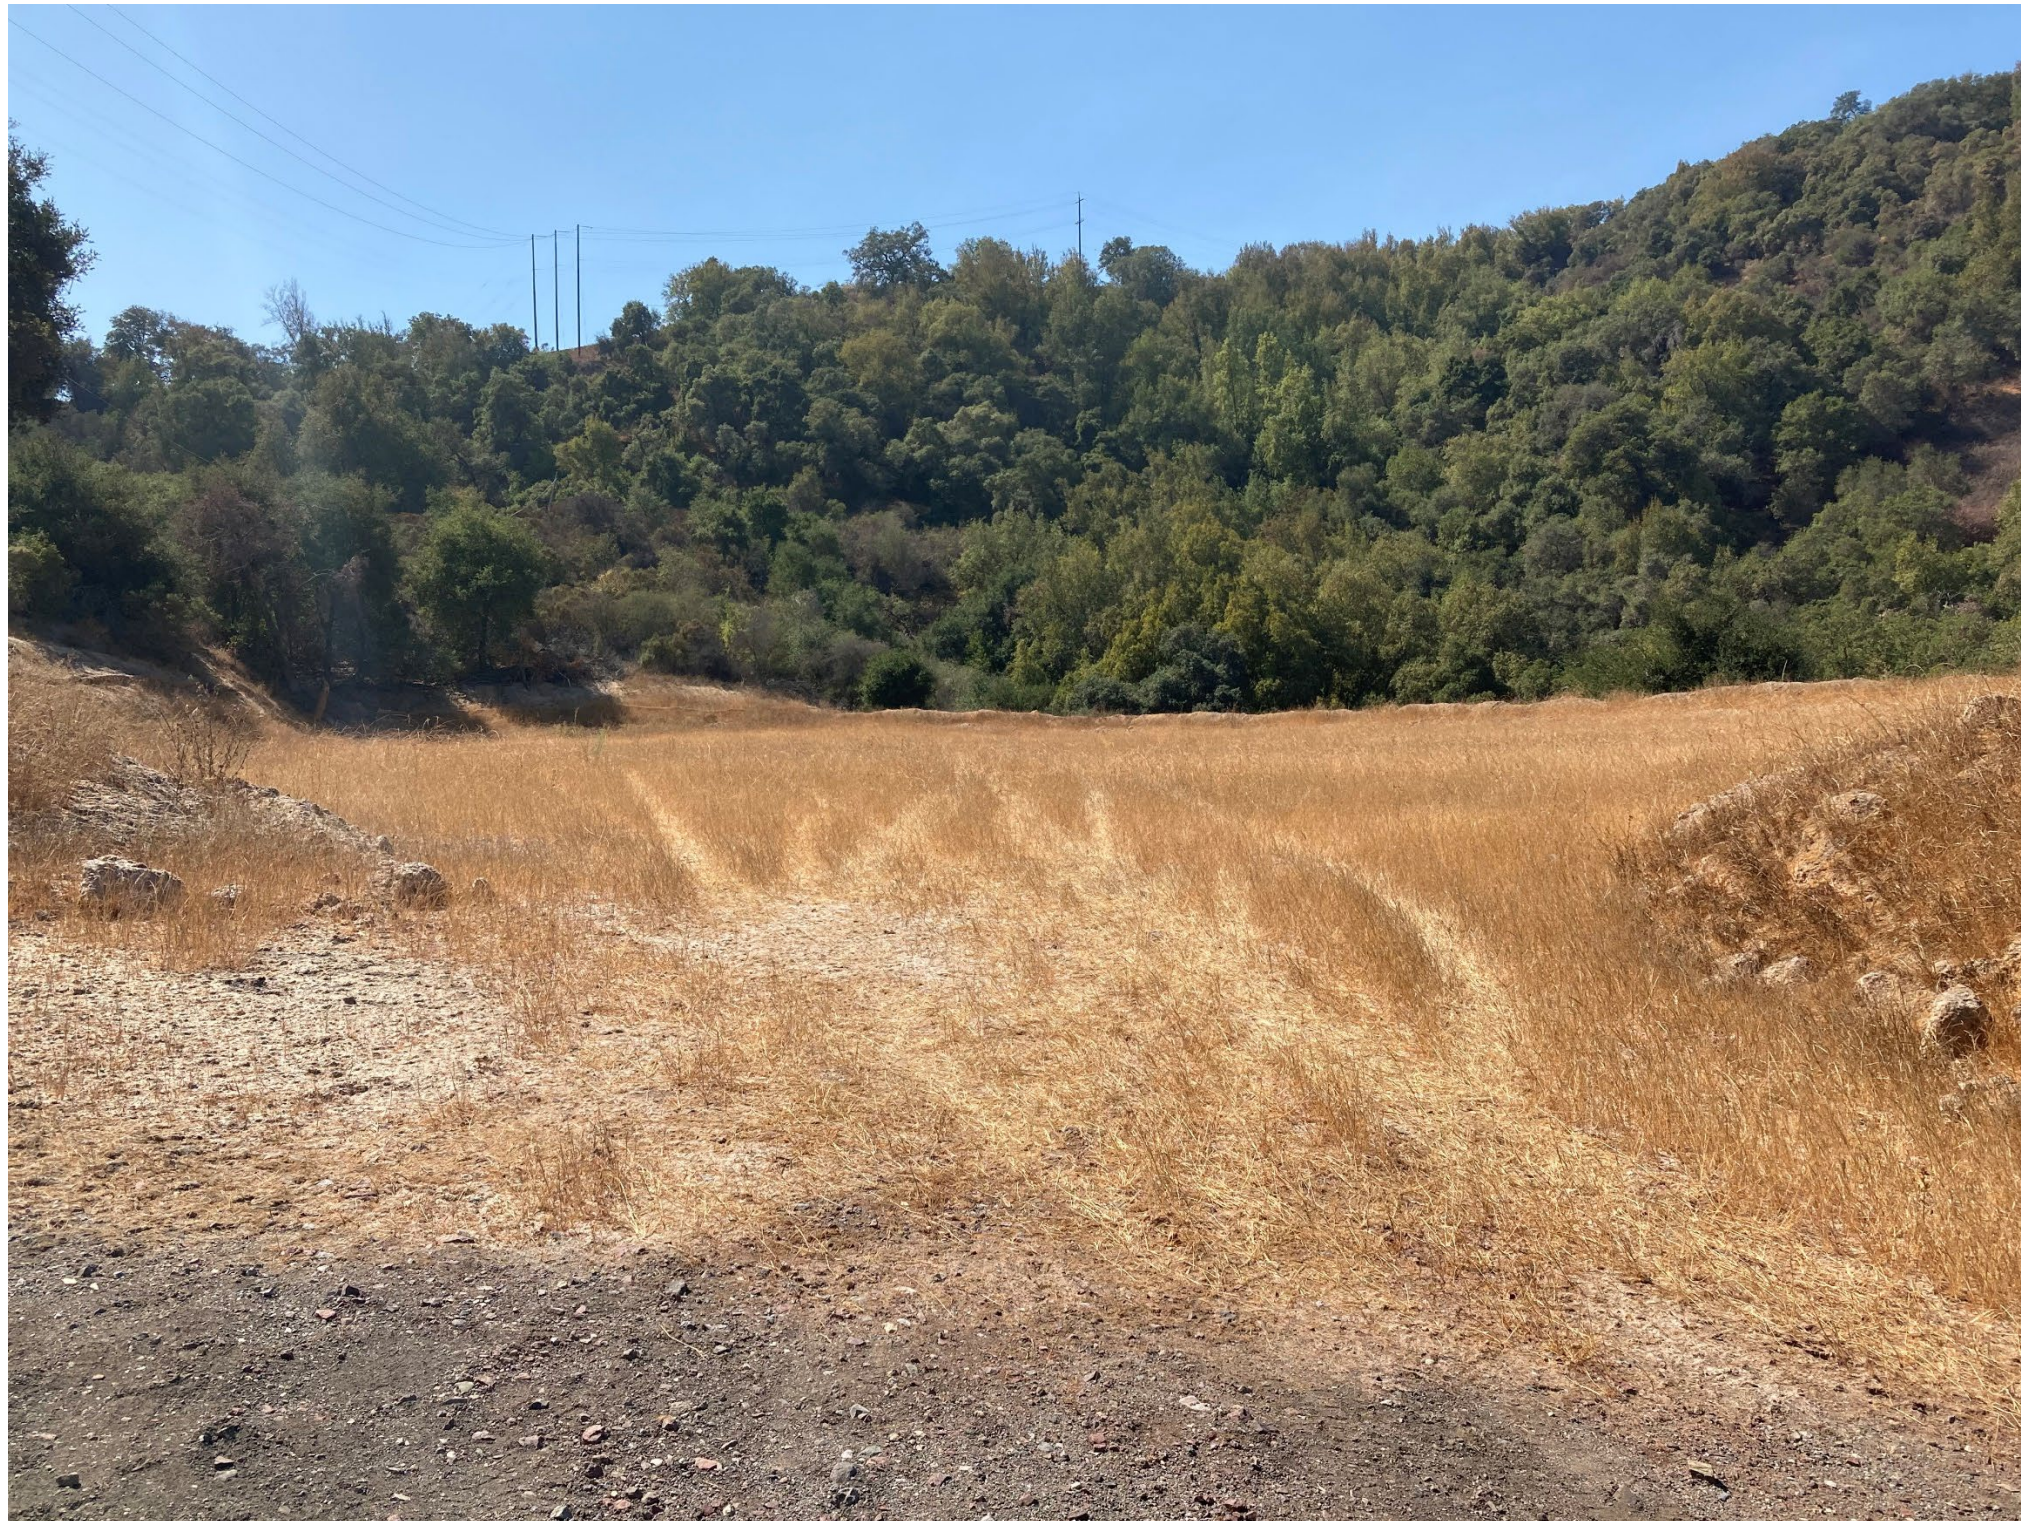
**Photo #28B – recently cut pad near Rock Plant**

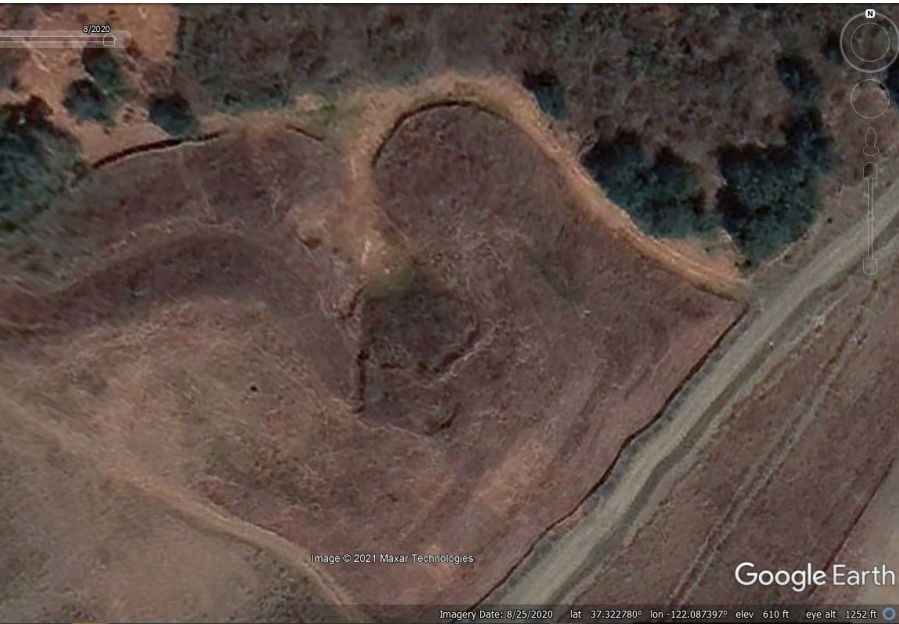
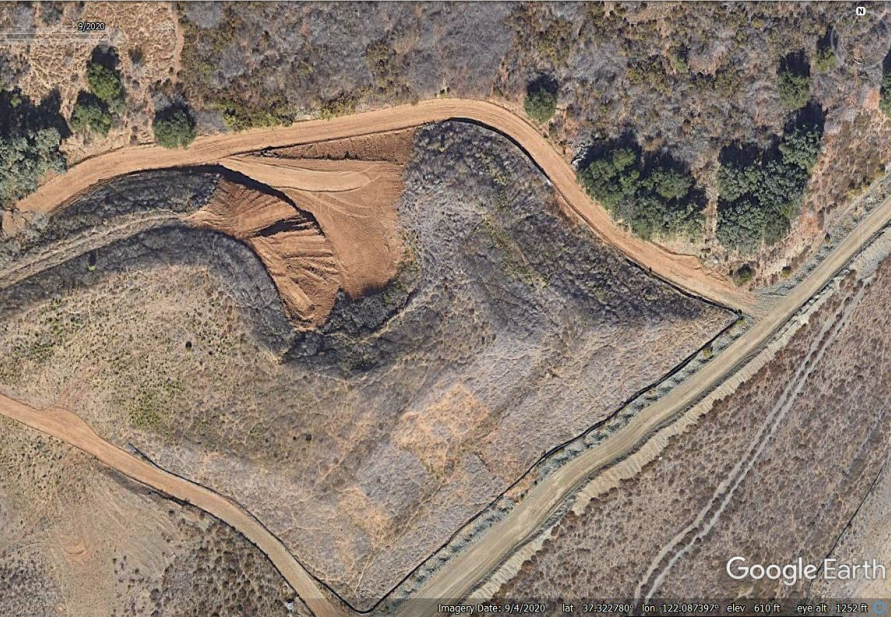
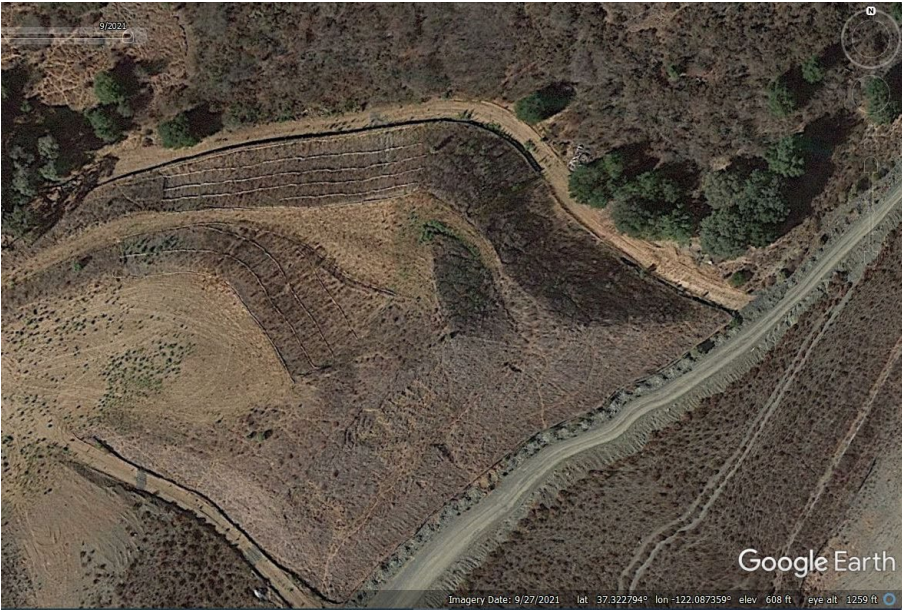
**Photo #29 – Shallow slumps in fill material that was added to EMSA beginning in September or October of 2017; slumps have been re-graded by the operator**  
**(Ground photo not taken in 2021; aerial photos from Google Earth)**
