SURFACE MINING INSPECTION REPORT

BACKGROUND

Lehigh Quarry is a vested hard rock quarry which has been in operation since approximately 1903. The operation primarily harvests limestone for the production of cement but has also produced greenstone aggregate in the past. Over time the quarrying operation has expanded, and now encompasses 546 acres of disturbed area. The site also includes a cement plant operating under a Use Permit and located outside of the Reclamation Plan area. The current Reclamation Plan was approved in 2012 as an amendment to the 1985 Reclamation Plan.

Photos from 2022 Annual SMARA Inspection Conducted on 9-20-2022

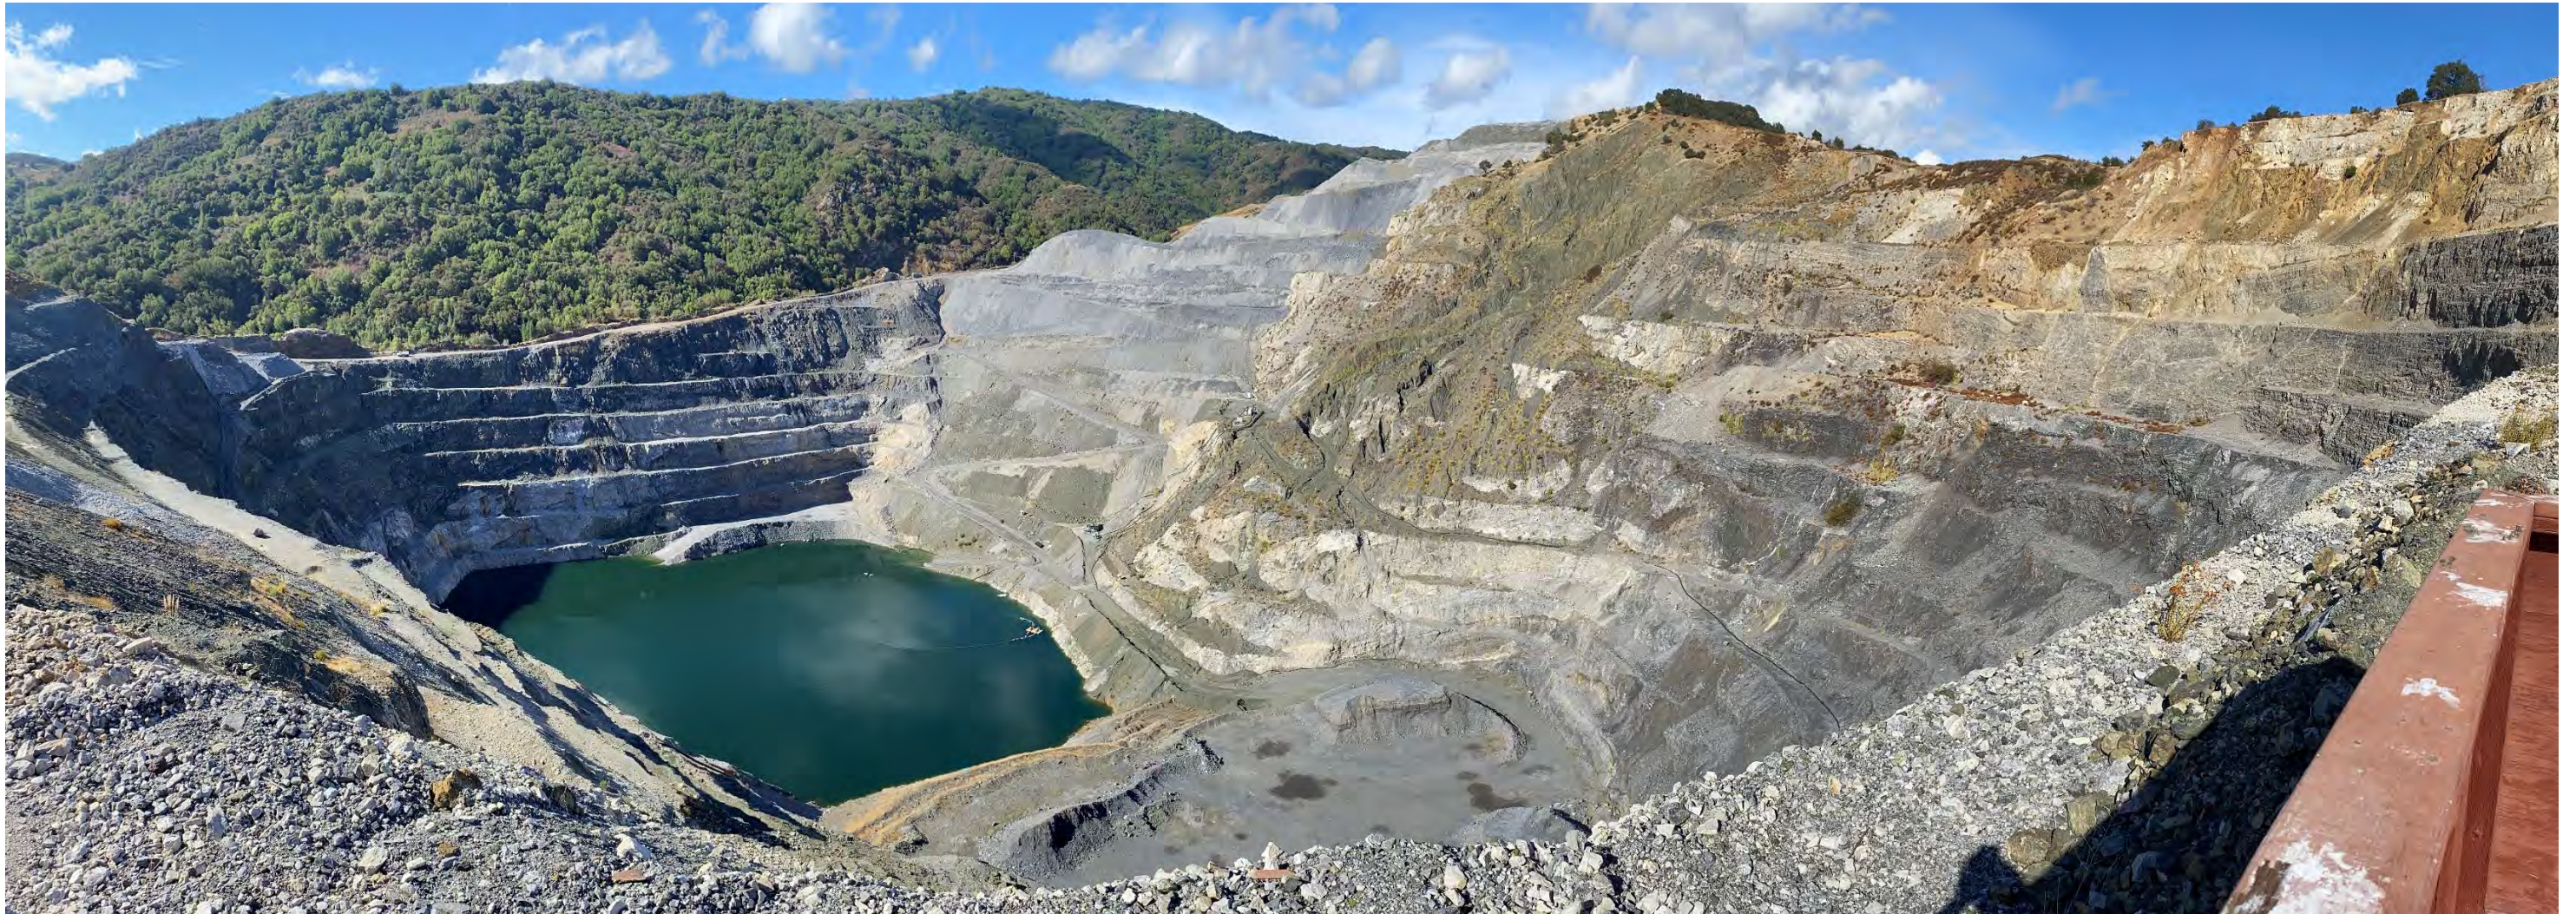
PHOTO #1 – North Quarry Main Pit (looking southwest)

The highwalls on the north, east, and south were previously excavated and benched, however multiple slides occurred over the years leading to failure of parts of the benches. The proposed RPA currently under review by the County proposes changes in slope geometry intended to address the main pit slope failures. No extraction of limestone was occurring in this area during the annual inspection. [See **PHOTO #1** and **PHOTO #2**.]

The highwalls on the north, east, and south are essentially complete (excavated benches); while the southern side of the pit is still being actively mined (blasting and loading). No extraction of limestone was occurring during the inspection. New material was being placed on the southern portion of the WMSA [See also **PHOTO #2.**]

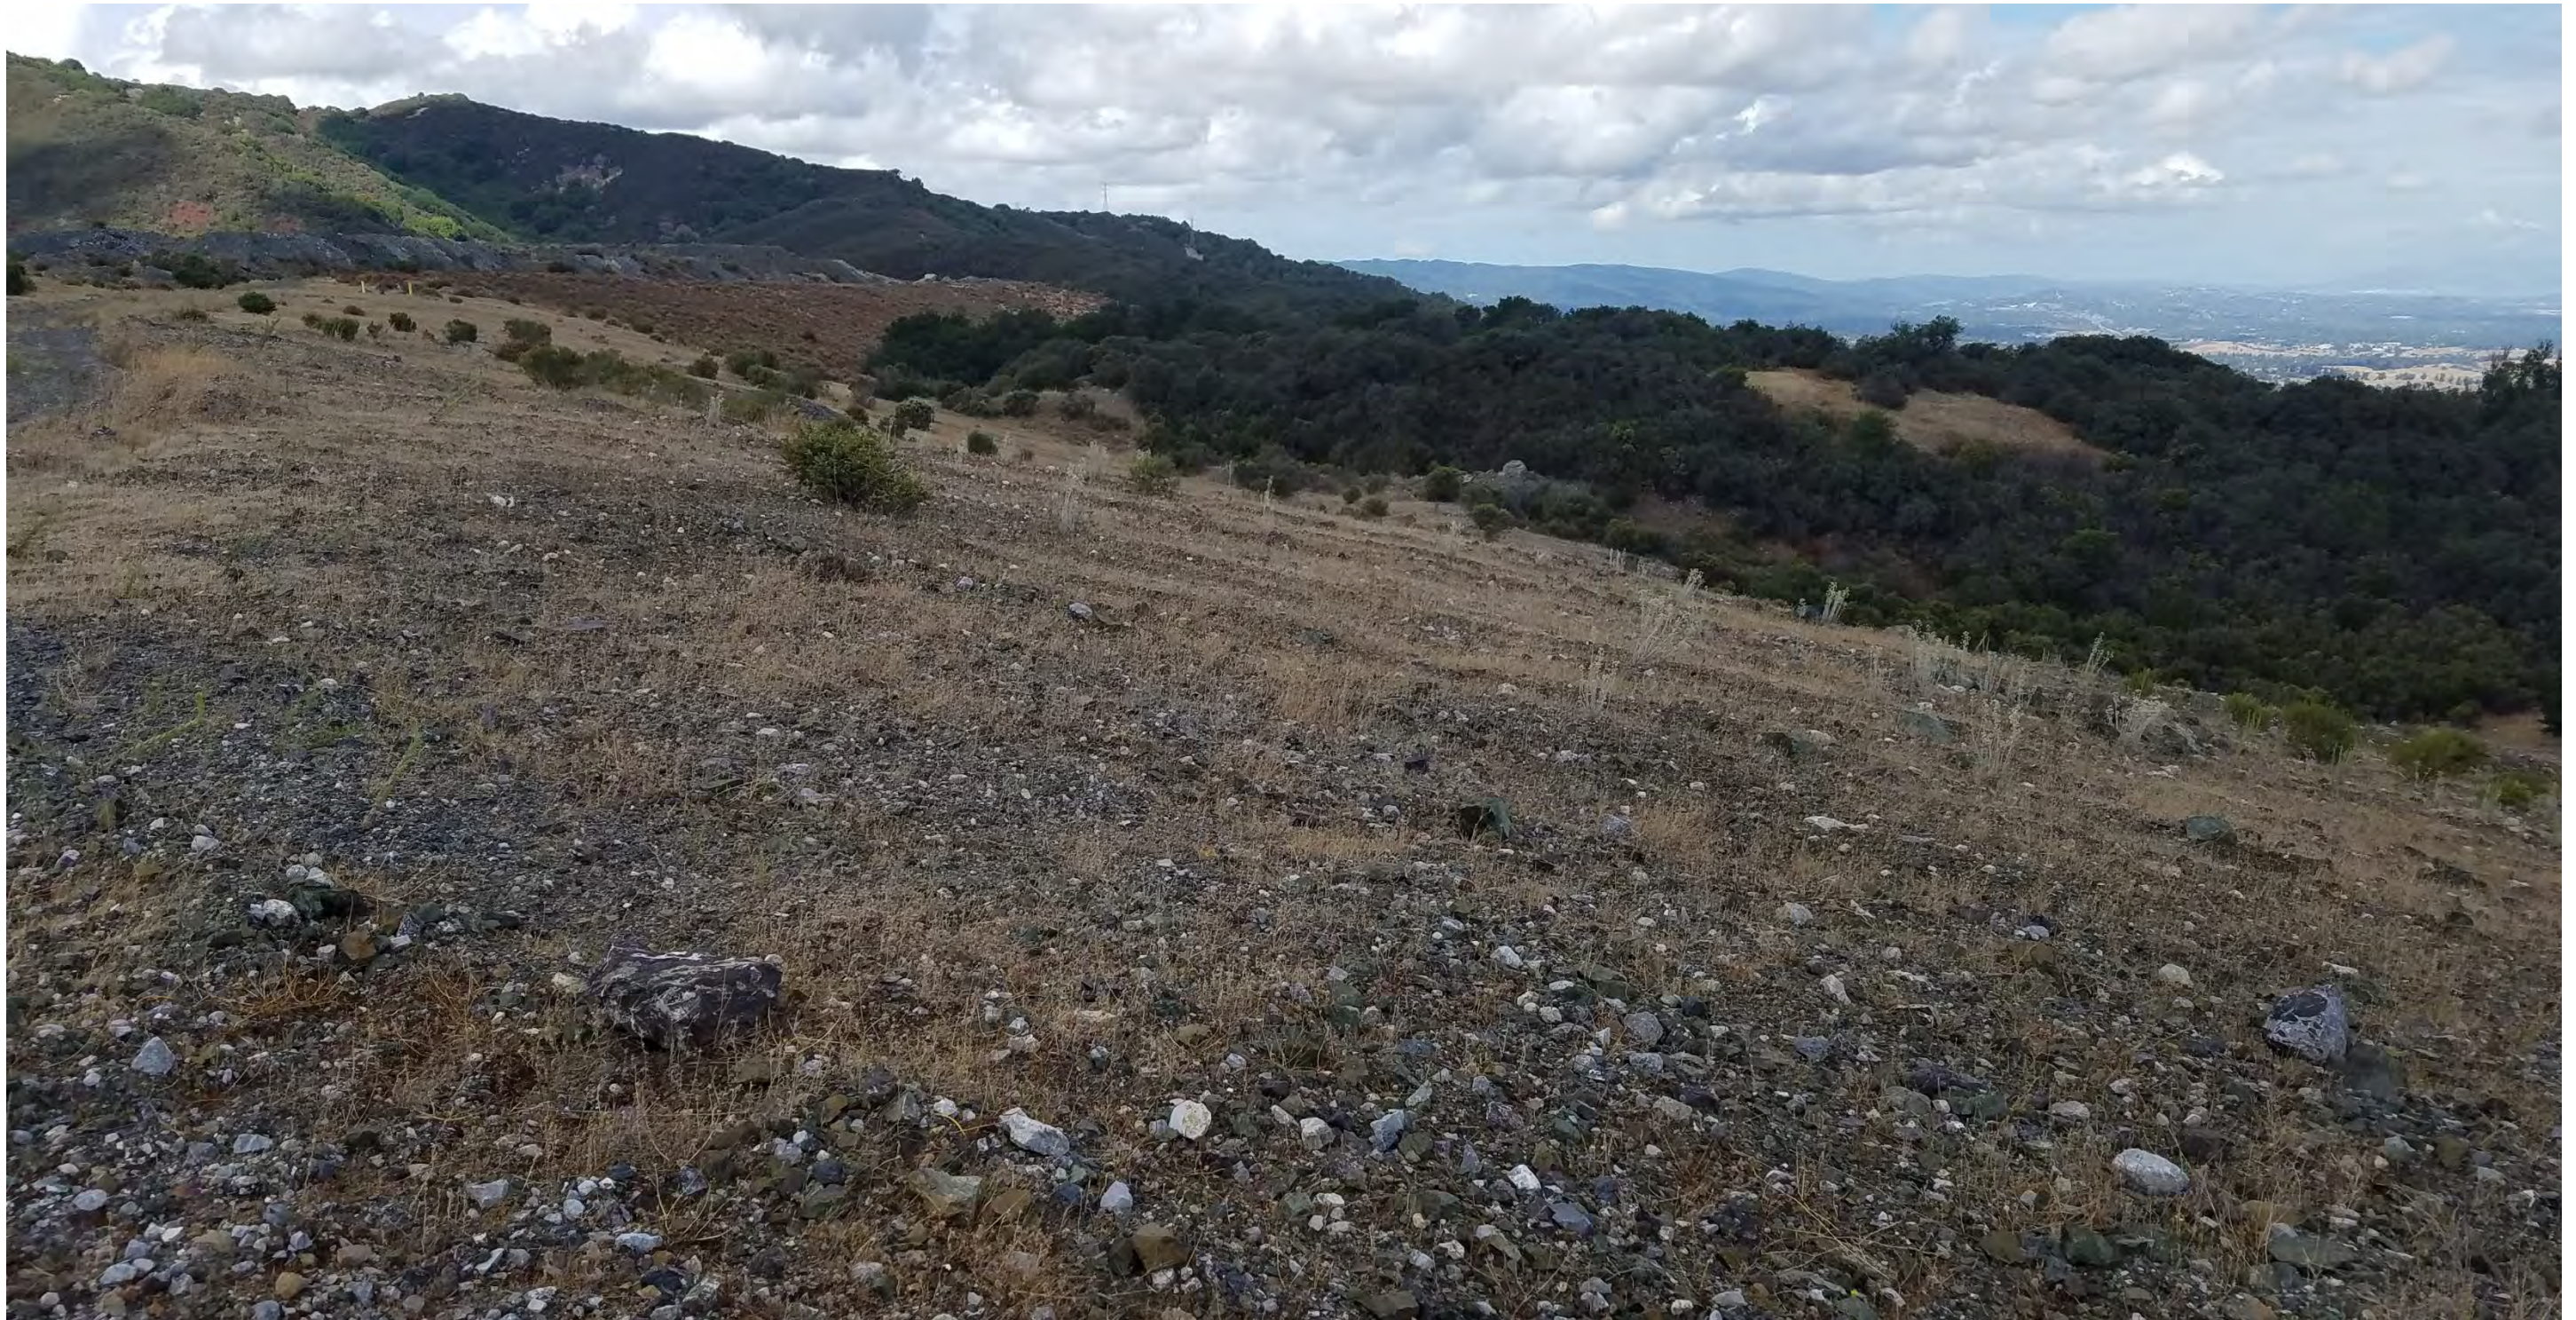
PHOTO #3 – WMSA (looking northward)

The northeast-facing slopes of the WMSA have well-established vegetation (grasses and some shrubs). [See **PHOTO #3** and **PHOTO #4**.] Topsoil and organics are stored and covered in the central portion of the WMSA. County staff observed deterioration of previously installed jute netting and minimal growth on the hydroseeded stockpile slopes. [See **PHOTOS #5A** and **#5B**.] Although no evidence of erosion was observed, the operator should monitor the stockpiles and replace erosion control measures as needed to prevent loss of stockpile material through erosion. The south slope of the WMSA was viewed by County inspectors, and although growth of hydroseeded grasses and shrubs on the south slope of WMSA was minimal, no evidence of erosion was observed. The operator should monitor this area and install erosion control BMPs as needed. [See **PHOTO #6**.] The approved Reclamation Plan calls for much of the material stored in the WMSA to be moved and placed as backfill into the main quarry pit.

hed vegetation (grasses and shrubs). [See also **Photo 4**]

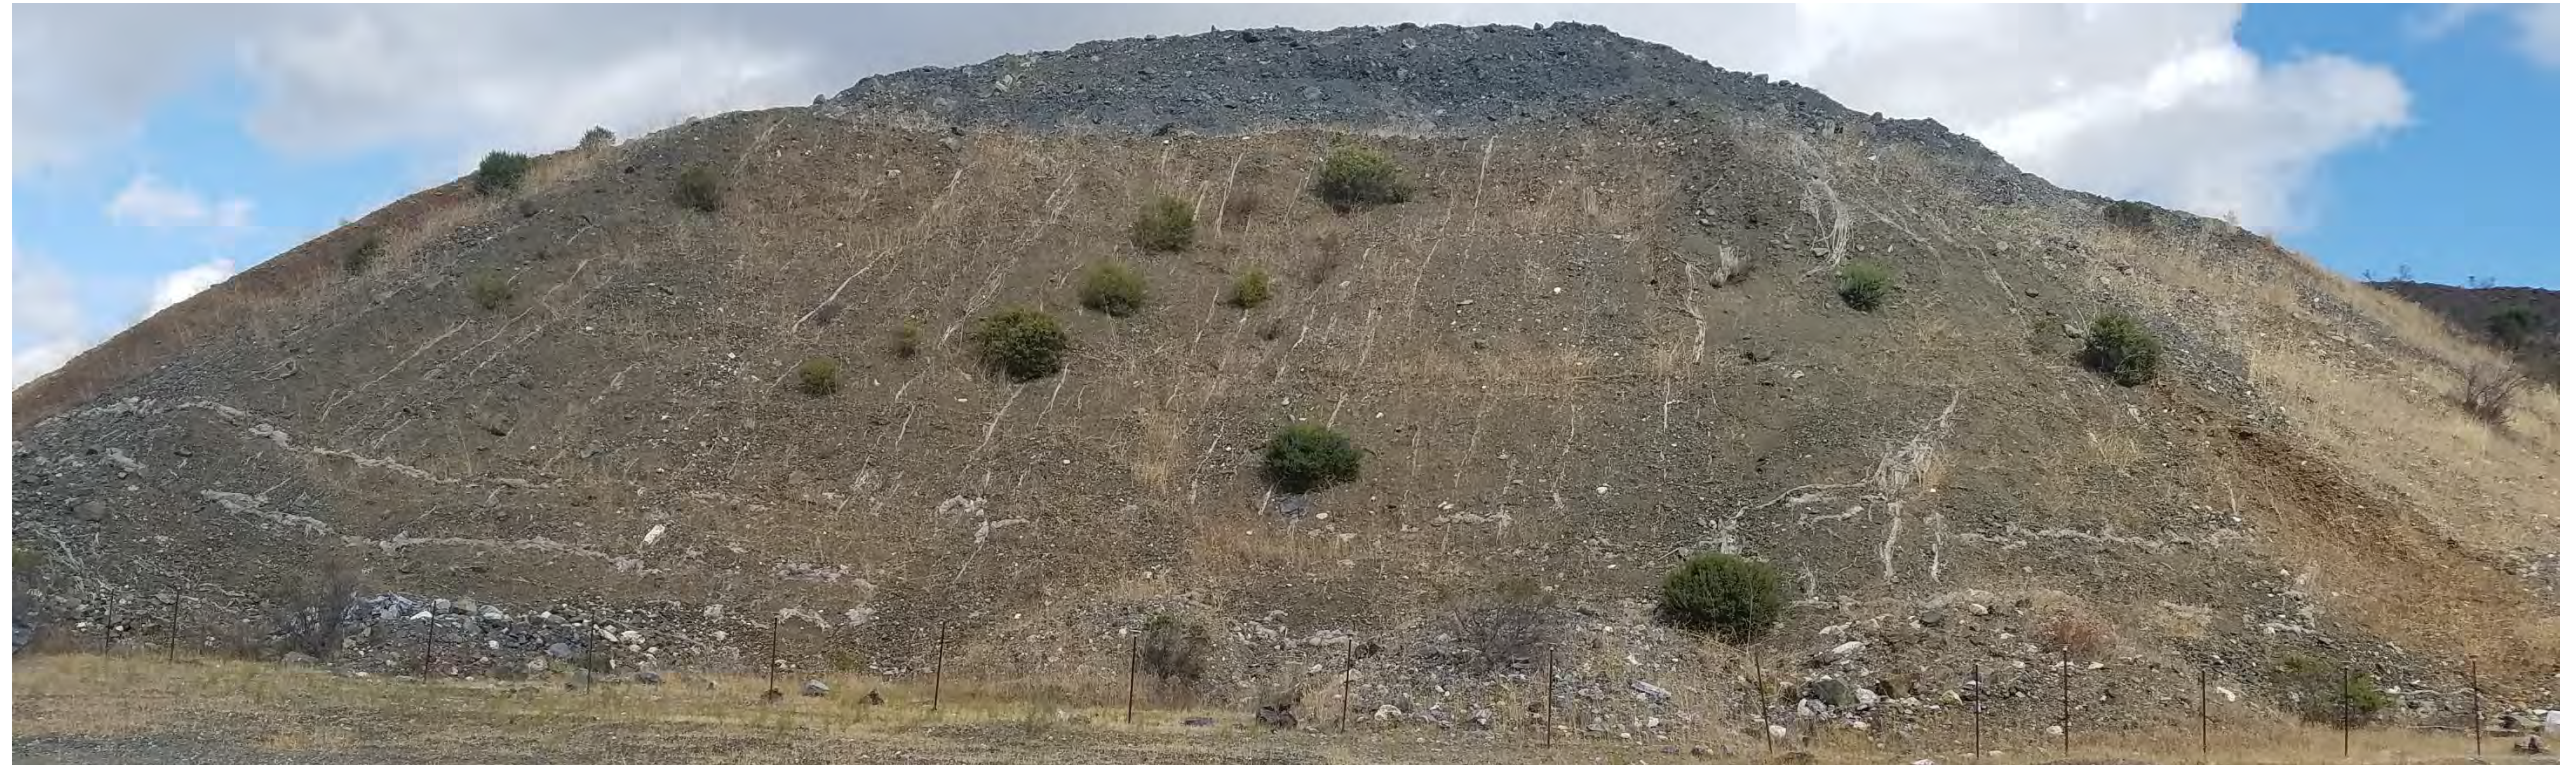
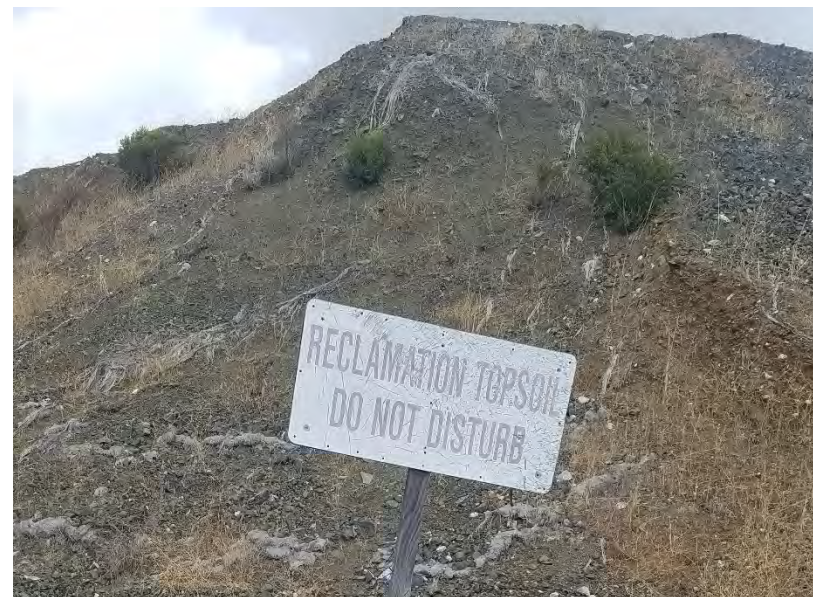
PHOTO #5A – Topsoil Stockpiles

Topsoil and organics are stored and covered in the central portion of the WMSA. County staff observed deterioration of previously installed jute netting and minimal growth on the hydroseeded stockpile slopes. Although no evidence of erosion was observed, County inspectors suggested that the operator monitor the stockpiles and replace erosion control measures as needed to prevent loss of stockpile material through erosion.

- 1) County inspectors suggested that the operator monitor the topsoil stockpiles and replace erosion control measures as needed to prevent loss of material through erosion. (See Map Location 2.)
- 2) Area of recent grading needs to be hydroseeded in order to minimize the potential for erosion during approaching rainy season. (See area between Map Locations 6 and 12.)
- 3) Recently formed ground cracks need to be monitored by the quarry operator to detect any increases in openings and evaluate the significance of any such changes. (See areas east of the Yeager Yard Landslide and the road to the main pit observation deck.)

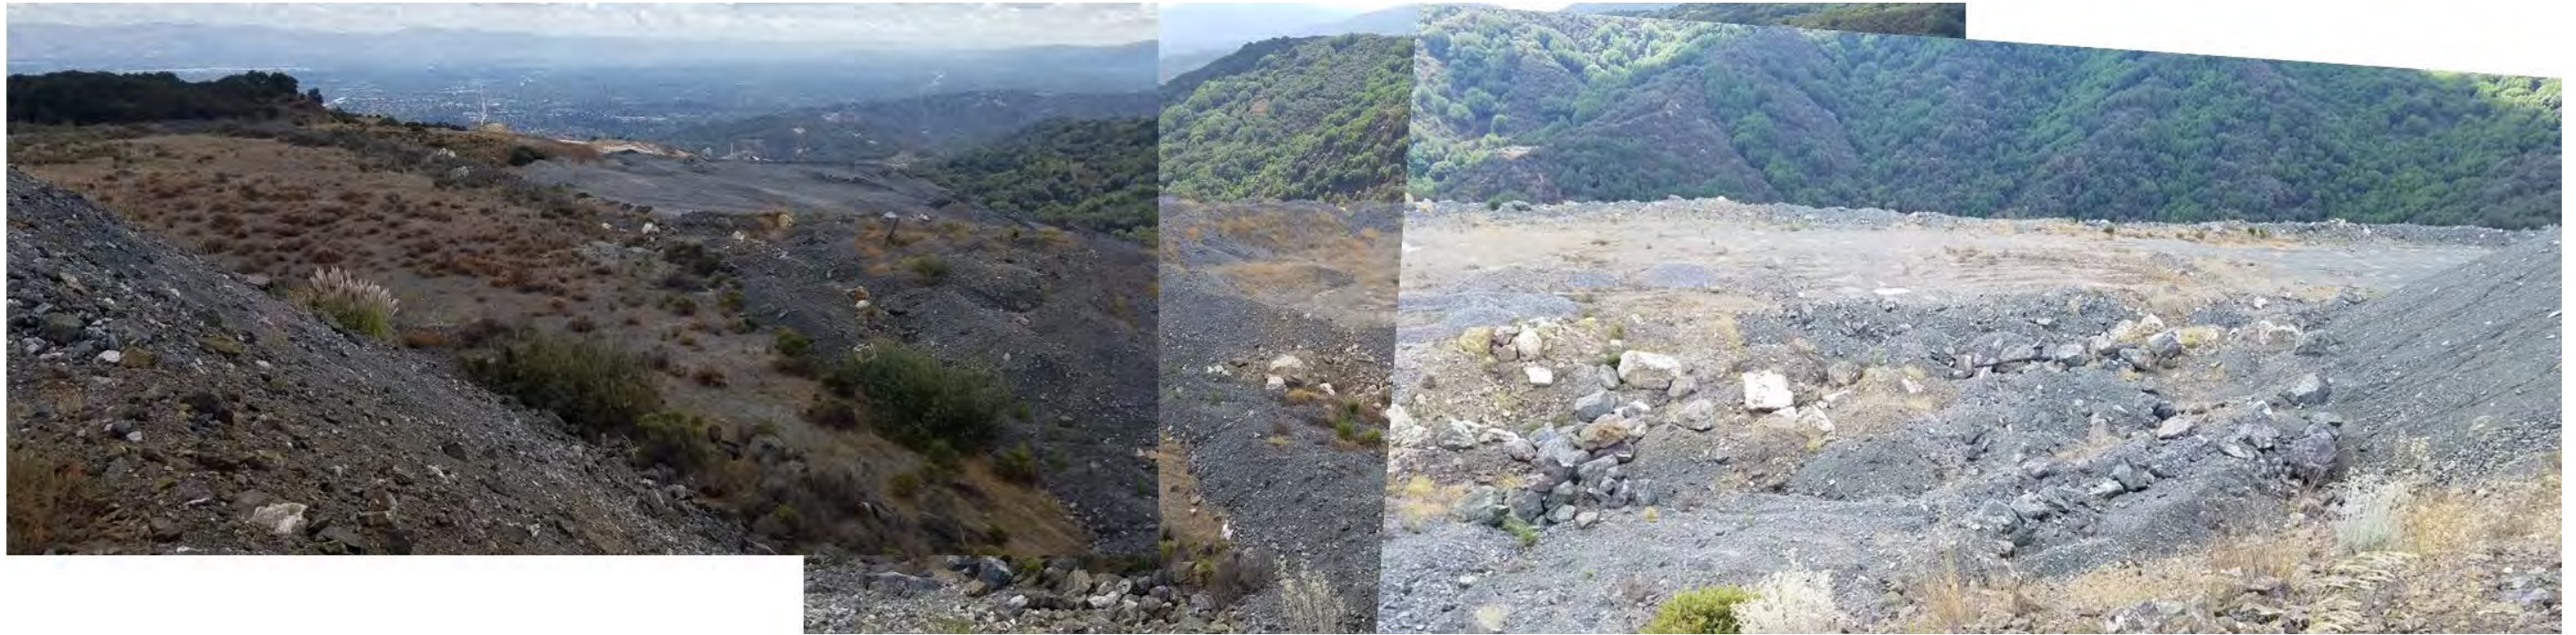
PHOTO #6 – WMSA South Slope (looking southeast)

The south slope of the WMSA was viewed by County inspectors, and although growth of hydroseeded grasses and shrubs on the south slope of WMSA was minimal, no evidence of erosion was observed. The operator should monitor this area and install erosion control BMPs as needed. The approved Reclamation Plan calls for much of the material stored in the WMSA to be moved and placed as backfill into the main quarry pit.

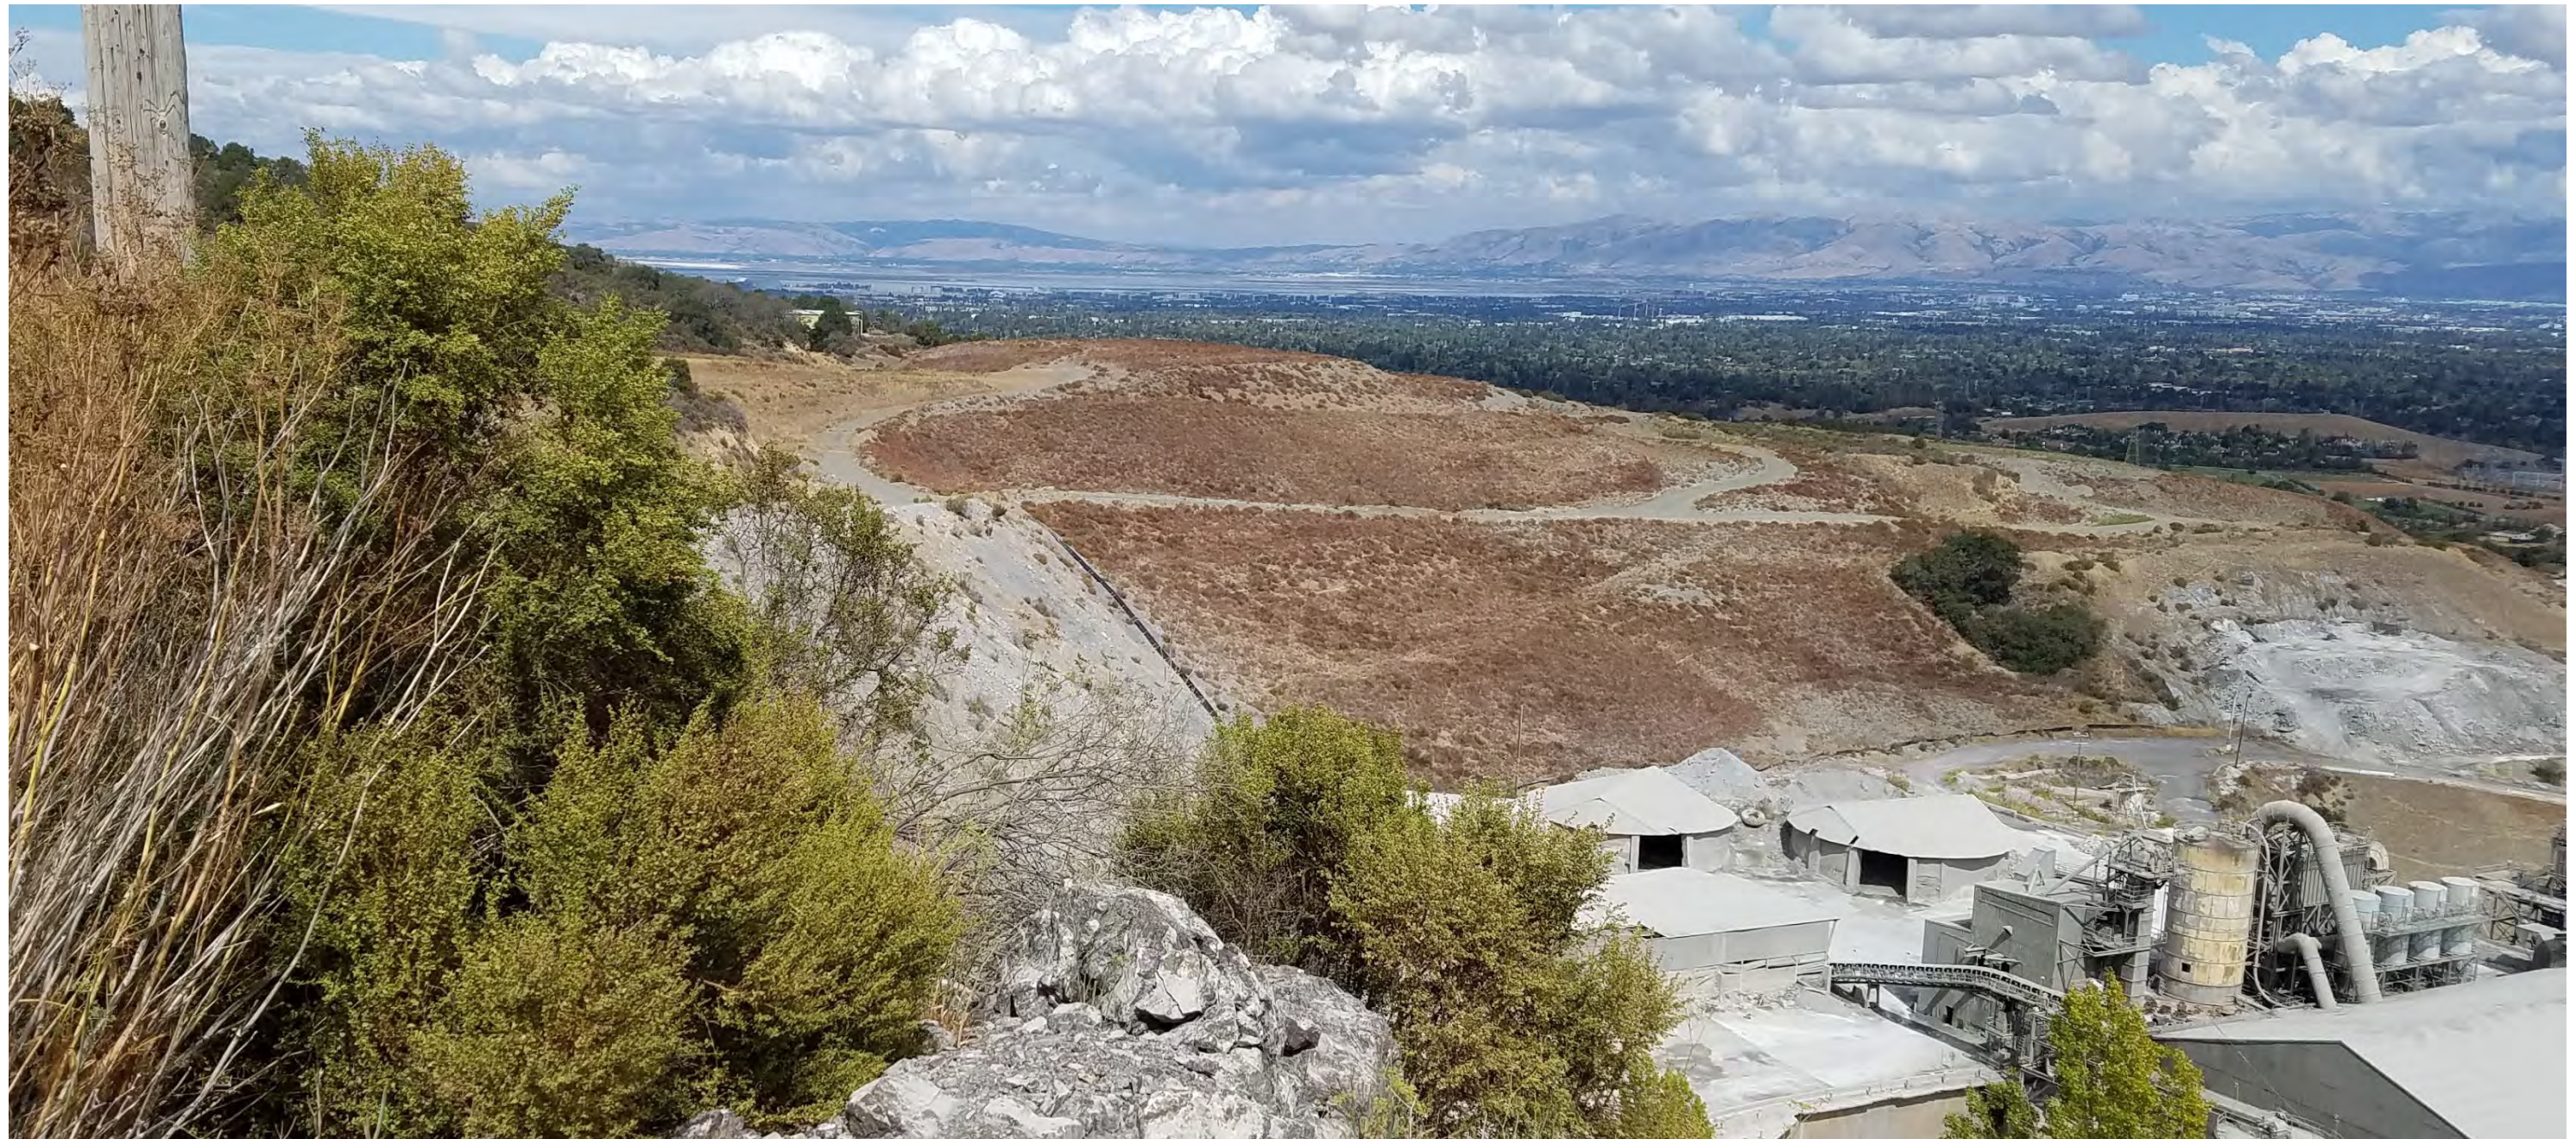
PHOTO #7 – Southern slopes of EMSA (looking northeast)

BMPs were previously placed on the slopes (wattles) and along the benches (rock check dams and silt fences).

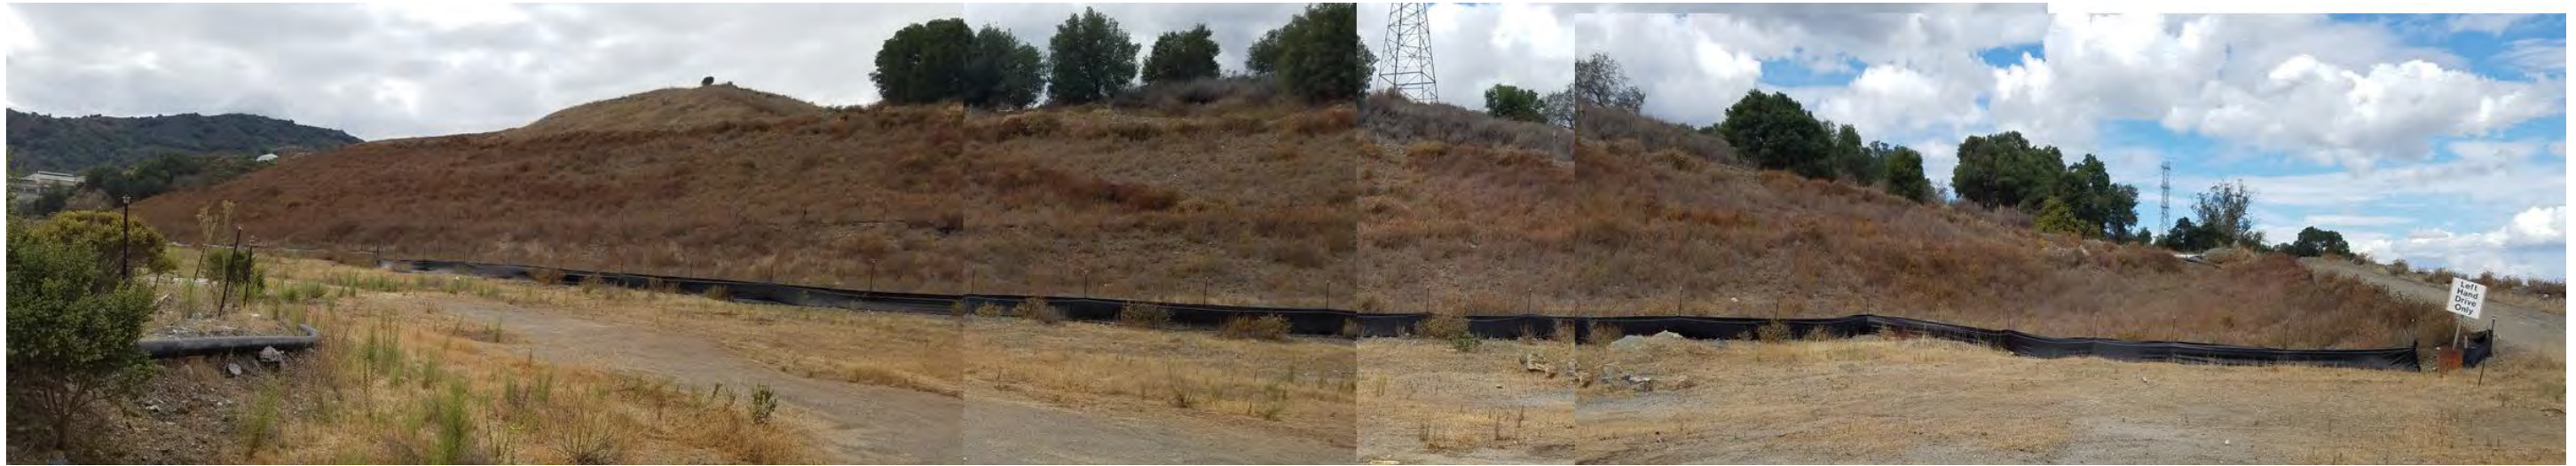
PHOTO #8 – Eastern slopes of EMSA, north of Pond 30 (looking northwest)

County inspectors observed substantial vegetation growth on the EMSA slopes.

Surface drainage from EMSA is directed into Pond 30 which is rock-lined with non-limestone rock. Water from Pond 30 is then directed to a vault and pumped to the upper treatment system.

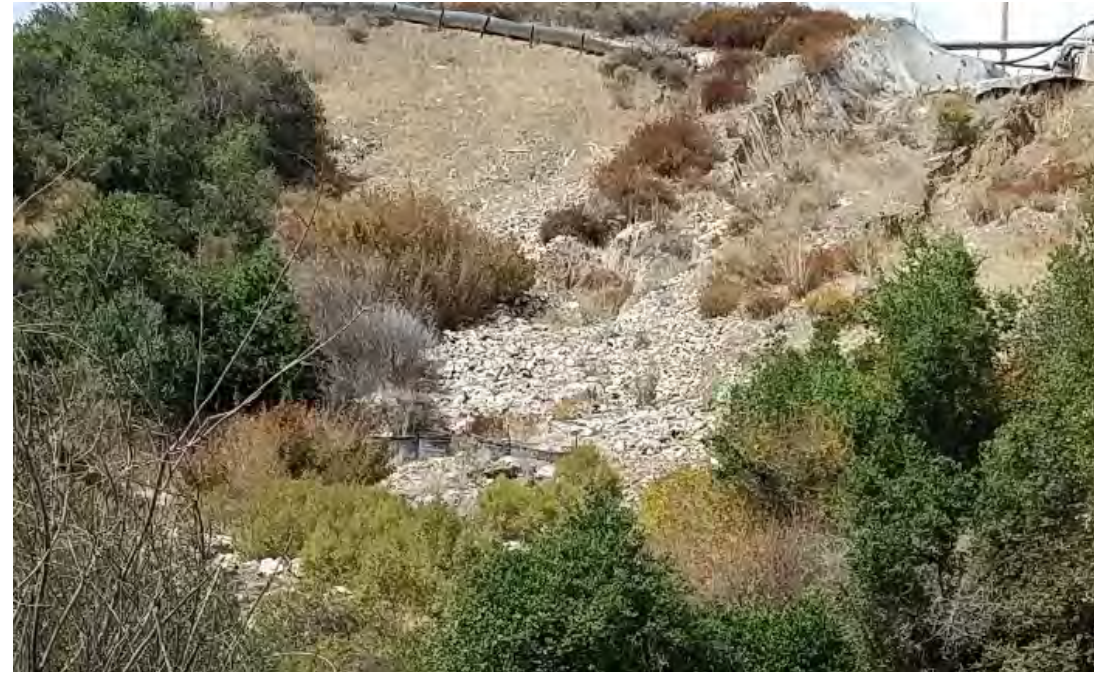
PHOTO #10A – Overflow scar below crusher sump

Drainage from around the crusher built in 2013 is directed into a sump that overflowed due to a power failure in 2014. As a result, an erosion gully formed on the steep slope west of the crusher. The operator has had the gully lined with jute netting and several silt fences and installed a soil-nail wall in the head of the erosion gully located downhill of the sump. [See **PHOTOS #10A and #10B.**] Eroded material accumulated at the toe of the slope and extended into the eastern side of Pond 13. Due to lack of rain, Pond 13 was completely dry during the 2021 inspection. [See **PHOTO #11.**] A half-pipe exists downstream of Pond 13 for the continuance of Permanente Creek. [See **PHOTO #12.**] The Permanente Creek Restoration Project (County File No. 2250-17G), submitted by Lehigh and currently under review by the County, proposes removal of the half-pipe.

The crusher was constructed in 2013 against a 70-foot high retaining wall. Drainage from around the crusher is directed into a sump which overflowed due to a power failure in 2014. As a result, an erosion gully formed on the steep slope west of the crusher. The operator has had the gully lined with jute netting and several silt fences and installed a soil-nail wall in the head of the erosion gully located downhill of the sump.

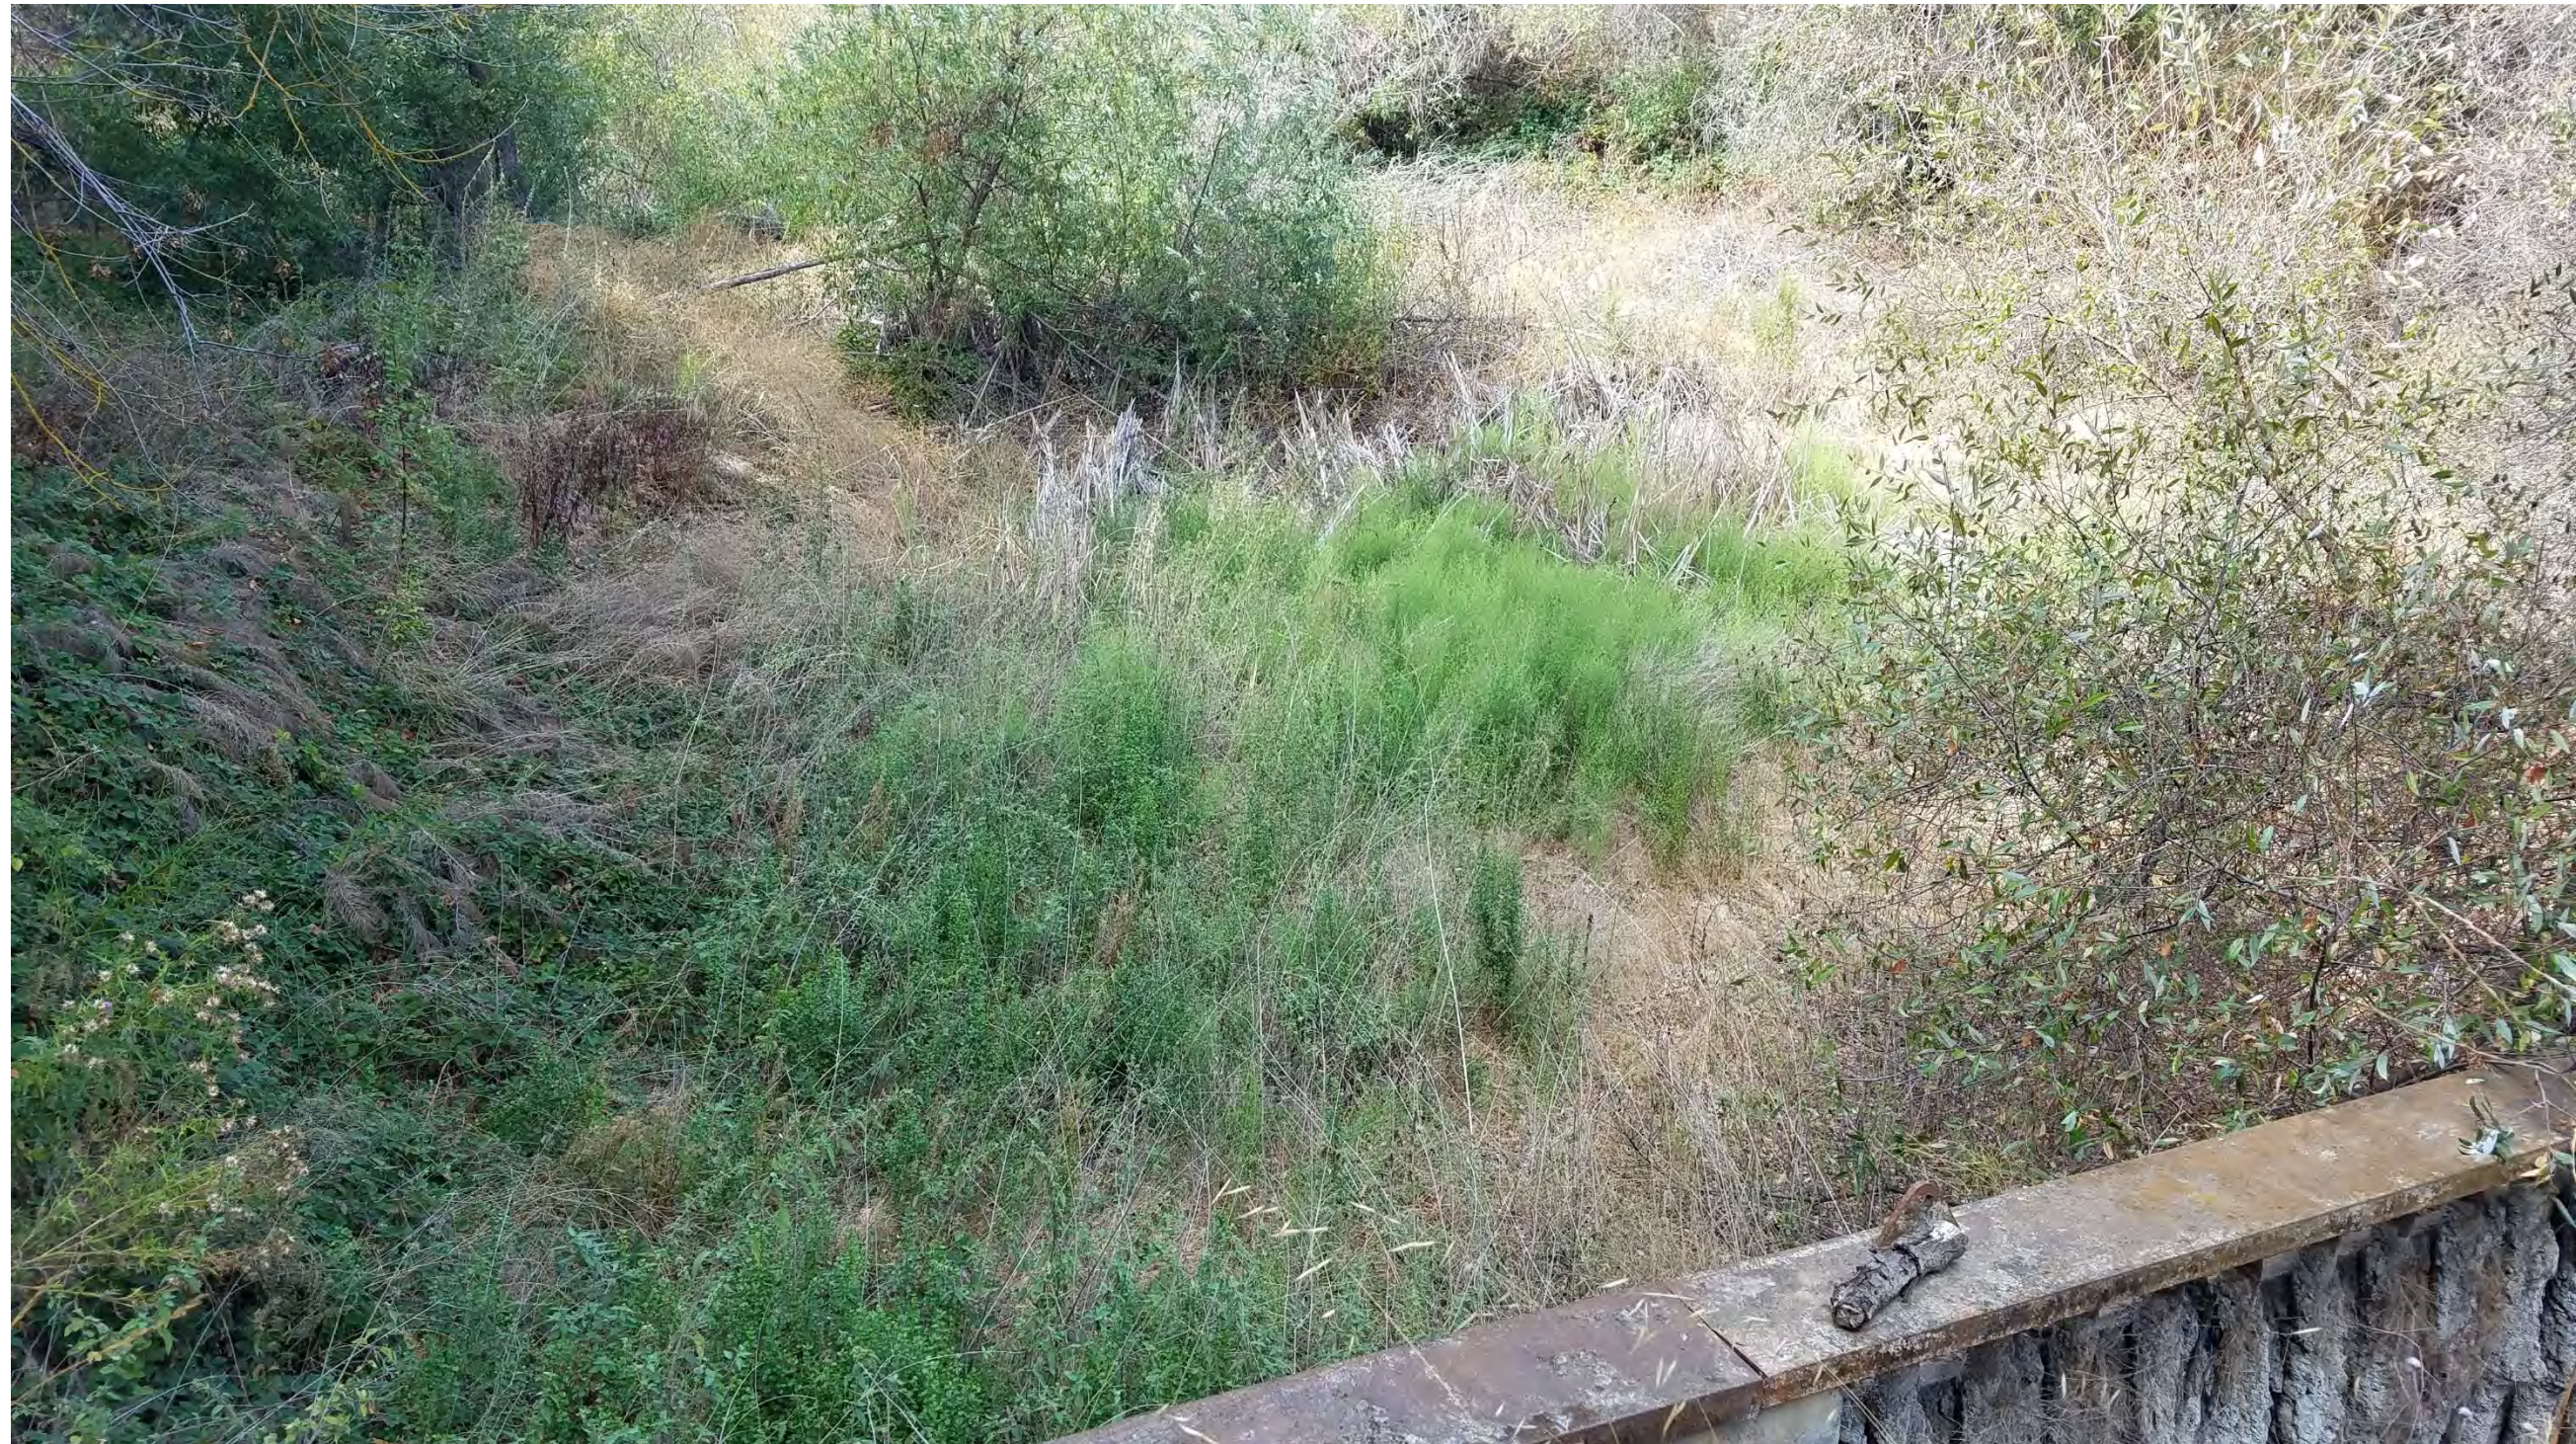
PHOTO #11 – Pond 13 (dry)

Eroded material accumulated at the toe of the slope and extended into the eastern side of Pond 13.

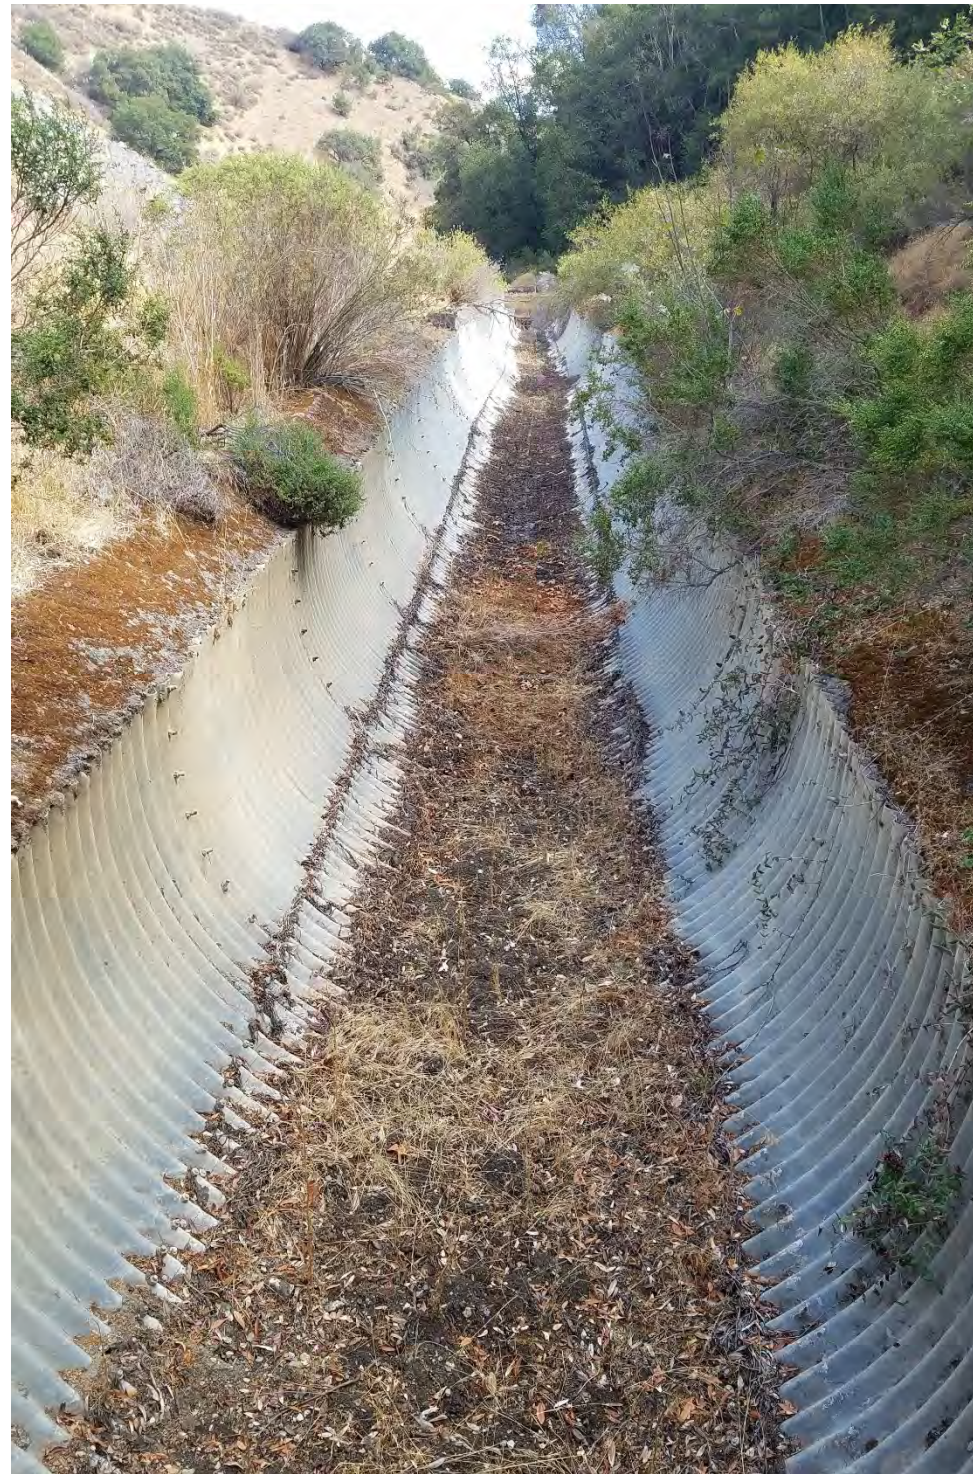
PHOTO #12 – Half-pipe for outflow of Pond 13

A half-pipe exists downstream of Pond 13 for the continuance of Permanente Creek. The Permanente Creek Restoration Project (County File No. 2250-17G), submitted by Lehigh and currently under review by the County, proposes removal of the half-pipe.
