SURFACE MINING INSPECTION REPORT

BACKGROUND

Lehigh Quarry is a vested hard rock quarry which has been in operation since approximately 1903. The operation primarily harvests limestone for the production of cement but has also produced greenstone aggregate in the past. Over time the quarrying operation has expanded, and now encompasses 546 acres of disturbed area. The site also includes a cement plant operating under a Use Permit and located outside of the Reclamation Plan area. The current Reclamation Plan was approved in 2012 as an amendment to the 1985 Reclamation Plan.

Photos from 2022 Annual SMARA Inspection Conducted on 9-20-2022

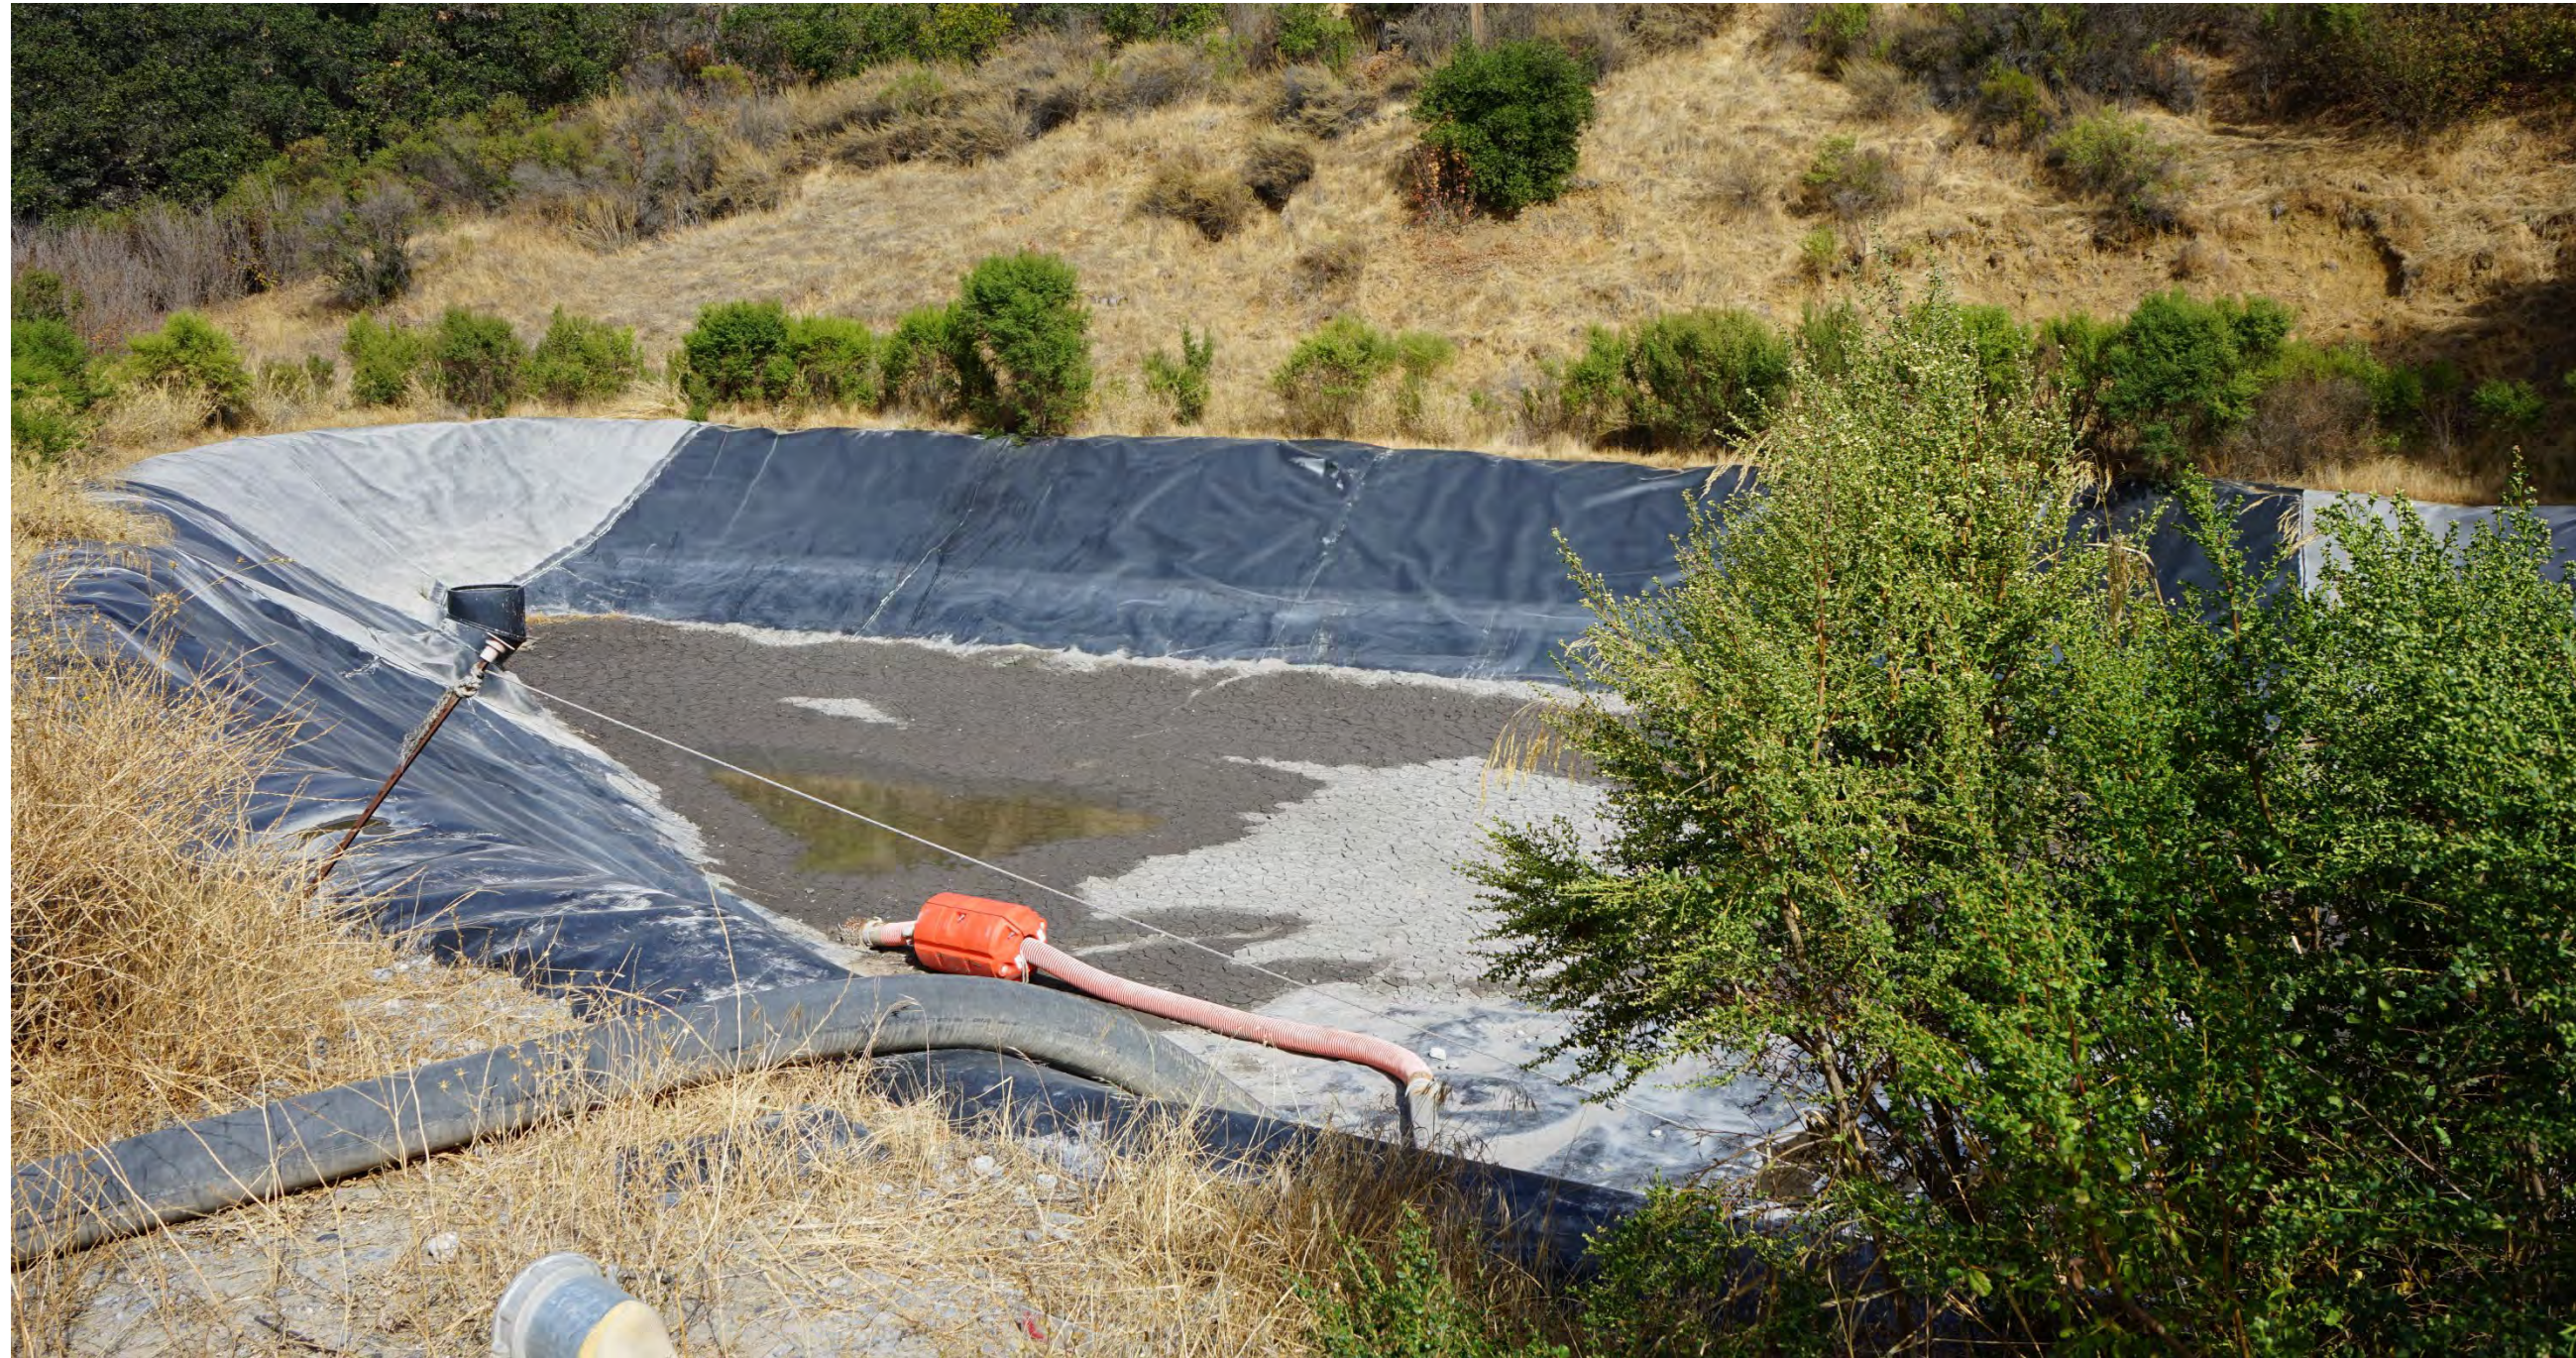
PHOTO #16 – Pond 17 with liner and sediment.

Pond 17 has been decommissioned and the runoff which was previously routed to Pond 17 now flows into a new basin in Permanente Creek installed at the direction of the San Francisco Bay Regional Water Quality Control Board.

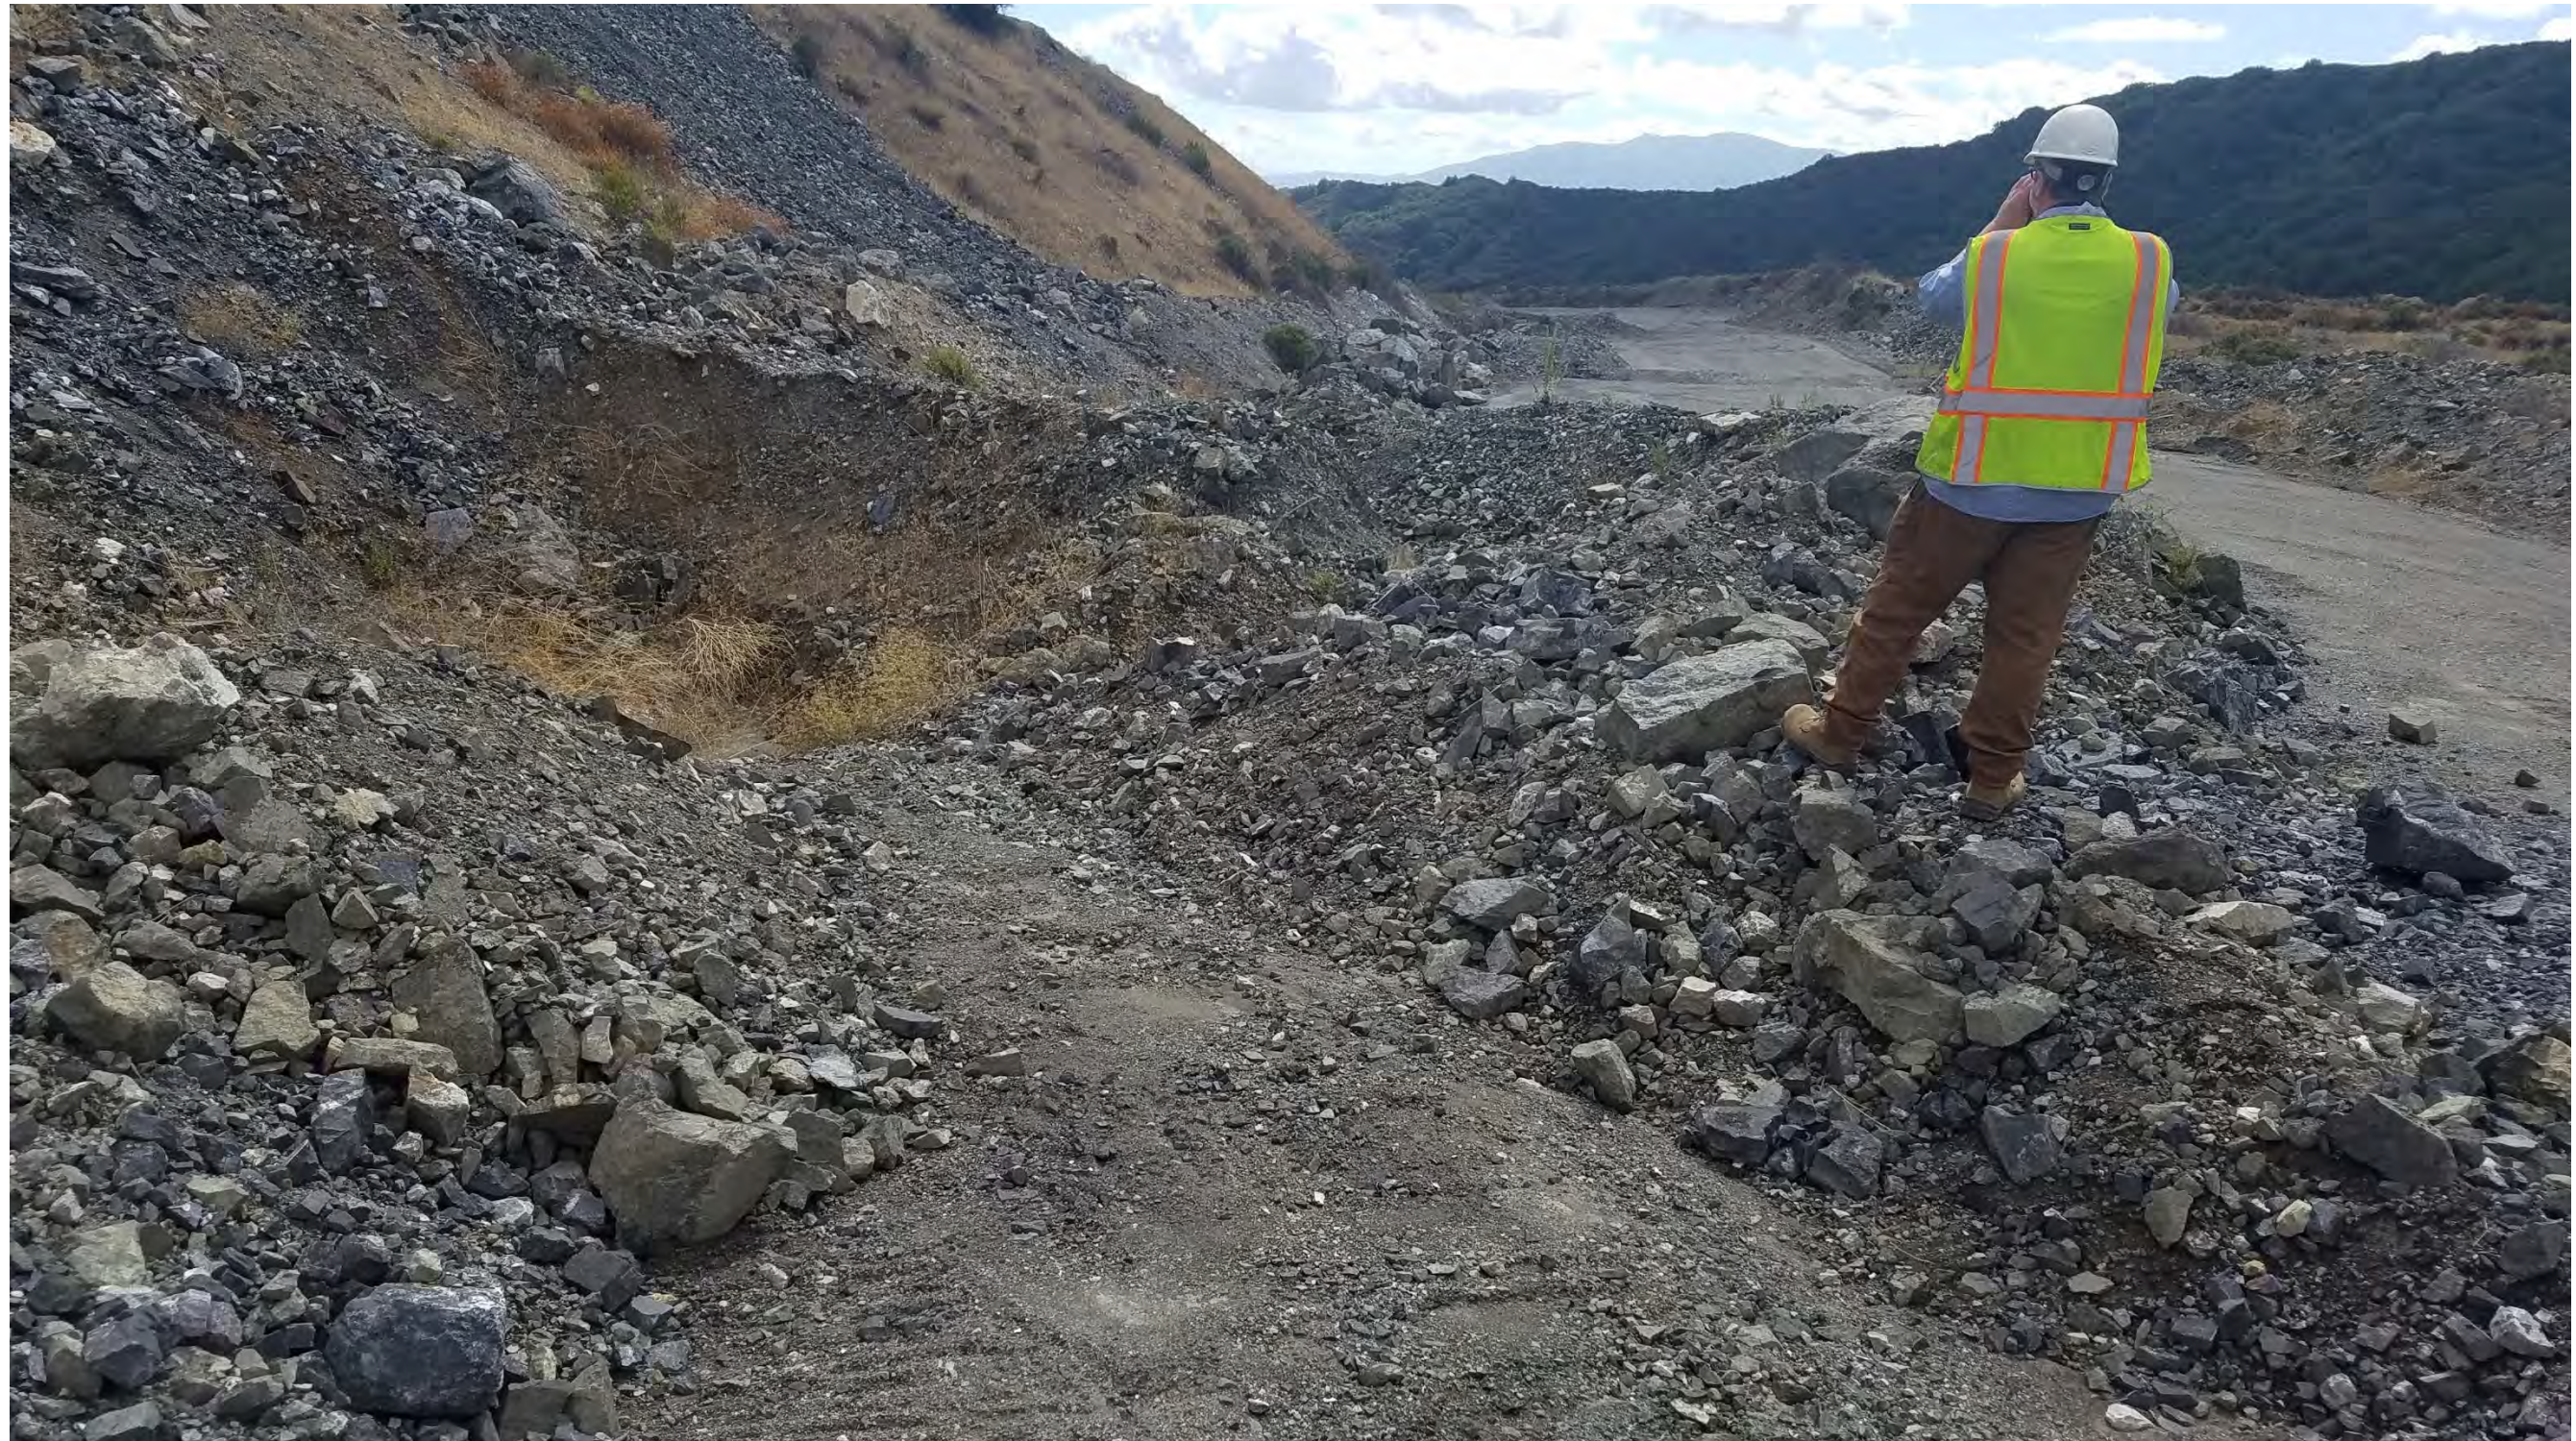
PHOTO #20 – Check dam on the WMSA road

Runoff and drainage are controlled on-site by various methods including check dams installed on internal access roads. [See **Photo #20** for example check dam.] Check dams are required to be made of non-limestone rock in order to prevent selenium contamination. Erosion control measures are typically installed before the rainy season and are inspected during winterization inspections. As noted above, the County of Santa Clara issued a Notice of Violation related to inadequate erosion control measures which resulted in a discharge of sediment into Permanente Creek. Since then, the operator made numerous improvements to erosion control BMPs, and created a lined sediment basin to prevent any more sediment or loose rock from entering the Permanente Creek channel. See the Violations Section below for additional information.

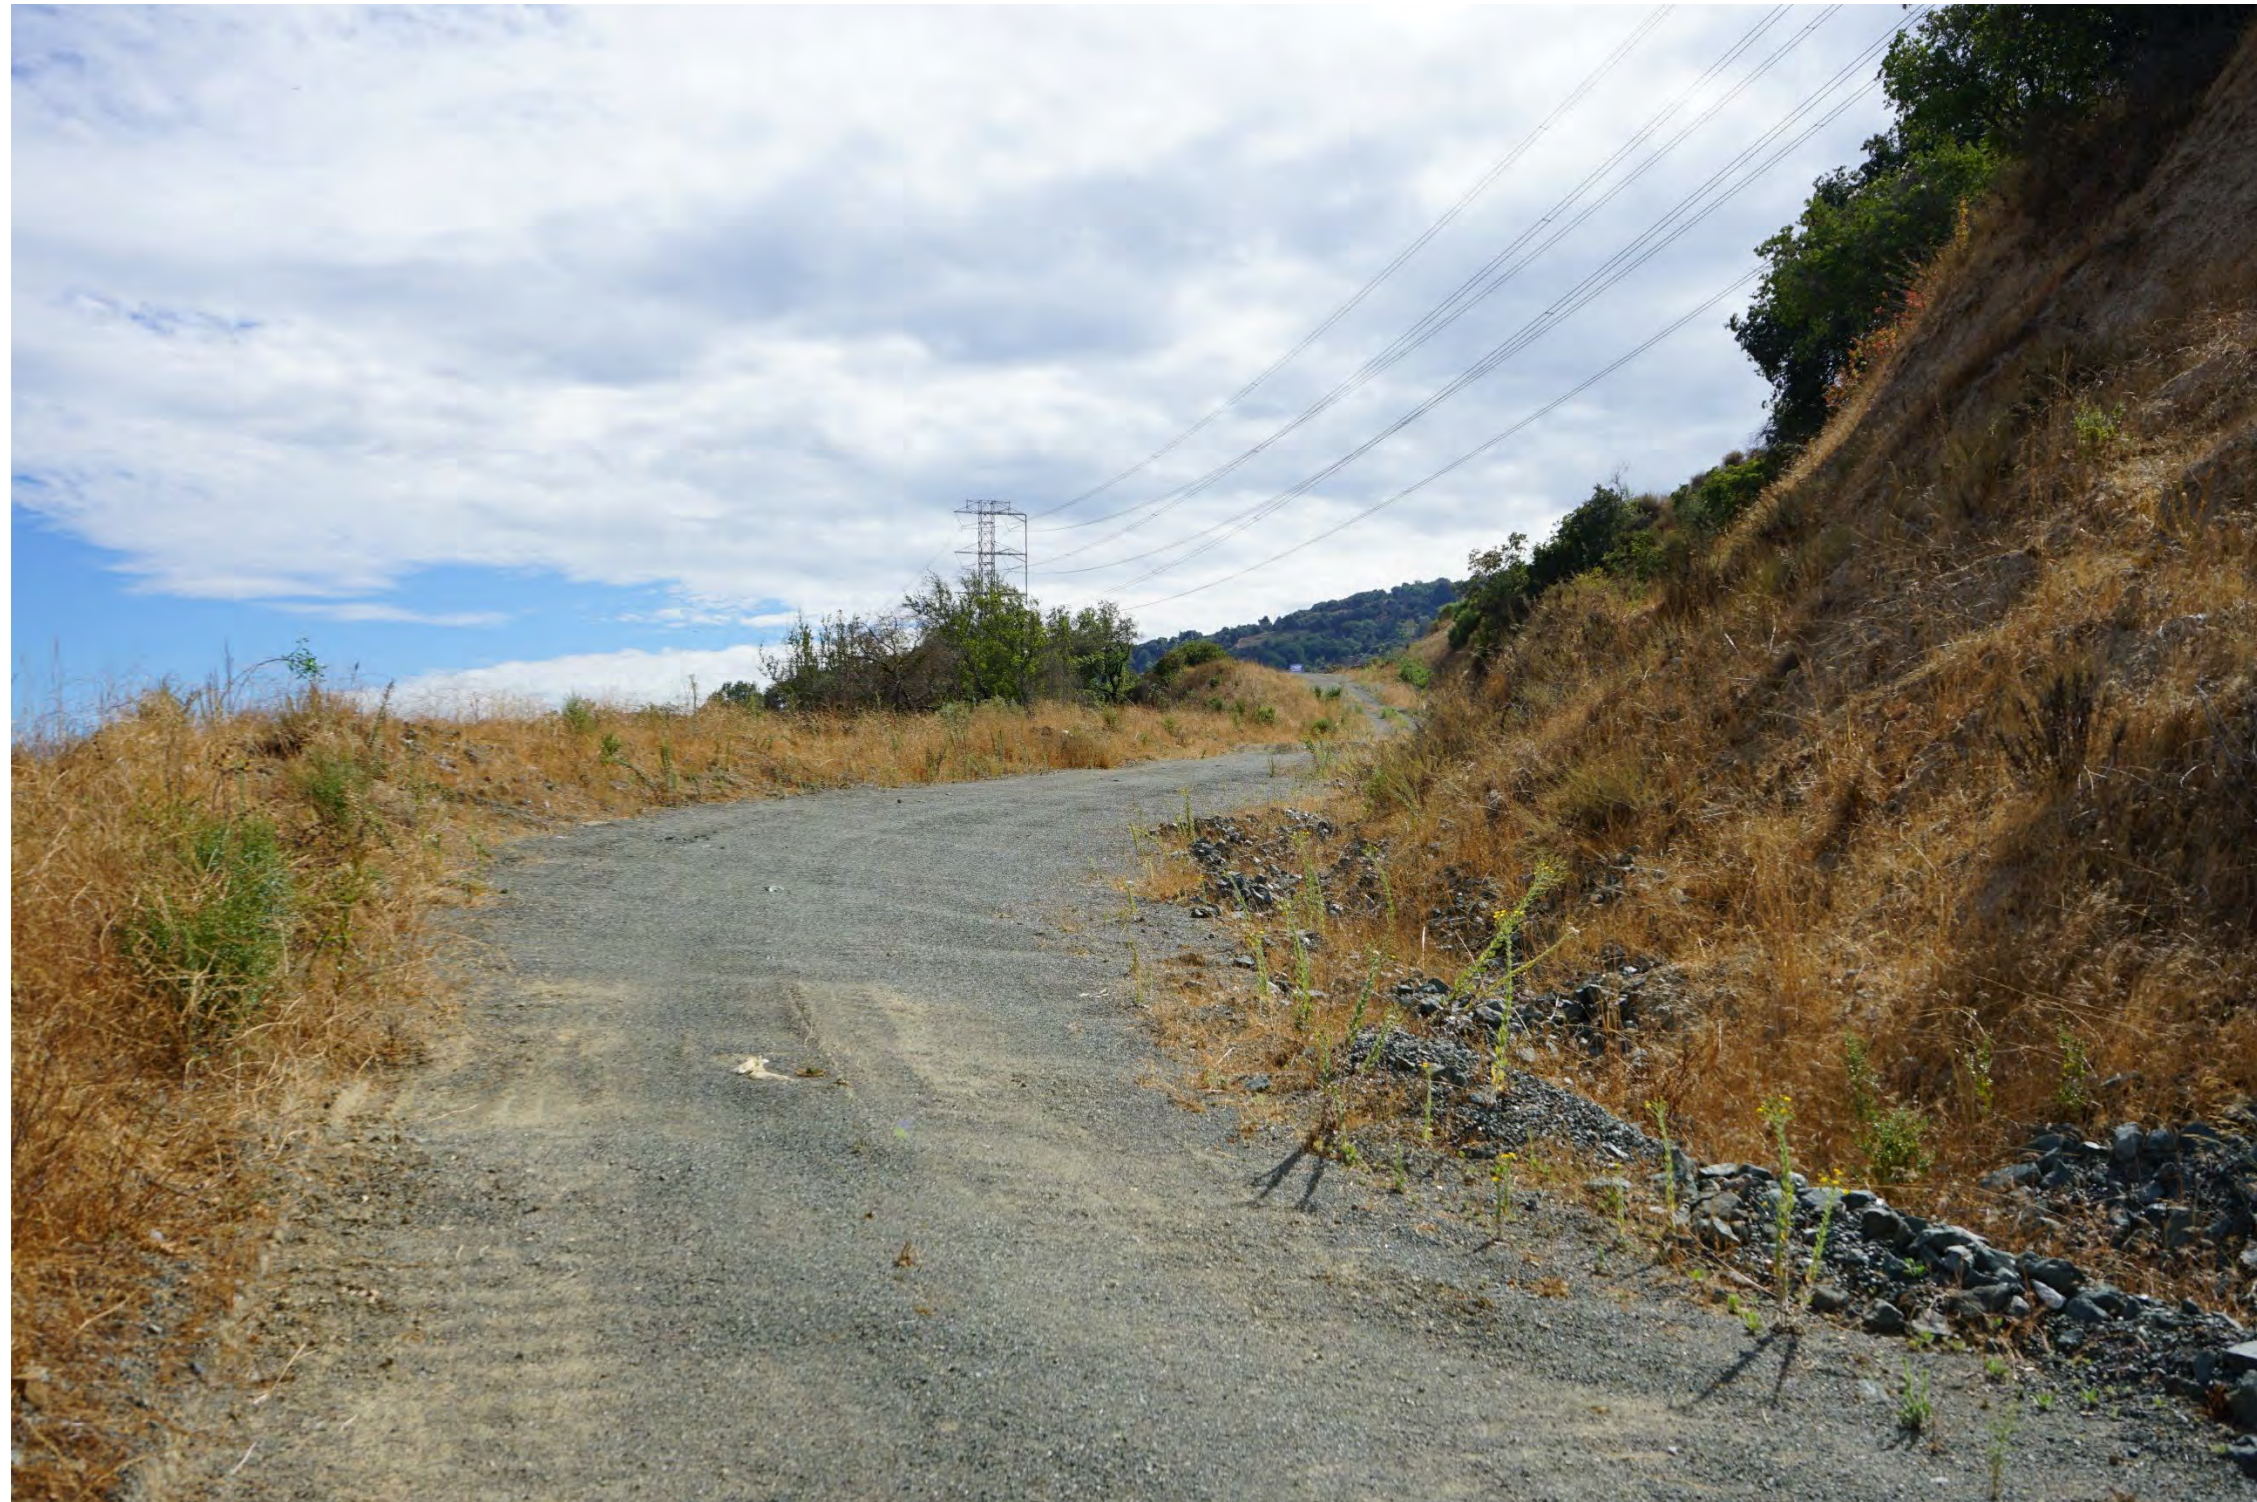
During the 2018 annual SMARA inspection inspectors observed that a new road linking Lehigh Quarry and Stevens Creek Quarry had been constructed without approval. The County issued a Notice of Violation on August 17, 2018 and noted the violation in the 2018 Lehigh Annual Inspection Report, dated August 8, 2018. Subsequently, Lehigh applied for a Reclamation Plan Amendment which, if approved, will expand the Reclamation Plan Boundary to include the haul road area. This reclamation plan amendment application is currently being processed. This haul road remains in place but is not being used. Inspectors noticed localized erosion which needs to be managed by installation of erosion control BMPs. [See **Photos #21A, and 21B.**] Installation and maintenance of erosion control BMPs will be verified during winterization inspection.

Photo #21A – Cut slope and drainage ditch on west side of unpermitted haul road

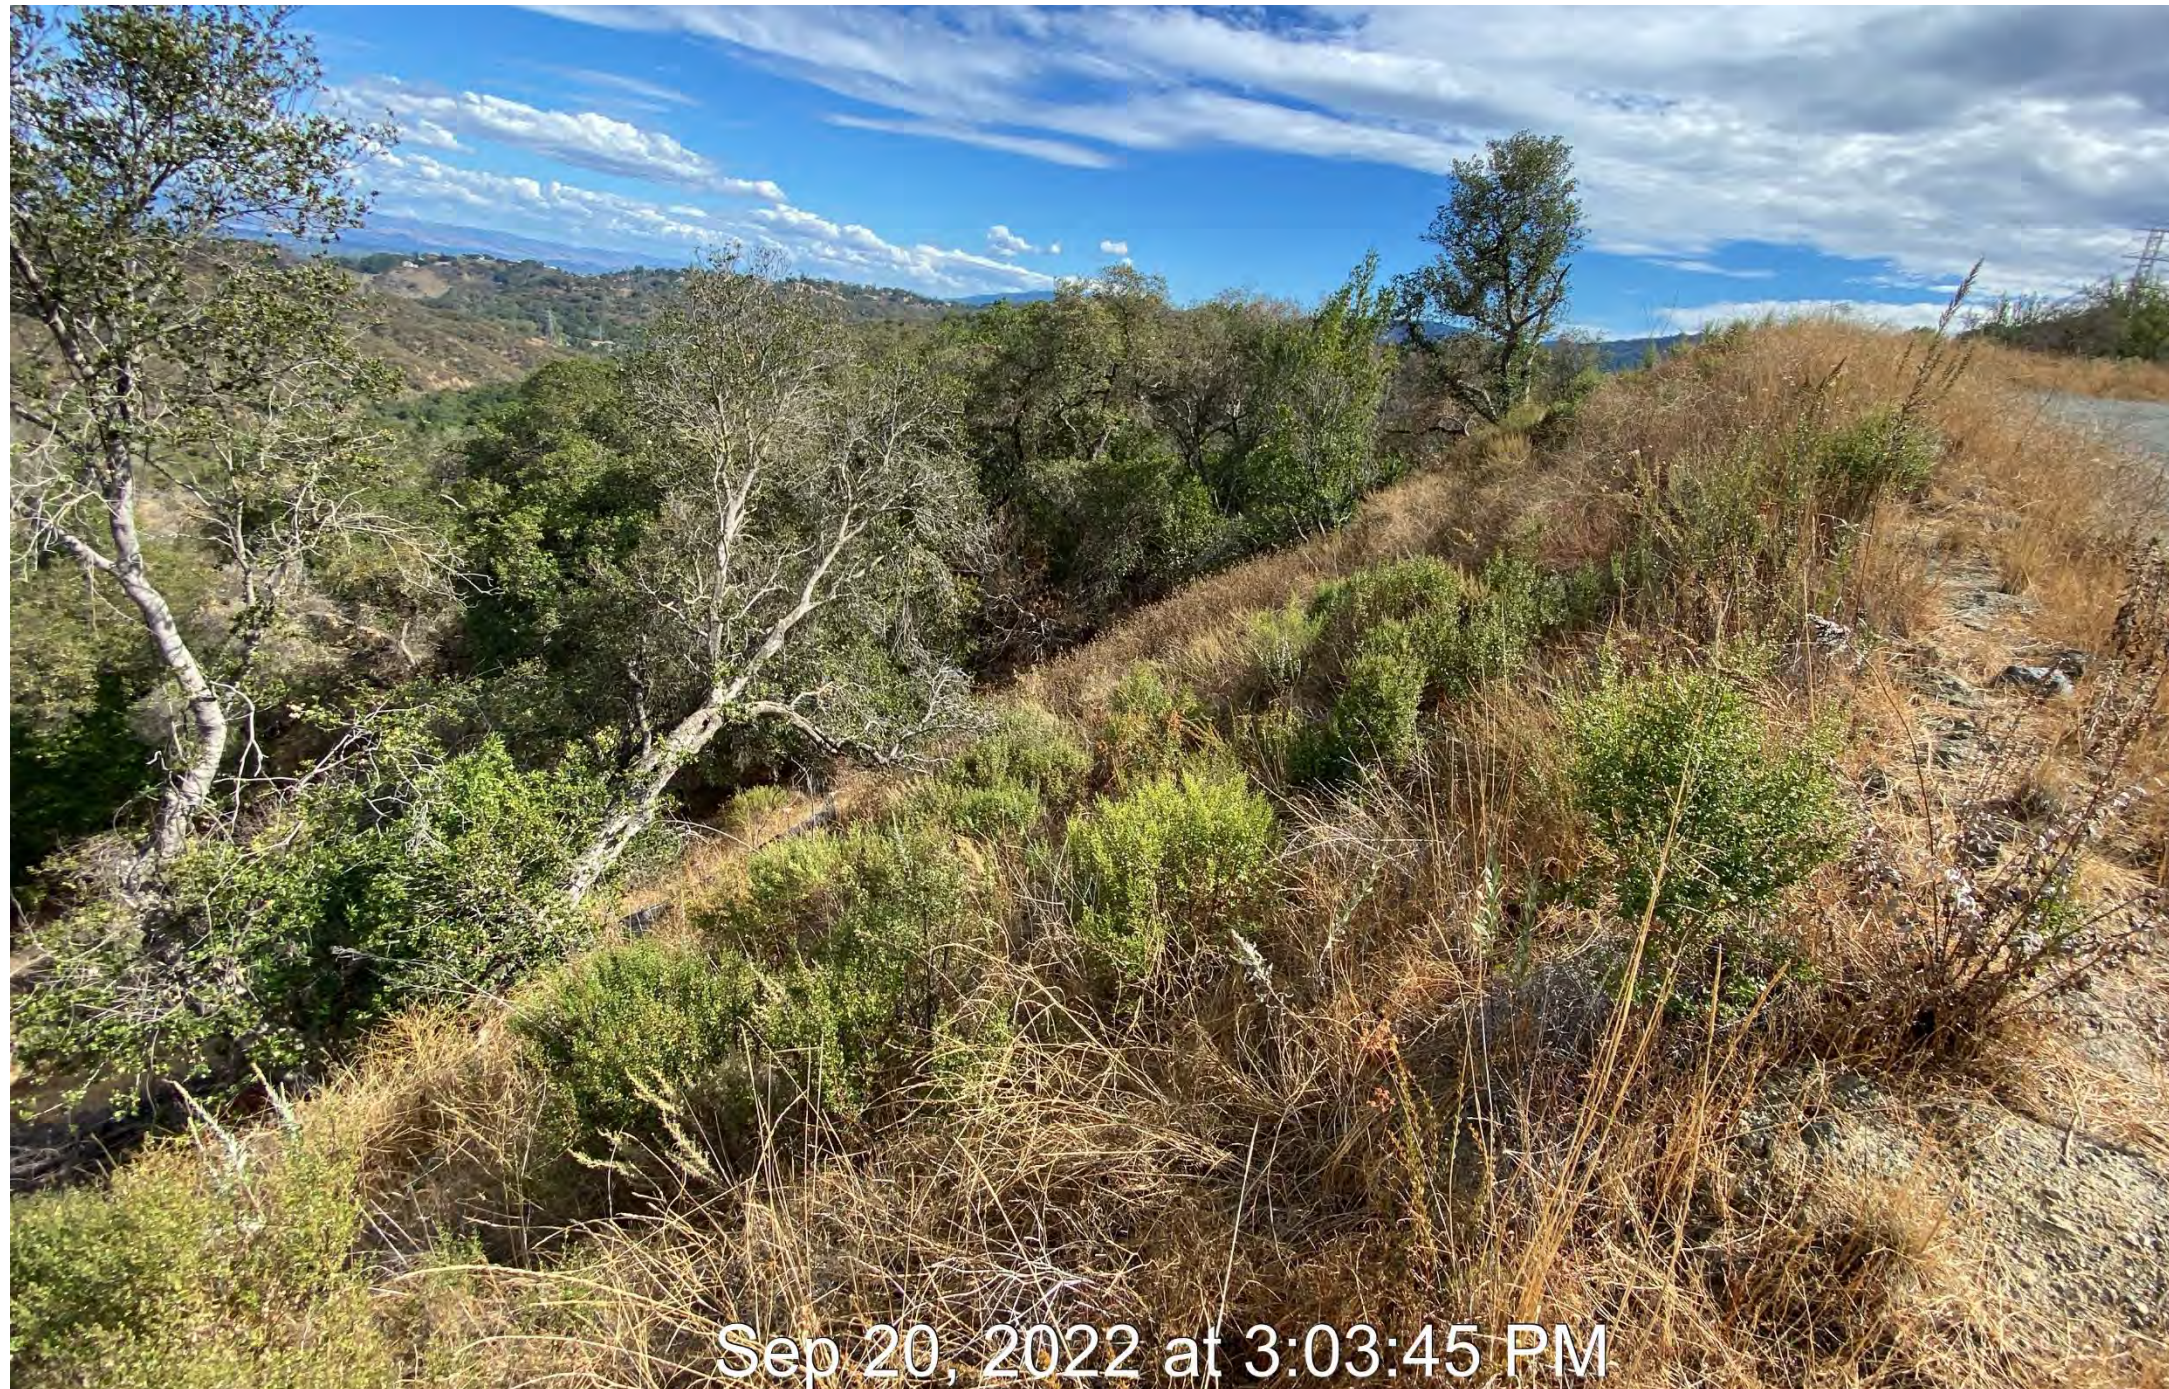
Photo #21B Fill slope below east side of illegally graded haul road

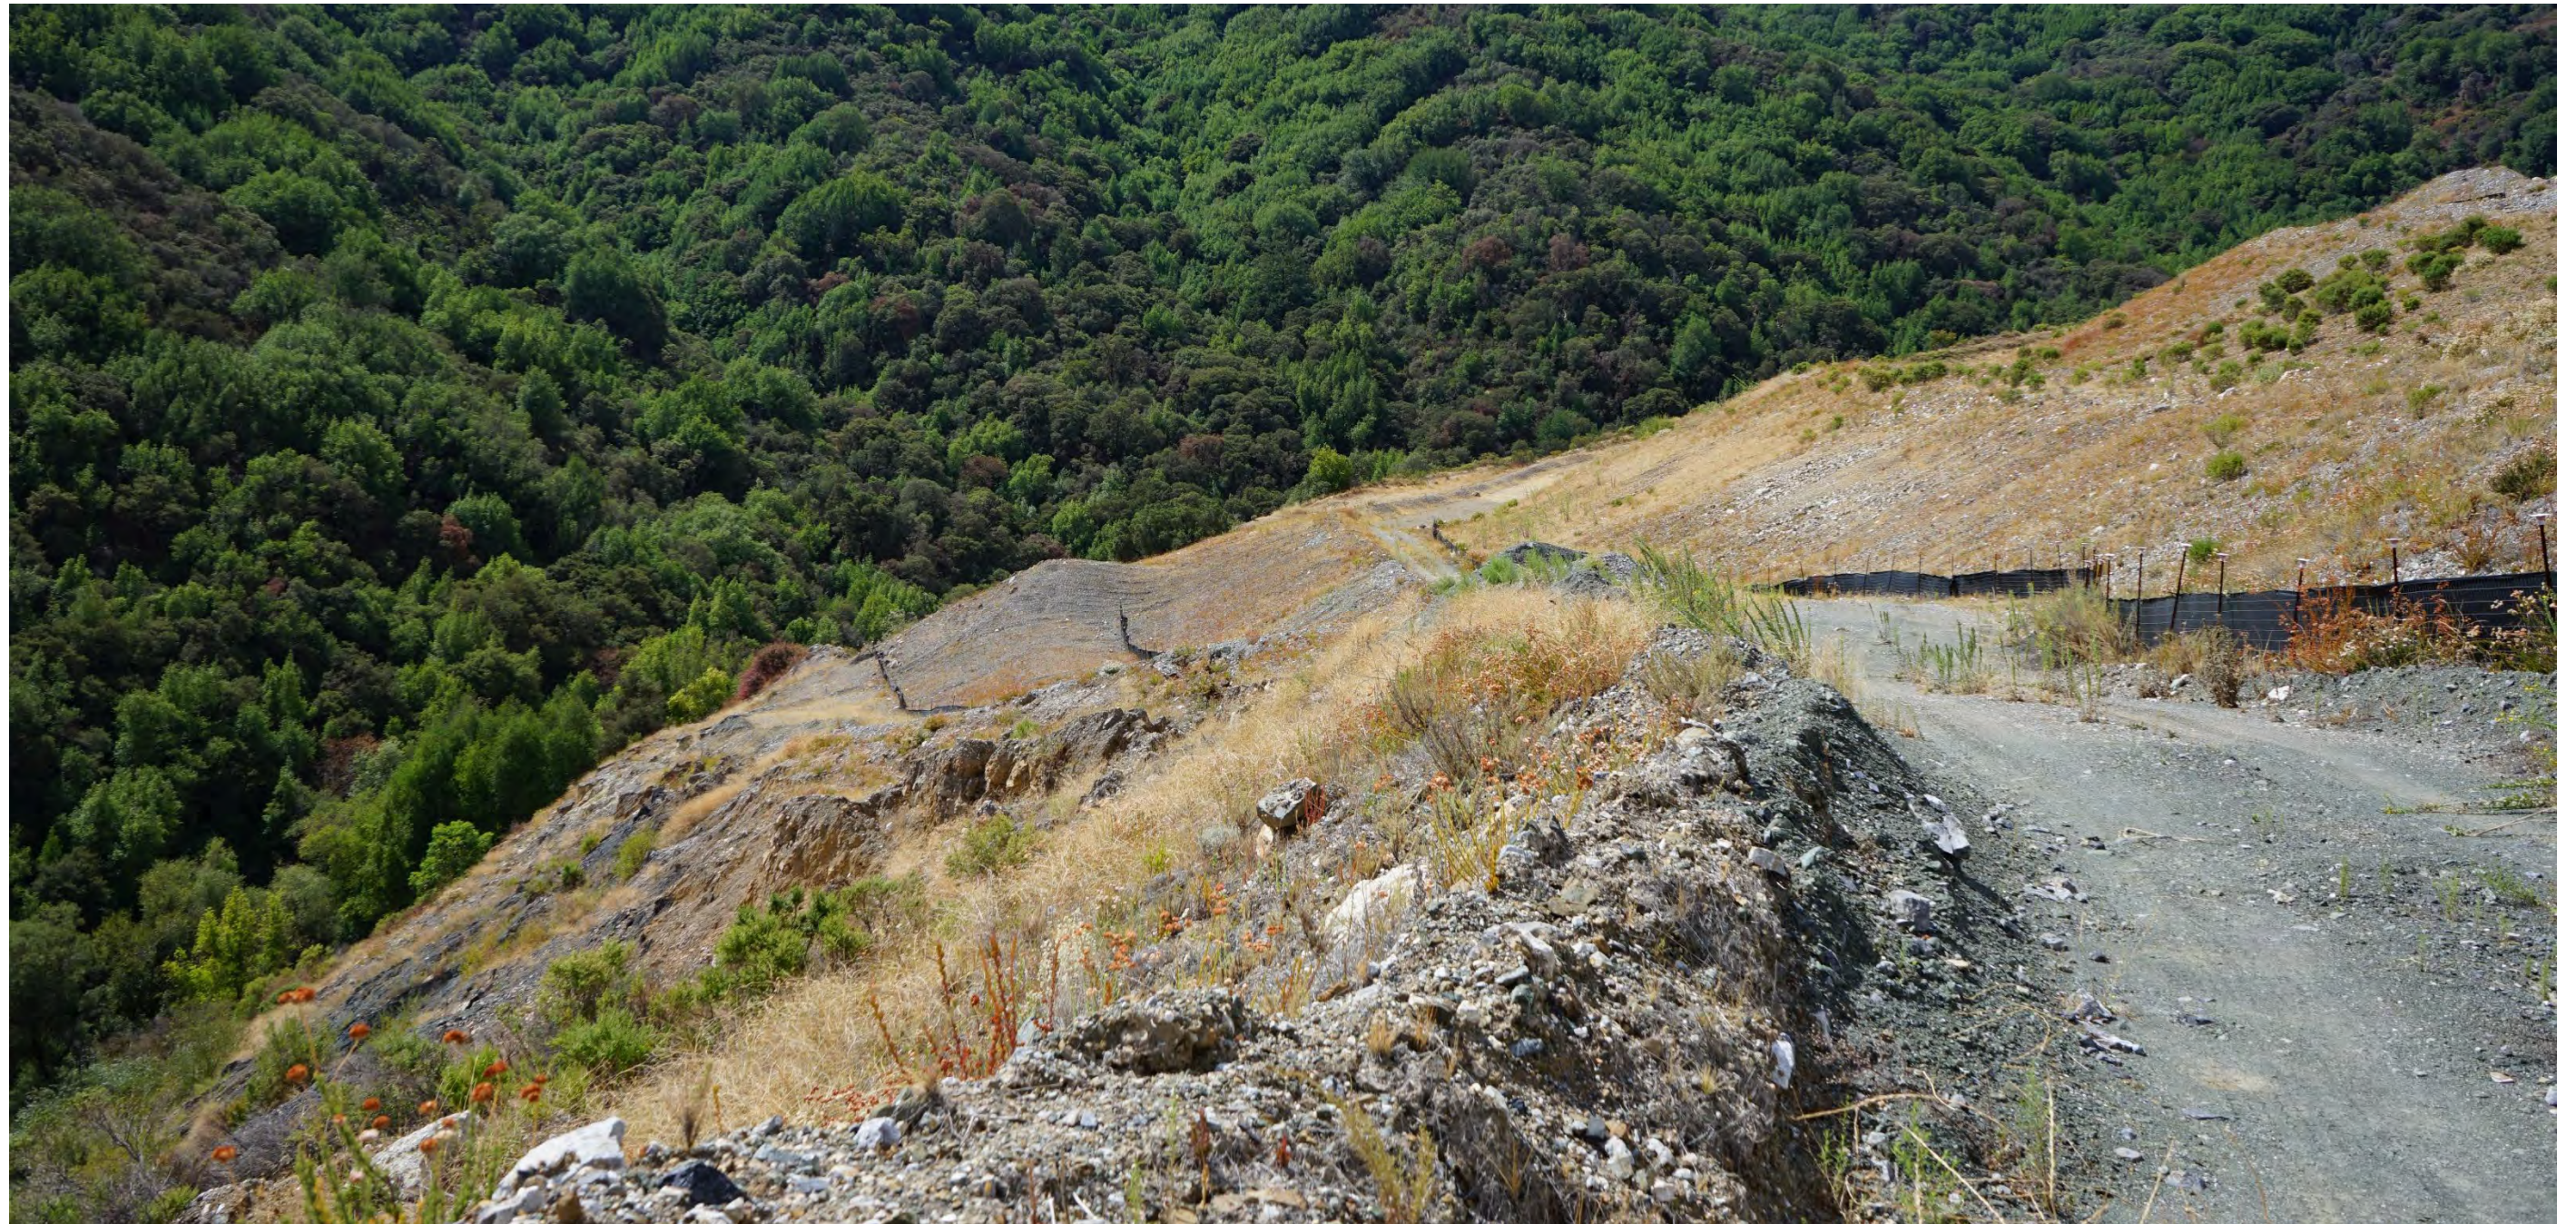
Photo #22 – Toe of Yeager Yard slide above Permanente Creek (out of view to the left)

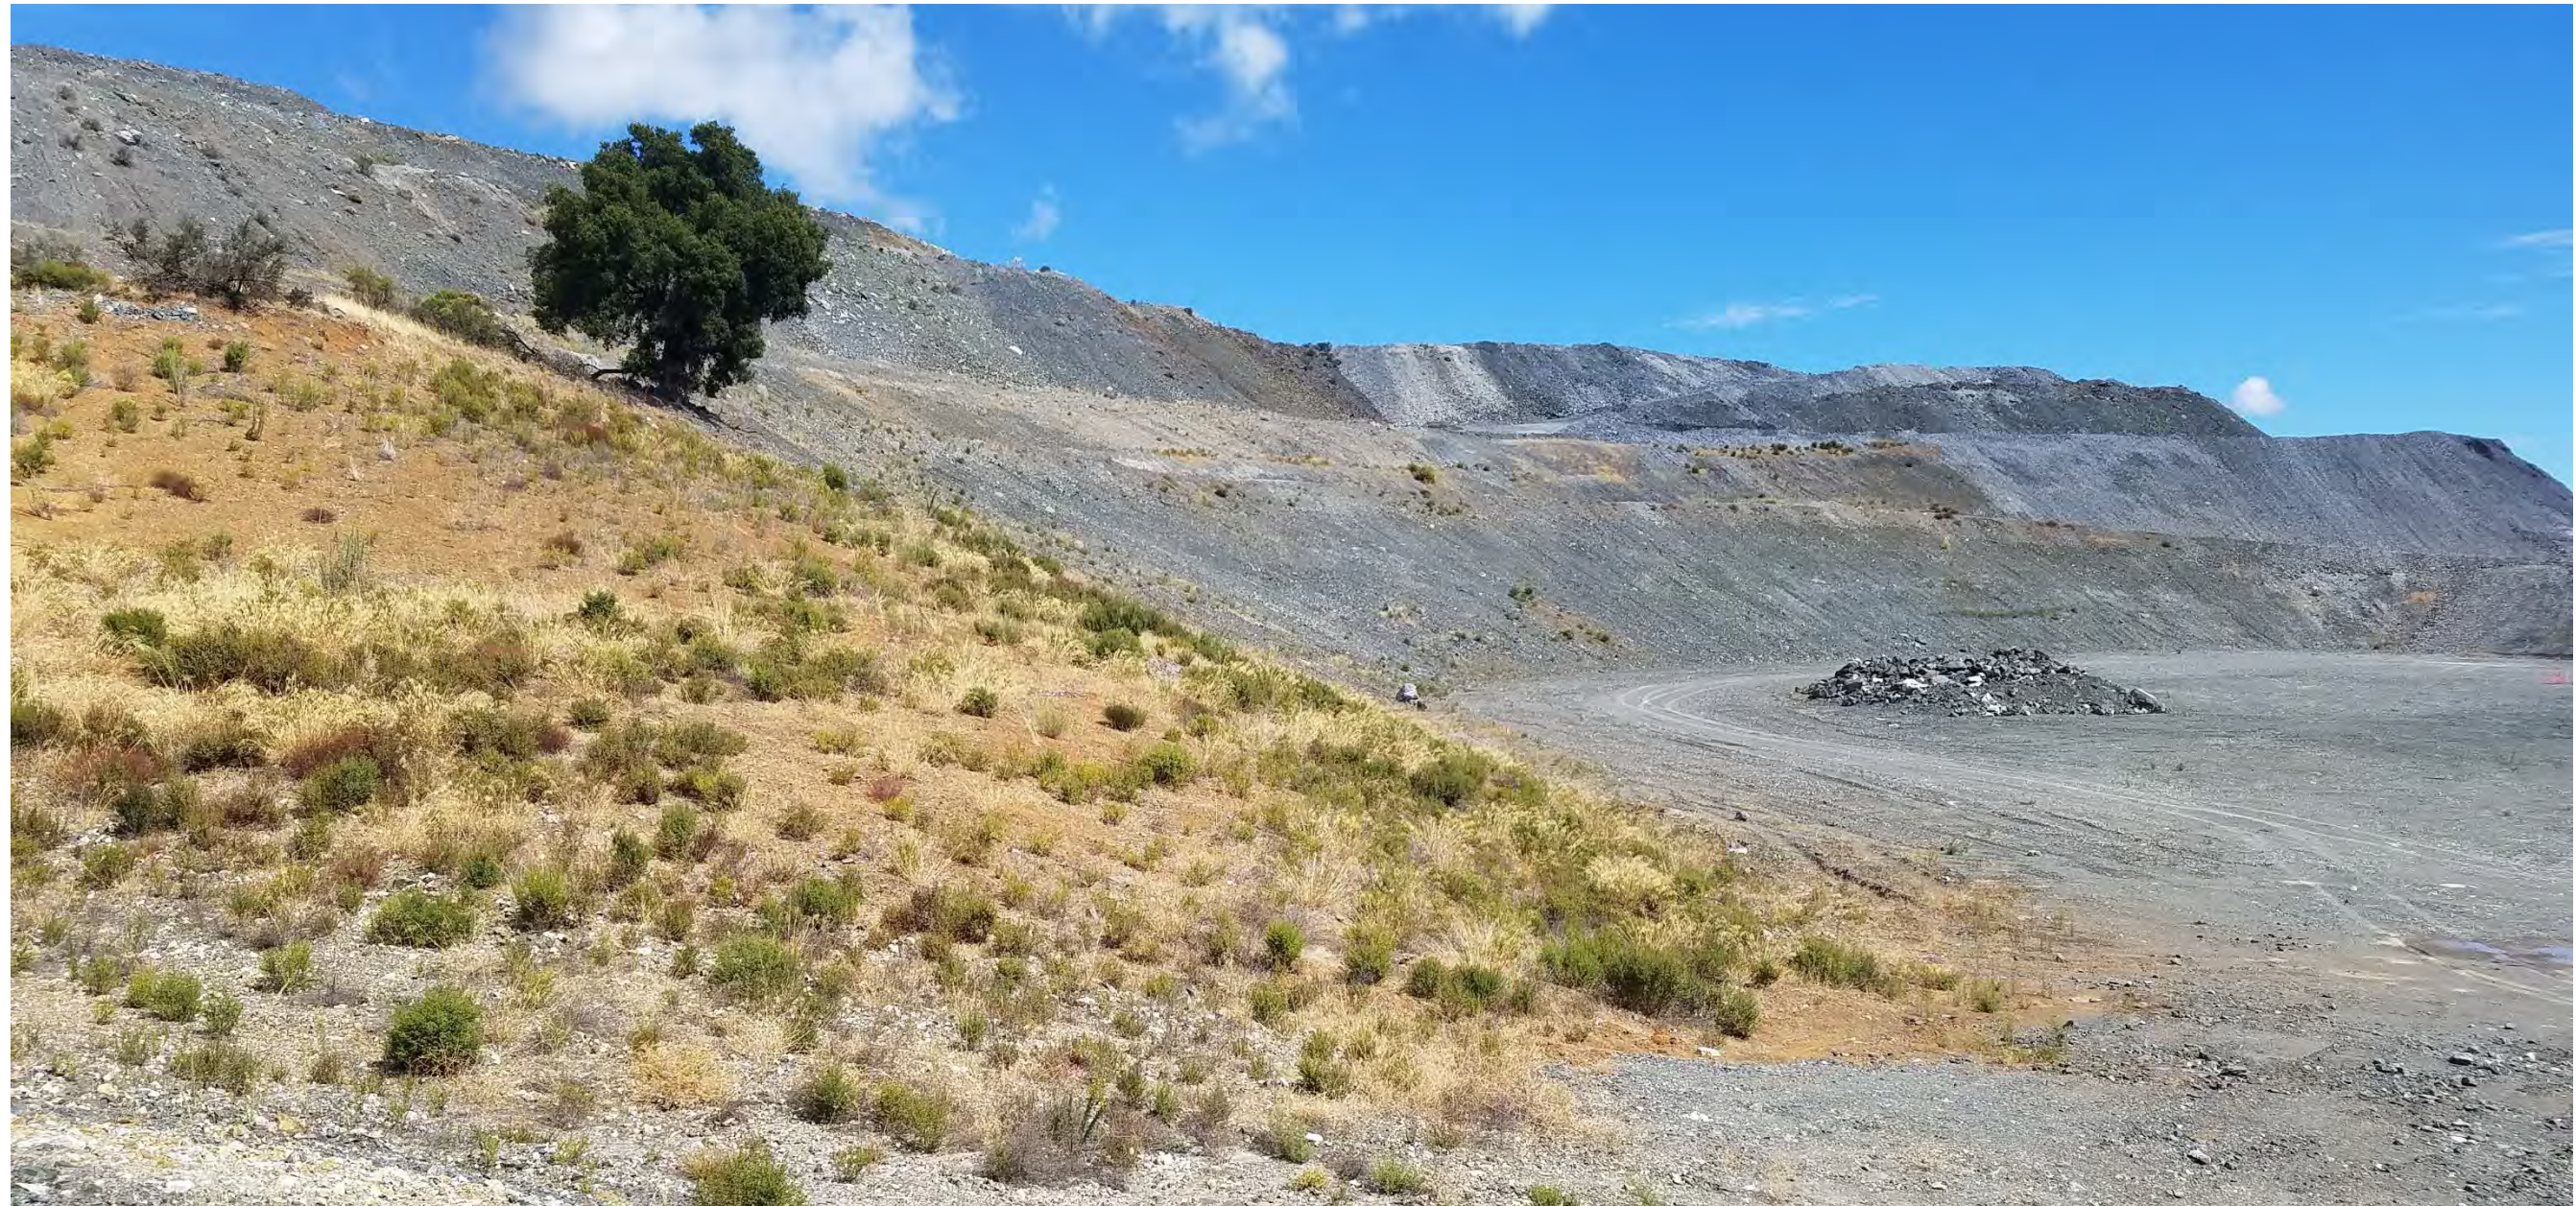
County inspectors continued to observe surface conditions in the area of the Yeager Yard Landslide. The upper portion of the slide that was previously excavated to remove up to 80 vertical feet of waste rock. [See **Photo 23.**] The hill on the left is the remnants of the former buried bedrock ridge. The lower portion of the Yeager Yard Landslide where debris flowed downhill into Permanente Creek. [See **Photo 24.**]

Photo #23 – Excavation above Yeager Yard

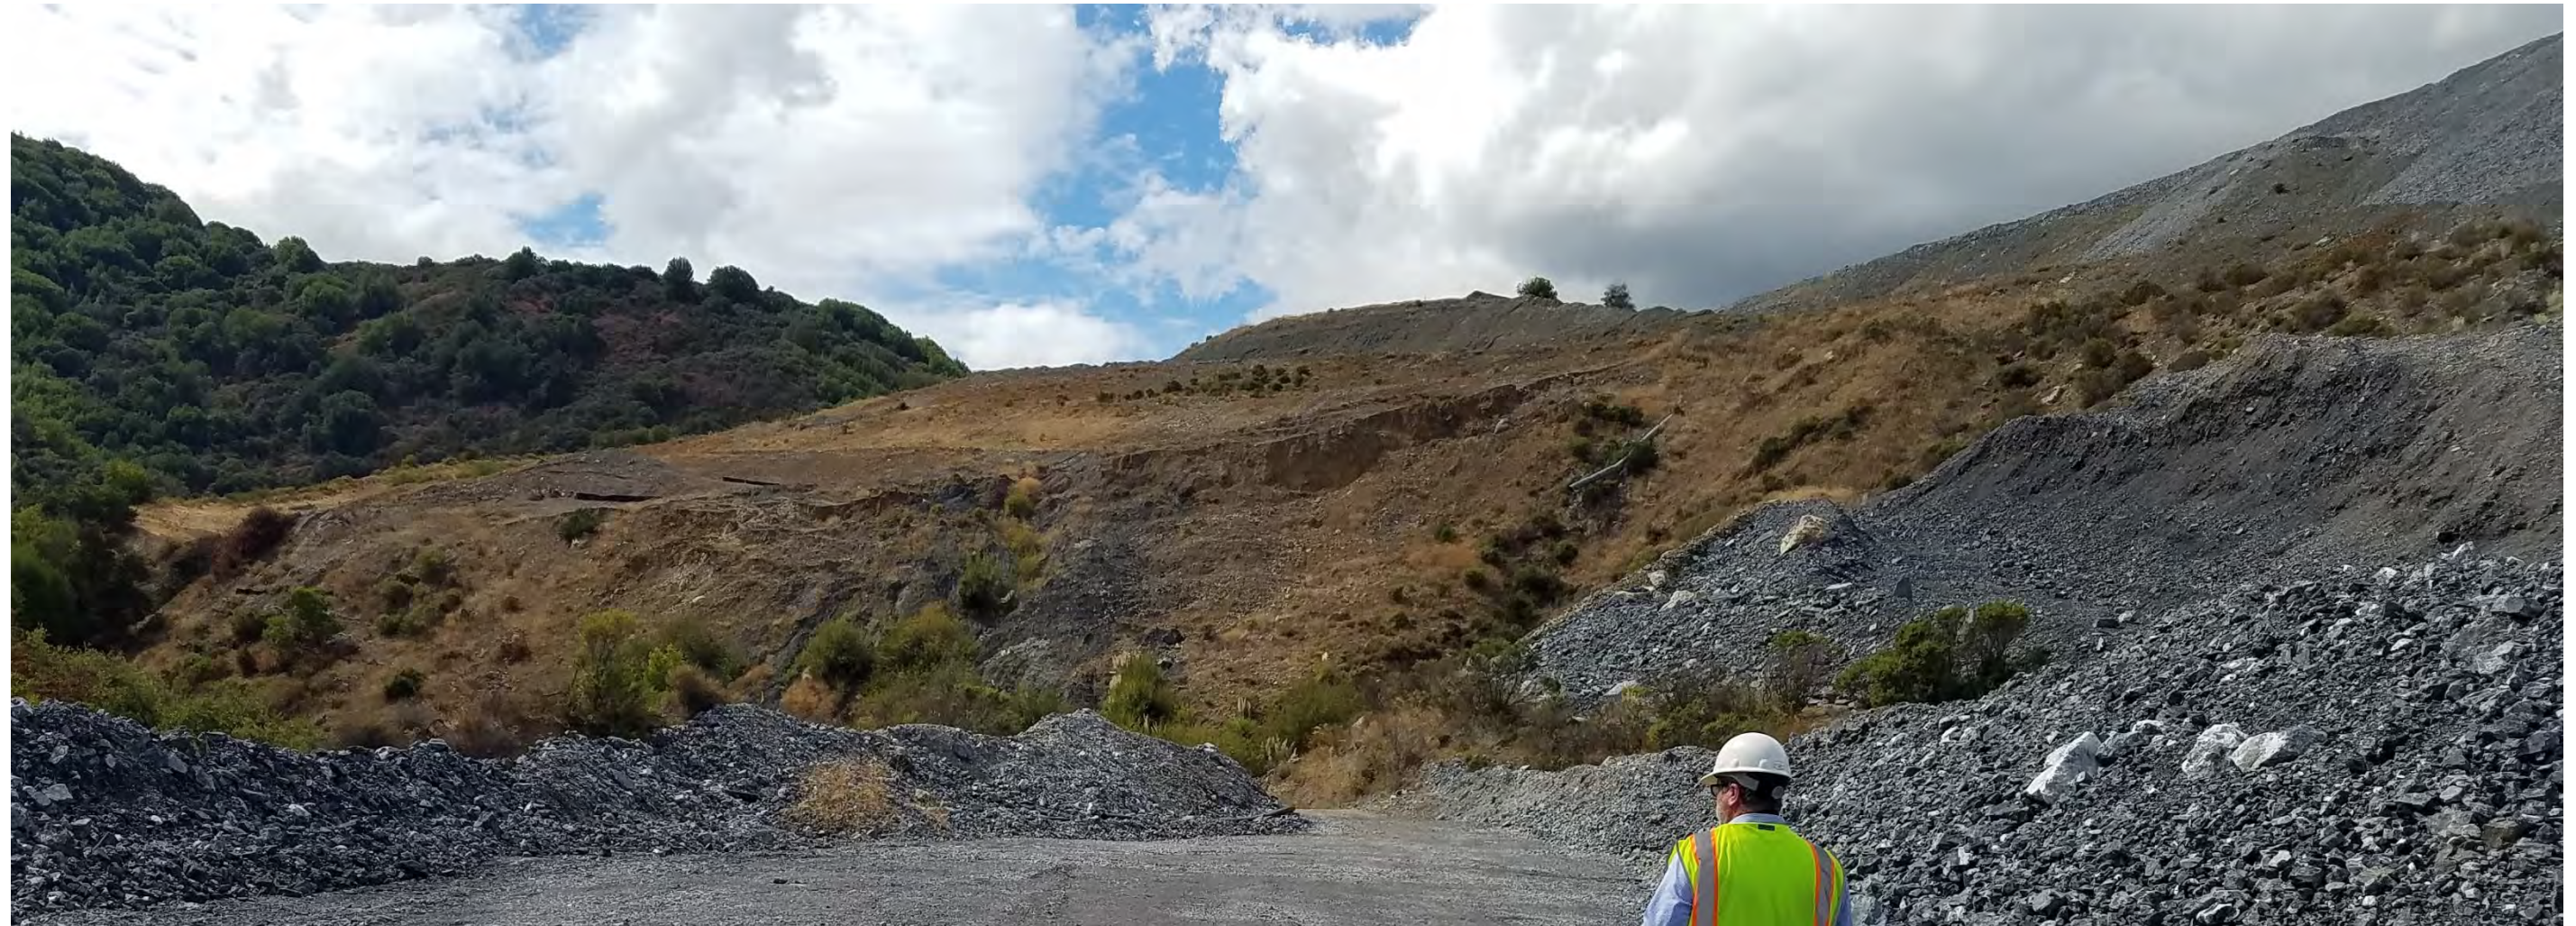
Photo #24 – Toe of Yeager Yard landslide above Permanente Creek (lower left)
