SURFACE MINING INSPECTION REPORT

BACKGROUND

Lehigh Quarry is a vested hard rock quarry which has been in operation since approximately 1903. The operation primarily harvests limestone for the production of cement but has also produced greenstone aggregate in the past. Over time the quarrying operation has expanded, and now encompasses 546 acres of disturbed area. The site also includes a cement plant operating under a Use Permit and located outside of the Reclamation Plan area. The current Reclamation Plan was approved in 2012 as an amendment to the 1985 Reclamation Plan.

Photos from 2022 Annual SMARA Inspection Conducted on 9-20-2022

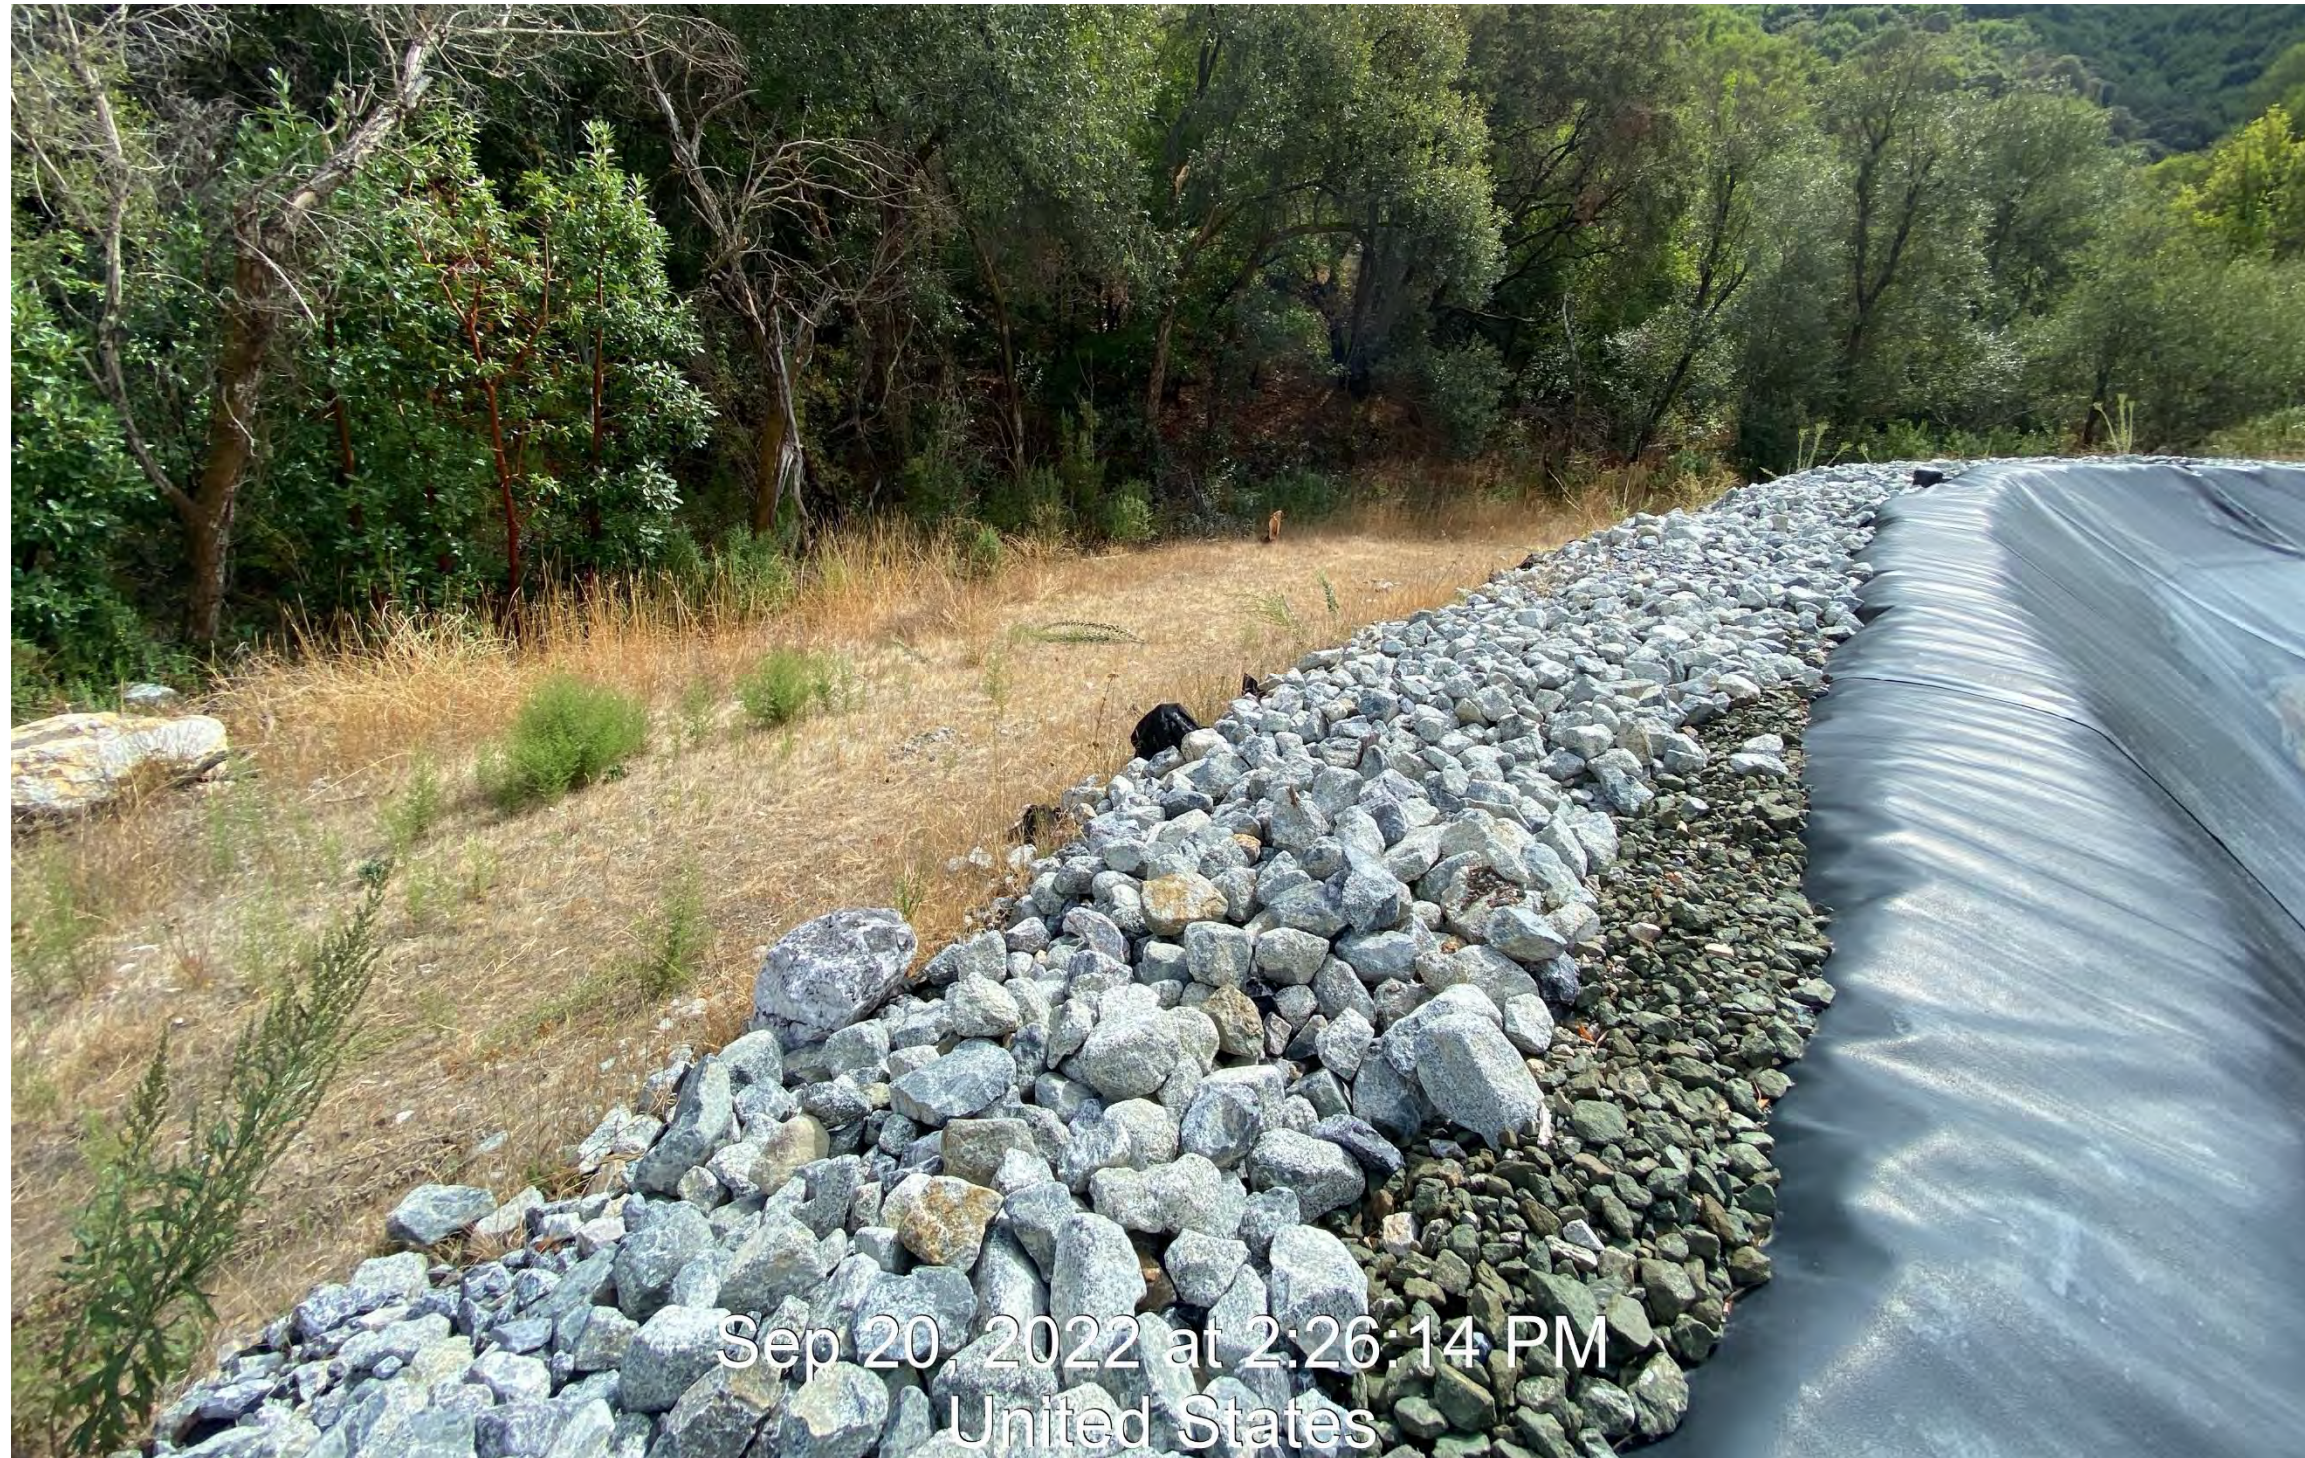
Photo #25 – Rock armor added to area where sediment was deposited into Permanente Creek from Yeager Yard slope

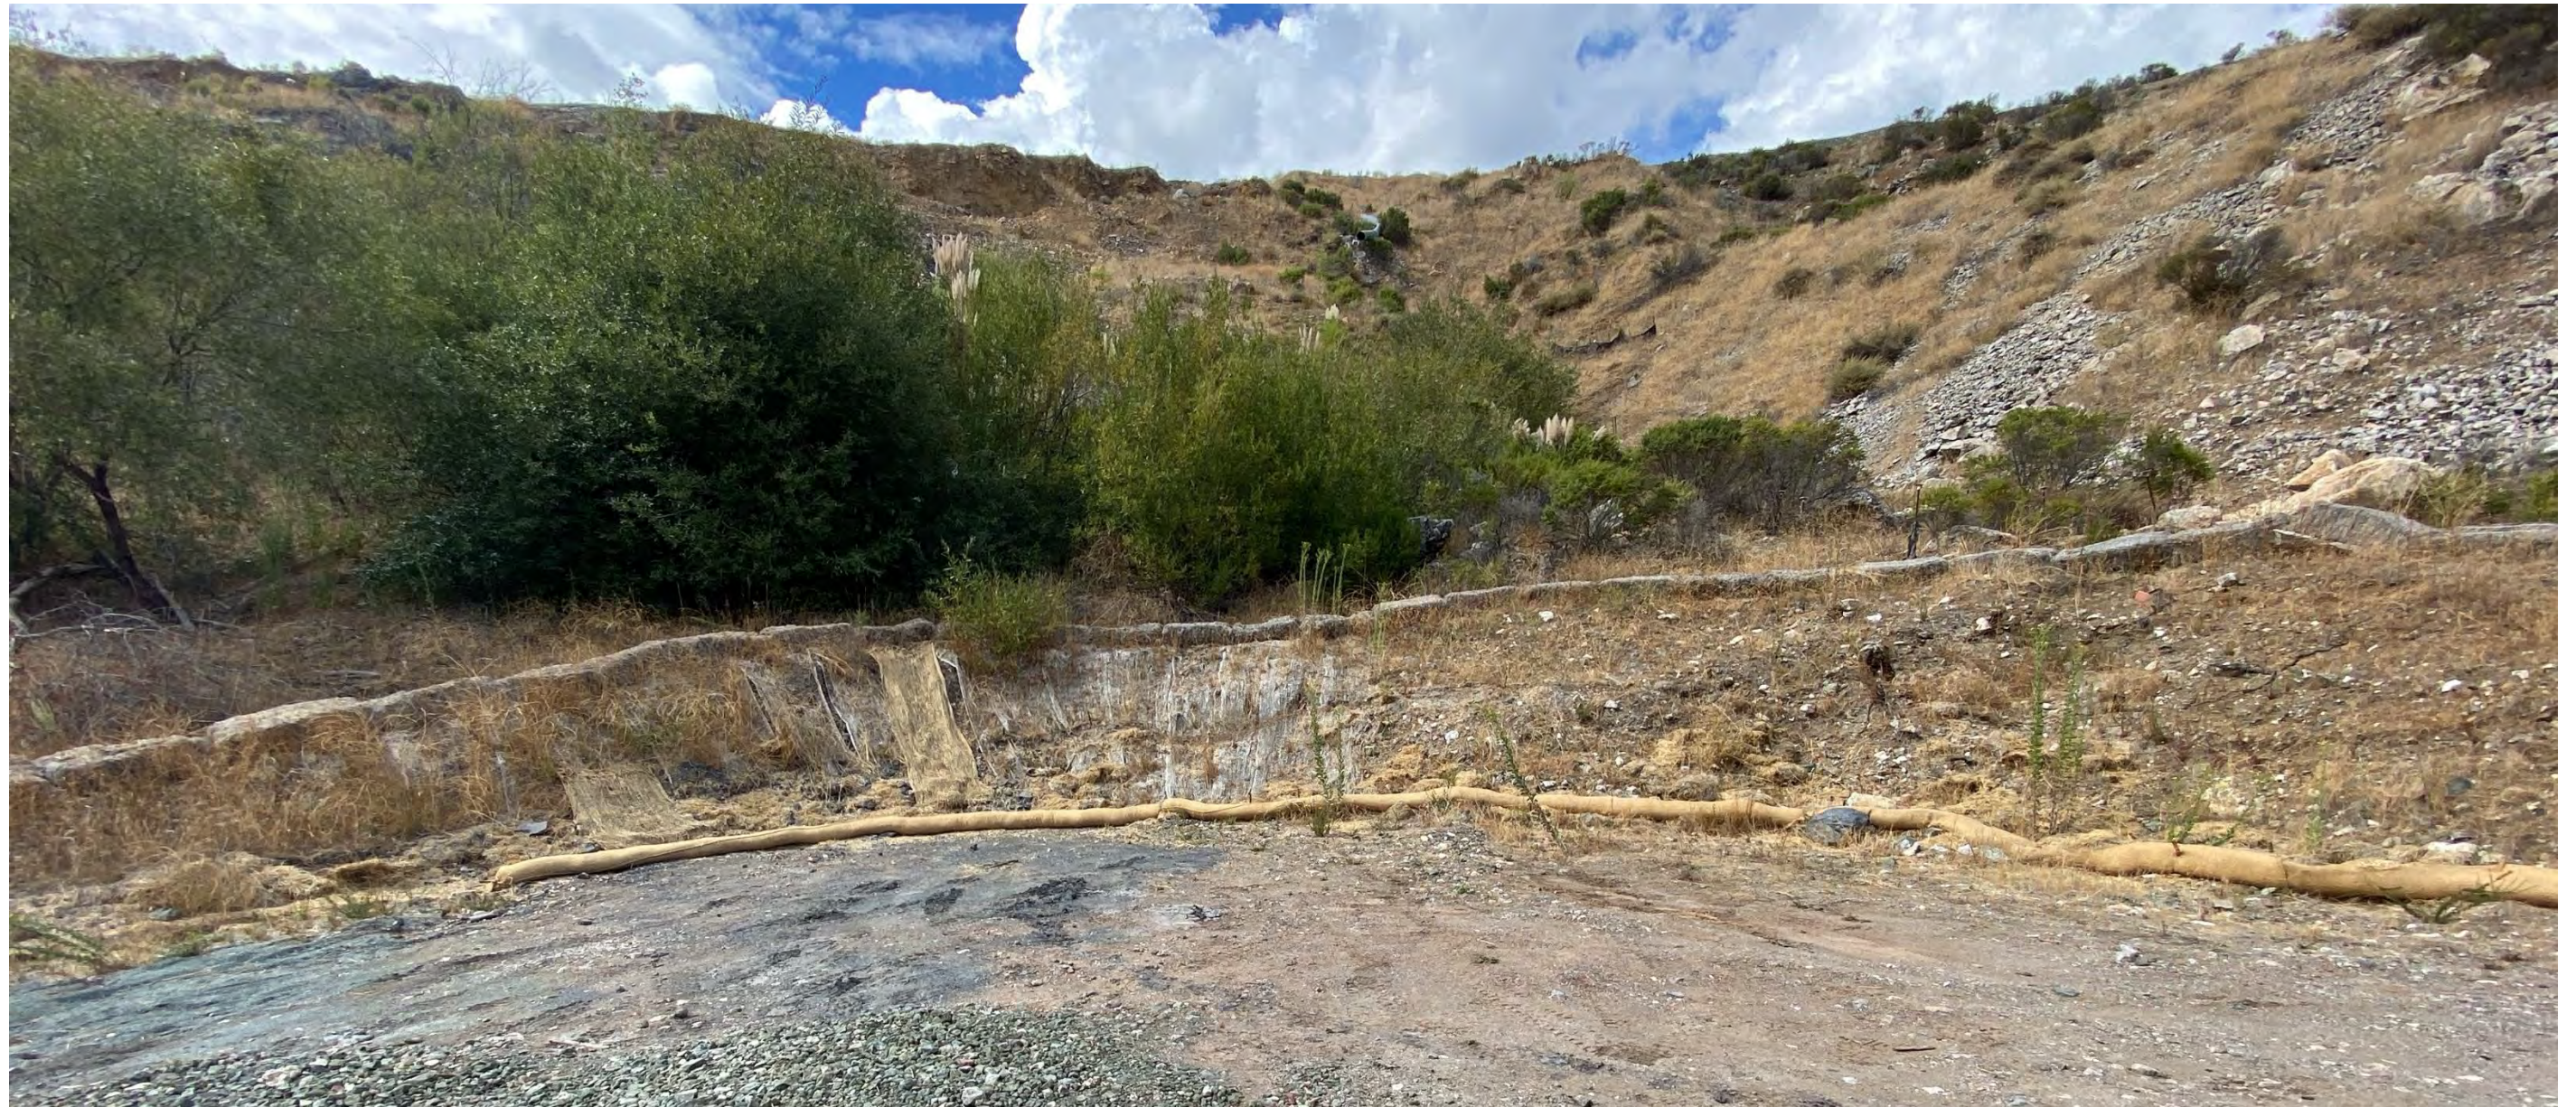
Photo #27 – Debris flow scar (source of sediment deposited in Permanente Creek).

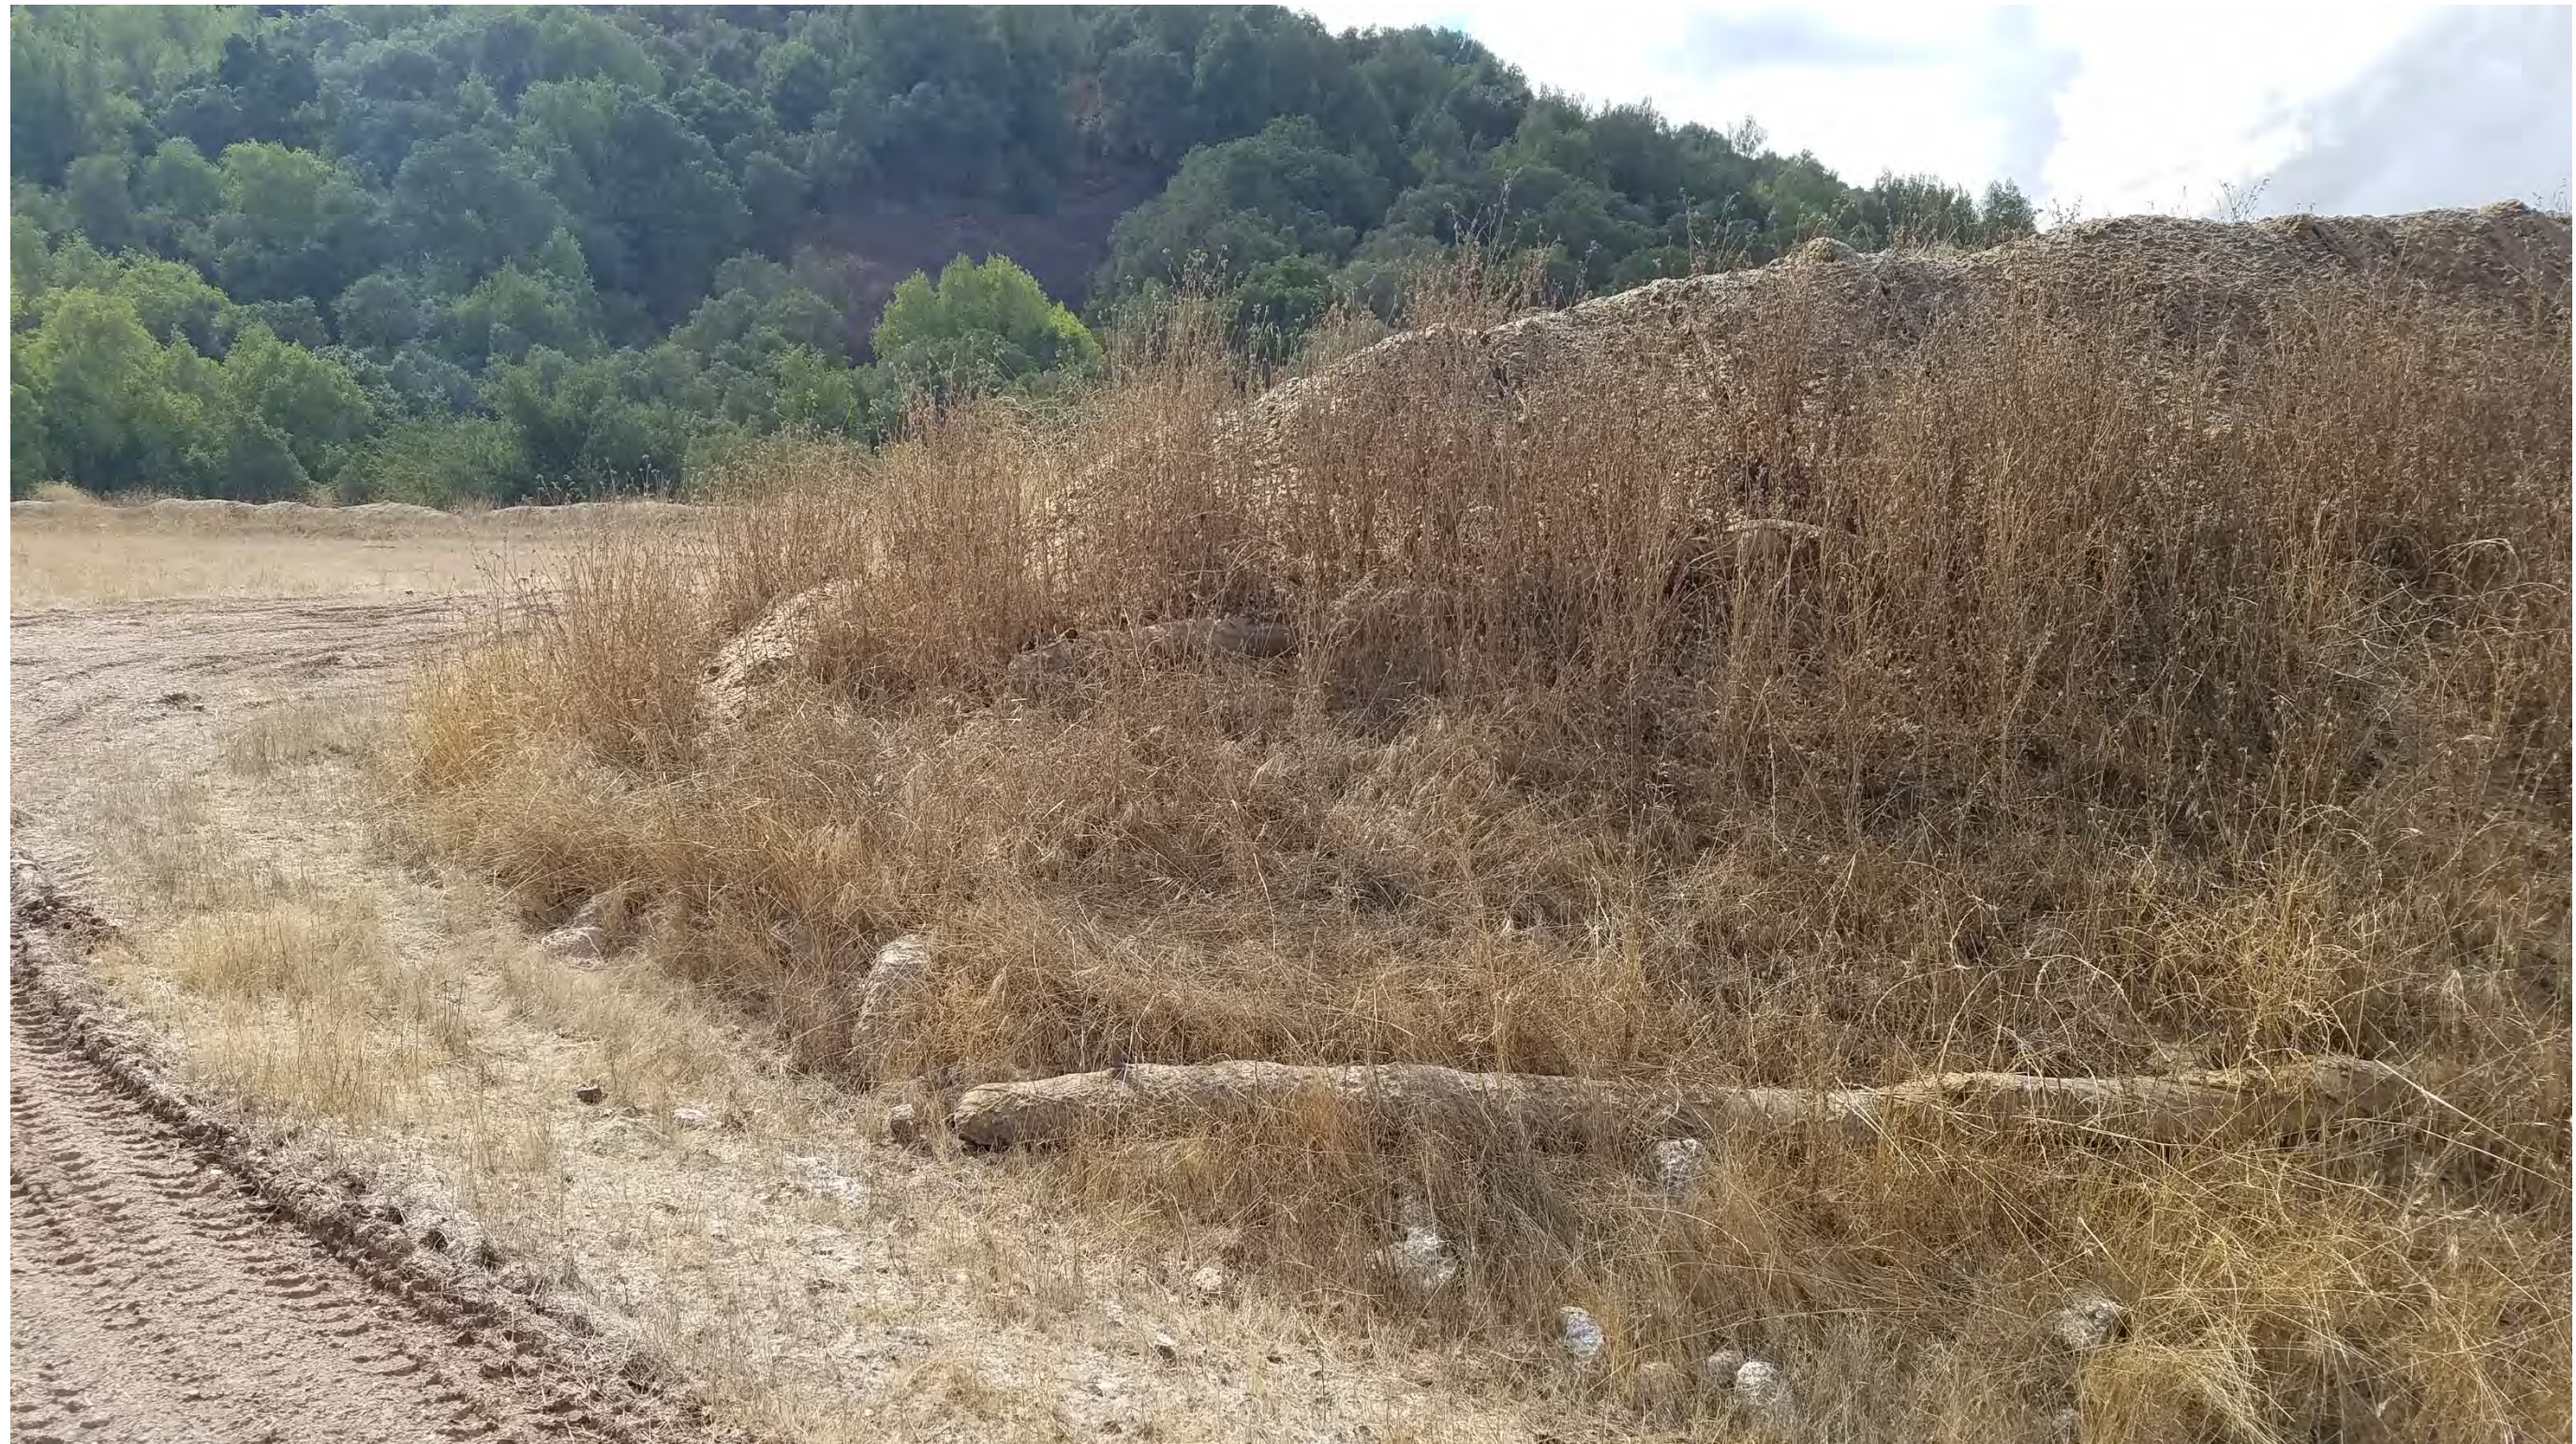
During the annual inspection in 2021, County inspectors observed an area in which recent grading had created a level pad adjacent to the modified utility road south of the Rock Plant. The fill slopes were covered with jute netting which have since been hydroseeded. [See **Photos 28A and 28B.**] In addition, at that time, County inspectors saw a localized area of shallow slumping of slopes on the northern side of fill placed in 2017 on top of the EMSA. Subsequent grading can be seen in Google Earth air-photos taken in 2020 and 2021. [See **Photos 29 A, B and C.**] Although County inspectors did not visit this area in 2022, a Google Earth air-photo taken this year (unspecified date) shows that vegetation has re-established in that area. [See **Photo 29 D.**]

Photo #28A - recent fill pad south of Rock Plant

- 1) County inspectors suggested that the operator monitor the topsoil stockpiles and replace erosion control measures as needed to prevent loss of material through erosion. (See Map Location 2.)
- 2) Area of recent grading needs to be hydroseeded in order to minimize the potential for erosion during approaching rainy season. (See area between Map Locations 6 and 12.)
- 3) Recently formed ground cracks need to be monitored by the quarry operator to detect any increases in openings and evaluate the significance of any such changes. (See areas east of the Yeager Yard Landslide and the road to the main pit observation deck.)

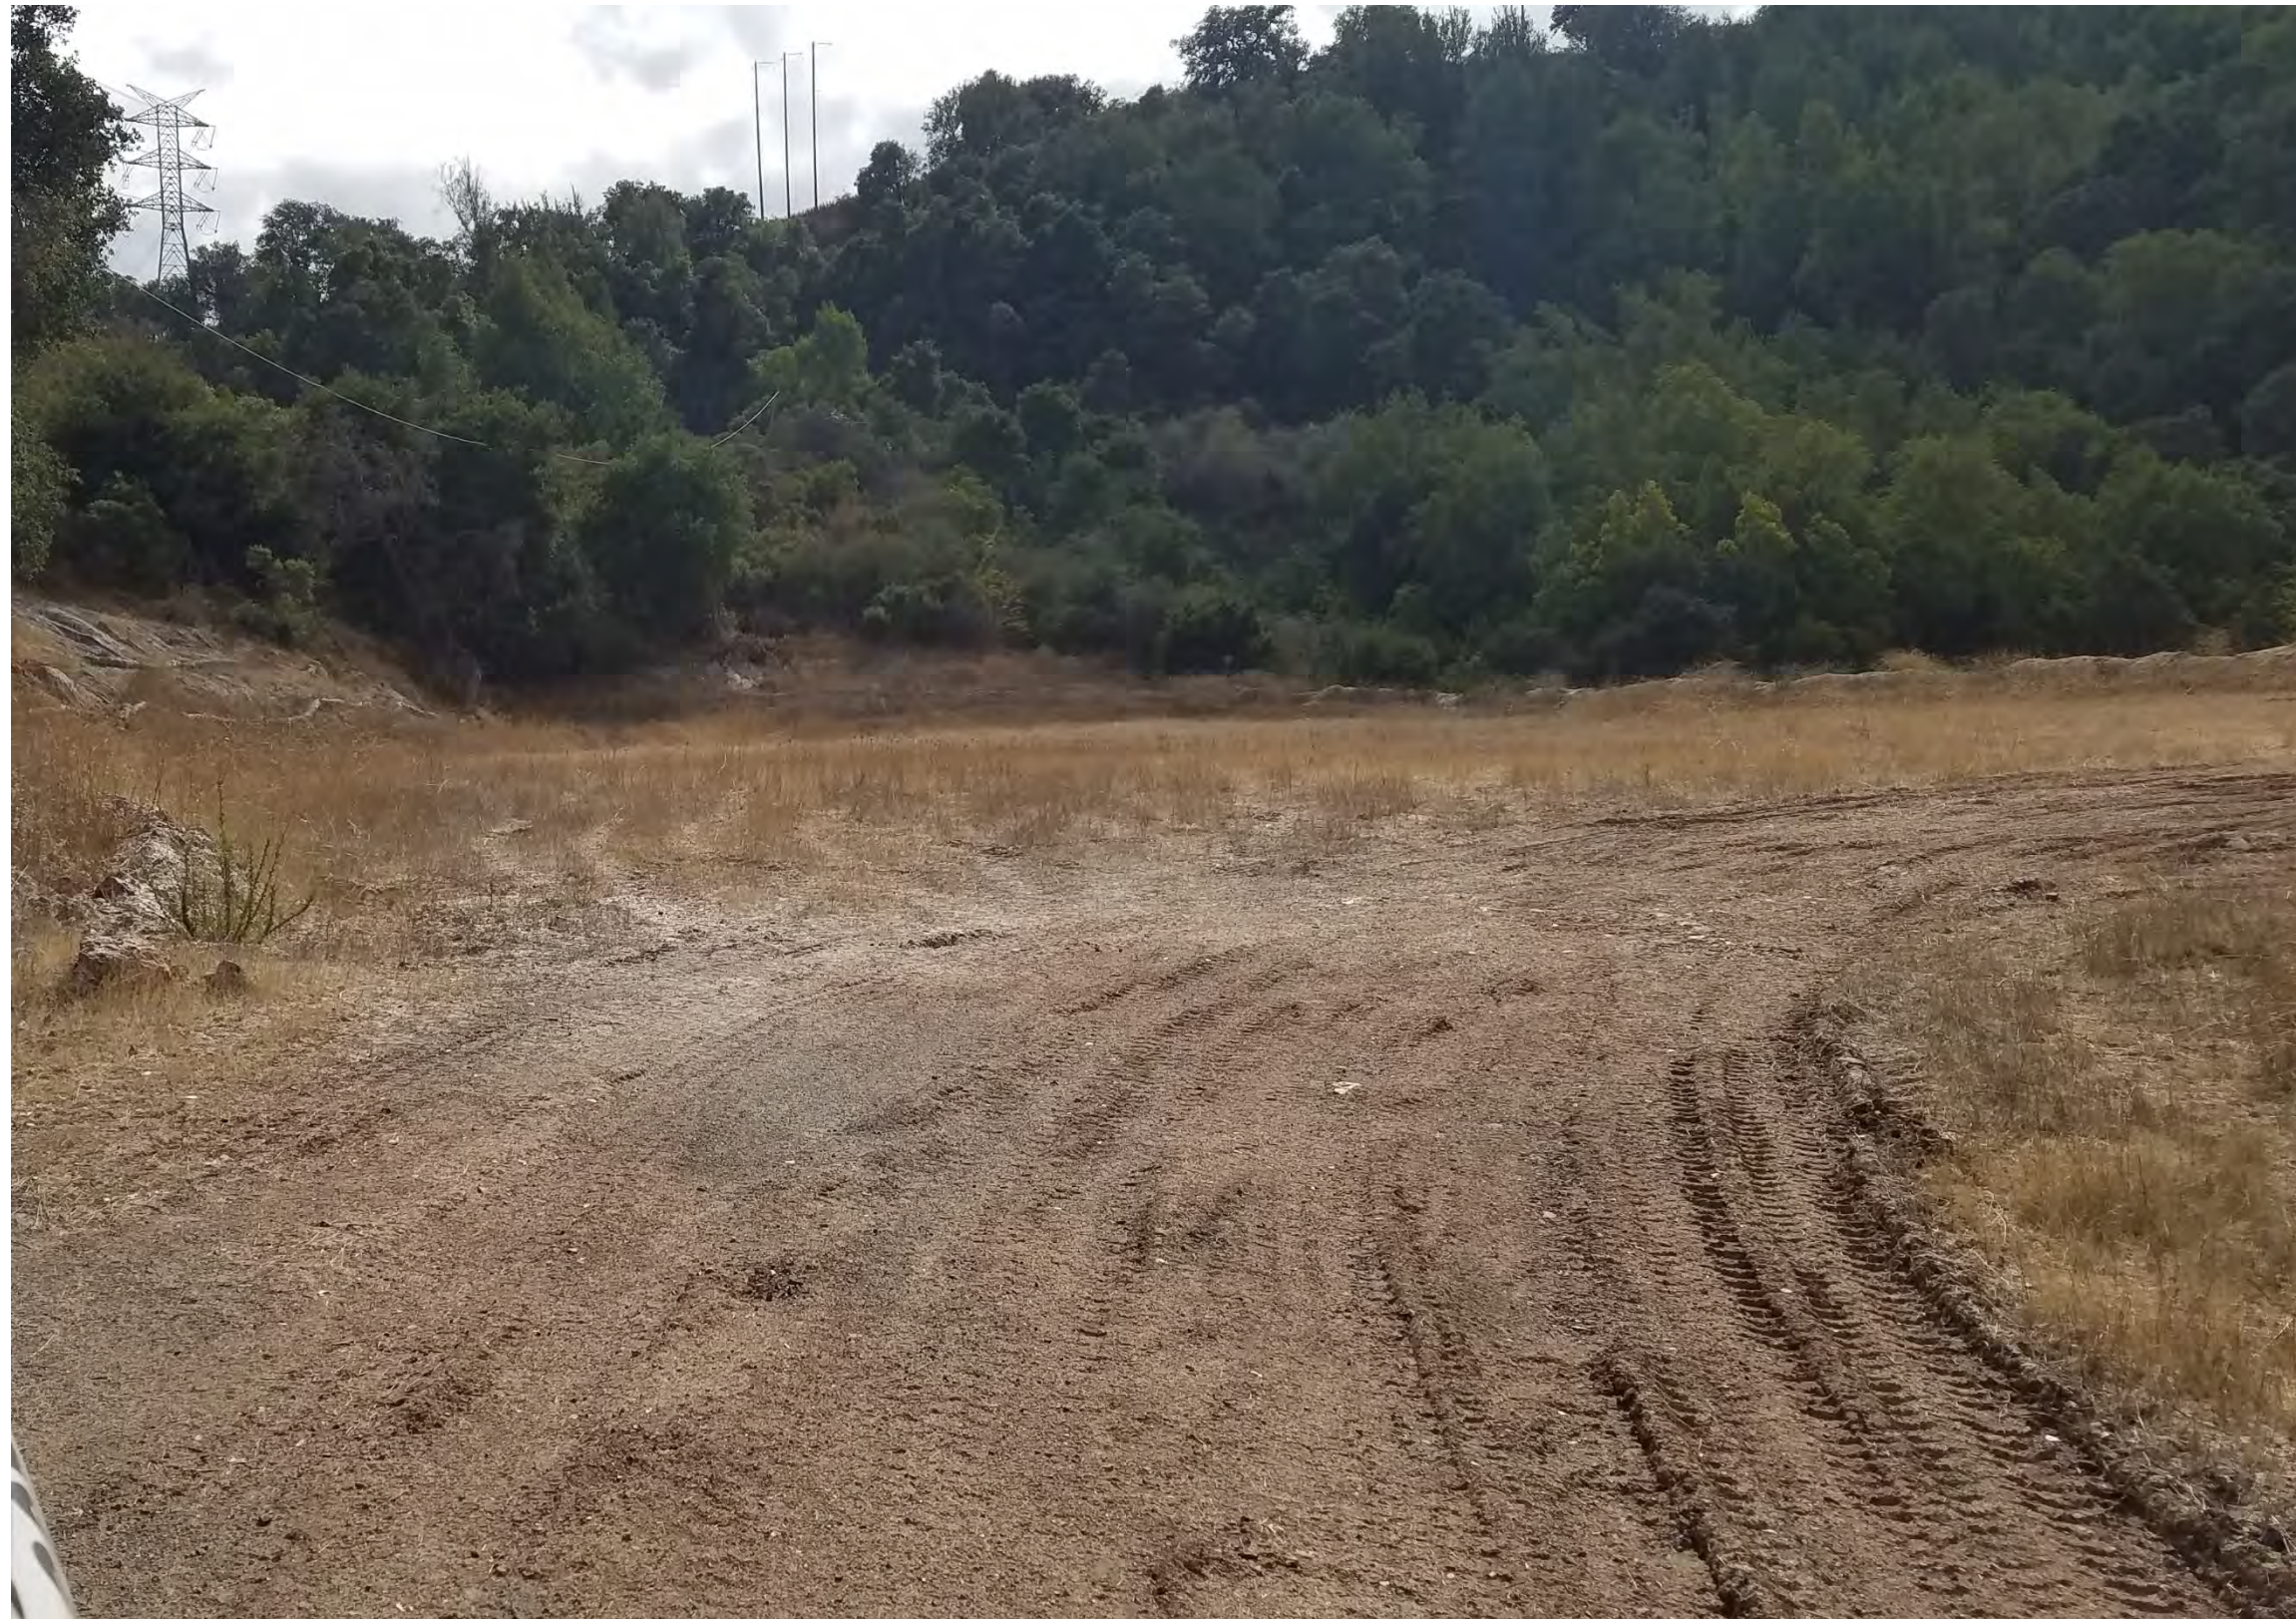
Photo #28B – recently cut pad south of Rock Plant

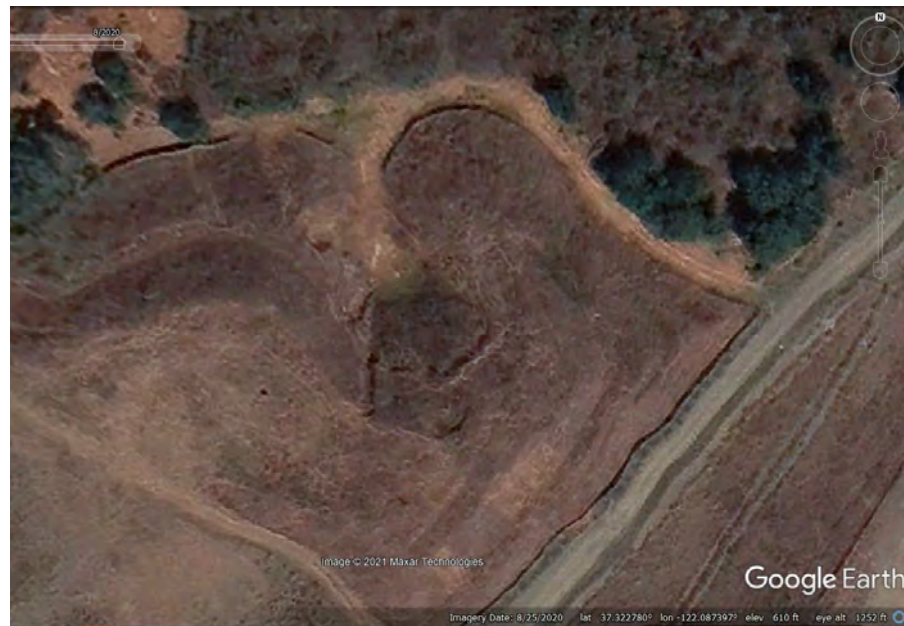
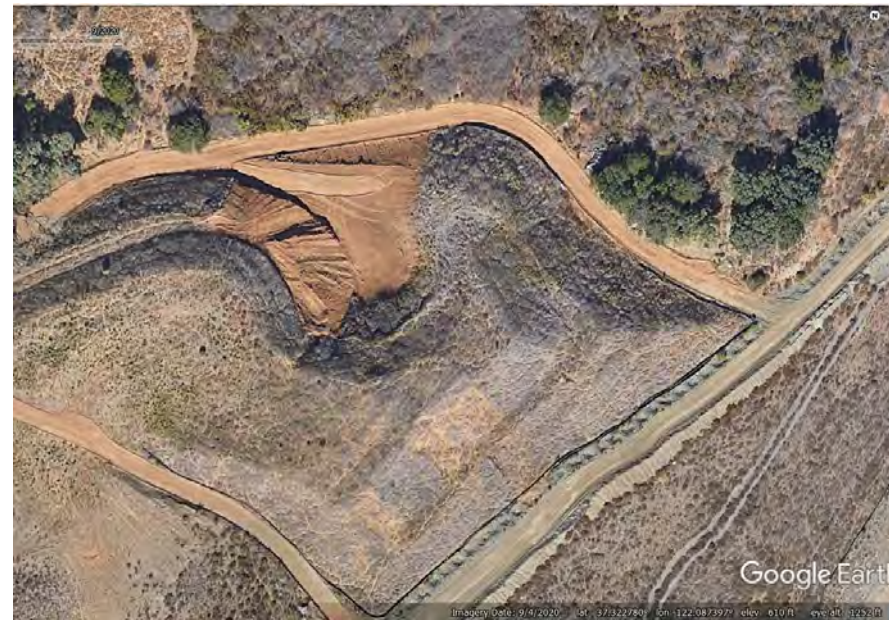
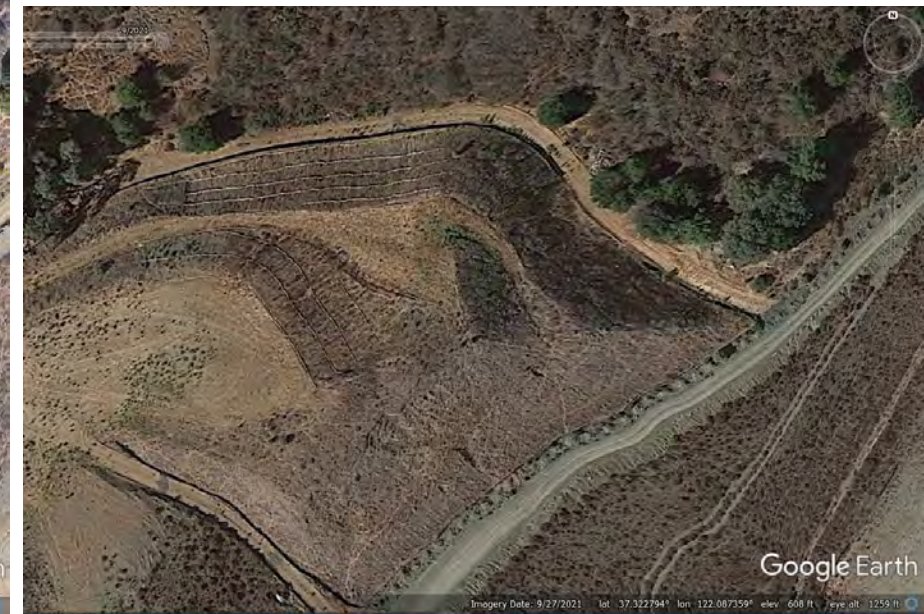
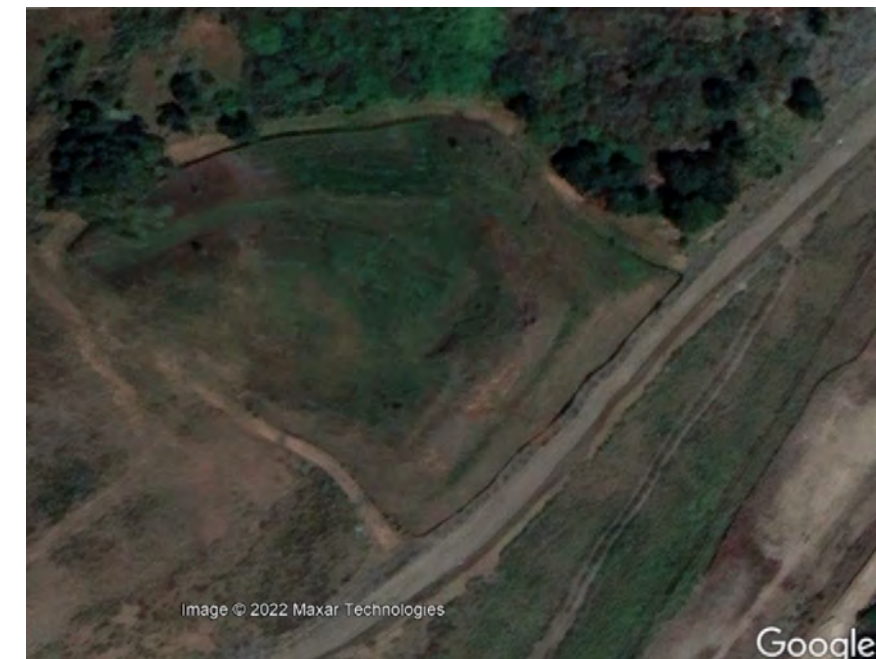
Map Location 3: Central portion of EMSA

Photos #29A, B, C, D – Shallow slumps in fill material that was added to EMSA beginning in September or October of 2017; slumps have been re-graded by the operator. Photo 29 D shows vegetation has started to establish as of 2022.

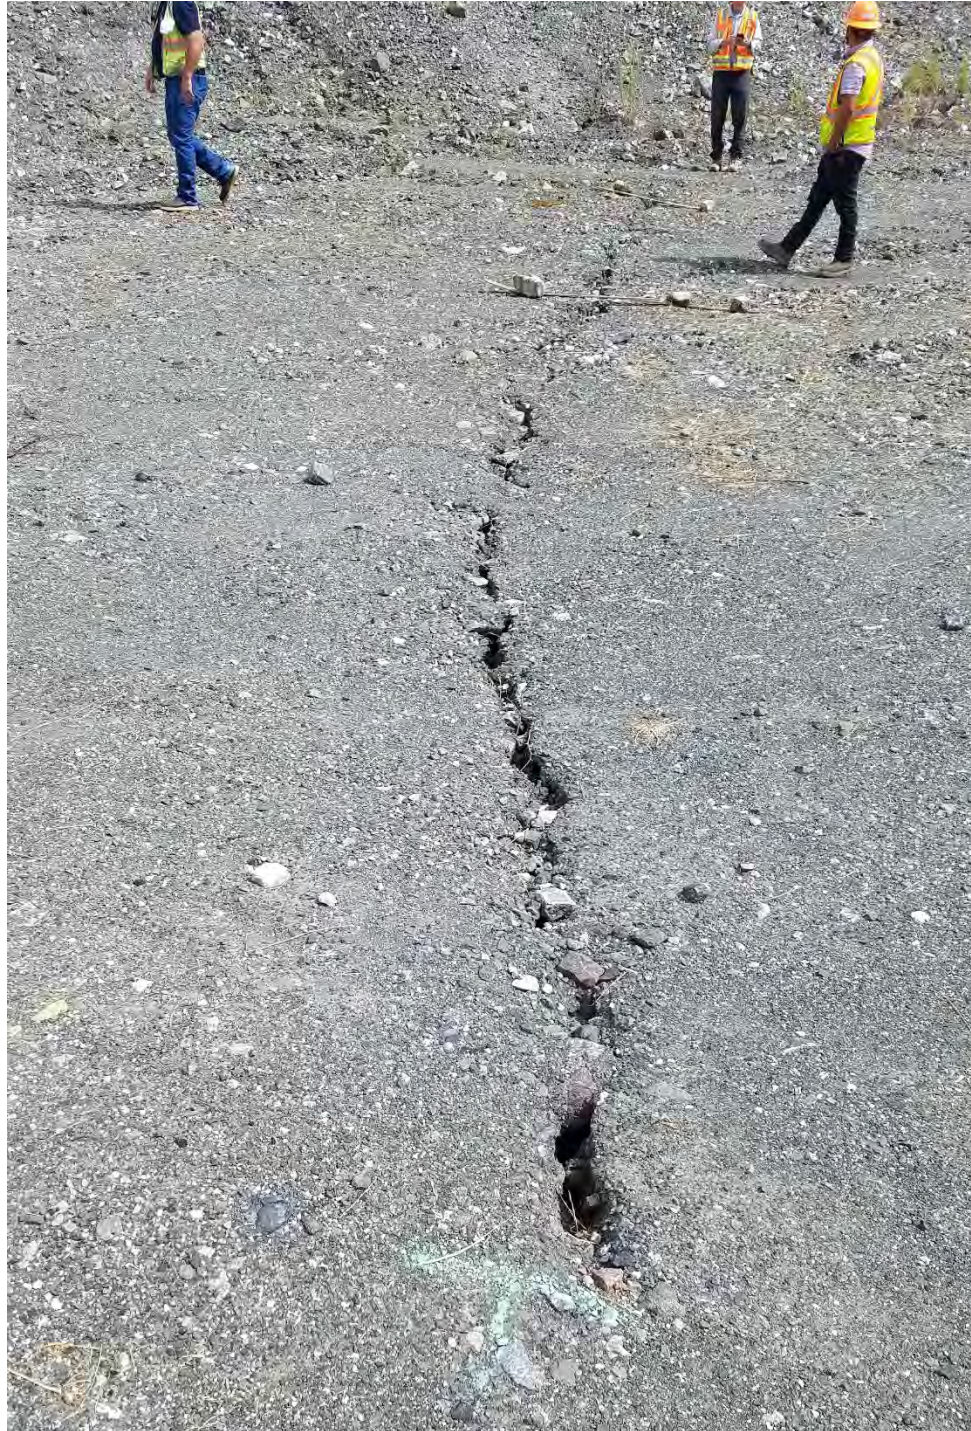
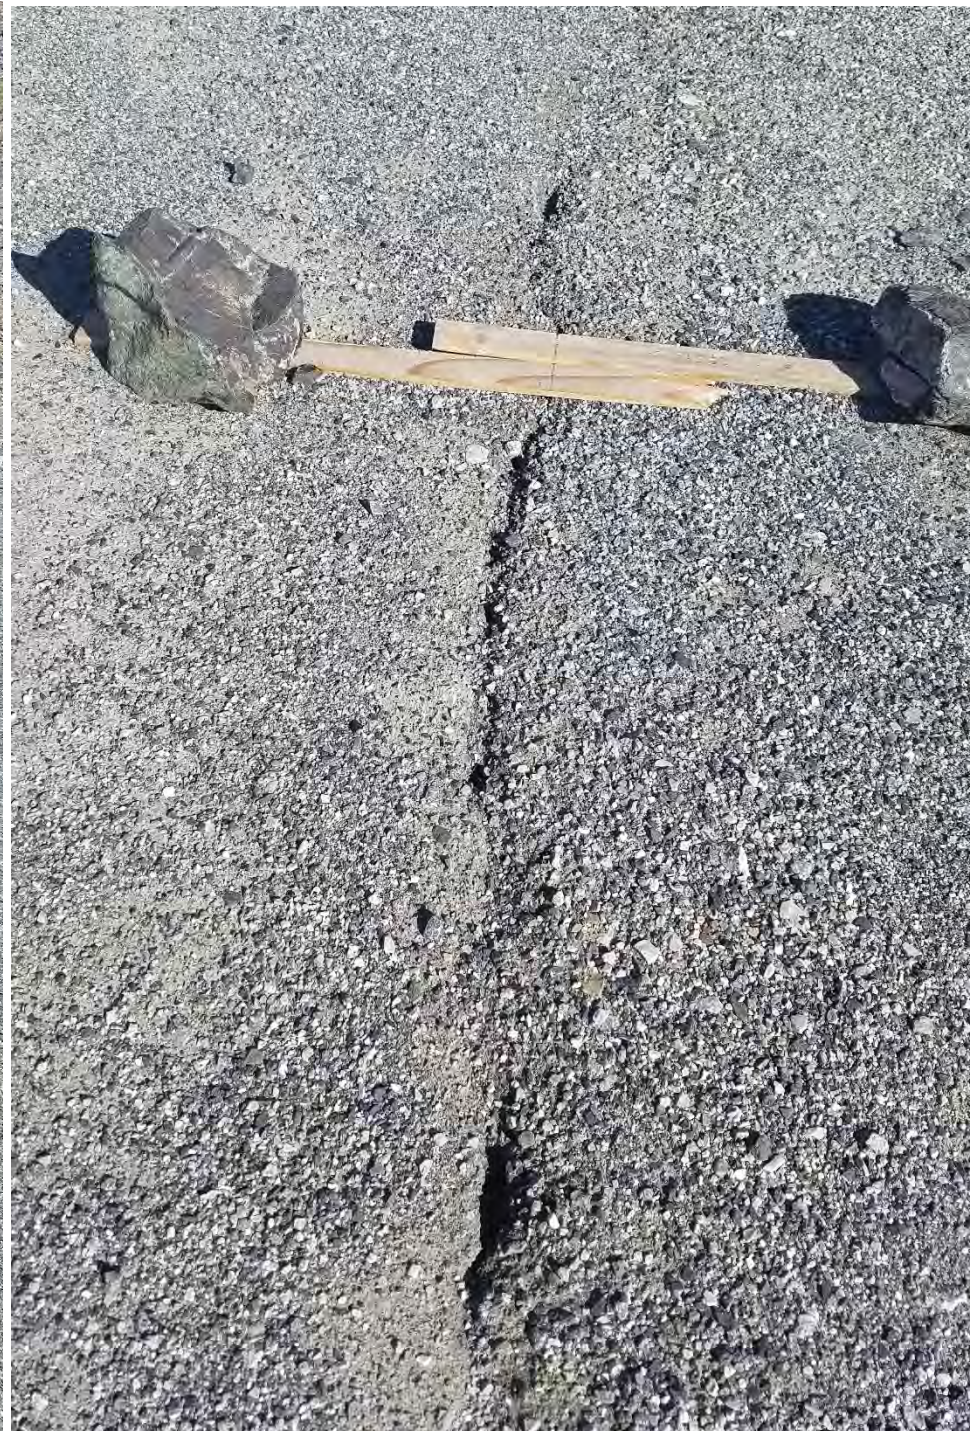
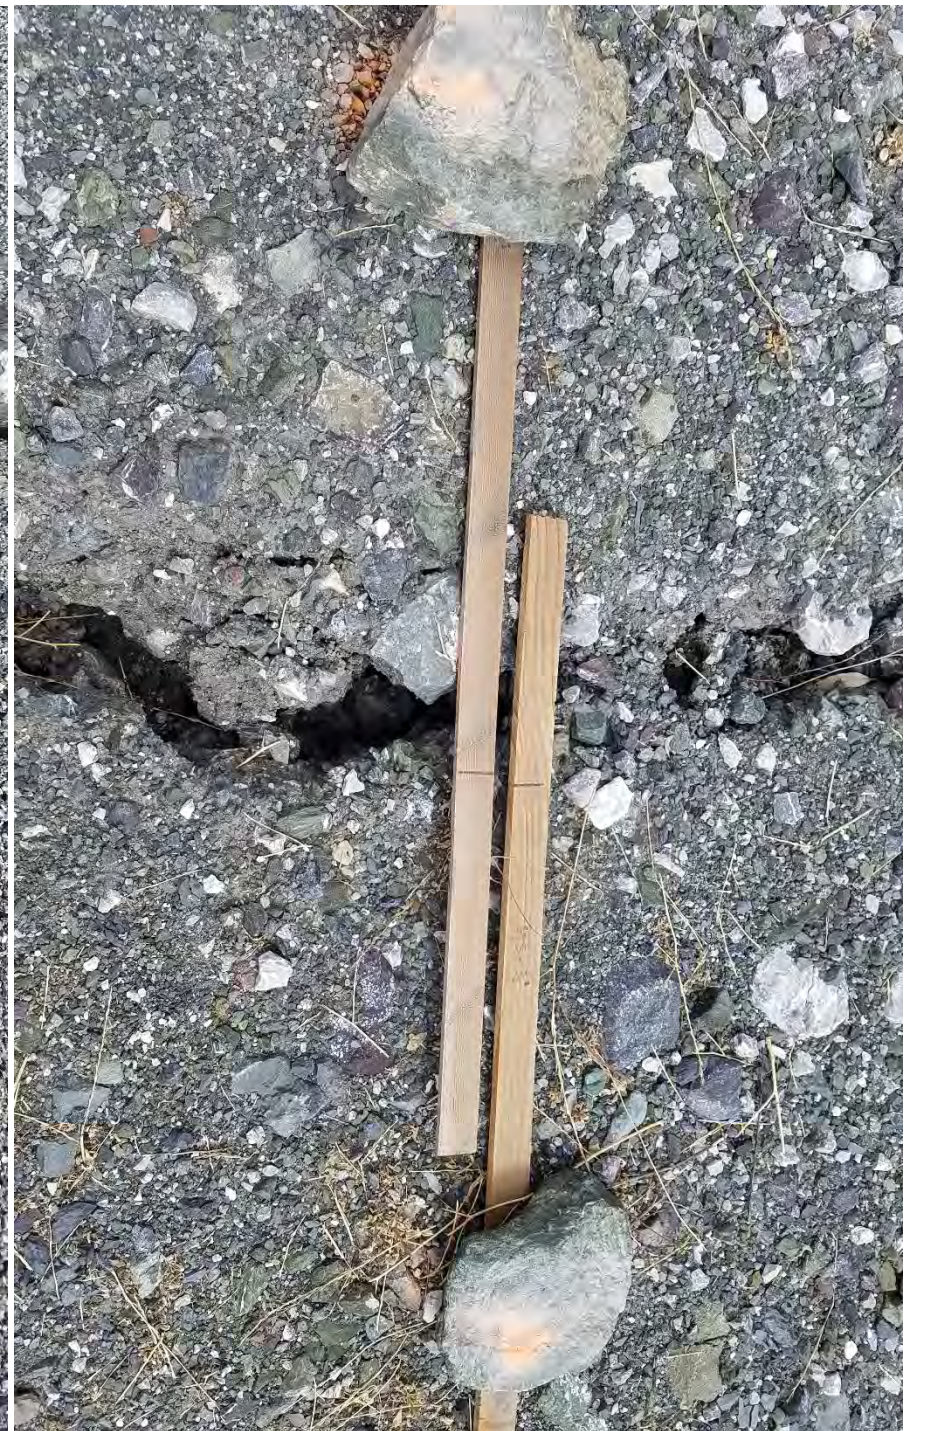
During this year's inspection, County inspectors observed (extensional) ground cracks that have formed in two areas; one is on the eastern side of the Yeager Yard Landslide [see **Photo 30 A**] and the other is on the road to the main pit observation deck [see **Photo 31A.**] Monitoring sticks have been placed by the quarry operator. [See **Photos 30B, 30C and Photo 31B.**] County inspectors will observe these cracks during upcoming monthly inspections.

Photos #30A, B and C – Recently formed ground cracks near eastern portion of Yeager Yard slide. (Monitoring sticks placed by Operator.)
