SURFACE MINING INSPECTION REPORT

BACKGROUND

Lehigh Quarry is a vested hard rock quarry which has been in operation since approximately 1903. The operation primarily harvests limestone for the production of cement but has also produced greenstone aggregate in the past. Over time the quarrying operation has expanded, and now encompasses 546 acres of disturbed area. The site also includes a cement plant operating under a Use Permit and located outside of the Reclamation Plan area. The current Reclamation Plan was approved in 2012 as an amendment to the 1985 Reclamation Plan.

Photos from 2022 Annual SMARA Inspection Conducted on 9-20-2022

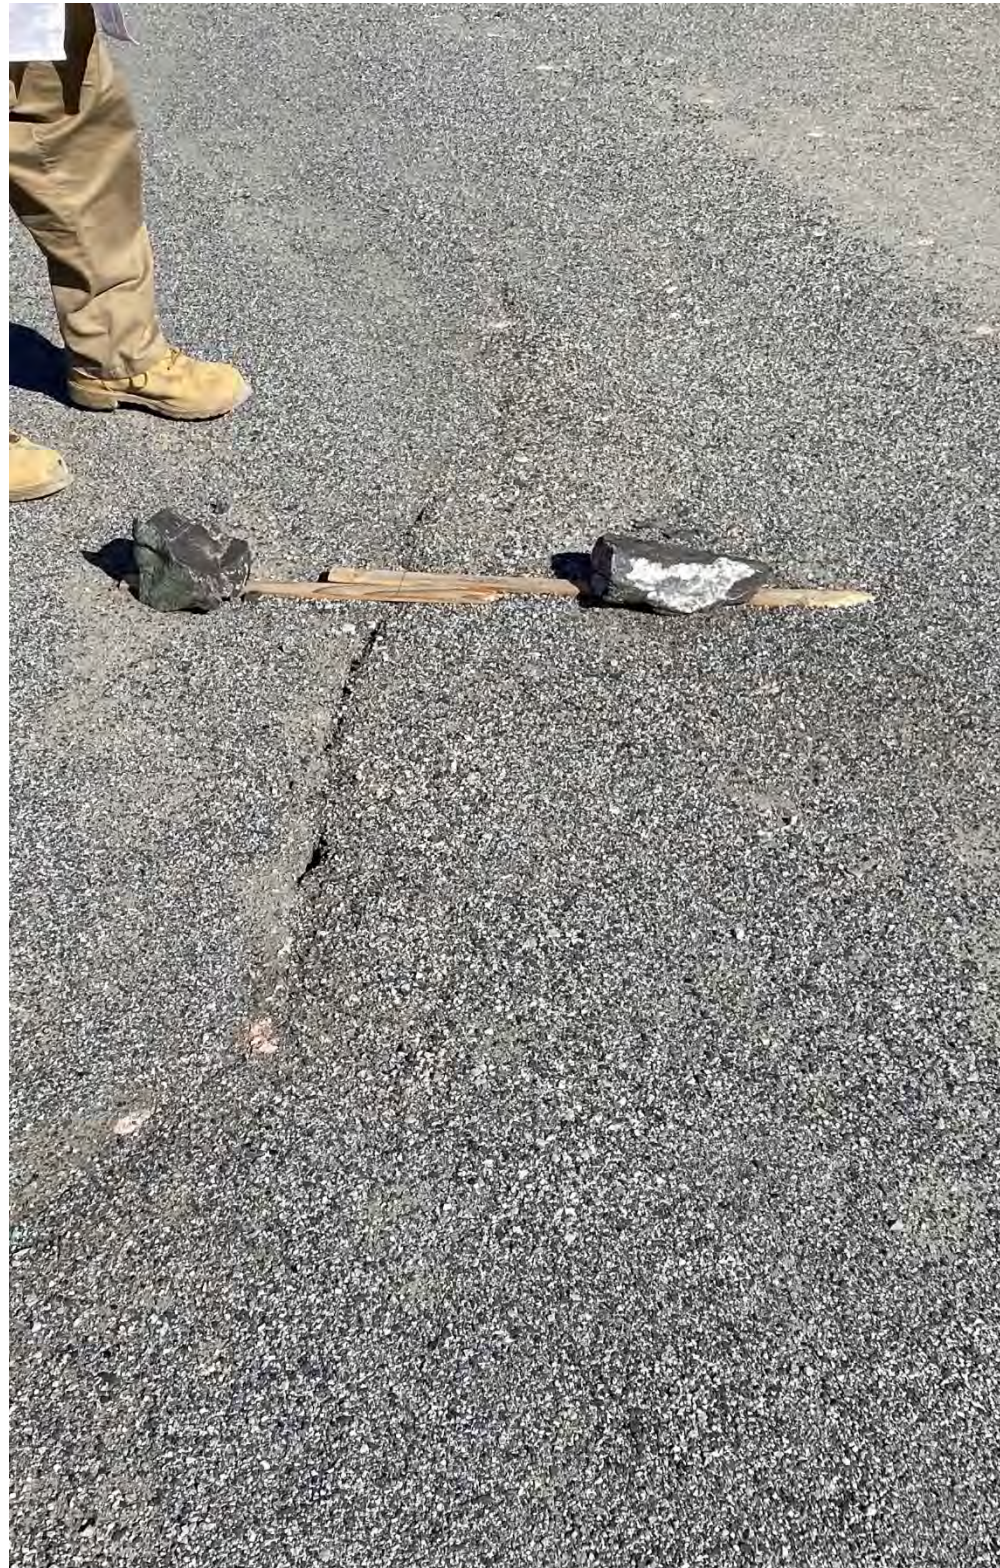
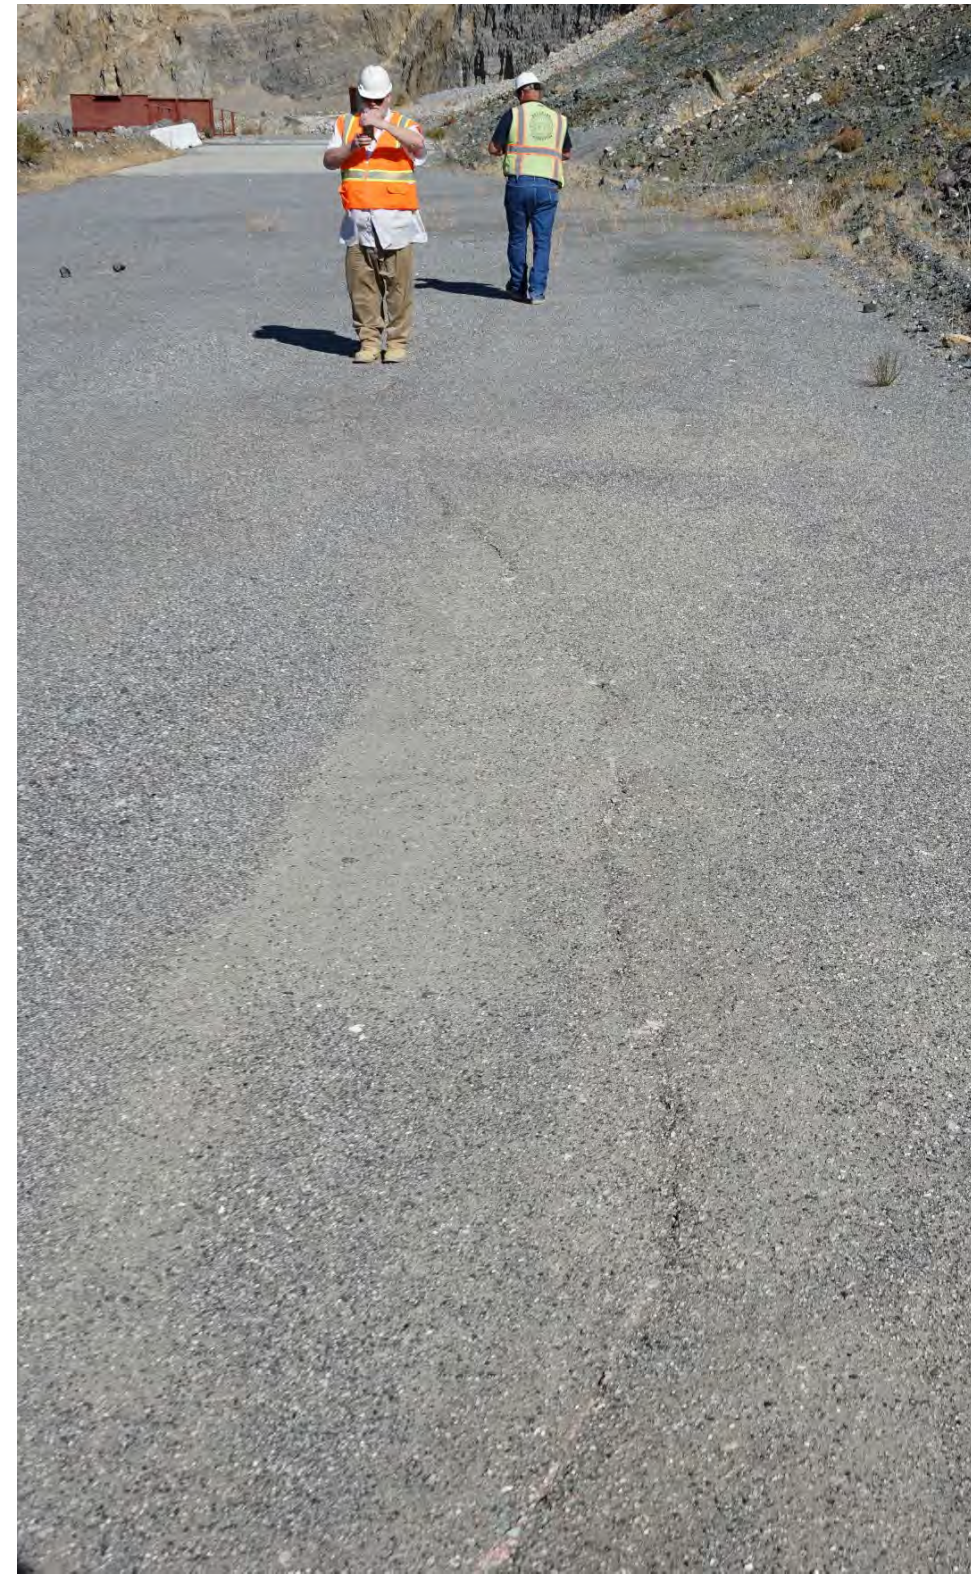
During this year's inspection, County inspectors observed (extensional) ground cracks that have formed in two areas; one is on the eastern side of the Yeager Yard Landslide [see **Photo 30 A**] and the other is on the road to the main pit observation deck [see **Photo 31A.**] Monitoring sticks have been placed by the quarry operator. [See **Photos 30B, 30C and Photo 31B.**] County inspectors will observe these cracks during upcoming monthly inspections.

Photos #31A and 31B – Recently formed ground cracks along road to main pit observation deck. (Monitoring sticks placed by Operator.)

- 1) County inspectors suggested that the operator monitor the topsoil stockpiles and replace erosion control measures as needed to prevent loss of material through erosion. (See Map Location 2.)
- 2) Area of recent grading needs to be hydroseeded in order to minimize the potential for erosion during approaching rainy season. (See area between Map Locations 6 and 12.)
- 3) Recently formed ground cracks need to be monitored by the quarry operator to detect any increases in openings and evaluate the significance of any such changes. (See areas east of the Yeager Yard Landslide and the road to the main pit observation deck.)
