TECHNICAL MEMORANDUM

DATE October 31, 2019

Project No. 179018601

GEOLOGIC AND GEOMORPHIC ASSESSMENT OF PERMANENTE CREEK, LEHIGH HANSON PERMANENTE QUARRY, SANTA CLARA COUNTY, CA

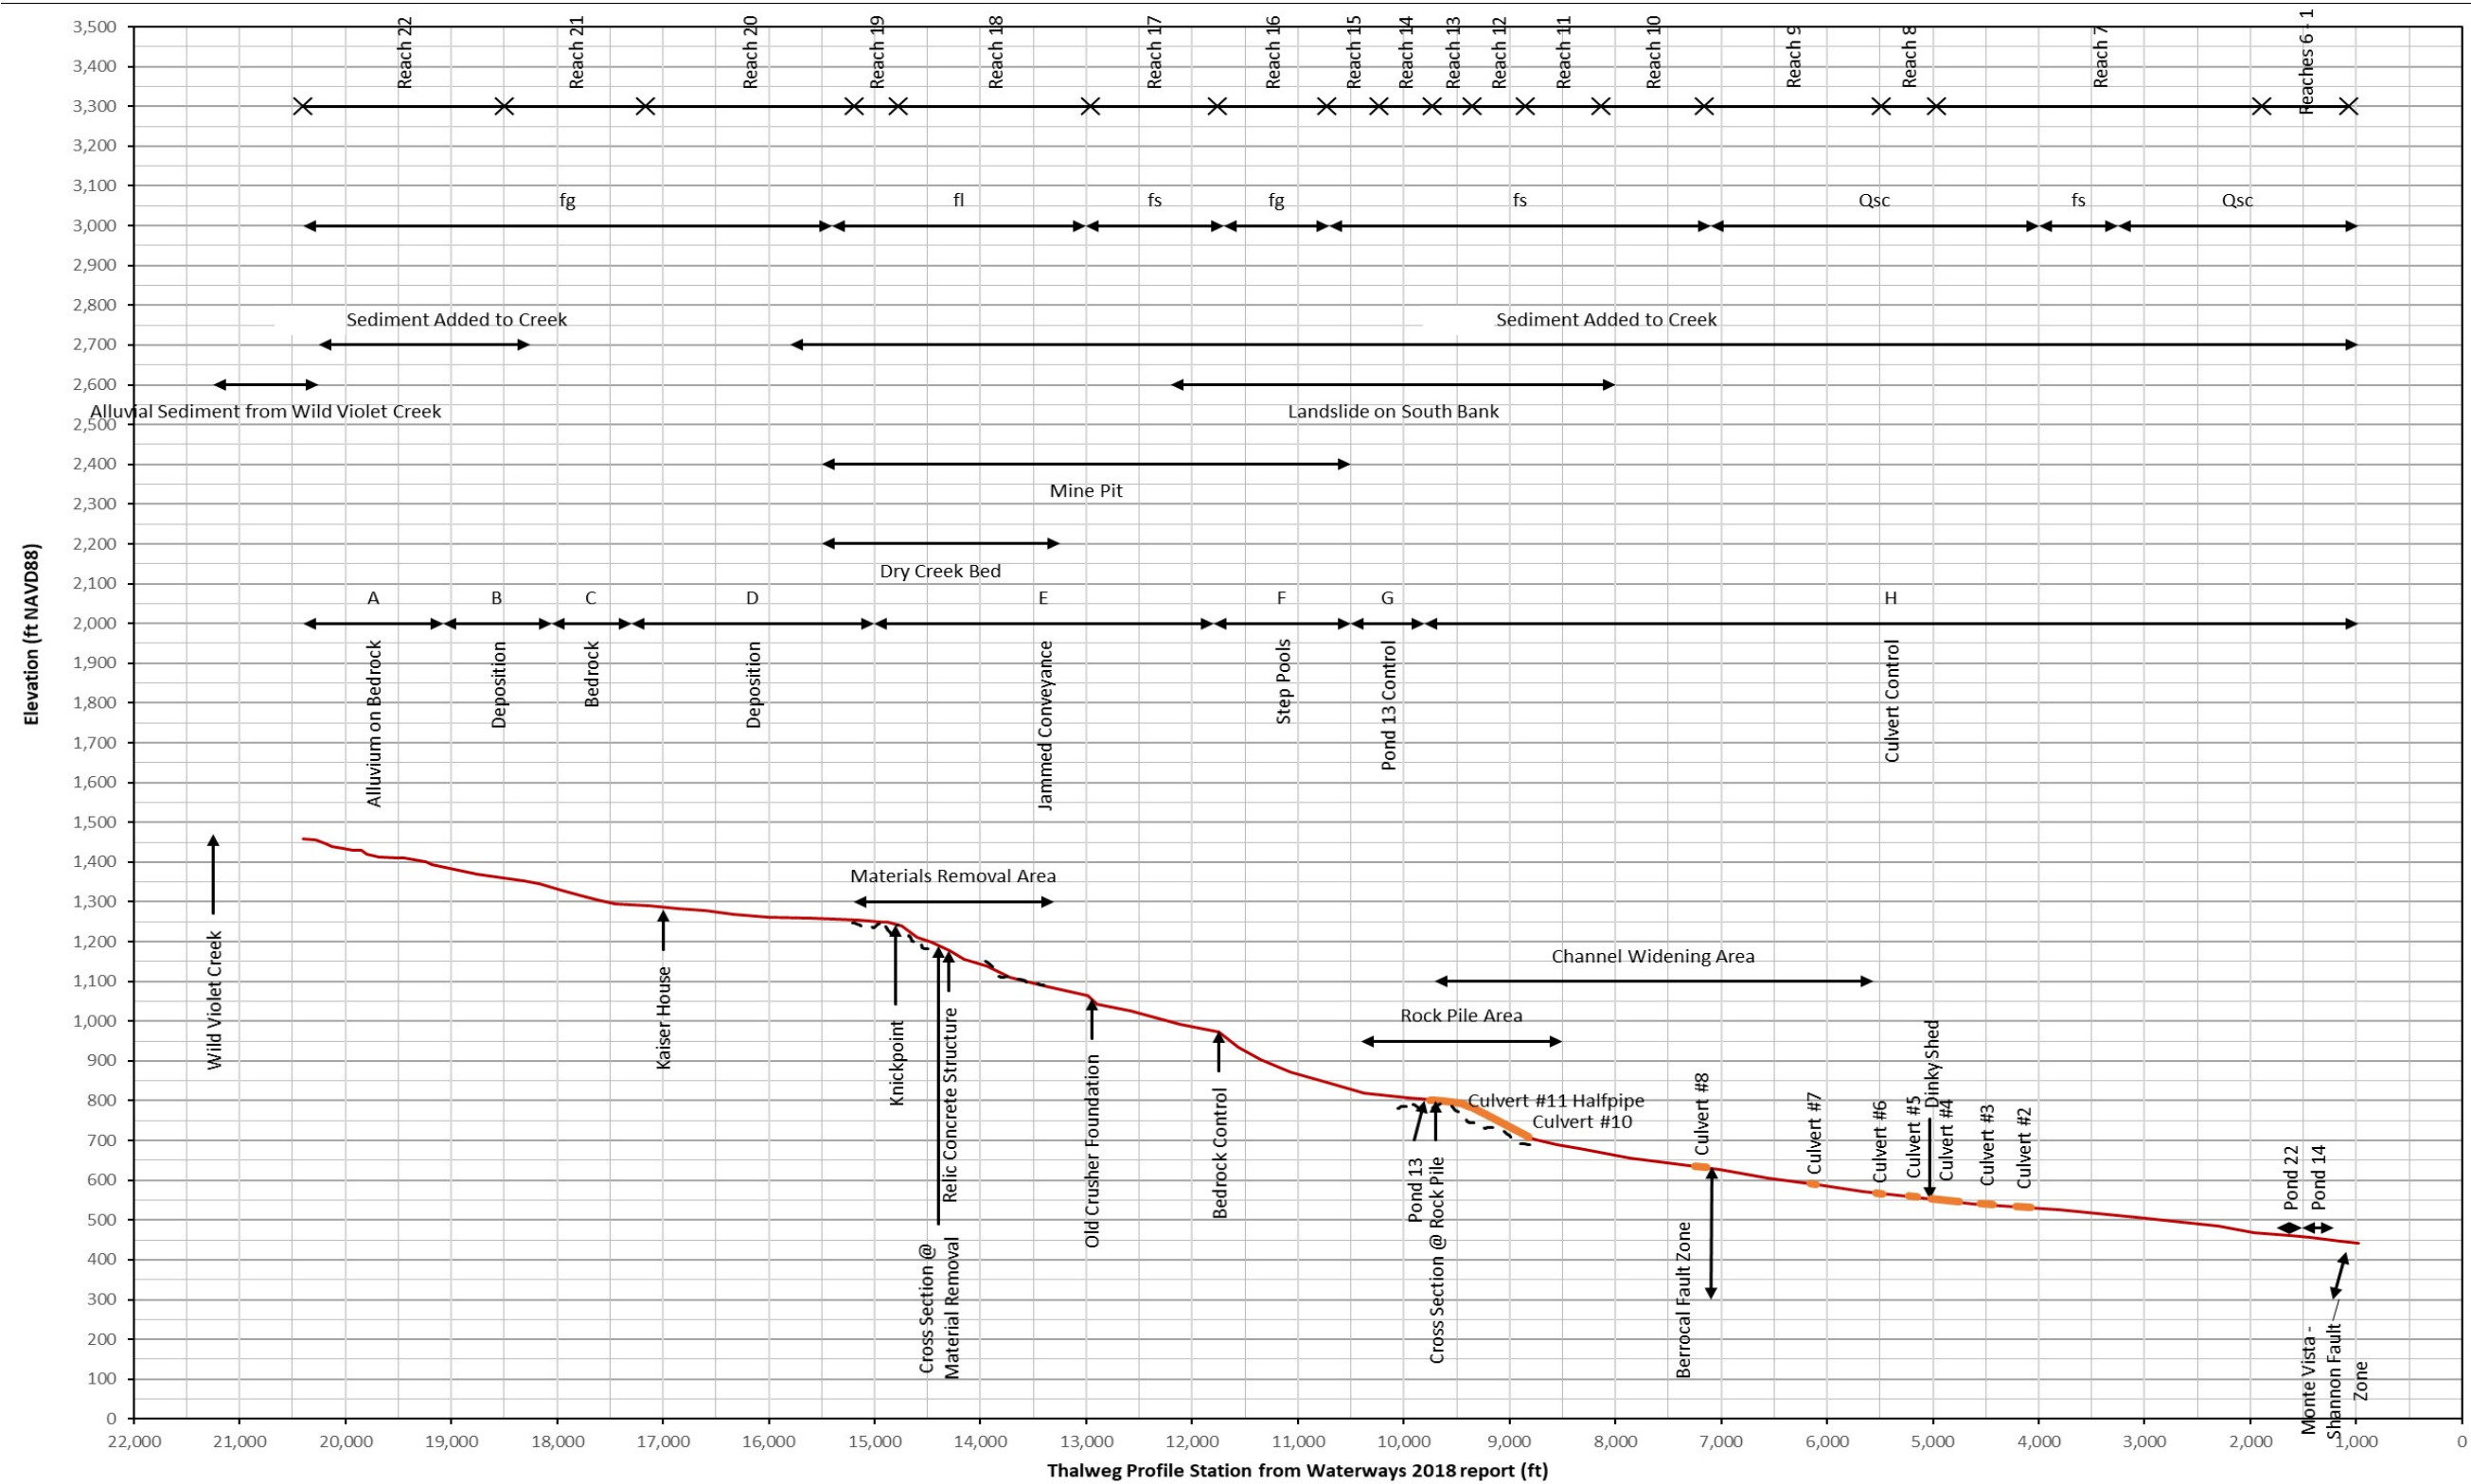
Figure 2: Permanente Creek Profile with geomorphic and geologic delineations. Stationing from Waterways (2019).

The profile of Permanente Creek can broadly be classified into depositional reaches and bedrock reaches (delineated on Figure 2 as Reach A, Reach B, etc.). The processes that define these reaches are the rate that sediment is supplied to the channel and the rate at which the channel can convey the supplied sediment. The rate of sediment supply is controlled by hillslope processes and the rate that sediment is delivered to the channel. The rate of sediment transport is controlled by the channel geometry and the hydraulic characteristics of the reach. The channel hydraulics are directly coupled to the rate at which water is delivered to the channel.

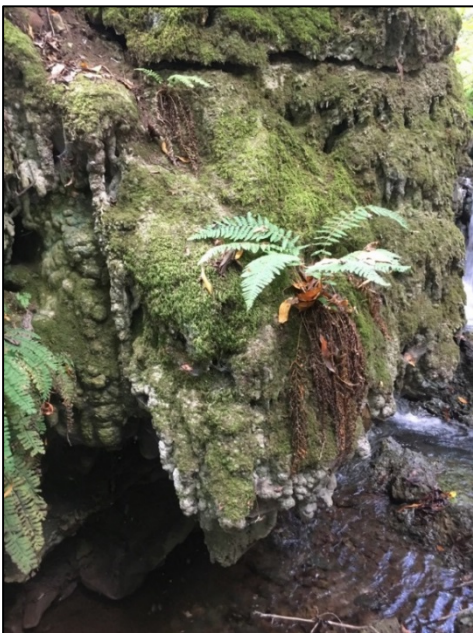
The upstream most knickpoint with the assessed channel is located at Station 148+00 within the Material Removal Area (Figure 2). This reach is characterized by a relatively low gradient reach upstream of this point and a steep reach downstream. The steep reach downstream is simultaneously receiving and conveying a large quantity of material, typically composed of the finer fraction of the total sediment load, and aggrading the coarser fraction, composed of large boulders.

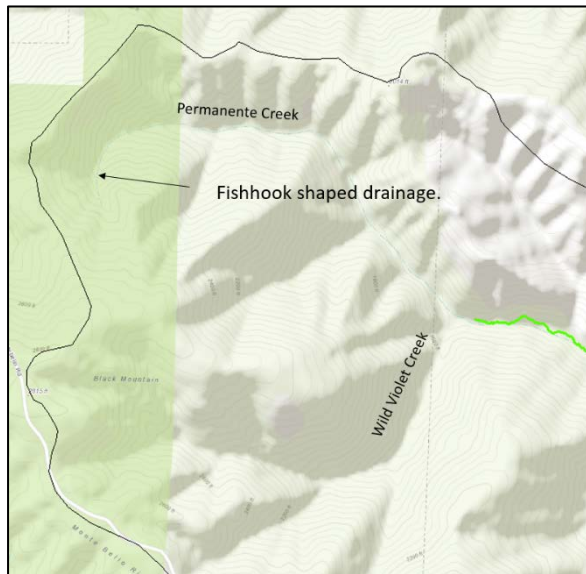
Figure 4 – Fishhook shaped headwaters

landscape features like wind gaps, where valley geometry and upstream drainage are mismatched, and fishhooks, where headwater streams exhibit a significant curved alignment where the drainage meets the basin edge. The fishhook morphology is observable in the Permanente Creek basin, and adjacent basins (Figure 4). Evidence of basin capture is significant to the current investigation as the changes in basin area related to basin capture can be associated with a disequilibrium between the channel morphology and the sediment regime of the river. More straightforwardly, this implies that the basin used to be bigger, and the current hydrologic regime may not be sufficient to transport the former natural sediment load.

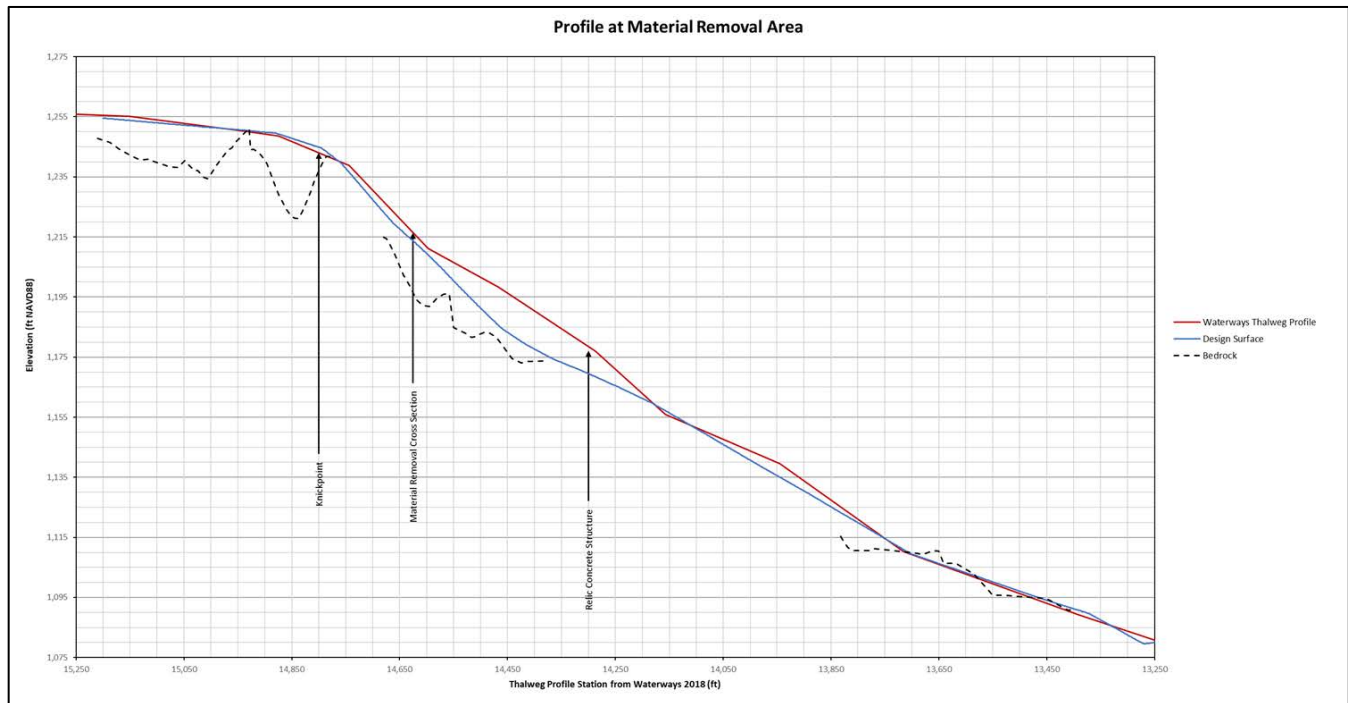
Figure 6: Profile of Material Removal Area from Station 152+50 to 132+50.

- There is a large relic concrete structure located in the left bank of the stream channel five to ten feet above the channel invert (143+00). There is a smaller relic concrete structure located in the channel further downstream. Golder understands that the removal of old mining infrastructure from the channel will increase the connectivity of the channel to the adjacent landscape and also that the relict structures may currently be contributing to the stability of this reach. We understand that weirs and steps will be constructed using material with a minimum size meeting the D50 of the specified material and a boulder sill w/ a minimum size meeting the D84. This design approach is intended to replace any potential stability relic structures are providing.

- The most challenging geologic and geotechnical issue in the Material Removal Area is the presence of the Upper Water Treatment System infrastructure, including the 1250 Pond and associated facilities located along the top of the creek bank and the access road to Permanente Creek. The lifetime of these facilities is uncertain at this time as they are required for on-going operations of the Facility. However, once reclamation is completed, they may no longer be necessary. If the facilities need to be protected during the creek restoration project, a retaining structure (e.g., Mechanically Stabilized Earth wall) will be necessary to maintain the road and the 1250 pond (as shown in Figure 4.0 of Waterways Updated Response Letter to the County dated 3-5-18 shown below). The retaining structure would be required as the design calls for pushing the north bank of the creek approximately 25 further north than current conditions.

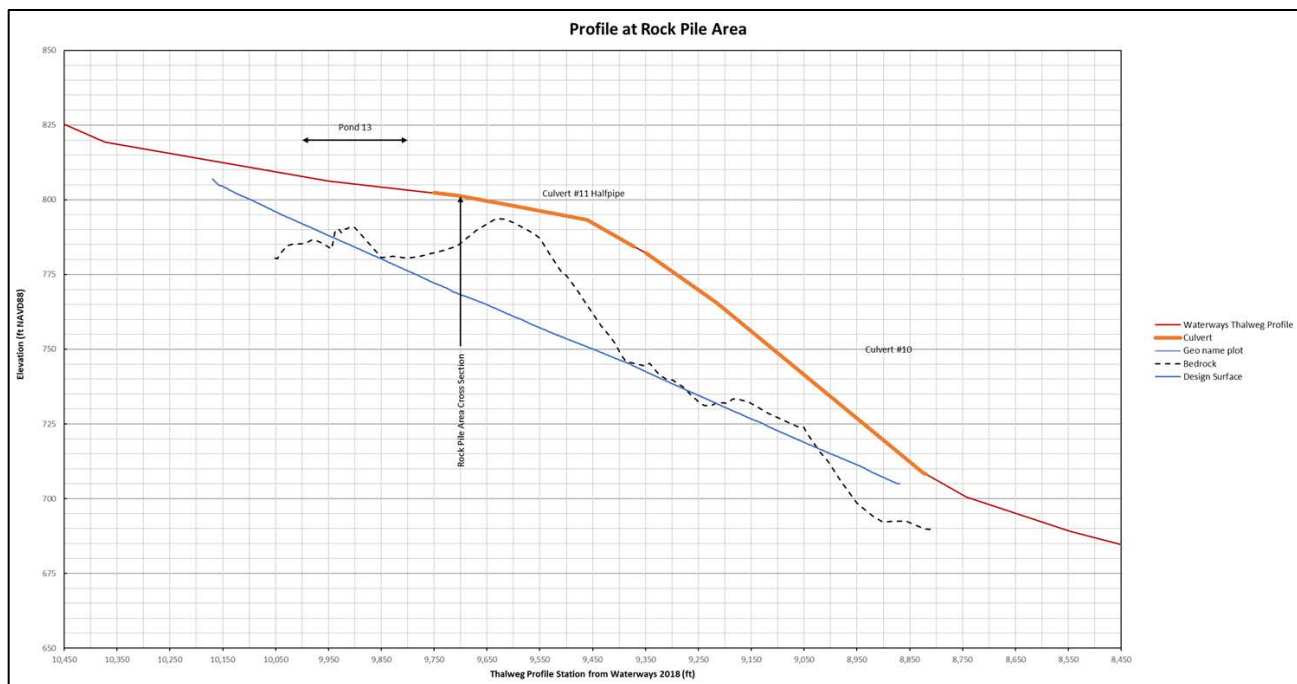
Figure 10: Profile of Rock Pile Area from Station 104+50 to 84+50.

- The removal of the two culverts and creation of a floodplain with an inset channel in this reach will re-establish the lateral connectivity of the channel to the adjacent hillslopes. Reconnecting the channel to the adjacent landscape will have positive benefits as designed by Waterways, but it will also increase the potential for a laterally migrating channel to affect adjacent hillslopes. The north valley wall will consist of the excavated Rock Pile and the south valley wall is defined as a large, ancient landslide based on regional geologic mapping.
