File: 219196 June 7, 2021

Gronwall Property 0 Gronwall Lane Los Altos, California

SLOPE STABILITY ANALYSIS REVISED

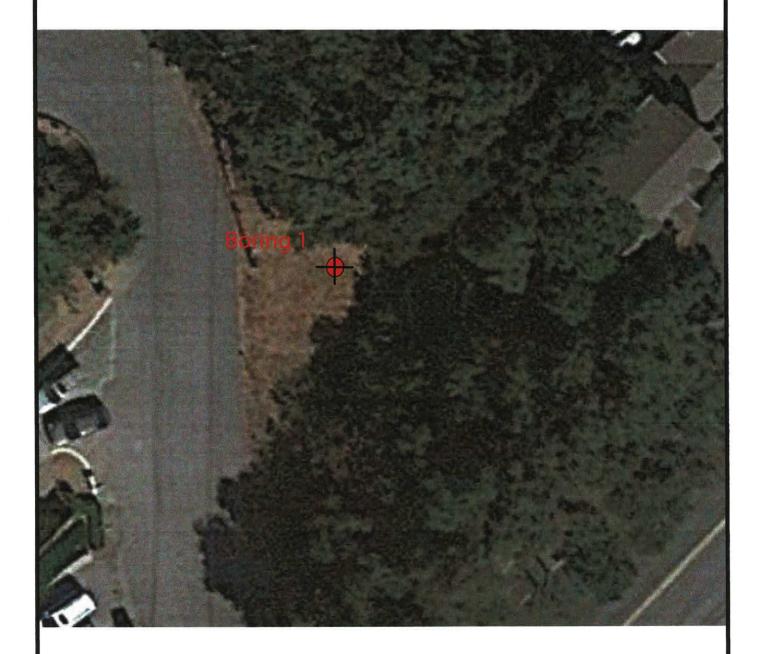
303 Vintage Park Dr., Suite 220, Foster City, CA 94404 Tel: (650) 349-3369 Fax: (650) 571-1878 Figure 1 - Site Photo with Approximate Boring Location

- Approximate Boring Location

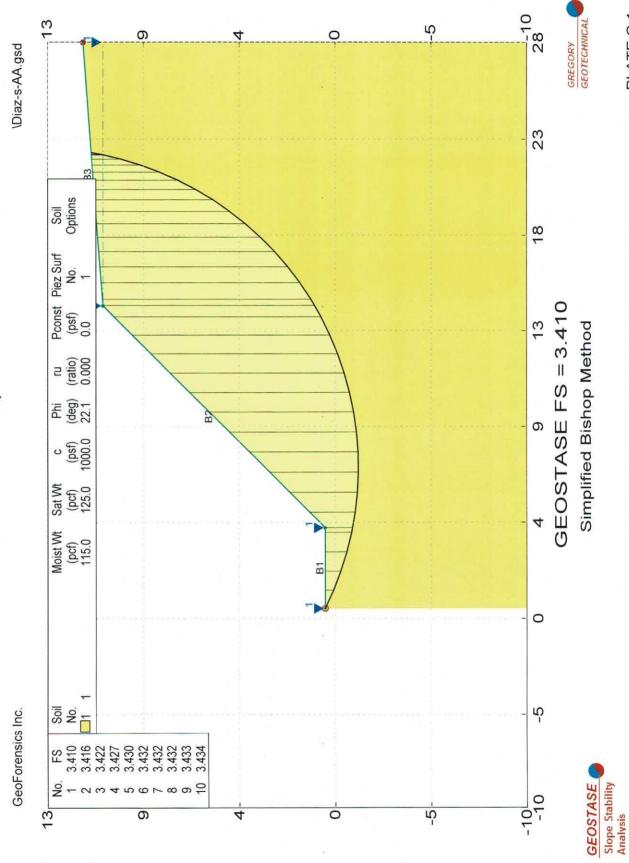
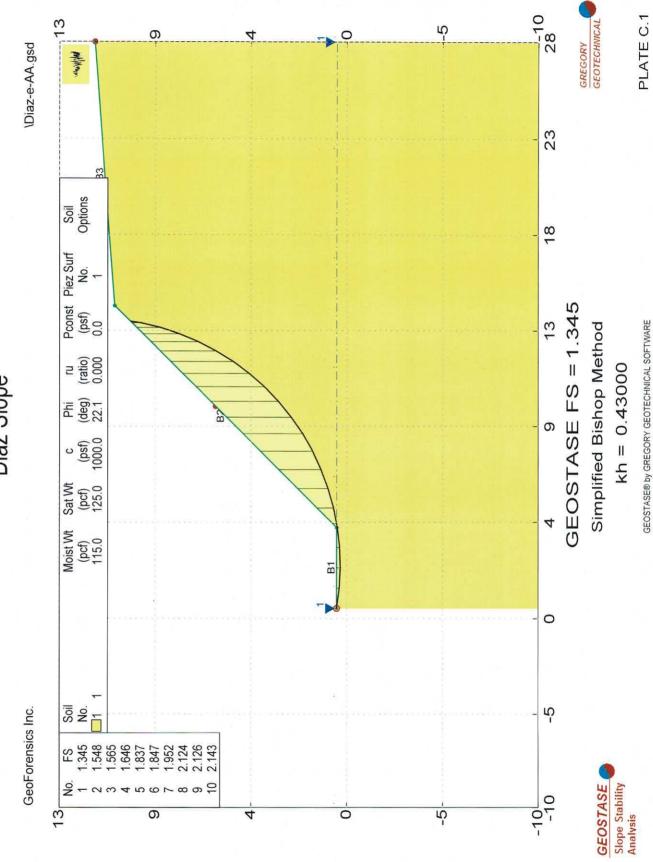
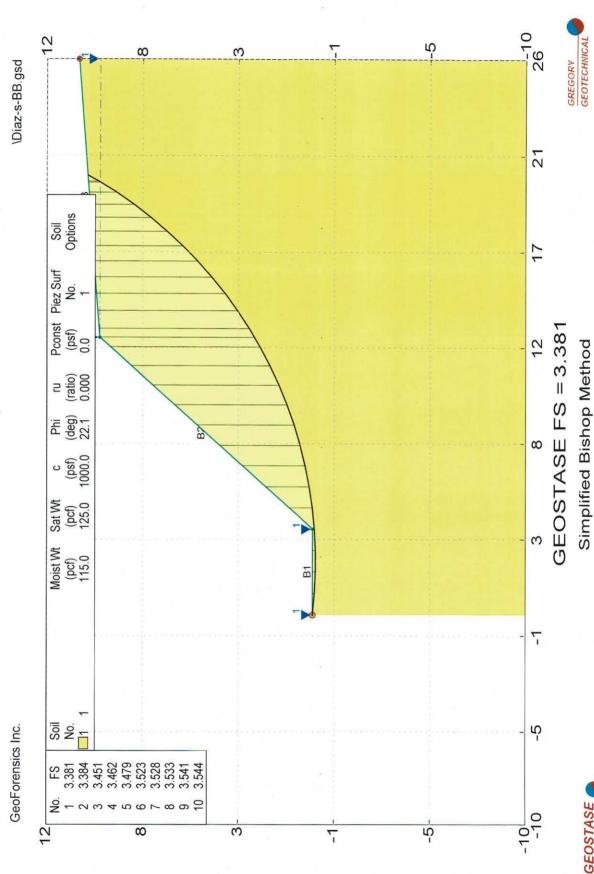
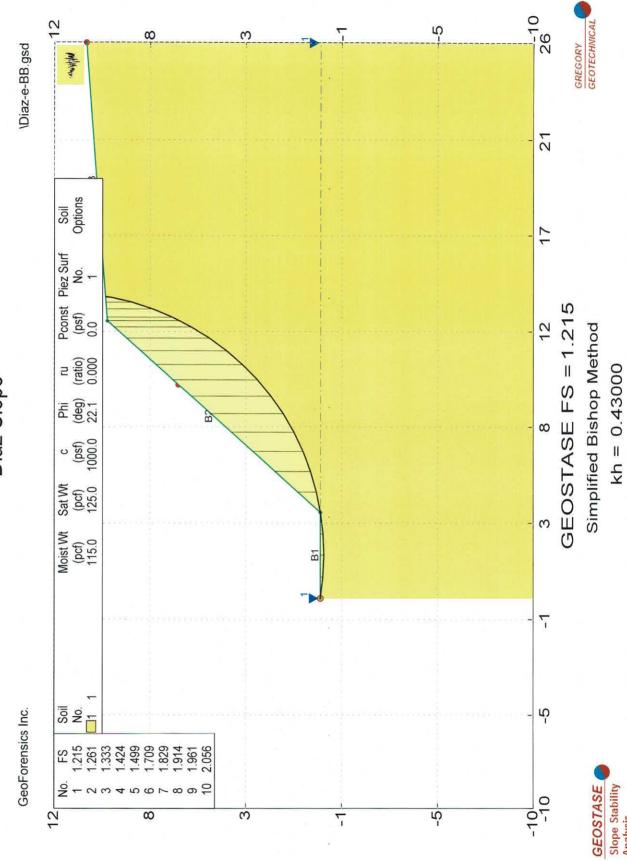
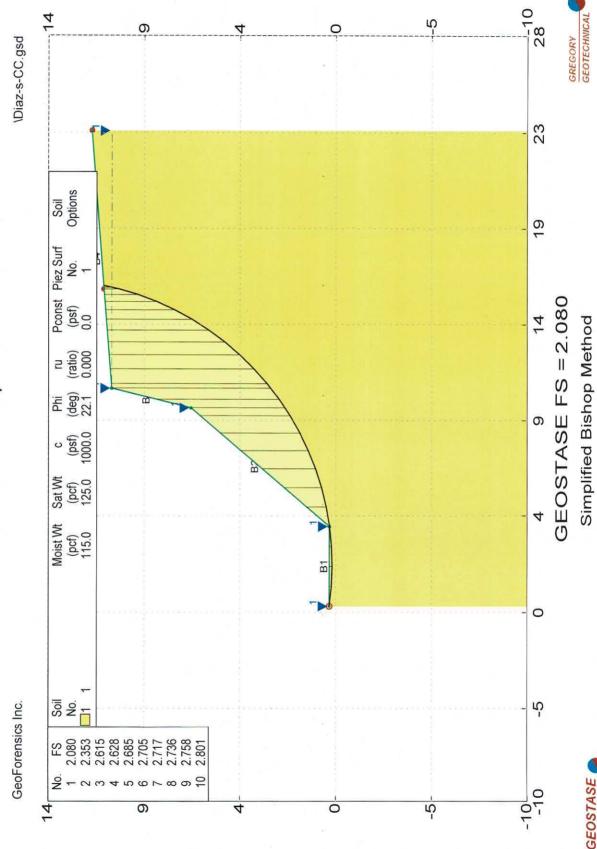
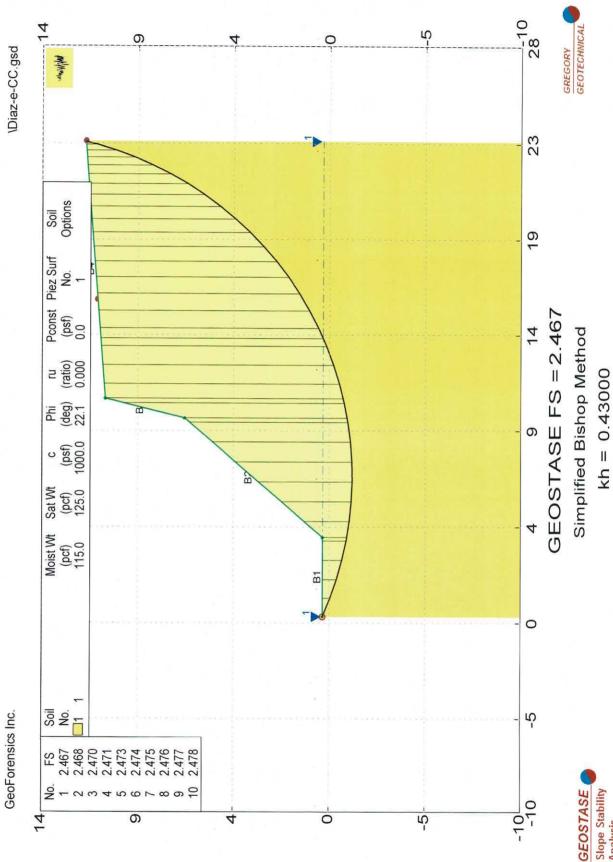
PLATE C.1

Our calculations found that all of the re-analyzed sections of the creek bank have adequate factors of safety for both static as well as seismic conditions. The static factors of safety ranged from 2.0 to 3.4, with seismic factors of safety ranging from 1.2 to 2.4.

Based upon our third slope stability analyses, the creek banks possess adequate slope stability such that there are no restrictions on development from a geotechnical perspective. However, as there is always a potential for shallow sloughing of topsoil materials along creek banks, we would recommend that no shallow improvements (e.g. slabs or spread footing supported elements) be located within 5 feet of the creek bank. Any improvement within this zone may be supported by drilled piers designed in conformance with recommendations from a geotechnical engineer, or our office.
