NORFLEET CONSULTANTS

December 7, 202
NC Proj. No. 201881.61

RE: Stevens Creek Quarry Use Permit and
Reclamation Plan Application
12100 Stevens Canyon Road
Cupertino, CA 95014

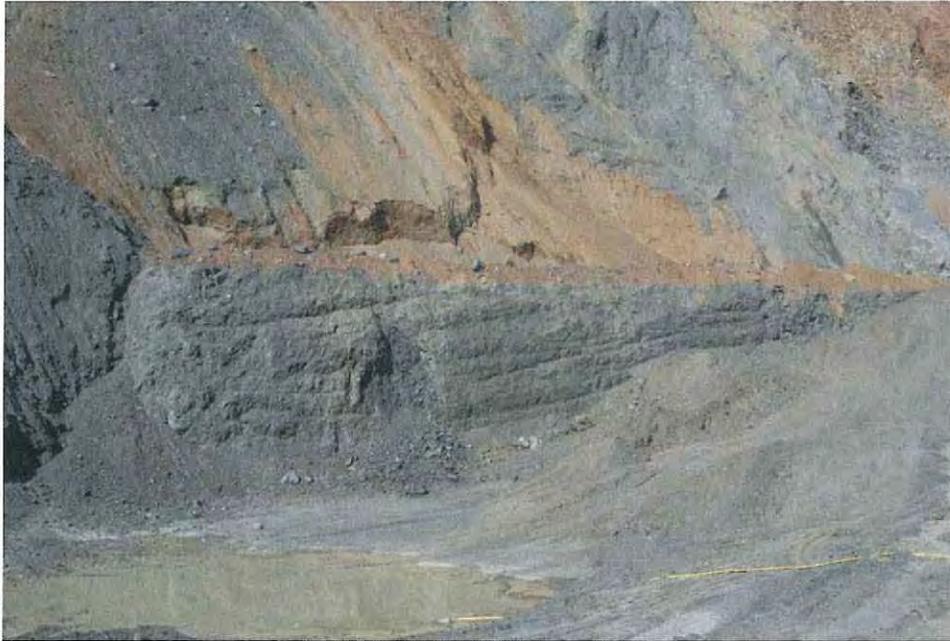
Photo 5: The serpentinite shear zone at the northwest corner of the quarry, looking north. Note the wedge-like failure. Picture 4 is at the far right side of this photograph. The cliff at the wedge-like failure is about 40 feet high.

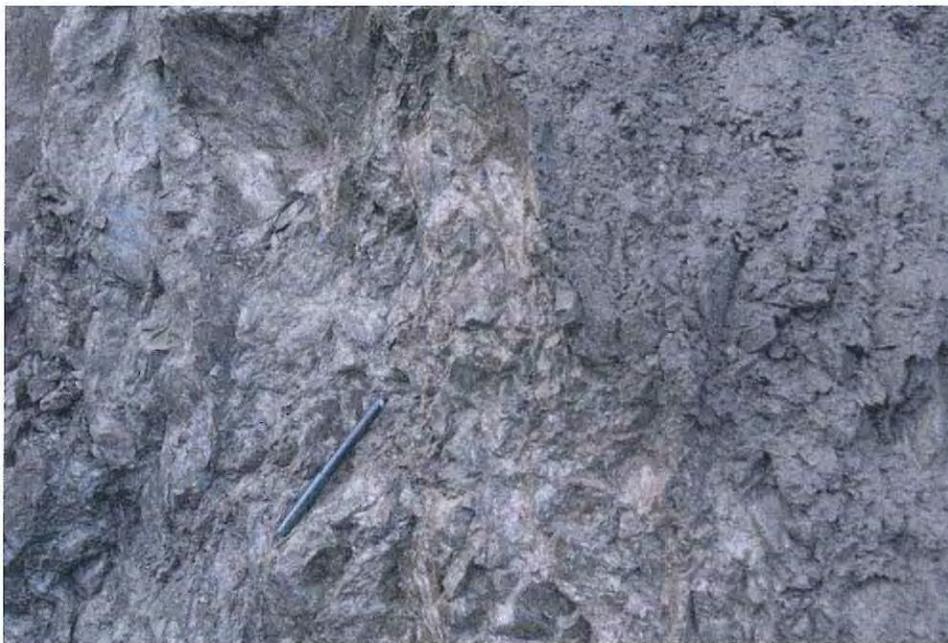
Photo 6: Shearing within the serpentinite wedge zone seen in the previous photograph.

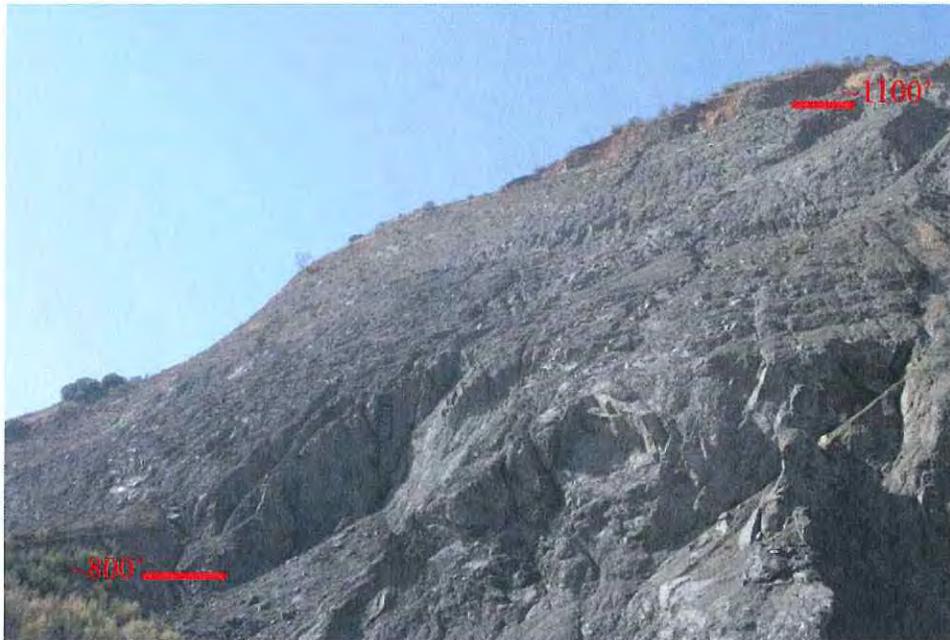
A zone of wedge failures in the unweathered greenstone occurs along the central section of the western face between elevations 750 to 1050¹ feet (Photos 14 and 18). These failures progress upwards to but do not appear to extend into the overlying weathered greenstone. This face trends ~N20E and slopes ~45 degrees east. We measured the failure planes of several of the wedge failures. The basal surface of those failures trends N10W to N20E and dips 45 to 60 degrees south. The dips of joints with a N-S trend and easterly dip in this area were mainly 45 to 60 degrees, but some dipped 25 to 35 degrees. The wedge failures appeared to be restricted to the more competent, less fractured greenstones. They did not extend south into more fractured greenstone (either weathered or unweathered).

Photo 14: Wedge failures in the lower part of the western face.

In the west slope, engineered wedge fill placed as part of the reclamation plan will extend to between 1000 and 1050 feet elevation, and much of the current zone of wedge failures will be covered and buttressed with fill. The western face final rock slope above the fill will dip approximately 32 degrees east (1.5:1). It appears at this time that the dip of basal planes of the current wedge failures will not daylight in the final rock slope.

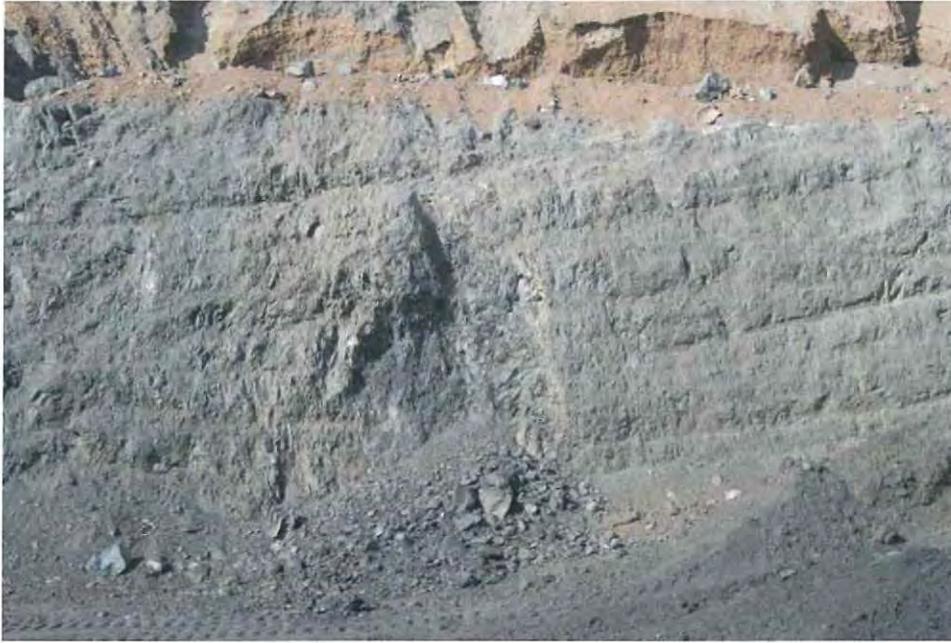
In outcrop scale, the overall shear trend in the exposed face is N25-30W with a high dip (~80 degrees east/west). The eastern end of the face contains fracture-bound angular greenstone blocks (6 inches to a few feet in size), while the western end of the face is highly sheared serpentine that contains numerous greenish pods in a black matrix. The pods are football shaped that are few inches to a few feet long. The long axes are sub-parallel to the overall shear strike direction. The pods do not appear to be significantly stronger than the surrounding matrix. We picked up a pod that was about 2 feet long by the ends. After a few minutes, the pod fell apart under its own weight along internal fractures. The pods and matrix can easily be broken apart with a rock hammer. The cut face is perpendicular to the overall shear trend and is a few months old. The face is failing by localized wedge failures and face spalling (Photos 15). There is no evidence of large-scale arcuate failures.

Photo 15: An apparent wedge failure in the shear zone in the northwest corner of the quarry. This is, instead, a spalling failure. A narrow zone along a vertical shear plane began to fail. There was then progressive spalling laterally away from the shear. The cliff at the wedge failure is about 40 feet high.

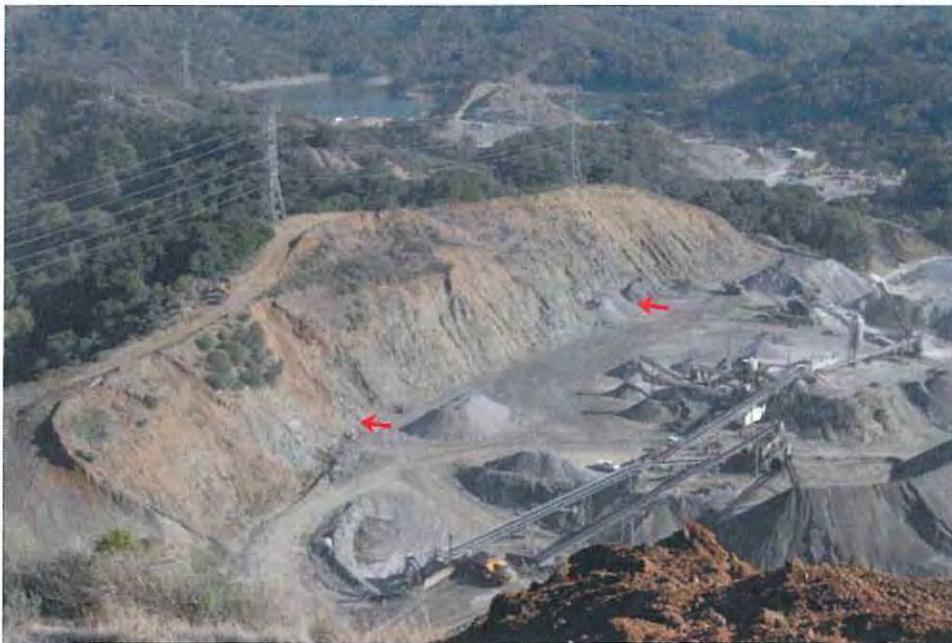
There are failures in weathered bedrock along the eastern cut slope of the quarry (Photo 16). That cut slope varies from 30 to 60 feet high and is 20 to 45 years old. The face trends ~N15W and slopes 45 to 55 degrees west. This face is quasi-parallel to and several hundred feet west of the trace of the Berrocal fault. The middle part of the face contains a series of landslides (both circular and planar failure surfaces; Photo 21). The area adjacent to the toe of this slope is used for temporary rock storage. The toe of this slope is routinely destabilized (a minor amount) by equipment as the stored material is removed.

Photo 16: The east face (weathered greenstone). The arrows indicate landslides where machinery has removed the toe of the slope and caused landslides (see photograph 21). The Berrocal fault is semi-parallel to and just on the other (east) side of the power lines.

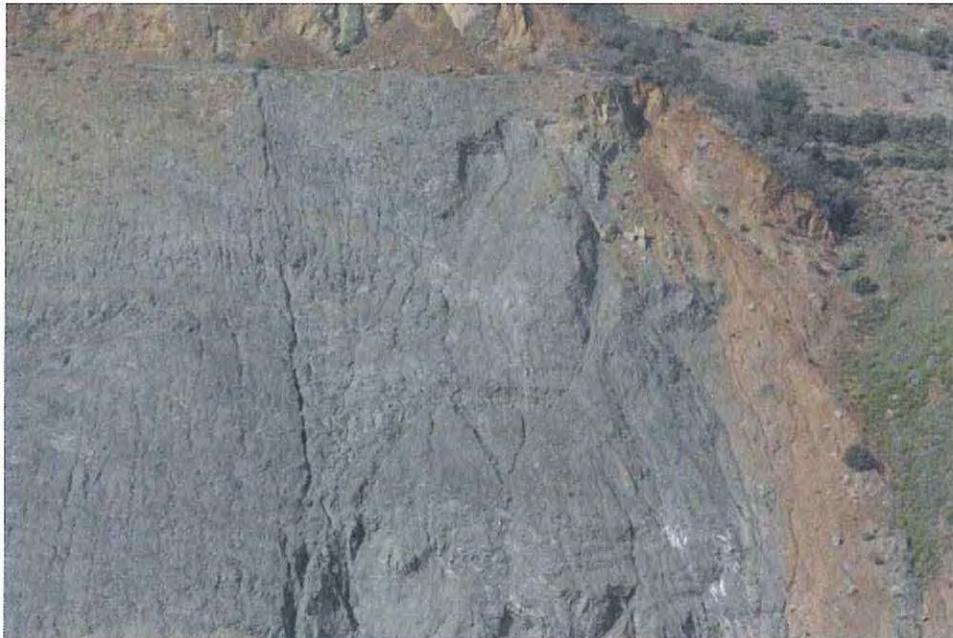
Photo 18: Wedge failure in the lower part of the western face.

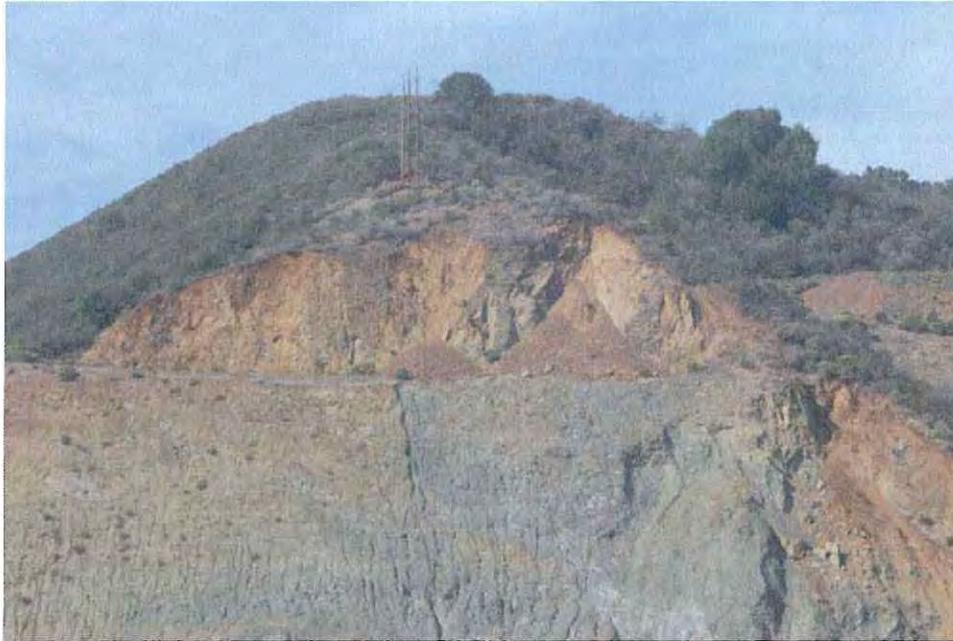
There are partial failures of the weathered greenstone face in the high bench in the western slope (Photo 19). The face is about 40 feet high, slopes about 75 degrees east, and trends north-south. There is a series of shears that trend east-west across that face. The shears are semi-vertical and are spaced 10 to 20 feet apart. There were several failures in the cut slope. It appears that these failures began with spalling of fractured rocks within the shear zone itself and progressively widened laterally (Photo 20). There was no obvious classical wedge failure or global failure of the cut face. The cut face in this bench more than 17 years old. The cut face below the bench is 7 to 8 years old.

Photo 19: The upper bench in the west face. Note the localized failures. This face is more than 17 years old.

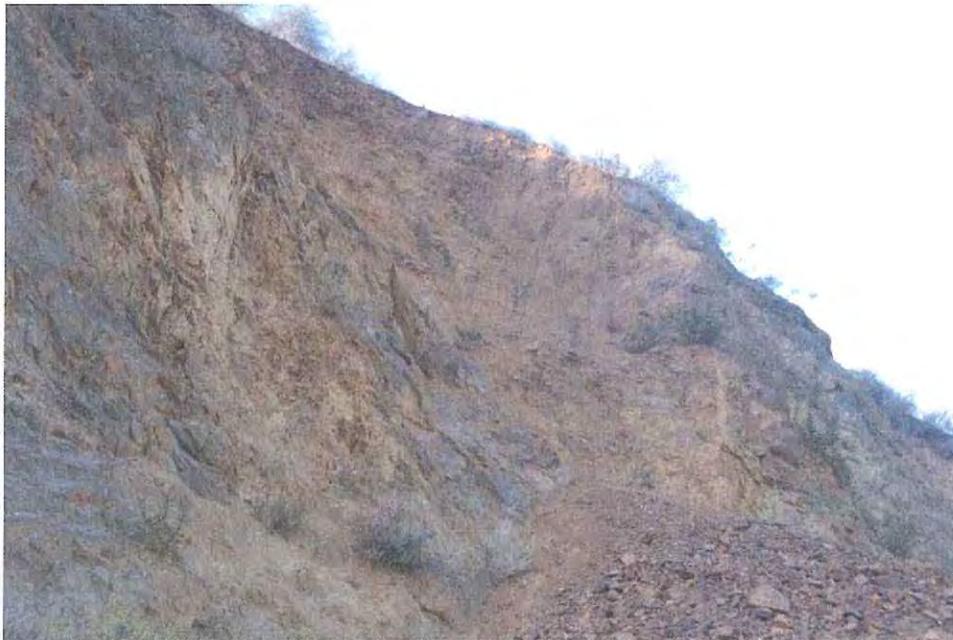
Photo 20: The failure in the middle of the upper bench. This is a progressive spalling failure rather than a wedge failure. Note the small size of the debris. This face is about 40 feet high.

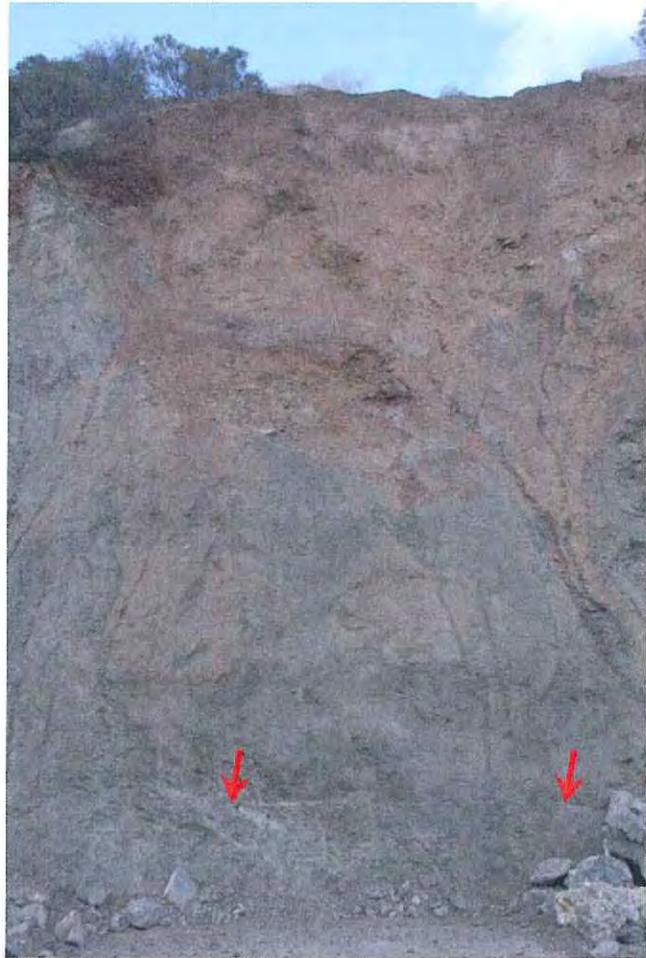
Photo 21: A landslide in the middle of the eastern face. The left arrow in photograph 16 shows its location. The lower arrows in this photograph mark the slide plane of the landslide that has been exposed by machinery as spoil piles were removed.

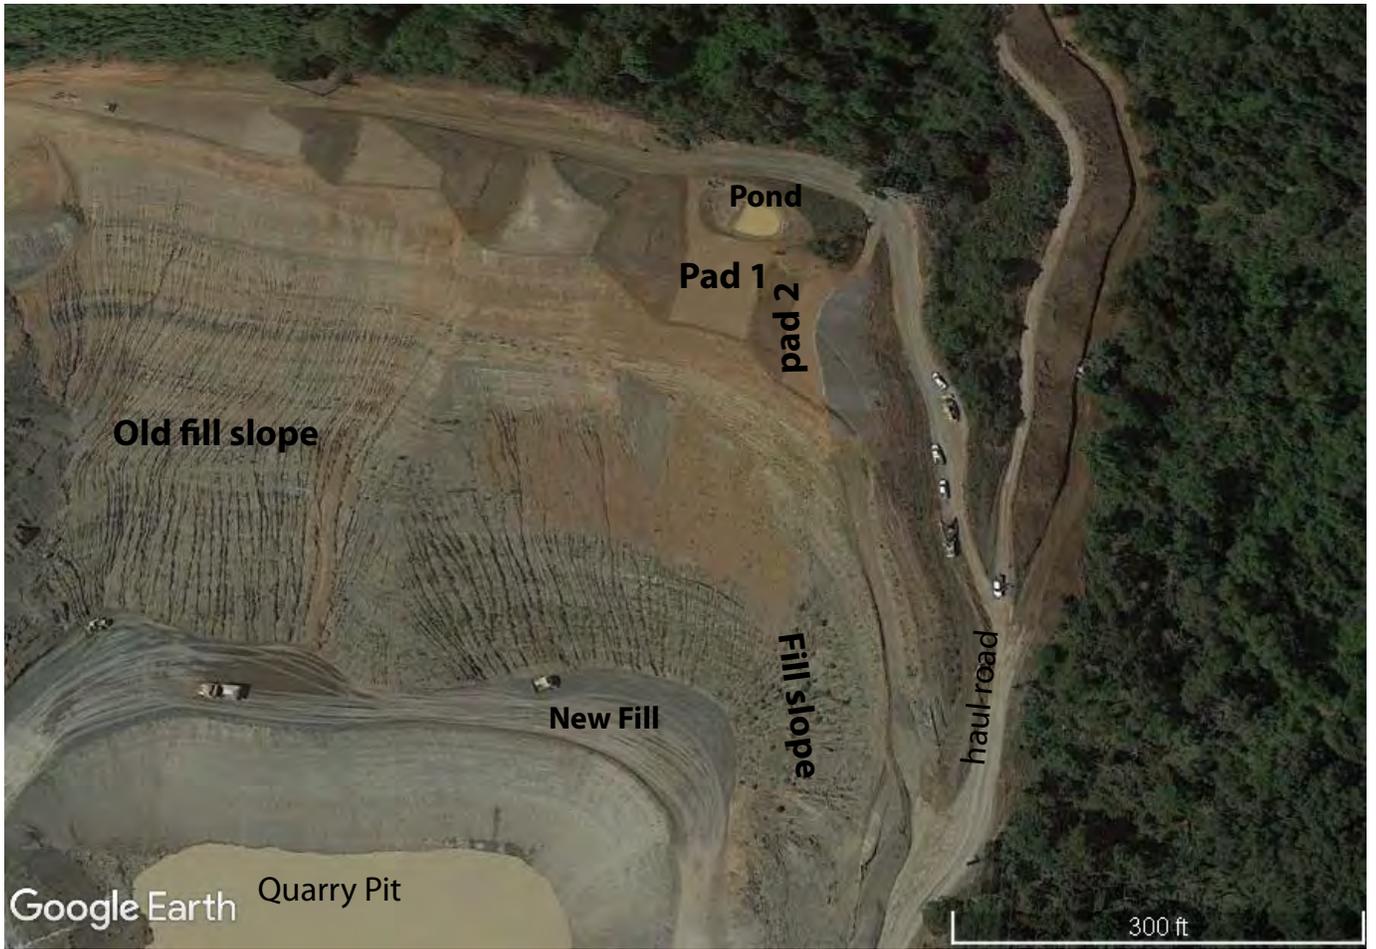
The quarry has deepened. Fractures have developed along the south edges of pads 1 and 2 (see next figures).

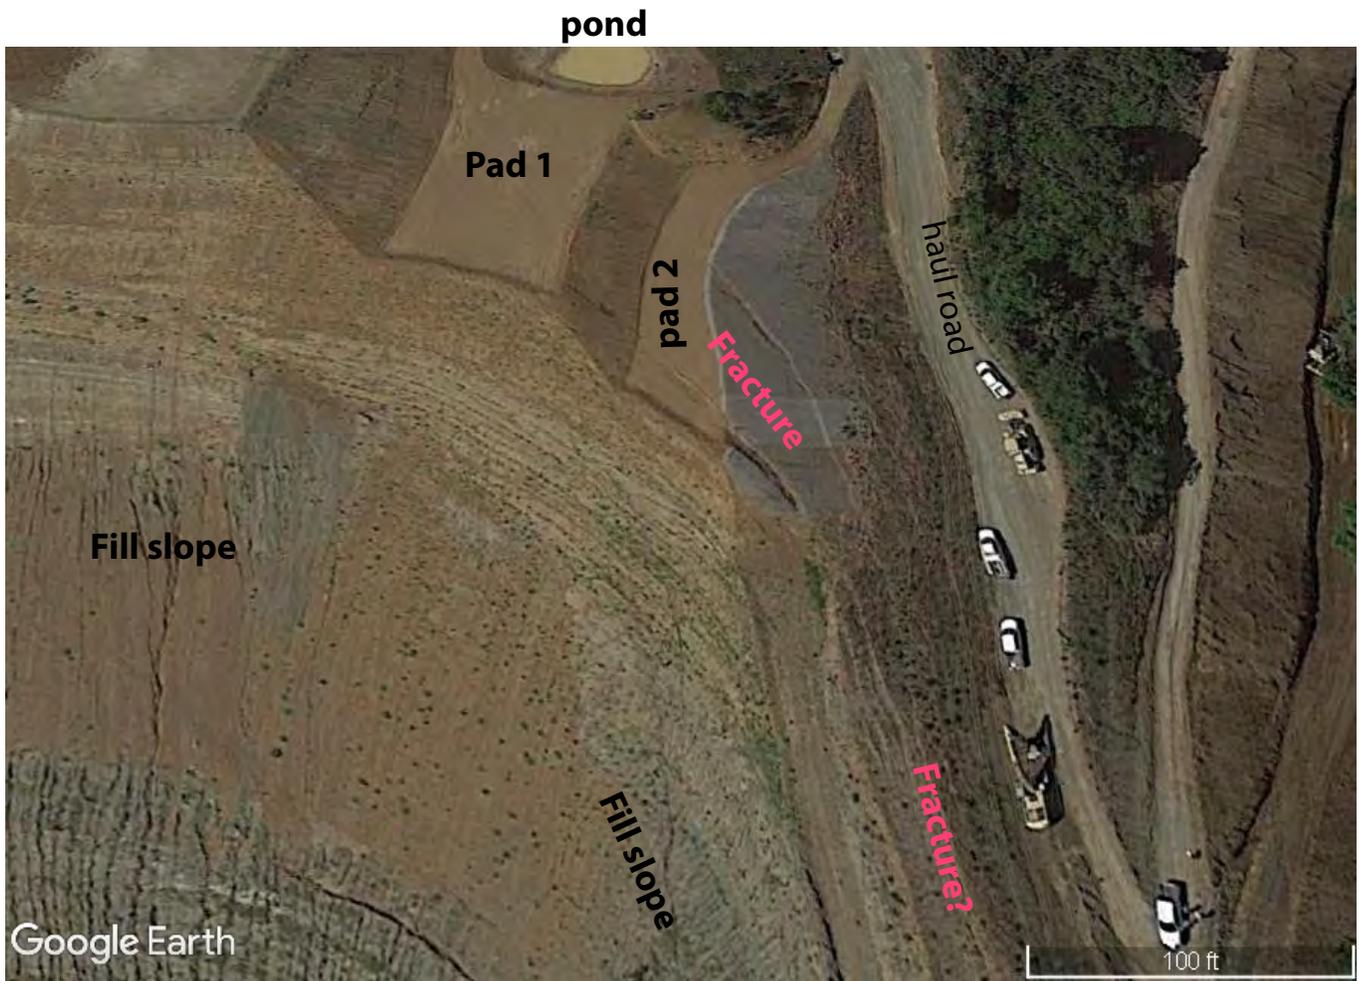
This is an enlargement of the photograph in figure 9. The fractures extend from the east side of Pad 1, across Pad 2 and curve south along the top of the east fill prism. The northern end of of the two fractures is easy to see, but their southern extent is unclear (hence the ?).

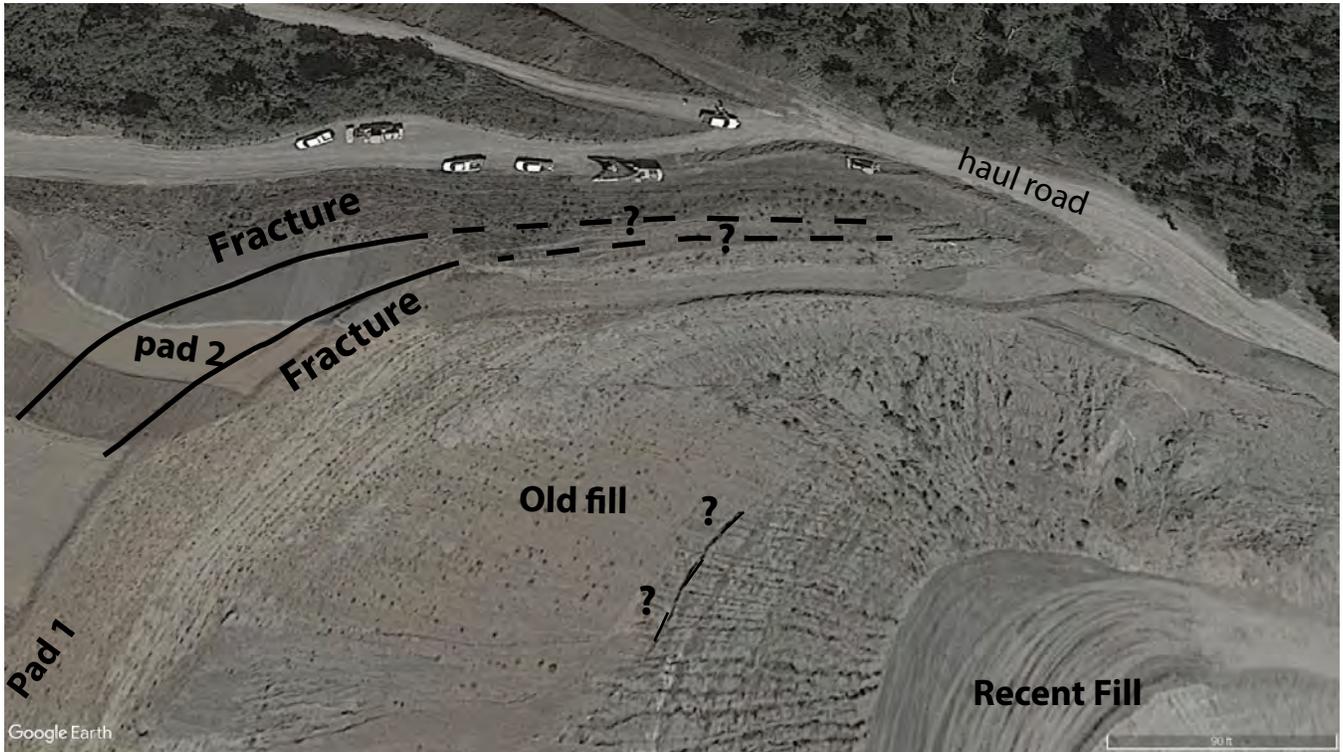
This is an oblique view of the Figure 9a photograph. The fracture traces are shown (dashed where uncertain). There may be a fracture in the fill face at the approximate location of the future fill face landslide.

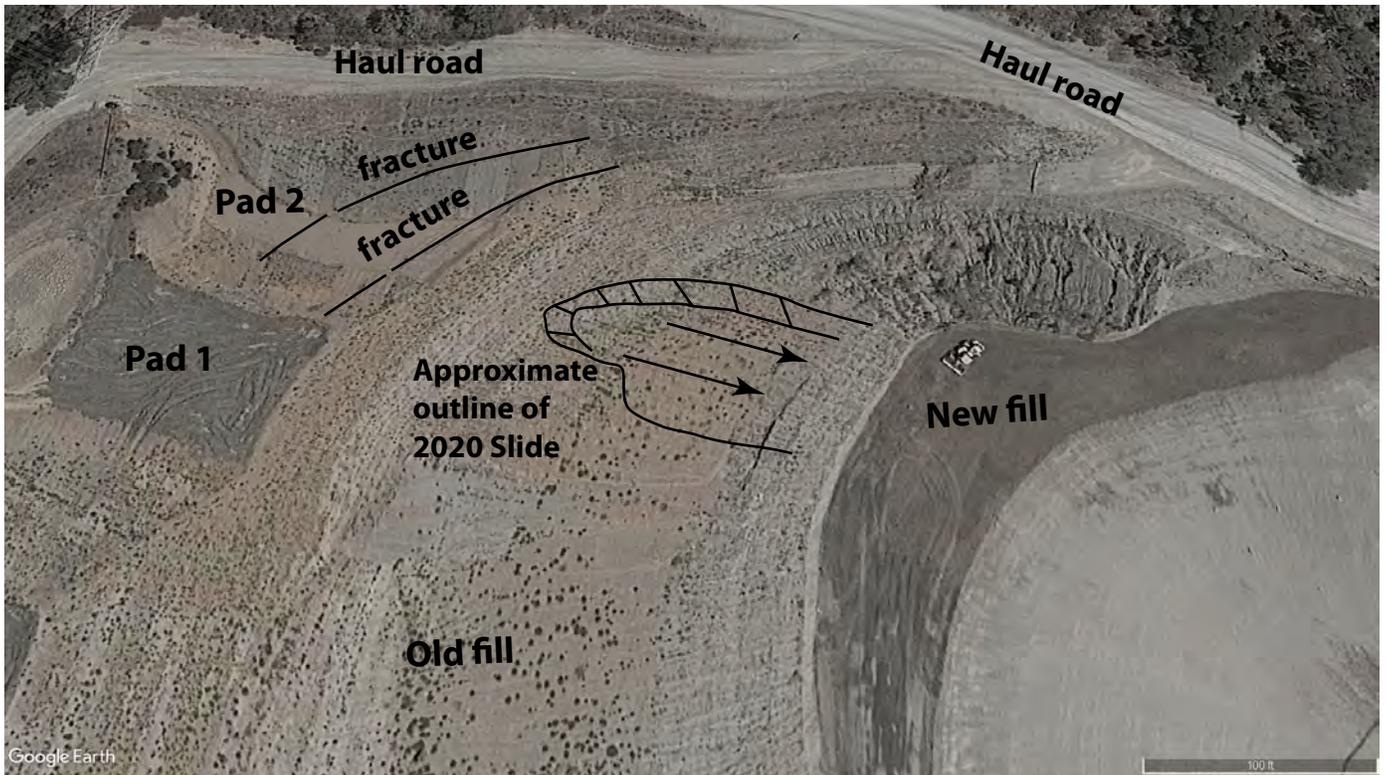
This is the most recent photograph on Google Earth. The approximate location and size of the currently visible landslide on the fill face is shown. I observed that landslide in May, 2019. See Figures 2 and 3.

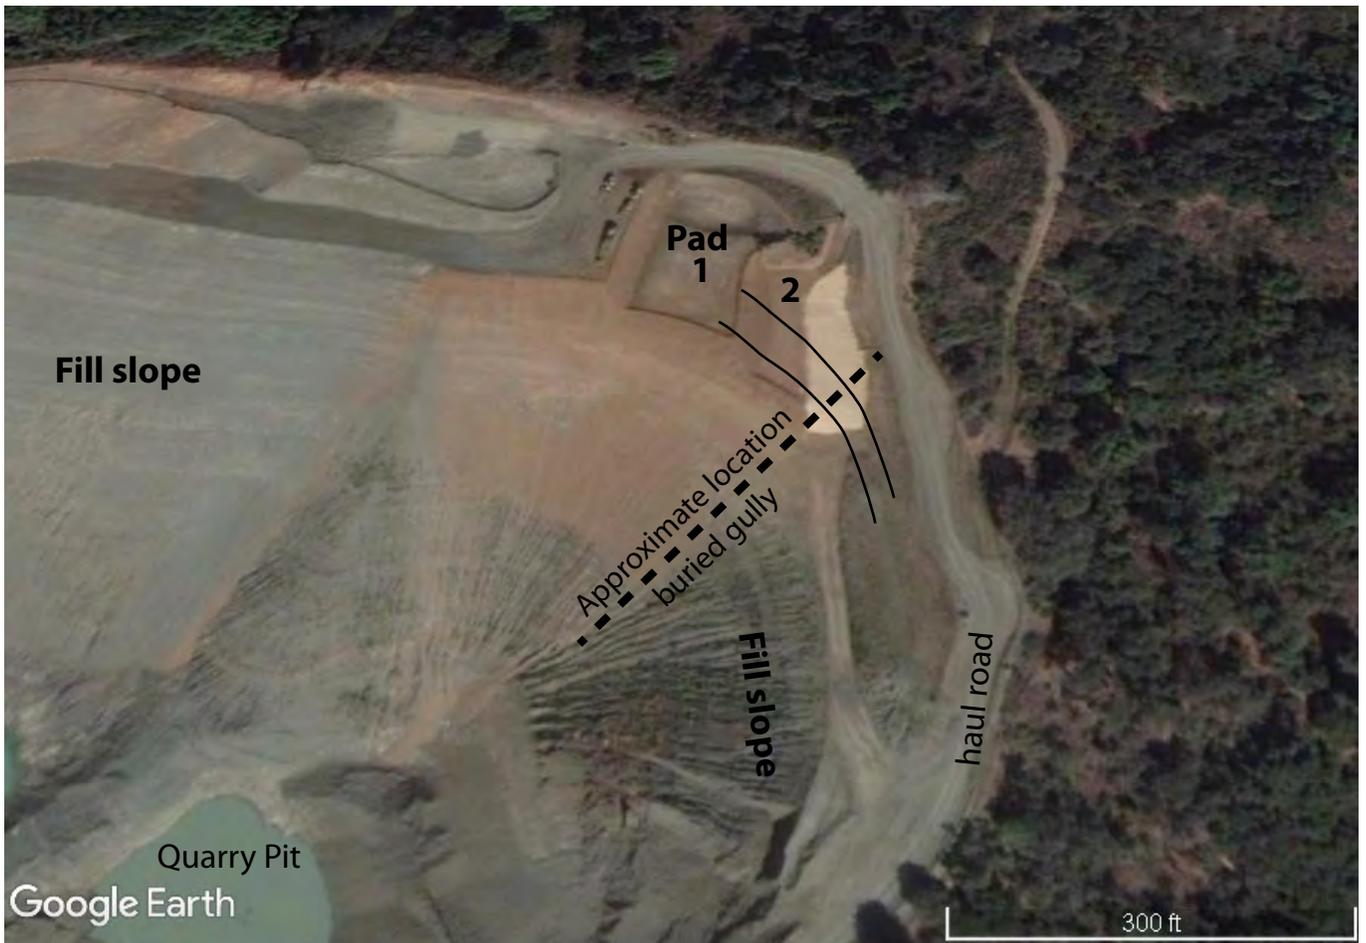
These are the physical relationships just prior to when the fractures formed (winter of 2017-18). The fractures occurred at the crest of the slope and define the zone of movement. The fill above the buried gully is at its the thickest when compared to either side (see Figure 2). This section of the face also has its steepest historical slope because fill was removed from the base of this slope (compare with Figure 6).

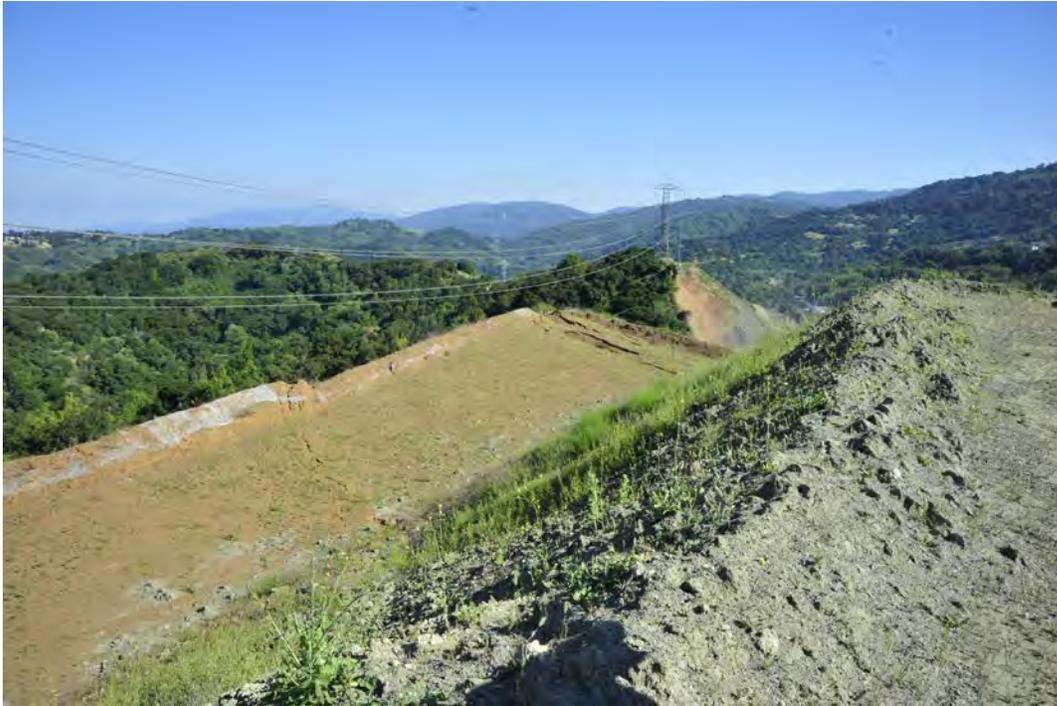
Photograph 7. Pad 2 as viewed from Pad 1. Ground cracks are visible at the south end of Pad 2.

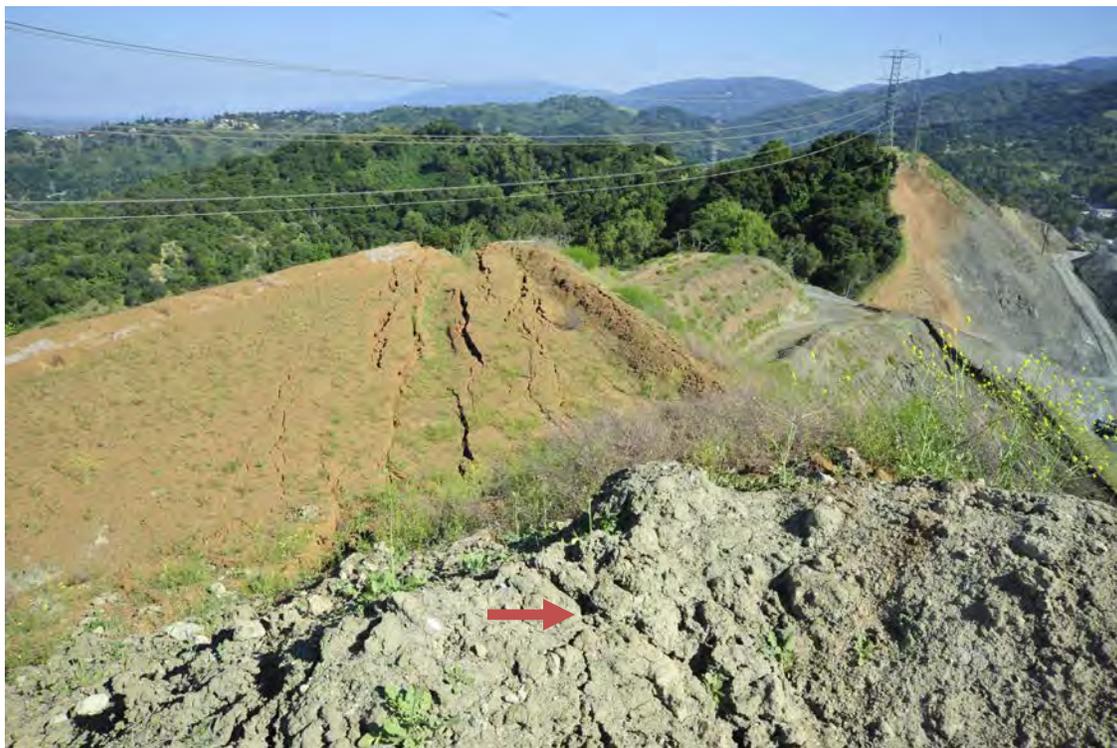
Photograph 8. Ground cracks at the south end of Pad 2 (visible in Photo 7). Looking from Pad 1 (foreground). The cracks extend into Pad 1 (arrow).

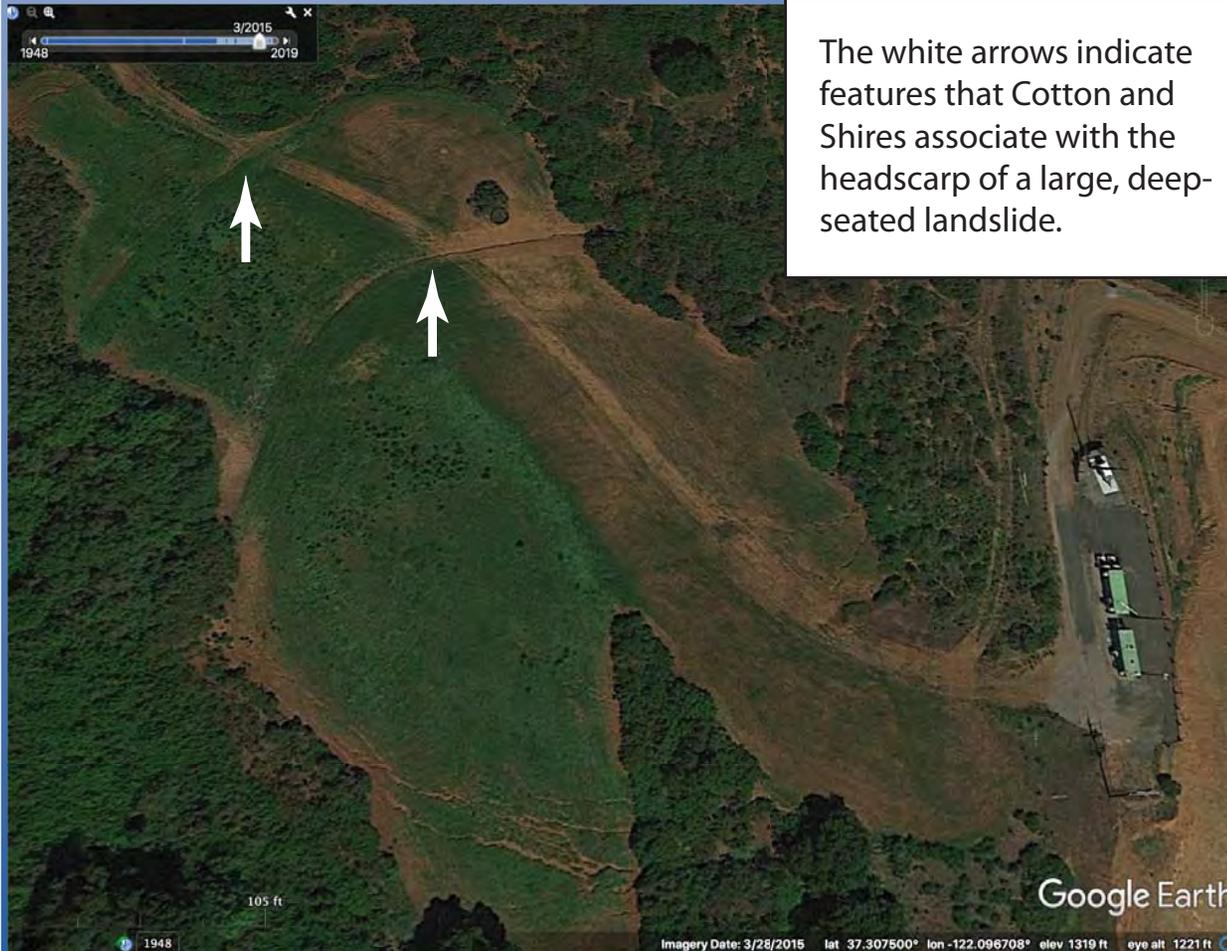
The white arrows indicate features that Cotton and Shires associate with the headscarp of a large, deep-seated landslide.
