July 29, 2022

File No.: 303659-001

PROJECT: LANDS OF BOURDET –STOCK PONDS
PACHECO PASS HIGHWAY, APN 898-19-005
SANTA CLARA COUNTY, CALIFORNIA

SUBJECT: Qualitative Evaluation of Past Performance of Stock Pond Stability

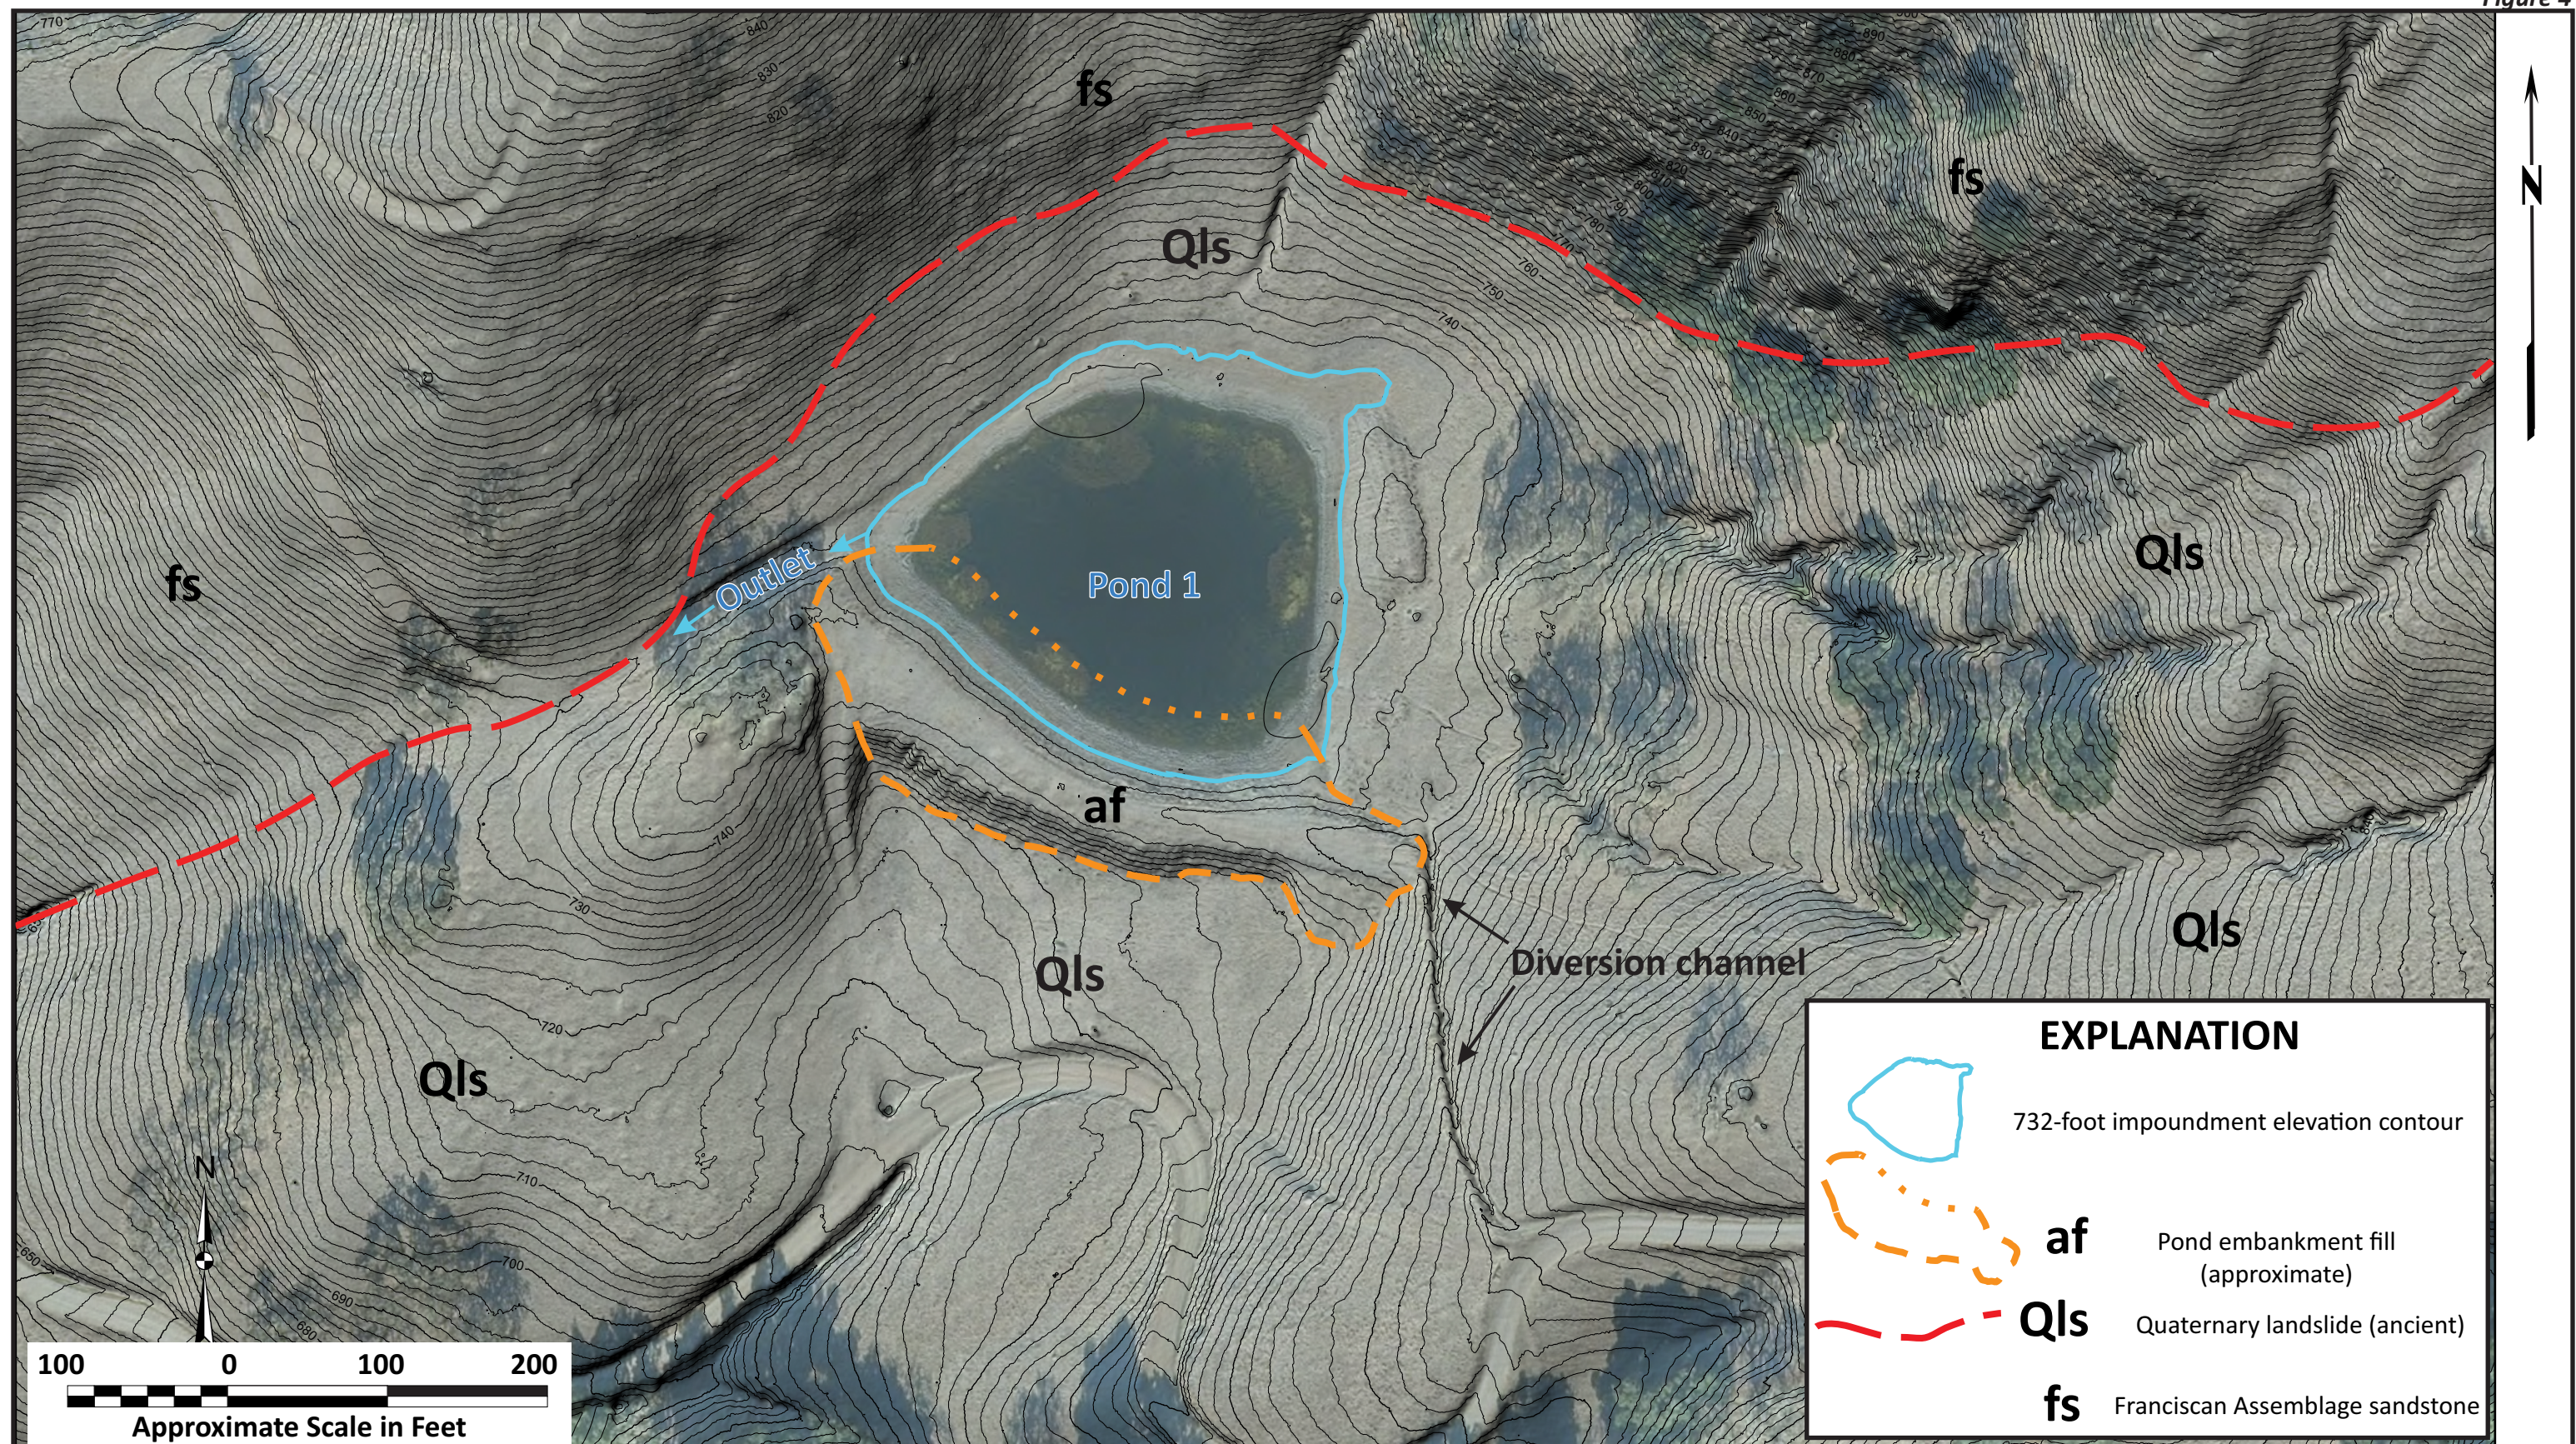
The Pond 1 embankment spans approximately 380 feet across a broad swale with a relatively flat floor. The embankment is approximately 16 feet high at the western end and approximately 10 feet high at the eastern end based on the 2020 LiDAR elevations, measured from the outboard toe to the crest. The outboard (south) face of the embankment is inclined between 32 and 34 degrees. The crest elevation ranges from 736 to 740 feet. An outlet is graded into a pre-existing topographic saddle at the west end of the pond. The outlet elevation is approximately 733 feet (interpolated between the 732 and 734 elevation contours). The 732 elevation contour is traced in blue on Figure 4 to illustrate the approximate maximum impoundment elevation of the pond.

The pond embankment materials consist of clayey gravels composed of the same Franciscan Assemblage shale and sandstone lithologies observed in outcrops and road cut exposures across the greater ranch property. Rilling (erosion) observed in the 2017 photos is present along the front face of the embankment and is most pronounced in the western half. Rilling channels are up to 2 feet deep and 1-3 feet across. The rilling extends only a few feet northward into the crest of the embankment and appears to be restricted to the side-cast fills placed in 2013 and 2015. The top of the embankment in this area slopes gently to the south. As such, we interpret the

rilling to be caused by precipitation runoff from the wide crest of the embankment flowing southward onto the front face during the wet winter of 2017. The rilling could not have been caused by overtopping of the embankment, as the outlet elevation (733 feet) is at least 3 feet lower than the crest (736 feet). No signs of leakage were observed on the front face of the pond embankment or on the native ground surface in front of it. The relatively flat to gently inclined floor of the swale to the south of the embankment shows not signs of erosion or channeling, and no established drainage channel was observed. No adverse signs of erosion were observed associated with the outlet.

The diversion channel identified in the 2013 photos that conveys runoff from the eastern end of the S-curve in the road into the pond is still present. The channel ranges from 2 feet deep near the road to 5 feet deep at the northern end and is approximately 3 to 5 feet wide. The channel is incised into highly variable Franciscan Assemblage mélange composed of sheared sandstone and shale with hard boulder size blocks of more competent rock, all of which is mapped as ancient landslide debris. Slope failures were observed in the east channel wall. The channel skirts the east end of the pond embankment, and embankment fill may be exposed in the west channel wall at this location.

The diversion channel that conveys runoff from the eastern end of the S-curve in the road into the pond appears to skirt the east end of the pond embankment, and embankment fill may be exposed in the west channel wall at this location. As such, it is our opinion that the diversion channel could erode the pond embankment and therefore presents a hazard to long-term stability of the pond. We recommend that the channel be removed and the hillside restored.

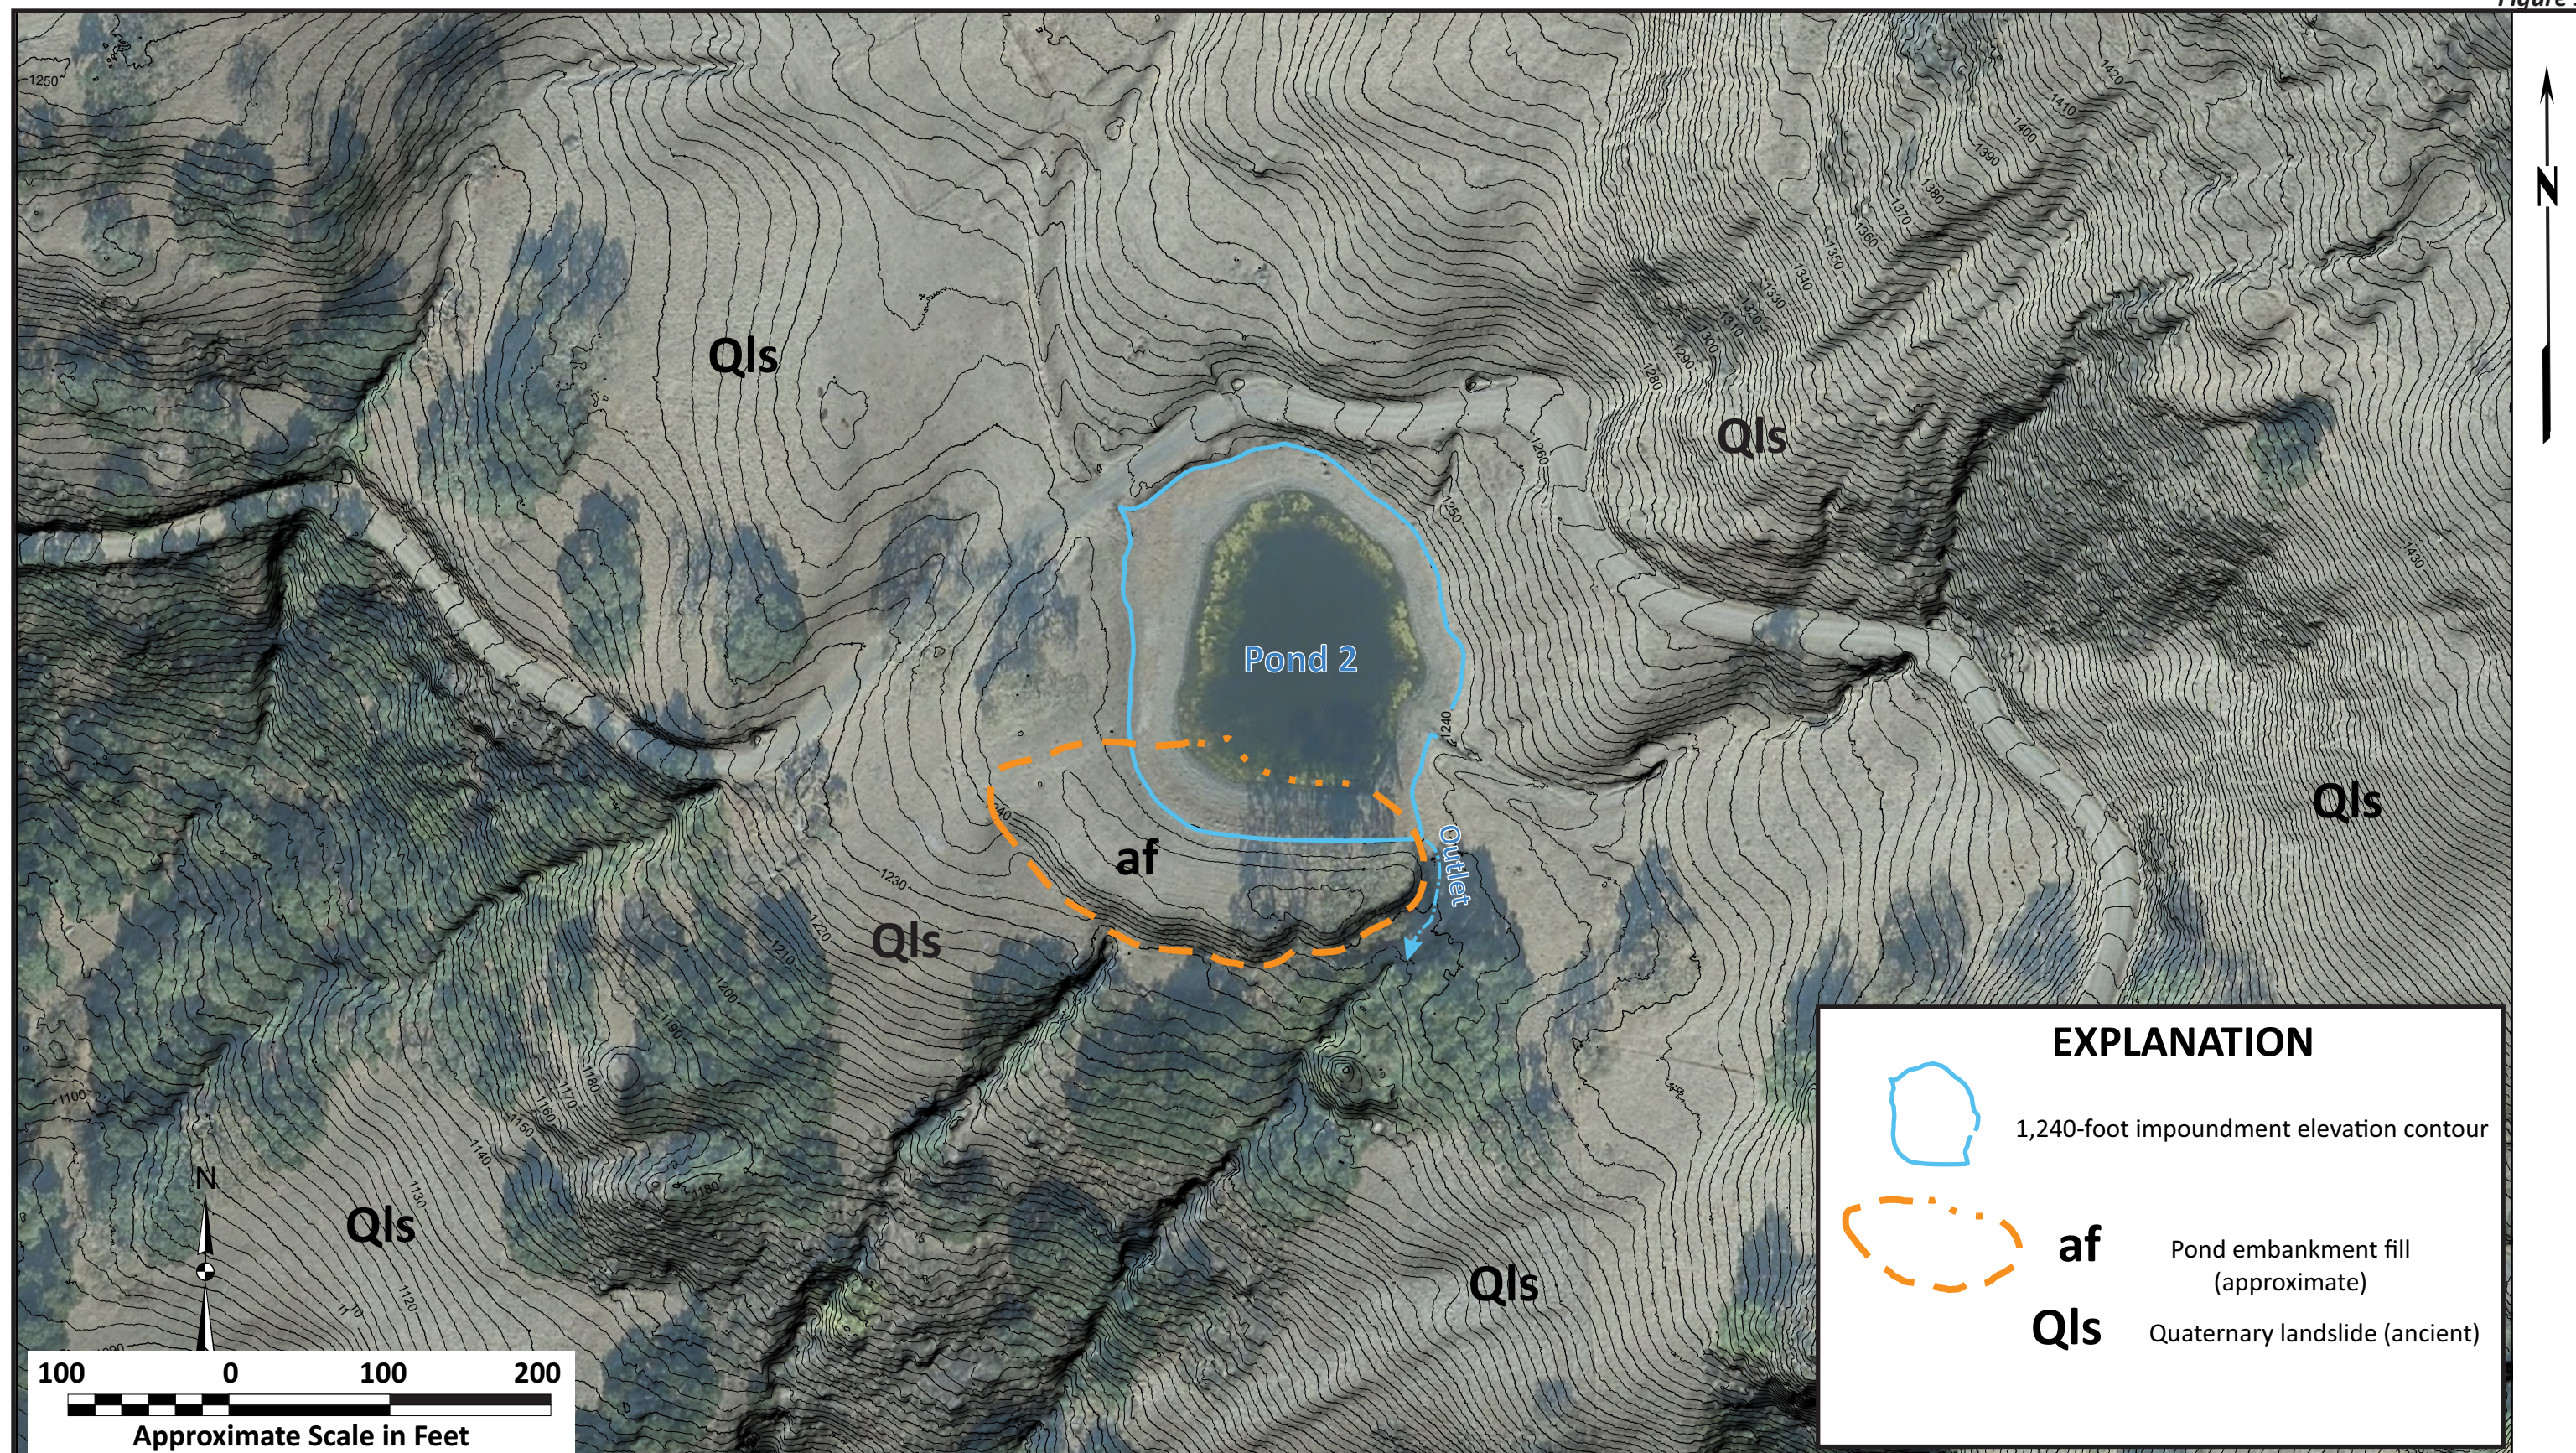
The Pond 2 embankment spans approximately 300 feet, measured at the outboard toe of the embankment. The Pond 2 embankment appears to have been constructed across a broad, gently-inclined swale with a natural v-shaped channel incised in the middle. The embankment is approximately 14 feet high in the middle, and 6 to 10 feet high at either end based on the 2020 LiDAR elevations, measured from the outboard toe to the crest. The outboard (south) face of the embankment is inclined between 31 and 34 degrees. The crest elevation ranges from 1,244 to

1,246 feet. An outlet approximately 10 feet wide and 1 to 2 feet deep is graded across flat ground around the east end of the embankment. The outlet elevation is approximately 1,240 feet. The 1,240 foot elevation contour is traced in blue on Figure 5 to illustrate the approximate maximum impoundment elevation of the pond. The outlet conveys water into a pre-existing (natural) incised drainage parallel to the one that was dammed to form the pond. The drainage at this point is well armored with massive outcropping of hard rock, and no adverse signs of erosion were observed associated with the outlet.

The pond embankment materials consist of clayey gravels composed of the same Franciscan Assemblage shale and sandstone lithologies observed in outcrops and road cut exposures across the greater ranch property. Minor rilling (erosion) was observed on the front face of the side-cast fills placed in 2013 and does not encroach onto the wide crest of the embankment. Small, rounded mounds of soil at the base of the embankment suggest that minor slumping of the fills occurred, likely during the rainy winter of 2017. The top of the embankment is generally flat. No signs of leakage were observed on the front face of the pond embankment, on the native ground surface in front of it, or in the original v-shaped drainage channel. We did not observe any signs of instability on or adjacent to the Pond 2 embankment. Several mature oak trees are growing on the eastern portion of the embankment. Two of the trees, located on the outboard side of the embankment, have fallen. The downed trees do not appear to have adversely impacted the embankment.

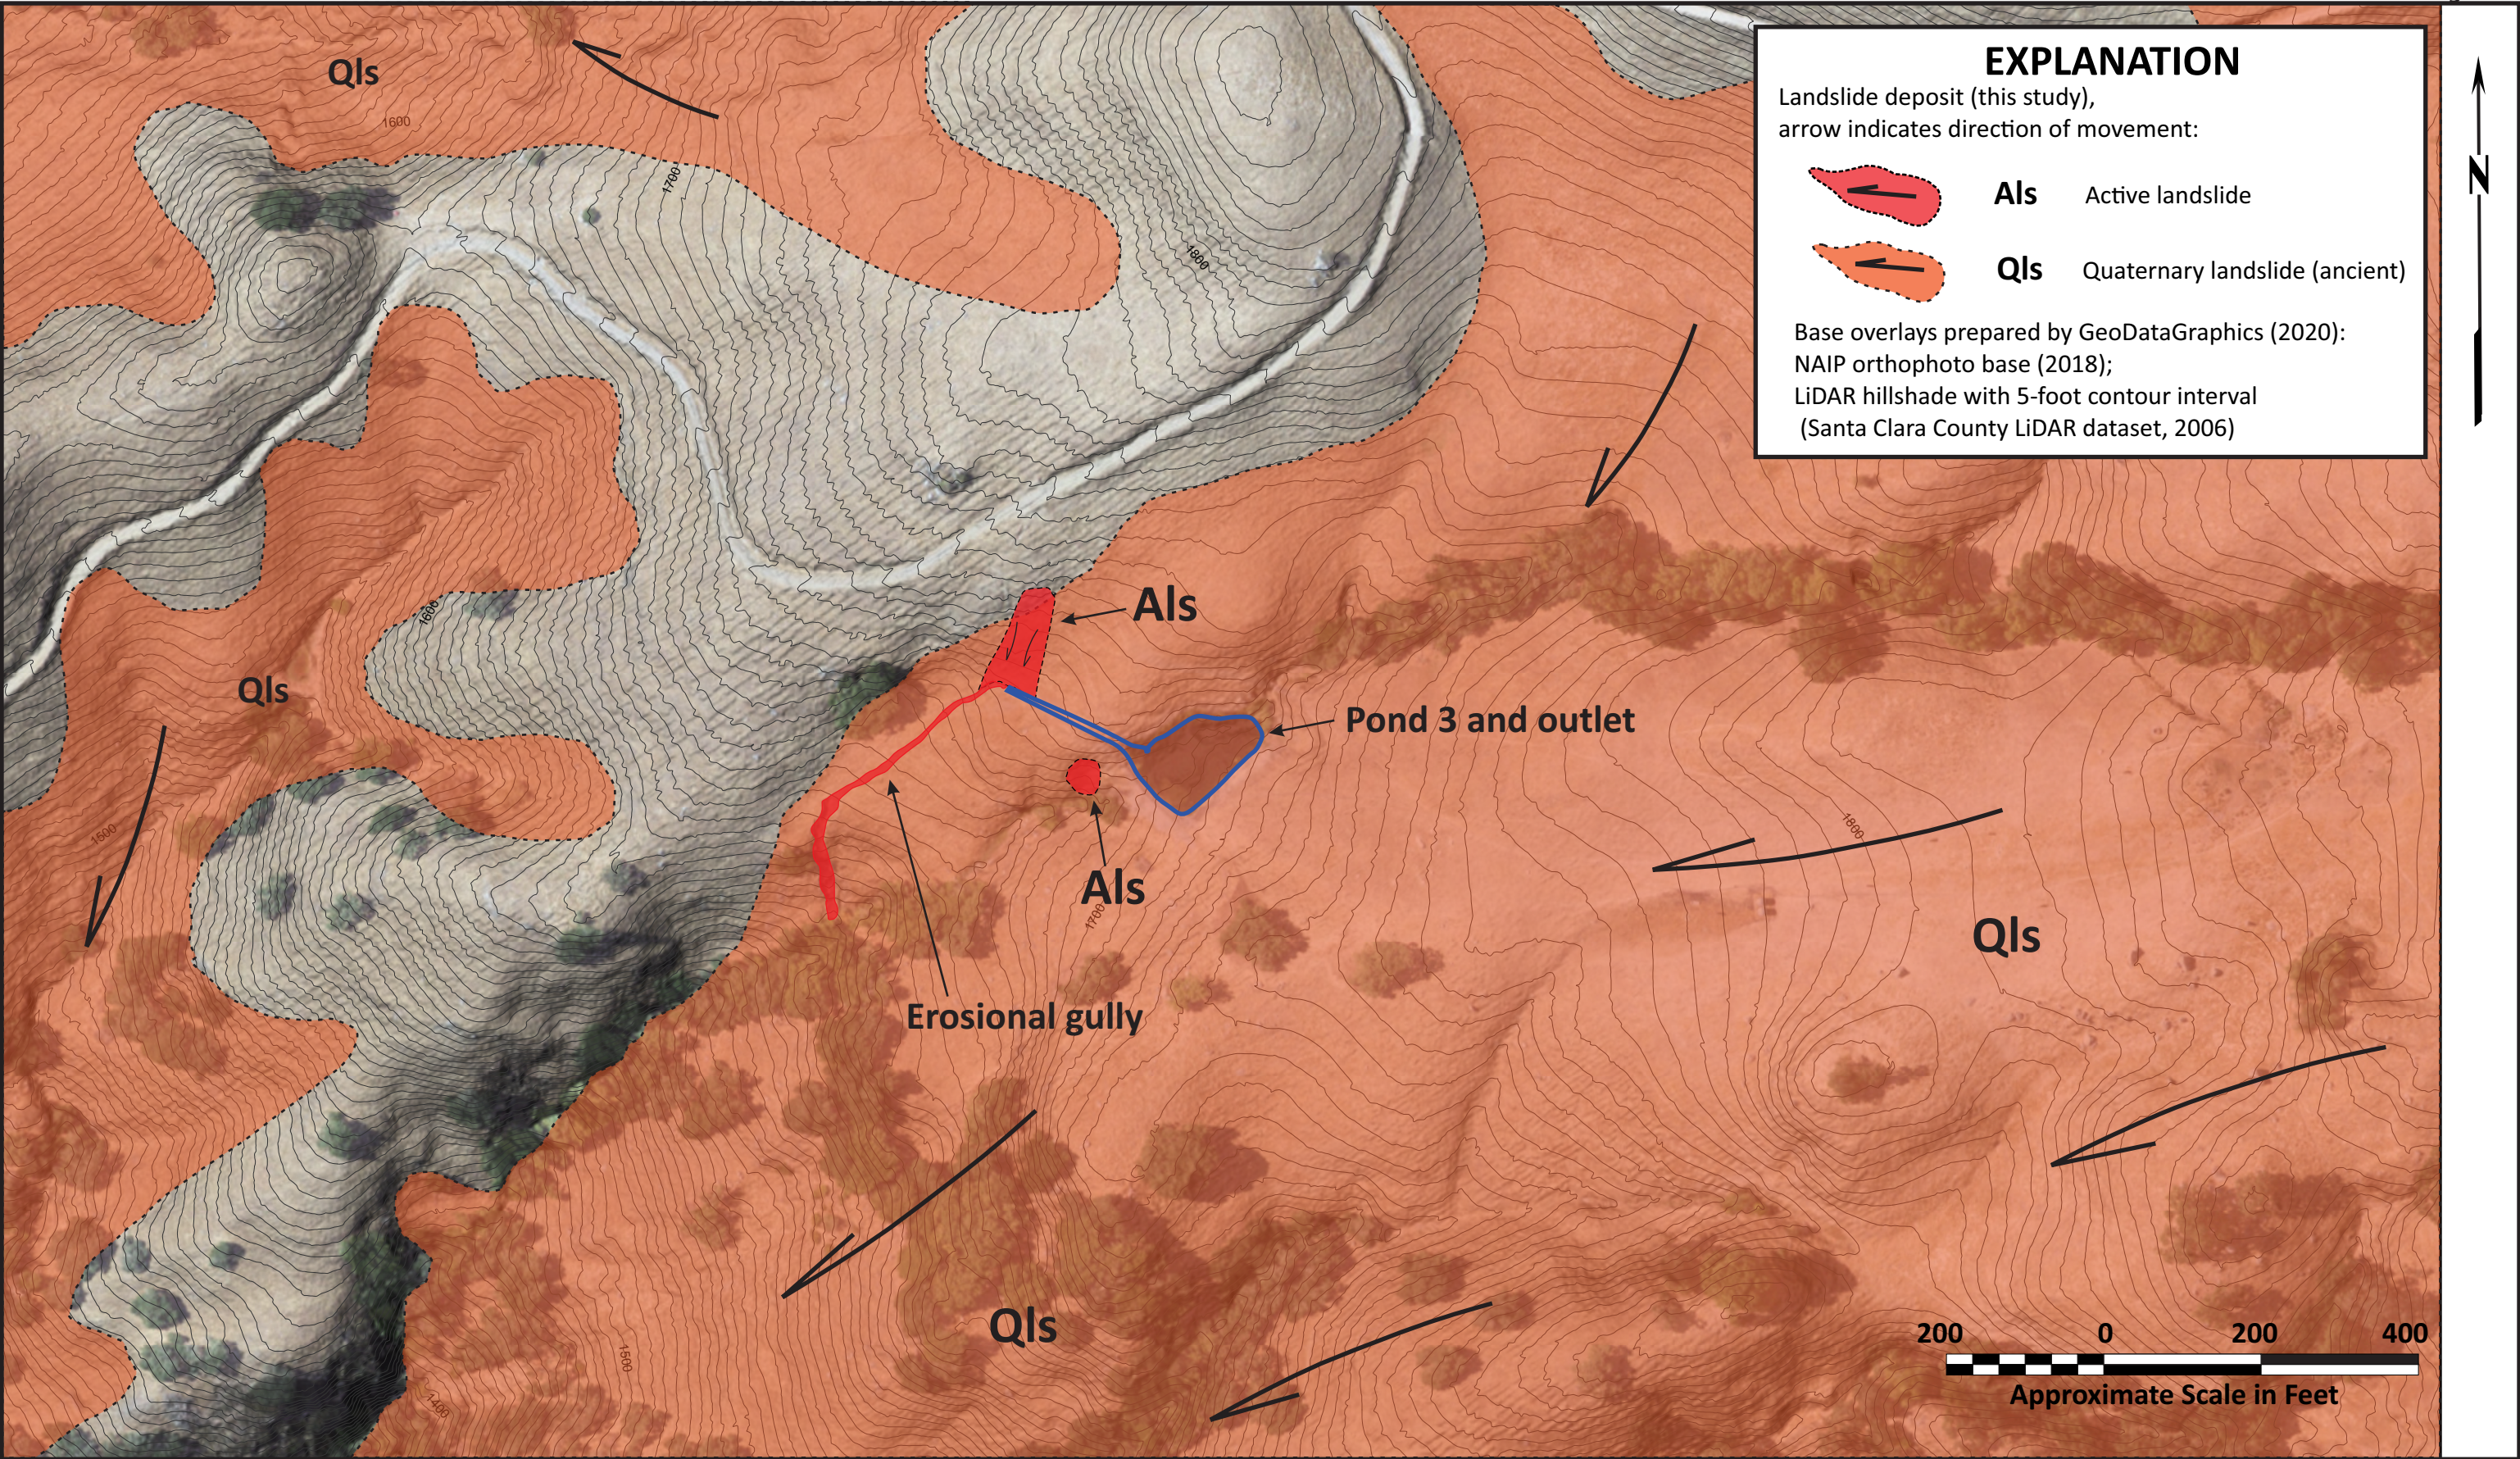
Figure 6

On July 22, 2022 we also re-visited Pond 3 to look for any changes that have occurred since our previous visit in February 2020. Our 2020 mapping of the Pond 3 area is included for reference (Figure 6).

The erosional gully downslope of the outlet appears to have widened and deepened. The slope above the confluence of the gully with the original drainage shows signs of incipient landsliding. Likewise, the active landslide (Als) that developed upslope (north) of the pond outlet appears to have enlarged and advanced further north toward the access road. Part of the landslide mass was wet, and a section of orange 3-inch pipe was exposed within the landslide mass. The small active landslide (Als) on the north bank of the drainage at the toe of the pond embankment has enlarged and is seeping water. This landslide is beginning to undermine the pond embankment.

As noted during our July 22, 2022 reconnaissance, erosion and landsliding in the area of Pond 3 has continued to expand since our April 2020 report was prepared. Active landslides threaten the pond embankment and the access road. As such we maintain our previous recommendation that Pond 3 be removed.

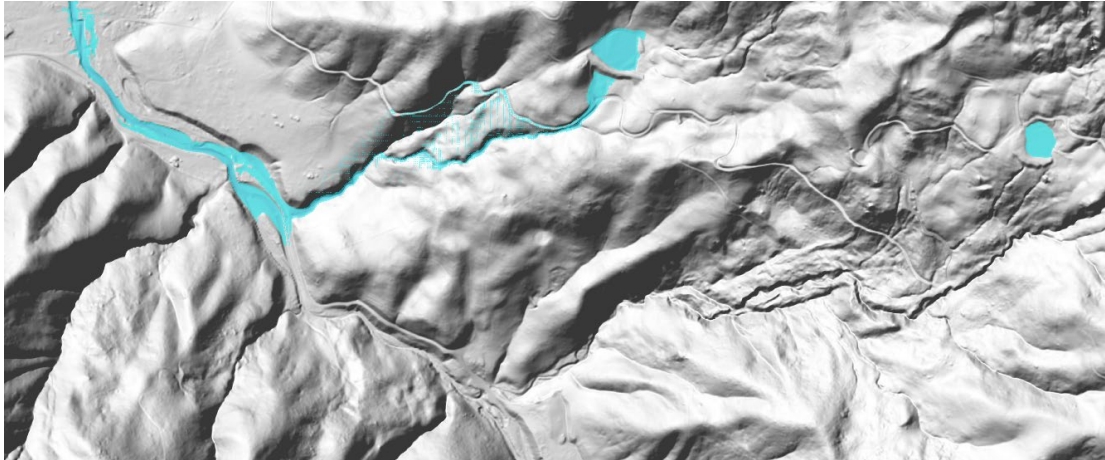
Figure 10 Pond #1 Breach Inundation Mapping

Breaching of Pond #1 and Pond #2 would cause peak flows exceeding the normal rainfall-runoff 100-year peak flows (Q100) at Culverts #3 and Culvert #6 (Table 1). Individual or simultaneous combined pond dam breaching would not cause peak flows approaching the Q100 at the bridge or the downstream property line.

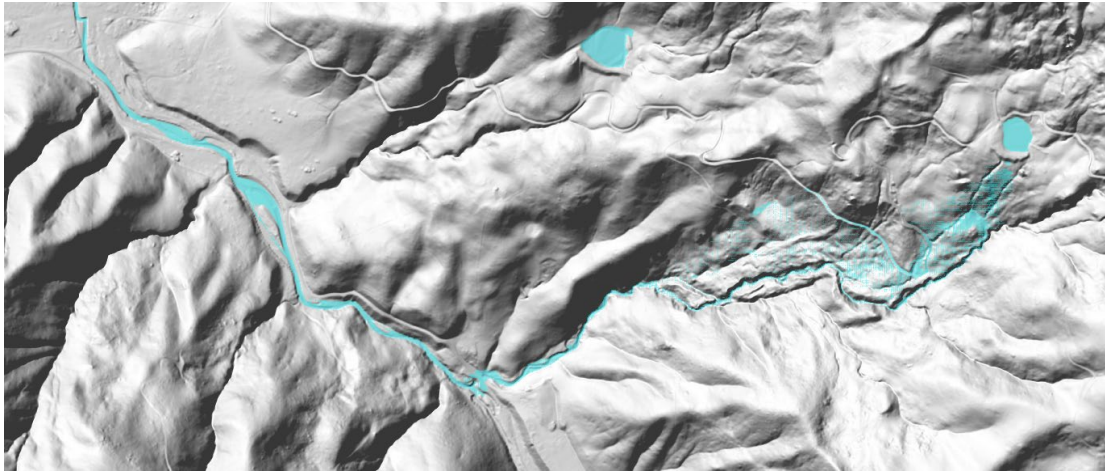
Figure 11 Pond #2 Breach Inundation Mapping

Breaching of Pond #2 would produce a peak flow about 50% higher than the Q100 at Culvert #6, likely causing overflowing of the road and possible minor road damage.
