**Date:** June 15, 2022

**From:** Amanda Werrell, M.S.  
Staff Biologist  
Sequoia Ecological Consulting, Inc.

**RE: Asphalt Grindings Technical Memorandum**

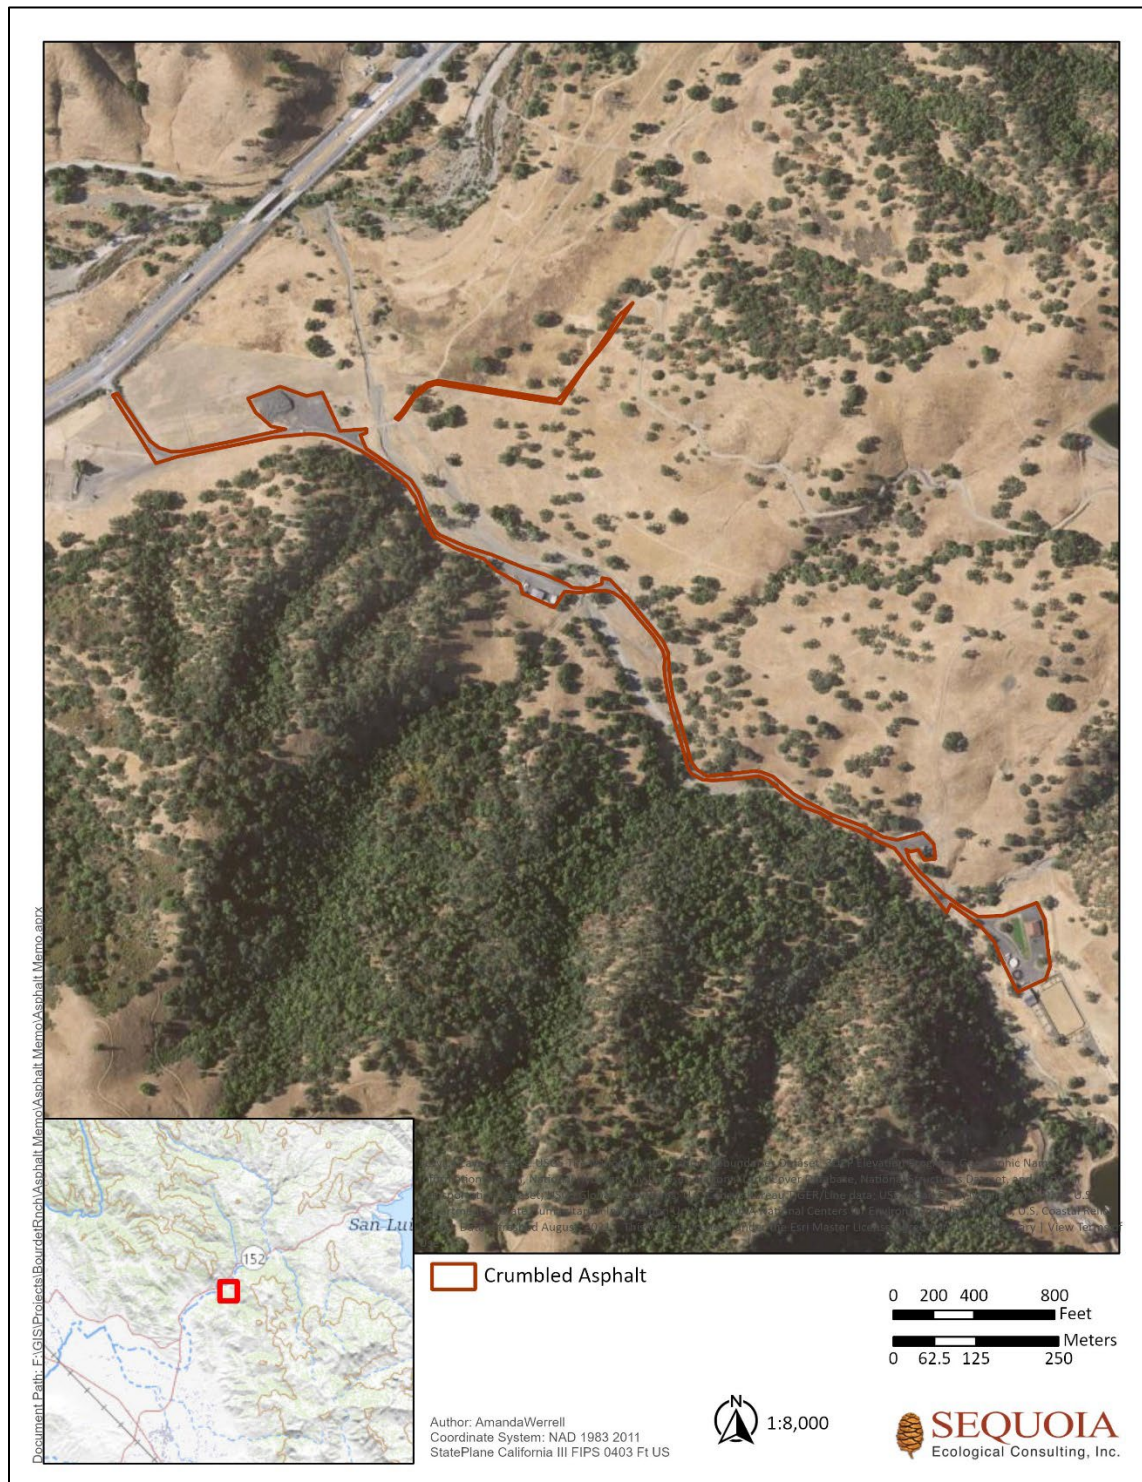
**Figure 1.** Approximate location of crumbled asphalt placed on road at Bourdet Ranch.

**Response:** Asphalt grindings were placed along the ranch road to improve road stability, reduce dust, and provide safe all-weather access along the road. Figure 1 illustrates the approximate placement of the asphalt grindings along the ranch road.
