**CAMEL HILL VINEYARDS
LOS GATOS, CALIFORNIA**

GEOTECHNICAL EXPLORATION FOR LANDSLIDE REPAIRS

March 15, 2024

PROJECT NO.
13831.002.000

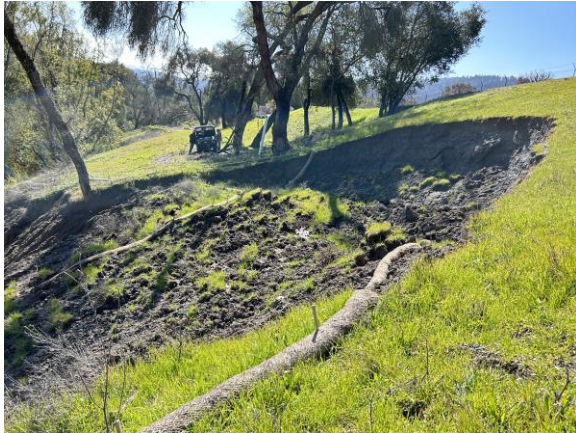
EXHIBIT 1.2-1: Upper Landslide

Based on field observations and post-storm aerial surveys, we estimate that the Upper Landslide was approximately 70 feet in width at the head of the landslide, approximately 90 feet in width at the toe, and approximately 115 to 120 feet in length. An approximately 10 to 12 feet high scarp is present at the head of the landslide. Topographic relief across the entire Upper Slide is approximately 50 to 55 feet. The slope has a gradient of approximately 2:1 (horizontal:vertical).

For the Upper Landslide, a grading solution to repair the landslide will include excavation of a keyway through the landslide debris, installation of subdrains, and placement of geogrid-reinforced engineered fill, keyed and benched into in-place bedrock to provide proper stability of the compacted fill.
