APPLICATION FOR TREE REMOVAL PERMIT

Tree Risk Assessment Summary Report

377 Tully Rd., San Jose

February 2024

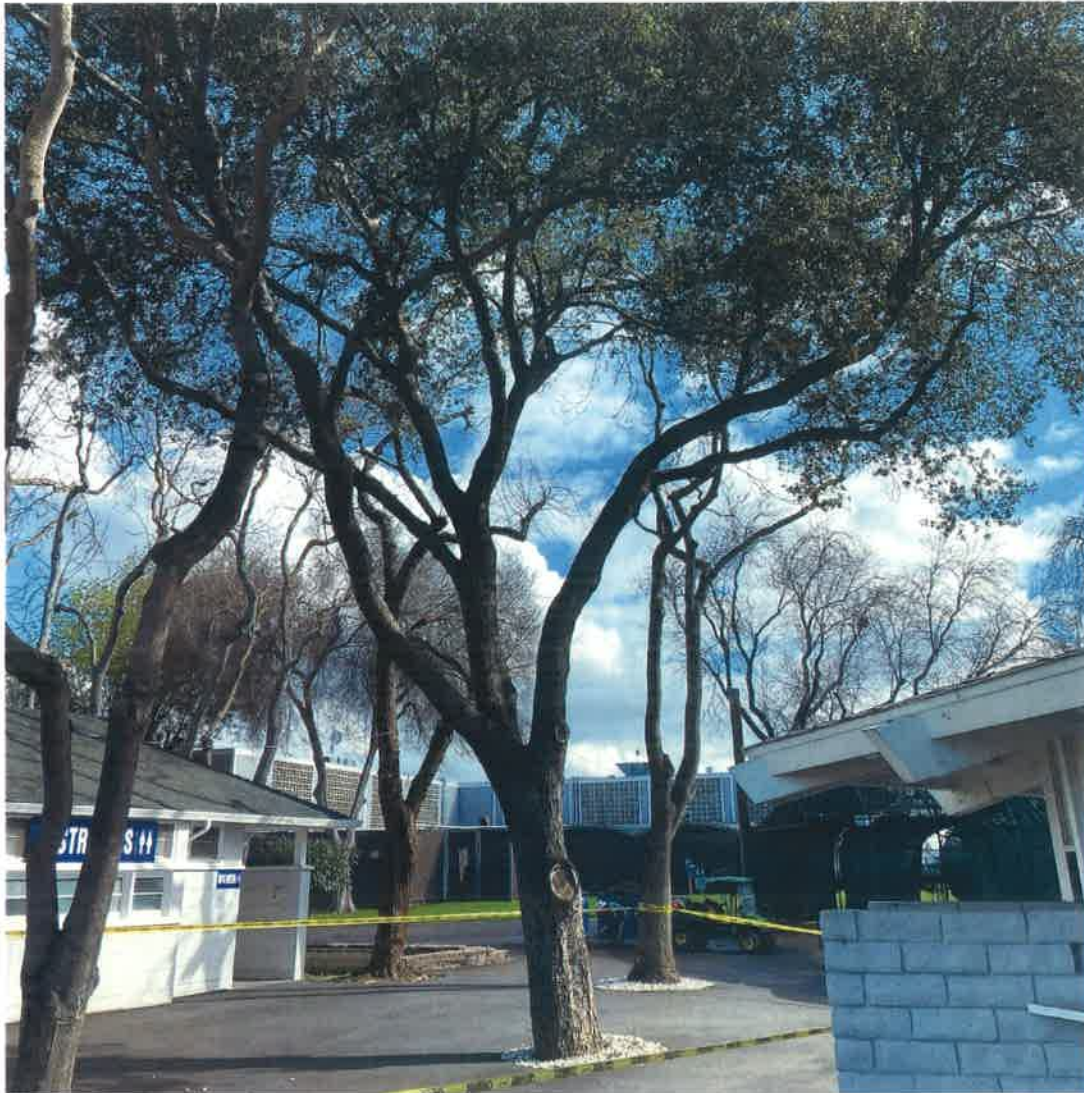
Photo 1. Tree #1 is located in between other trees and buildings, in a planting well.

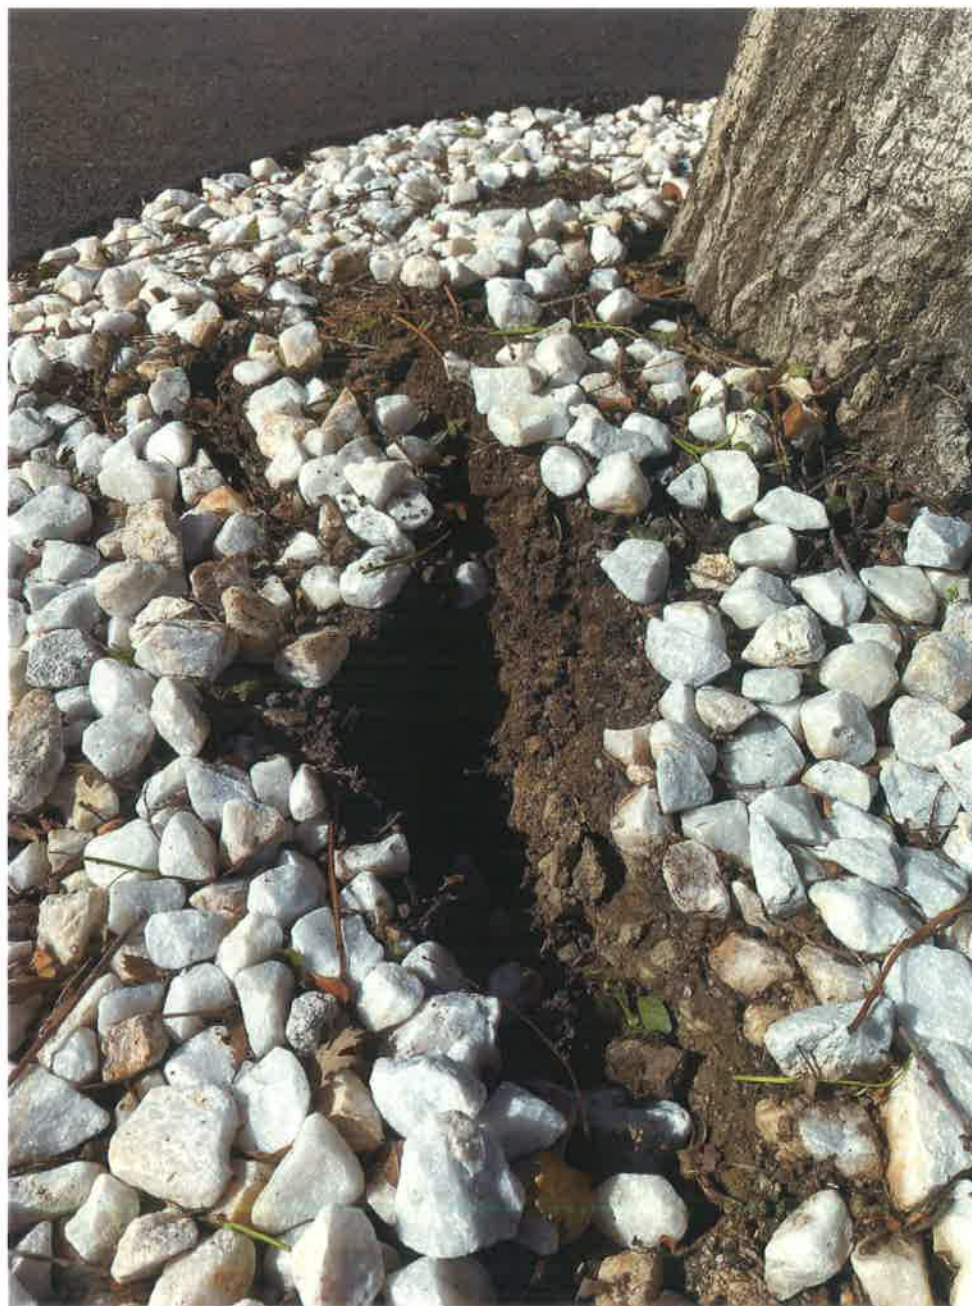
- Tree #1 had a risk rating of high for root plate failure. The whole tree is in the process of failing, the tree is currently being upheld by two other trees, and the whole tree should be removed for safety. This tree does fall under protected tree status. This tree qualifies for an exception falling under Santa Clara County Municipal Codes Division Sec. C16-4 section b. Once the tree is removed there will be no remaining risk.
- Target ratings (occupancy rate) were constant with a high or high likelihood of impacting the targets.
- Completely removing the tree is the only way to eliminate all risk. Ultimately, the acceptable tolerance of risk is set by the tree managers.

The likelihood of root collar failure is imminent with a high likelihood of impacting the restroom in the area within 1 year. The consequences of the likely failure would be significant. The risk rating is High.

Photo 2. Soil separation and root destabilization were observed, the tree is leaning on other trees near by.

Whole tree removal.

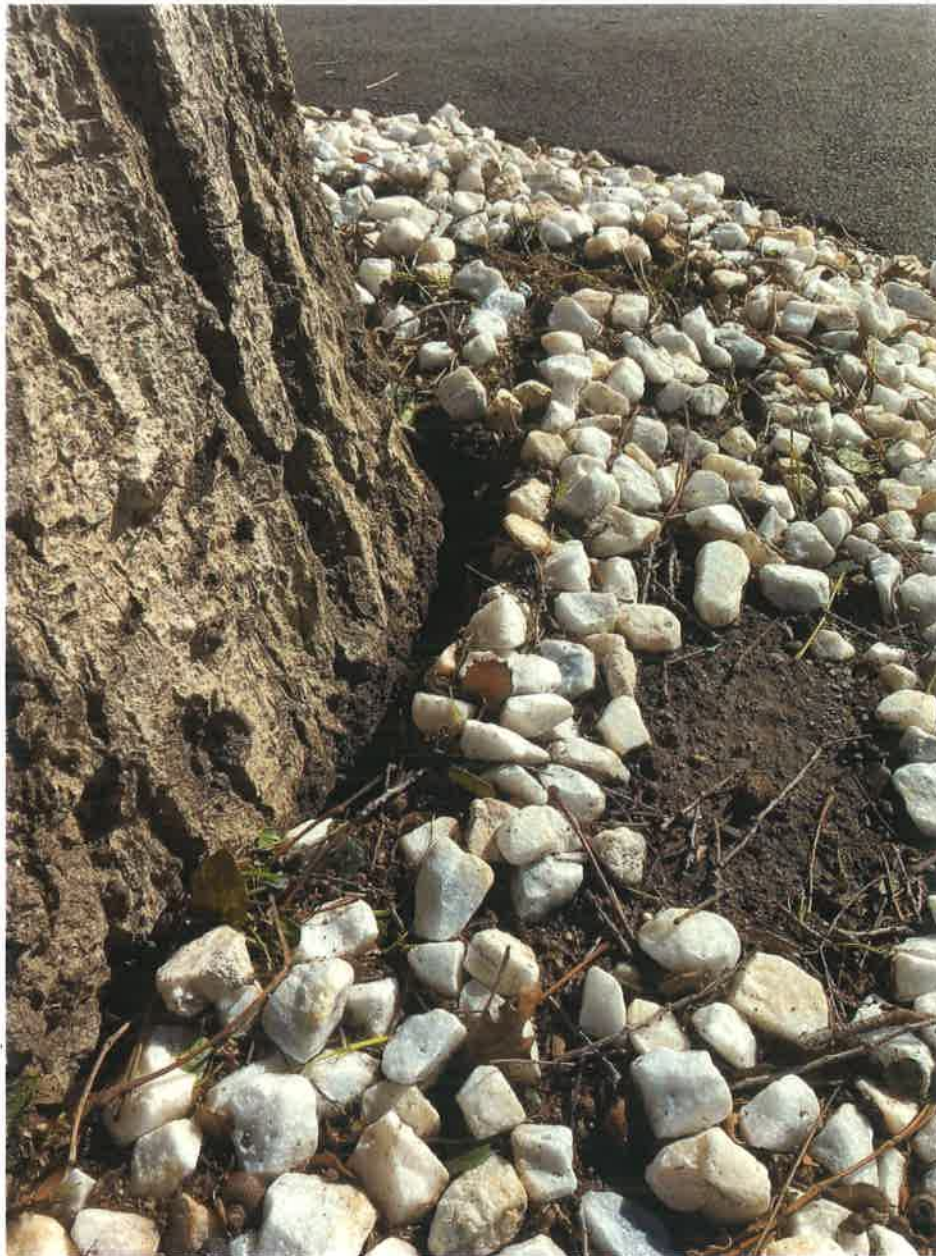
The roots are uplifting. Small deadwood < 2" in diameter within the canopy.

Photo 3. Another view of the soil conditions, and the roots starting to uplift.

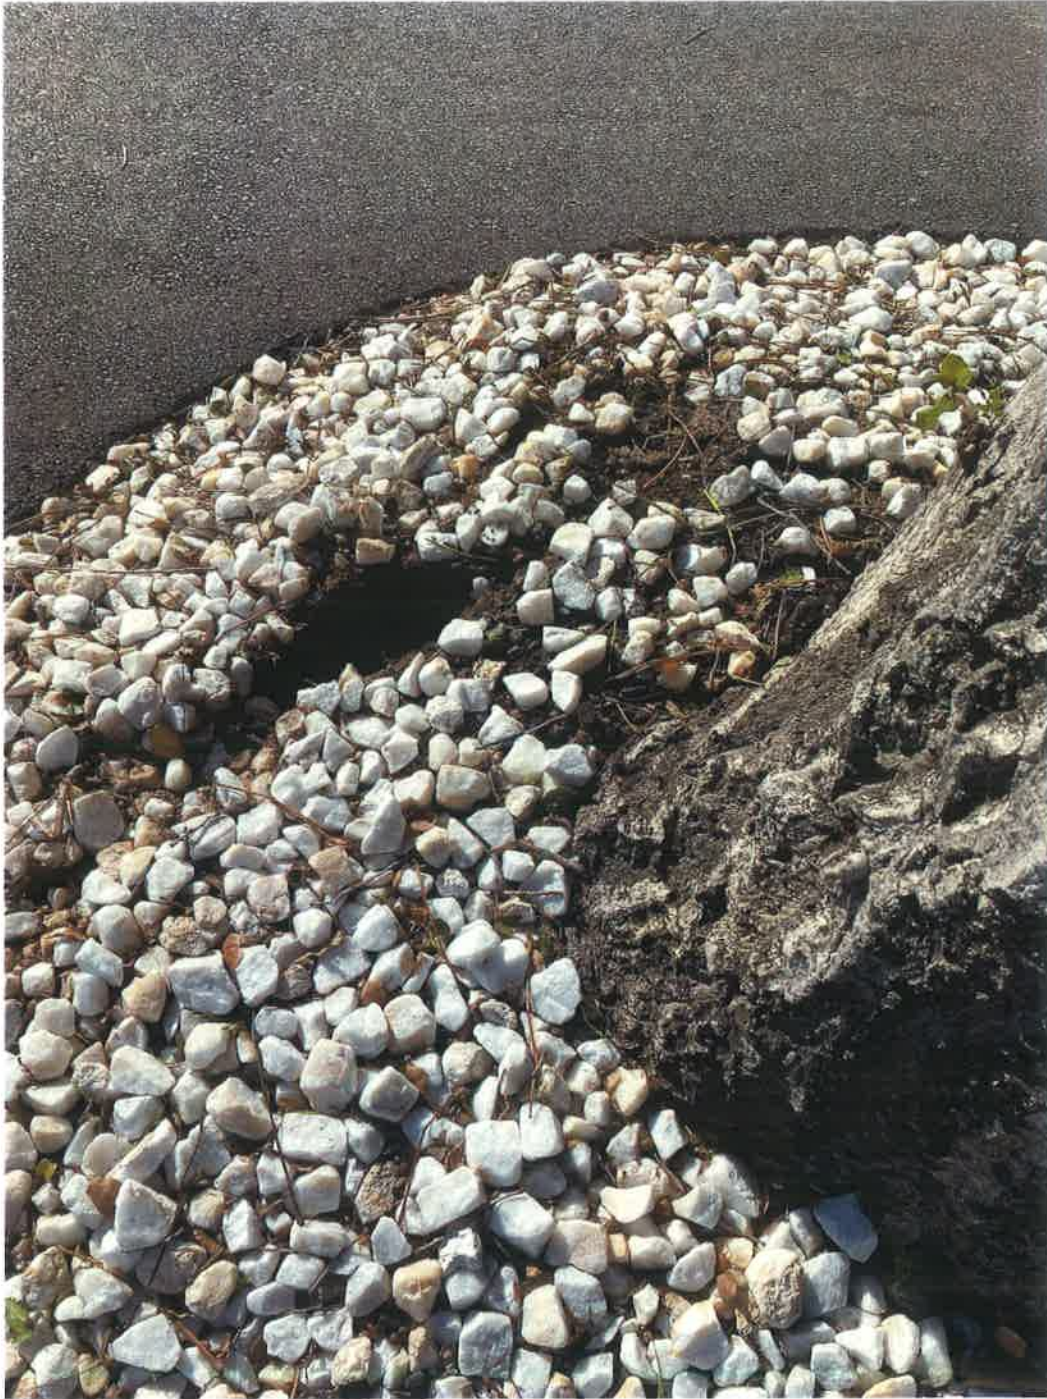
Photo 4. Close-up view of the soil change.

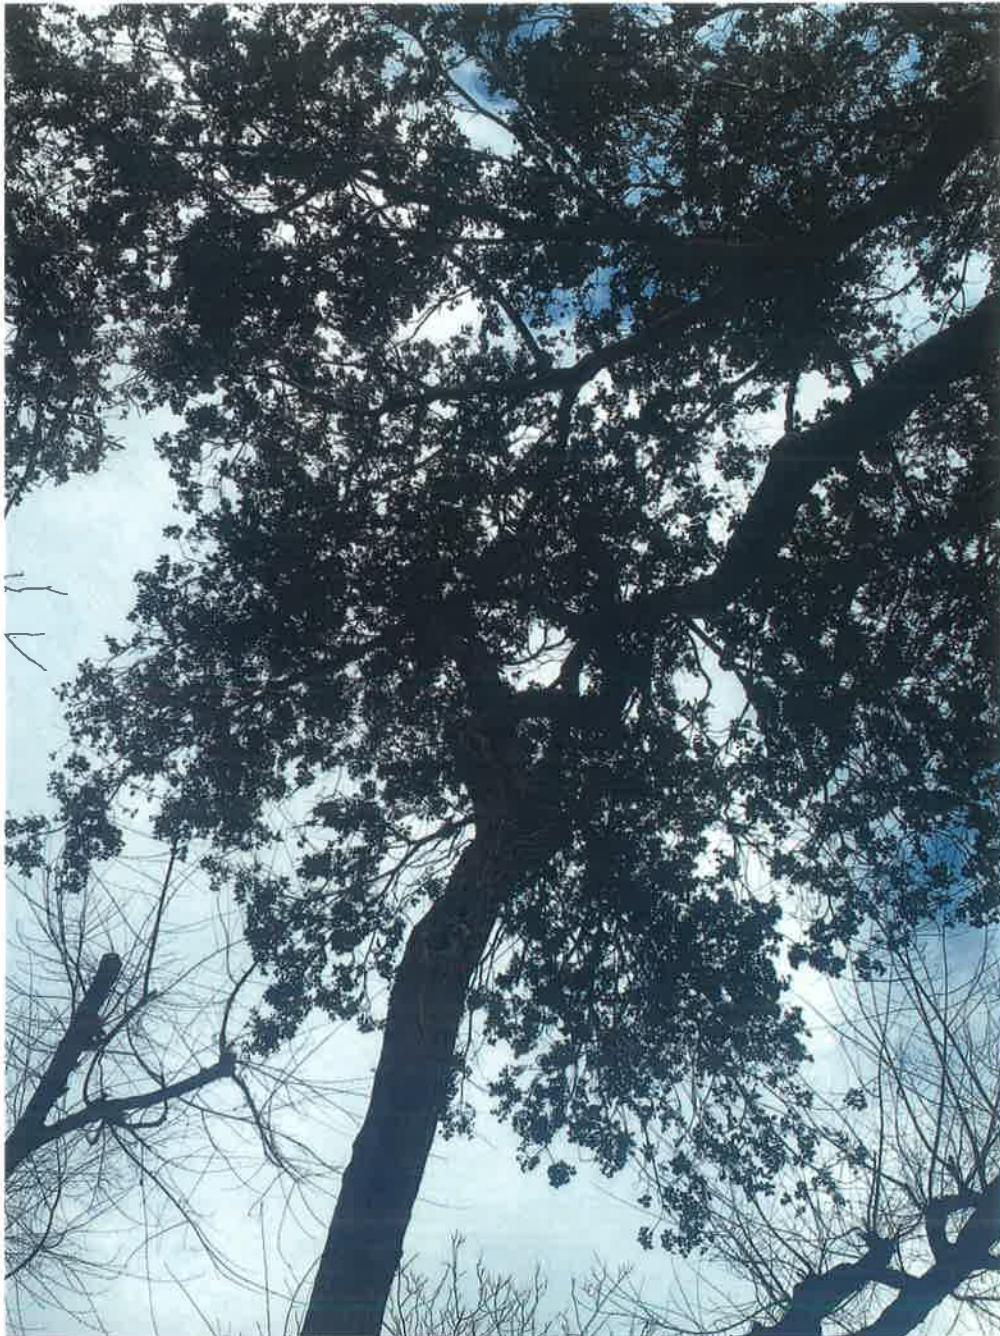
Photo 5. Tree #1 leaning on and supported by one of the nearby trees.

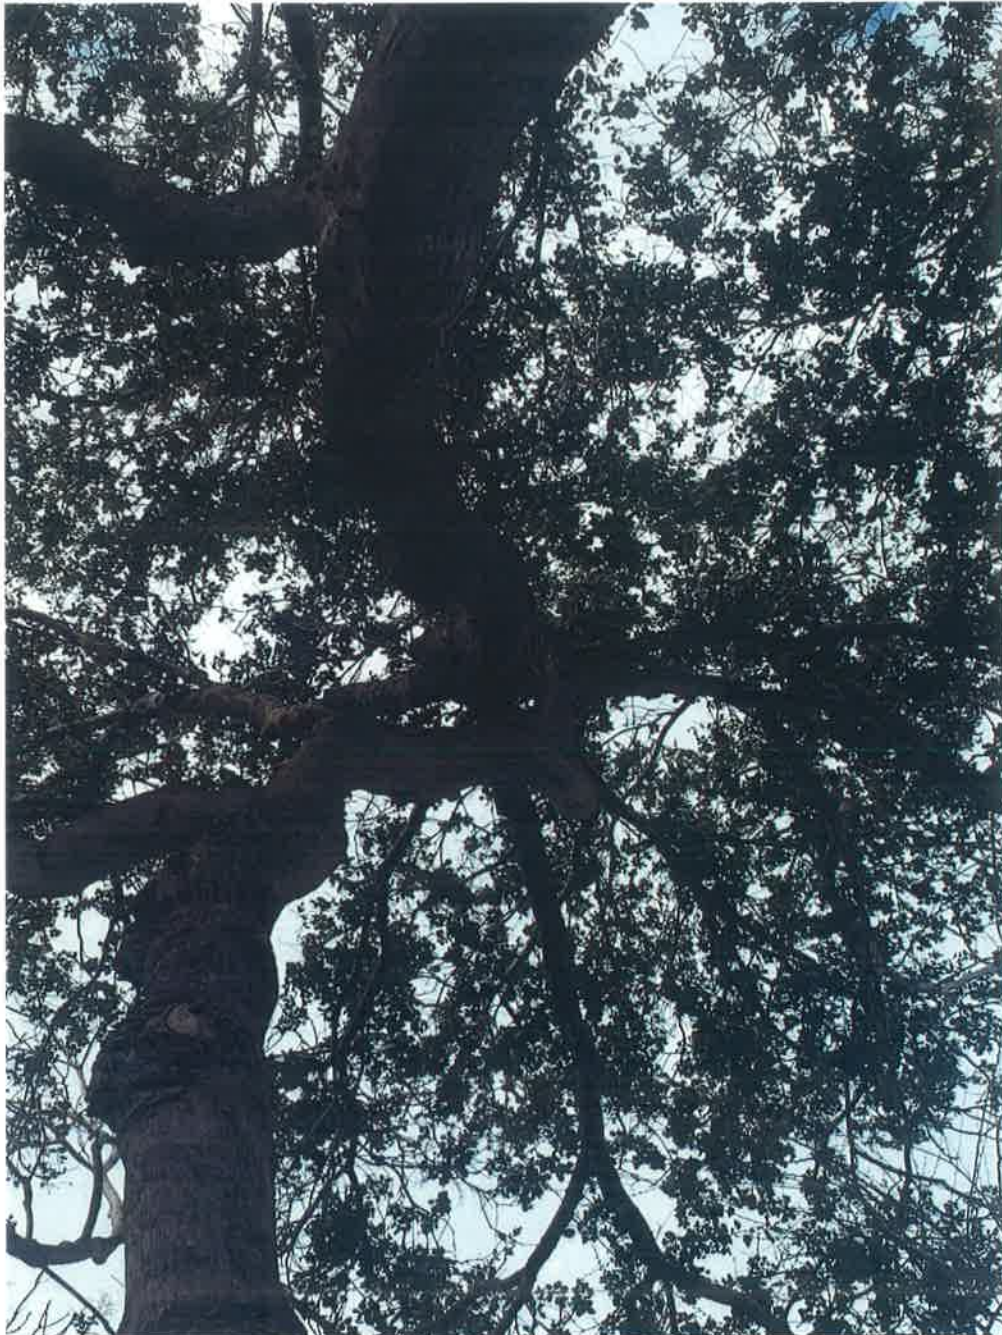
Photo 6. A nearby tree is supporting the subject oak.
