# Tree Risk Assessment Summary Report

840 Guadalupe Parkway, San Jose

July 2024

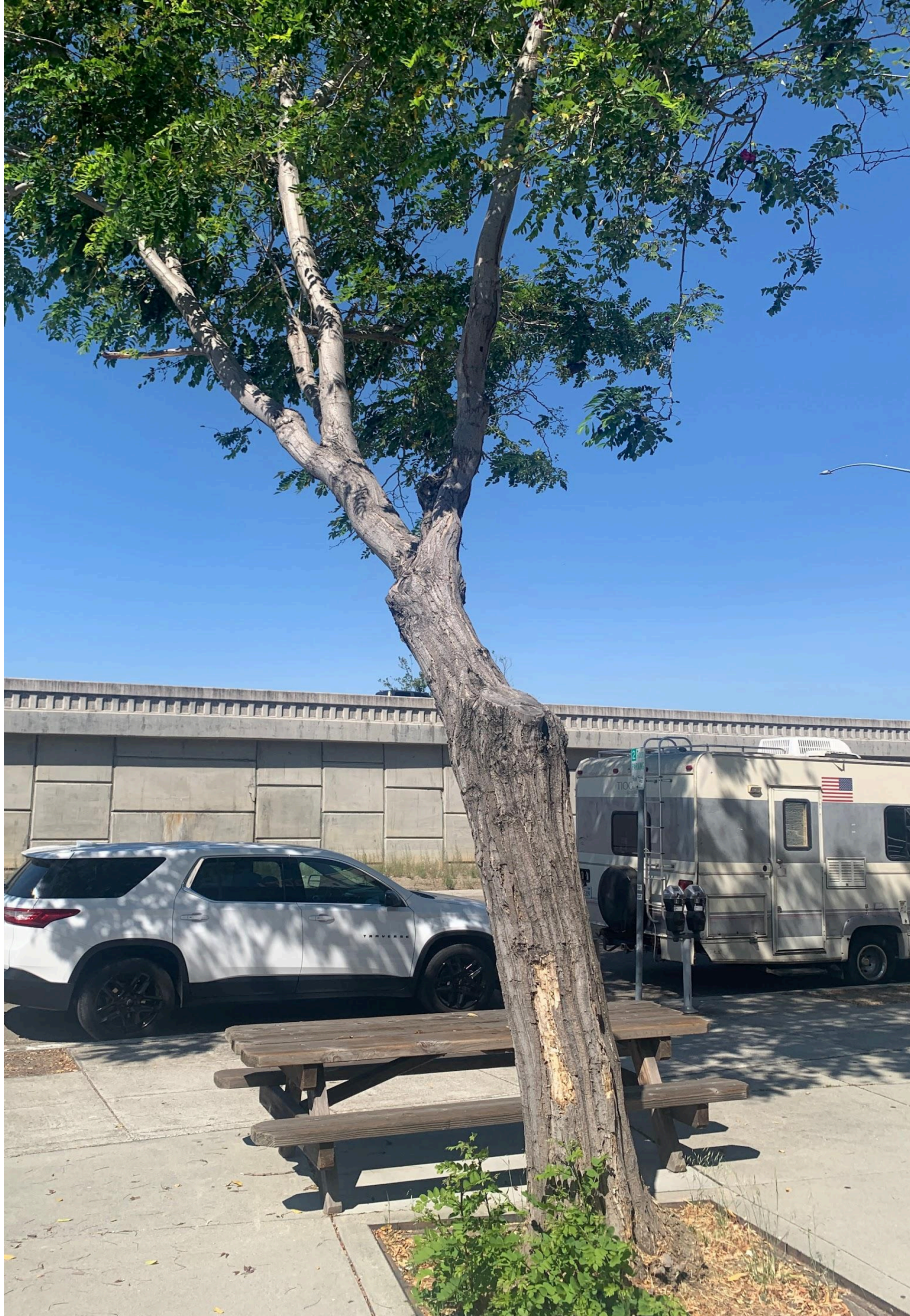
Damage/decay to the trunk, large canopy failure, unbalanced canopy.

Likelihood of trunk failure is probable with a high likelihood of impacting the picnic bench/walking path in the area within 3 years. The consequences of the likely failure would be minor if no people or vehicles were present at the time of failure. Consequences would be higher if the site was occupied. The risk rating is Moderate.

**Photo 1. Tree # 1 is located next to a picnic bench. Trunk decay and the missing canopy from the previous failure are shown in this photo.**

Remove Tree

- Tree #1 had a risk rating of moderate for trunk failure. The tree has some decay in the trunk and sound feedback that should be monitored if the tree is retained. The canopy can be pruned to reduce the end weight, but nothing can reverse the decay. Once the deadwood is removed the remaining risk stays the same. When the majority of the canopy previously failed, it caused excess stress to the tree. Removing the tree is the only way to eliminate all risk. Should the client decide to retain the tree, monitoring every three to five years or after major storm events should be done. To reduce the risk while the tree is present, moving the picnic bench is recommended. Ultimately the tolerance of risk is set by the tree manager, but removal of this tree is recommended. According to the Santa Clara County municipal code [Sec. C16-4](#) this tree falls under an exception shall the Planning Director, or his or her designee deems the risk too high then no permit is required.

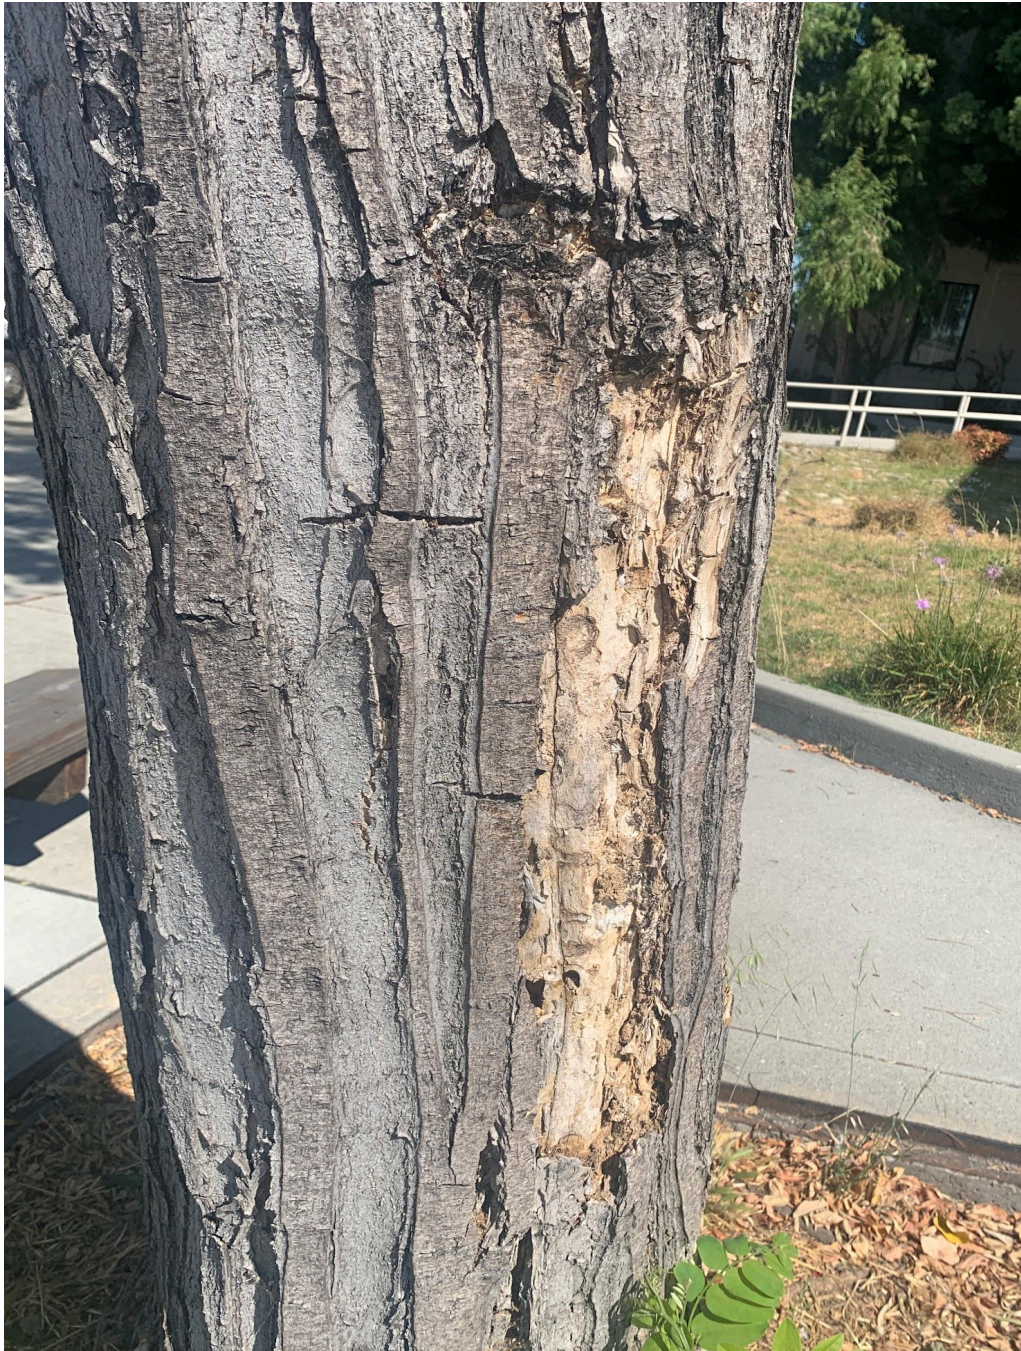
**Photo 2. Closer view of the decay in the trunk. There was sounding feedback in the trunk indicating internal decay.**

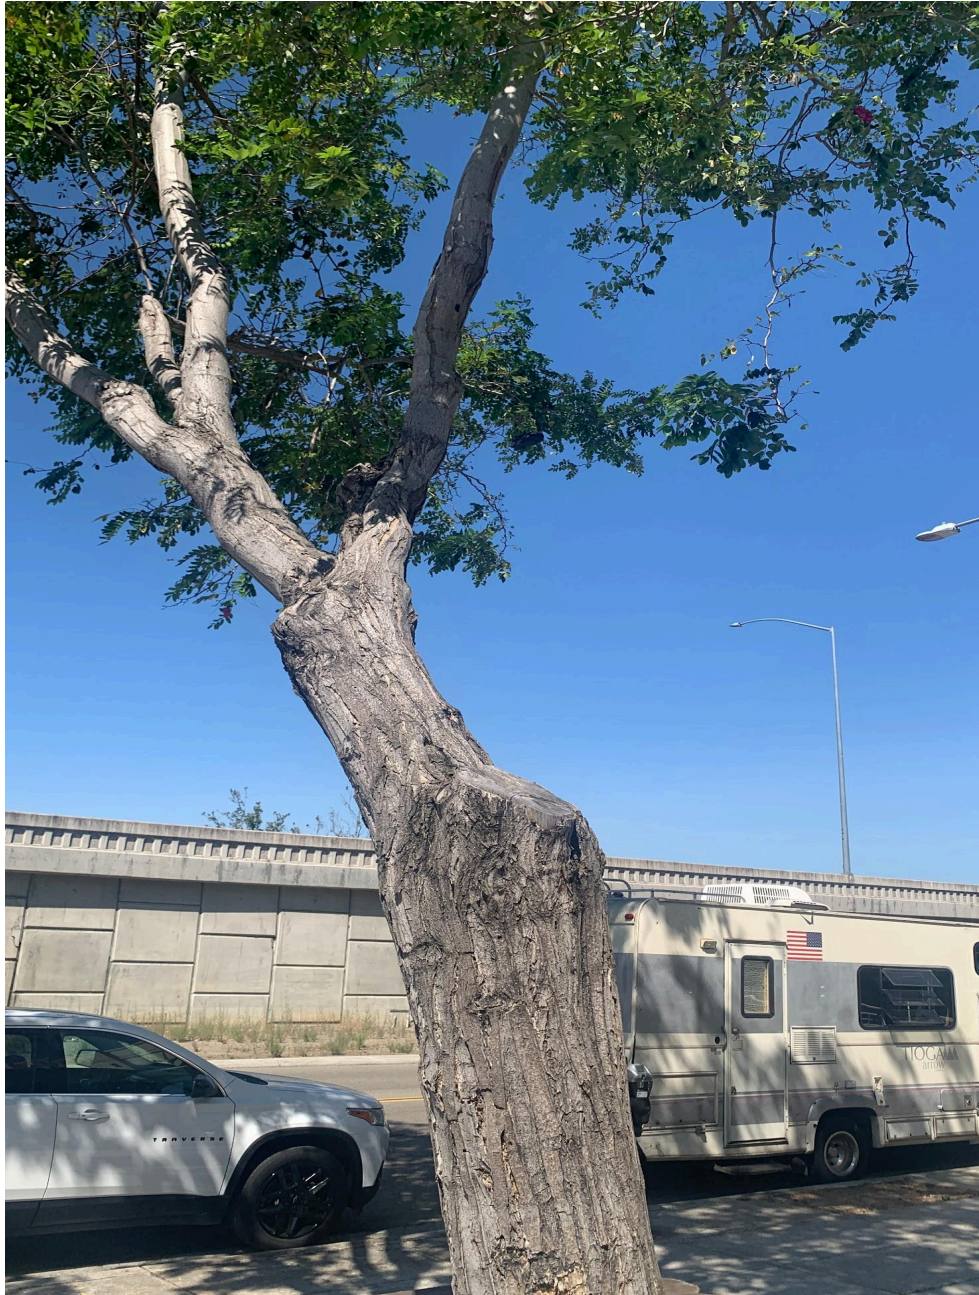
**Photo 3. A closer view of the trunk where the previous failure occurred.**

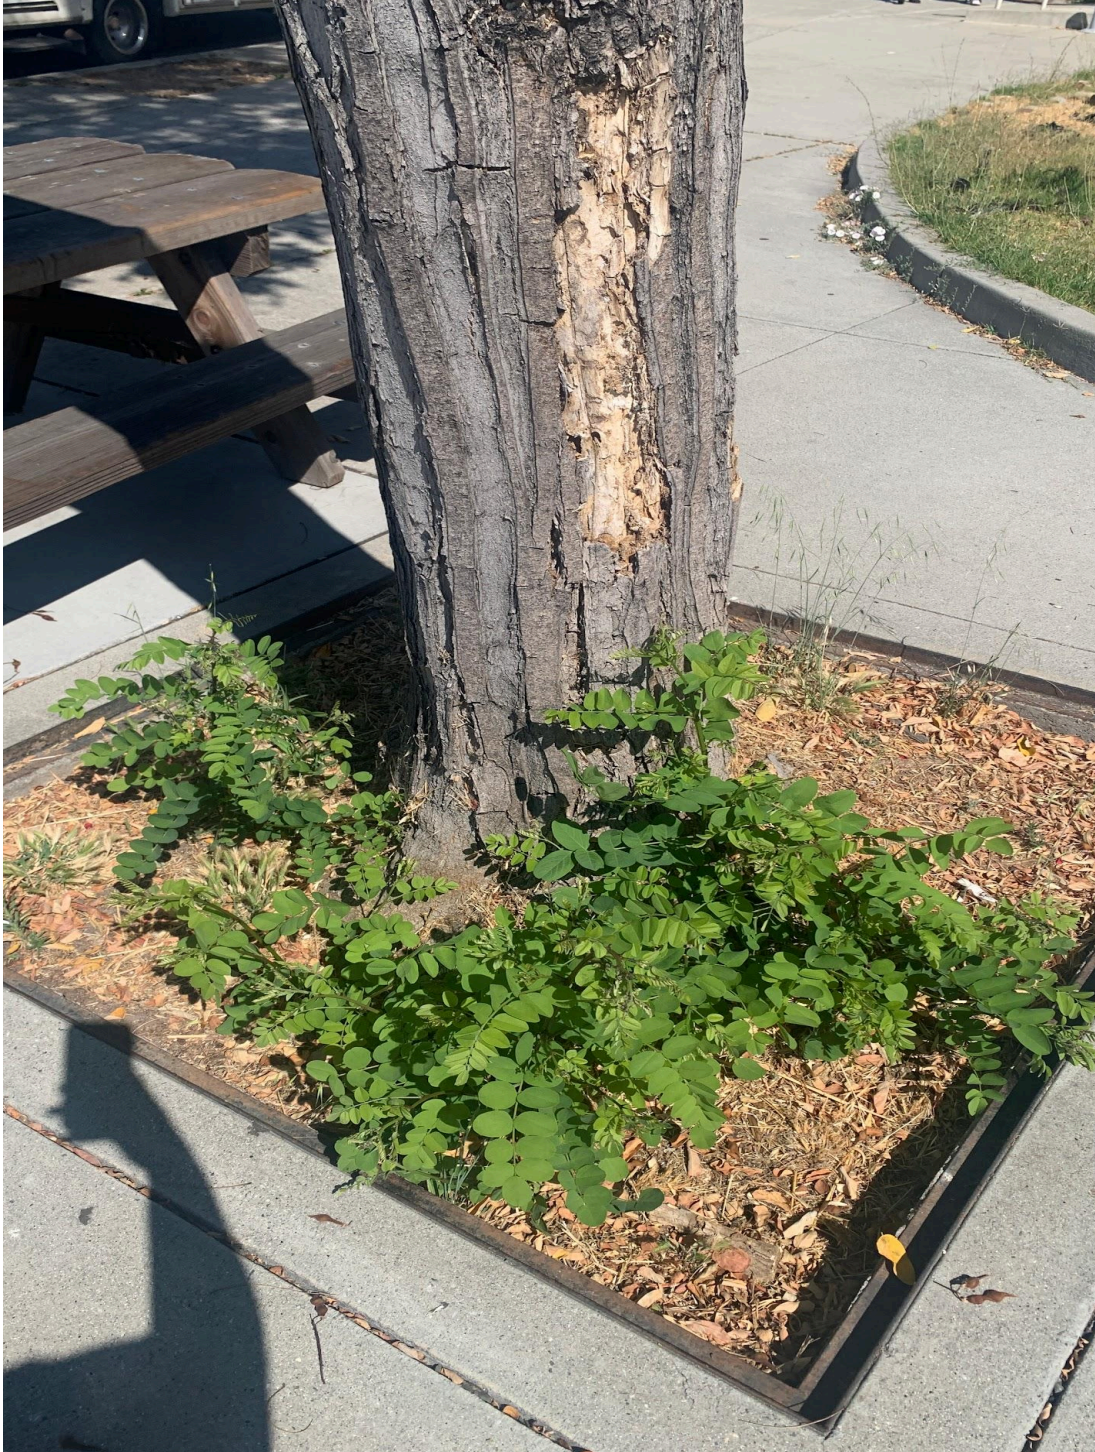
**Photo 4. Another view of the base of the trunk, and the decay at the base.**
