SURFACE MINING INSPECTION REPORT

This letter report summarizes the findings of PMC's annual Surface Mining and Reclamation Act (SMARA) site inspection of the Permanente Quarry in Cupertino, CA (Mine ID #91-43-0004) conducted on September 26 and 27, 2013. PMC was retained by Santa Clara County to assist County staff with the annual SMARA mine inspection and to provide written documentation of our observations, issues of concern and recommendations.

2013 SMARA INSPECTION PHOTOS

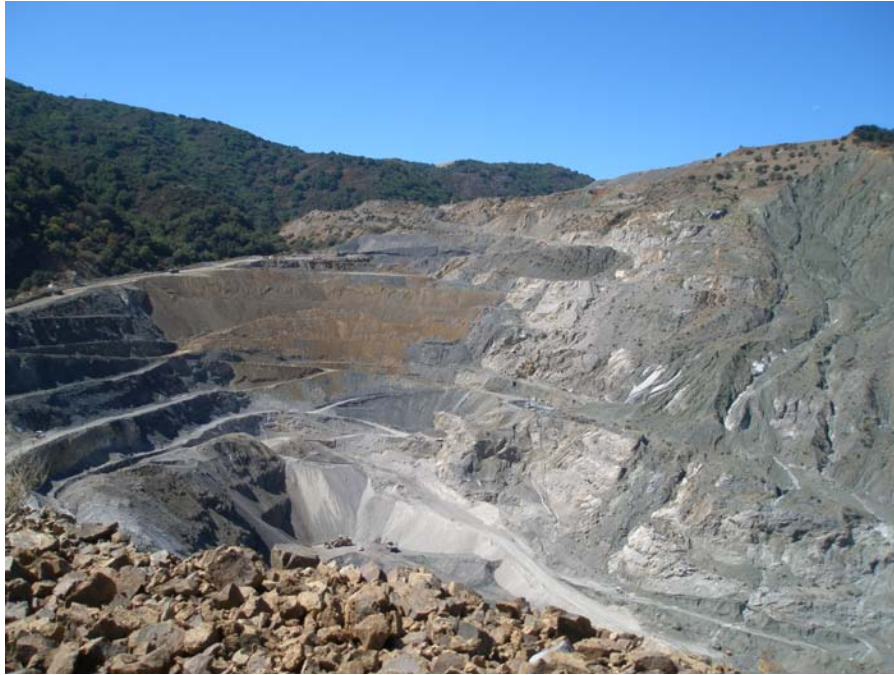
A fourth apparent landslide occurs on the western side of the pit. This area of movement was noted by Golder and Associates in their November 2007 Slope Stability Evaluation report and may extend westward below the toe of the eastern slope of the WMSA overburden stockpile (right center of Photo 1). The County's Geologist, Mr. James Baker, referred to this western landslide as the "Haul Road Slide." The placement of overburden backfill against the western toe of the North Quarry is intended to stabilize this slide.

Photo 1: North Quarry, southwest portion. Waste rock material being placed at toe of western slope. Potential “Haul Road Slide” in eastern slope of WMSA, right of image. Floor elevation of quarry at approximately 725 feet msl. Dated September 26, 2013.

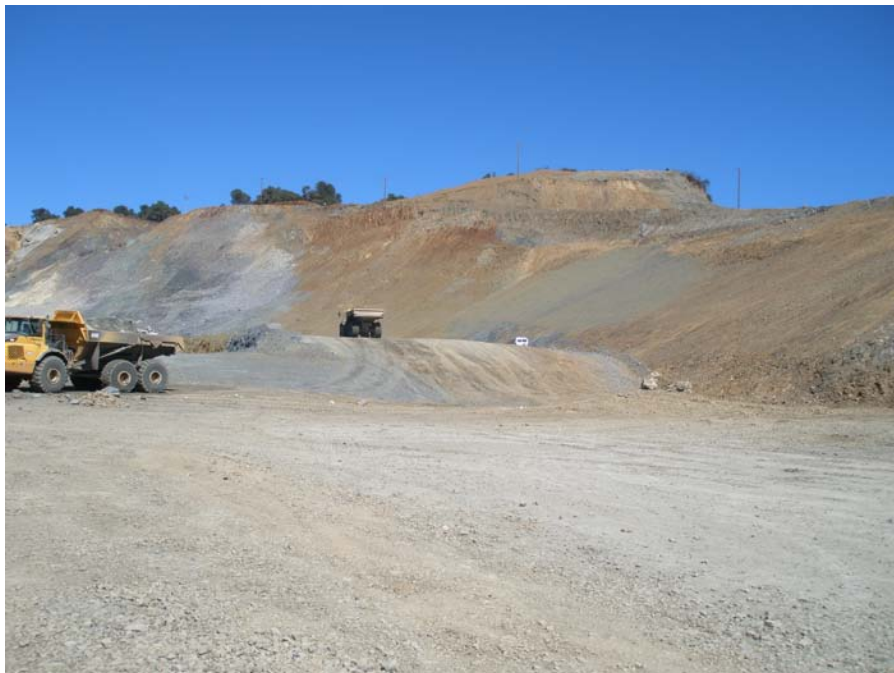
Photo 2: Upper portion of eastern highwall of North Quarry with slopes at final grade. First bench being cut to elevation at right side of photo. Dated September 26, 2013.

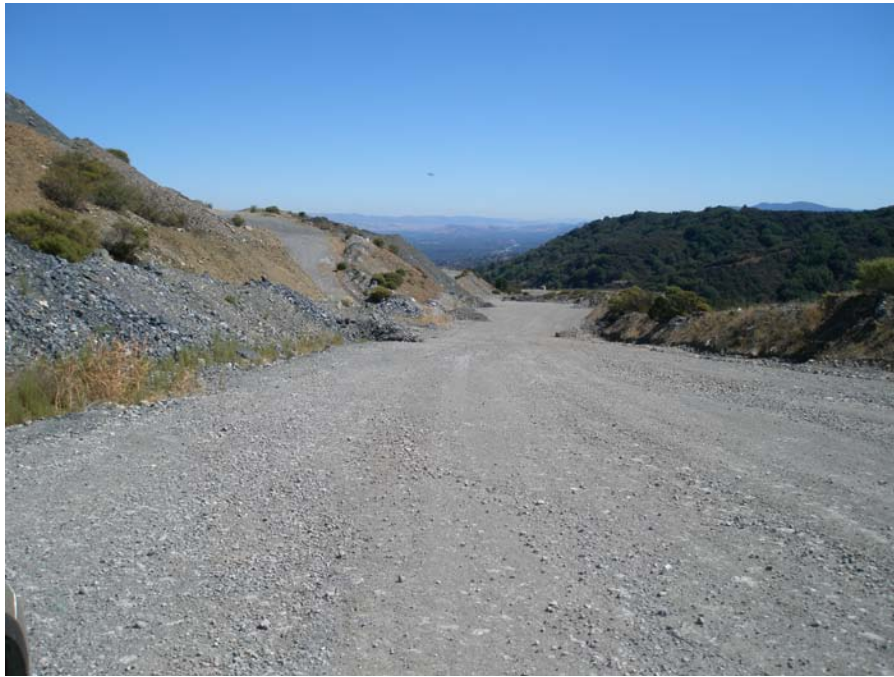
As part of the site's stormwater management, numerous rock checkdams have been placed along the haul roads. However, the rock material initially used for these checkdams was limestone. To mitigate the potential for selenium to leach, the operator replaced the limestone check dams with greenstone or other non-limestone rock (Photo 3).

Photo 3: Check dams on WMSA haul road that were replaced with non-limestone materials, looking eastward. Dated September 26, 2013.

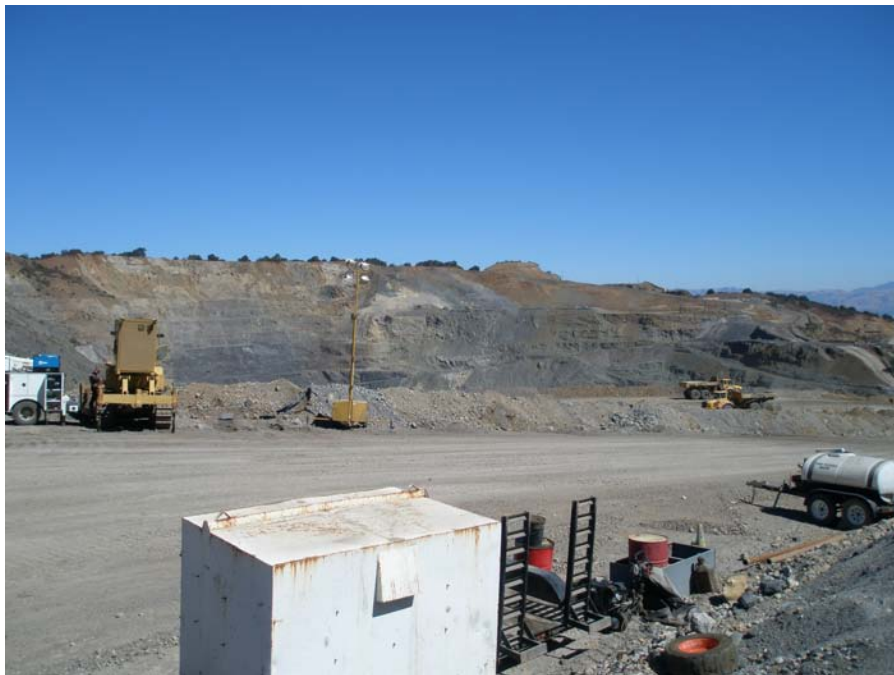
Photo 4: Looking northeast at the North Quarry. Mid-Pen Rockslide area at in center of image being removed by recent mining. Dated September 26, 2013

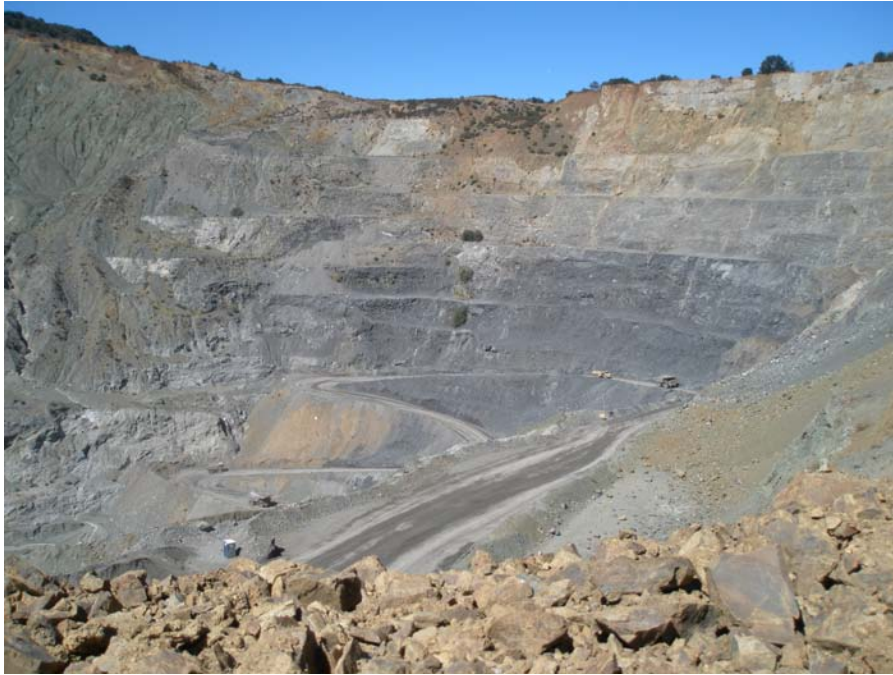
Photo 5: Looking northwest at Scenic Easement Rockslide in center of image. Dated September 26, 2013.

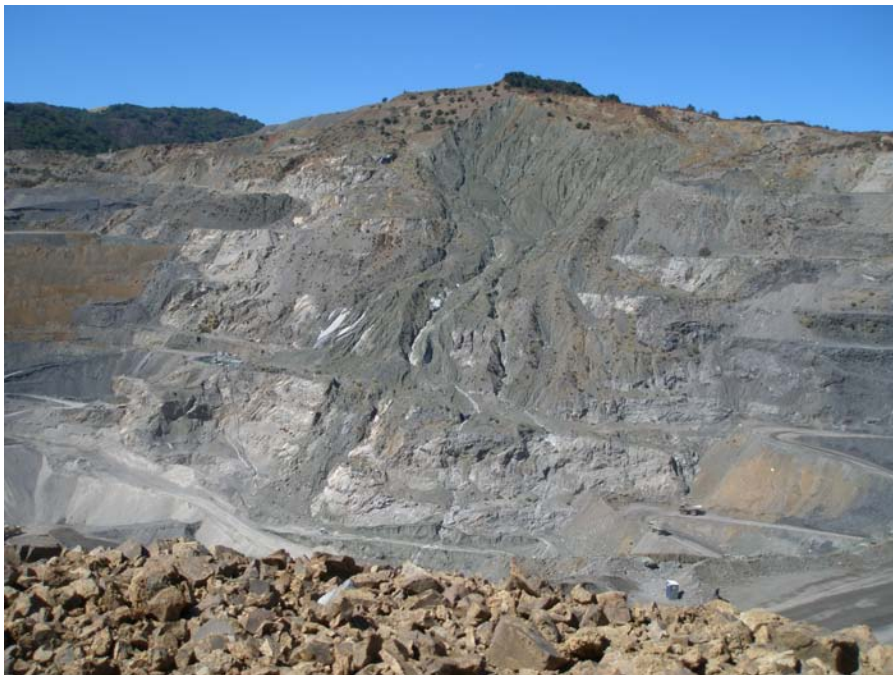
The northern highwall of the North Quarry has had three large rockslides, which are described in the RPA. No major new movement on these rockslides was observed during the 2013 inspection. The Mid-Pen Rockslide that extended approximately halfway down the eastern highwall is being graded out as part of the mining (Photo 4). The Scenic Easement Rockslide has a slope failure that extends down slope approximately as far as the Mid-Pen Rockslide (Photo 5). This rockslide lowered the ridgeline contrary to the 1972 Ridgeline Protection Easement requirement. The largest slide, the Main Rockslide, appears to extend across most of the current height of the northwestern highwall (Photo 6).

Photo 6: Looking west at Main Rockslide and WMSA. Dated September 26, 2013.

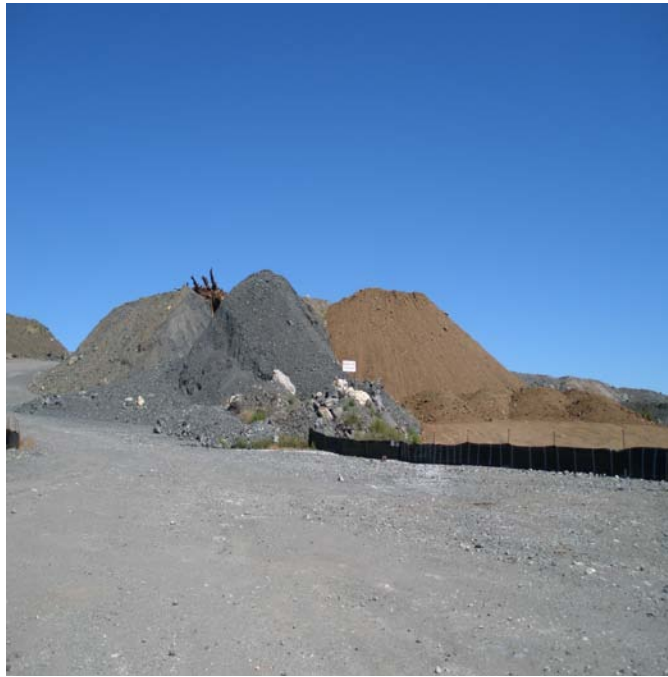
Photo 7: New topsoil storage area in WMSA, looking north. Sign and silt fence in foreground. Dated September 26, 2013.

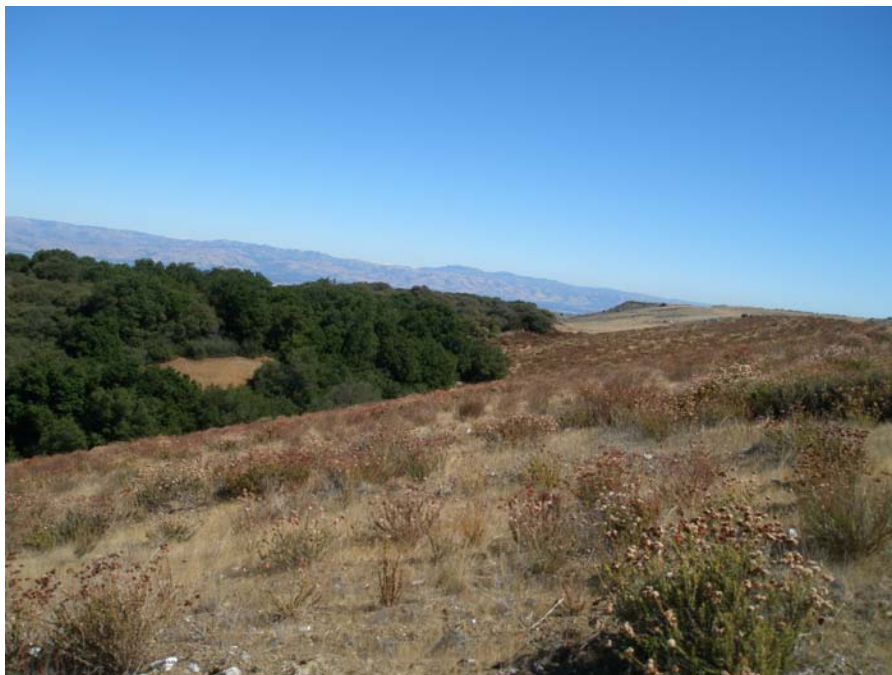
Photo 8: Portion of re-vegetated north-facing slope of WMSA, looking east. A portion of this slope will be removed in Phase 2 to backfill of North Quarry. Dated September 26, 2013.

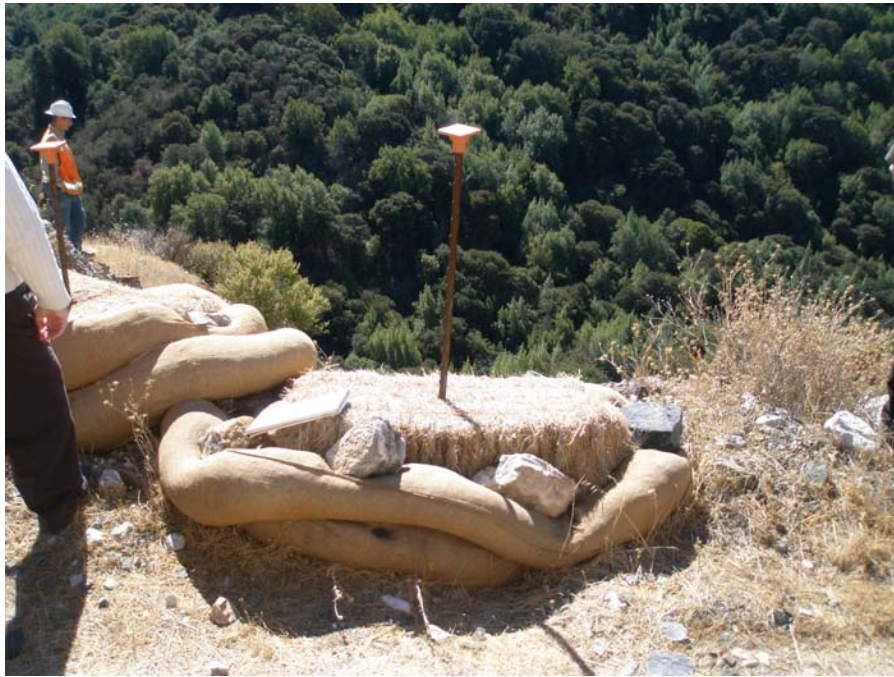
Photo 9: Rocked outfall in mid-slope bench on southern WMSA slope with straw waddles and bales, looking southwest into Permanente Creek. Dated September 26, 2013.

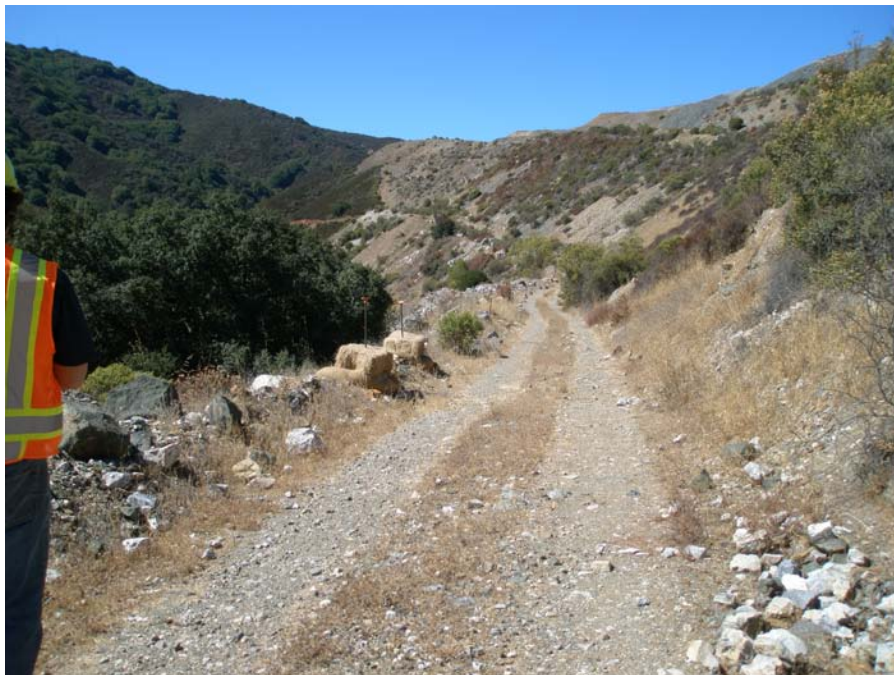
Photo 10: Straw waddles and bales at outfalls of mid-slope bench on southern slope of WMSA, looking looking west. Dated September 26, 2013.

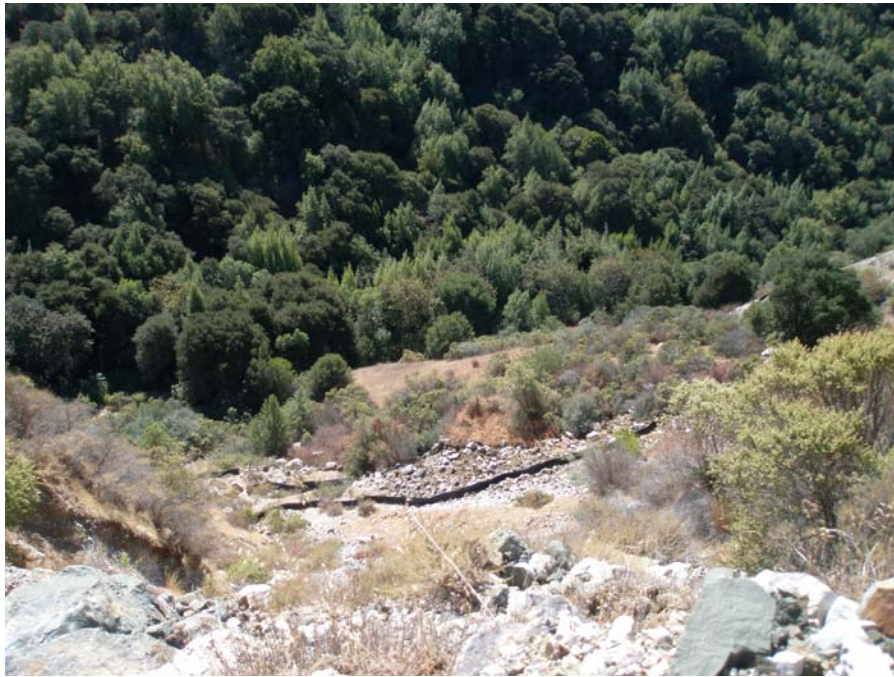
Photo 11: Silt fencing on southern slope of WMSA below outfall in Photo 9. Note soil mixed with talus adjacent to silt fence may be result of past slide. Dated September 26, 2013.

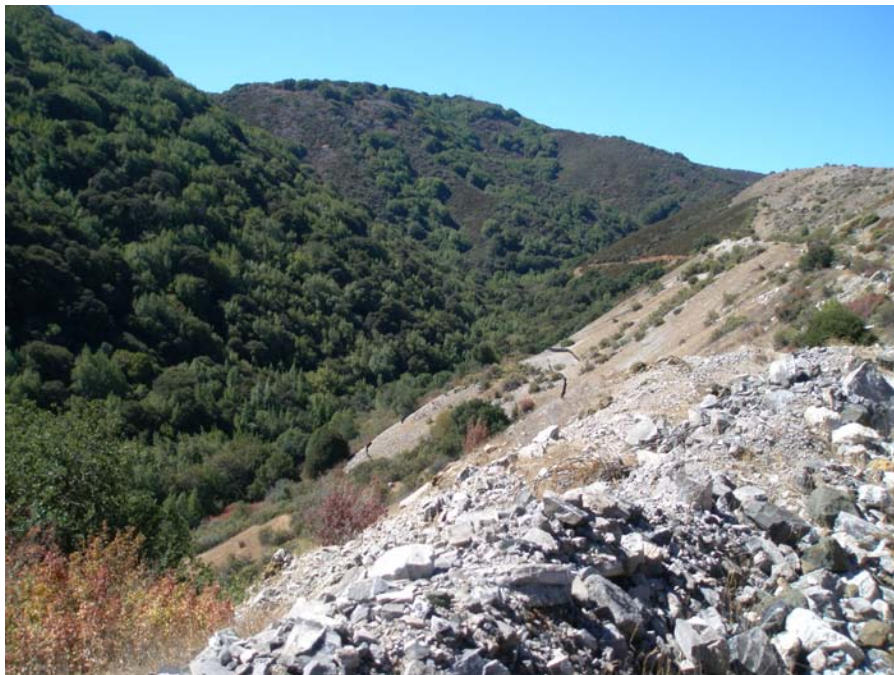
Photo 12: Southern slope of WMSA with silt fencing, looking west up Permanente Creek. Dated September 26, 2013.

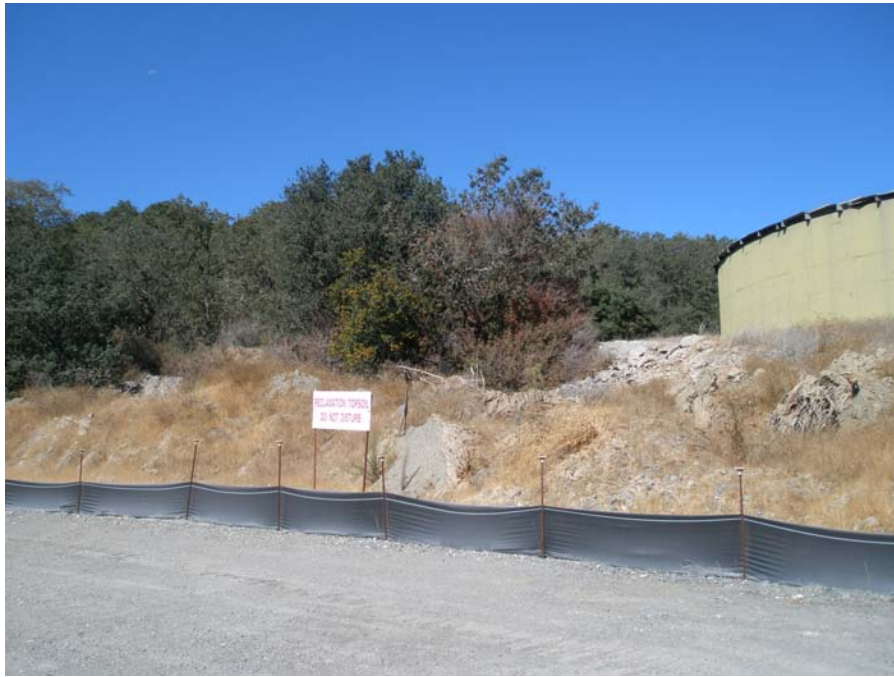
Photo 13: Topsoil storage area EMSA with sign and silt fence, looking west. Abandoned water tank at right side of image. Dated September 26, 2013.

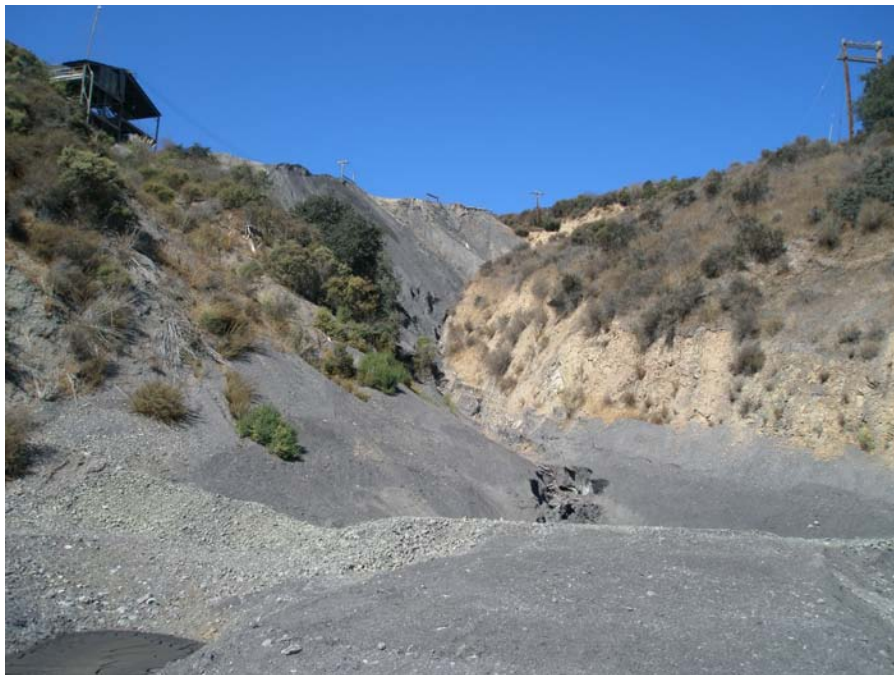
The operator has created a network of lined and unlined drainage ditches to convey stormwater runoff from the EMSA into holding ponds. During the 2012-13 rainy season a slope failure occurred in a slope adjacent to the eastern end of the conveyor tunnel that deposited limestone rock in the upper portions of the drainage ditch that runs along the western edge of the EMSA (Photo 14). This material was removed, a series of sediment catch basins were created and the ditch cleaned out and relined with greenstone (Photos 15 and 16). Continued failure of the slope is anticipated, therefore periodic cleanout of the sediment catch basins is now part of the stormwater management plan. The EMSA drainage ditches were all relined with greenstone, a non-limestone rock, and they appeared to be capable of functioning as intended. The lowermost stormwater pond is called Pond 30 (Photo 17), which discharges runoff through a culvert into Permanent Creek. Rock armoring with greenstone was done to mitigate this erosion at the outfall of Pond 30 (Photo 18). County staff should inspect the channels, ponds and culvert outfall as part of the pre-winter site inspection to document that the structures will function properly.

Photo 14: Slope failure north of eastern end of 500-foot long conveyor tunnel in Crusher/Support Area, looking west. Sediment catch basins constructed above western perimeter drainage ditch in foreground. Dated September 26, 2013.

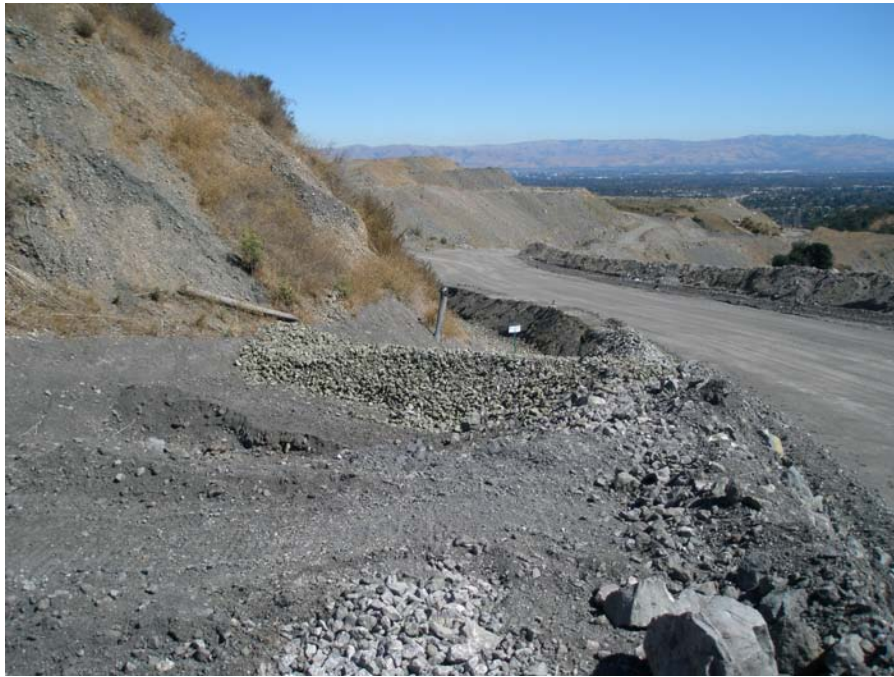
Photo 15: Sediment catch basin, greenstone rock weir and western perimeter drainage ditch in EMSA, looking northeast. Dated September 26, 2013.

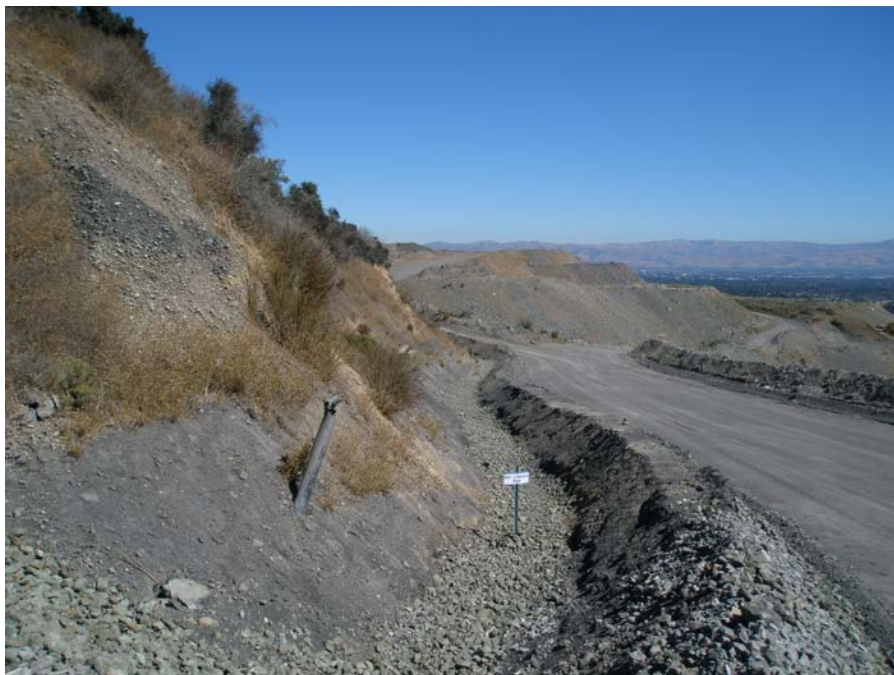
Photo 16: Western perimeter drainage ditch in EMSA. Ditch cleaned out and greenstone rock placed in bottom, looking northeast. Dated September 26, 2013.

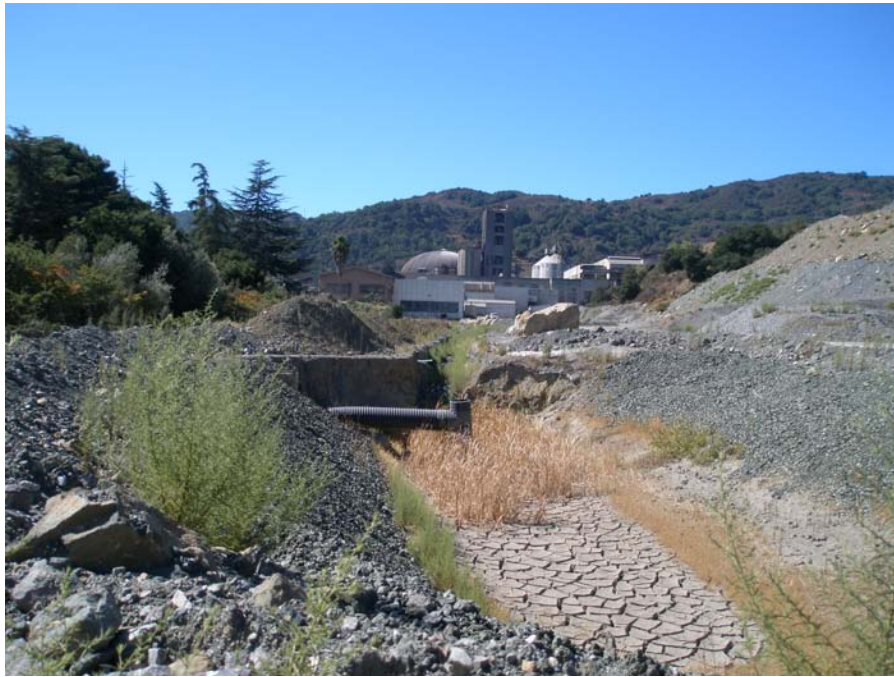
Photo 17: Pond 30 lowest pond in EMSA and drains into Permanente Creek, looking south at cement plant. Walls of pond and drainage ditch relined with greenstone. Dated September 26, 2013.

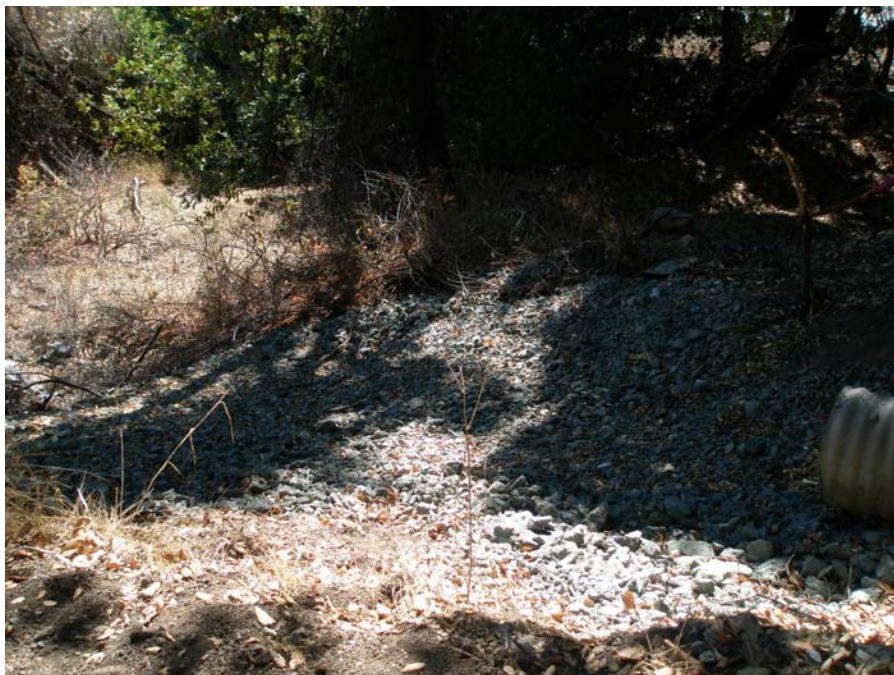
Photo 18: Pond 30 outfall to Permanente Creek, relined with greenstone. Dated September 26, 2013.

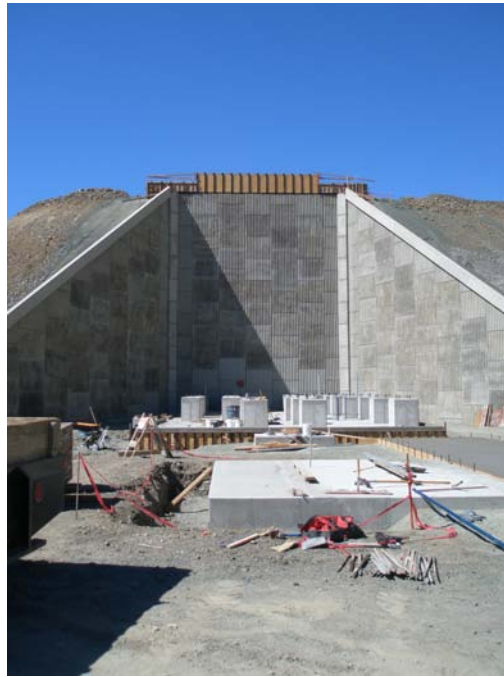
Photo 19: New primary crusher structure, looking west. Drainage from area will be collected and pumped into North Quarry for treatment before discharge. Dated September 26, 2013.

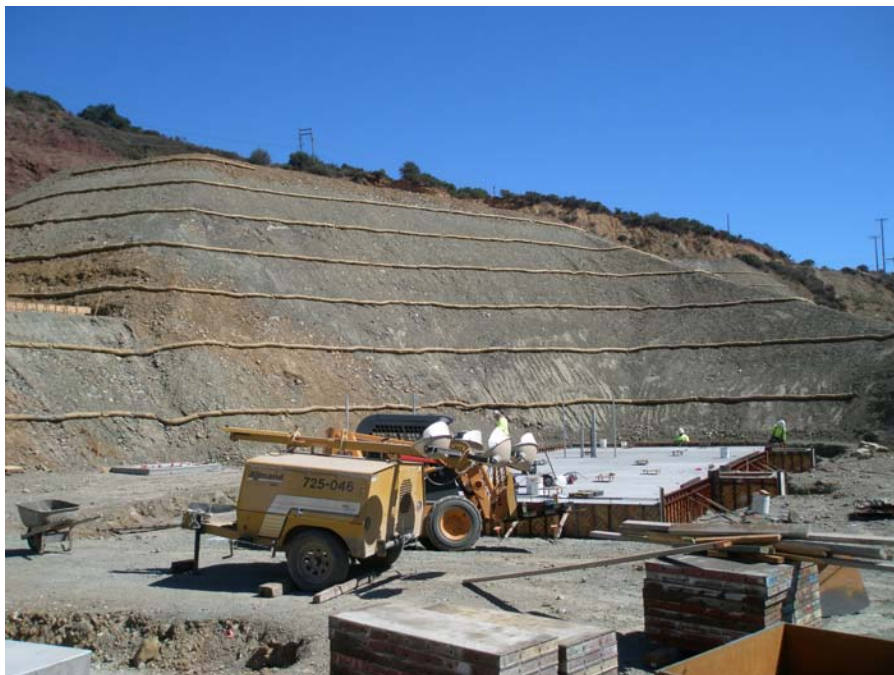
Photo 20: New secondary crusher pad area, looking northeast. Note straw waddles on slope. Slope will be hydroseeded before this winter. Dated September 26, 2013.

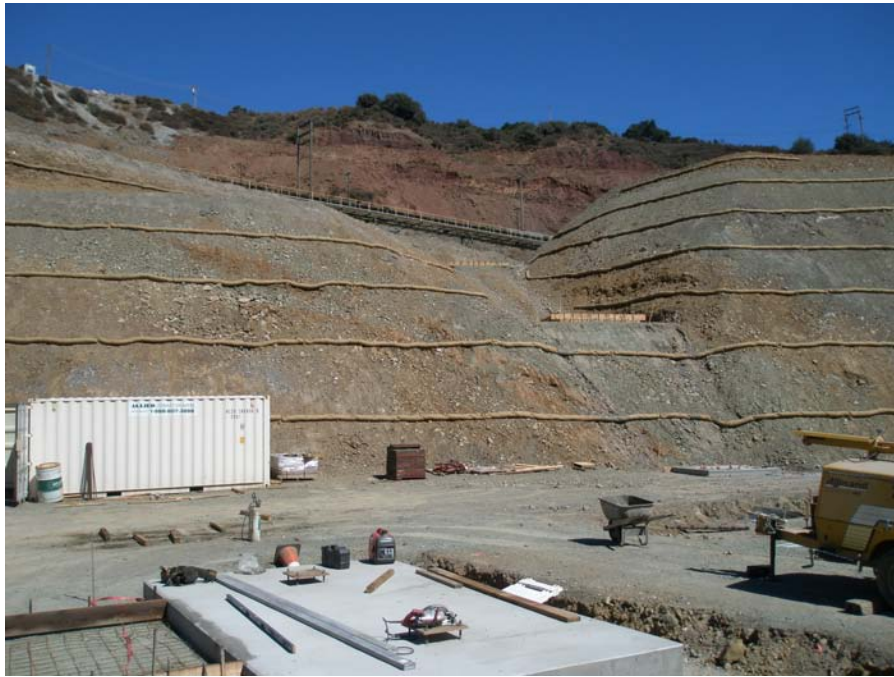
Photo 21: New primary and secondary crusher area, looking northeast. Looking at location where new crushers will tie into existing conveyor. Portion of convey to left of notch will be removed. Dated September 26, 2013.

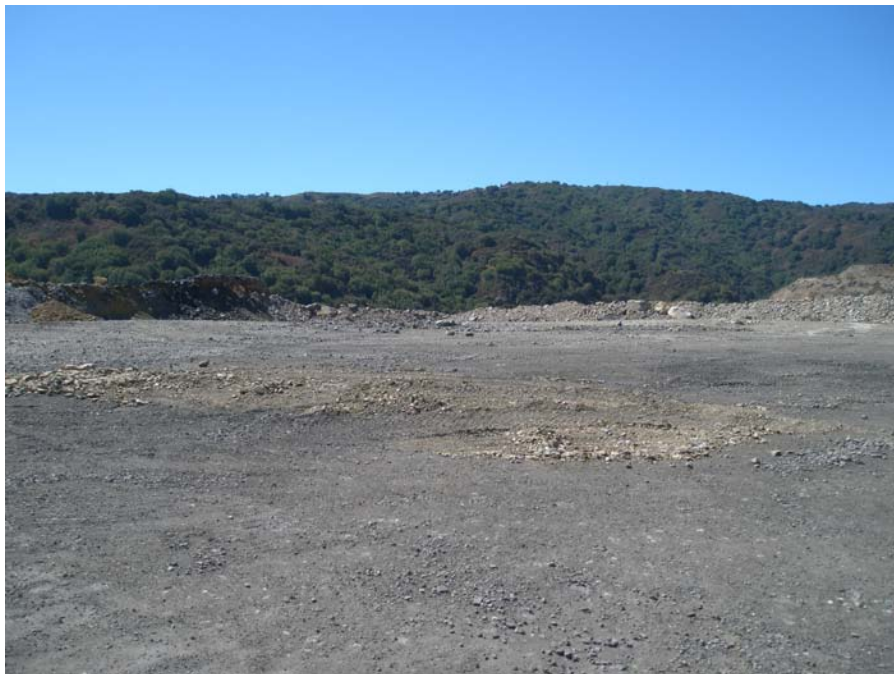
An upper bench area located north of the mine office had a stockpile of limestone rock that was sufficiently high as to be visible from the Town of Cupertino. County staff noted this material during the 2012 pre-winter site inspections and removal was required. During the 2013 inspection, the area of this limestone stockpile and found that it had been removed (Photo 22).

Photo 22: Previous temporary limestone stockpile area at eastern edge of North Quarry and north of mine office area. Limestone material has been removed, looking southwest. Dated September 26, 2013.

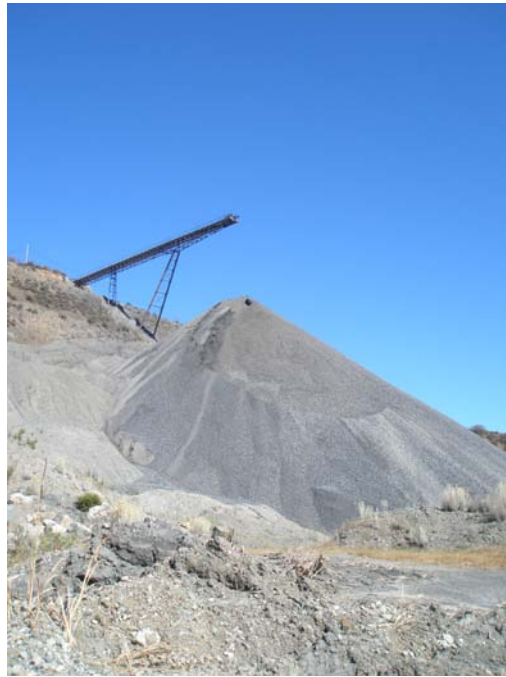
Photo 23: Surge pile, looking northeast from area of Pond 13B. Dated September 26, 2013.

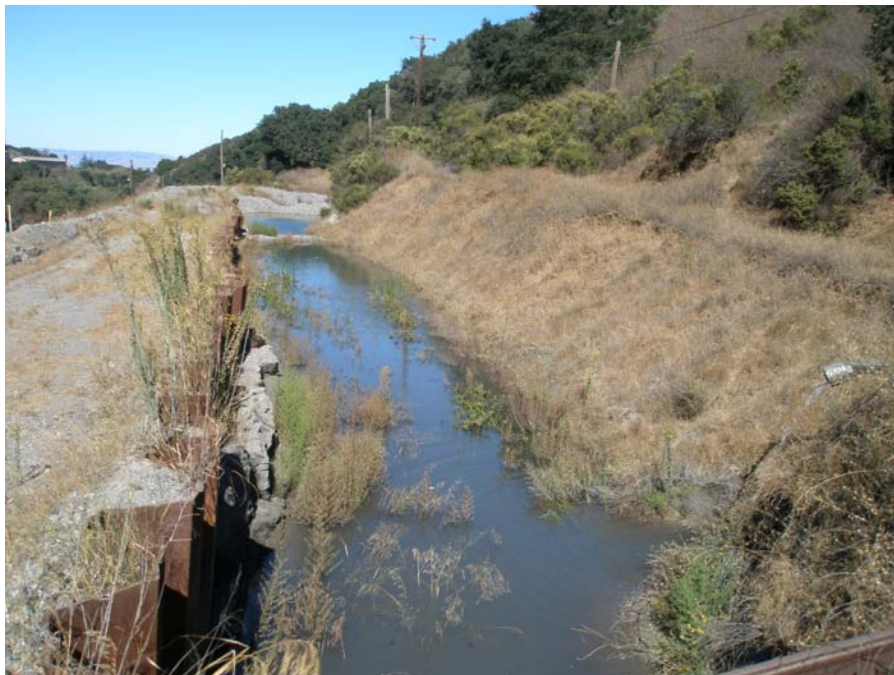
Photo 24: Pond 17 collects runoff from Rock Plant, looking north. Dated September 26, 2013.

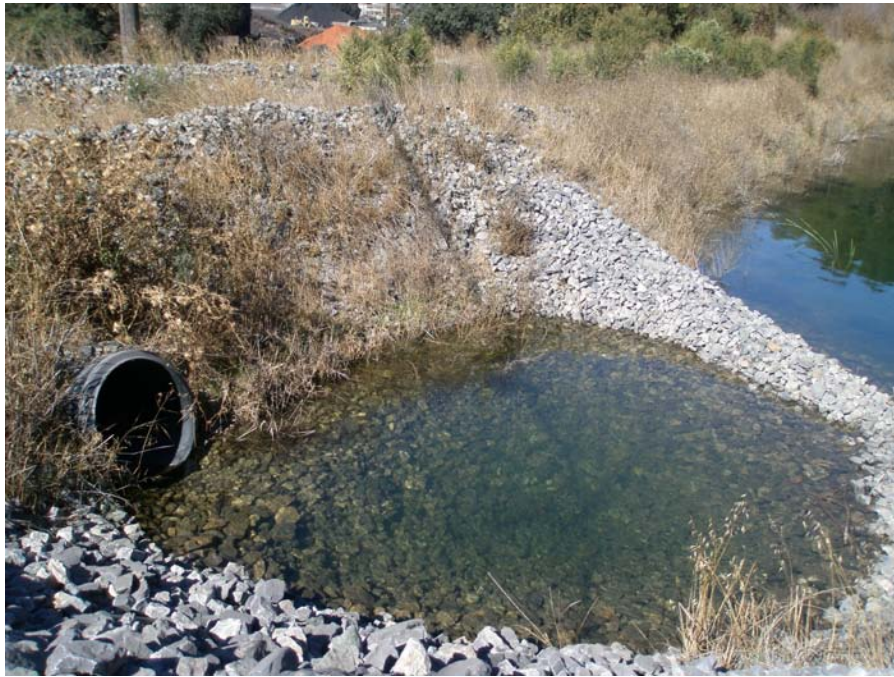
Photo 25: Pond 17 outfall to Permanente Creek, looking north. Dated September 26, 2013.

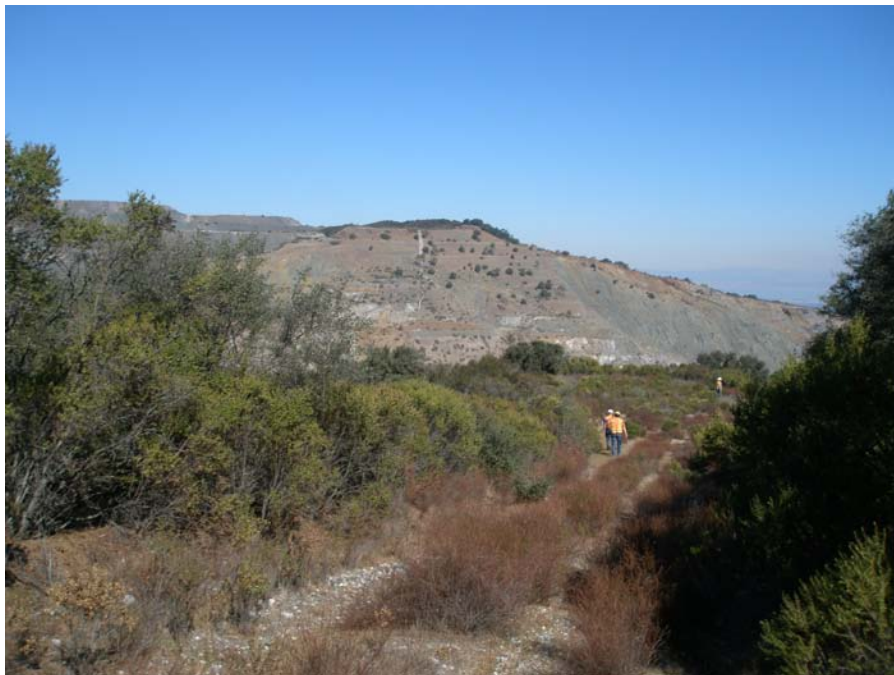
Photo 26: Re-vegetated drill roadway and pad in South Quarry Exploration near N37° 18.898', W122° 06.843', looking north at west side of quarry. Dated September 27 2013.

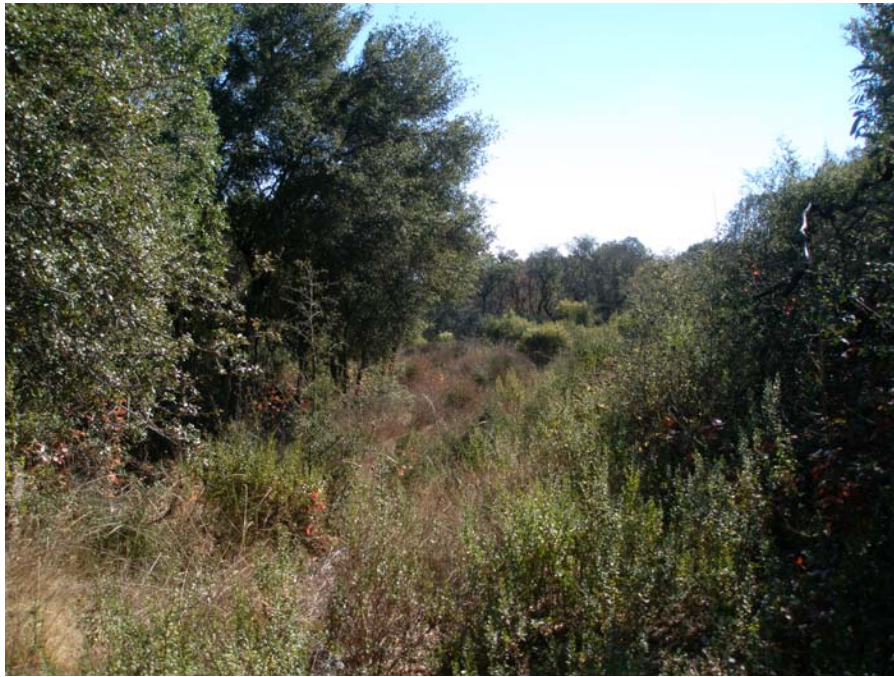
Photo 27: Re-vegetated drill roadway in South Quarry Exploration area near N37° 18.707', W122° 06.448', looking east. Dated September 27, 2013.

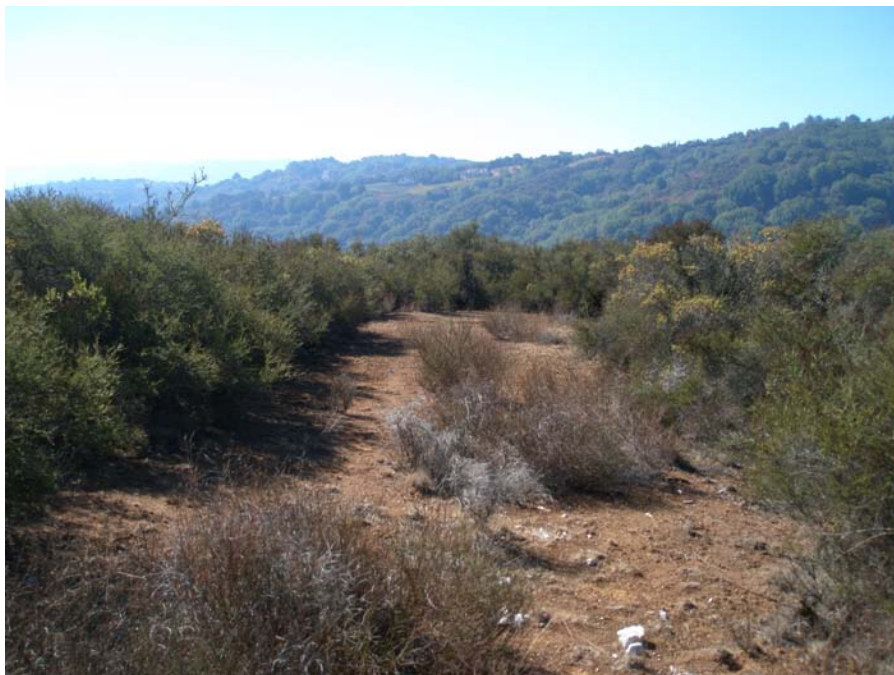
Photo 28: Re-vegetated drill pad in South Quarry Exploration area near N37° 18.670', W122° 06.457', looking south. Dated September 27, 2013.

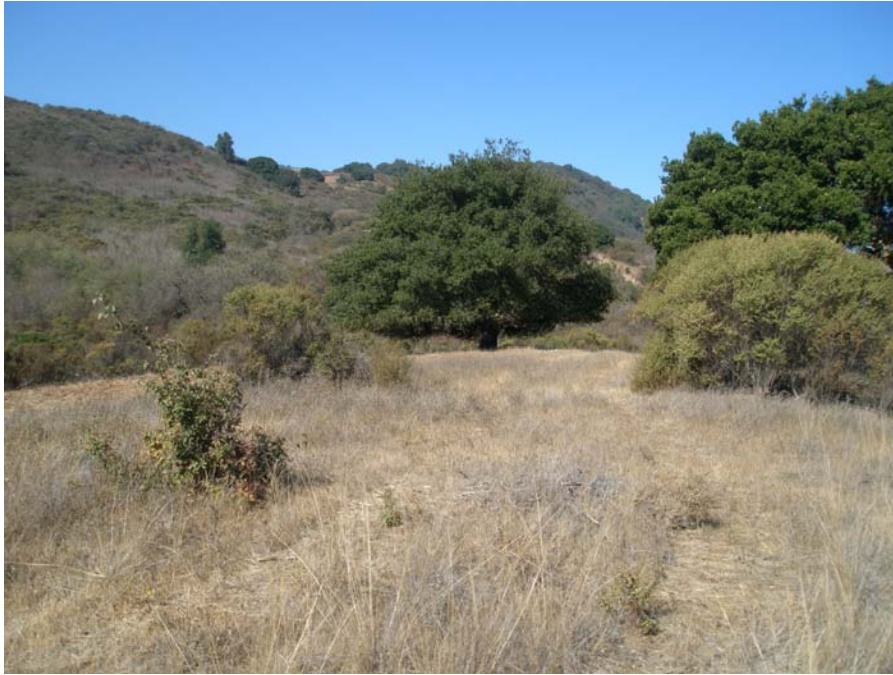
Photo 29: Re-vegetated drill pad in South Quarry Exploration area near N37° 18.555', W122° 05.731', looking west. Dated September 27, 2013.
