SURFACE MINING INSPECTION REPORT

I. Mine Name (As Shown on Approved Reclamation Plan) Permanente Quarry	Inspection Date: 9/4 & 9/5, 2014	CA MINE ID# 91- 43-0004
--	--	-----------------------------------

This letter report summarizes the findings of PMC's annual Surface Mining and Reclamation Act (SMARA) site inspection of the Permanente Quarry in Cupertino, CA (Mine ID #91-43-0004) conducted on September 4 and 5, 2014. PMC was retained by Santa Clara County to assist County staff with the annual SMARA mine inspection and to provide written documentation of our observations, issues of concern and recommendations.

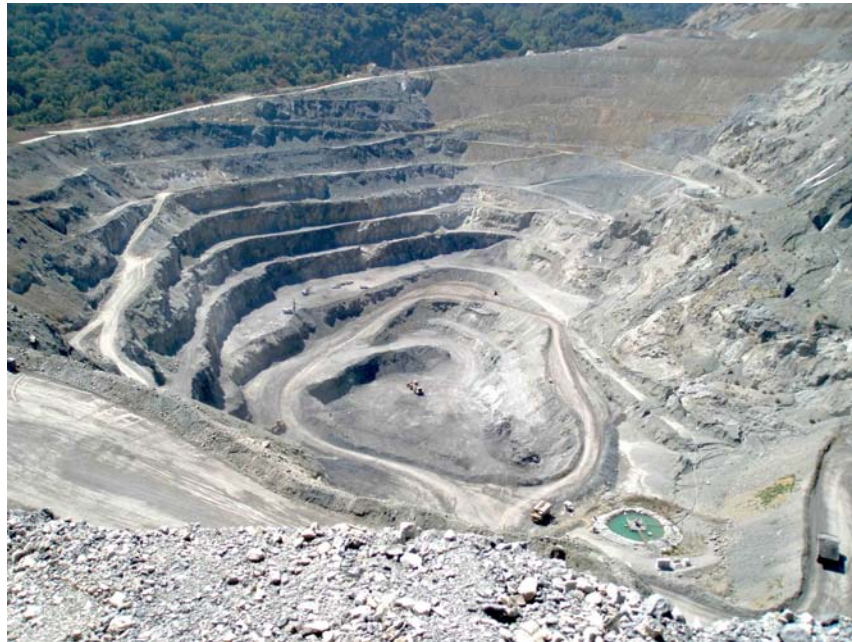
A fourth apparent landslide occurs on the western side of the pit. This area of movement was noted by Golder and Associates in their November 2007 Slope Stability Evaluation report and may extend westward below the toe of the eastern slope of the WMSA overburden stockpile (right of center of Photo 1). The County's Geologist, Mr. James Baker, referred to this western landslide as the "Haul Road Slide." The placement of overburden backfill against the western toe of the North Quarry is intended to stabilize this slide.

Photo 1: North Quarry, southwest portion. Waste rock material being placed at toe of western slope. Potential "Haul Road Slide" in eastern slope of WMSA, right of image. Floor elevation of quarry at approximately 650 feet msl. Dated September 4, 2014.

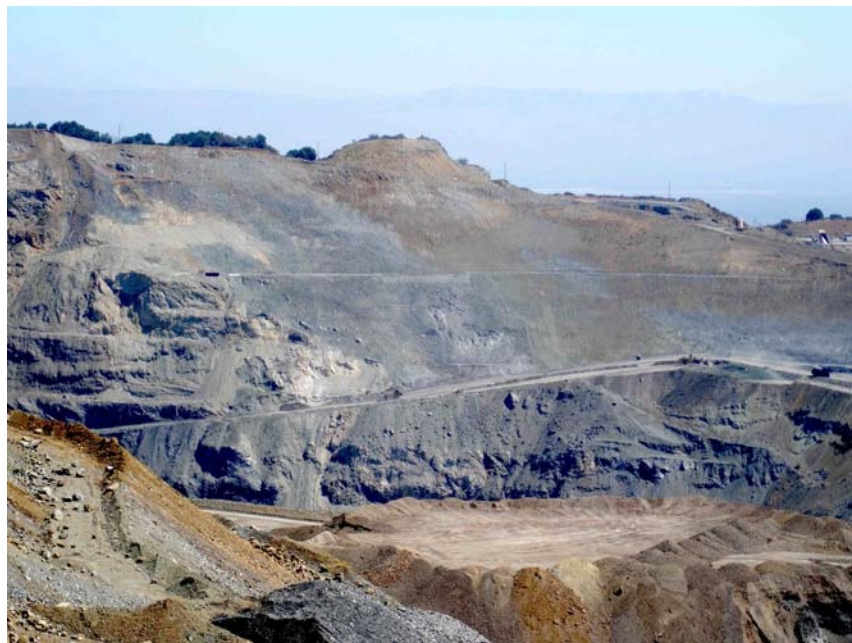
Photo 2: Upper portion of eastern highwall of North Quarry with slopes at final grade. Dated September 4, 2014.

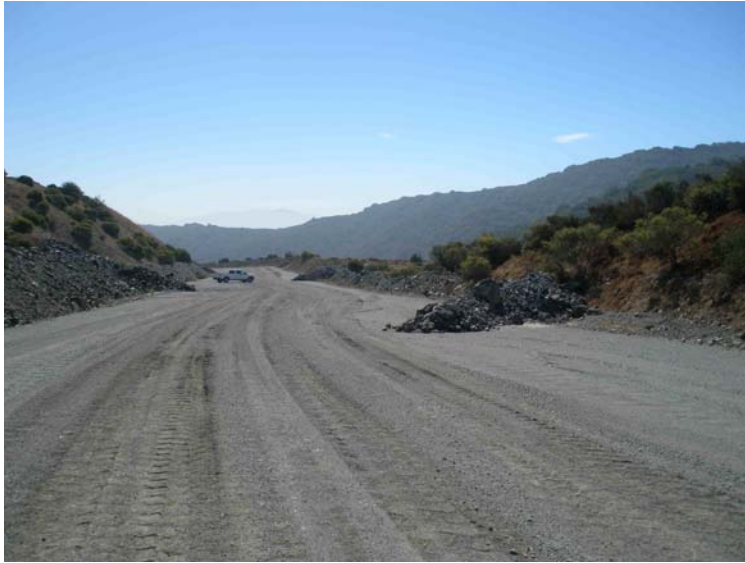
As part of the site's stormwater management, numerous rock checkdams have been placed along the haul roads. Limestone check dam materials have been replaced with non-limestone greenstone rock to reduce the potential for selenium to leach into stormwaters, (Photo 3).

Photo 3: Check dams on WMSA haul road that were replaced with non-limestone materials, looking eastward. Dated September 4, 2014.

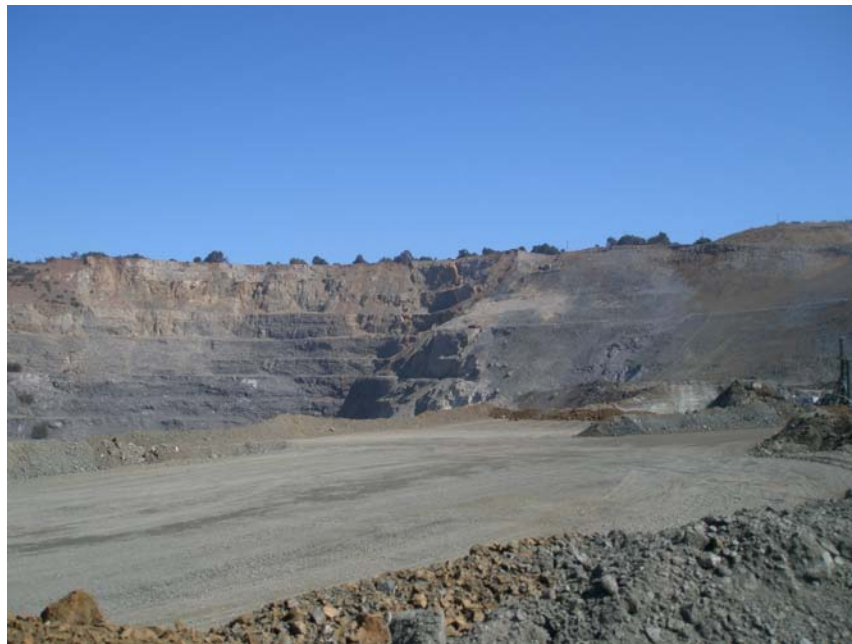
The northern highwall of the North Quarry has had three large rockslides, which are described in the RPA. No major new movement on these rockslides was observed during the 2014 inspection. The upper portions of the Mid-Pen Rockslide that extends approximately halfway down the eastern highwall was graded out recently during mining (Photo 4). The Scenic Easement Rockslide has a slope failure that extends down slope approximately as far as the Mid-Pen Rockslide (Photo 5). This rockslide lowered the ridgeline contrary to the 1972 Ridgeline Protection Easement requirement. The largest slide, the Main Rockslide, appears to extend across most of the current height of the northwestern highwall (Photo 6).

Photo 4: Looking northeast at the North Quarry. Mid-Pen Rockslide area at in center of image upper portion removed by recent mining. Compare to Photo 4 in 2013 inspection report. Dated September 4, 2014

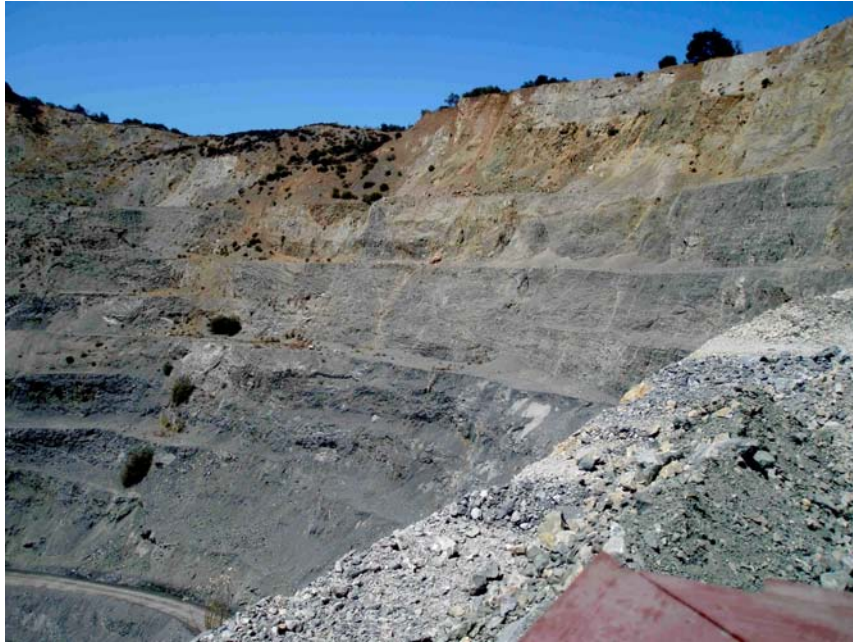
Photo 5: Looking northwest at Scenic Easement Rockslide in left half of image. Dated September 4, 2014.

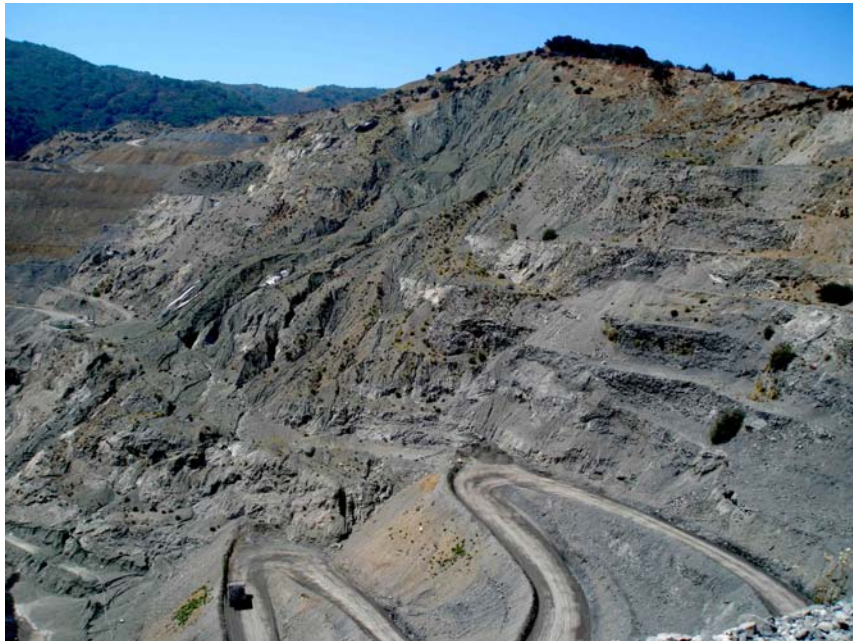
Photo 6: Looking west at Main Rockslide and WMSA. Dated September 4, 2014.

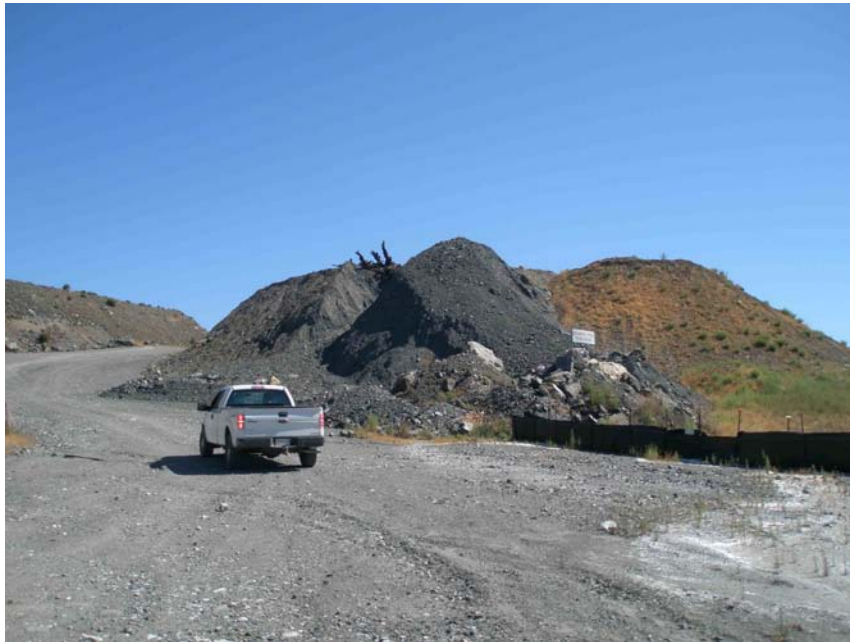
Photo 7: Eastern topsoil storage area in WMSA, looking north. Sign and silt fence in foreground. Dated September 4, 2014.

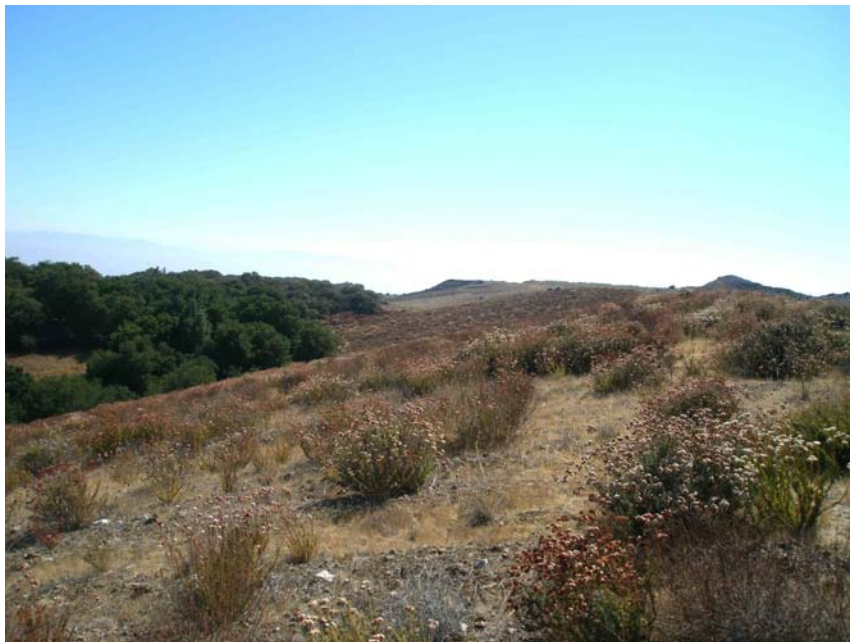
Photo 8: Portion of re-vegetated north-facing slope of WMSA, looking east. A portion of this slope will be removed in Phase 2 to backfill of North Quarry. Dated September 4, 2014.

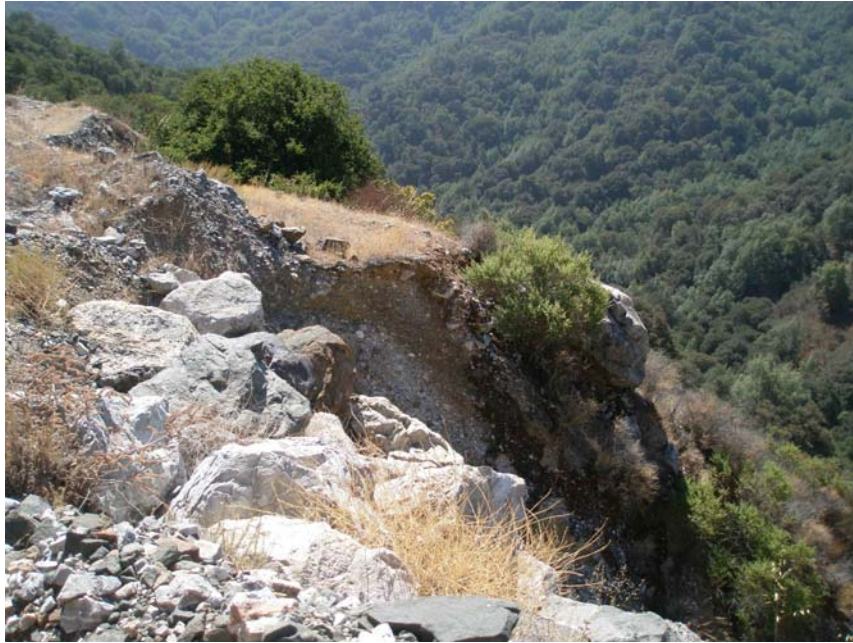
Photo 9: Rocked outfall in mid-slope bench on southern WMSA slope, looking southwest into Permanente Creek drainage. Dated September 4, 2014.

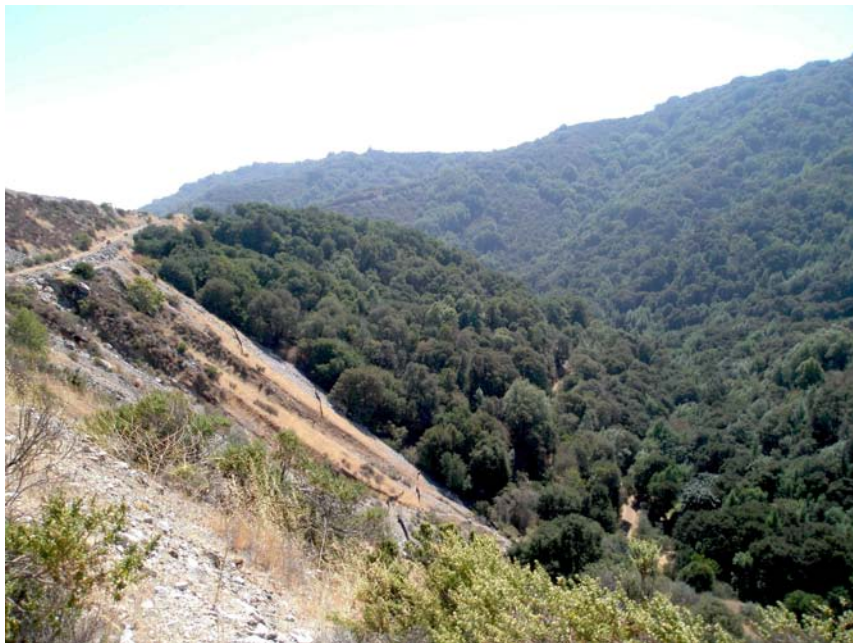
Photo 10: Straw waddles and bales at outfalls of mid-slope bench on southern slope of WMSA, looking west. Dated September 4, 2014.

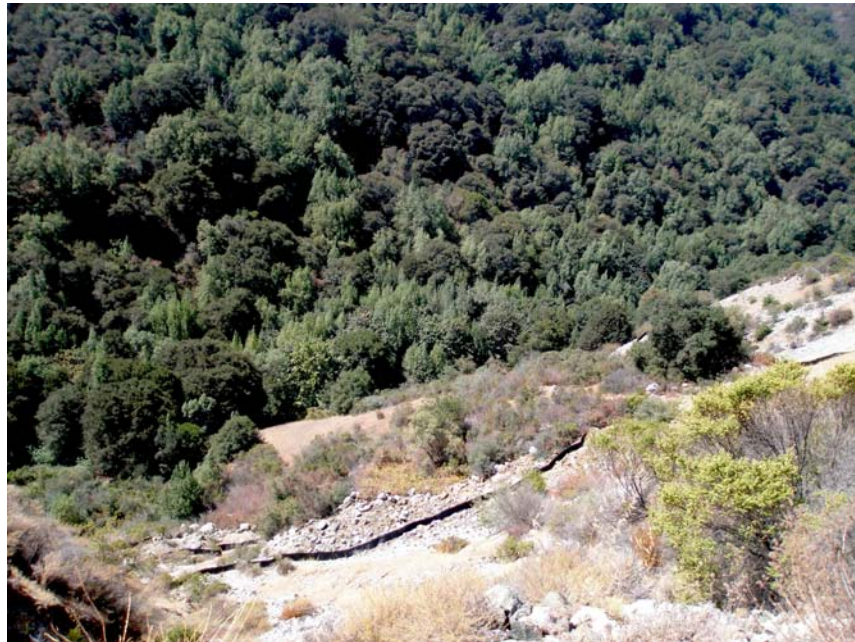
Photo 11: Silt fencing on southern slope of WMSA below outfall in Photo 9. Note soil mixed with talus adjacent to silt fence may be result of past slide; silt fence shows no significant displacement. Dated September 4, 2014.

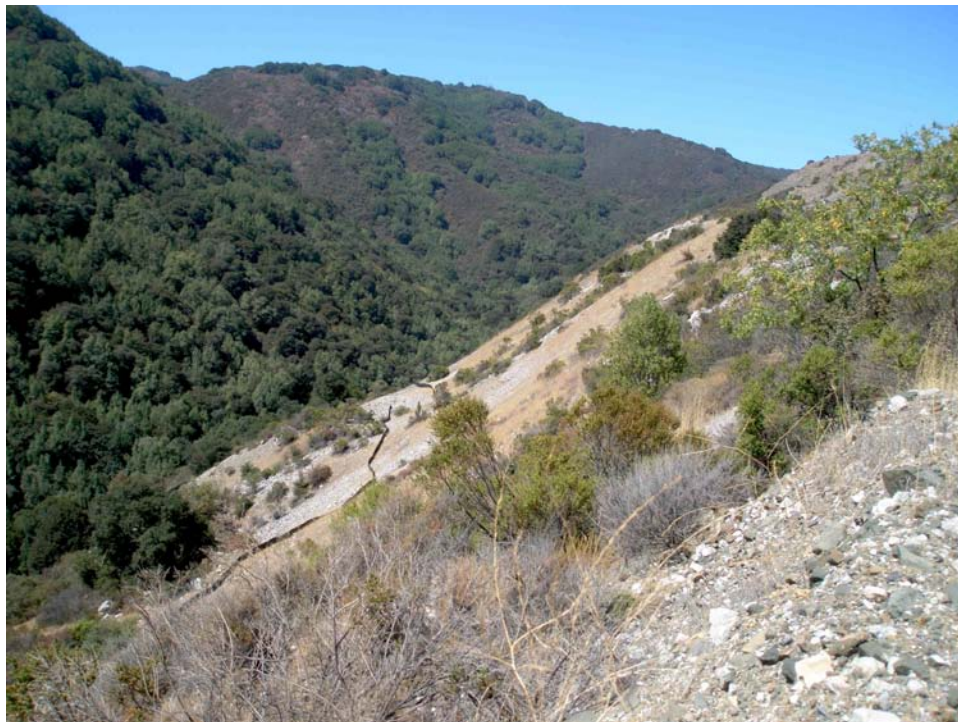
Photo 12: Southern slope of WMSA with silt fencing, looking west up Permanente Creek. Dated September 4, 2014.

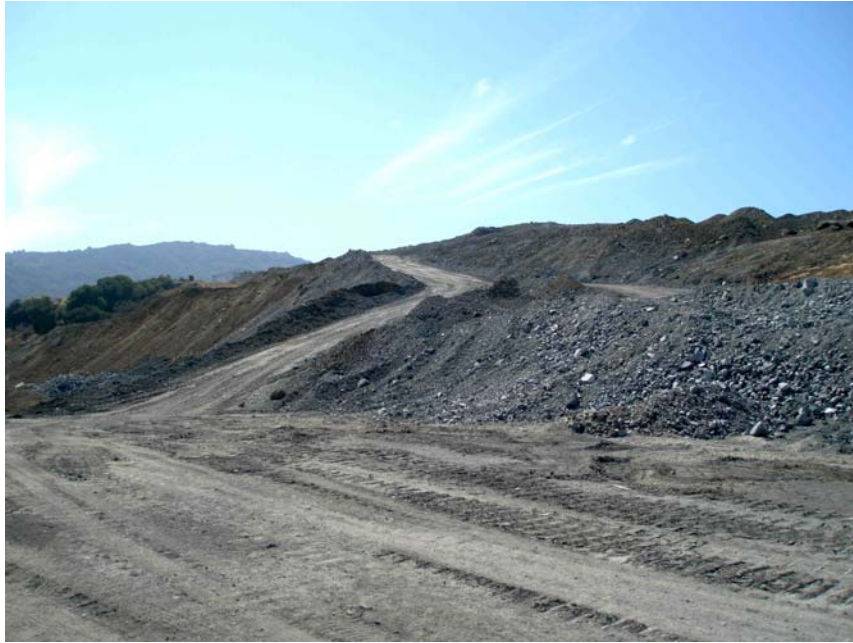
Photo 13: Recent grading northeastern EMSA looking southwest. Grading will be completed before winter. Dated September 4, 2014.

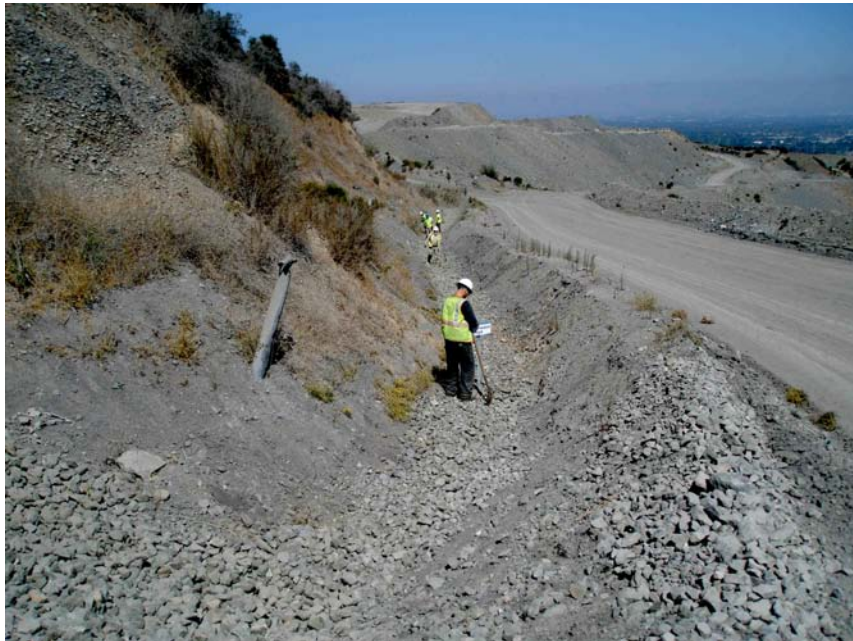
The operator has created a network of lined and unlined drainage ditches to convey stormwater runoff from the EMSA into holding ponds. During the 2012-13 rainy season a slope failure occurred in a small spill fill previously placed in the upper portion of the drainage just north of the eastern end of the conveyor tunnel (Photos 15 and 2013 Photo 14). This deposited limestone rock in the upper portions of the drainage ditch that runs along the western edge of the EMSA (Photo 14). This material was removed last year. A series of sediment catch basins were created as an additional BMP to trap sediment and minimize the requirement of cleaning out the ditch (Photos 15 and 16). The western ditch was being cleaned out during the inspection (Photo 14). Continued failure of the drainage ditch slope is anticipated.

Photo 14: Western perimeter drainage ditch in EMSA. Ditch being cleaned out and greenstone rock lining bottom, looking northeast. Dated September 4, 2014

3. The final report of the re-vegetation test plots should be submitted to the County.
4. The drainage ditches and sediment catch basins constructed in the EMSA rock storage area should be monitored, cleaned out, and repaired as necessary.

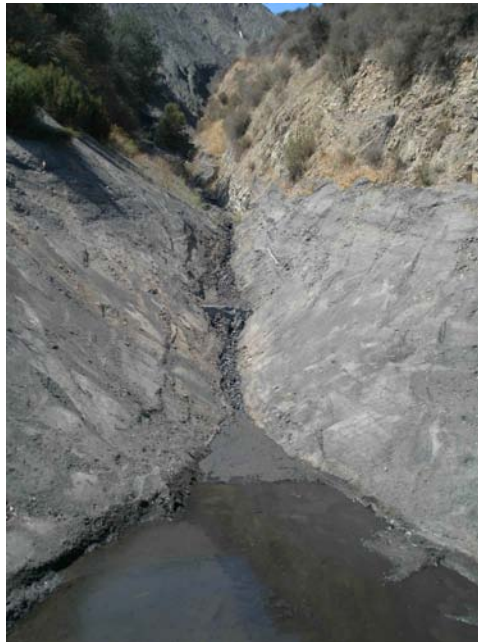
Photo 15: Sediment catch basin at toe of slope failure north of eastern end of 500-foot long conveyor tunnel in Crusher/Support Area, looking west. Dated September 4, 2014.

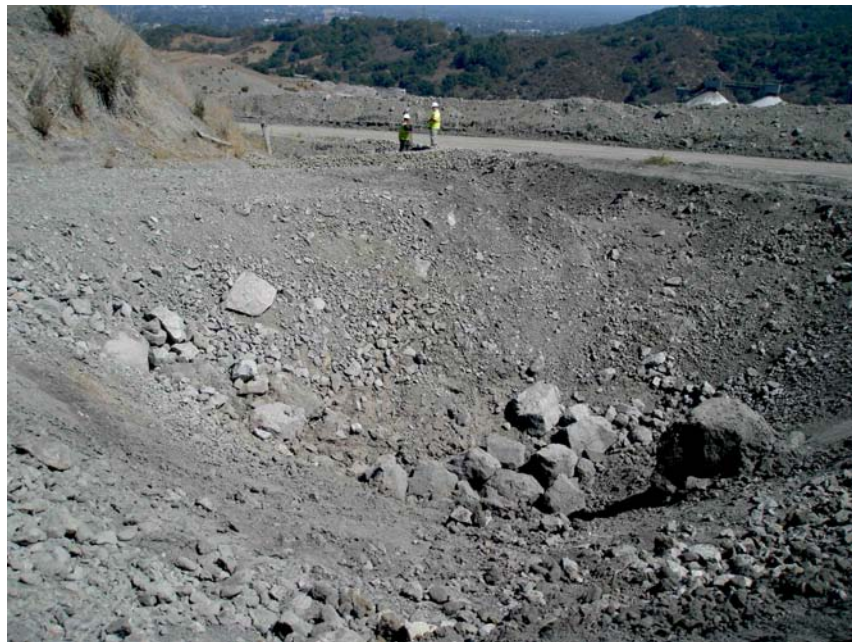
Photo 16: Second sediment catch basins constructed above western perimeter drainage ditch in background. Dated September 4, 2014.

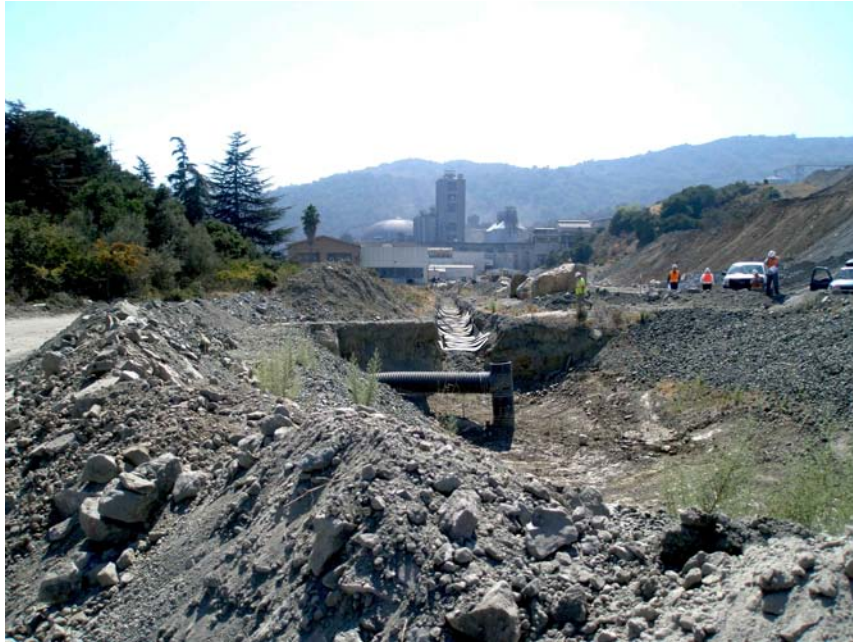
Photo 17: Pond 30 lowest pond in EMSA and drains into Permanente Creek, looking south at cement plant. Walls of pond and drainage ditch relined with greenstone. Dated September 4, 2014.

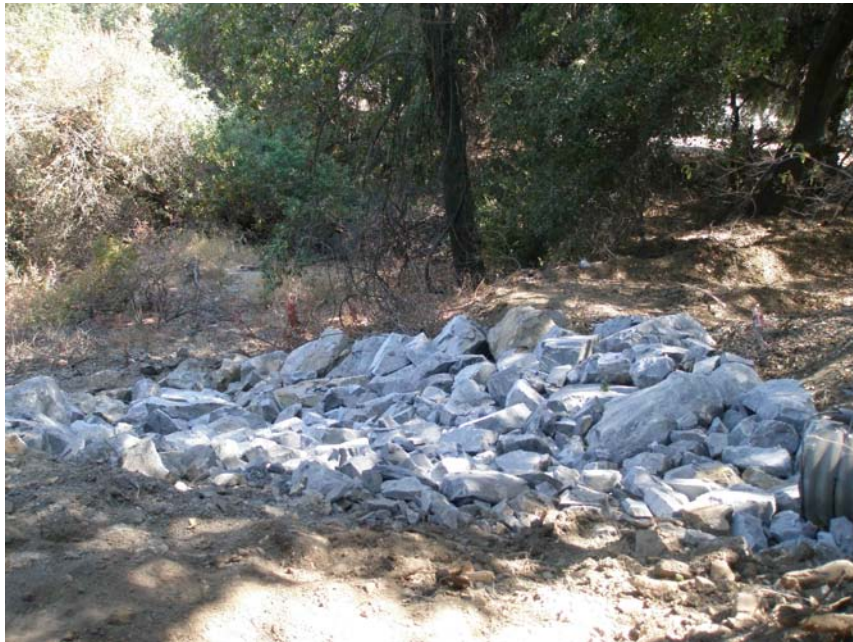
Photo 18: Pond 30 outfall to Permanente Creek, relined with coarser greenstone. Dated September 4, 2014.

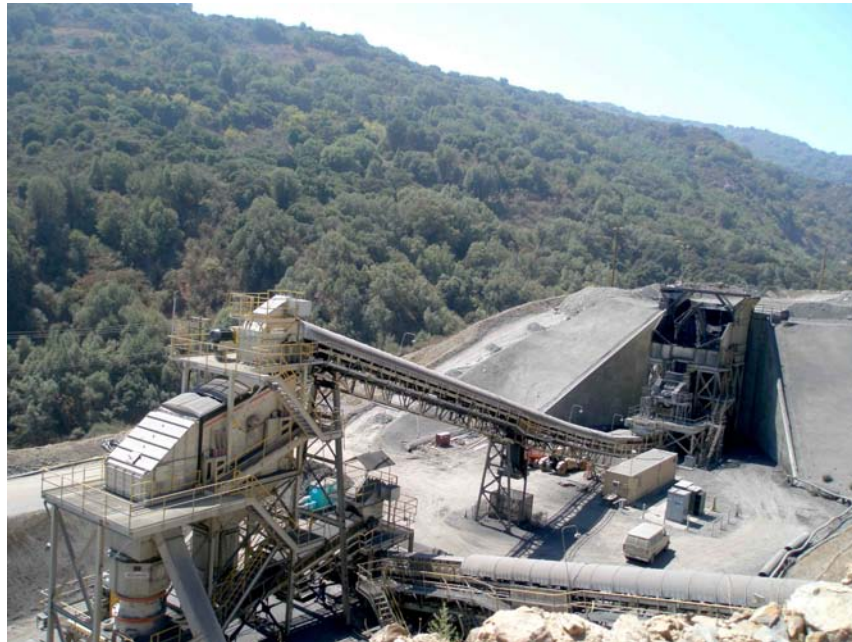
Photo 19: New primary and secondary crusher structures, looking southwest. Drainage from area will be collected and pumped into North Quarry for treatment before discharge. Dated September 4, 2014.

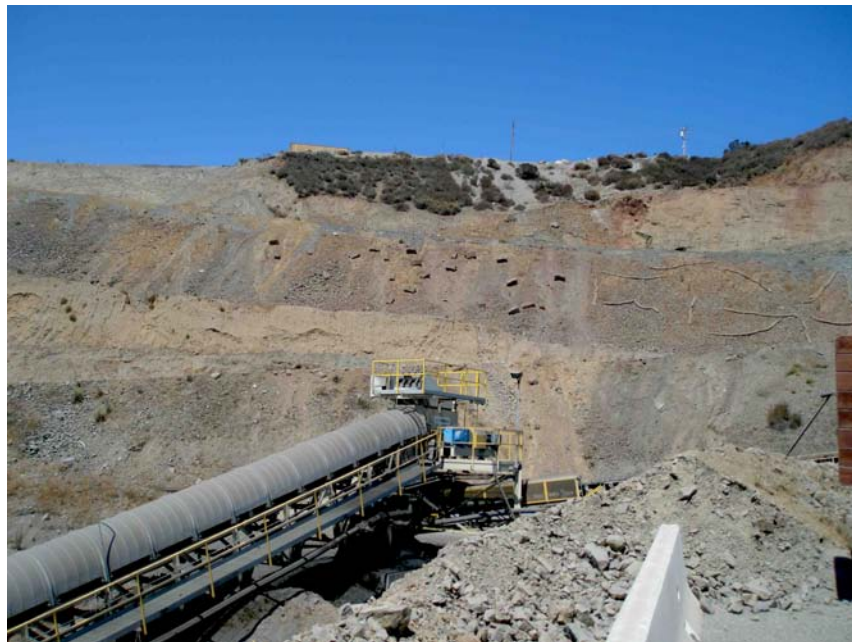
Photo 20: New secondary crusher conveyor dumps to tunnel conveyor, looking north. Note straw bails and waddles on slope. Slope was hydroseeded last winter. Dated September 4, 2014.

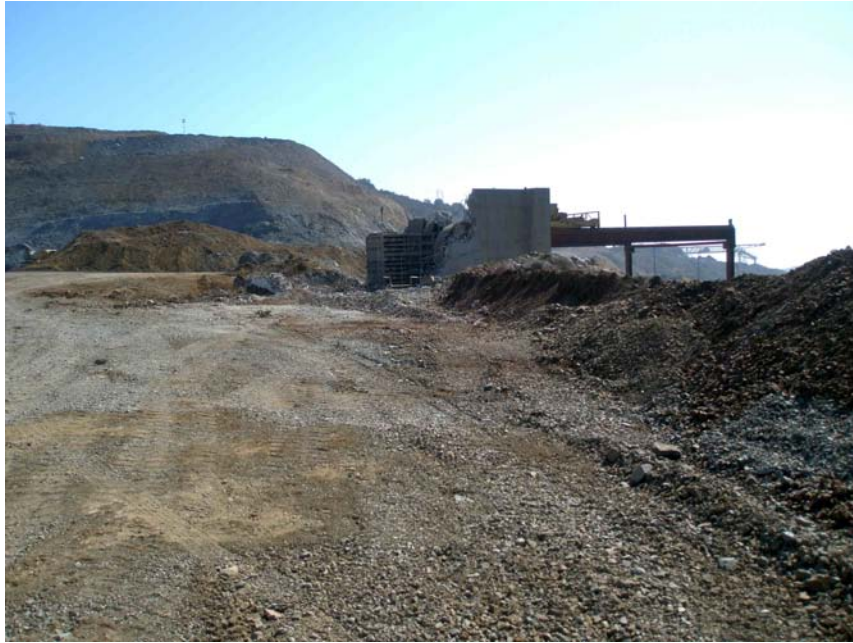
Photo 21: Old primary crusher being dismantled, looking east.. Dated September 4, 2014.

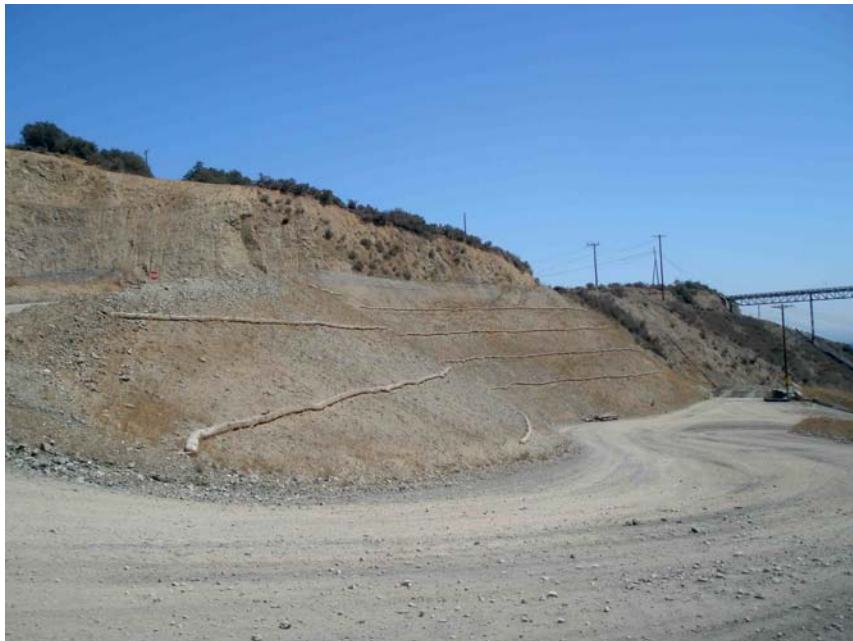
Photo 22: Slopes on roadway to new crusher area. Slope straw waddled and hydroseeded before last winter. Dated September 4, 2014.

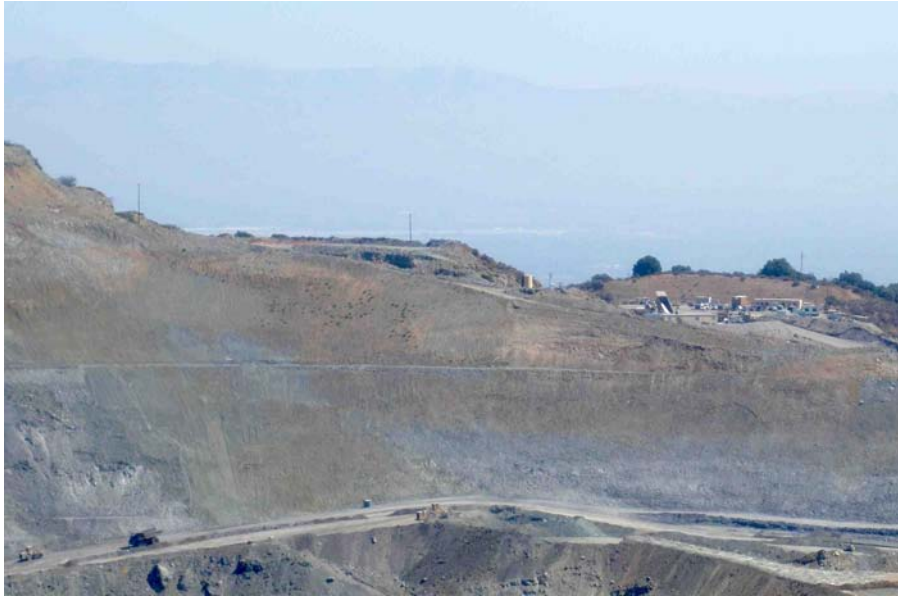
An upper bench area located north of the mine office had a stockpile of limestone rock that was sufficiently high as to be visible from the City of Cupertino. County staff noted this material during the 2012 pre-winter site inspections and removal was required. During the 2014 inspection, the area of this limestone stockpile was found that it had been removed (Photo 23).

Photo 23: Upper bench area above mine office, stockpile of limestone removed, looking east. Dated September 4, 2014.

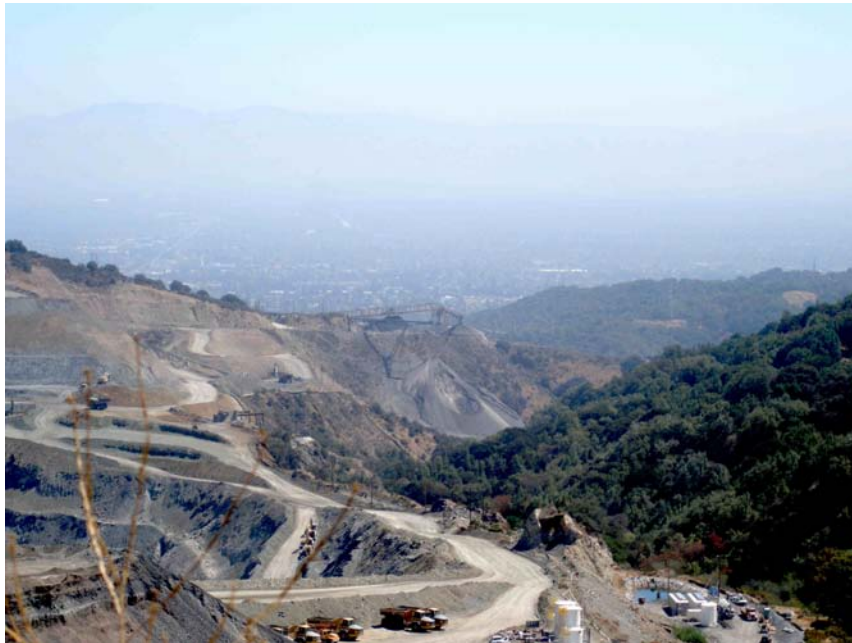
Photo 24: Surge pile below conveyor in center of image, looking east. Dated September 4, 2014.

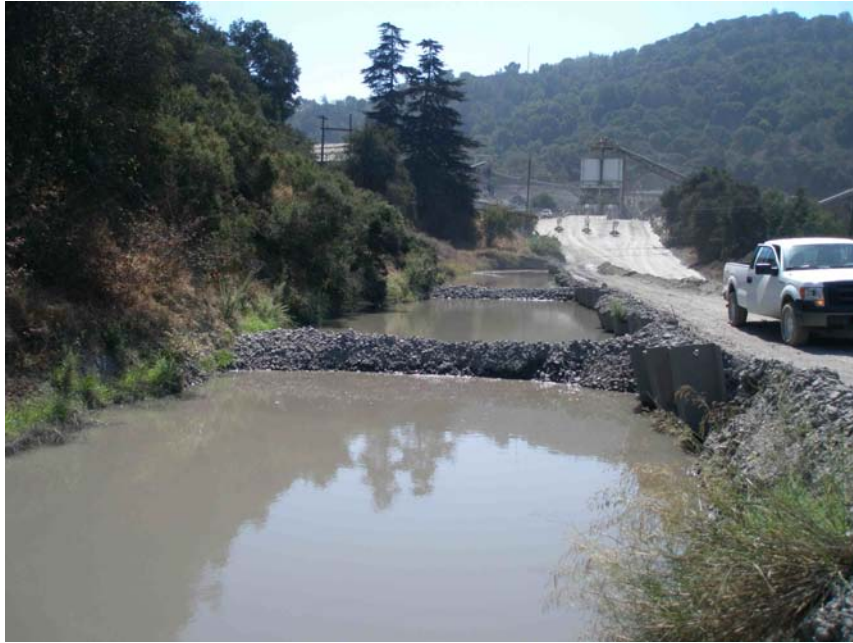
Photo 25: Pond 17 collects runoff from Rock Plant, looking south. Dated September 4, 2014.

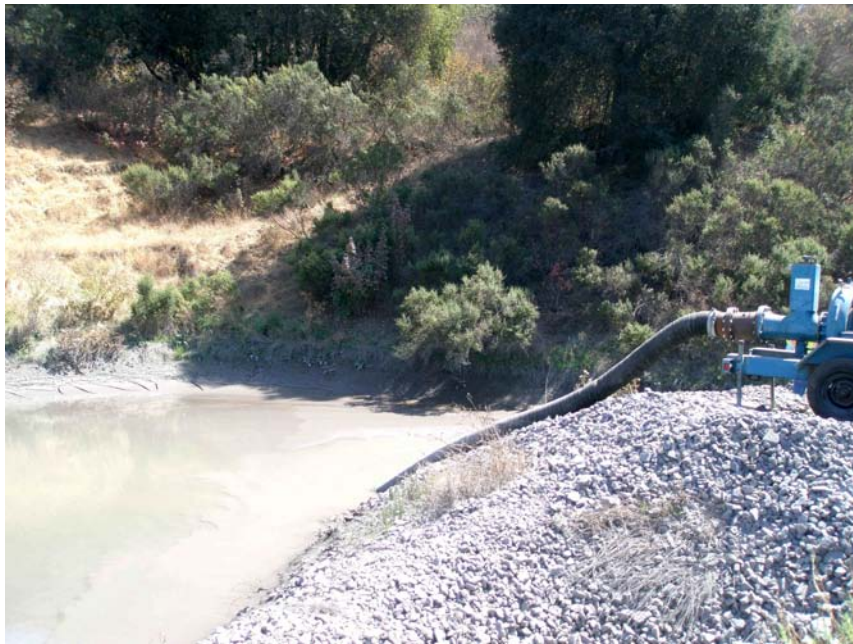
Photo 26: Pond 17 with pump to recycle water back to rock plant. Dated September 4, 2014.

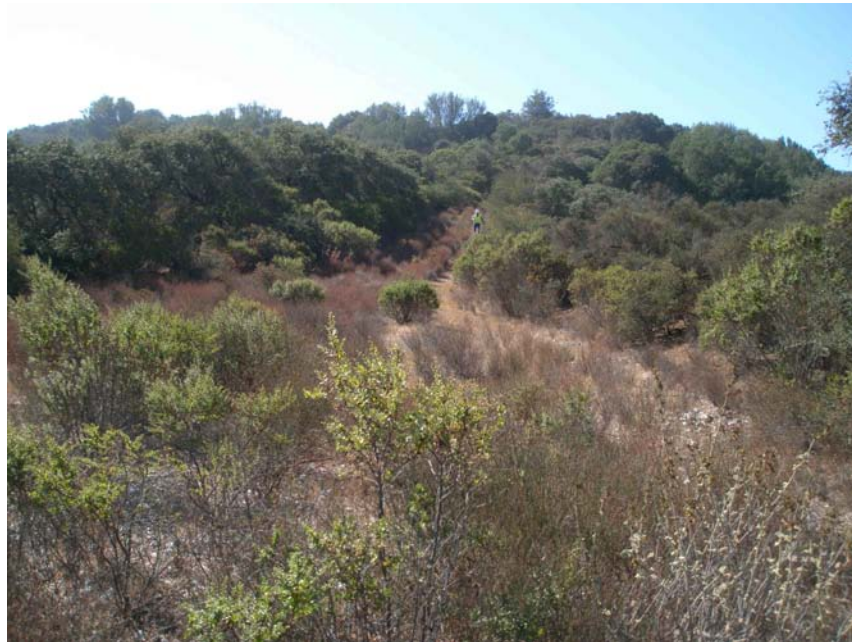
Photo 27: Re-vegetated Pit 3 East Road in South Quarry Exploration area near N37° 18.894', W122° 06.844', looking south from drill site gt 3-5A. Dated September 5, 2014.

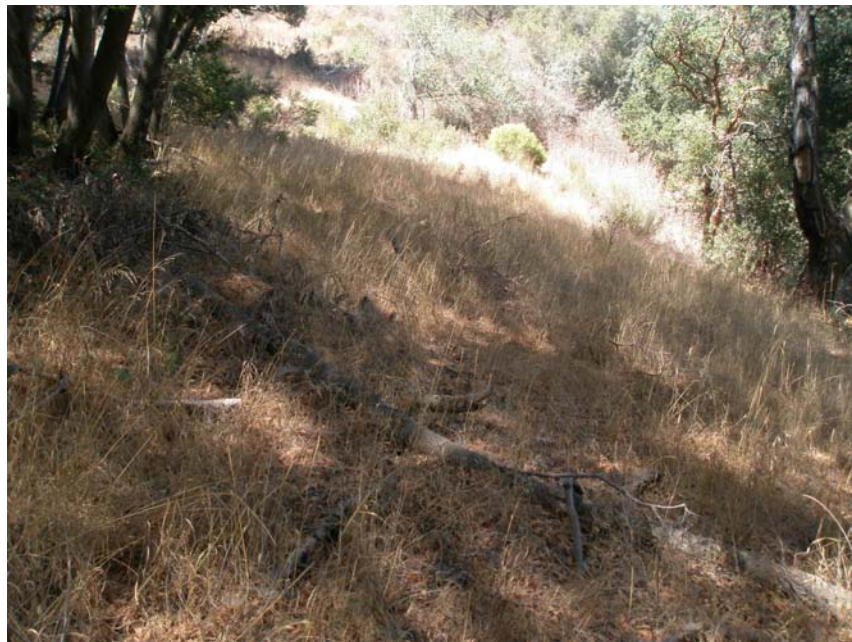
Photo 28: Re-vegetated exploration area geo 4-35 in South Quarry Exploration area near N37° 18.725', W122° 06.148', looking northwest. Dated September 5, 2014.

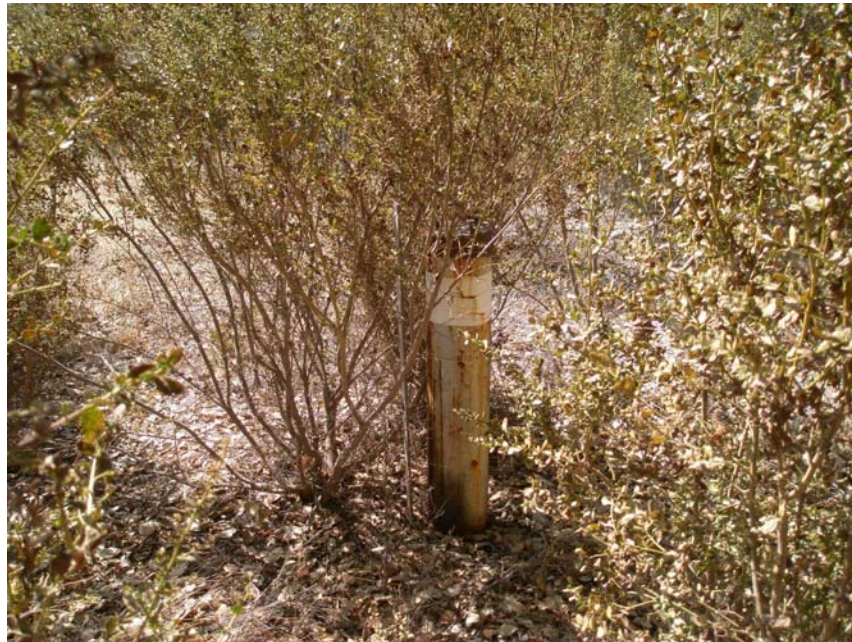
Photo 29: Re-vegetated drill pad with monitoring well HG-9 in South Quarry Exploration area near N37° 18.800', W122° 06.169', looking south. Dated September 5, 2014.

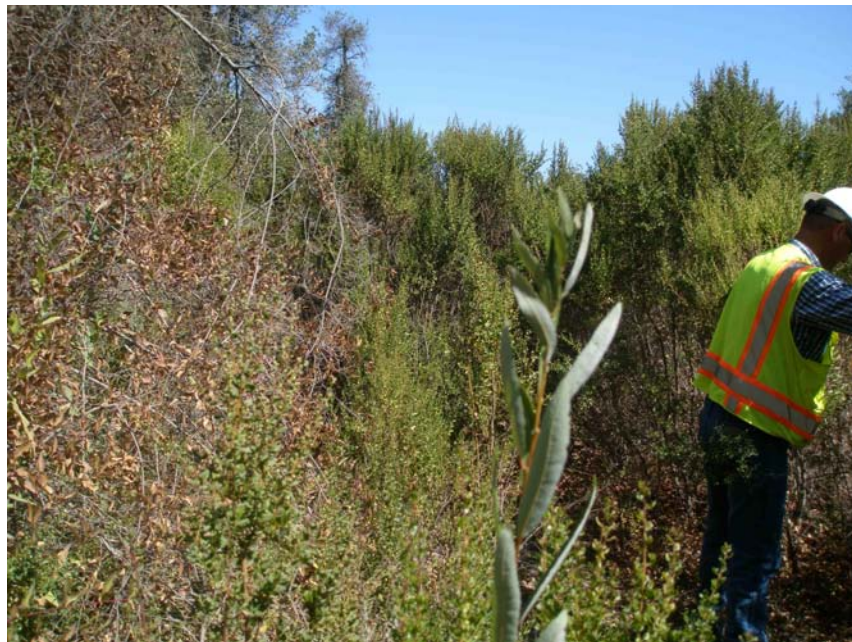
Photo 30: Re-vegetated drill roadway in South Quarry Exploration area near N37° 18.865', W122° 06.214', looking northwest. Dated September 5, 2014.
