State of California **DEPARTMENT OF CONSERVATION**OFFICE OF MINE RECLAMATION

MRRC-1 (4/97) Page 1 of 5 (Rev. 07/13)

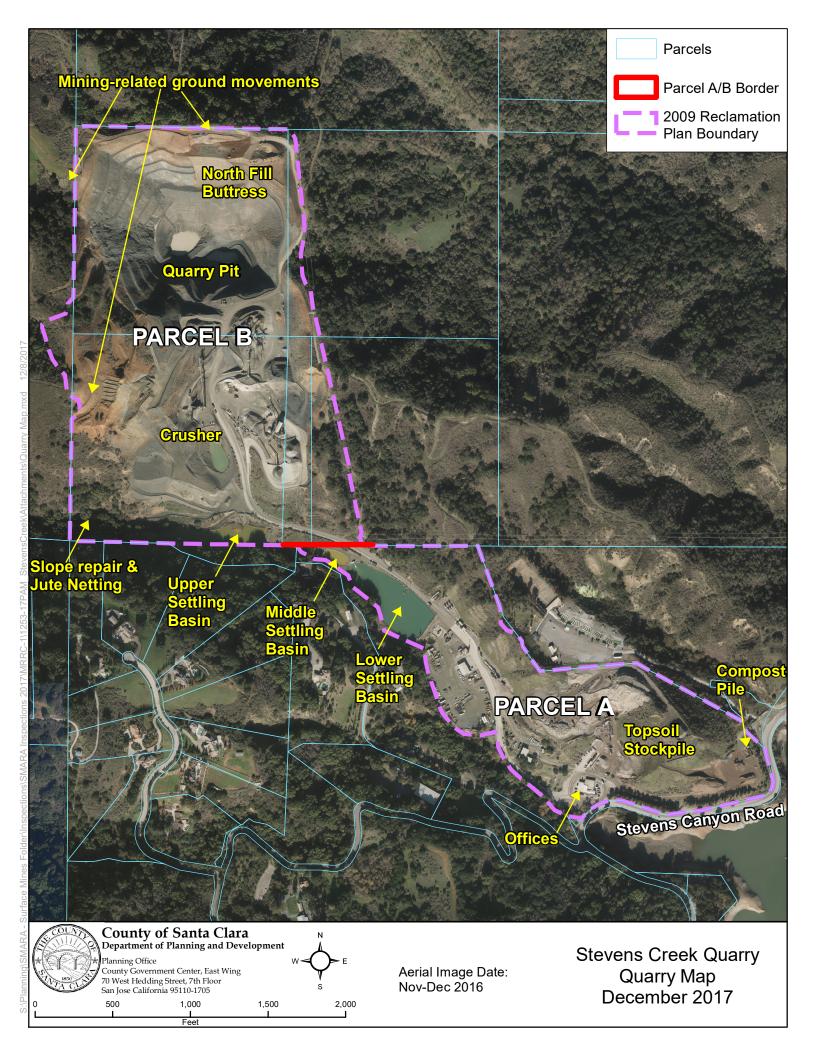
SITE CONDITIONS (Continued)

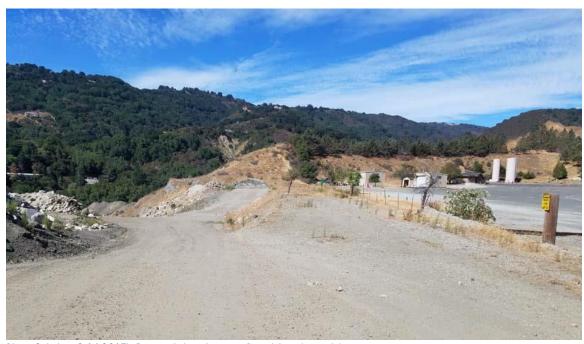
Photo 2 (taken 9-14-2017): Repaired slope between Parcel A and gun club.

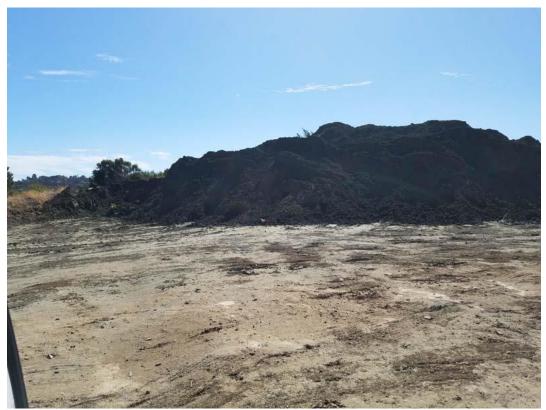
Photo 3 (taken 9-14-2017): Stockpiled soil on Parcel A.

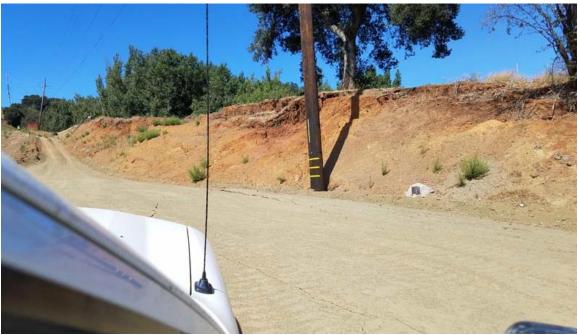
Photo 8 (taken 9-14-2017): Headscarp of failure on north high wall and perimeter road.

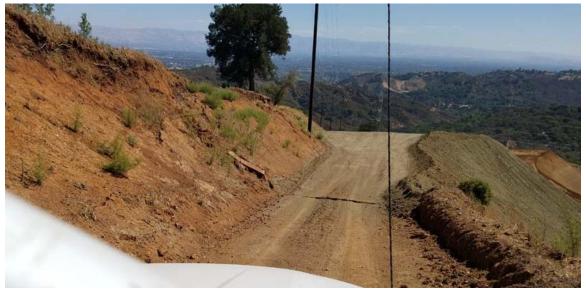
Photo 9 (taken 9-14-2017): Area of former retaining wall above north high wall.

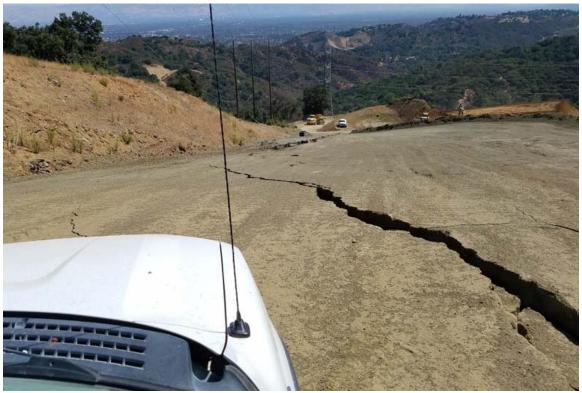
Photo 10 (taken 9-14-2017): Ground crack on perimeter road above buttress fill of north high wall.

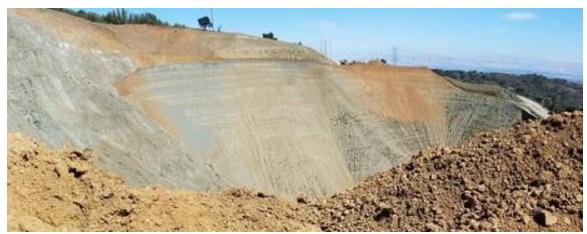
Photo 11 (taken 9-14-2017): Buttress fill on north high wall.

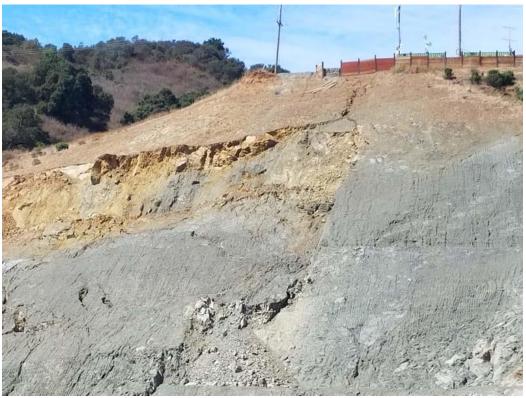
Photo 14 (taken 9-14-2017): Slope failure on western high cut wall.

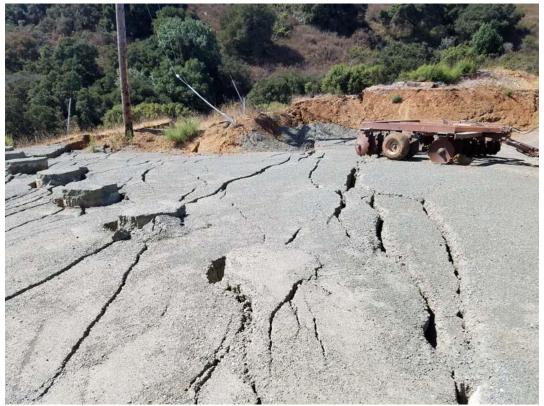
Photo 15 (taken 9-14-2017): Ground cracks and subsidence at northwest property line.

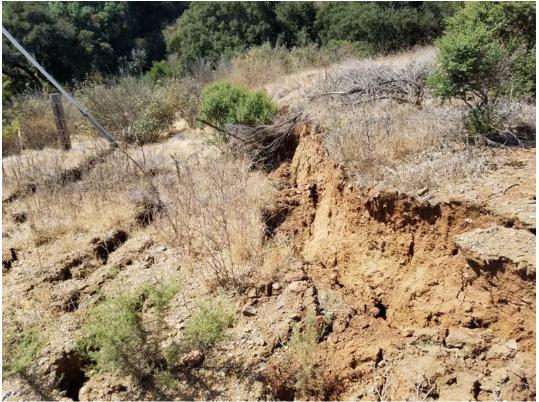
Photo 16 (taken 9-14-2017): Ground cracks and headscarp beyond northwest property line.

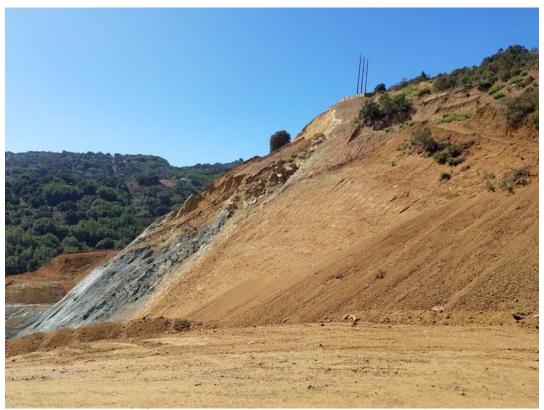
Photo 17 (taken 9-14-2017): Slope failure on southwestern high cut wall, looking south.

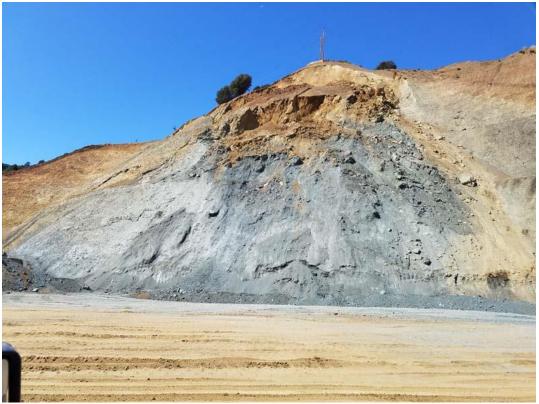
Photo 18 (taken 9-14-2017): Slope failure on southwestern high cut wall, looking west.

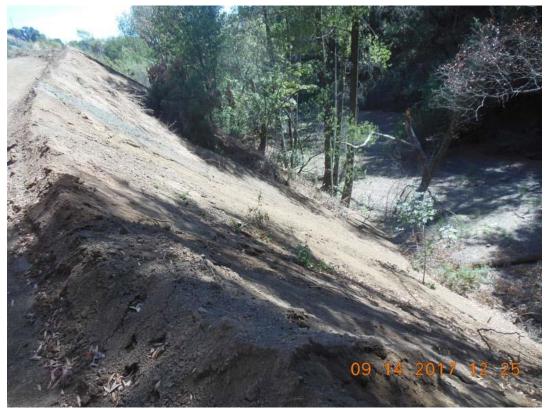
Photo 19 (taken 9-14-2017): Regraded slope along the north side of Rattlesnake Creek. (Jute netting installed Oct 2017.)

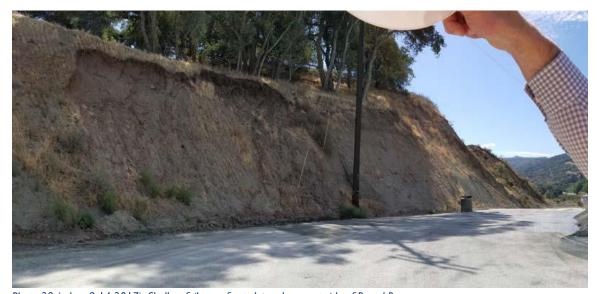
Photo 20 (taken 9-14-2017): Shallow failures of cut slope along east side of Parcel B.
