APPENDIX G-1

GEOLOGY REPORT

Subject: Geologic Investigation Proposed Lexington Quarry Site

Subject: Letter Report for Inclusion in EIR Geotechnical and Geologic Concerns at Proposed Lexington Quarry Site

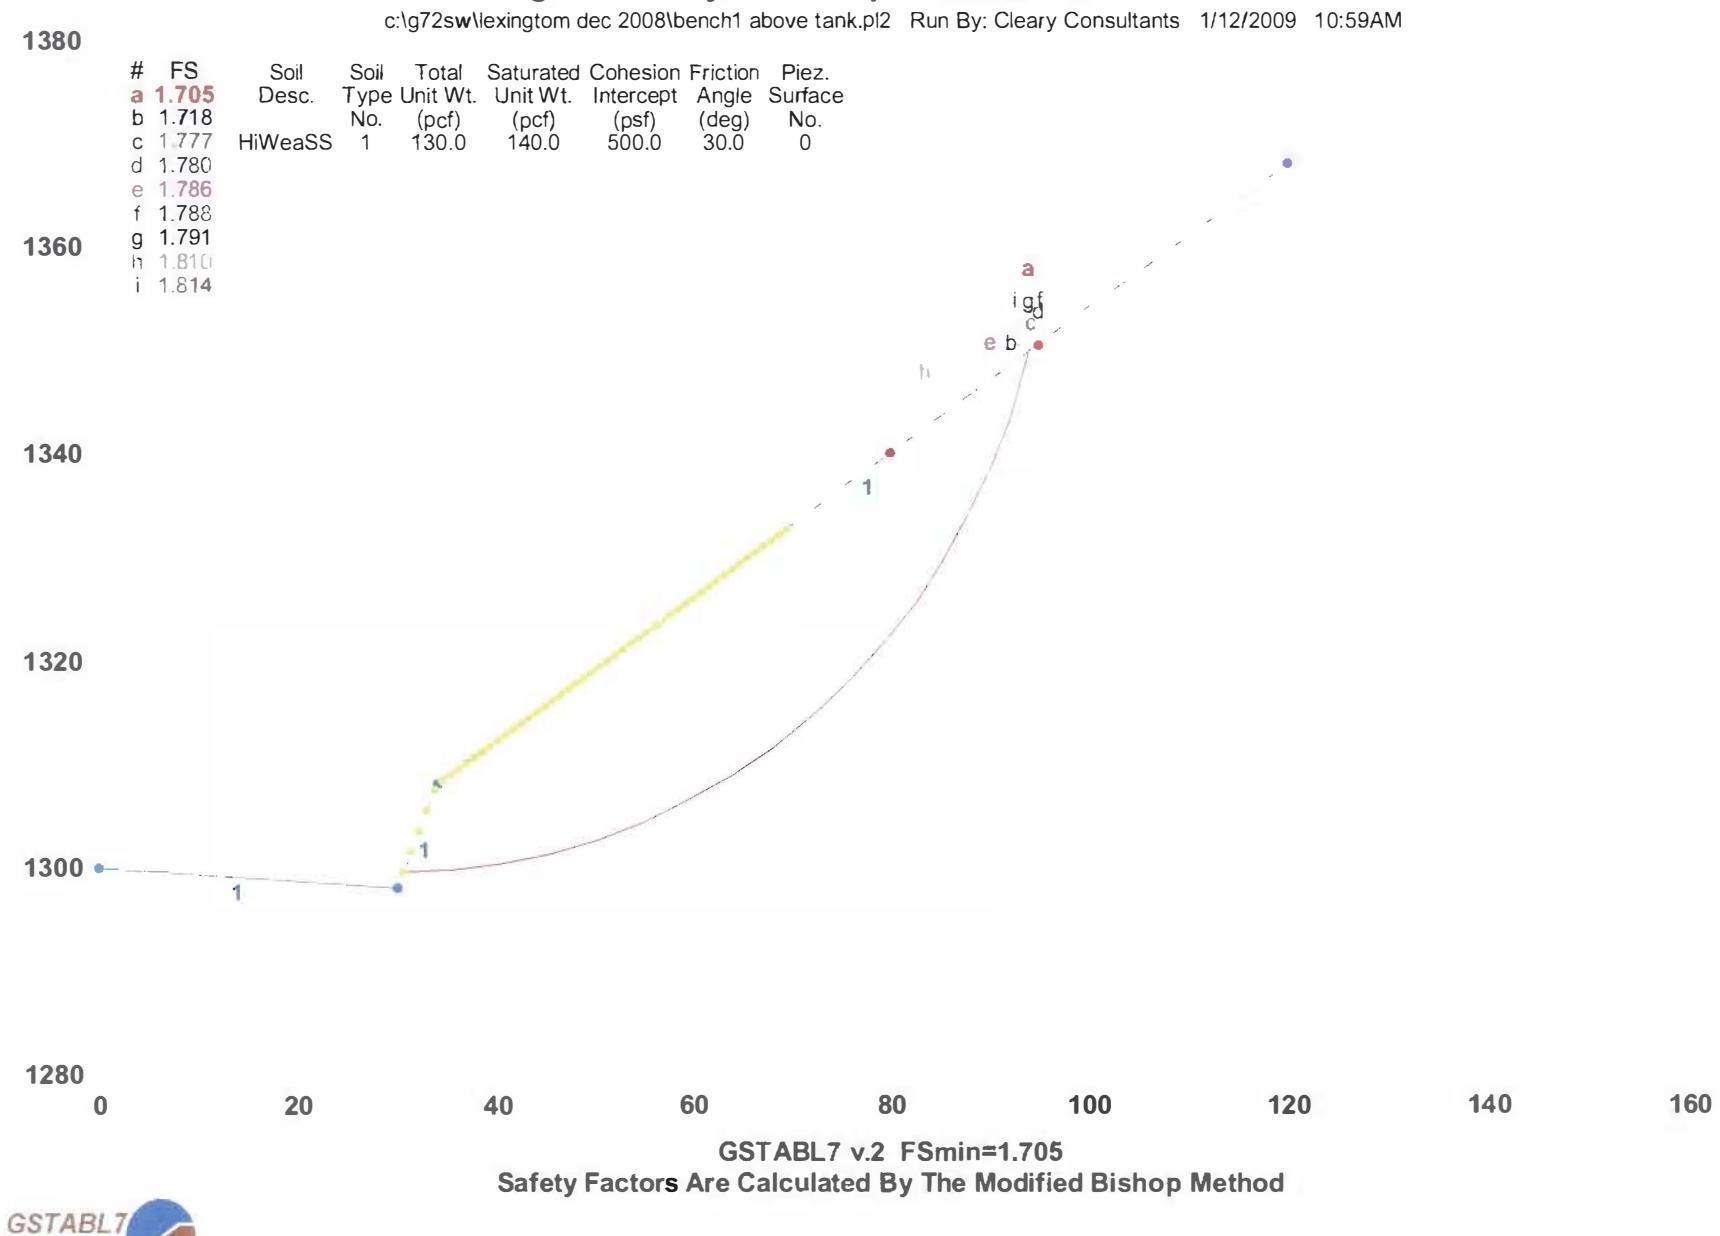
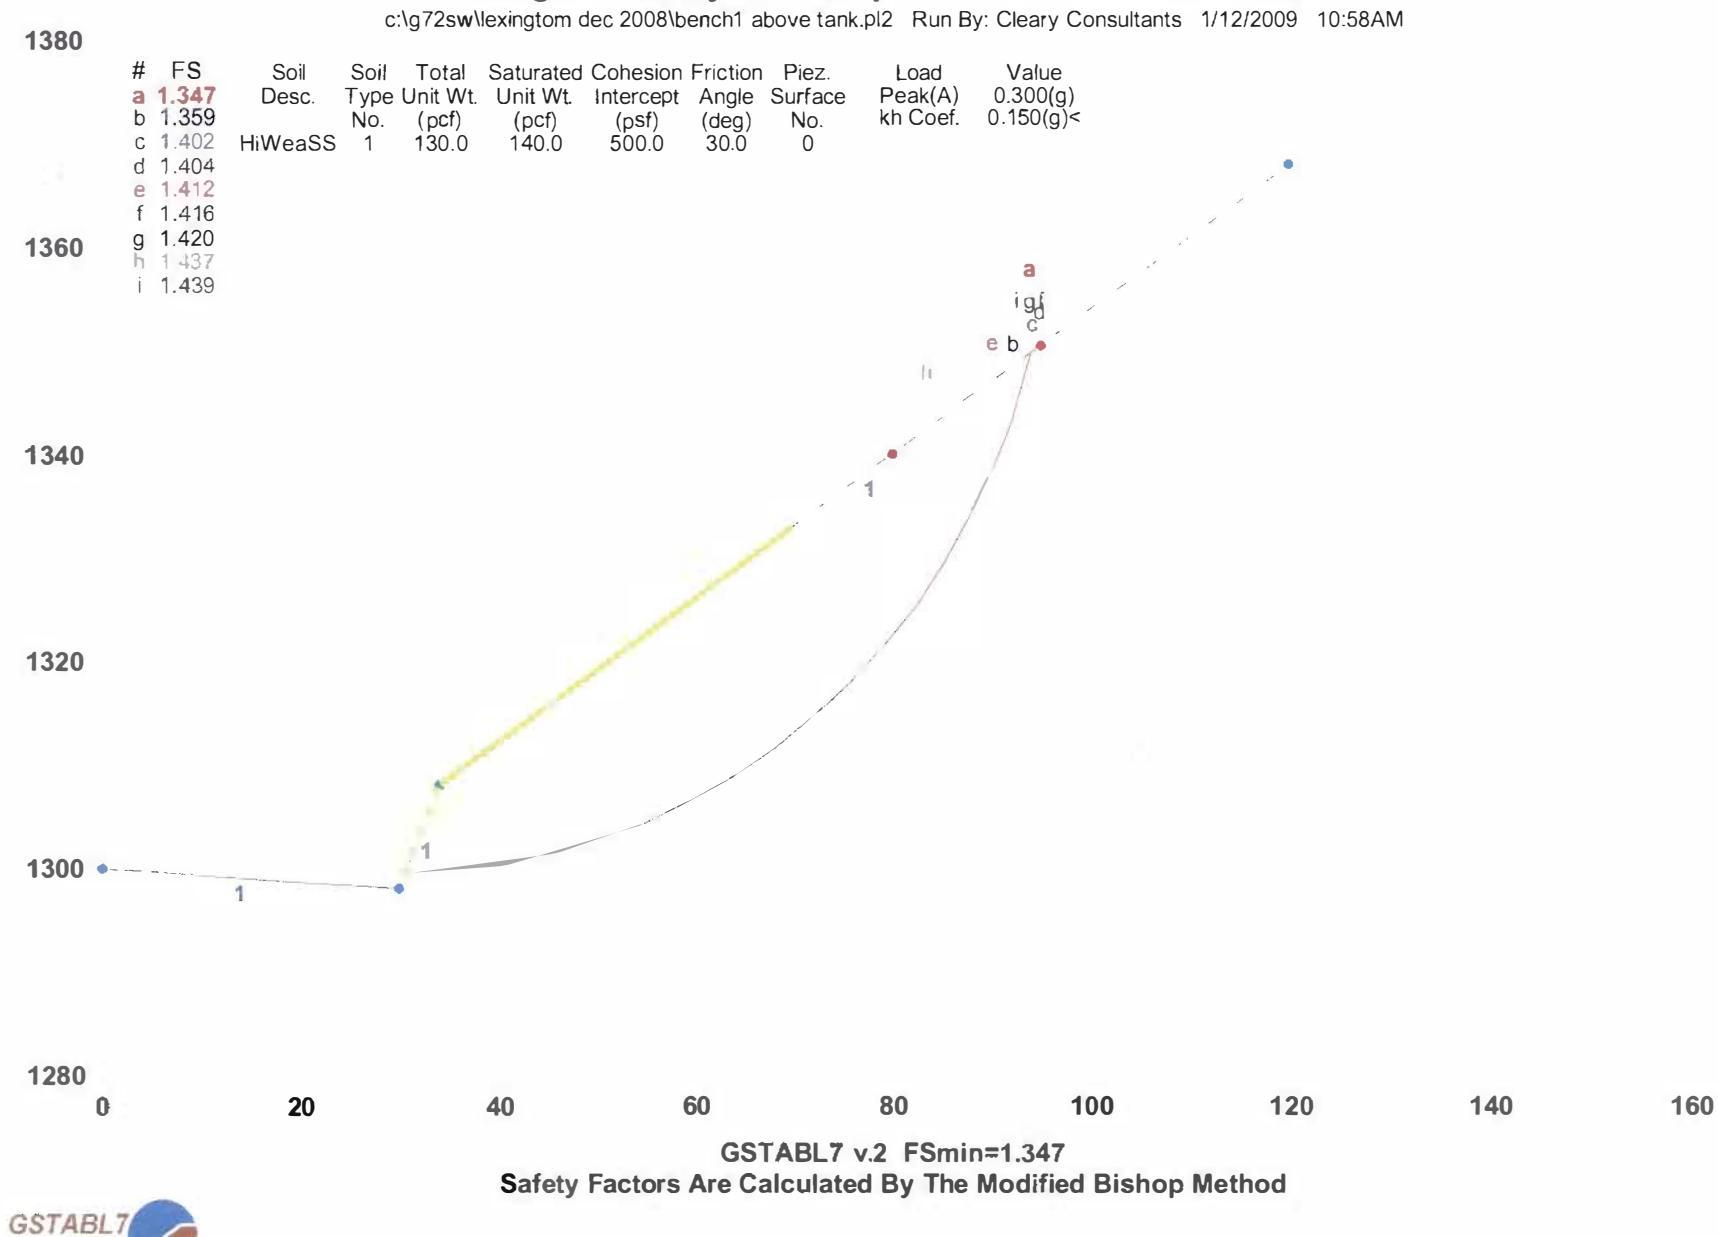
Lexington Quarry East Slope Bench 1 above H2O Tank

EAST SLOPE STABILITY ANALYSIS LOCATIONS (Profiles Modified to Reflect Current or Planned Final Slope Conditions)

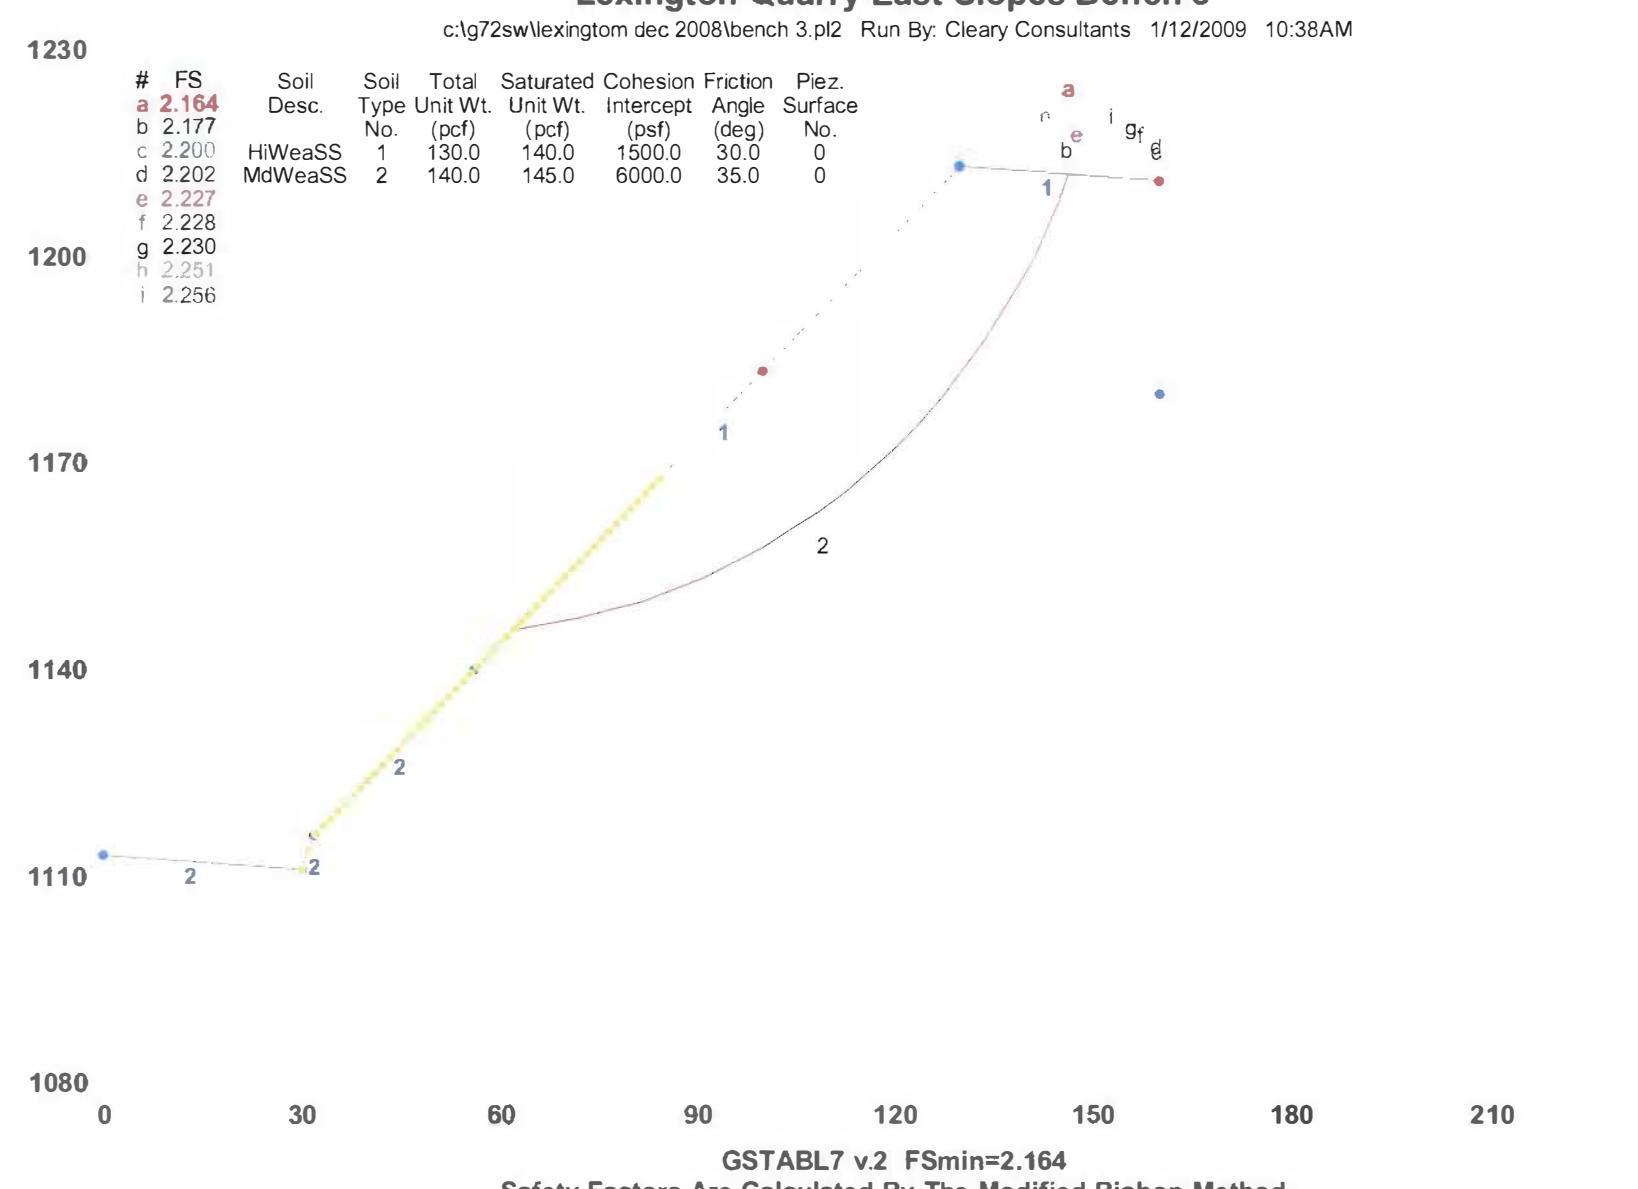
Lexington Quarry East Slopes Bench 3

Safety Factors Are Calculated By The Modified Bishop Method

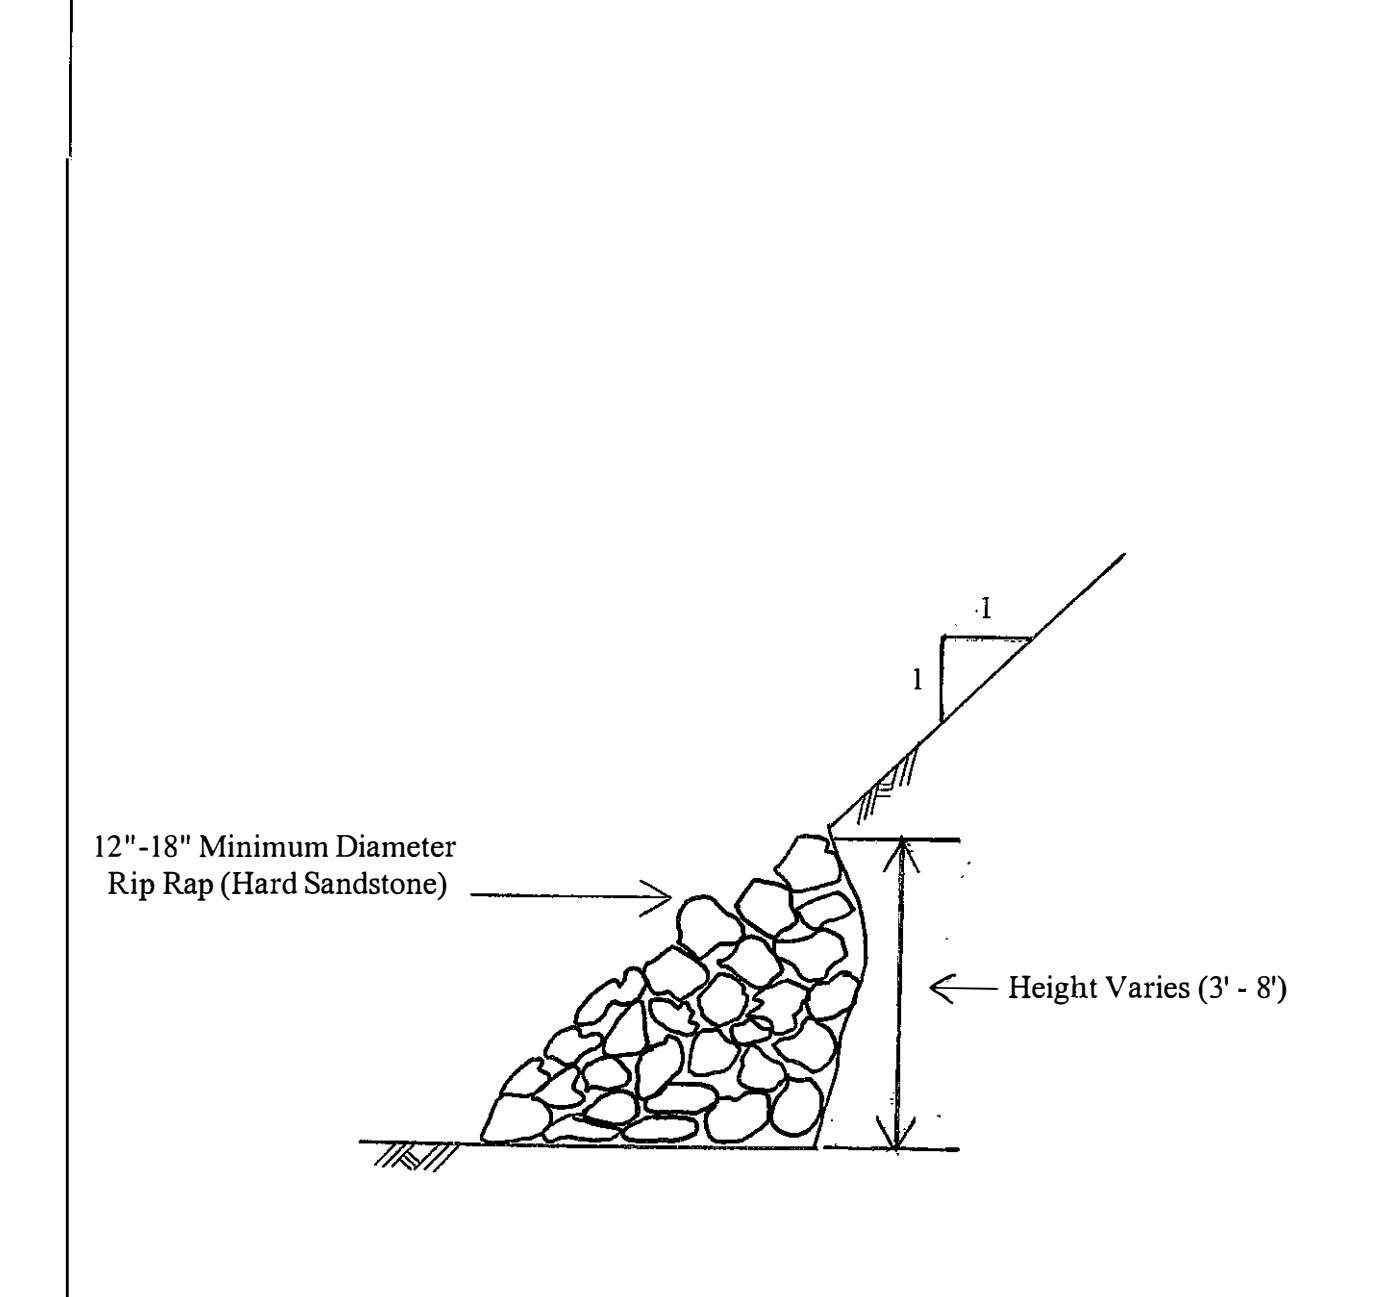
RIP RAP REPAIR DETAIL AT OVERSTEEPENED TOE CUT				
CLEARY CONSULTANTS, INC. Geotechnical Engineers and Geologists		EAST SLOPE, BENCH 2		
		Lexington Quarry		
		Santa Clara County, California		
APPROVED BY	SCALE	PROJECT NO.	DATE	DRAWING NO.
GF	Not To Scale	898.2A	February 2009	1

Attachments:Drawing 1 – Rip Rap Repair at Oversteepened Toe Cut (Bench 2)
Ruth and Going Sheets 1 and 2, Alternate West Slope Grading (above Basin #2)
dated October 1, 2008 (Delivered to Santa Clara County)
Ruth and Going Revised Plan Set for Lexington Quarry dated February 13, 2009
(15 Sheets, Delivered to Santa Clara County)
