# **ARBORIST REPORT**

Tree Inventory & Descriptions

#### **Dialysis Clinic**

2121 Alexian Drive, San Jose, California

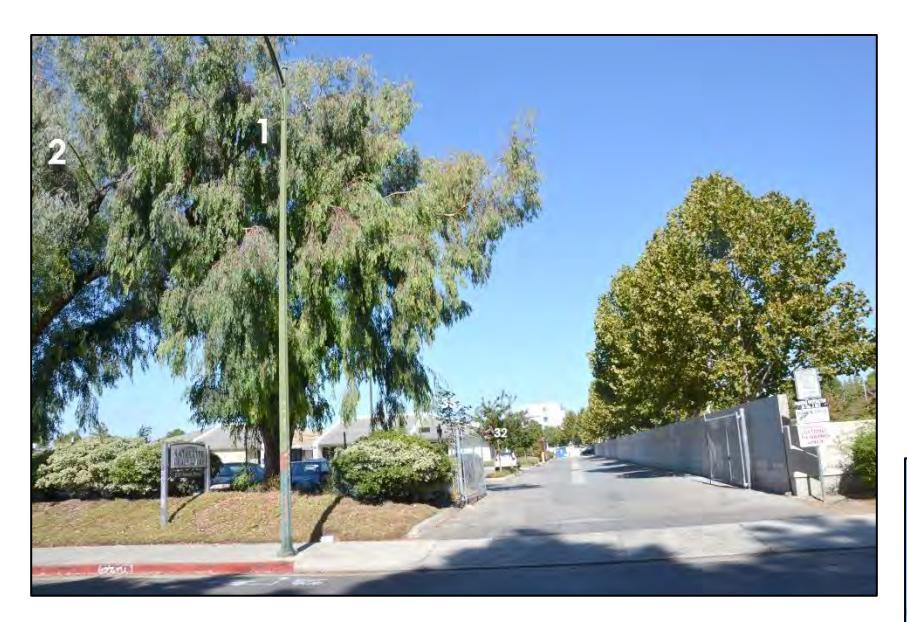
<u>Upper photo</u>: **red ironbark Eucalyptus #1 and 2** at left. At right are London plane trees on neighboring property to the northeast. Canopies of these trees overhang the masonry wall and the project site by up to 15 feet.

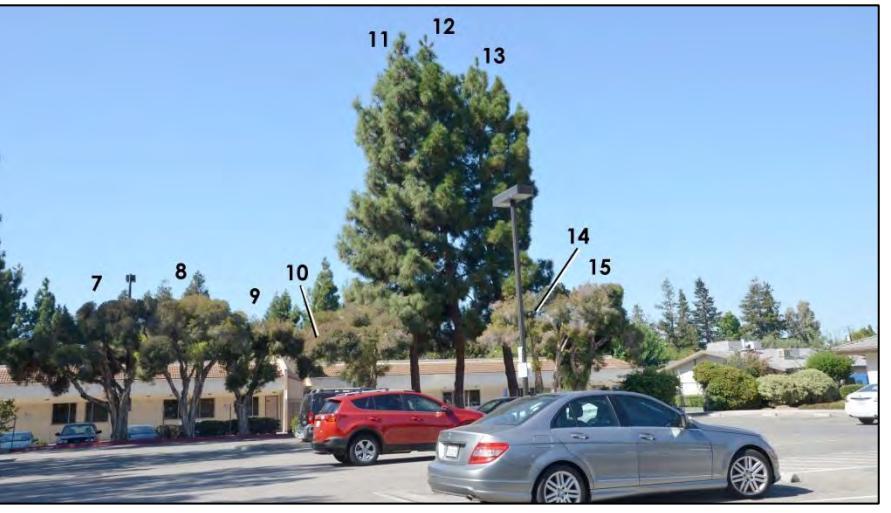
Lower photo: flaxleaf paperbark trees #7-10 and 14-15, with Canary Island pines #11-13 in between.

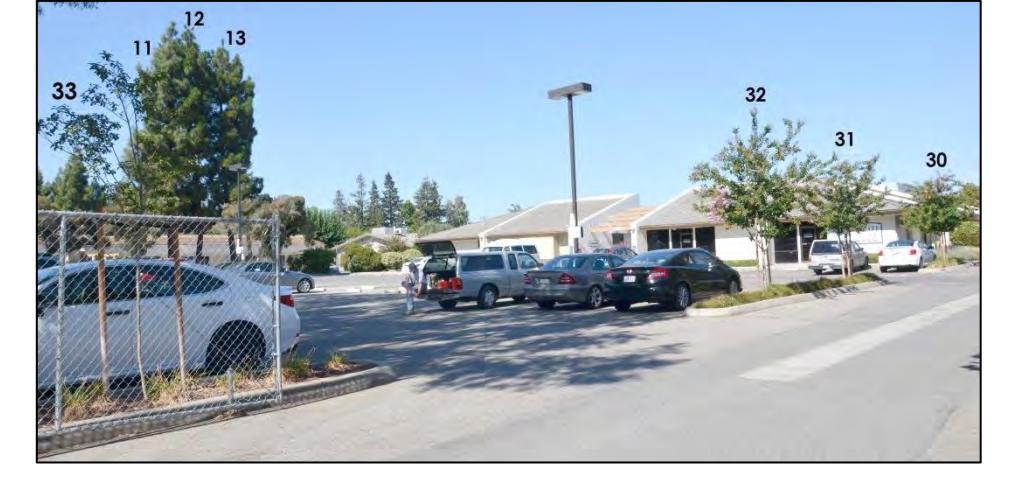
<u>Upper Left</u>: **crape myrtle #33** in the foreground at left, with **Canary Island pines #11-13** in the background. At right **crape myrtles #30-32** are labeled.

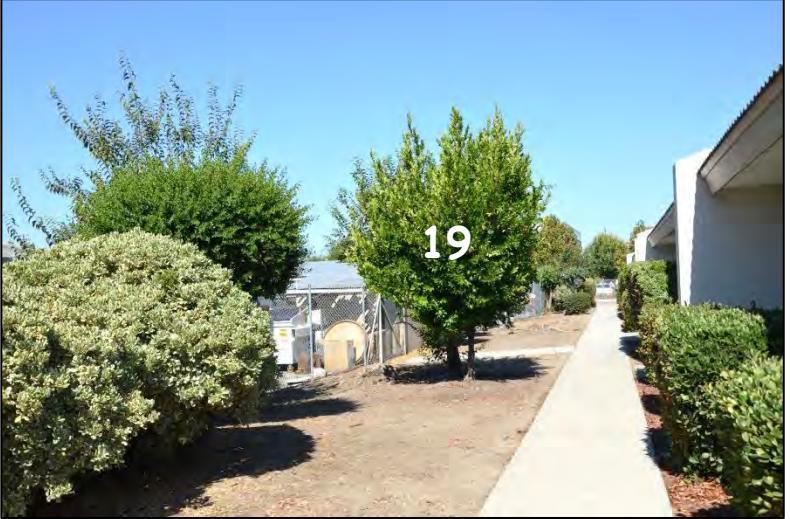
<u>Upper Right</u>: the southwest side of the existing building, and the parking lot extending toward the rear of the site, viewed southwest to northeast. **Trees #16 - 24** are located in this area. These are small trees; many not located on the plan we received. **Tree #19** is a 4-inch diameter Carolina laurel cherry.

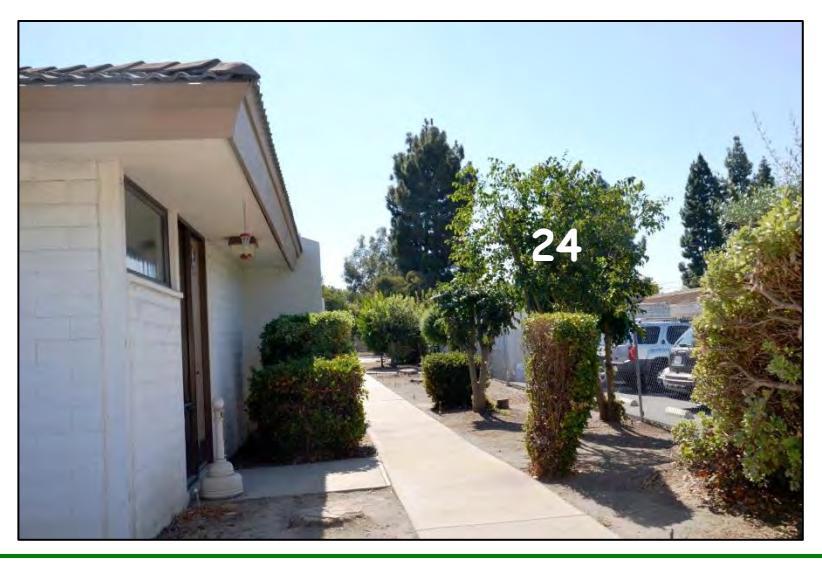
Lower Right: same as above, but viewed from northwest to southeast. **Tree #24** is a 4 + 4 inch diameter European hackberry.

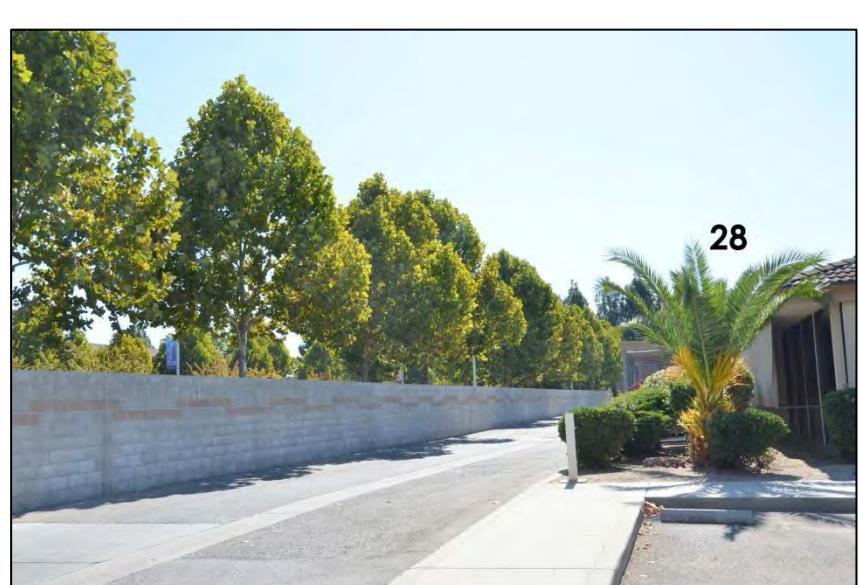
*27	olive	19	30*45	100	60	Fair	A beautiful, vigorous tree but it drops copious amounts of fruit over the parking lot.
*28	<i>Phoenix canariensis,</i> Canary Island palm	20	12*18	80	60	Fair	Four feet of clear trunk.
29	<i>Lagerstroemia</i> hybrid, crape myrtle	2	12*10	80	50	Fair/Good	
30	crape myrtle	3	15*12	85	50	Fair/Good	
31	crape myrtle	2	14*10	80	50	Fair/Good	
32	crape myrtle	3	16*10	80	60	Fair/Good	
33	crape myrtle	1	10*5	50	60	Fair/Poor	Too shaded by nearby large Eucalyptus to do well.

Upper Left: rear (northwest) parking lot perimeter, with olive #27 labeled. London plane trees on neighboring property are in the background.
