Project No. **13831.002.000**

November 15, 2023 Revised March 4, 2024

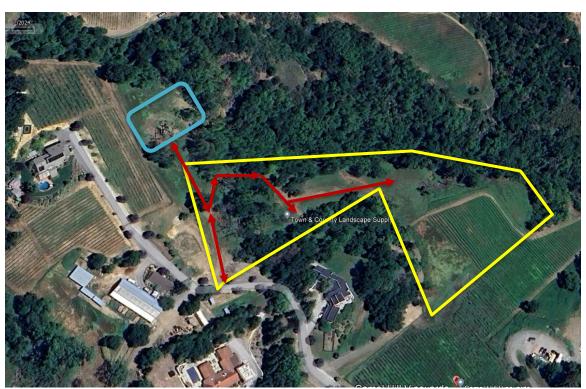
Figure 1 Google Earth aerial view 2/2024. Area in blue designates the upper slide, the area outlined in majenta is the path of the jeep trail, and yellow is the assigned area for review. This photo shows current conditions, green background is seasonal groundcover.

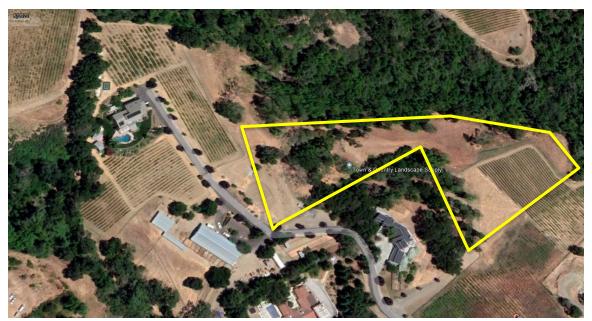
Figure 2 Google Earth aerial view 6/2022. <u>Minimal</u> change in tree cover from previous year. The brown background is absent of groundcover due to summer weather conditions.

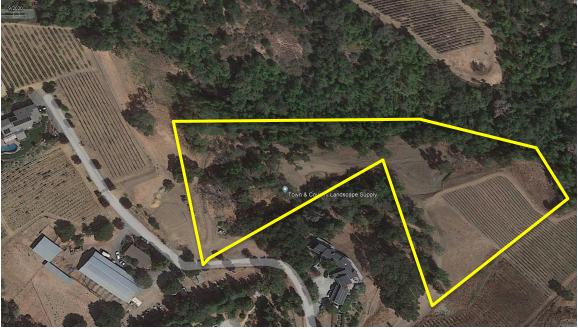
Figure 3 Google Earth aerial view 9/2020. <u>Minimal</u> change in tree cover from previous year. The brown background is absent of groundcover due to summer weather conditions.

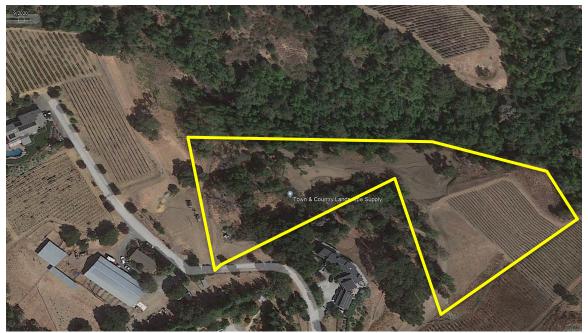
Figure 4 Google Earth aerial view 8/2018. <u>Significant</u> change in tree cover from previous year. The brown background is absent of groundcover due to summer weather conditions.

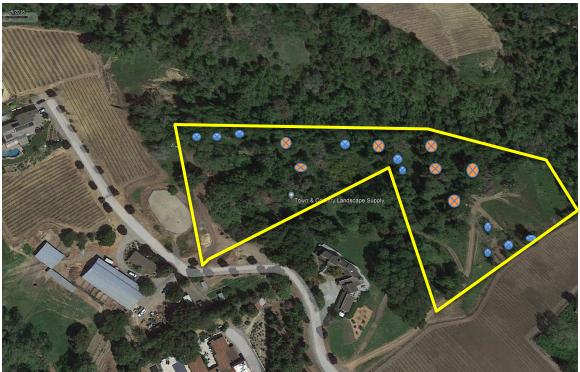
Figure 5 Google Earth aerial view 4/2016- Shows an established tree canopy with minimal change from the previous year. Trees located on the map are trees that do not appear in the following year. Oaks noted in blue ~8 inches to 12 inches DBH, oaks in orange ~ 13 inches to 18 inches DBH.

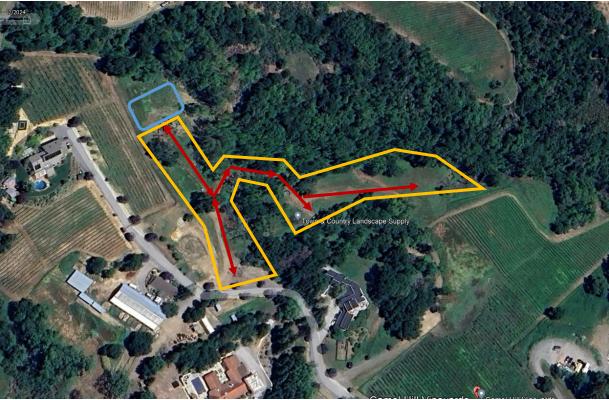
Figure 1 Google Earth aerial view 2/2024. Area in blue designates the upper slide, the area outlined in magenta is the path of the jeep trail, and yellow is the assigned area for inventory.
