Subject: **REVISED GEOTECHNICAL SLOPE STABILITY ANALYSIS REPORT**
Sargent Ranch Quarry Site
Sargent, Santa Clara County, California

REVISED GEOTECHNICAL SLOPE STABILITY ANALYSIS REPORT
FOR
PROPOSED SARGENT RANCH QUARRY SITE
SARGENT, CALIFORNIA

SEPTEMBER 12, 2016
PROJECT NO. 3.31274

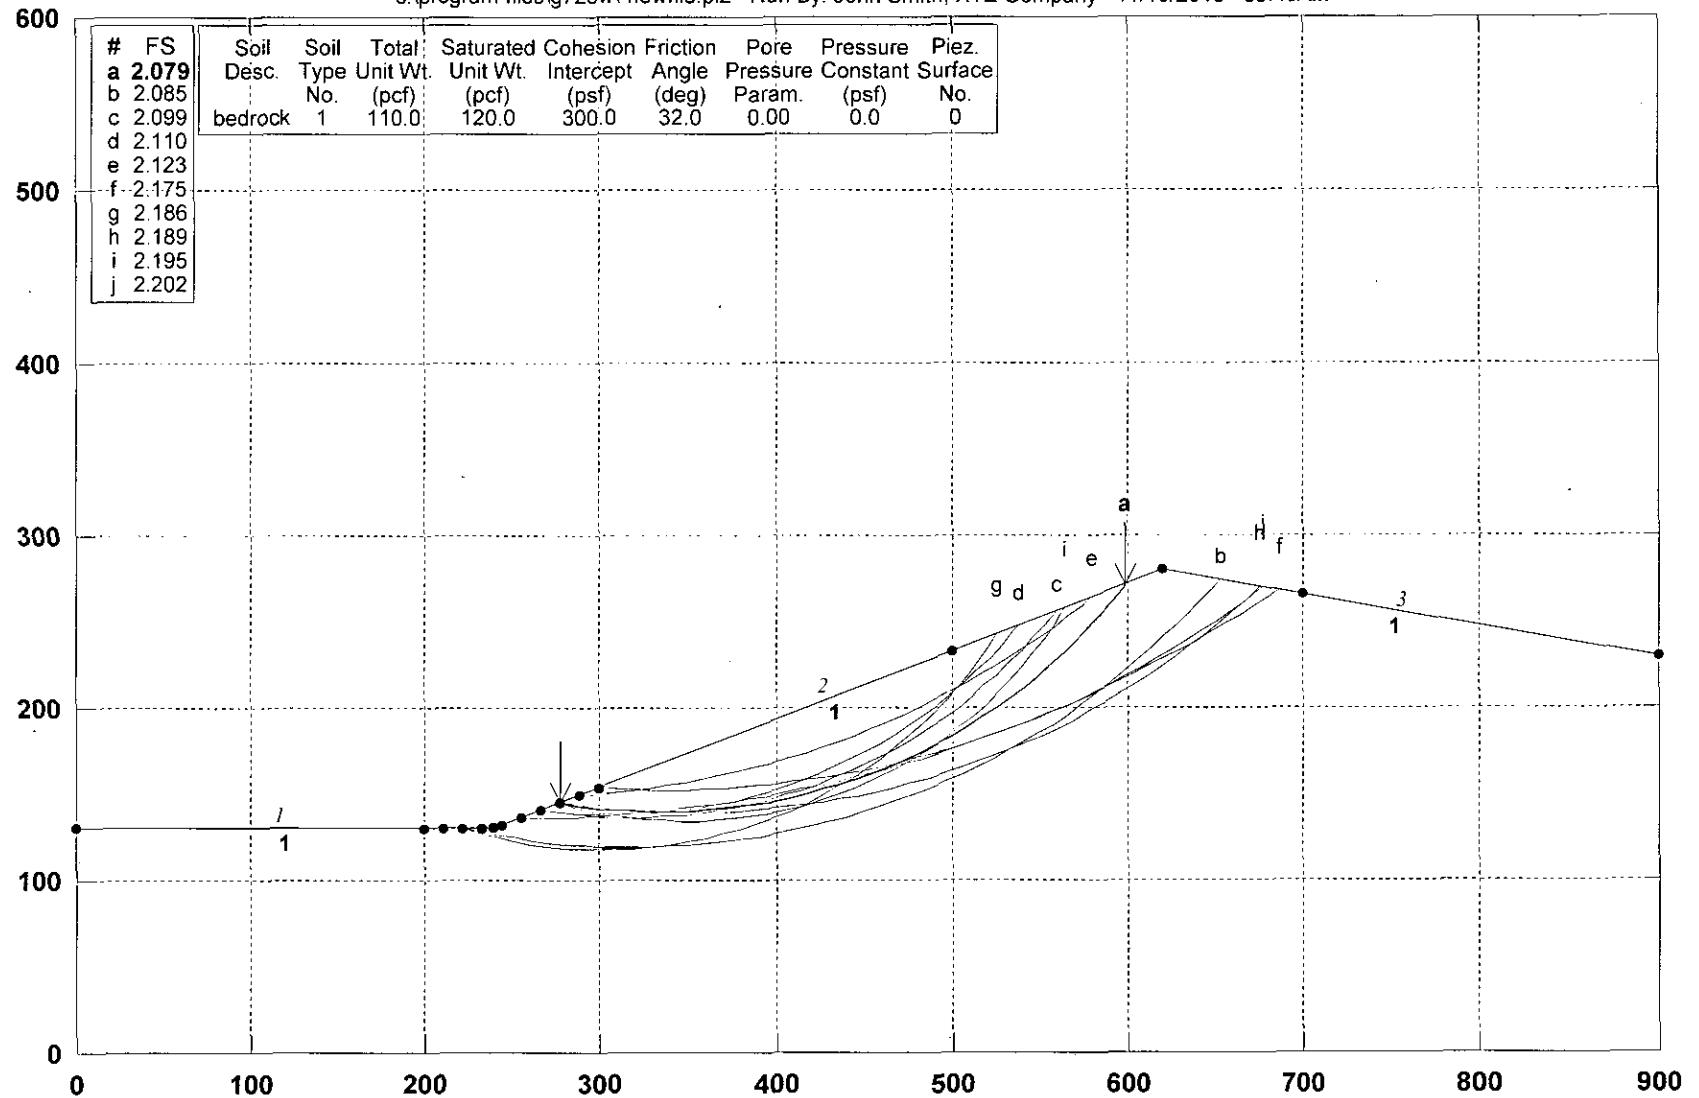
Sargent Ranch Quarry Site Section A-A'

GSTABL7 v.2 FSmin=2.079

Safety Factors Are Calculated By The Modified Bishop Method

Location	Phase	Type Failure	Factor of Safety	Comments
1. Section A-A'	3/4	Cross Bedded	2.08	West facing Slopes
2a. Section B-B'	3/4	Daylight	0.76	Would be stable at 4:1
2b. Section B-B'	3/4	Cross Bedded	1.73	Verify during ex
3a. Section C-C'	3/4	Daylight	0.81	Bedding parallel to slope
3b. Section C-C'	3/4	Cross Bedded	1.85	Verify during ex
3c. Section C-C'	3/4	Cross Bedded	1.26	0.15g pseudo
3d. Section C-C'	3/4	Daylight	0.81	Water at 190' (5' head)
3e. Section C-C'	3/4	Cross Bedded	1.85	Water at 190' (5' head)
3f. Section C-C'	3/4	Daylight	0.95	Water at 255' (5' head)
4a. Section E-E'	3/4	Daylight	0.69	Planar Failure
4b. Section E-E'	3/4	Daylight	0.61	Circular Failure
4c. Section E-E'	3/4	Cross Bedded	1.52	Circular Mode

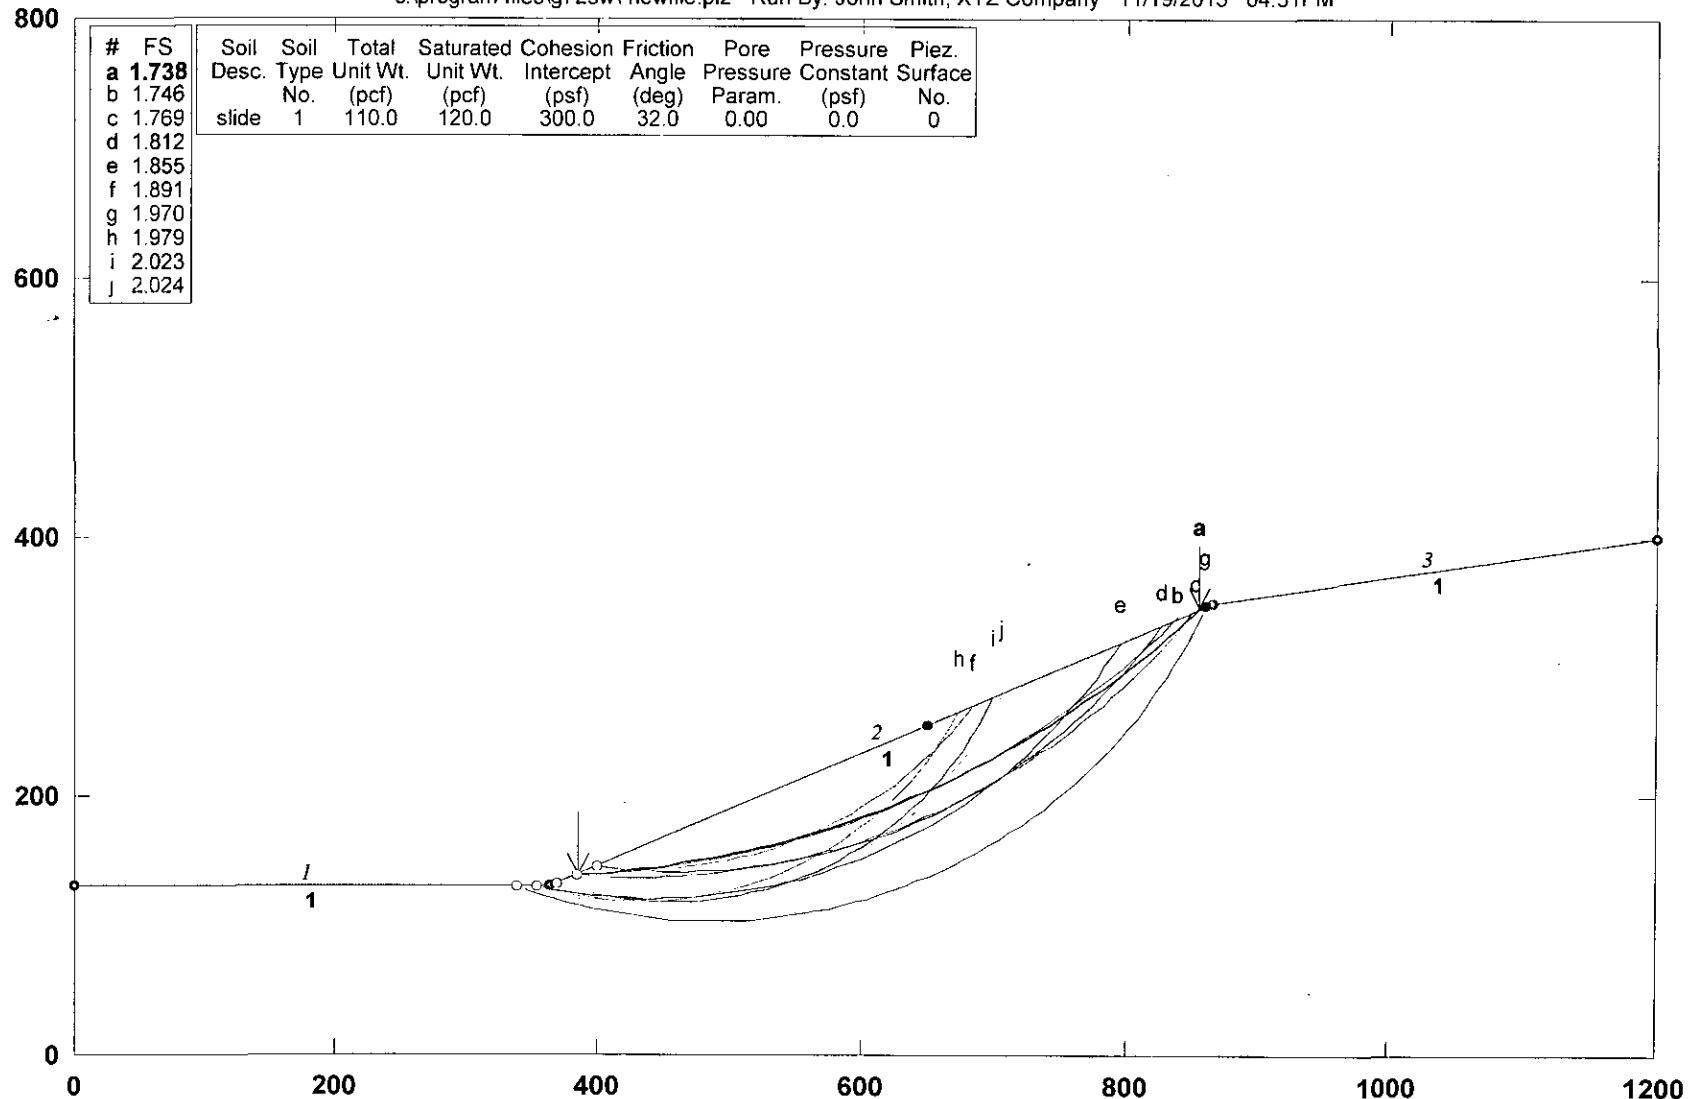
Sargent Ranch Quarry Site Section B-B' Deep Clay Bedding

GSTABL7 v.2 FSmin=1.738

Safety Factors Are Calculated By The Modified Bishop Method

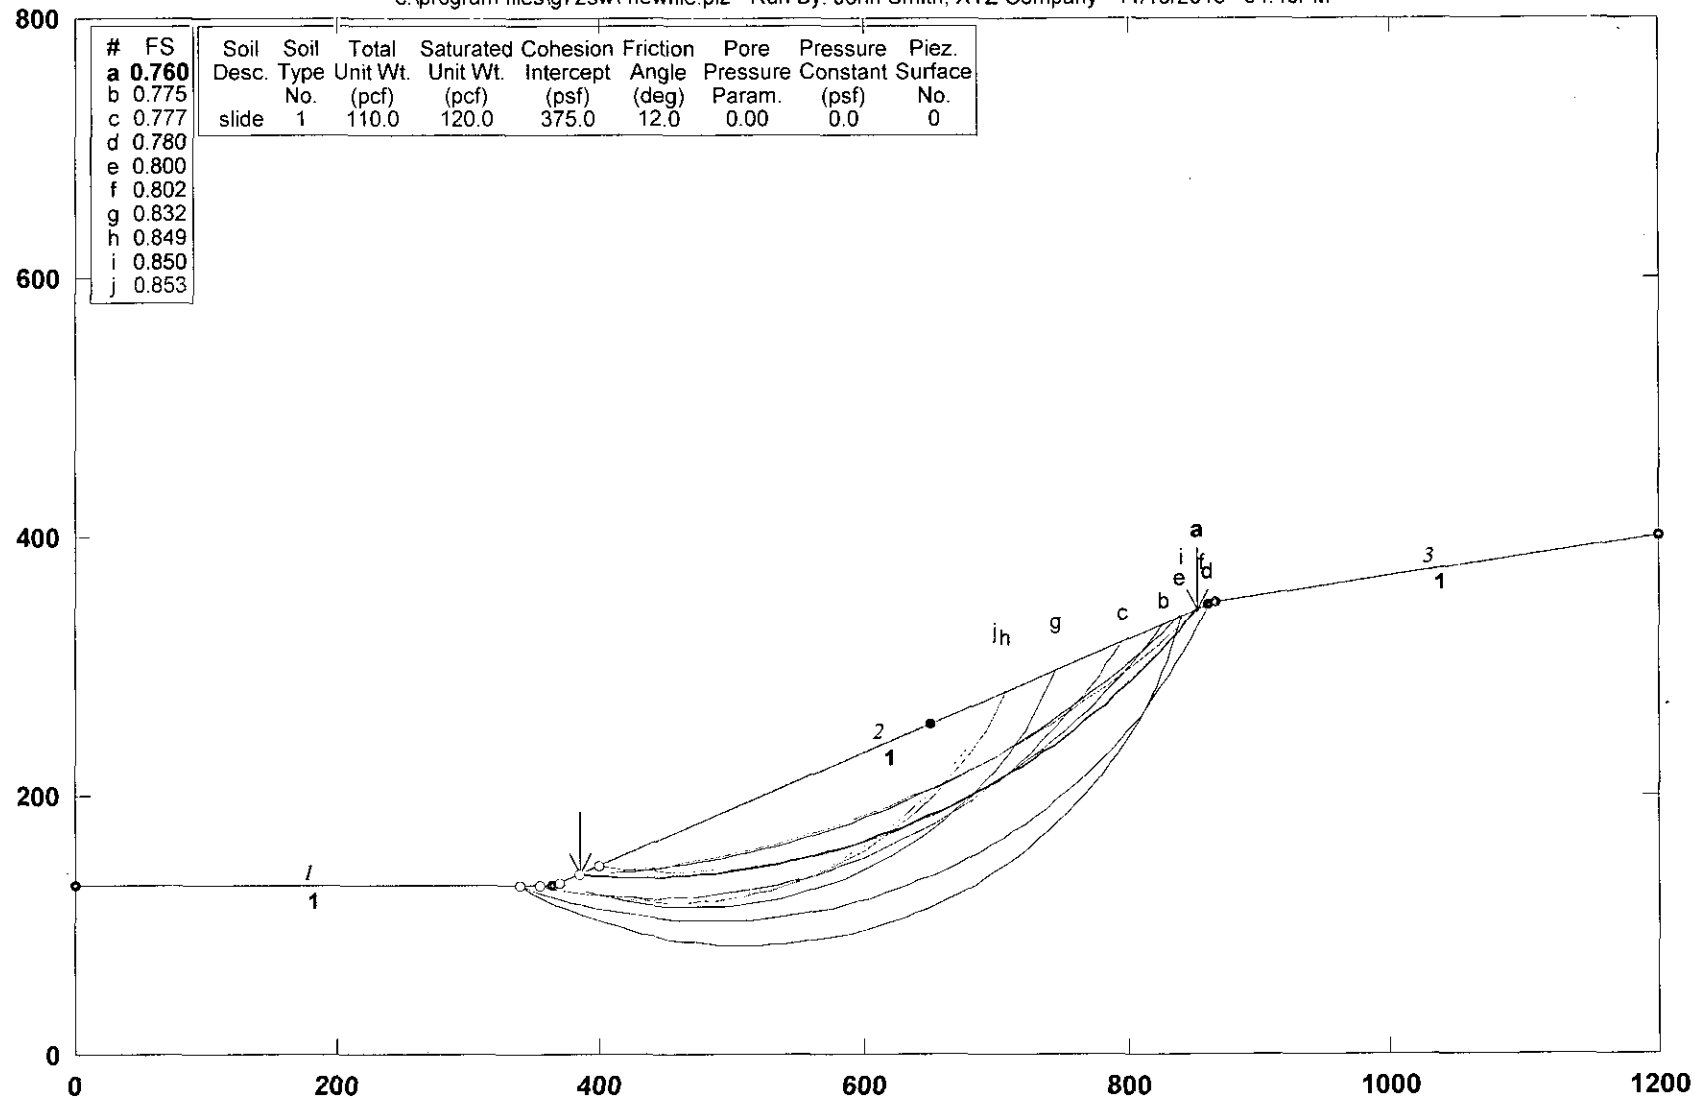
Sargent Ranch Quarry Site Section B-B' Deep Clay Bedding

GSTABL7 v.2 FSmin=0.760

Safety Factors Are Calculated By The Modified Bishop Method

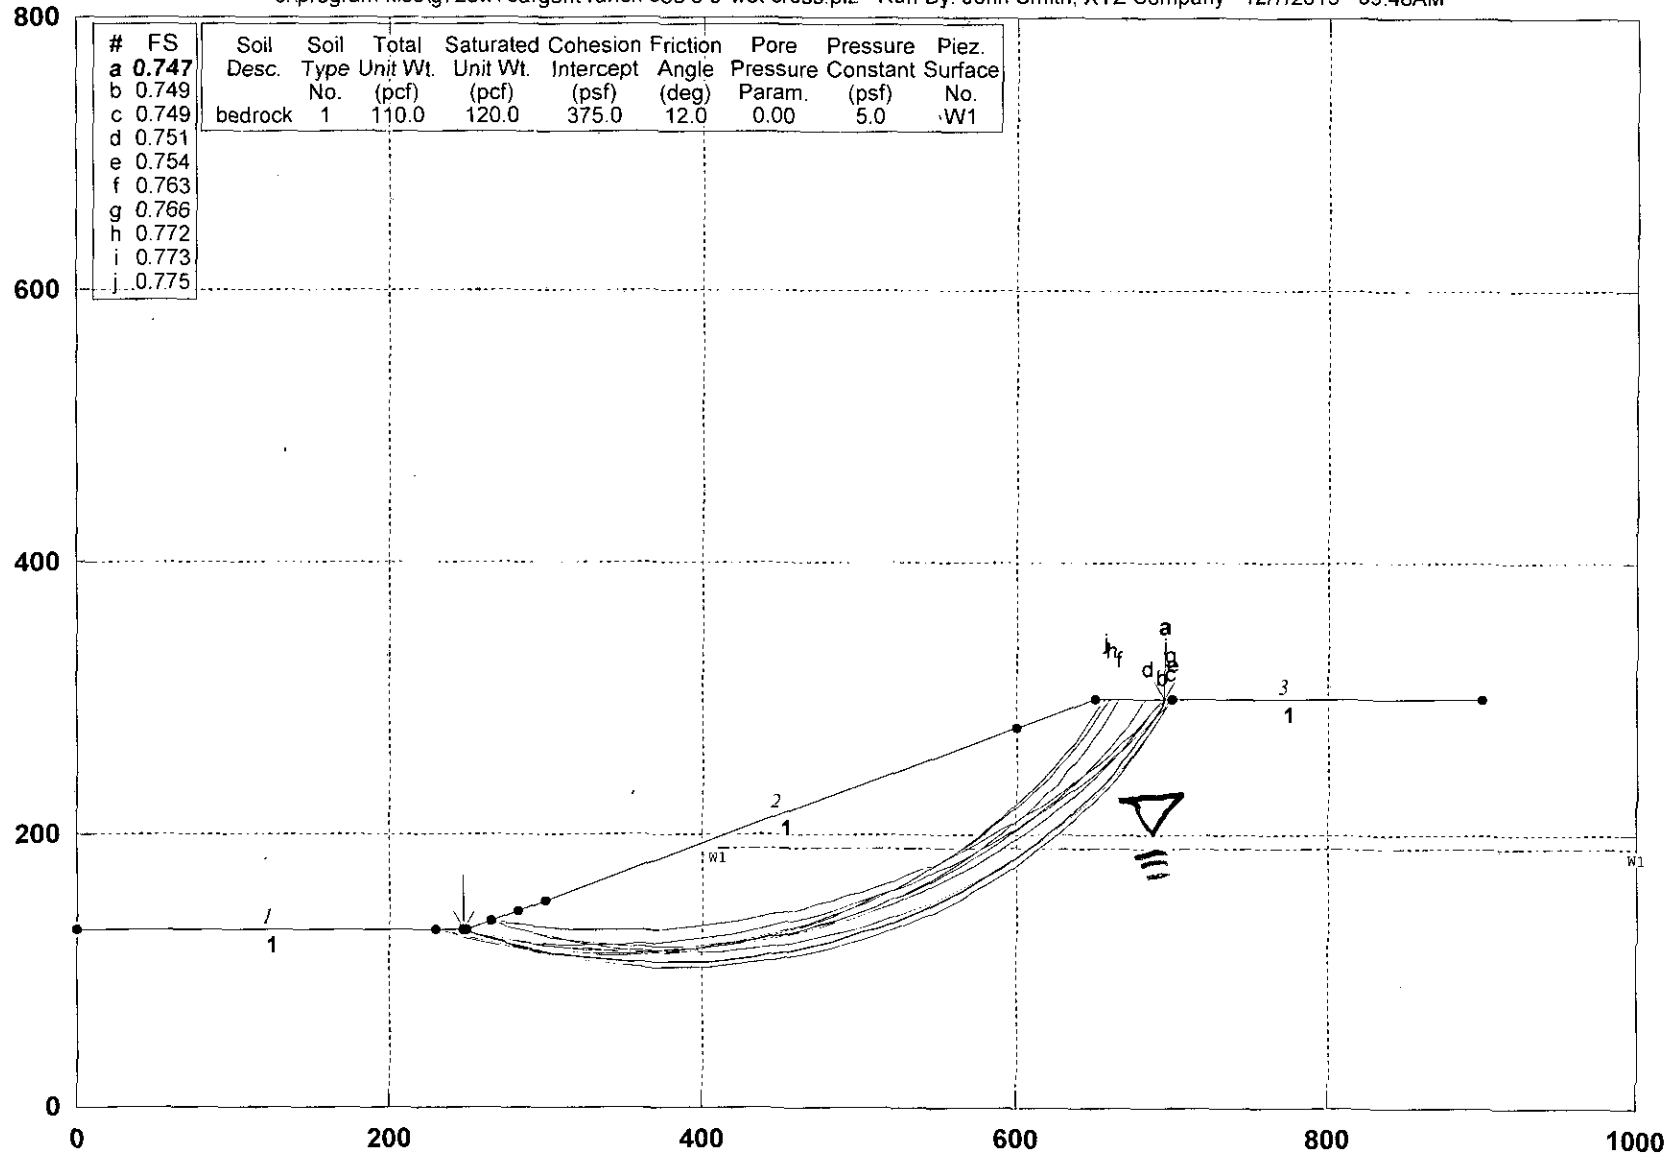
Sargent Ranch Quarry Site Section C-C' with water

GSTABL7 v.2 FSmin=0.747

Safety Factors Are Calculated By The Modified Bishop Method

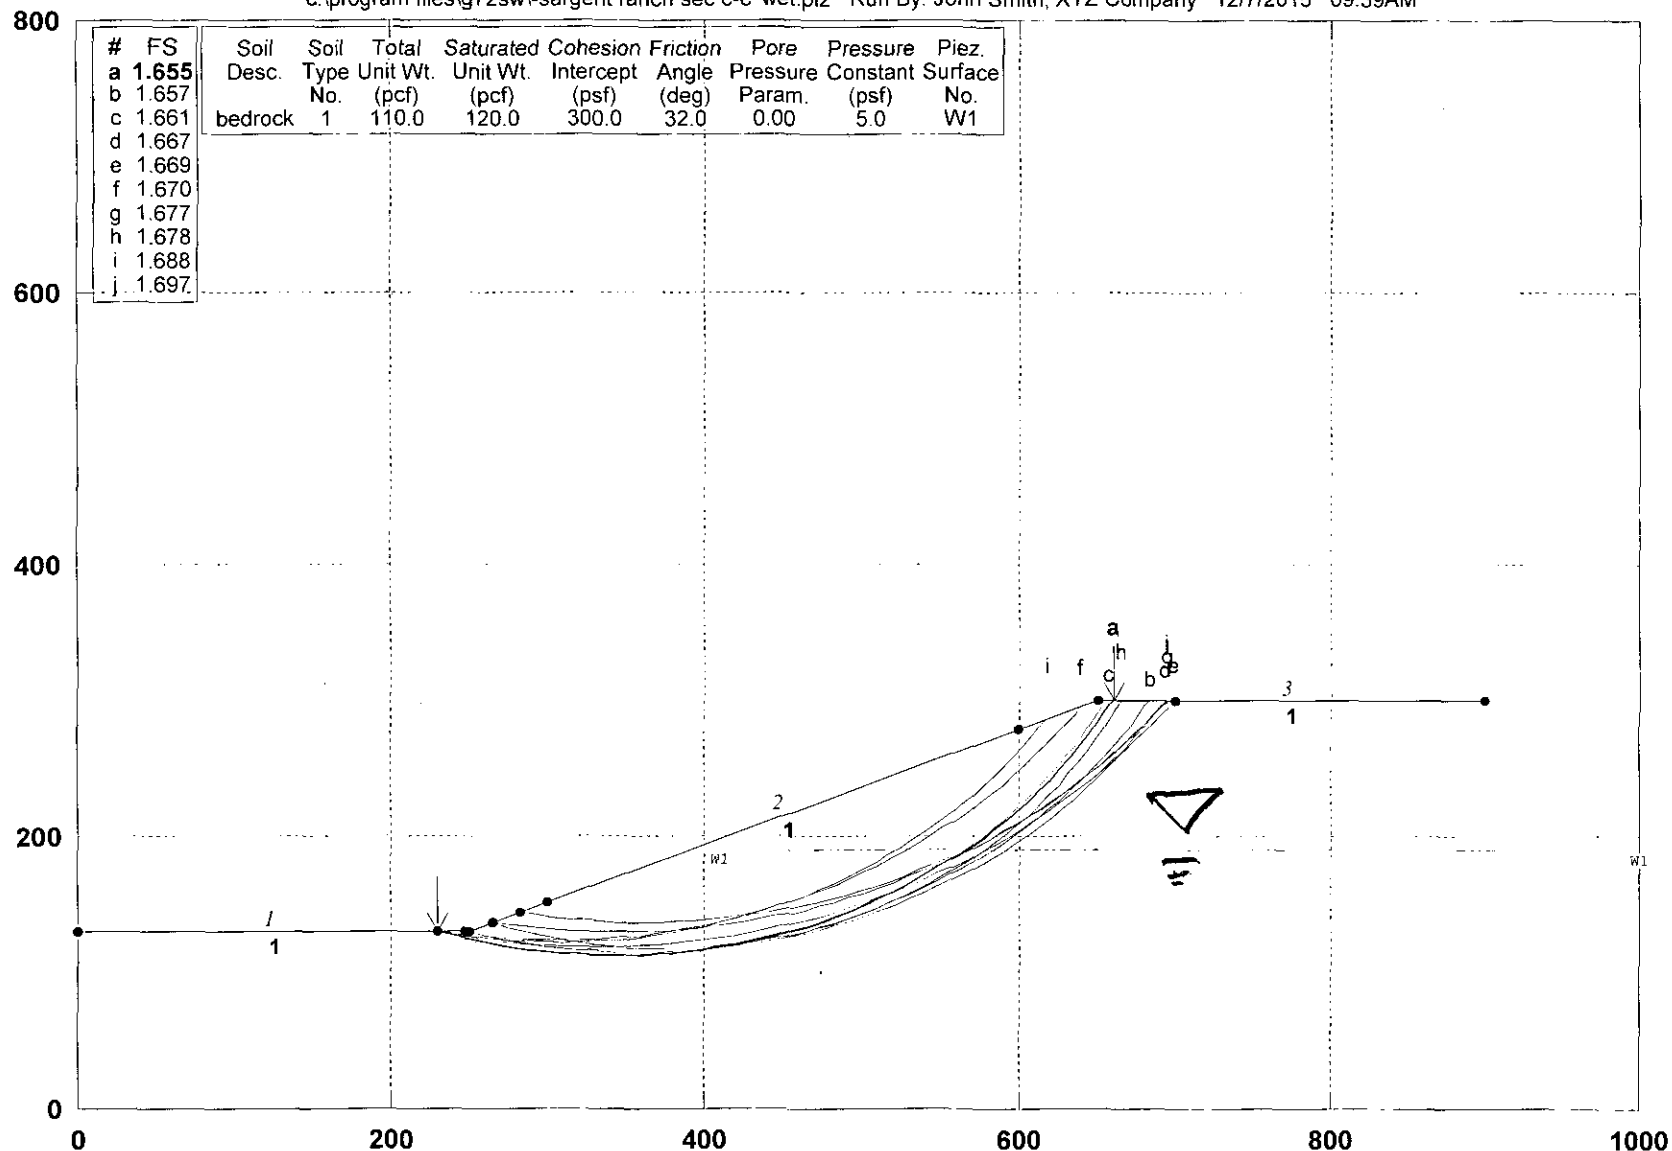
Sargent Ranch Quarry Site Section C-C' Typical Seismic

GSTABL7 v.2 FSmin=1.655

Safety Factors Are Calculated By The Modified Bishop Method

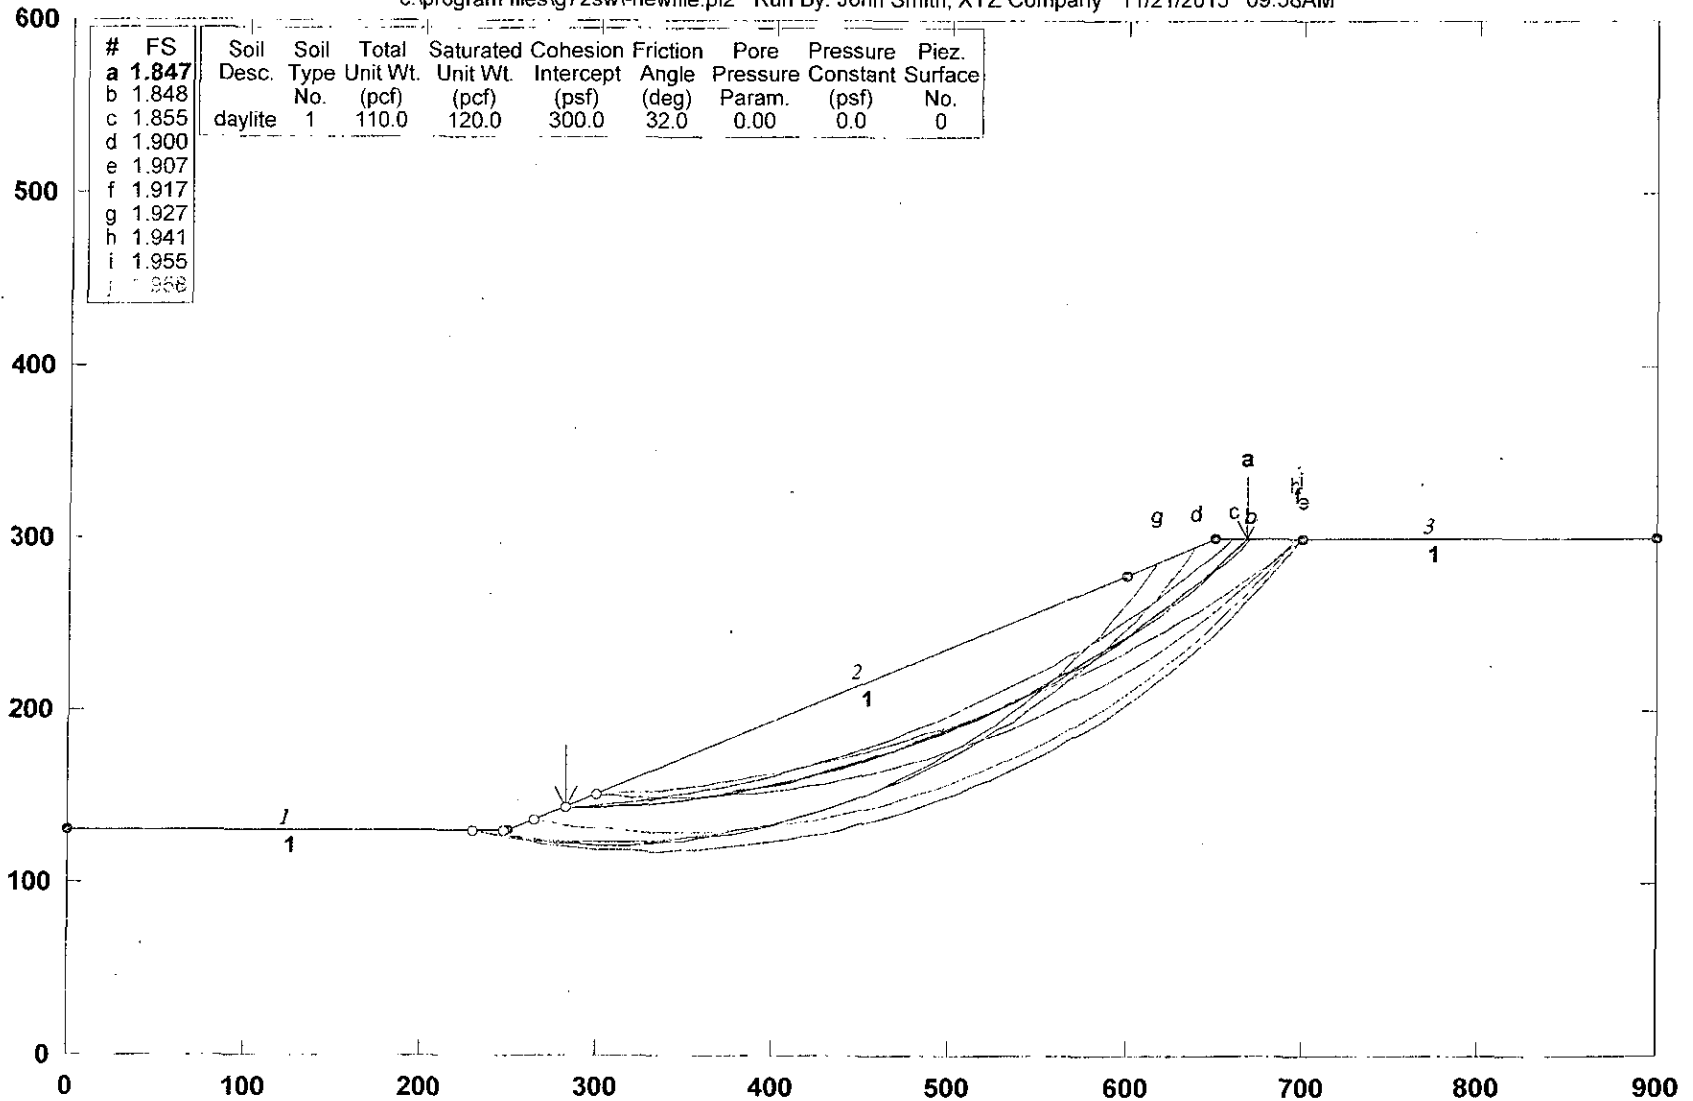
Sargent Ranch Quarry Site Section C-C' Daylighted Clay Bedding Low

GSTABL7 v.2 FSmin=1.847

Safety Factors Are Calculated By The Modified Bishop Method

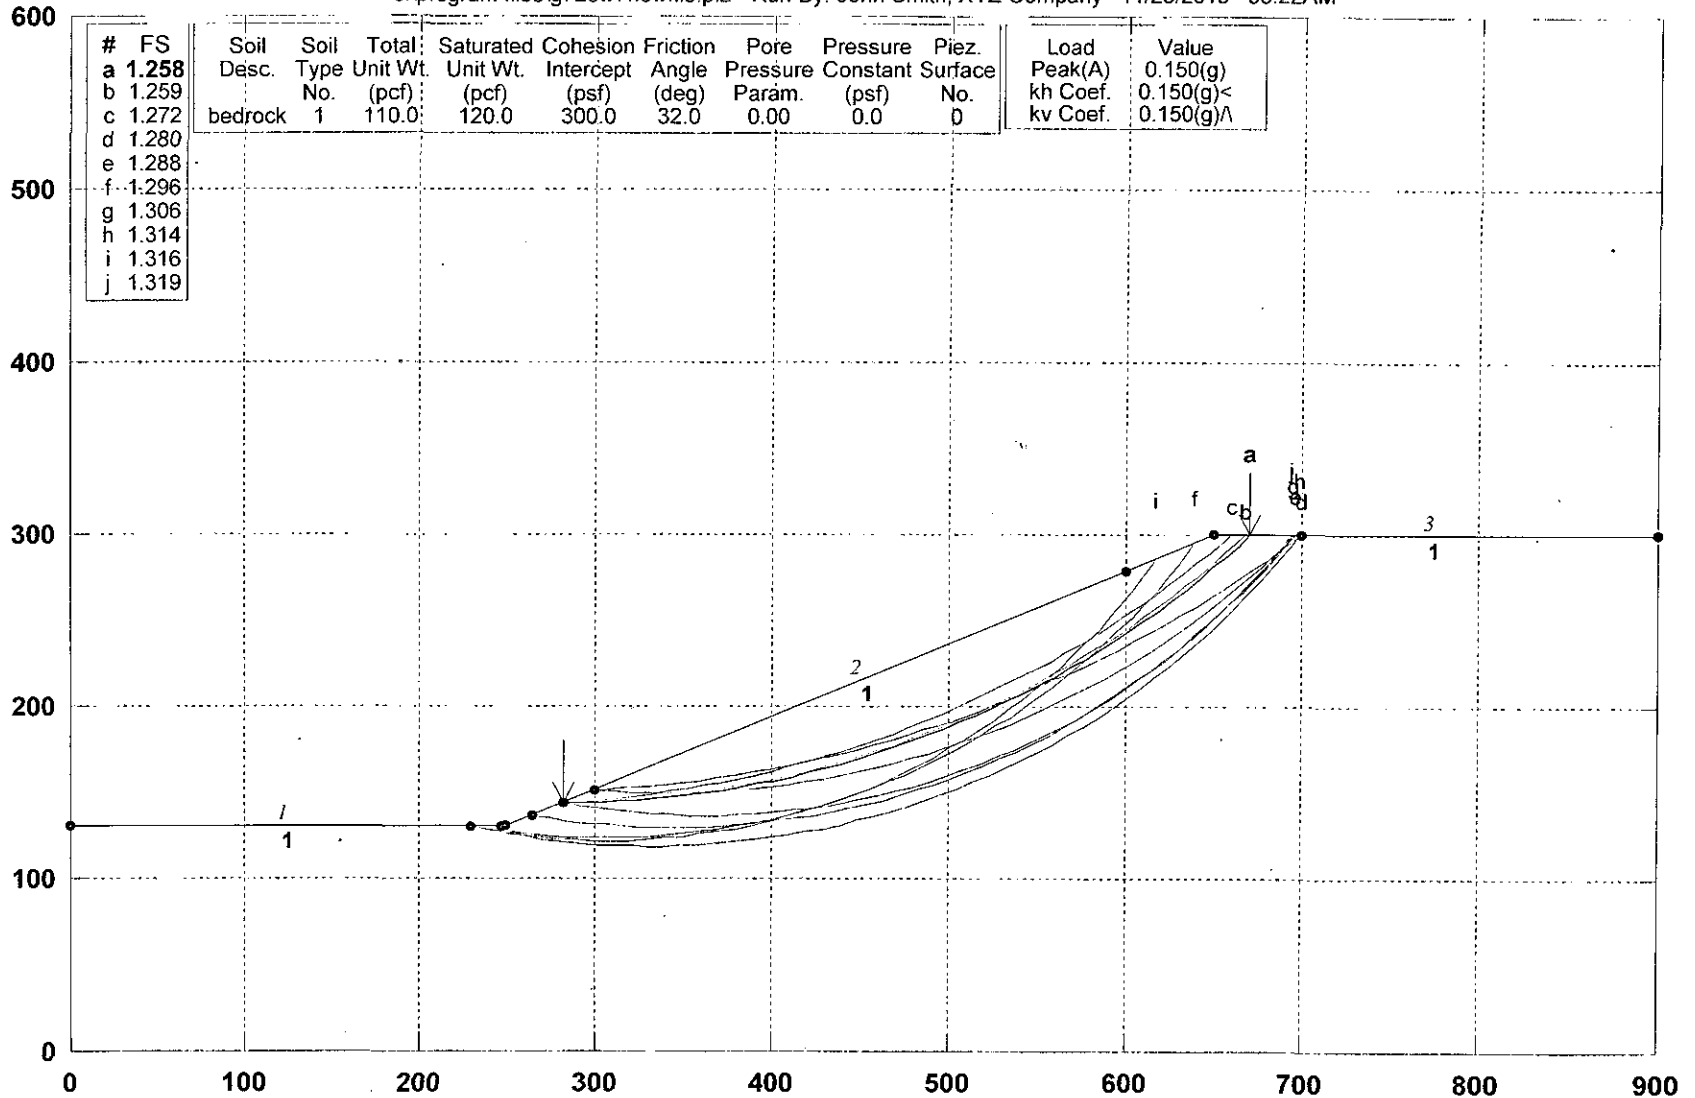
Sargent Ranch Quarry Site Section C-C' Typical Seismic

GSTABL7 v.2 FSmin=1.258

Safety Factors Are Calculated By The Modified Bishop Method

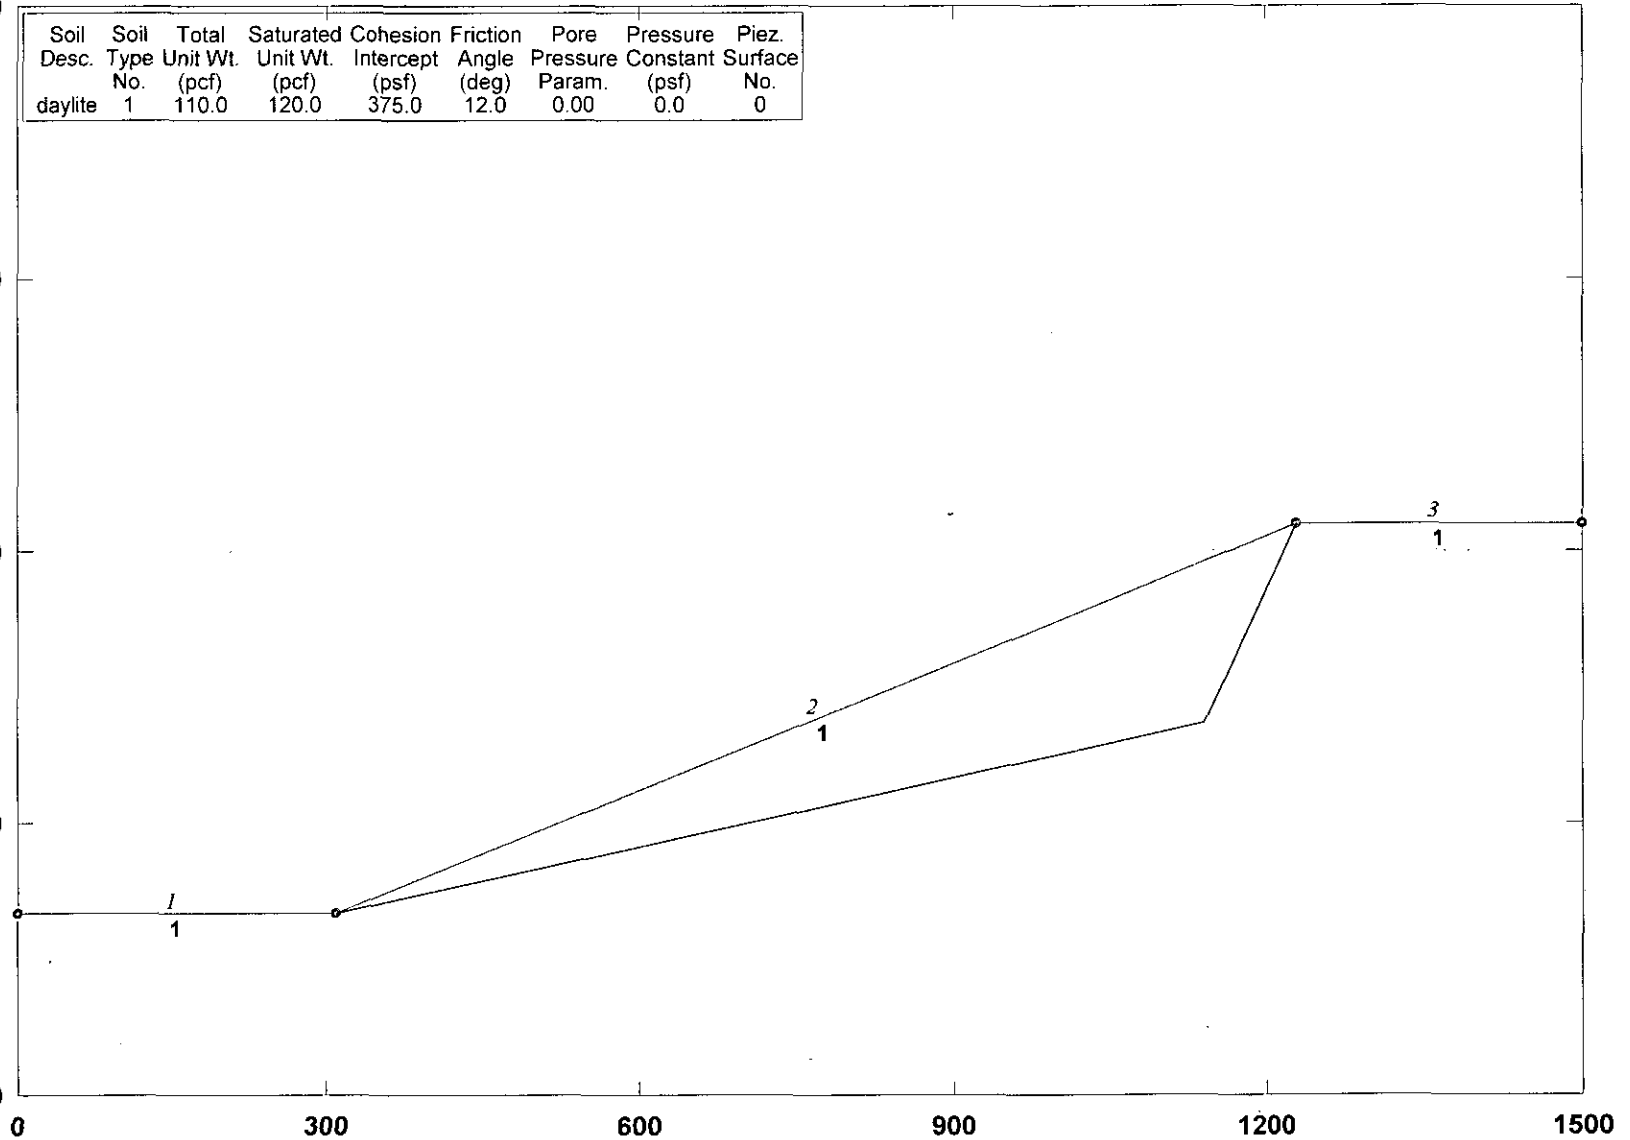
Sargent Ranch Quarry Site Section E-E'Daylighted Clay Bedding

GSTABL7 v.2 FSmin=0.687

Factor Of Safety Is Calculated By The Simplified Janbu Method

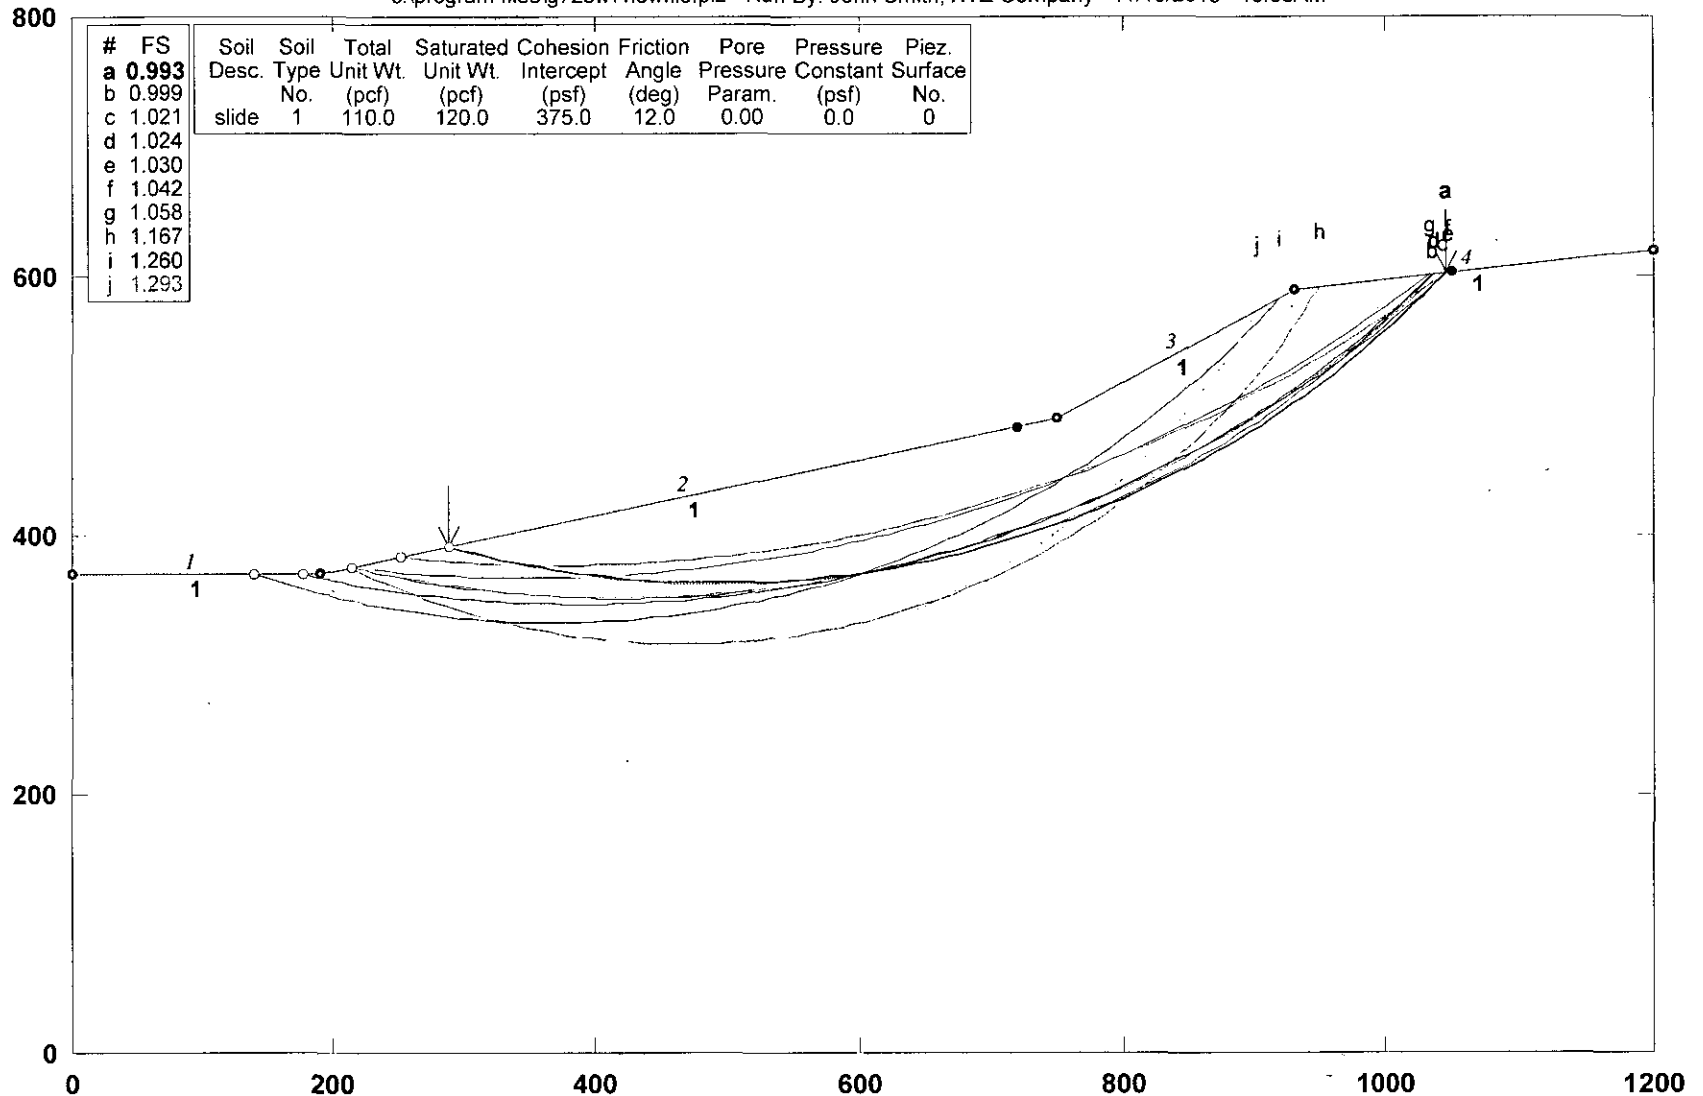
Sargent Ranch Quarry Site Section L-L' Back Calc

GSTABL7 v.2 FSmin=0.993

Safety Factors Are Calculated By The Modified Bishop Method

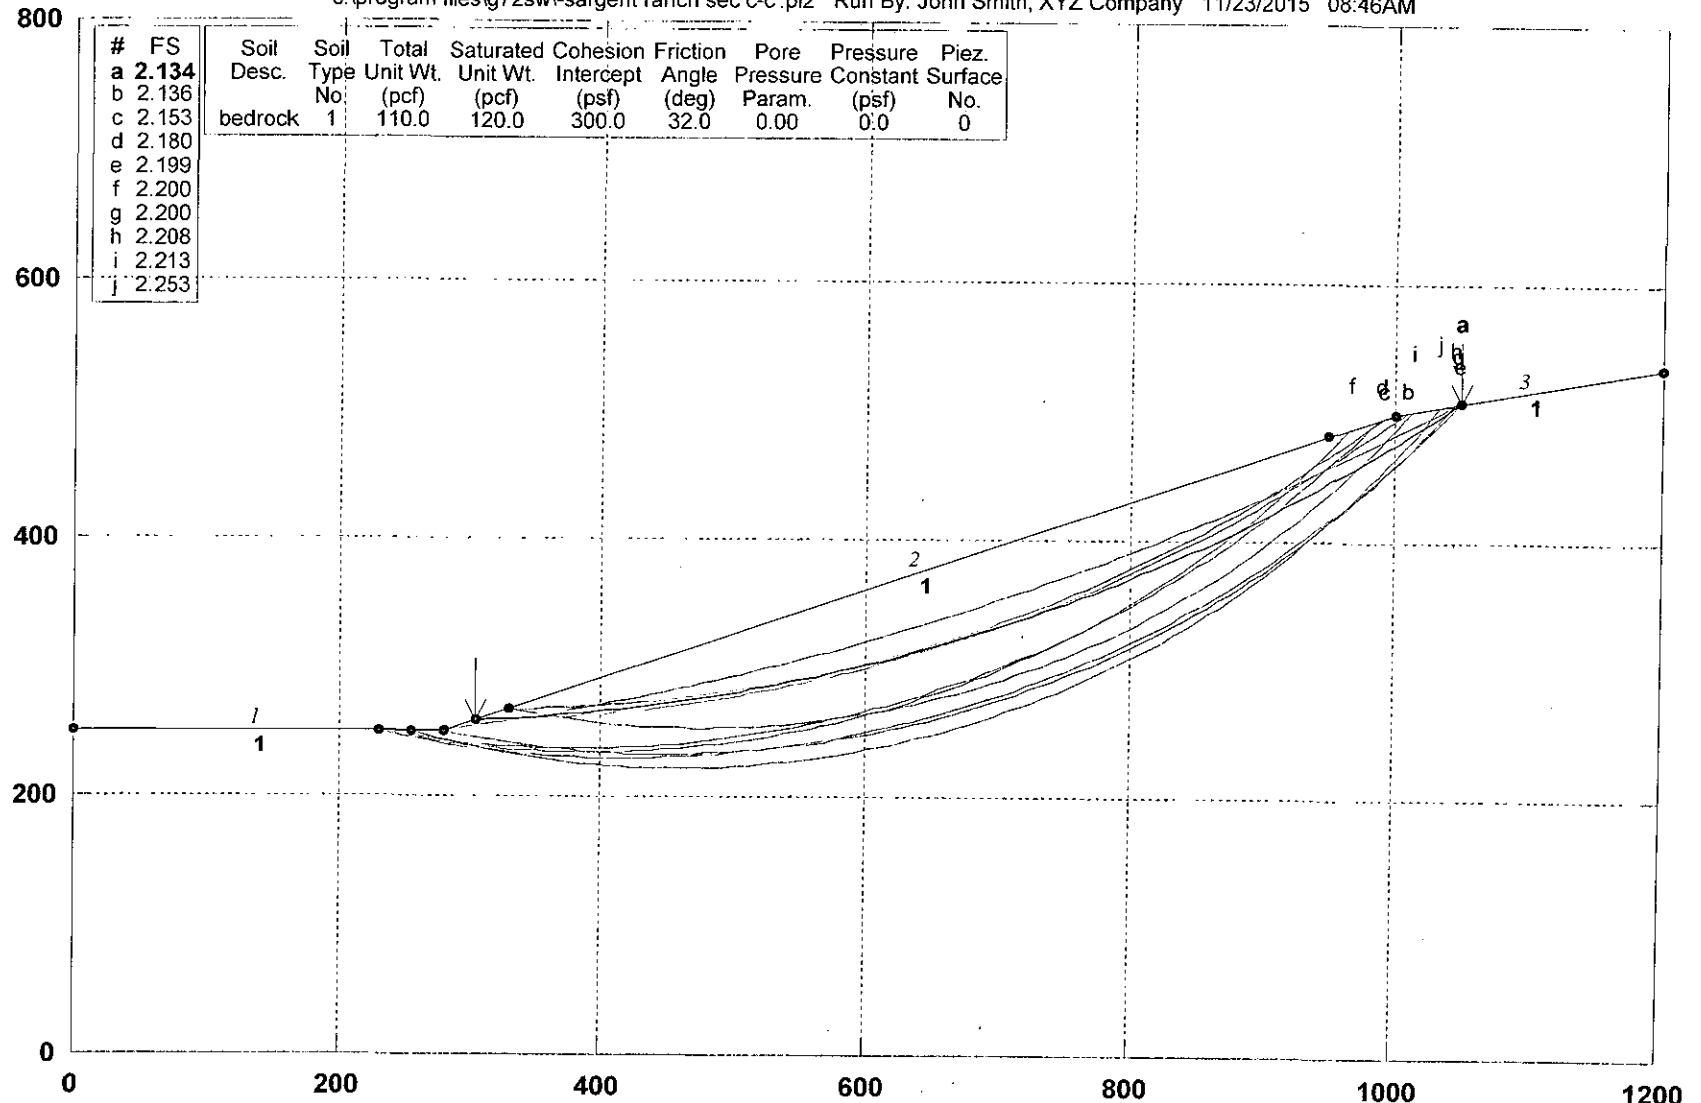
Sargent Ranch Quarry Site Section Q-Q' Cross Bedded

GSTABL7 v.2 FSmin=2.134

Safety Factors Are Calculated By The Modified Bishop Method

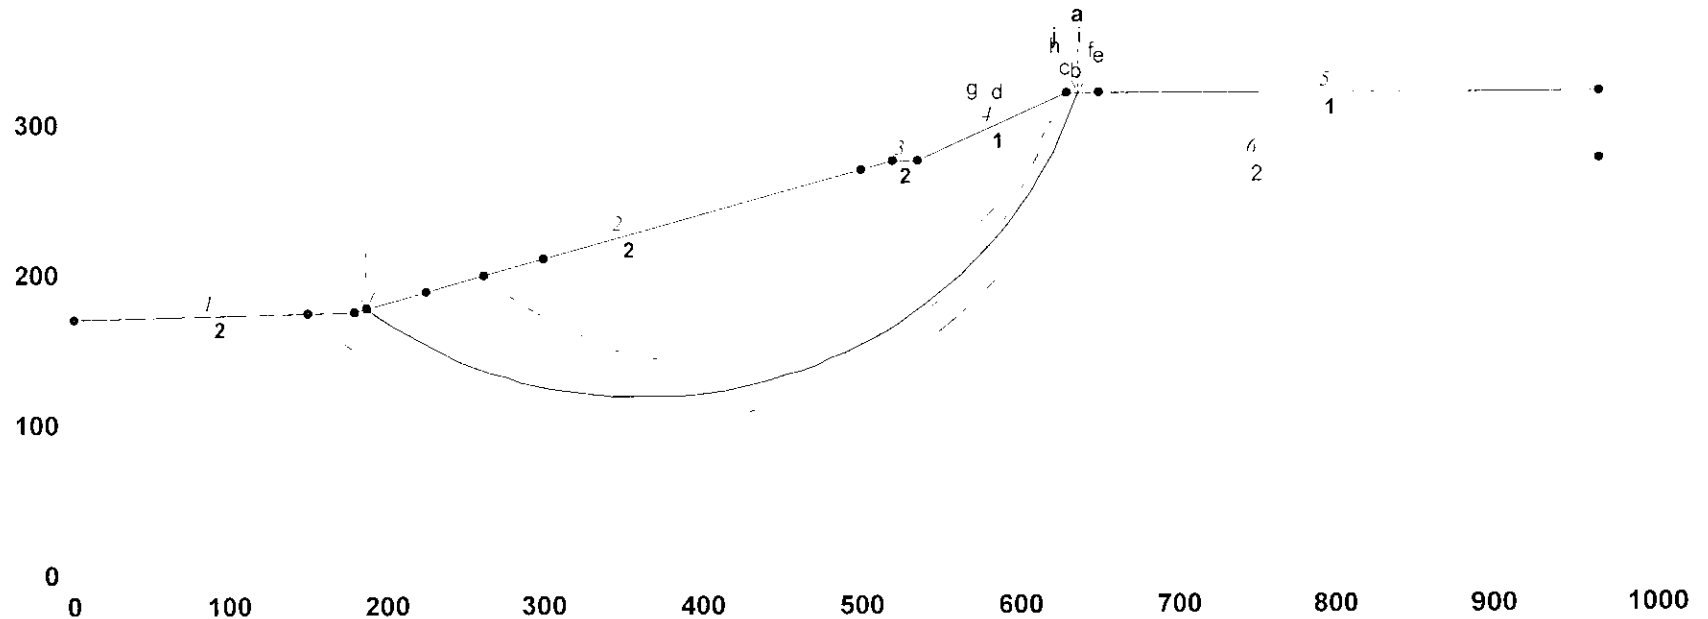
Sargent Ranch Sec A-A' Civil Overburden

GSTABL7 v.2 FSmin=1.452

Safety Factors Are Calculated By The Modified Bishop Method

For the overburden and topsoil stockpile areas adjacent Phases 3 and 4 (Civil Section A-A') we assume the material will be a combination of clays, silt, and sand, with minor amount of gravels and cobbles. We assume that minimal compactive effort will be used in placing the stockpile. Due to the setback distance shown on the plan, the stockpiles will not have a negative impact on the Phase 3 mining limit backcut. However, based on our analysis of the stability of the stockpiles themselves, the factor of safety will be 1.45, static and 0.95 seismic against sliding. As a result, we recommend that the Phase 4 stockpile be setback from the top edge of Phase 3, on its east face, at least an additional 20 feet (total 35').

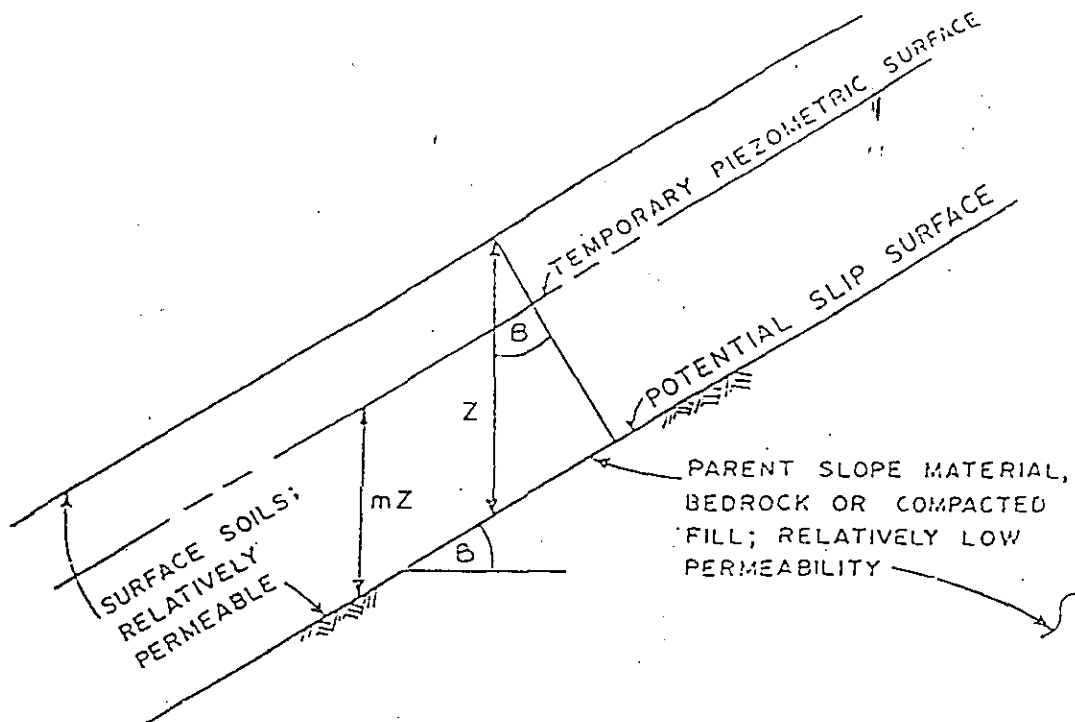
$$F = \frac{C + (\gamma - m\gamma_w) Z \cos^2 B \tan \phi}{\gamma Z \sin B \cos B}$$

WHERE: F = FACTOR OF SAFETY
 γ = UNIT WEIGHT OF THE SOIL (sat)
 γ_w = UNIT WEIGHT OF THE WATER
 C = COHESION
 ϕ = ANGLE OF SHEARING RESISTANCE
 Z = VERTICAL DEPTH OF THE SLIP SURFACE
 m = FRACTION OF Z SUCH THAT mZ IS THE VERTICAL HEIGHT OF THE TEMPORARY WATER SURFACE ABOVE THE SLIP SURFACE.
 B = SLOPE ANGLE

The natural topsoil areas steeper than 2:1 are unstable for shallow failure (under three feet deep) when saturated. Most of the cuts though are deeper so this will be only a localized condition.
