## SURFACE MINING INSPECTION REPORT

### **2014 Annual SMARA Inspection of the Stevens Creek Quarry County File 1253-94P-07P-14PAM State Mine ID #91-43-0007**

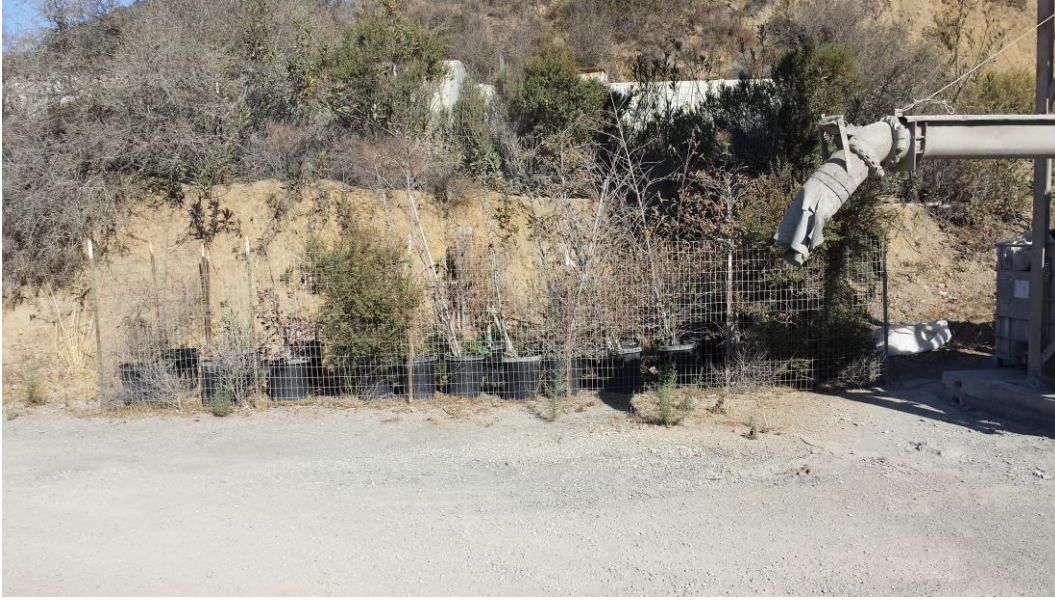
Photo by Jim Baker, Sept. 11, 2014

Re-vegetation of 2.4 sloped acres along the northern boundary of Parcel A remains ongoing. Two revegetation test plots were established on the slopes; trees and shrubs were stored in containers adjacent to the slopes to acclimate to the location. Trees that were planted on the slopes did not survive the acclimation period. The operator attempted to have the 2.4 acres planted in previous years; however, insufficient survival of the plants prevented final planting. The County recommends the operator consult with a qualified biologist or botanist to reconsider the plant choice for the location, taking into consideration the climate, soils, and slope of the land.

Vegetation test plot area, all vegetation appears to be dead.

1. Mine operator should install test plots to test the revegetation plan, and consult with a botanist or qualified biologist to test for survival rates of the plant pallet.
2. The operator should hydroseed the un-vegetated portions of the buttress fill being placed in the northeast corner of the quarry and any bare road berms along the eastern and northern perimeter road as necessary to prevent erosion. This shall be re-checked and verified by the County during the next winterization inspection for bmp's.

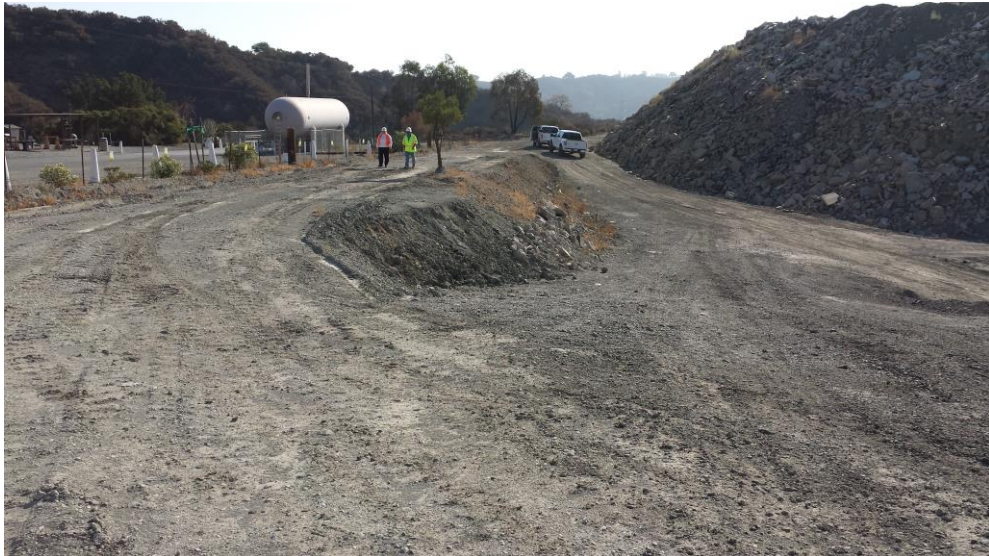
Photo by Jim Baker, Sept. 2014

Top of repaired slop (previous slump) along northern property line of Parcel A. This appears to have been completed properly.

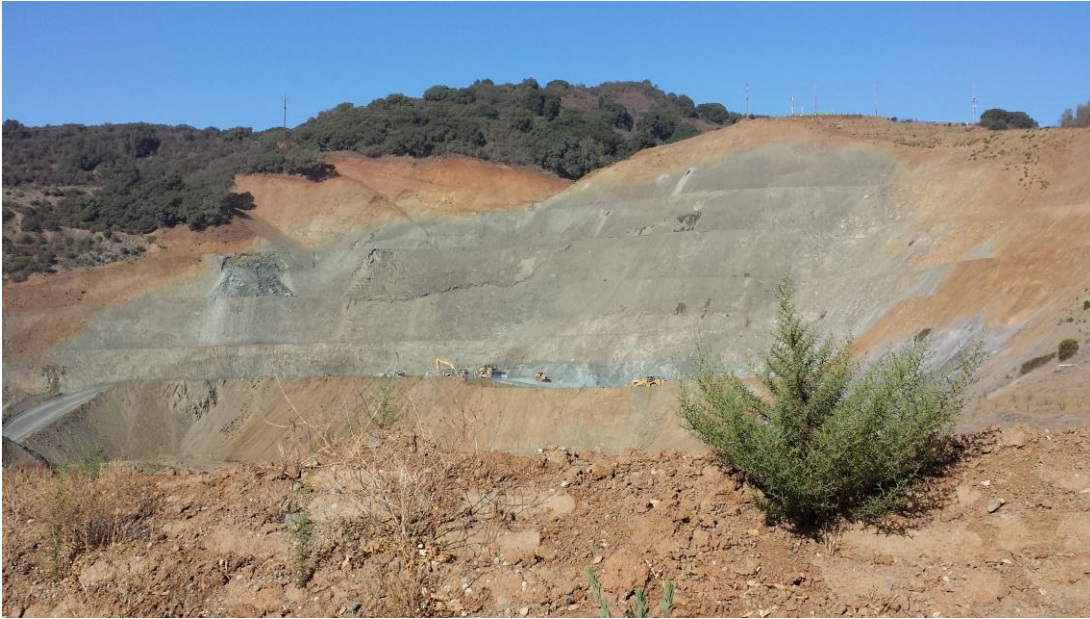
**Photo by Jim Baker, Sept. 11, 2014**

Looking west at high wall cuts. Localized slumping has occurred between benches that will be buried by fill during reclamation.

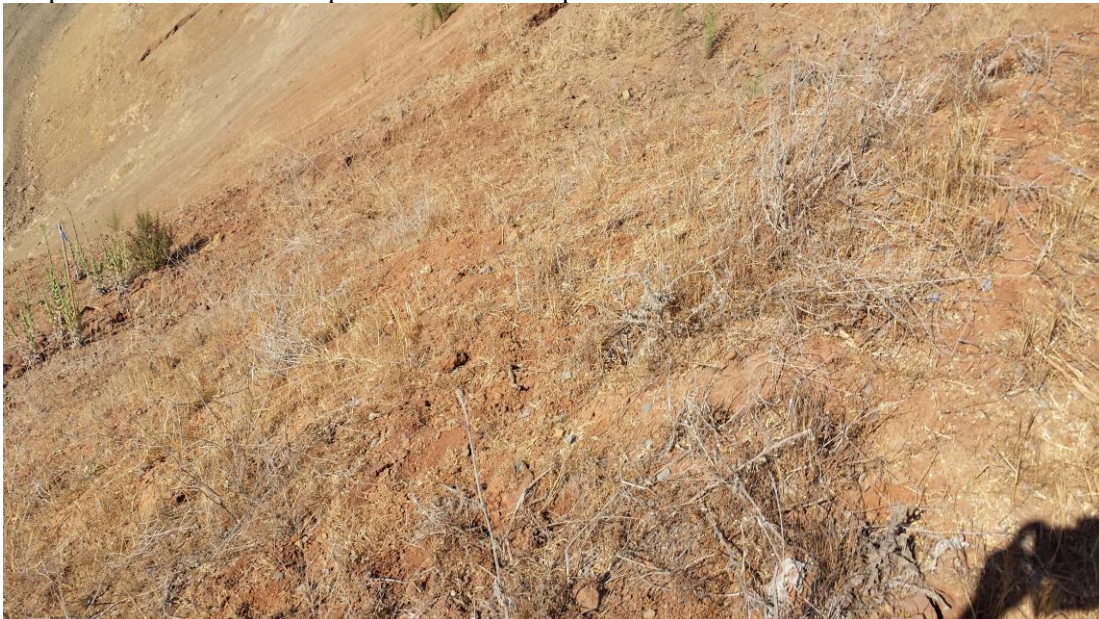
**Photo by Jim Baker, Sept. 11, 2014**

Looking down on northern slope of pit. Localized cracking and erosion rills have formed in the slope that will be cut back per the reclamation plan.

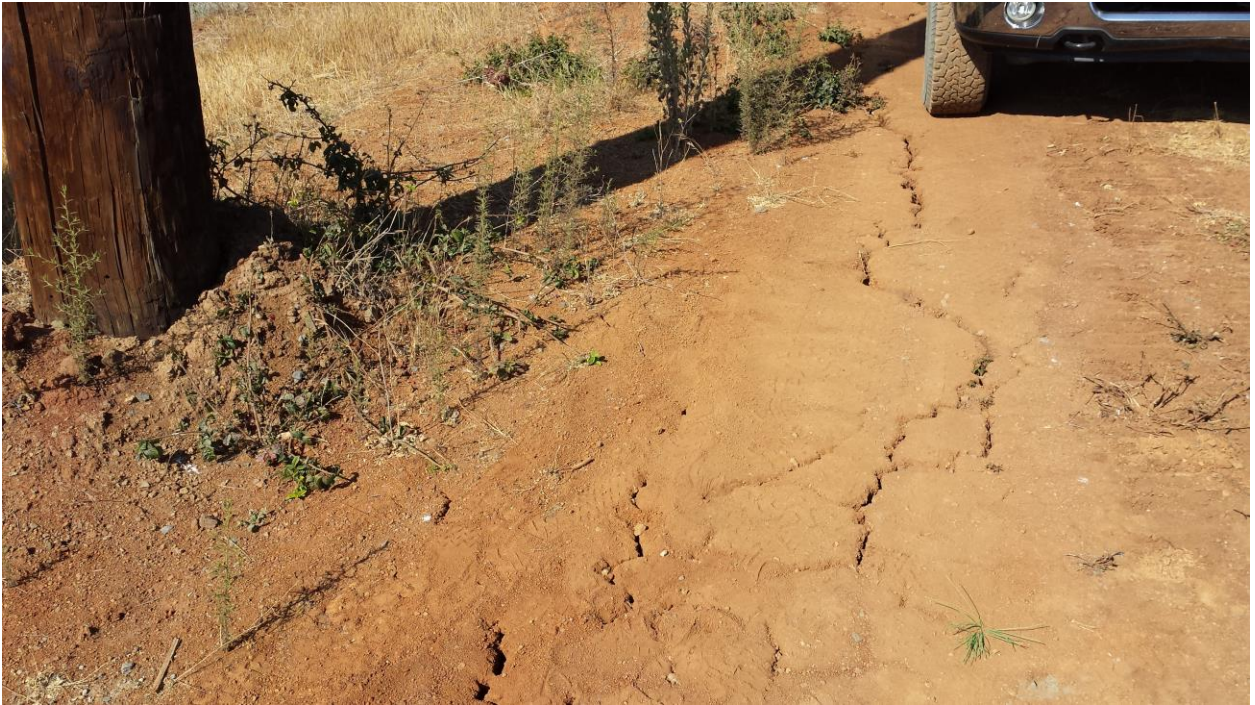
**Photo by Jim Baker, Sept. 11, 2014**

Mining is conducted in Parcel B in a north-northwest trending quarry where Franciscan greenstone bedrock is extracted. Mining also continues on Parcel A. Inspectors observed that most of the equipment for crushing and sorting rock materials is located on the floor of the quarry in Parcel B. Excavation of the northeastern corner of Parcel B quarry is done to expand operations and mitigate an unstable highwall area. This expanded mining area removed a portion of the perimeter Pacific Gas and Electric Company power line access road. At the September, 2014 inspection, the operator informed the County that PG&E will replace the utility pole with two new poles east of location.

Open cracks in the road near the power pole that will be replaced indicate tension resulting from slope movement. The area will be cut down to allow runoff to flow to the east, that will also relieve some of the stress that the overburden is applying to the cut slope below.

3. The operator should submit photo documentation regarding the removal and replacement of the PG&E pole, in the northeast corner of Parcel B. Should also contact their consulting geologist to assess slope instability of this area and incorporate any recommendations made.

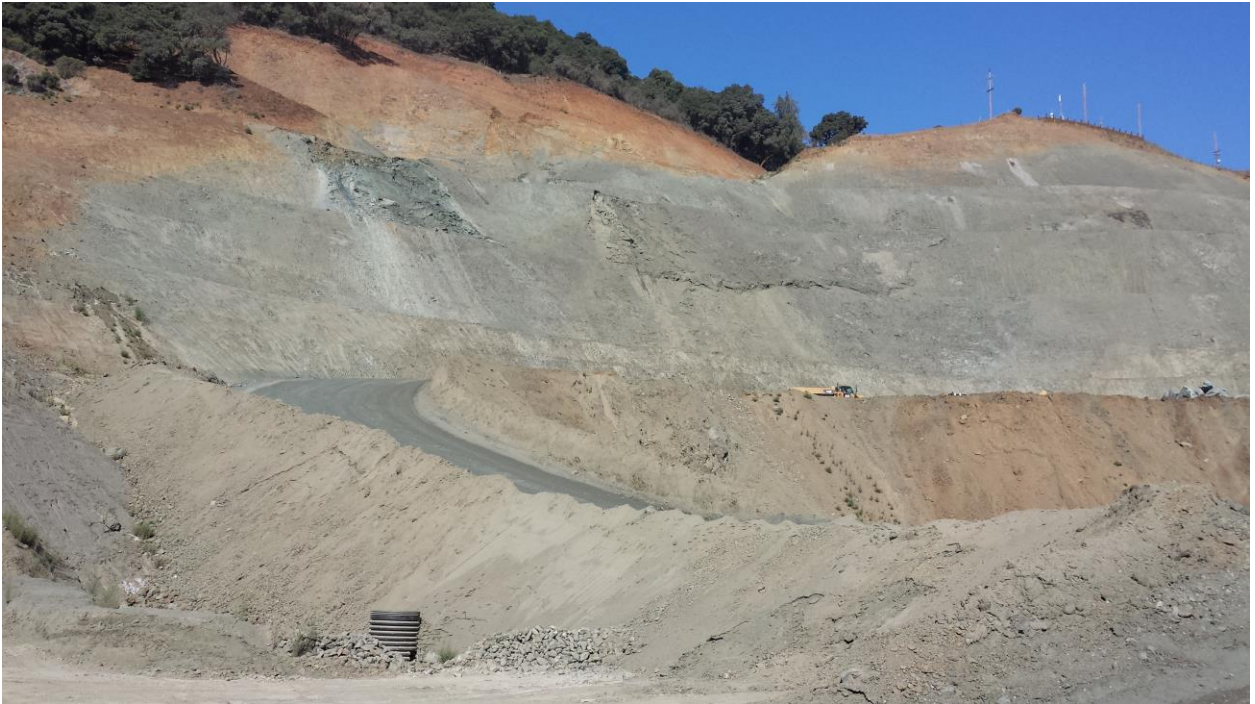
Looking up at slumps in high wall cut slope on west side of pit.

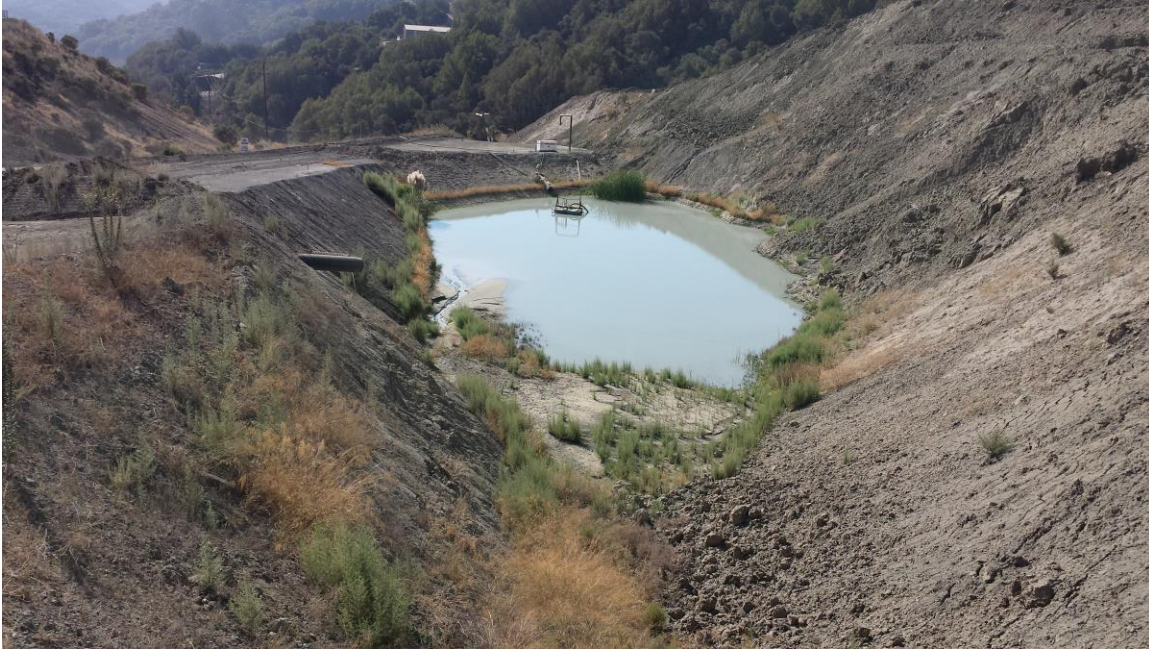
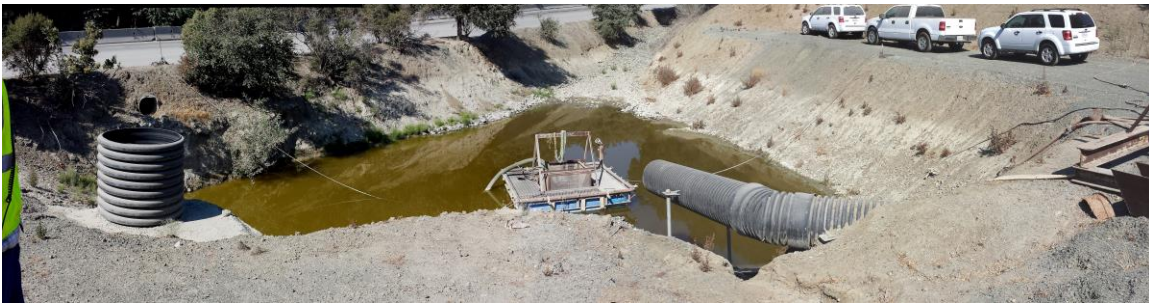
Photo by Jim Baker, Sept. 11, 2014.

Pond near plant appears to have adequate capacity.
