SANTA CLARA COUNTY, CALIFORNIA
STEVENS CREEK QUARRY
**MINE AND RECLAMATION DESCRIPTION
FOR NEW USE PERMIT AND AMENDED RECLAMATION PLAN**
CA MINE ID 91-43-0007

MAY | 2019

Benchmark Resources

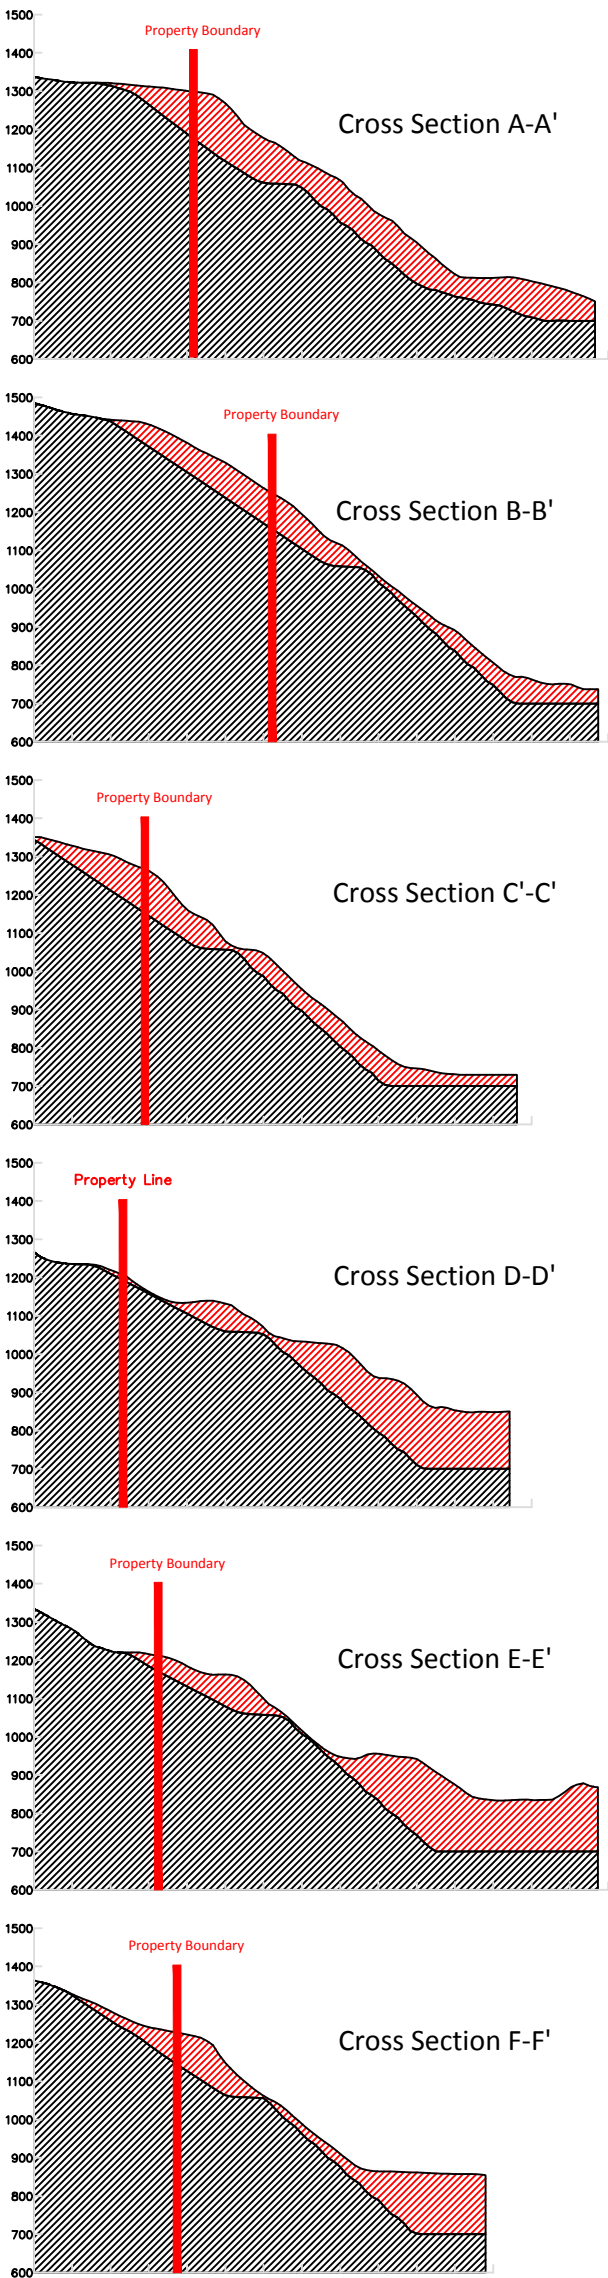
1. See Figure 5 for cross section locations.

The quarry includes an aggregate plant, topsoil plant, and recycle plant for broken asphalt and concrete. Equipment used to harvest rock includes frontend loaders, haul trucks, bulldozers, and graders. Figure 3, provides the current (2018) locations of key quarry features. Figure 5, "Mine Plan," and Figure 6, "Mine Plan Cross Sections," show the plans for mining the site.

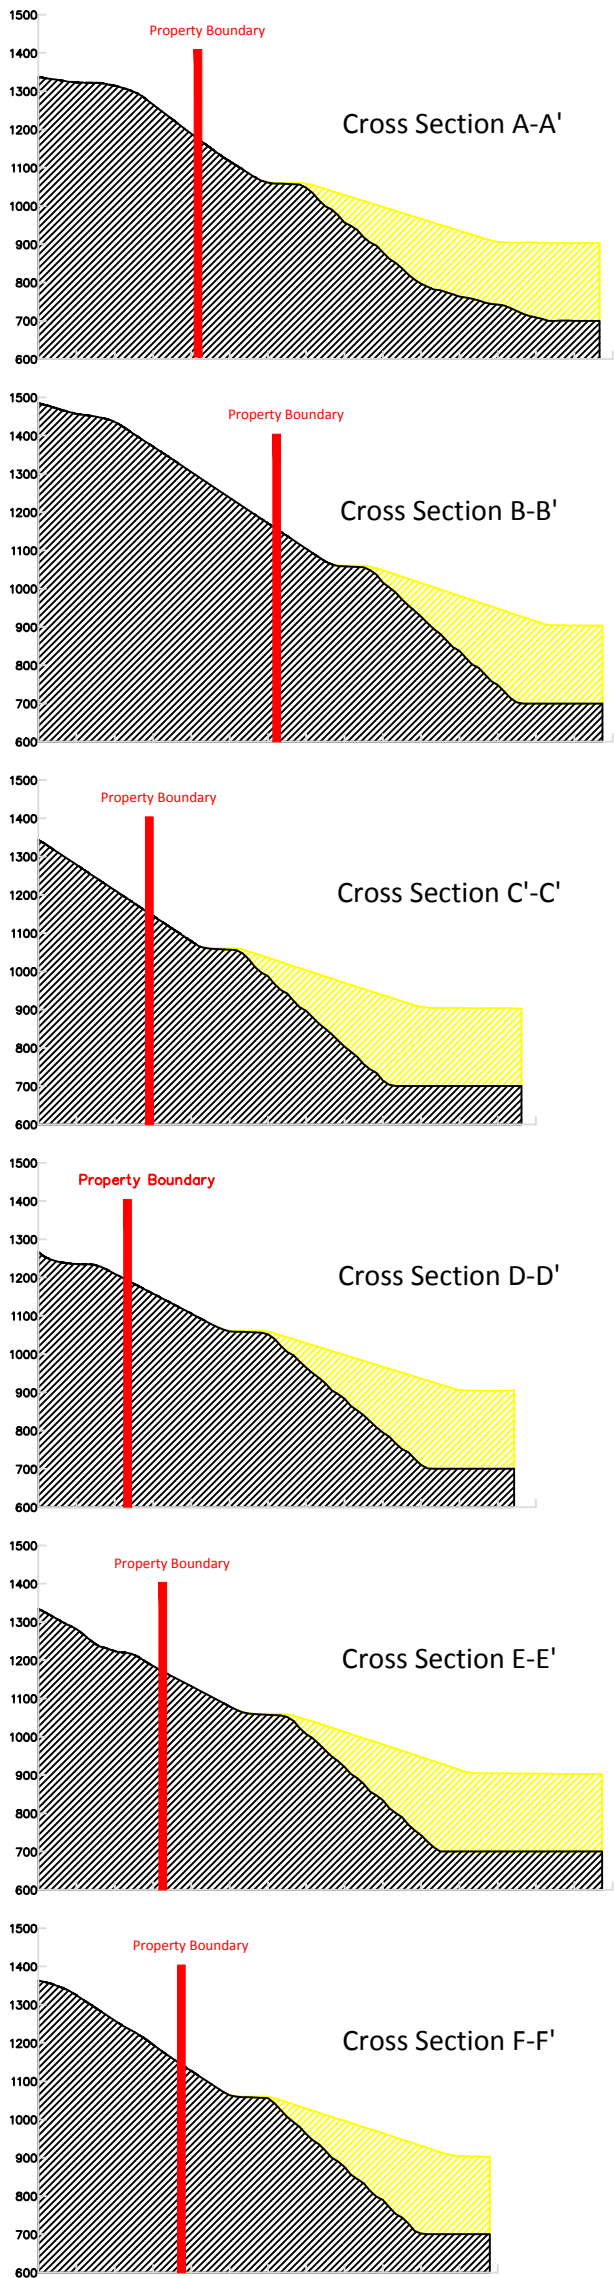
1. See Figure 7 for cross section locations.

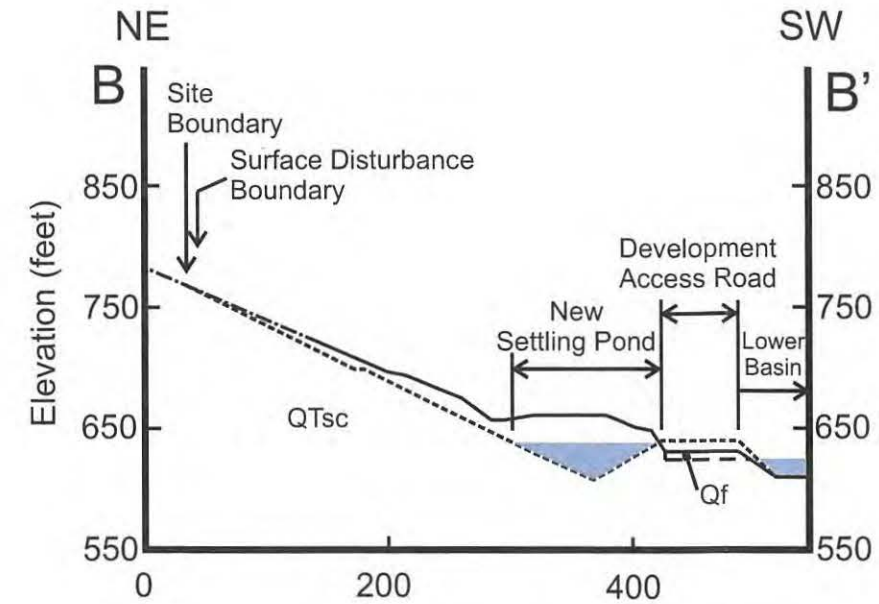
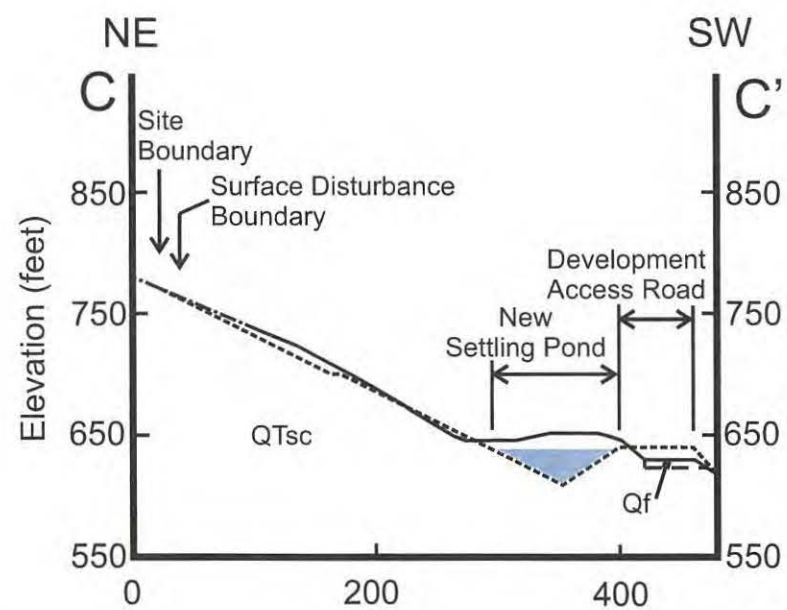
- EXISTING GROUND SURFACE, APPROXIMATE.
- - - PROPOSED GROUND SURFACE AT 2:1 SLOPE W/ 8 FEET BENCH, APPROXIMATE.
- · - · - INFERRED GROUND SURFACE
- - - GEOLOGIC CONTACT, APPROXIMATE
- B-6 ↓ APPROX. BORING LOCATION, TYP.
- QTsc SANTA CLARA FORMATION
- Qf EXISTING FILL

Our interpretations of the subsurface conditions as extrapolated from the information obtained during our site reconnaissance, subsurface exploration and published geologic literature, are presented on Cross Sections A-A', B-B' and C-C' presented as Plate 5, Geologic Cross Sections. More detail pertaining to the subsurface conditions is presented of the boring logs

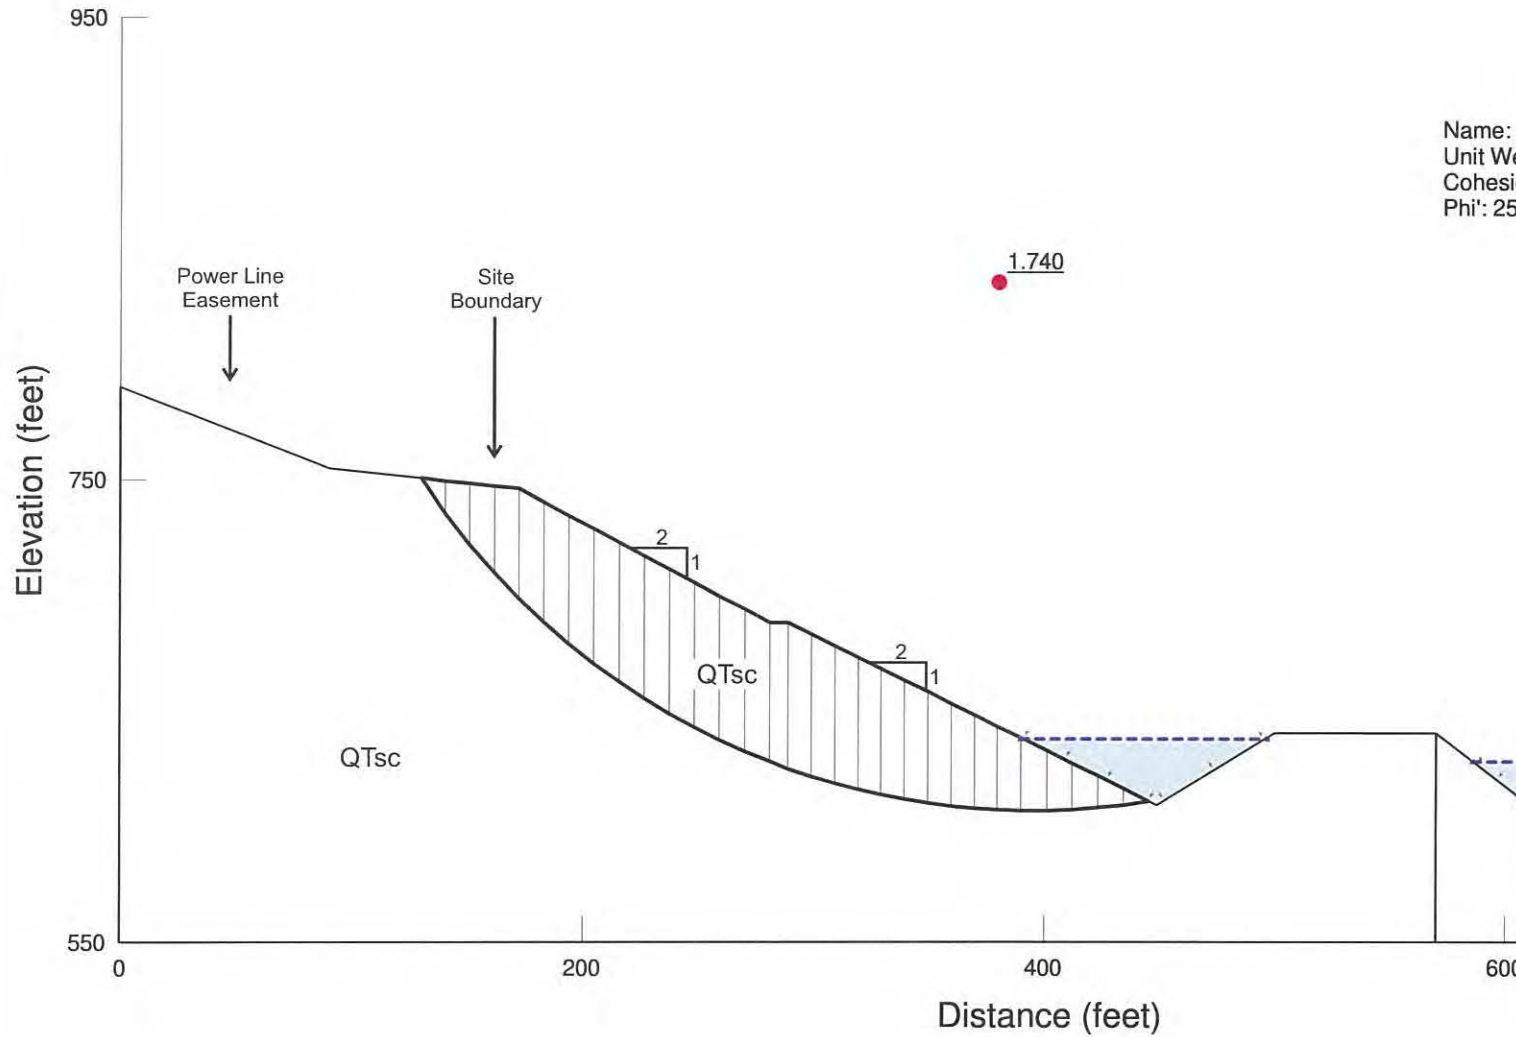
PLATE
 19

Name: Santa Clara Formation (QTsc)
 Unit Weight: 130 pcf
 Cohesion: 1,000 psf
 Phi: 25 °

Initially, the cut slopes along the east and north sides of the proposed NSP were to be cut at a slope gradient of 1.5H:1V. However, our stability analysis indicated that such gradients were not considered stable under seismic loading although acceptable Factors of Safety (FOS) exceeding 1.5 were obtained under static conditions. No intermediate drainage terraces/benches were planned as part of the original design.
