Appendix G

Geology and Hydrology

G1. Geotechnical and
Geomorphic Assessment
of Permanente Creek
(Golder Associates,
October 21, 2019)

GEOLOGIC AND GEOMORPHIC ASSESSMENT OF PERMANENTE CREEK, LEHIGH HANSON PERMANENTE QUARRY, SANTA CLARA COUNTY, CA

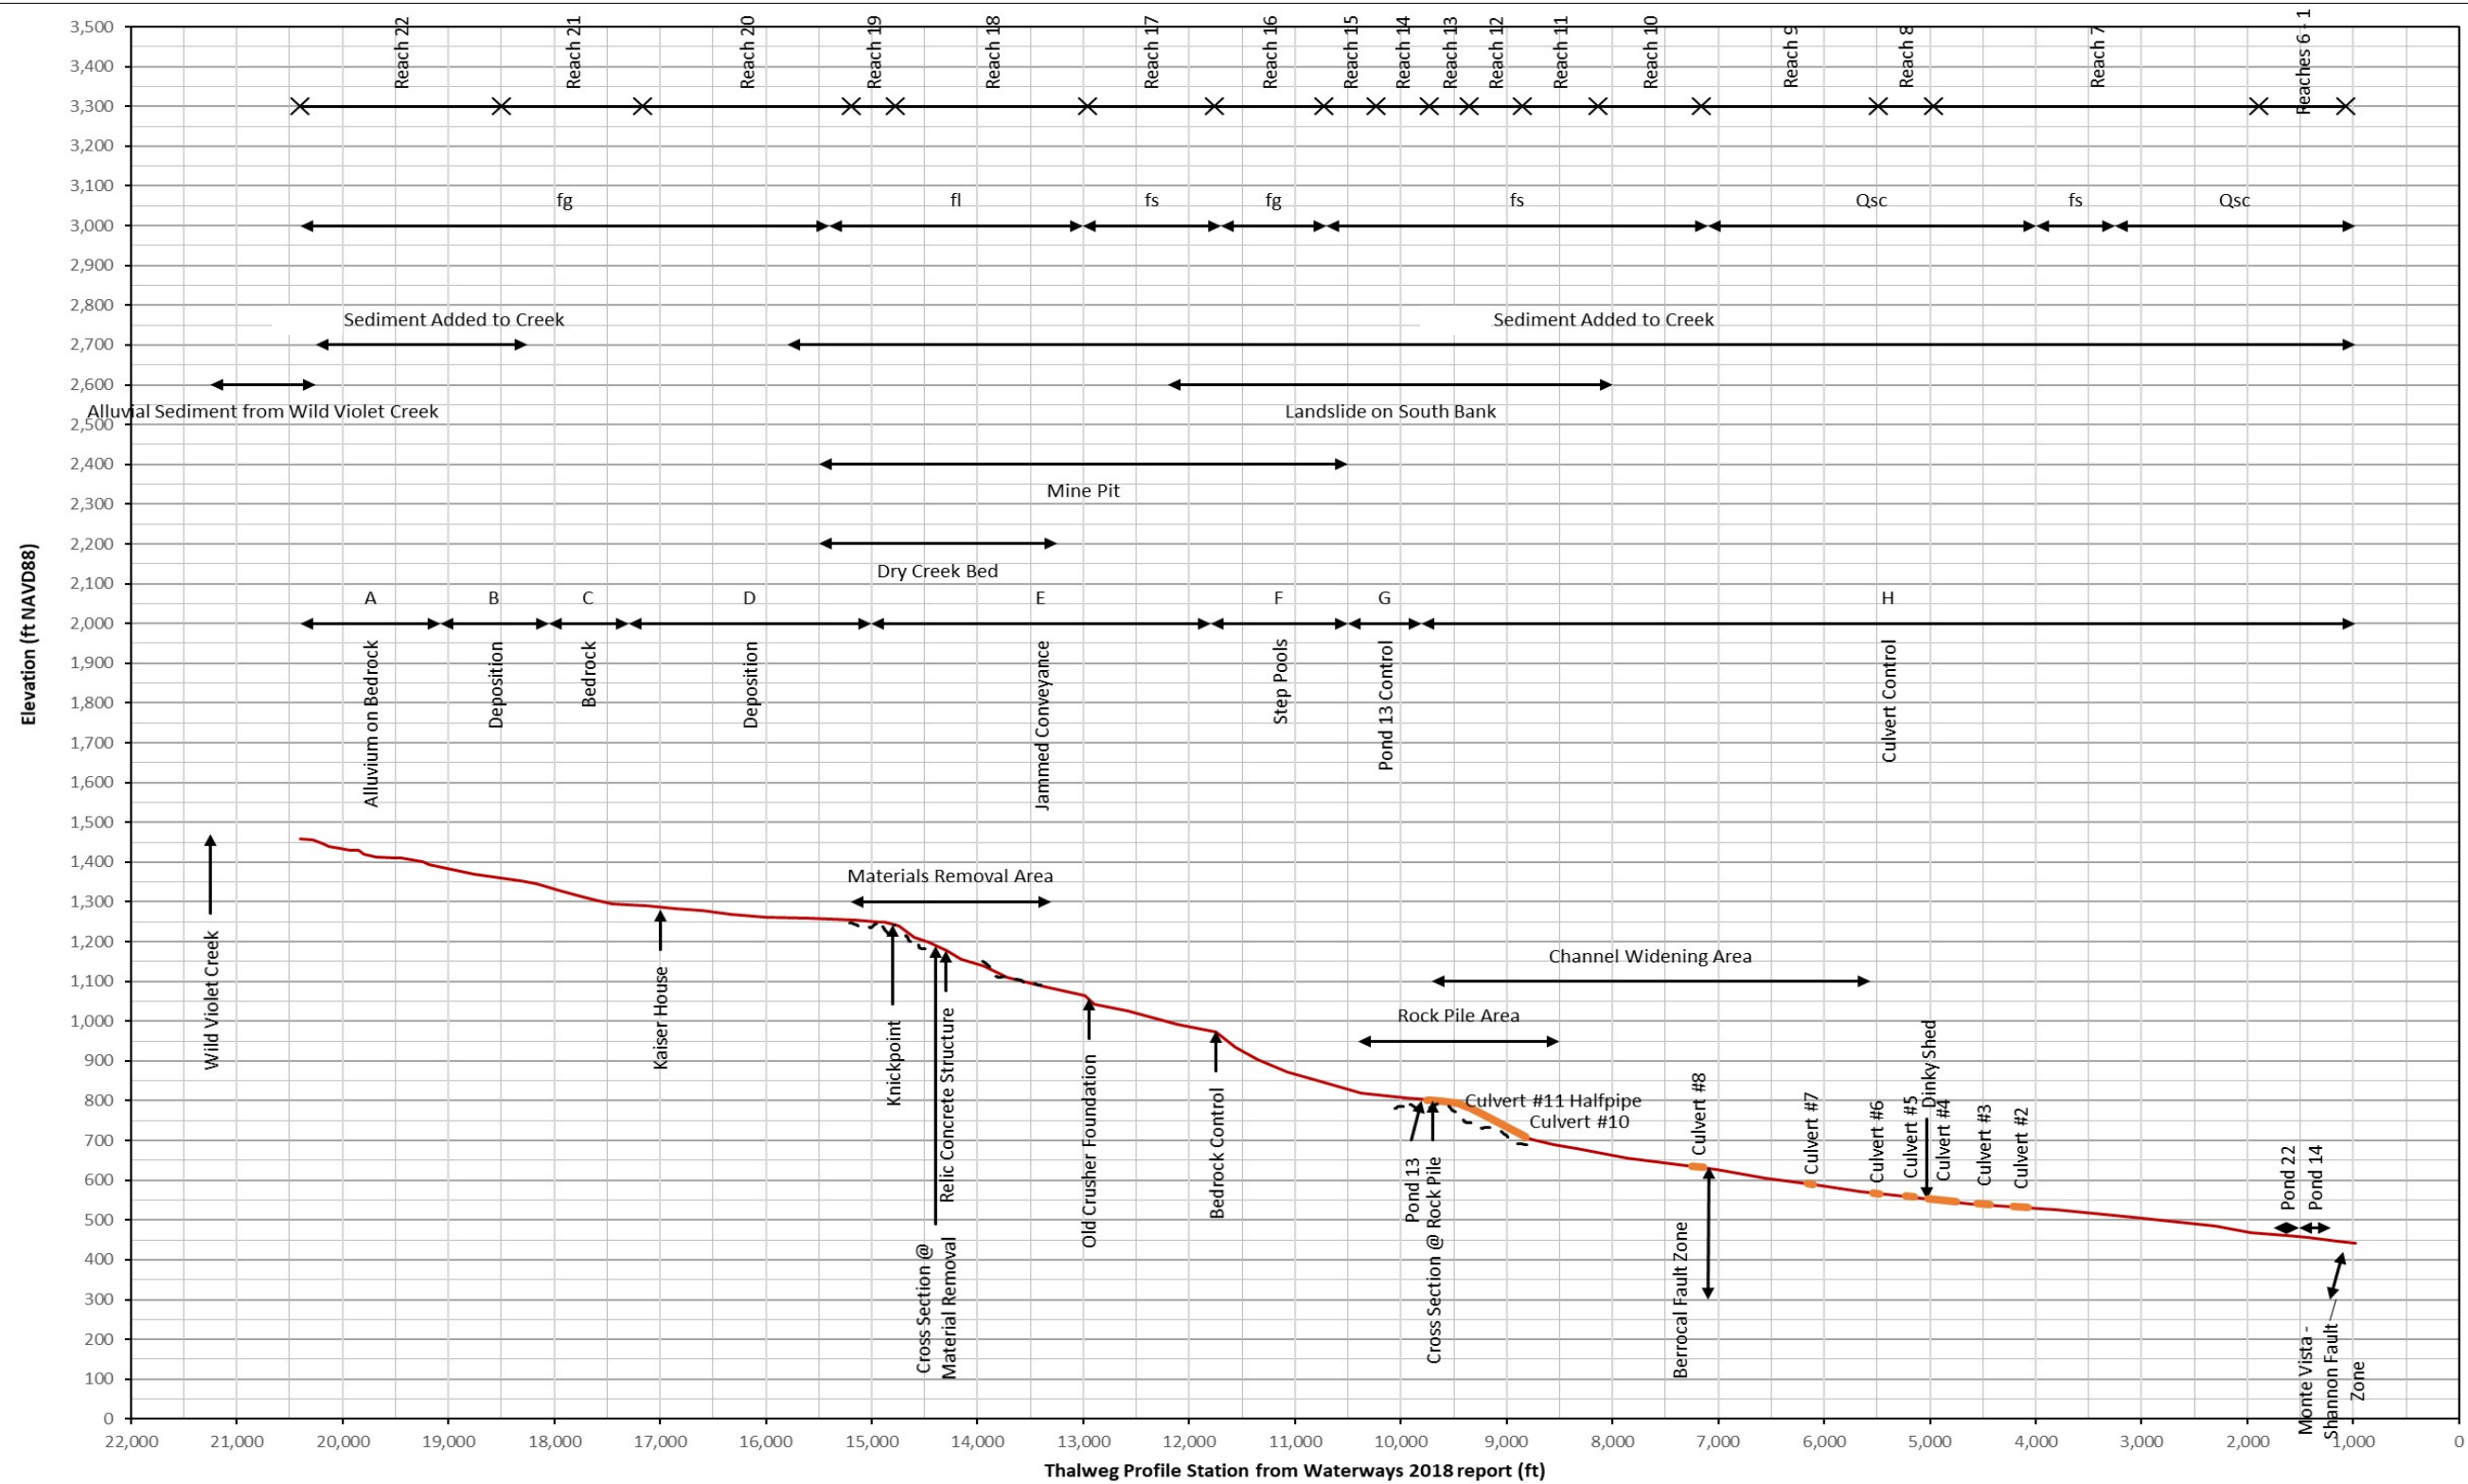
Figure 2: Permanente Creek Profile with geomorphic and geologic delineations. Stationing from Waterways (2019).

The profile of Permanente Creek can broadly be classified into depositional reaches and bedrock reaches (delineated on Figure 2 as Reach A, Reach B, etc.). The processes that define these reaches are the rate that sediment is supplied to the channel and the rate at which the channel can convey the supplied sediment. The rate of sediment supply is controlled by hillslope processes and the rate that sediment is delivered to the channel. The rate of sediment transport is controlled by the channel geometry and the hydraulic characteristics of the reach. The channel hydraulics are directly coupled to the rate at which water is delivered to the channel.

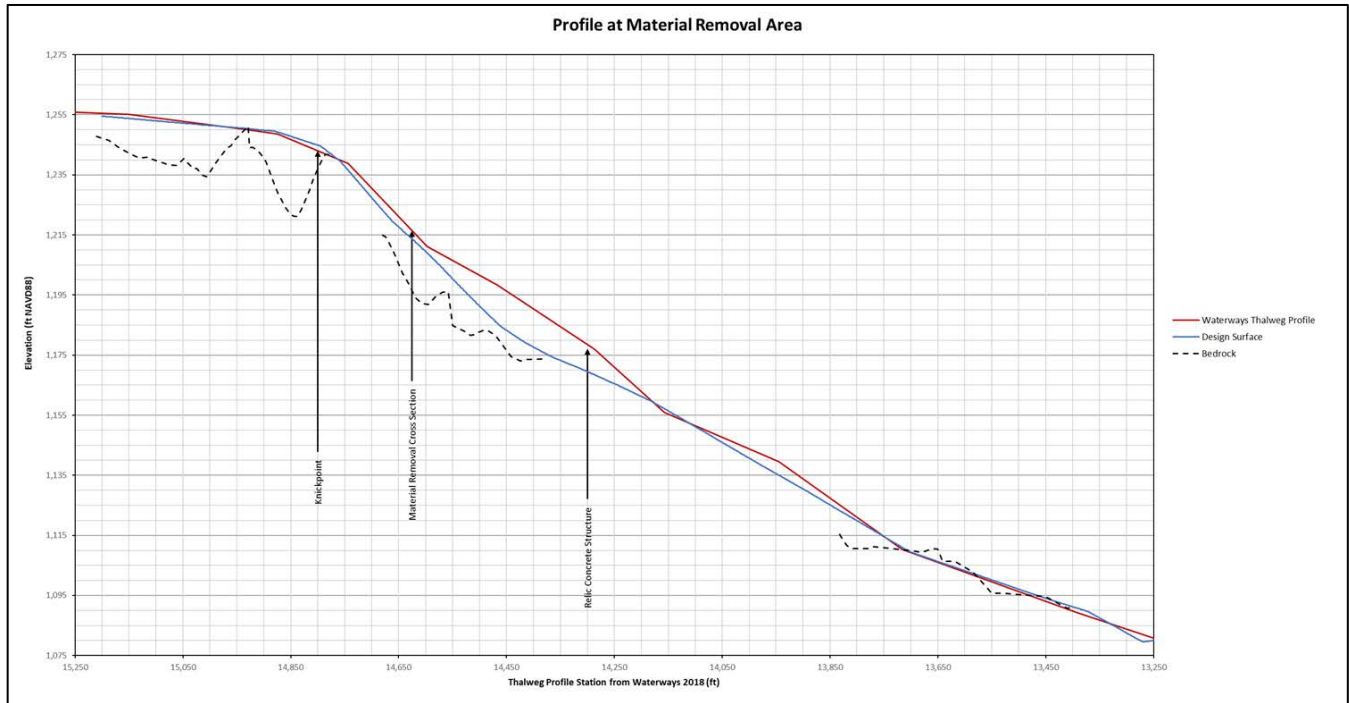
Figure 6: Profile of Material Removal Area from Station 152+50 to 132+50.

The following bullet points provide Golder's observations of the design as compared to conditions observed in the site reconnaissance and as informed by the seismic refraction survey data.

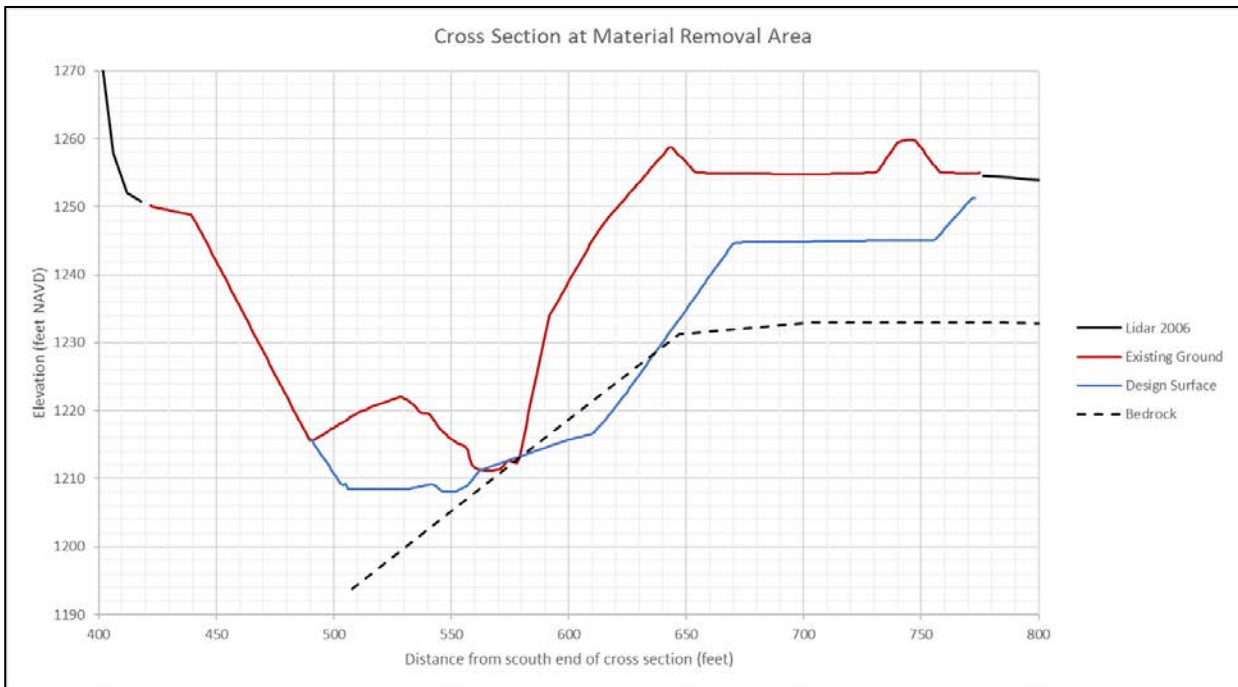
Figure 8: Cross section at Material Removal Area. Located at Thalweg Profile Station 146+00. Note depth to bedrock is approximate and estimated based on seismic refraction data.
