SURFACE MINING INSPECTION REPORT

I. Mine Name (As Shown on Approved Reclamation Plan) Permanente Quarry	Inspection Date: 9/4 & 9/5, 2014	CA MINE ID# 91- 43-0004
--	--	-----------------------------------

2014 SMARA INSPECTION PHOTOS

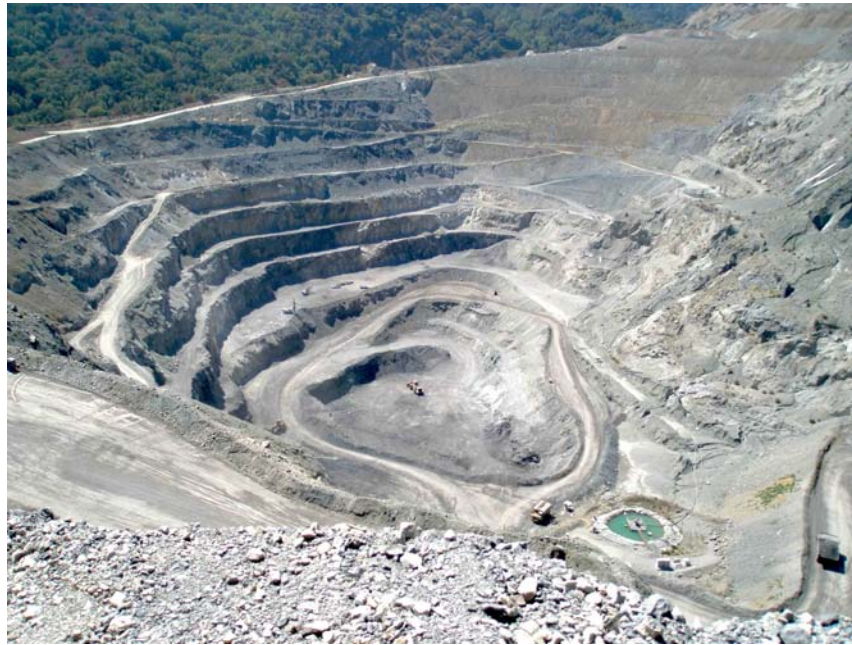
Photo 1: North Quarry, southwest portion. Waste rock material being placed at toe of western slope. Potential "Haul Road Slide" in eastern slope of WMSA, right of image. Floor elevation of quarry at approximately 650 feet msl. Dated September 4, 2014.

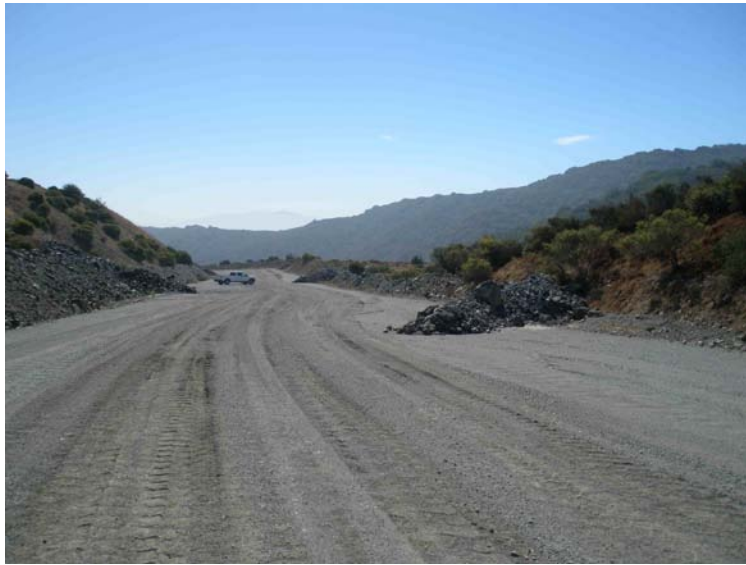
As part of the site's stormwater management, numerous rock checkdams have been placed along the haul roads. Limestone check dam materials have been replaced with non-limestone greenstone rock to reduce the potential for selenium to leach into stormwaters, (Photo 3).

Photo 3: Check dams on WMSA haul road that were replaced with non-limestone materials, looking eastward. Dated September 4, 2014.

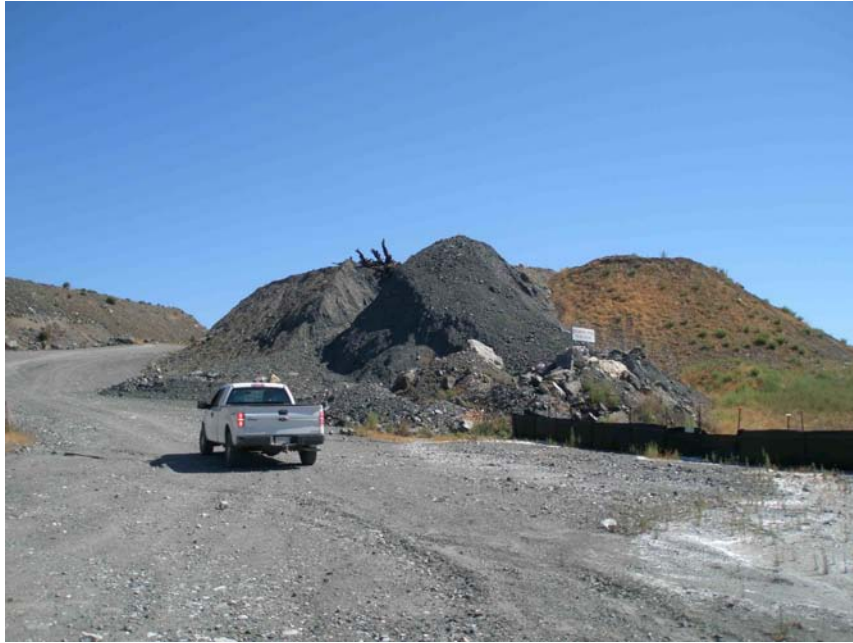
Photo 7: Eastern topsoil storage area in WMSA, looking north. Sign and silt fence in foreground. Dated September 4, 2014.

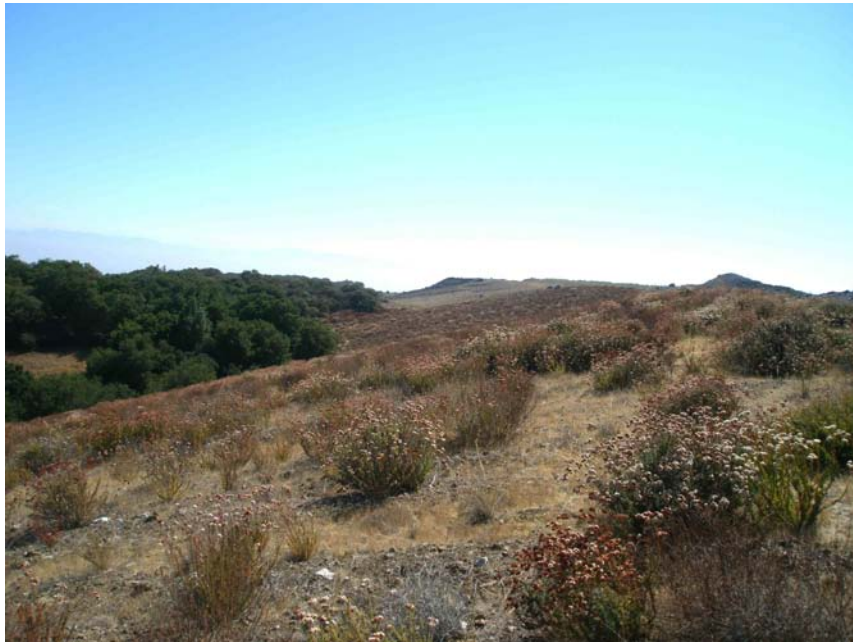
Photo 8: Portion of re-vegetated north-facing slope of WMSA, looking east. A portion of this slope will be removed in Phase 2 to backfill of North Quarry. Dated September 4, 2014.

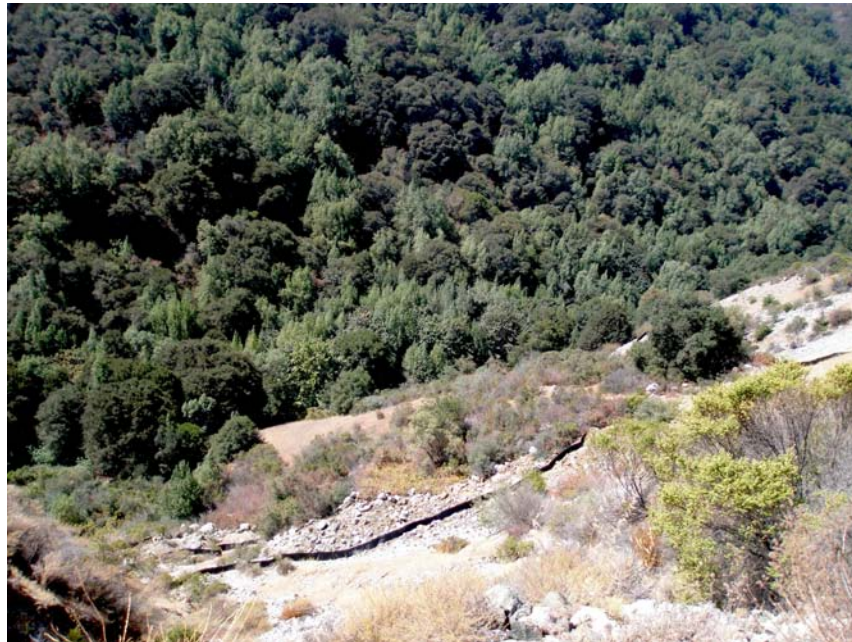
Photo 11: Silt fencing on southern slope of WMSA below outfall in Photo 9. Note soil mixed with talus adjacent to silt fence may be result of past slide; silt fence shows no significant displacement. Dated September 4, 2014.

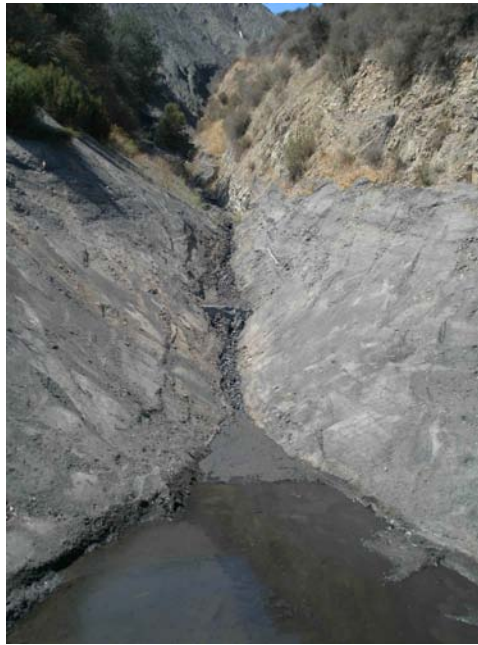
Photo 15: Sediment catch basin at toe of slope failure north of eastern end of 500-foot long conveyor tunnel in Crusher/Support Area, looking west. Dated September 4, 2014.

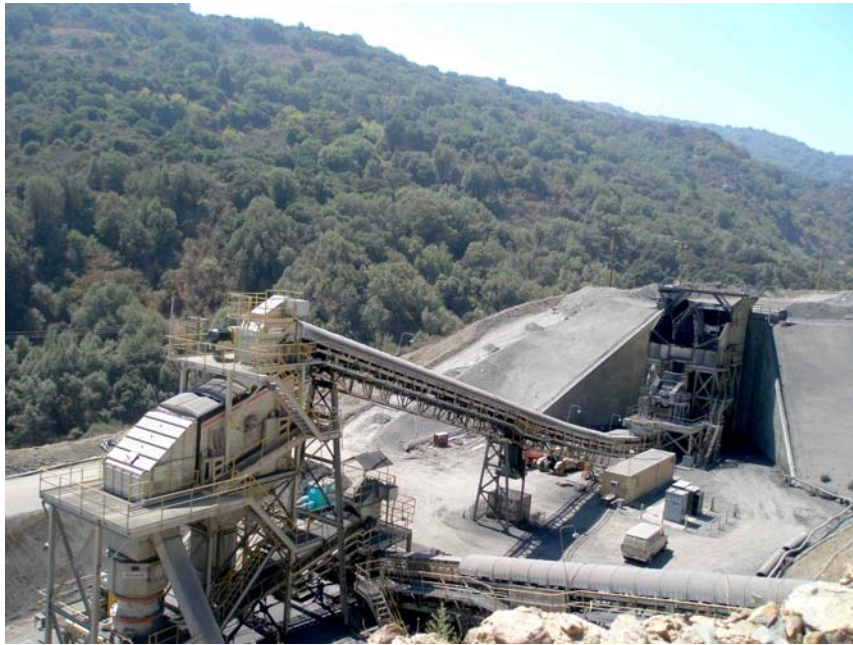
Photo 19: New primary and secondary crusher structures, looking southwest. Drainage from area will be collected and pumped into North Quarry for treatment before discharge. Dated September 4, 2014.

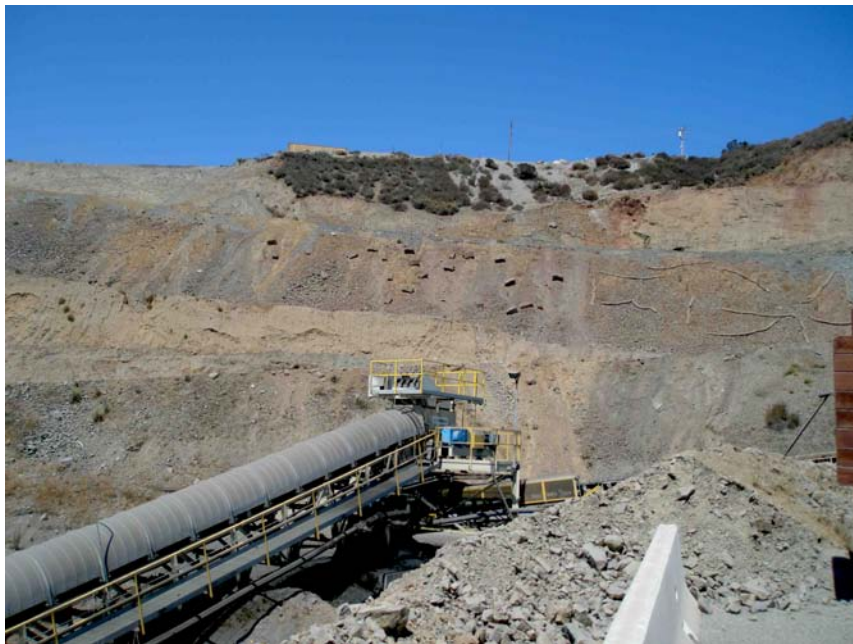
Photo 20: New secondary crusher conveyor dumps to tunnel conveyor, looking north. Note straw bails and waddles on slope. Slope was hydroseeded last winter. Dated September 4, 2014.

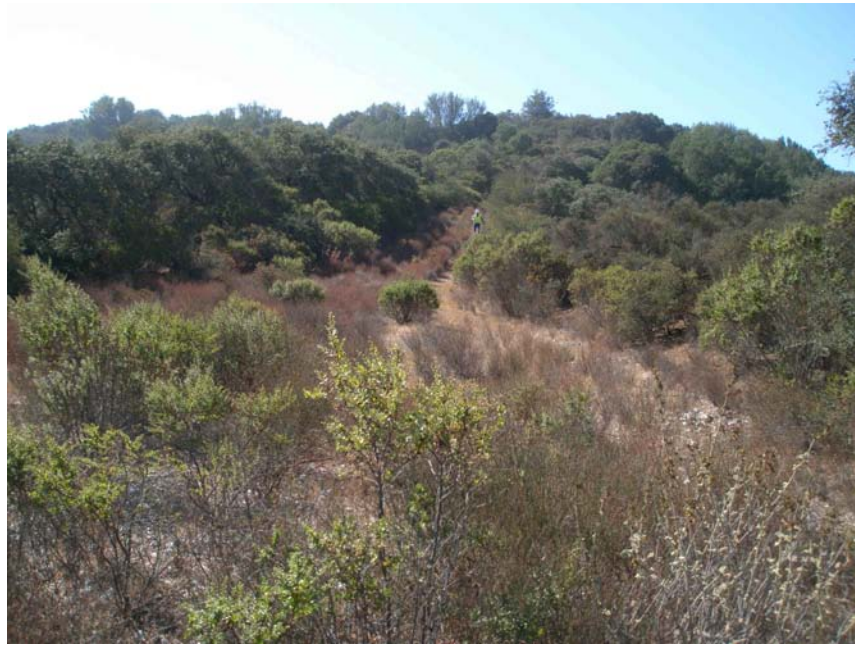
Photo 27: Re-vegetated Pit 3 East Road in South Quarry Exploration area near N37° 18.894', W122° 06.844', looking south from drill site gt 3-5A. Dated September 5, 2014.

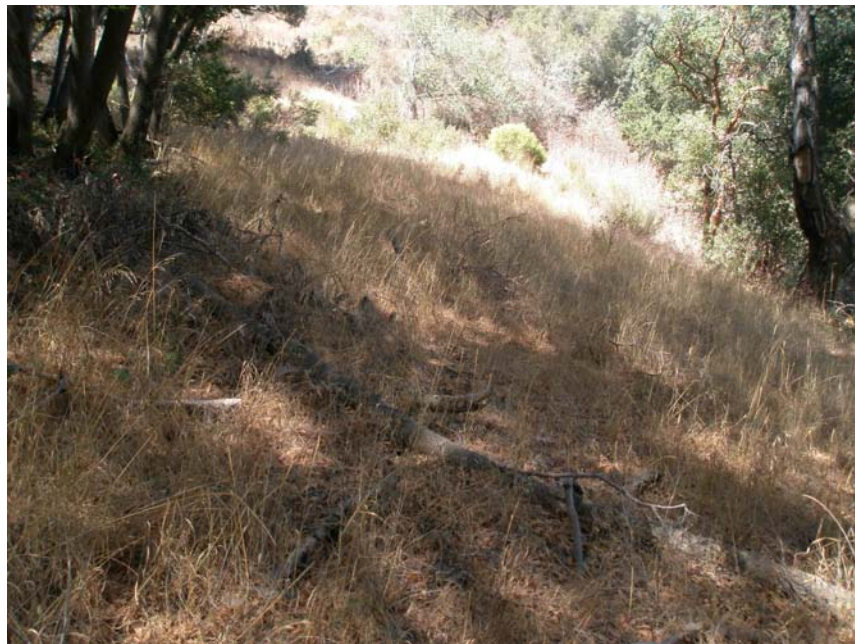
Photo 28: Re-vegetated exploration area geo 4-35 in South Quarry Exploration area near N37° 18.725', W122° 06.148', looking northwest. Dated September 5, 2014.

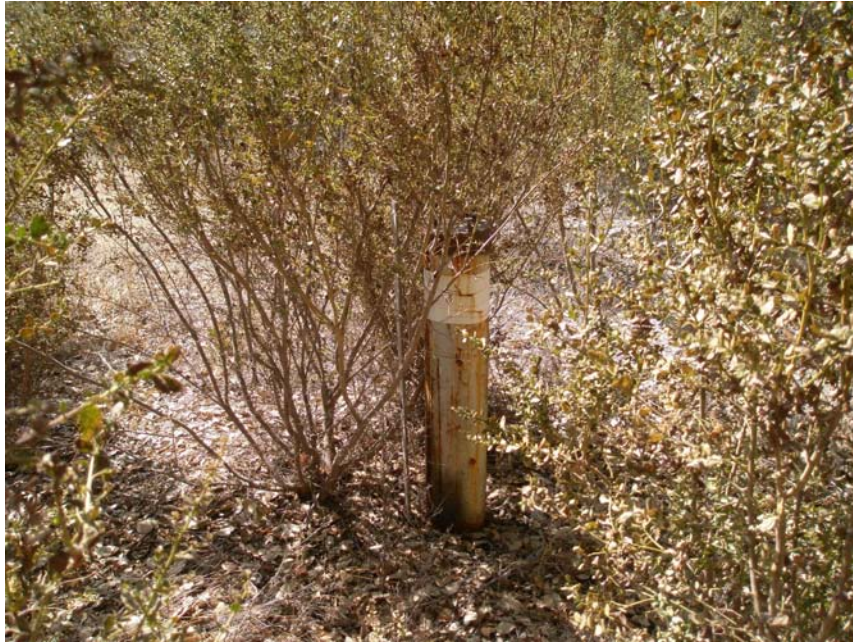
Photo 29: Re-vegetated drill pad with monitoring well HG-9 in South Quarry Exploration area near N37° 18.800', W122° 06.169', looking south. Dated September 5, 2014.

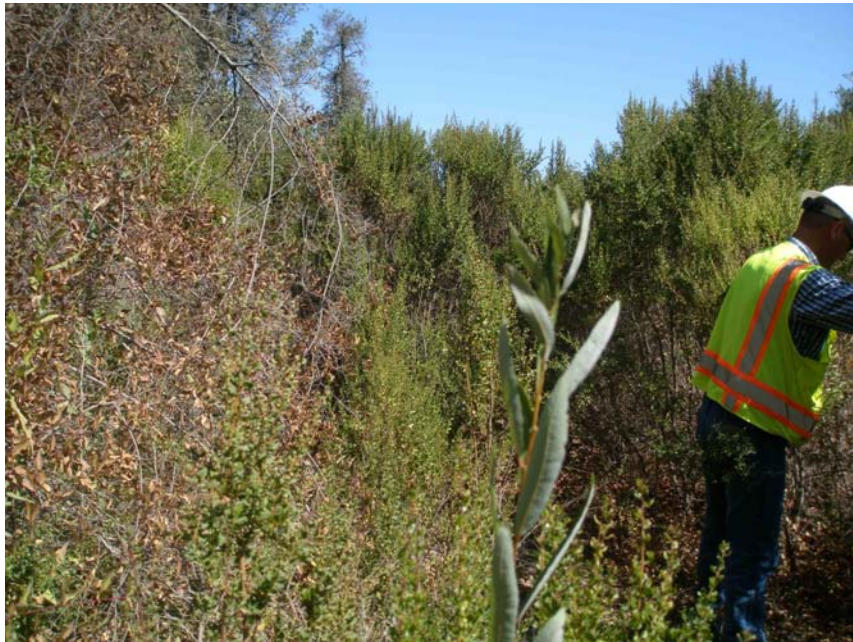
Photo 30: Re-vegetated drill roadway in South Quarry Exploration area near N37° 18.865', W122° 06.214', looking northwest. Dated September 5, 2014.
