County of Santa Clara Planning Commission

4. Public meeting to consider Annual Status Report No. 4 for the period July 1, 2015 to June 30, 2016 regarding compliance by Lehigh Southwest Cement Company with the 2012 Reclamation Plan Amendment conditions of approval, Mitigation Monitoring and Reporting Program (MMRP), annual SMARA inspections and financial assurance cost estimates for Permanente Quarry. File 2250-16PAM; Property Address/Location: 24001 Stevens Creek Blvd., Cupertino, CA 95014; Assessor's Parcel No. 351-09-013, -020, -022, -025; 351-10-005, -033, -037, -038; 351-11-001, -005, -006, -007, -081. (ID# 84182)

This is the fourth Lehigh Permanente Quarry RPA Annual Report (AR4) and provides public documentation of Quarry compliance for the monitoring period 2015-2016. Section 1 provides an introduction and overview of the content of AR4. A description of current operations at the Quarry is provided in Section 2. Section 3 provides a summary of compliance with the conditions of approval, with additional information regarding compliance (aerials, maps, site inspection information, and technical reports) provided in Appendices A through E. Lehigh is currently in compliance wi

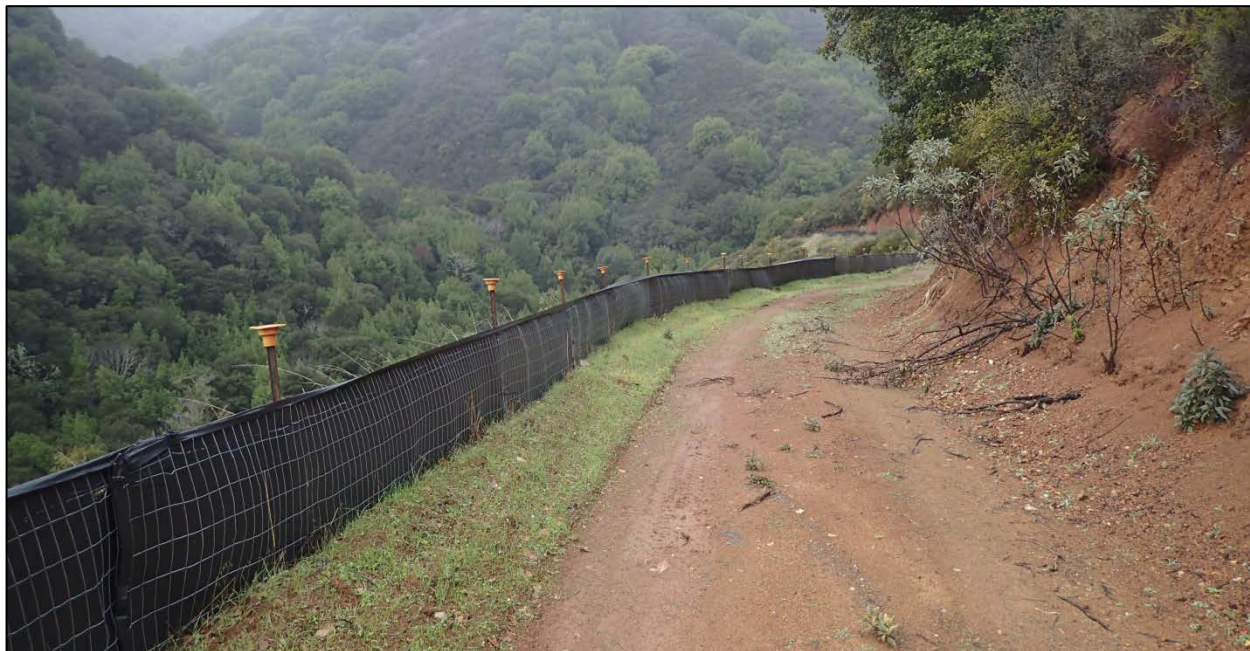
Photograph 1. Repaired silt fence on south side of side-hill access road across from "Turner Ready Line" noted in March 2016 Erosion Control Inspection Report.

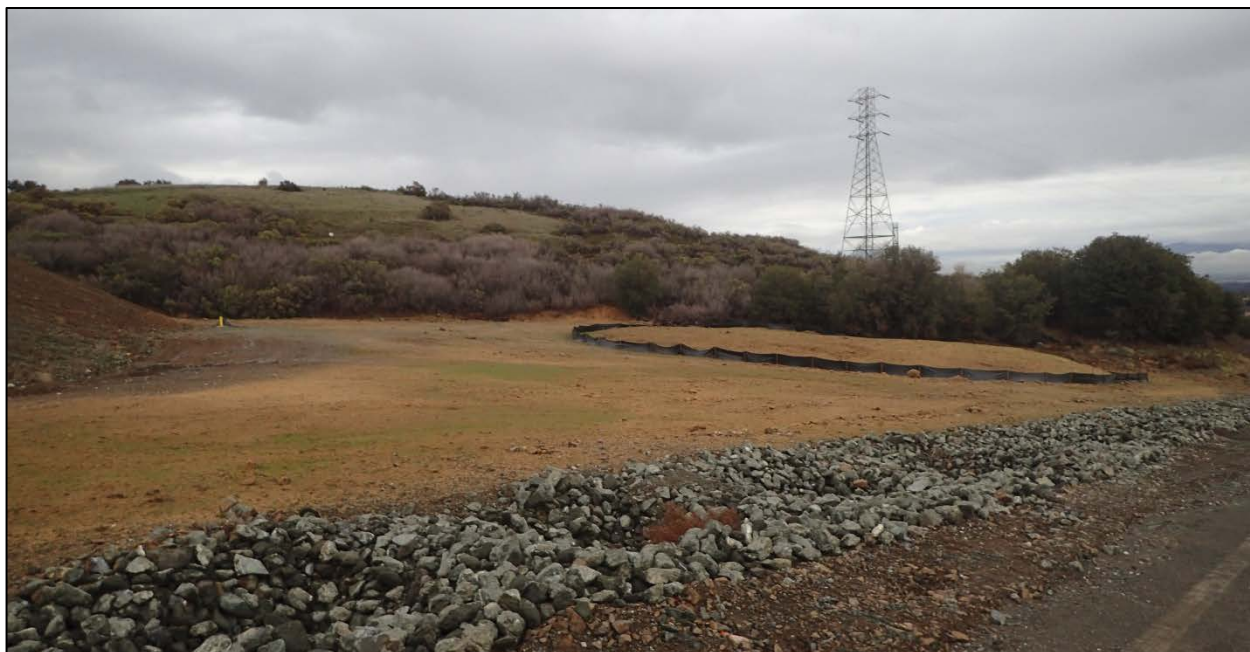
Photograph 2. Repaired silt fence surrounding the topsoil stockpile located in the EMSA noted in the March 2016 Erosion Control Inspection Report.

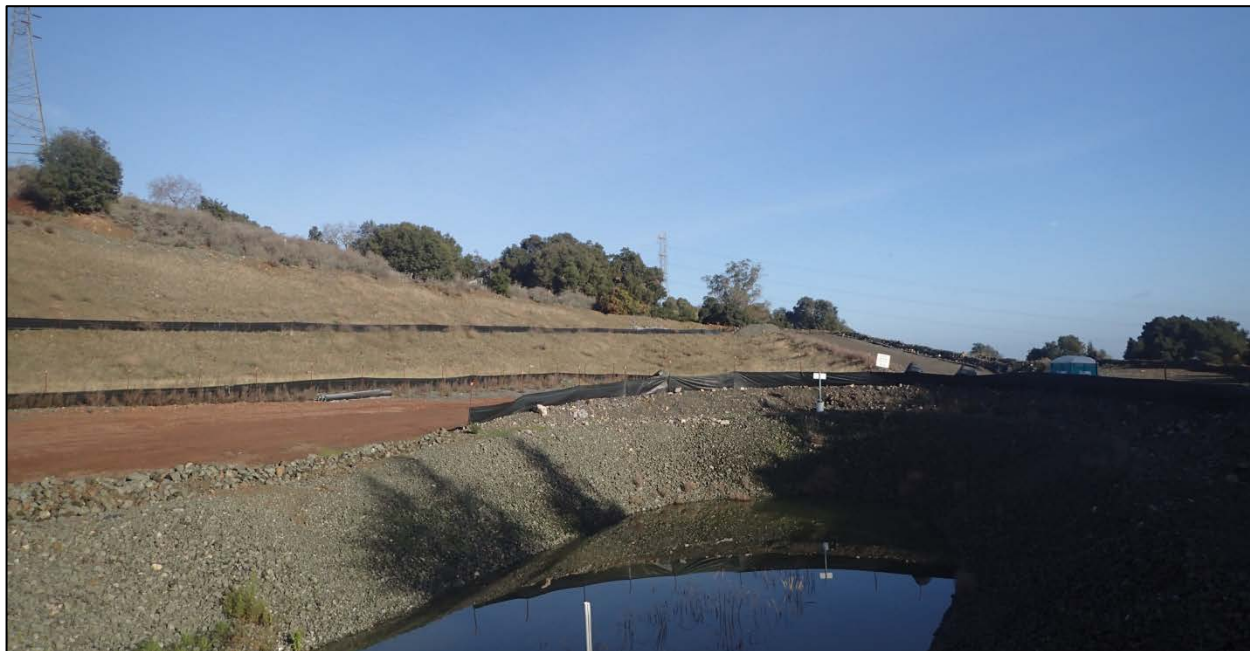
Photograph 3. Repaired silt fence surrounding Pond 30, noted in the March 2016 Erosion Control Inspection Report.

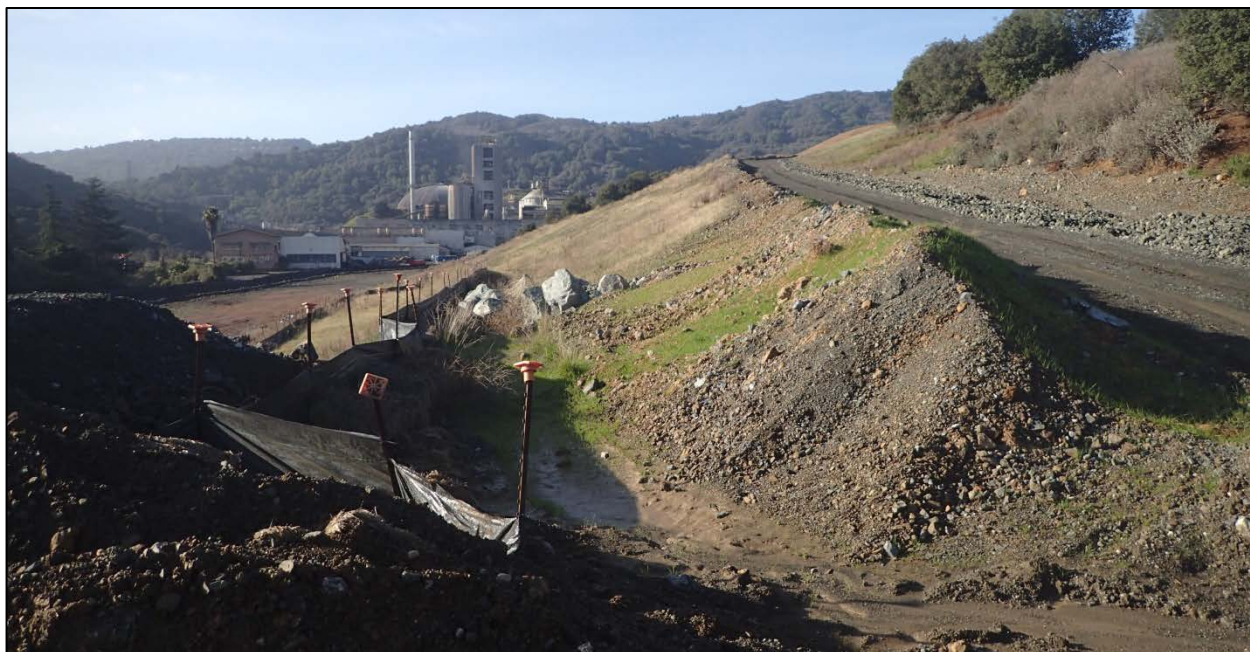
Photograph 4. Repaired silt fence on the downhill side of the sill that drains portions of the lower EMSA towards Pond 31A. This repair was recommended as part of the March 2016 Erosion Control Inspection Report.

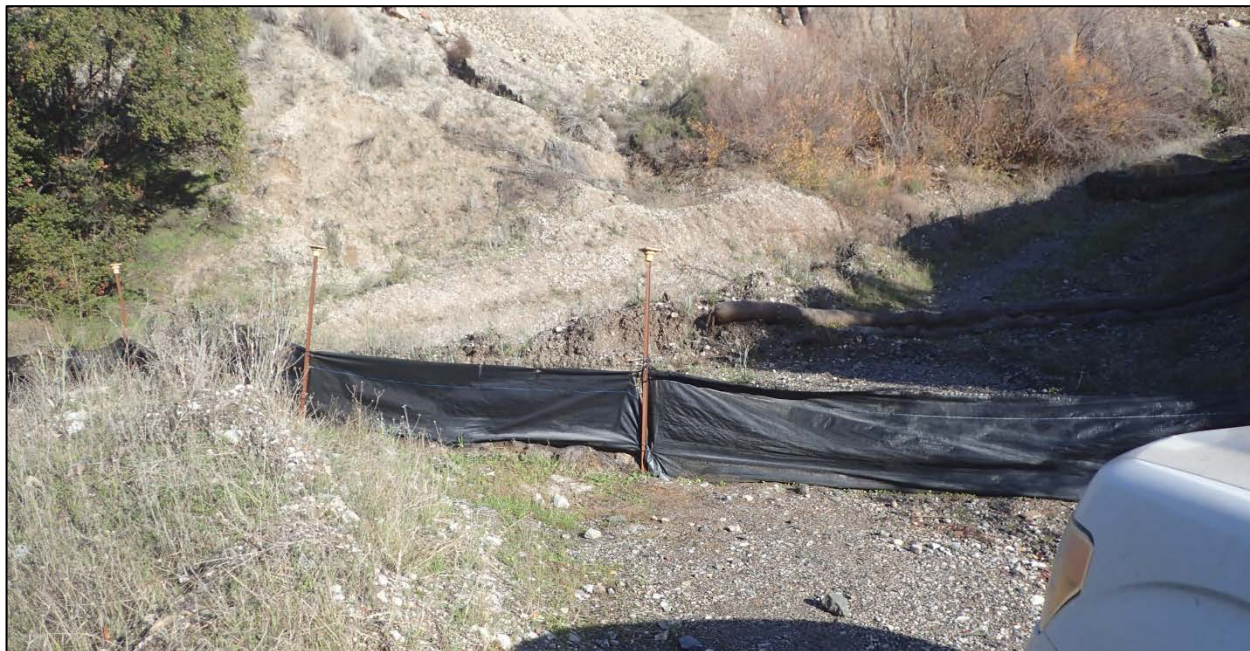
Photograph 5. Repaired silt fence located on an access road adjacent to Pond 13, noted in the March 2016 Erosion Control Inspection Report. This portion of silt fence was replaced after regular vehicle traffic through this area was ceased.

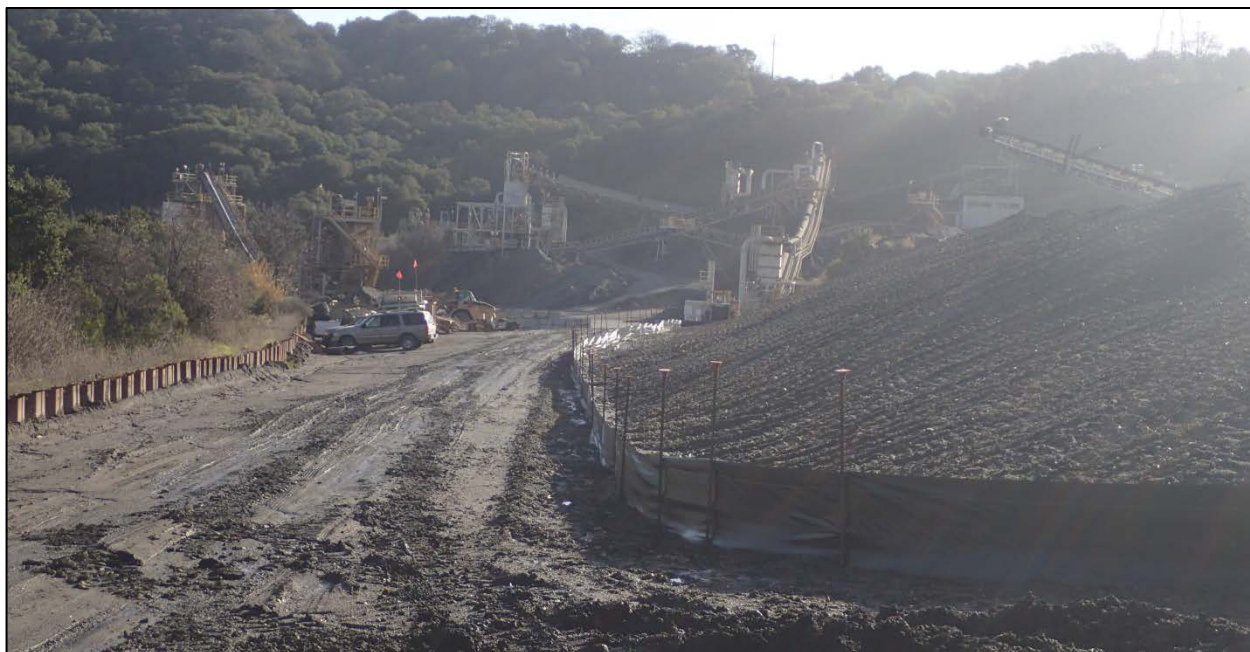
Photograph 6. Repaired silt fence located within the rock plant, noted in the March 2016 Erosion Control Inspection Report. A portion of silt fence was hand-dug out and replaced with new T-posts and non-wire-backed silt fence.

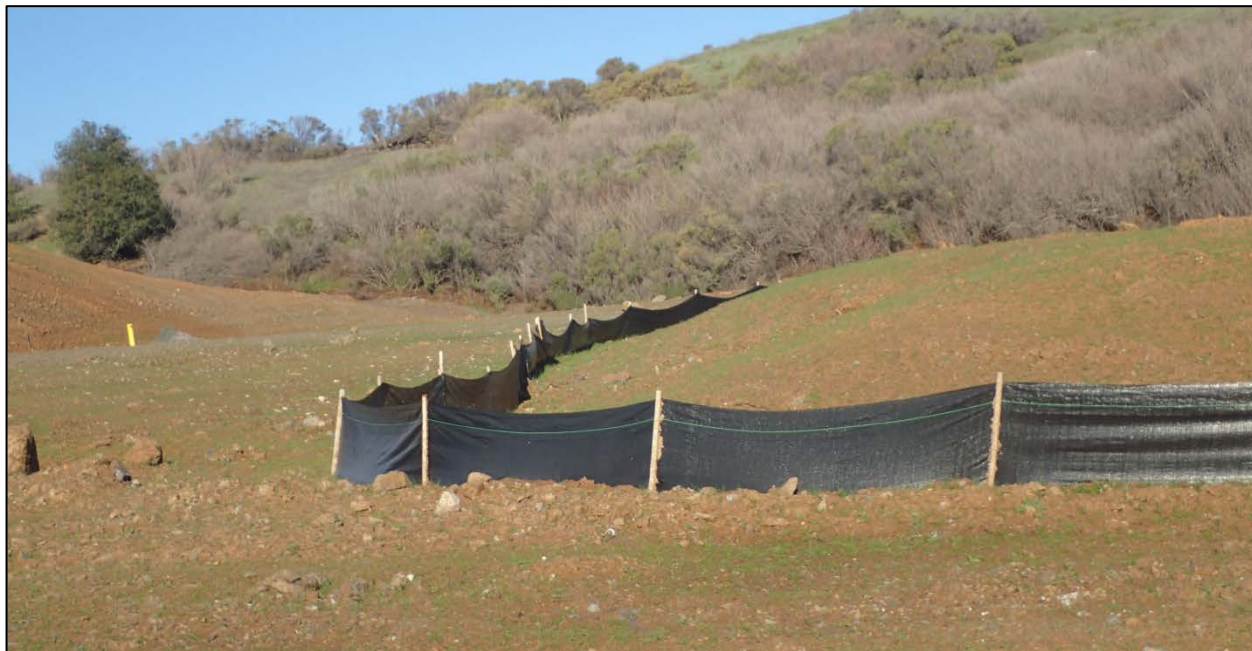
Photograph 7. Repaired silt fence surrounding the topsoil stockpile in the EMSA; also documented earlier in this compilation of photographs (Photograph 2).

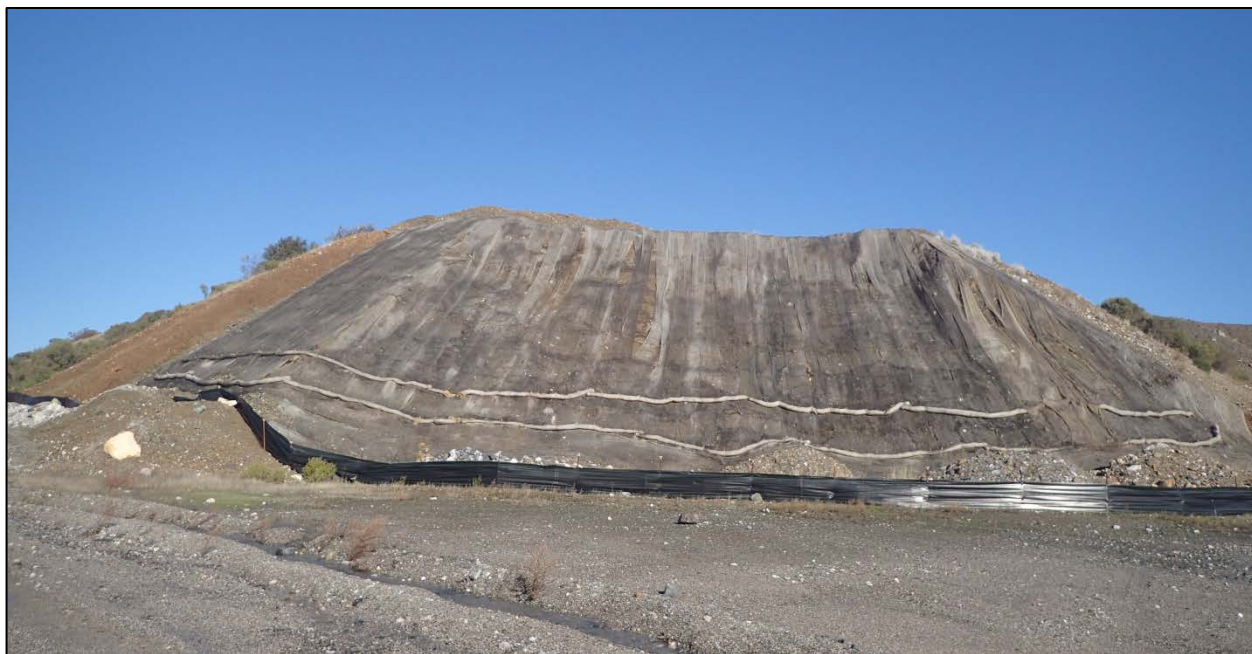
Photograph 8. Repaired silt fence located at the toe of the slope of the topsoil stockpile located in the upper WMSA. This area was originally noted as in need of repair in the March 2016 Erosion Control Inspection Report.

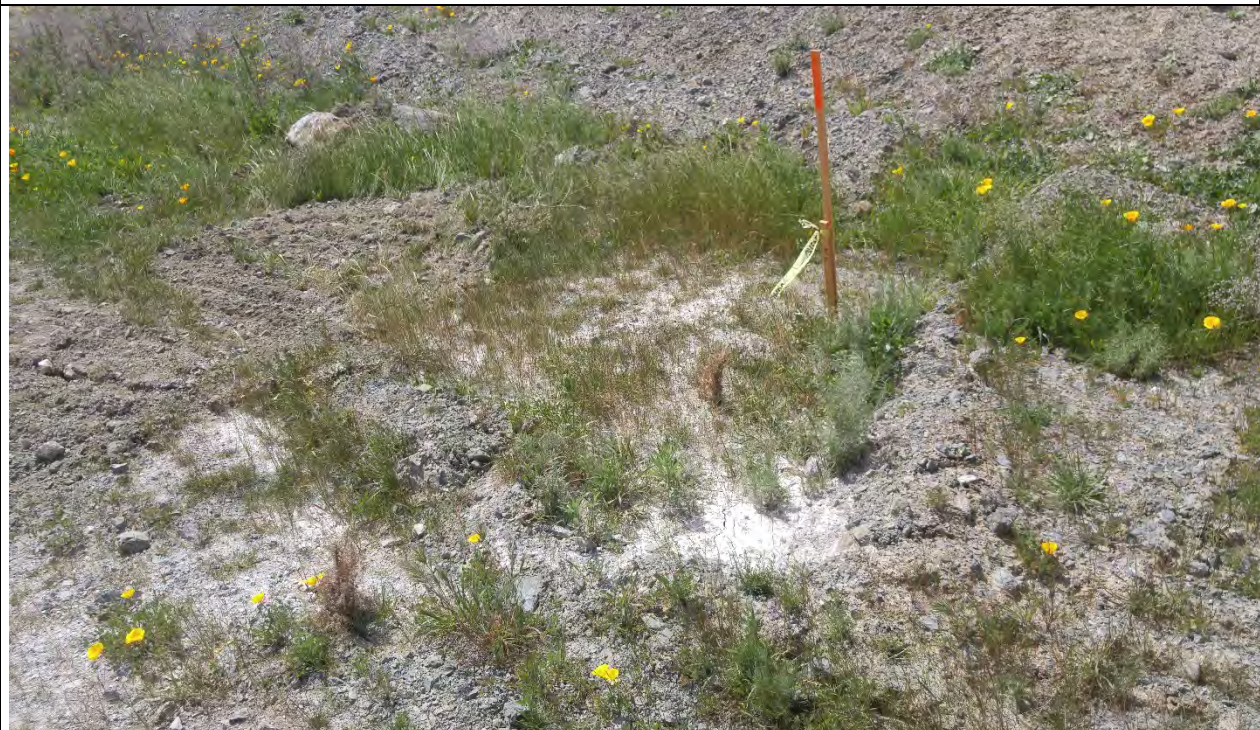
**PHOTO B1: WATER ACCUMULATION AT EC-16**

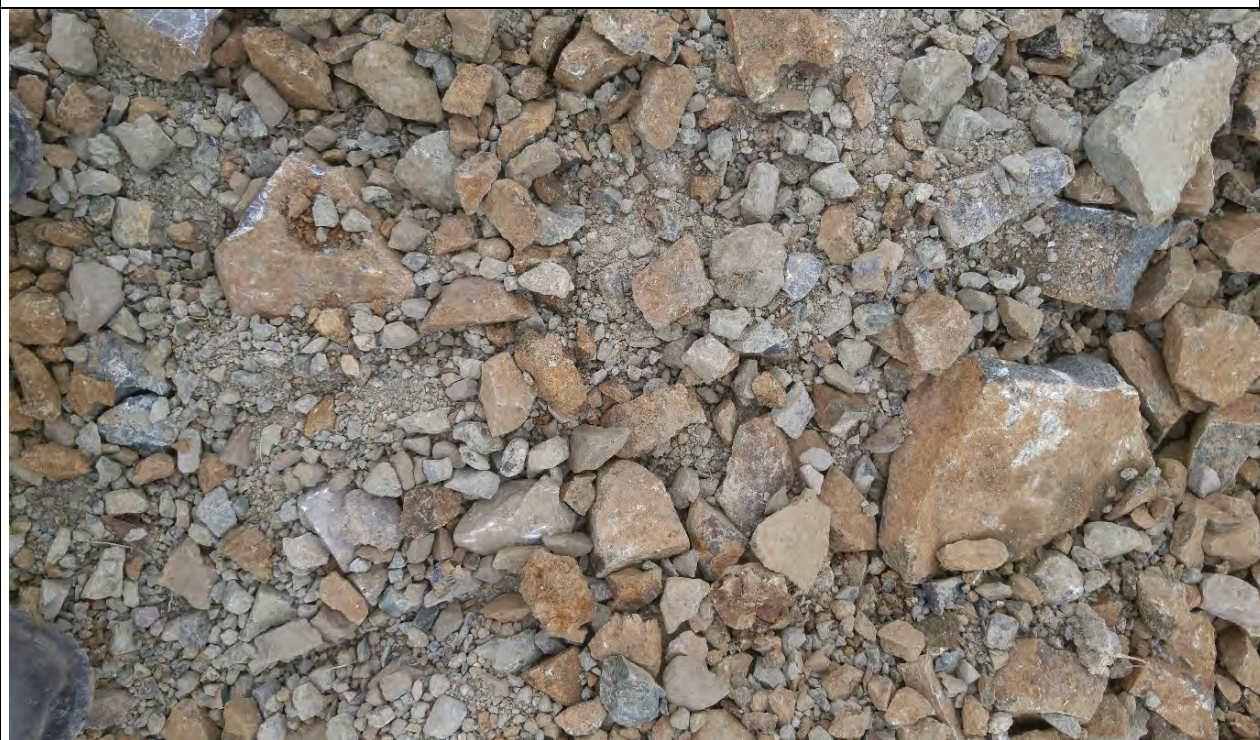
**PHOTO B2: EMSA SURFACE MATERIAL**

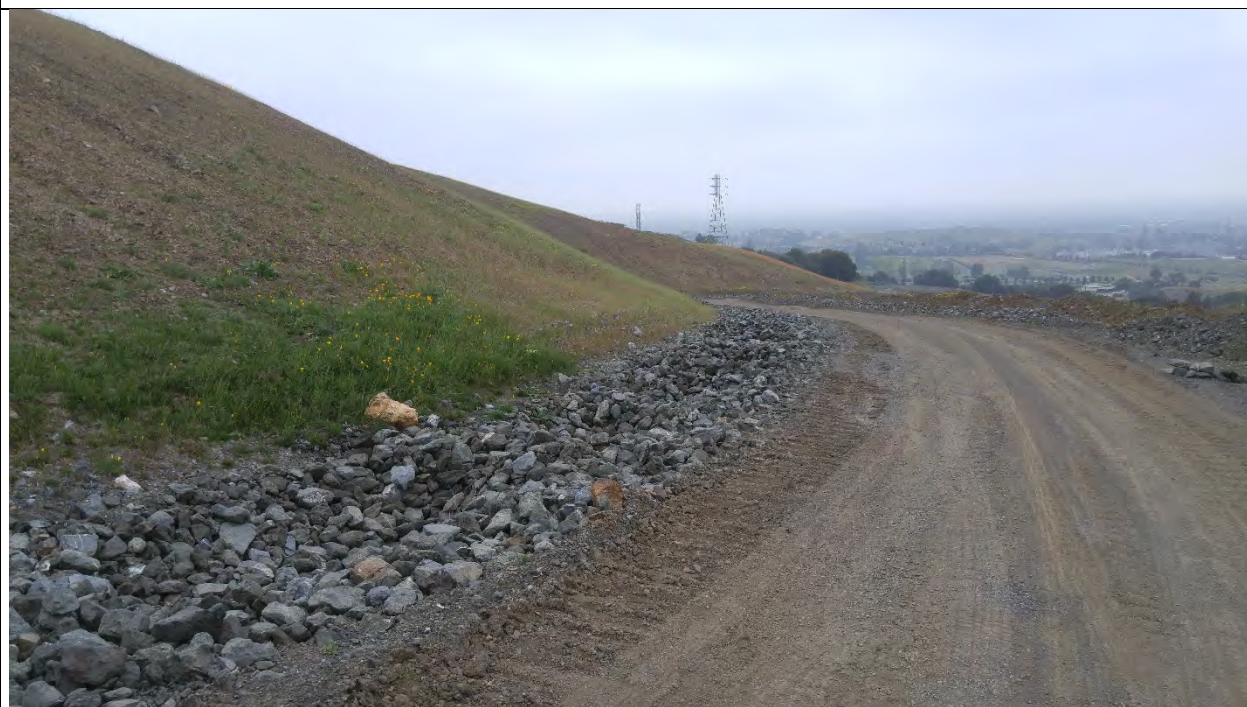
PHOTO B3: EC-15 AND HAUL ROAD DRAINAGE SWALE

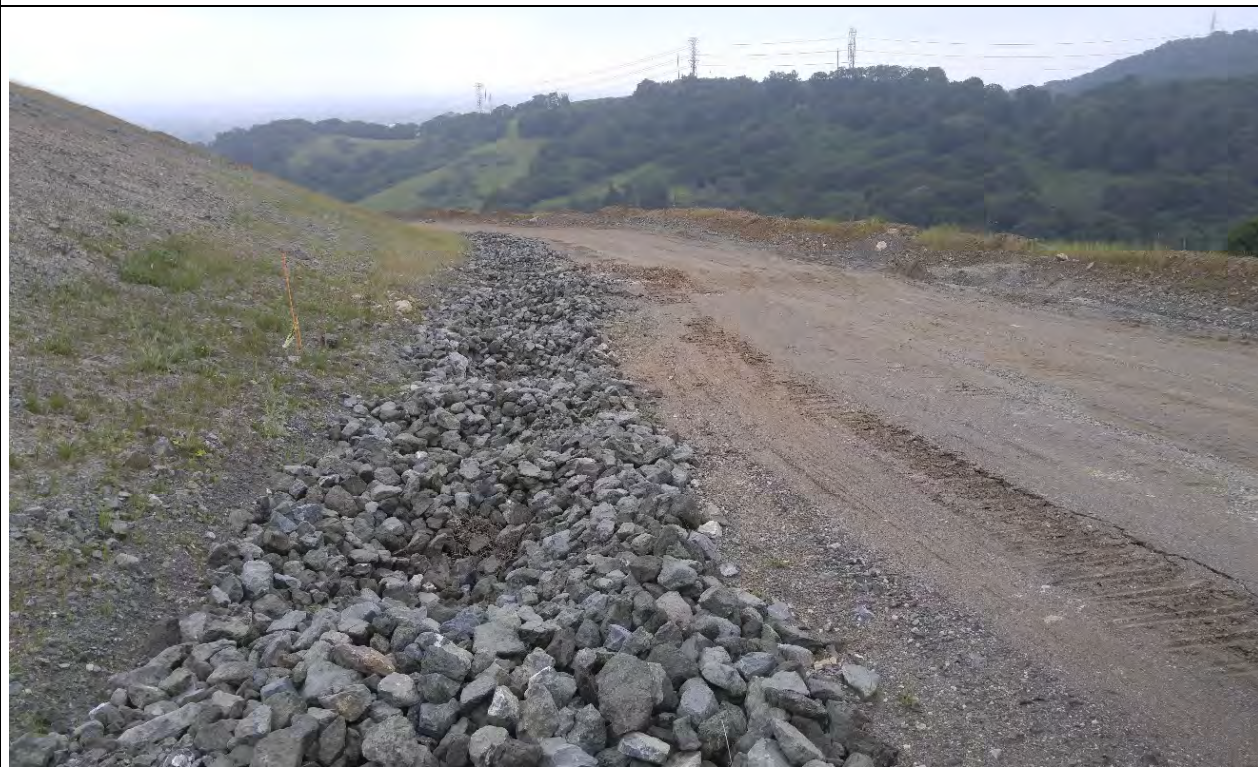
PHOTO B4: EC-13 AND HAUL ROAD DRAINAGE SWALE

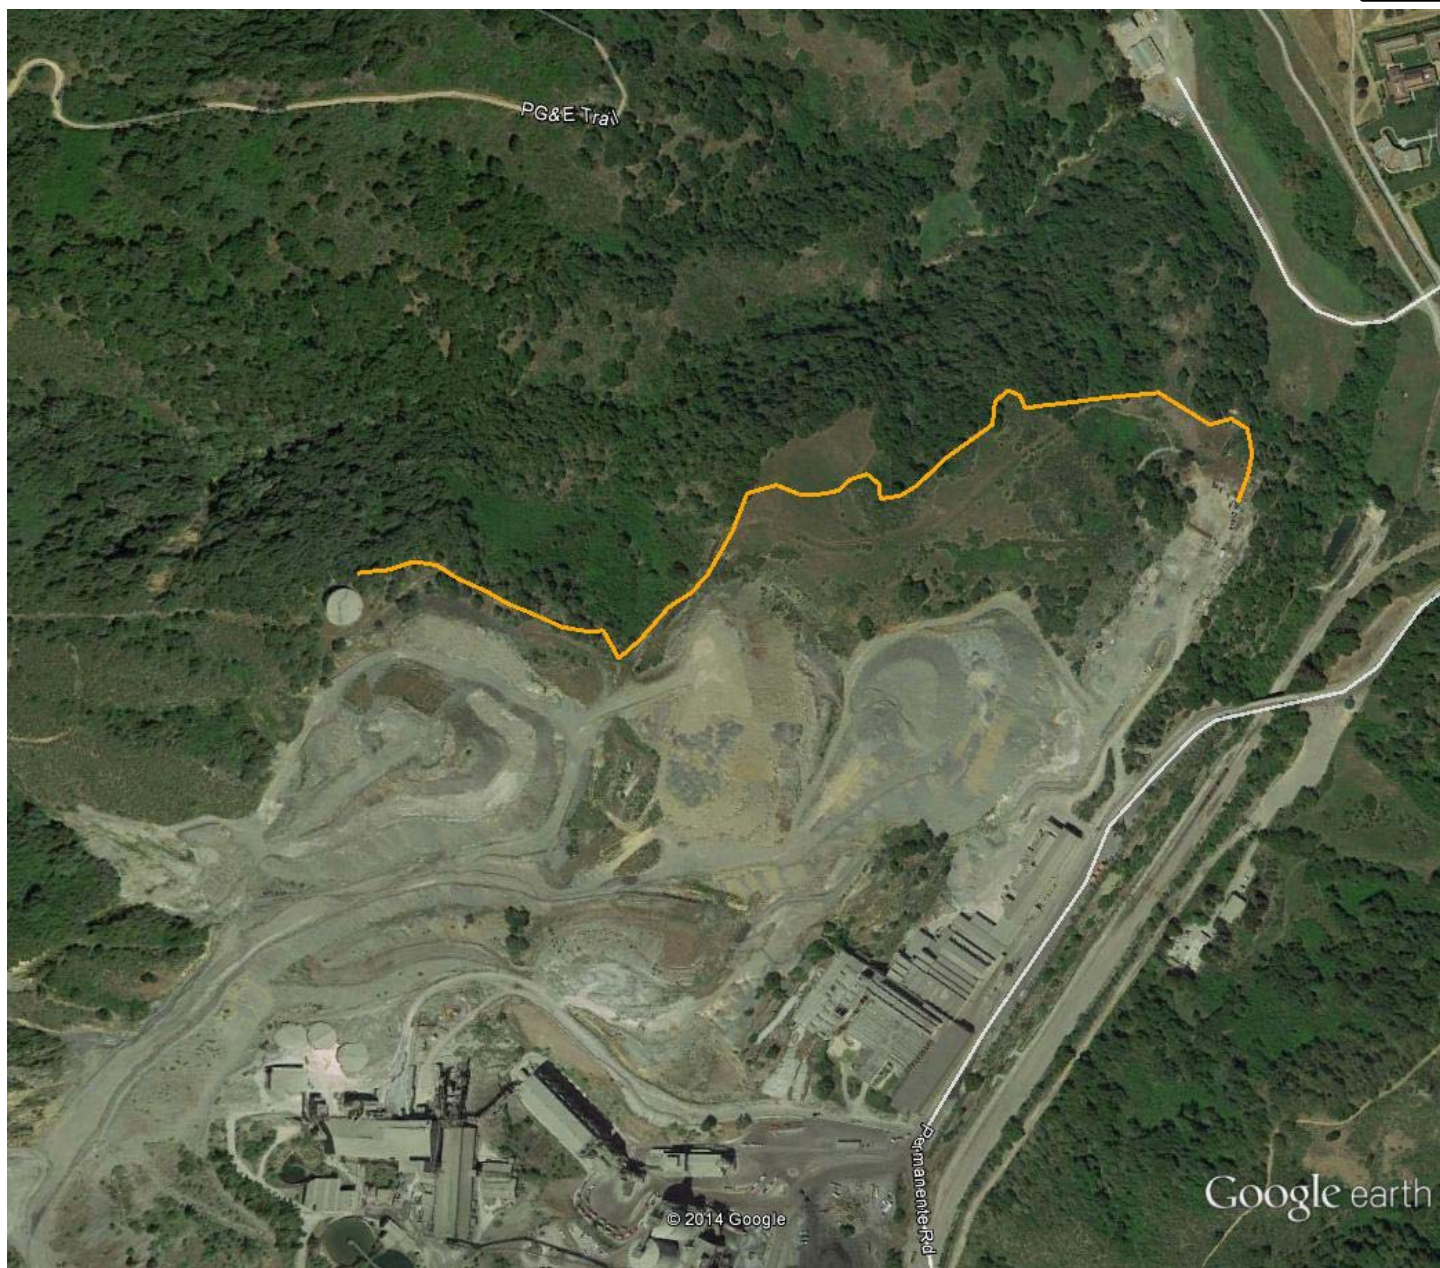
Figure 1. Location of RPA Boundary Demarcation in the EMSA.

In order to maintain compliance with COA 22, improvements to the durability and visibility of the RPA Boundary were made by repainting the existing T-posts. All T-posts were observed to be standing in the exact locations as when they were placed.

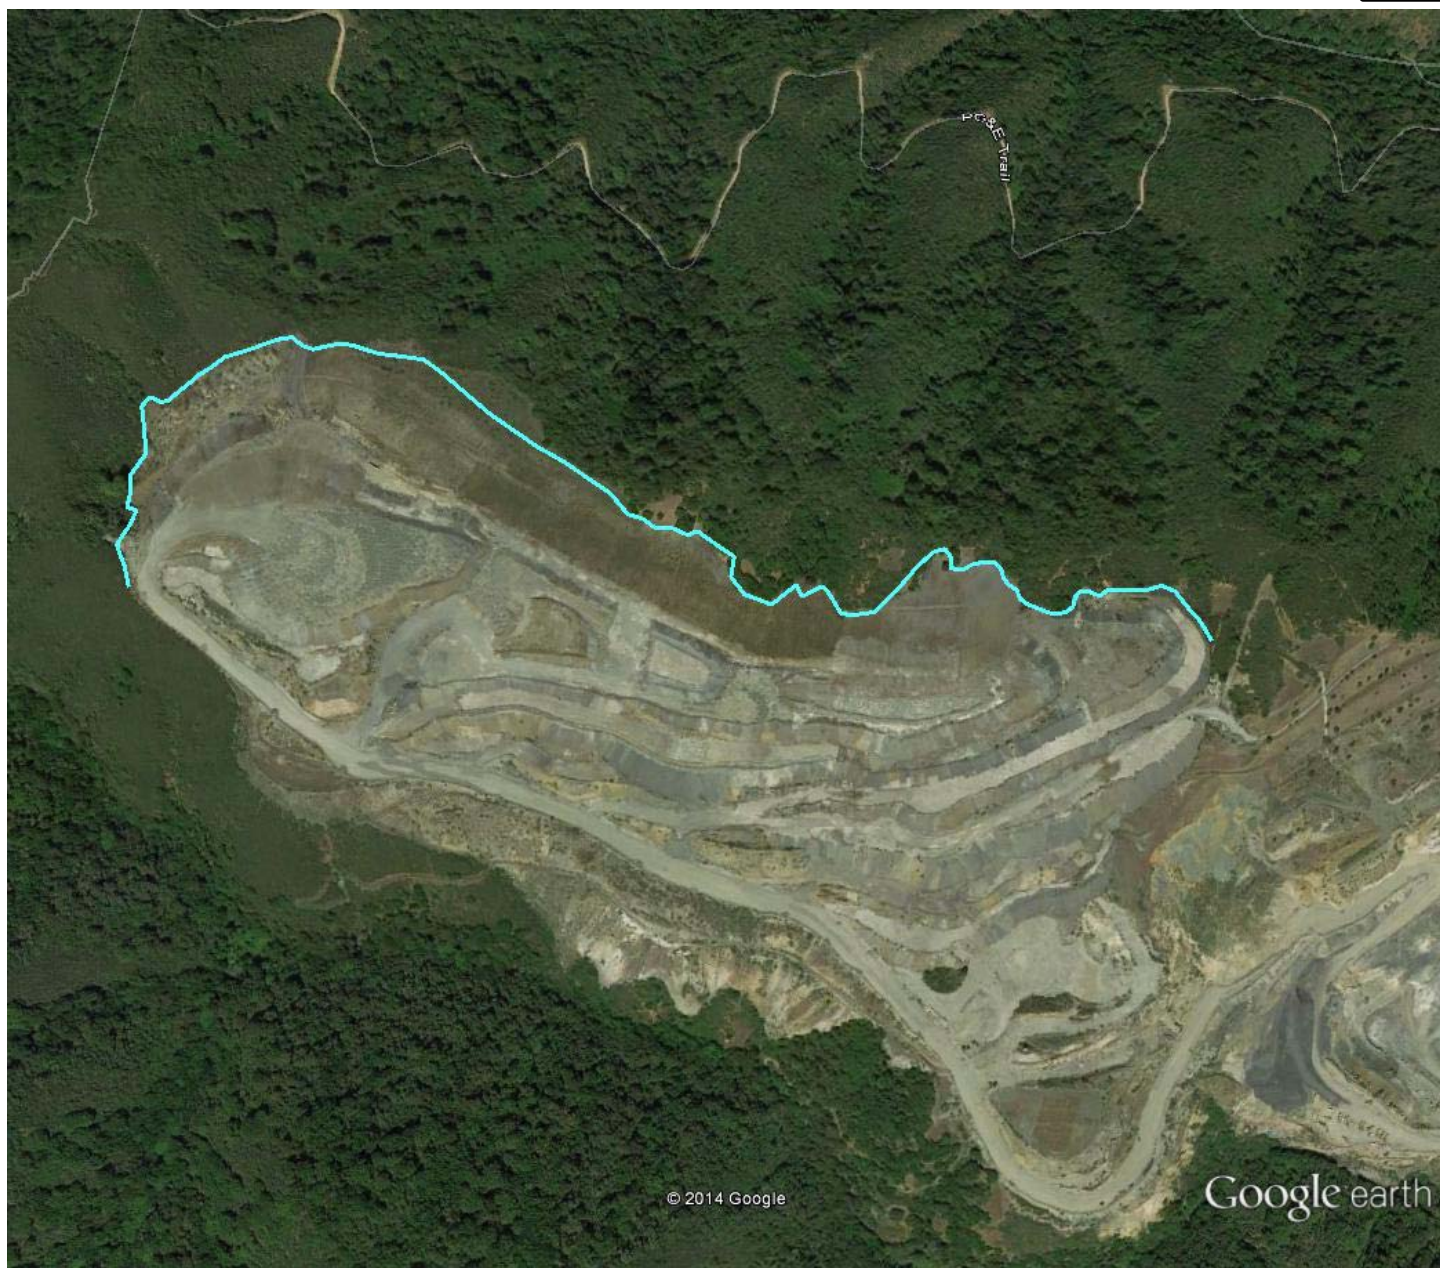
Figure 2. Location of RPA Boundary Demarcation in the WMSA.

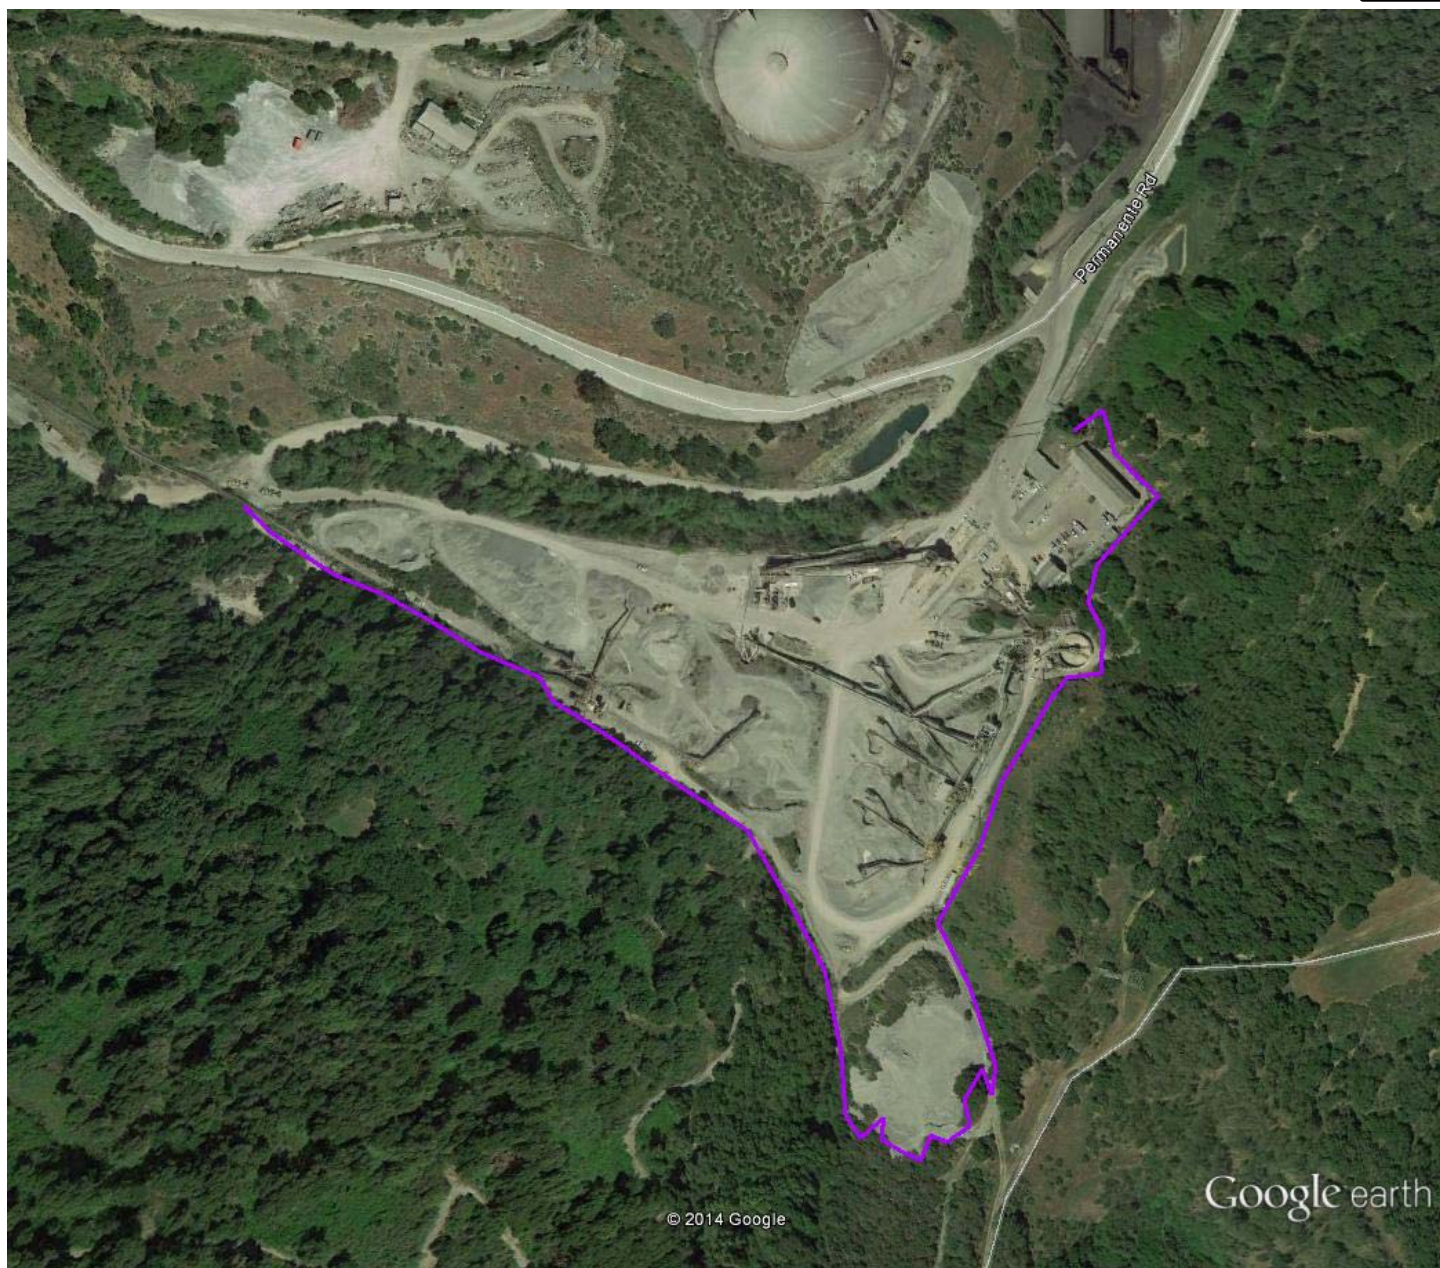
Figure 3. Location of RPA Boundary Demarcation in the Rock Plant.
